# Scottish Sanitary Survey Project

Restricted Sanitary Survey Report  
Ouse Ness  
OI 452  
March 2009

# Shoreline Survey Report

## Ouse Ness OI 452

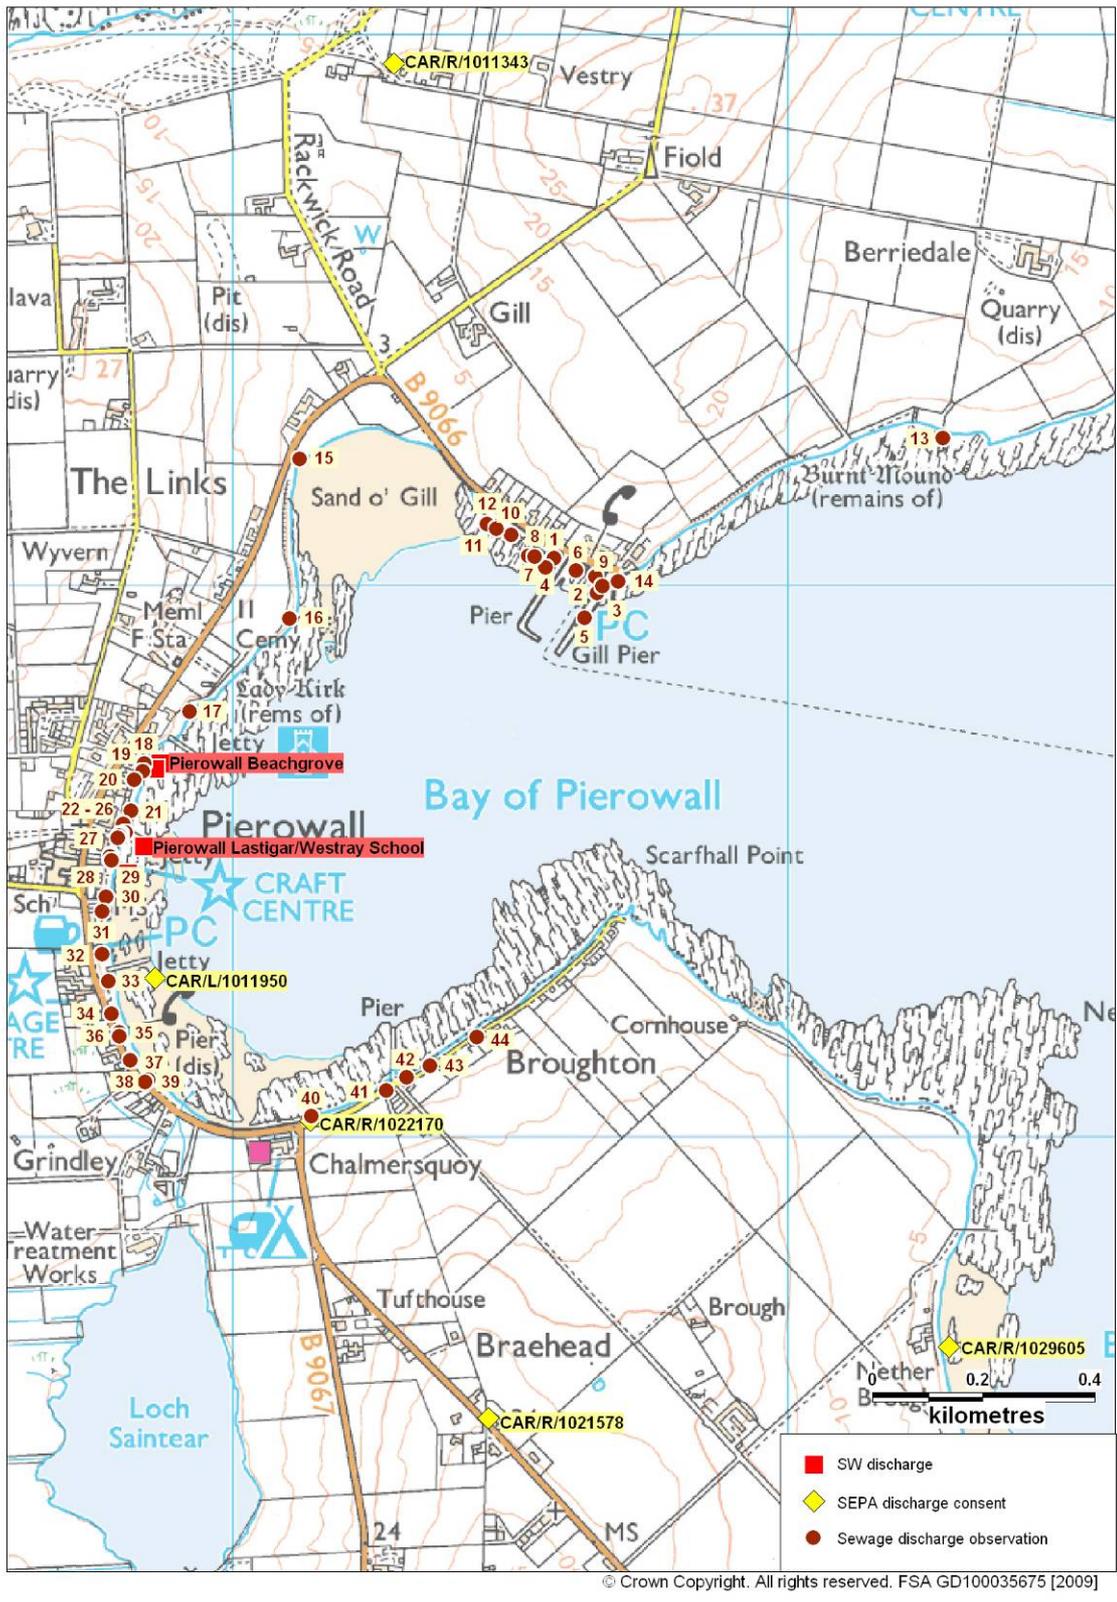
Figure 3.1 Sewage discharges at Ouse Ness

Septic tanks and outfall pipes were also observed during the shoreline survey and these are listed in Table 3.3. Their locations have been included in the mapped discharges in Figure 3.1. Further details can be found in the shoreline survey report in the appendix. All of these sewage discharges were observed around the Bay of Pierowall. No discharges were reported or observed on the shoreline adjacent to the fishery itself.

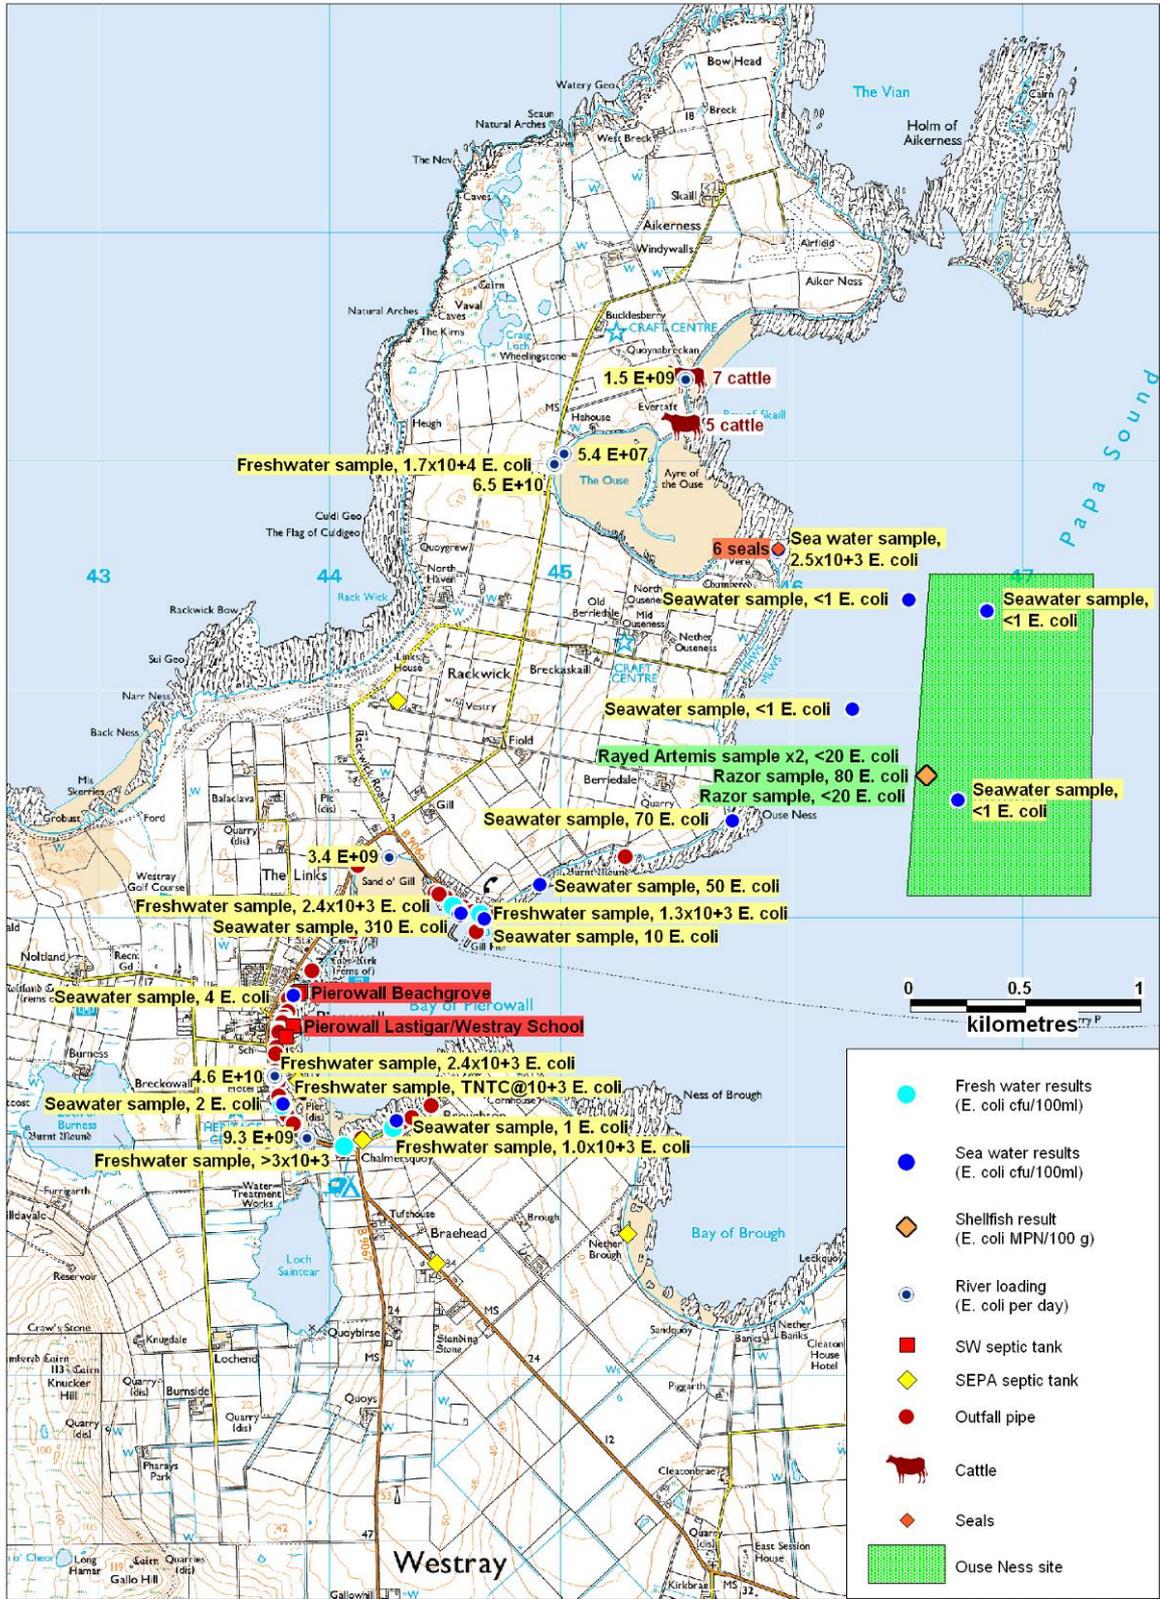
Figure 9.1 Summary of shoreline observations

In summary, identified sources of potentially significant contamination are:

- Contaminated freshwater streams in the area
- Contaminated outfall pipes in the area
- Livestock grazing on the shoreline

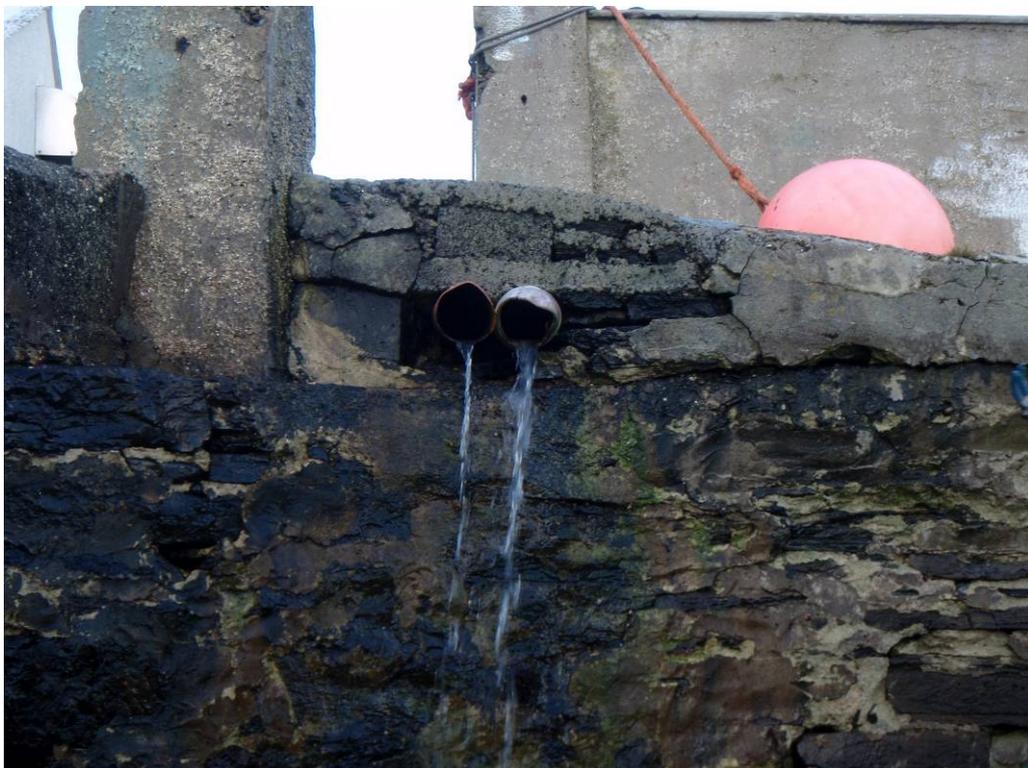
Figure 12. Two pipes coming out of the wall onto shoreline, fresh water sample 2

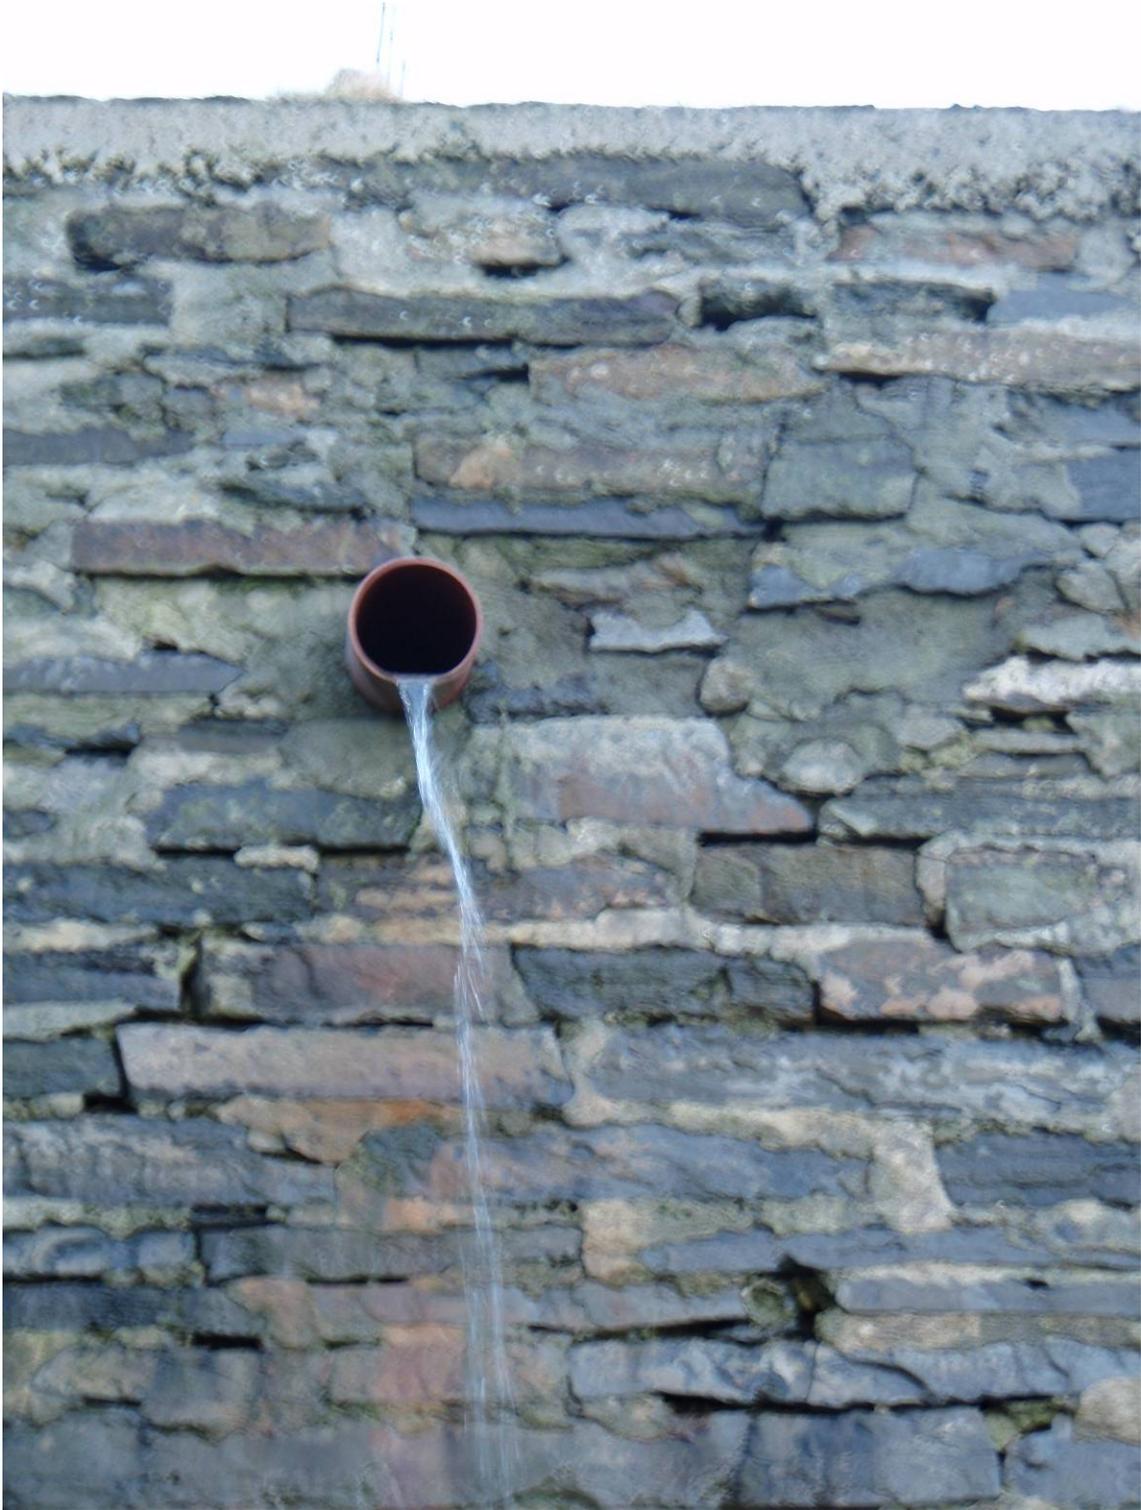
Figure 13. Pipe flowing from wall onto shoreline, fresh water sample 3

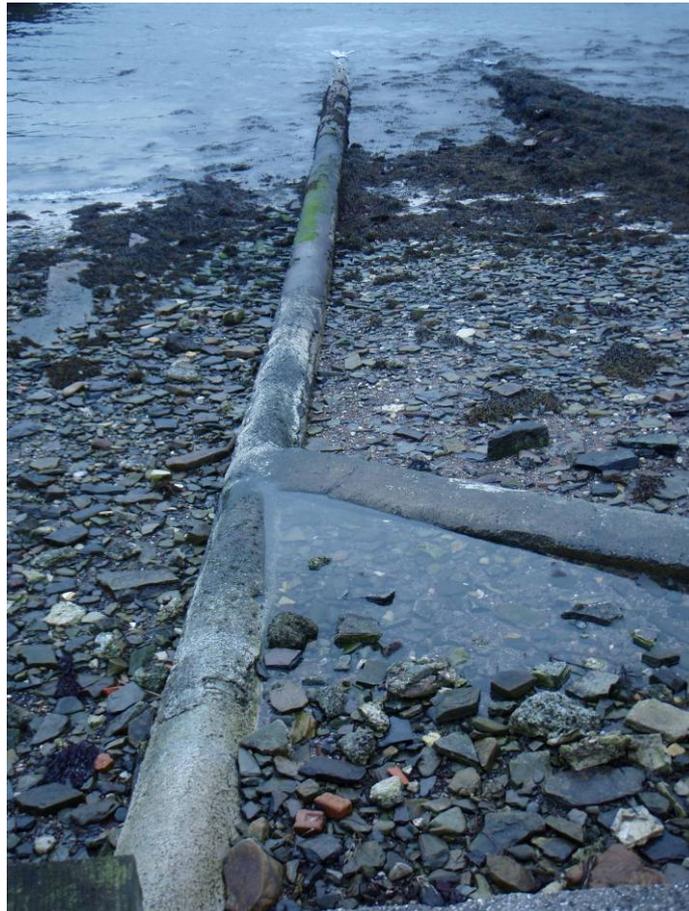
15	02/03/09	4:06 PM	HY 44580 49053	344580	1049053	Figure 14	Two pipes running into the sea. One pipe with a header cap/59cm diameter.
16	02/03/09	4:14 PM	HY 44565 49026	344565	1049026	-	Ouse Ness seawater sample 6 (16:15). Taken next to pipes mentioned above.
17	02/03/09	4:16 PM	HY 44565 49037	344565	1049037	-	More pipes (13cm diameter) running into the sea.
18	02/03/09	4:19 PM	HY 44545 49056	344545	1049056	-	15cm diameter broken pipe, no flow.
19	02/03/09	4:20 PM	HY 44533 49057	344533	1049057	-	15cm diameter pipe concreted over. Ouse Ness fresh water sample 4 (16:22), suspected sewage pipe.
20	02/03/09	4:24 PM	HY 44526 49091	344526	1049091	-	Pipe from wall, small flow, suspected surface water runoff.
21	02/03/09	4:26 PM	HY 44502 49096	344502	1049096	Figure 15	Two pipes, sewage fungus below both. One flowing, one not. Ouse Ness fresh water sample 5 (16:32). Flow (jug) 0.5 litre/3.5 seconds. Smell of

Figure 14. Two pipes running into the sea

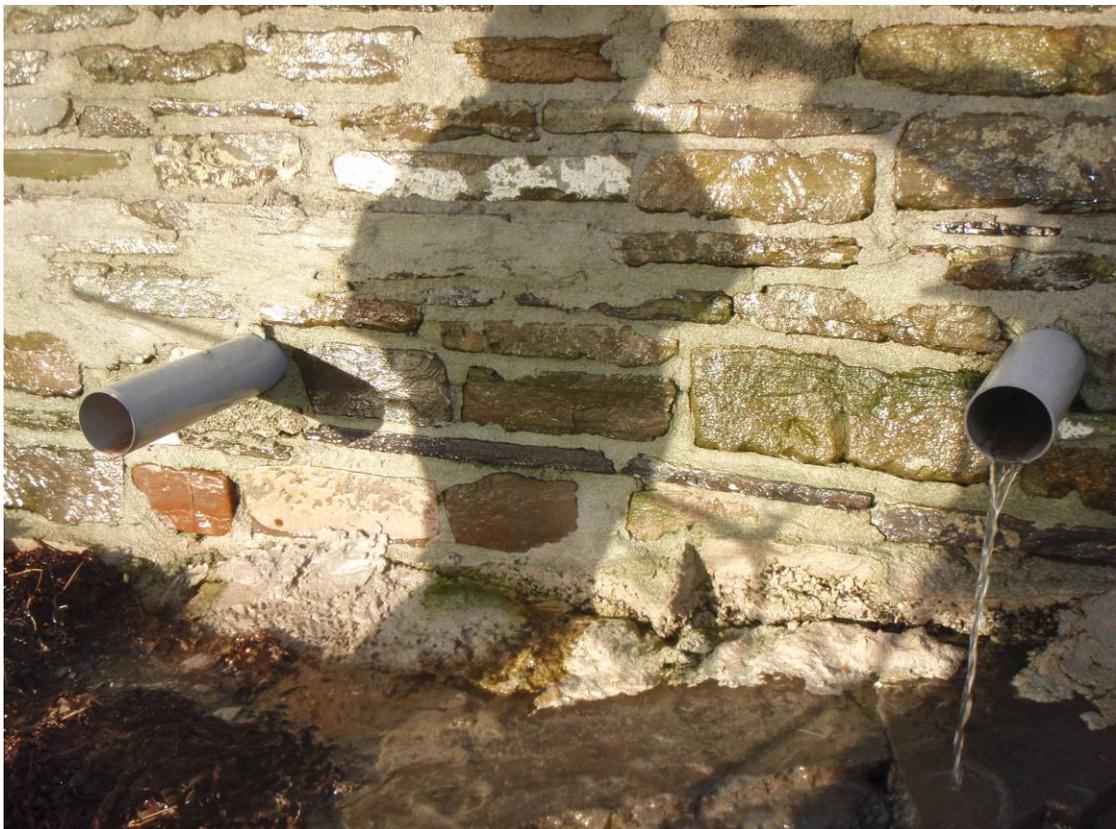
Figure 15. Two pipes with sewage fungus below, fresh water sample 5

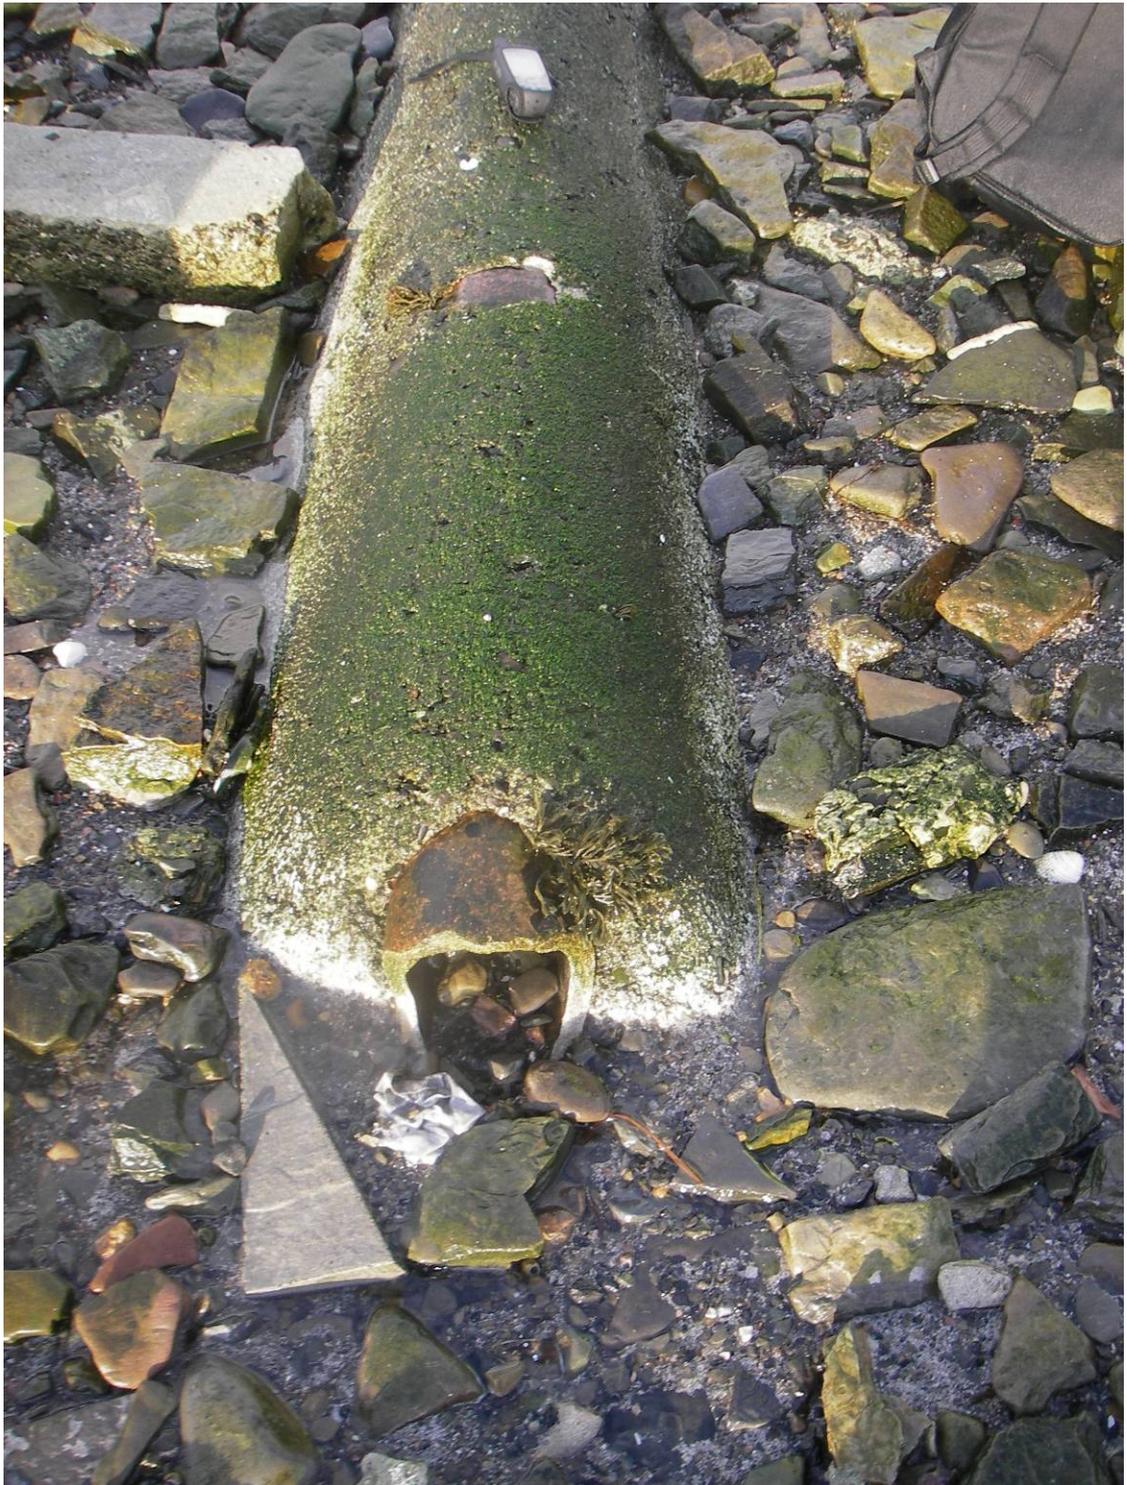
No.	Date	Time	NGR	East	North	Associated photograph	Description
							sewage.
22	02/03/09	4:33 PM	HY 44476 49107	344476	1049107	Figure 16	15cm diameter pipe covered in concrete. Ouse Ness fresh water sample 6 (11:35). Suspected sewage pipe.
23	02/03/09	4:37 PM	HY 44459 49115	344459	1049115	Figure 17	15cm diameter broken pipe, small flow. Ouse Ness fresh water sample 7. Approx. 20 houses along this road, pipes running to shore from most of them.
24	02/03/09	4:40 PM	HY 44426 49138	344426	1049138	-	Mound of broken pipes - no apparent source or attachments. Photo of Sand O'Gill
25	02/03/09	4:42 PM	HY 44411 49181	344411	1049181	-	Surface water drain.
26	02/03/09	4:45 PM	HY 44330 49249	344330	1049249	-	Boats on shore. Several farms behind on hill (photo).
27	02/03/09	4:47 PM	HY 44260 49266	344260	1049266	Figure 18	Stream running onto beach. Will be sampled and measured on following day.
28	03/03/09	9:30 AM	HY 45543 51359	345543	1051359	Figures 19, 20, 21 & 22	Large stream running into Bay of Skail. W 1.50, D 0.07 - Flow 0.137, D 0.12 - Flow 0.219. Ouse Ness fresh water sample 8. 7 cattle in field behind.

Figure 16. Pipe covered in concrete, fresh water sample 6

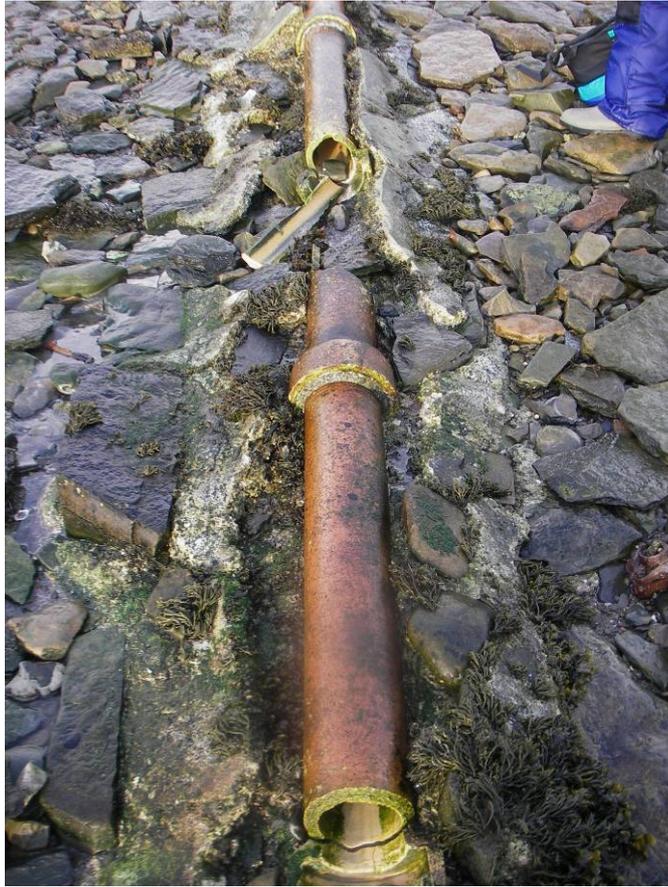
Figure 17. Broken pipe, fresh water sample 7

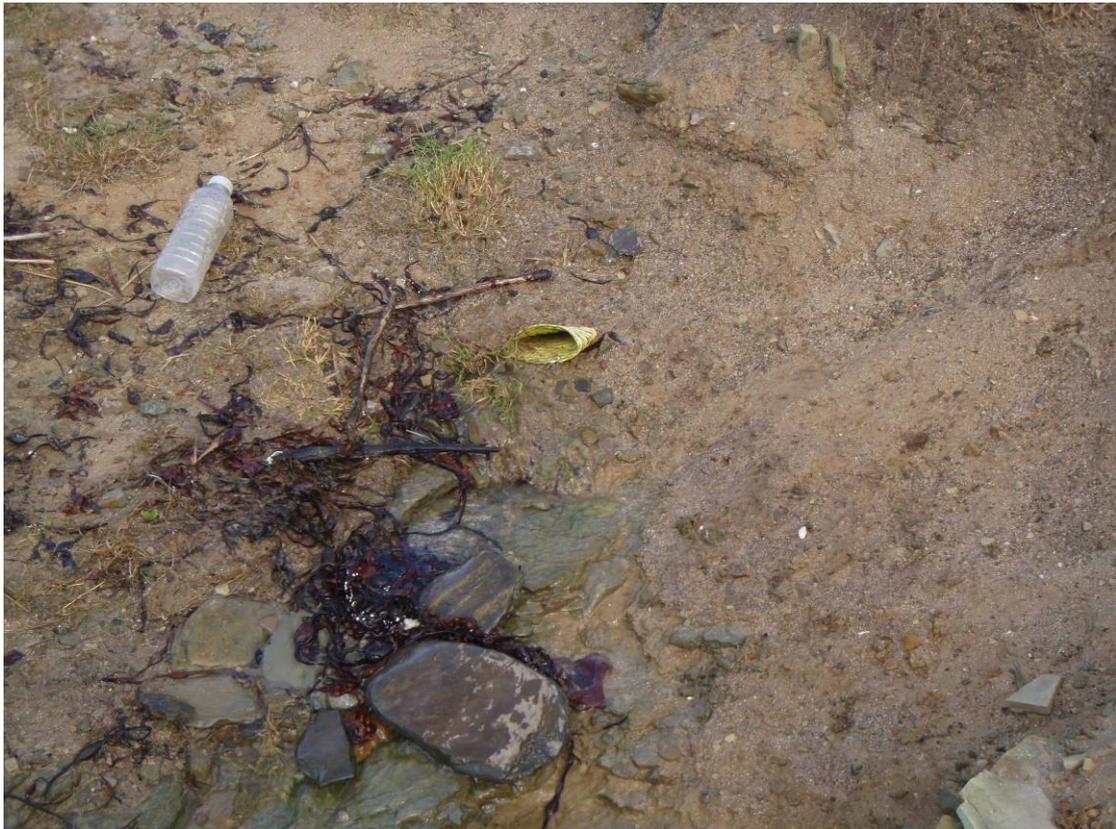
Figure 25. Pipe flowing onto shoreline, fresh water sample 11

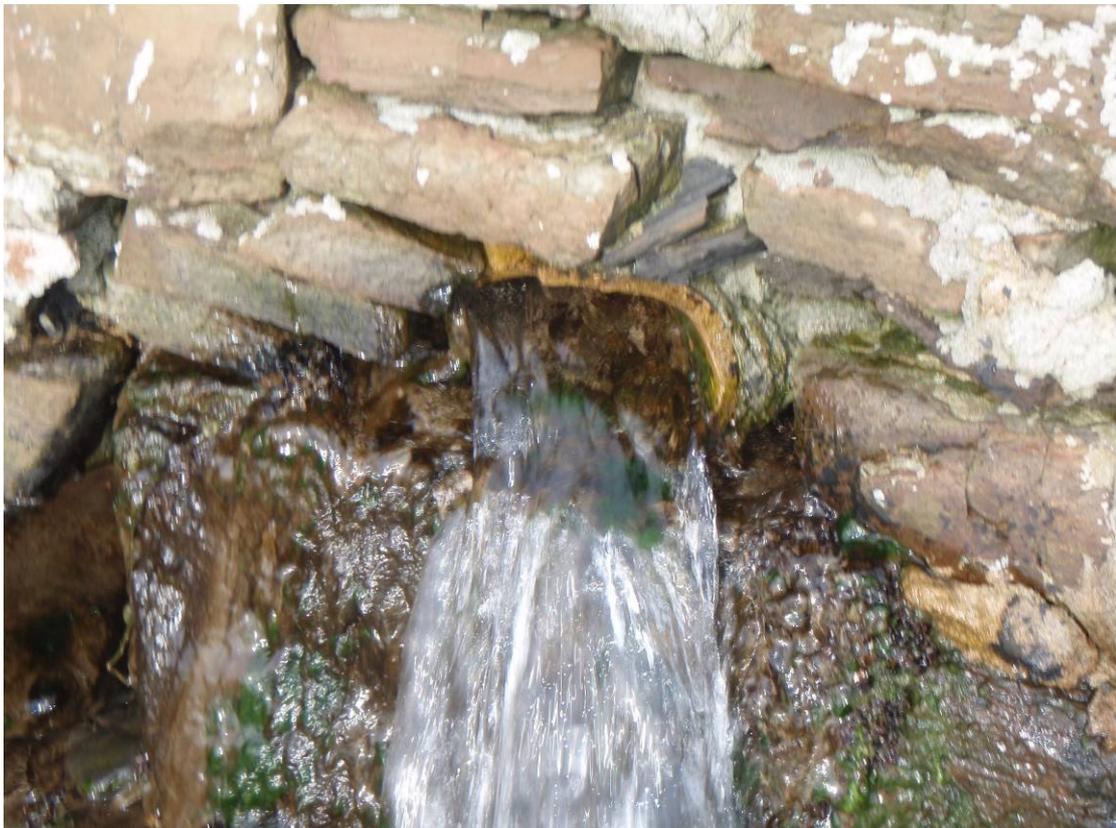
Figure 26. Large flow coming from broken pipe, fresh water sample 12

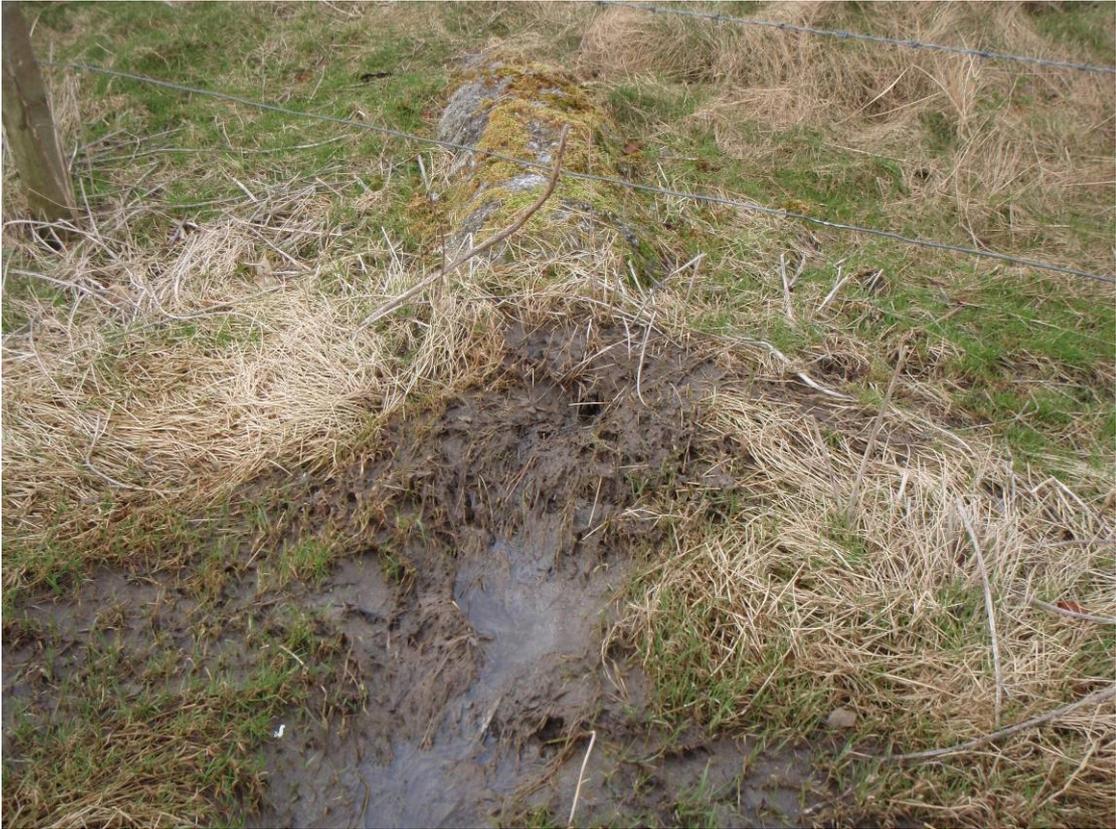
Figure 27. Concrete pipe with stagnant stream below

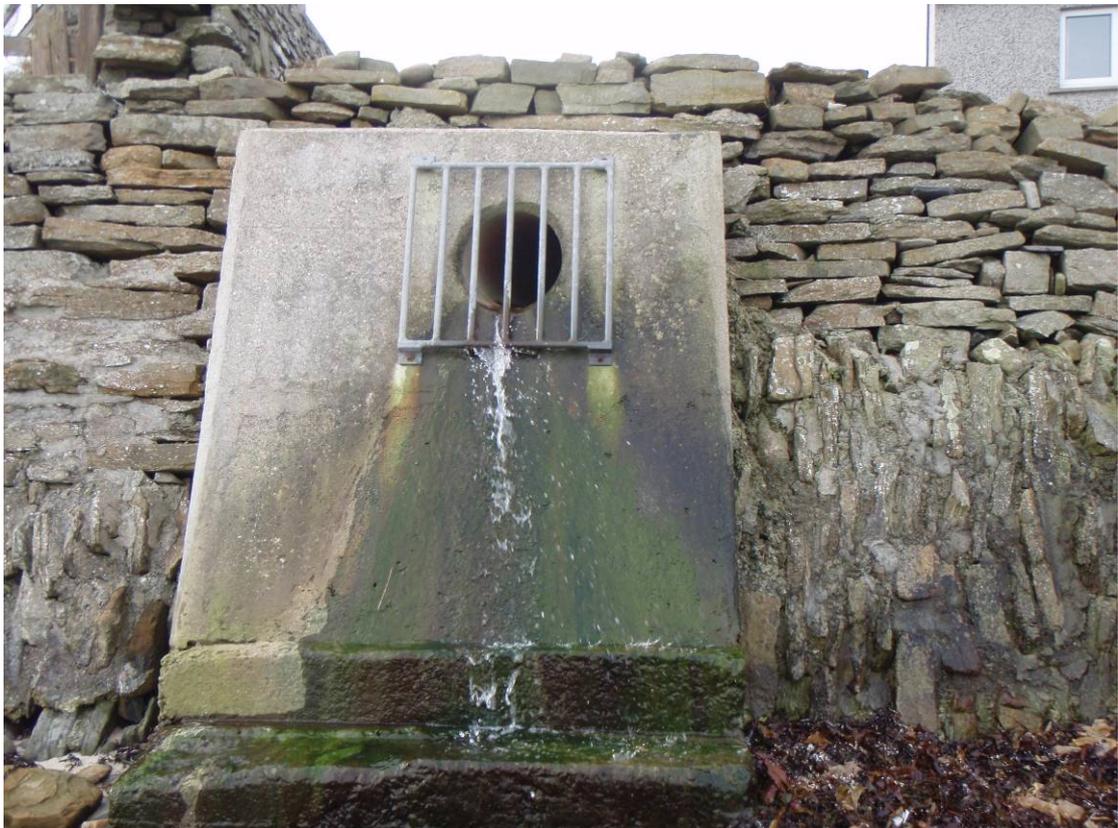
Figure 30. Suspected storm overflow for community septic tank, fresh water sample 15

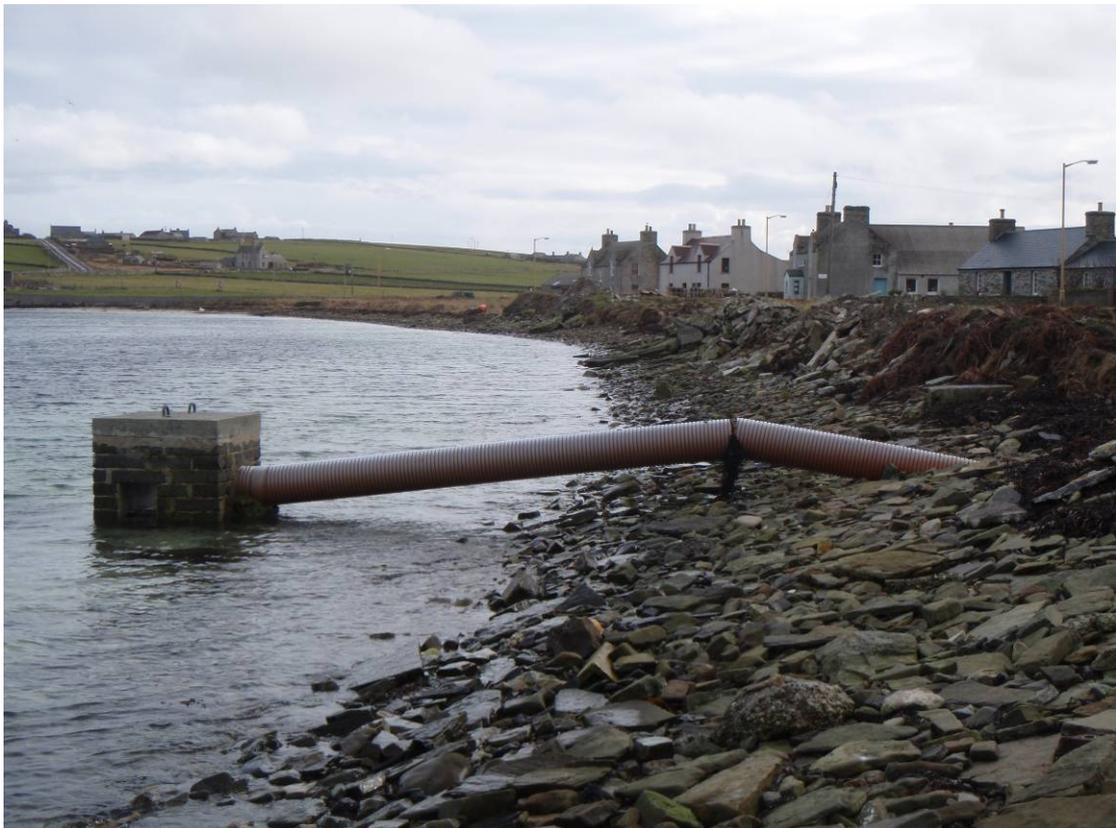
Figure 34. Broken pipe flowing out to sea, sea water sample 11

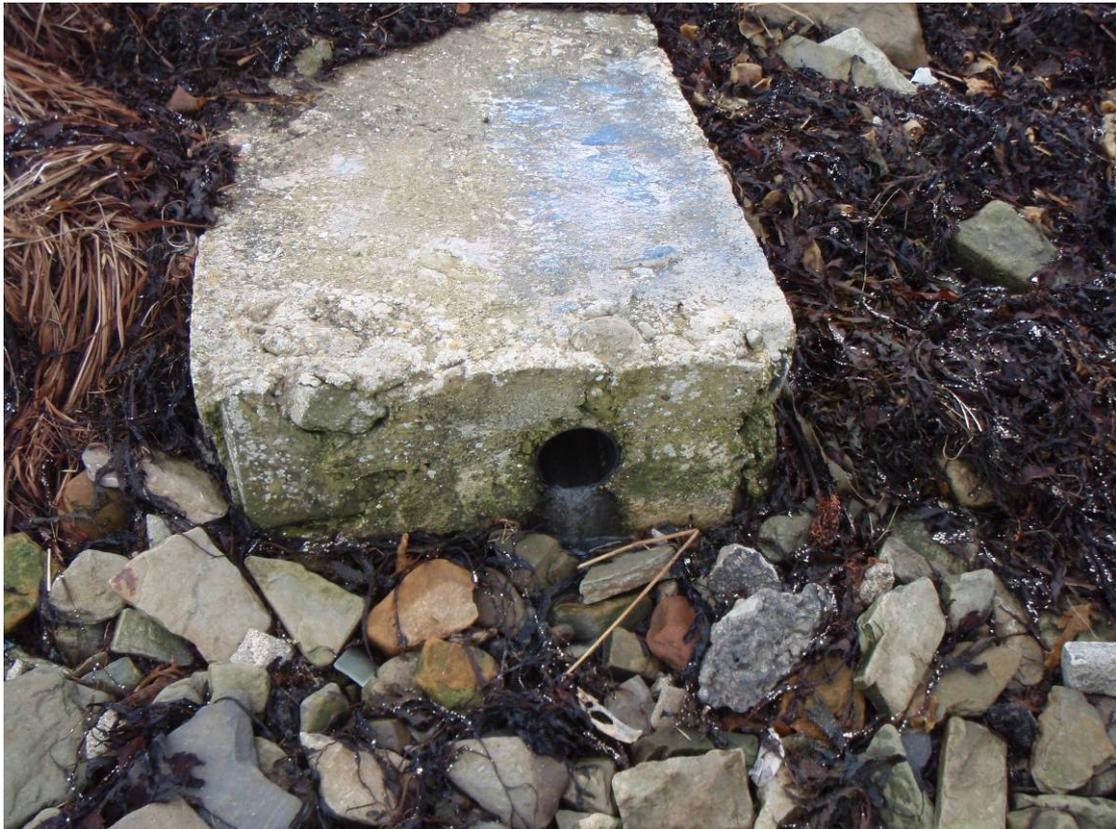
Figure 35. Pipe encased in concrete, sewage fungus, fresh water sample 18

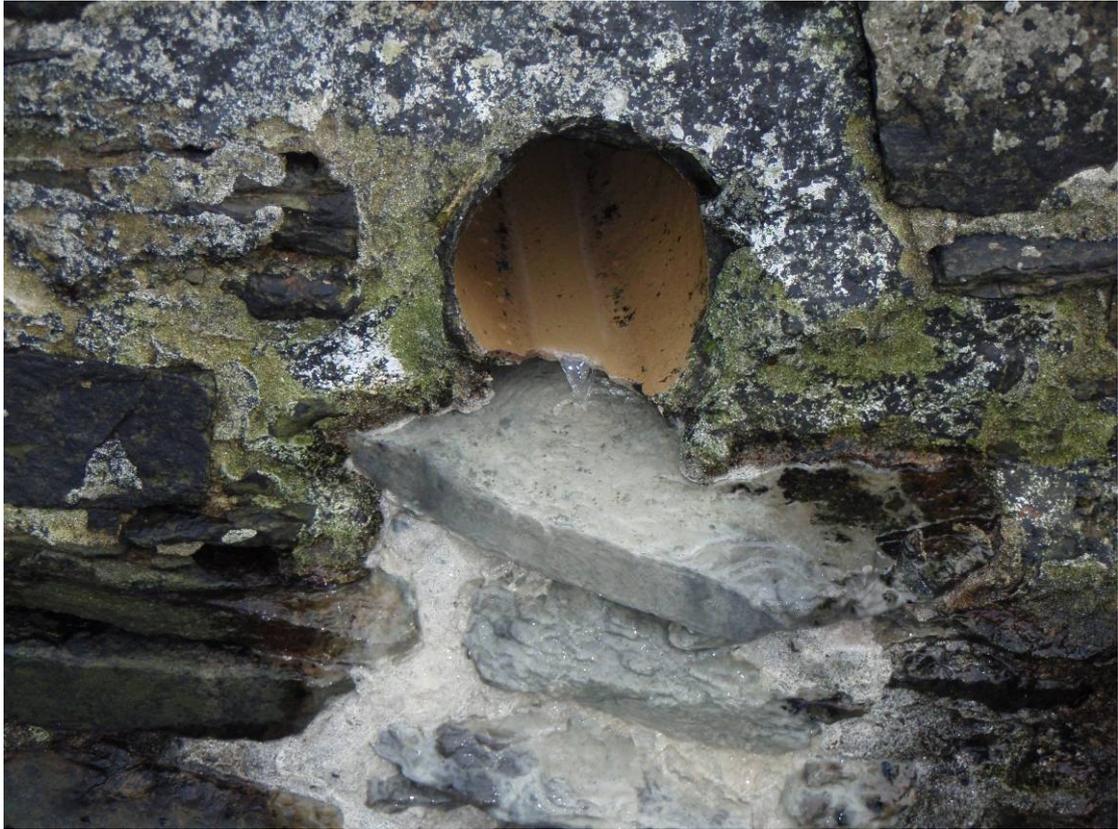
Figure 39. Broken pipe with sewage fungus, fresh water sample 21
