Scottish Sanitary Survey Review

Campbeltown Loch AB-029-008-04 February 2014

| Report Title | Campbeltown Loch Review | | | | |
| Project Name | Scottish Sanitary Survey | | | | |

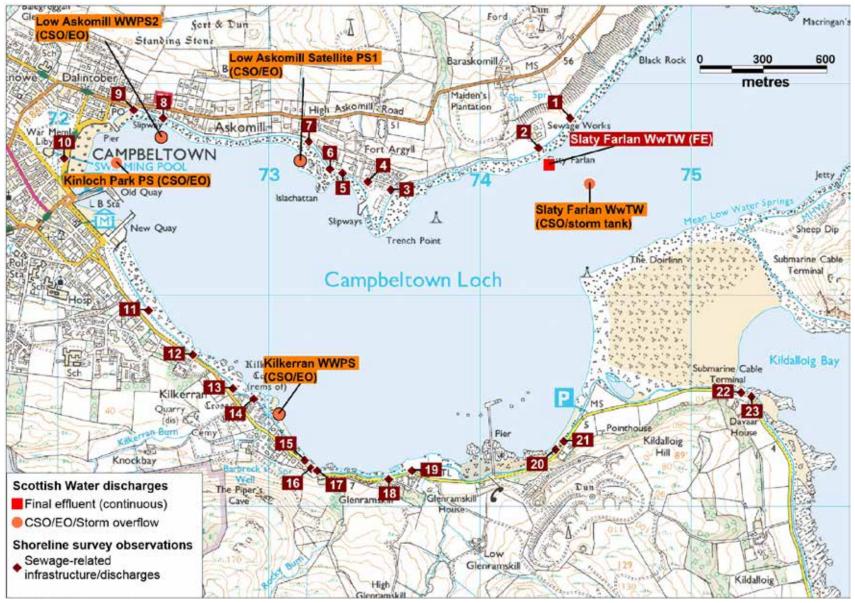
Figure 2.2 Map of updated sewage discharges and 2013 shoreline survey observations

Private discharges associated with Davaar House are the nearest sources to the fishery and are likely to affect water quality at the southeastern extent of the cockle bed. However the impact from these is considered to be relatively minor in comparison to the potential impacts from the relocated Slaty Farlan CSO and storm tank overflow.

It is recommended that the production area boundaries be amended slightly to exclude observed discharge pipes associated with Davaar House. The amended boundary is recommended as the area bounded by lines drawn between NR 7522 2030 and NR 7451 2008 and between NR 7451 2008 and NR 7455 1959 and between NR 7518 1955 and NR 7558 1990, extending to MHWS.

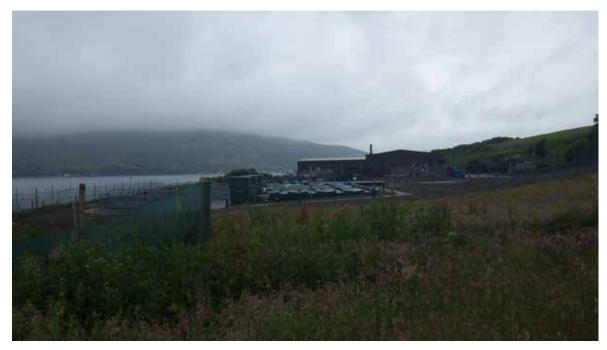
The 2013 shoreline survey identified the Slaty Farlan WWTW and the seawater sample taken from the shoreline adjacent to the works returned a result of 9 *E. coli* cfu/ 100 ml. Infrastructure associated with Low Askomill WWPS No. 1 & 2 was also observed onshore (observations 8 and 9). A manhole cover was observed along the upper shore west of Kilkerran WWPS. Two discharge pipes with a manhole cover over one were located over 500 m southeast of Kilkerran PS.

Figure 3: Overview of Slaty Farlan WWTW, looking west (Waypoint 4)

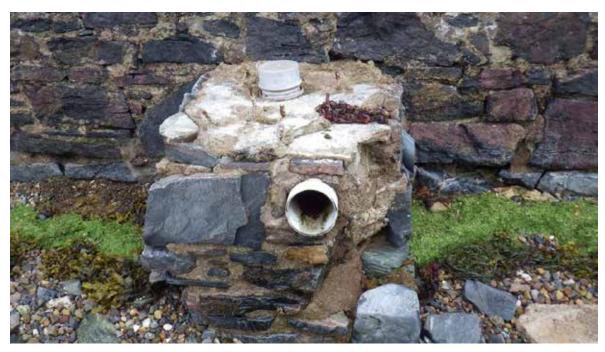
Figure 5: Discharge pipes on shoreline at Lower Askomill Road (Waypoint 17)

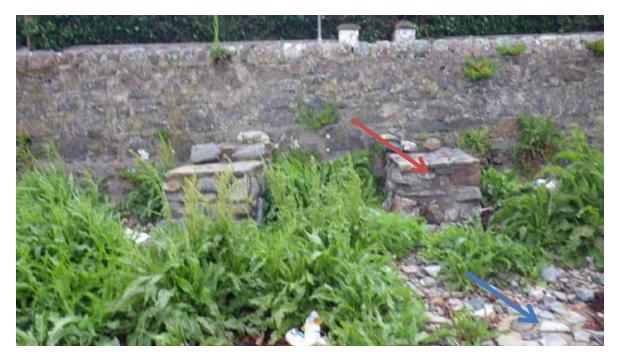
Figure 6: Example of tied-in sewage discharge pipe along the shore side of Lower Askomill Road (red arrow) with concrete infill on foreshore (blue arrow). (Waypoint 19)

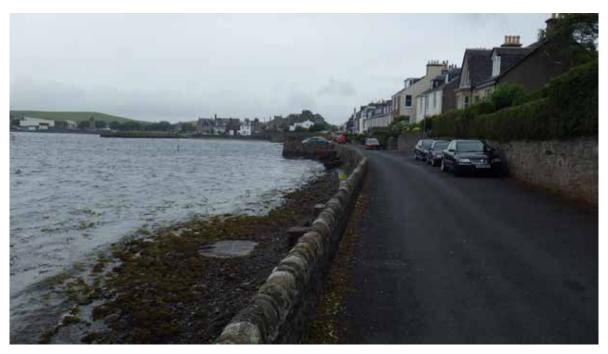
Figure 7: Lower Askomill Road, with shore tie-in (centre, lower picture), manhole cover for main sewer (to left on shore) with pumping station in middle centre of picture on shore. Scottish Water consented discharge is indicated by yellow pole in water in centre left of photograph. (Waypoint 22)

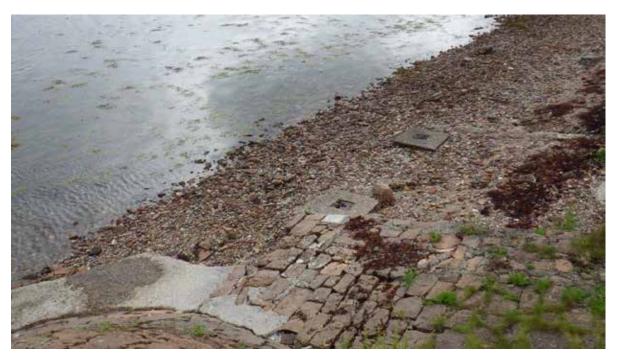
Figure 12: Small manholes at SE end of esplanade. (Waypoint 42)

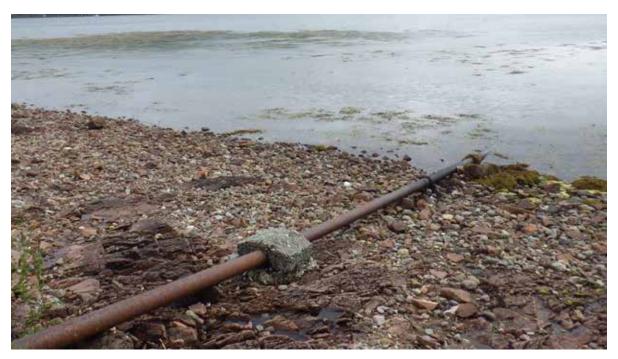
Two samples were taken of observed discharges from metal pipes. One was taken from a pipe thought to have been observed in the 2008 survey (observation No. 11/12), near Kilkerran (>1 km west of the cockle bed). This returned a result of 3000 *E. coli* cfu/100 ml. The second sample was taken from a pipe with toilet paper around the end, approximately 500 m west of the cockle bed. It returned a result of

Figure 13: Typical discharge pipe running into Campbeltown Loch from shore in Kilkerran. (Waypoint 44)

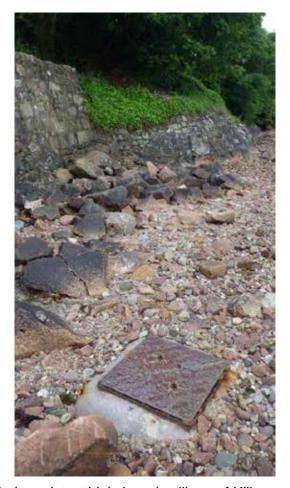
Figure 14: Manhole on inter-tidal shore in village of Kilkerran. (Waypoint 46)

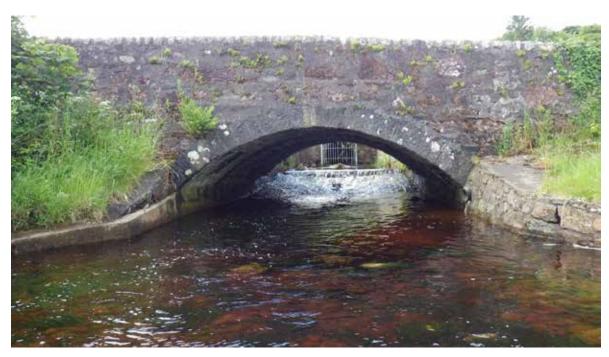
Loadings from watercourses in the 2013 survey were generally higher overall, with the highest loadings entering from Kilkerran Burn and Glenramskill Burn, south of the loch. These are located approximately 1.5 km and 1 km to the west of the cockle bed respectively, with Rocky Burn located between them. Two planning applications indicated new sewage inputs to an unnamed watercourse along the south shore. These were to areas close to Kilkerran Burn, so this watercourse may receive contamination from those sources.

Figure 16: Glenramskill Burn, with unidentified discharge pipe on right shore next to bridge wall. (Waypoint 61)

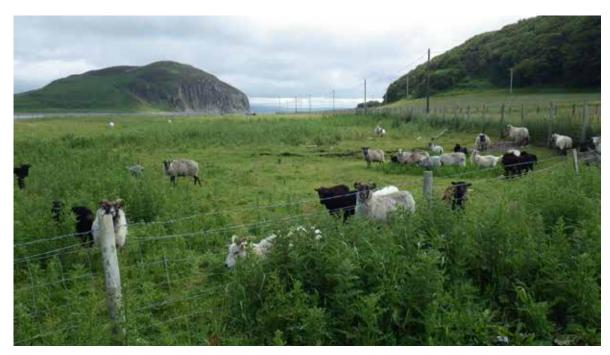
Overall the largest agricultural impacts to the fishery continue to come from the land south of the cockle bed. This land continues to be used to rear both sheep and cattle. Land around Glenramskill is now reported to be used for silage crops. No updates were made on Kildalloig Farm, due to the survey not extending that far south. Other contamination inputs are expected from livestock reared on Davaar Island itself. Overall, the number of sheep and cattle observed in the 2013 survey is considerably less than was observed during the 2008 survey. It is unclear whether this reflects or true changes in livestock numbers kept in the area, as the surveys were taken close together in terms of season: May and July.

Figure 18: Livestock present in field adjacent to fishery area (behind fence at rear of field) with Davaar Island in the background. (Waypoint 67)
