# Scottish Sanitary Survey Project

Restricted Sanitary Survey Report  
Arran: Pirnmill  
NA 008 330 16  
January 2009

# Shoreline Survey Report

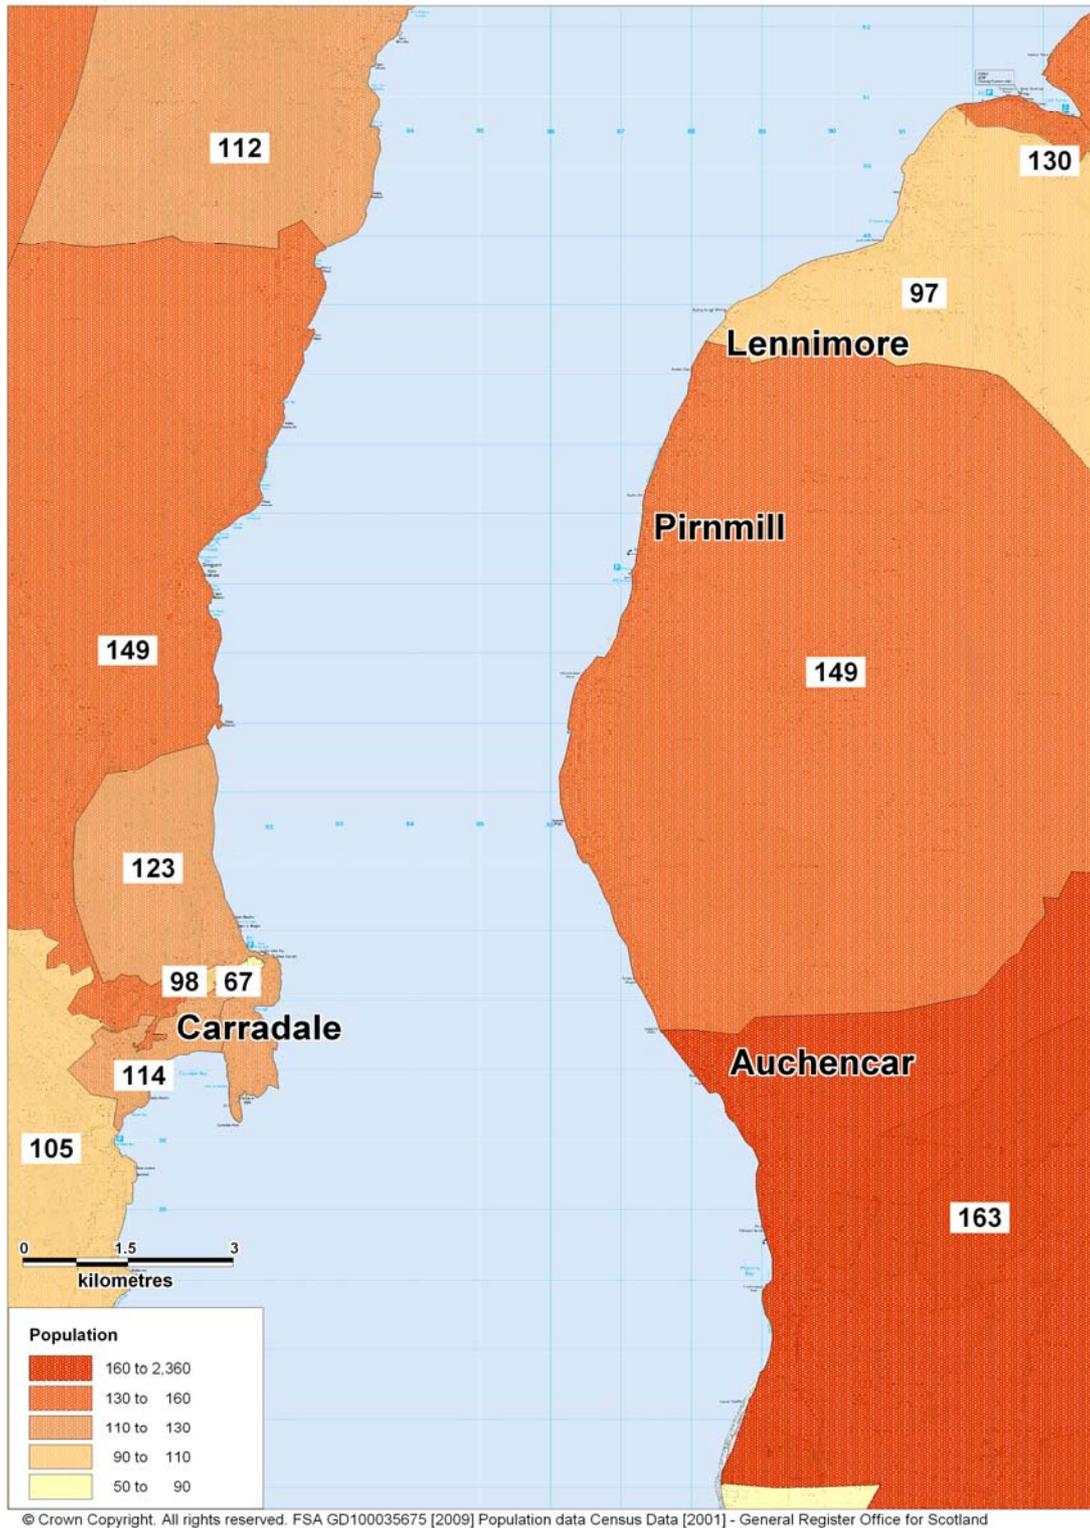
Figure 1.2 Human population of Pirrmill

Figure 1.2 shows the census output areas that are directly adjacent to Arran: Pirnmill. There are three census output areas on the eastern coastline and seven on the western coastline. On the eastern coastline are the small settlements of Lennimore, Pirnmill and Auchencar and on the western coastline is the settlement of Carradale with a population of 279 (2001). Human faecal contamination would be expected to be mainly associated with these settlements. There is little seasonal population in the area with no campsites/caravan sites and only several B&Bs.

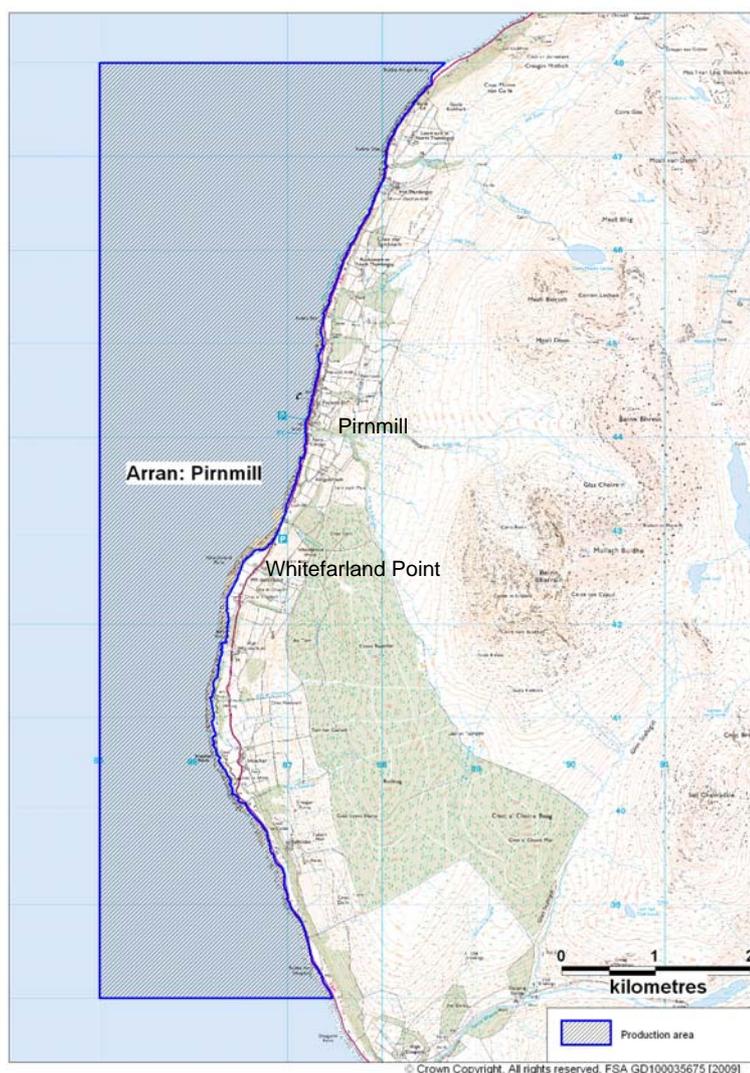
The fishery at Arran: Pirmill is comprised of a wild Razor fish (*Ensis spp.*) bed within the Arran: Pirmill (SIN NA 008 330 16) production area, as illustrated in Figure 2.1.

The razor bed extends from NR 86136 40625 (south end) to NR 88256 47825 (north end) and occupies a narrow strip of seabed following the shore, going no deeper than 8 metres. The harvester intends to fish no further south than Whitefarland Point, just south of the town of Pirmill. The razor clams will be harvested all year round (weather permitting) by hand by divers.

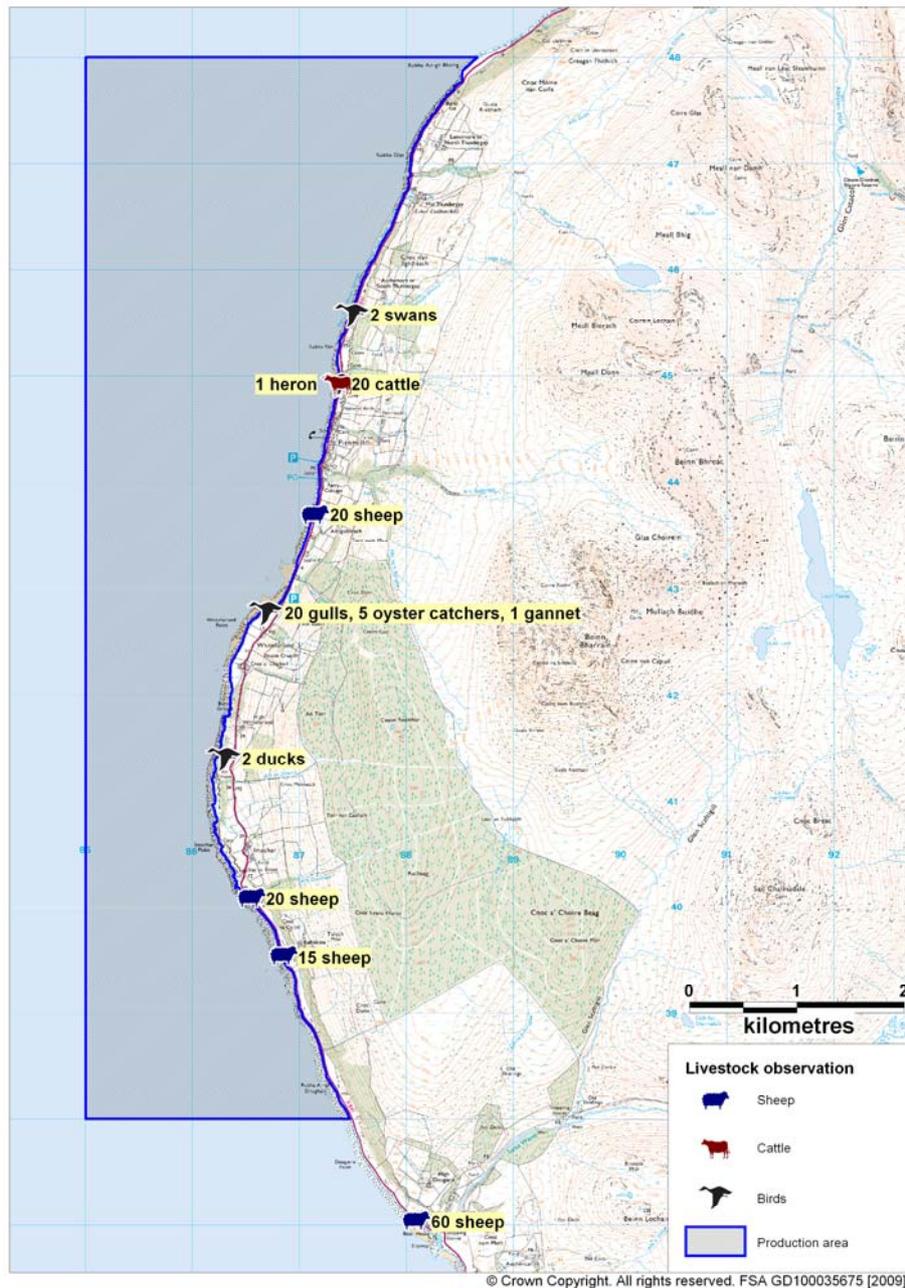
Figure 4.1 Wildlife and livestock observed during the shoreline survey at Arran: Pirnmill

During the shoreline survey, sheep were observed in fields close to the shoreline along the stretch of coastline south of Pirnmill (see Figure 4.1). Approximately 20 cattle were also observed in a field north of Pirnmill. In all cases due to the raised beaches, livestock did not have any obvious direct access to the shoreline. However, it is not known what access livestock may have to freshwater courses discharging to the production area. Based on stream contamination levels observed during the shoreline survey, it is likely that livestock have access to these watercourses.

While the Isle of Arran does host some colonies of breeding seabirds, the Arran: Pirnmill stretch of coastline does not host significant colonies. Seabirds such as gulls will always be present along the coastline but their distribution is likely to be even over time and as such would not materially affect placement of an RMP. During the shoreline survey 20 gulls, 5 oyster catchers & 1 gannet were observed on the shoreline just north of Whitefarland (see Figure 4.1).

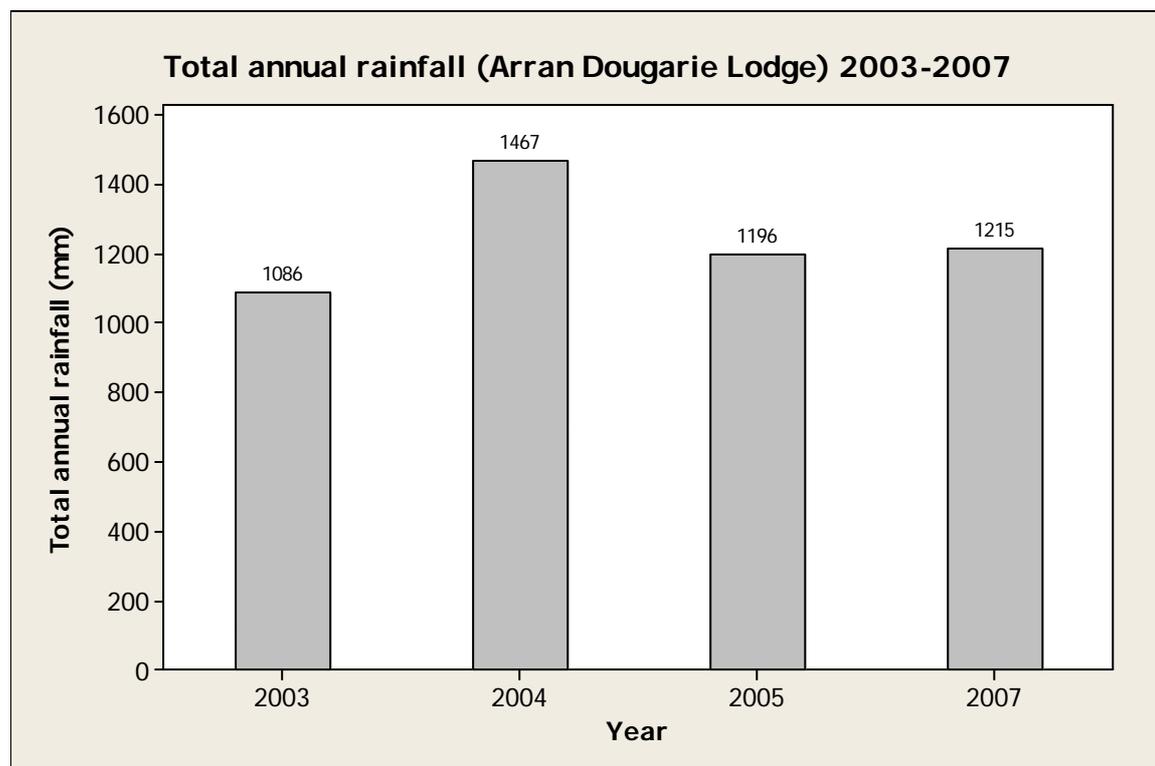
Figure 5.1 Total annual rainfall at Arran Dougarie Lodge 2003 – 2007 (no records for 143 days, including October 2006).

Total annual rainfall varied markedly, with 2004 much wetter than either 2003 or 2005.

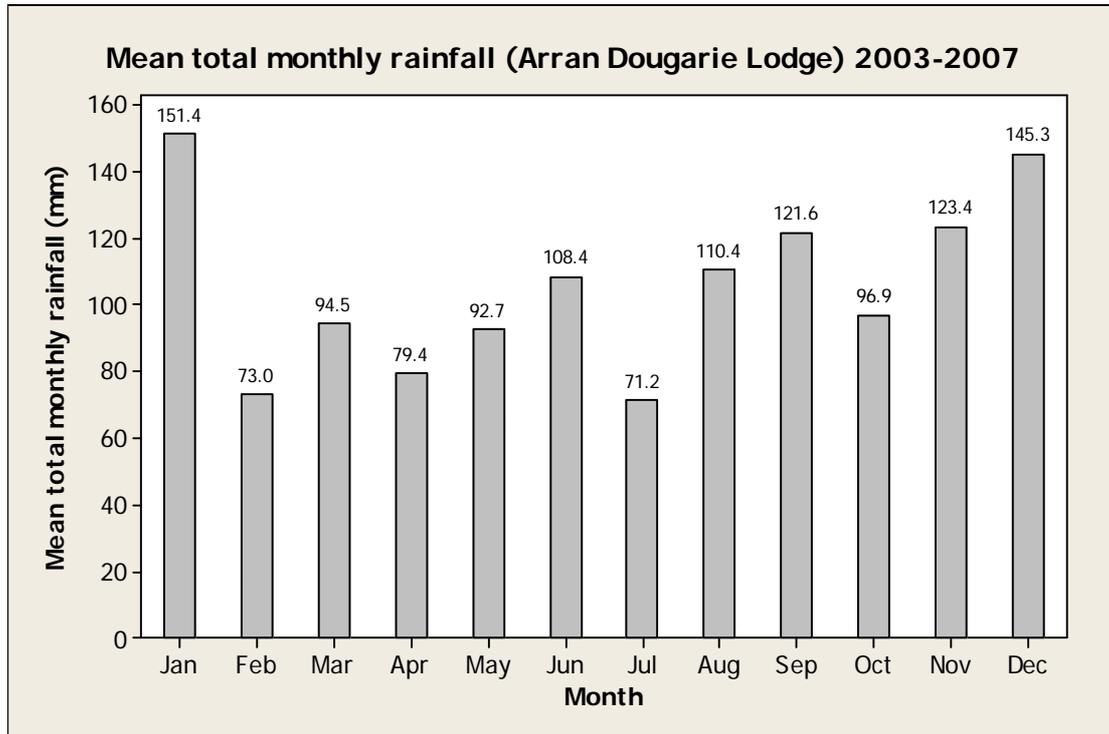
Figure 5.2 Mean total monthly rainfall at Arran Dougarie Lodge 2003 – 2007 (no records for 143 days, including October 2006.)

The wettest months were January, September, November and December. The largest increases in rainfall over the previous months occurred in August and November. For the period considered here (2003 – 2007), only 33 % of the days experienced no rainfall while 43 % of days experienced rainfall of 1mm or less. Average February rainfall amounted to less than half that received in January.

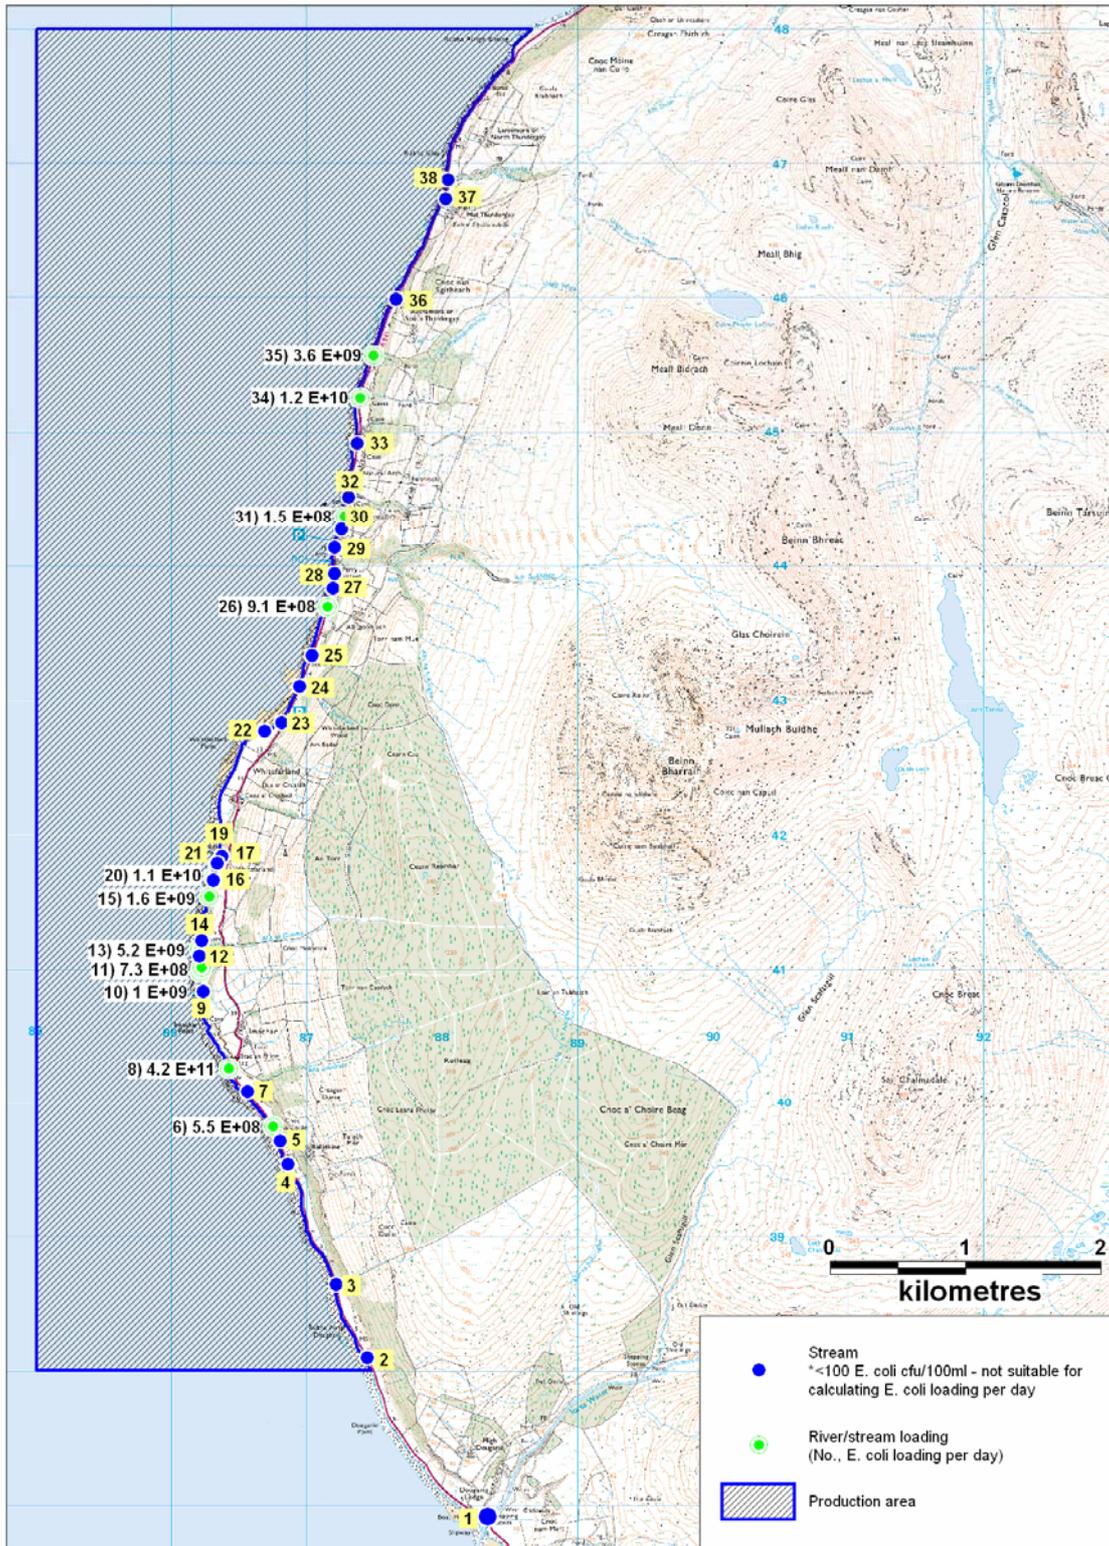
Figure 6.1. Location of stream/river flows and loadings at Arran: Pirmill

Of the streams/ivers sampled, 71% contained  $<100 E. coli$  (CFU/100 ml). Calculated loadings are based on the flows and dimensions observed during the shoreline survey only, and may not be representative of conditions year round. Most of the streams contributing significant  $E. coli$  loadings to the fishery were located in the southern half of the area.

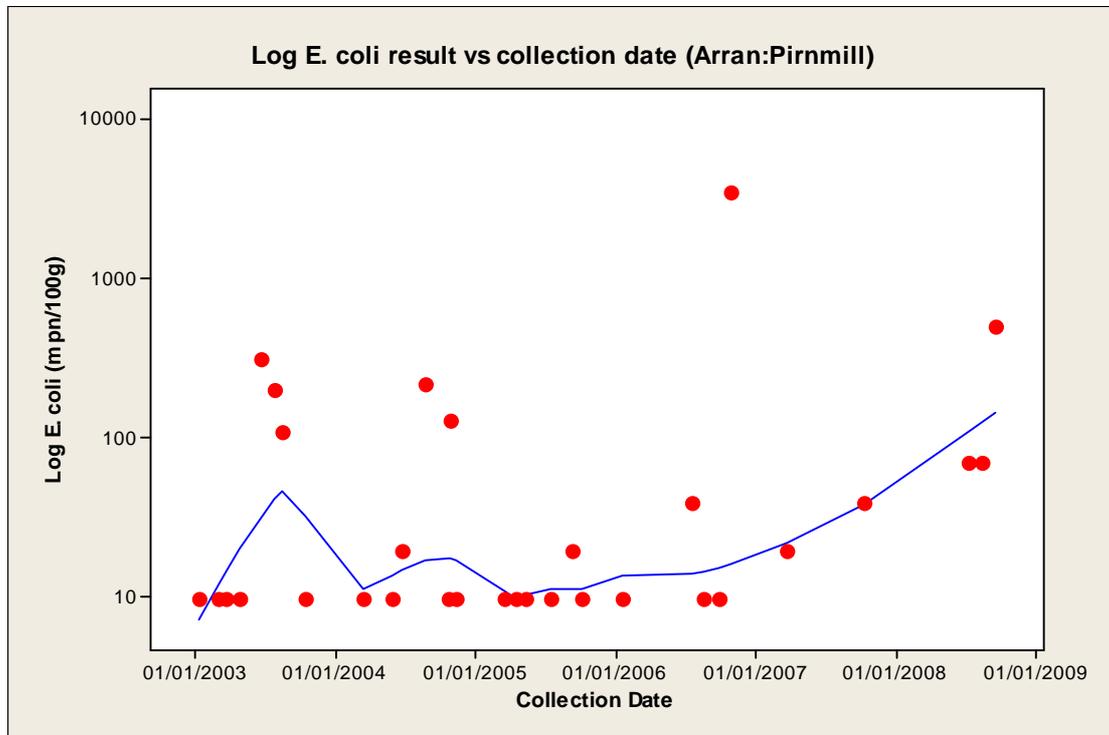
Figure 7.1 Scatterplot of *E. coli* result (MPN/100g) for razor clams vs collection date with rolling geometric mean.

In 2003 and 2004, results seem to peak in the summer months while the majority of results obtained at other times are very low. However, in recent years there have been no results of  $<20$  *E. coli* /100 g and peak results have been higher. It should be noted that fewer samples were submitted during this period, leading to declassification of the area in 2008.

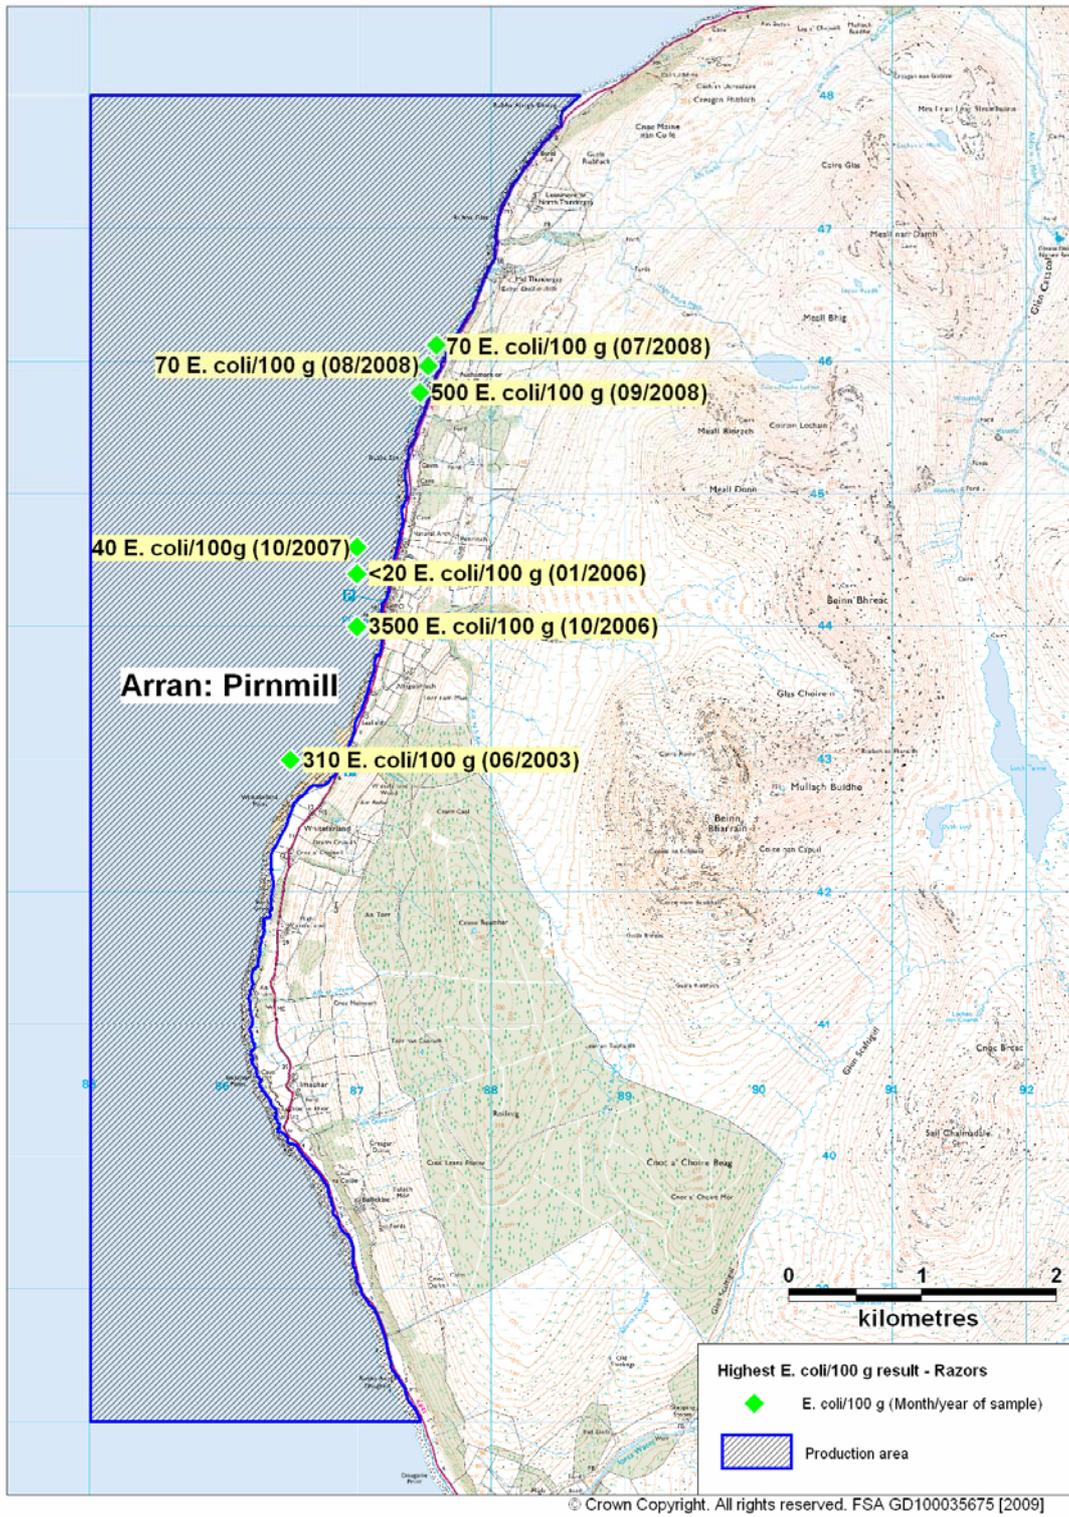
Figure 7.2 Highest *E. coli*/100 g result for each razor clam sampling location during 2003 – 2008 at Arran: Pirmill

Samples have only been recorded as having been taken in the northern half of the production area and usually quite close to the shore – as would be expected from the deeply shelving seabed. Most of the samples have been reported against two locations and the geographical analysis is difficult. However, it should be noted that the highest result (3500 *E. coli* MPN/100 g) was reported for a sample taken at NR 870 440. Figure 7.2 shows each sampling location labelled with the highest *E. coli* result for razor clams taken from that point over the 2003 - 2008 five year period.

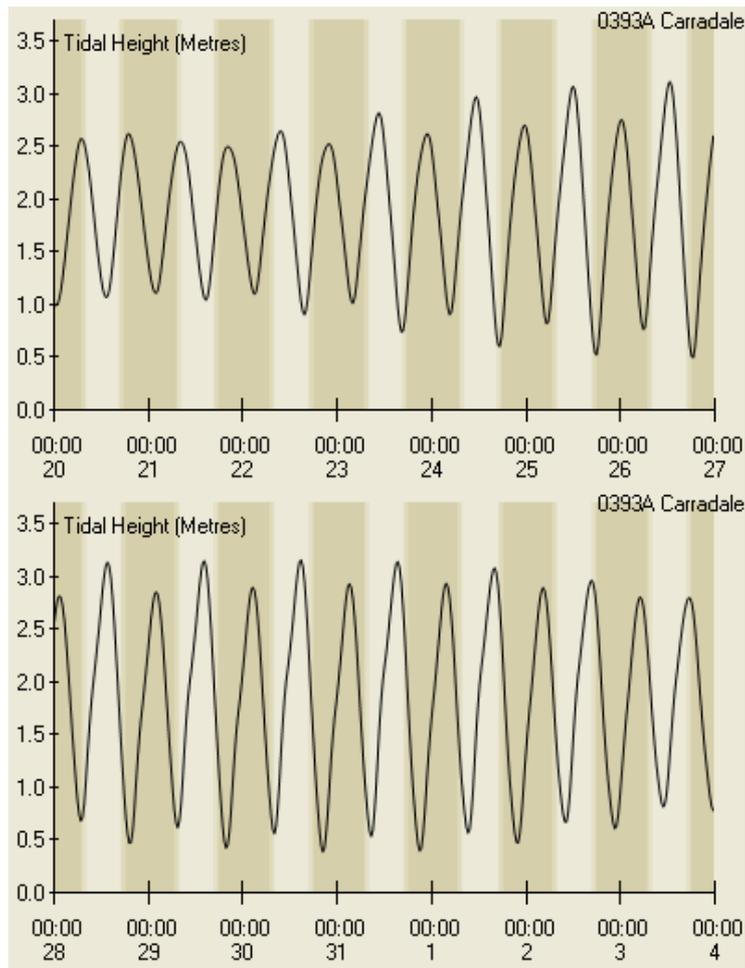
Figure 8.3 Tidal curves for Carradale

The following is the UKHO summary description for Carradale:  
The tide type is Semi-Diurnal.

MHWS	3.1 m
MHWN	2.6 m
MLWN	1.1 m
MLWS	0.4 m

Predicted heights are in metres above chart datum. The tidal range at spring tide is therefore approximately 2.7 m and at neap tide 1.5 m.

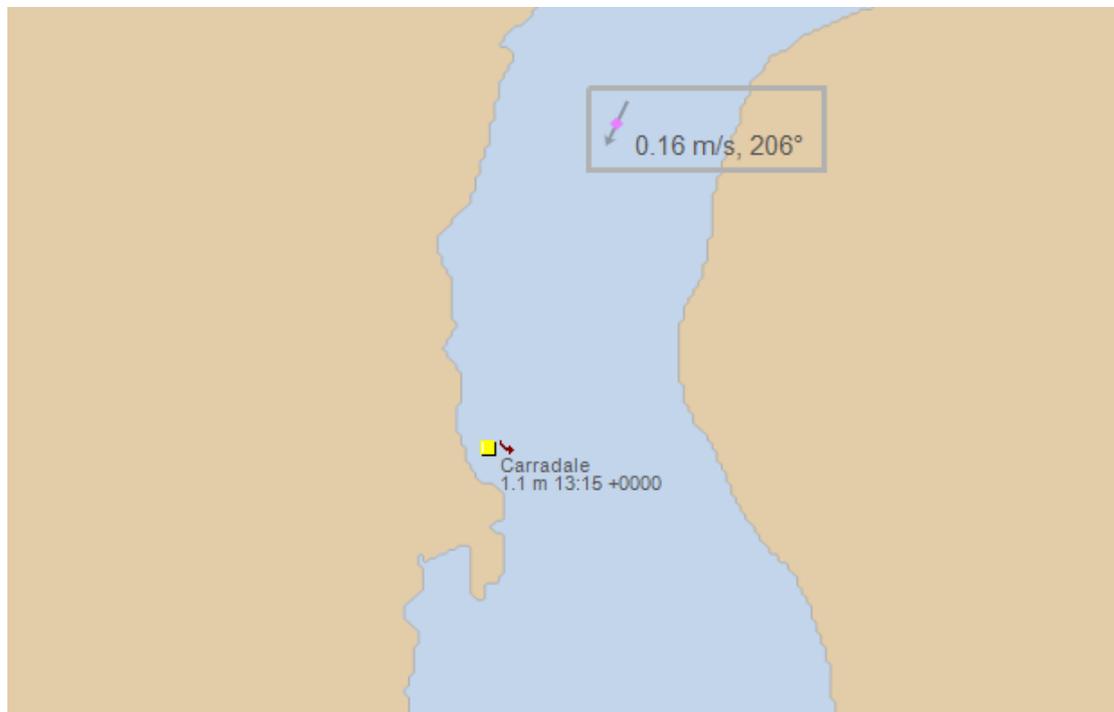
Figure 8.4 Maximum ebb tide flow and direction on a large spring tide at SN040G (from Admiralty TotalTide)

Tidal flows at the diamond are generally bi-directional, with water moving in a north-easterly direction on the flood and south-westerly on the ebb.

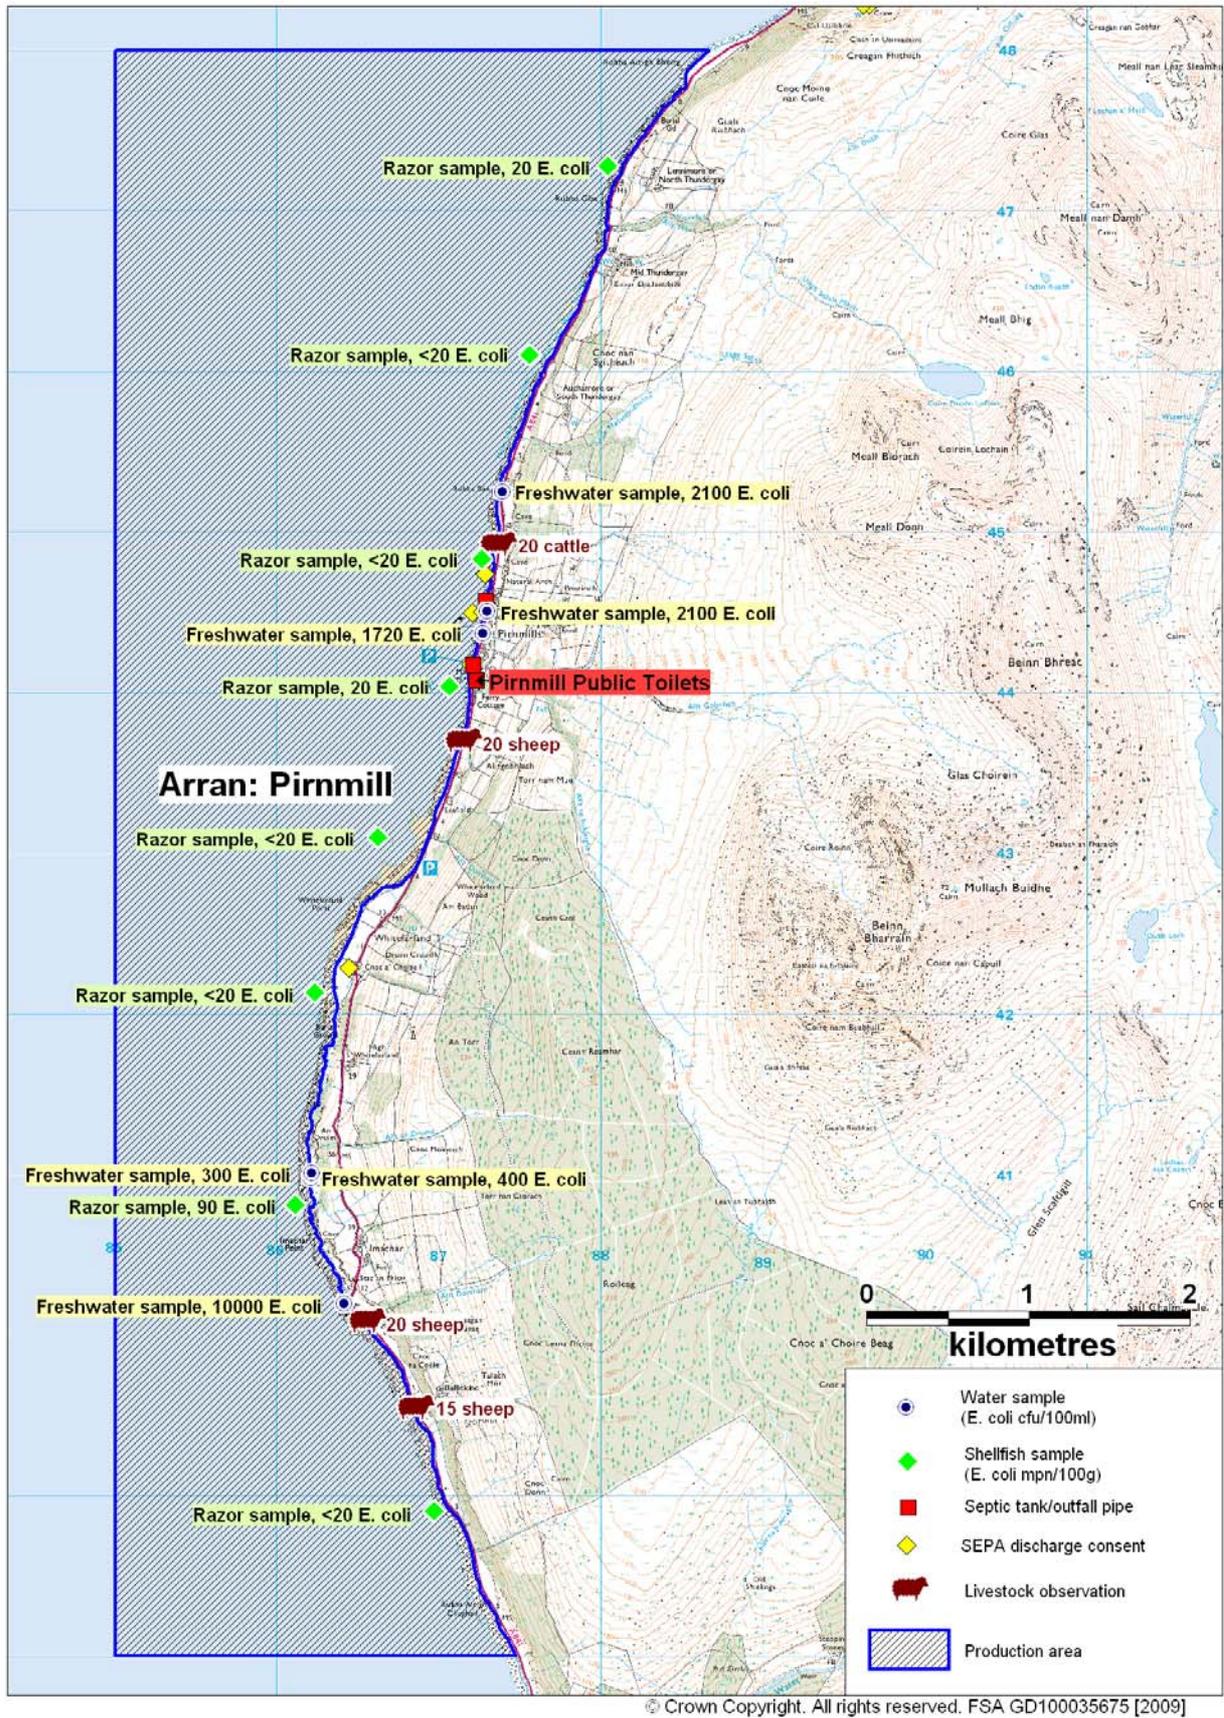
Figure 9.1 Summary of shoreline observations

In summary, identified sources of potentially significant contamination are:

- Contaminated freshwater streams in the area
- Pirnmill septic tanks and outfall pipes

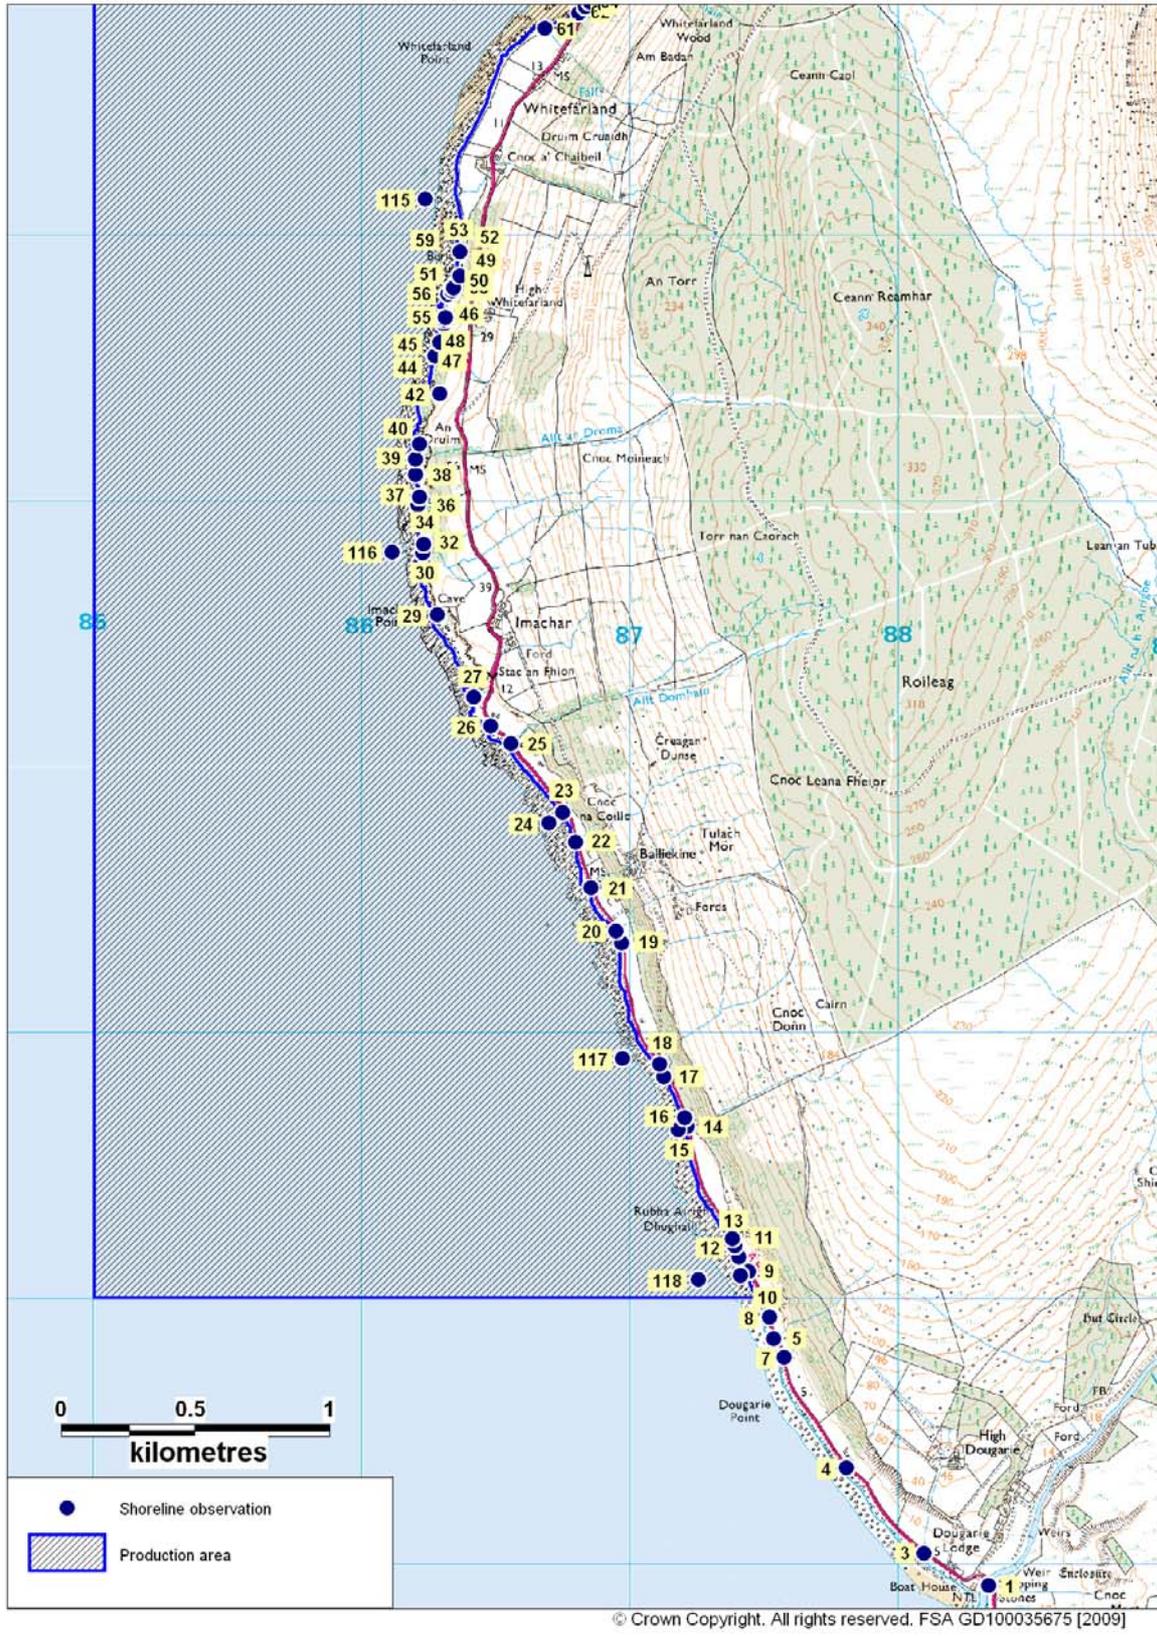
Figure 1. Shoreline observations – Southern end of Arran: Pirmill

The majority of the livestock were observed south of Whitefarland Point. Sheep were frequently seen in the hills above the shoreline from the area of coastline stretching from Balliekine to Cnoc a' Chaibeil. North of Whitefarland Point livestock was more sparse with only a few sheep and 20 cattle observed.

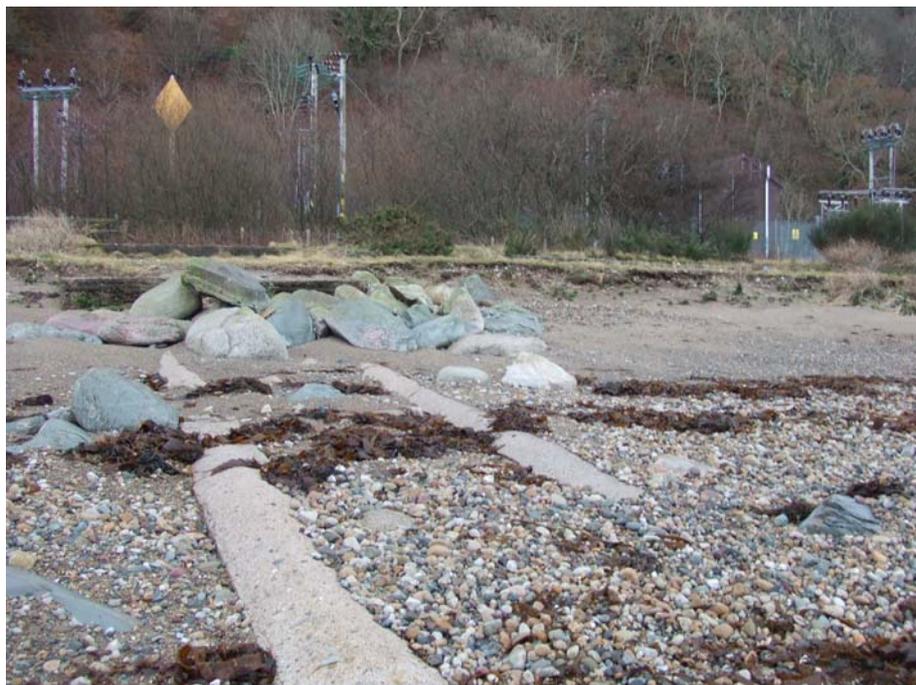
Figure 13. Concrete pipe structure, possibly for electricity cables.

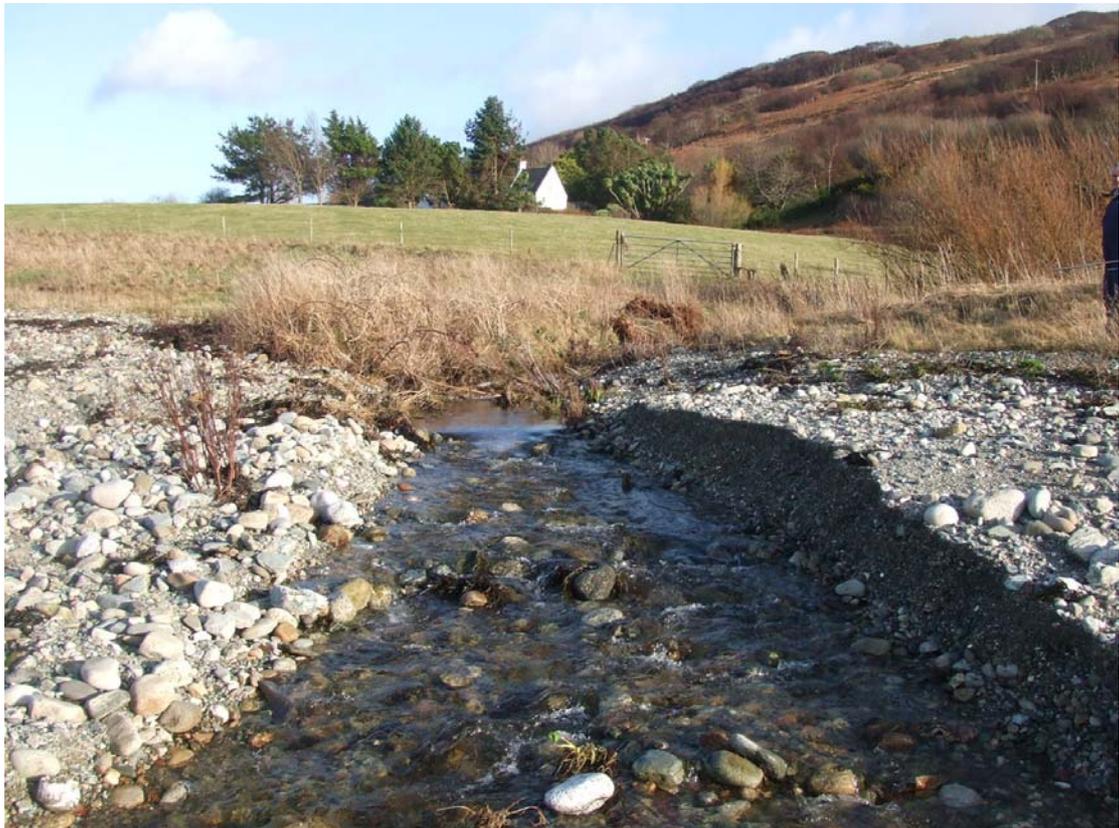
Figure 25. Large stream running beside 6 houses. Water sample 14, day 2.

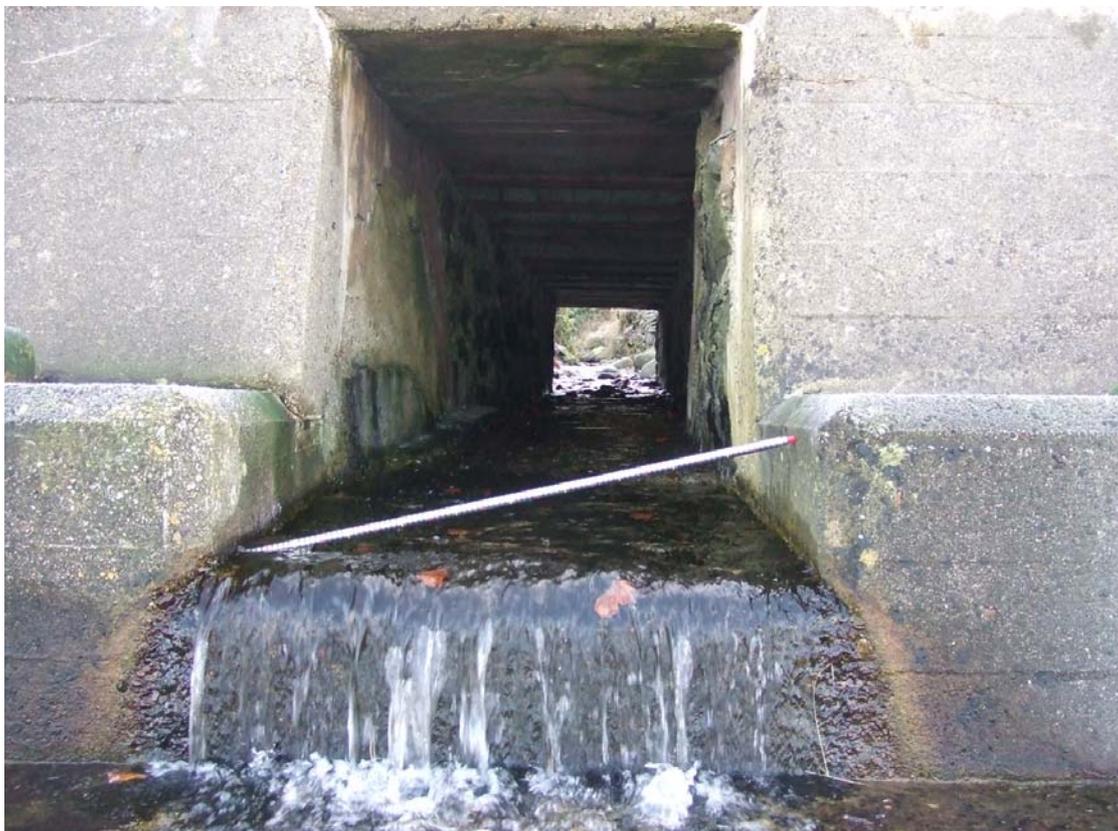
Figure 27. Large stream running through culvert in road and beside house, water sample 8, day 3

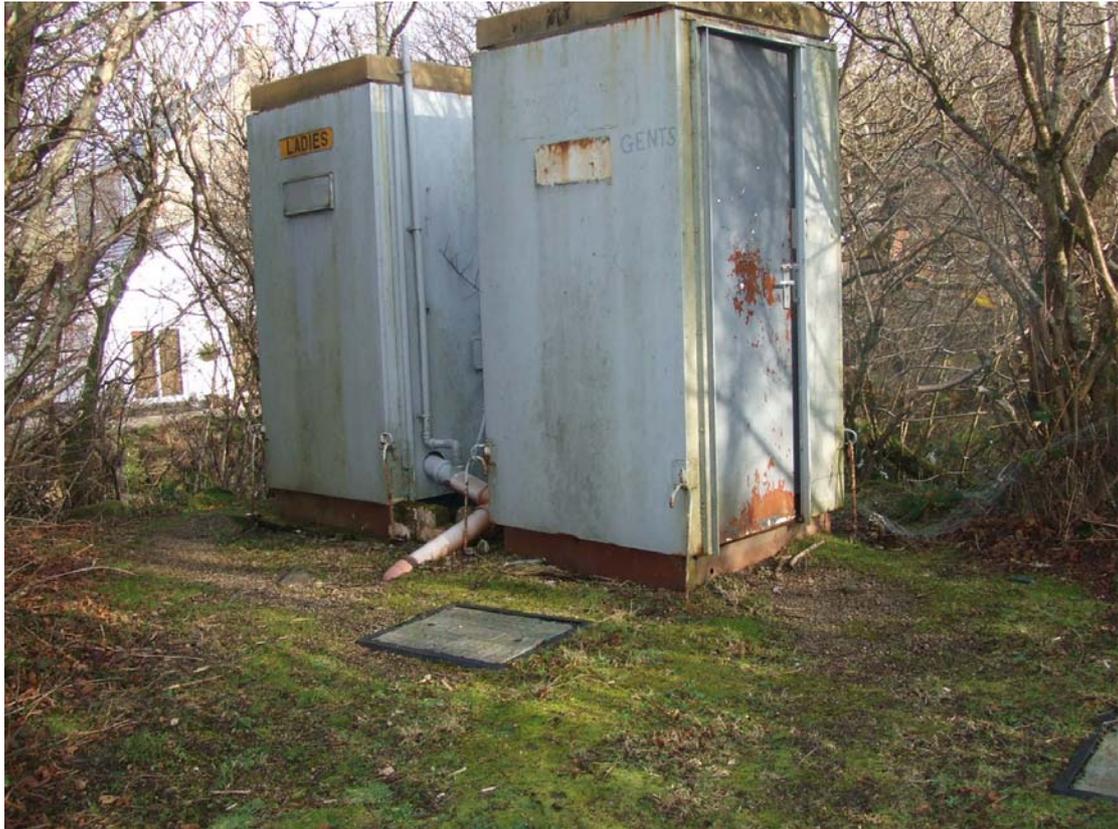
Figure 30. Pirnmill public toilets with inspection covers and suspected septic tank

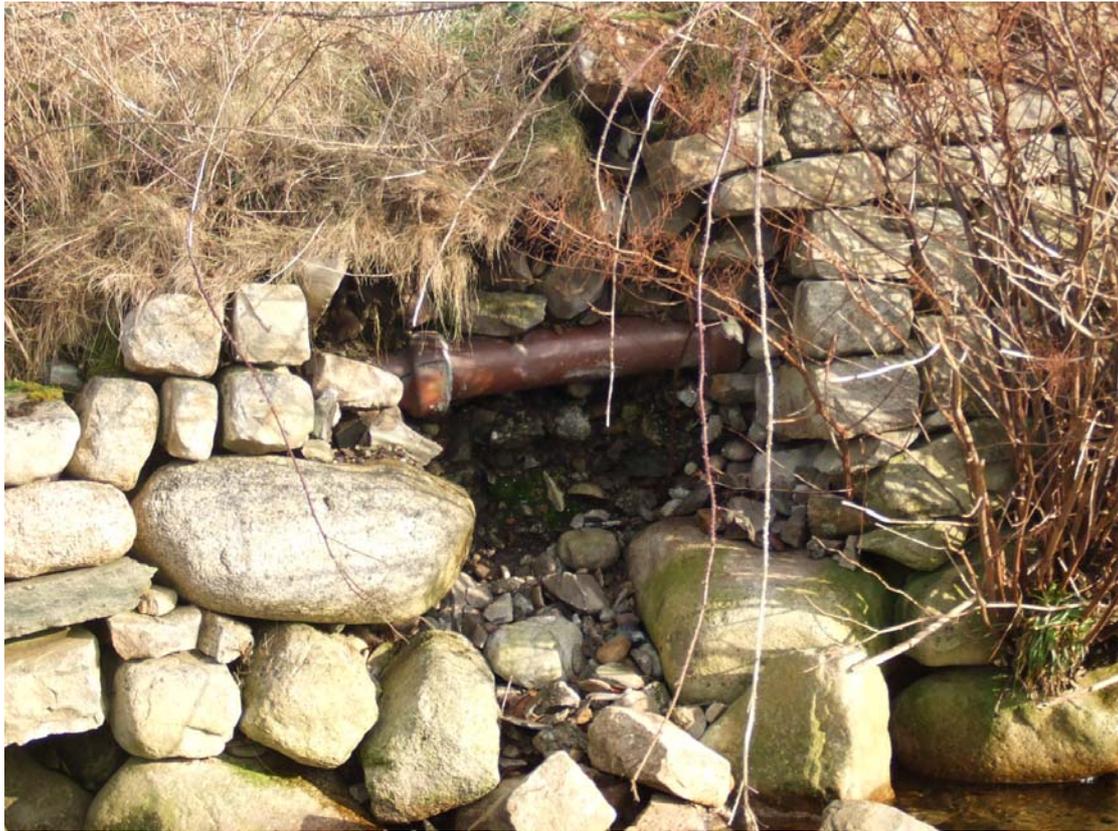
Figure 32. Clay pipe running alongside River Allt Gobhlach

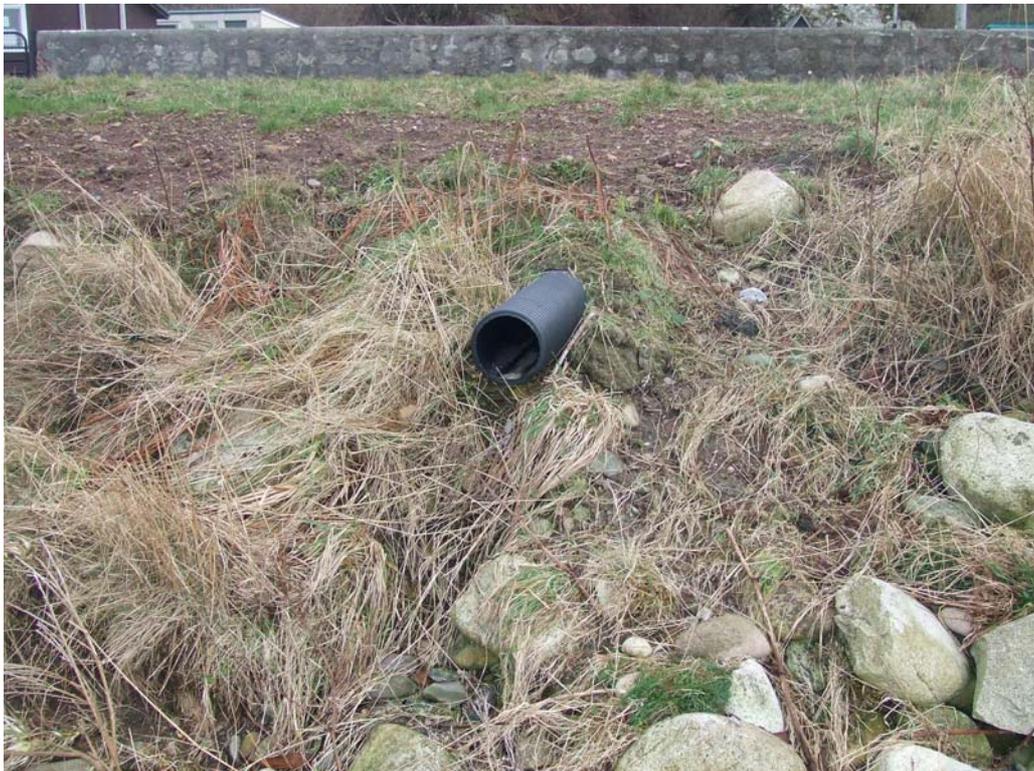
Figure 36. Black pipe under road, no flow

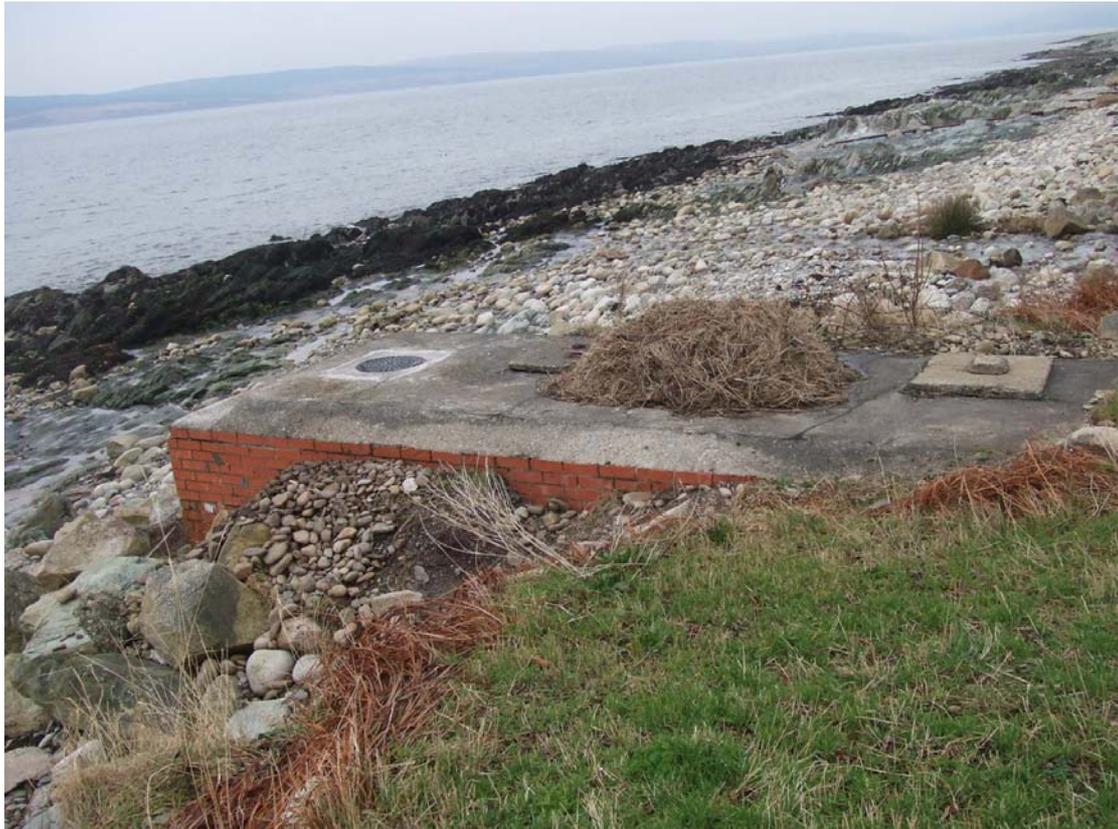
Figure 37. SW septic tank
