# Scottish Sanitary Survey Project

Restricted Sanitary Survey Report  
Arran: Pirnmill  
NA 008 330 16  
January 2009

# Shoreline Survey Report

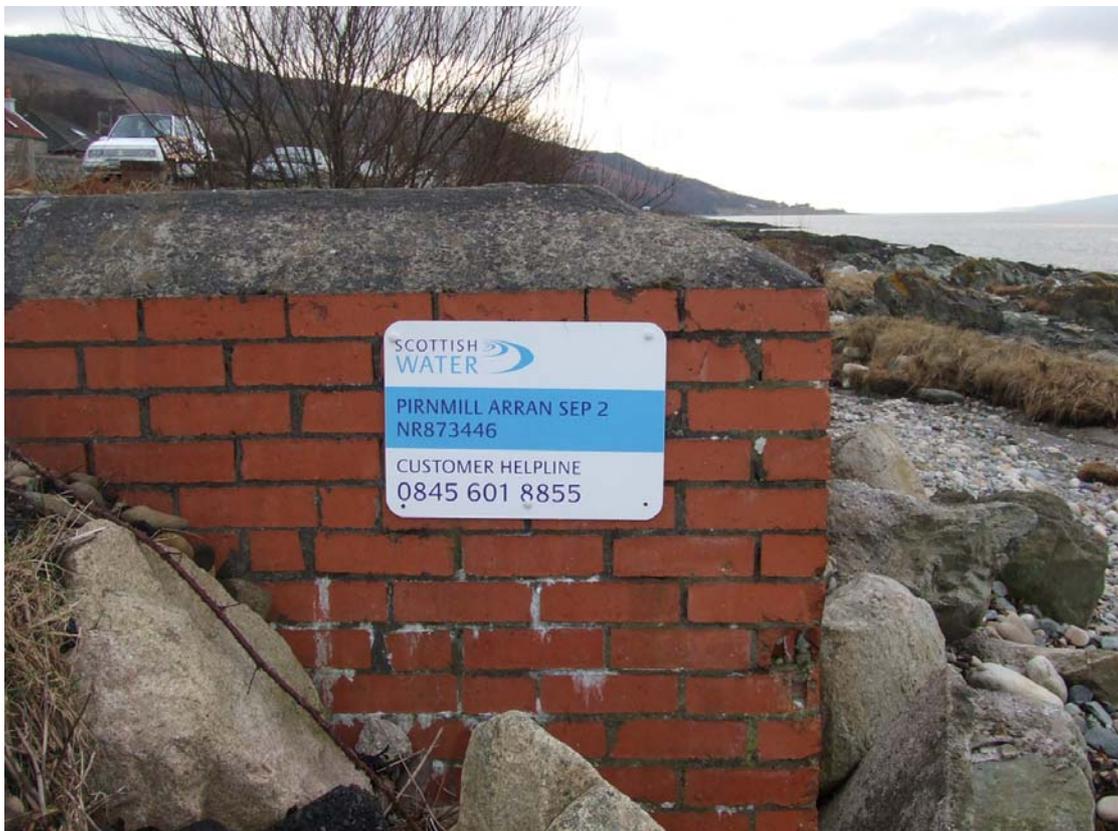
Figure 38. SW Pirnmill Arran septic tank

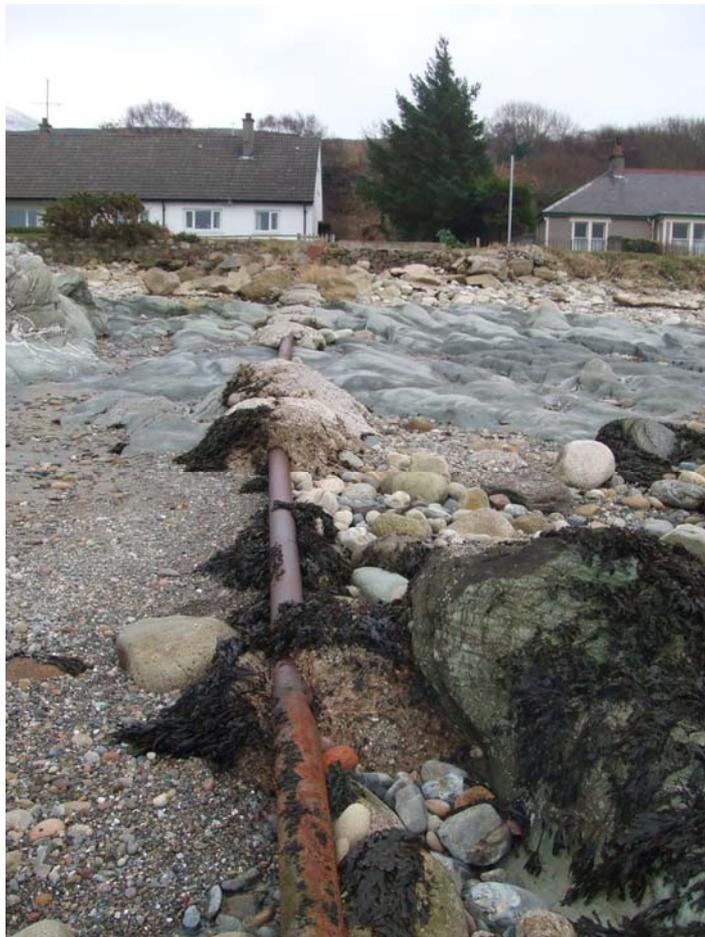
Figure 40. Septic tank and outfall pipe, water sample 22, day 3

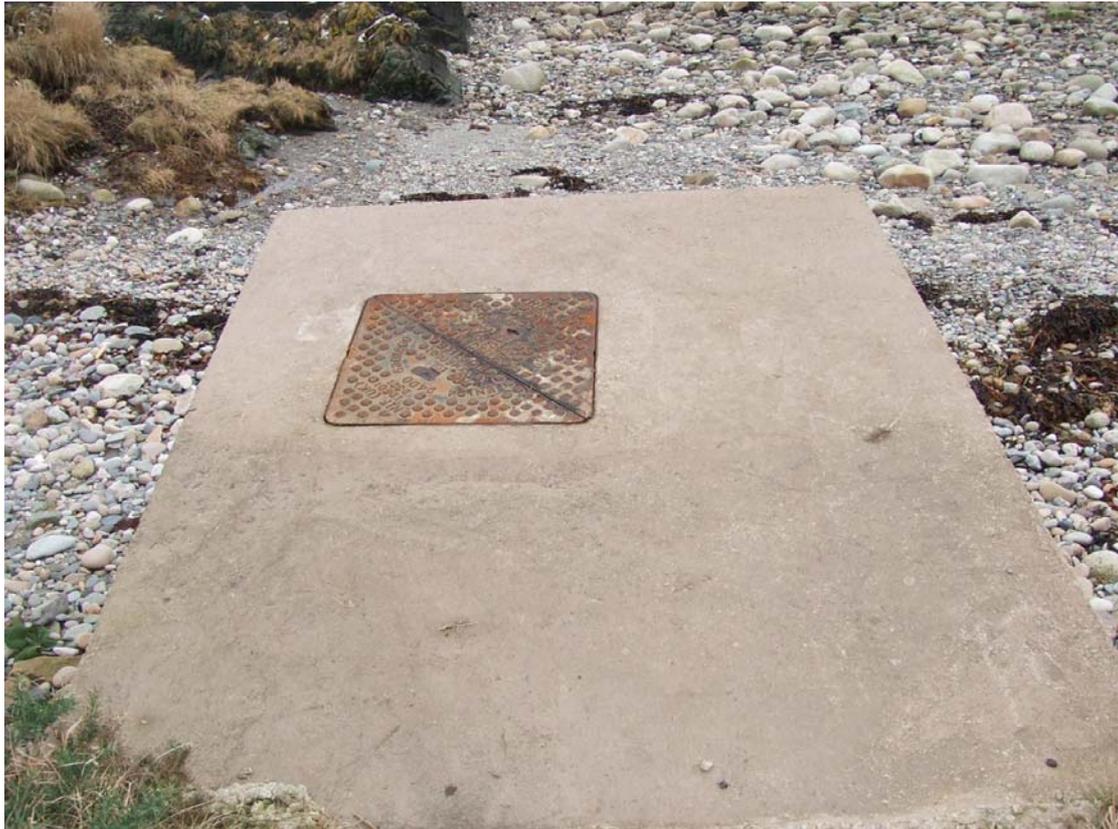
Figure 41. Concrete block with inspection cover, no visible outfall pipe
