# Scottish Sanitary Survey Project

Sanitary Survey Report  
Badcall Bay(HS 494)  
Eddrachillis Bay (TBA)  
April 2010

## Report Distribution – Badcall Bay

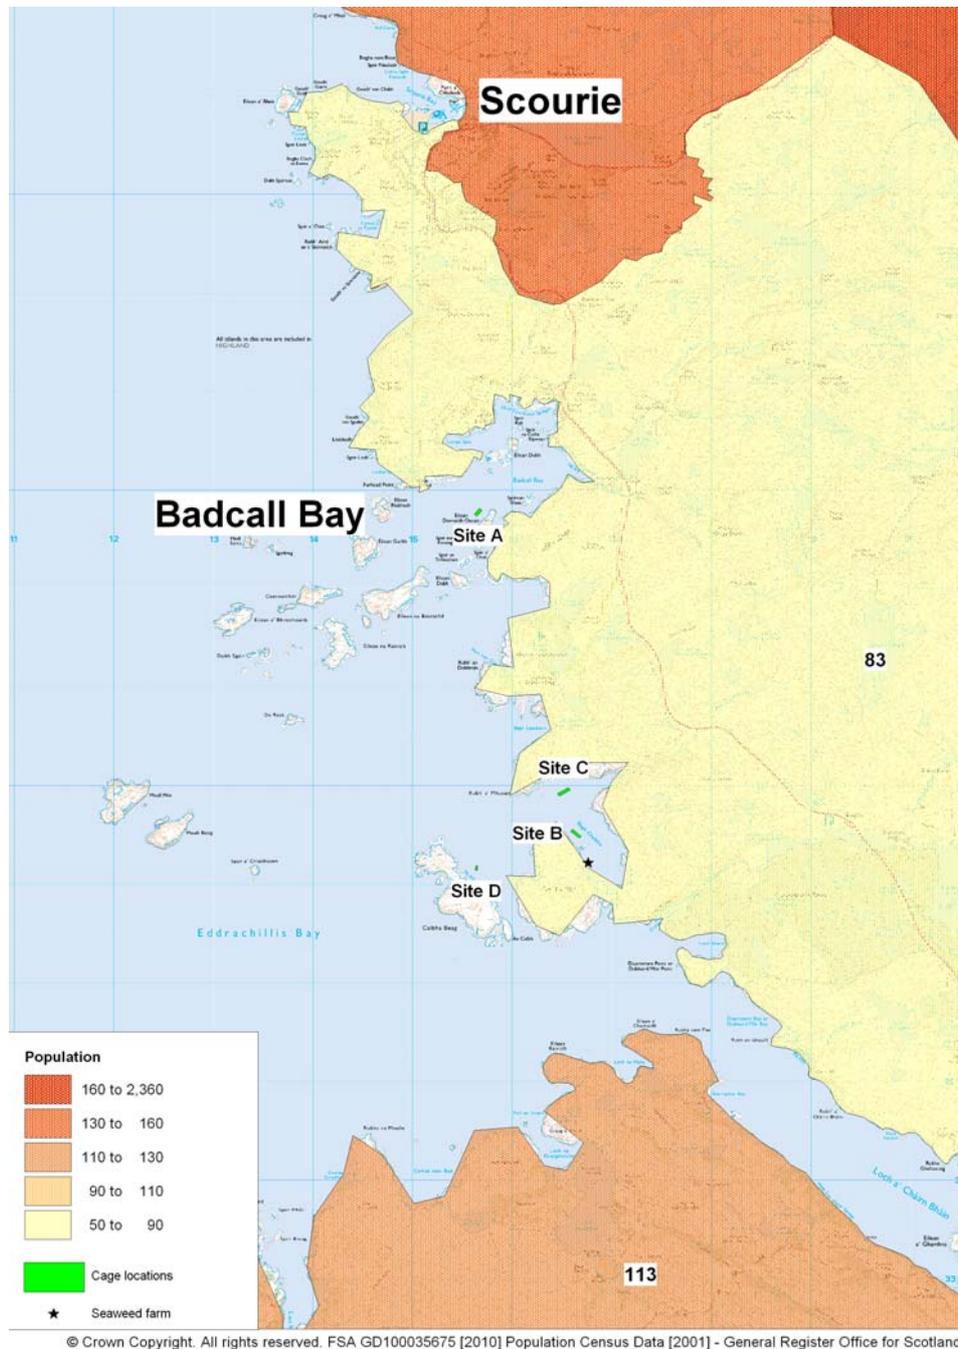
Figure 3.1 Human population surrounding Badcall/Eddrachillis Bay.

Figure 3.1 shows information obtained from the General Register Office for Scotland on the population within the census output areas in the vicinity of Badcall Bay and Eddrachillis Bay at the time of the last census in 2001.

Population densities in the area are very low. There is one large population census area immediately adjacent to the fishery sites, with a total population of 83. There are only a few scattered dwellings on the shore of this area, most of which are located around the head of Badcall Bay. The small village

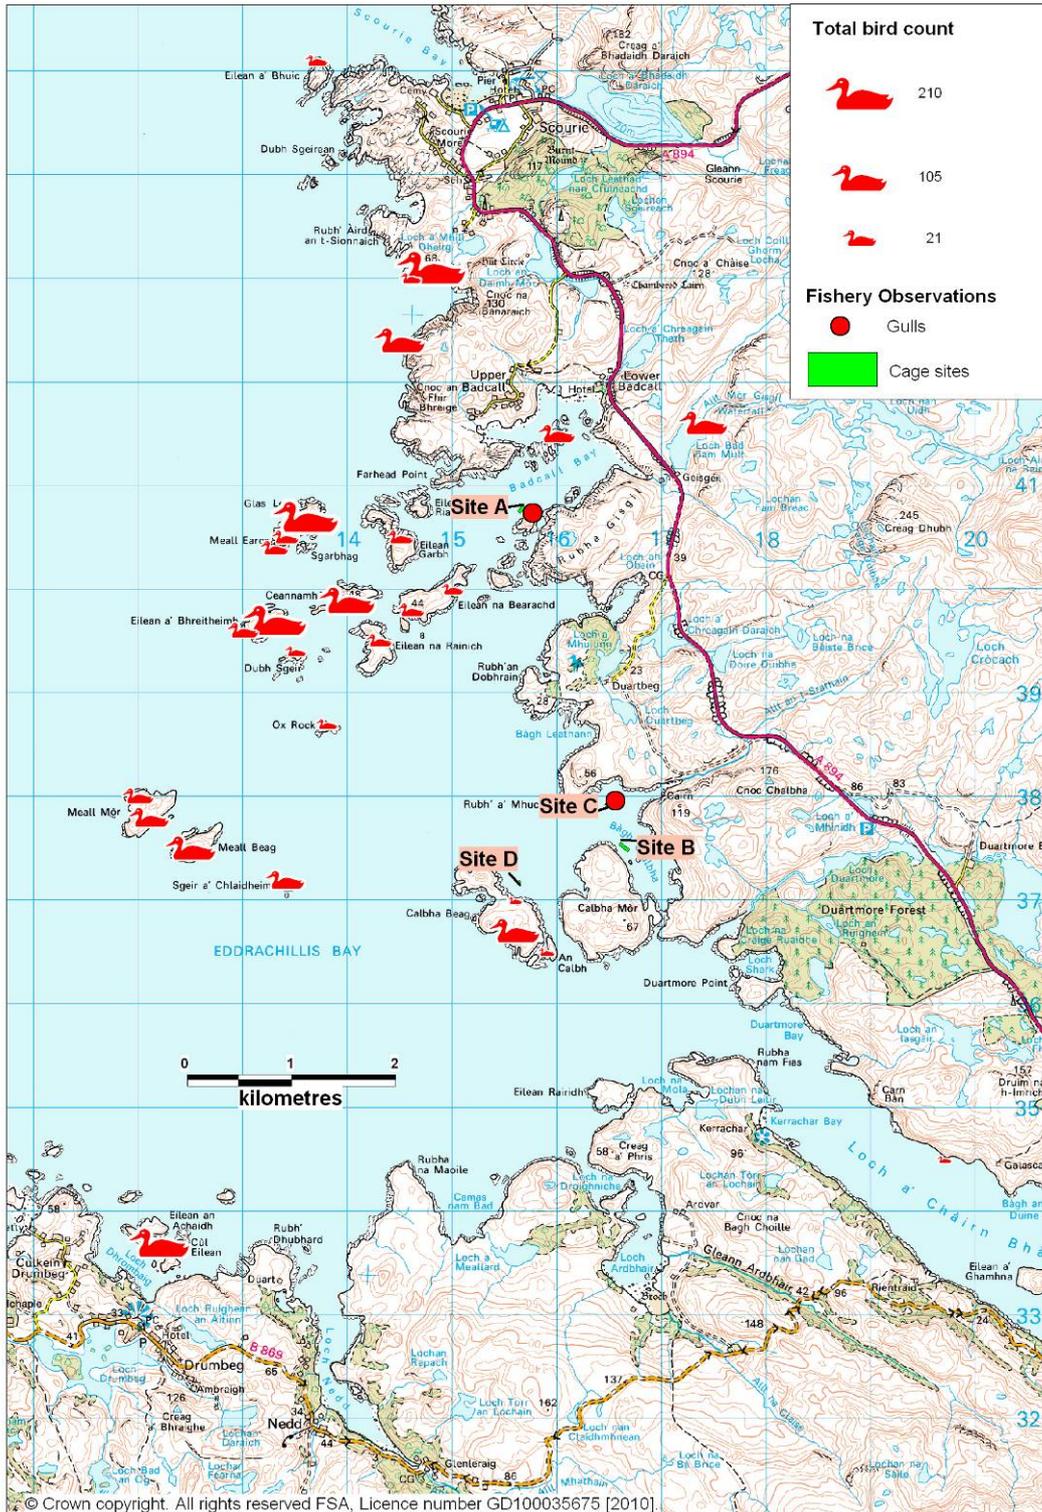
Figure 8.1 Breeding seabird counts within 5 km of the cage sites

The location of breeding seabird pairs is thematically mapped in Figure 8.1, with each recorded pair counted as two individuals. They were mainly concentrated on the small islands around the mouth of Badcall Bay, with some also breeding on the small island next to site D. Contamination of the cage sites from these birds would be via direct deposition as they feed, and through runoff from streams draining the areas in which they nest, rest or roost. As sites A and D are closest to islands on which the birds nest, faecal contamination carried by land runoff from the nesting areas may be of more importance at these sites compared to the other two sites. Impacts from these species are expected to peak during the summer breeding season, although some species are likely to be resident year round. Significant numbers of gulls were recorded in the vicinity of sites A and C during the shoreline survey.

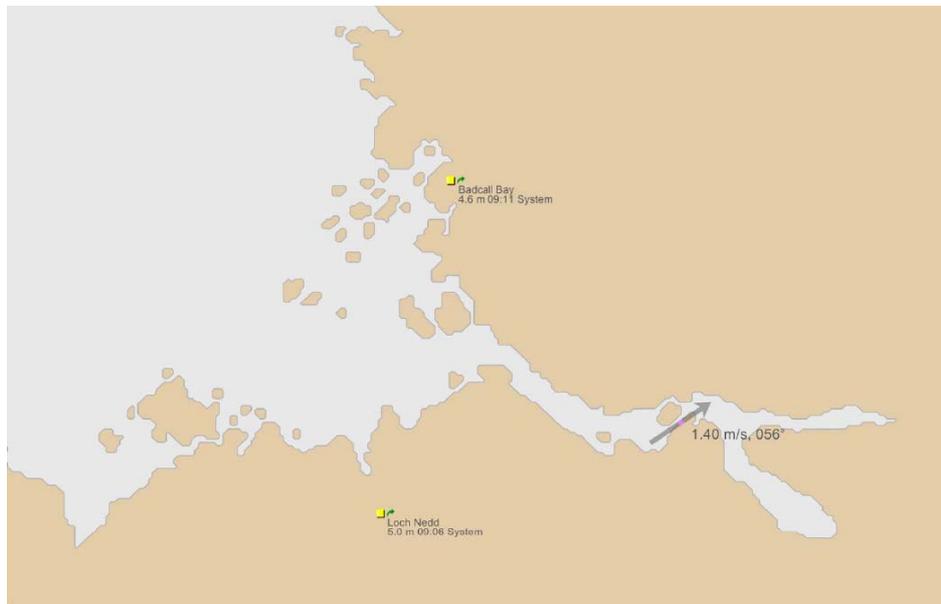
Figure 14.4 Spring flood tide in inner Eddrachillis Bay

Tidal stream information was available for one station in the extreme inner part of Eddrachillis Bay. The location of this station, together with the tidal streams for peak flood and ebb tide, are presented in Figures 14.4 and 14.5 and the tidal diamond is presented in Table 14.1.

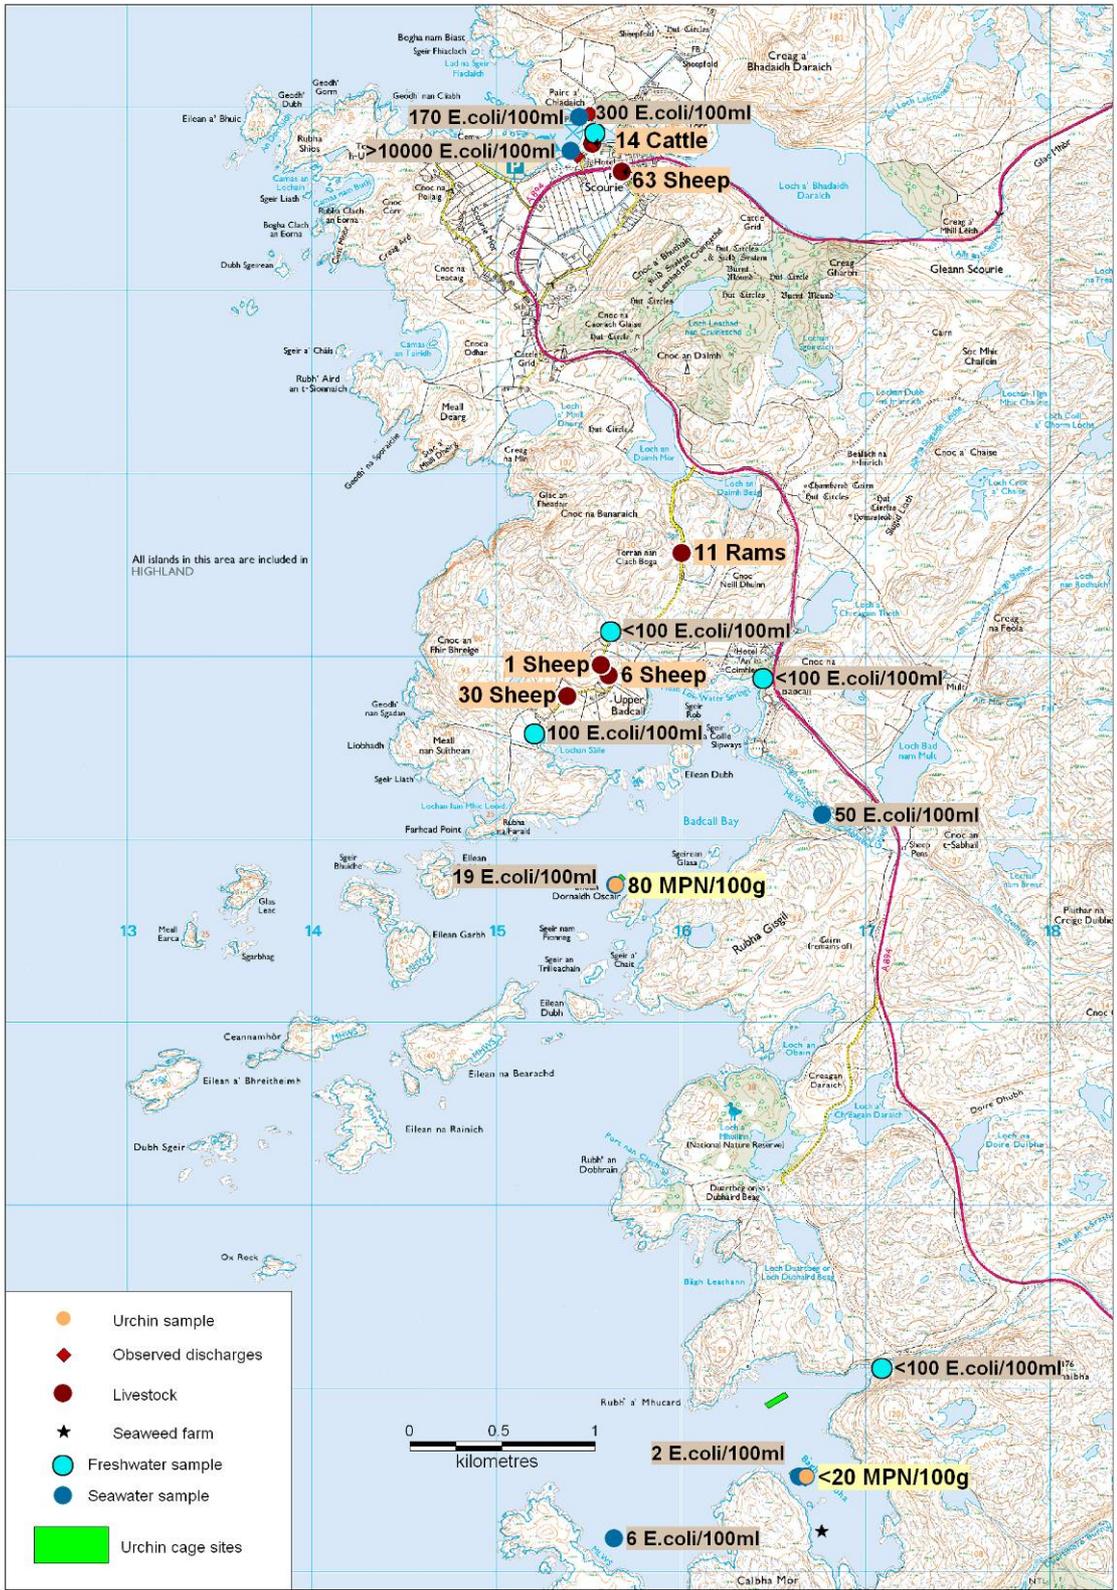
Figure 15.1 Summary of shoreline observations

Discharges were recorded at Scourie, which is about 7 km from the nearest cage site by sea. It is likely that there is an increase in human population in the general area in summer, as there is a caravan site at Scourie, and there is hotel and B&B accommodation both in Scourie and at Badcall Bay. A number of salmon farm service boats and other smaller craft were observed in the area.

The majority of the surrounding land is rough scrub and grass with rocky outcrops, and is steeply sloped in most places. A flock of 37 sheep was recorded on pastures by the north shore of Badcall Bay, with 11 rams seen about 1 km further north. Livestock was also observed in another two clusters, one at Scourie, and one over 2 km inland from Eddrachillis Bay. Seals were observed in the area, and large numbers of gulls were recorded near sites A and C.

None was particularly large or carrying high levels of *E. coli* at the time (<100 to 300 cfu/100ml). Seawater samples taken at Scourie had highest levels of *E. coli* (170 and >10000 cfu/100ml). A seawater sample taken at site A contained 19 *E. coli* cfu/100 ml, and the salinity was 26.3 ppt. Two water samples taken at site B both contained 2 *E. coli* cfu/100ml, and salinities were 34.3 and 31.4 ppt. One taken at site D contained *E. coli* 6 cfu/100ml and had a salinity of 32.9 ppt. A final seawater sample was taken on the eastern shore of Badcall Bay, adjacent to where a stream discharges. This contained 50 *E. coli* cfu/100ml and had a salinity of 17.9 ppt. Shellfish samples were taken from the two sites where stock were present. A sample from site A contained 80 *E. coli* MPN/100g, and a sample from site B contained <20 *E. coli* MPN/100g. Therefore, at the time of survey, freshwater influence and levels of contamination in seawater and shellfish were slightly higher at Badcall Bay where site A is located compared to the other sites further south.

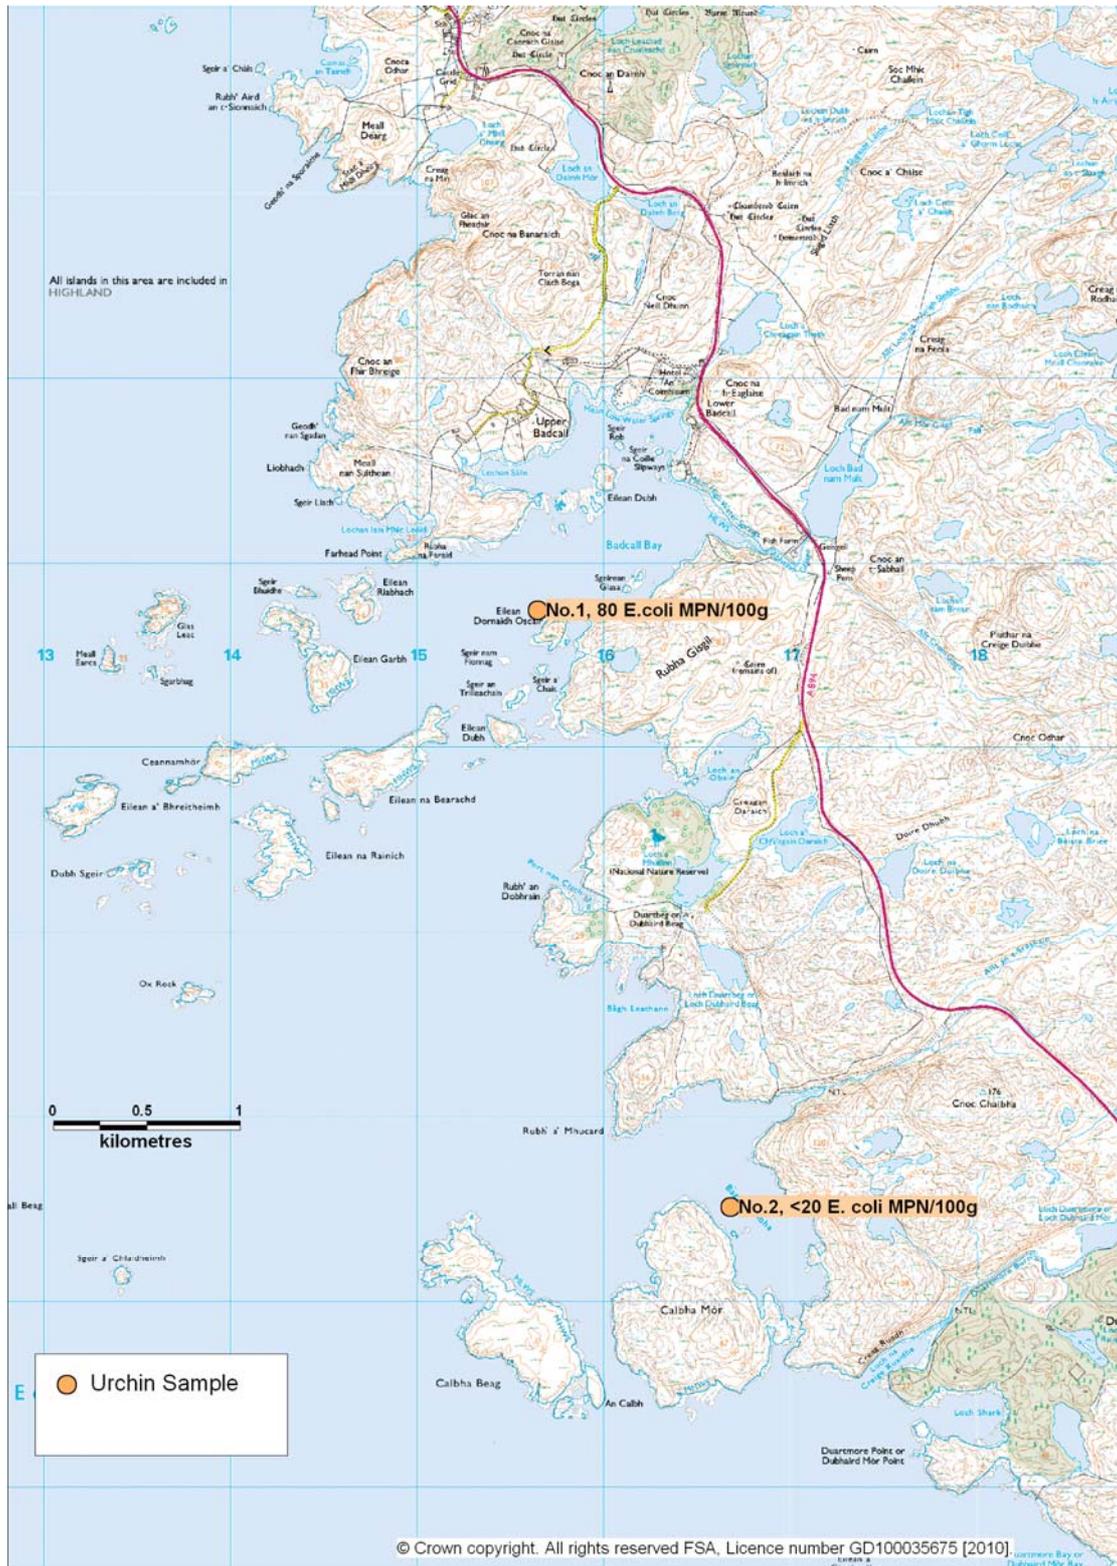
Figure 3. Shellfish sample results map

No.	Date	Sample	Grid Ref	Type	E. coli (mpn/100g)
1	29/09/09	Urchin 1A	NC 15650 40747	Sea urchin	80
2	29/09/09	Urchin 1B	NC 16680 37513	Sea urchin	<20

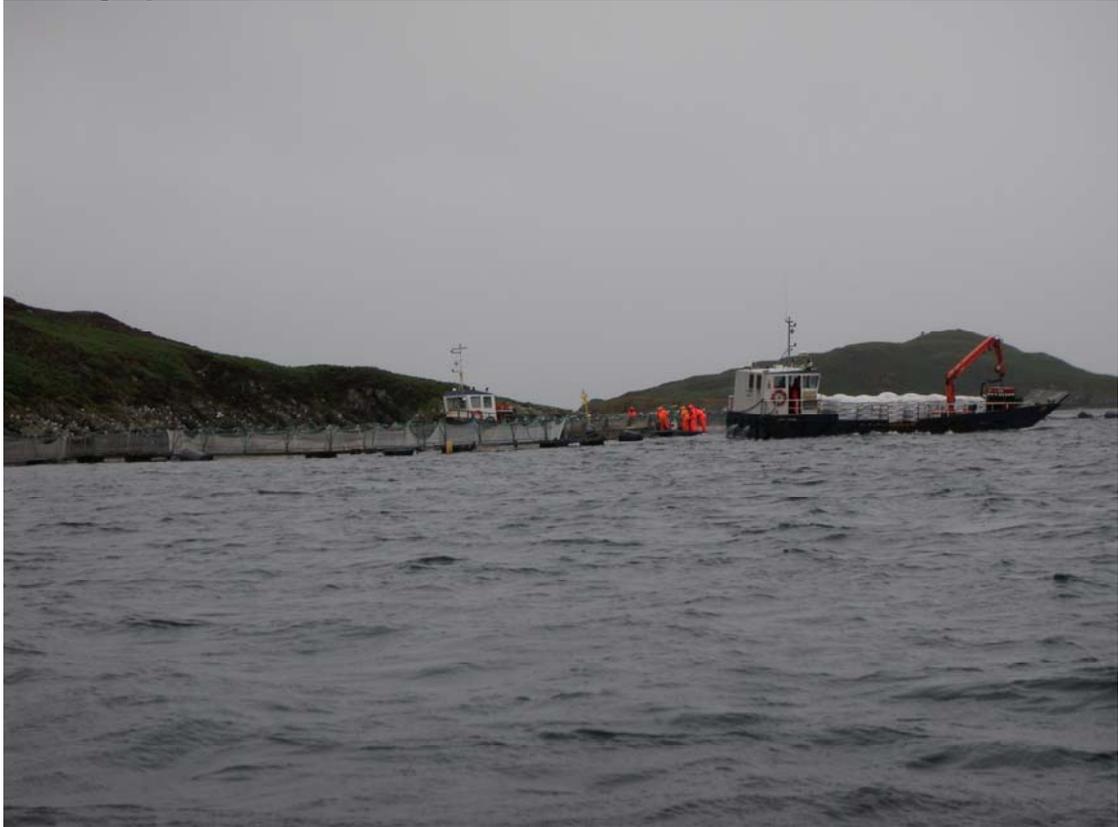
Figure 4. Salmon farm with urchin cages suspended beneath walkways

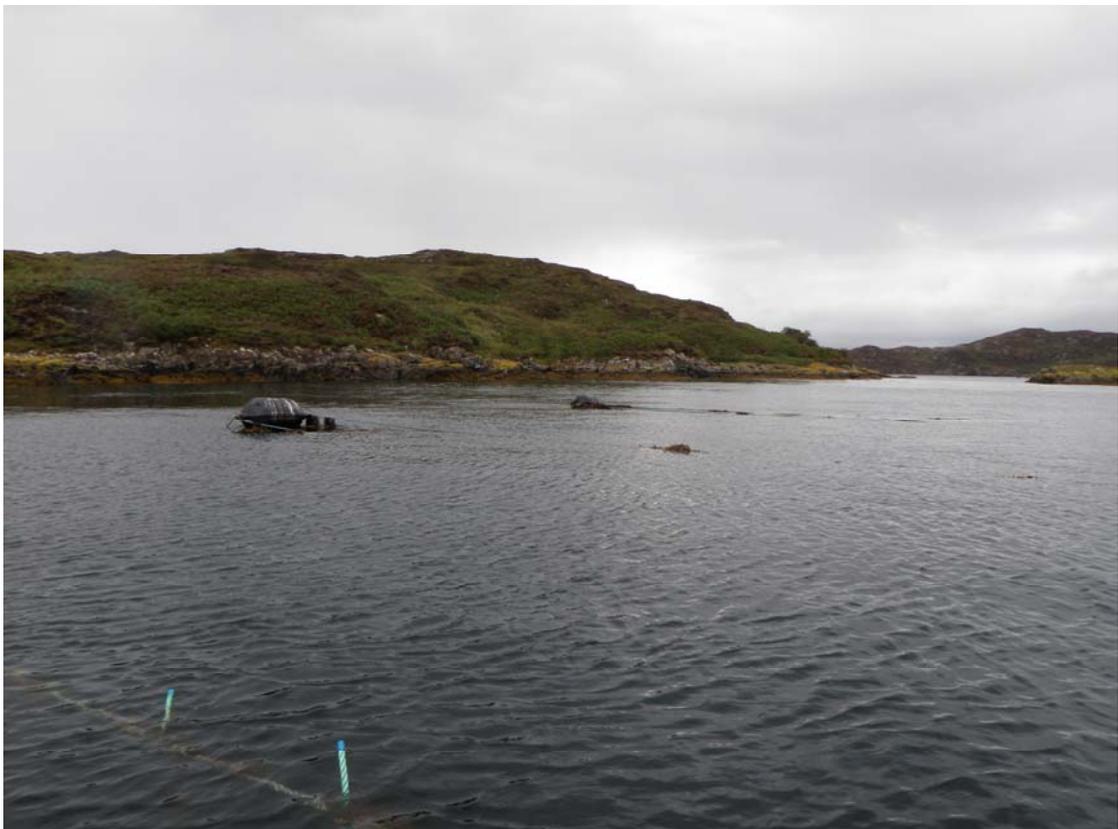
Figure 5. Seaweed culture at Bàgh Chalbha

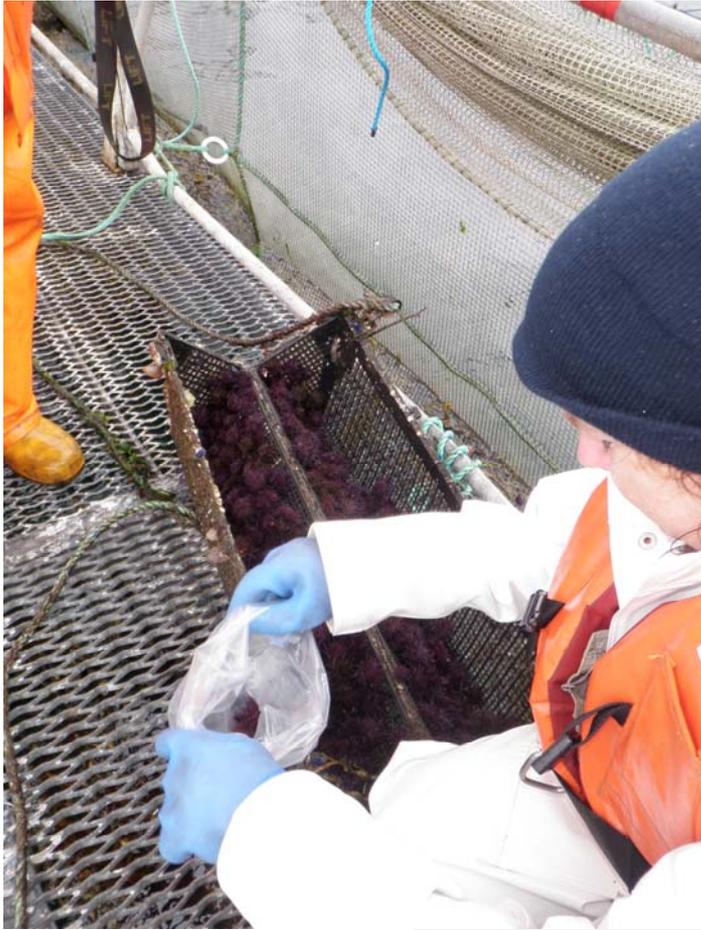
Figure 6. Sampling from urchin cages

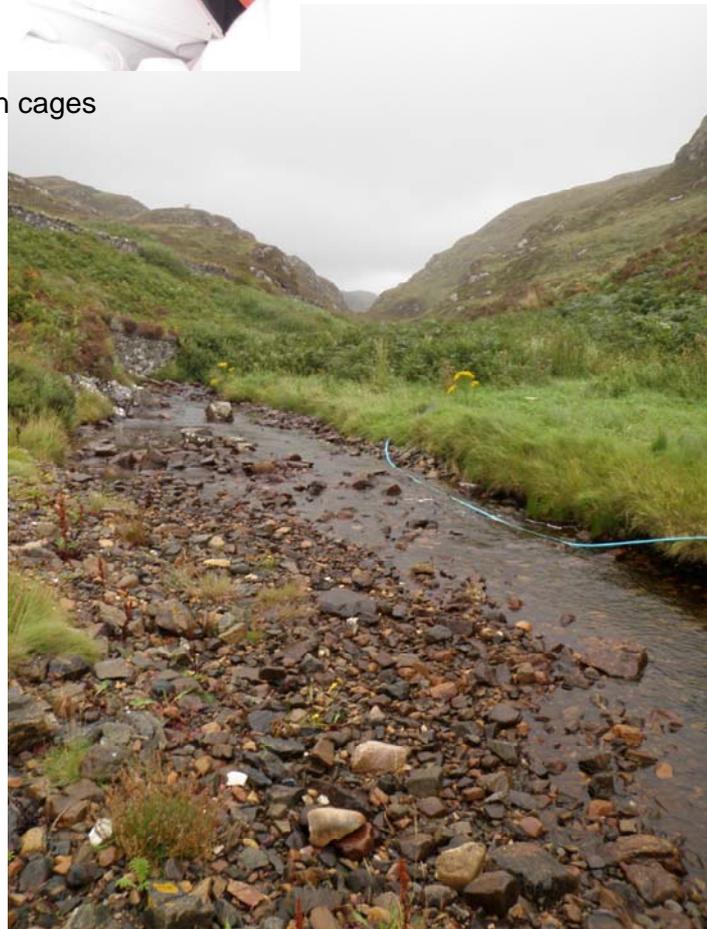
Figure 7. Stream at Lower Badcall

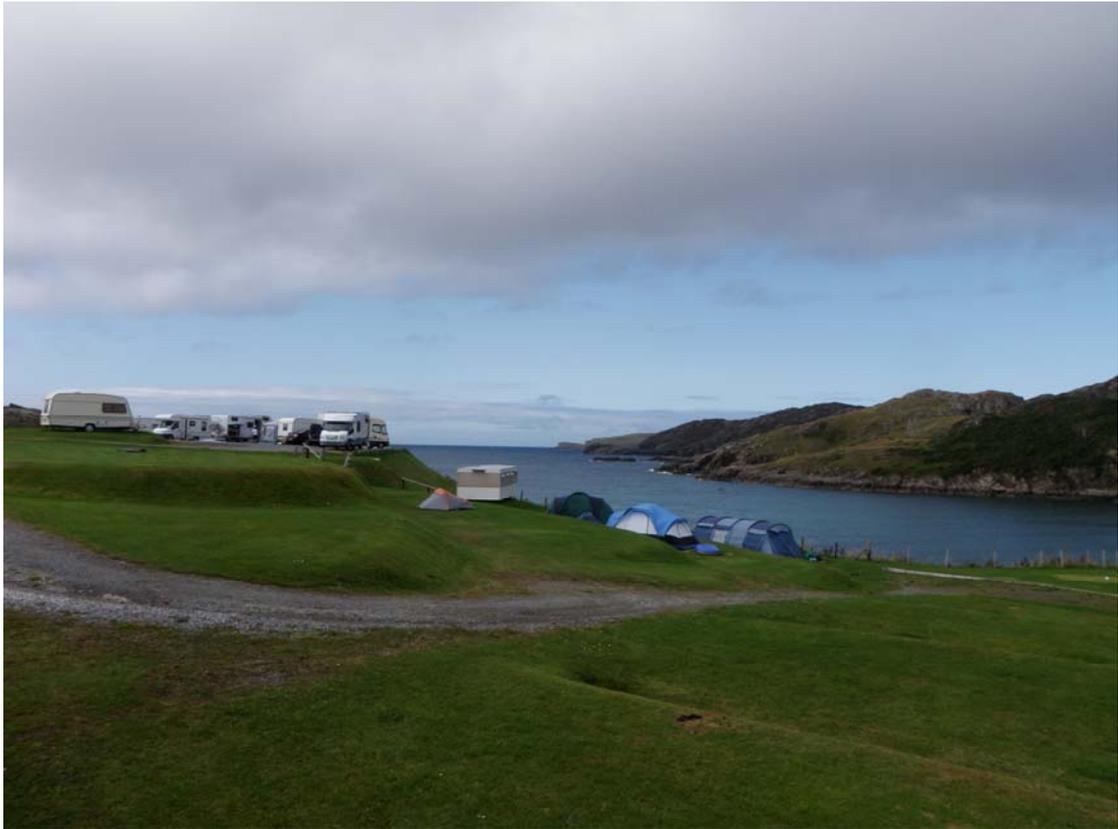
21	190	12-Aug-09	14:27:19	NC 15458 44671	215458	944671	Figure 8	Café and campground, at least 3 static pitches, 6 mobile caravans and 6 tents, toilets
22	191	12-Aug-09	14:48:23	NC 15512 44965	215512	944965	Figure 9	Pipe in seawall, concrete, dribbling, sewage fungus and smell
23	192	12-Aug-09	14:50:07	NC 15501 44965	215501	944965	Figure 10	Iron pipe in seawall, no flow. Trickle of water through wall below pipe, with green algal growth
24	193	12-Aug-09	14:54:43	NC 15532 44912	215532	944912		Picnic area and dog waste bins
25	194	12-Aug-09	14:56:07	NC 15534 44864	215534	944864		Culvert, water from pond drains to bay through this. 28 ducks
26	195	12-Aug-09	15:02:56	NC 15532 44962	215532	944962		Large home or lodge

Figure 8. Campground at Scourie

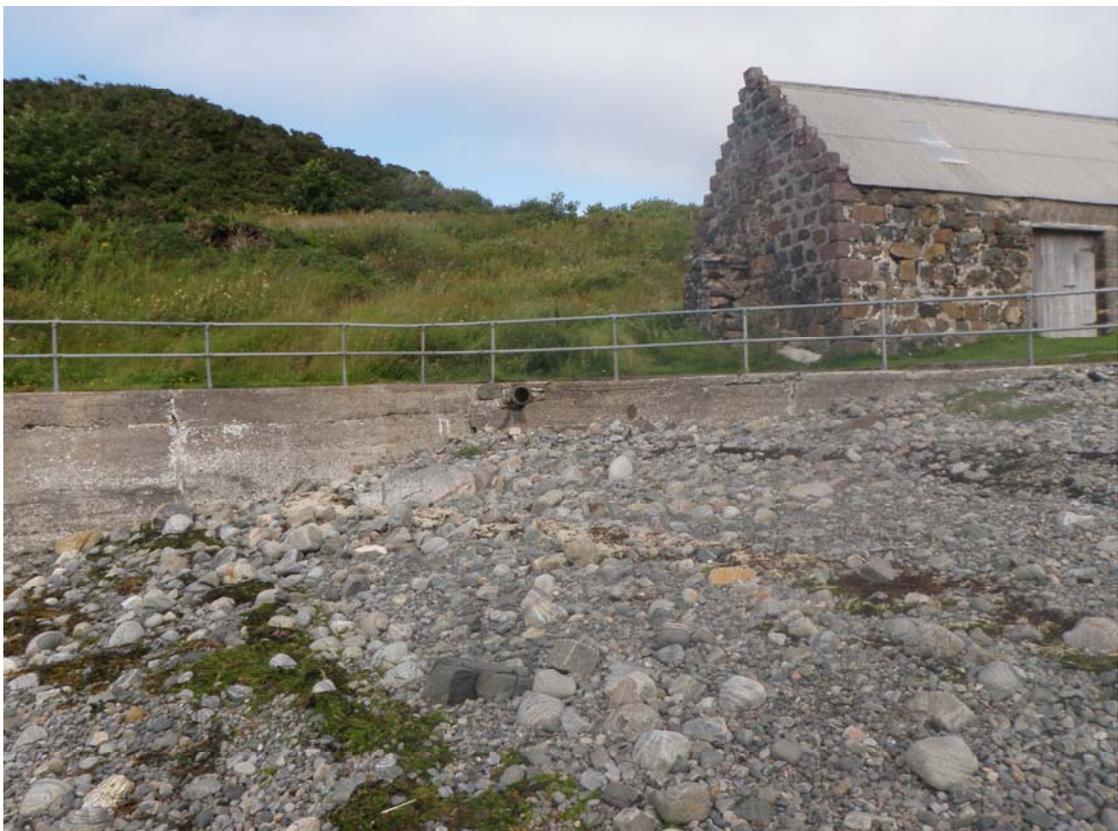
Figure 9. Concrete pipe in jetty wall, Scourie

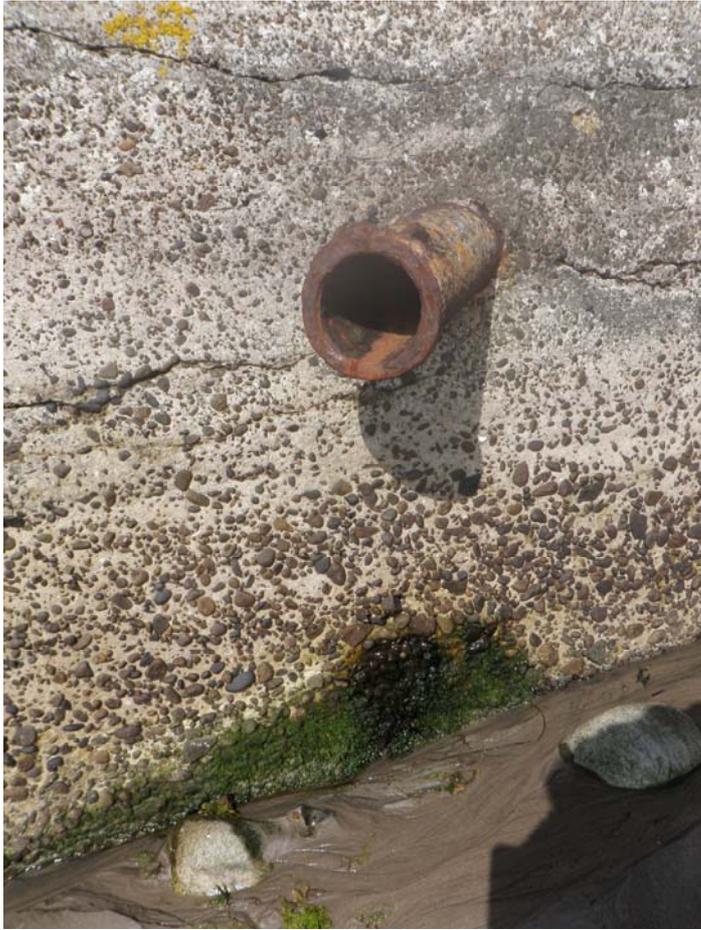
Figure 10. Iron pipe in seawall, Scourie

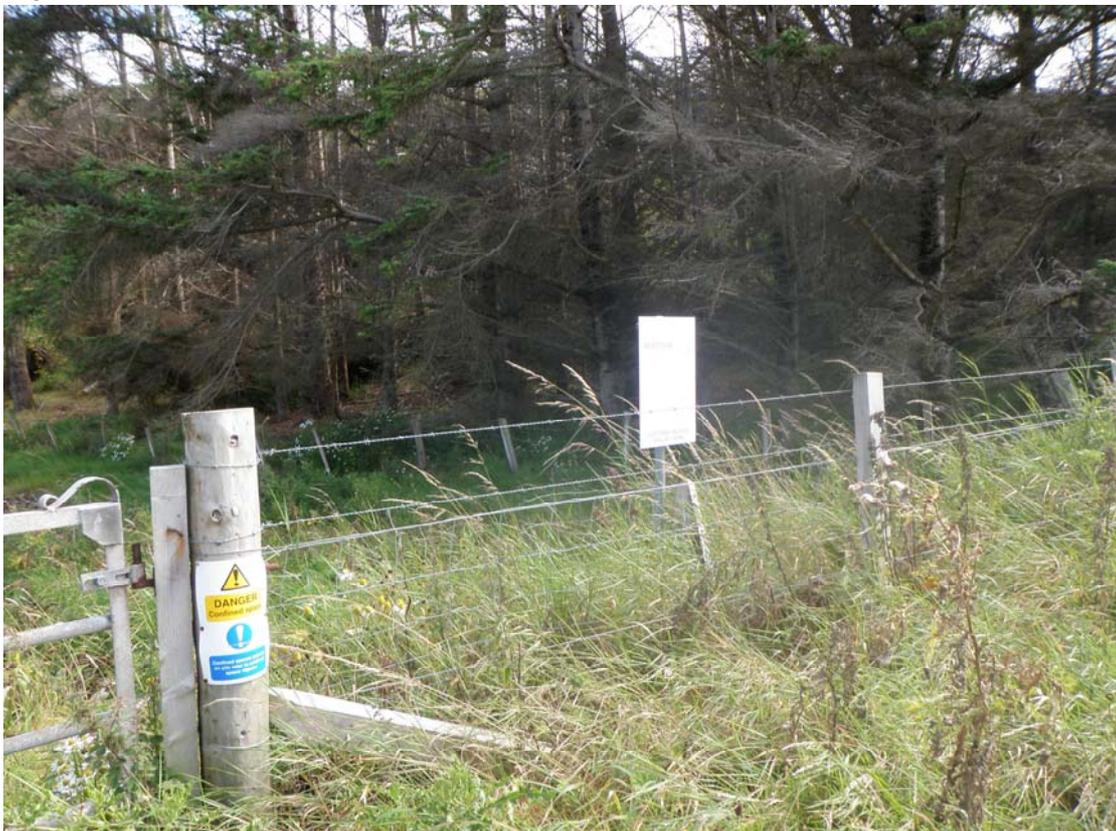
Figure 11. Septic tank at Scourie village

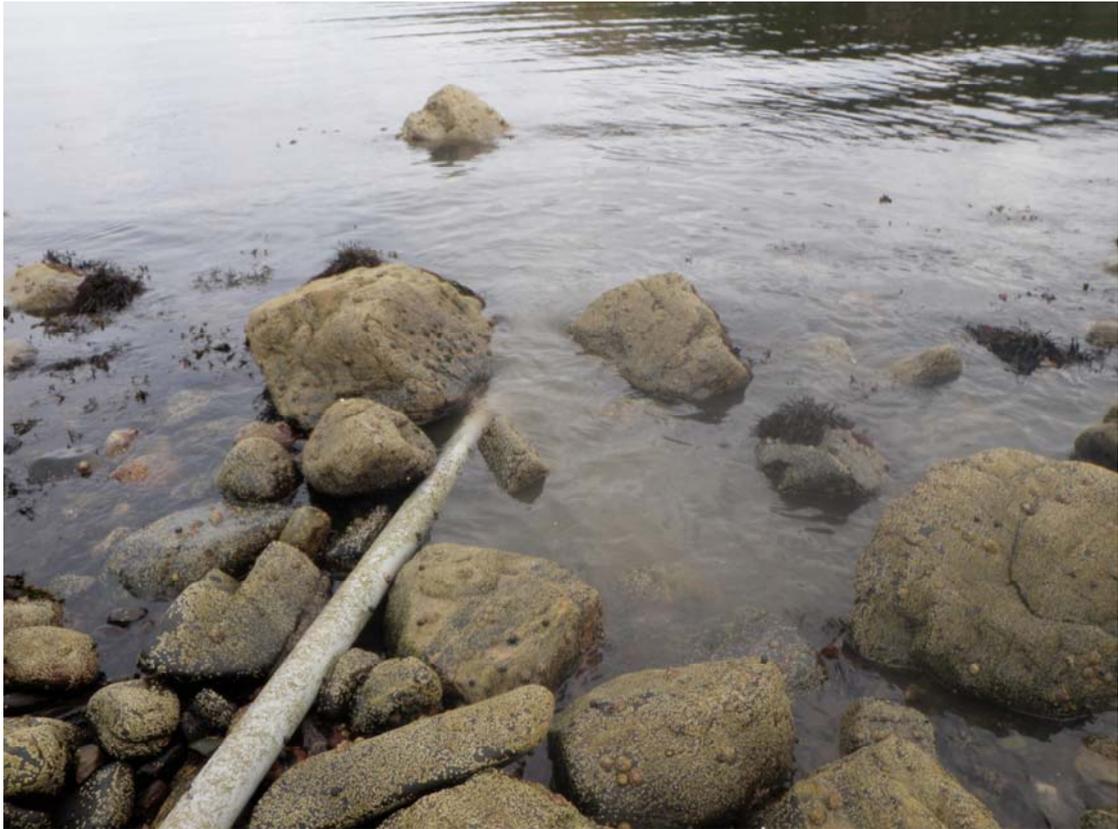
Figure 12. Discharge pipe at shore below campground

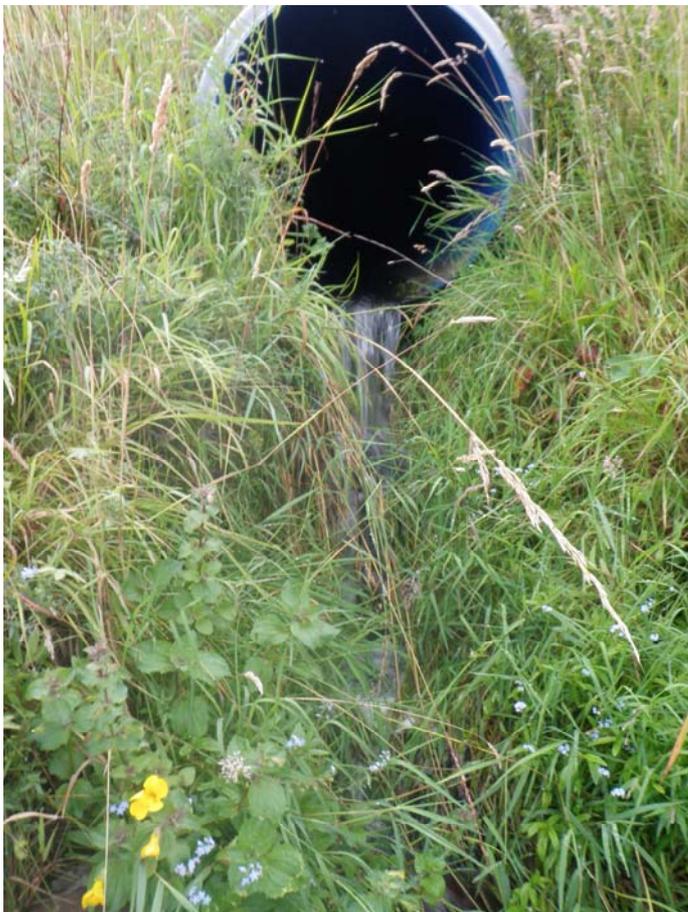
Figure 13. Flow through corrugated pipe in hillside below campground

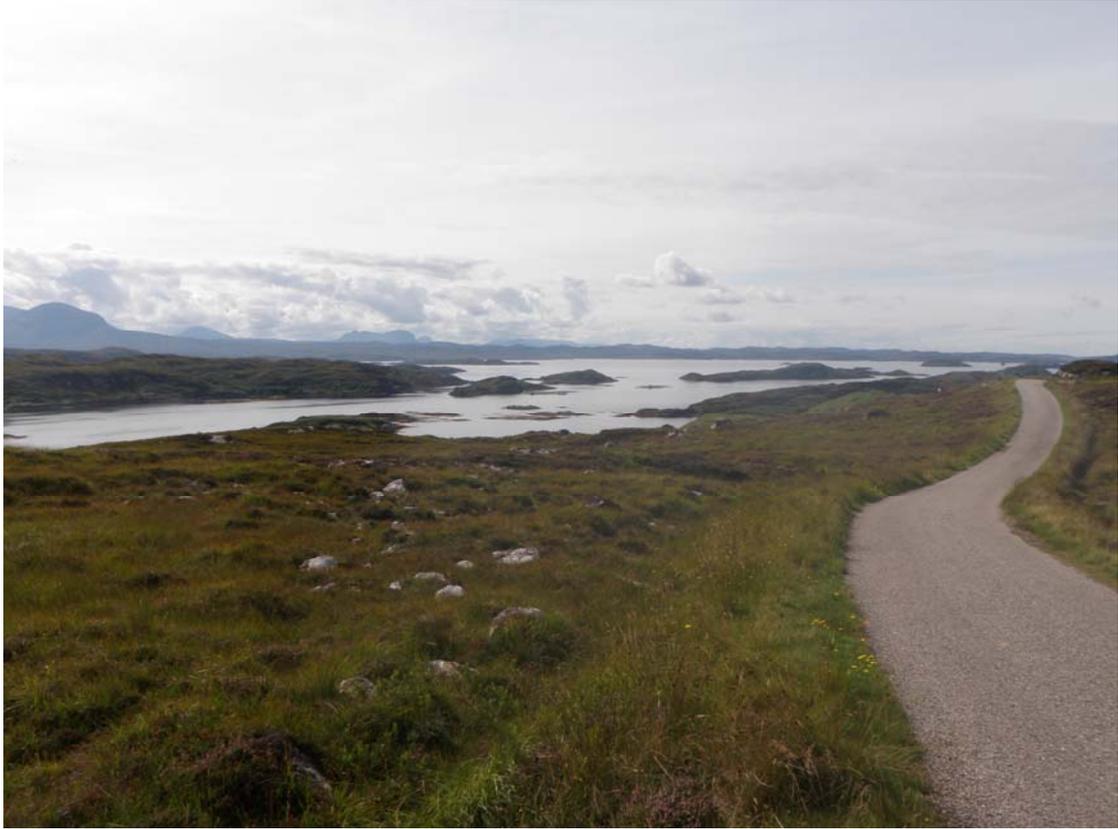
35	204	13-Aug-09	10:33:42	NC 17184 38140	217184	938140	Figure 14	Stream sampled yesterday, width 2.1 m, depth 11 cm, 0.2m/s. Photograph viewing west along north shore of Badcall Bay
36	205	13-Aug-09	11:25:03	NC 16009 42568	216009	942568		11 rams
37	206	13-Aug-09	11:33:02	NC 15625 42138	215625	942138	Figure 15	Stream, width 70 cm, depth 10 cm, flow 0.022m/s. Water sample 9. Photograph looking southeast toward Loch Duart shore base
38	207	13-Aug-09	11:42:55	NC 15778 42084	215778	942084		House, no visible pipes on shore looking sw of this point
39	208	13-Aug-09	11:49:33	NC 15612 41899	215612	941899		House, 6 sheep
40	209	13-Aug-09	11:52:01	NC 15388 41786	215388	941786		House, 30 sheep
41	210	13-Aug-09	12:03:04	NC 15213 41580	215213	941580		Stream, width 65 cm, depth 14 cm, flow too slow to detect. Water sample 10. Goose droppings
42	211	13-Aug-09	12:22:09	NC 15518 41814	215518	941814		3 houses
43	212	13-Aug-09	12:23:58	NC 15571 41955	215571	941955		2 houses, 1 sheep

Figure 14. Looking west along Badcall Bay shoreline

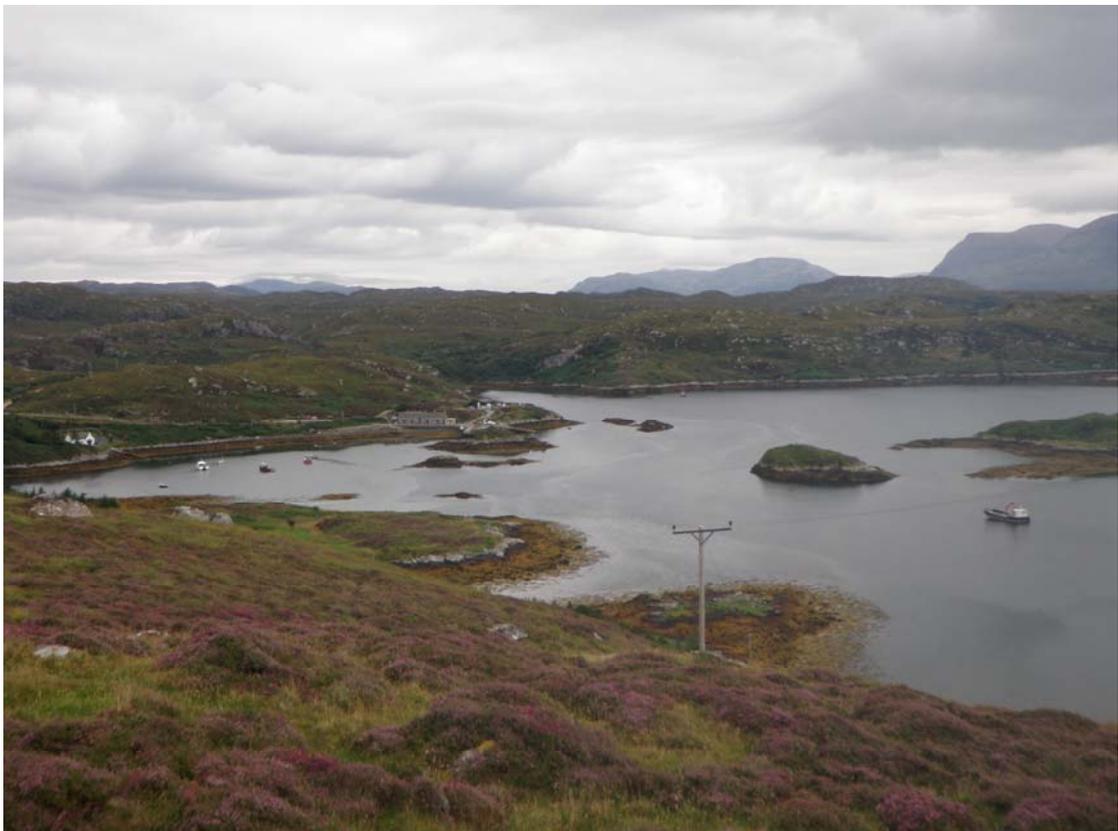
Figure 15. Looking southeast across Badcall Bay to Loch Duart shore base

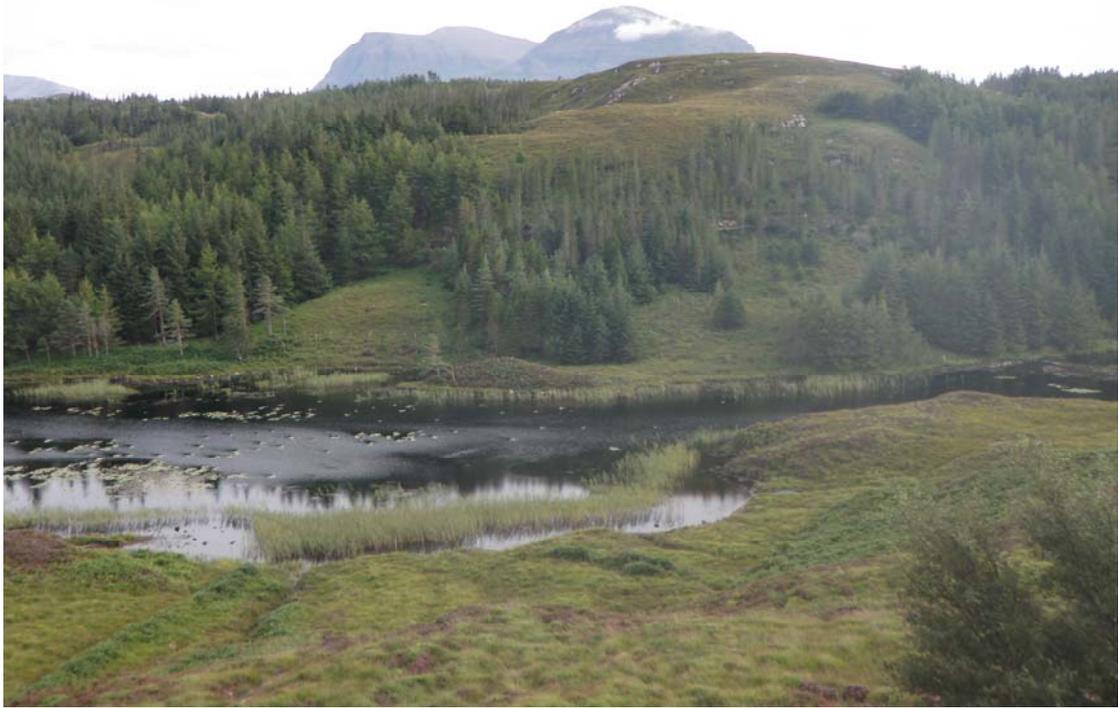
44	213	13-Aug-09	17:12:13	NC 15849 44725	215849	944725		Public toilets, dog waste bin, picnic area
45	214	13-Aug-09	17:39:18	NC 19158 37684	219158	937684		Crofts, 3 cattle, 42 sheep
46	215	13-Aug-09	17:57:48	NC 16363 41984	216363	941984	Figure 16	View point of weirs and ponds, upper Duartmore Burn.
47	216	13-Aug-09	17:58:24	NC 16365 41984	216365	941984		Edrachilles hotel plus cottage, small home, and static caravan
48	na	29-Sep-09	na	NC 16448 41880	216448	941880		Water sample BB1A, stream at Badcall
49	na	29-Sep-09	na	NC 17094 38111	217094	938111		Water sample BB2A, Allt an t-Strathain
50	na	29-Sep-09	na	NC 16646 37513	216646	937513		Seawater sample BB3A
51	na	29-Sep-09	na	NC 16680 37513	216680	937513		Seawater sample BB4A

Figure 16. Looking down over Duartmore Burn
