Scottish Sanitary Survey Project

Restricted Sanitary Survey Report Ettrick Bay AB 389 September 2008

Ettrick Bay Restricted Survey Report Final 17/12/09

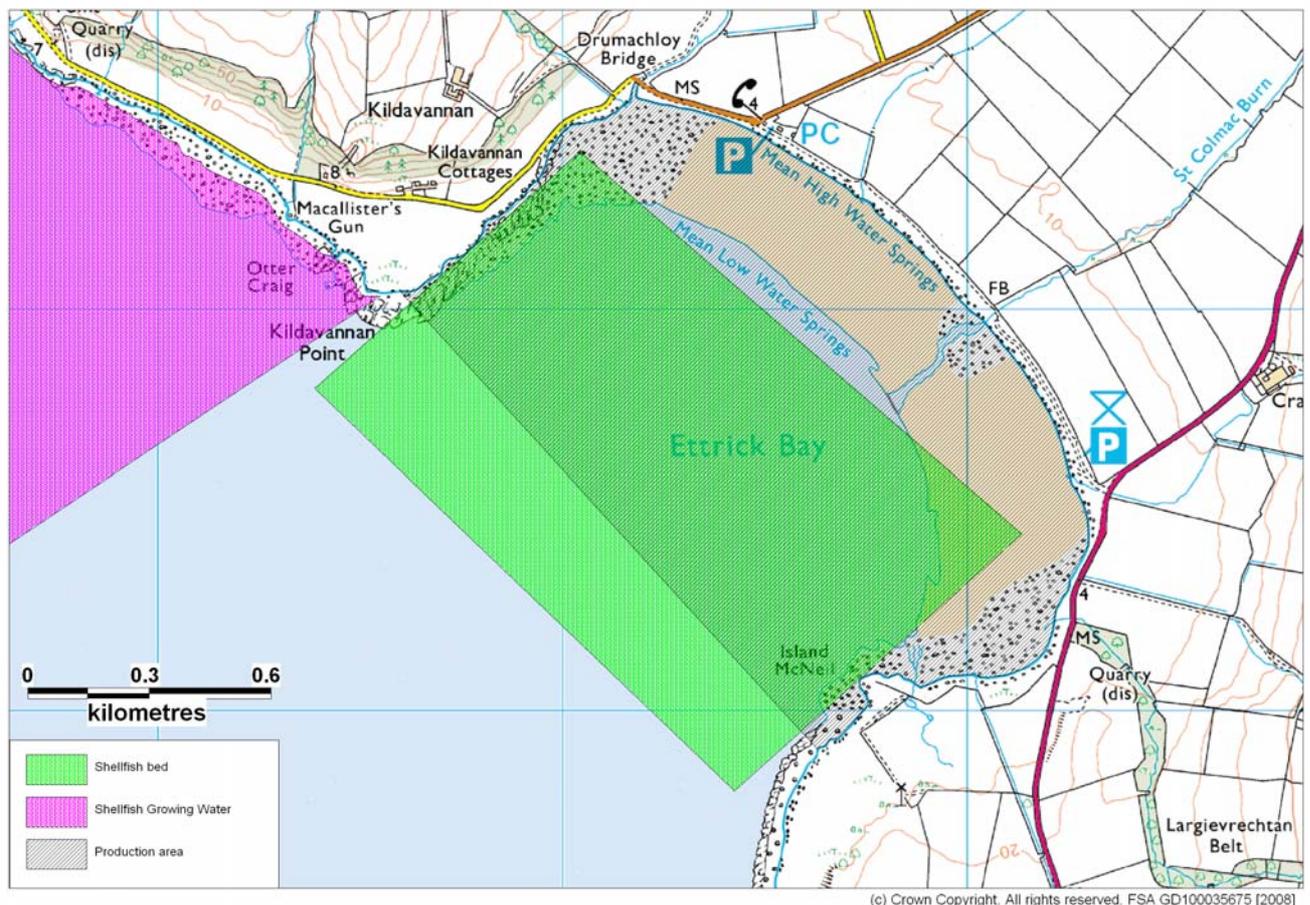
Figure 2.1 Ettrick Bay Fishery

There is currently no RMP assigned to this area. The bay does not fall within a designated Shellfish Growing Water, though it does lie immediately to the southeast of the Kyles of Bute Shellfish Growing Water (see Figure 2.1).

The actual shellfishery as identified by the harvester covers the area bounded by lines drawn between NS 02387 65803, NS 03043 66394, NS 04134 65441 and NS 03425 64800. The razor clams will be fished all year round (weather permitting) by hand and mechanical methods by divers from boats.

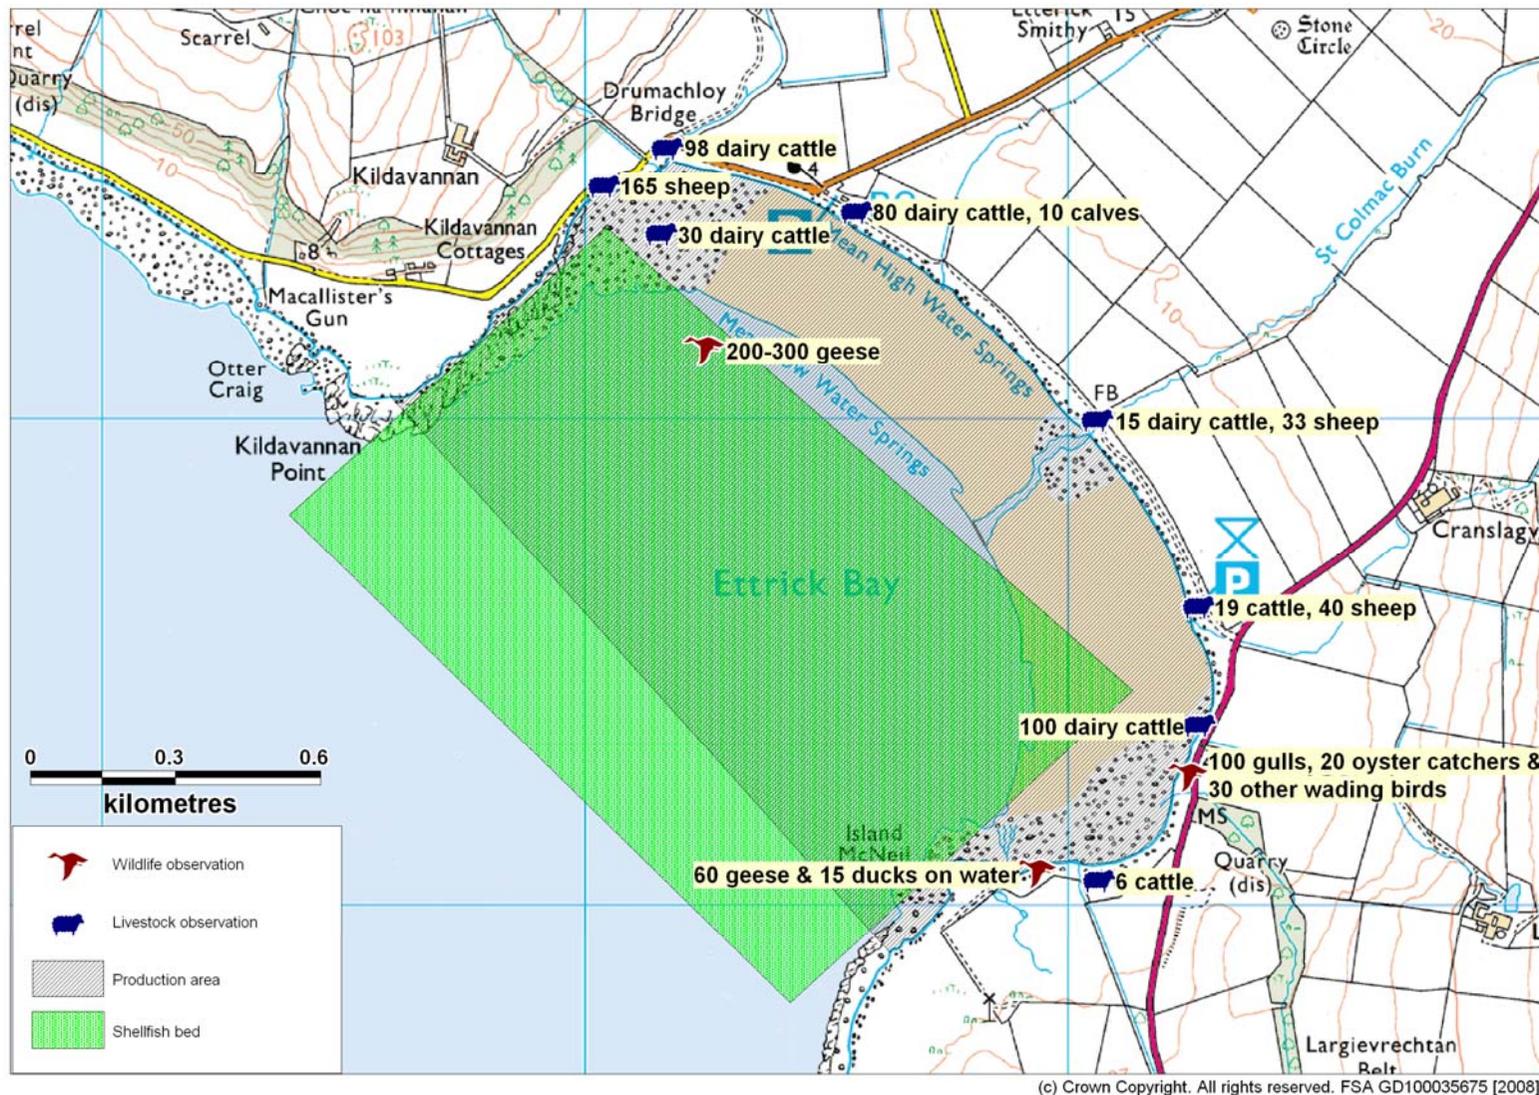
Figure 4.1 Wildlife and livestock observations at Etrick Bay

During the shoreline survey, approximately 350 cattle and 205 sheep were observed grazing in the fields surrounding Ettrick Bay (see Figure 4.1).

The shoreline survey identified that sheep grazed widely around the Ettrick Bay coastline. Livestock were concentrated at either end of the bay, with a larger number at the north-western end. Dairy cattle and sheep were also observed grazing close to St Colmac Burn, which runs across the sand to discharge in the middle of the bay.

While the Isle of Bute does host some colonies of breeding seabirds, Ettrick Bay rarely hosts significant colonies. Seabirds such as gulls will always be present on the bay but their distribution is likely to be even over time and as such would not materially affect placement of an RMP. During the shoreline survey roughly 350 geese were spotted on the eastern shoreline in addition to 15 ducks, 100 gulls, 20 oystercatchers and 30 other wading birds at the far western end of the bay (see Figure 4.1).

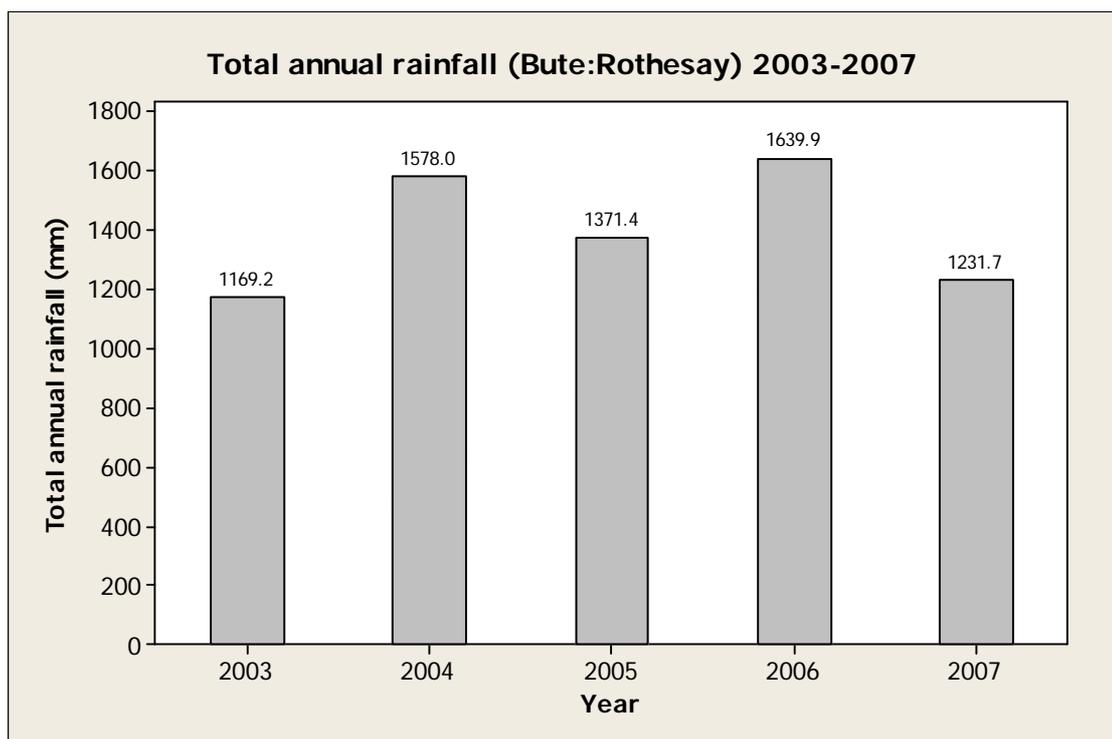
Figure 5.1 Total annual rainfall at Bute: Rothesay 2003 – 2007 (no records for December 2007, plus an additional 6 days in July & 2 days in September).

As the rainfall records from Bute are nearly complete, total annual rainfall and mean monthly rainfall can be calculated, and are presented in Figures 5.1 and 5.2.

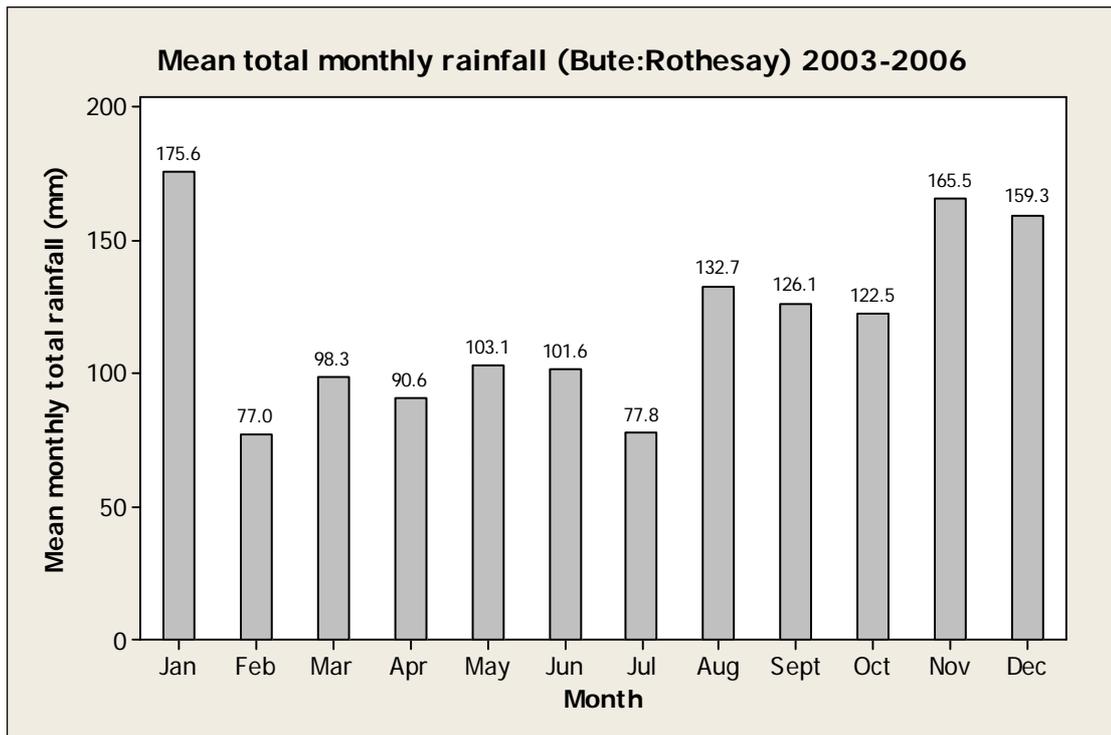
Figure 5.2 Mean total monthly rainfall at Bute: Rothesay 2003 – 2006
(2007 not included due to missing data)

The wettest months were January, November and December. For the period considered here (2003 – 2006), only 39.40% of the days experienced no rainfall. 9.38% of days experienced rainfall of 1mm or less.

It can be expected that levels of rainfall dependent faecal contamination entering the production area from these sources will be higher during the autumn and winter months. It is possible that faecal matter can build up on pastures during the drier summer months when stock levels are at their highest, leading to more significant faecal contamination of runoff at the onset of the wetter weather in the autumn.

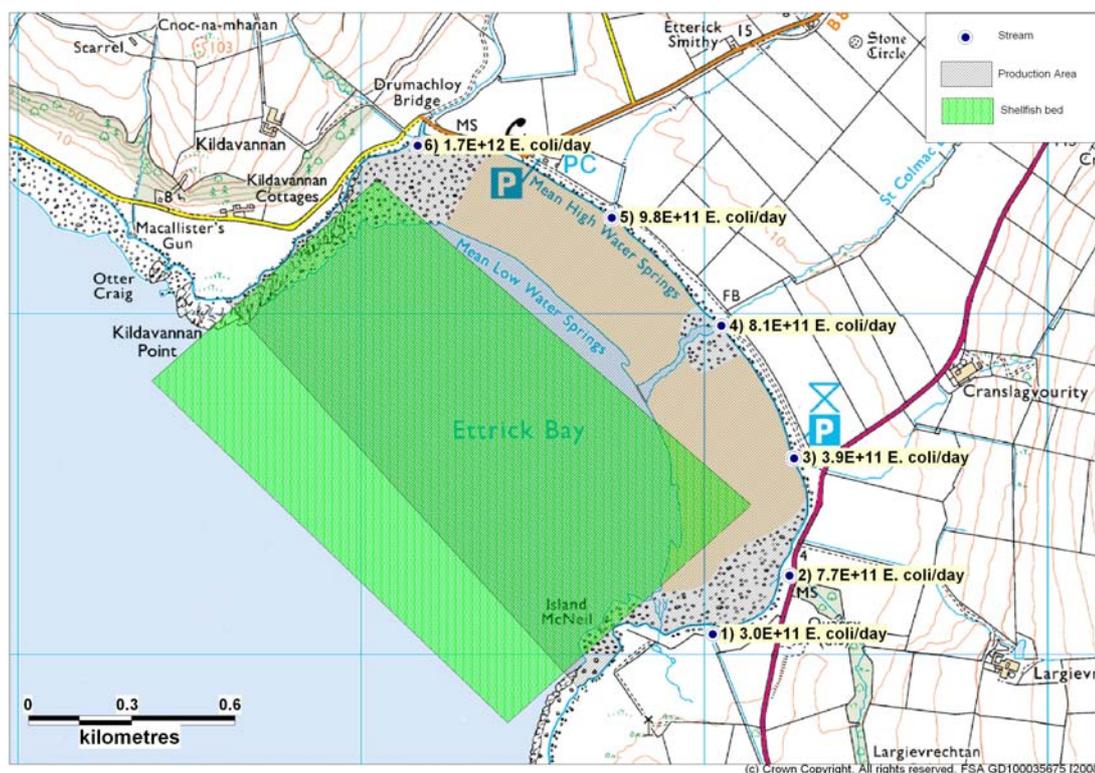
Figure 6.1 Location of river flows and loadings at Ettrick Bay

There is no river gauging station in the vicinity of Ettrick Bay. There are 8 streams discharging into Ettrick Bay and their locations can be seen in Figure 6.1. The following streams were sampled during the shoreline survey. These represented the largest freshwater inputs to Ettrick Bay.

All of the streams sampled contained between 1800 and 5000 cfu *E.coli*/100 ml, which indicated significant levels of faecal contamination. Calculated loadings are based on the flows and dimensions observed during the shoreline survey only.

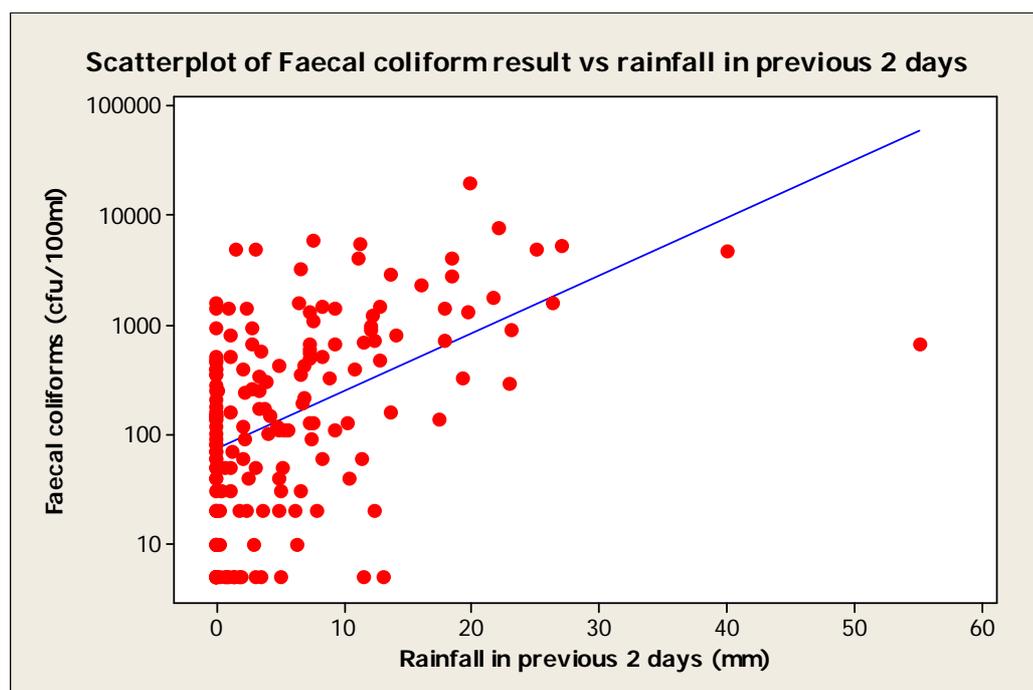
Figure 7.1 Scatterplot of Faecal Coliform results against rainfall in previous 2 days

The coefficient of determination indicates that there was a moderately strong positive relationship between the faecal coliform result and the rainfall in previous two days (Adjusted R-sq=22.5%, p=0.000 Appendix 3).

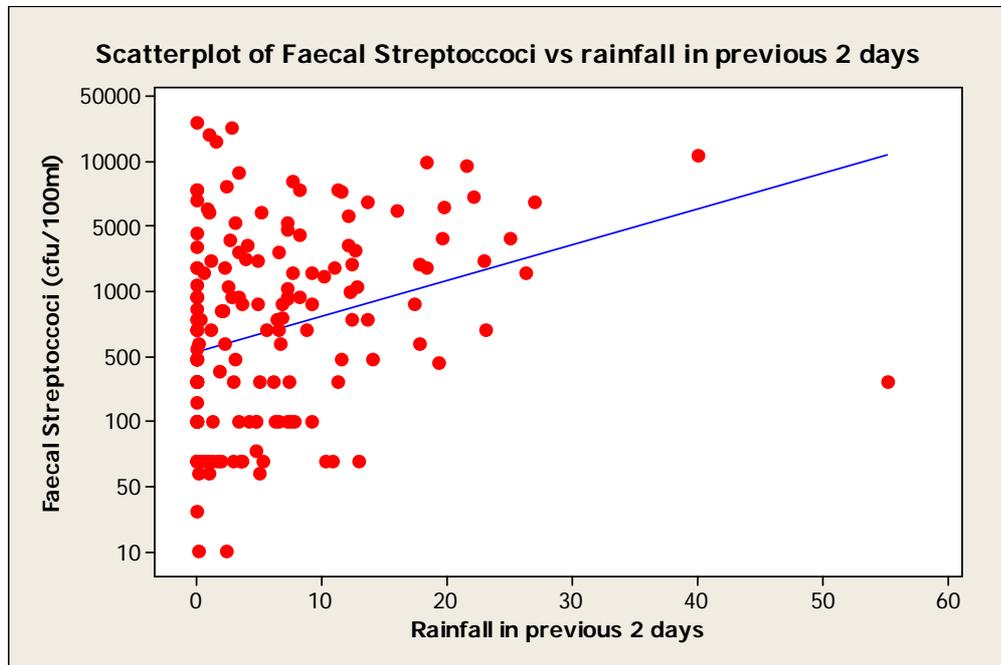
Figure 7.2 Scatterplot of Faecal Streptococci results against rainfall in previous 2 days

The coefficient of determination indicates that there was a weak positive relationship between the Faecal Streptococci result and the rainfall in previous two days (Adjusted R-sq=8.2%, p=0.000 Appendix 3).

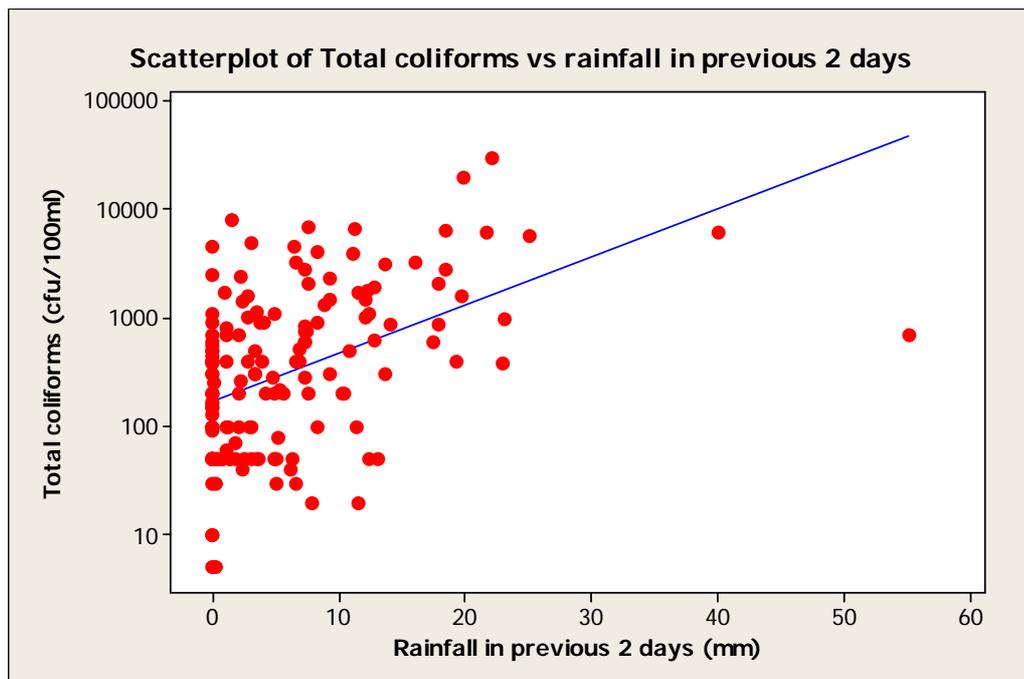
Figure 7.3 Scatterplot of Total Coliform results against rainfall in previous 2 days

The coefficient of determination indicates that there was a moderately strong positive relationship between the Total Coliform result and the rainfall in previous two days (Adjusted R-sq=20.7%, p=0.000 Appendix 3).

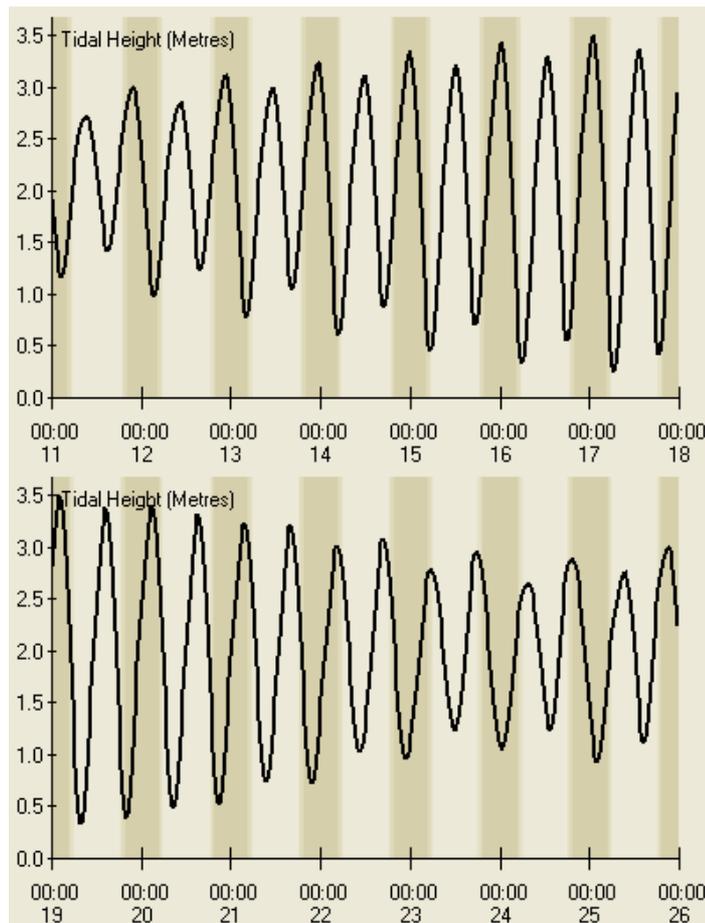
Figure 8.4 Tidal curves for Millport

The two tidal curves below are for the port of Millport, the nearest secondary port—they have been output from UKHO TotalTide. The first is for seven days beginning 00.00 GMT on 11th September 2008. The second is for seven days beginning 00.00 GMT on 19th September 2008. Together they show the predicted tidal heights over high/low water for a full neap/spring tidal cycle.

The following is the UKHO summary description for Millport:
The tide type is Semi-Diurnal.

MHWS	3.4 m
MHWN	2.7 m
MLWN	1.0 m
MLWS	0.4 m

Predicted heights are in metres above chart datum. The tidal range at spring tide is therefore approximately 3 m and at neap tide 2.3 m.

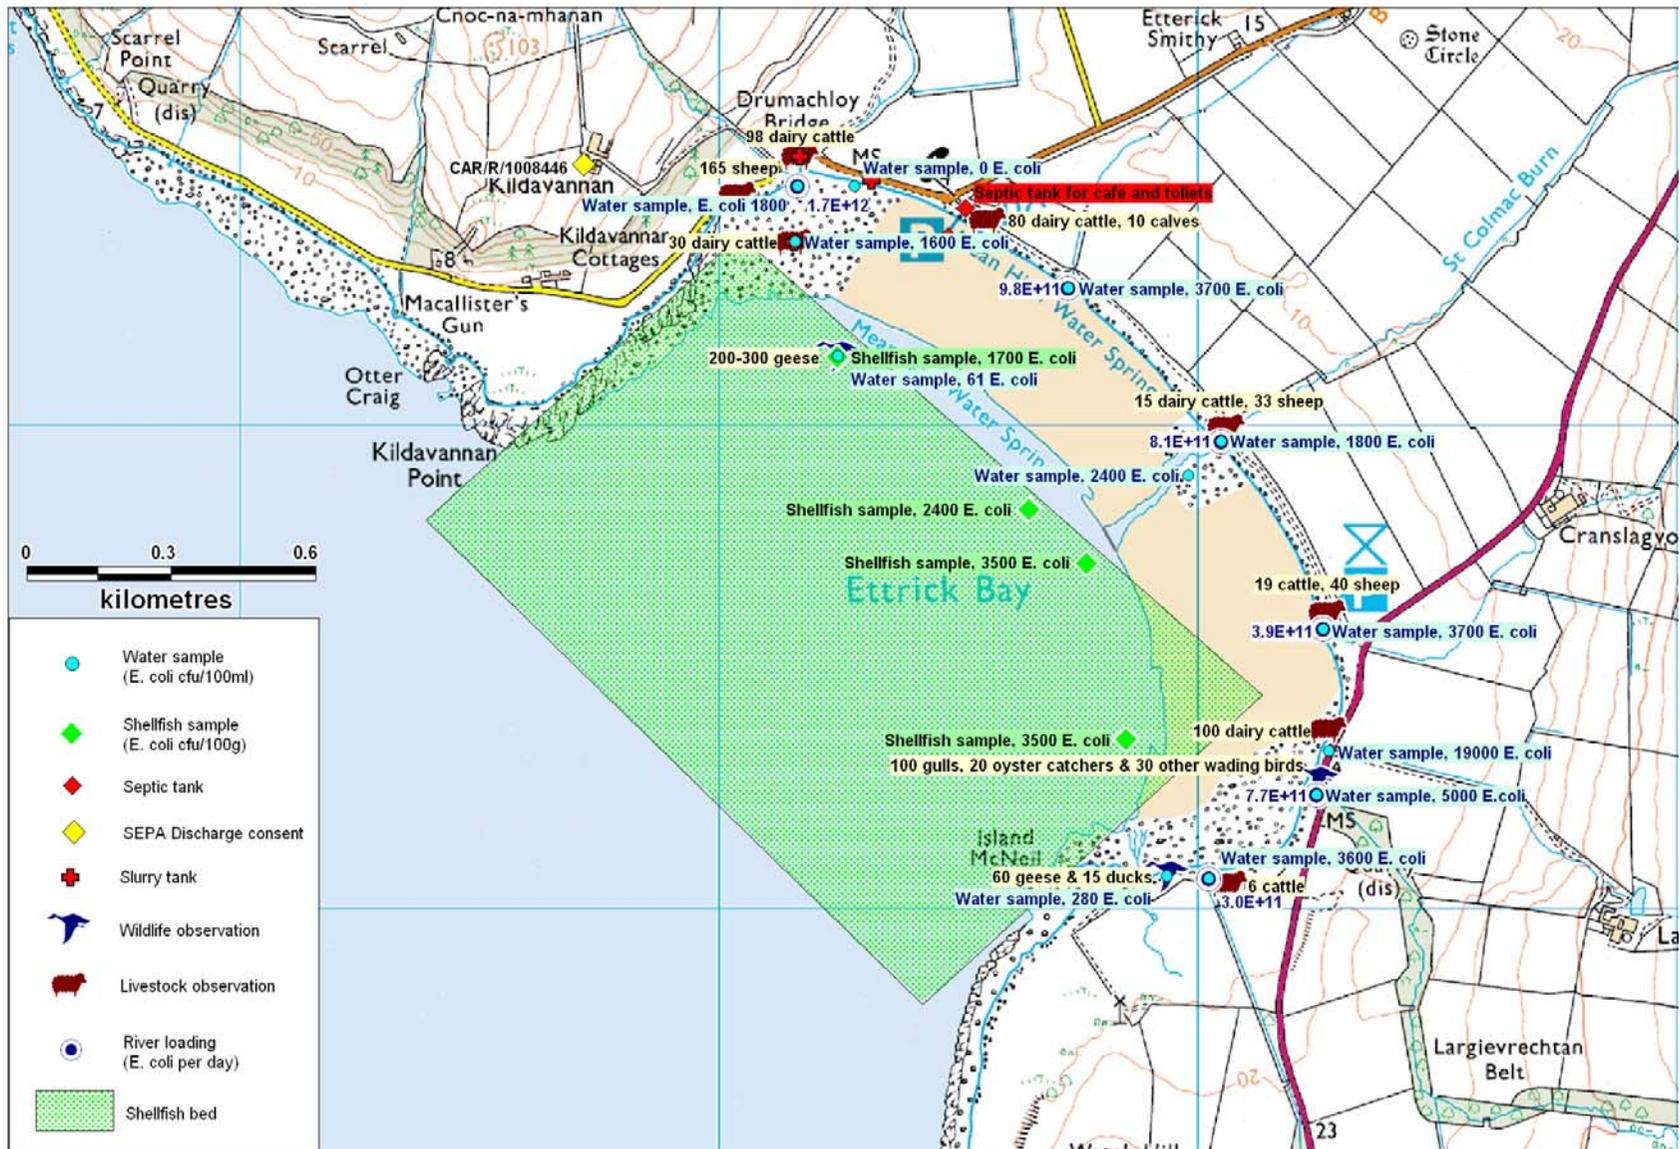
Figure 9.1 Summary of shoreline observations

In summary, identified sources of potentially significant contamination are:

- Heavily contaminated freshwater input from streams running through grazed land.
- Inputs from livestock grazing on the shoreline.
- Slurry tanks and dung heap near shoreline.
- The septic tank for the café and public toilets at the southeastern end of the shoreline discharging onto the beach.

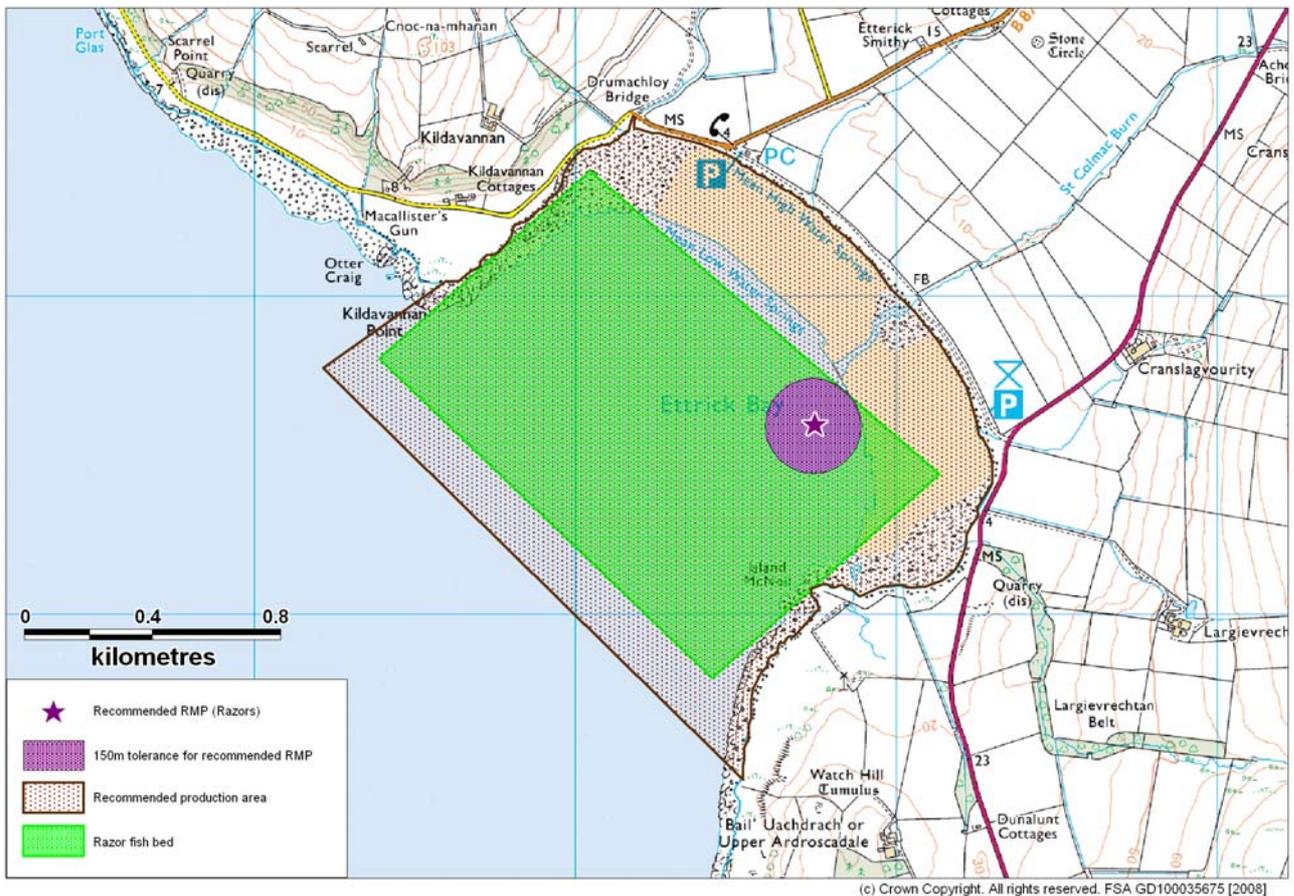
Figure 11.1 Recommendations for Etrick Bay

Figure 11.1 illustrates the recommended RMP and new production area boundaries for Etrick Bay.

It is recommended that the boundaries of the new Etrick Bay razor fish production area be set as the area bounded by lines drawn between NS 03522 64480, NS 02211 65774, NS 02596 66048 and then extended to MHWS.

The RMP should be placed close to St Colmac Burn at NS 03746 65598 (see Figure 11.1) with a 150 m tolerance.

Sampling frequency should be monthly as there is inadequate monitoring history on which to base less frequent sampling.

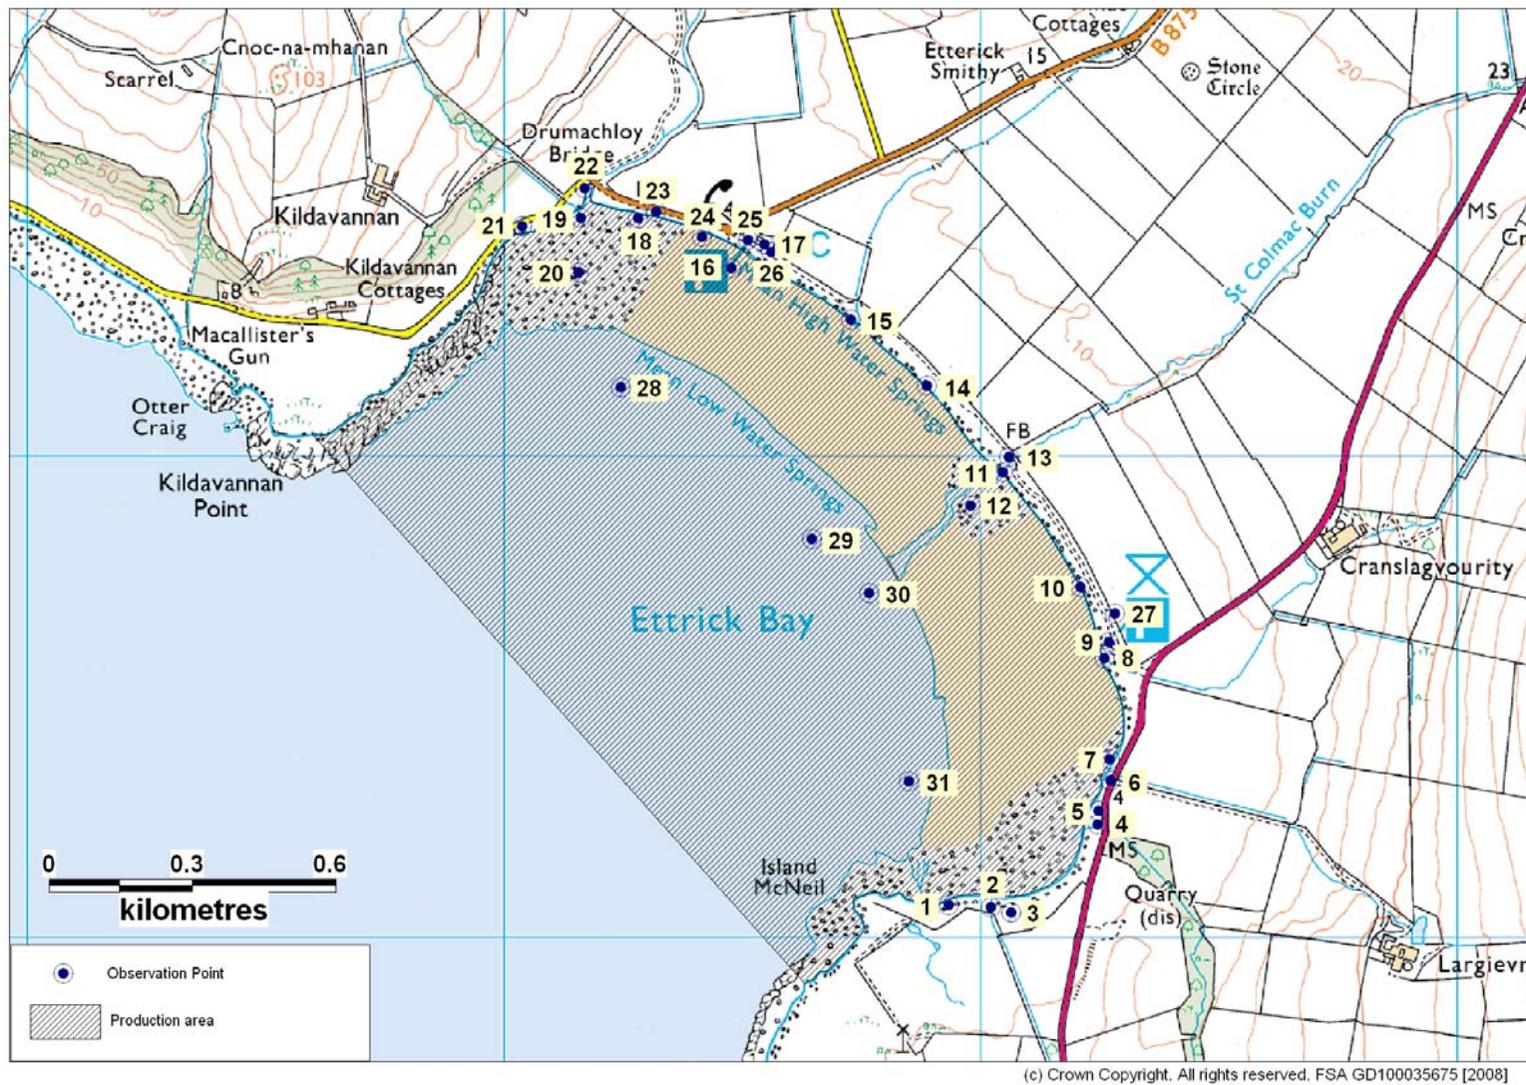
Figure 1 Shoreline observations

Observations can be found in Table 1.

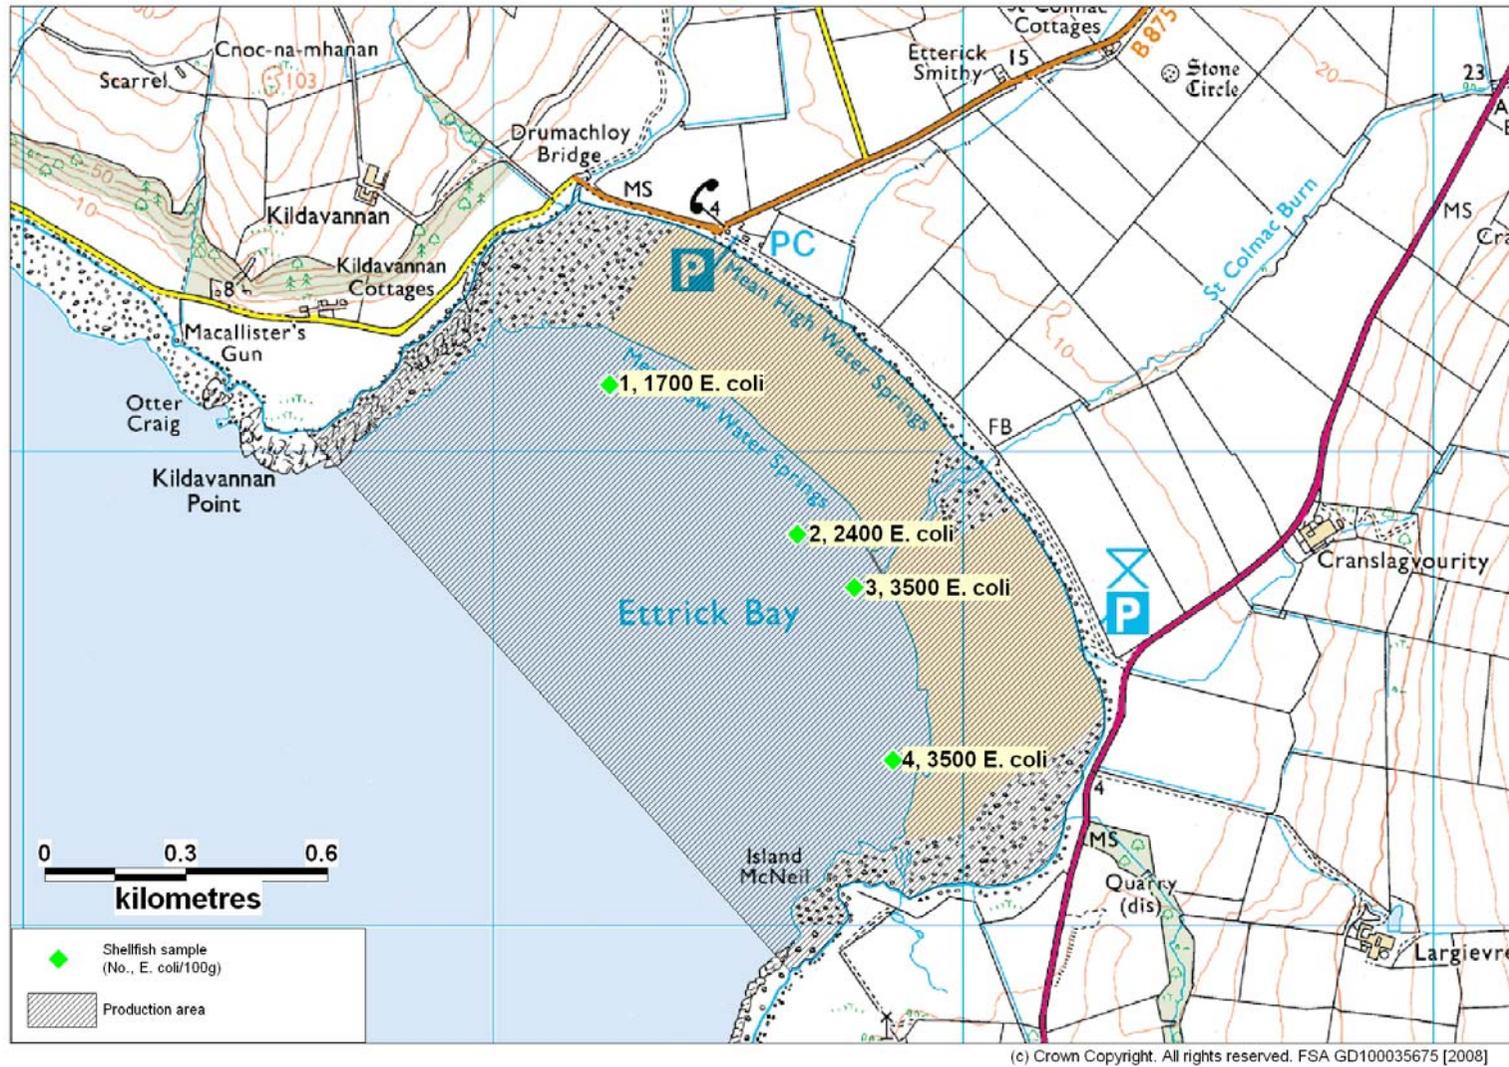
Figure 3 Shellfish sample results

No.	Date	Sample	Grid Ref	Type	E. coli (cfu/100g)
1	17.09.08	Ettrick Razor sample 1	NS 03248 66144	Razor clam	1700
2	17.09.08	Ettrick Razor sample 2	NS 03648 65828	Razor clam	2400
3	17.09.08	Ettrick Razor sample 3	NS 03769 65717	Razor clam	3500
4	17.09.08	Ettrick Razor sample 4	NS 03852 65325	Razor clam	3500

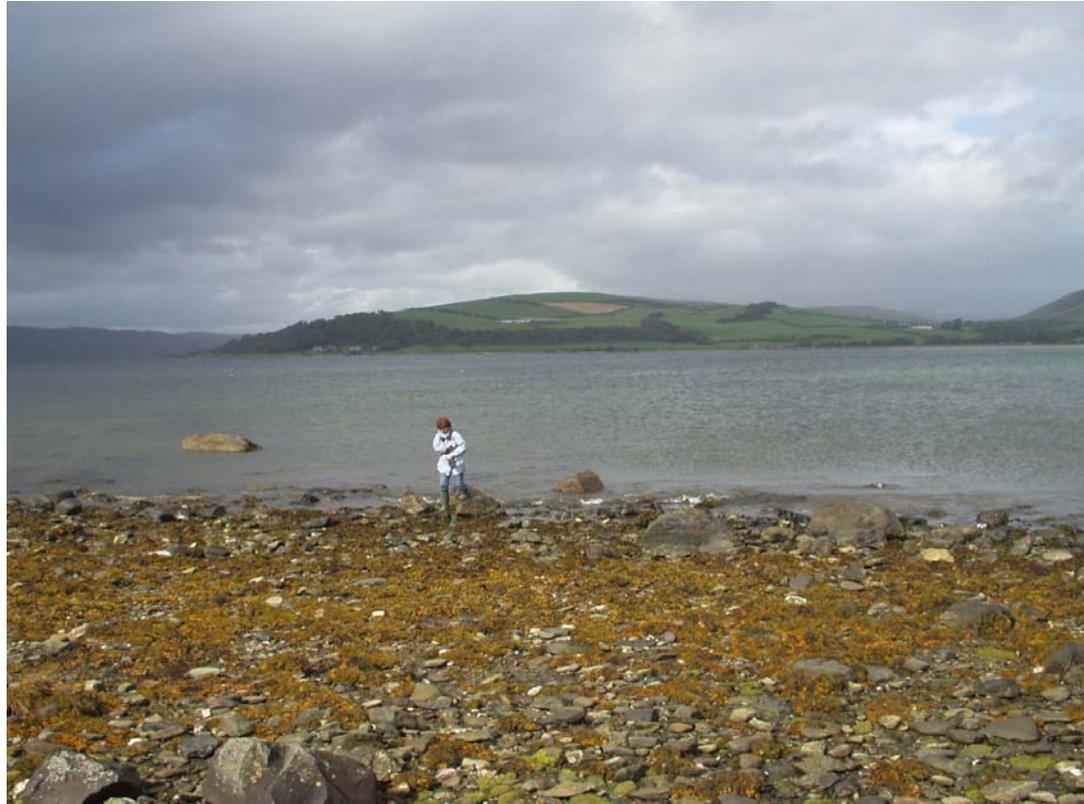
Figure 5 Collection point of seawater sample 1

No.	Date	Time	NGR	East	North	Associated photograph	Description
1	11.09.08	13:22	NS 03935 65067	203935	665067	Figure 5	Seawater 1, salinity 34 ppt, 60 geese and 15 ducks on water,
2	11.09.08	13:36	NS 04024 65063	204024	665063		Stream – 115cm x 15cm x 0.562, Freshwater sample 2
3	11.09.08	13:38	NS 04066 65052	204066	665052		Farmhouse, 6 cows in field
4	11.09.08	13:45	NS 04248 65235	204248	665235	Figure 6	Stream – 330cm x 10cm x 0.543, Fresh water sample 3
5	11.09.08	13:48	NS 04249 65264	204249	665264		Birds on shore; .100 gulls, 20 oyster catchers and 30 other wading birds. Significant number of cockle shells and some mussels shells
6	11.09.08	13:52	NS 04275 65326	204275	665326	Figure 7	Stream under road, pipe 45cm diameter. Freshwater sample 4.
7	11.09.08	13:53	NS 04274 65371	204274	665371	Figure 8	Dairy farm & house. ~ 100 dairy cattle
8	11.09.08	14:00	NS 04262 65580	204262	665580		Stream – 120cm x 50cm x 0.202, Freshwater sample 5.

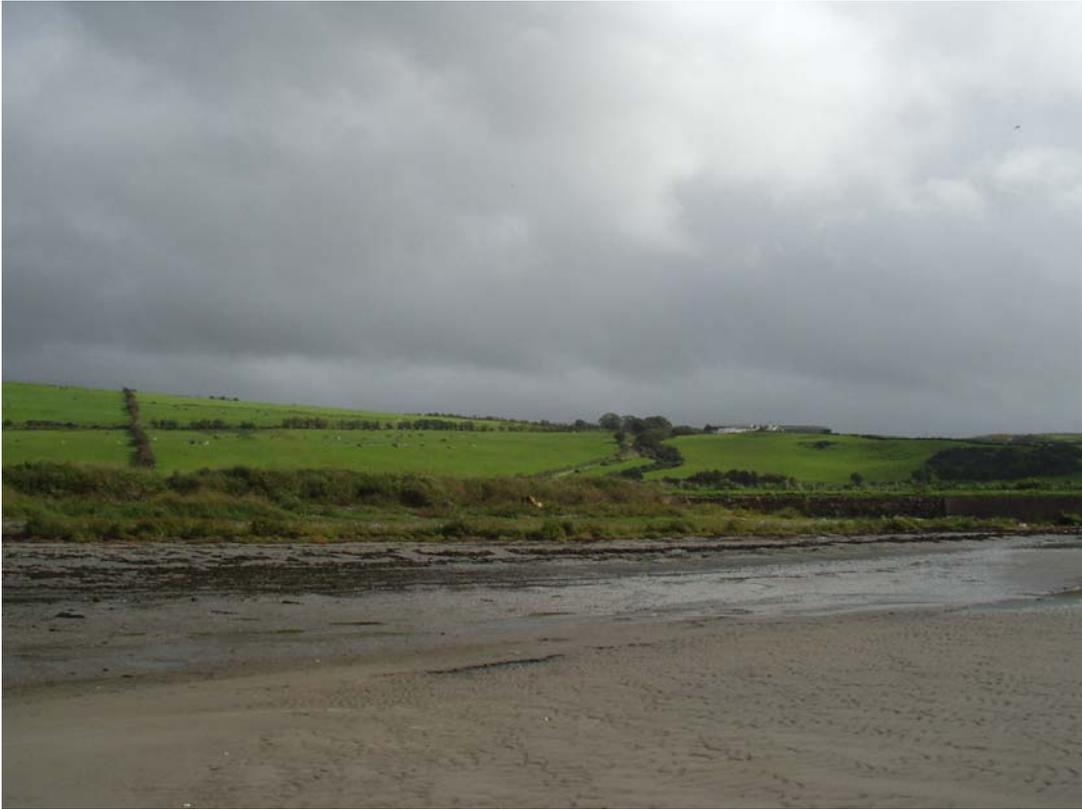
Figure 8 Dairy house and farm on the hill

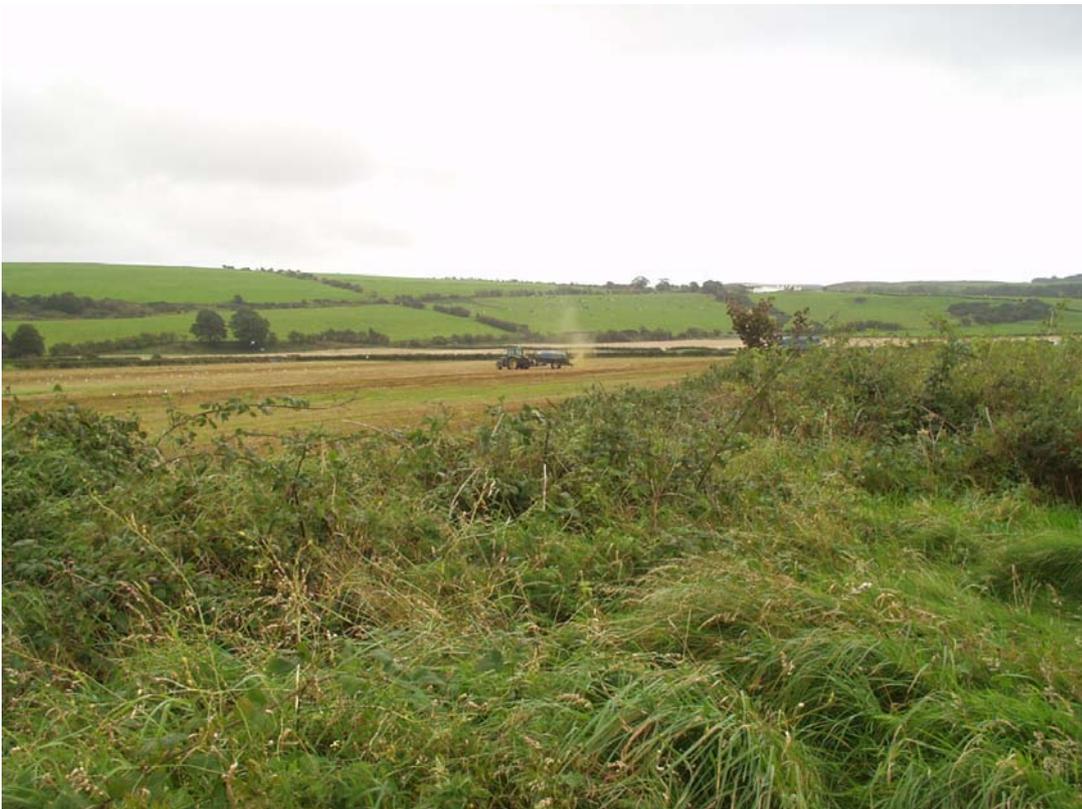
Three slurry pits were observed during the shoreline survey, though no information on the disposal or spreading of slurry on surrounding fields was available. Slurry spreading was observed on a field adjacent to St. Colmac Burn during the shoreline survey. A dung heap was observed at the southeastern end of the bay.

Figure 9 Slurry spreading on adjacent field

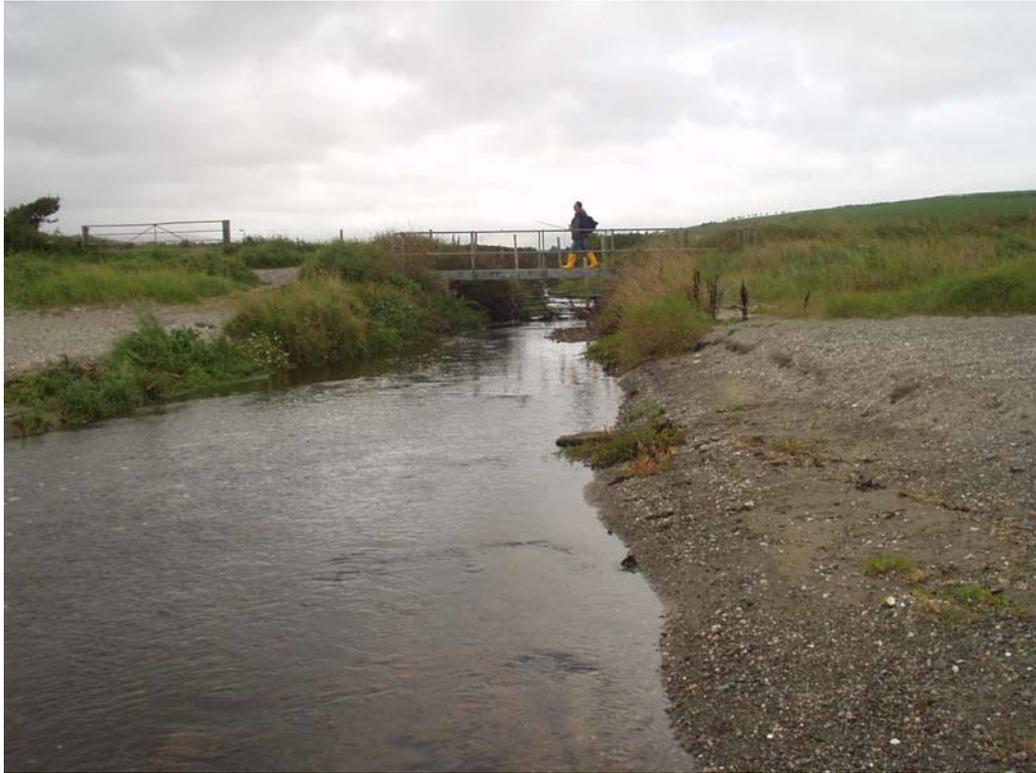
Figure 10 St Colmac Burn, collection point of freshwater sample 6

9	11.09.08	14:02	NS 04272 65614	204272	665614		Farmhouse, 9 cows & 40 sheep plus additional 10 cows on horizon
10	11.09.08	14:04	NS 04212 65729	204212	665729		Sanitary debris in high tide mark
11	11.09.08	14:10	NS 04049 65968	204049	665968	Figure 10	St Colmac Burn – 760cm x 20cm x 0.343. Freshwater sample 6
12	11.09.08	14:15	NS 03981 65898	203981	665898		Seawater sample 7, Salinity=10ppt
13	11.09.08	14:19	NS 04062 65999	204062	665999	Figure 9	15 dairy cows & 33 sheep. Slurry spreading in field to right.
14	11.09.08	14:21	NS 03890 66147	203890	666147		Sanitary debris in the high tide mark
15	11.09.08	14:22	NS 03730 66285	203730	666285	Figure 11	Stream – 210cm x 50cm x 0.291, Freshwater sample 8, brown scum visible at side of stream
16	11.09.08	14:35	NS 03479 66393	203479	666393	Figure 12	Outflow pipe (could not see end of pipe), café and toilets in background.
17	11.09.08	14:38	NS 03548 66441	203548	666441		Public Toilets and cafe

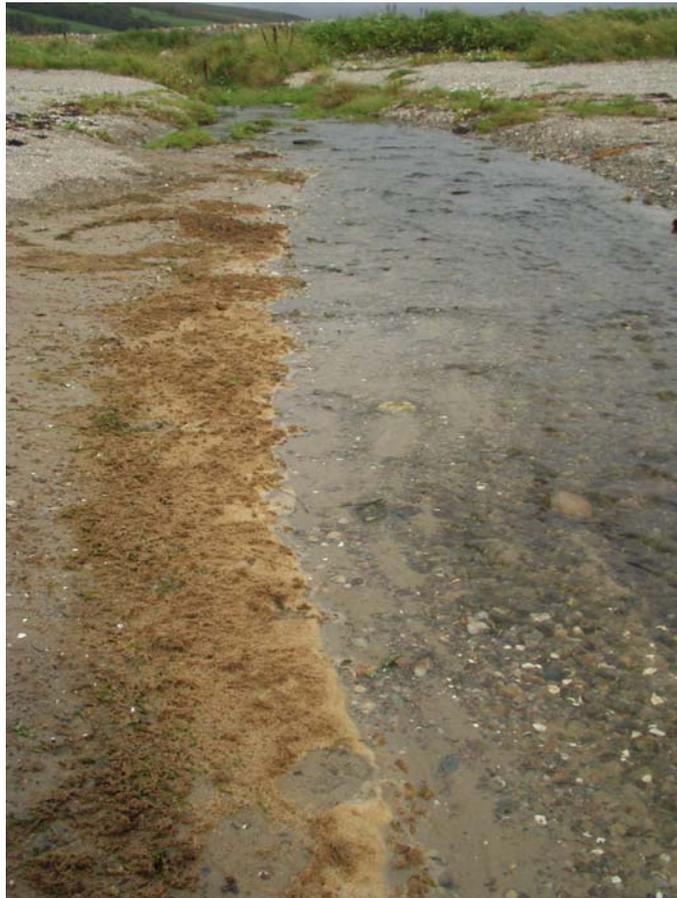
Figure 11 Collection point of freshwater sample 8, brown scum at the side of stream

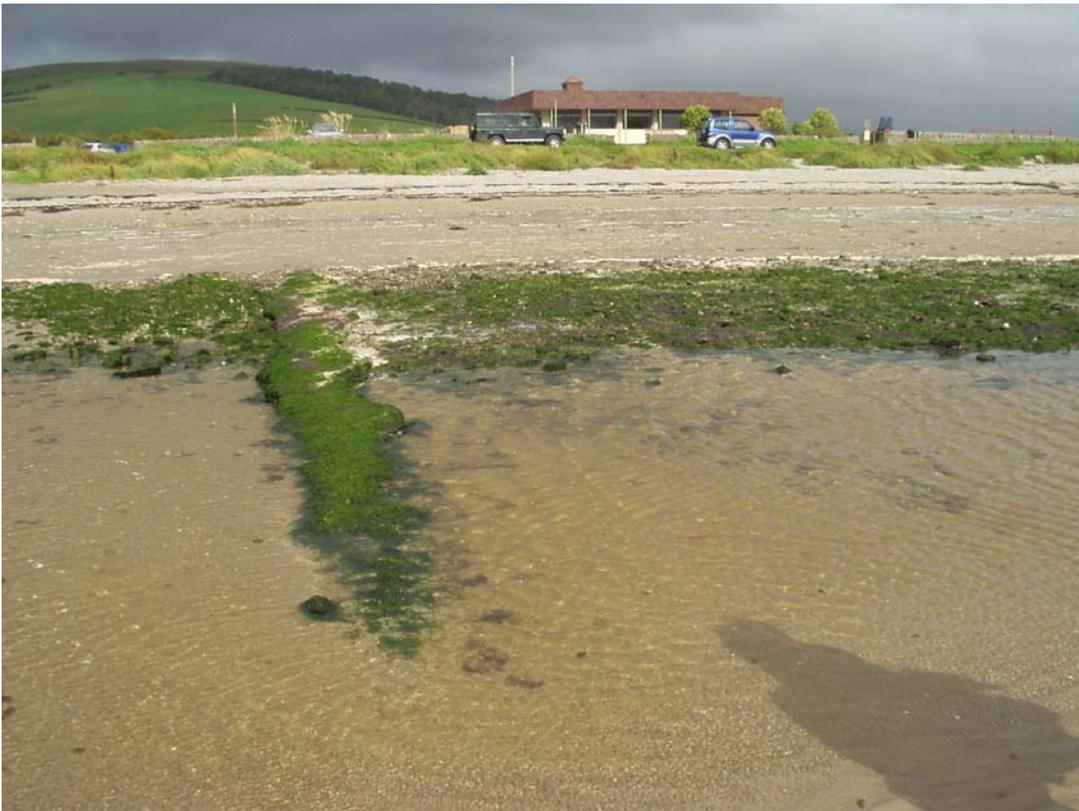
Figure 12 Outflow pipe, end not visible

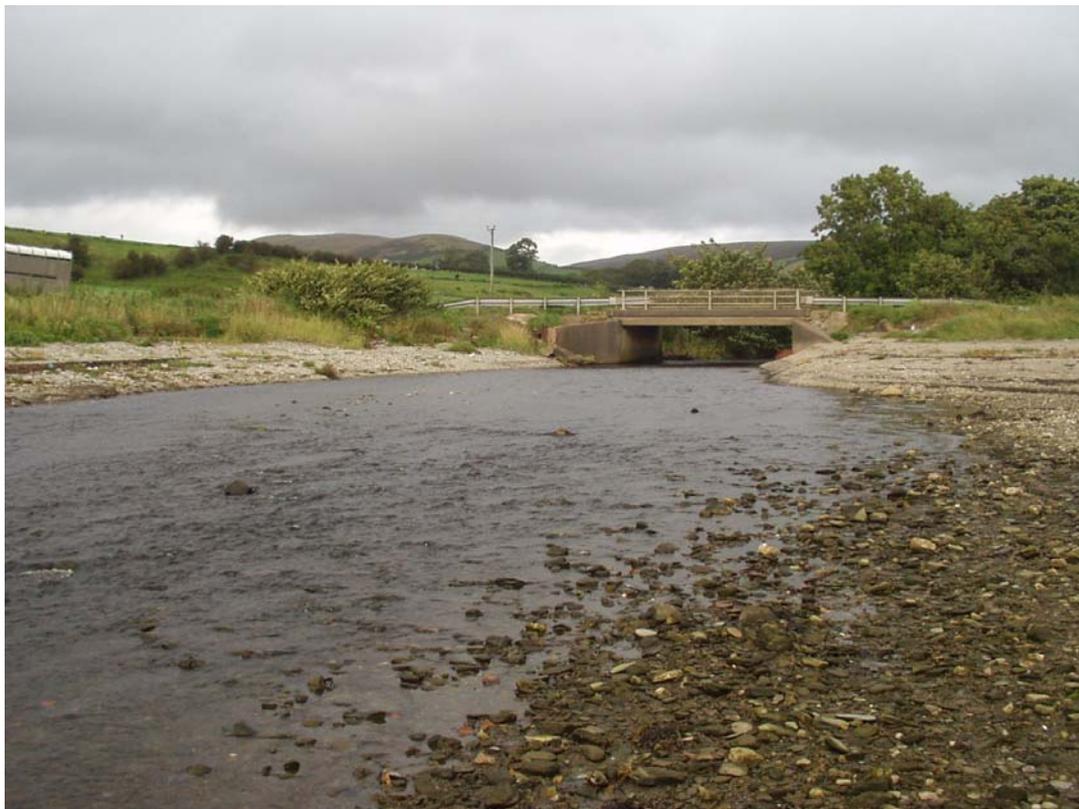
Figure 13 Collection point of seawater sample 11

18	11.09.08	14:45	NS 03283 66497	203283	666497		Plastic onto cast iron water pipe, flowing, 20cm diameter, Freshwater 9.
19	11.09.08	14:50	NS 03164 66497	203164	666497		Burn – 740cm x 22.5cm x 0.645, Freshwater sample 10
20	11.09.08	14:55	NS 03159 66382	203159	666382	Figures 13 & 14	Seawater sample 11, salinity=25ppt. Farm, house and slurry tank to the north plus 30 dairy cattle.
21	11.09.08	14:59	NS 03041 66479	203041	666479		125 sheep in field, 40 in field behind
22	11.09.08	15:02	NS 03171 66558	203171	666558		Farm, house and slurry tank, 98 dairy cows
23	11.09.08	15:04	NS 03321 66509	203321	666509		Farm, house and slurry tank. Cattle and sheep in distance (too far to count)
24	11.09.08	15:08	NS 03418 66457	203418	666457		Cast iron pipe, not flowing, may be broken.
