Scottish Sanitary Survey Project

Restricted Sanitary Survey Report Ettrick Bay AB 389 September 2008

Ettrick Bay Restricted Survey Report Final 17/12/09

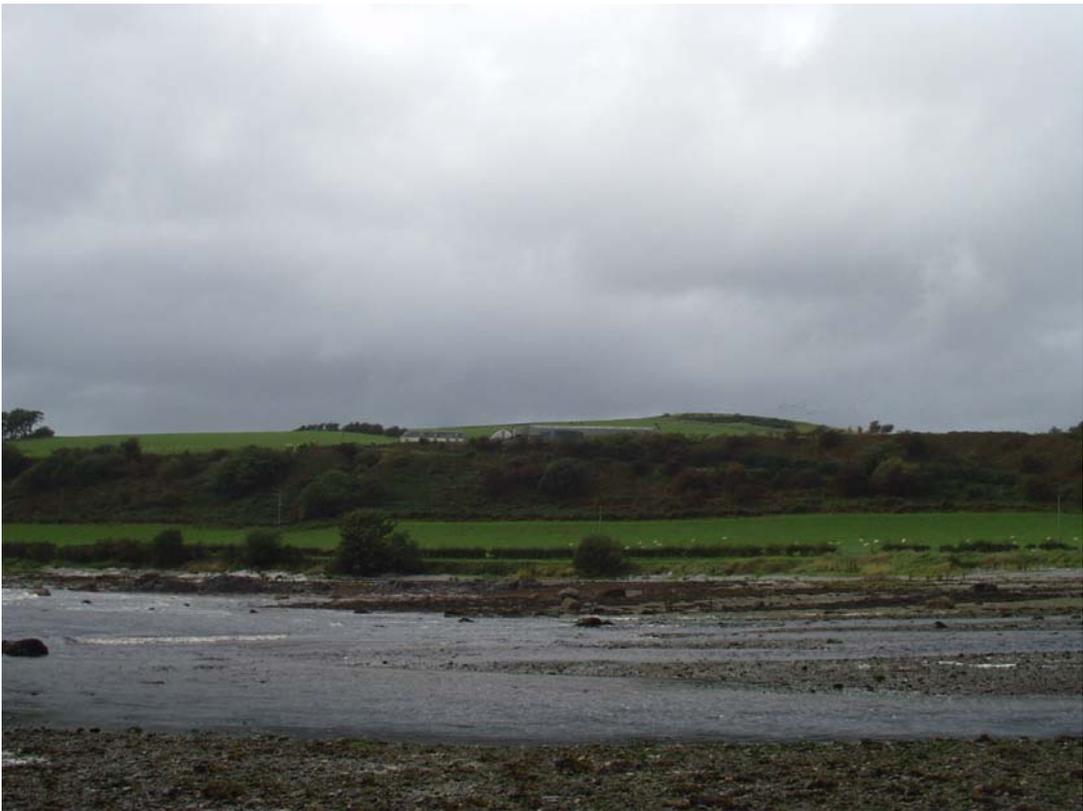
Figure 14 Farm house and slurry tank to the north plus 30 dairy cattle

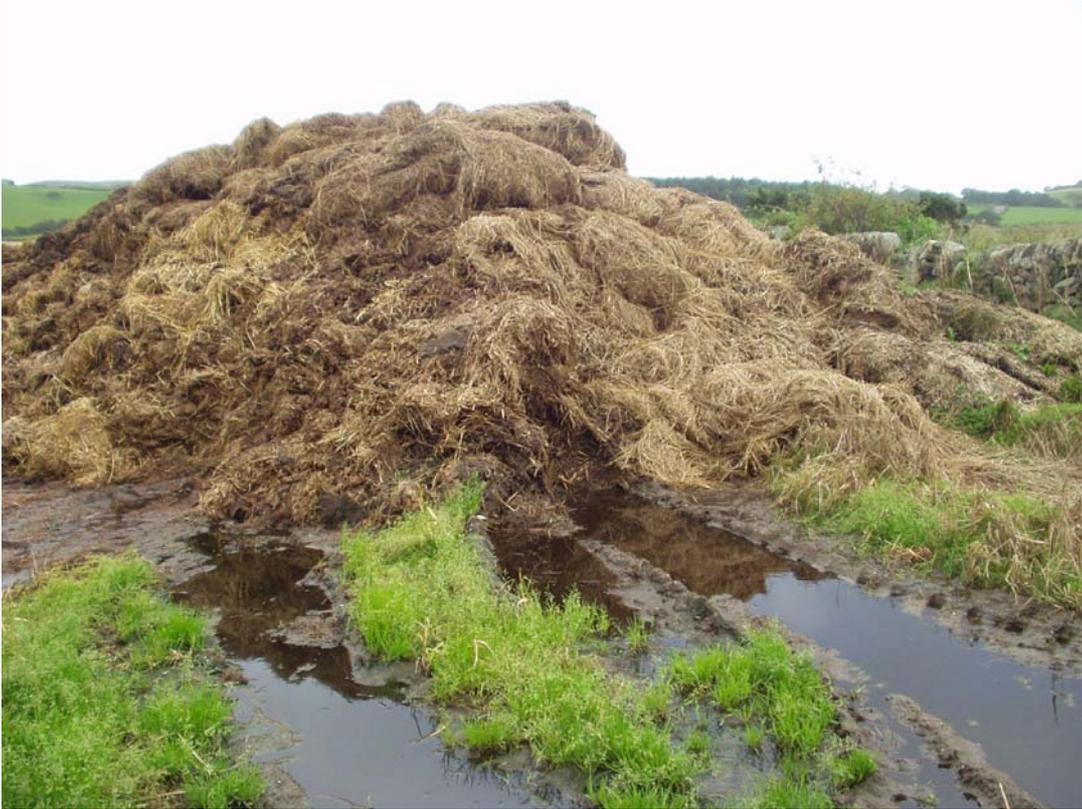
Figure 16 Dung heap in field
