**Sanitary Survey Report
Ganavan Bay Cockles
AB-697-1512-04
May 2015**

Report Title	Ganavan Bay Cockles
Project Name	Scottish Sanitary Survey
Client/Customer	Food Standards Agency Scotland
Cefas Project Reference	C6316A
Document Number	C6316A_2014_28
Revision	V1.0
Date	20/05/2015

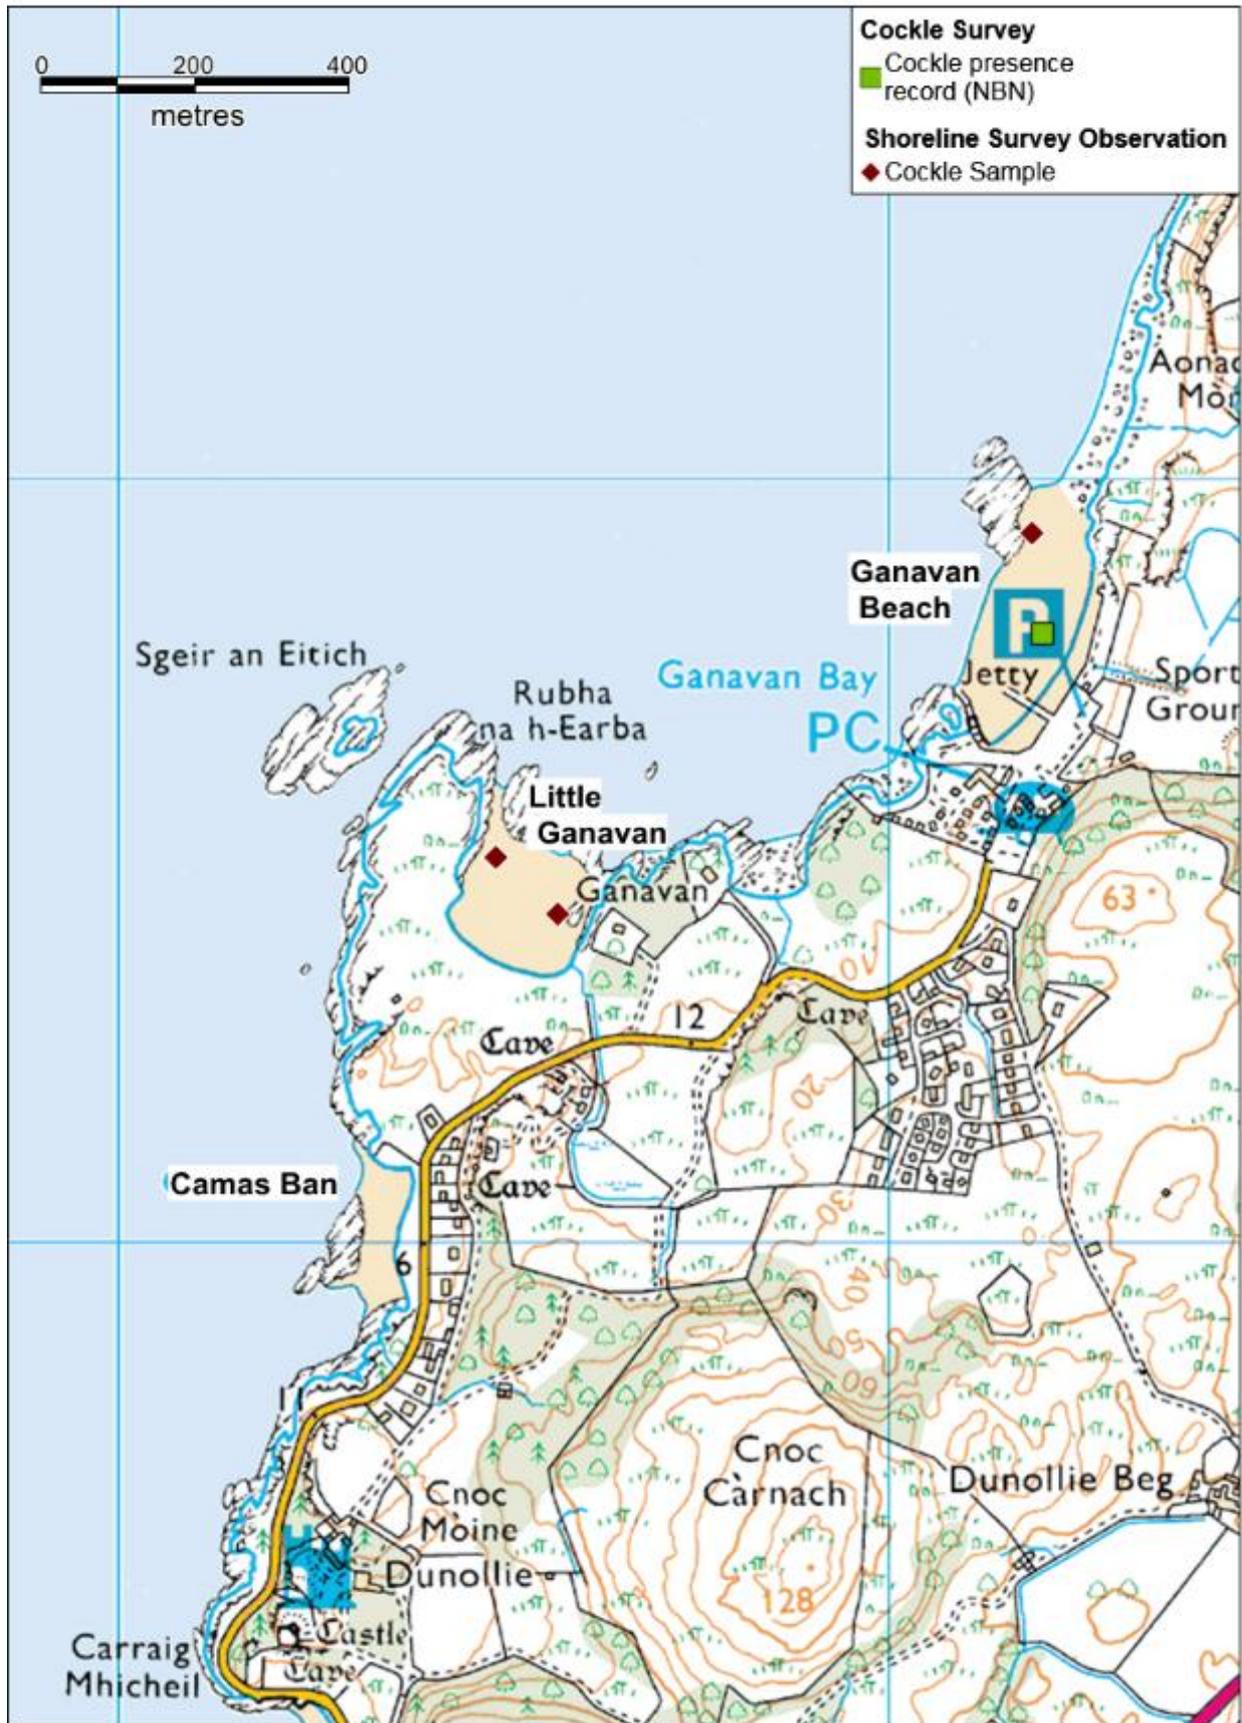
Figure 2.1 Ganavan Bay Fishery

There are no cockle stock assessments available for the sites. Cockles can be present throughout the intertidal zone, and sometimes subtidally, but substrate type and particle size will influence whether cockles are present. Cockles were found at both the main Ganavan beach and at Little Ganavan during the shoreline survey although on the main Ganavan Beach they were found towards the northern end but not in the vicinity of the jetty. Cockles were previously reported at a point from approximately midway between those two locations during a biodiversity survey (CSGBI, 2013), indicating that cockle populations were present there in September 2013. This location, and the successful shoreline survey sampling points, are shown in Figure 2.1. Only one cockle was found at Camas Bàn. It is known that cockle populations are usually successful at recovering after harvesting (Tyler-Walters, 2007).

The two small inlets located between the two beaches within Ganavan Bay are shown as being shingle on the OS map. However, on aerial imagery they show as being at least partially sand and therefore cockles may also be present at those locations.

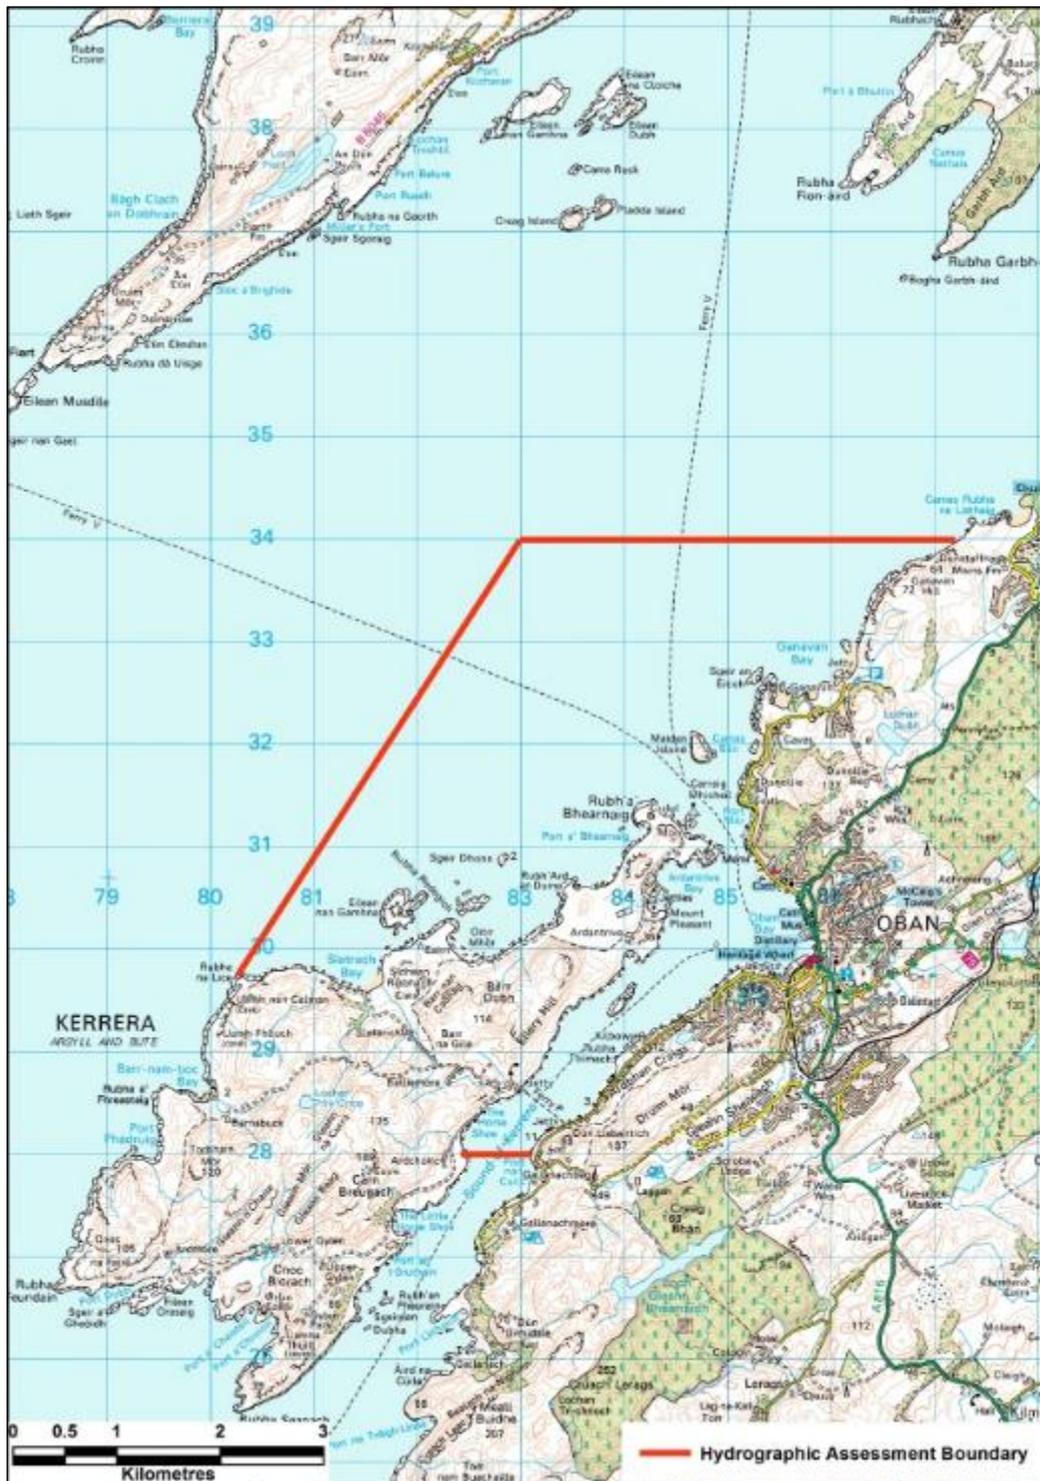
Figure 13.1 Extent of the Ganavan Bay hydrographic study area

The assessment area encompasses the northern part of the Sound of Kerrera, Oban Bay, and adjacent waters in the Firth of Lorn extending from Rubha na Lice, on the Isle of Kerrera, northwards to Camas Rubha na Liathaig. The assessment area extends 3-4 km offshore in to the Firth of Lorn from the Isle of Kerrera and the mainland. At its widest, the Sound of Kerrera is approximately 2 km in width, while Oban Bay is approximately 1.5 km² in area. Ganavan Bay is found at the northern end of the assessment area.

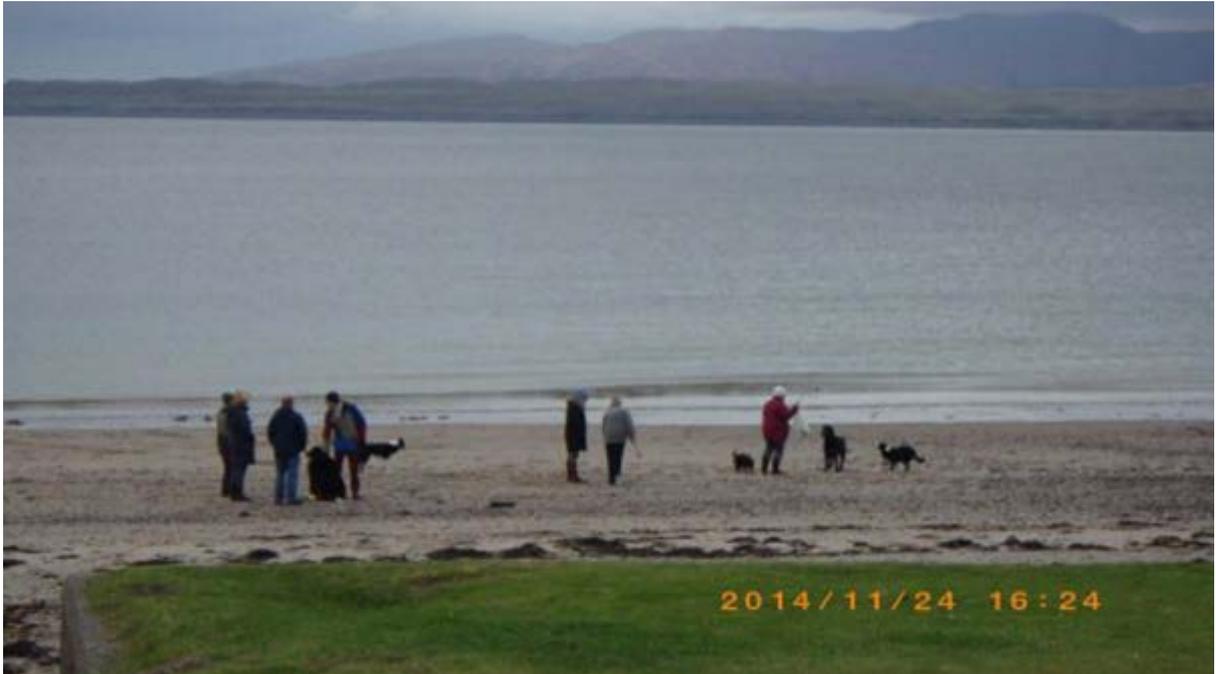
Figure 3. Dog walkers on Ganavan Beach associated with wp 7.

No official campsites or caravan parks were seen in the area surrounding the survey area. There are no B&B's or hotels in the area. The beach at Ganavan was very popular with visitors and dog walkers were observed throughout the day of the survey (Fig 3).

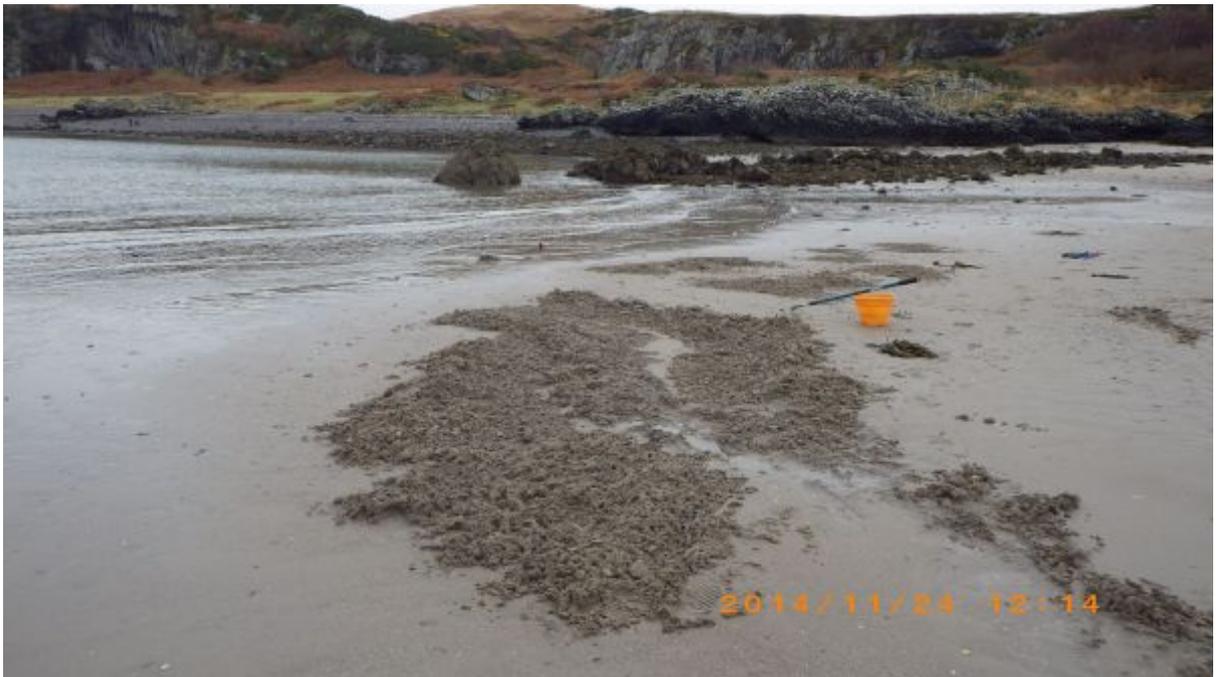
Figure 4. Site of shellfish sample GBSF1 associated with wp 5.

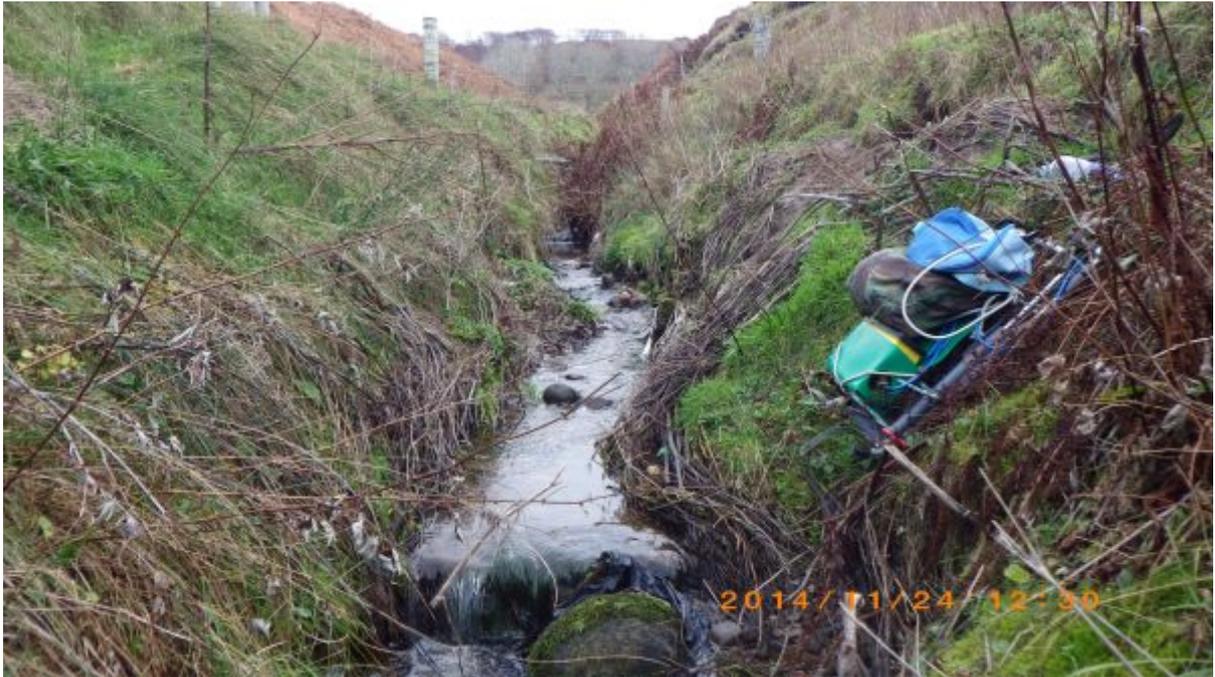
Figure 5. Watercourse associated with wp 7.

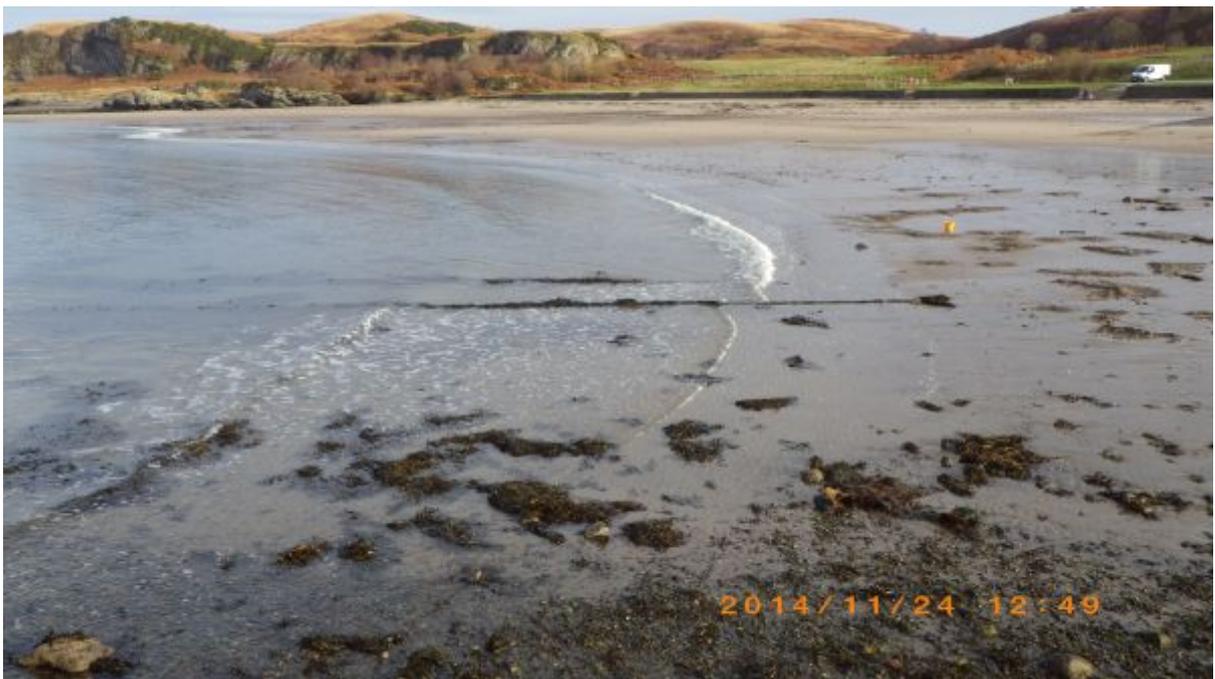
Figure 6. Two pipes visible at low tide associated with wp 10.

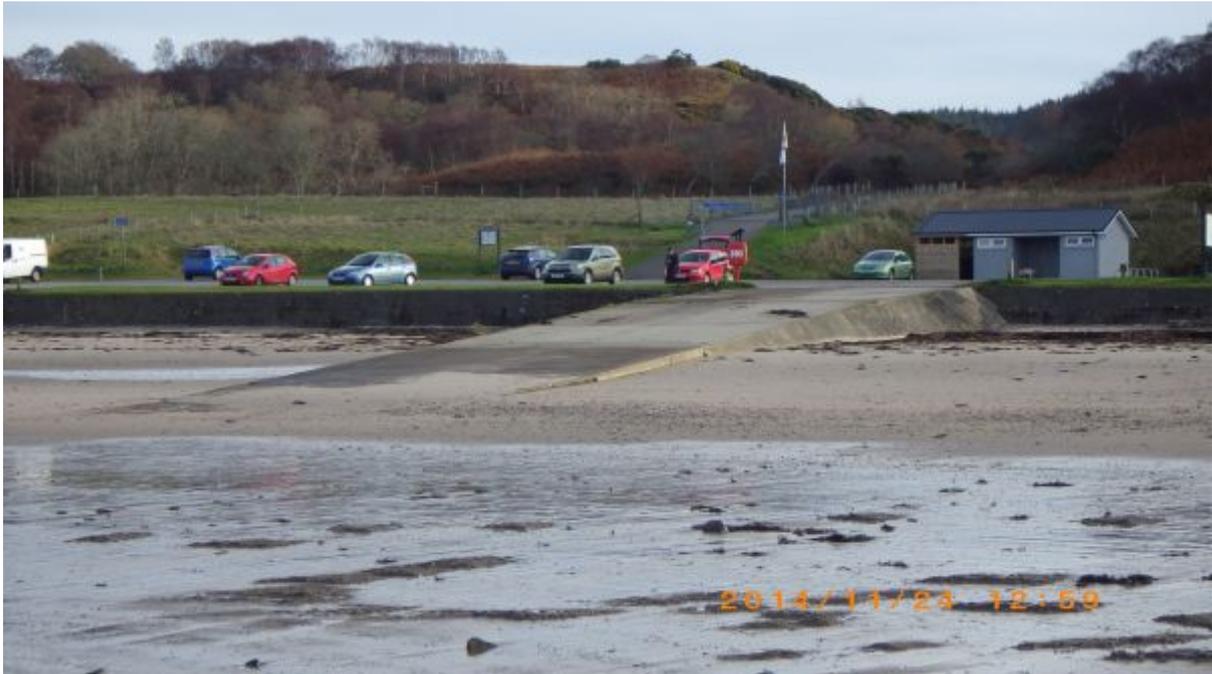
Figure 7. Car park and toilet block at Ganavan Beach associated with wp10.

No.	NGR	Associated Photograph (Appendix 5)	Associated Sample	Description
1	NM 86116 32704	Fig 6 & Fig 7		Two 20 cm ceramic pipes visible at low tide. Housing development at the south end of the beach. Public toilet facility on carpark.
2	NM 86044 32638	Fig 8 & 9		15cm cast iron pipe from direction of houses onto rocky shore, no flow, barnacles growing inside the pipe.
3	NM 85750 32524	Fig 10 & 11		Two pipes running over the rocks from septic tank, One was a 12 cm ceramic pipe discharging a trickle of water from pipe. The second was a 12 cm plastic pipe also discharging a trickle of water.
3a	NM 85750 32522		100000	Flow 7.1 ml/s from ceramic pipe associated with wp 16.
3b	NM 85751 32506		<1000	Flow 4.8 ml/s from plastic pipe associated with wp 18.
4	NM 85353 32086	Fig 12	670	Small watercourse associated with wp 29 running from direction of two houses before joining together on the sand. Strong unpleasant odour.

8	24/11/2014	11:49	NM 86106 32693	186107	732694		GBSW2	Planned seawater sample.
9	24/11/2014	11:50	NM 86119 32702	186120	732703			Planned shellfish sample location, only one cockle found- no sample taken.
10	24/11/2014	11:51	NM 86116 32704	186116	732704	Fig 6 & Fig 7		Two 20 cm ceramic pipes visible at low tide. Housing development at the south end of the beach. Public toilet facility on carpark.
11	24/11/2014	12:05	NM 86044 32638	186044	732638	Fig 8 & 9		15cm cast iron pipe from direction of houses onto rocky shore, no flow, barnacles growing inside the pipe.
12	24/11/2014	12:09	NM 85994 32570	185994	732570			Watercourse running alongside housing development onto shore. Less than 1 m wide, no sample taken.
13	24/11/2014	12:17	NM 85846 32443	185847	732444		GBFW3	Planned freshwater sample.

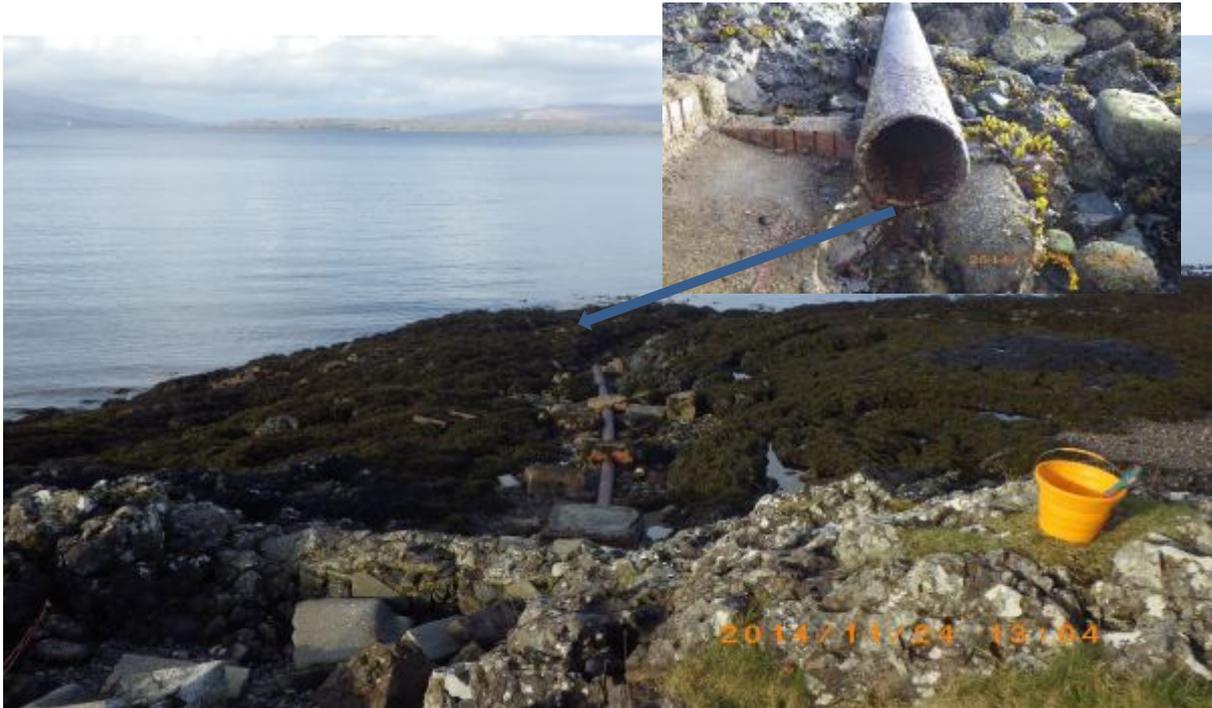
Figures 8 and 9 (insert). Pipe from housing development with barnacles growing inside associated with wp 11.

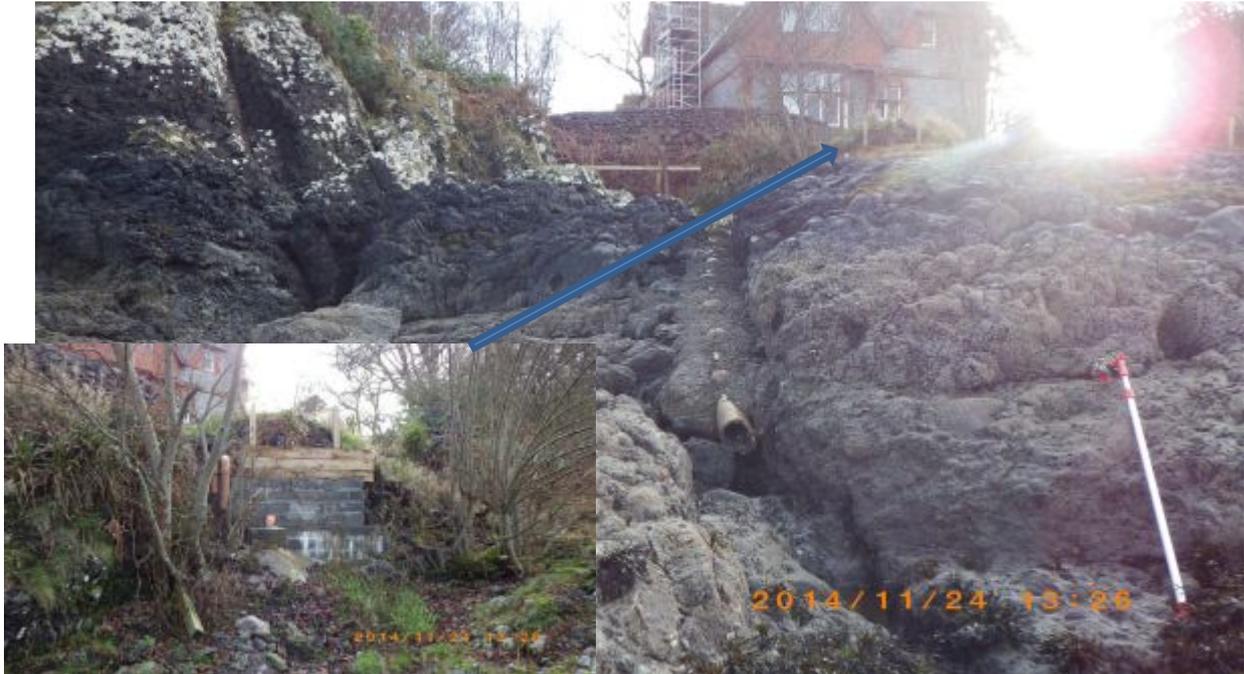
Figures 10 & 11 (insert). Two pipes from septic tank- samples taken from end of ceramic pipe and from plastic pipe associated with wp 15.

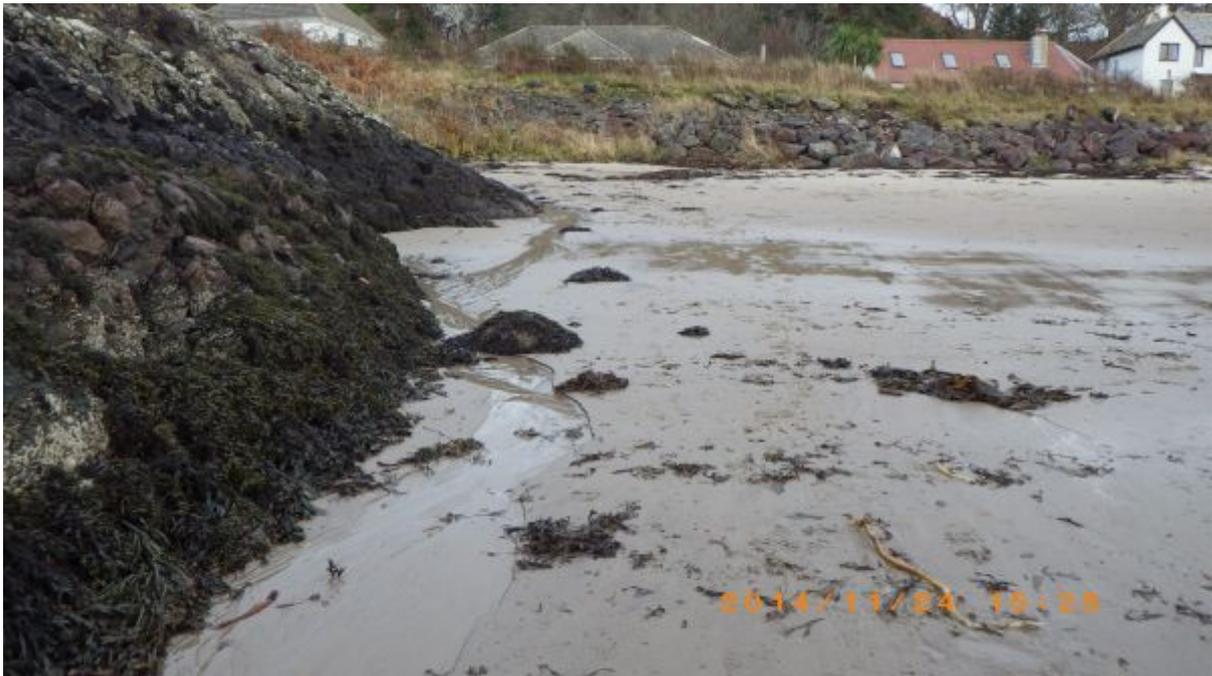
Figure 12. Watercourse running over sand with unpleasant odour, associated with wp 30.

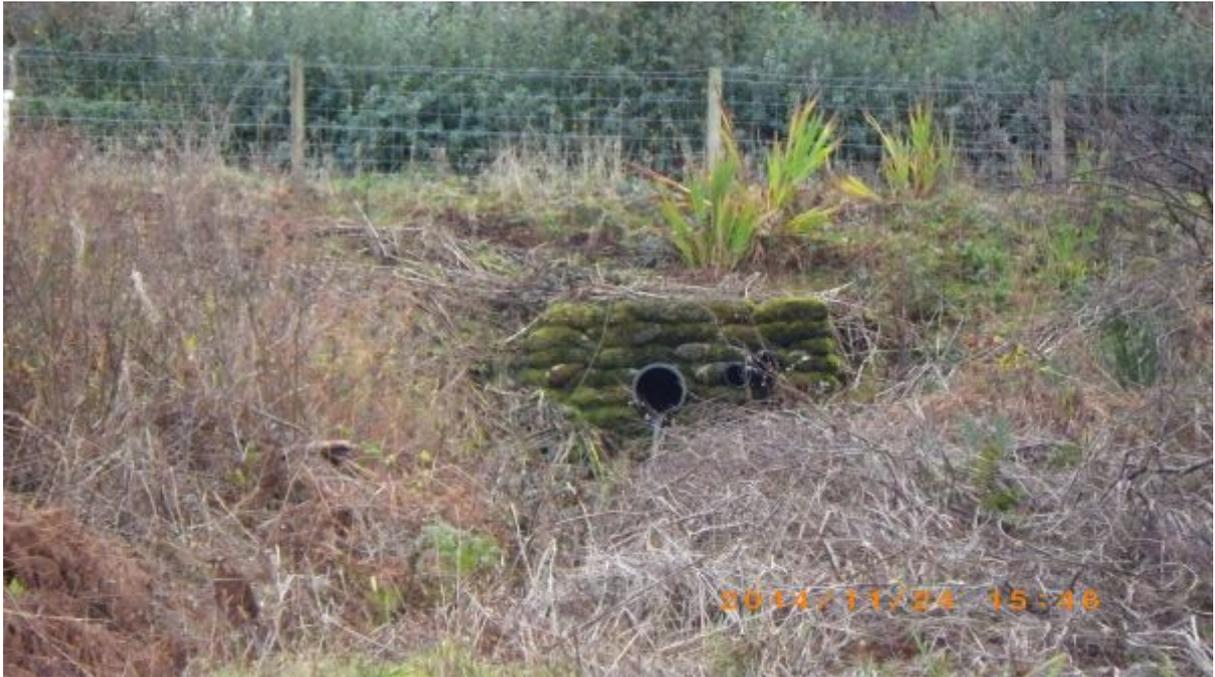
Figure 13. Watercourse diverted under road via pipe associated with wp 33.

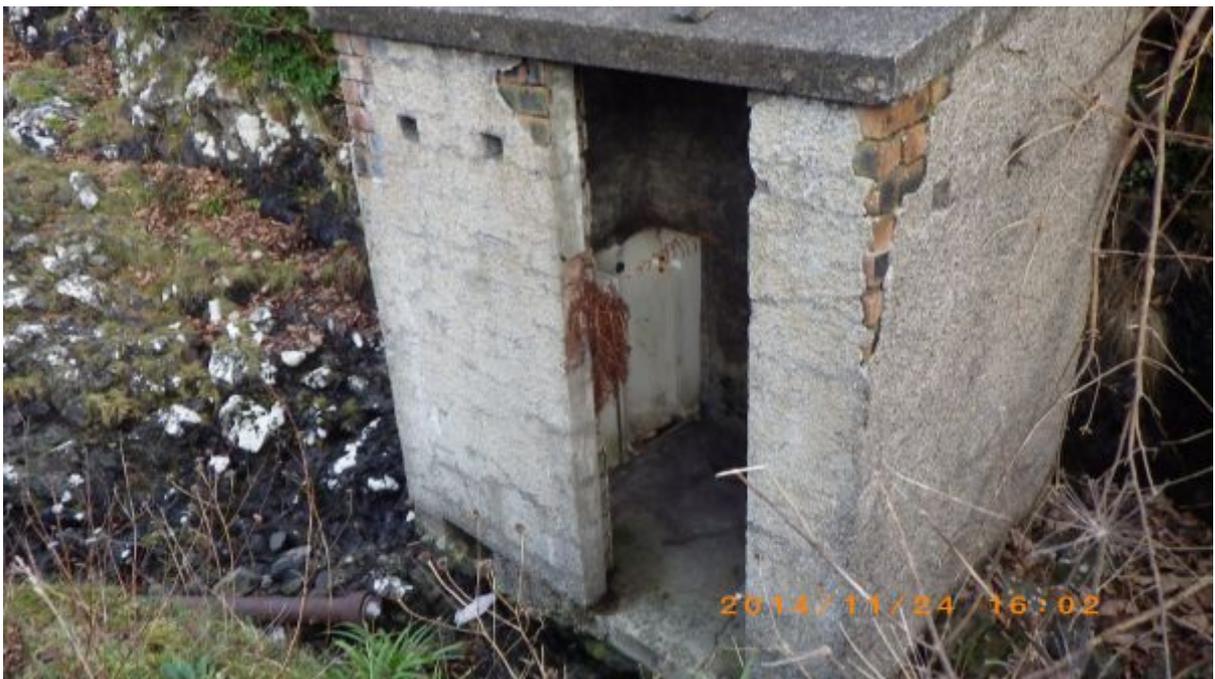
Figure 14. Disused urinal with metal outflow pipe associated with wp 34.

Human population was sparse, with 15 private dwellings overlooking Camas Bàn Beach and a new housing development noted at the south end of Ganavan Beach. Public toilets were noted at Ganavan Beach car park, with two partially buried ceramic pipes visible at low tide on adjacent Ganavan Beach. A seawater sample taken next to these pipes returned a result of 1 *E. coli* cfu/100 ml. A dry cast iron pipe below houses was noted further to the south. A large private dwelling was noted to the southwest of Ganavan Beach which had a ST at the bottom of the garden with two pipes (one ceramic and one plastic) on the rocks down to the shore. Both pipes had discharges and returned freshwater sample results of 100,000 and <1000 *E. coli* cfu/100 ml respectively. A dry metal pipe coming from a disused urinal in a brick/concrete building was also noted south of Camas Bàn.
