Scottish Sanitary Survey Report

**Sanitary Survey Report
Loch na Keal and Loch na Keal West
AB-284 and AB-286
June 2014**

Report Title	Loch na Keal and Loch na Keal West Sanitary Survey Report
Project Name	Scottish Sanitary Survey
Client/Customer	Food Standards Agency Scotland
Cefas Project Reference	C5792C
Document Number	C5792C_2013_19
Revision	V1.0
Date	25/06/2014

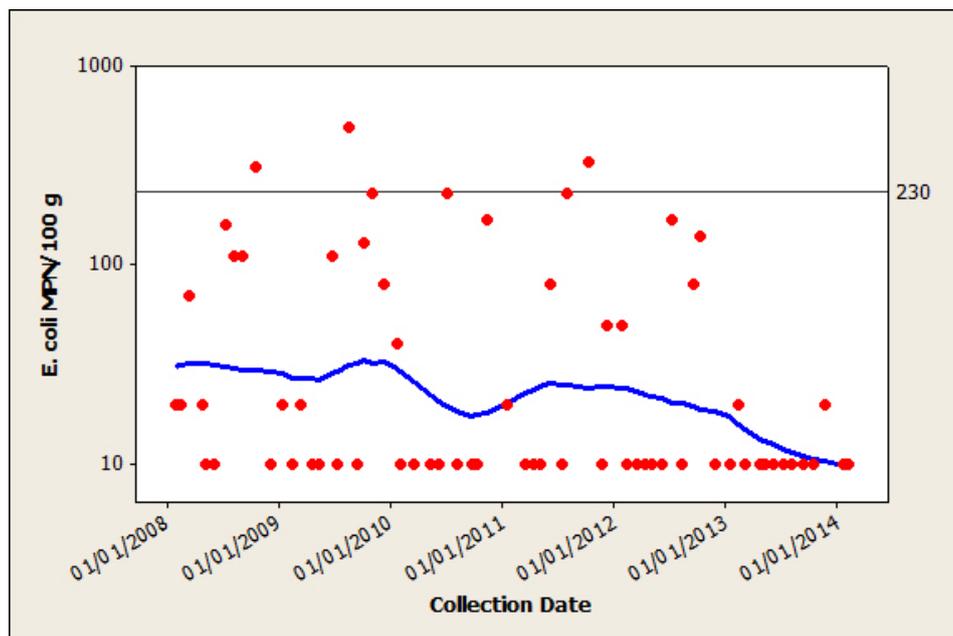
Figure 11.2 Scatterplot of *E. coli* results by collection date at Loch na Keal, fitted with a lowess line

E. coli monitoring results at Loch na Keal show an overall downward trend, with no results exceeding 100 *E. coli* MPN/100 g since late 2012.

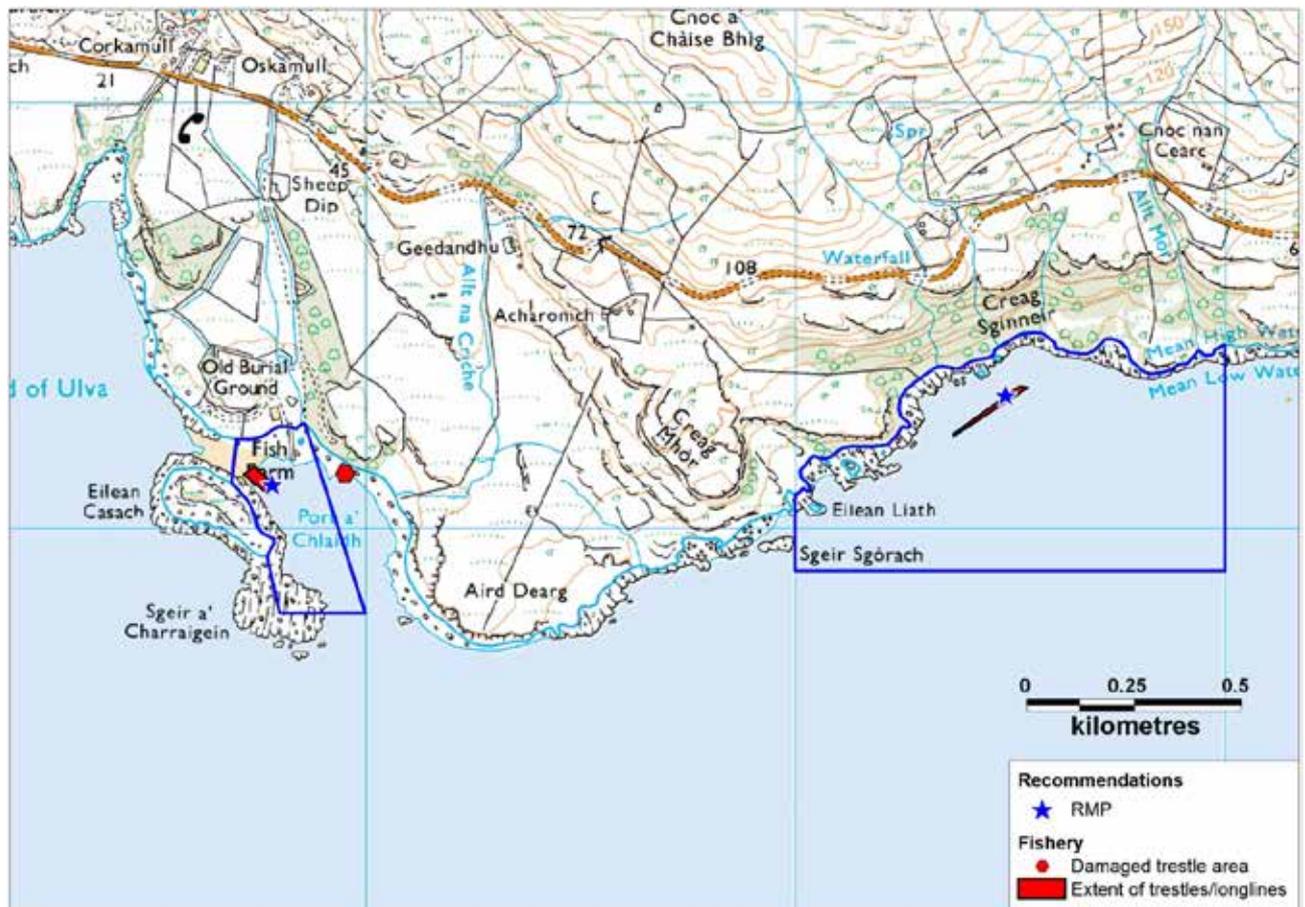
Figure 17.1 Map of recommendations at Loch Na Keal And Loch Na Keal West

The recommended production area boundaries and RMPs are shown in Figure 17.1.

It is recommended that the RMP for the Loch na Keal production area be shifted slightly to the northeast end of the longline to ensure that it reflects contaminating sources arising from watercourses discharging nearer to this end of the fishery. It is recommended that the RMP for the Loch na Keal West production area be restricted to the western half of Port a Chlaidh and that the RMP be moved to the southeast corner of the set of trestles on the west side of Port a Chlaidh to reflect potential contamination reaching the fishery via watercourses along the eastern shoreline.

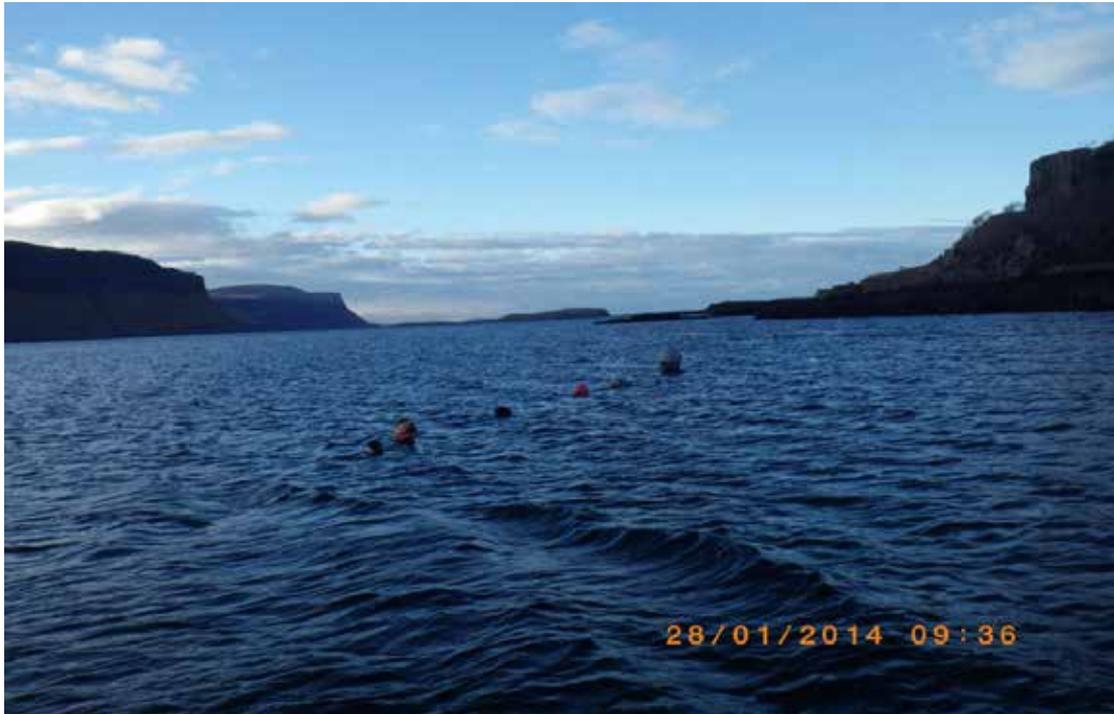
Figure 3: Long line with suspended oyster baskets at Eilean Liath (Waypoint 4)

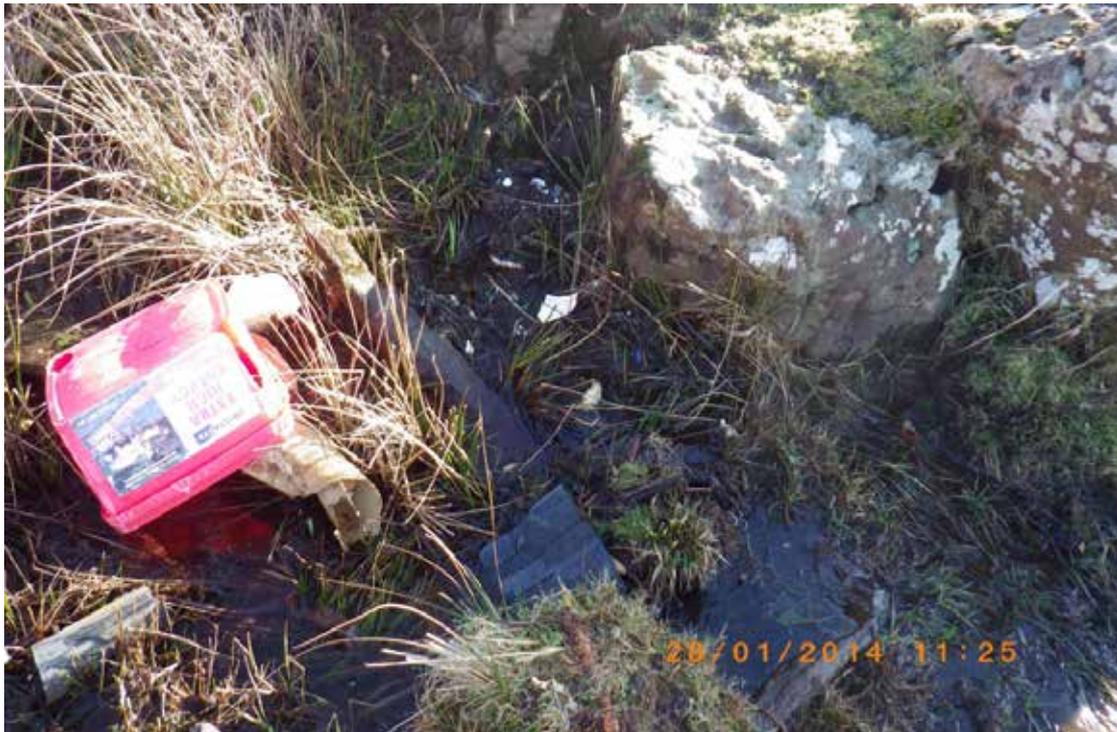
Figure 5: Ground water from bog and scattered debris at Eilean Casach (Waypoint 23)

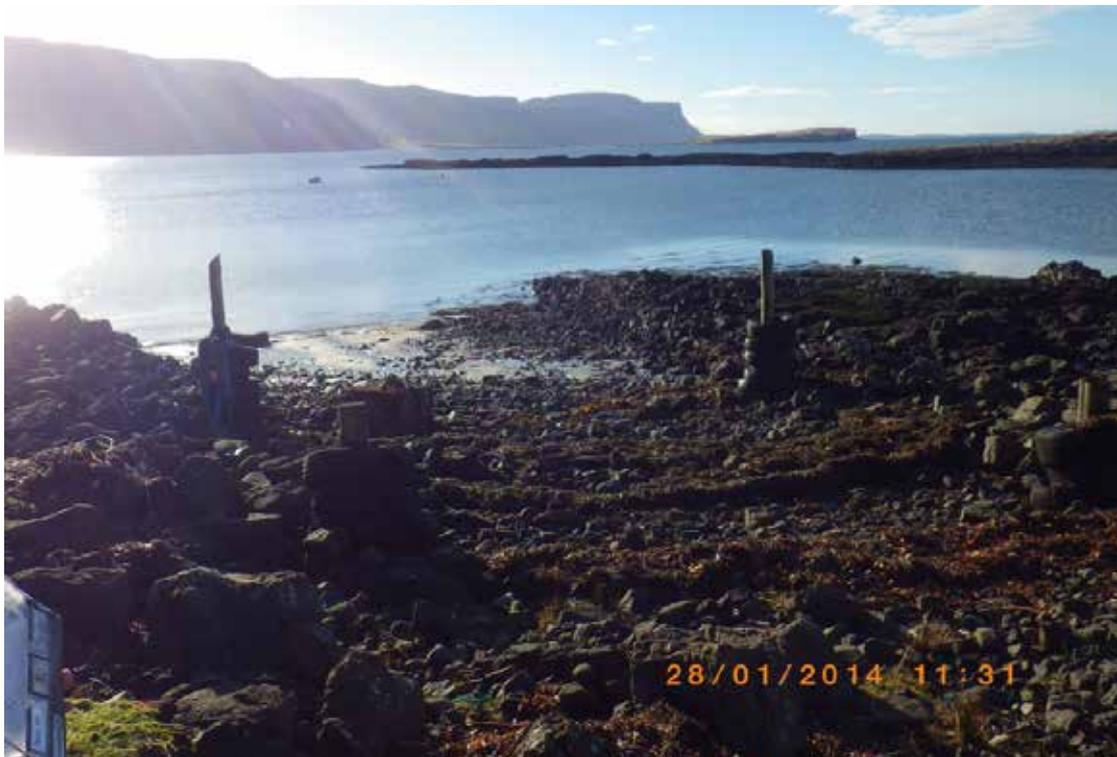
Figure 6: Natural slipway on shore at Eilean Casach (Waypoint 24)

There were no piers or slipways in the Eilean Liath production area. Eilean Casach production area possessed two slipways and a floating pontoon (Figure 7) used by the fish farm base, and a small natural slipway (Figure 6) used by the harvester Mr Mawhinney. Ulva Ferry also had a small combined pier and slipway.

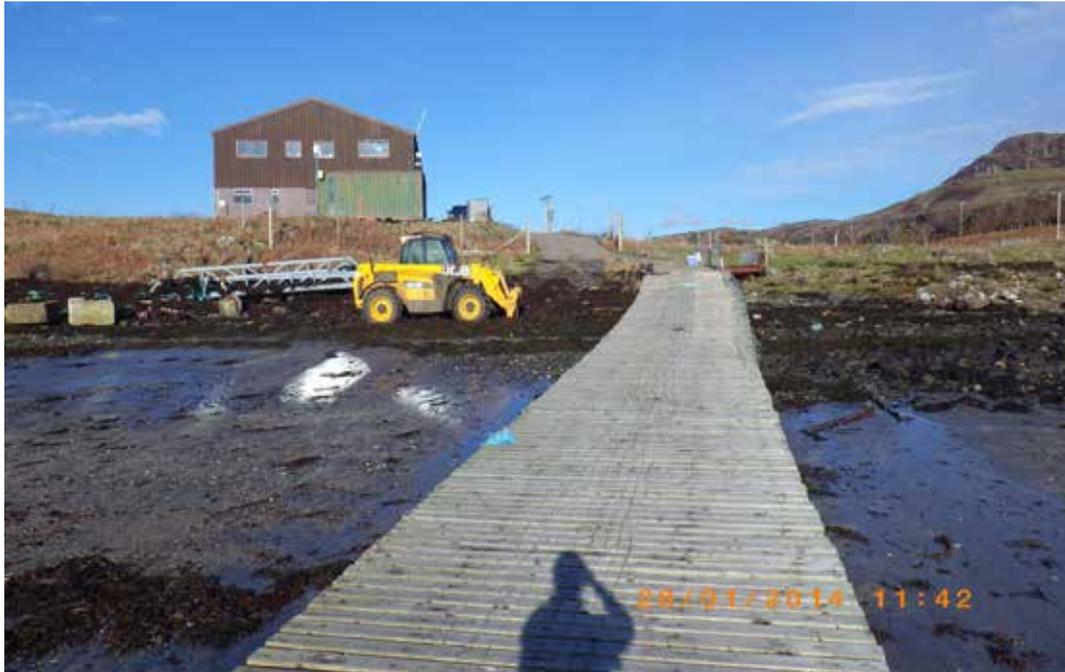
No.	Date	Time	NGR	East	North	Associated photograph	Associated sample	Description
								shore to the loch. One sheep noted in field above the stream.
23	28/01/2014	11:24	NM 46056 39120	146057	739120	Fig. 5		Ground water coming from bog. Not sampled as same source as waypoint 22 stream. Debris present.
24	28/01/2014	11:30	NM 45946 39176	145947	739177	Fig. 6		Natural slipway on shore. No discharge pipe present. Two buoys and 2 moorings in the bay.
25	28/01/2014	11:35	NM 45870 39200	145870	739200		LNKFW6	Planned freshwater sample 6.
26	28/01/2014	11:35	NM 45869 39202	145870	739203			Observations associated with sample from waypoint 25. Width 1.10 m; Depth 13 cm; Flow 0.328m/s; 0.003. Stream situated east of the fish farm base, running down algae covered shore. Ten gulls, two crows, one heron and one oyster catcher visible.
27	28/01/2014	11:41	NM 45818 39210	145819	739210	Fig. 7		Fish farm pontoon with access road at top of the shore. No discharge pipes noted.

Figure 7: Floating pontoon at Eilean Casach fish farm (Waypoint 27)

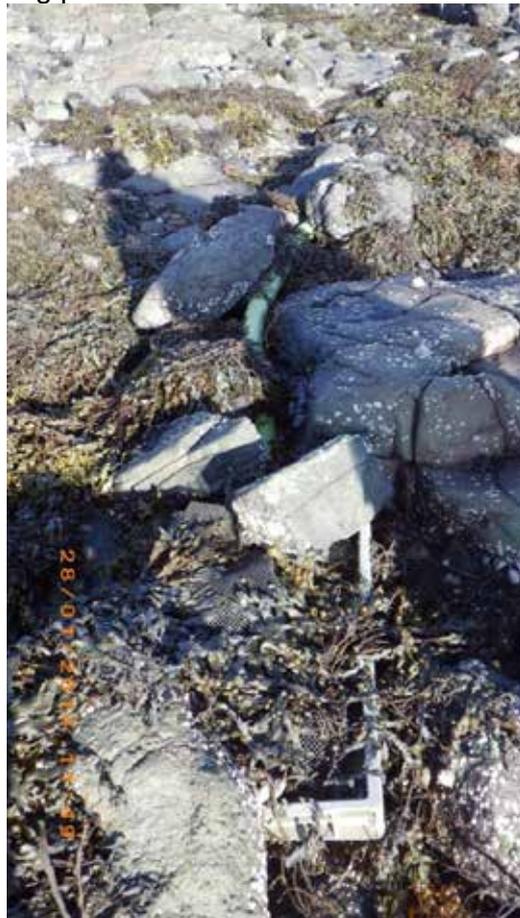
28	28/01/2014	11:47	NM 45722 39190	145722	739191	Fig. 8		Rough slipway on shore. Shed building above shore next to fish farm building. Four sheep noted at shed area. Two oyster trestles on the shore. A 6 cm dia. plastic pipe running from intake box on the shore up towards shed. Intake rather than output, no discharge noted.
29	28/01/2014	11:52	NM 45650 39228	145650	739229			Storage area for fish farm equipment at top of the shore.
30	28/01/2014	12:07	NM 45444 39886	145445	739886		LNKFW7	Planned freshwater sample 7.
31	28/01/2014	12:07	NM 45444 39887	145445	739888	Fig. 9		Observations associated with sample from waypoint 30. Width 50 cm; Depth 9 cm; Flow 0.662 m/s; S.D. 0.015. Large amount of algae and debris backed up on the shore line.

Figure 8: Plastic pipe and intake box on shore at Eilean Casach fish farm (Waypoint 28)

pump intake pipe for shellfish washing, rather than output pipe (information acquired from harvester) (Figure 8).

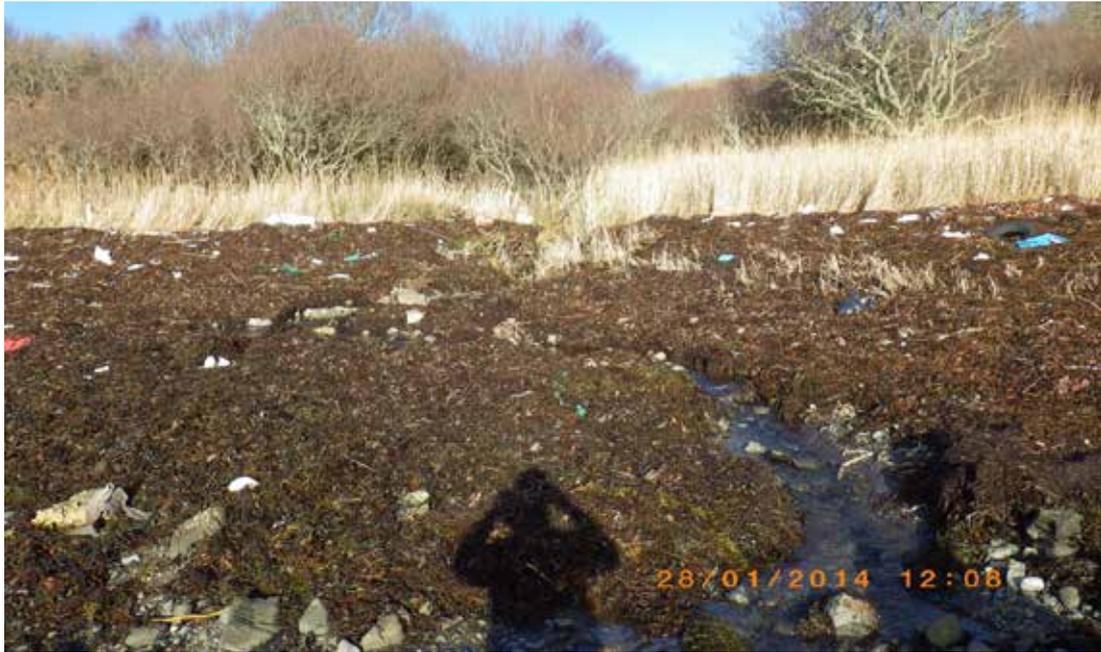
Figure 9: Large amount of algae and debris backed up on shore in bay in Sound of Ulva. Water sample LNKFW7 (Waypoint 31)

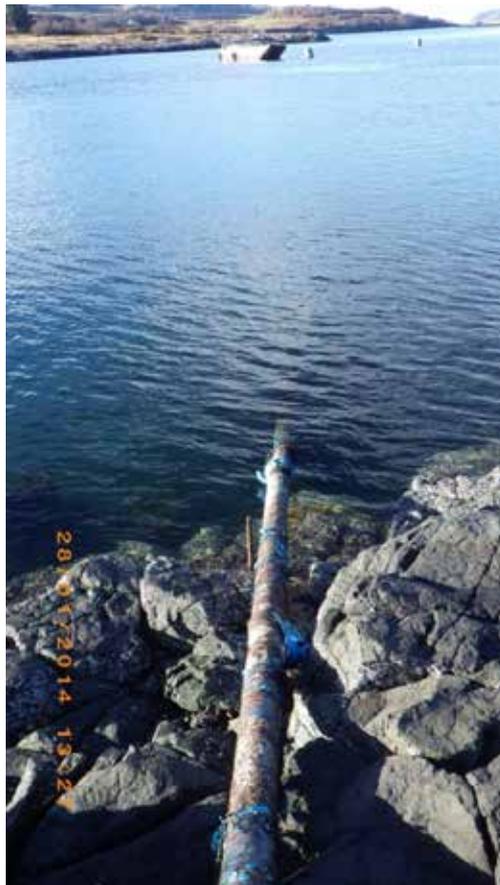
Figure 10: Discharge pipe running from public toilet block into loch at Ulva Ferry (Waypoint 35)

The shoreline survey recorded a public toilet block at Ulva ferry discharging to the sound between Ulva and Mull. No corresponding consent was provided for this observation, however a planning application was found for the replacement of the toilet block in 2003.

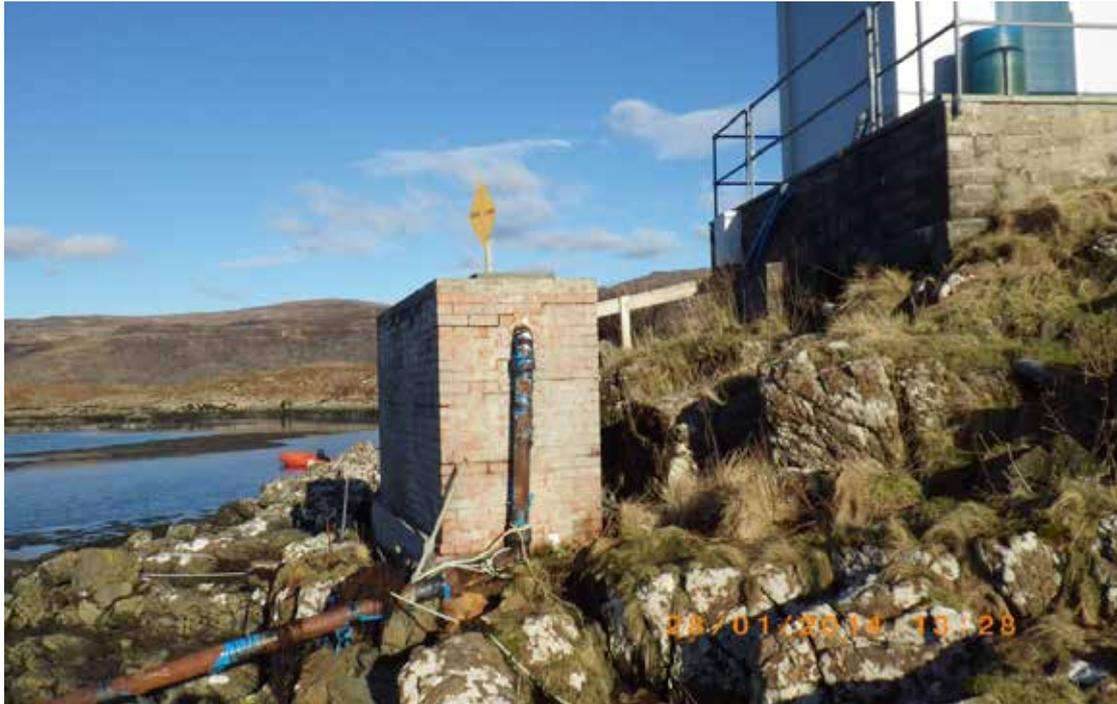
Figure 11: Public toilet block and discharge pipe at Ulva Ferry (Waypoint 35)

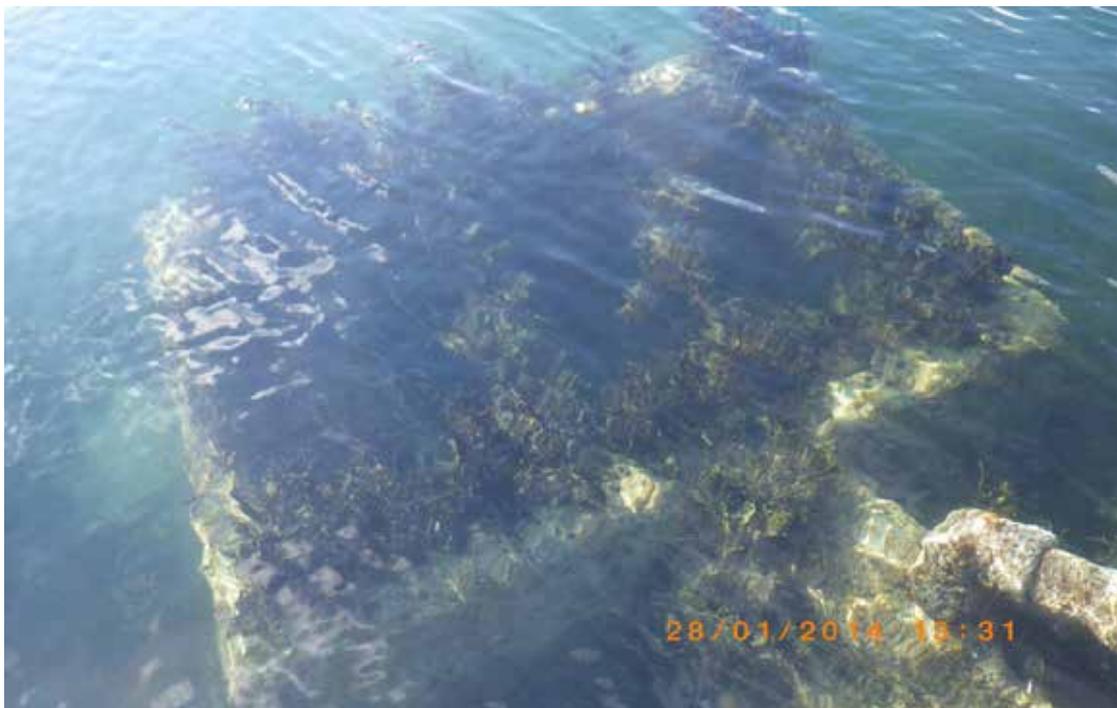
Figure 12: Discharge pipe running into submerged chamber (Waypoint 37)

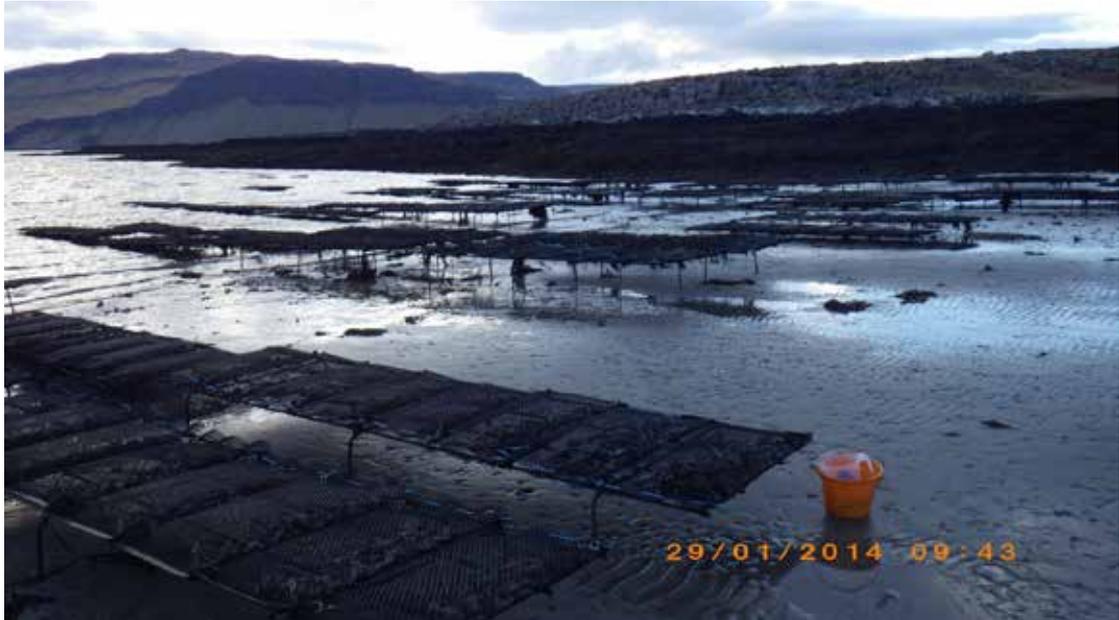
Figure 13: Oyster trestles at Eilean Casach (Waypoint 42)

Another area of trestles was reported east of the Eilean Casach site. There were five trestles, three of which had poches with oysters in. This site has been damaged by winter storms with some loss of stock.
