**Sanitary Survey Report  
Loch Roag: Barraglom  
LH-185-120-08  
September 2013**

| <b>Report Title</b> | Loch Roag: Barraglom Sanitary Survey Report |
| <b>Project Name</b> | Scottish Sanitary Survey |
| <b>Client/Customer</b> | Food Standards Agency<br>Scotland |

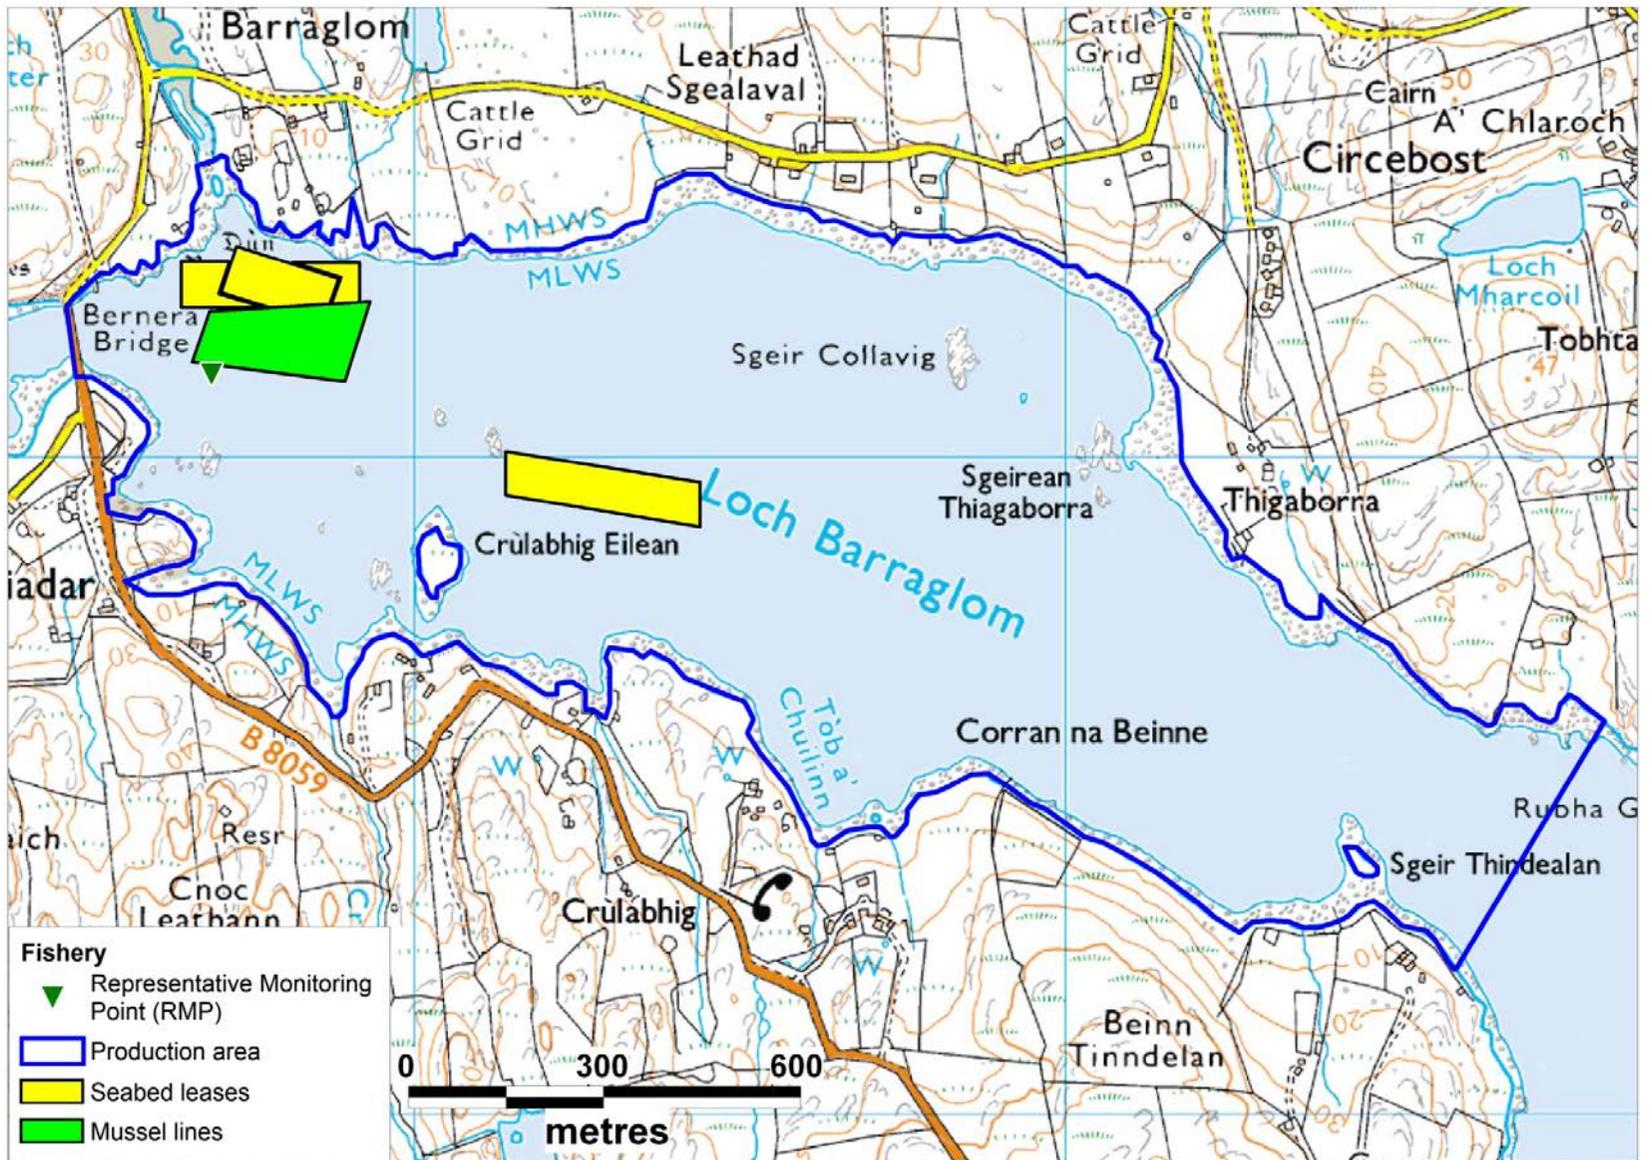
**Figure 2.1 Loch Roag: Barraglom Area Fishery**

At the time of the shoreline survey, the mussels were reported to be grown on three rows of longlines with 8 meter droppers. The actual location of the mussel farm was recorded during the shoreline survey and is shown together with the current production area boundaries, RMP and Crown Estate seabed lease areas in Figure 2.1.

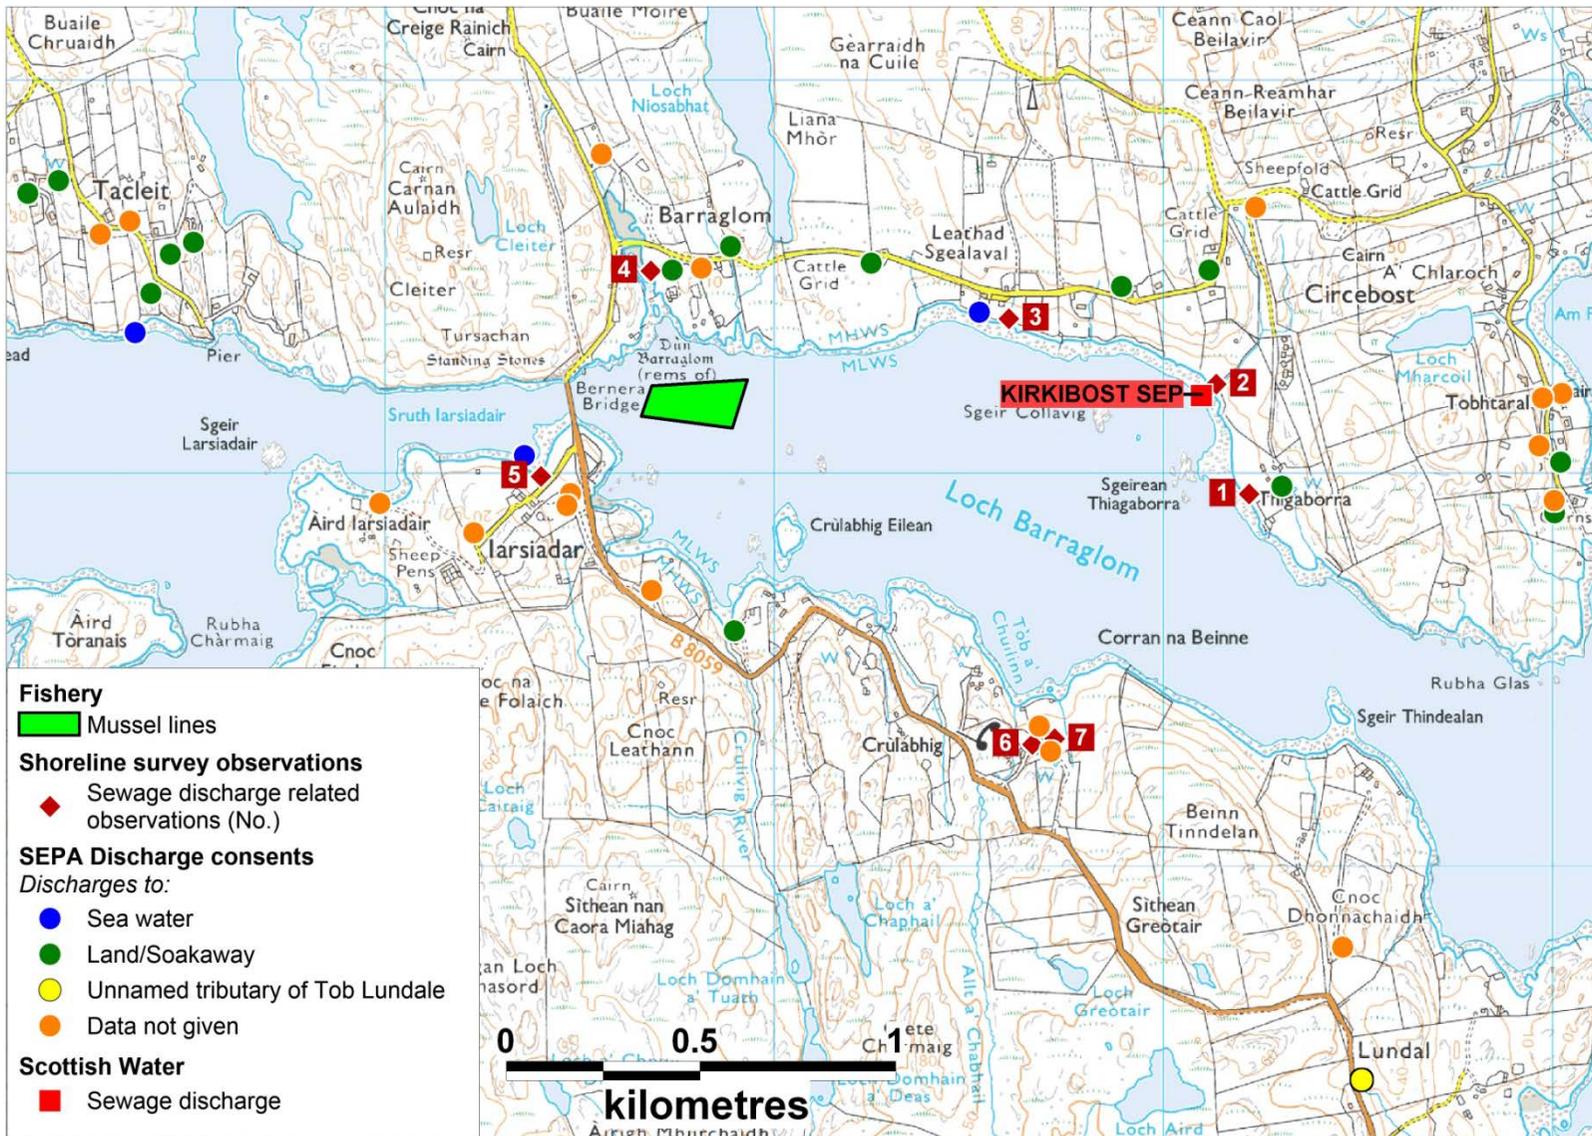
**Figure 4.1 Map of discharges for Loch Roag: Barraglom**

Seven observations of sewage infrastructure were noted during the shoreline survey. These are listed in Table 4.3.

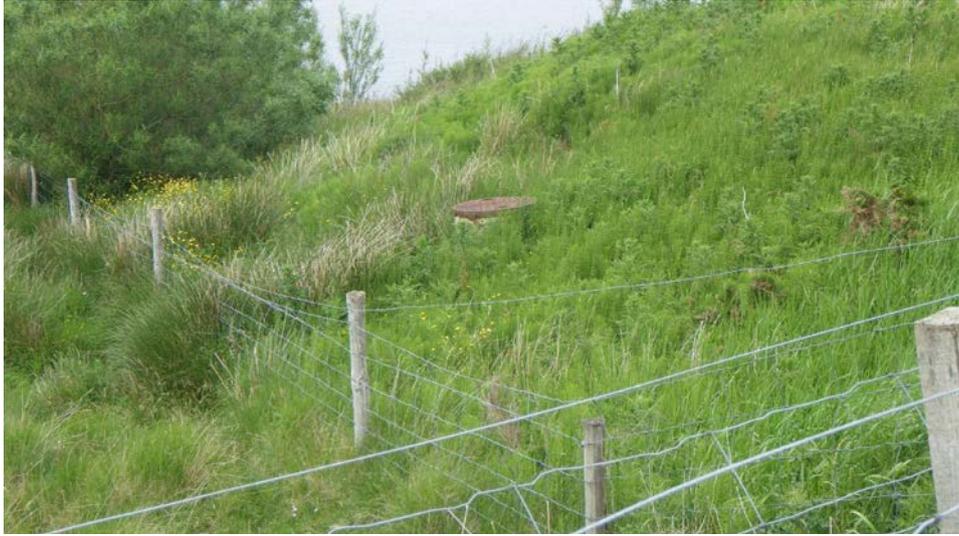
**Figure 4.2 Manhole cover reported in Shoreline Survey Observation 5**

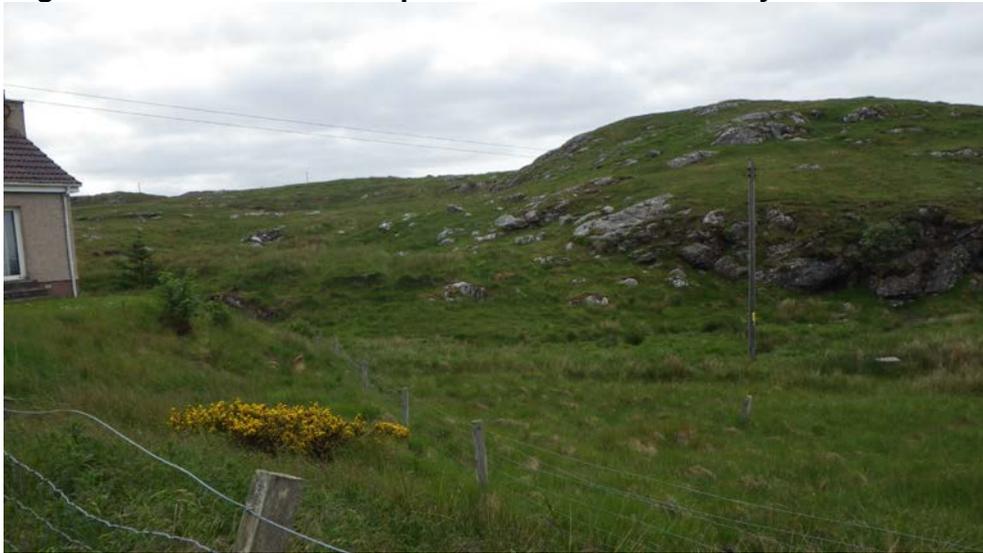
**Figure 4.3 Location of concrete structure reported in Shoreline Survey Observation 5**

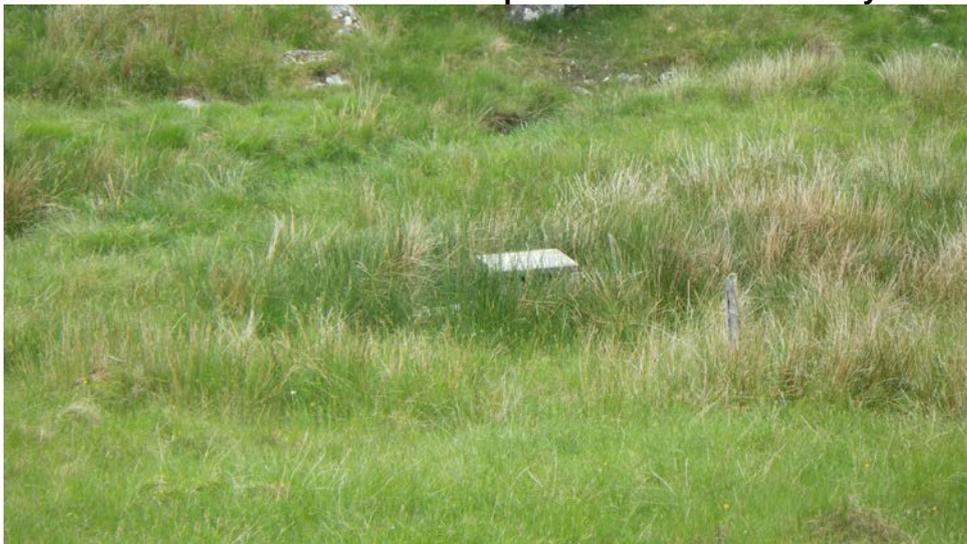
**Figure 4.4 Concrete structure reported in Shoreline Survey Observation 5**

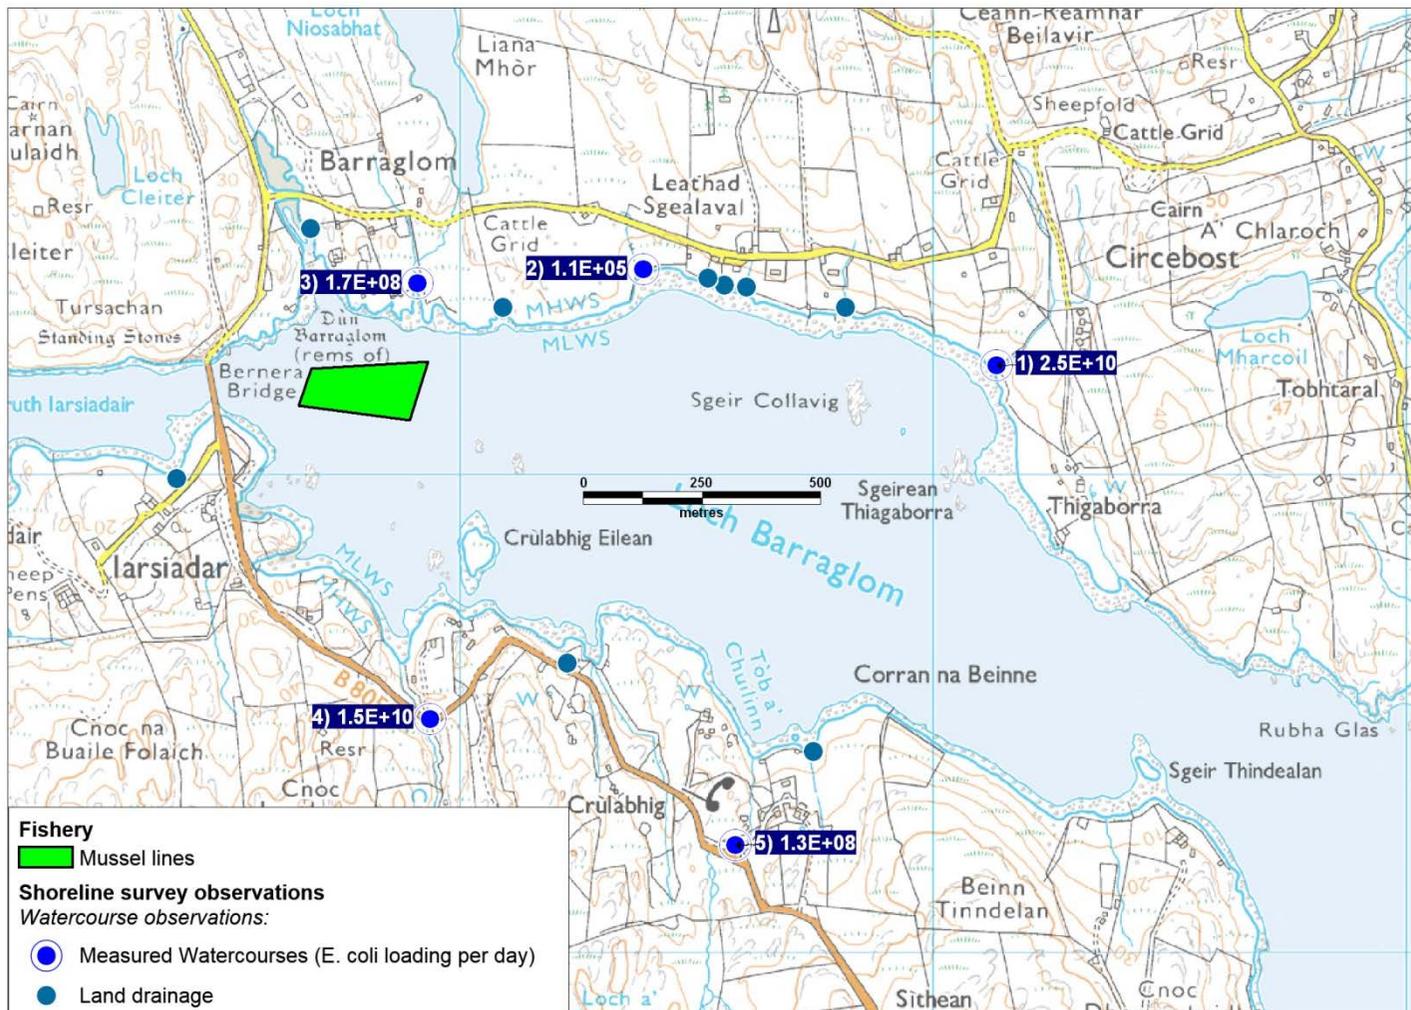
**Figure 8.1 Watercourse locations and estimated loadings**

The highest loading was recorded to the northeast of the production area, at Allt Millegro at 2.5x10<sup>10</sup> *E. coli* per day. The catchment area of this watercourse includes farmland, dwelling houses and a pipe suspected to be from the Kirkibost septic tank was also noted further upstream. The freshwater input lies >1 km east of the fishery.

The other significant freshwater input noted during the survey entered from the south from the River Cruilivig at 1.5x10<sup>10</sup> *E. coli* per day. This watercourse enters 600 m south of the southern extent of the fishery.

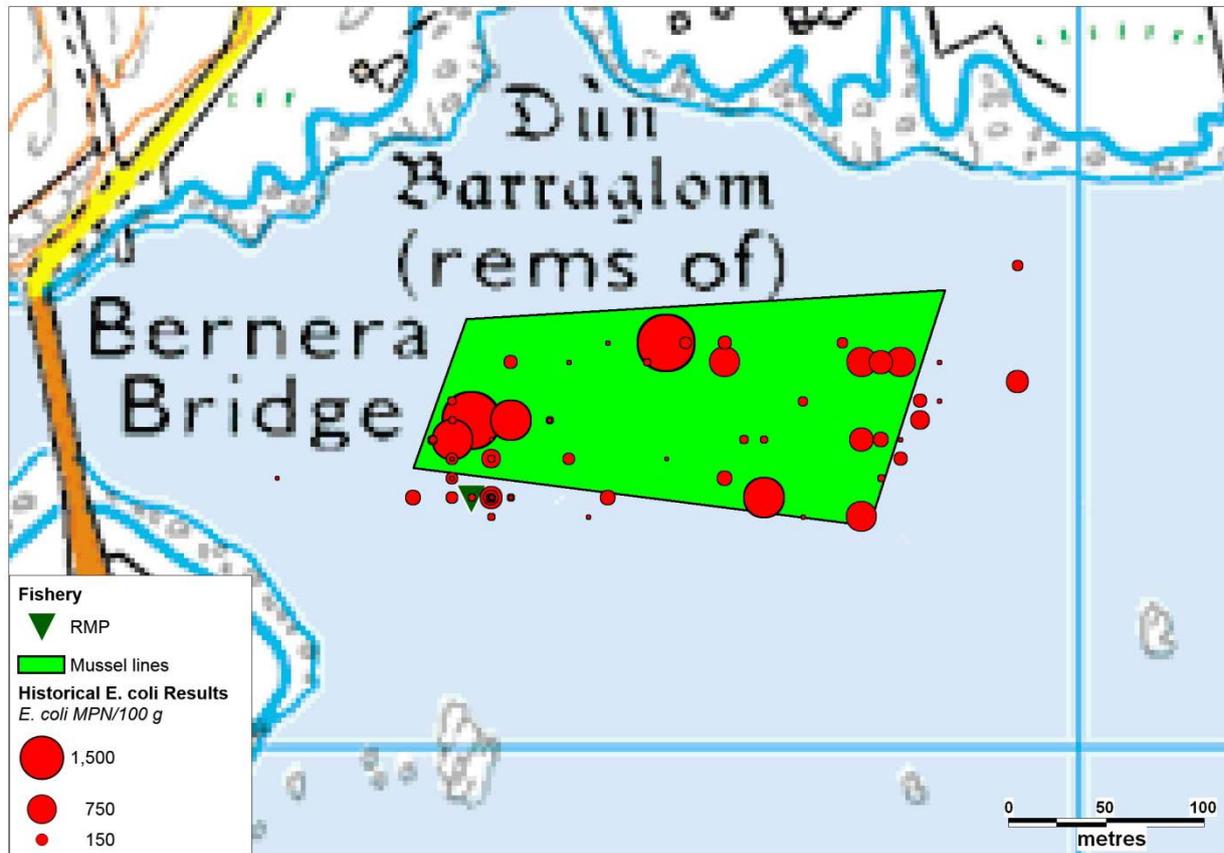
**Figure 11.1 Reported sampling locations for common mussels at Loch Roag Barraglom, with symbols graduated by *E. coli* result**

The geographical locations of Loch Roag: Barraglom sample results are displayed in Figure 11.1, with the symbols thematically mapped by size with respect to the magnitude of the *E. coli* result.

Samples had been taken from across the general extent of the mussel farm with higher results being associated with samples taken over the western half of the location of the present mussel lines.. Results varied between <20 and 3500 *E. coli* MPN / 100 g. A statistically significant difference was found between results and season, with lower results being obtained from samples taken in spring compared to summer, autumn and winter. Location of samples varied, though the majority were taken within the recorded mussel farm area.

It is recommended that the production area be curtailed along the eastern boundary to exclude the Kirkibost discharge. It is further recommended that the RMP be moved to the western side of the fishery to reflect contamination arising from septic tanks located to the east of the mussel farm.

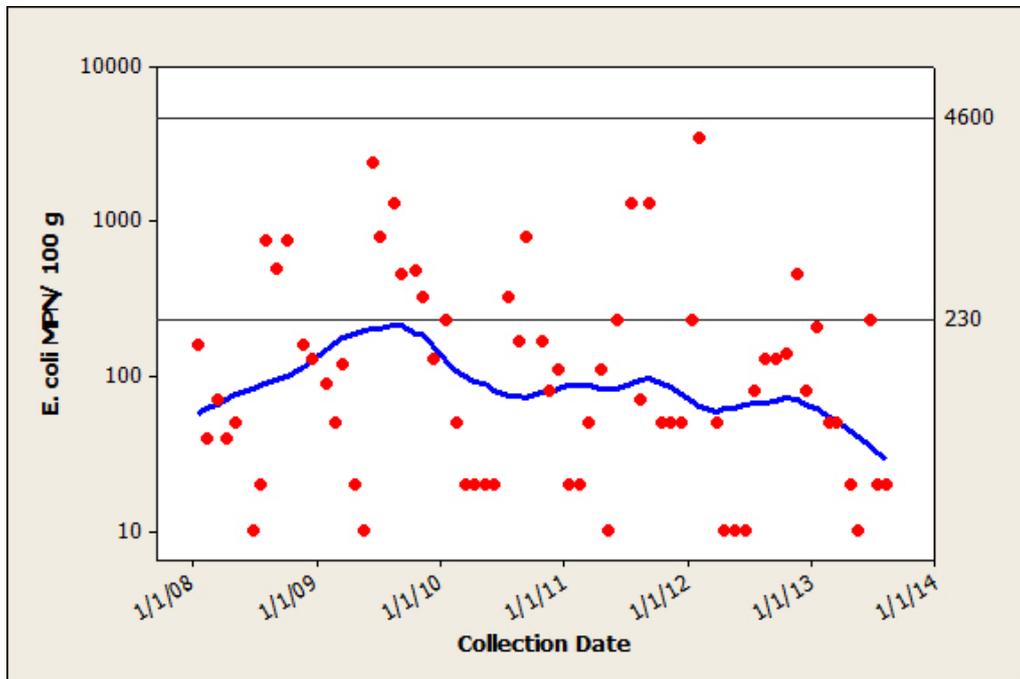
**Figure 11.2 Scatterplot of *E. coli* results by collection date at Loch Roag Barraglom, fitted with a lowess line**

Contamination levels are shown to have peaked in 2009 and have since gradually declined, although the highest result of 3500 *E. coli* MPN/100 g was seen in early 2012.

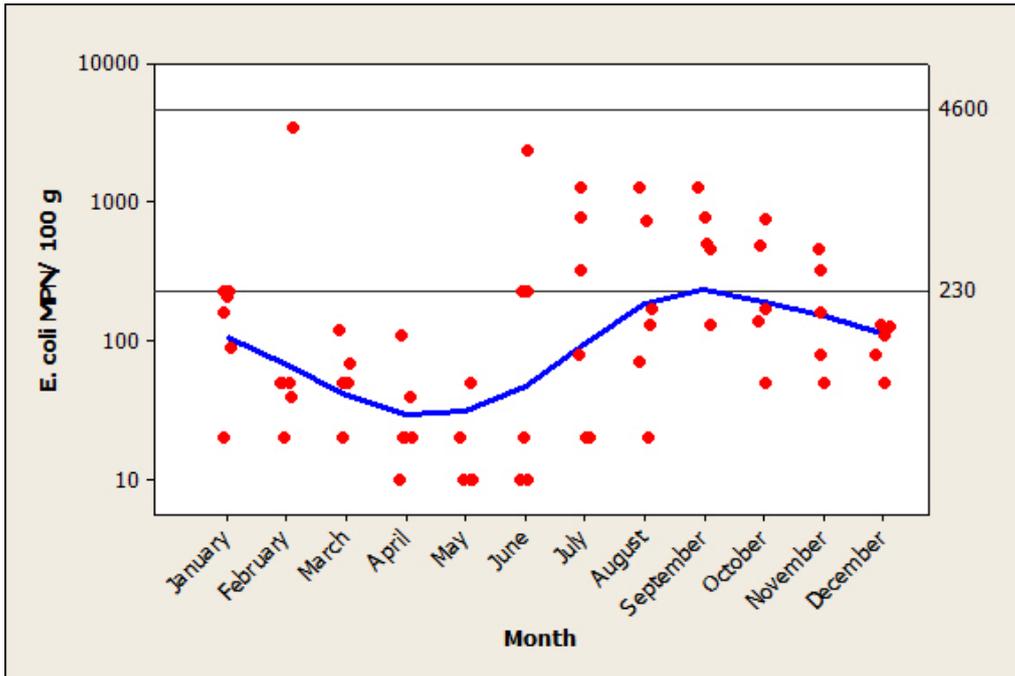
**Figure 11.3 Scatterplot of *E. coli* results by month at Loch Roag Barraglom, fitted with a lowess line**

The trend line shows a minimum in May and a maximum in September. Despite the highest result being recorded in February, higher results were generally seen from June to November.

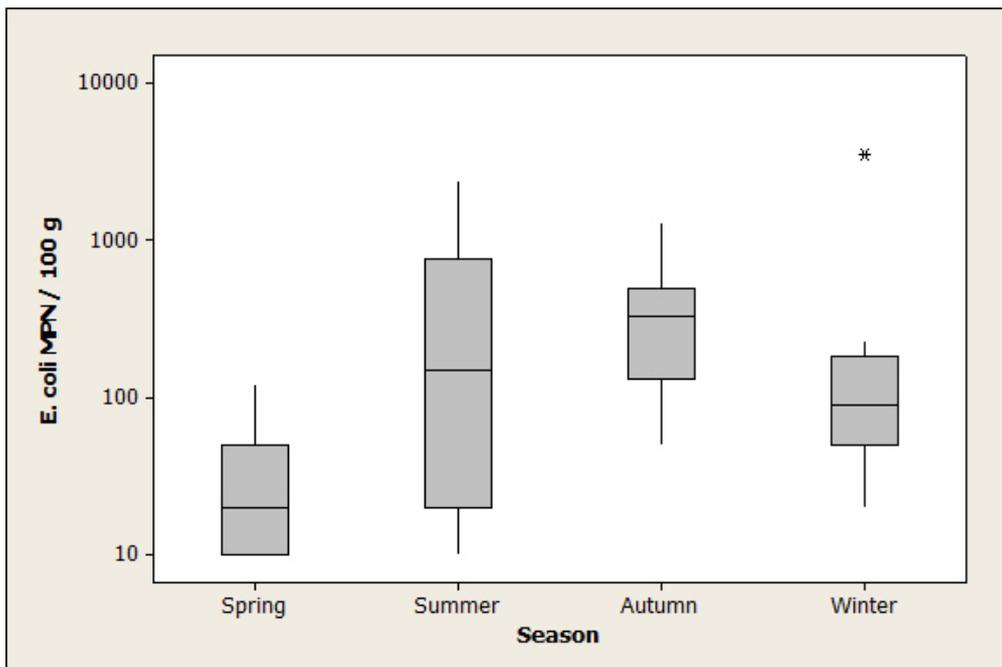
**Figure 11.4 Boxplot of *E. coli* results by season at Loch Roag Barraglom**

A significant difference was found between *E. coli* results by season (one-way ANOVA,  $p = 0.000$ , Appendix 4), with results in spring lower than those in summer, autumn and winter.

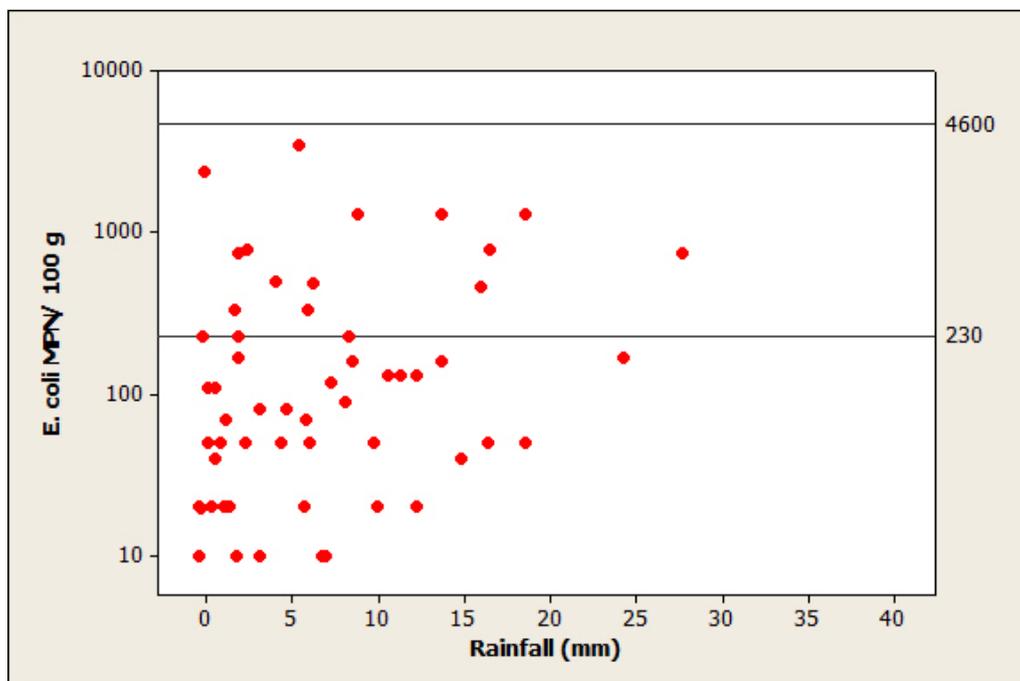
**Figure 11.5 Scatterplot of *E. coli* results against rainfall in the previous two days at Loch Roag Barraglom**

A significant correlation was found between *E. coli* results and the previous two day rainfall (Spearman’s rank correlation  $r = 0.266$ ,  $p = 0.047$ ). However, this appears to be related to a decrease in the number of low results seen after increasing amounts of rainfall and the two highest *E. coli* results were seen after no or low amounts of rainfall.

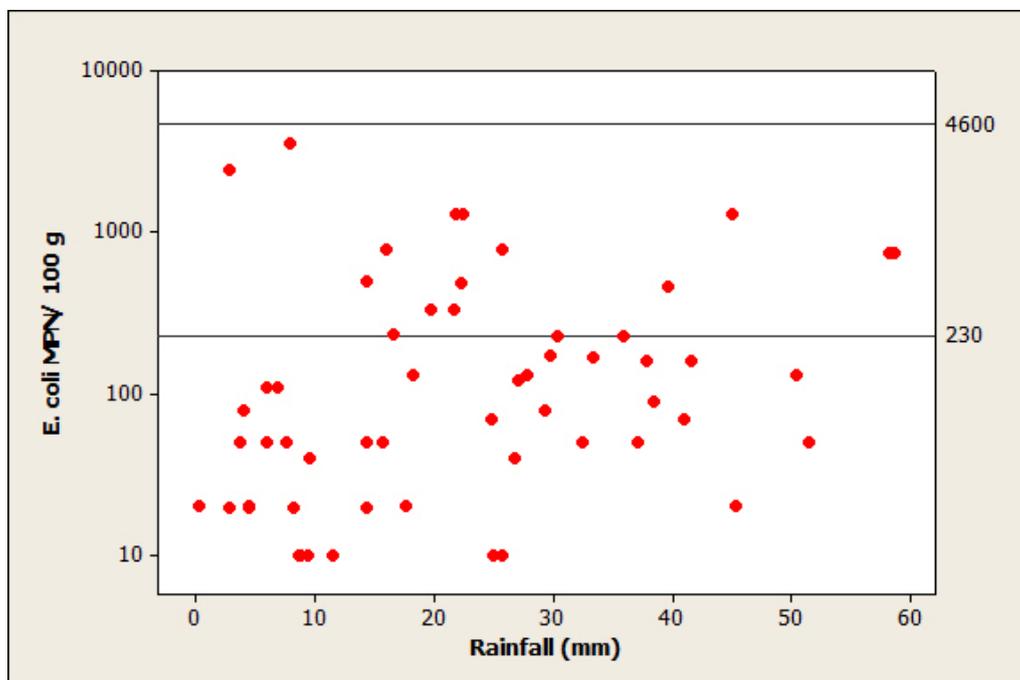
**Figure 11.6 Scatterplot of *E. coli* results against rainfall in the previous seven days at Loch Roag Barraglom**

A significant correlation was found between *E. coli* results and the previous seven day rainfall (Spearman’s rank correlation  $r = 0.332$ ,  $p = 0.012$ ). While the two highest *E. coli* results were seen after low seven-day rainfall amounts, there appeared to be some general increase in *E. coli* results with increasing rainfall values.

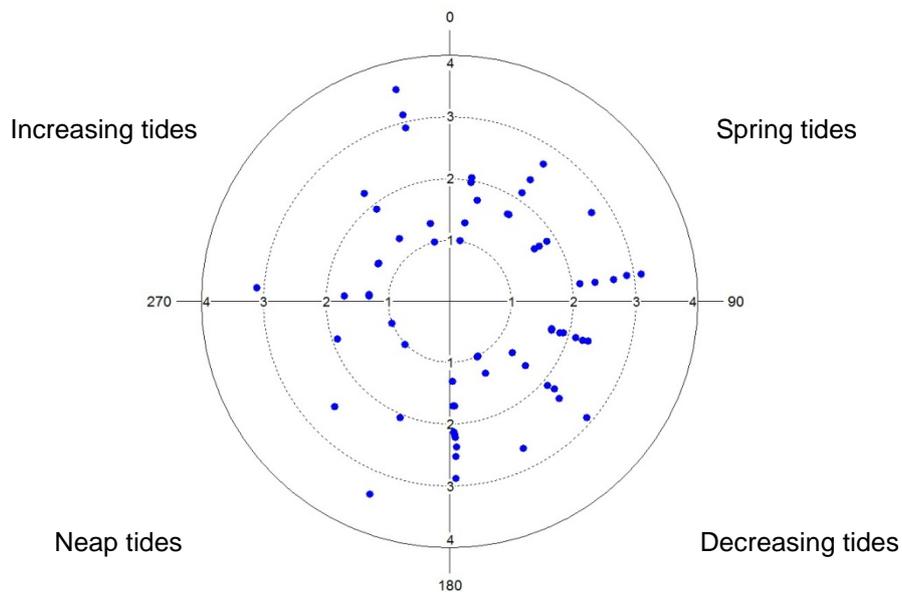
**Figure 11.7 Polar plots of  $\log_{10}$  *E. coli* results versus the spring/neap tidal cycle at Loch Roag Barraglom**

A significant correlation was found between  $\log_{10}$  *E. coli* results and the spring/neap tidal cycle (circular-linear correlation  $r = 0.219$ ,  $p = 0.044$ ). A greater proportion of samples taken during decreasing tides gave *E. coli* results  $>100$  MPN/100 g than over other parts of the spring/neap tidal cycle although high results did occur at other tidal states.

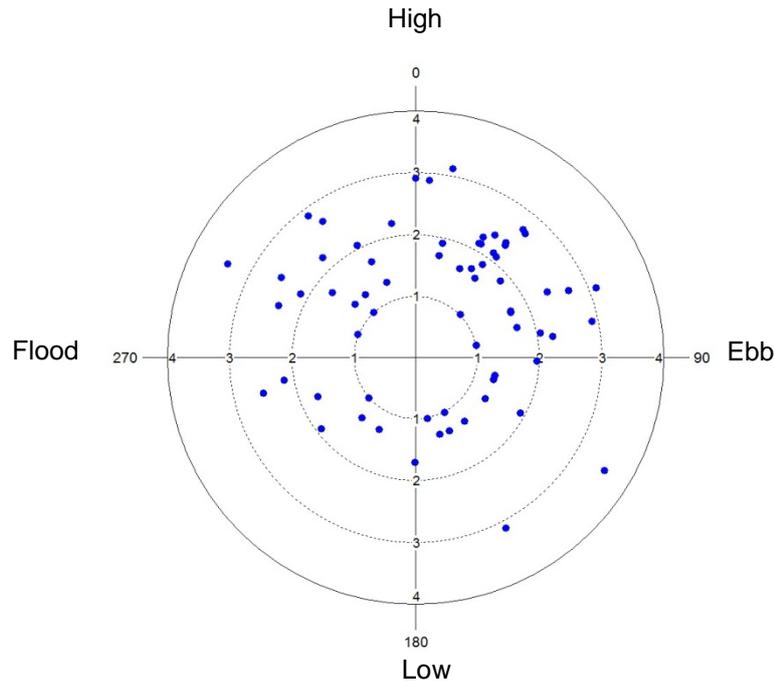
**Figure 11.8 Polar plots of  $\log_{10}$  *E. coli* results on the high/low tidal cycle at Loch Roag Barraglom**

A significant correlation was found between  $\log_{10}$  *E. coli* results and the high/low tidal cycle (circular-linear correlation  $r = 0.305$ ,  $p = 0.002$ ). The majority of elevated results were taken between the last half of flood tide and the first half of ebb tide.

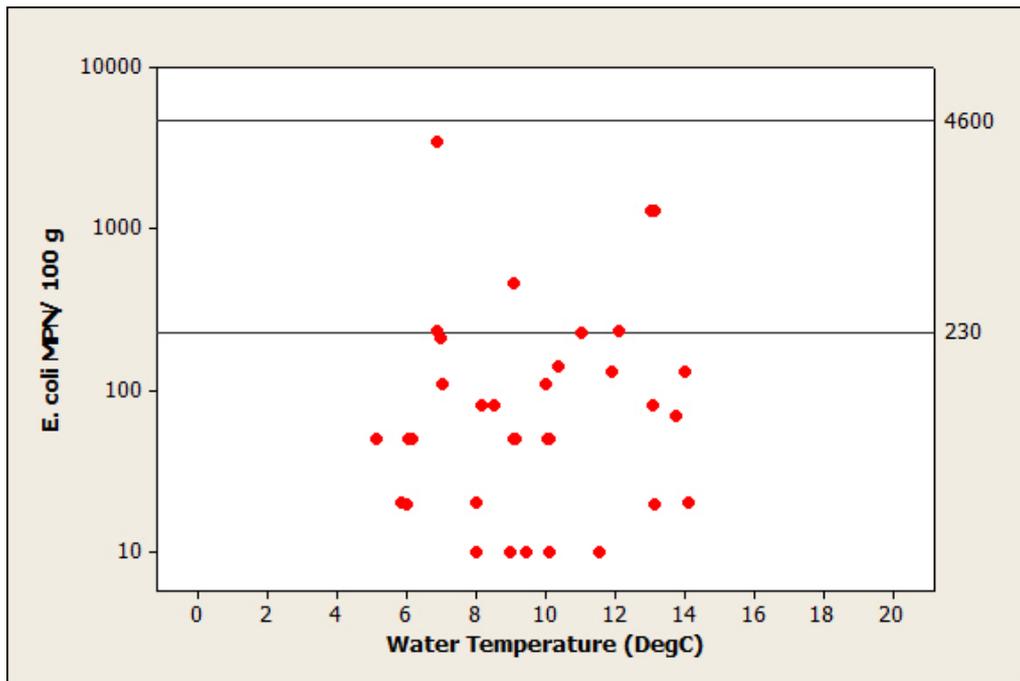
Figure 11.9 Scatterplot of *E. coli* results against water temperature at Loch Roag Barraglom

No significant correlation was found between *E. coli* results and water temperature (Spearman's rank correlation  $r = 0.157$ ,  $p = 0.376$ ).

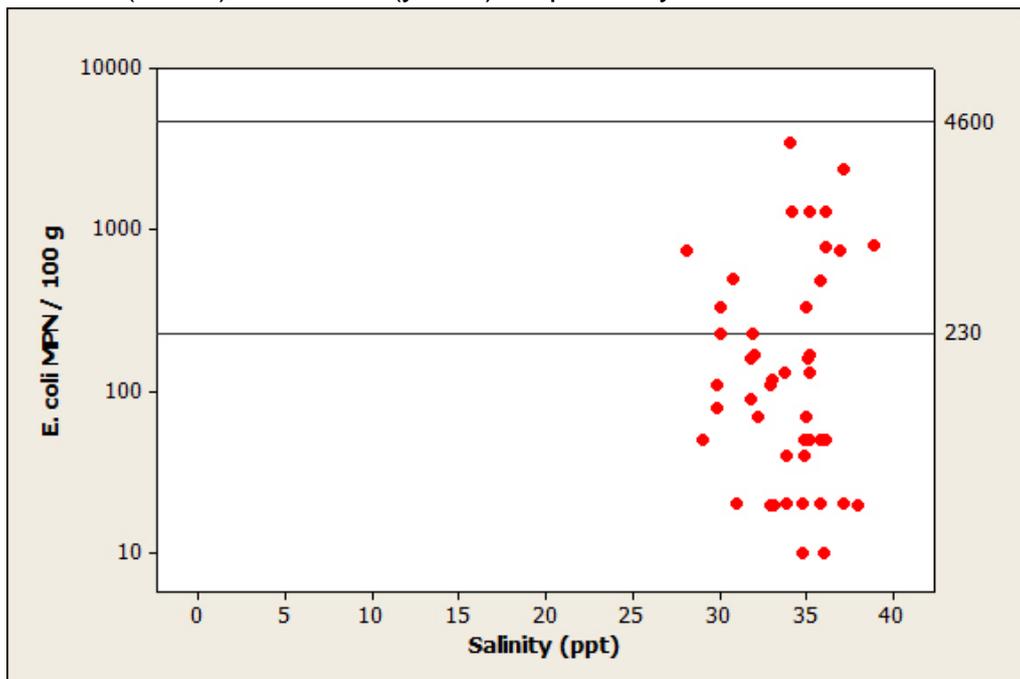
Figure 11.10 Scatterplot of *E. coli* results against salinity at Loch Roag Barraglom

No significant correlation was found between *E. coli* results and salinity (Spearman's rank correlation  $r = -0.086$ ,  $p = 0.561$ ).

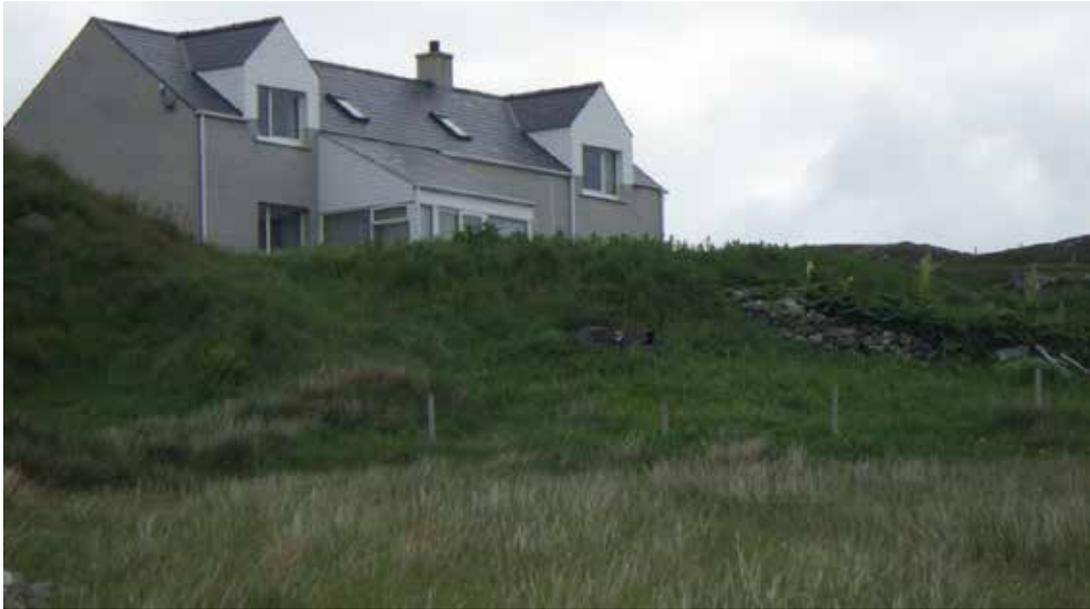
| No. | Date | Time | NGR | East | North | Associated photograph | Associated sample | Description |
|---|---|---|---|---|---|---|---|--|
| 1 | 26/06/2013 | 9:51 | NB 18299 34014 | 118300 | 934015 | Figure 3 | | Start of survey at North side of Loch at eastern end shoreline survey route. House name: Thigaborra, no access to property. 2 car wrecks on upper shore. |

Figure 3. House:Thigaborra at start of survey route. Waypoint 1.

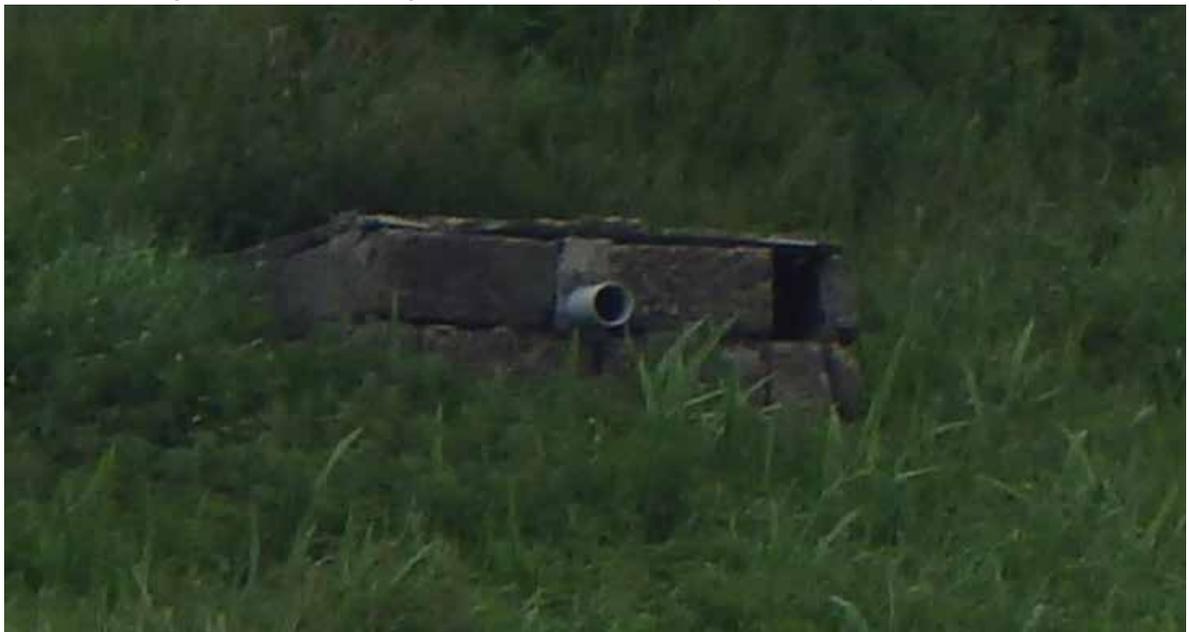
Figure 4. Pipe within Thigaborra's property boundaries. Waypoint 2.

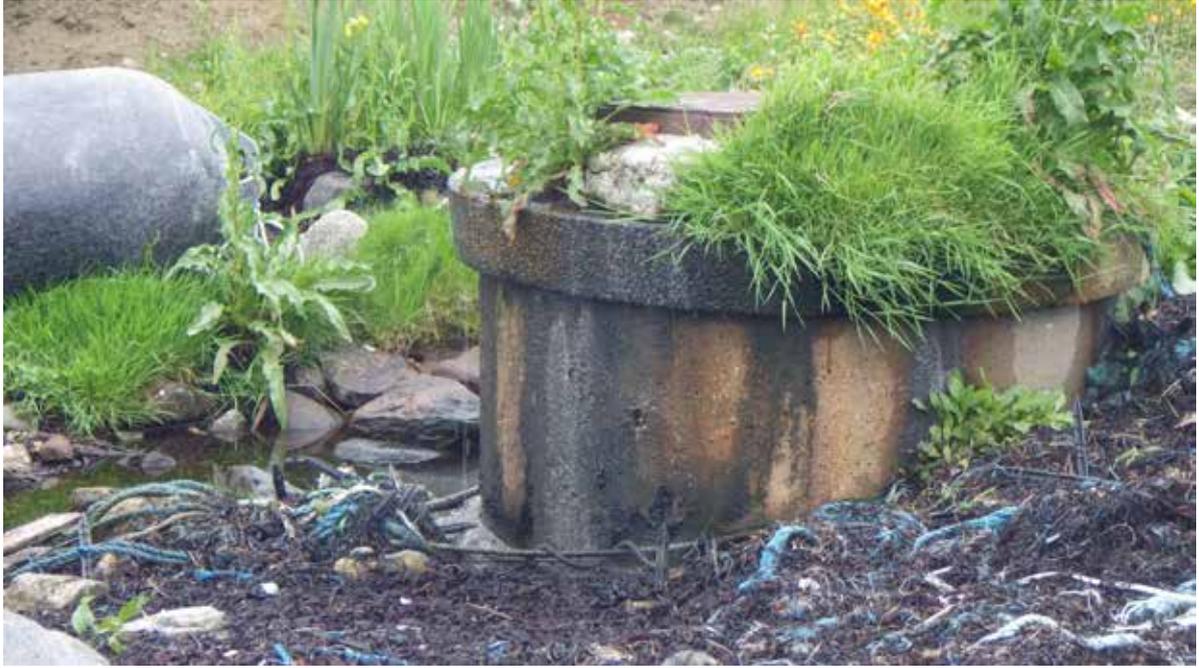
Figure 5. Outfall pipe discharging into watercourse. Waypoint 5.

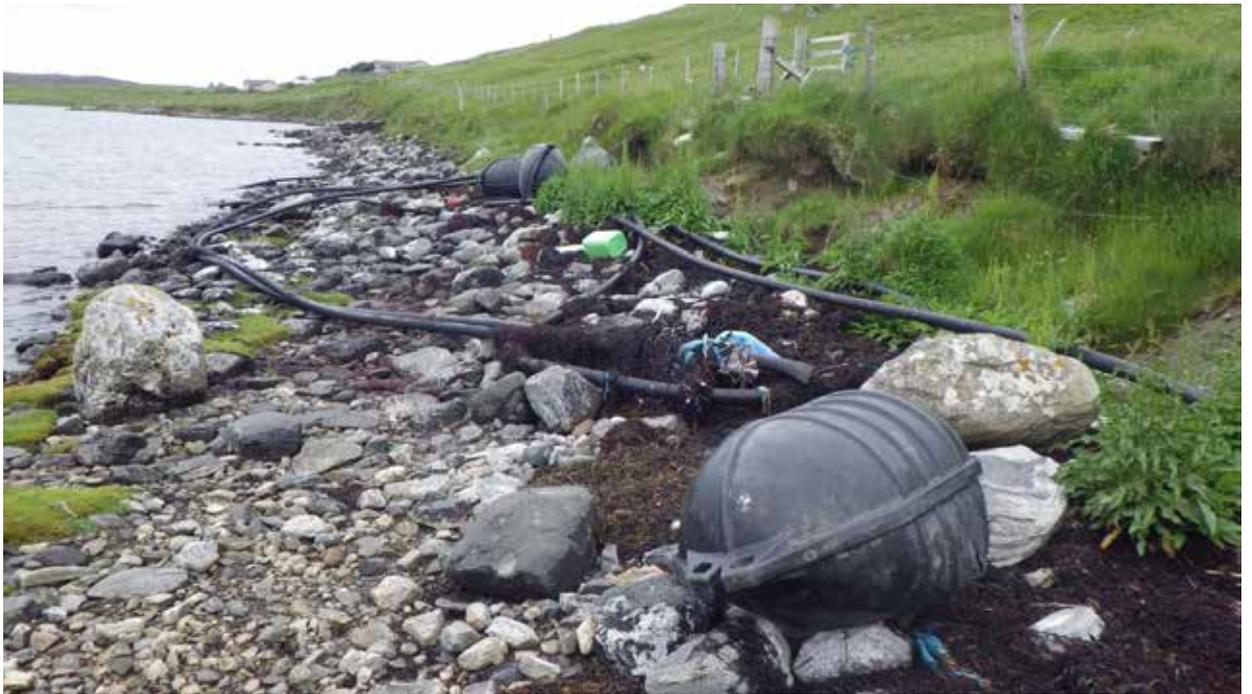
| No. | Date | Time | NGR | East | North | Associated photograph | Associated sample | Description |
|---|---|---|---|---|---|---|---|--|
| 8 | 26/06/2013 | 10:30 | NB 18102 34258 | 118103 | 934258 | Figure 6 | | Debris on shore (floats and plastic piping). One oyster catcher. |

Figure 6. Debris on shore. Waypoint 8.

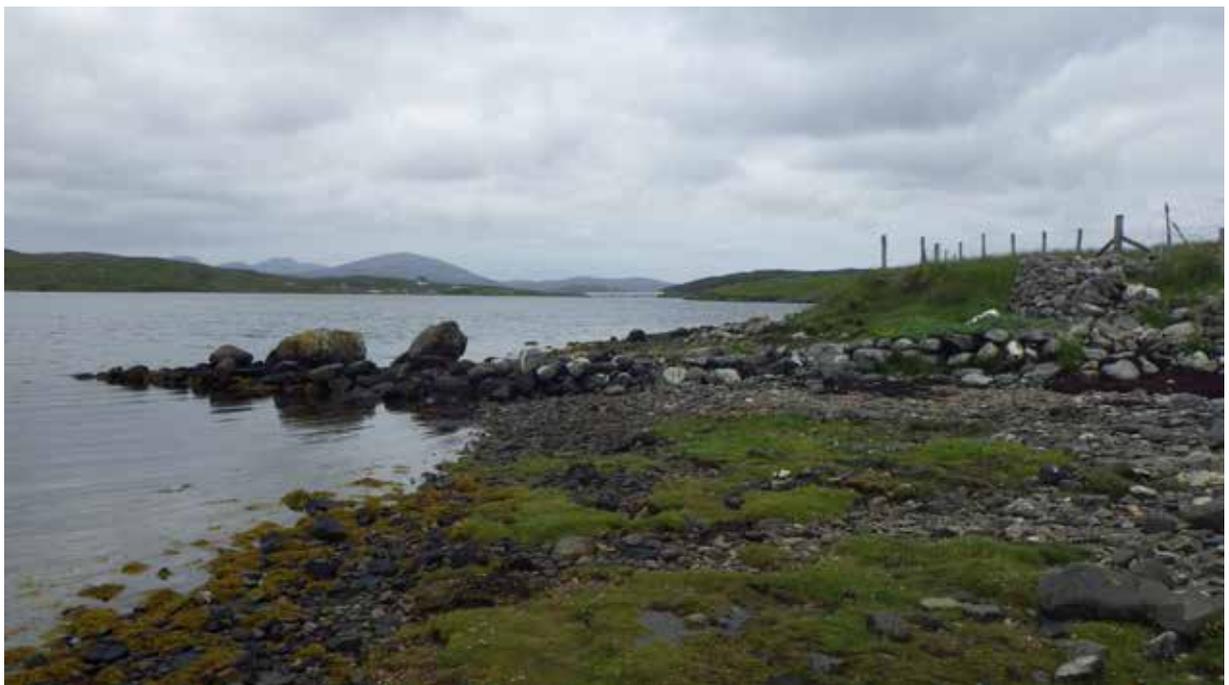
| No. | Date | Time | NGR | East | North | Associated photograph | Associated sample | Description |
|---|---|---|---|---|---|---|---|---|
| 13 | 26/06/2013 | 10:55 | NB 17755 34350 | 117756 | 934351 | Figure 9 | | Stone structure just below house. Tide was high. |

Figure 9. Stone structure running from shore into Loch. Waypoint 13.

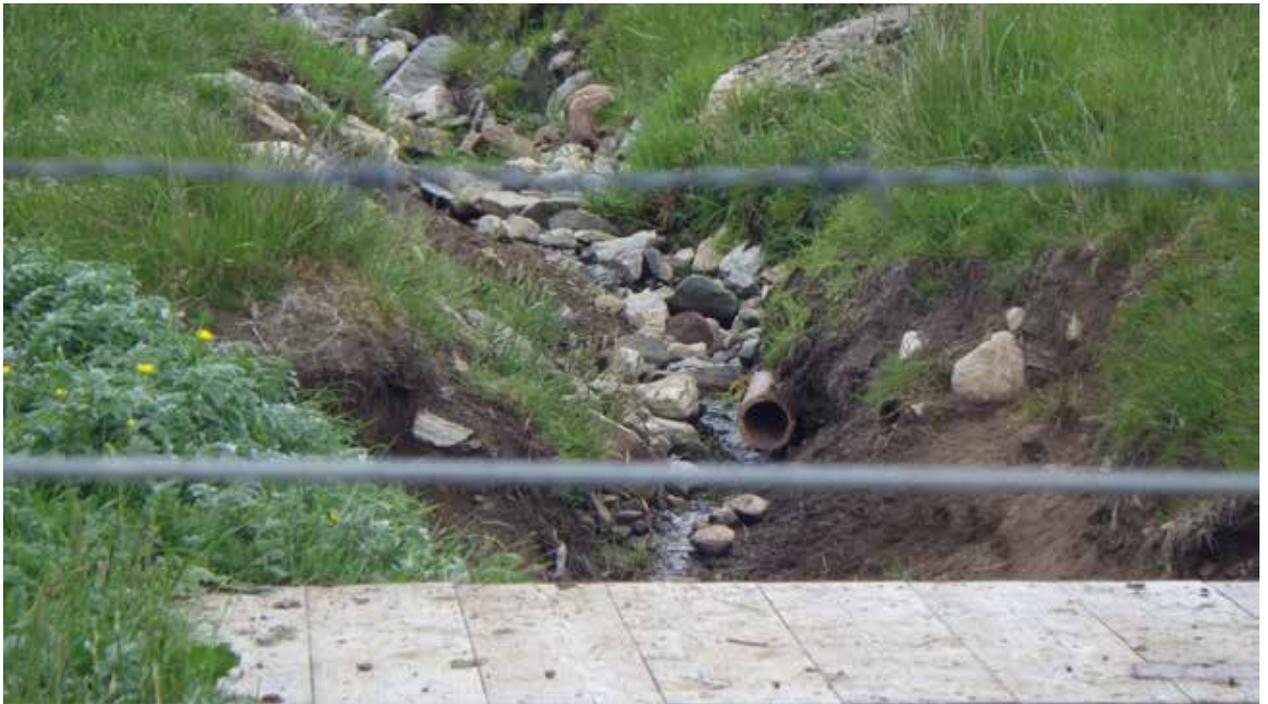
Observation 3 relates to a small concrete structure with pipe protruding out of it. Clay piping runs in a channel down from the structure towards the shore. No outfall was noted, however. This structure looks like an old concrete septic tank with overflow and outfall. It may represent CAR/R/1063347 septic tank which plots less than 100 m to the east, or could be a septic tank unreported to SEPA.

Figure 11. Pipe in channel running down from housing in field. Waypoint 15.

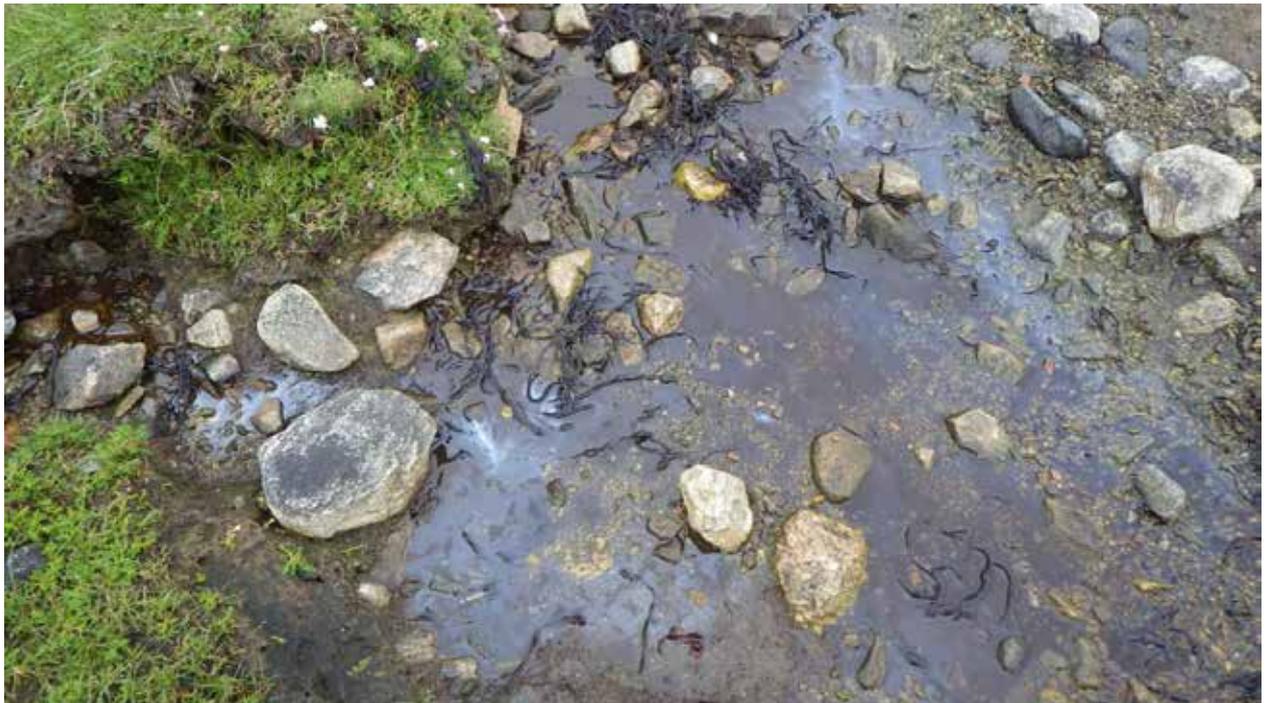
Under rainfall conditions, it is expected that the areas of stagnant water identified during the shoreline survey would flow into the loch.

Figure 12. Stagnant pool beside LBFW03 sample point. Waypoint 18.

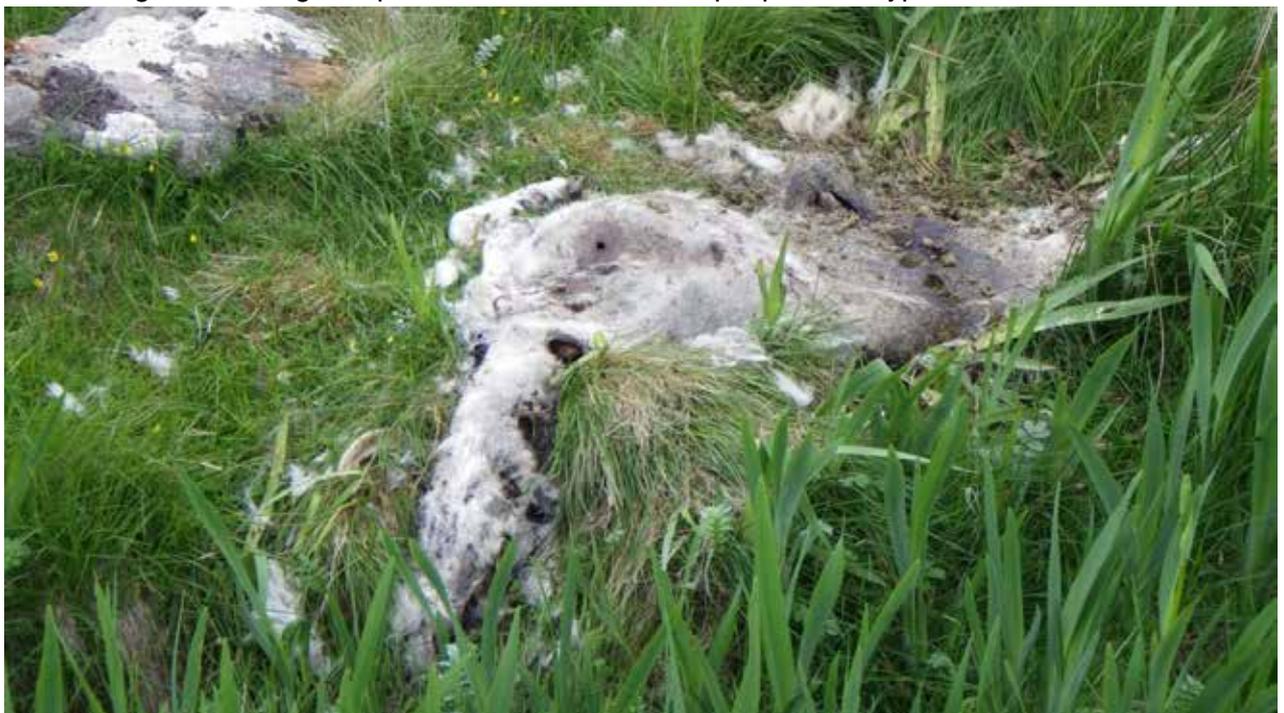
Figure 13. Decomposing sheep carcass close to shore. Waypoint 27.
