**Sanitary Survey Report  
Loch Roag: Barraglom  
LH-185-120-08  
September 2013**

| <b>Report Title</b> | Loch Roag: Barraglom Sanitary Survey Report |
| <b>Project Name</b> | Scottish Sanitary Survey |
| <b>Client/Customer</b> | Food Standards Agency<br>Scotland |

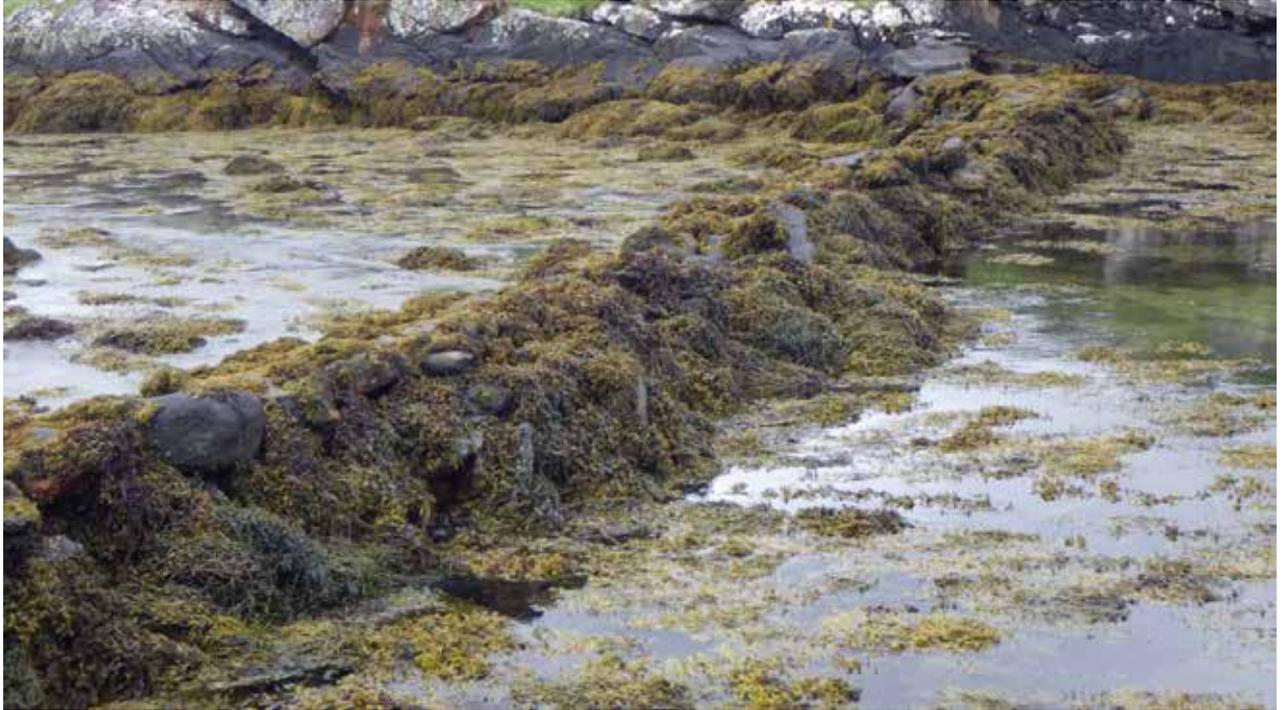
| No. | Date | Time | NGR | East | North | Associated photograph | Associated sample | Description |
|---|---|---|---|---|---|---|---|--|
| 29 | 26/06/2013 | 12:33 | NB 16685 34518 | 116685 | 934518 | Figures 14-16 | | <p>Large watercourse/inlet in the loch, which at the north end has a road causeway built across it, with two corrugated pipes under the road allowing flow through (Figure 16). Flow not measured as could not gain access. Width of the inlet/watercourse measured across the causeway as 30m from wetted bank to wetted bank.</p> <p>South of the causeway, stone dam/structure built across the inlet/watercourse covered in seaweed (Figure 14). Depth 31cm. Flow 0.059m/s SD: 0.004. Measurement made on the loch side of the structure.</p> <p>Clay pipe running from house to shoreline no outflow (in-</p> |

Figure 14. Dam at planned water site. Waypoint 29.

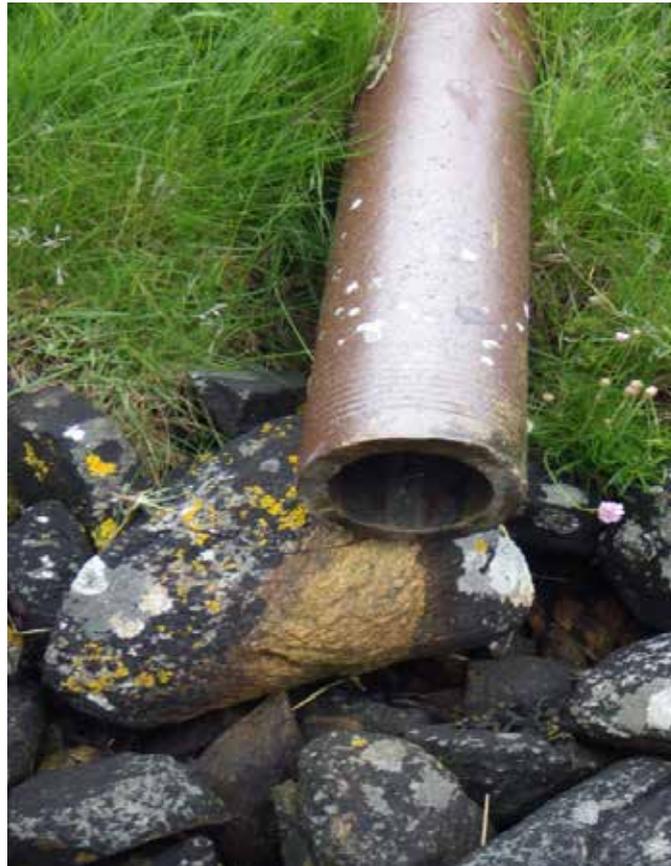
Figure 15. Claypipe running from house to shoreline. Waypoint 29.

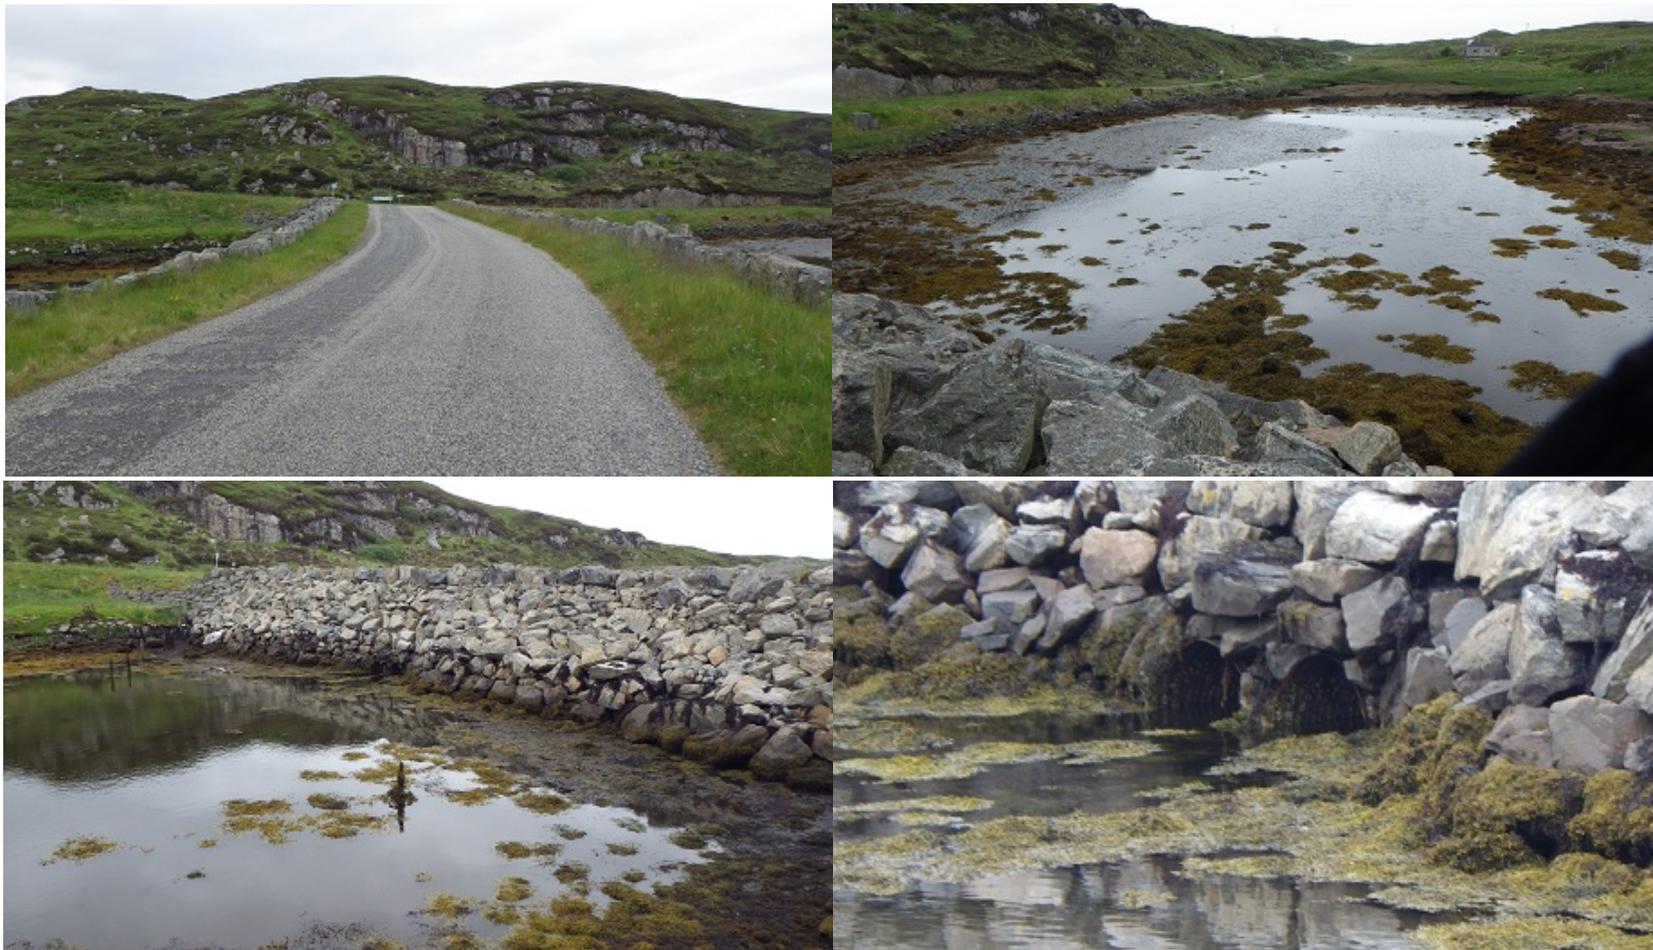
Figure 16. Road causeway across loch inlet with corrugated pipes allowing flow under road. Waypoint 29.

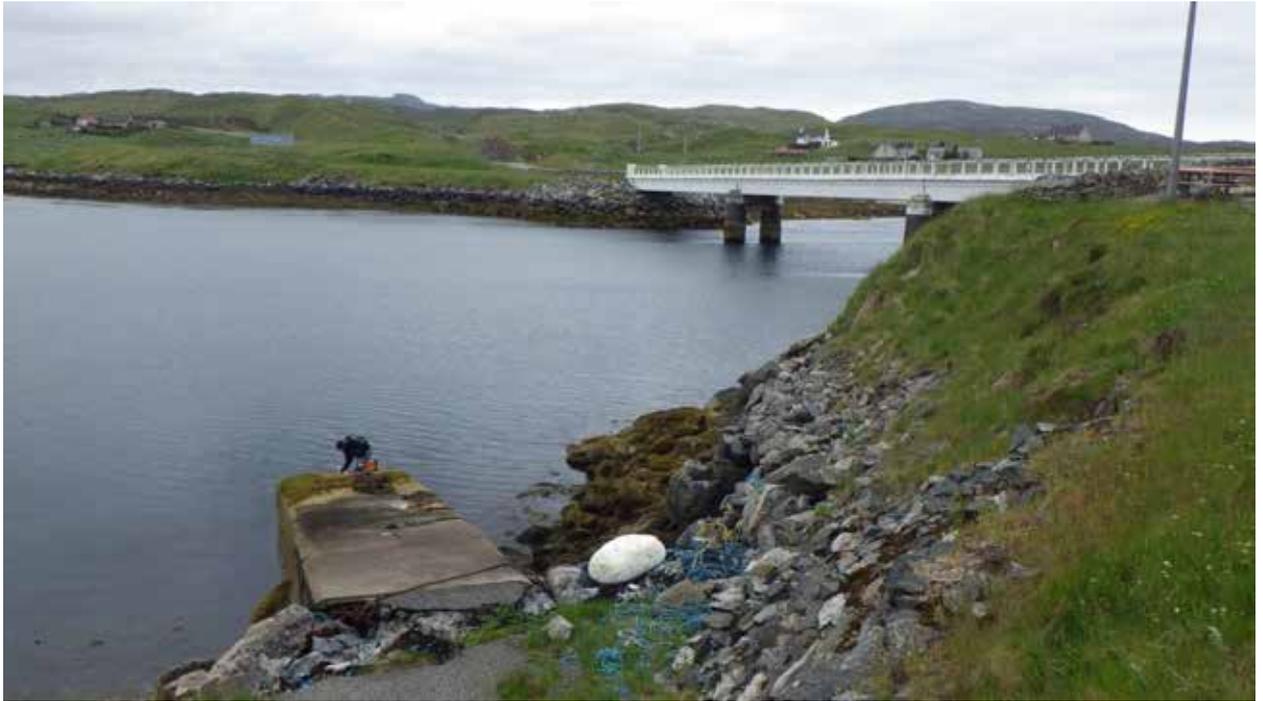
| No. | Date | Time | NGR | East | North | Associated photograph | Associated sample | Description |
|---|---|---|---|---|---|---|---|--|
| 30 | 26/06/2013 | 13:26 | NB 16512 34263 | 116513 | 934264 | Figure 17 | LBSW01 | Sea water sample taken from slipway. |

Figure 17. Sea water sample taken from slipway. Waypoint 30.

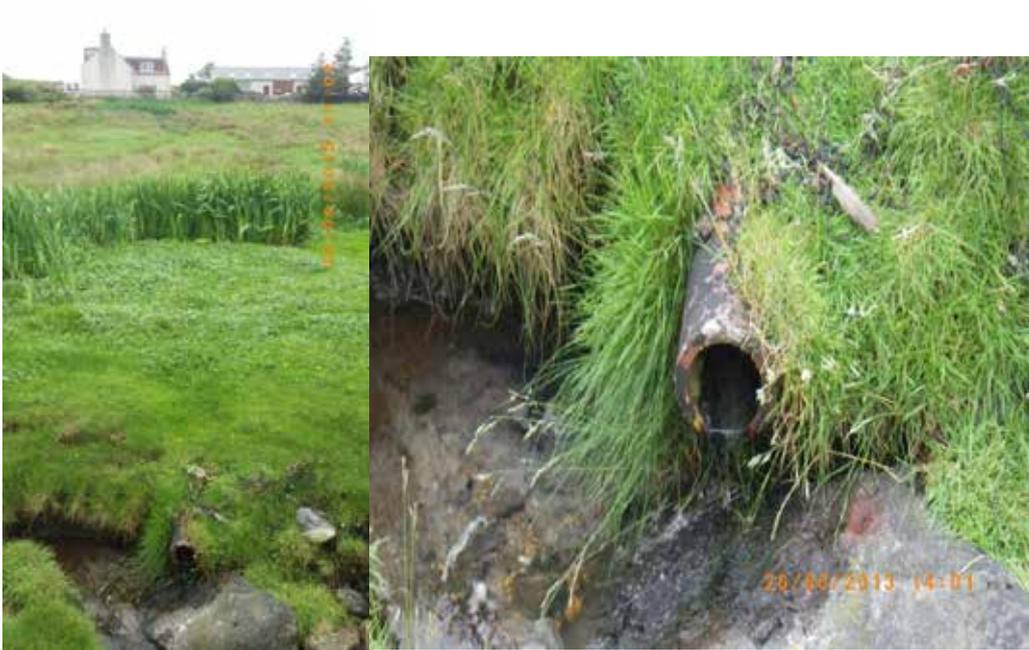
Figure 18. Pipe discharging into watercourse from below house. Waypoint 38.

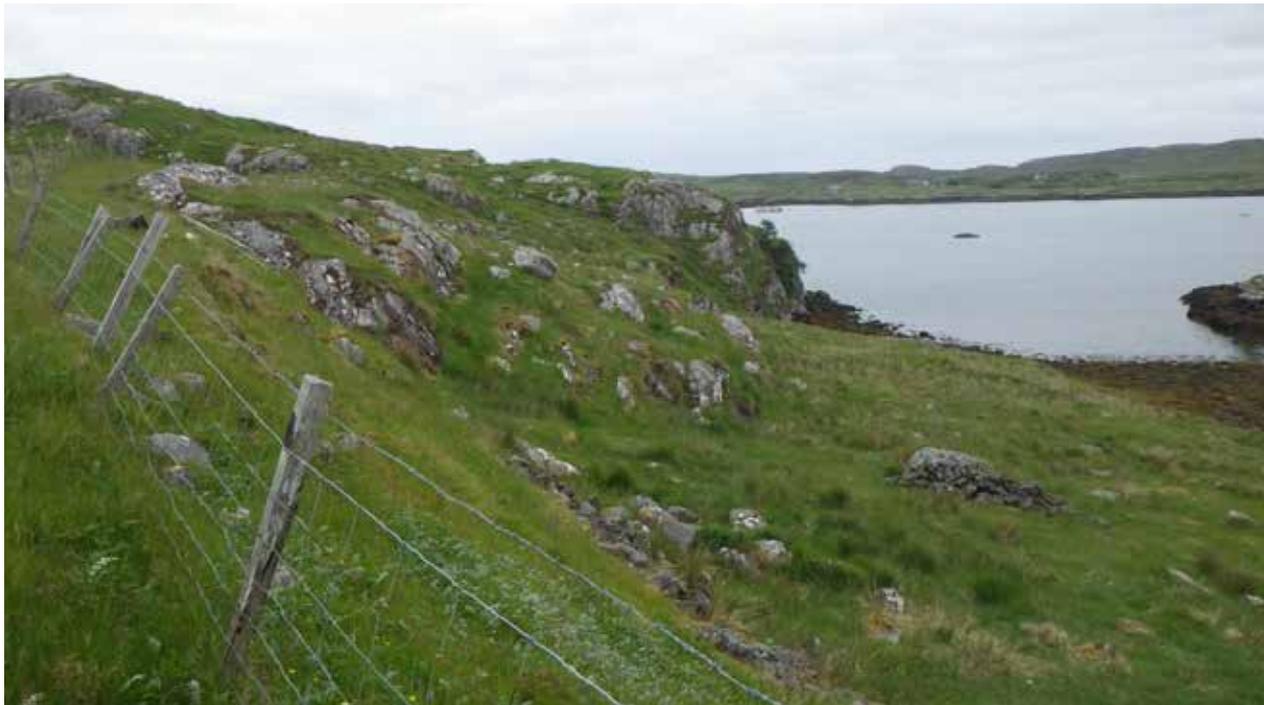
| No. | Date | Time | NGR | East | North | Associated photograph | Associated sample | Description |
|---|---|---|---|---|---|---|---|--|
| 41 | 26/06/2013 | 14:32 | NB 16863 33547 | 116864 | 933548 | Figure 19 | | No access to shore, barbed wire fencing and steep shoreline |

Figure 19. No access to shore. Waypoint 41.

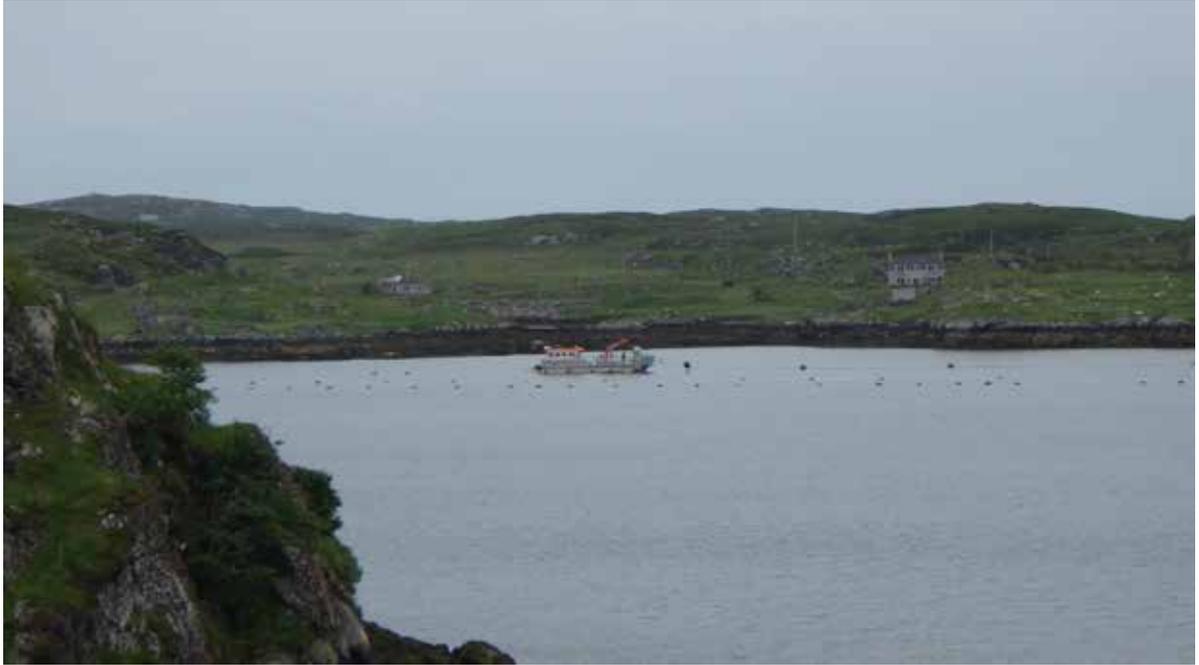
| No. | Date | Time | NGR | East | North | Associated photograph | Associated sample | Description |
|---|---|---|---|---|---|---|---|--|
| 43 | 26/06/2013 | 14:38 | NB 16937 33486 | 116937 | 933486 | Figures 20 & 21 | | Measurements: Depth 6cm, width: 1.5m. Flow rate: 0.441 m/s SD: 0.016. Watercourse overgrown and deep below road. Difficult access. Harvester's boat in operation by mussel lines |

Figure 21. Harvesters' boat in operation. Waypoint 43.

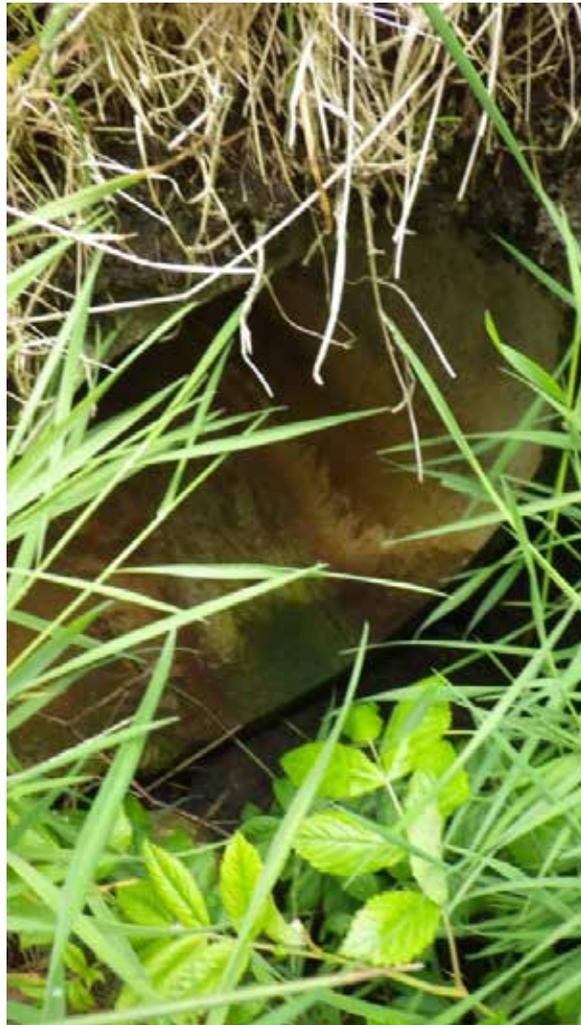
Figure 22. Concrete pipe at planned sampling point. Waypoint 46.

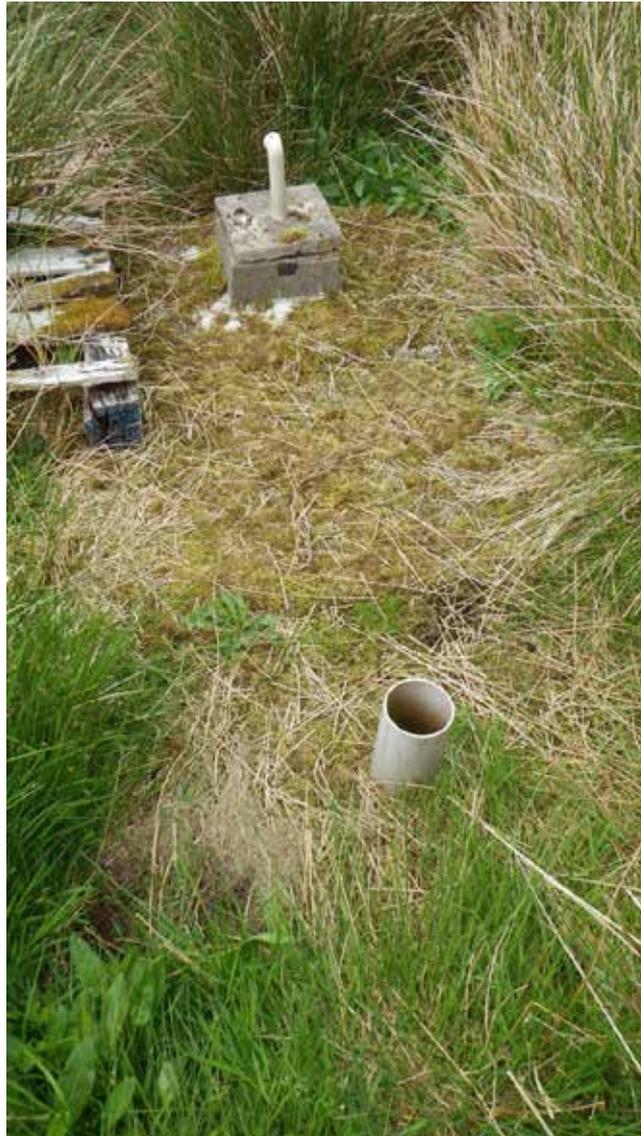
Figure 23. Possible septic tank. Waypoint 50.
