Scottish Sanitary Survey Review

Loch Roag: Ceabhagh and Eilean Chearstaigh

LH-344 and LH-381

February 2015

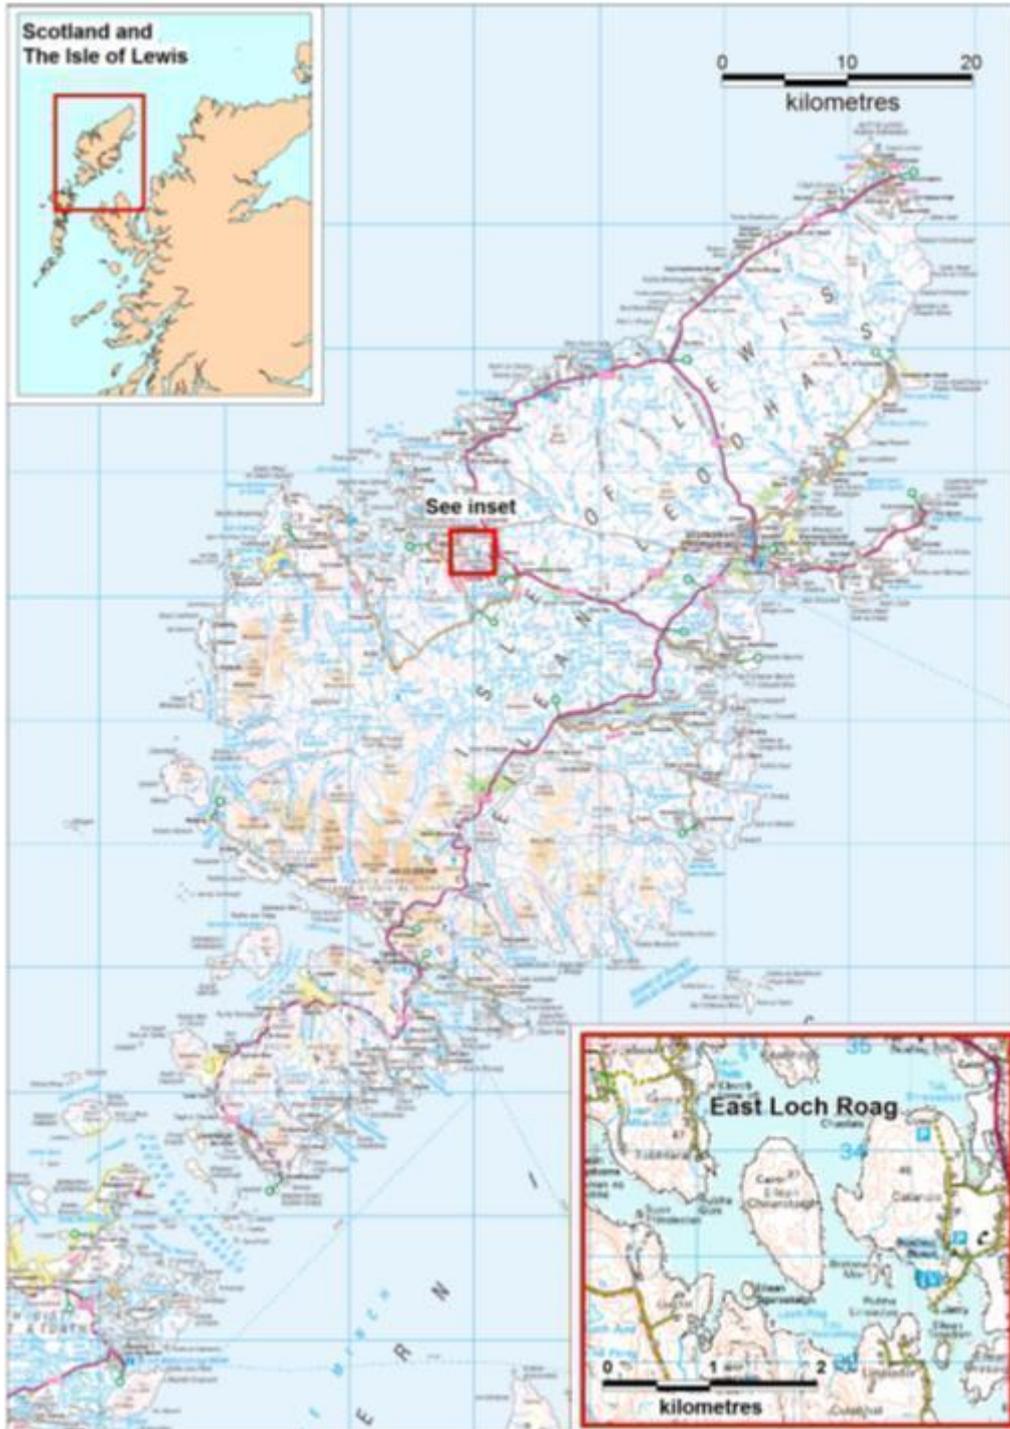
Figure 1.1 Location of East Loch Roag

The location of East Loch Roag, which contains the production areas Loch Roag: Ceabhagh and Loch Roag: Eilean Chearstaigh, is shown in Figure 1.1.

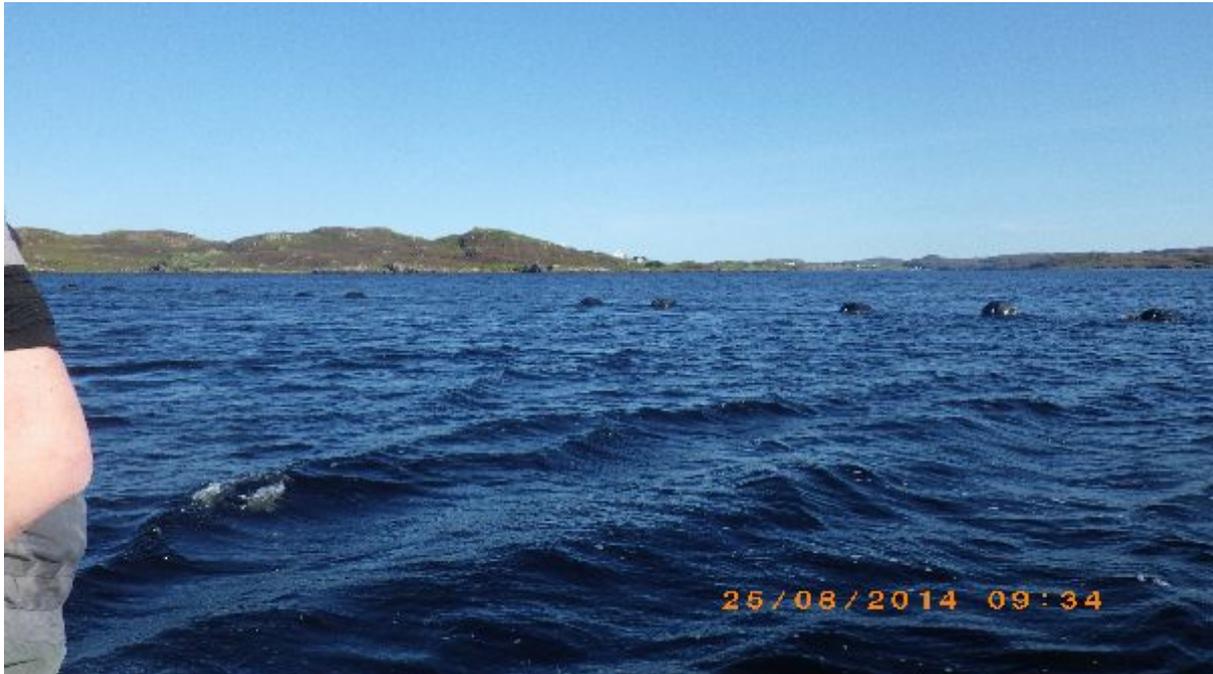
Fig 3: Longlines at Eilean Sgarastaigh (WP3, looking north)

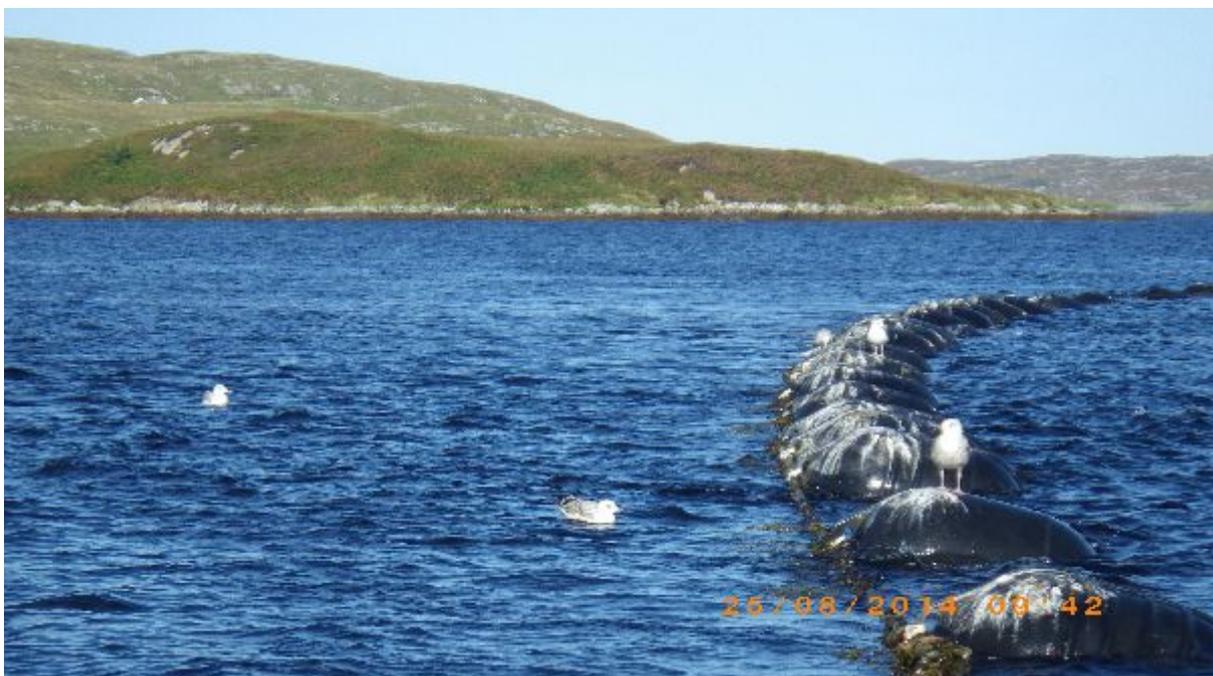
Fig 4: Longlines at Buckle point, showing fouling and birds present (WP 11)

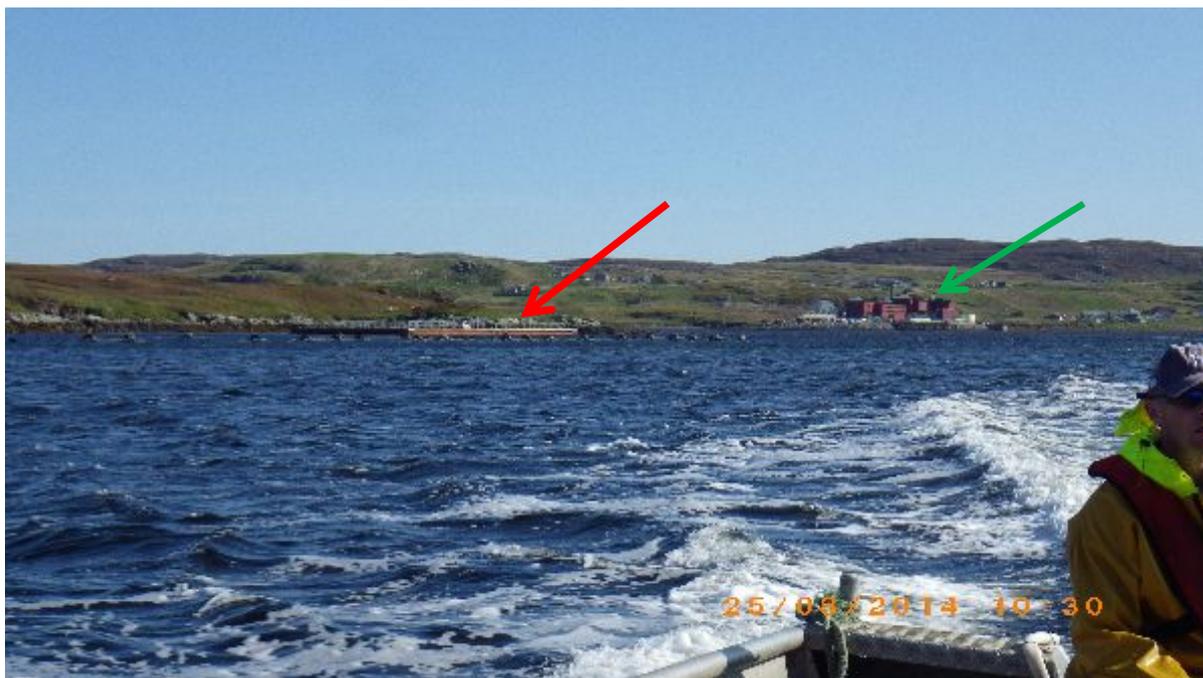
Fig 5: Longlines at Keava, with disused salmon cages (not associated with the mussel farm) highlighted with red arrow. Factory located in village of Breascleit is highlighted with green arrow. Photo taken from point to SW of WP22, looking NE.

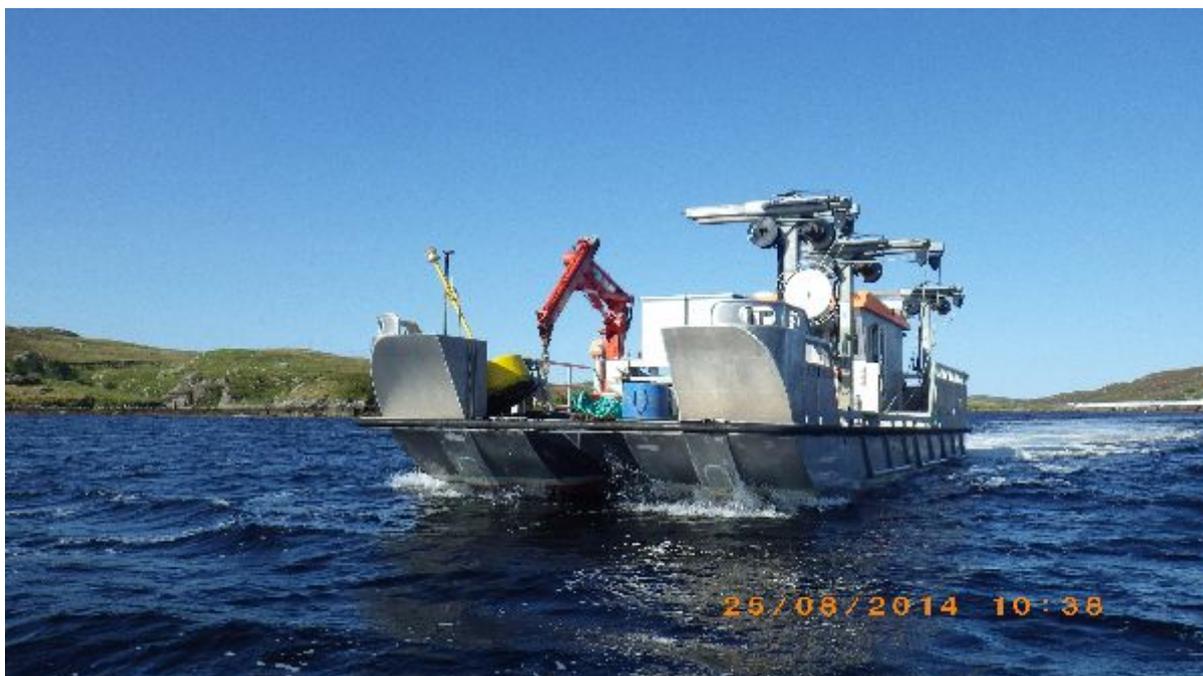
Fig 6: Aluminium mussel farm harvesting vessel – photo taken on passage in Loch Barraglom on return to shore base.

The fishery at the sites in Ceabhagh (Keava) and Eilean Chearstaigh consist of cultivation of common mussels (*Mytilus edulis*) on a longline system. All of the sites use a form of New Zealand continuous longline where the mussel rope is looped in turn for each dropper. This allows for easier handling and deployment from the farm barge (Fig. 6 – not included in Table 1). The

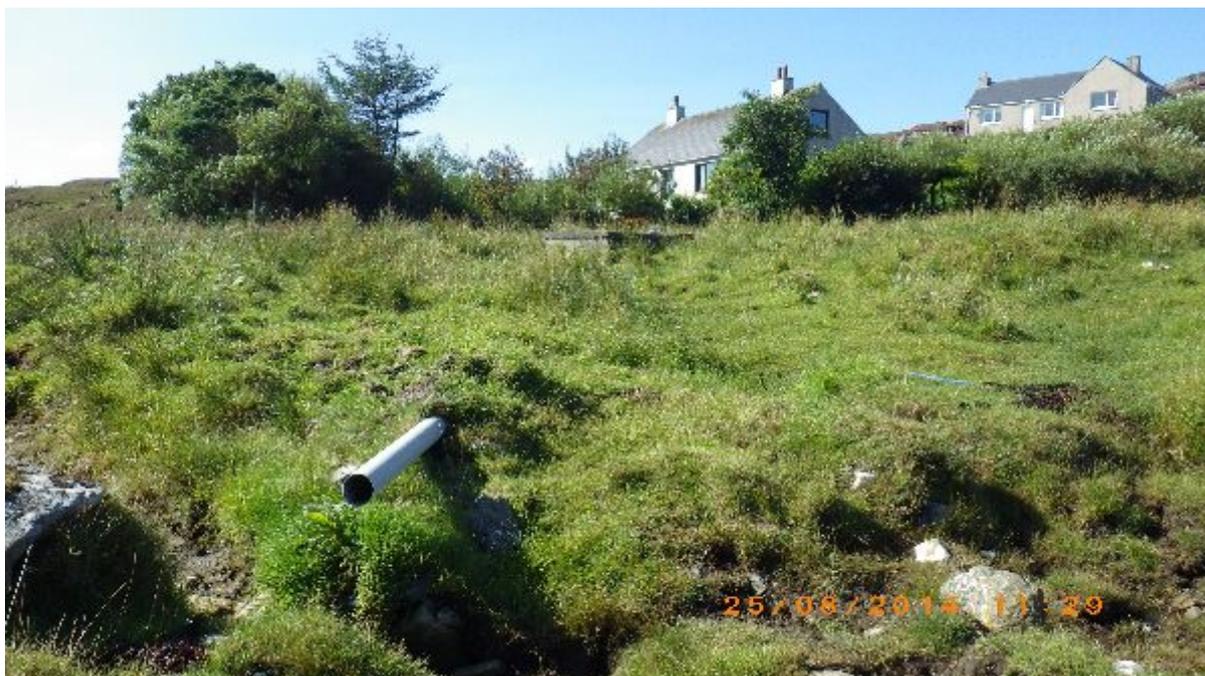
Fig 7: House at Tobhtaral with septic tank and active discharge, associated with unplanned freshwater sample LRFW1,WP 31.

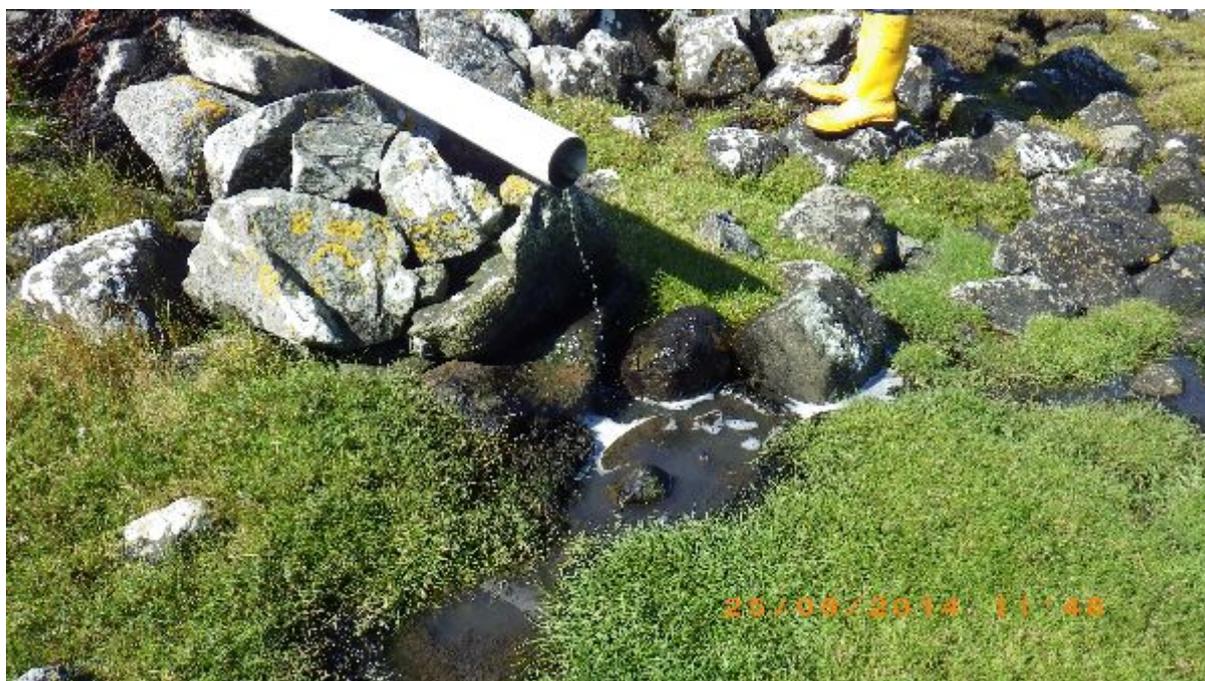
Fig 8: Pipe with active discharge on shoreline at Tobhtaral associated with unplanned freshwater sample LRFW2 (WP 34).

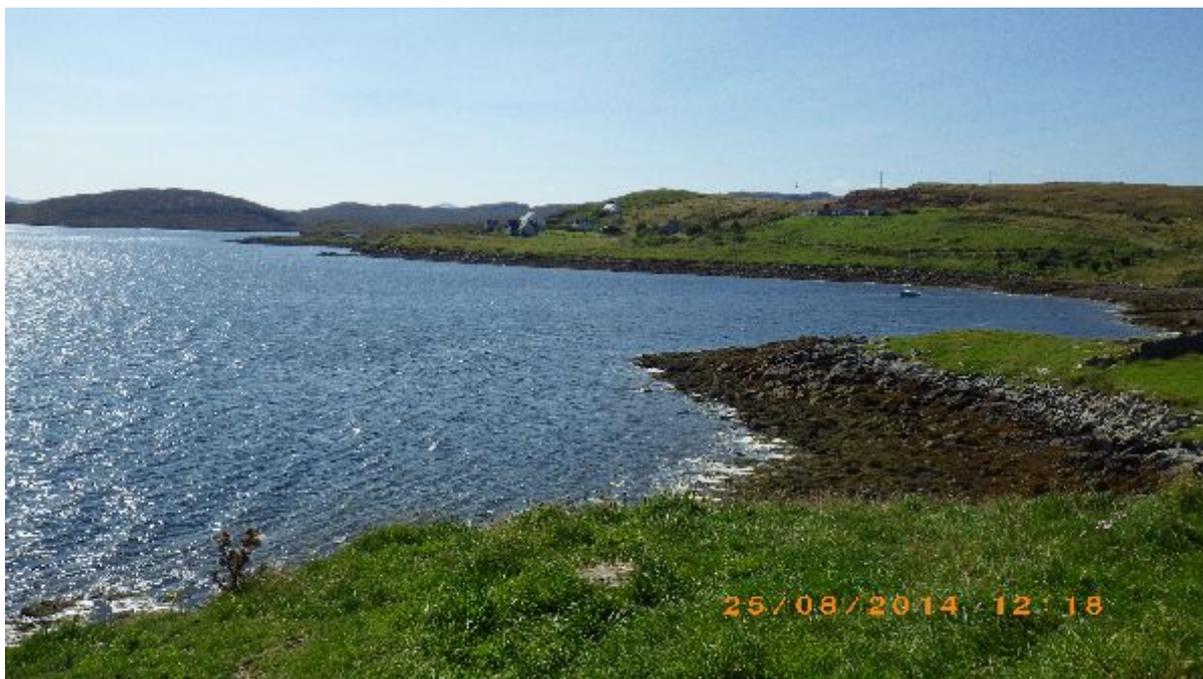
Fig 9: Bay at Tobhtaral, looking S from WP 37. Sheep observed in this area were behind camera.

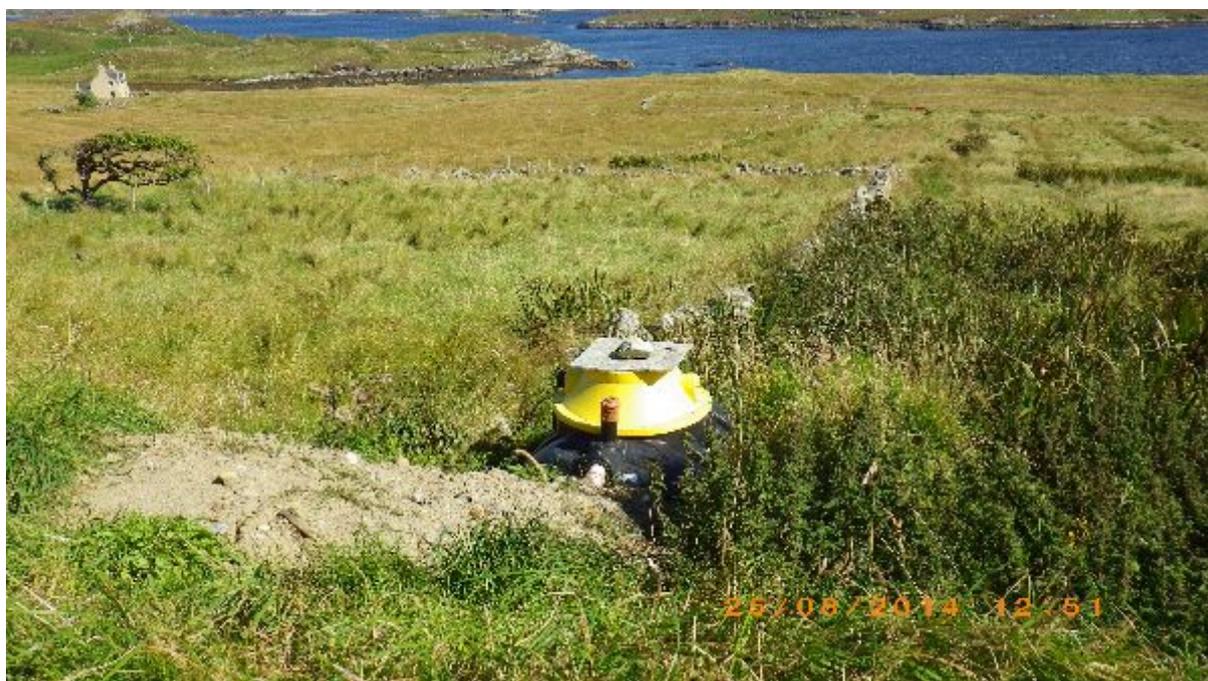
Fig 10: Septic tank situated below road at Circebost, WP 44.

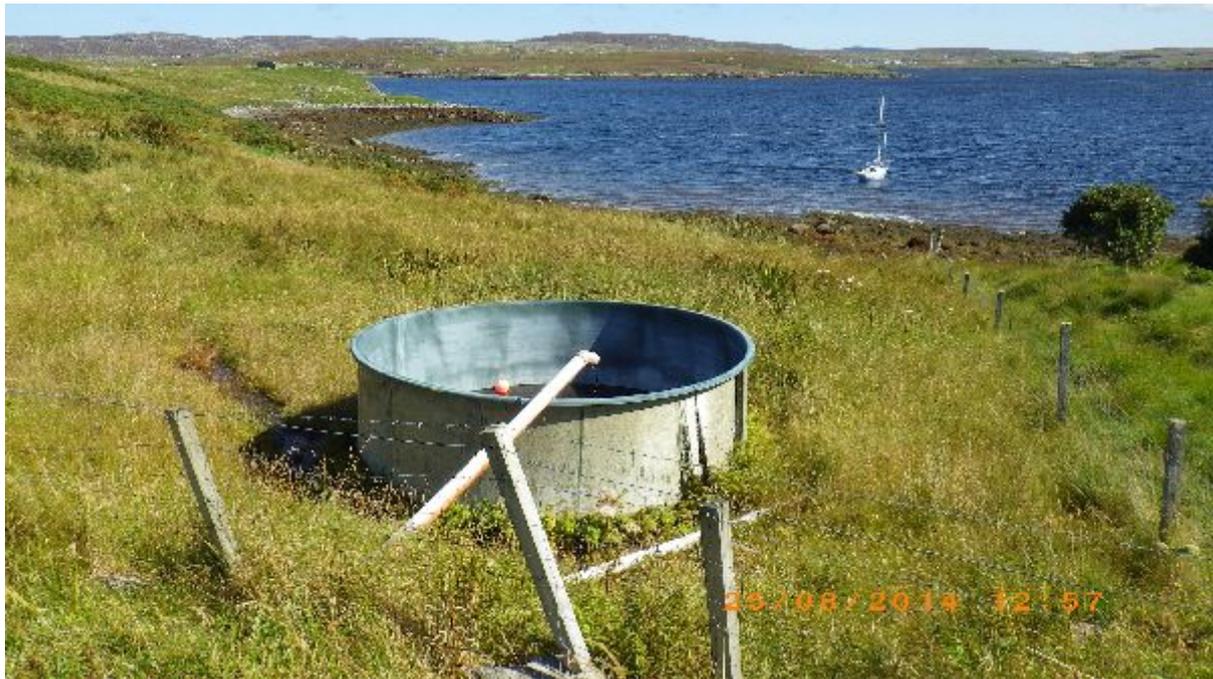
Fig 11: Large, open tank below public road, with pipe and inflow running in. Waypoint 45.

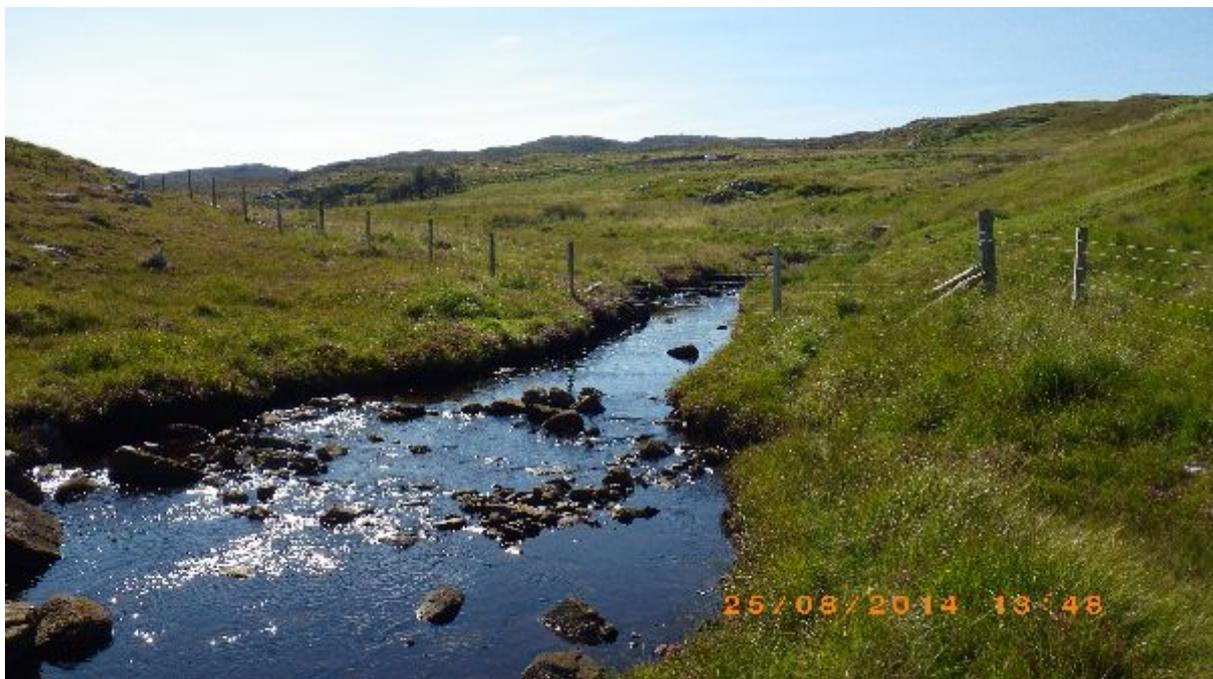
Fig 12: Lundale River, site of planned freshwater sample LRFW5 from WP 47.

46	25/08/2014	13:29	NB 18654 32010	118655	932011			Start of shore section 3. Field below road with 33 sheep.
47	25/08/2014	13:38	NB 18851 32229	118851	932230	Fig. 12	LRFW5	Freshwater sample, planned. Isolated position. Sample associated with observations in WP48.
48	25/08/2014	13:38	NB 18851 32229	118851	932229			Flow 0.100 m/s SD 0.008, depth 25 cm; 0.135 m/s SD 0.047, depth 25 cm. Total width 2.45 m.
49	25/08/2014	13:51	NB 18917 32365	118918	932365	Fig. 13		Septic tank at house above shore. No outflow observed. One rabbit seen.
50	25/08/2014	14:07	NB 18771 32732	118772	932732			Many sheep droppings and six sheep in field above shore.
51	25/08/2014	14:18	NB 18593 32155	118594	932156			End of shore survey section 3. Dwelling by road. No septic tank observed.
52	25/08/2014	14:58	NB 19918 32211	119918	932211		LRFW6	Freshwater sample, isolated position, planned. Sample associated with WP53.
53	25/08/2014	14:58	NB 19918 32211	119918	932211			Flow 0.397 m/s SD 0.003, depth 14 cm, width 10 cm. Measurement in cleft rock channel with V section.

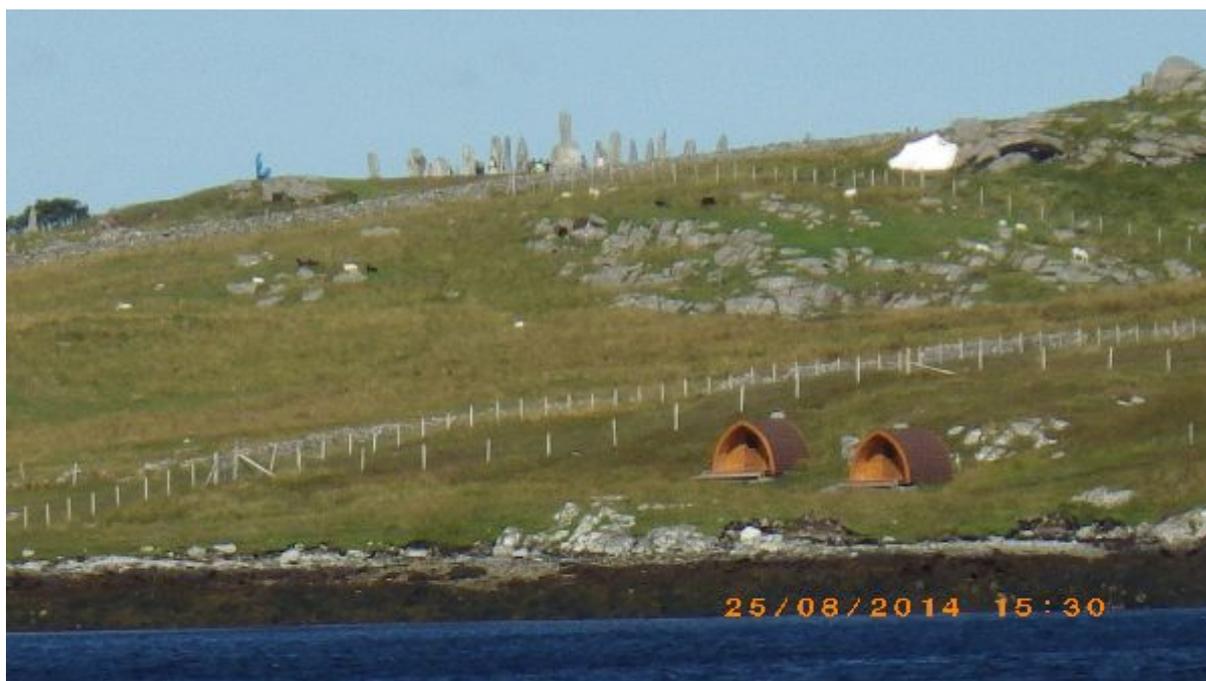
Fig 14: Two of three camping pods located across water from survey route, adjacent to (west of) Calanais standing stones. Photo taken from WP57, looking NE.

No.	Date	Time	NGR	East	North	Associated photograph	Associated sample	Description
57	25/08/2014	15:29	NB 20711 32322	120712	932323	Fig. 14, 15		On the opposite shore the Calanais Stones Visitor Centre is visible from this waypoint with three camping pods below, close to shore. Fig 14 only shows two of these. Two small craft on mooring. Small pier on shore (Fig. 15).
58	25/08/2014	15:33	NB 20789 32213	120790	932214			End of survey day 1.
59	26/08/2014	9:01	NB 20827 32195	120828	932196			Start of survey day 2. Field with 29 sheep adjacent to west of the bay.
60	26/08/2014	9:11	NB 21048 32326	121049	932326			Field with six sheep. Droppings plentiful. Area previously used for grazing, better ground.
61	26/08/2014	9:14	NB 21030 32400	121030	932401		LRSW7	Seawater sample, planned.
62	26/08/2014	9:20	NB 21054 32212	121055	932213	Fig. 16		Ceramic 15 cm diameter pipe running down foreshore. End not visible due to tide level. Section broken near to high water mark, no flow visible.

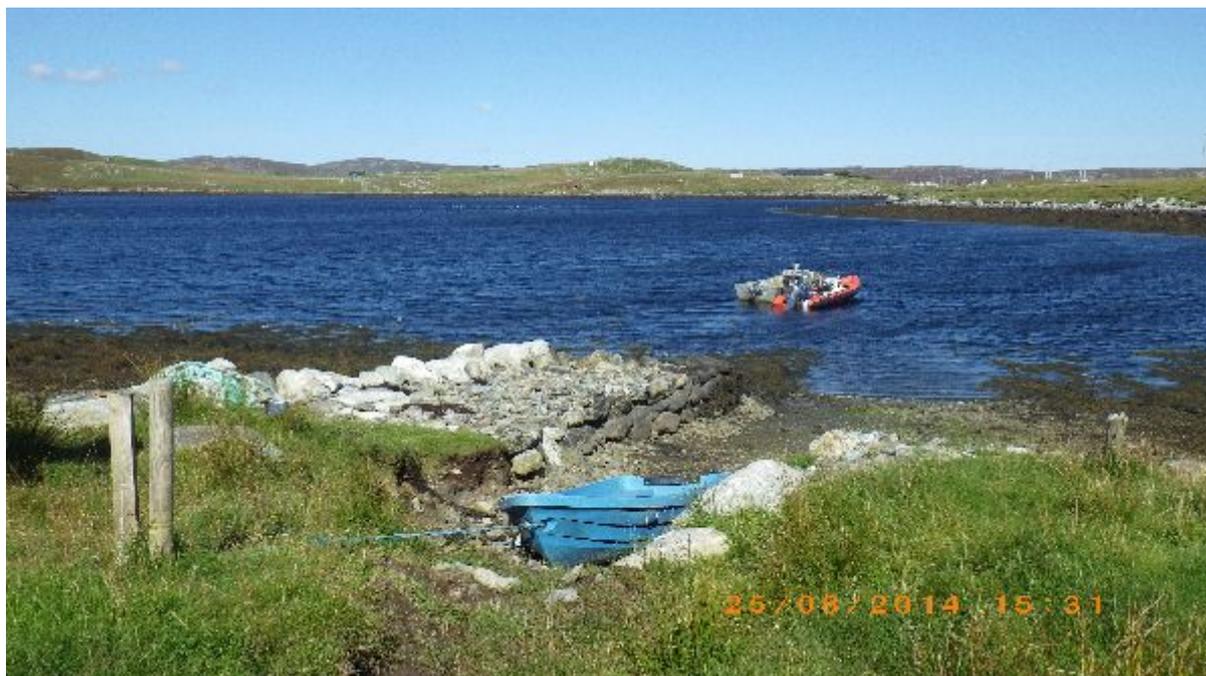
Fig 15: Launching site, with work boat & RIB moored offshore. WP 57.

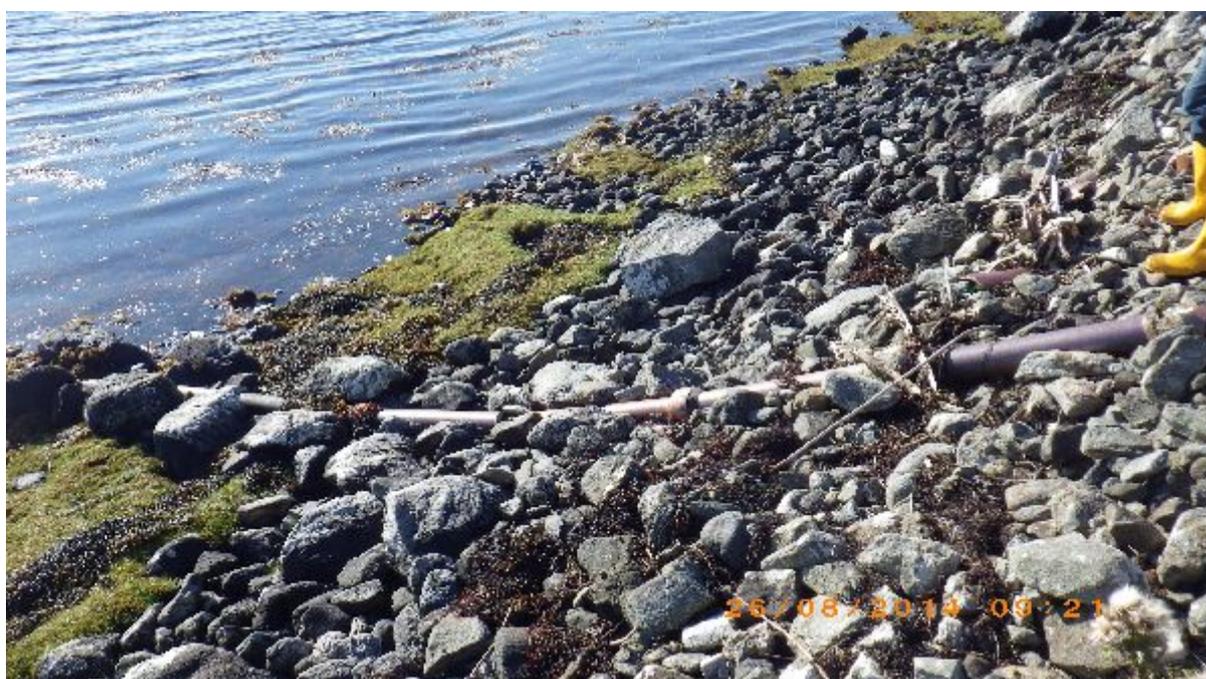
Fig 16: Pipe running from foreshore into bay with end below sea level, WP62. No flow observed at broken section on upper shore.

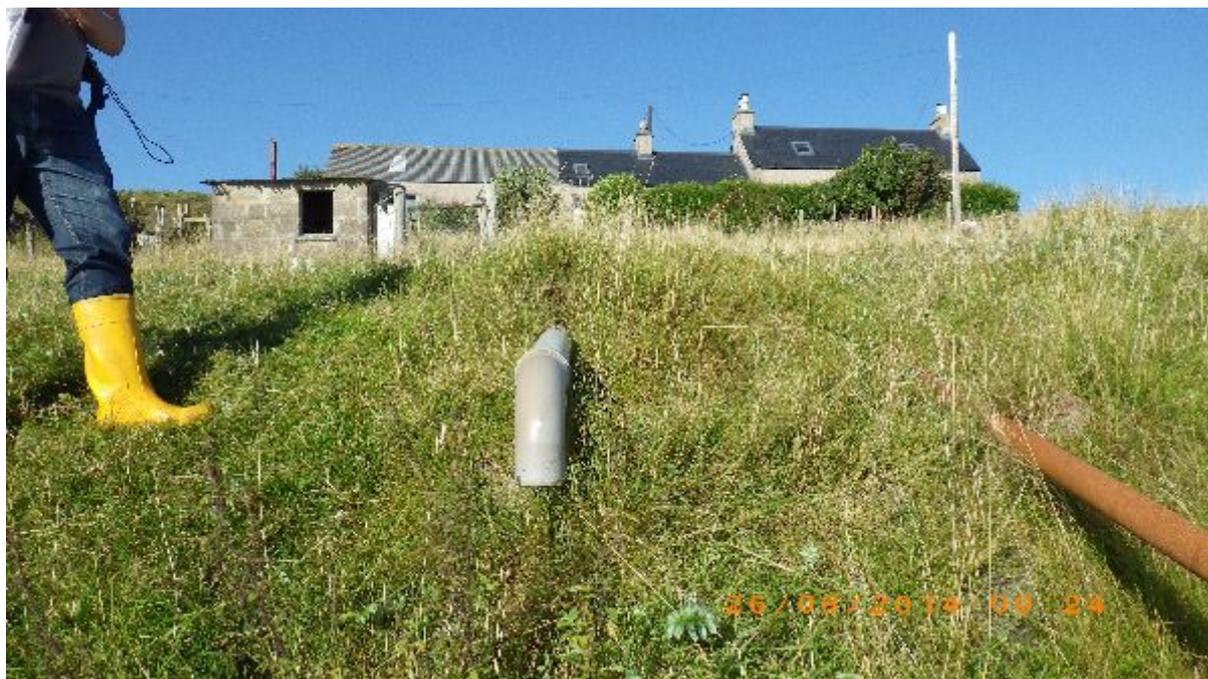
Fig 17: Further pipes running onto foreshore, WP 63. No flow present.

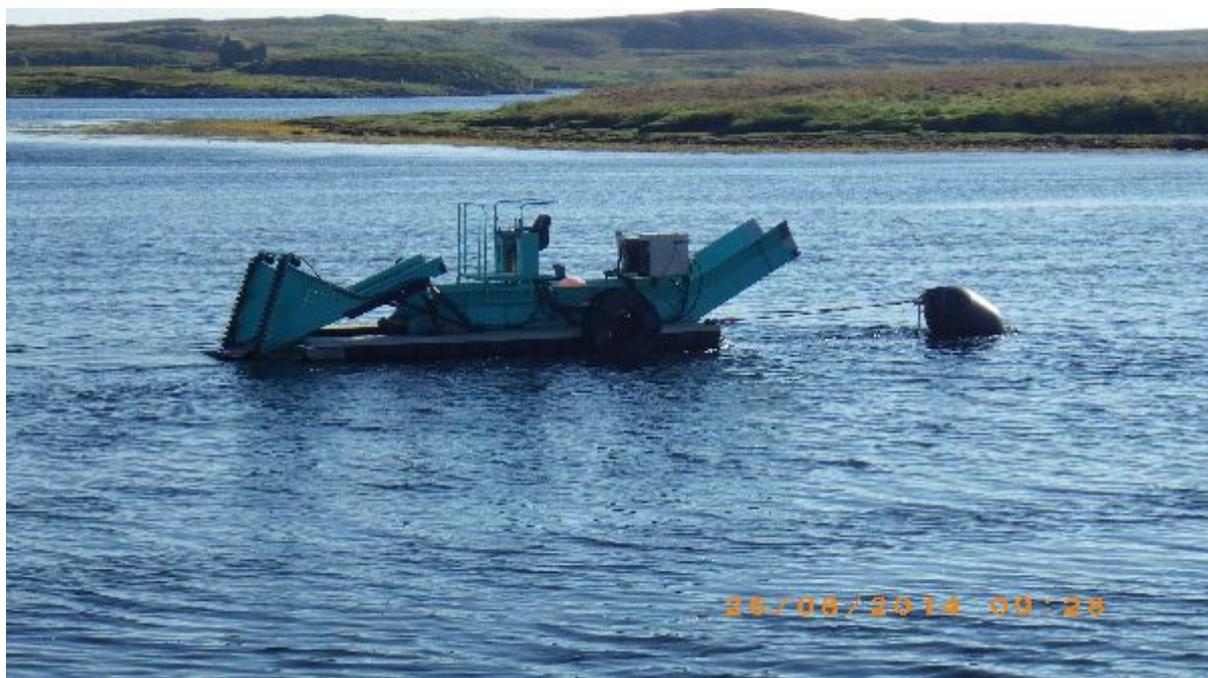
Fig 18: Seaweed harvesting vessel at mooring. WP 64.

63	26/08/2014	9:23	NB 21051 32197	121052	932198	Fig. 17		Standard 10 cm diameter plastic soil pipe plus one metal 5 cm diameter pie ending on upper foreshore. No discharge in either. Ground above inspected for septic tank but none observed.
64	26/08/2014	9:23	NB 21050 32197	121050	932198	Fig. 18		Workboat at mooring. Seaweed harvesting vessel.
65	26/08/2014	9:31	NB 21017 31994	121017	931995		LRFW7	Freshwater sample, planned. Sample associated with WP66.
66	26/08/2014	9:31	NB 21017 31994	121017	931995			Flow 0.140 m/s SD 0.006, depth 2 cm, width 14 cm.
67	26/08/2014	9:38	NB 21070 31986	121071	931987			Three moorings, one occupied with a 6 m RIB.
68	26/08/2014	9:41	NB 21151 31870	121152	931870	Fig. 19		Large covered septic tank on shore with one 10 cm plastic pipe inlet. No sign of discharge pipe to shore below. Discharge pipe present on upper side of tank, with no active discharge.
69	26/08/2014	9:51	NB 21180 31690	121181	931691	Fig. 20		Caged storage area on intertidal for harvested seaweed. Silage bales in field above road.

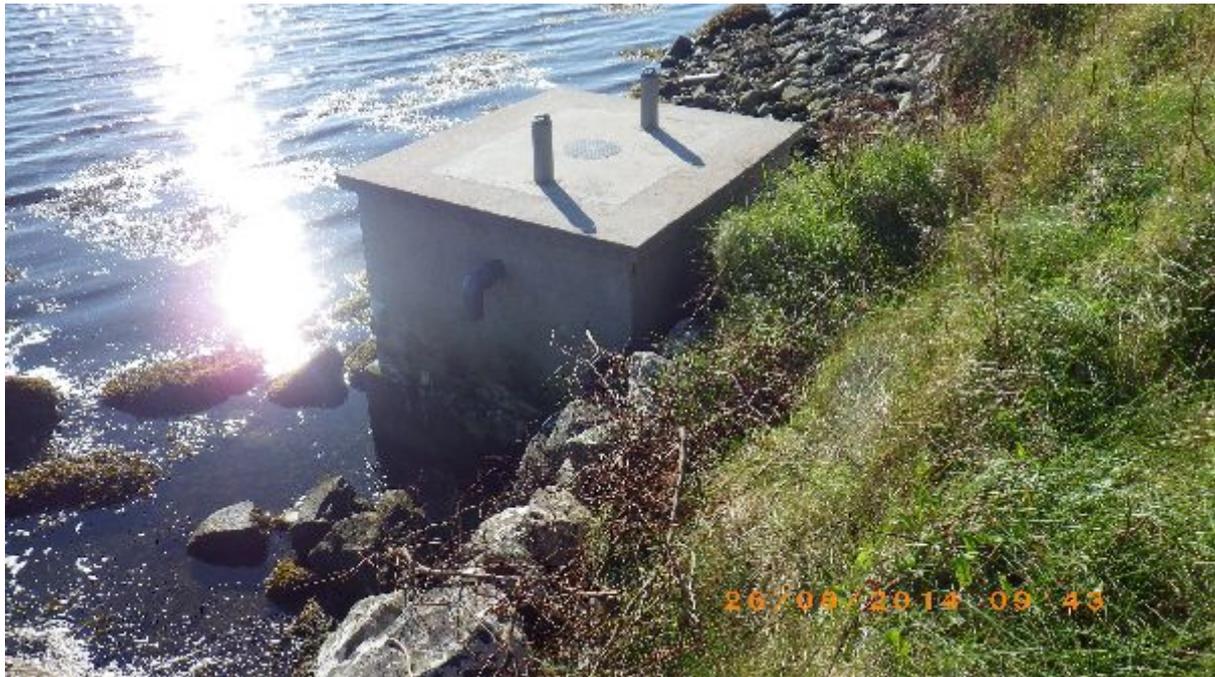
Fig 19: Septic tank on foreshore WP 68.

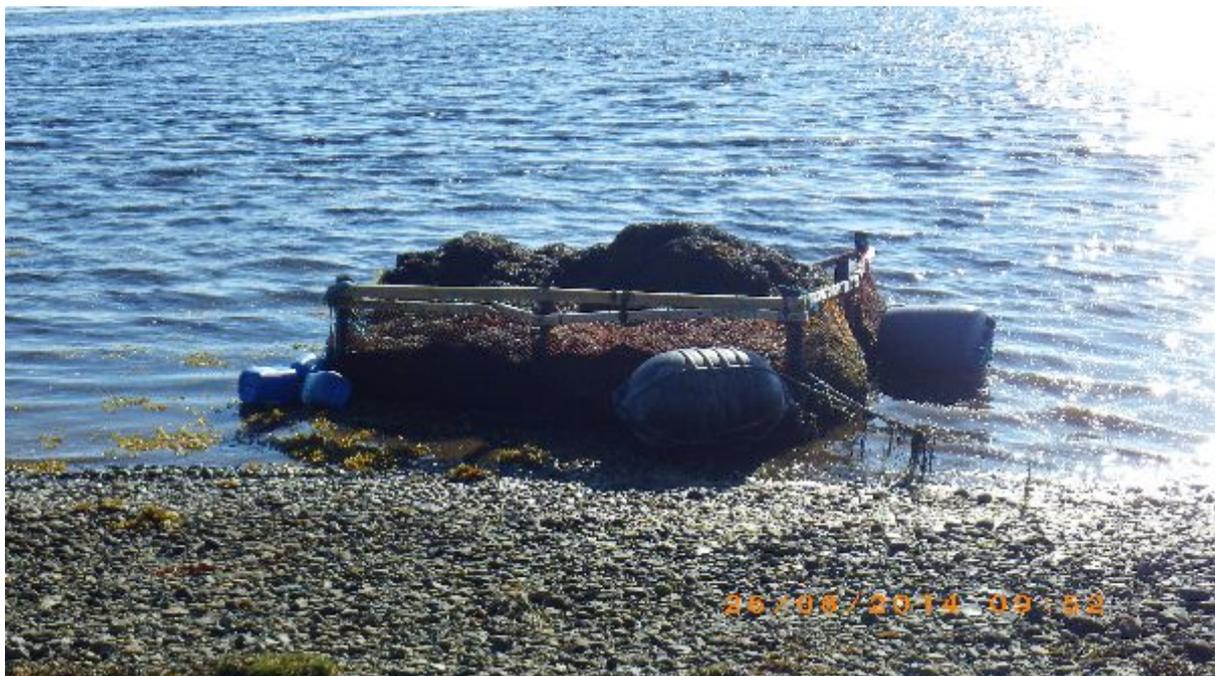
Fig 20: Storage raft with harvested seaweed moored on foreshore. WP 69.
