Scottish Sanitary Survey Project

Restricted Sanitary Survey Report North Ford UB 493 March 2010

Shoreline Survey Report

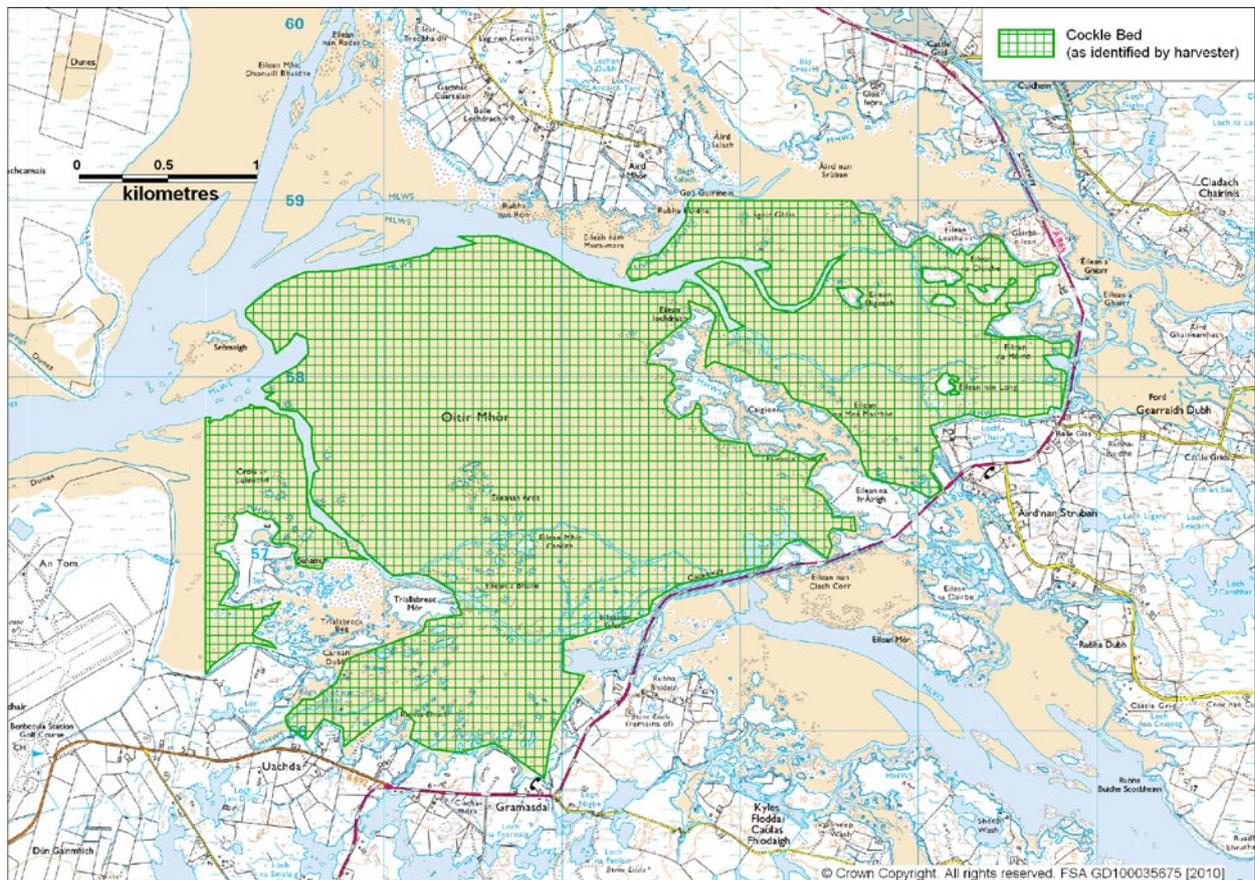
Figure 2.1 North Ford fishery

The cockle bed was identified by the harvester on the classification application form as the sands at Oitir Mhor, south of the inlet Beul an Toim, east of NF80 to the causeway road A865 and south of NF 800 590.

The boundaries of the common cockle bed are mapped in Figure 2.1.

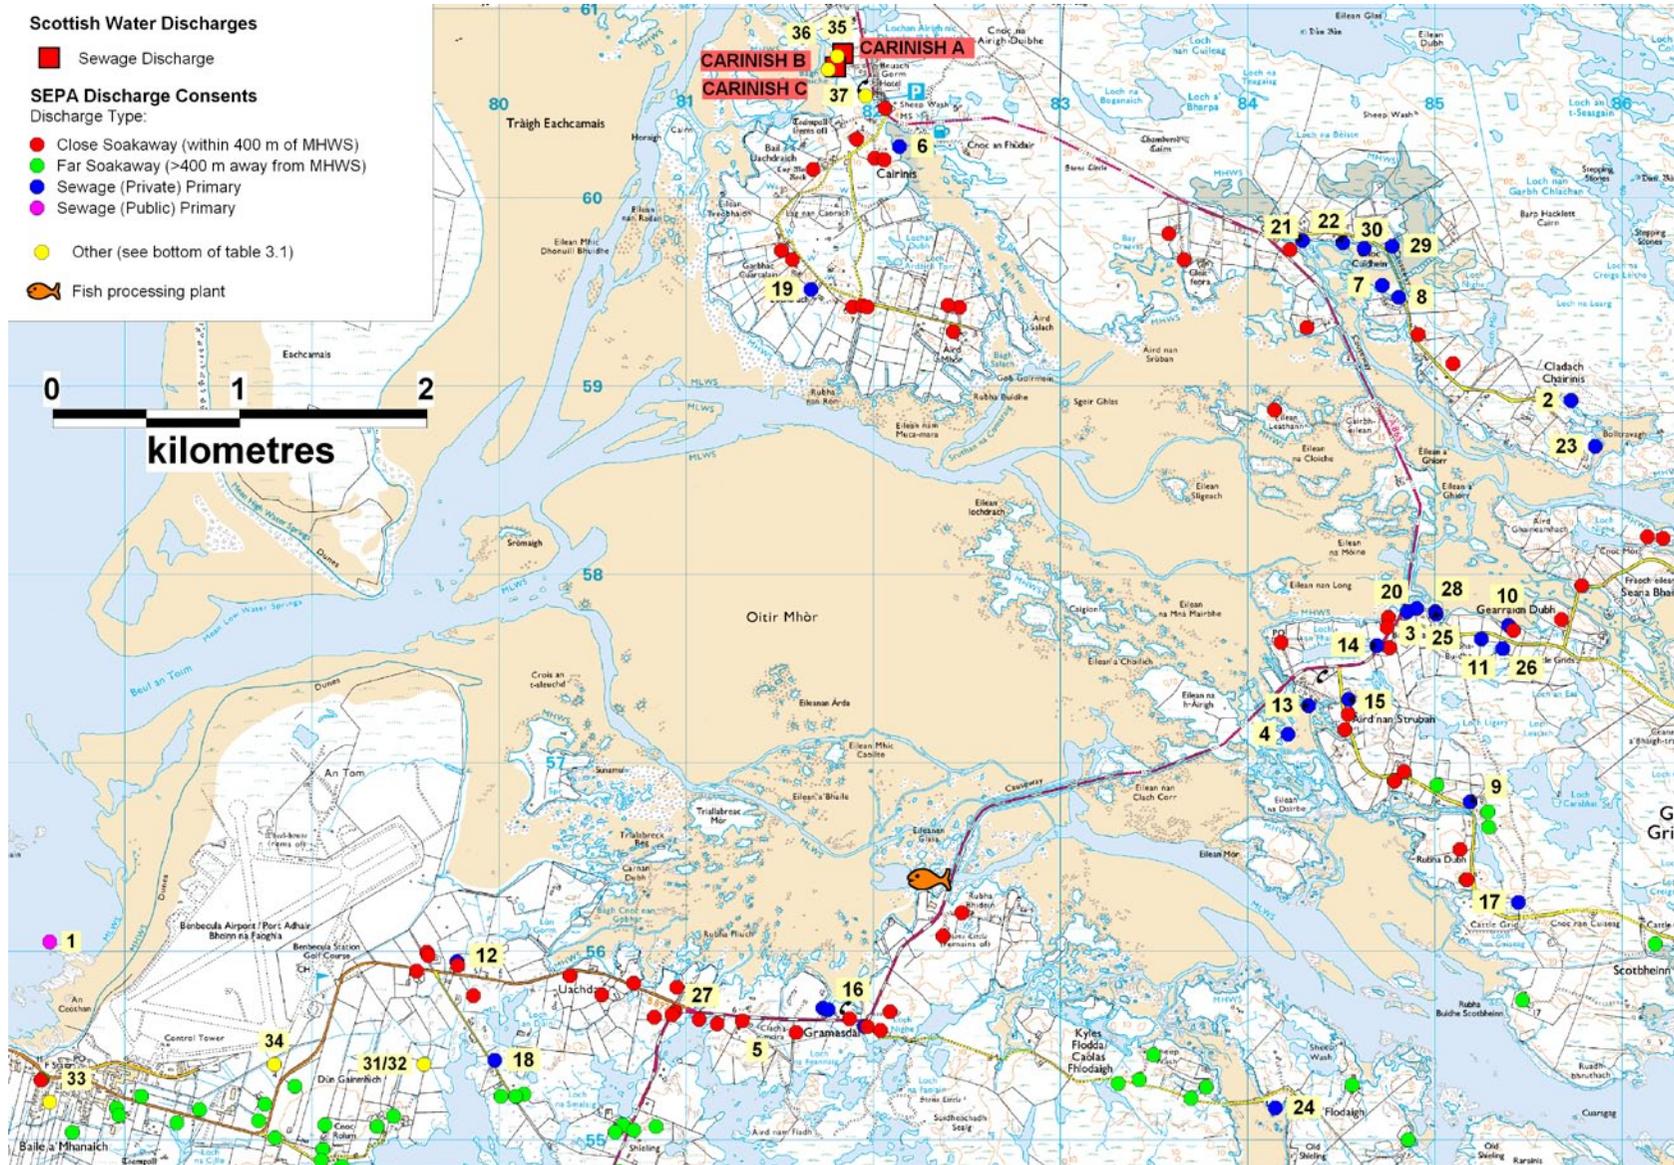
Figure 3.1 Sewage discharges at North Ford

There is a fish processing plant located at NF 8230 5638 (see Figure 3.1). SEPA have identified that as there is no public sewer in the area it is likely that the effluent from the plant will include sewage effluent. However, there is no official record of this.

In Figure 3.1 the discharge consents have been thematically mapped to identify soakaways within 400 m of MHWS, soakaways <400 m from MHWS, sewage (private) primary discharges (septic tanks), a sewage (public) primary discharge, other discharges and the fish processing plant.

Although potential sources of sewage are present around most of the bay, the bulk of direct discharges from septic tanks are located at the eastern end of the bay and so will most acutely affect the eastern side of the cockle bed.

The secondary sewage discharge at Balavanich lies just outside the entrance to the bay, and could potentially impact the southwestern edge of the cockle bed, particularly if it were to malfunction.

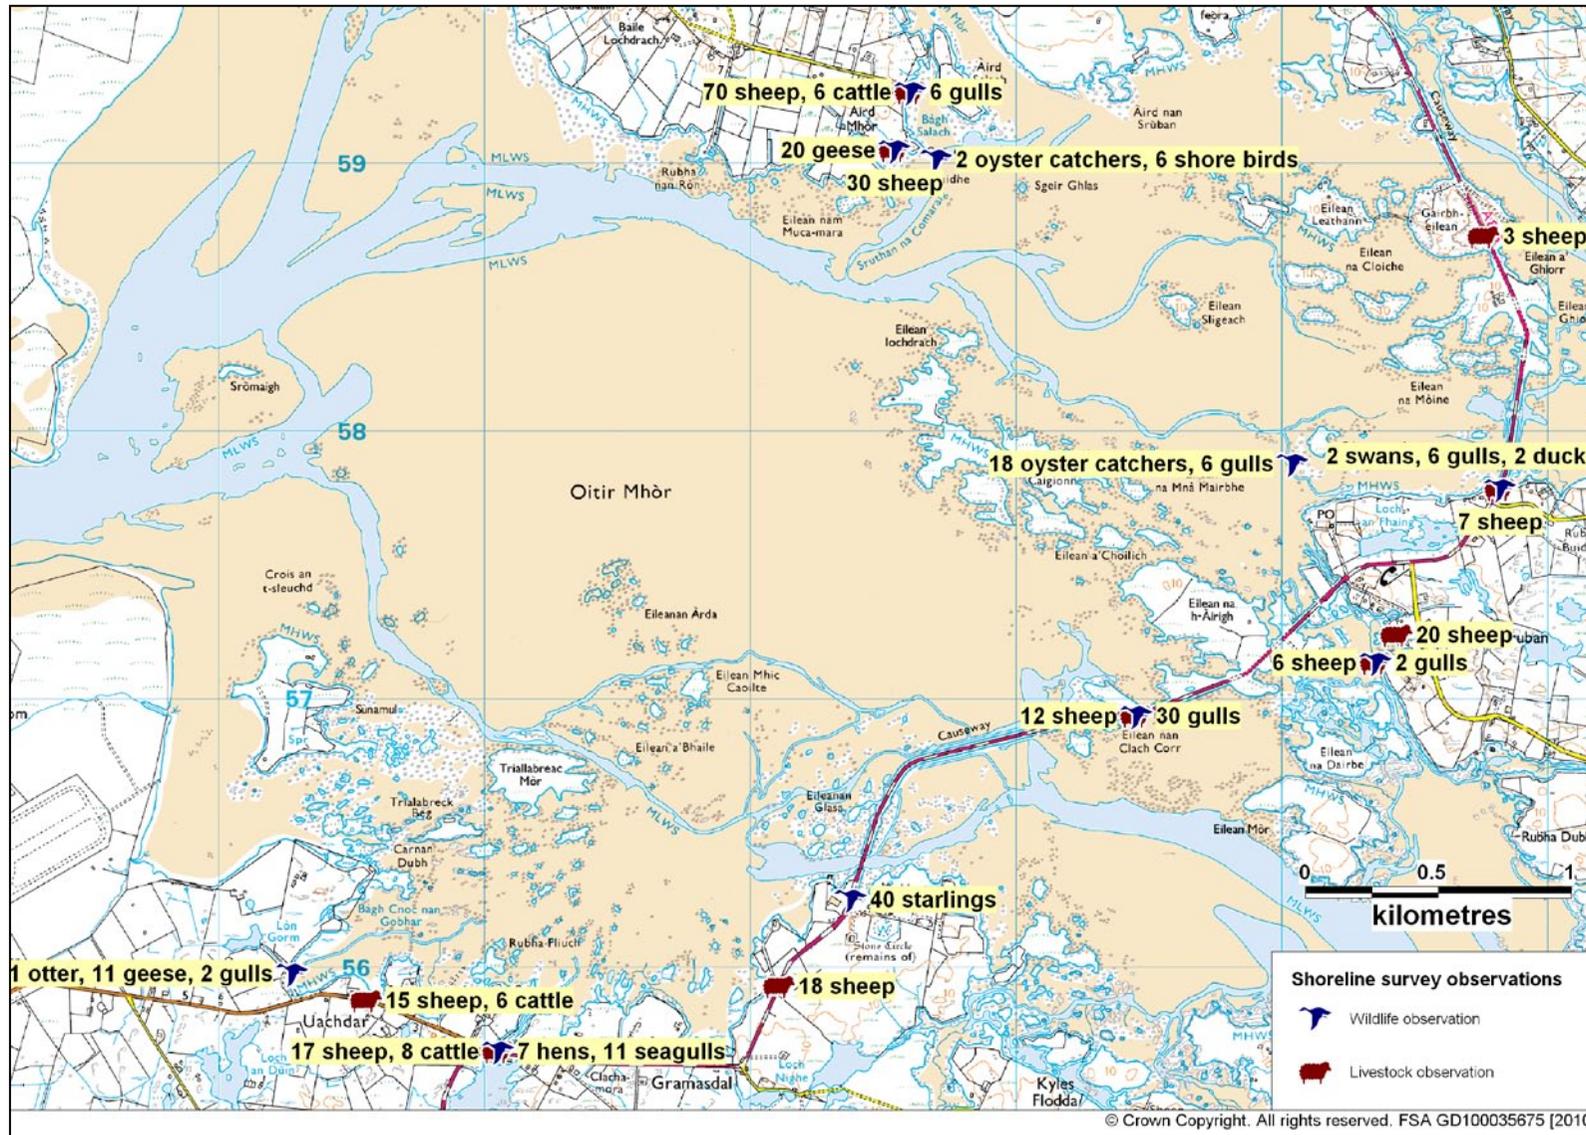
Figure 4.1 Livestock and wildlife present at North Ford during the shoreline survey

On the southern shoreline of North Ford 50 sheep and 14 cattle were seen grazing on crofts close to the shoreline. On the eastern shoreline of North Ford an additional 38 sheep were scattered around crofts either side of the causeway. The northern shoreline had the most livestock with 100 sheep and 6 cattle grazing in crofts next to the shoreline.

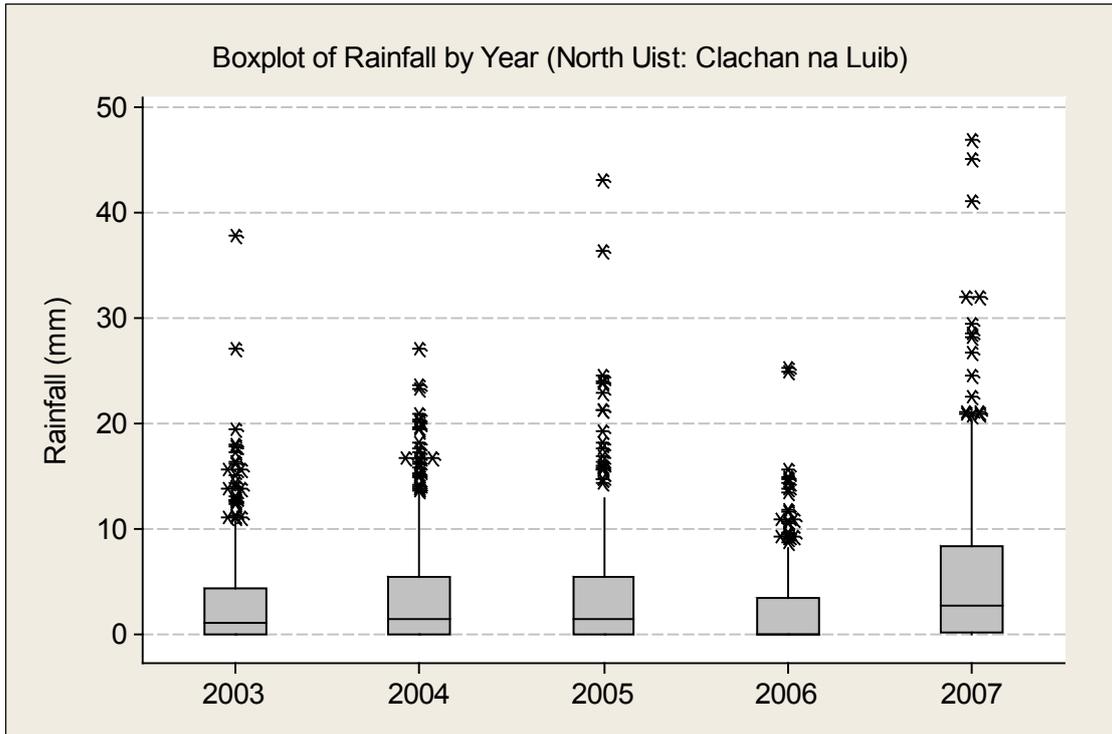
Figure 5.1 Boxplot of daily rainfall at North Uist by year

Figure 5.1 shows that there was considerable variation in the median daily rainfall from year to year. Overall, 2006 saw the lowest median rainfall, of 0mm. The highest individual rainfall events occurred in 2005 and 2007, with 2007 being wetter overall.

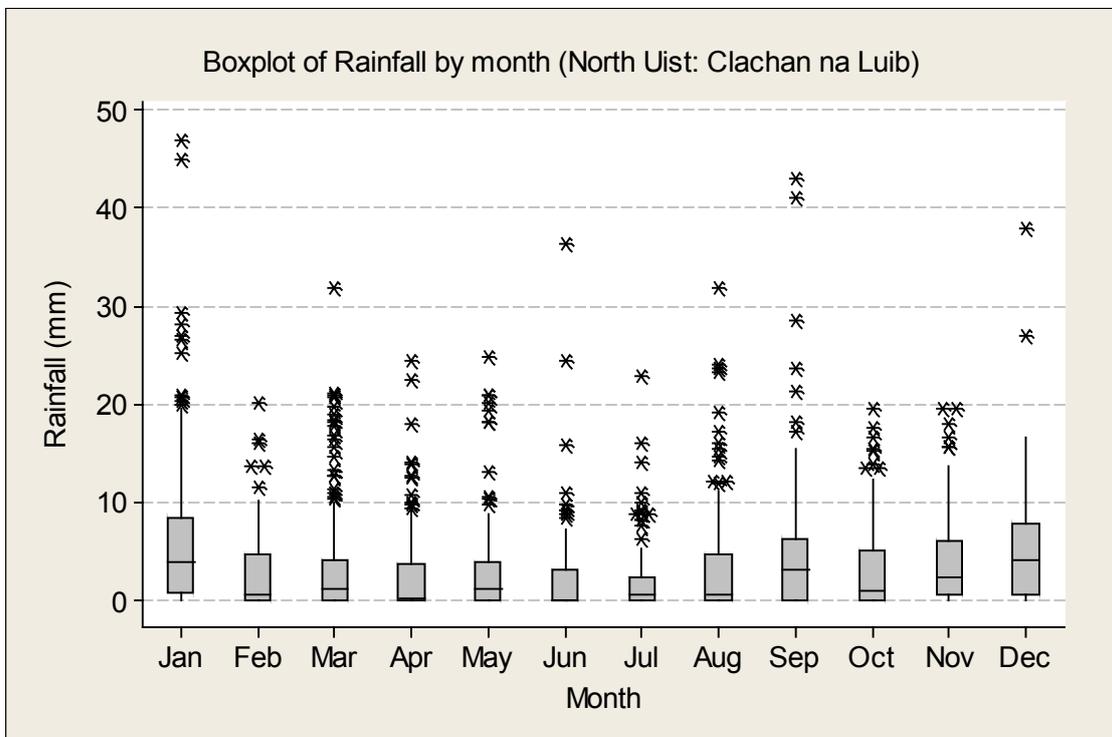
Figure 5.2 Boxplot of daily rainfall values at North Uist by month

The wettest months were December and January, but high individual rainfall events generally occurred throughout the year although the most extreme events (>40 mm/day) were only seen in January and September in this dataset. For the period considered here (2003 – 2007), 36% of days for which records were available experienced no rainfall while 47% of days experienced rainfall of 1mm or less. Although the mean rainfall was 4 mm per day, there were 8 occasions where daily rainfall exceeded 30mm. The highest daily rainfall recorded (47mm) fell in January 2007.

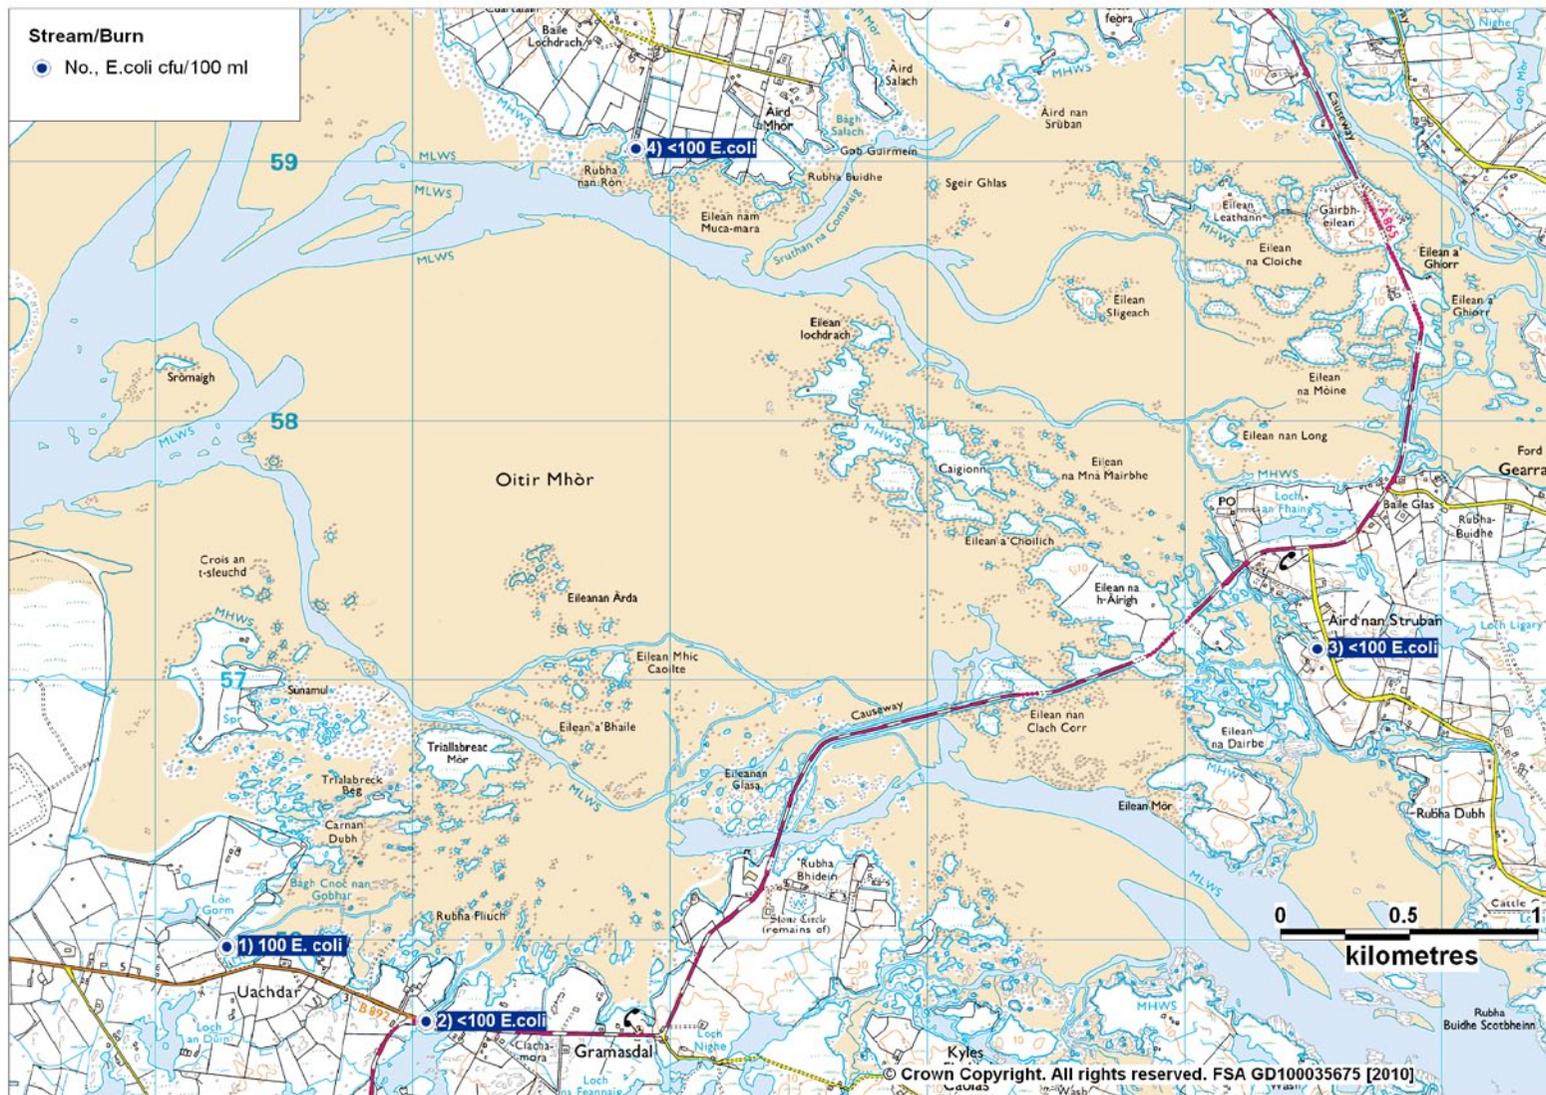
Figure 6.1. Location of streams and fresh water sample results at North Ford

All but one sample result fell below the level of detection of the test used. Results indicated that levels of bacterial contamination from *E. coli* were low in all sampled streams on the day of survey. It is expected, however, that bacterial concentrations in these streams may be higher after rainfall.

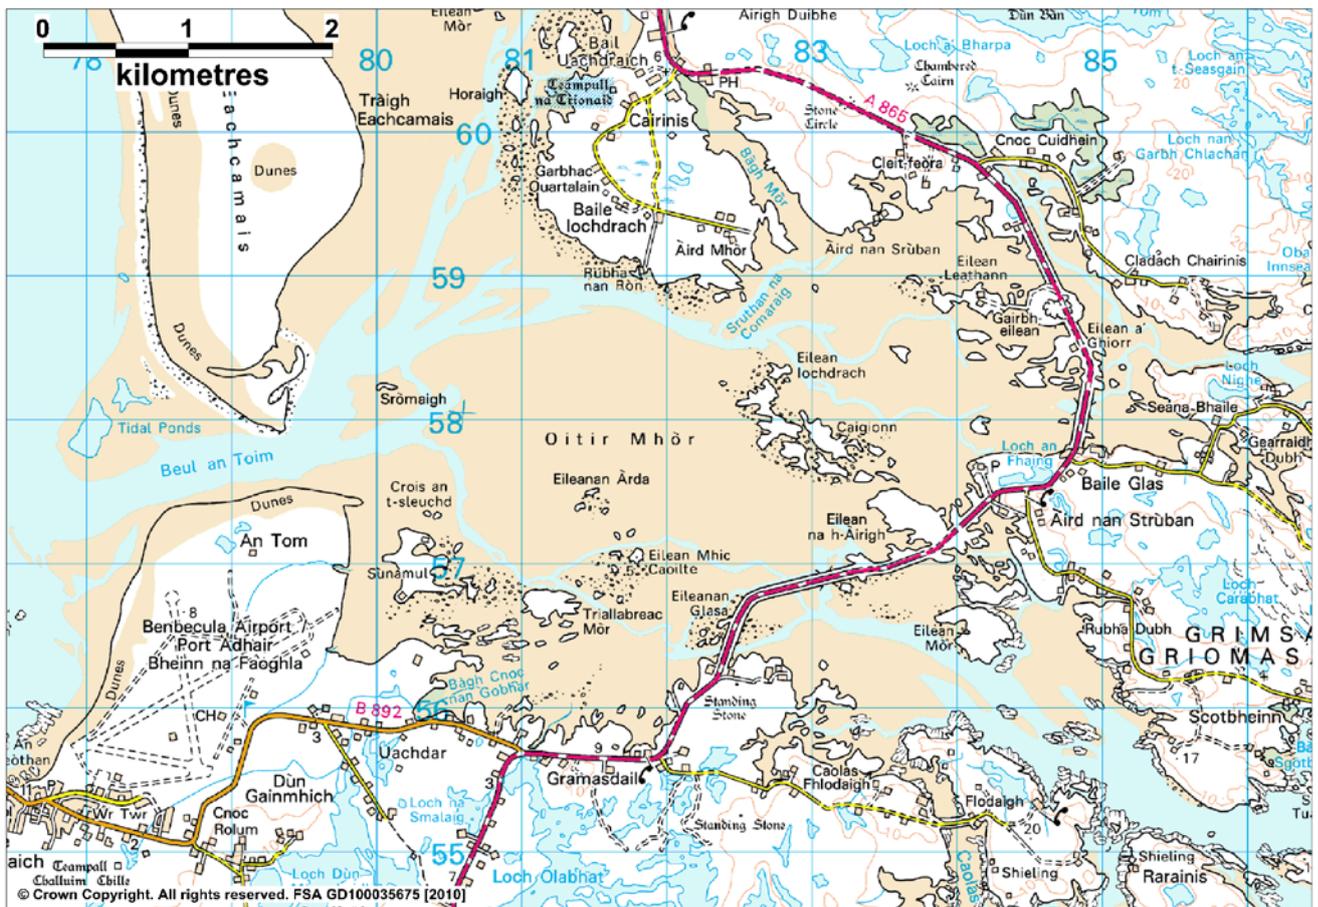
Figure 8.1 North Ford bathymetry chart and OS map

Electronic hydrographic data was not available for the North Ford area. The Ordnance Survey map shows that the majority of the area is intertidal (see Figure 8.1), which appears as drying area on UKHO Admiralty charts.

The charts show that with distance from the coastline of the Baleshare and Benbecula islands, the depth increases from a shallow drying area to depths of up to 50 m. The area is open to water flow from both the west side of the bay via the Beul an Toim and from the southeast side of the bay via a channel between Grimsay and Benbecula islands. Water is able to flow between the two areas via culverts beneath the causeway to both the north and south of Grimsay.

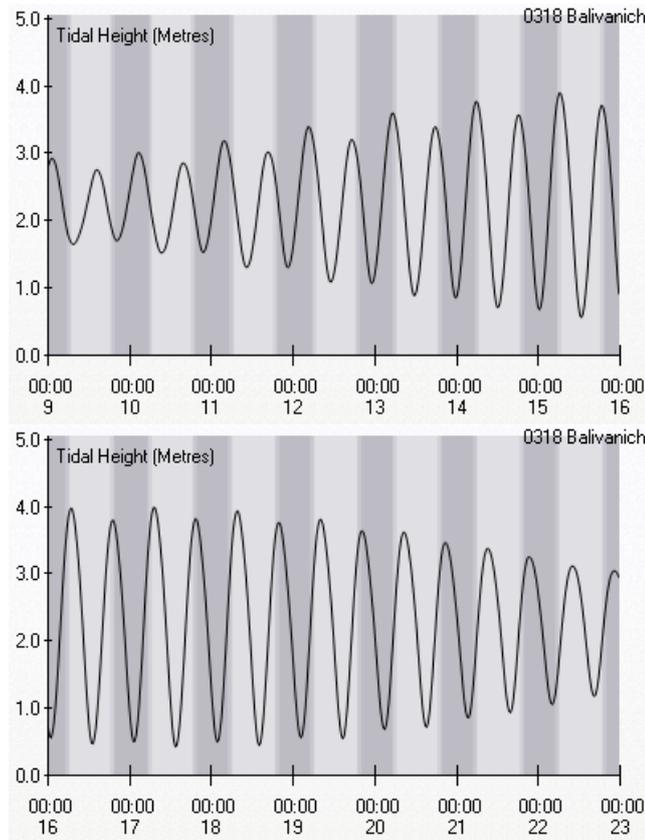
Figure 8.2 Tidal curves for Balivanich

The tide type is Semi-Diurnal.

MHWS	4.1 m
MHWN	3.1 m
MLWN	1.5 m
MLWS	0.5 m

Predicted heights are in metres above chart datum. The tidal range at spring tide is therefore approximately 2.6 m and at neap tide 2.6 m.

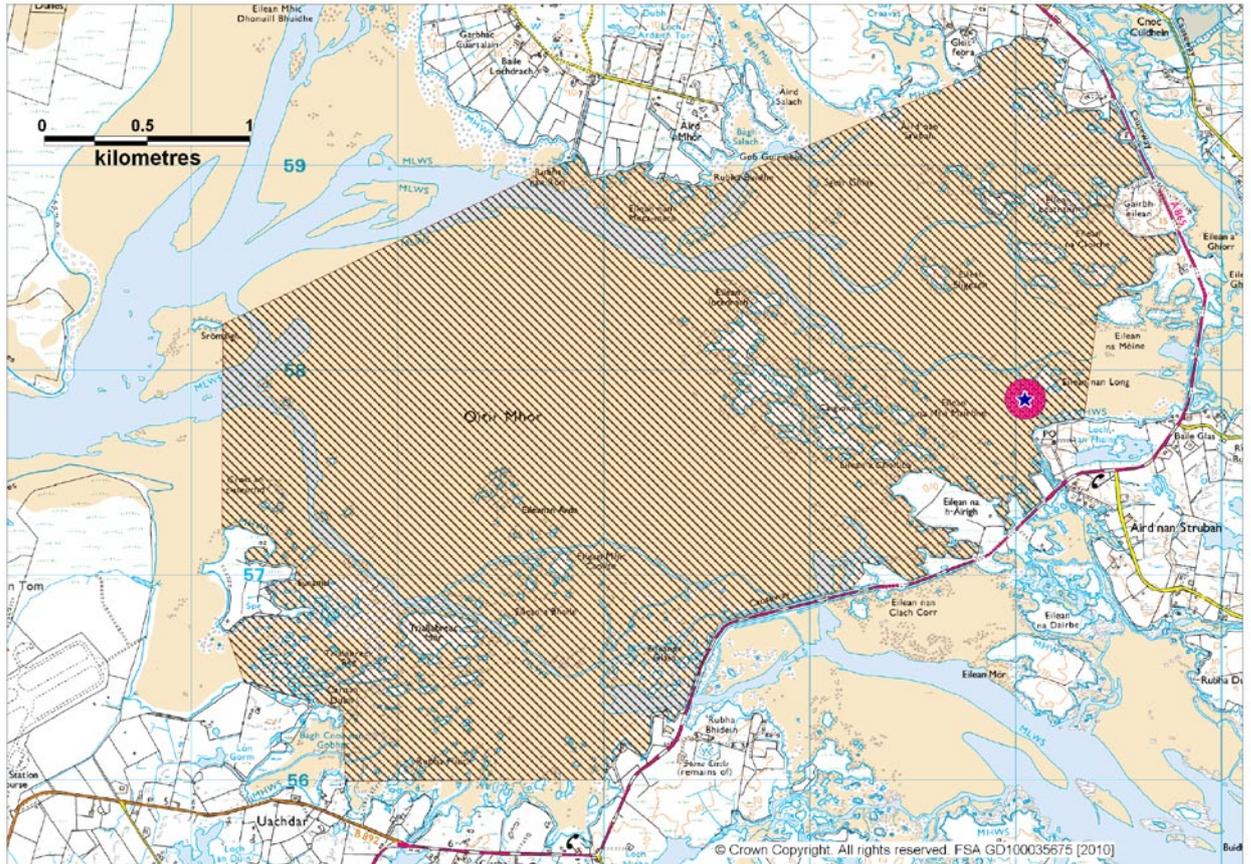
Figure 11.1 Recommendations for North Ford

The locations of the recommended production area boundaries, RMP and tolerance zone are illustrated in Figure 11.1.

The recommended production area boundaries are described as the area bounded by lines drawn between NF 8254 5890 to NF 8383 5945 and between NF 8440 5831 to NF 8433 5776 and between NF 8200 5600 to NF 8075 5600 to NF 8073 5633 and between FN 8026 5647 to NF 8017 5672 and between NF 8015 5722 to NF 8015 5823 to NF 8178 5900 extending to MHWS. This area encompasses the bed as identified by the harvester, while excluding areas that are likely to experience higher levels of contamination due to the proximity of livestock or septic tank discharges.

It is recommended that the RMP be set at NF 8405 5786. This is near to the shore and to the largest cluster of consented discharges at the shoreline.

As there is likely to be substantial variation in cockle density across the North Ford area, it is recommended that a 100 m tolerance be allowed for sampling. This will allow for some variability in density while still ensuring that monitoring is undertaken reasonably close to the assigned RMP.

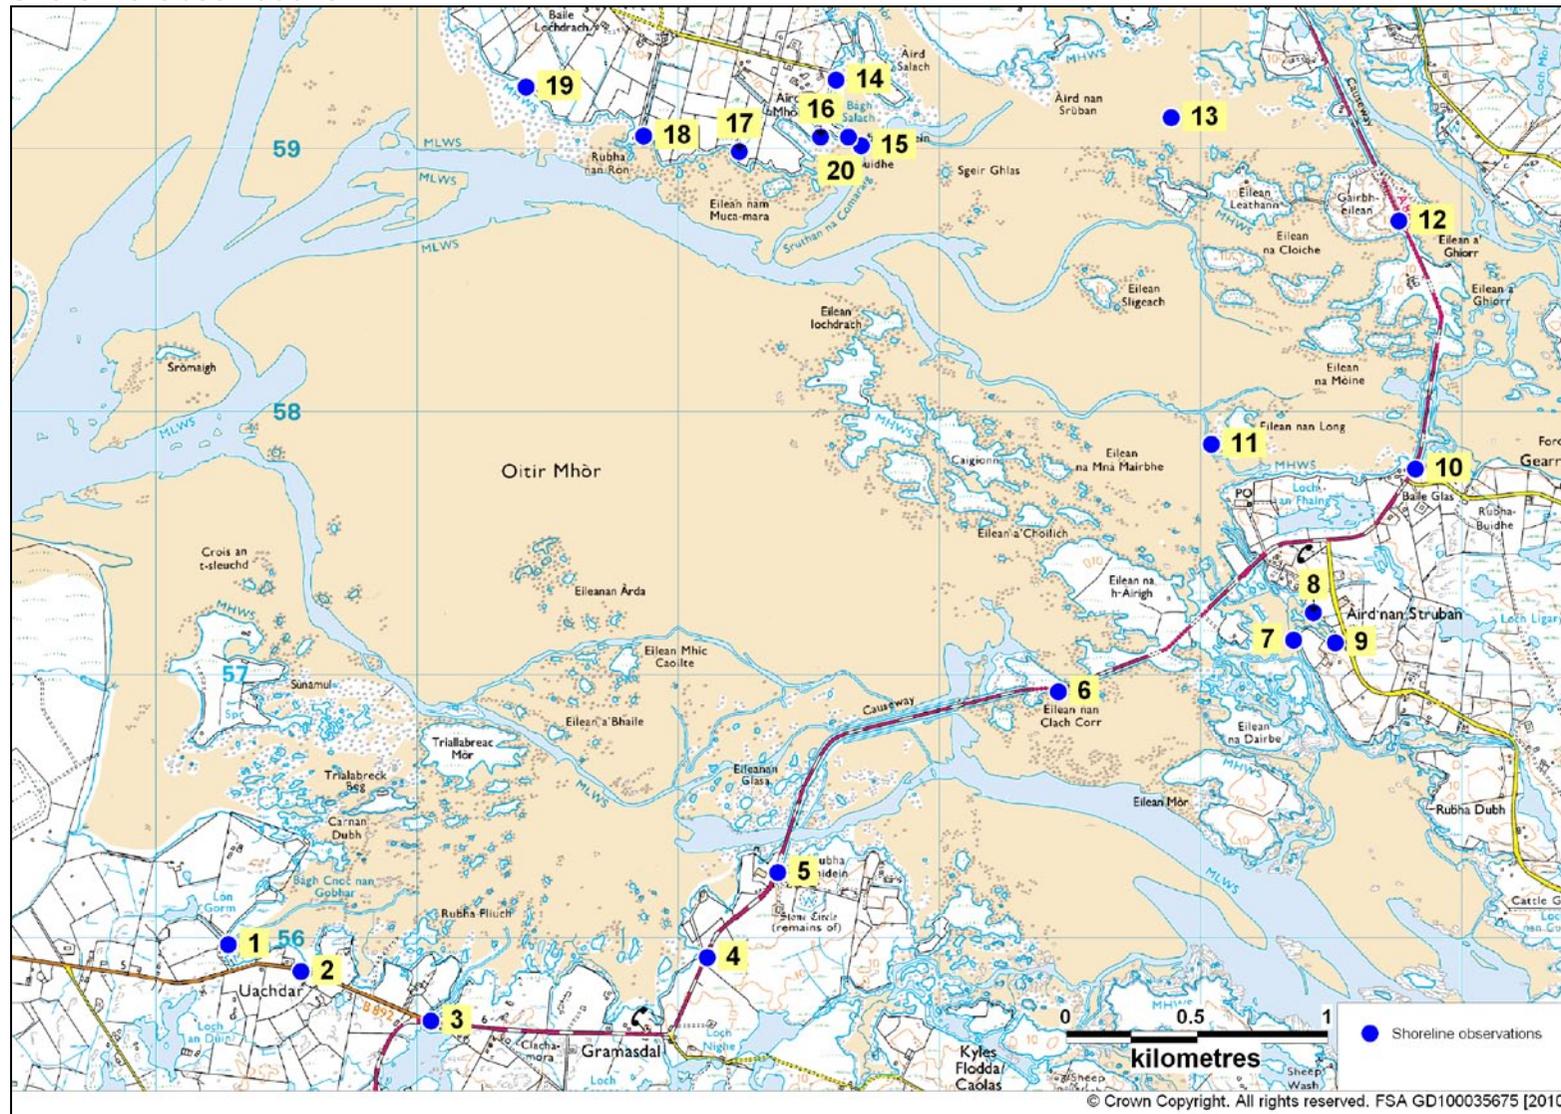
Figure 1. Shoreline Observations

No.	Date	Time	NGR	East	North	Associated photograph	Description
1	15/03/2010	08:55	NF 80278 55974	80278	855974	Figure 4.	Fresh water discharge onto shore. NFFW1 (North Ford Fresh Water Sample 1) Width: 1.3m Depth: 67cm. Flow: +0.011 +0.003 m/sec SD 0.018. 3 houses visible, 1 otter, 11 geese, 2 gulls, evidence of sheep but none visible at shore, up in fields other side of road.
2	15/03/2010	09:08	NF 80556 55873	80556	855873	-	MacLeans Bakery. Cow shed opposite, 6 cows visible. 15 sheep on shore machair.
3	15/03/2010	09:20	NF 81053 55684	81053	855684	Figure 5.	Freshwater run off onto shore, NFFW2 (North Ford Fresh Water Sample 2). Width: 1m Depth: 18cm. Flow: -0.355 -0.376 m/sec SD 0.024. Opposite side of road, small holding with 17 sheep, 8 cattle, 7 hens, 11 seagulls.
4	15/03/2010	09:40	NF 82111 55926	82111	855926	-	6 sheep at shore, 12 sheep land side of road. Kyles of Flodda junction 9 sheep.

5	15/03/2010	09:40	NF 82381 56250	82381	856250	-	Fish processing plant. 40 starlings.
6	15/03/2010		NF 83456 56937	83456	856937	-	Causeway, 30 gulls, 12 sheep.
7	15/03/2010	10:00	NF 84357 57134	84357	857134	-	6 small holdings, croft land, 6 sheep, 2 gulls, evidence of cockles and mussels.
8	15/03/2010	10:10	NF 84434 57239	84434	857239	Figure 6.	Aird nan Strubh minor FW input, 20 sheep.
9	15/03/2010	10:20	NF 84518 57123	84518	857123	Figure 7.	FW input NFFW3 (North Ford Fresh Water Sample 2). Width: 65cm, Depth: 1-2cm. Flow: pooh sticks, travel 1m in 8 secs.
10	15/03/2010	11:00	NF 84824 57784	84824	857784	-	Start of second causeway at Baile Glas. 2 nesting swans, 7 sheep, 6 gulls, 2 ducks.
11	15/03/2010	11:15	NF 84042 57878	84042	857878	-	Beach exposed. Evidence of mussels and juveniles cockles close in, some adult cockles further out. Sand fine and compacted. Cockle sample NFC1. NFSW1 (North Ford Sea Water Sample 1). 40 houses overlook this area, 18 oyster catchers, 6 gulls.

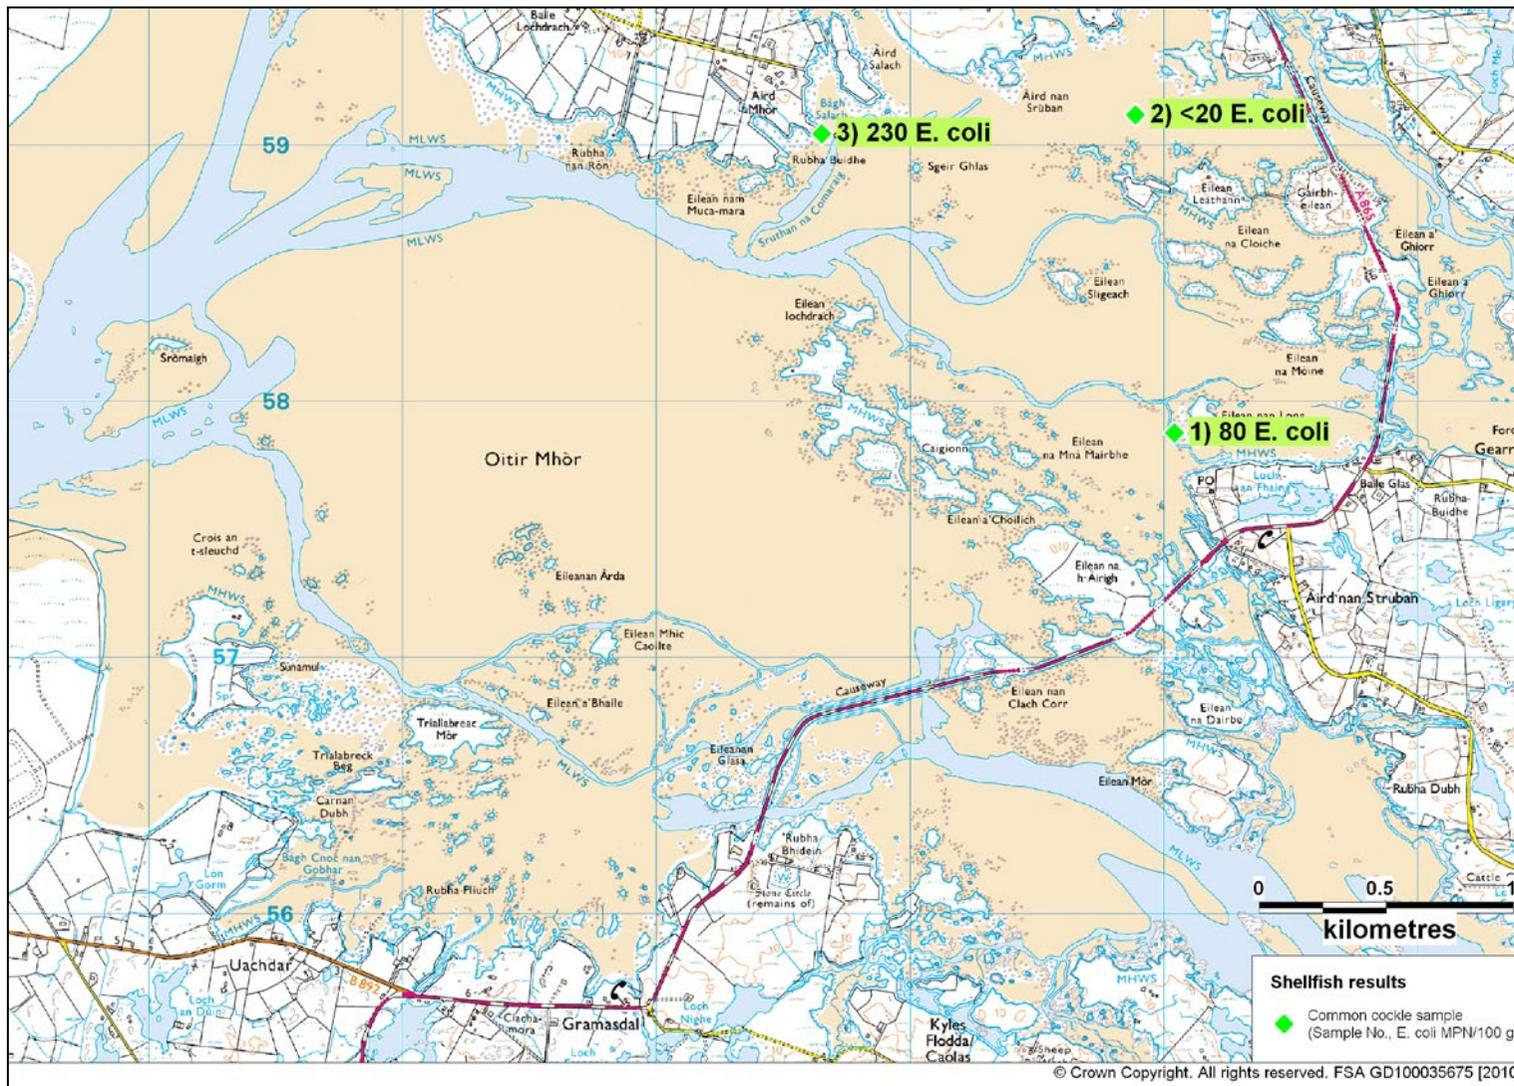
Figure 3. Shellfish sample results

No.	Date	Sample	Grid Ref	Type	<i>E. coli</i> (cfu/100g)
1	15/03/2010	NFC1	NF 84042 57878	Common cockles	80
2	15/03/2010	NFC2	NF 83889 59121	Common cockles	<20
3	15/03/2010	NFC3	NF 82653 59048	Common cockles	230

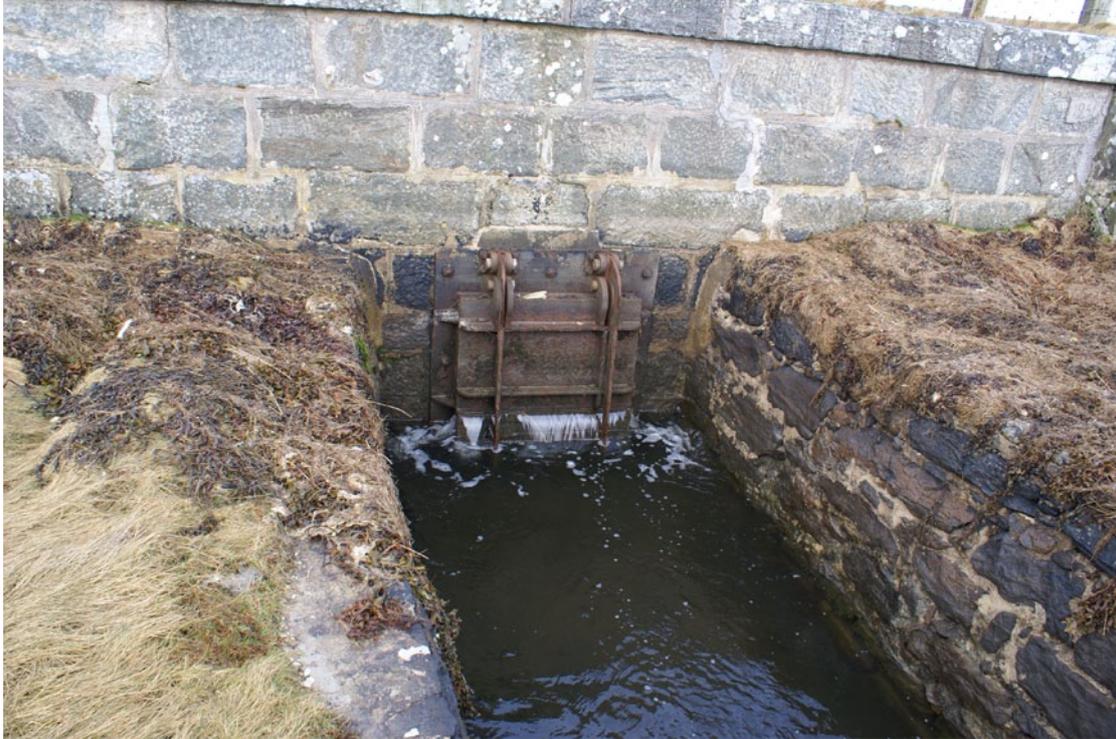
Figure 4. Location of NFFW1 sample

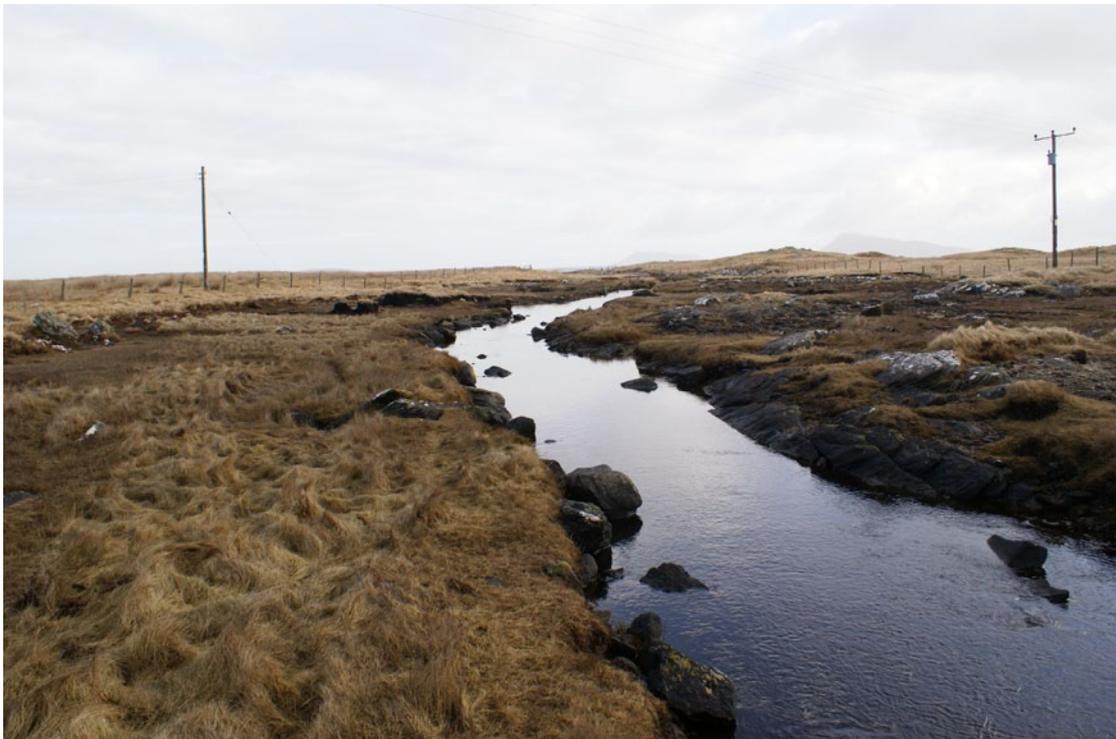
Figure 5. Location of NFFW2 sample

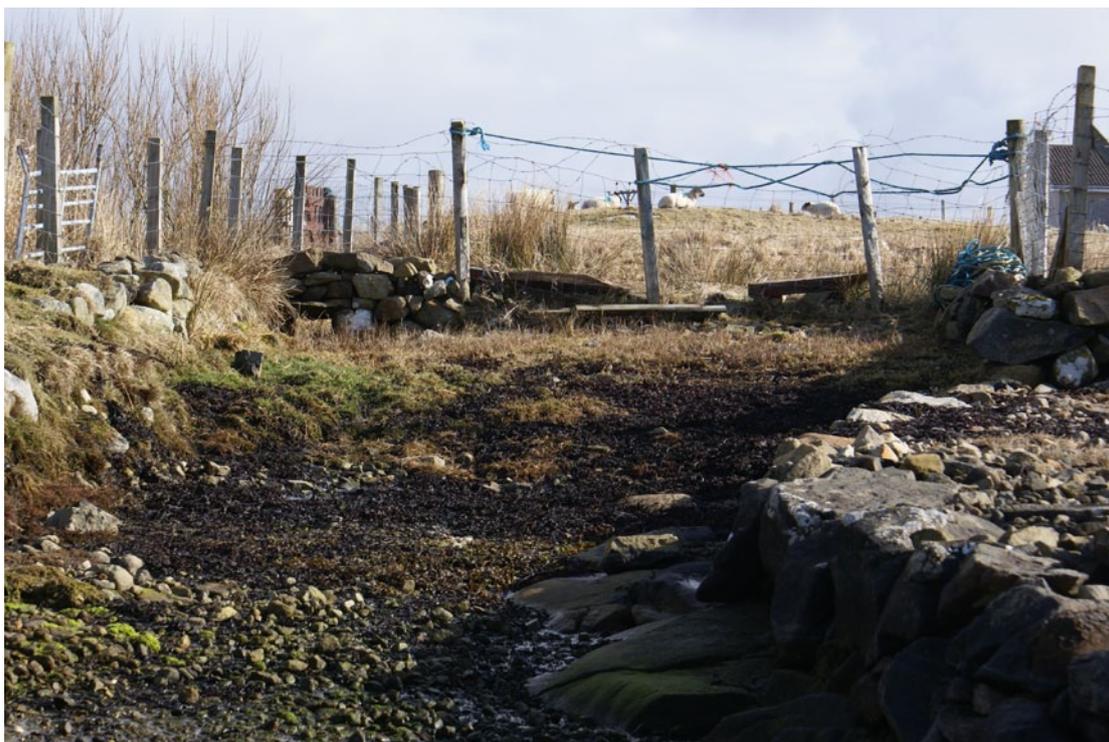
Figure 6. Sheep close to shoreline

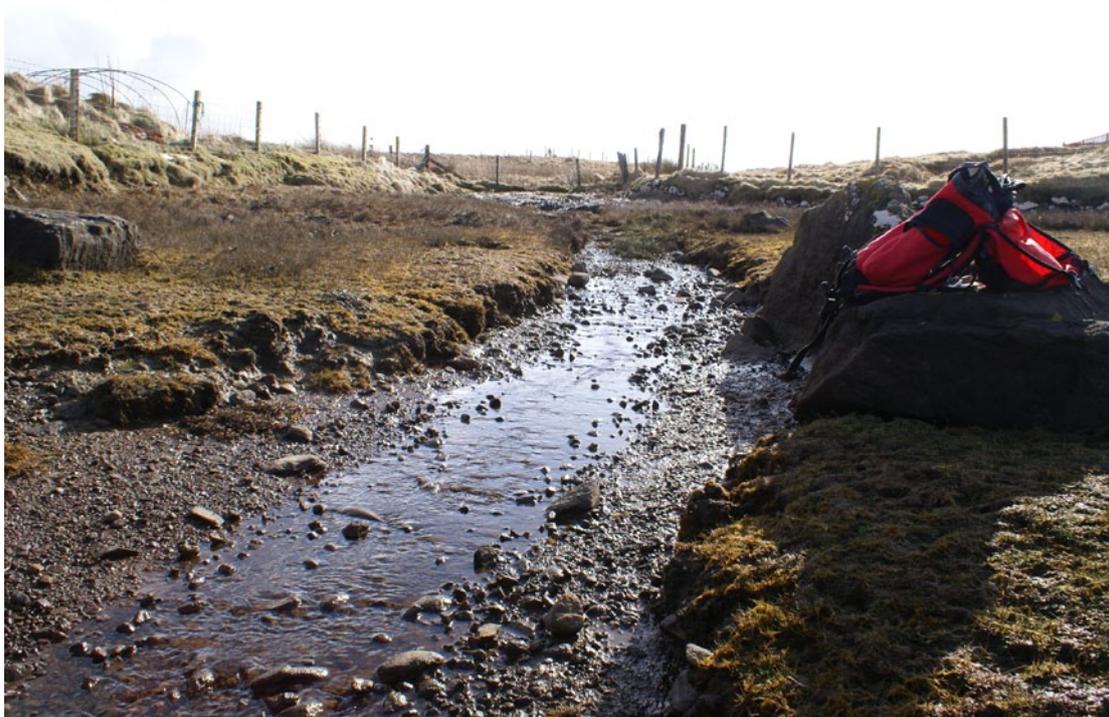
Figure 7. Location of NFFW3 sample

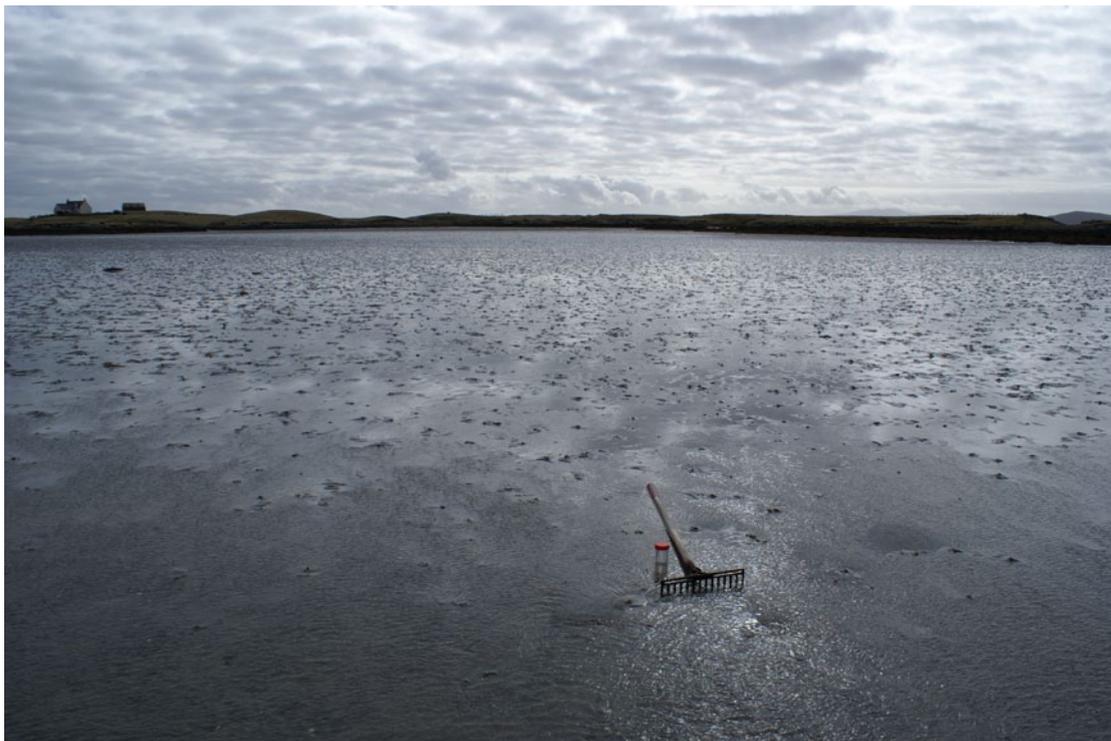
Figure 8. Location of NFC2 sample

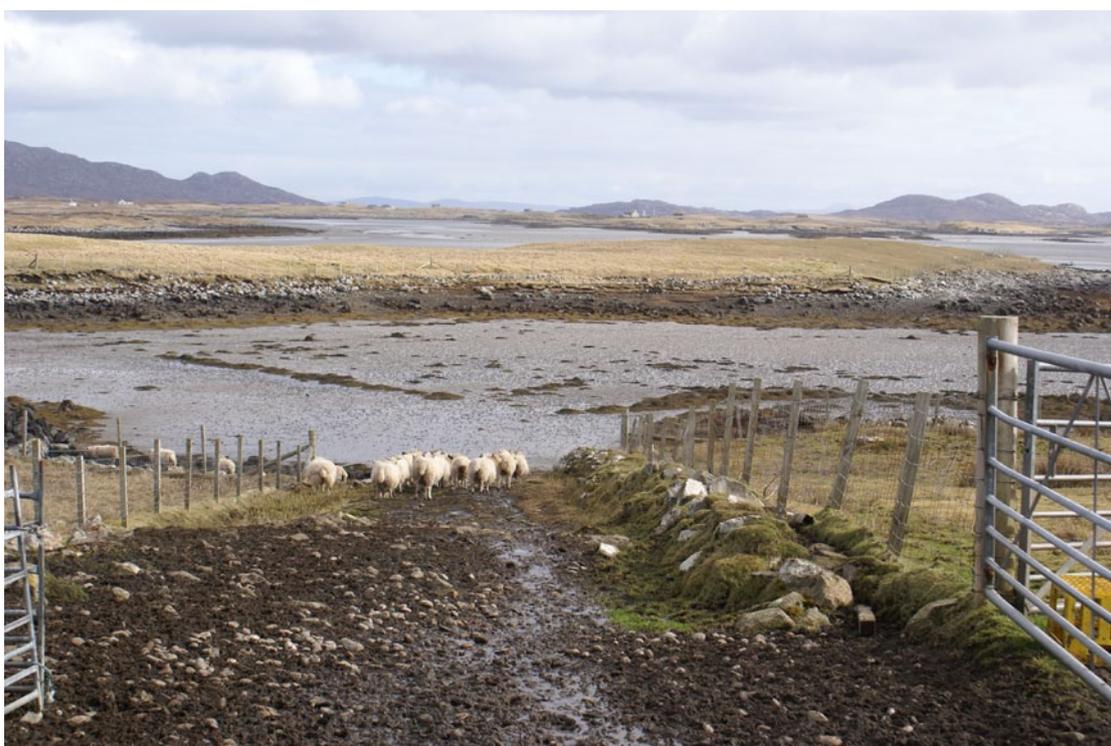
Figure 9. Sheep on shoreline
