Scottish Sanitary Survey Project

Restricted Sanitary Survey Report North Ford UB 493 March 2010

Shoreline Survey Report

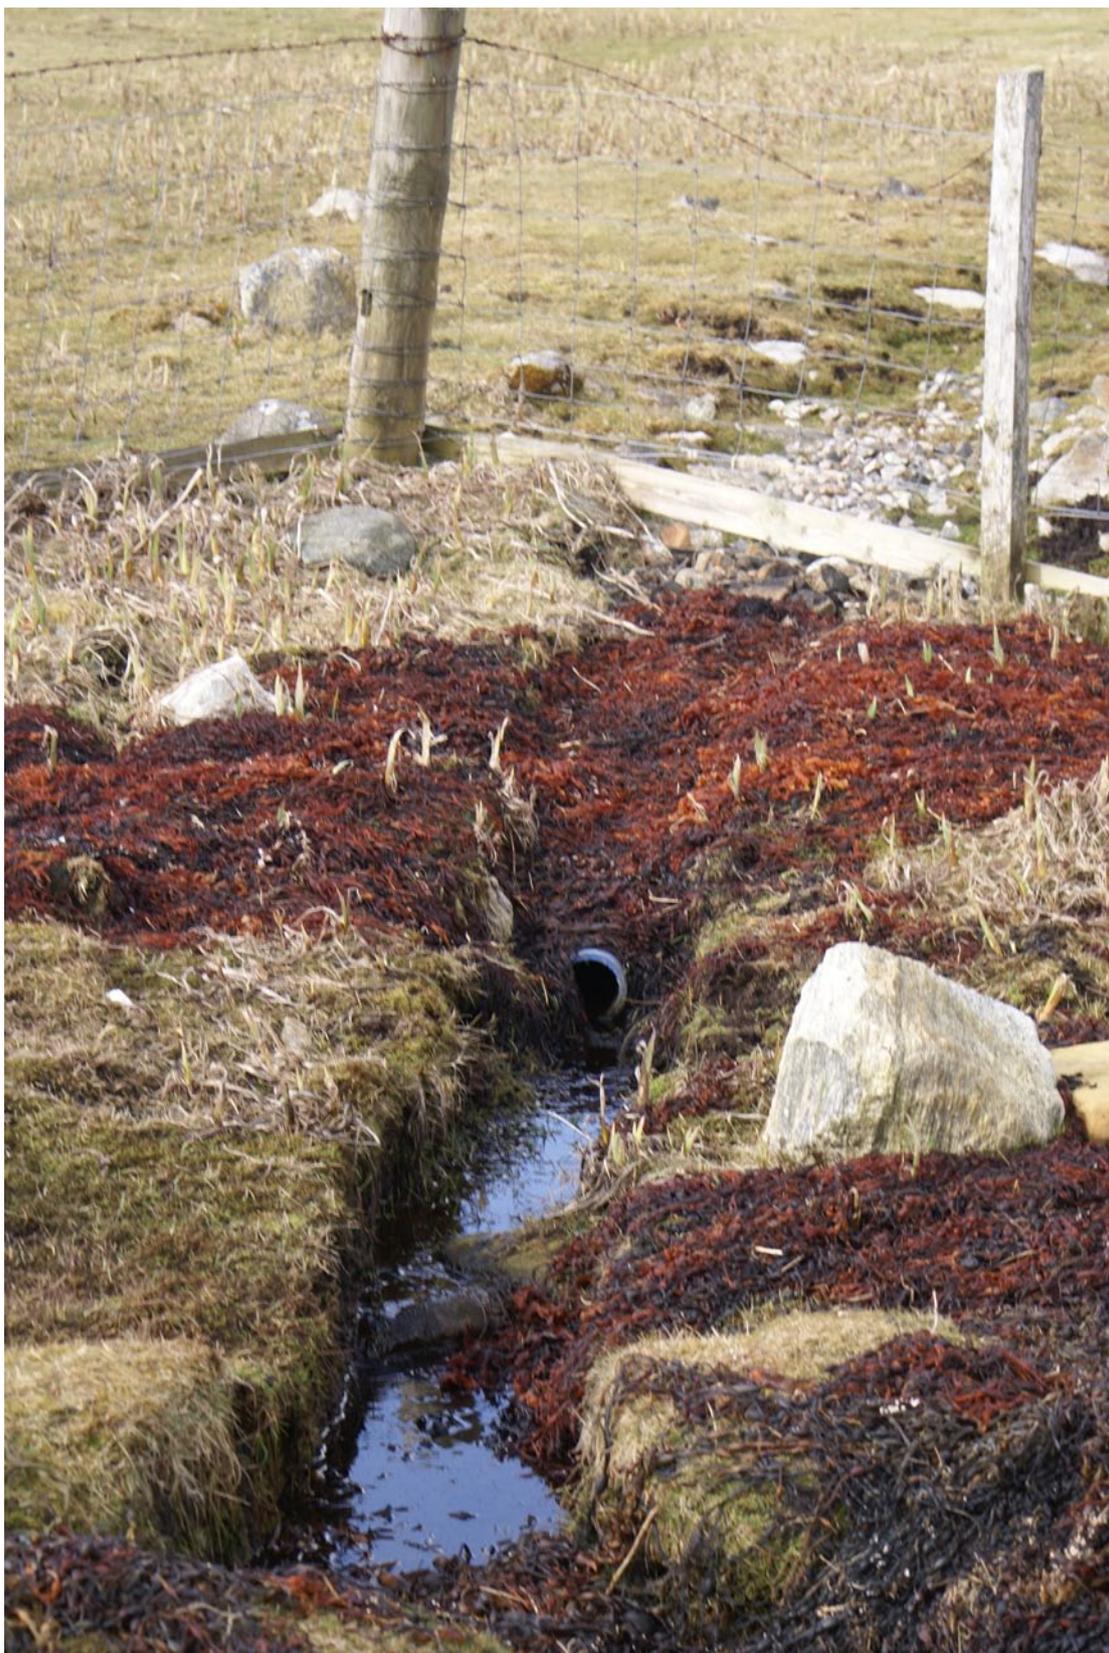
Figure 10. Location of NFFW4 sample

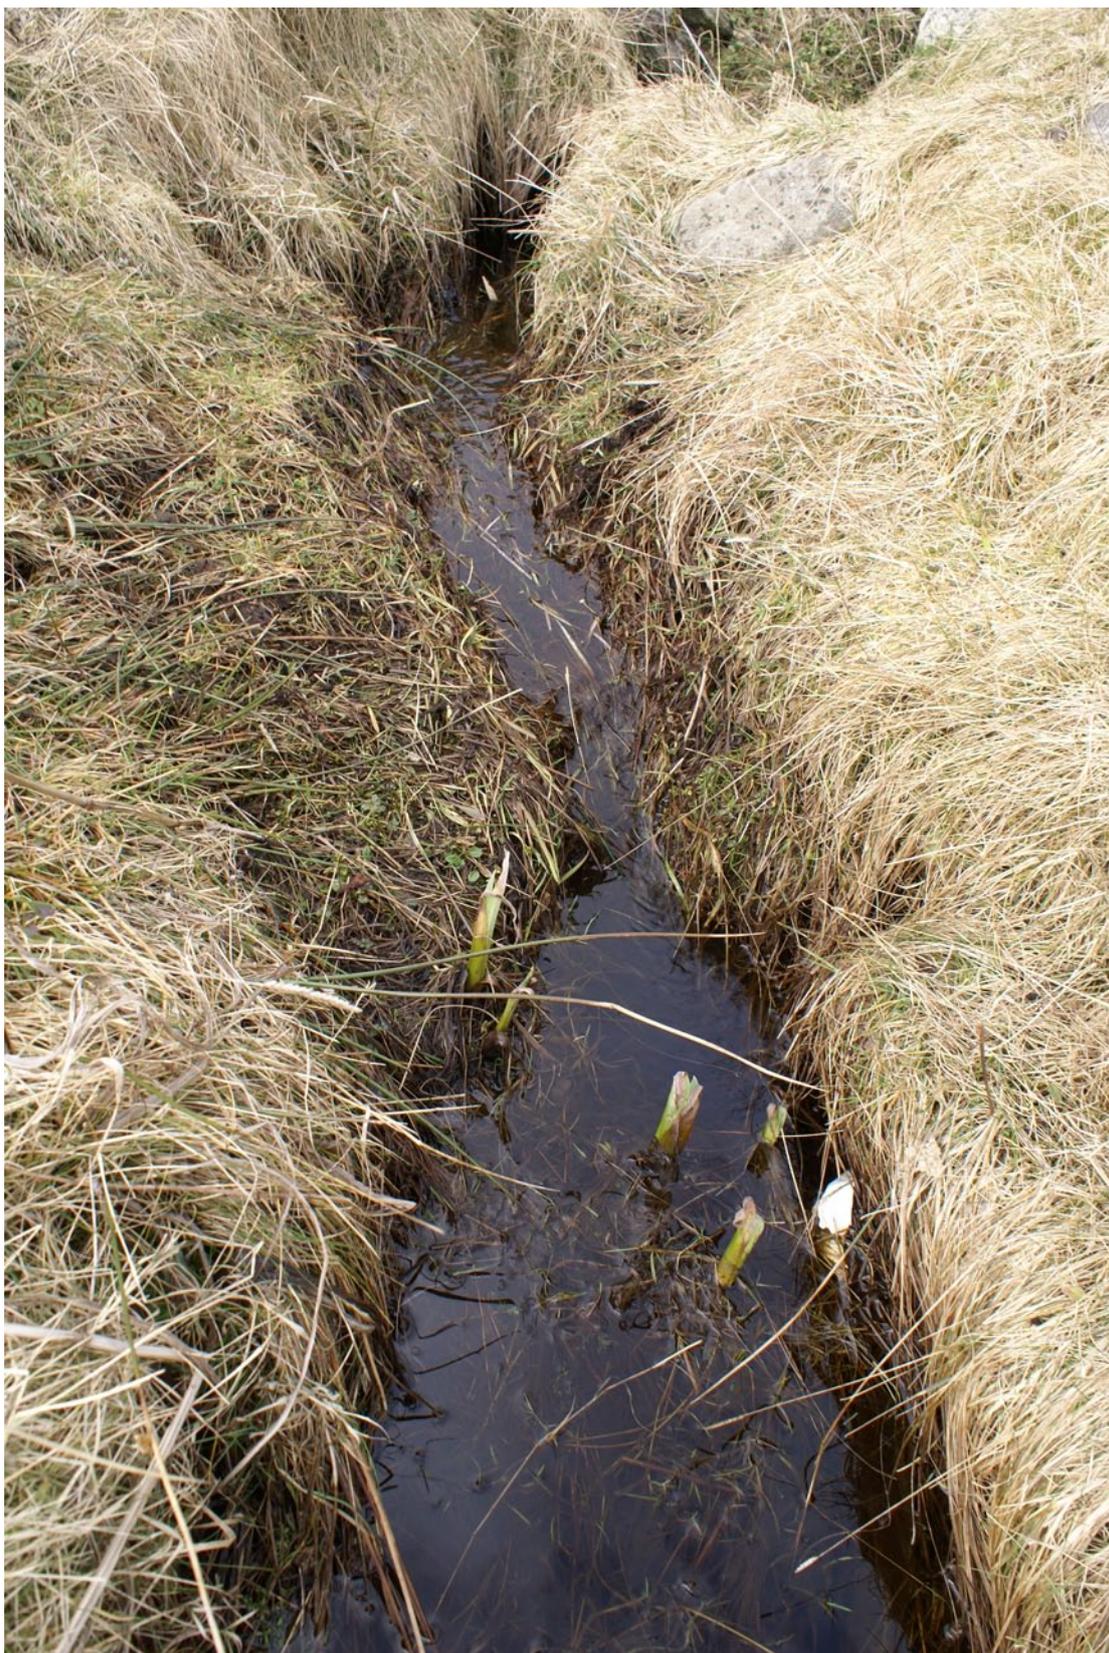
Figure 11. Location of NFFW 5 sample

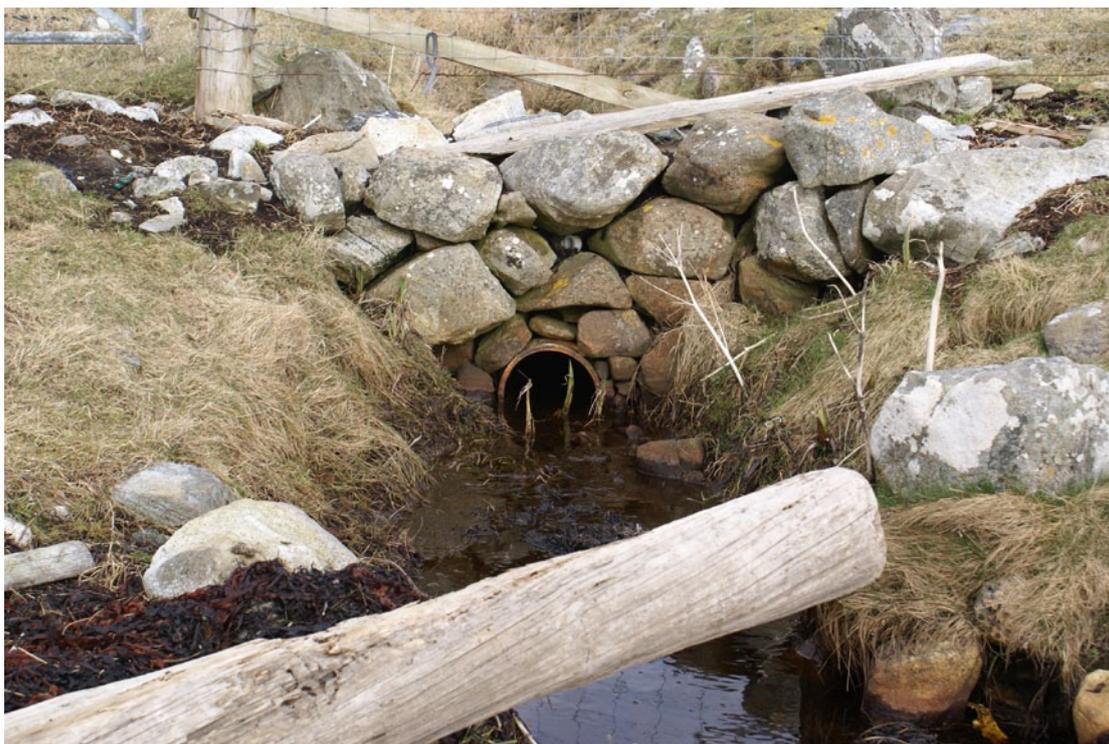
Figure 12. Location of NFFW 6 sample
