# Scottish Sanitary Survey Project

## Restricted Sanitary Survey Report Sound of Gigha AB 510 February 2010

# Shoreline Survey Report

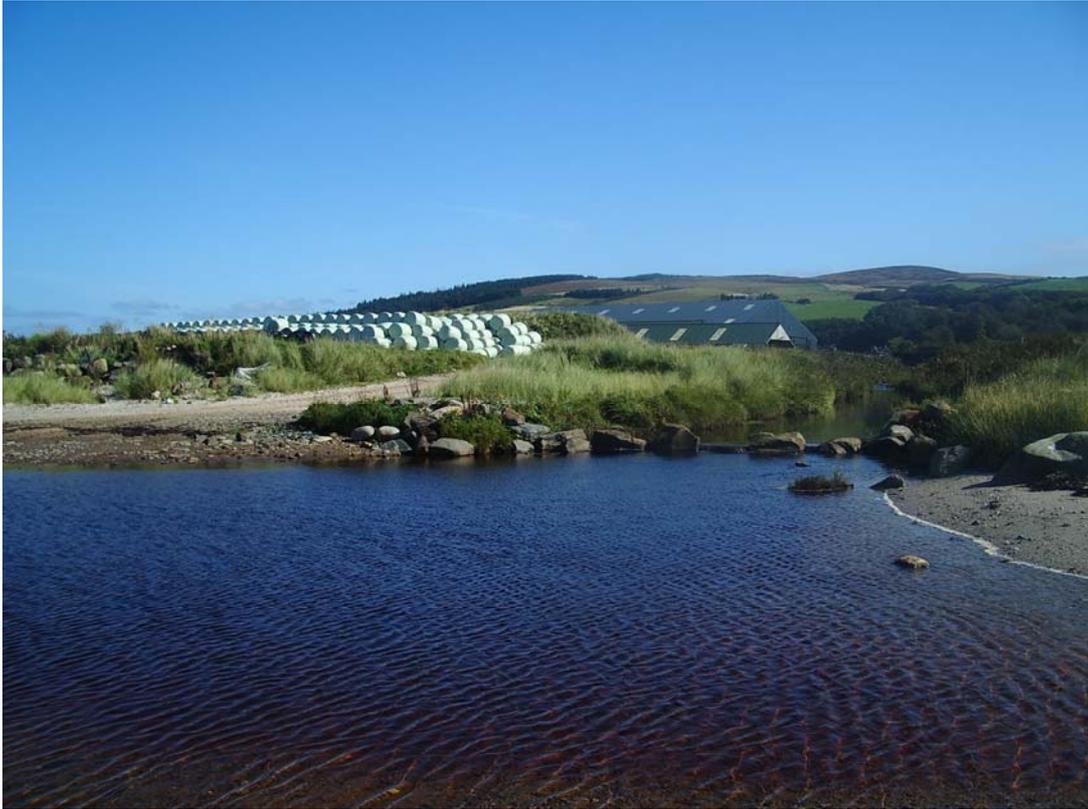
Figure 4. Kilean Burn, location of fresh water sample 1 (EFW1)

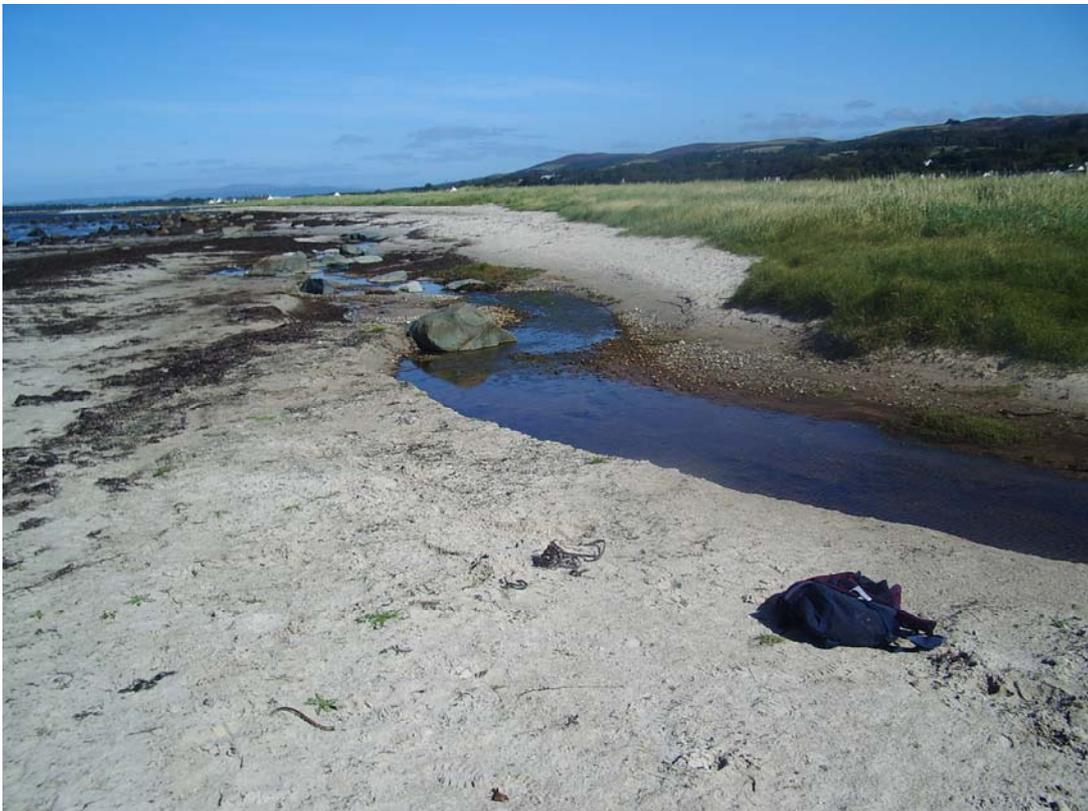
Figure 5. Small stream, location of fresh water sample 3 (EFW3)

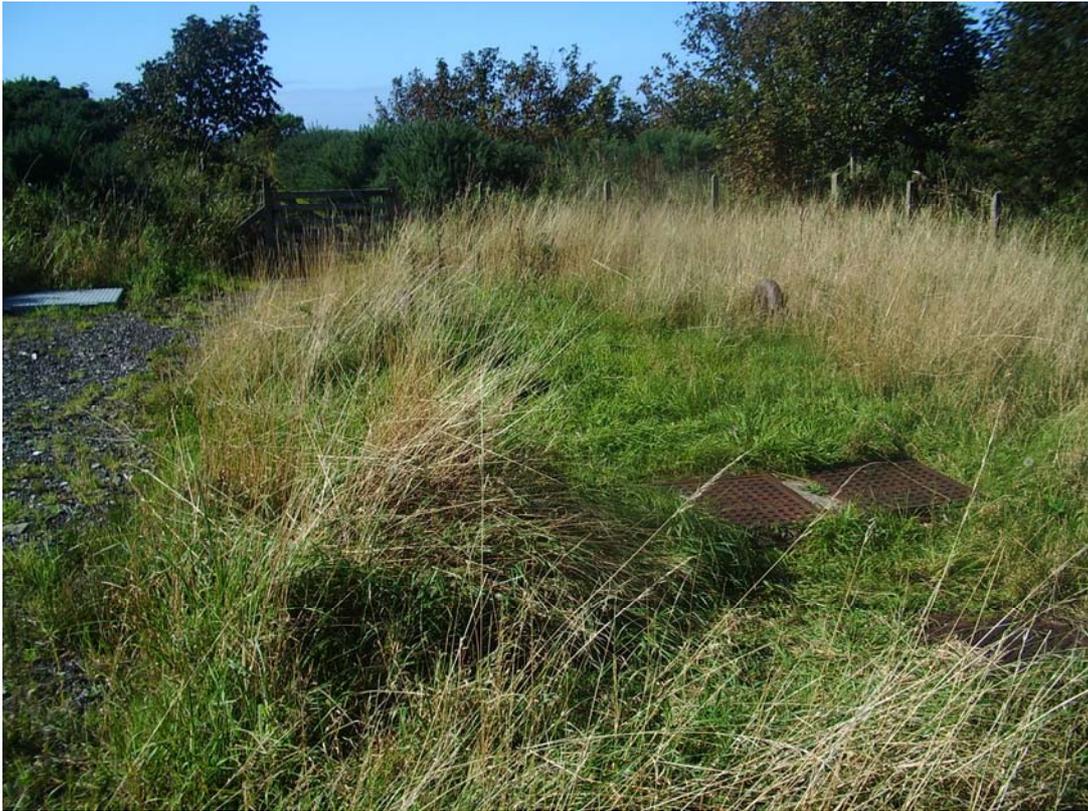
Figure 8. Tayinloan septic tank and inspection covers

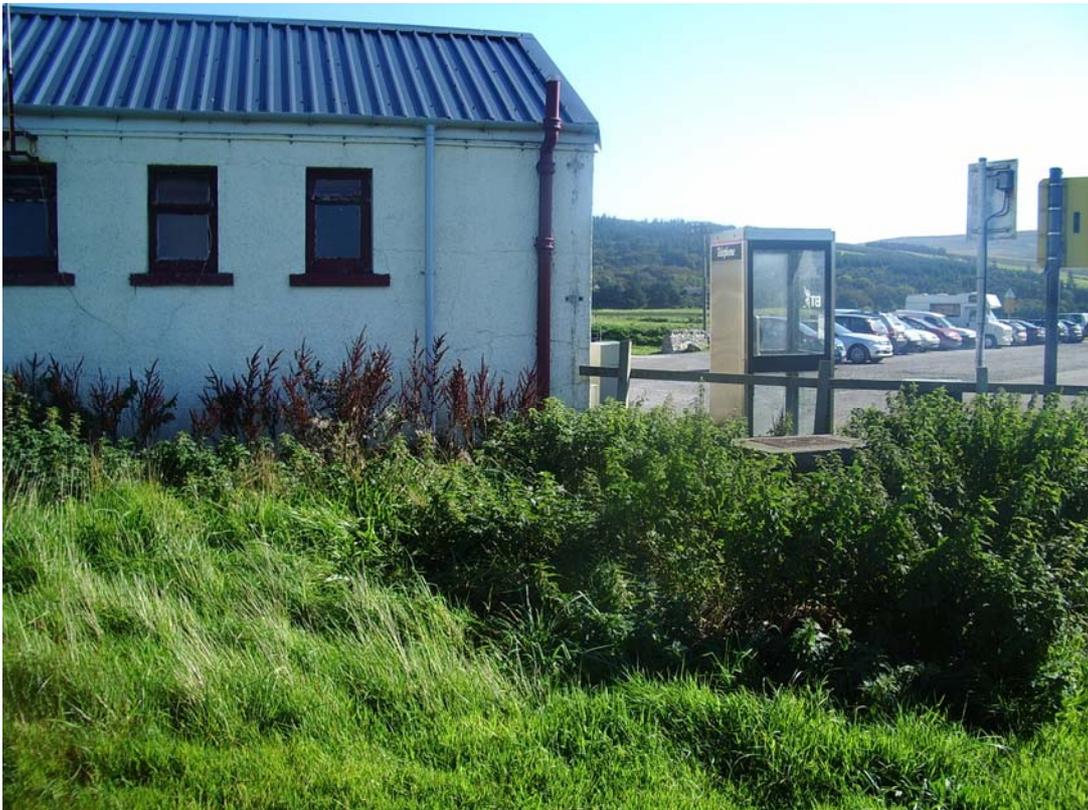
Figure 9. Ferry terminal and public toilets with septic tank

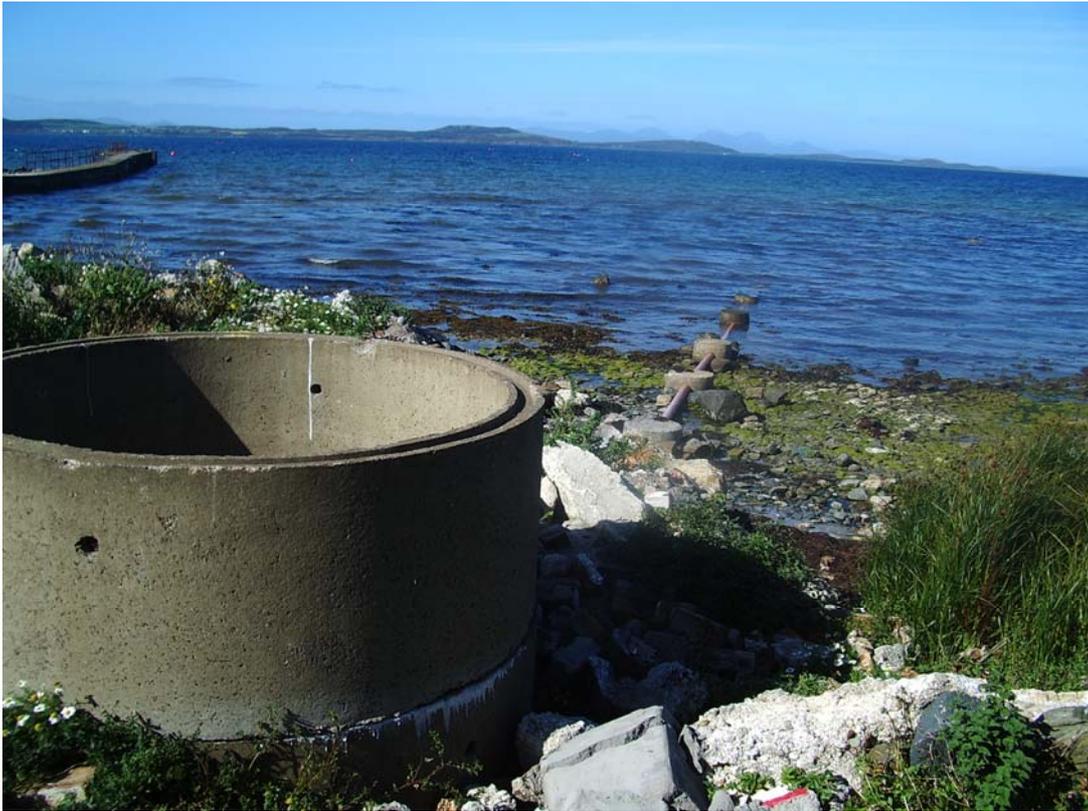
Figure 10. Pipe from farm flowing into the sea

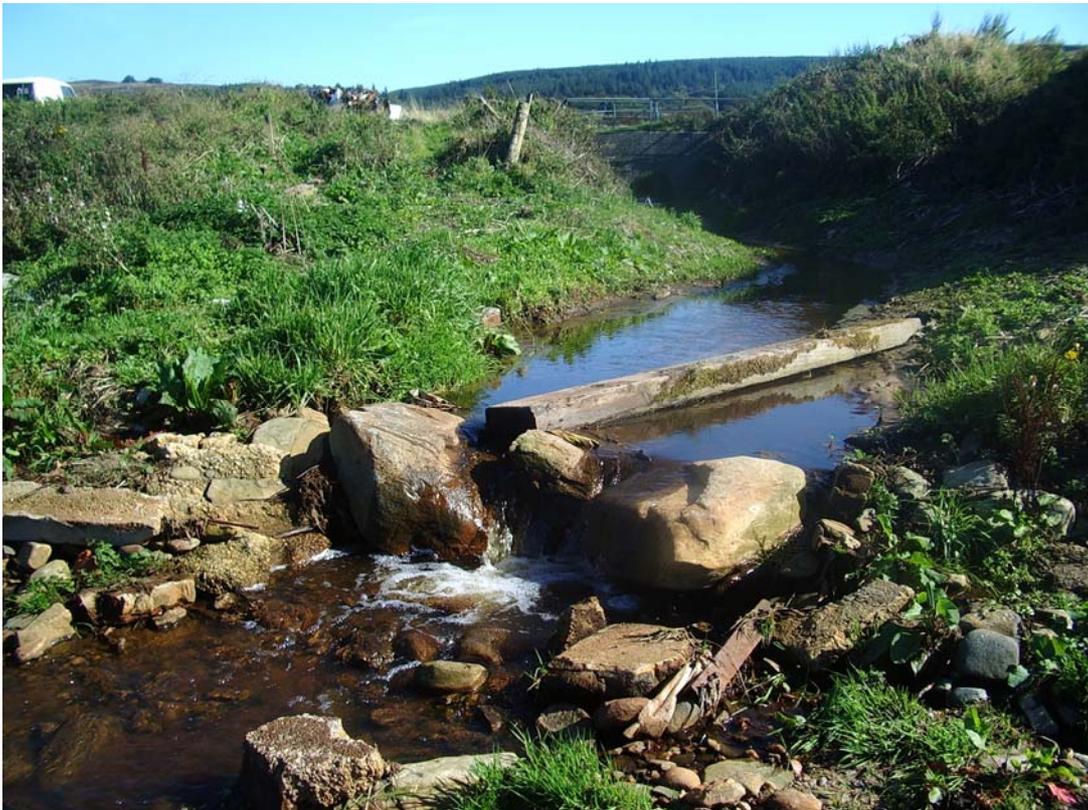
Figure 11. Small stream by farm, fresh water sample 5 (EFW5)

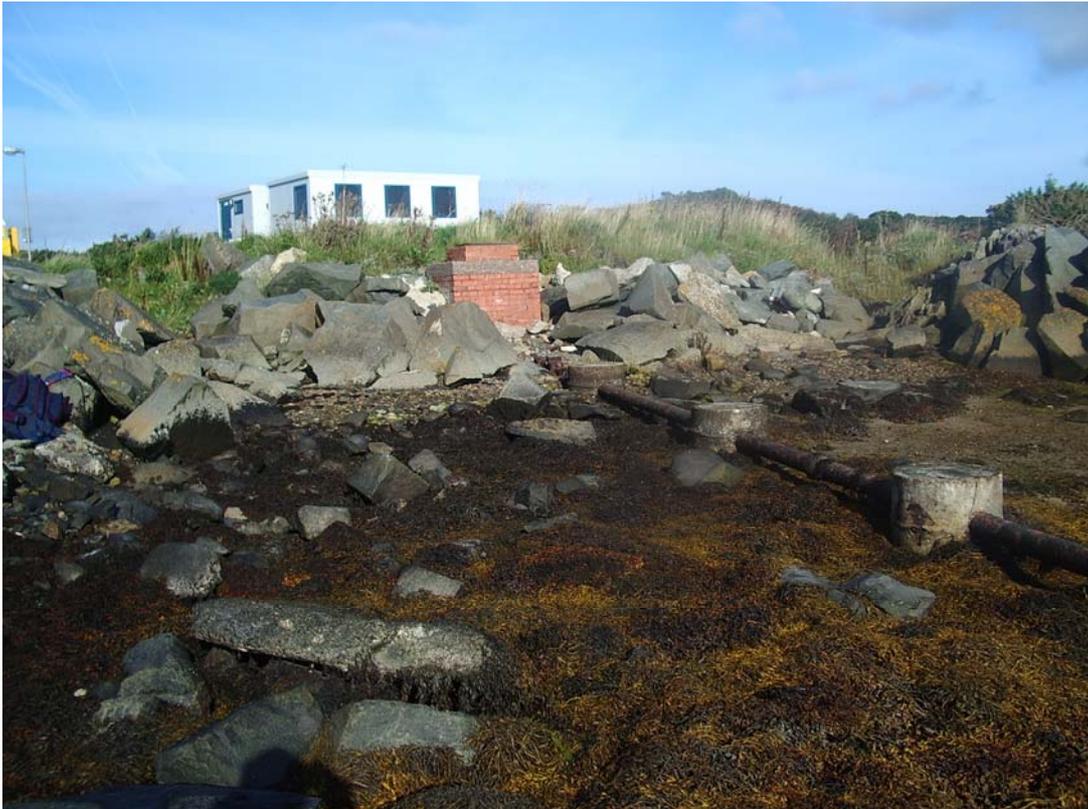
Figure 12. Septic tank, public toilets and outfall pipe

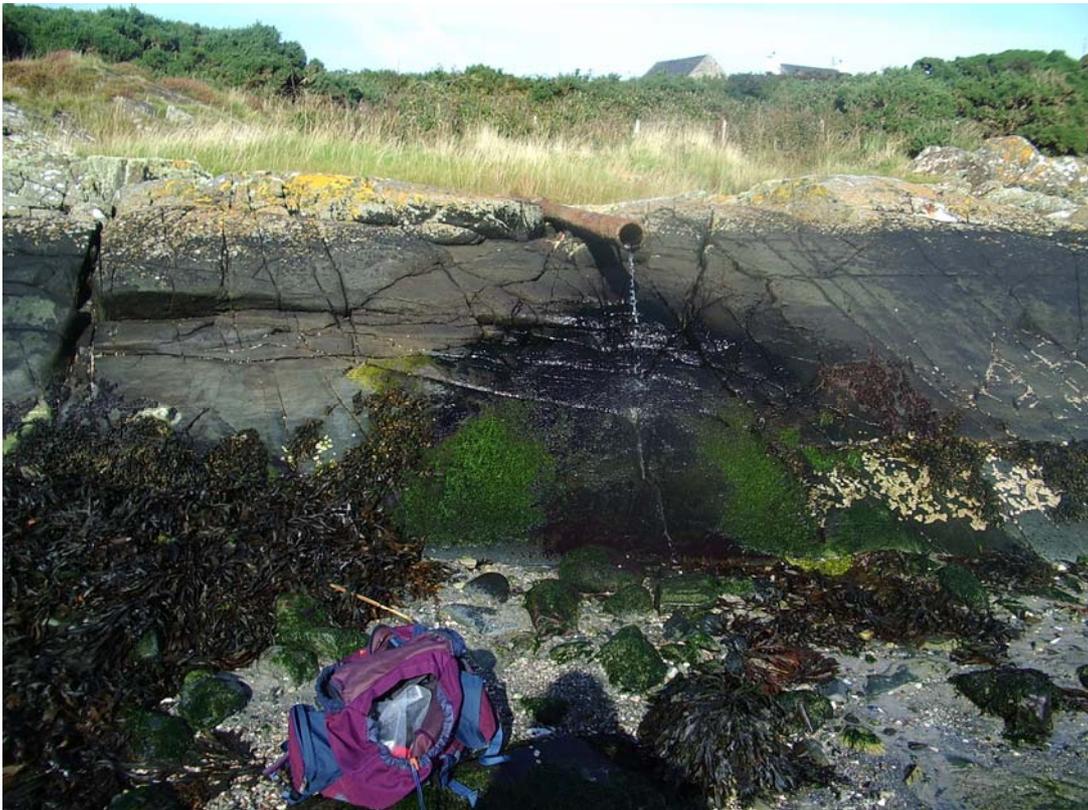
Figure 13. Outfall pipe, fresh water sample 23 (EFW8)

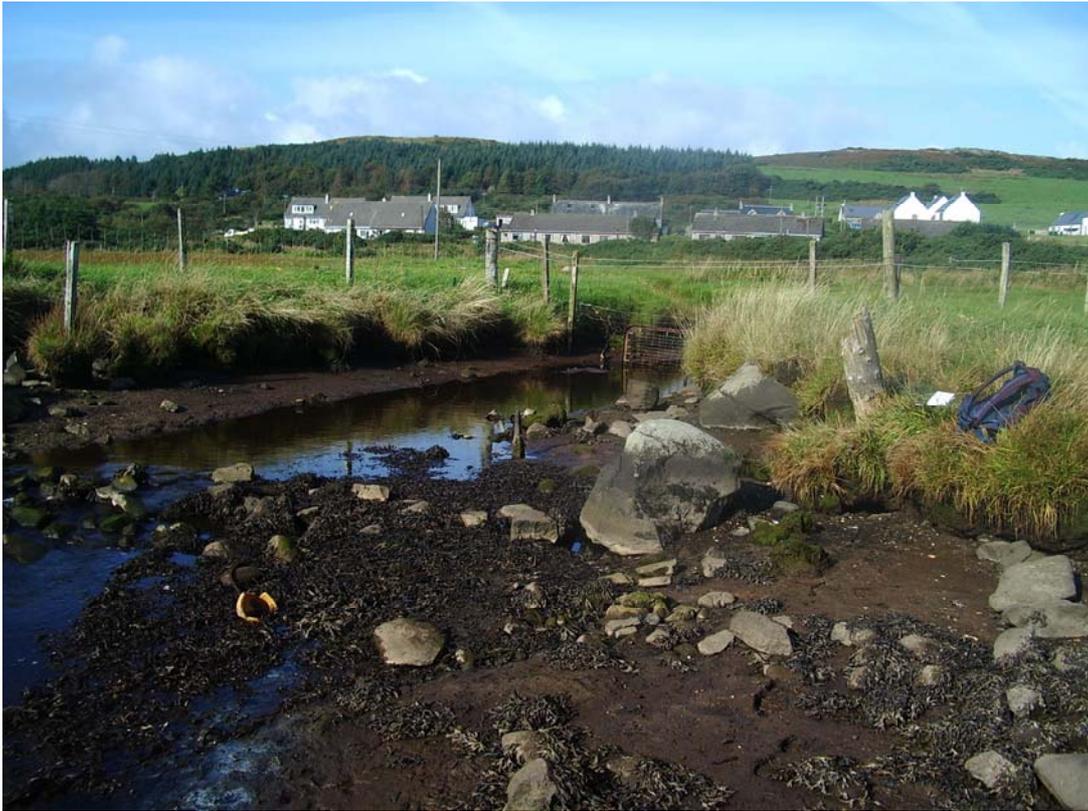
Figure 14. Stream near village, fresh water sample 24 (EFW9)

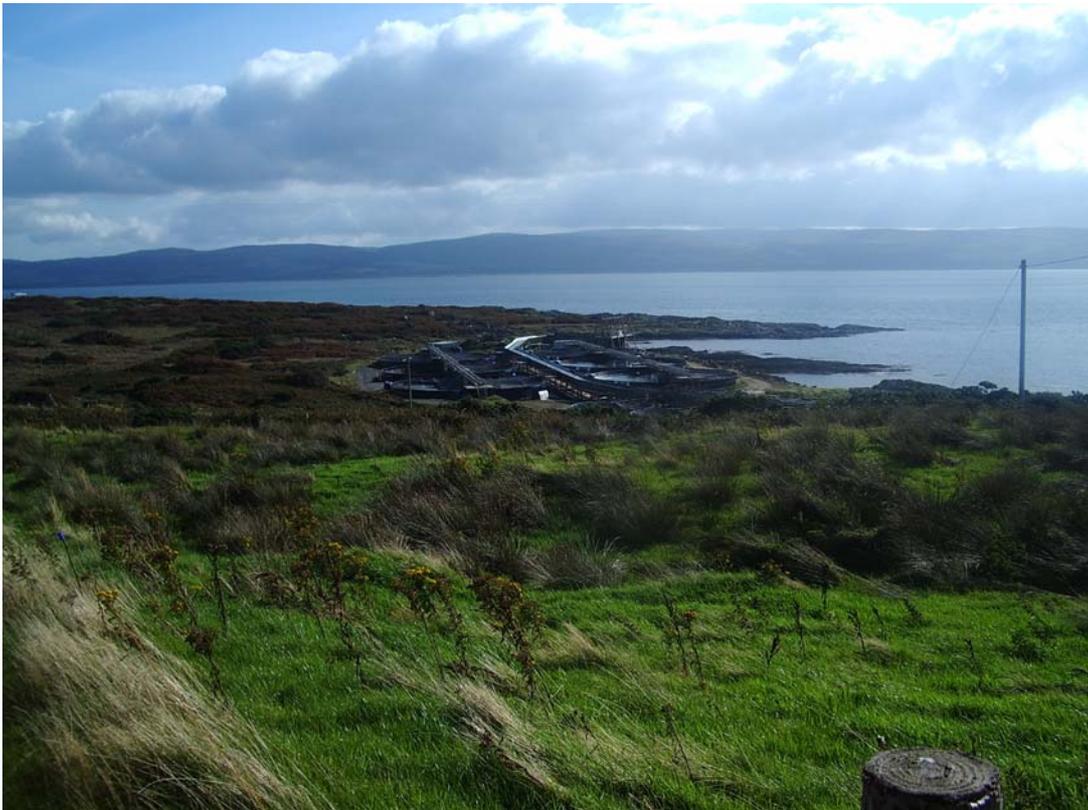
Figure 15. Onshore halibut farm

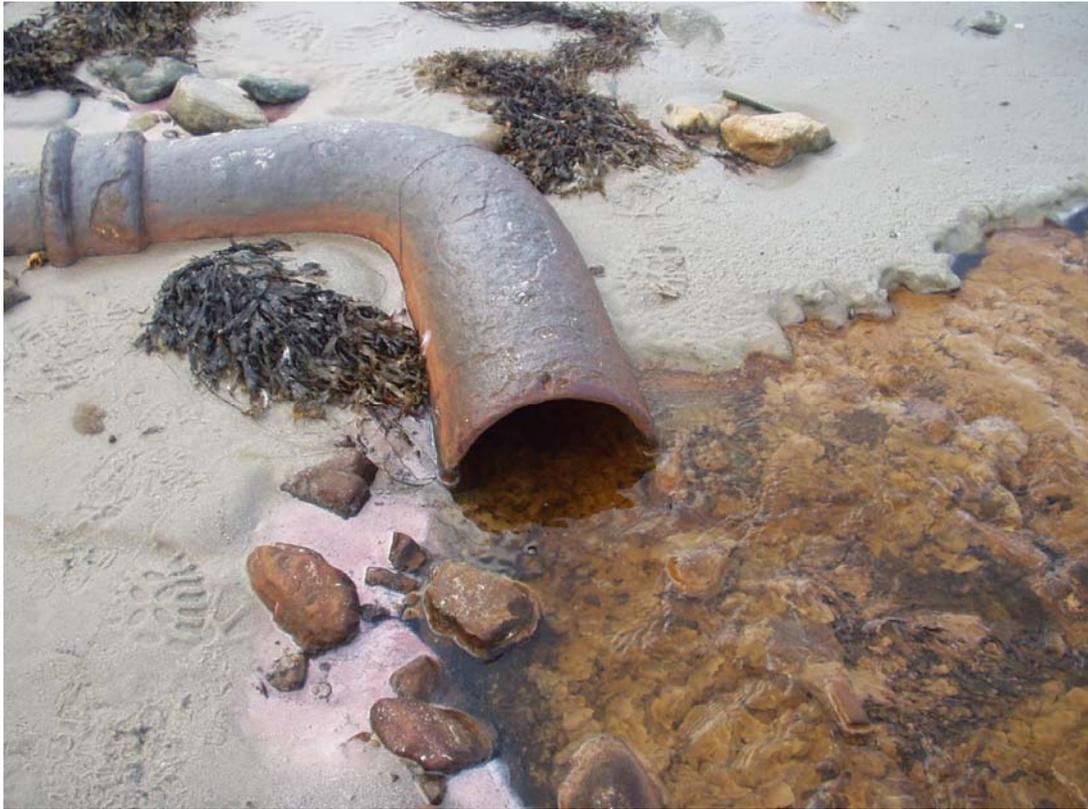
10	17/09/2009	NR 69469 47194	20cm diameter cast iron outfall pipe – flowing.	FWA	130

Figure 16. Cast iron outfall pipe, location of fresh water sample 12 (FWA)

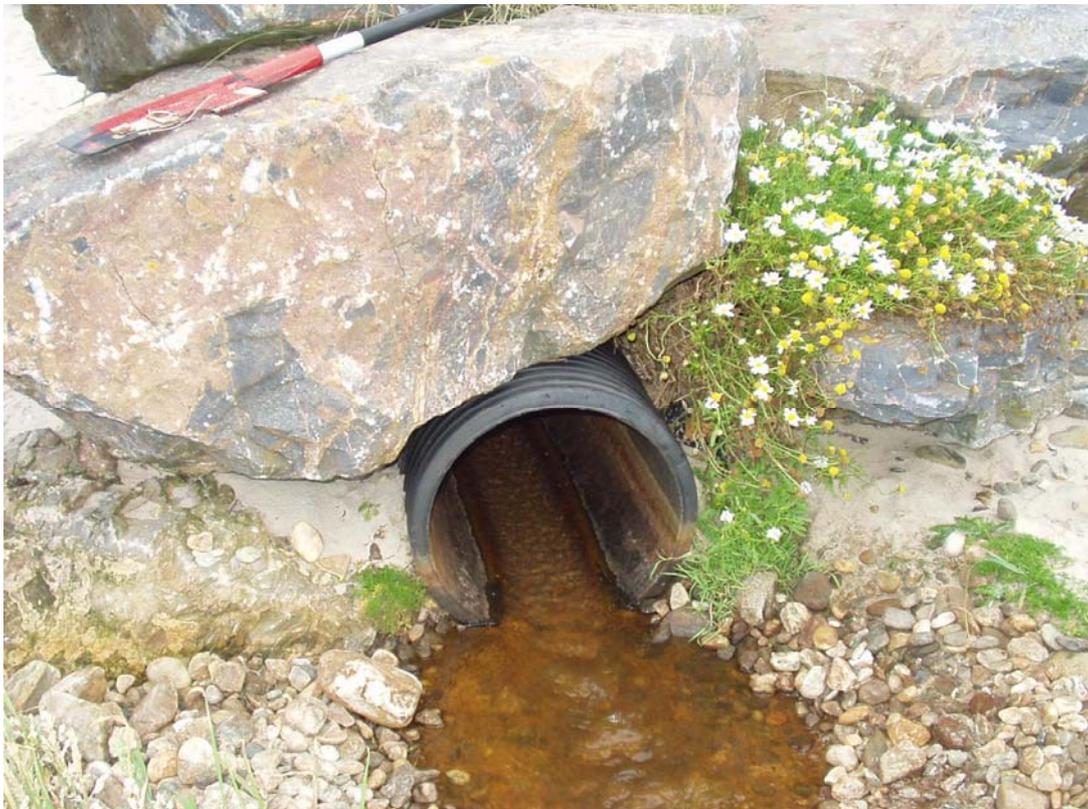
Figure 17. Outfall pipe, location of fresh water sample 17 (FWG)
