Scottish Sanitary Survey Project

Restricted Sanitary Survey Report Vallay UB 490 May 2010

Scottish Sanitary Survey Project
Restricted Survey

Production area: Vallay
 Site name: Traigh Bhalaigh Site 2
 Species: Common Cockles (*Cerostoderma edule*).
 Harvester: Duncan MacInnes
 Local Authority: CnES
 Status: New site

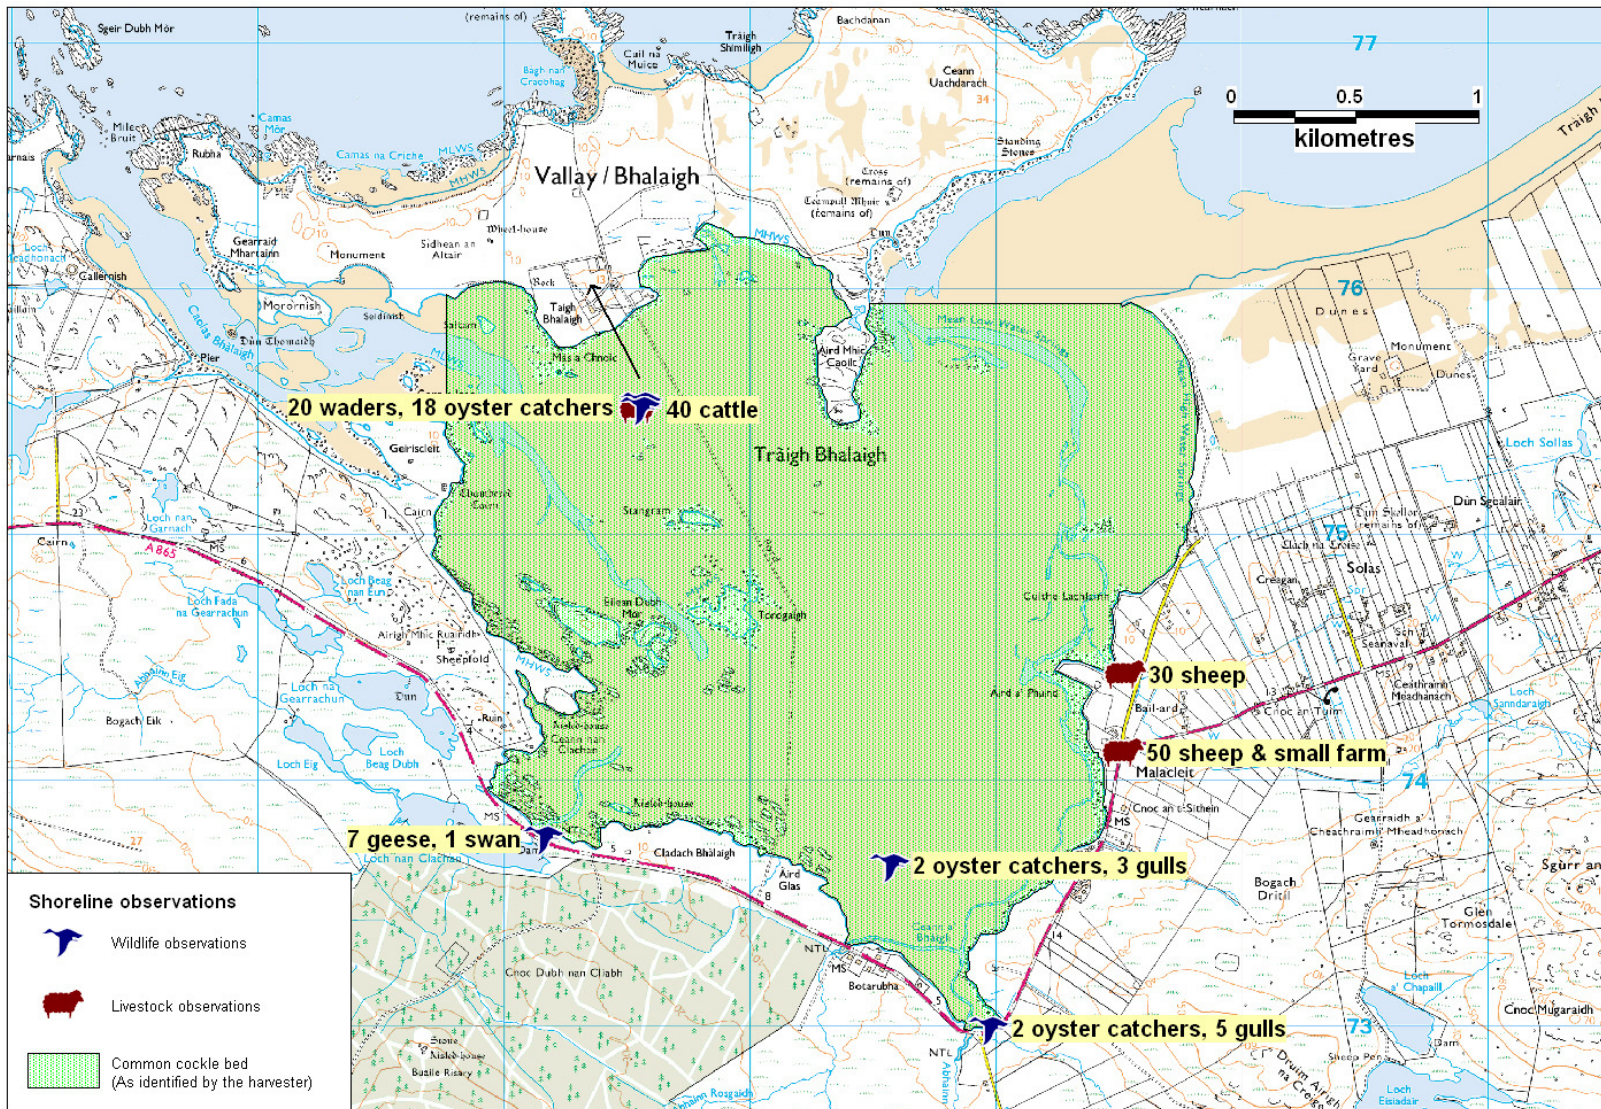
Figure 4.1 Livestock and wildlife present at Vallay during the shoreline survey

On the eastern shoreline of the cockle bed, close to Malacleit a small farm and 50 sheep were observed. Slightly further north of Malacleit an additional 30 sheep were observed. From the intertidal zone, approximately 40 cattle were observed on the island of Vallay. No other livestock was observed at the time of the shoreline survey.

On the basis of these observations, the risk of contamination of the shellfishery from livestock sources will be greatest south of the island of Vallay and on the east side of the cockle bed, adjacent to Malacleit.

During the shoreline survey gulls, oyster catchers, waders geese and other seabirds were observed on and around the Vallay cockle bed (see Figure 4.1). These seabirds were mainly observed at the north end of the cockle bed near the island on Vallay and along the southern end of the cockle bed. No other wildlife was observed at the time of the shoreline survey. However, it is likely that other seabirds may be present in the area. The distribution and numbers of additional species was not investigated. On the basis of the shoreline survey observations, the risk of contamination of the shellfishery from wild birds will be greatest at the far northern and southern end of the cockle bed. However, this does not provide information as to whether this difference in bird density applies more generally than just at the time of the survey.

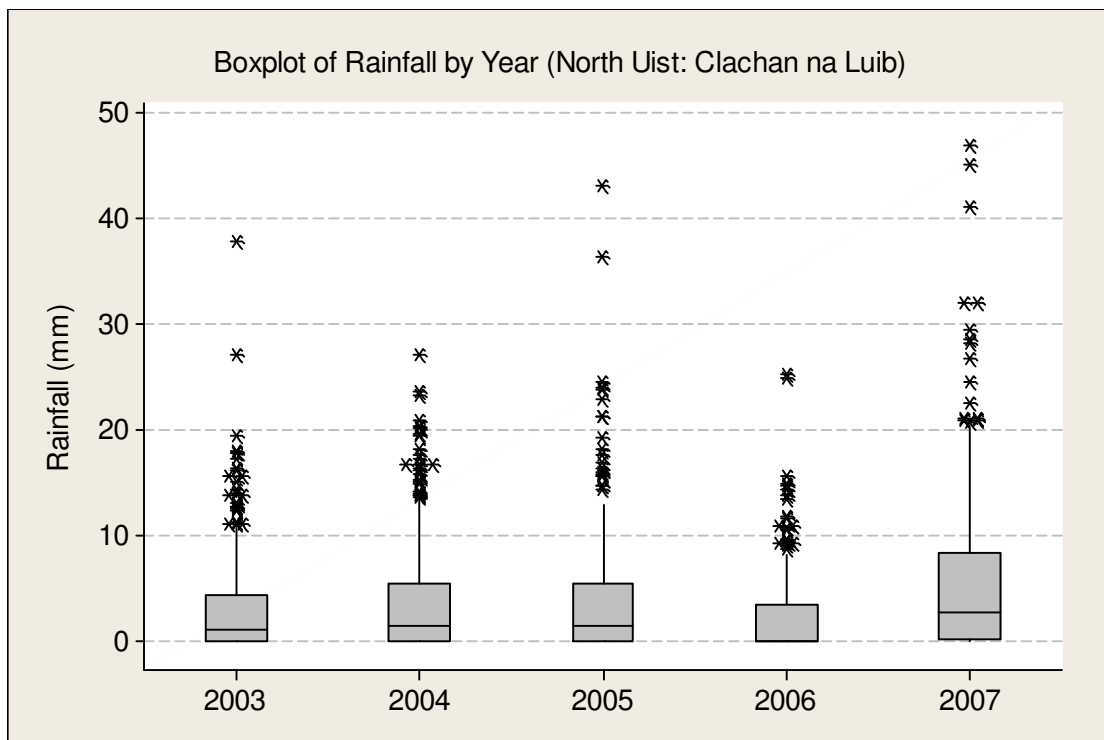
Figure 5.1 Boxplot of daily rainfall at North Uist by year

Figure 5.1 shows that there was considerable variation in the median daily rainfall from year to year. Overall, 2006 saw the lowest median rainfall, of 0mm. The highest individual rainfall events occurred in 2005 and 2007, with 2007 being wetter overall.

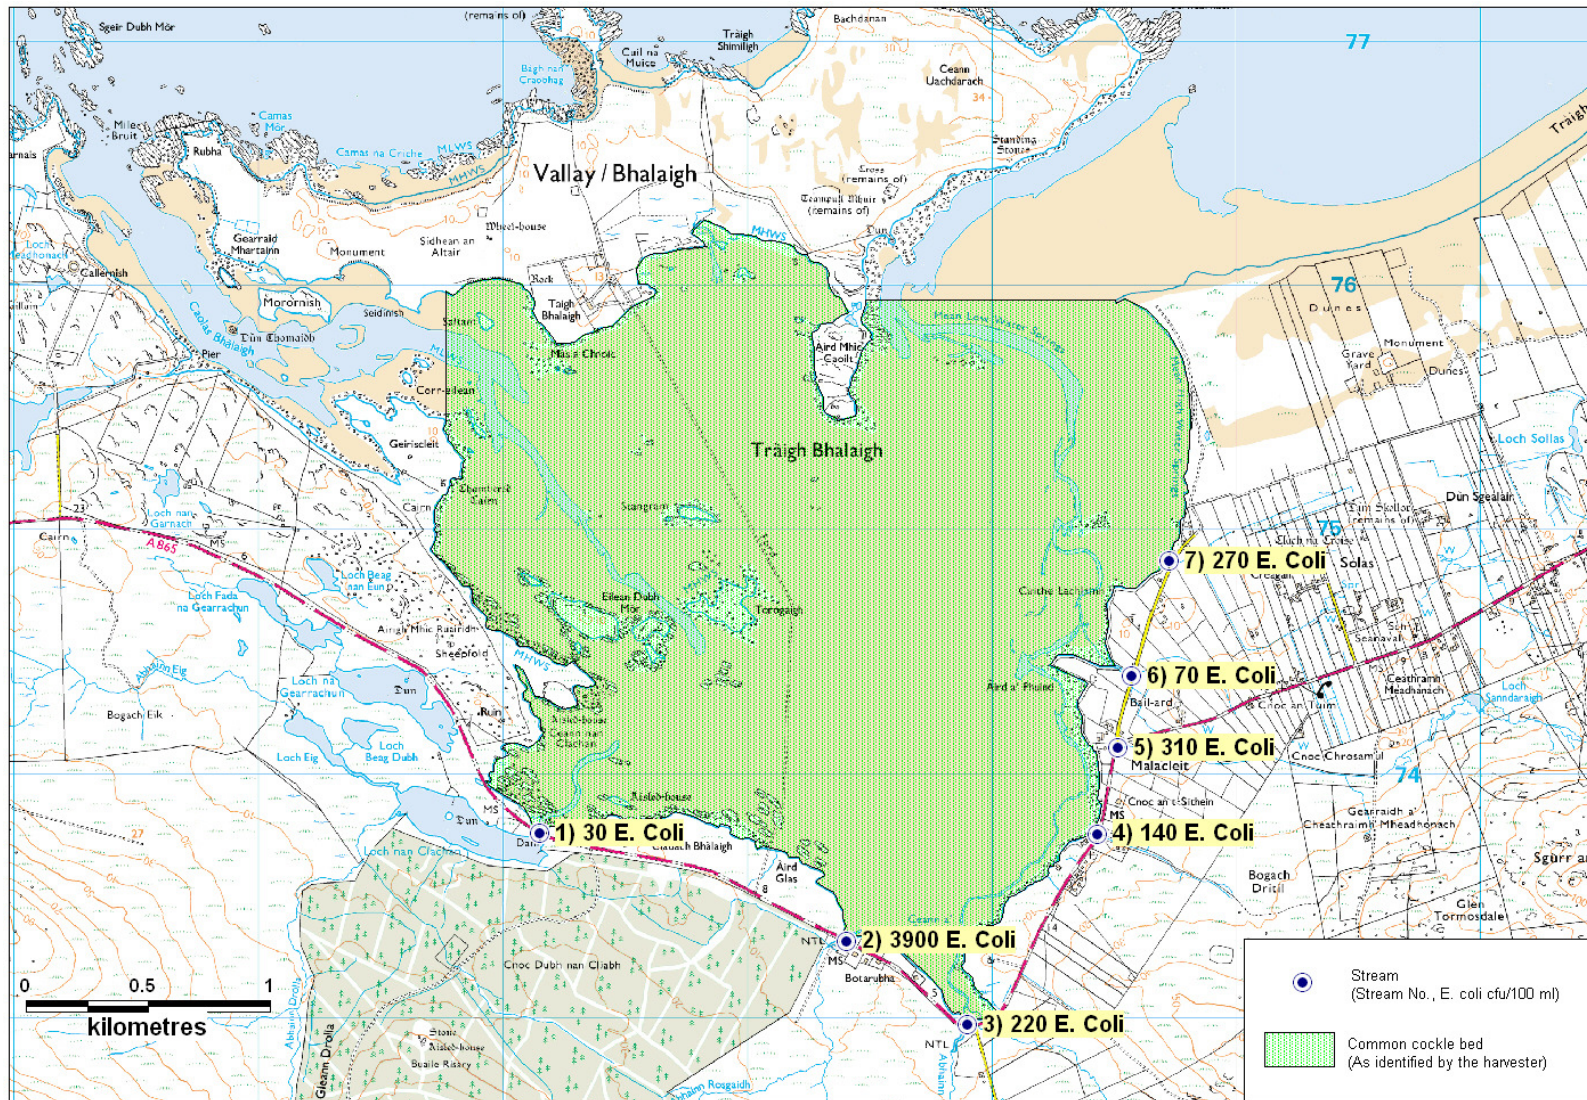
Figure 6.1. Location of streams and fresh water samples at Vallay

All of the fresh water streams sampled discharged directly onto the cockle bed. The majority of the streams (five out of seven) were located along the eastern shoreline and the remaining two on the south western shoreline of the cockle bed. The streams discharging into the eastern shoreline of the cockle bed had fresh water results varying from 70 to 310 *E. coli* cfu/100 ml. The highest result of 3900 *E. coli* cfu/100 ml was taken from the stream discharging into the southern side of the cockle bed close to Bocarubha. The stream located furthest west had the lowest result of 30 *E. coli* cfu/100 ml. These results indicate that *E. coli* contamination of the fresh watercourses was therefore relatively low on the day of the survey, with the exception of the stream next to Bocarubha, which would be expected to have a significant impact on the shellfishery. It would be expected that levels of faecal contamination in all of the streams would increase significantly after greater periods of rainfall. However, these samples represented conditions at one point in time only and contamination levels present in the identified watercourses could vary considerably from these values.

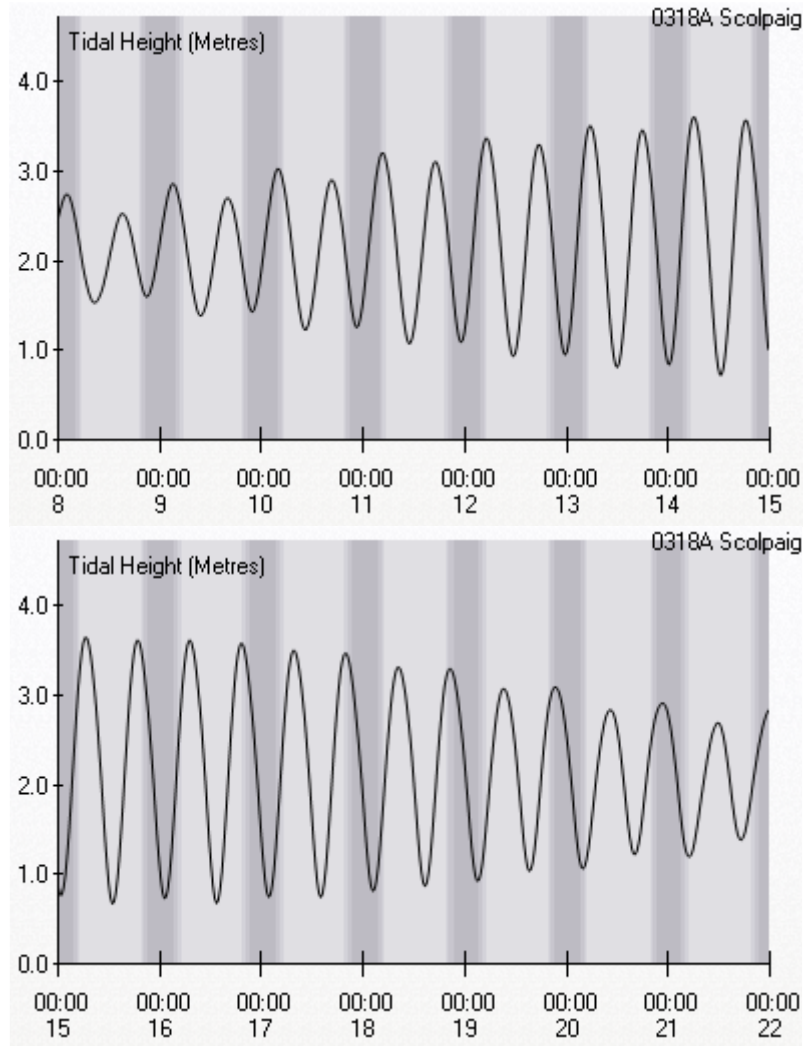
Figure 8.2 Tidal curves for Scolpaig

The tide type is Semi-Diurnal.

MHWS	4.5 m
MHWN	3.8 m
MLWN	1.5 m
MLWS	0.7 m

Predicted heights are in metres above chart datum. The tidal range at spring tide is therefore approximately 3.0 m and at neap tide 3.1 m.

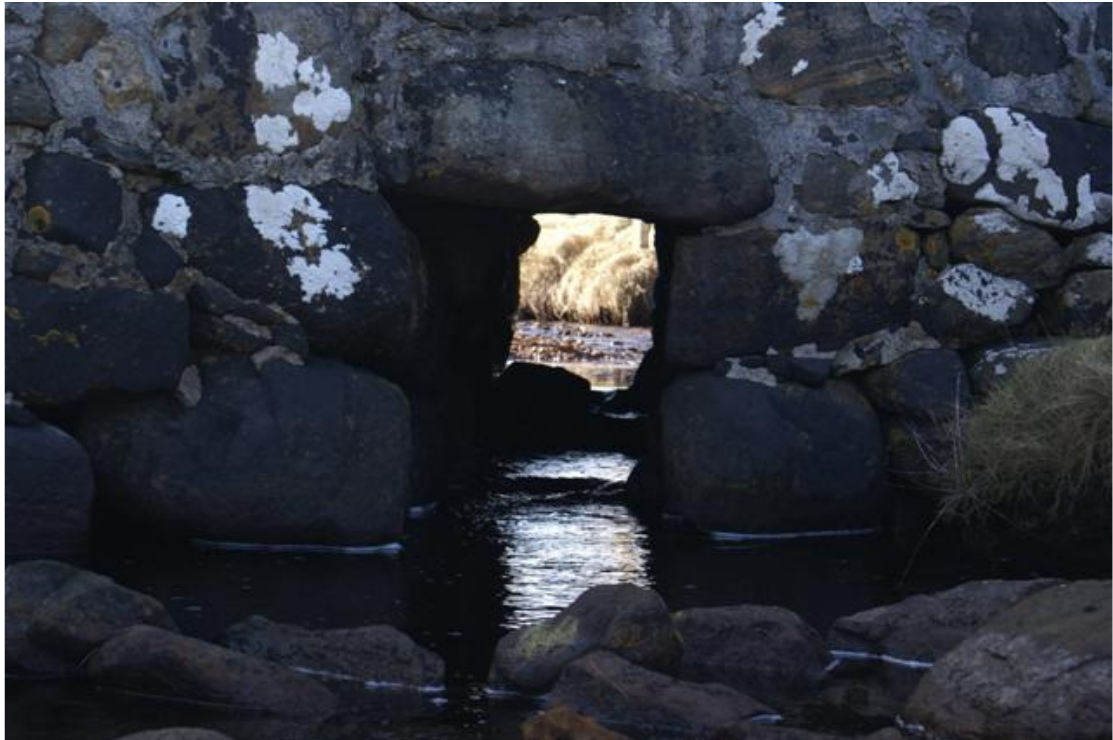
Figure 4. Culvert flowing under road
