Scottish Sanitary Survey Review

West of Lunna

SI 380

November 2014

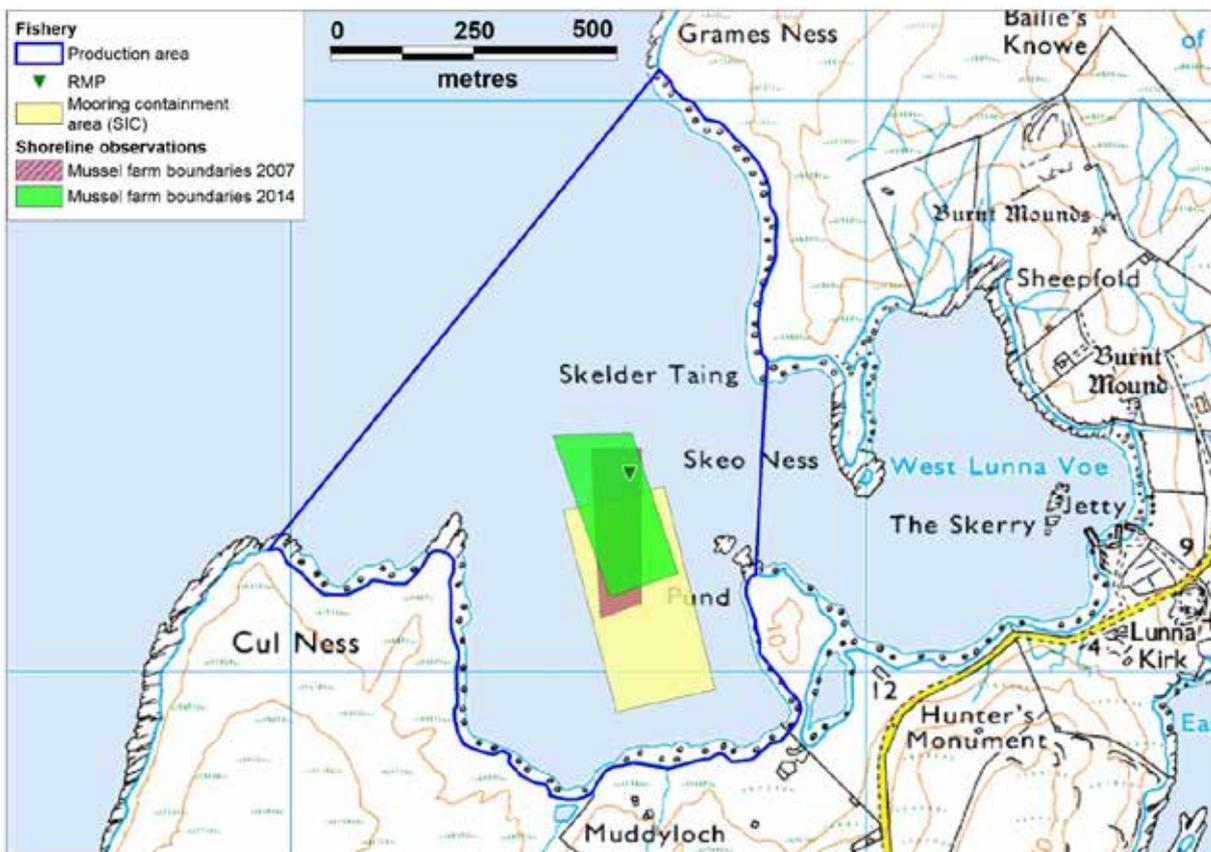
Figure 1.2 West of Lunna fishery

The current production area boundaries and RMP are currently the same as those recommended in the 2008 report, and are displayed in Figure 1.2 with the farm boundaries recorded during the 2007 and 2014 shoreline surveys.

The size of the mussel farm is noted to have increased since 2007. The 2014 survey reported nine double headed longlines with 8 m droppers, a substantial increase over the three lines present in 2007. The site is licensed for 12 x 300 m twin-headline long-lines, suggesting there is potential to increase the size of the farm in the future. The operator planned to completely harvest the site over summer 2014 and new droppers were to be added immediately afterwards.

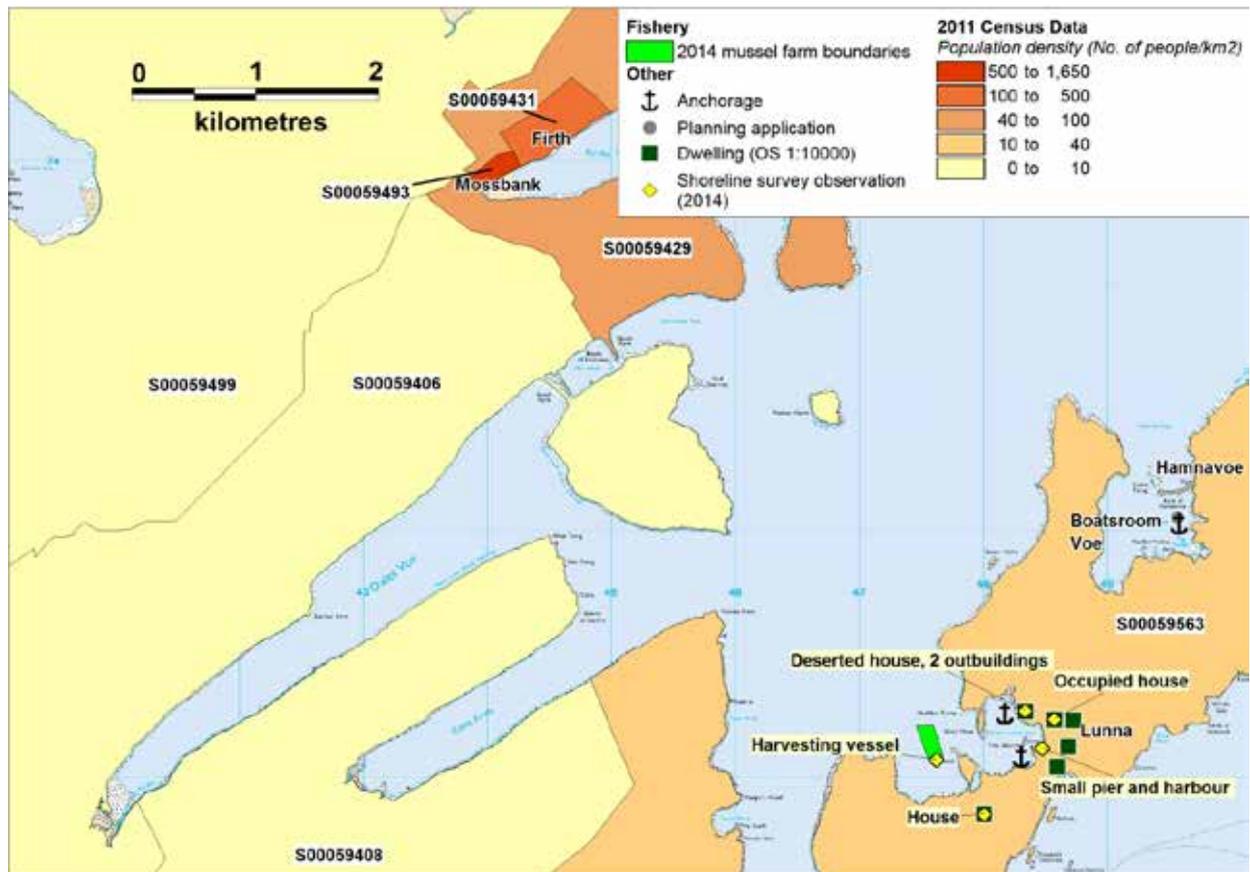
Figure 2.1 Current distribution of human population around West of Lunna

The overall human population in the areas around West of Lunna fishery has decreased between census years. In the area immediately adjacent to the fishery (S00059563) there has been a relatively large decrease in population. Population increases were noted in two areas approximately 6 km northwest of the fishery, where the villages of Mossbank and Firth are located. The main settlements around West of Lunna include Lunna, Hamnavoe and Collafirth. A search was carried out on the Shetland Island Council Planning Portal in October 2014 for planning applications within these areas (Shetland Islands Council, 2014). Only one application of relevance was noted (Reference No. 2013/007/WL), which was for the deployment of a pontoon at Boatsroom Voe northeast of West of Lunna and would consist of a 50x50 m steel framed structure (see comment below on aspects relating to boating activity.) One house noted near the shoreline was observed to be unoccupied at the time of shoreline survey. Not all properties were visible from the shoreline, therefore additional properties further from the shoreline in the vicinity of the fishery were identified from the OS 1:10000 map and are shown in Figure 2.1.

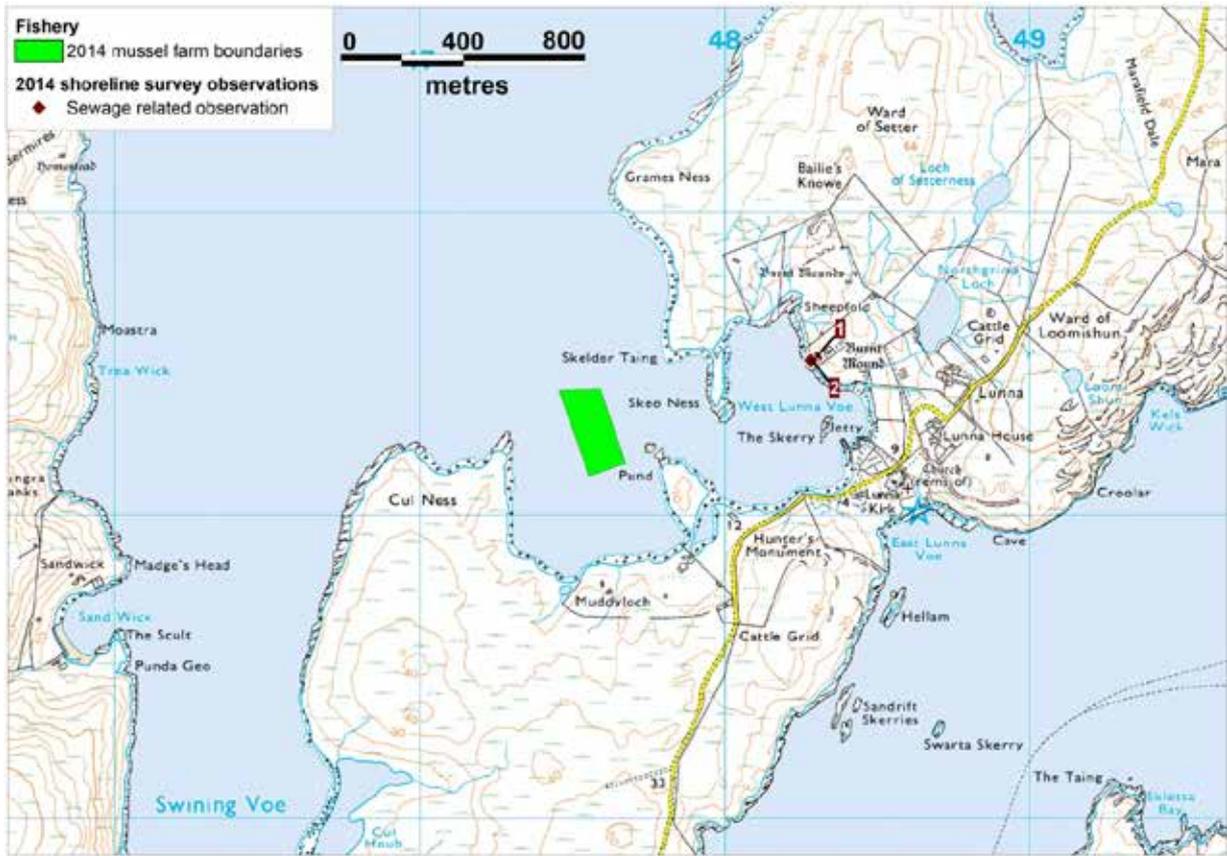
Figure 2.2 Map of sewage related observations from the 2014 shoreline survey

No further information on STs around West of Lunna was found during the internet search carried out for this review. During the 2014 survey, two sewage related observations were made, which are listed in Table 2.2 with their location displayed in Figure 2.2.

Impacts from sewage are also expected to have decreased since the 2008 report. Whilst the house with a ST discharging to West Lunna Voe was derelict, the remaining houses are expected to have STs to soakaway. However, it remained unclear whether contamination from these STs would potentially impact West Lunna Voe should the soakaway fields fail.

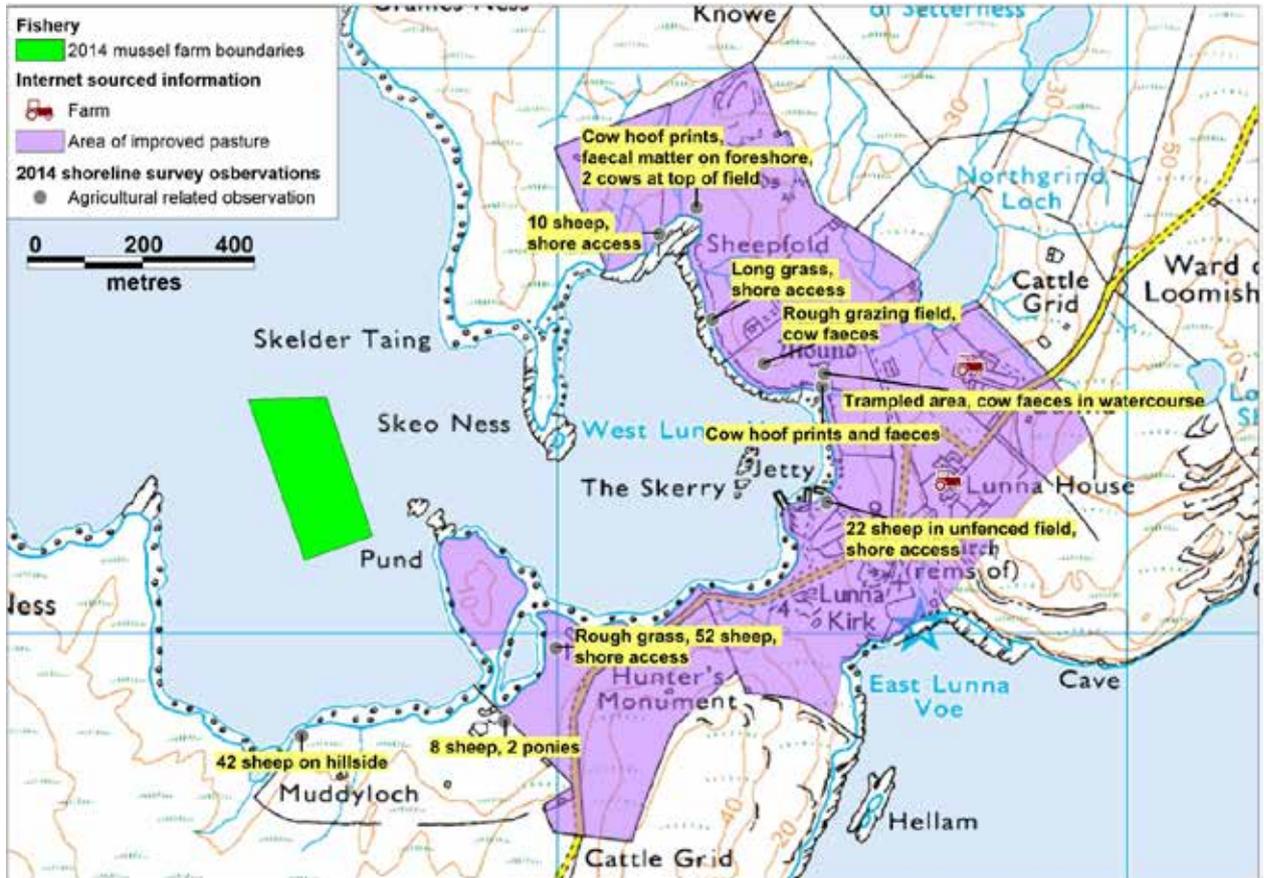
Figure 3.1 Map of potential agricultural sources at West of Lunna

The extent of the improved pasture area has been obtained from satellite imagery (van Excel, 2014) and is displayed in Figure 3.1. From satellite imagery, two farms were also noted east of West Lunna Voe; these are also displayed in Figure 3.1. Both farms had large sheds associated with the main farm building, but it remained unclear whether these were used for storing agricultural machinery or livestock during harsher winter months. It should also be noted that sheep were visibly on the small grassy outcrop of Pund to the southeast of the fishery.

The 2014 shoreline survey recorded a similar number of sheep on land to the east and south of the fishery (n=134). The shore remains accessible along much of the coastline, although no livestock were observed on the shoreline during the survey. Evidence of cattle (hoof prints and faeces) was noted on three separate occasions on land east of the fishery, including along the watercourse that links Northgrind Loch to the voe. A seawater sample was taken adjacent to the mouth of this watercourse and it returned a high result of 800 *E. coli* cfu/100 ml, suggesting livestock were likely to have contributed to contamination levels in this watercourse.

Overall, agricultural based faecal contamination impacts remain significant at the West of Lunna fishery. Sheep remain the predominant livestock in the area, with livestock concentrated on areas of improved pasture and with access to the shoreline. Significant contamination is expected from the watercourse associated with Northgrind Loch, which appears to be used by cattle kept in the area. Contamination is also anticipated to be washed into surrounding watercourses and West Lunna Voe during periods of significant rainfall, which will also wash across the fishery. Overall, contamination impacts are expected to remain highest at the eastern extent of the fishery from contamination entering from West Lunna Voe. However,

there may also be impacts from livestock kept on the southern shore, particularly from Pund where sheep were observed.

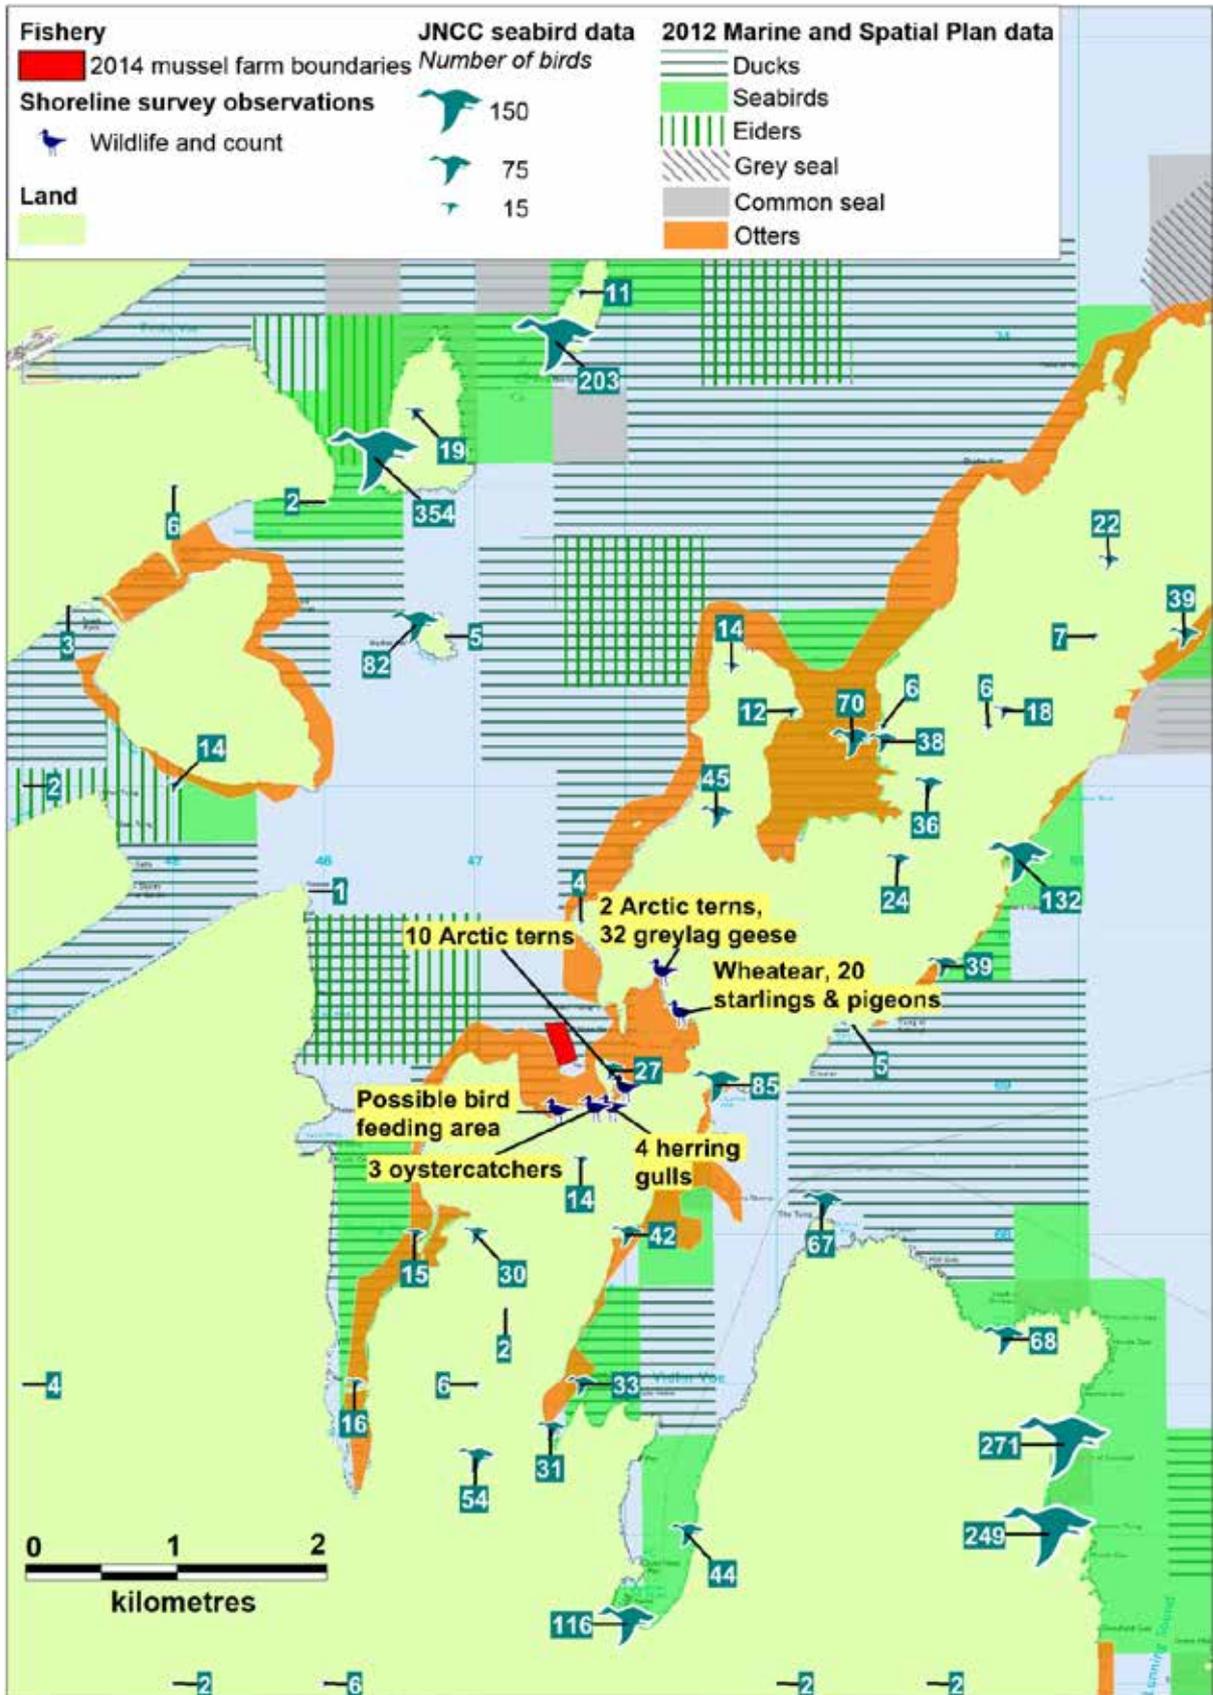
Figure 4.1 Map of wildlife around West of Lunnabegar

New information suggests contamination impacts from wildlife may be more significant than assumed in the 2008 report. The area is now known to support populations of both common and grey seals, as well as significant bird colonies and plenty of suitable coastal habitats to support a healthy otter population. However, overall the contamination impact from wildlife is expected to remain relatively small and will be localised and unpredictable.

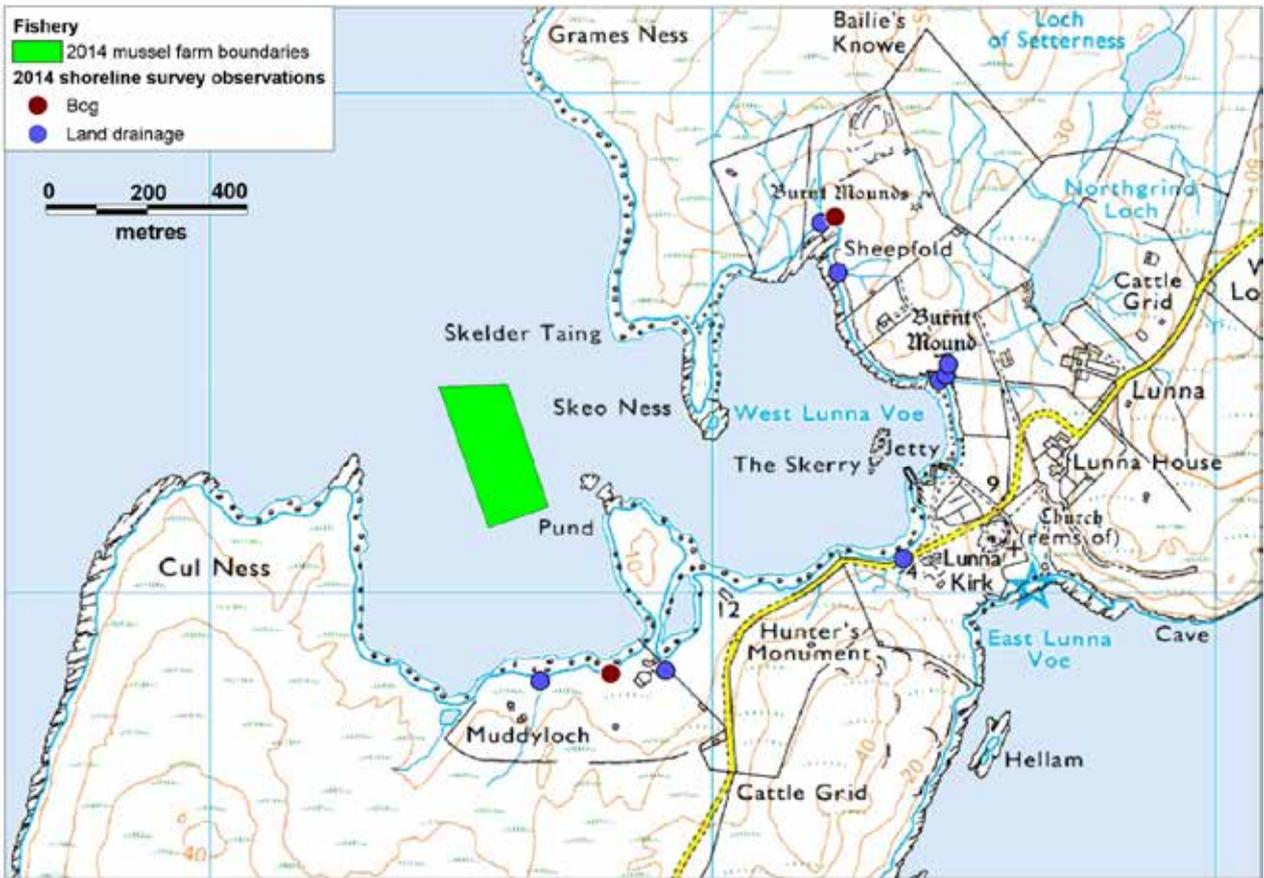
Figure 5.1 Areas of potential freshwater input to West of Lunna from the 2014 shoreline survey

No watercourses were found to be flowing sufficiently to allow for measurement and sampling during the 2014 survey. Therefore, no comparison of loadings between the two surveys is possible. However, a seawater sample taken adjacent to the outflow from Northgrind Loch returned an high result of 800 *E. coli* cfu/100 ml, suggesting contamination levels at this watercourse remained high. Cattle hoofprints and droppings were noted around the watercourse, which may have contributed to the recorded contamination. The locations of areas of land drainage and bog noted during the 2014 survey are displayed in Figure 5.1.

It is anticipated areas of land drainage, and potentially the boggy areas as well, would flow during and after periods of heavy rainfall. This would act to flush land based contamination e.g. from wildlife, livestock and STs into surrounding watercourses or directly to the voe.

There is no evidence to suggest that significant contamination will arise from freshwater inputs other than the watercourse coming from Northgrind Loch. During and after periods of heavy rainfall, freshwater contamination impacts are expected to be higher, particularly at the eastern and southern extents of the fishery.

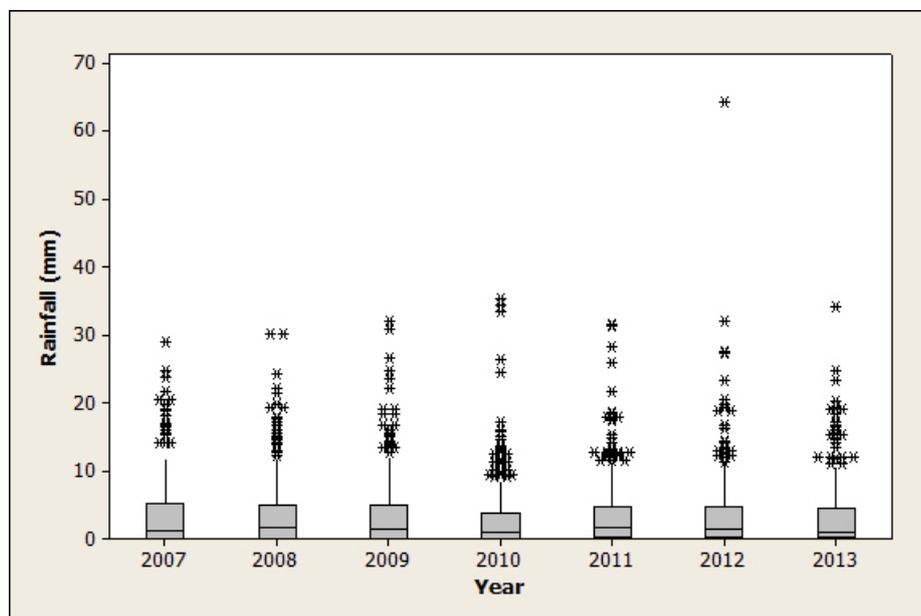
Figure 6.1 Boxplot of daily rainfall at Lerwick by year (2007-2013)

The 2007-2013 data showed that rainfall on the majority of days is less than 10 mm, with rainfall greater than 30 mm occurring in nearly all years and one exceptionally high rainfall event of over 60 mm occurring in one year. This represented no change from the pattern seen in the data used in the 2008 sanitary survey report.

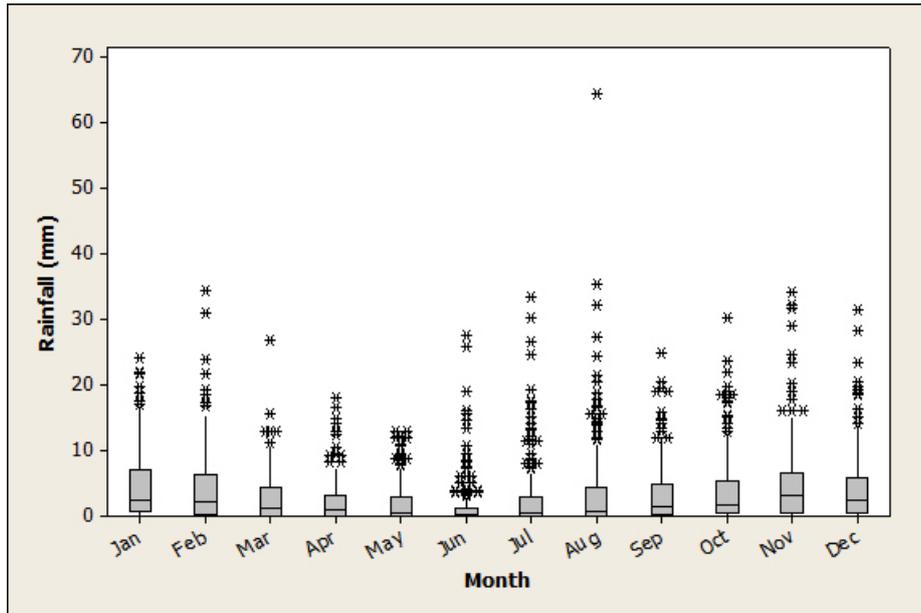
Figure 6.2 Boxplot of daily rainfall at Lerwick by month (2007-2013)

The 2008 report noted that the months September to January were the wettest, with July and August the driest. In the 2007-2013 dataset, daily rainfall values were higher during the autumn and winter. Rainfall peaked in October (1348 mm) and was driest in June (429 mm). Rainfall values exceeding 30 mm/d occurred in February, July, August, October, November and December. There has also been an increase in the number of months where >30 mm rainfall/day is recorded, though this could be affected by the second assessment period covering a greater number of years. Extreme events of >60 mm rainfall/day occurred in August during both periods.

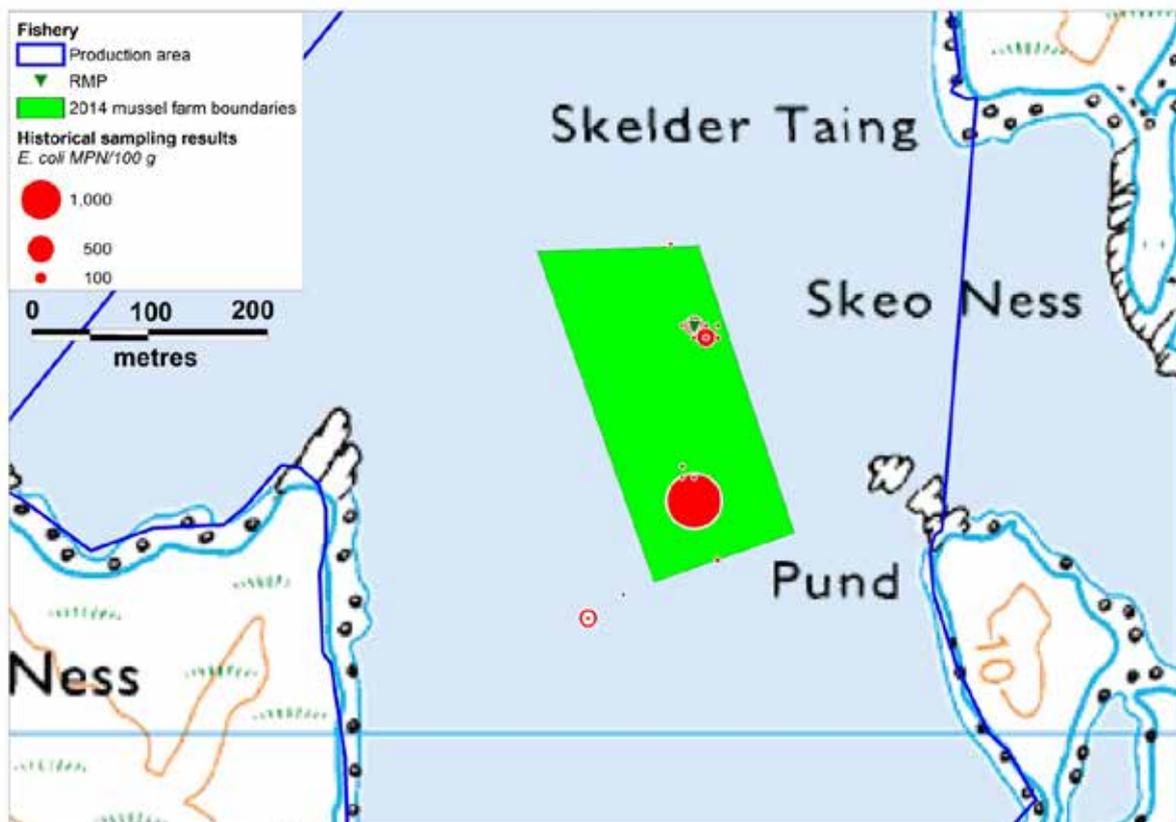
© Crown Copyright and Database 2014. All rights reserved. Ordnance Survey Licence number GD100035675
Figure 7.1 Sample results and locations from West of Lunna common mussel fishery

An unpaired t-test was carried out to determine whether there was a statistically significant difference between sampling results between the areas. No statistically significant difference was found between sample results between the two areas (T-test, $t = -0.62$, $DF = 46$, $p = 0.536$).

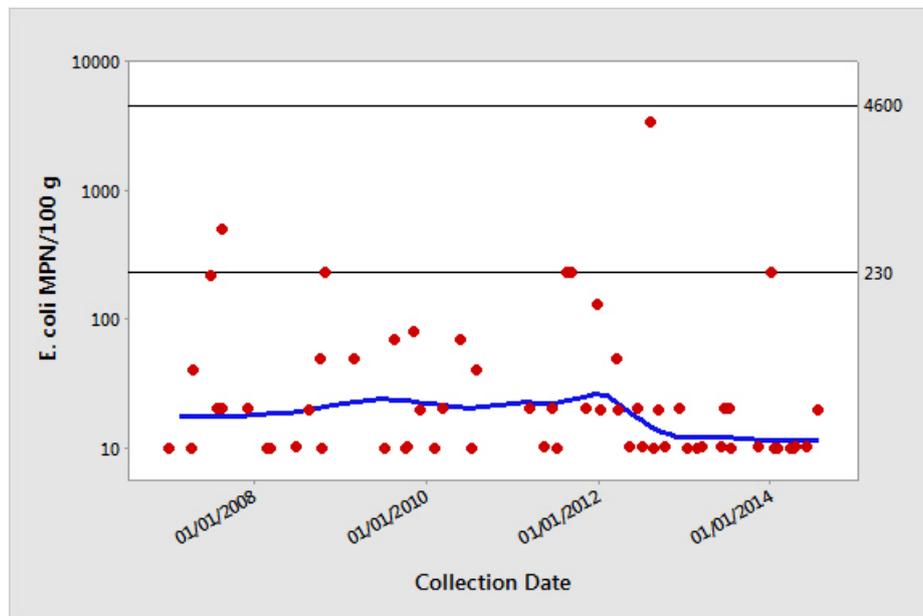
Figure 7.2 Scatterplot of West of Lunna *E. coli* results by date (2007-2014)

There was an increase in the proportion of sample results below the limit of detection (<20 *E. coli* MPN/100 g) from approximately mid-2012 onward. However, the highest result also occurred during this time frame, in August 2012.

Overall, West of Lunna sample results have been low, with only two results exceeding 230 *E. coli* MPN/100 g since sampling began in 2007. Sampling location has varied between the RMP and the southern end of the mussel farm over time, with the highest result recorded against a sample taken at the southern end of the mussel farm. However, no statistically significant difference was found in results between sampling areas. An improvement in *E. coli* results from 2012 onward is apparent due to an increase in the number of results below the limit of detection.

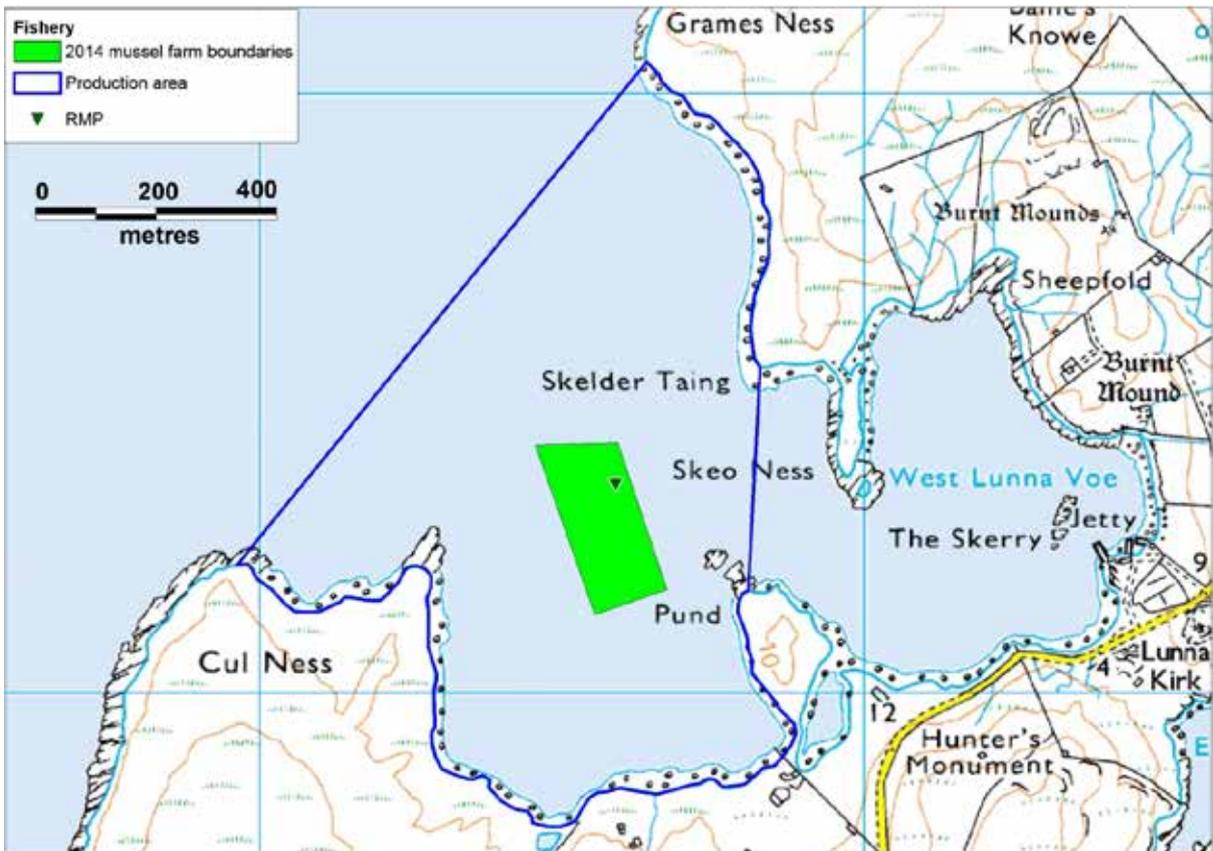
Figure 10.1 Recommended production area boundaries and RMPs for the West of Lunna fishery

There have been some small changes to the recommended sampling plan in light of slight changes in the location of the main contamination sources. The revisions to the sampling plan are as follows:

There was no compelling evidence to suggest that any other part of the fishery is subject to greater levels of contamination than the RMP location, and therefore no change to the RMP is recommended.

The tolerance should be amended to 40 m to allow for movement of the lines This makes it consistent with recommendations at other long line mussel sites.

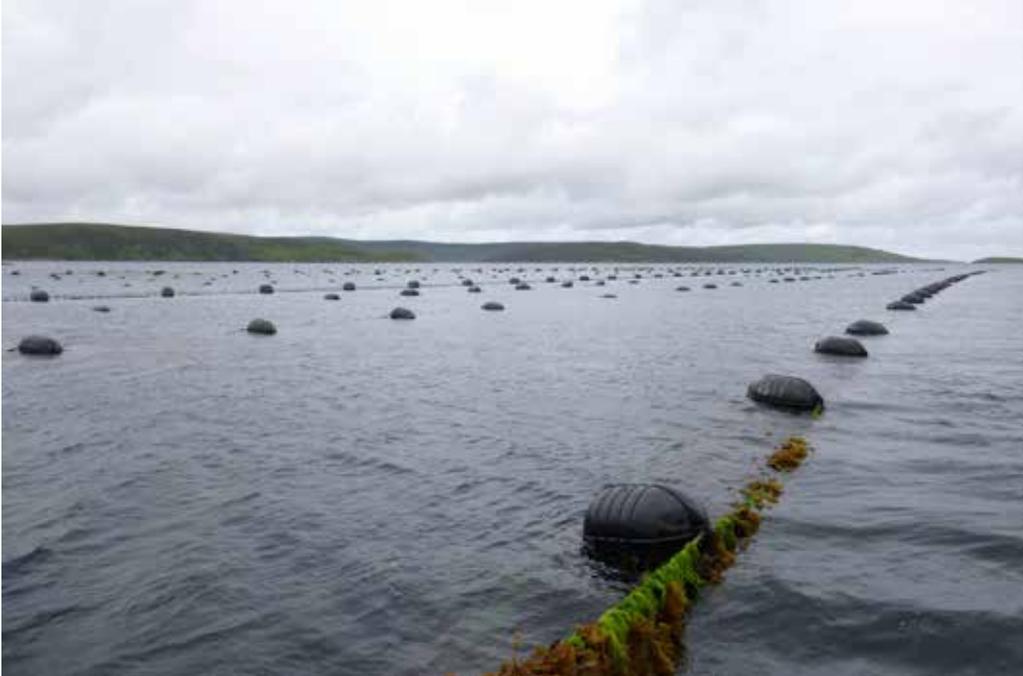
Figure 4 – Mussel lines at the Cul Ness fishery looking north west.

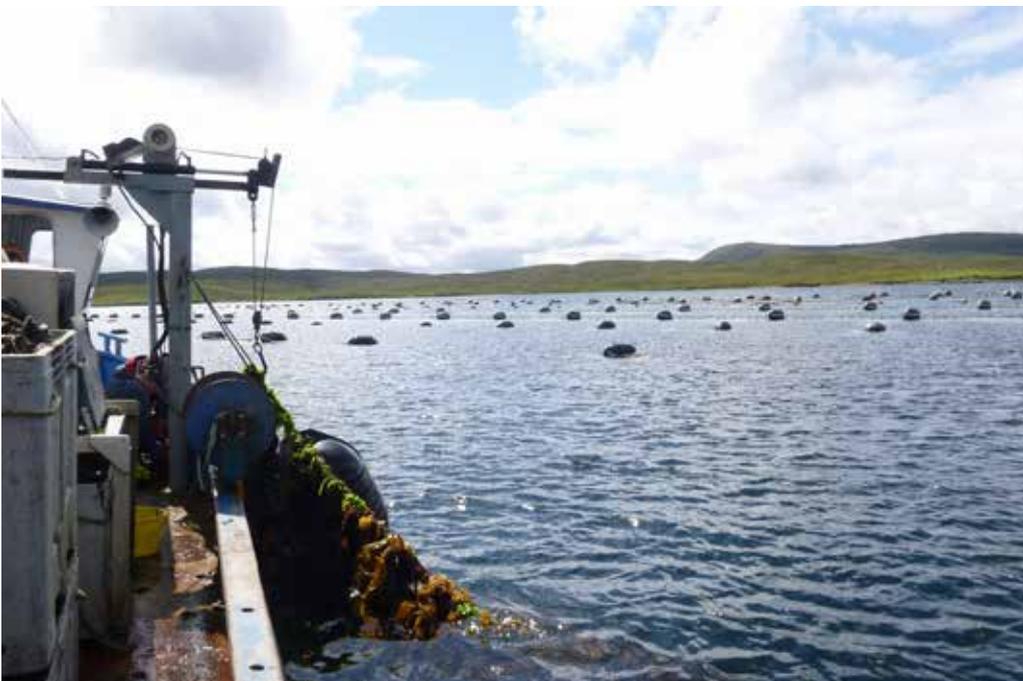
25	29/07/2014 11:49	HU 47386 69761	447386	1169761		WLV-SW04	Seawater sample collected at northern production area boundary.
26	29/07/2014 11:55	HU 47594 69417	447594	1169417	Figure 5	WLV-MUSS03 (Top), WLV-MUSS04 (Bottom) & WLV-SW05	NE corner of Cul Ness fishery. 2 mussel samples collected; surface sample collected from the top of a dropper, bottom sample collected from bottom of a dropper. Salinity Profile 3 collected (ppt/°C): 10m 35.28/12.2, 5m 35.15/12.3, 3m 35.15/12.3, surface 35.17/12.6. Seawater sample collected.
27	29/07/2014 12:12	HU 47613 69361	447613	1169361			Monthly <i>E.coli</i> sample collected from RMP by SW

Figure 5 – Mussel lines at the Cul Ness fishery looking south.

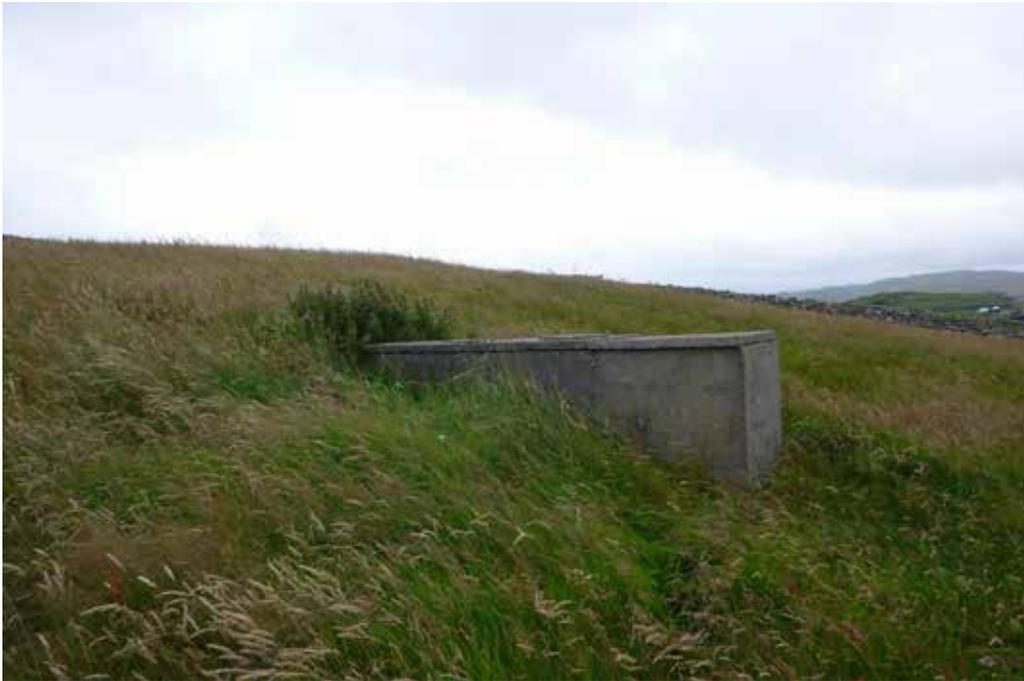
Figure 6 – Concrete septic tank associated with a deserted property.

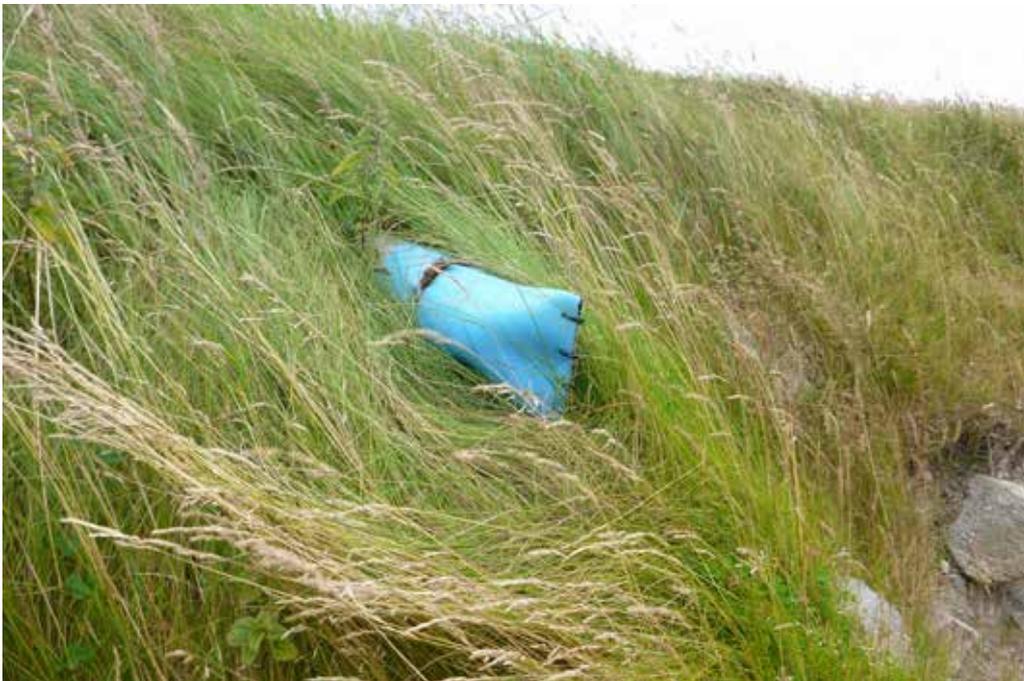
Figure 7 – Capped pipe associated with the septic tank in Figure 6.

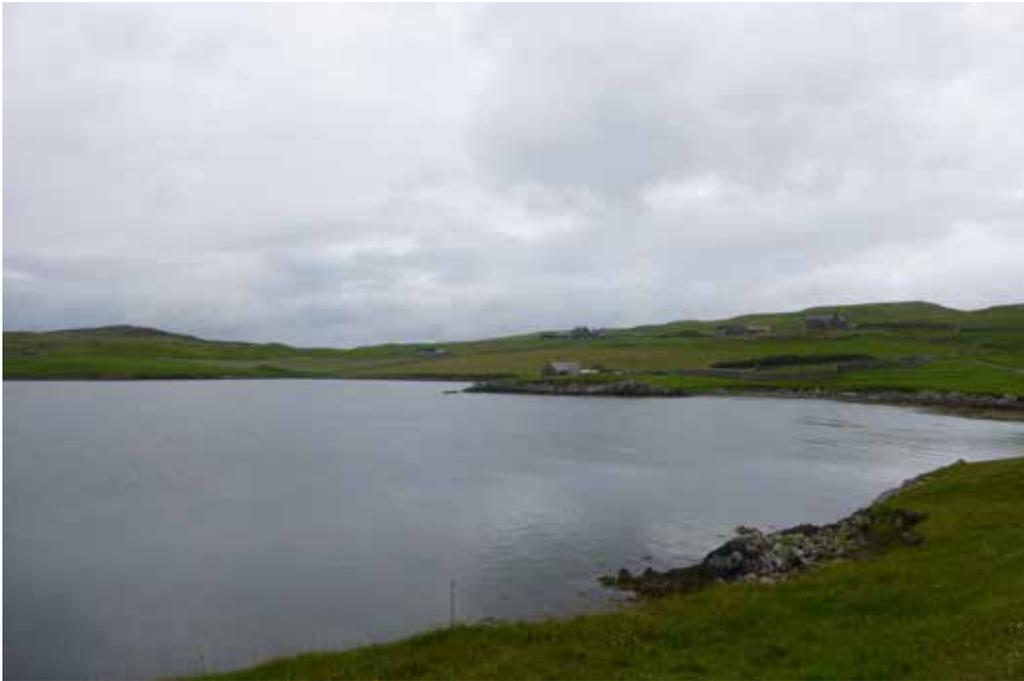
Other properties encountered during the walk were situated above the fields fringing the shoreline, or beyond the road that serves the Lunna Ness peninsular (Figure 8).

Figure 8 – Overview of properties scattered around West Lunna Voe.

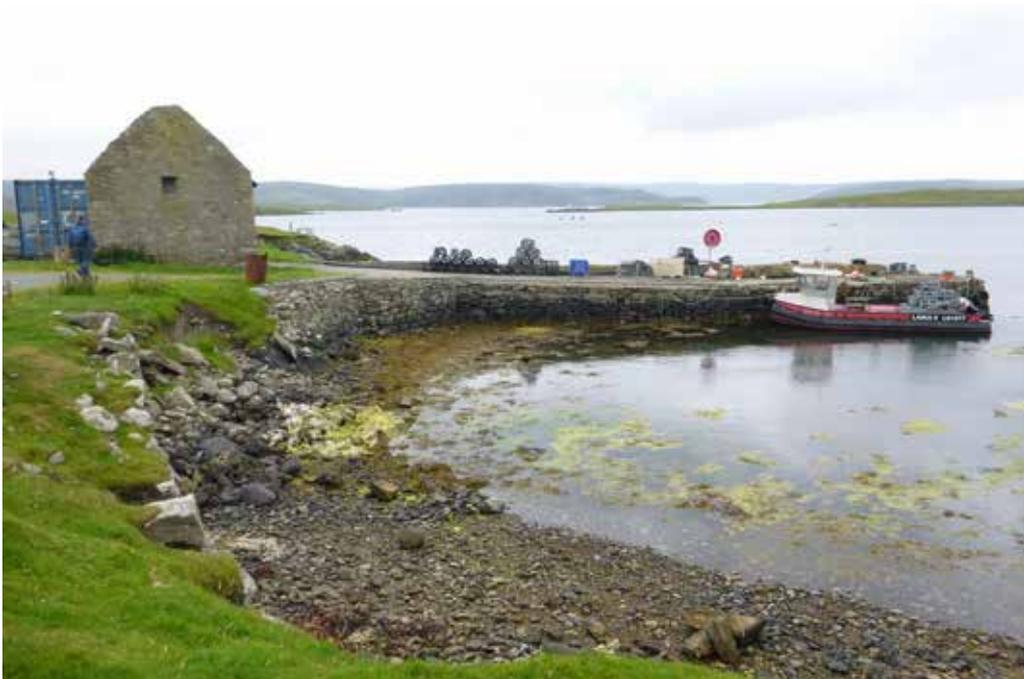
12	29/07/2014 09:20	HU 48474 69234	448474	1169234	Figure 9		Small pier and harbour with small fishing boat moored. Creels stacked on the pier. Stone building and shipping container adjacent to pier associated with fishing activity. Pipework for seawater circulation system observed leading to and coming from container. 2 moorings in the bay beyond the pier. 22 sheep in rough grazing field surrounding pier, with access to the shore. This area is unfenced and includes the hillside above the road.
13	29/07/2014 09:28	HU 48381 69071	448381	1169071	Figure 12		Single track road that serves the Lunna Ness peninsular runs just above the rocky shoreline. Drainage ditch on the inland side of the road with occasional culverts under the road to the shore.
14	29/07/2014 09:33	HU 48254 69071	448254	1169071	Figure 8		Photo illustrating distribution of properties and their proximity to the voe.
15	29/07/2014 09:39	HU 47998 68975	447998	1168975			Field of rough grass with 52 sheep which have access to the shore. Small lagoon behind an island also occupied by sheep accessed along a pebble beach at low water. Approximately 10 Arctic terns observed, in flight and on the beach indicating that this may be a breeding habitat.

Figure 9 – Jetty and workboat at the head of West Lunna Voe.

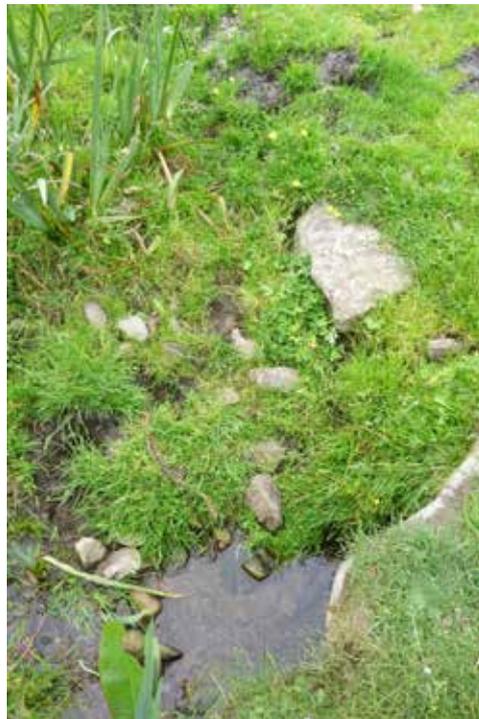
No freshwater samples were obtained from any of the three watercourses indicated in the survey plan due to a lack of flow at the time of the survey. These watercourses were boggy areas, sometimes with small stagnant pools (Figure 10). At a watercourse near the head of the voe flow measurements were attempted although these were unsuccessful. A seawater sample was collected instead from the beach, warranted by the presence of cattle hoof prints and faeces along the watercourse (Figure 11), and this was found to have an *E.coli* count of 800 cfu/100 ml.

Figure 10 – Watercourse illustrating low water level.

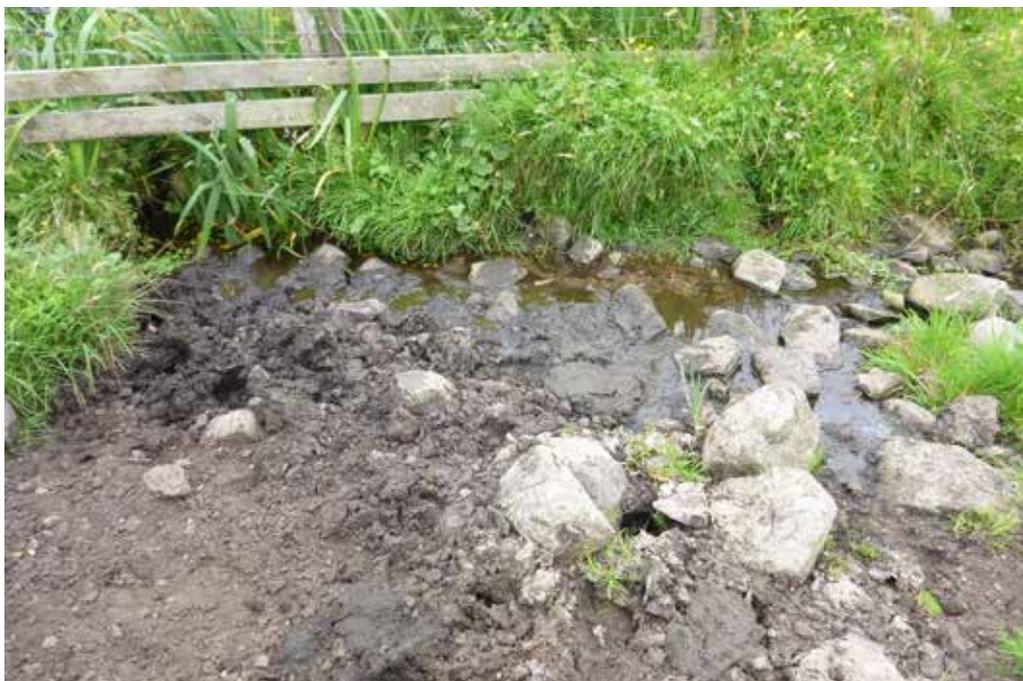
Figure 11 – Watercourse with cattle faeces.

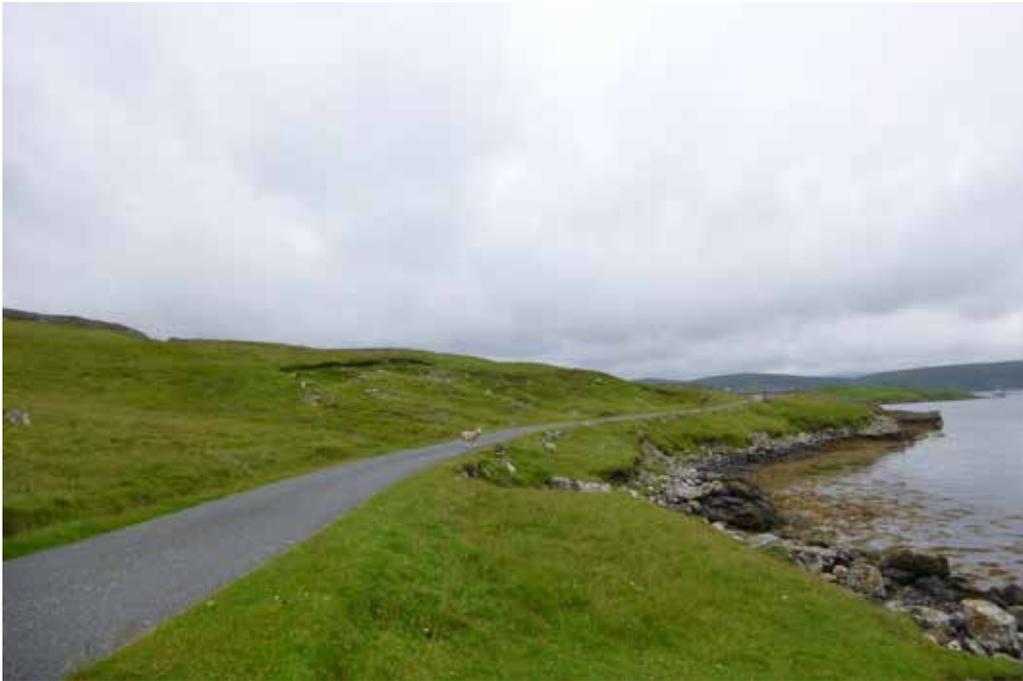
recorded. For a short duration the single track road runs adjacent to the shoreline, with a drainage ditch on the landward side (Figure 12).

Figure 12 – The single track road serving Lunna Ness illustrating proximity to shore
