# Scottish Sanitary Survey Programme

**Sanitary Survey Report**  
Production Area: North Uist 2  
SIN: UB 540  
July 2011

# Report Distribution – North Uist 2

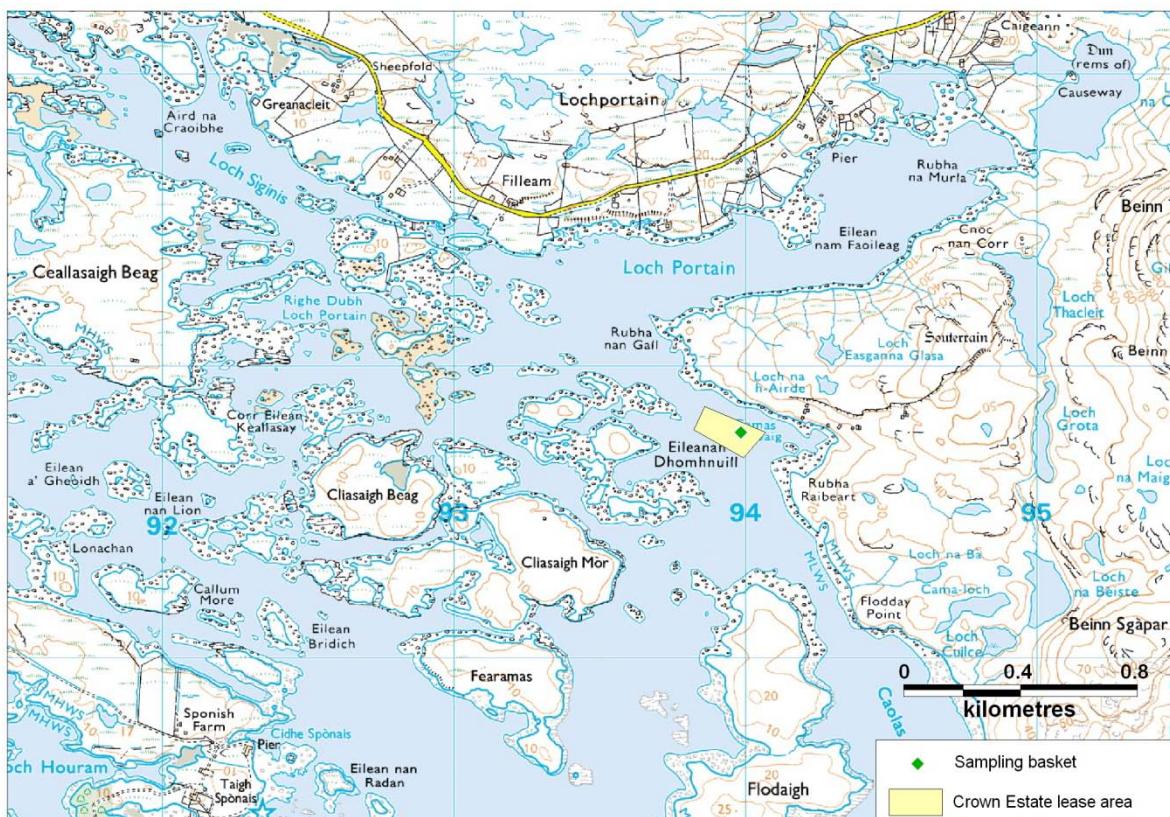
**Figure 2.1 North Uist 2 Fishery**

At the time of shoreline survey, no equipment had yet been installed on site. The harvester identified that he intended to install eight 220 m long lines with 6 m droppers, with an aim to begin harvesting in 2013. A buoy with a creel basket of mussels was set out on the site to allow monthly sampling to commence prior to installation of the longlines. The basket was set at a depth of 14 m and its location is shown mapped in Figure 2.1. A Crown Estate lease was issued for the area, which is identified in Figure 2.1, and the mussel farm is to be situated within the lease area boundaries. The sampling officer identified that as of 19 October 2011, equipment had still not been installed on site.

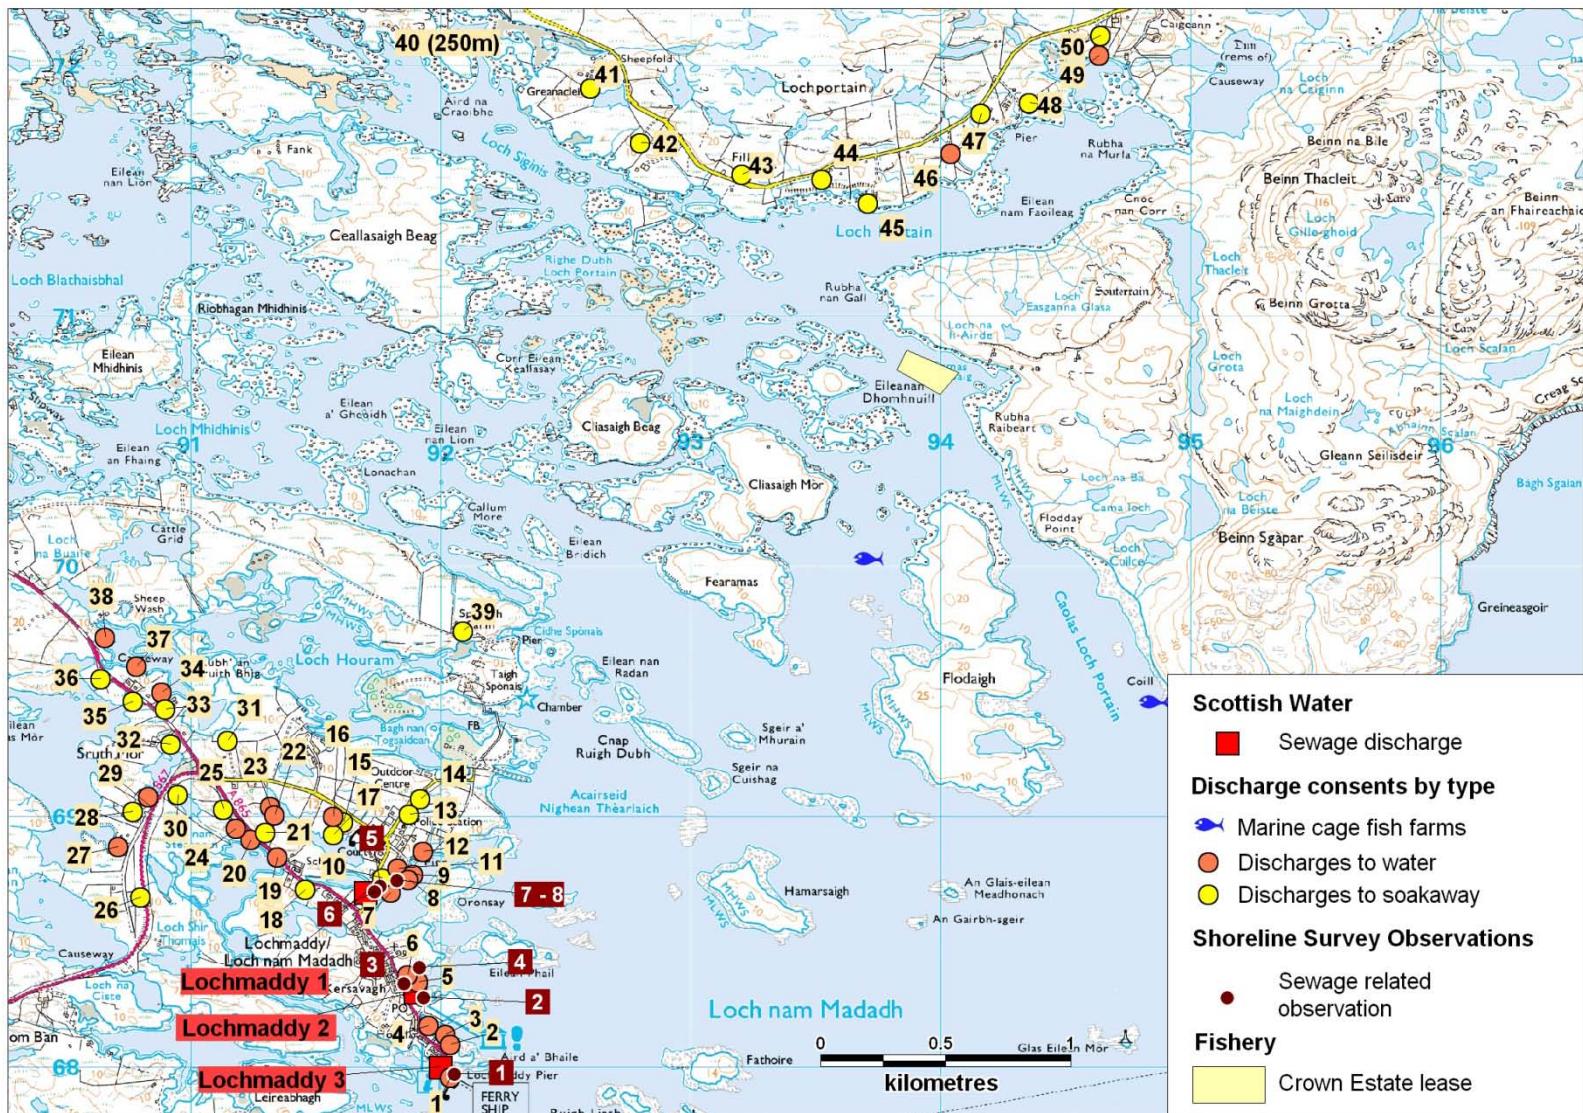
Figure 4.1 Map of discharges for North Uist 2

The discharge from the NHS surgery may be more likely to contain human enteric pathogens than the other discharges due to the likelihood of ill people visiting the surgery. As this lies approximately 3 km from the fishery, it is not expected to pose a significant risk to the bacteriological quality of the shellfish.

However, enteric viruses may persist longer than bacteria in the environment and therefore the potential for contamination of the fishery with human viruses, such as norovirus, will depend on water movement around the loch and the fishery.

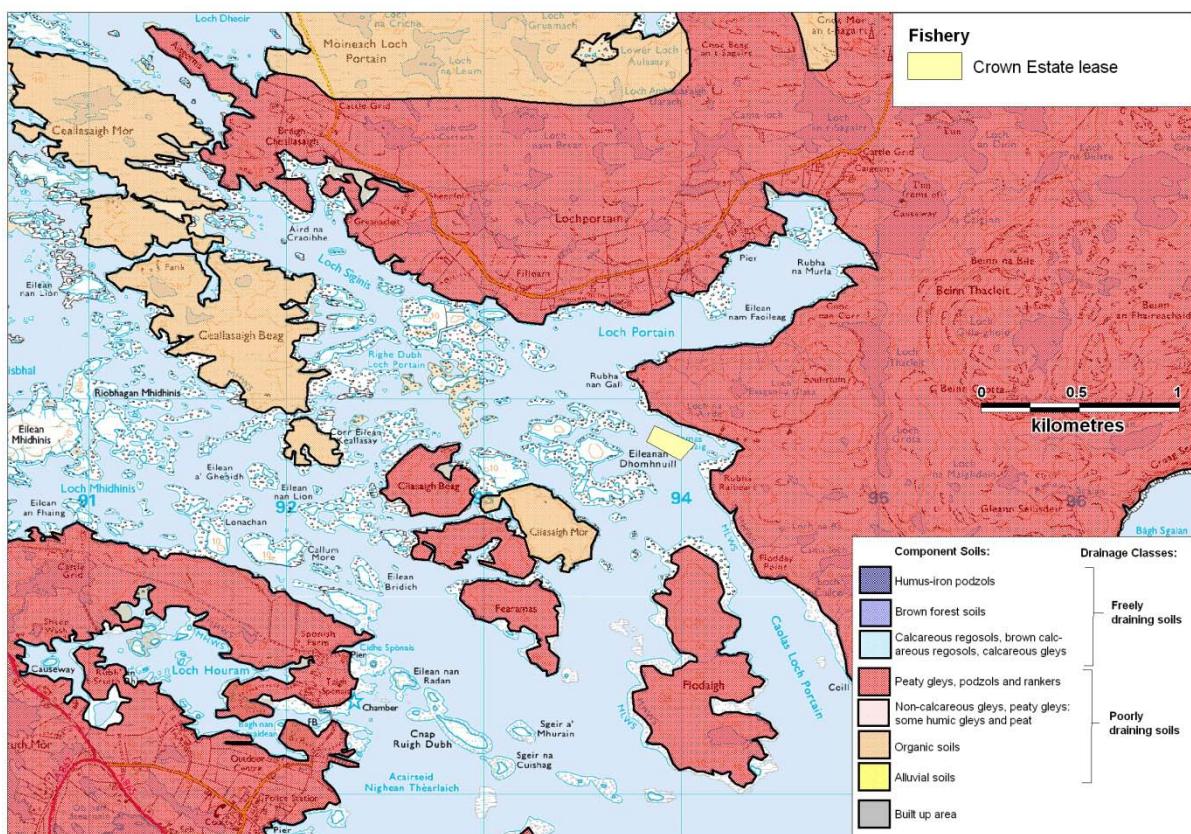
**Figure 5.1 Component soils and drainage classes for Loch nam Madadh**

Geology and soil types were assessed following the method described in Appendix 1. A map of the resulting soil drainage classes is shown in Figure 5.1. Areas shaded red and orange indicate poorly draining soils.

The two types of component soil found in the area are composed primarily of peaty gleys, podzols and rankers and organic soils. Both types of soils are classed as poorly draining. Therefore, the potential for runoff contaminated with *E. coli* from human and/or animal waste is relatively high along the entire coastline of Loch nam Madadh.

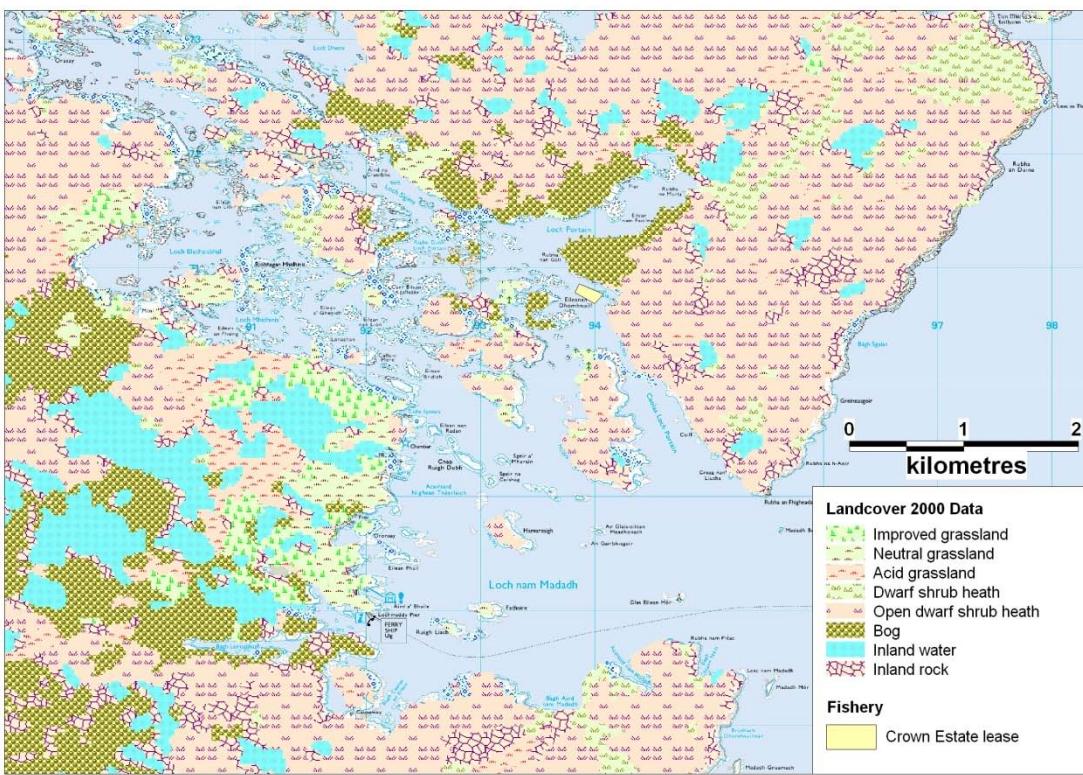
**Figure 6.1 LCM2000 class land cover data for Loch nam Madadh**

The land immediately adjacent to the fishery and Loch Portain is predominantly classed as bog and open dwarf shrub heath with some areas of supra-littoral rock. Areas of improved grassland and natural (either neutral or acid) grassland are found along the western shore to the southwest of the fishery. Most of the land cover types in the area are likely to be used to some extent for rough grazing.

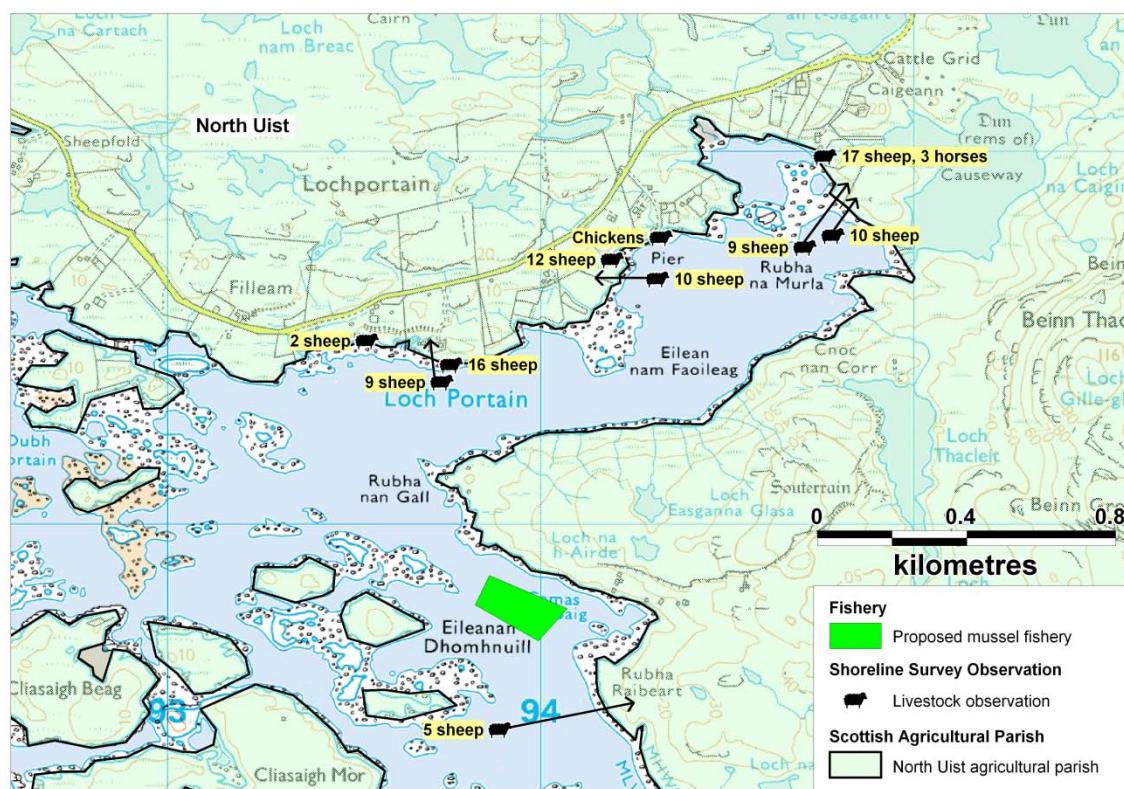
**Figure 7.1 Livestock observations at Loch nam Madadh**

were observed on moorland to the south of the proposed mussel farm. No cattle were observed during the survey, and no livestock were observed at Lochmaddy, although land cover data and OS mapping shows areas likely to be in agricultural use. Livestock counts taken during the shoreline survey relate only to the time of the site visit on 28-29 June, 2011 and are dependent upon the observer's viewpoint.

The spatial distribution of animals observed and noted during the shoreline survey is illustrated in Figure 7.1.

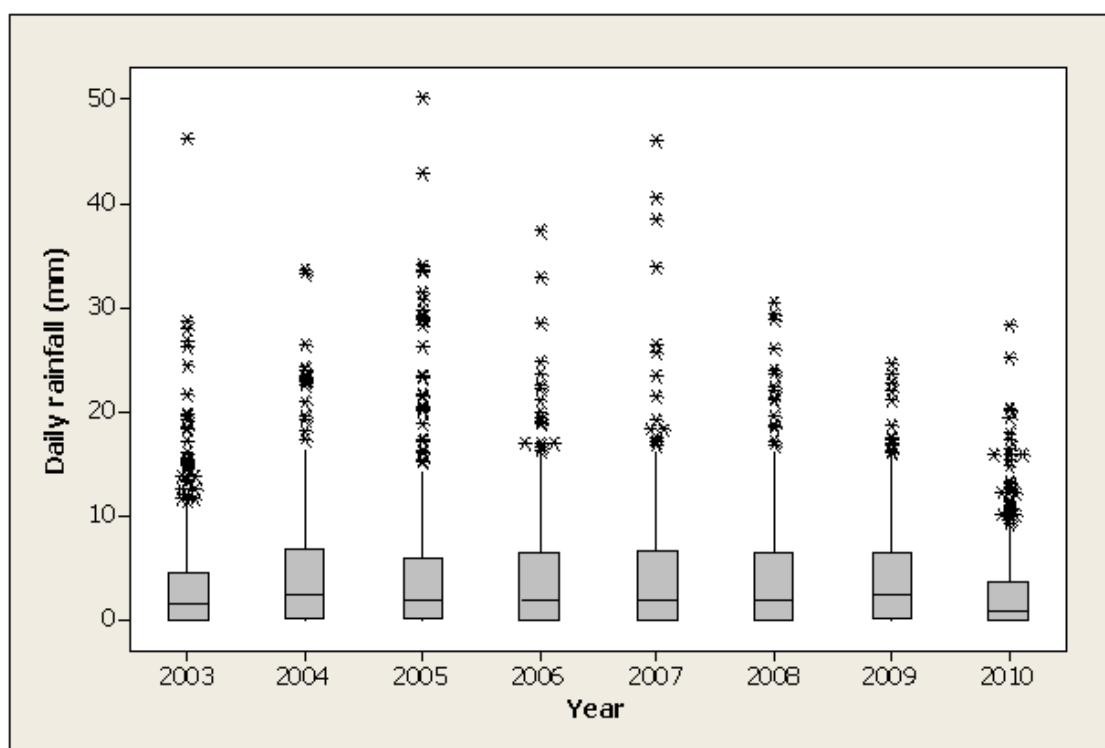
Figure 9.1 Box plot of daily rainfall values by year at Harris: Quidnish, 2003-2010

Figure 9.1 shows that most years showed a similar pattern but that 2010 was drier than the other years. High rainfall events, >30 mm in 24 hours, occurred in all years except 2009 and 2010.

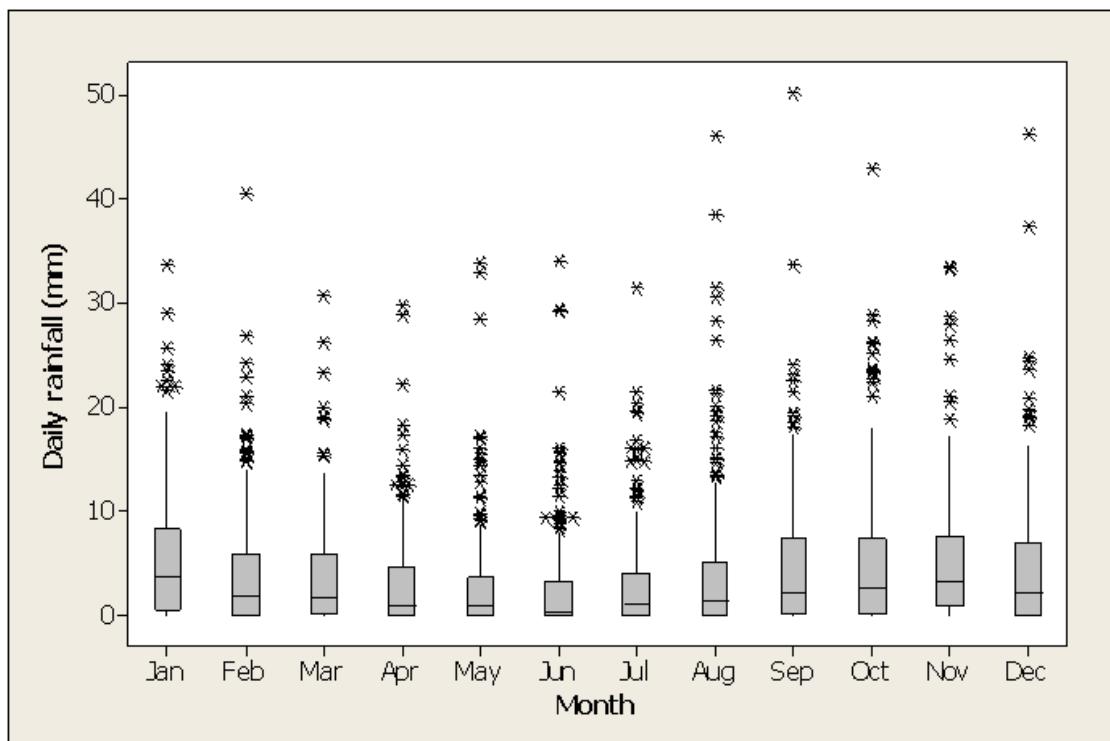
**Figure 9.2 Box plot of daily rainfall values by month at Harris: Quidnish, 2003-2010**

Weather was wettest in the period from August to January. More extreme rainfall events (in which over 30mm fell in a day) occurred during all months except April: the more extreme events occurred from August to February. For the period considered here (2003-2010), 42% of days experienced rainfall less than 1 mm, and 12% of days experienced rainfall of 10 mm or more.

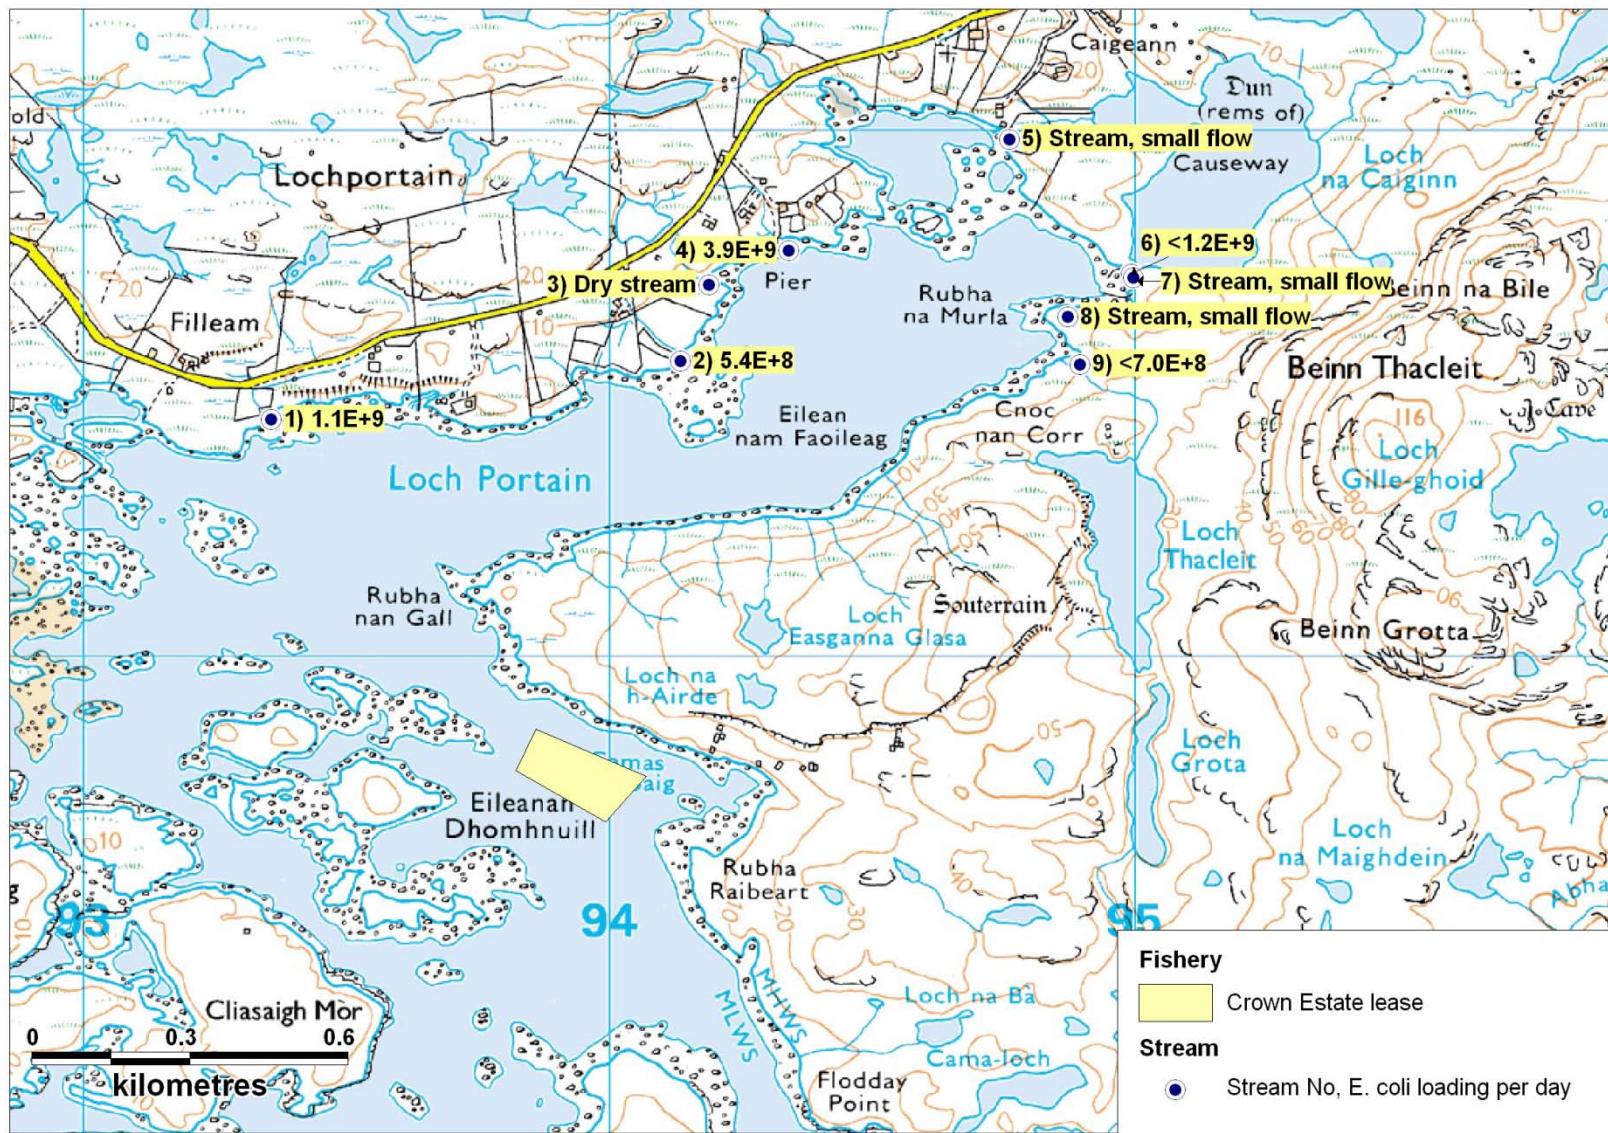
**Figure 13.1 Map of river/stream loadings at North Uist 2**

The streams were listed in Table 13.1 were observed during the shoreline survey. Where possible, these were measured and sampled. The locations, together with the calculated loadings, are shown in Figure 13.1. There had been heavy rain two days prior to the survey. The first day of the survey was dry while some showers occurred on the second day.

The observed streams were all located on the northern and eastern shores of Loch Portain. The southern shore of that area was not accessible by foot and so the streams shown on the southern shore in Figure 13.1 could not be observed. No streams were observed from the boat on the shore in the vicinity of the proposed mussel fishery.

south (approximately 1 km from the fishery; not shown in Figure 13.1). These could also contribute to the contamination at the fishery, depending on currents. However, the loadings of the other streams that were measured would suggest that their contribution would be small, unless specific additional sources of contamination occur at the southern locations.

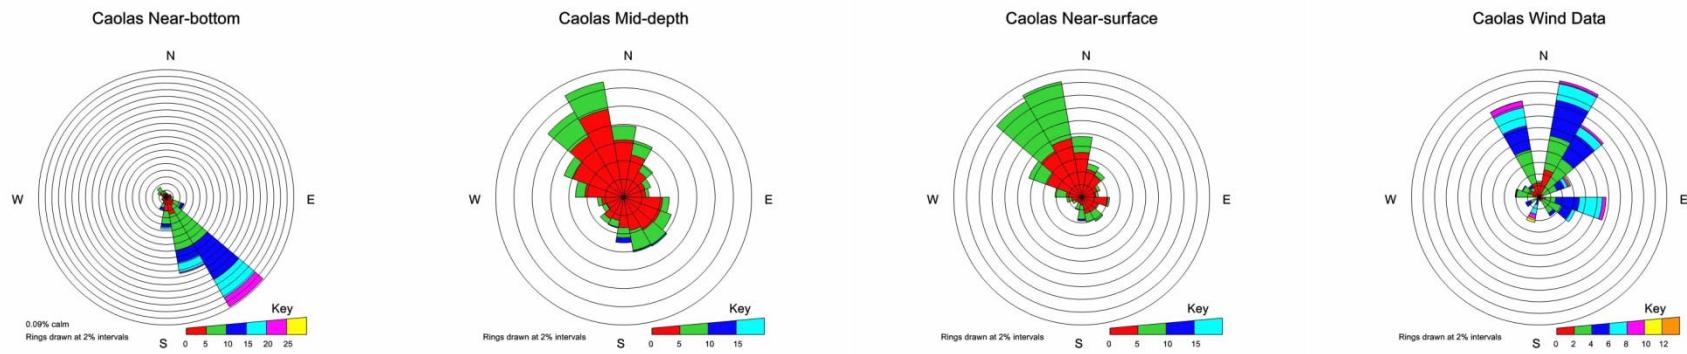
**Figure 14.4 Current and wind plots for the Caolas current meter study**

Currents measured in cm/s. Wind measured in m/s. As per convention, currents are plotted against the direction towards which they are travelling while winds are plotted against the direction from which they are travelling. The length of each segment in a plot relates to the proportion of observations lying in that direction. The speed relates to the colour key beneath each plot. The proportion that each colour takes up in an individual segment relates to the proportion of observations in that direction having speed in that range. Directions are in degrees magnetic.

The currents recorded at near-bottom were strongly directional, flowing in a south-easterly direction along the channel over all states of tide. Current speeds were low to moderate with a median speed of 8.4 cm/s (0.08 m/s; 0.16 knots) and a maximum speed of 26.7 cm/s (0.27 m/s; 0.52 knots). Currents at mid-depth and near-surface were weaker and more variable in direction: currents tended to flow in a north-westerly to north-north-westerly direction for most of the time, although currents flowing in the opposite direction, when they did occur, were stronger for some of the time. The median current speed near the surface was 4.2 cm/s (0.04 m/s; 0.08 knots) and the maximum current speed was 16.3 cm/s (0.16 m/s; 0.32 knots). The differences in current directions could have been due to one, or both, of two causes. There could be a permanent vertically differentiated flow with outgoing currents in the channel predominating at depth and incoming currents predominating nearer the surface. However, as the flow measurements pertained to a two week period during winter, it is difficult to draw conclusions about current movement over a broader period of time. Seasonal variation in both thermo- and halocline regimes may occur in fjordic/fjardic systems. Two salinity profiles recorded during the shoreline survey showed less than 0.1 ppt difference in salinity between sub-surface and 10 m, indicating no stratification over that range of depths. Alternatively, the effect may have been due to the winds that occurred during the study period. A plot of near-surface current direction versus wind speed and direction did not show a marked association between current and wind (see Figure 14.5).

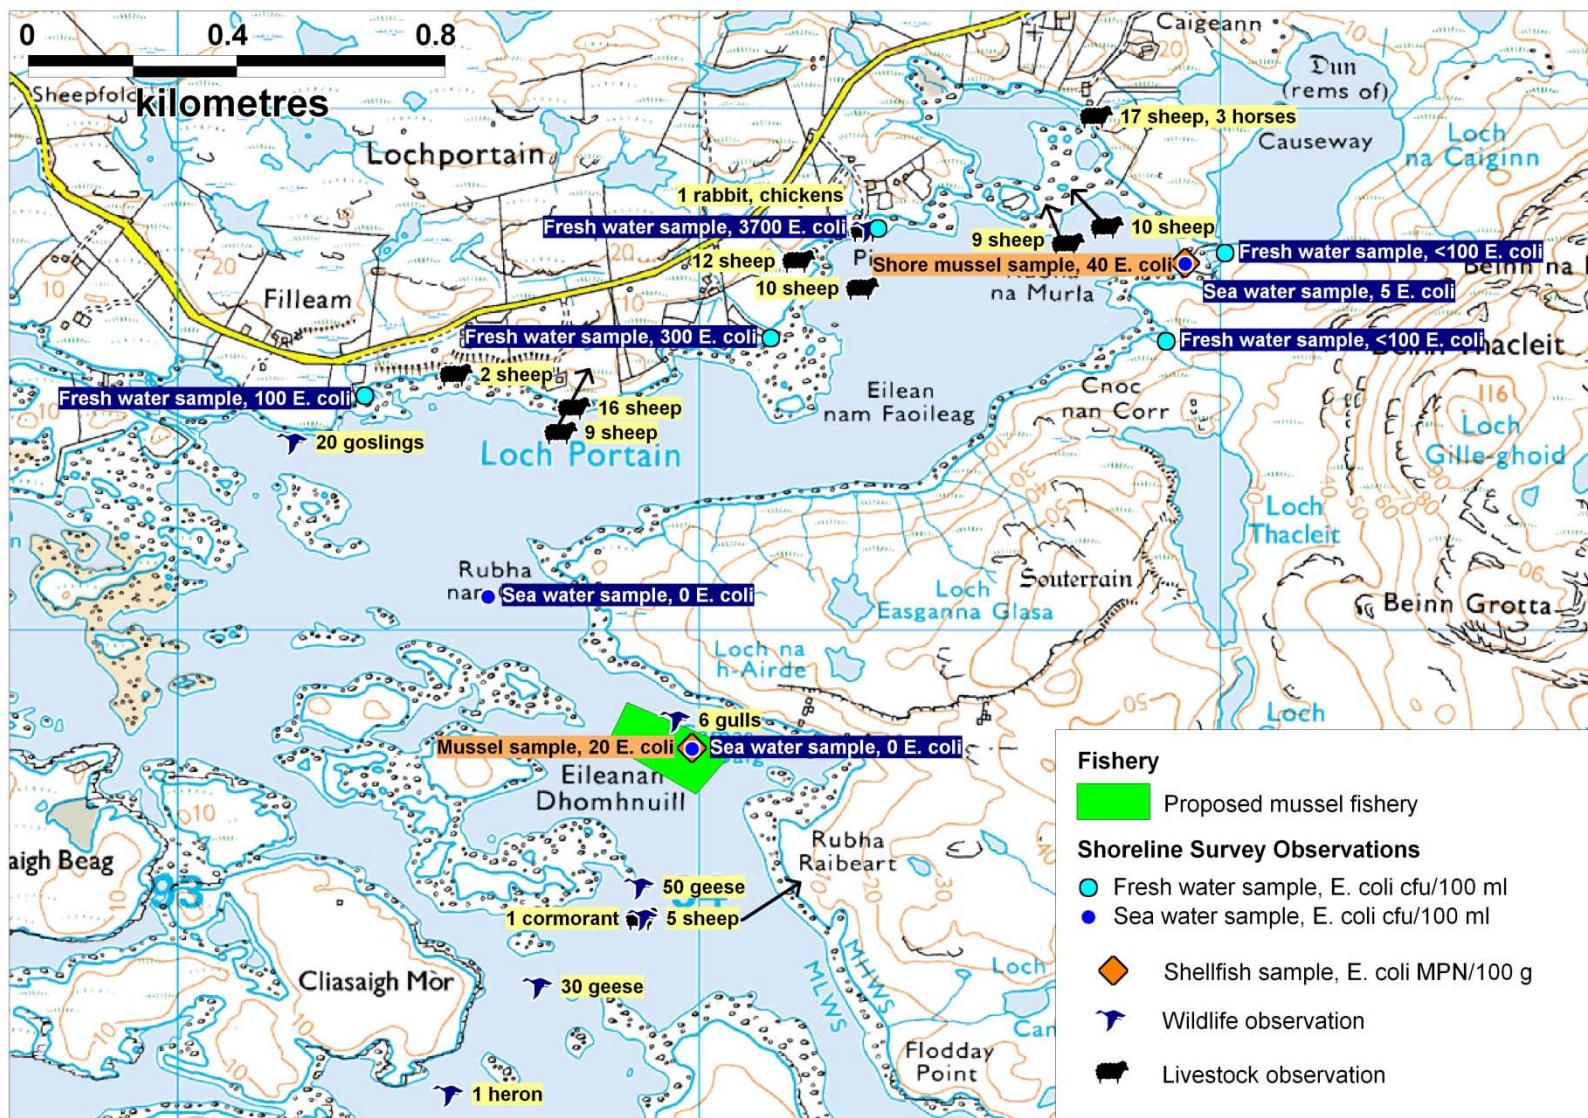
**Figure 15.1 Summary of shoreline survey findings for Loch nam Madadh – Loch Portain**

There are two centres of population on the coastline adjacent to the loch, Lochmaddy and Lochportain. Lochportain is closest to the fishery, however there are only approximately a dozen dwellings, scattered along the northern shoreline. During the shoreline survey, no outfall pipes were observed leading across the shore from any of the houses suggesting that they may be connected to soakway systems.

Livestock were observed grazing along most of the northern shoreline of Loch Portain and animals were able to access the shoreline and watercourses. In total 3 ponies and approximately 85 sheep were observed over the two days. No livestock animals were observed in or around Lochmaddy or on the southern shoreline of Loch Portain.

In total, approximately 70 geese were observed in and around the shoreline of Loch Portain and within close vicinity of the fishery. In addition to the geese, small numbers of several other seabirds were also observed including 1 cormorant, 6 gulls and 1 heron.

Figure 15.1 and Figure 15.2 show summary maps of the most significant findings from the shoreline survey for Loch Portain and the area around Lochmaddy.

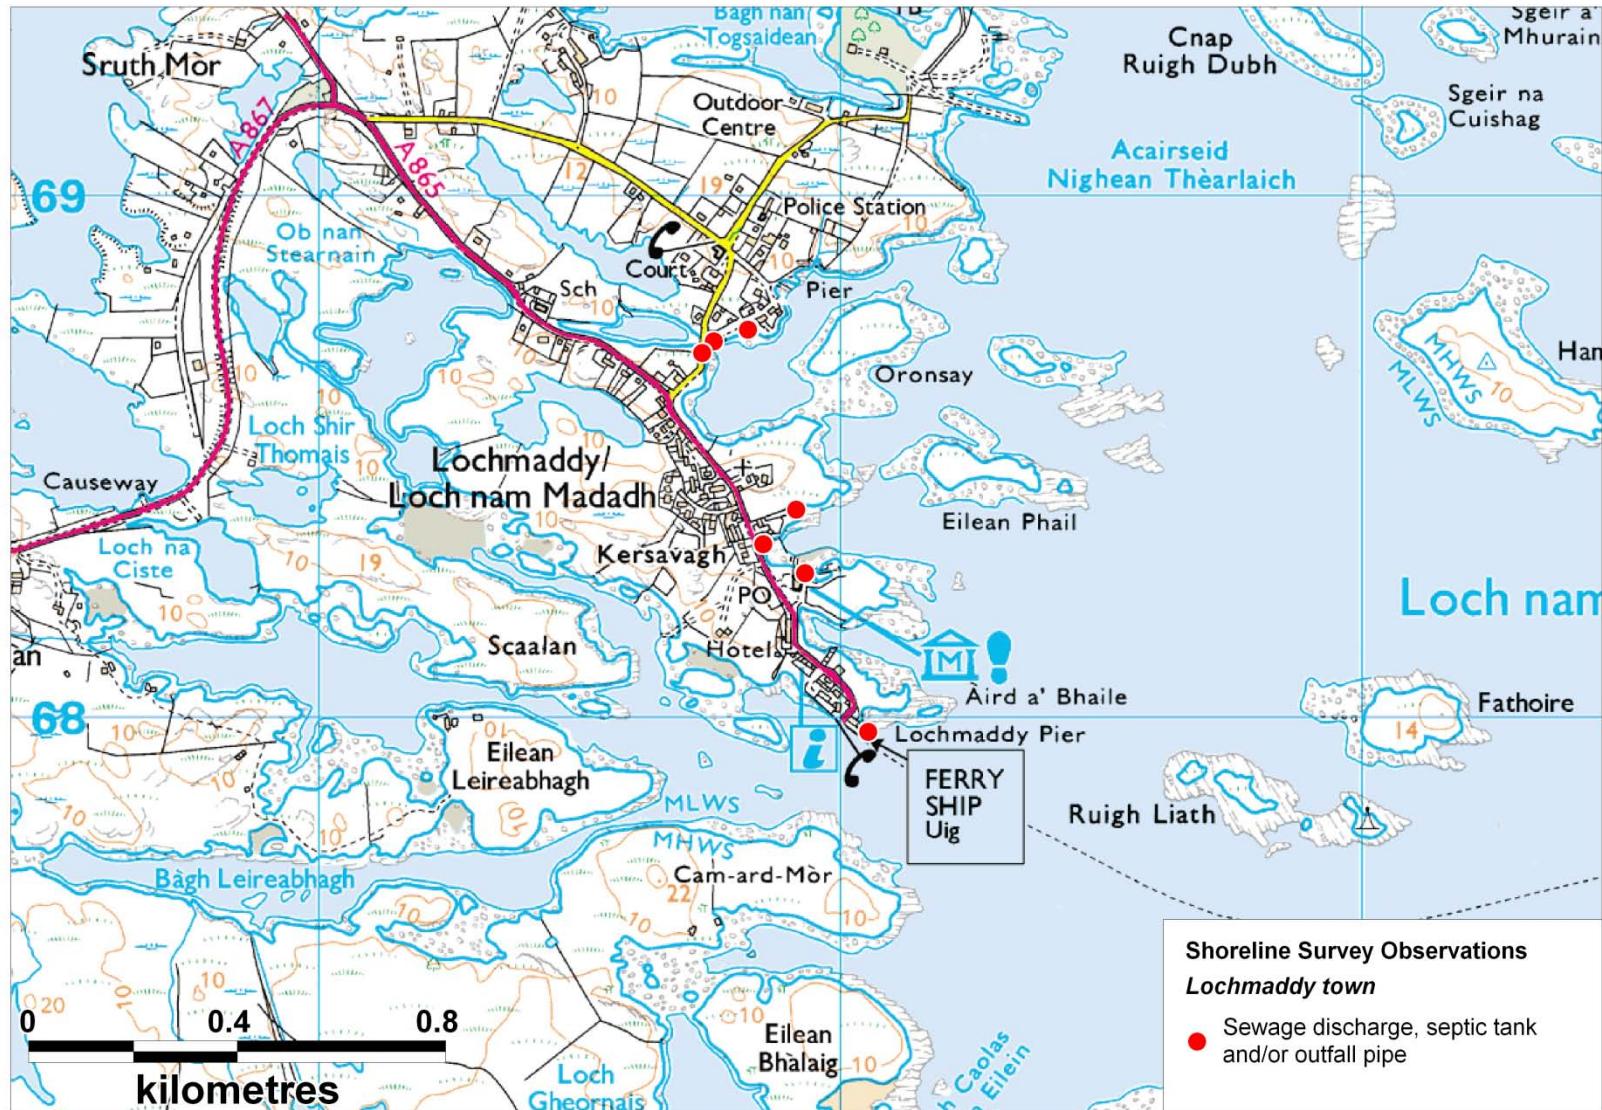
**Figure 15.2 Summary of shoreline survey findings for Lochmaddy village**

At Lochmaddy, the locations of two Scottish Water septic tanks and a possible third were identified. However, none had flowing outfall pipes. A further four outfall pipes were observed, three leading under a road and the fourth leading from the visitors centre. None of the pipes were observed to be flowing at the time.

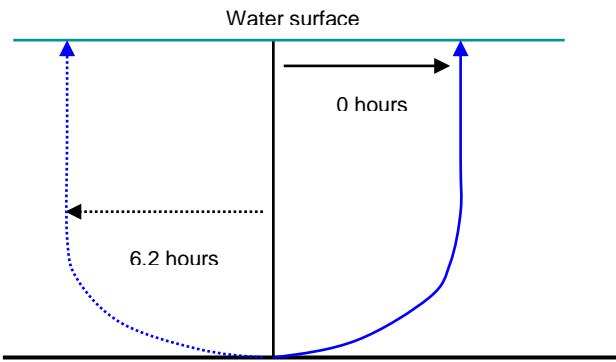
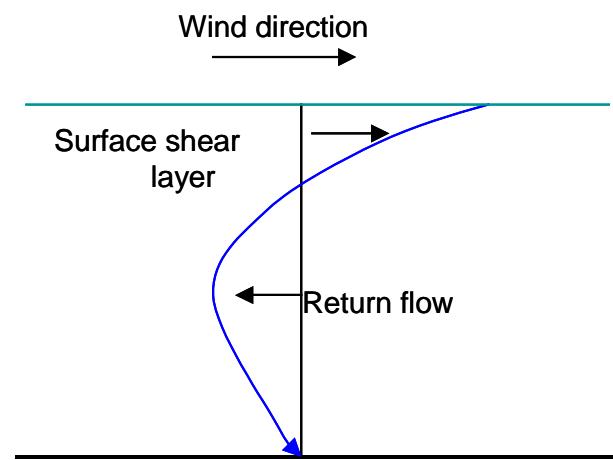
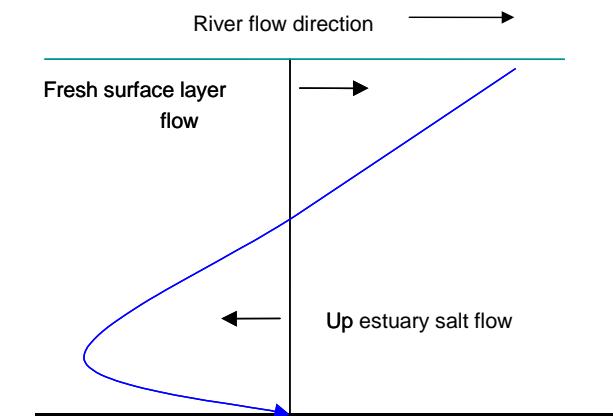
Figure 1. Typical vertical profiles for water currents. The black vertical line indicates zero velocity so portions of the profile to the left and right indicate flow moving in opposite directions. a) Peak tidal flow profiles. Profiles are shown 6.2 hours apart as the main tidal current reverses direction over a period of 6.2 hours. b) wind driven current profile, c) density driven current profile.

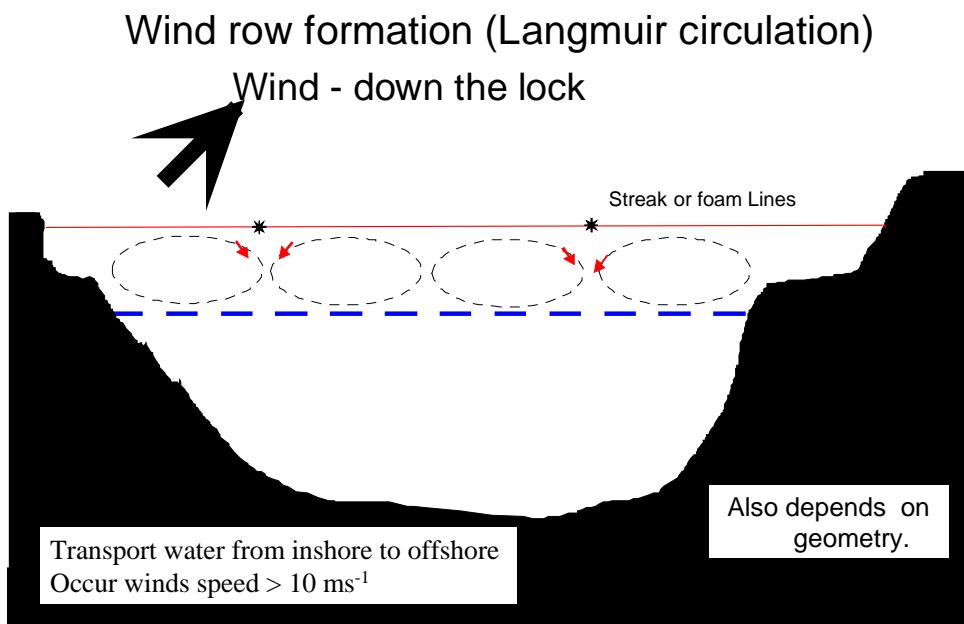
Figure 2. Schematic of wind driven ‘wind row’ currents. The dotted blue line indicates the depth of the surface fresh(er) water layer usually found in sea lochs.

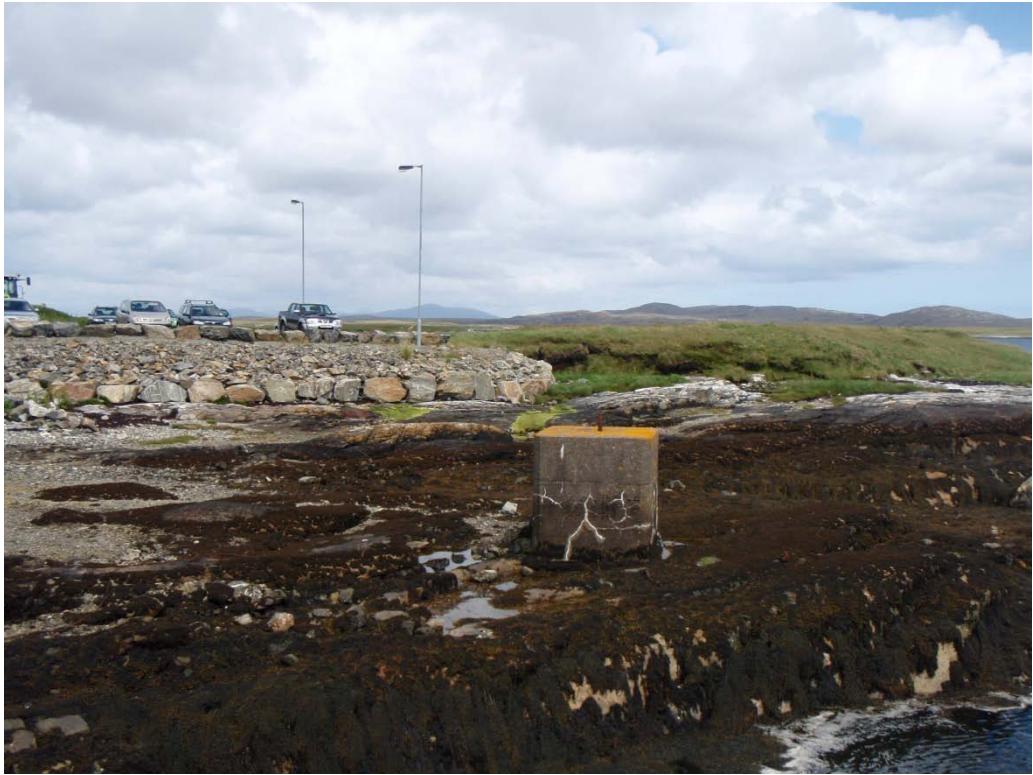
Figure 6. Possible location of Scottish Water septic tank Lochmaddy No.3

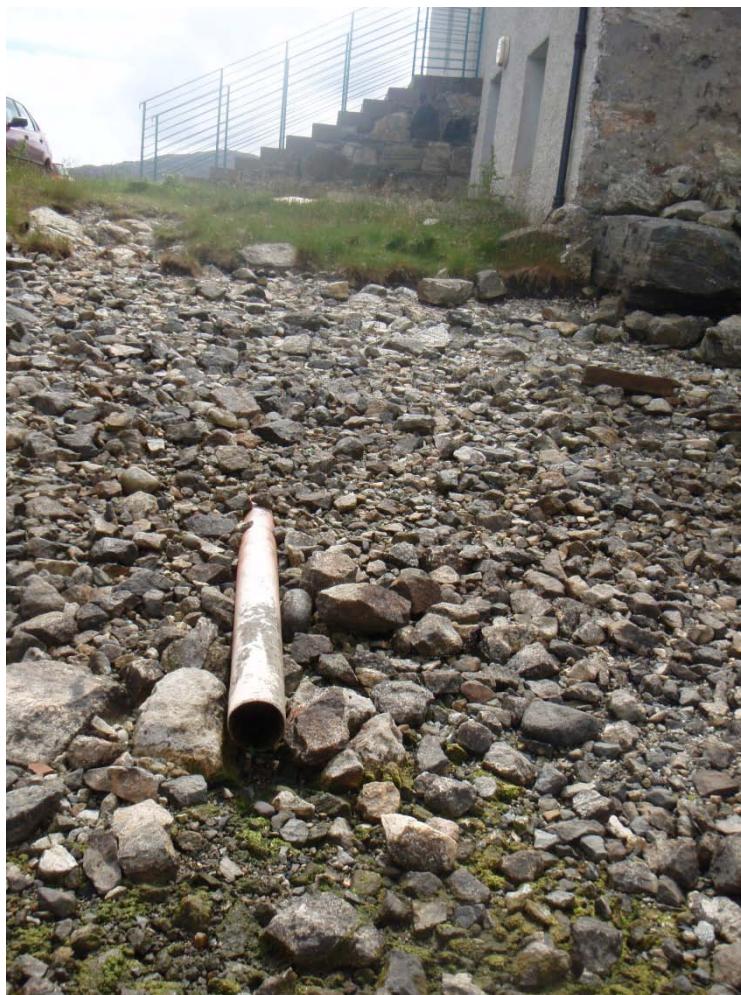
Figure 7. Outfall pipe leading down from visitor's centre, little flow

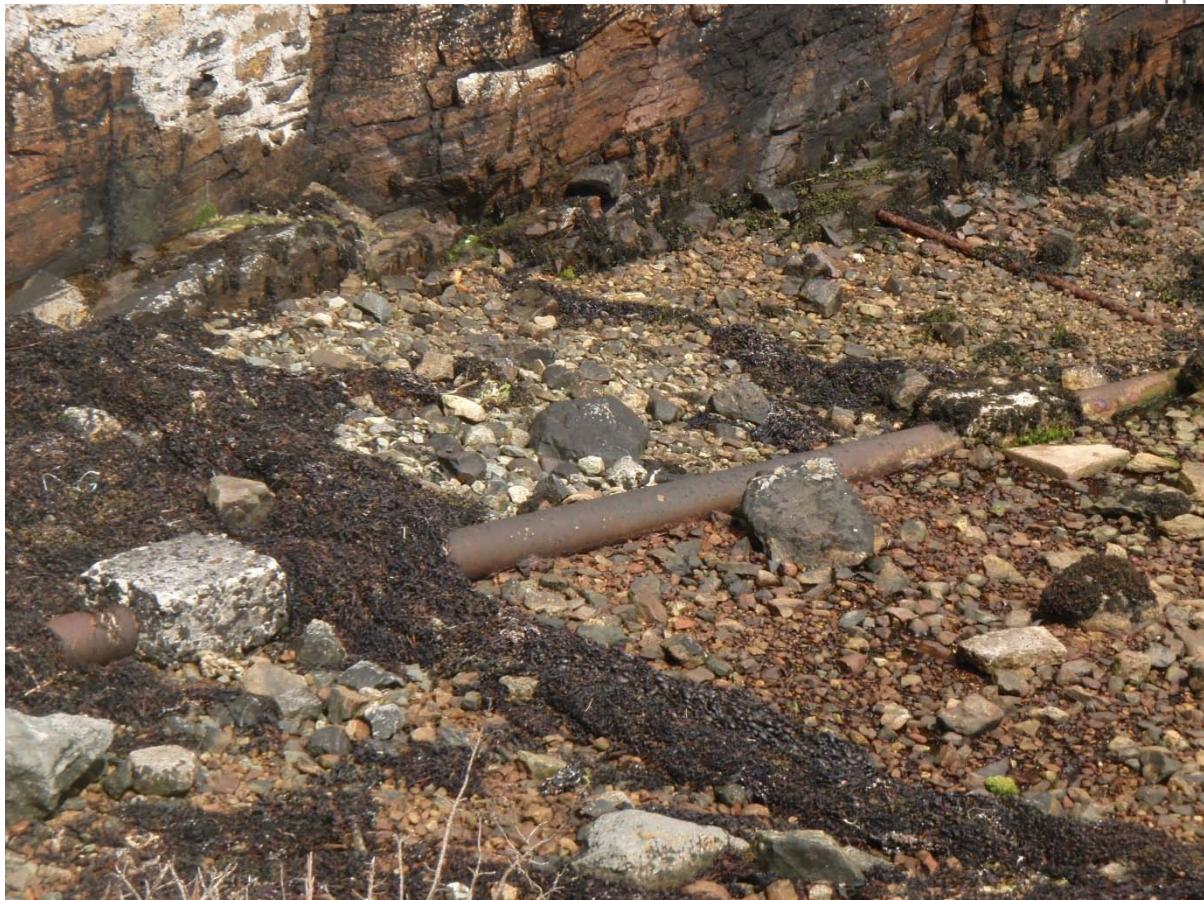
Figure 8. Pipes leading under road onto shoreline in Lochmaddy

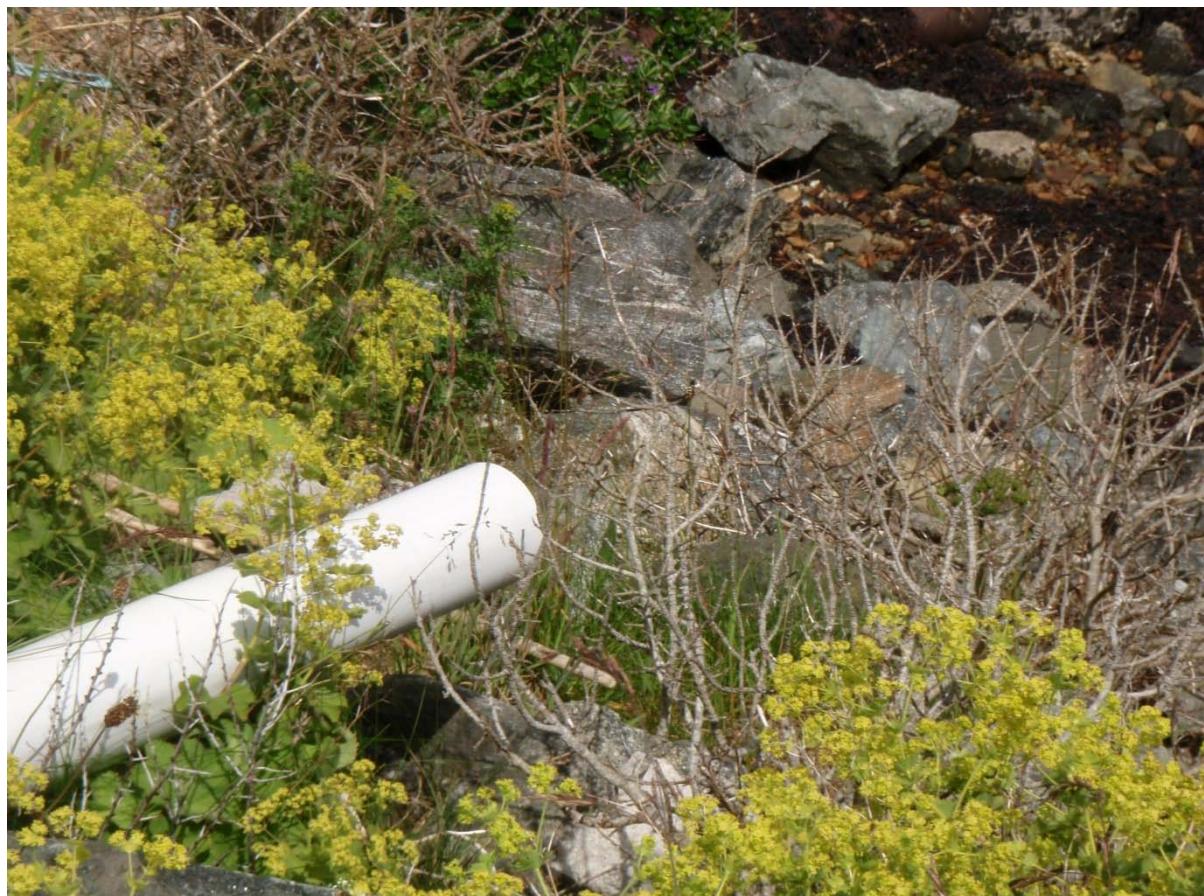
Figure 9. Pipe leading under road onto shoreline in Lochmaddy

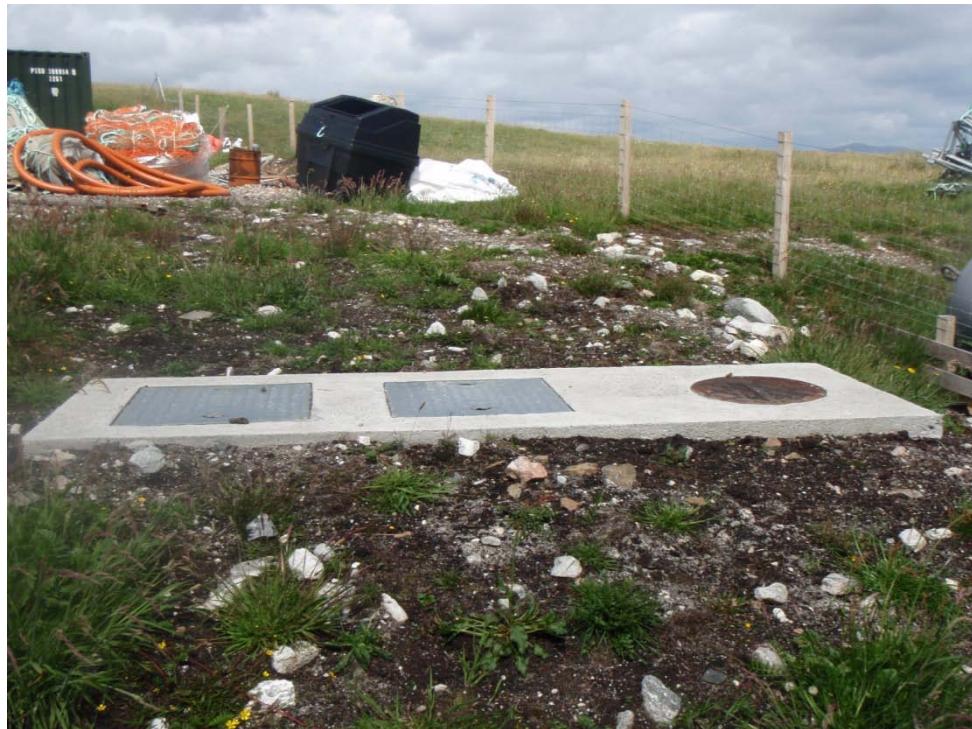
Figure 10. Scottish Water Lochmaddy No.2 septic tank

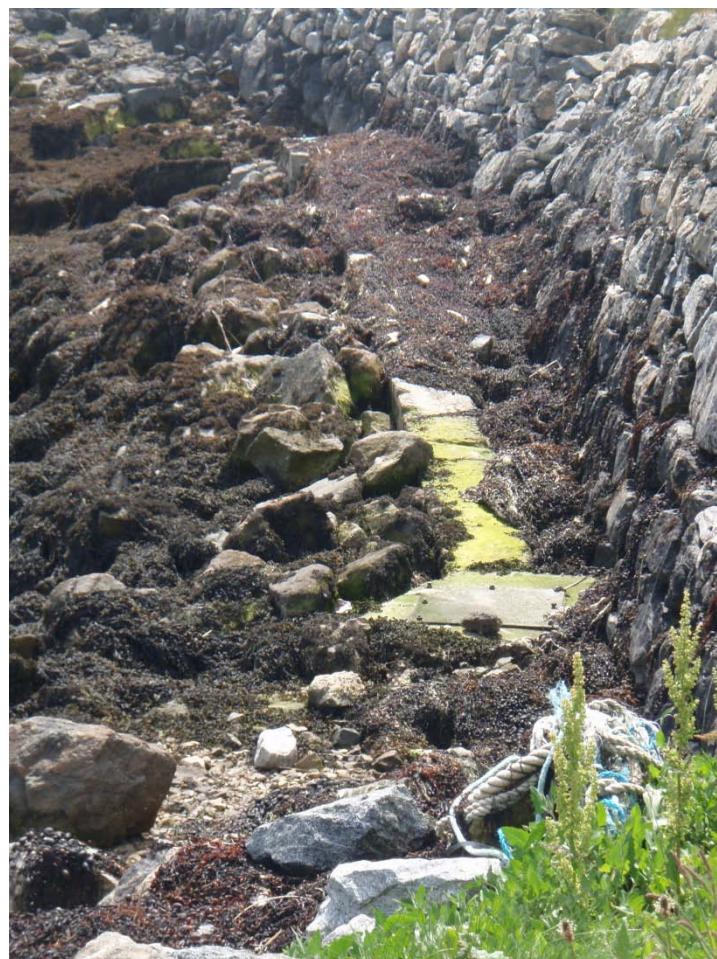
Figure 11. Outfall pipe and inspection cover on opposite side of road to Scottish Water Lochmaddy No. 1 septic tank
