# Scottish Sanitary Survey Programme

**Sanitary Survey Report**  
Production Area: North Uist 2  
SIN: UB 540  
July 2011

# Report Distribution – North Uist 2

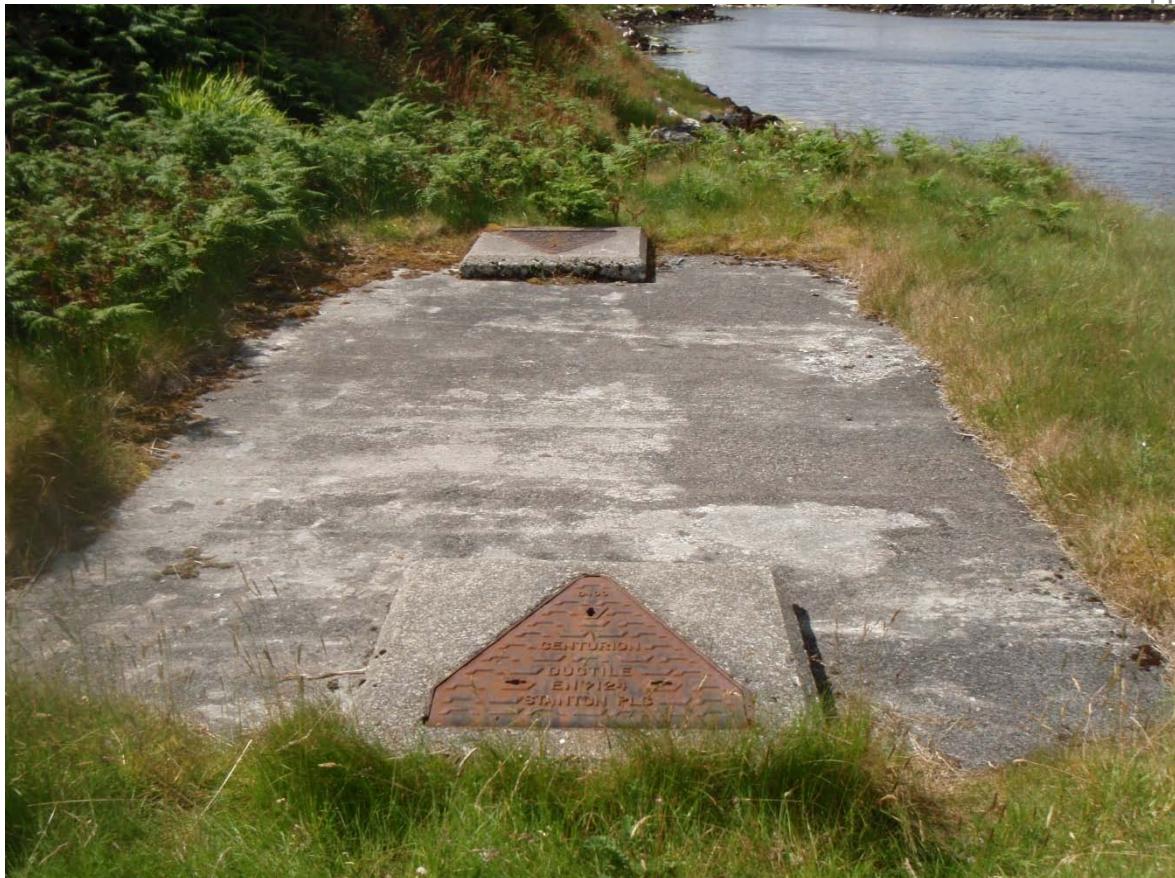
Figure 12. Scottish Water Lochmaddy No. 1 septic tank

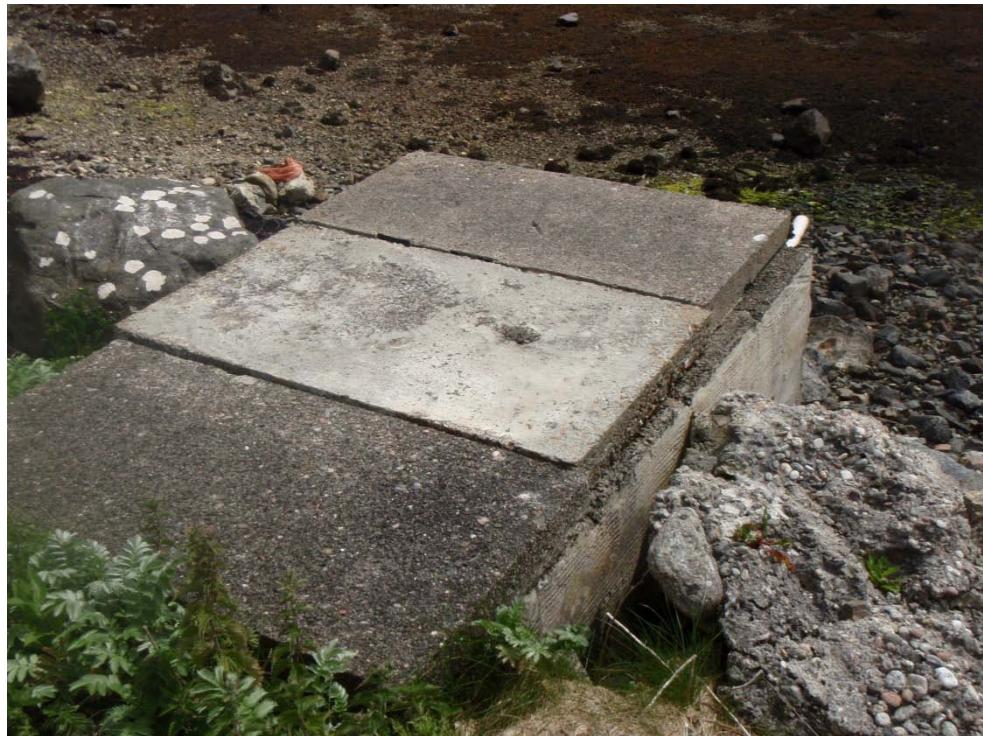
Figure 14. Outfall pipe covered in concrete slabs

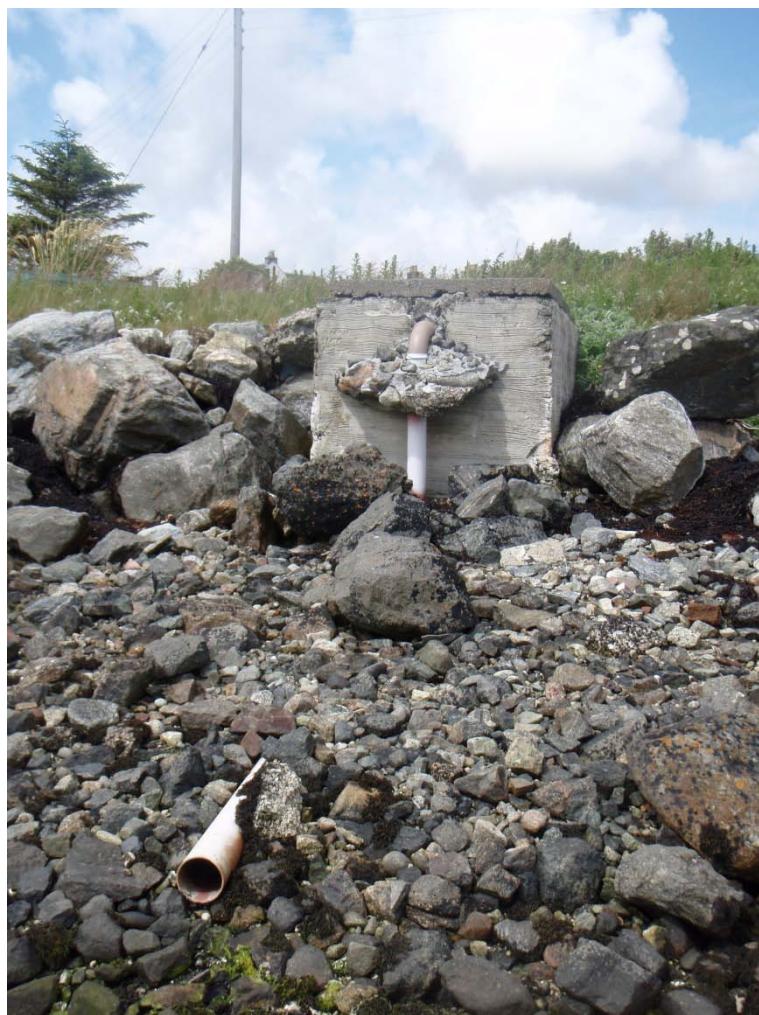
Figure 15. Outfall pipe shown in Figure 14, very little flow

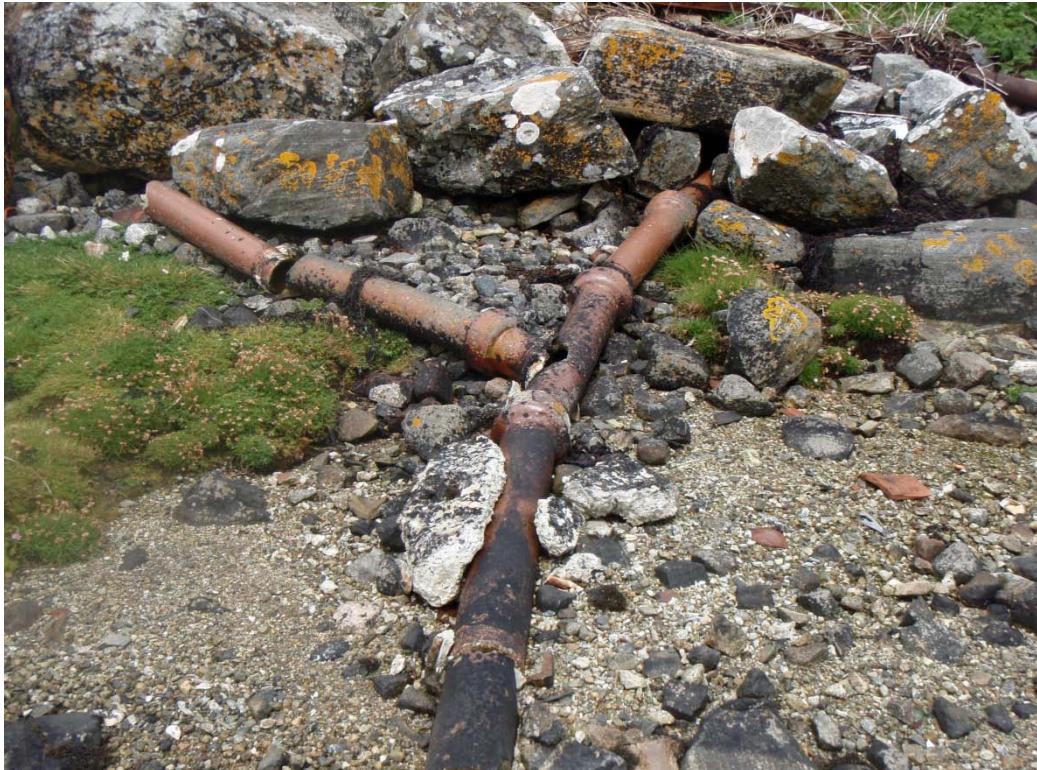
8	28/06/2011	NF 91825 68746	Broken pipe, no flow

Figure 16. Broken pipe, no flow

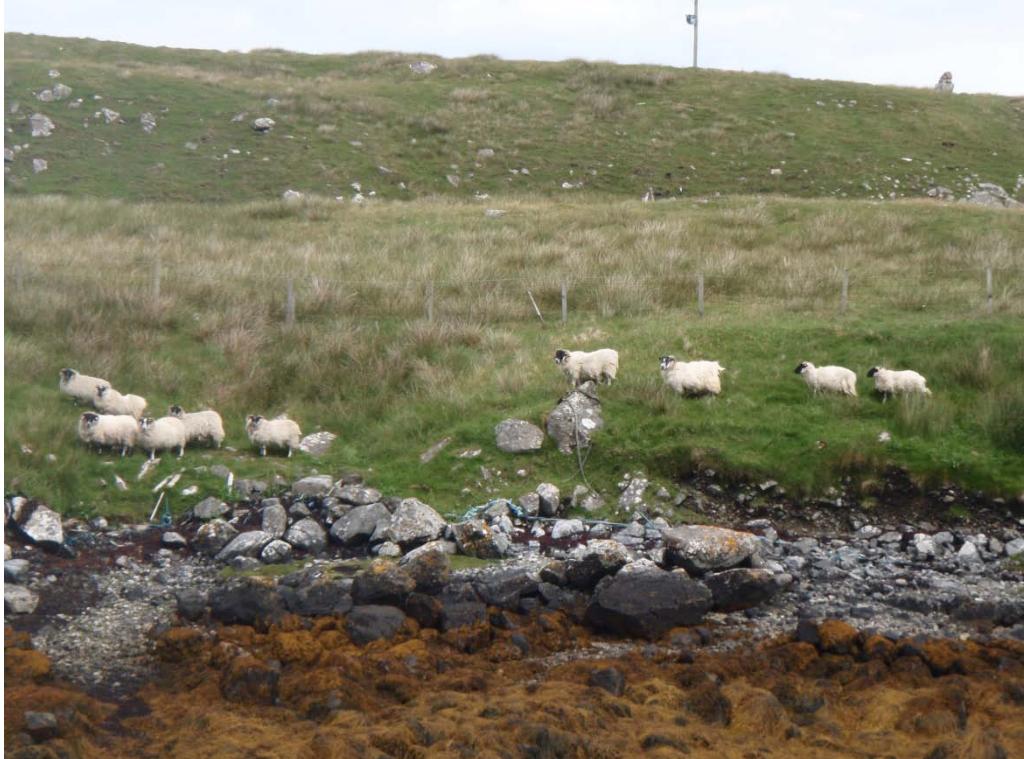
Figure 18. Sheep on N shoreline of Loch Portain
