Scottish Sanitary Survey Project

Sanitary Survey Report
Loch Erisort: Outer
LH 357
February 2010

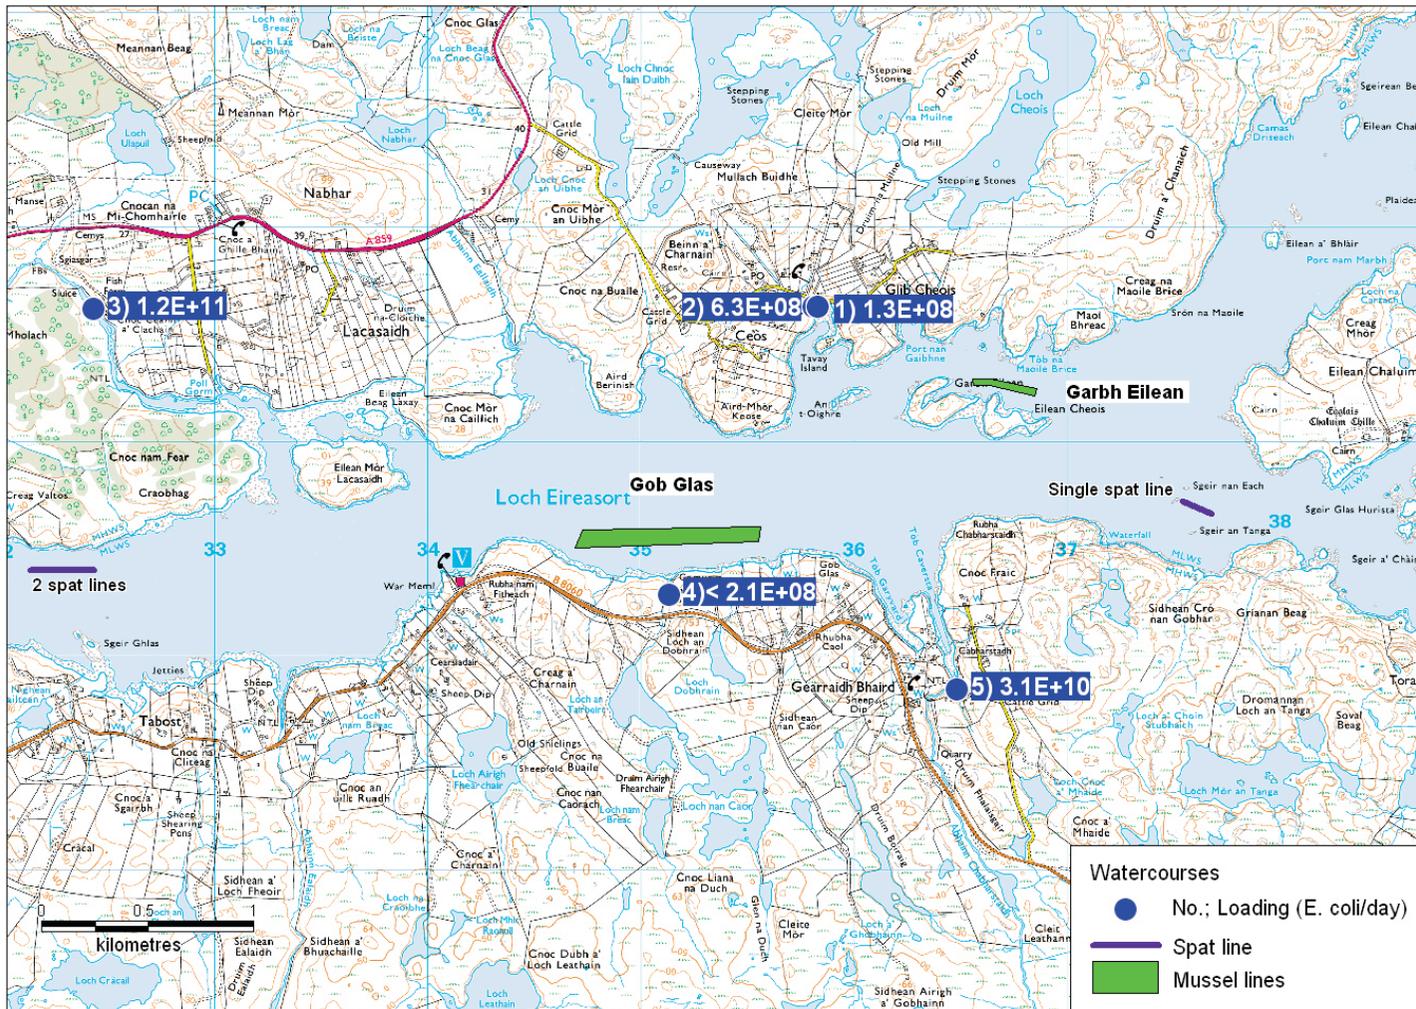
Produced by Cefas Weymouth Laboratory. © Crown Copyright and Database 2011. All rights reserved. Ordnance Survey licence number [GD10035675]
Figure 13.1 Map of stream loadings at Loch Erisort: Outer

The calculated loading for watercourse number 3 in Table 13.1 was high. However, this is located more than one kilometre from the nearest mussel lines. The loading for watercourse number 5 was moderately high. Again, it is located some distance from the nearest mussel lines. However, depending on the currents in the area, these two could impact on the lines at Gob Glas under certain conditions. Loadings for the other three watercourses were low. Although one of these entered the loch on the shore immediately adjacent to the mussel lines at Gob Glas, the *E. coli* results for the water sample collected at the time of the shoreline survey was below the limit of detection of the test, indicating that no significant amount of faecal contamination was present. Loadings from all of these watercourses would be expected to increase following heavy rain.

Some other small watercourses are marked on the OS map on the shores adjacent to the mussel lines at Gob Glas and Garbh Eilean. The shore at these points could not be accessed during the shoreline survey. It is likely that these watercourses only flow following moderate to heavy rainfall. Two named watercourses, Abhainn Eallaidh (on the north side of the loch) and Abhainn Eallaidh (on the south side) were not recorded or sampled during the shoreline survey. Due to their location and distance from the fisheries, these are unlikely to impact significantly on the water quality at the mussel farms.

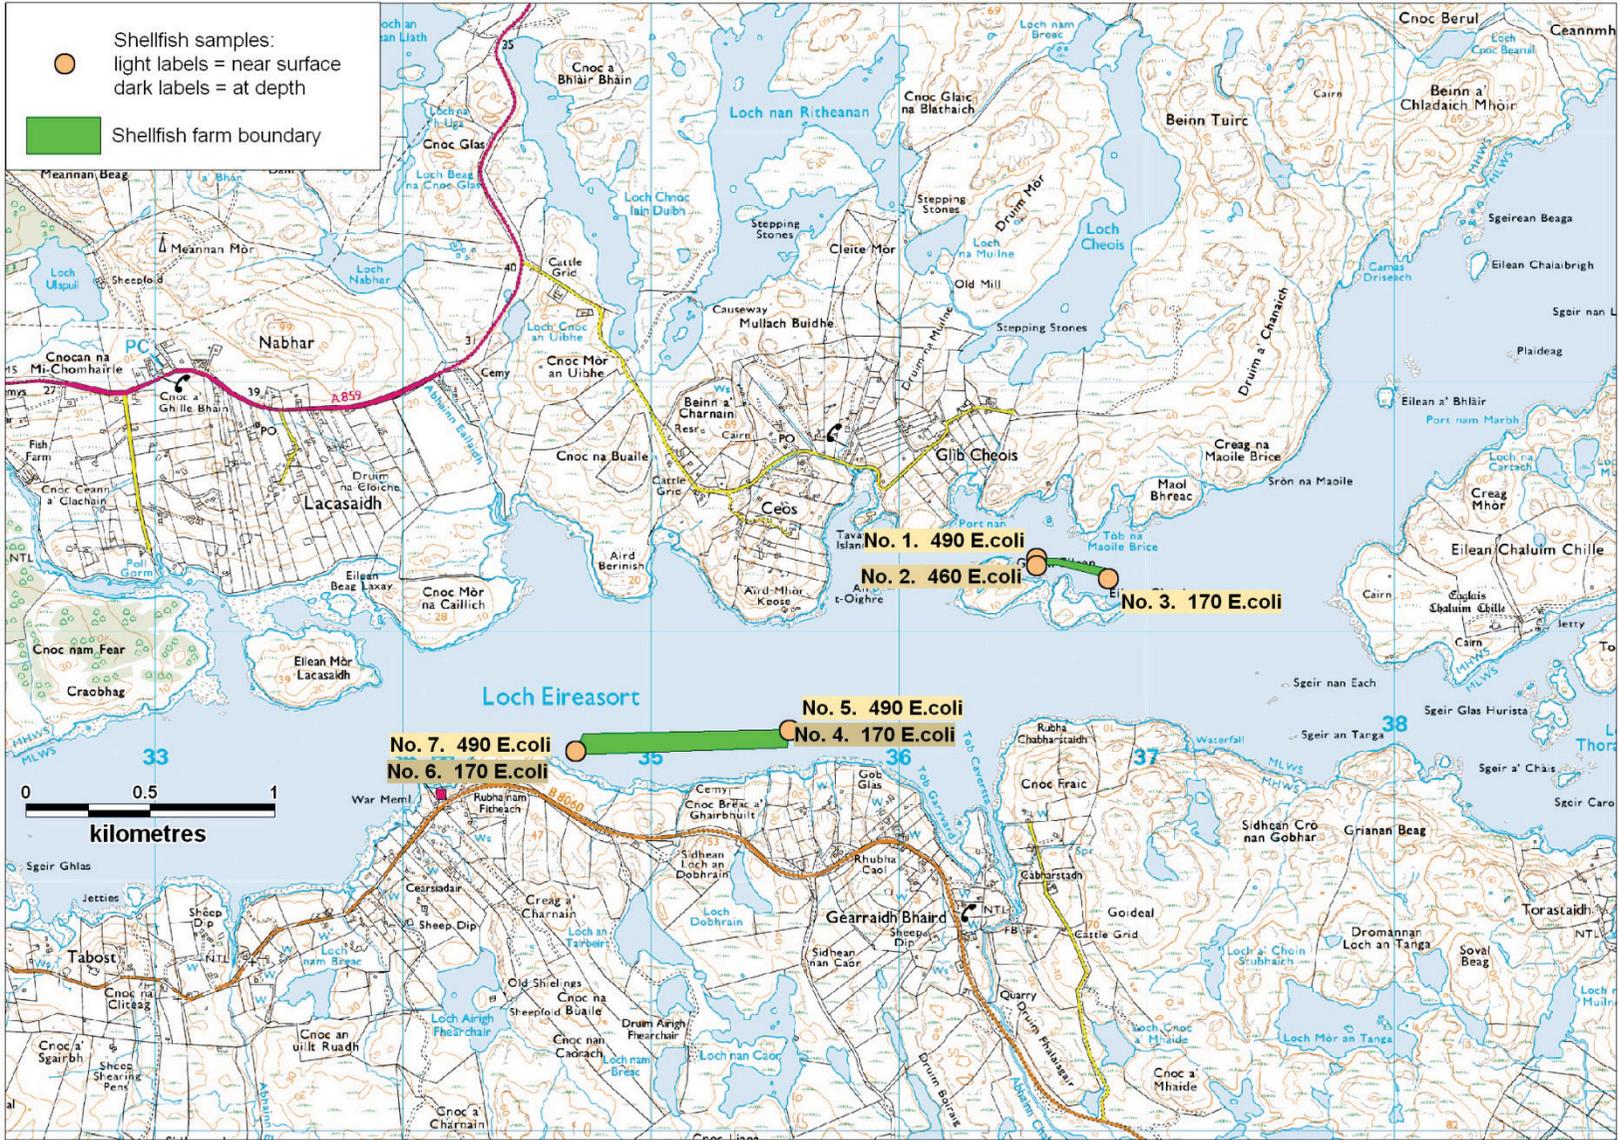
Figure 5. Shellfish sample results map – Loch Erisort

No.	Date	Sample	Grid Ref	Species	Depth (m)	<i>E. coli</i> (MPN/100g)
1	22/09/2010	EST 11	NB 3656 2129	Mussel	<1m	490
2	22/09/2010	EST 12	NB 3656 2126	Mussel	3m	460
3	22/09/2010	EST 14	NB 3685 2121	Mussel	<1m	170
4	22/09/2010	EST 17	NB 3556 2061	Mussel	6m	170
5	22/09/2010	EST 18	NB 3556 2061	Mussel	1m	490
6	22/09/2010	EST 20	NB 3470 2052	Mussel	6m	170
7	22/09/2010	EST 21	NB 3470 2052	Mussel	1m	490

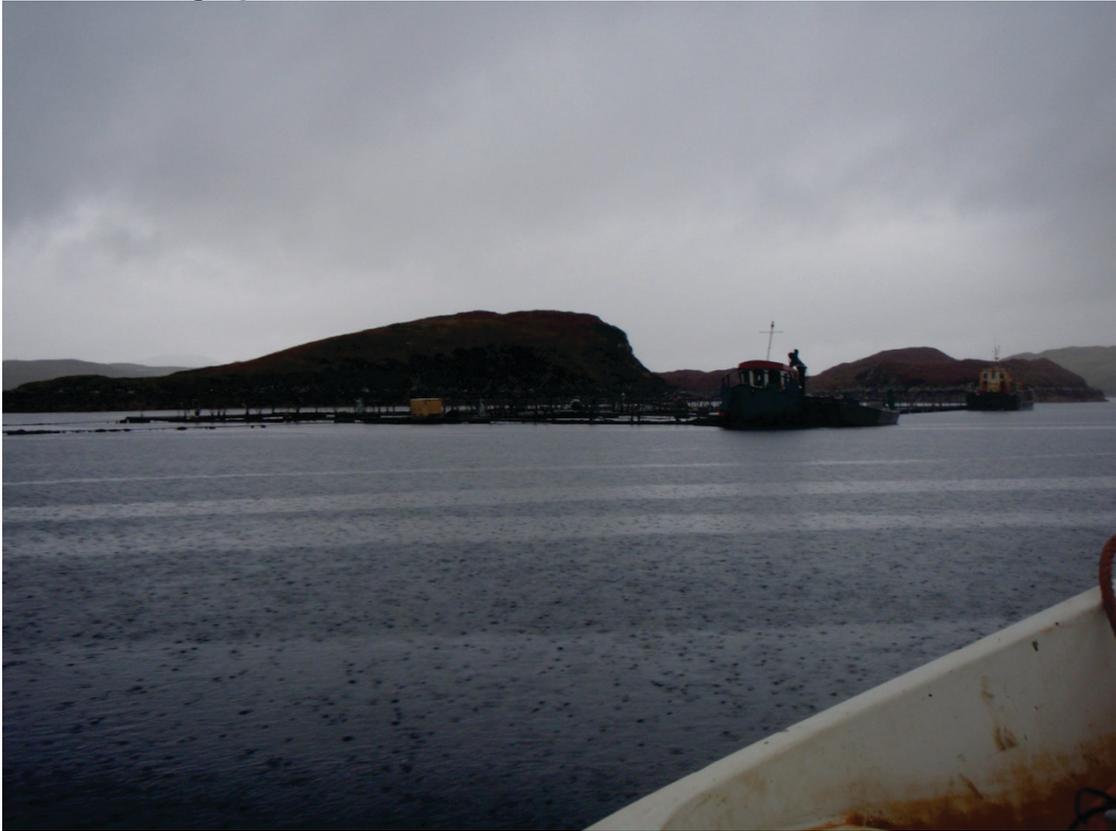
Figure 6. Mussel farm at Garbh Eilean with 2 large boats

No.	Date	Time	NGR	East	North	Associated photograph	Description
1	22/09/2010	09:25	NB 36556 21293	136556	921293	Figure 6,7	Mussel farm - converted salmon cages with 7m droppers plus 2 long lines. Two large workboats, two small boats
2	22/09/2010	09:37	NB 36556 21293	136556	921293		Water sample 10, mussel sample 11 taken from bottom of float, salinity profile 5, 1 otter/mink seen swimming between the lines
3	22/09/2010	09:56	NB 36559 21260	136559	921260		Salinity profile 6
4	22/09/2010	09:59	NB 36557 21264	136557	921264		Mussel sample 12, 3m depth
5	22/09/2010	10:10	NB 36847 21214	136847	921214		Water sample 13 plus mussel sample 14 (surface), salinity profile 7
6	22/09/2010		NB 37421 21538	137421	921538		1 eagle. Heavy rain
7	22/09/2010	10:35	NB 38577 22920	138577	922920	Figure 8	Sewage outfall for Loch Luerbost works, no boil observed, salinity 35, water sample 15
8	22/09/2010		NB 36802 21330	136802	921330		10 sheep observed on hill above cove opposite side of loch to rafts

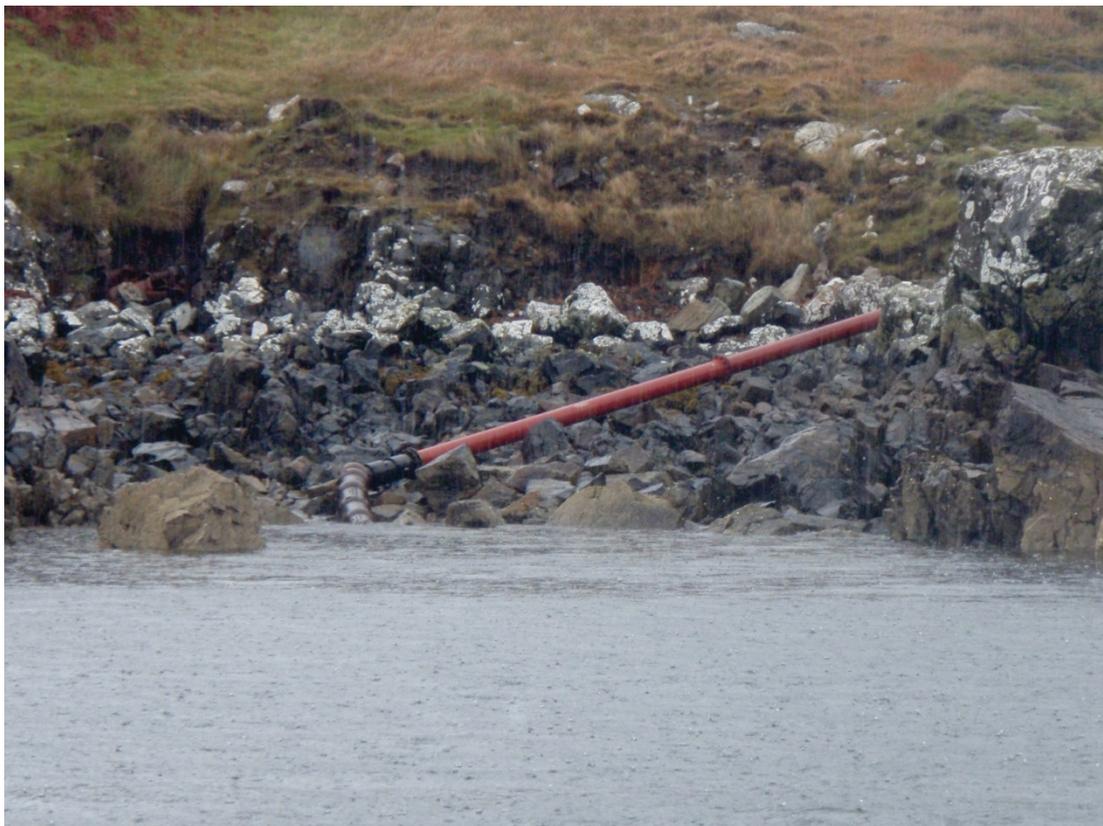
Figure 8. Sewage discharge pipe for Loch Leurbost in Outer Loch Erisort

The only community discharge observed during the shoreline survey was the main discharge for Loch Leurbost: this discharges to the outer part of the loch, approximately 2.5 km northeast of the Garbh Eilean mussel farm. Private discharges were observed along the south shore at Tob Caversta. A visitors centre and public toilet at Tabost was likely to have a septic tank and discharge, though it was not possible to access the shore behind them to observe it. Some of the homes around the loch are reportedly only occupied during the summer tourist season, and there was B&B accommodation in the area.

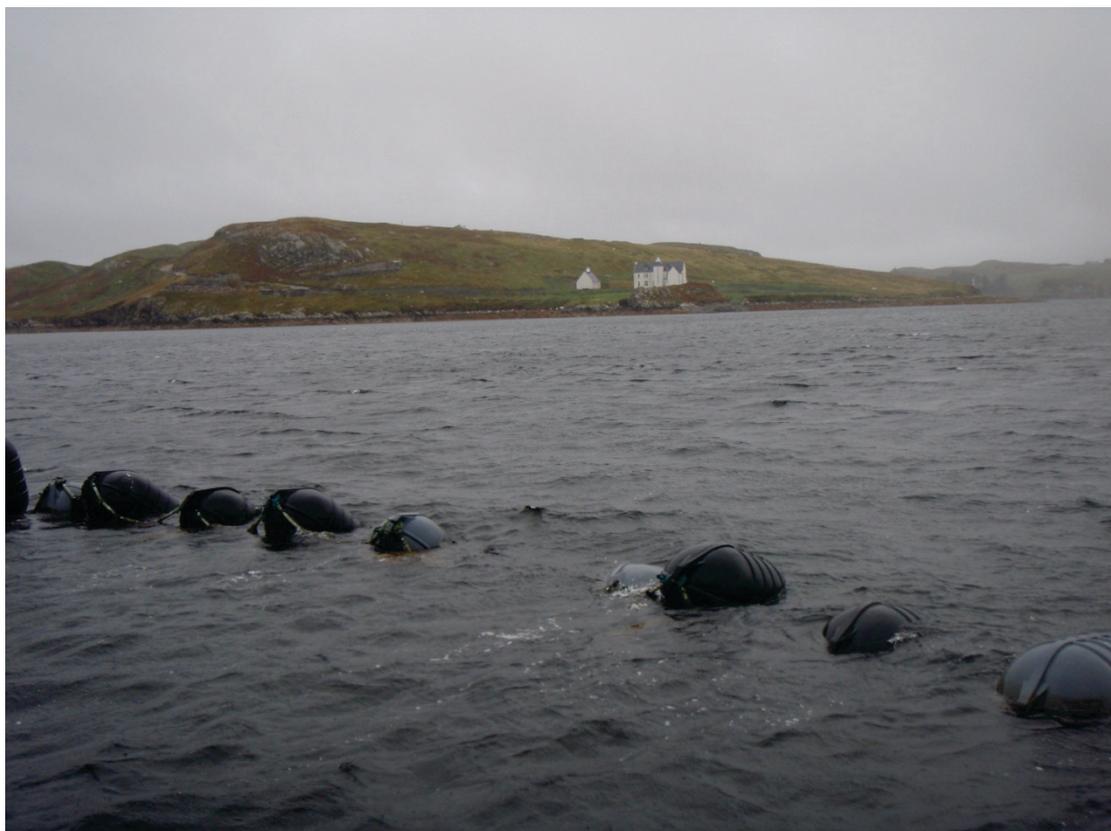
Figure 9. Mussel lines at Gob Glas, looking toward north shore

9	22/09/2010		NB 35559 20605	135559	920605	Figure 9	Gob Glas, 2 rows of long lines, end of lines, water sample 16, mussel sample 17 (6m) and 18 (top of lines), salinity profile 8
10	22/09/2010	11:50	NB 34698 20521	134698	920521		Far end of lines, water sample 19, mussel samples 20 (bottom) and 21 (top), salinity profile 9
11	22/09/2010		NB 34723 20588	134723	920588		outer corner of lines, both have 6-7 meter droppers
13	29/09/2010	09:58	NB 36361 20184	136361	920184		Stream directly east on opposite shore of Tòb Caversta, opposite shore rocky and steep with no foreshore. 4 sheep on field to west
14	29/09/2010	10:02	NB 36366 20172	136366	920172	Figure 10,11	Septic tank, foul odour. Pipe runs underground, but puddled water at surface appears foul, sewage fungus apparent. Seawater sample EST1.
15	29/09/2010	10:14	NB 36375 20152	136375	920152		Septic tank, no detectable odour, pipe runs underground. Water sample EST 2

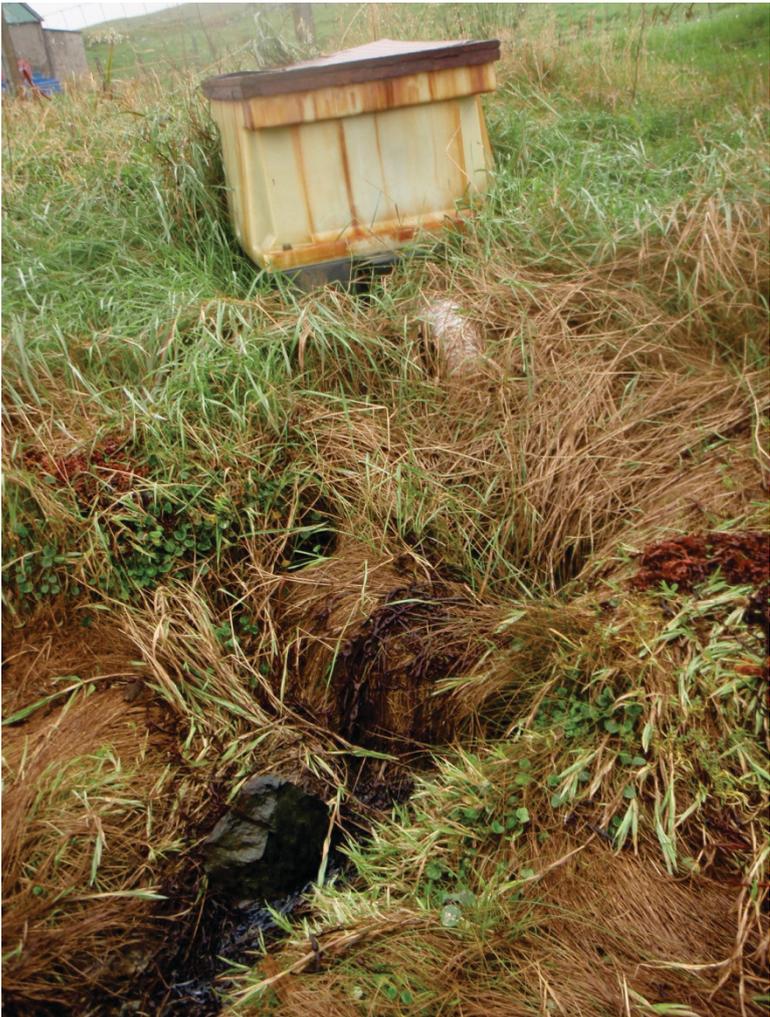
Figure 10. Septic tank with foul discharge

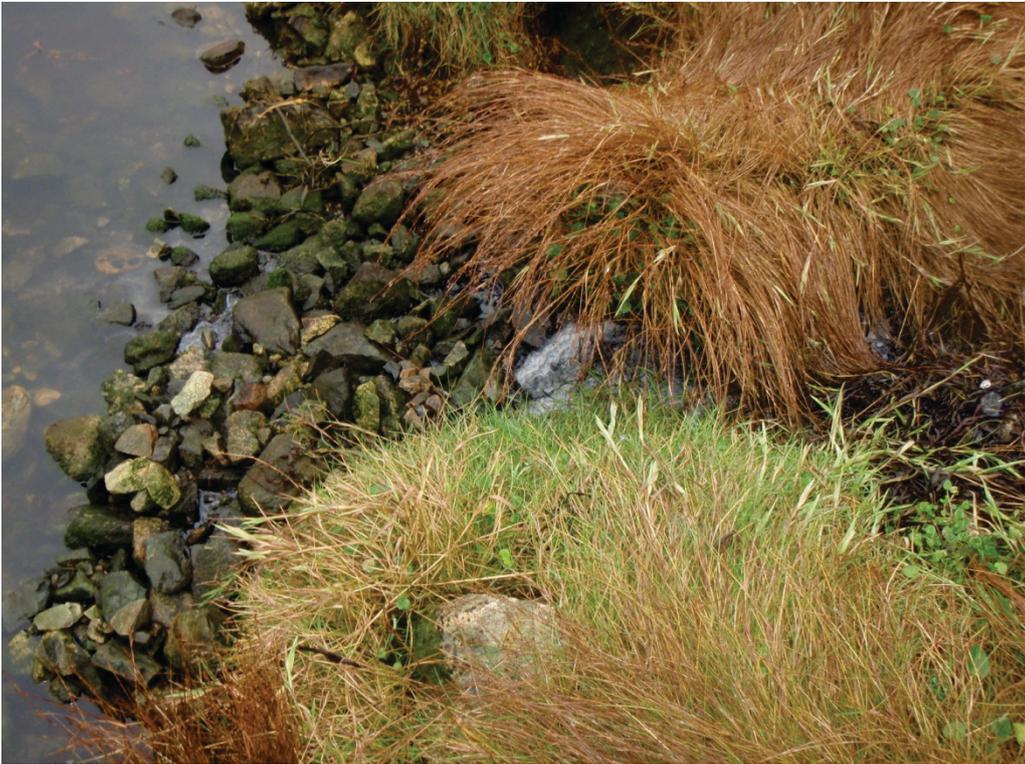
Figure 11. Sewage fungus in discharge from tank in Figure 10

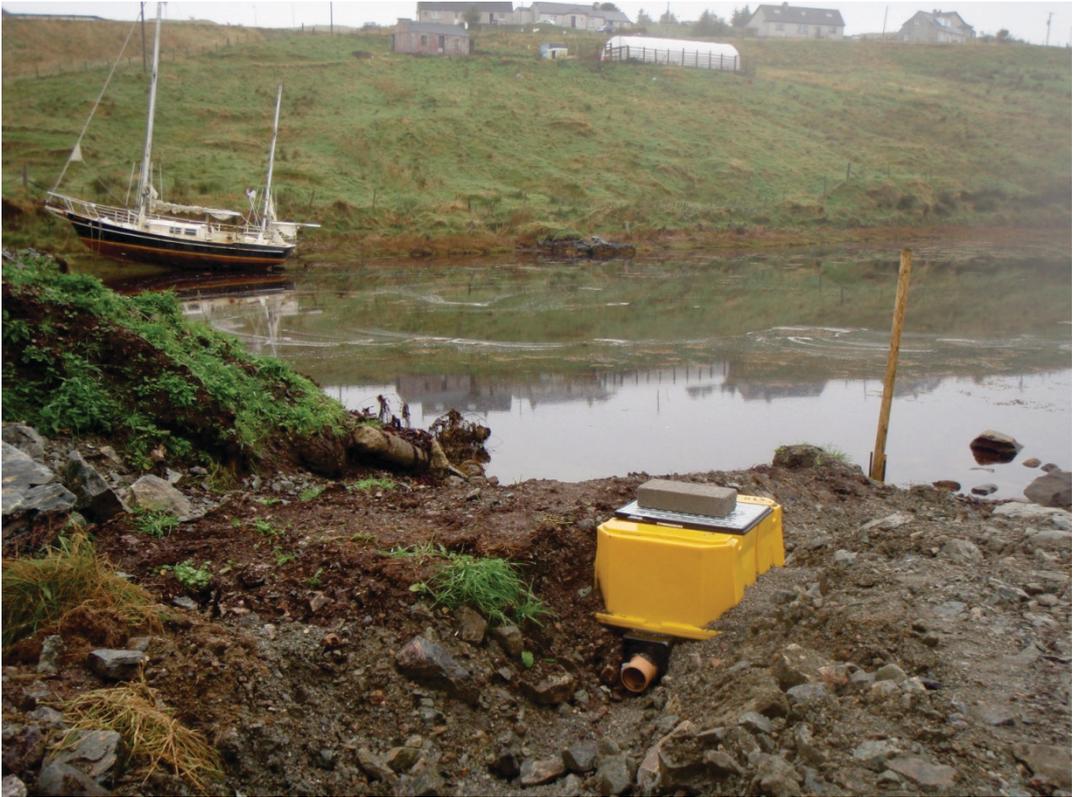
Figure 12. New septic tank at Tòb Garyvard

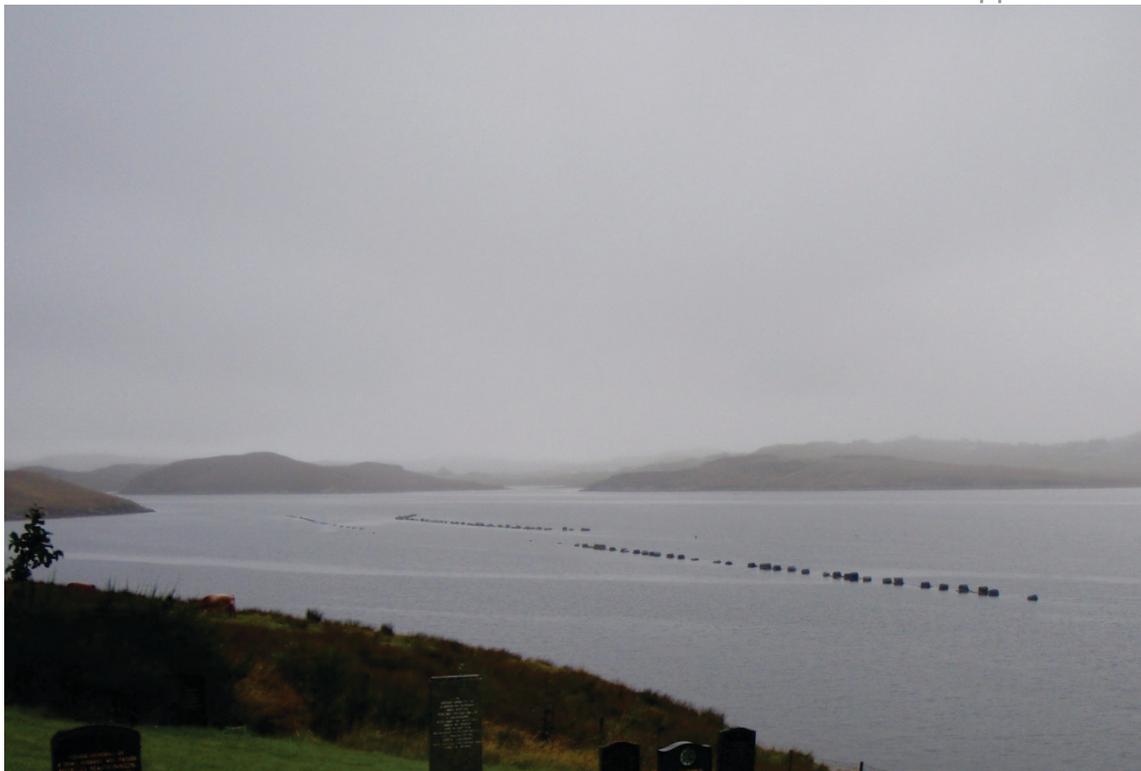
Figure 14. View of western side of Gob Glas farm from cemetery

25	29/09/2010	11:20	NB 35343 20317	135343	920317		Cemetery entrance, 10 sheep to east, 15 in view on hill beyond the 10, 4 in field to west above cemetery.
26	29/09/2010	11:15	NB 35330 20360	135330	920360	Figure 14	Corner of cemetery overlooking shellfish farm. 2 cattle visible in field to west
27	30/09/2010	12:18	NB 35131 20295	135131	920295		Stream, 0.45m wide, 0.15m deep, flow 0.359 m/s. Water sample 10. Cattle droppings along side of stream, area poached
28	29/09/2010	11:37	NB 34951 20156	134951	920156		15 sheep above concrete pens at layby
29	30/09/2010	11:59	NB 34773 20166	134773	920166		Stream, very low flow into a stagnant pond. No sample taken.
30	30/09/2010	13:09	NB 34169 20339	134169	920339		unknown
31	30/09/2010	16:01	NB 33720 19846	133720	919846		7 sheep
32	30/09/2010	16:00	NB 33458 19754	133458	919754		4 cattle toward shore
33	30/09/2010	16:00	NB 33259 19559	133259	919559		3 greenhouses

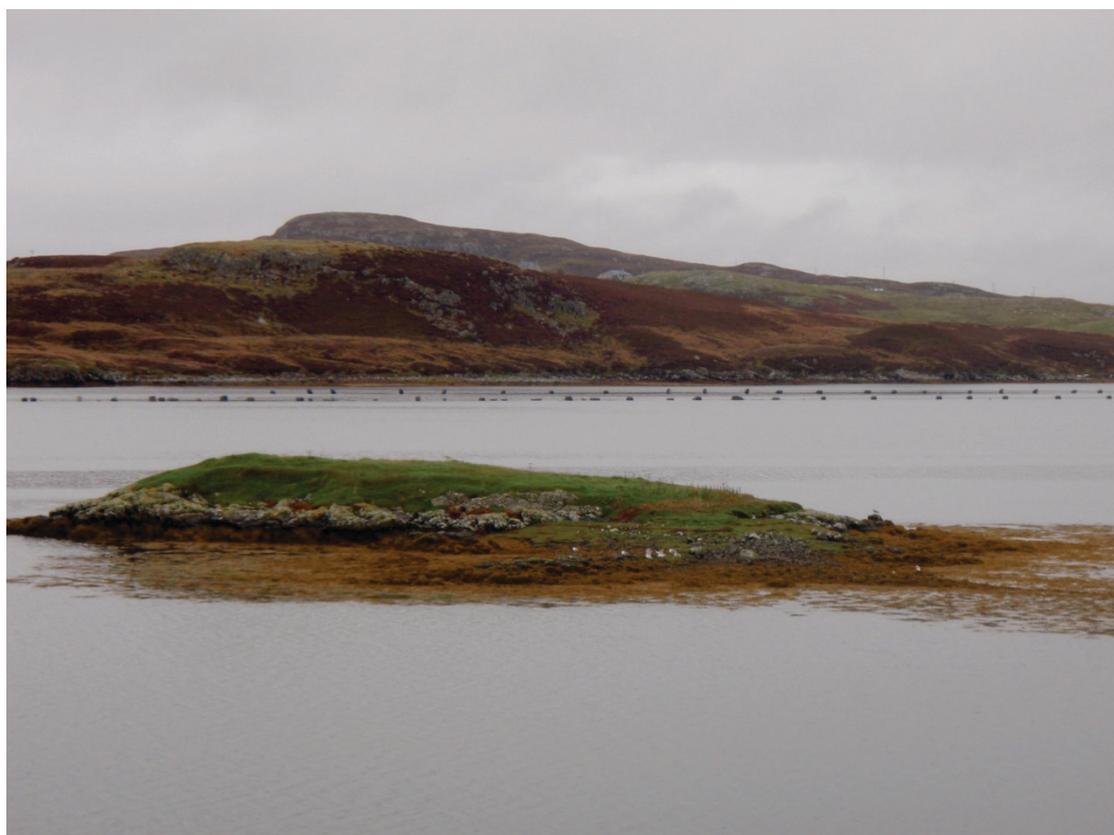
Figure 15. Spat lines viewed from south shore of Loch Erisort

No.	Date	Time	NGR	East	North	Associated photograph	Description
34	30/09/2010	15:58	NB 32965 19607	132965	919607		11 cattle, 3 houses
35	30/09/2010	15:56	NB 32860 19597	132860	919597		6 grey sheep on left. Pairc House (Western Isles ICT Advisory Services)
36	30/09/2010	15:55	NB 32805 19575	132805	919575		new house on left, 3 sheep visible on right, farm buildings and silage beyond sheep
37	30/09/2010	15:55	NB 32806 19575	132806	919575		8 sheep on right
38	30/09/2010	15:54	NB 32627 19589	132627	919589		Spat lines visible in distance, photo, 8 sheep plus 2 homes downhill
39	30/09/2010	15:50	NB 32566 19603	132566	919603		6 sheep visible on right, driveway with dung on left
40	30/09/2010	15:48	NB 32300 19670	132300	919670		silage bales, stored to left of road, 58 sheep a little way back on right
41	29/09/2010	12:14	NB 32339 19889	132339	919889	Figure 15	View of 2 spat lines from south shore. 8 gulls and 10 cormorants on rocks just offshore, 5 sheep on shoreline

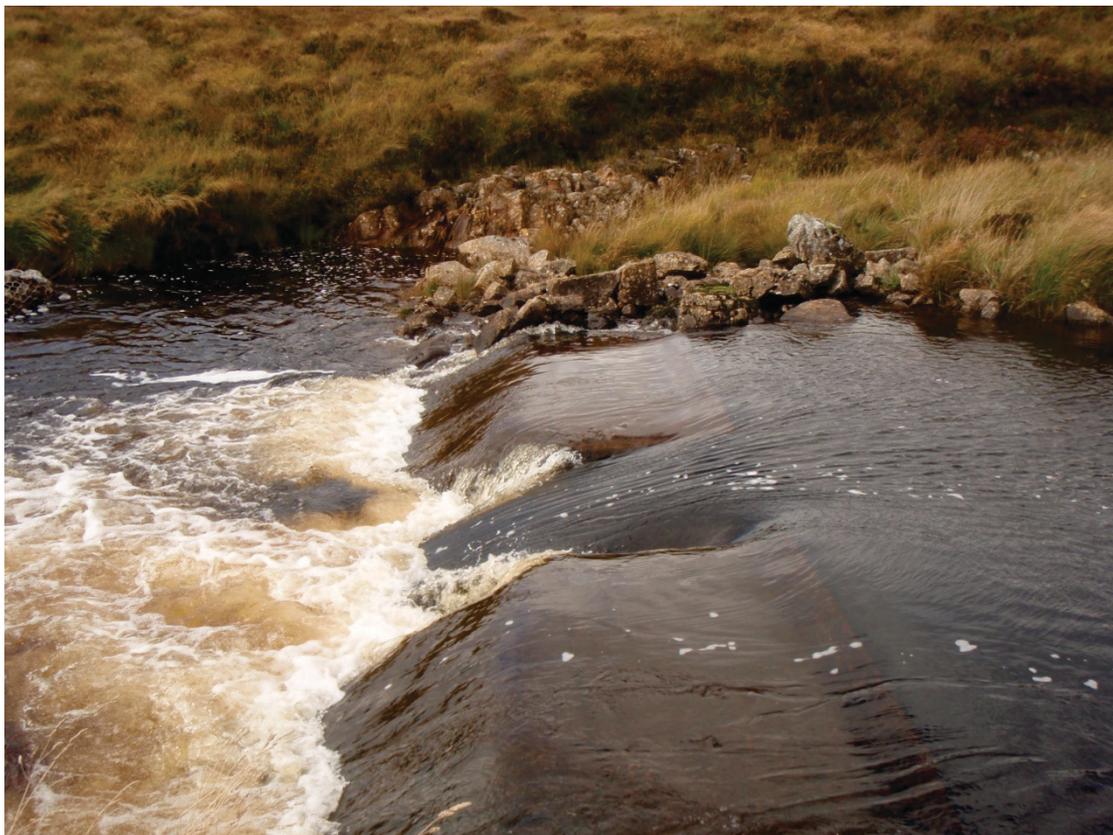
Figure 16. Weir on Abhainn Lacasaidh

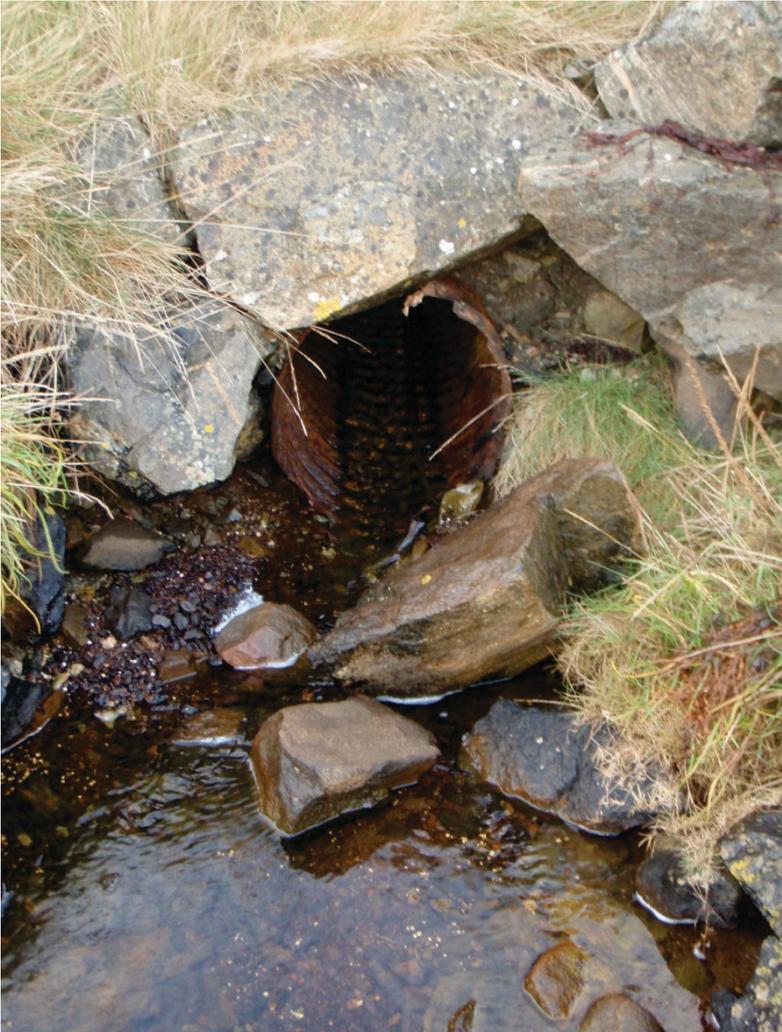
Figure 20. Culverted stream at Ceos

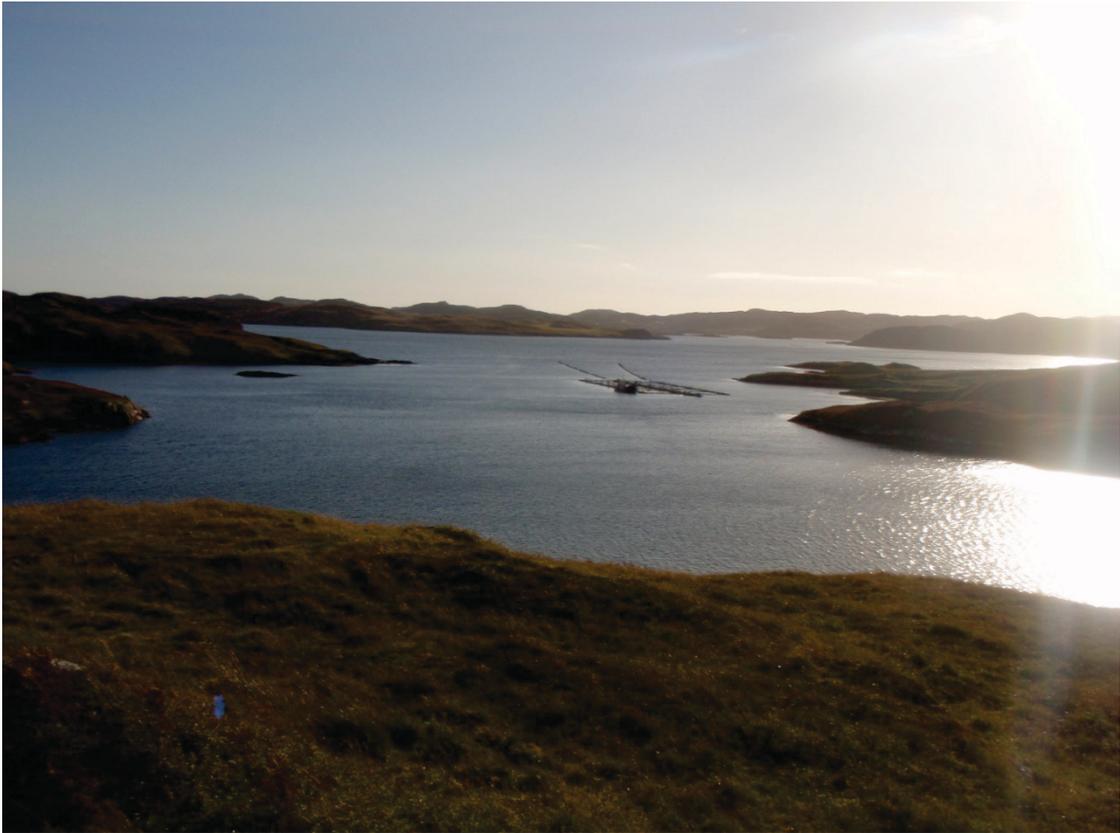
Figure 22. View across Garbh Eilean mussel farm

82	30/09/2010	09:36	NB 36089 21413	136089	921413	Figure 22	Vantage point for 2 photographs of south side of loch and Garbh Eilean site. Large number of sheep droppings, 16 sheep on hill above.
83	30/09/2010	09:53	NB 36277 21629	136277	921629		Field seep, ground wet but not deep enough to measure or sample
