Scottish Sanitary Survey Report

Sanitary Survey Report
Loch Sunart
HL-206-1237-08
February 2014

Report Title	Loch Sunart Sanitary Survey Report
Project Name	Scottish Sanitary Survey
Client/Customer	Food Standards Agency Scotland
Cefas Project Reference	C5792C
Document Number	C5792C_2013_13
Revision	V1.0
Date	06/02/2014

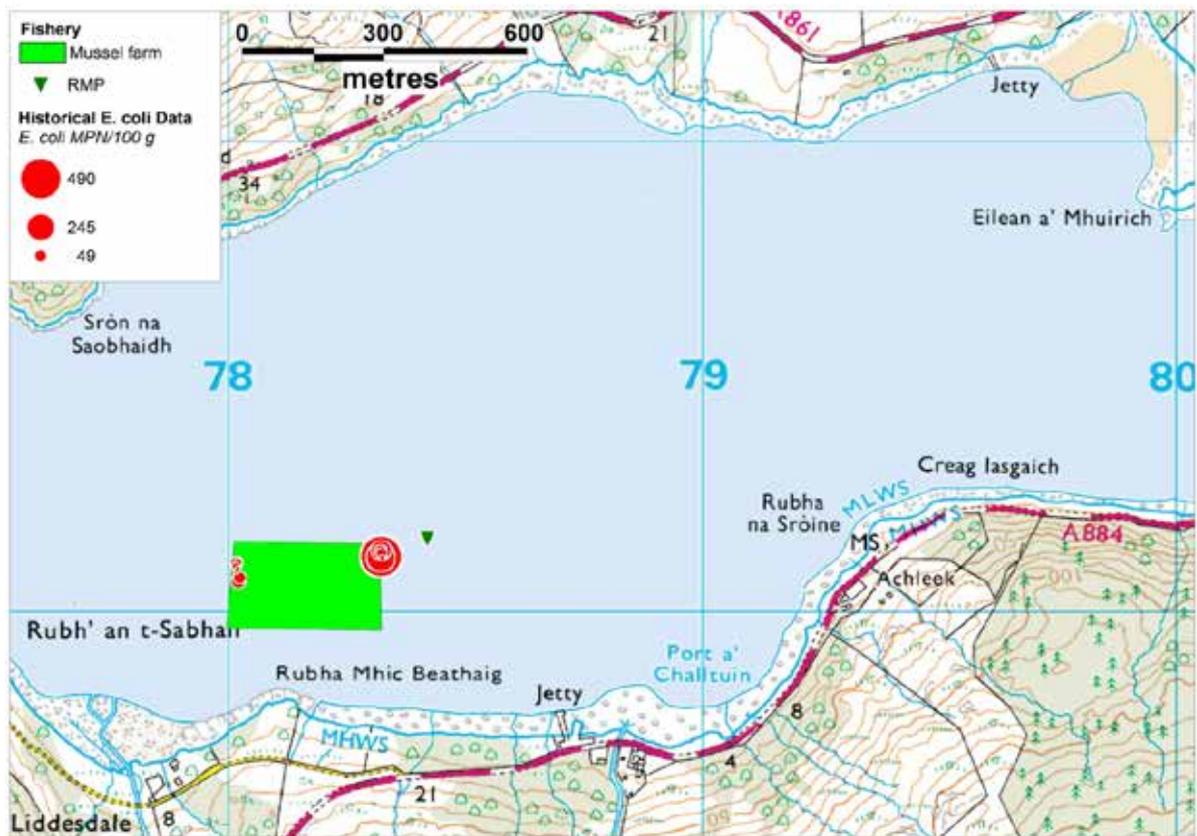
Figure 11.1 Map of reported sampling locations at Loch Sunart

The geographical locations of Loch Sunart sample results are displayed below in Figure 11.1. Two areas have been sampled: the northeast and the west extents of the farm. Of the six samples taken from the northeast location, three were associated with the full classification (taken August to October) and three with the fast track classification, which were taken in the latter half of June and July. The seven samples taken from western location were taken between February and early June. The current provisional RMP is located approximately 100 m northeast of the northeast corner of the farm and from the most recent sampling points.

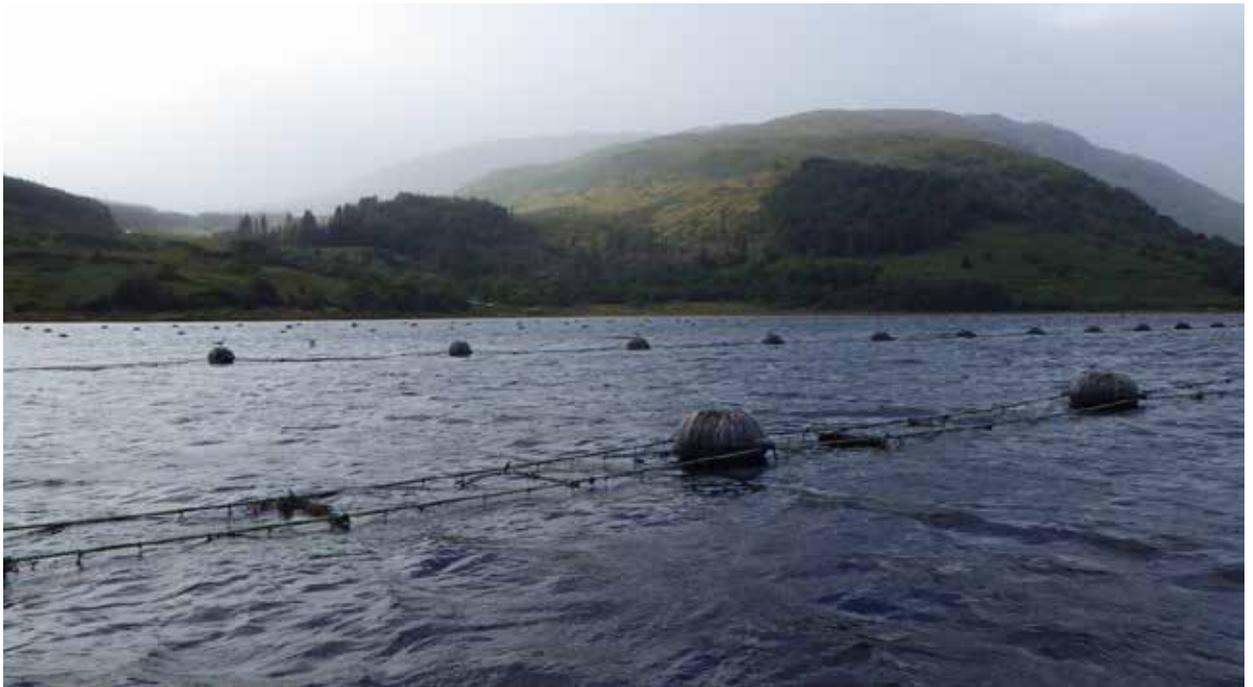
Fig 3: NE end of second line looking S. Waypoint 7, sample LSSW1.

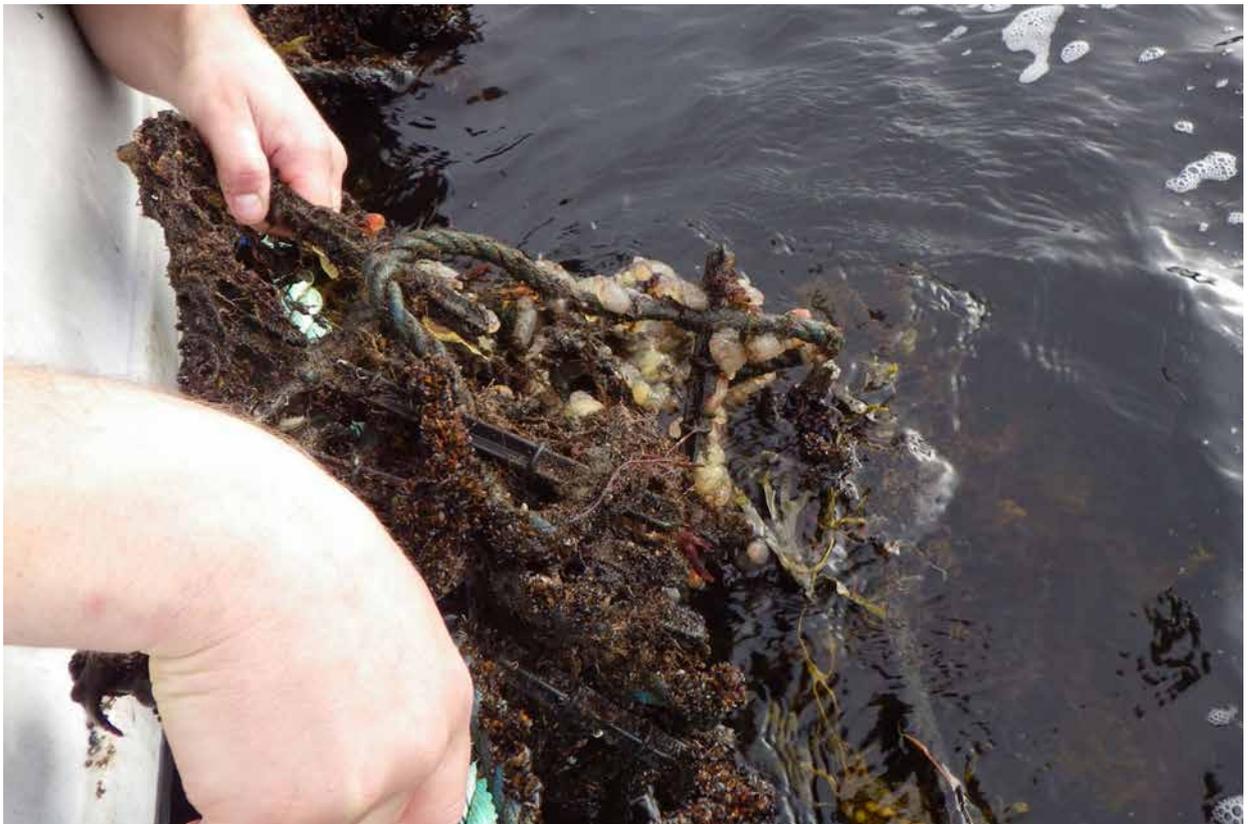
Fig 4: Ladder style dropper present on the three northernmost longlines on the site with a covering of juvenile mussel spat (animals too small to sample).

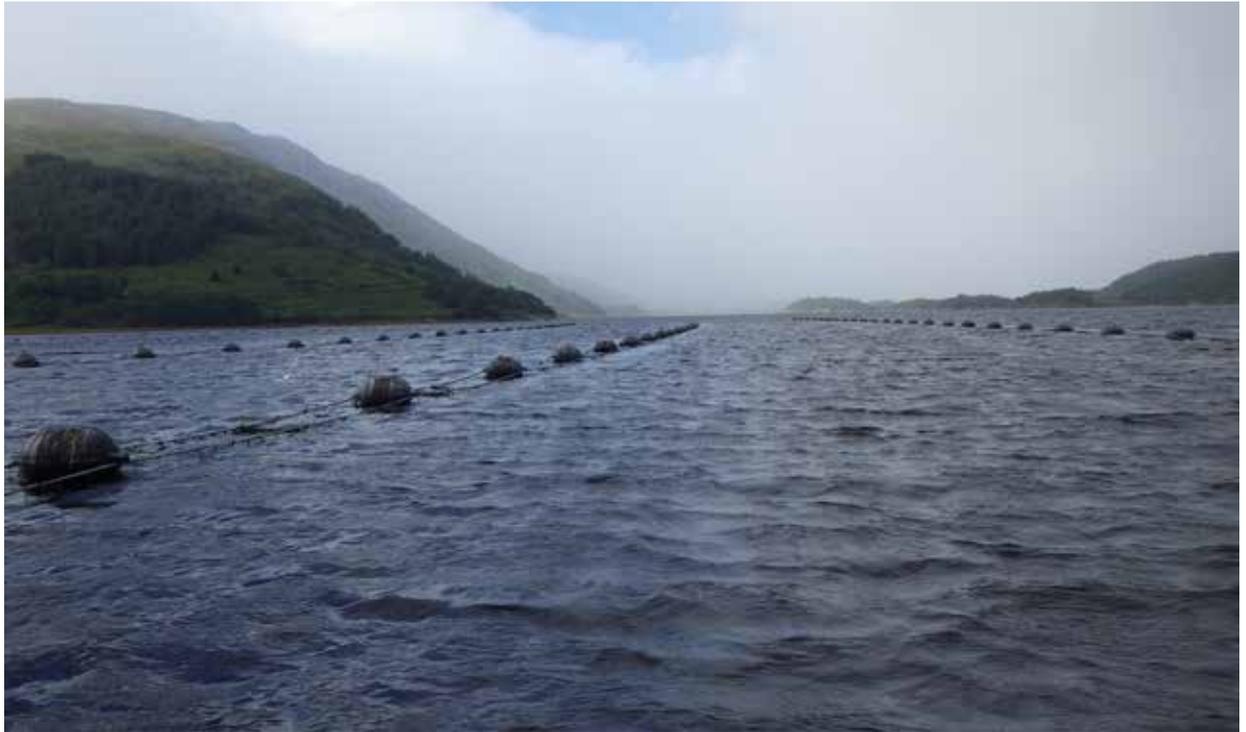
Fig 5: General overview of the longlines at the Liddesdale Mussel farm, looking directly down Loch Sunart to the W. (Waypoint 12, location of LSSF2)

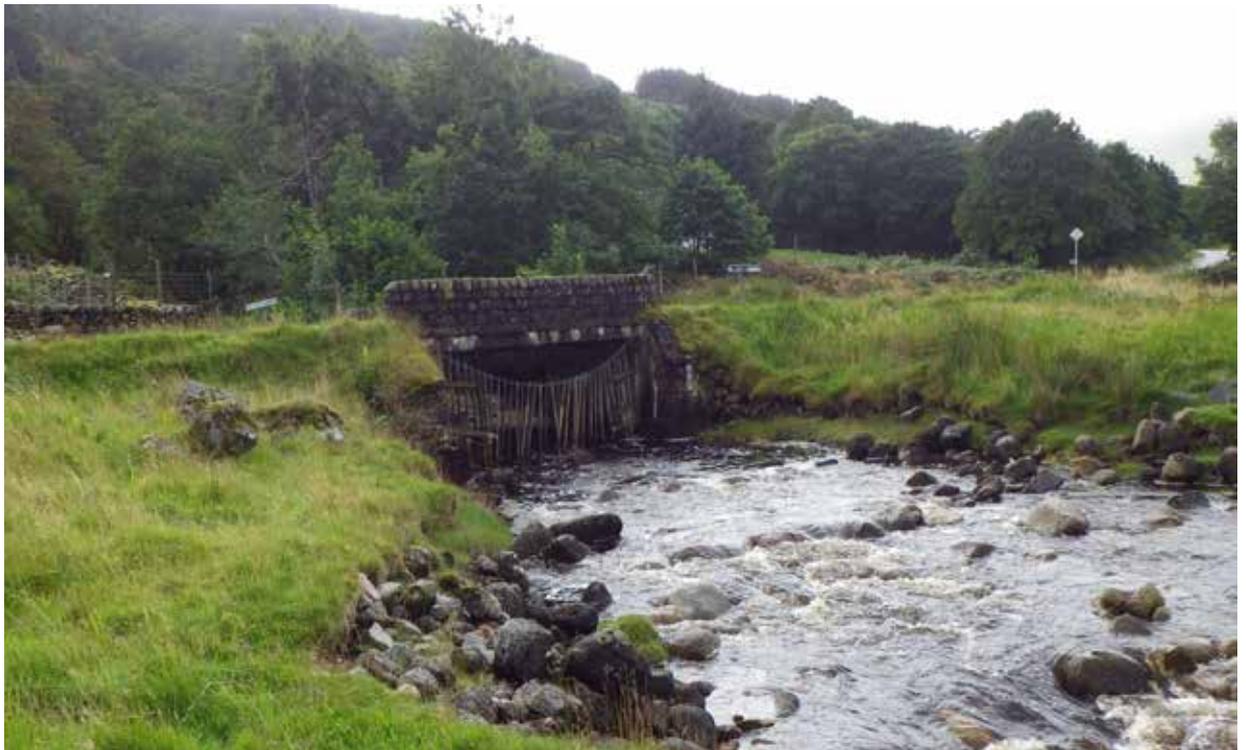
Fig 6: Allt na h-Airigh river running under A884 road – the site of freshwater sample LSFW1, Waypoint 19.

No.	Date	Time	NGR	East	North	Associated photograph	Associated sample	Description
19	02/09/2013	13:17	NM 78833 59718	178833	759718	Fig 6	LSFW1	Freshwater sample LSF1. Sample associated with observations made in waypoint 20.
20	02/09/2013	13:20	NM 78834 59722	178835	759722			Observations: width 5 m, flows (1) depth 50 cm, 0.0380 m/s SD 0.042 (2) depth 74 cm, 0.272 m/s SD 0.071.
21	02/09/2013	13:31	NM 78723 59733	178724	759733	Fig 7		Old yard - appears disused and no signs of recent activity. No discharges visible on shoreline. Two moorings present with 1 yacht moored and 1 mussel harvesting raft.
22	02/09/2013	13:33	NM 78672 59725	178673	759726			Small stream not sampled because flowing from uninhabited woodland above.
23	02/09/2013	13:40	NM 78385 59736	178386	759737	Fig 8		Red deer stag grazing on shore.
24	02/09/2013	13:43	NM 78255 59748	178255	759749			Small stream not sampled because flowing from uninhabited woodland above.

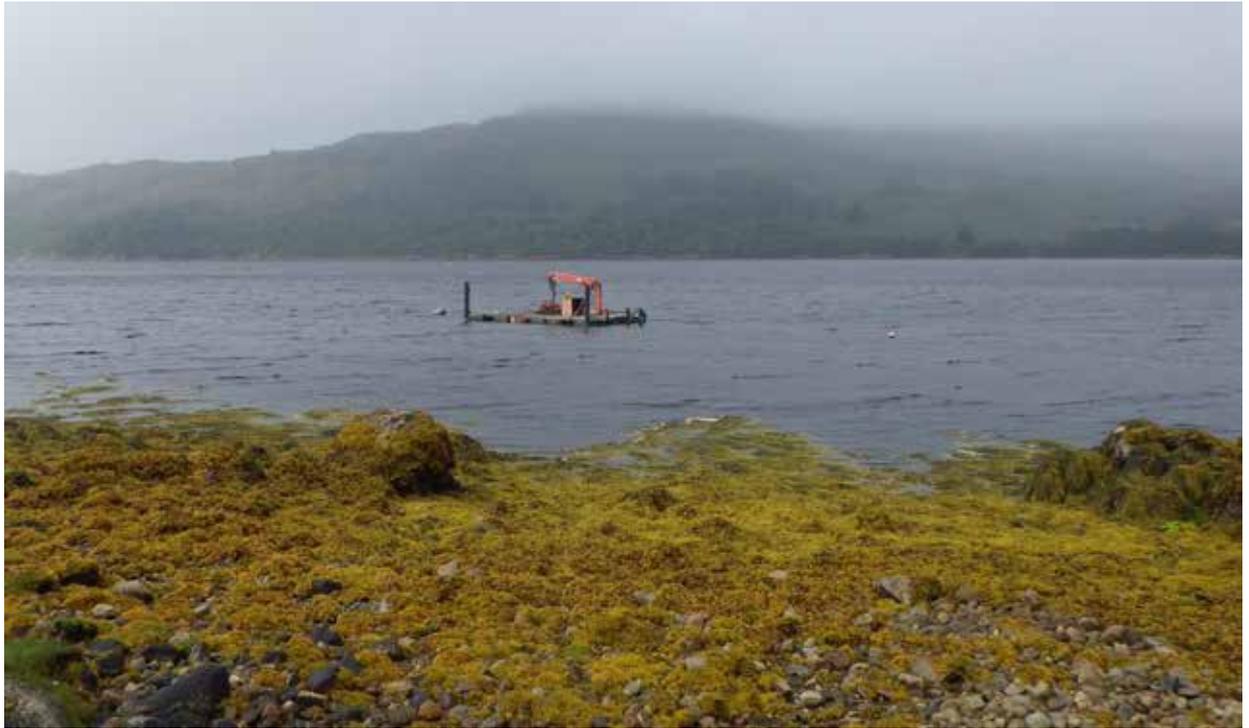
Fig 7: Commercial Harvest raft moored off S shore. Waypoint 21.

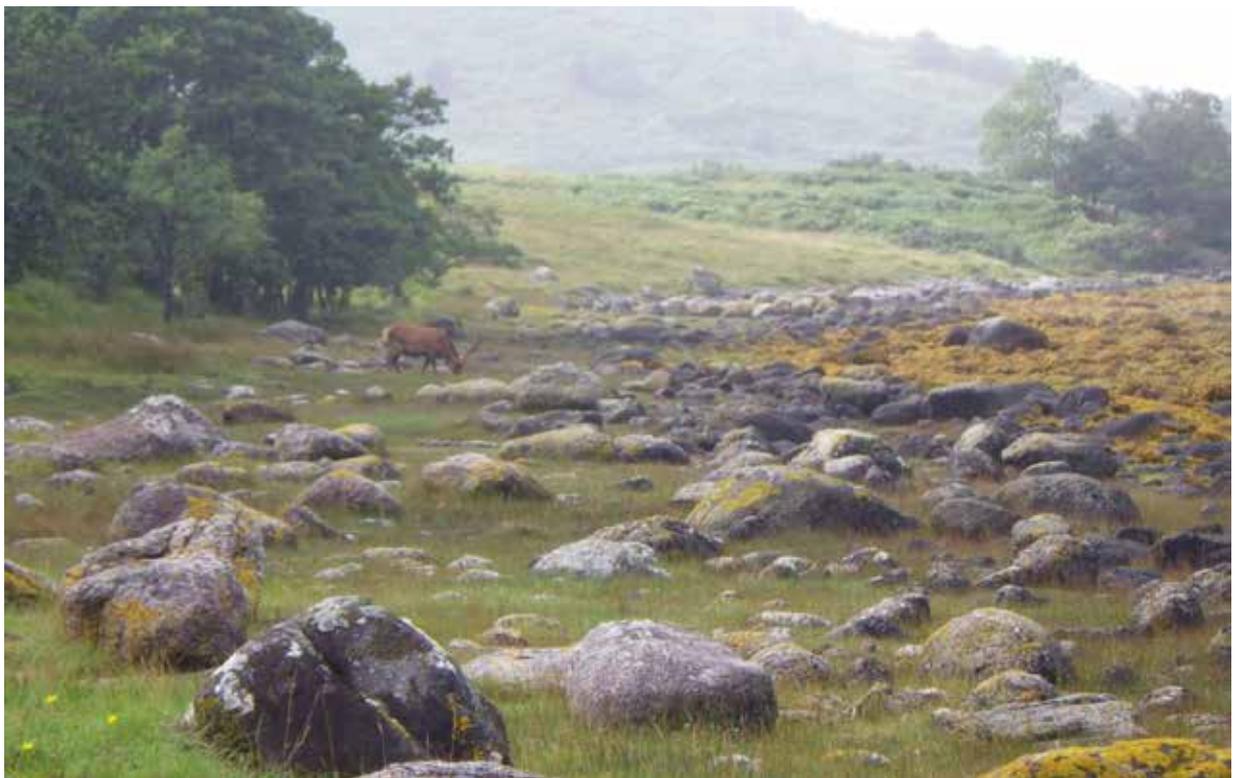
Fig 8: Typical shoreline along S shore of Loch Sunart, with rough ground above shore. Red deer stag grazing on the shoreline. Waypoint 23.

Very few birds were seen during the survey, with only one grey heron and two pigeons noted on the second day of survey. On the first day of the survey a red deer stag was seen grazing on the southern foreshore (Fig.8) and on the second day an otter was observed in the sea near the north shore (Waypoint 52).

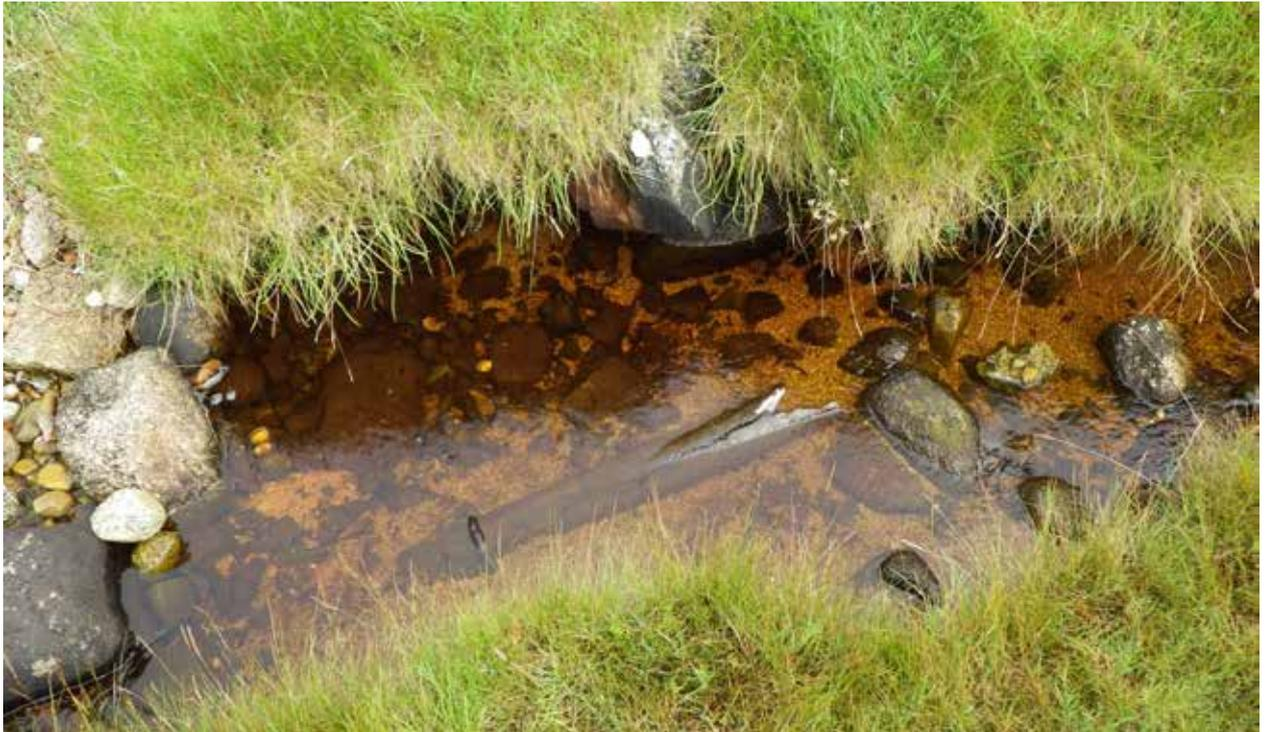
Fig 9: Section of broken pipe present in unnamed stream at waypoint 27. No evidence of discharge into bay, or inflow into stream above or below presence of pipe. Site of extra freshwater sample (LSFW2).

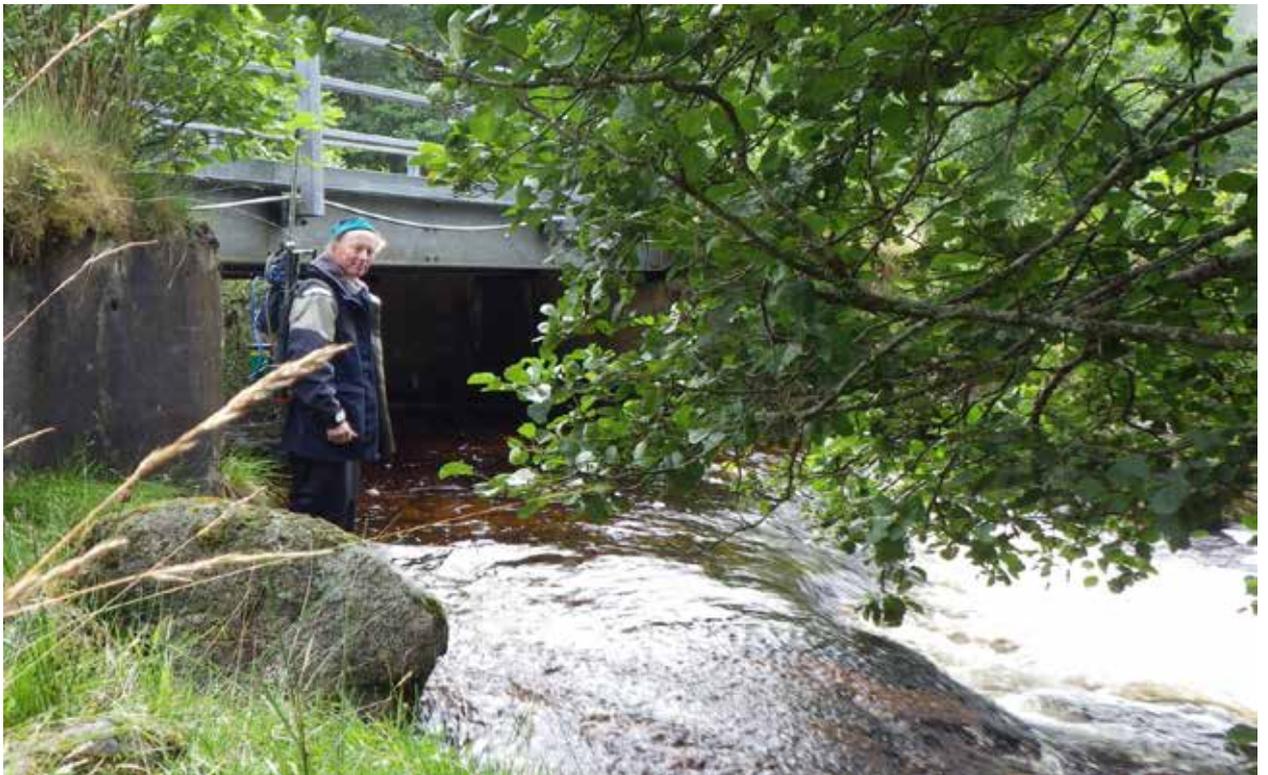
Fig 10: Liddesdale Burn running under unnamed, dead-end minor road – the site of freshwater sample LSF3. Waypoint 29.

The largest watercourse in the area is the Strontian River (Fig.11), which discharges into Loch Sunart on its north shore at NM 81355 61067. On the southern shore of the loch, the Allt na h-Airigh enters the loch at NM 78834 59746, and the Liddesdale Burn (Fig.10) enters at NM 77801 59666. On the northern shore numerous smaller watercourses enter the loch, the largest of which (after the Strontian River) are the Burn an Uillt at NM 79901 61298 and the Allt a Mhuilinn at NM 78922 61139.

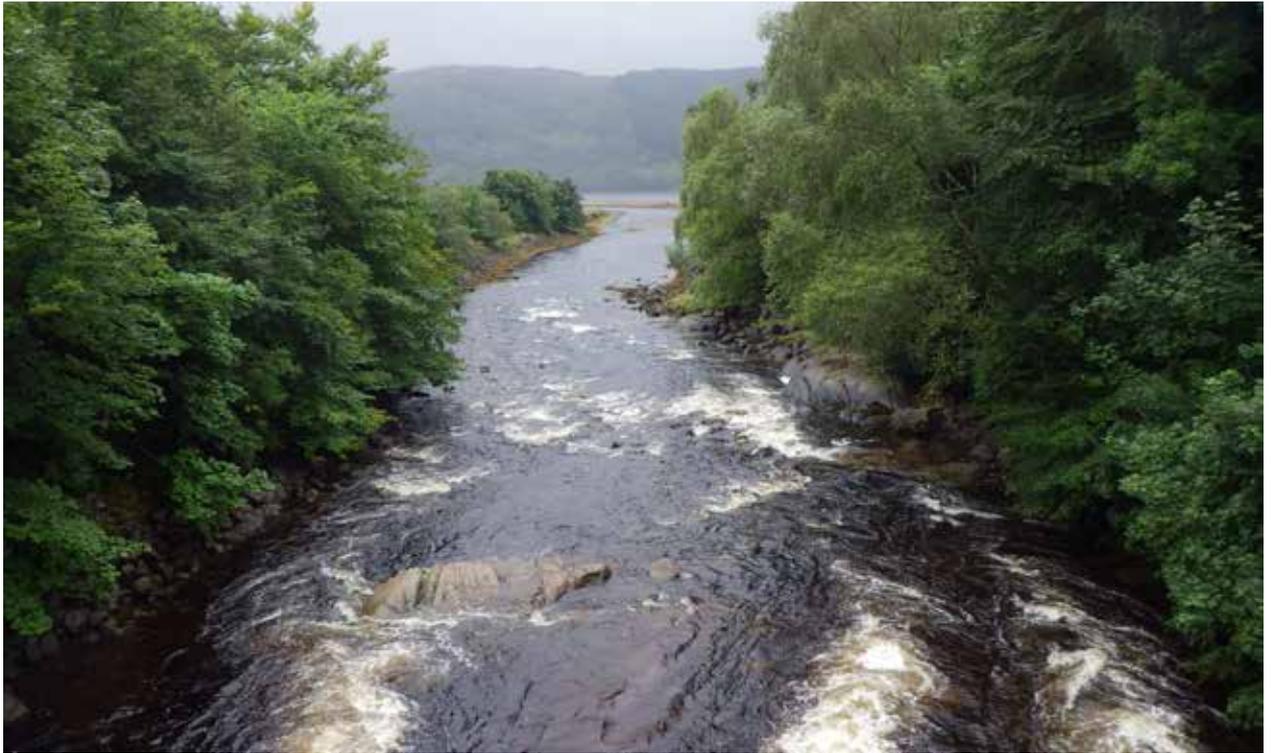
Fig 11: Strontian River taken from the road bridge in the village. Access to the banks and into the river to sample was not possible at this location. Waypoint 32.

31	02/09/2013	14:14	NM 77818 59589	177819	759590			End of survey S shoreline Day 1. On return to van two sheep seen on the shore at site of WP17.
32	03/09/2013	9:12	NM 81391 61698	181392	761698	Fig 11		Star of survey Day 2. No freshwater sample at bridge because of steep banks and fast flow - not safe to access.

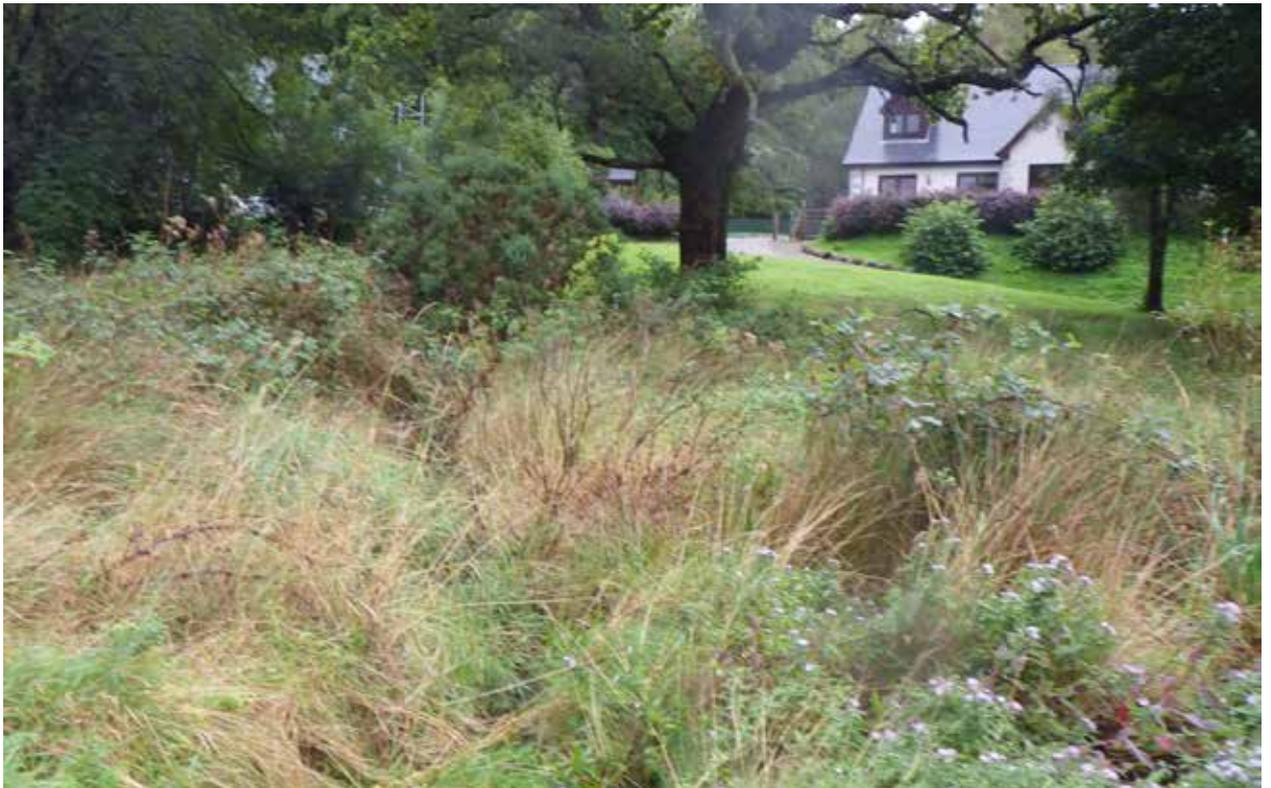
Fig 12: Houses present near the mouth of the Strontian River. A small burn runs through the centre of the photo, and there was building work underway on the house (hidden by trees left of centre of photo). Waypoint 33, location of extra freshwater sample LSF4.

No.	Date	Time	NGR	East	North	Associated photograph	Associated sample	Description
33	03/09/2013	9:19	NM 81346 61531	181346	761532	Fig 12	LSFW4	Extra freshwater sample taken at small stream running from hotel grounds. Sample taken because of houses immediately above (including one under construction). Sample associated with observations in waypoint 34.
34	03/09/2013	9:23	NM 81348 61531	181348	761531			Observations: width 60 cm, depth 21 cm, flow 0.130 m/s SD 0.017.
35	03/09/2013	9:28	NM 81280 61396	181281	761396			Pontoon plus slipway for hotel.
36	03/09/2013	9:29	NM 81278 61386	181278	761387			Small stream running into main river - not sampled - no houses adjacent.
37	03/09/2013	9:33	NM 81291 61396	181292	761396		LSFW5	Returned to slipway to sample main river as it was the best place to sample before the river entered Loch Sunart. The river was still very deep and fast flowing at this point (in spate), so it was not possible to take flow measurements properly. Freshwater sample (LSFW5) taken. Sample associated with observations in waypoint 38.

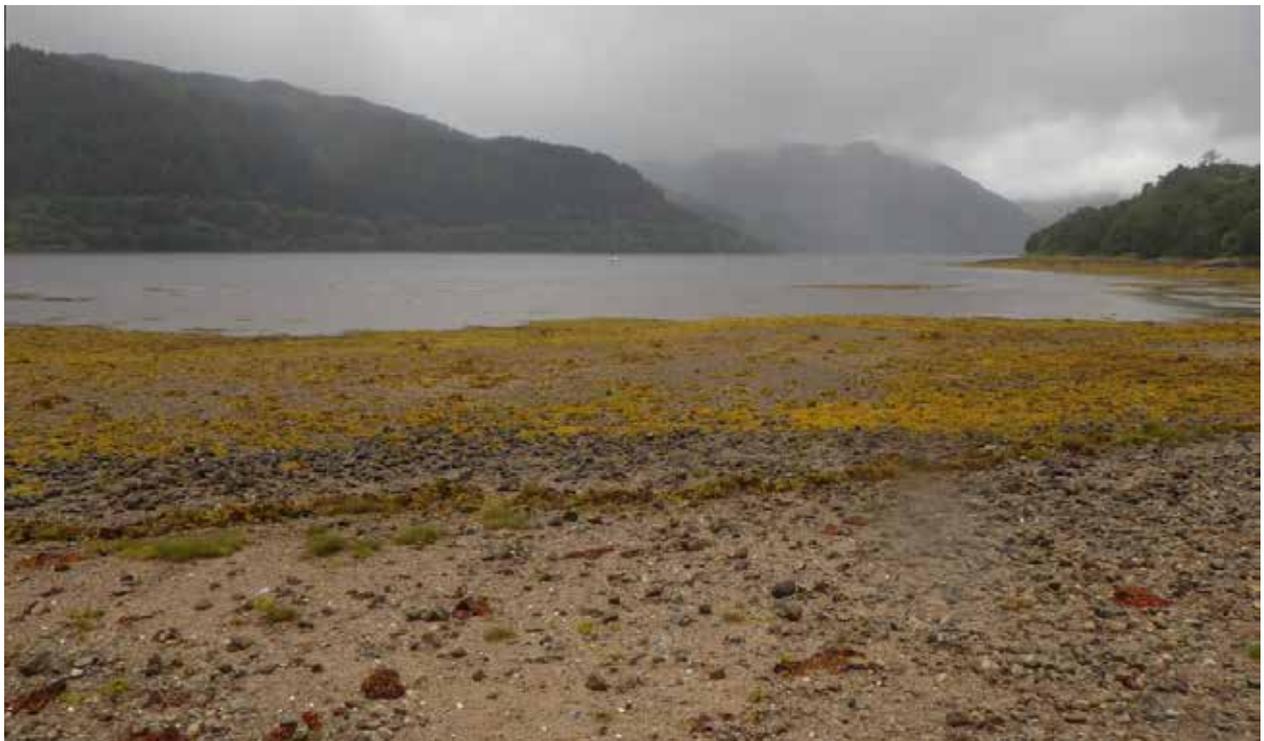
Fig 14: View west along the loch from the Sunart river estuary with two moored pleasure craft right of centre, taken from waypoint 39.

38	03/09/2013	9:37	NM 81293 61398	181293	761399			Observations: width 15 m (visual estimate); flow 0.0806 m/s SD 0.081. Depth at side of slipway approx. 80cm. No further measurements possible due to depth of river.
39	03/09/2013	9:45	NM 81178 61155	181179	761155	Figs 13, 14 and 15		Photo of Kilcamb Lodge Hotel, L. Sunart W and E. Total of 5 moorings off bay, 3 unoccupied and 2 with pleasure craft moored.

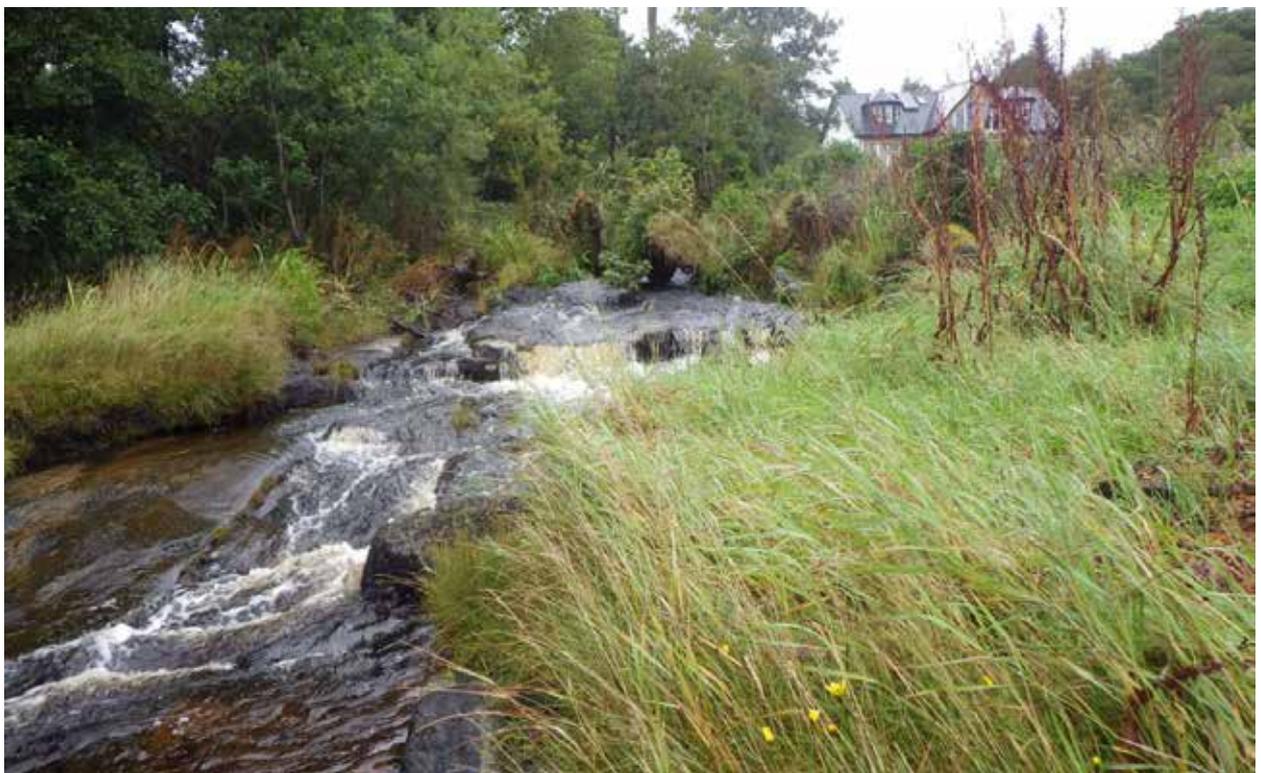
Fig 16: Allt-ard-nan-Staing River, with housing adjacent. Waypoint 46. Location of sample LSF6.

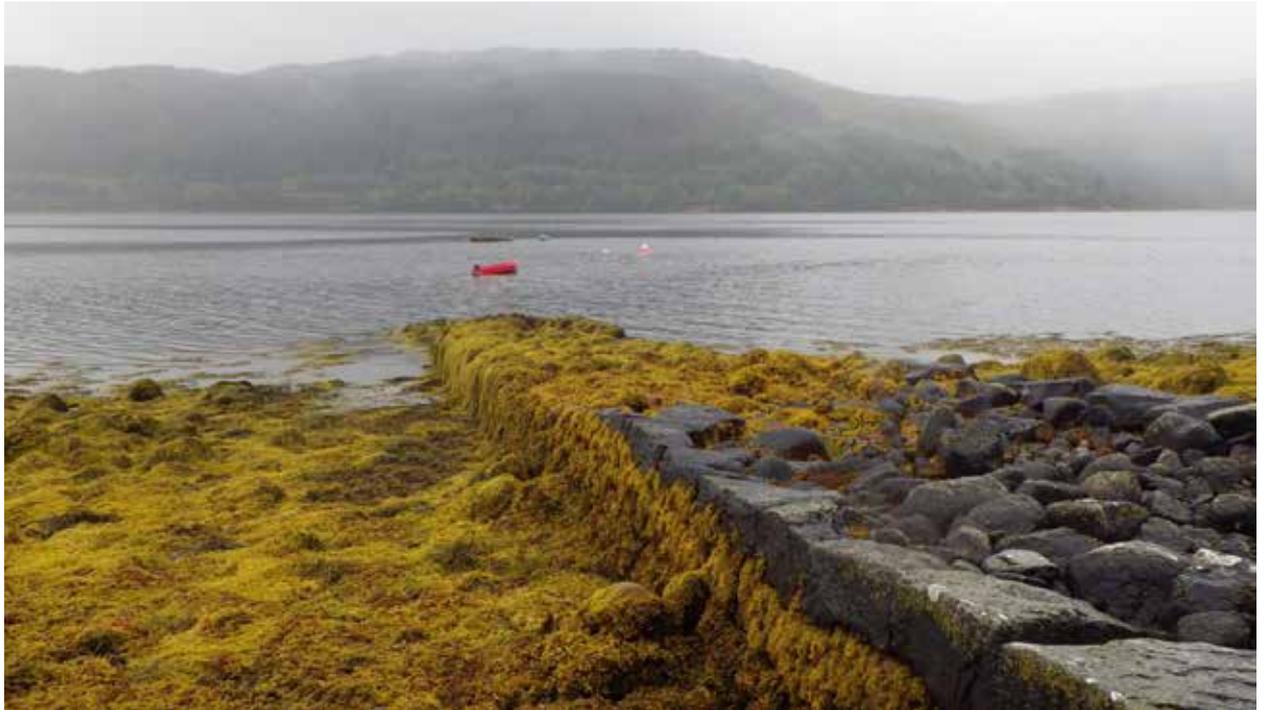
Fig 17: Jetty on northern shore of Loch Sunart, with boats on mooring offshore. Waypoint 50.

No.	Date	Time	NGR	East	North	Associated photograph	Associated sample	Description
50	03/09/2013	10:43	NM 79622 61177	179623	761178	Fig 17		Old stone jetty with some boats above shoreline. 4 moorings present with 2 occupied, one with a small pleasure craft, and one with a commercial raft.
51	03/09/2013	10:47	NM 79517 61136	179518	761137			Small stream similar to waypoint 40.
52	03/09/2013	10:56	NM 79226 61021	179227	761021			Wildlife: otter seen in sea by shoreline.
53	03/09/2013	11:03	NM 79000 61064	179000	761065		LSFW7	Freshwater sample. Sample associated with observations in waypoint 54.
54	03/09/2013	11:07	NM 78993 61079	178993	761080			Observation: width 90 cm, depth 4 cm, flow 0.433 m/s SD 0.009
55	03/09/2013	11:14	NM 78914 61128	178914	761129		LSFW8	Freshwater sample. Sample associated with observations in waypoint 56.
56	03/09/2013	11:16	NM 78911 61131	178912	761132			Observations: width 7 m (1) depth 20 cm, flow 0.110 m/s SD0.008; (2) depth 32 cm, flow 0.226 SD0.021; (3) depth 24 cm, flow 0.228 m/s SD 0.012; (4) depth 31 cm, flow 0.284 SD0.017.

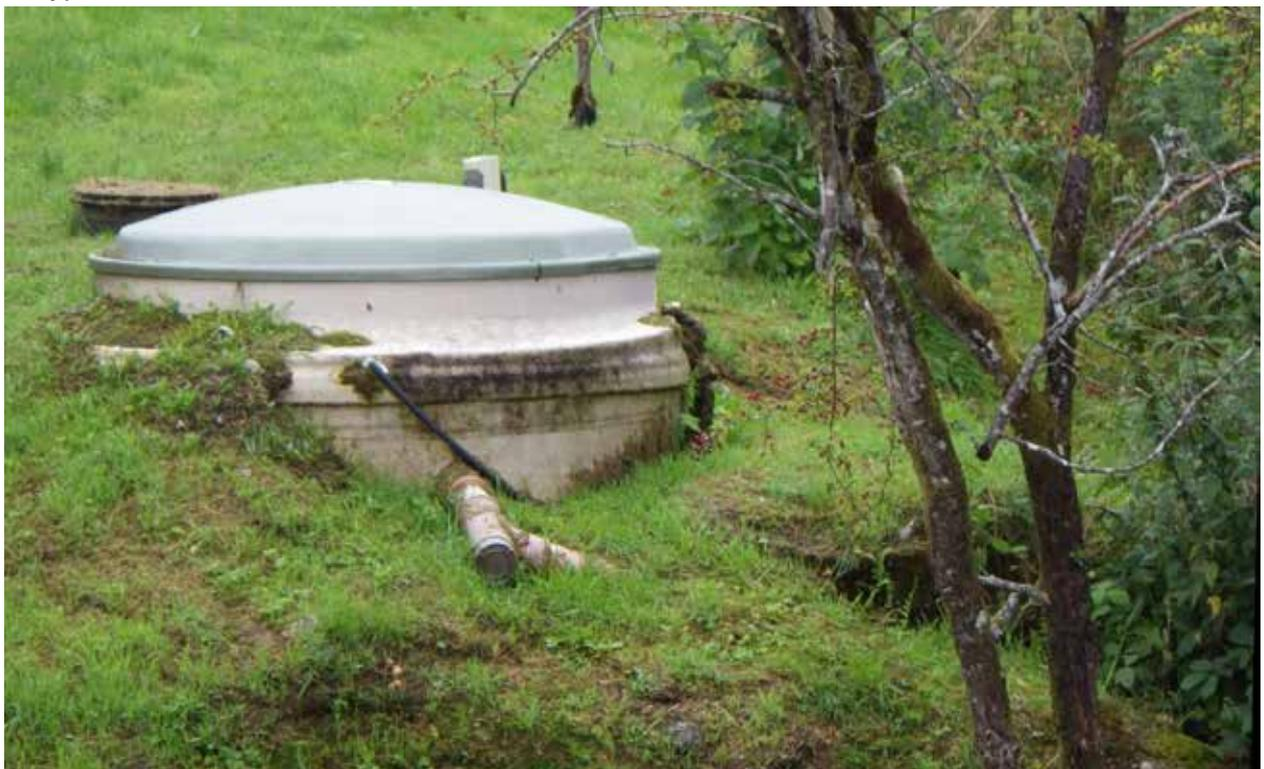
No.	Date	Associated Photograph (Appendix 5)	Description
1	03/09/2013	Fig 18	Septic tank outfall possibly directly into Allt Ard nan Staing, noted while walking along main A861 road back to start point.

Observation 1 reported a domestic septic tank with a pipe running into a watercourse. There appear to be electrical cables going to the unit suggesting that this may be a package sewage treatment works. The watercourse receiving the effluent was identified as Allt Ard na Staing by local signage, but is named as Bun an Uillt on Ordnance Survey maps. This watercourse enters the loch at Ardnastang on the northern shore.

Fig 18: Tank observed on roadside while walking along main road back to start point. Drain at front of tank exits into river (Allt ard nan Staing) out of shot to the right. Waypoint for this photo is 58, and the river was sampled earlier in the survey at waypoint 46 (see also Fig. 16).

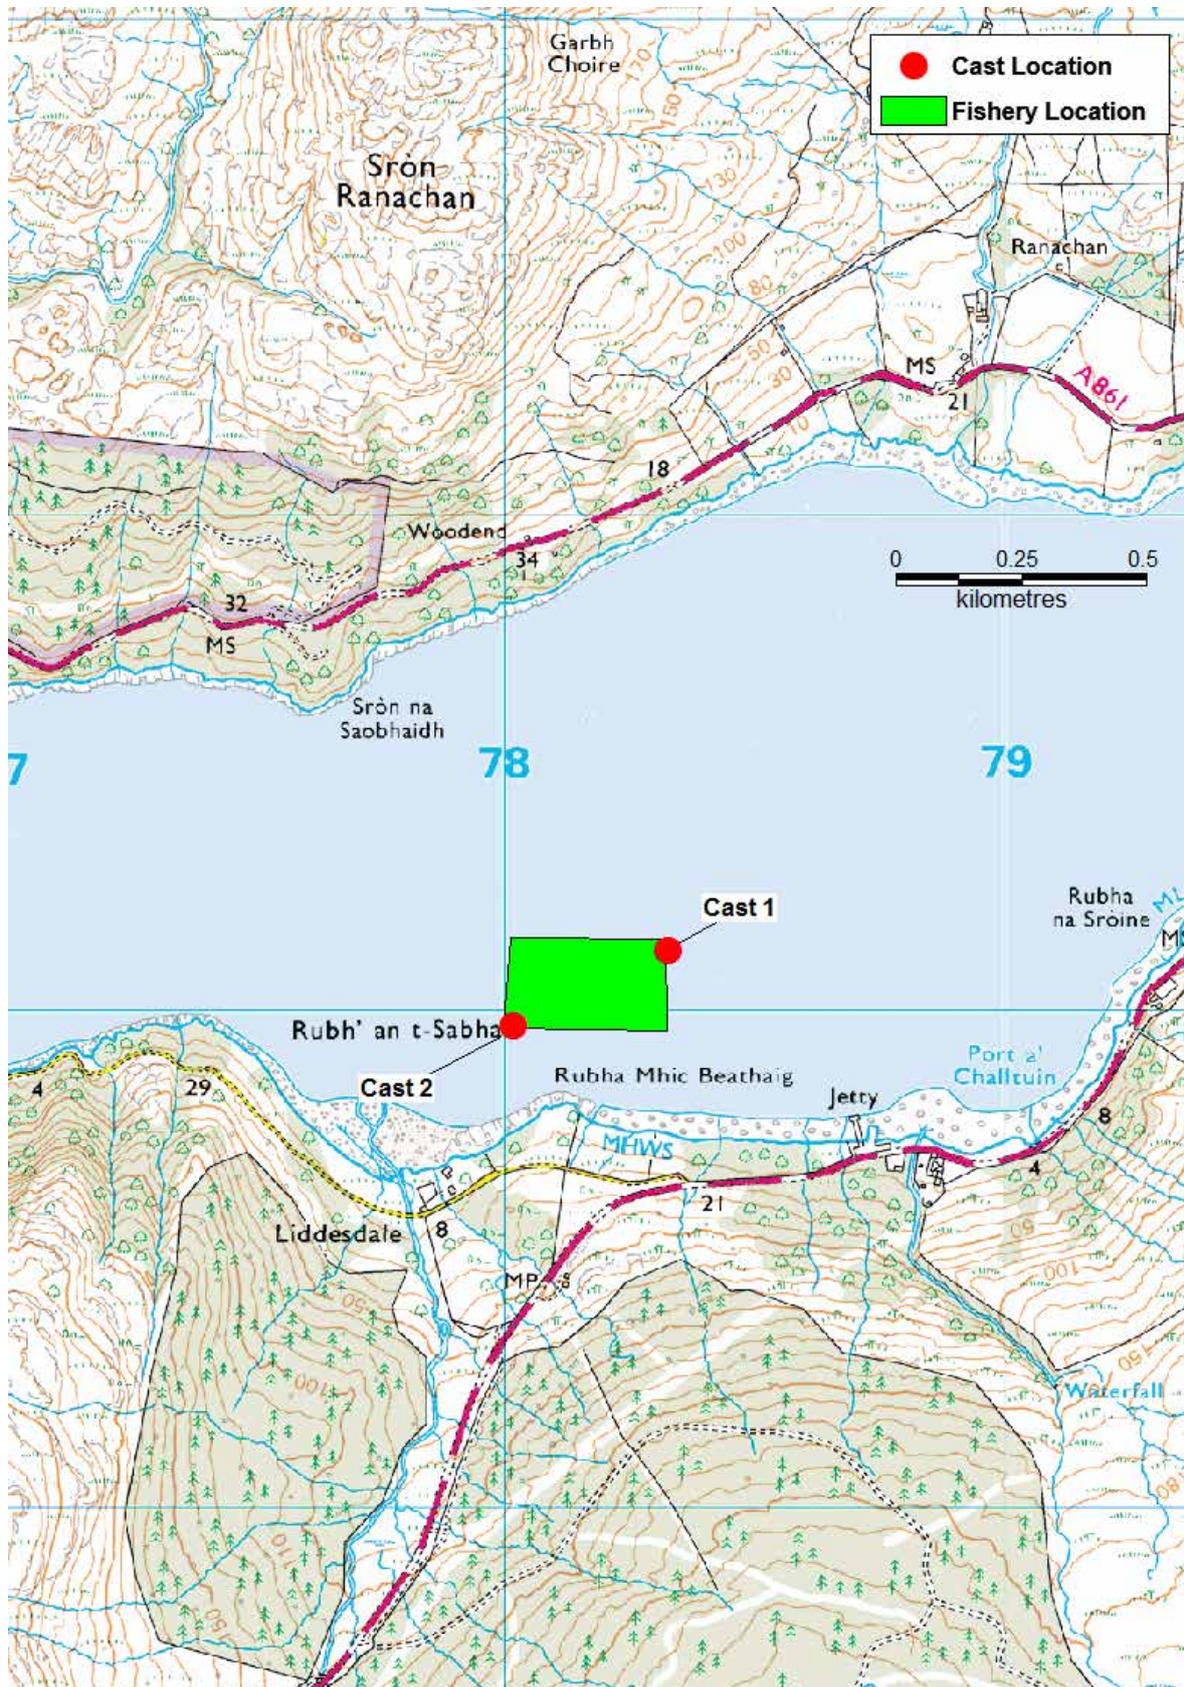
Figure A7.1 CTD cast locations

Data obtained during the shoreline survey. The locations of the casts are shown in Figure A7.1.
