Scottish Sanitary Survey Project

Sanitary Survey Report Loch Leven: Upper HL 171 February 2010

Report Distribution – Loch Leven: Upper

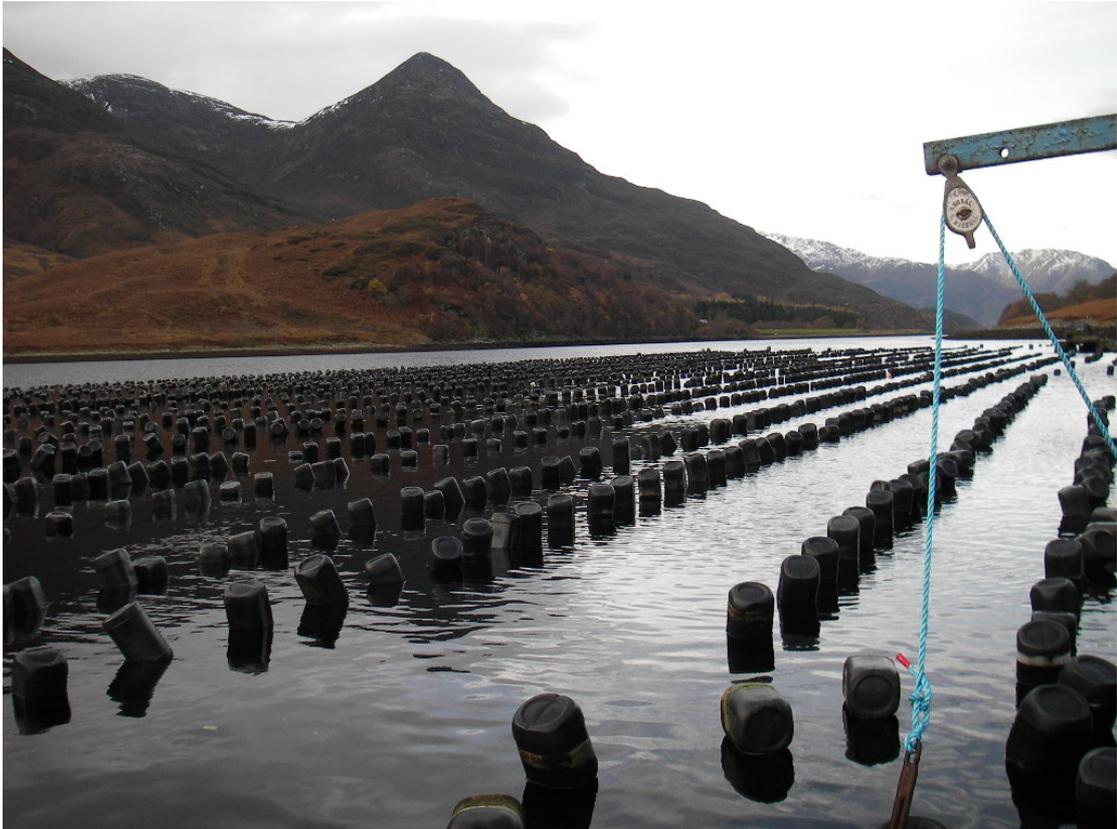
Figure 4 View of the mussel lines

The fishery consists of approximately 20 mussel lines of varying length over an approximately rectangular area of 9,400 square metres. The header lines hang 3 metres below the supporting buoys to avoid the largely fresh water in the upper 3 metres. The mussels are grown on 4 to 6 m droppers from the header lines. The growth cycle takes from 2.5 to 3 years. On the shore side of the lines is a raft on which the cleaning/grading machine is operated. Mussels from both the Lower and Upper Loch Leven sites are brought here for processing. After processing, they are held in holding nets through holes in the raft at a depth of approximately 3 m for between 12 and 48 h to allow them to recover before transport (see Figure 5). Samples for classification purposes have traditionally been taken from these holding nets – the mussels will have originally been sourced from either of the sites. The location of the presently specified RMP plots approximately 50 m to the west of the mussel lines and approximately 40 m to the west of the lease (see Figure 1). It should be noted that RMPs used to be specified to only 100 m accuracy.

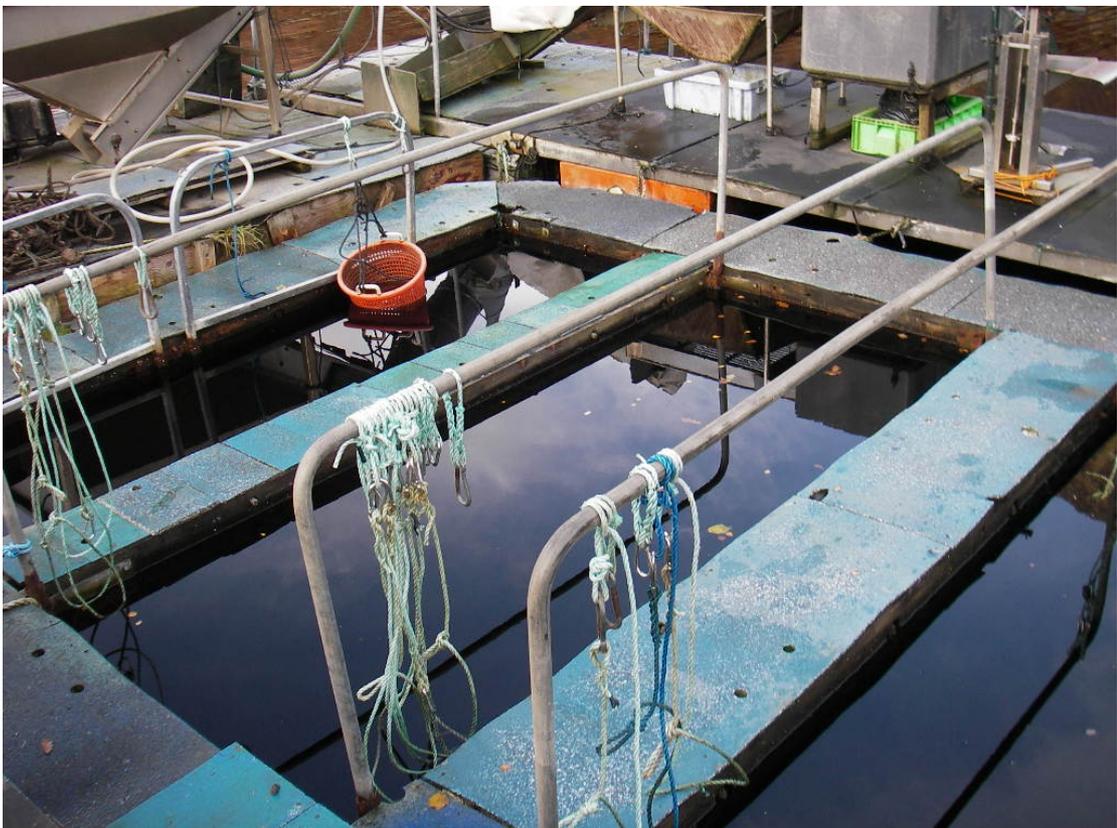
Figure 5 Part of the mussel holding area

Mussels are cleaned and graded from a raft kept between the mussel lines and the north shore of the loch. Mussels from both the Lower (HL 170) and Upper Loch Leven sites are brought here for processing. After processing, mussels are held in holding nets suspended through holes in the raft at a depth of approximately 3 m for between 12 and 48 hours (see Appendix 7, Figure 5). The harvester reports that this to allows the mussels to recover prior to transport. Samples provided by the grower for classification purposes have traditionally been taken from these holding nets. The mussels could have originally been sourced from anywhere within the Upper Loch Leven site.

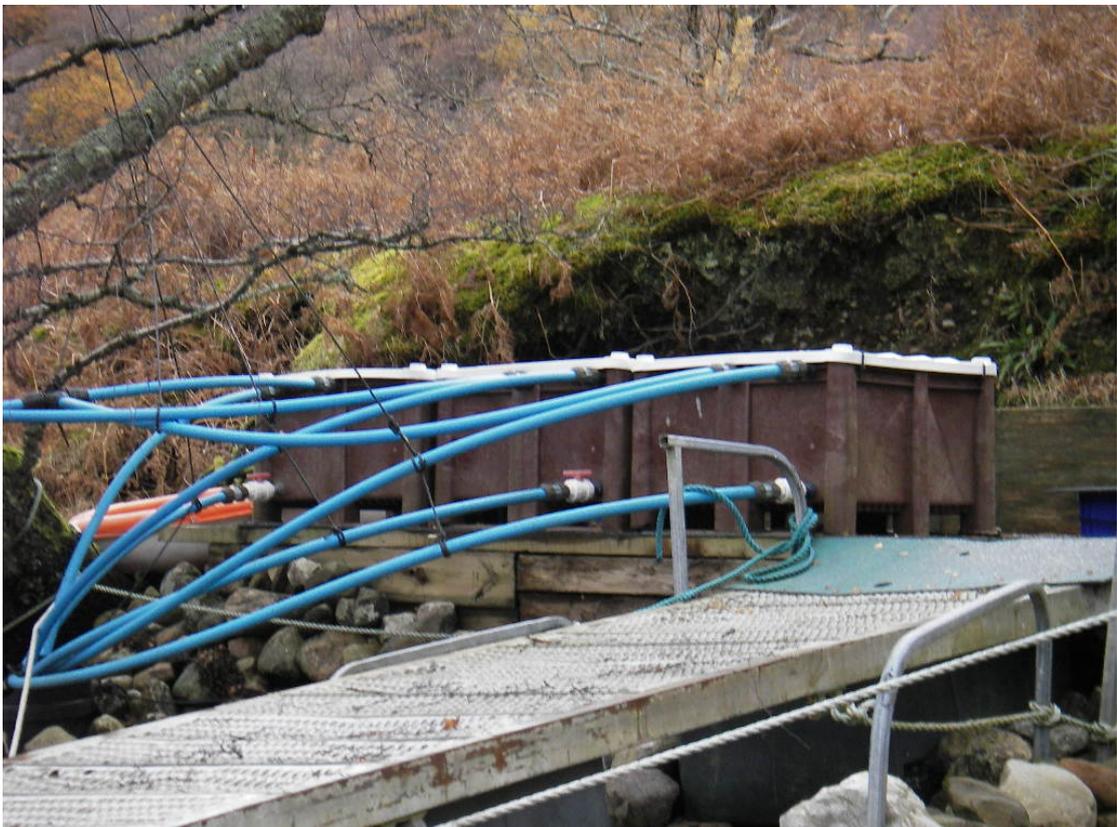
Figure 7 Purification system above the fishery

There is a purification system on the shore above the fishery (Appendix 8, Figure 7). This is operated when the sites are class B. The wastewater from the processing unit and the purification system are both discharged in the vicinity of the fishery.

There is a purification system on the shore above the fishery (Figure 7). This is operated when the sites are class B. The waste water from the processing unit and the purification system are both discharged in the vicinity of the fishery.

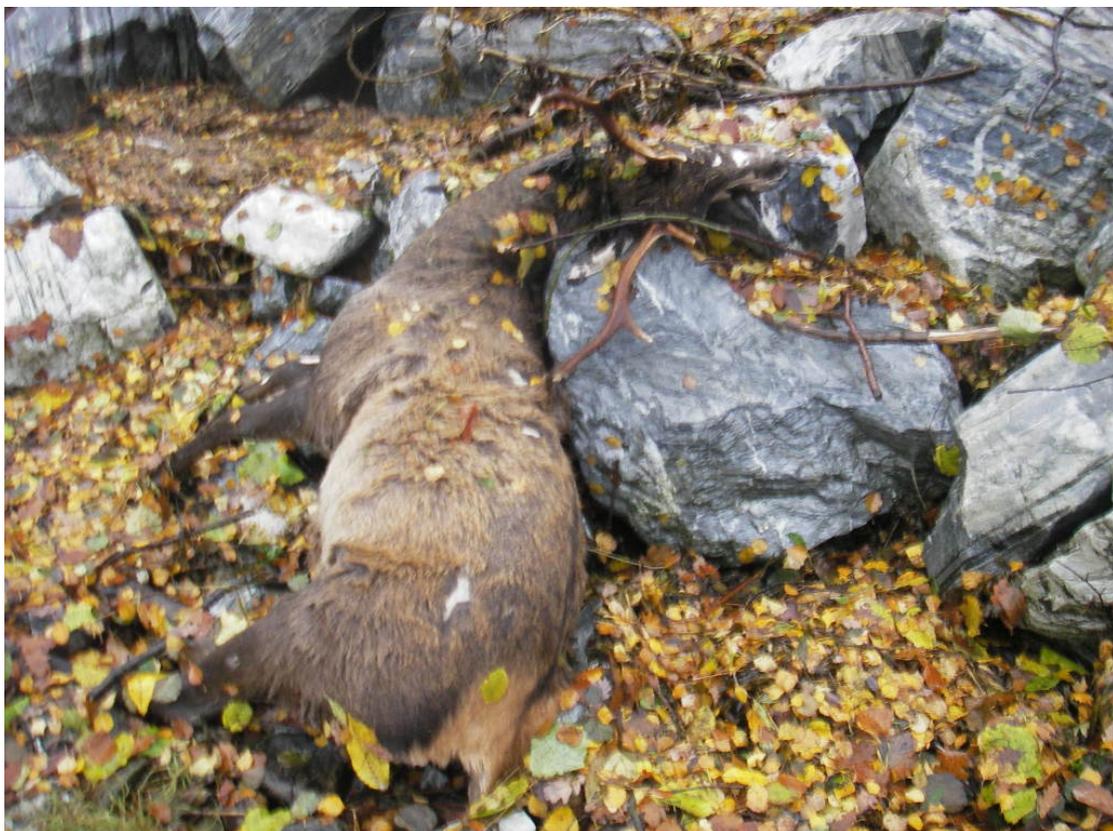
Figure 11 Dead stag on shoreline

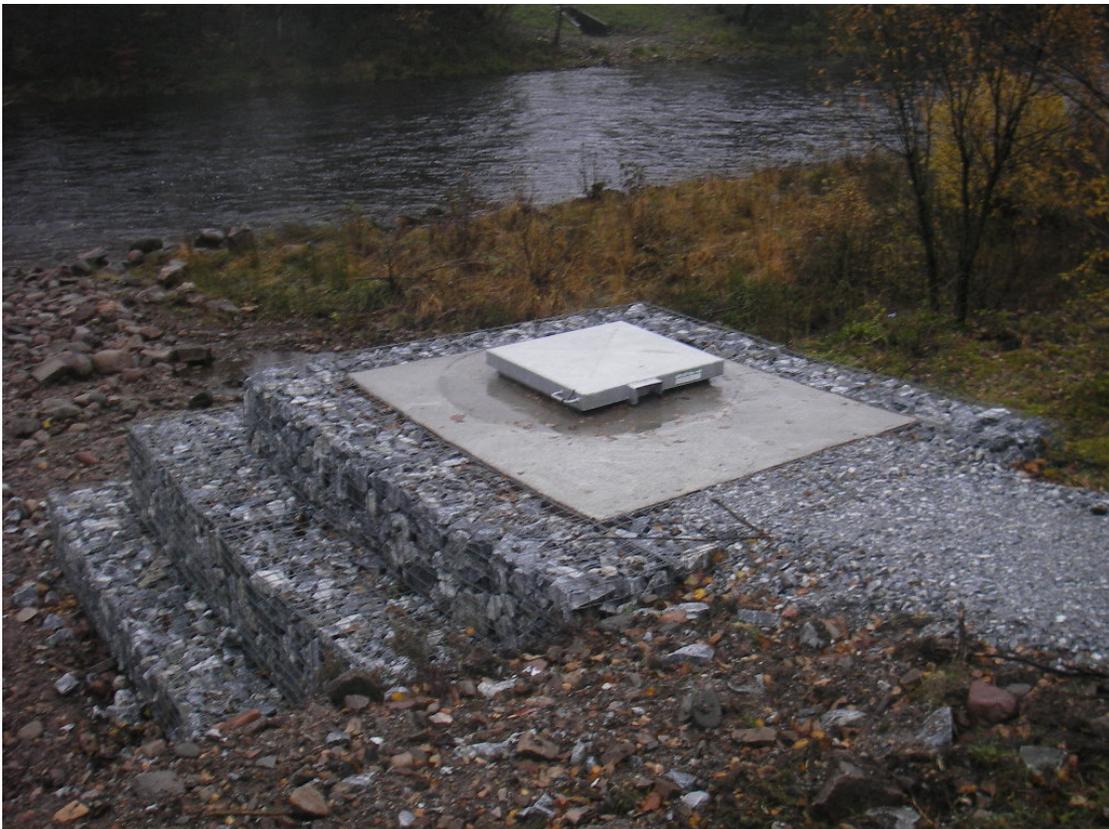
Figure 13 New Combined Sewer Overflow for Kinlochleven WTP

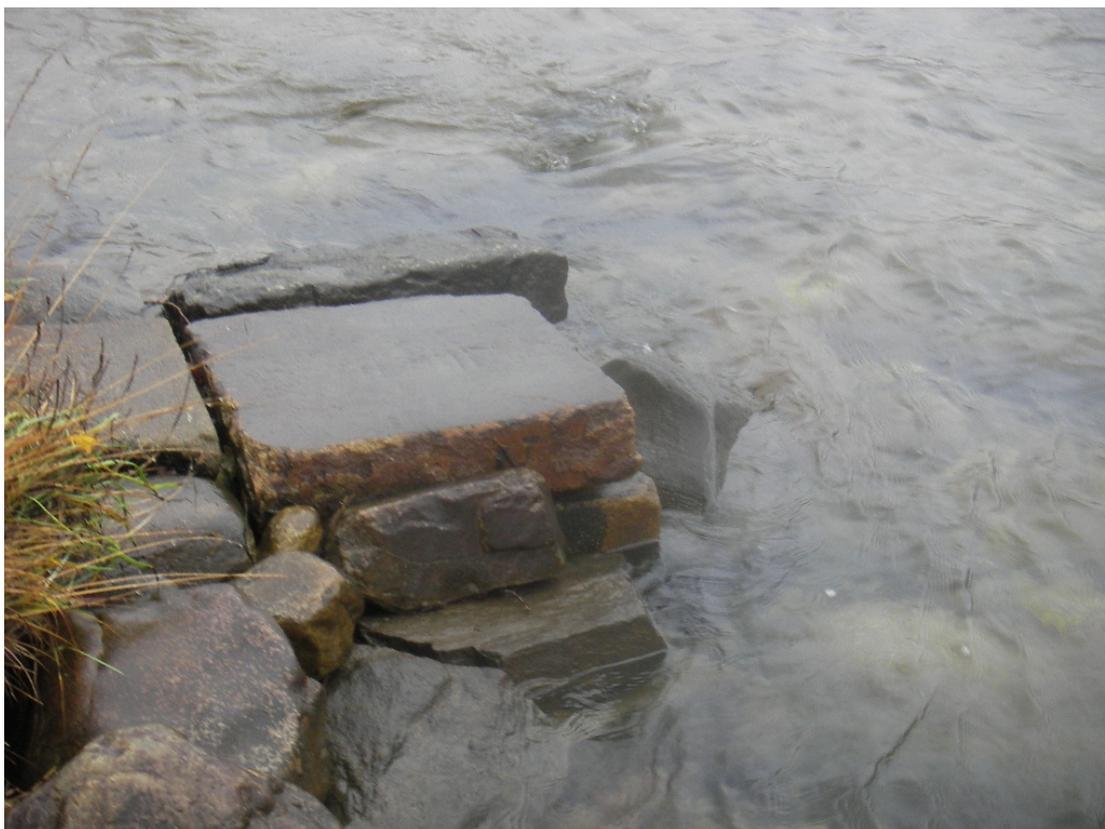
Figure 16 Septic tank outlet
