Scottish Sanitary Survey Report

Sanitary Survey Report
Loch Kanaird
RC-625-1233-13
May 2014

Report Title	Loch Kanaird Sanitary Survey Report
Project Name	Scottish Sanitary Survey
Client/Customer	Food Standards Agency Scotland
Cefas Project Reference	C5792C
Document Number	C5792C_2013_17
Revision	1.0
Date	09/05/2014

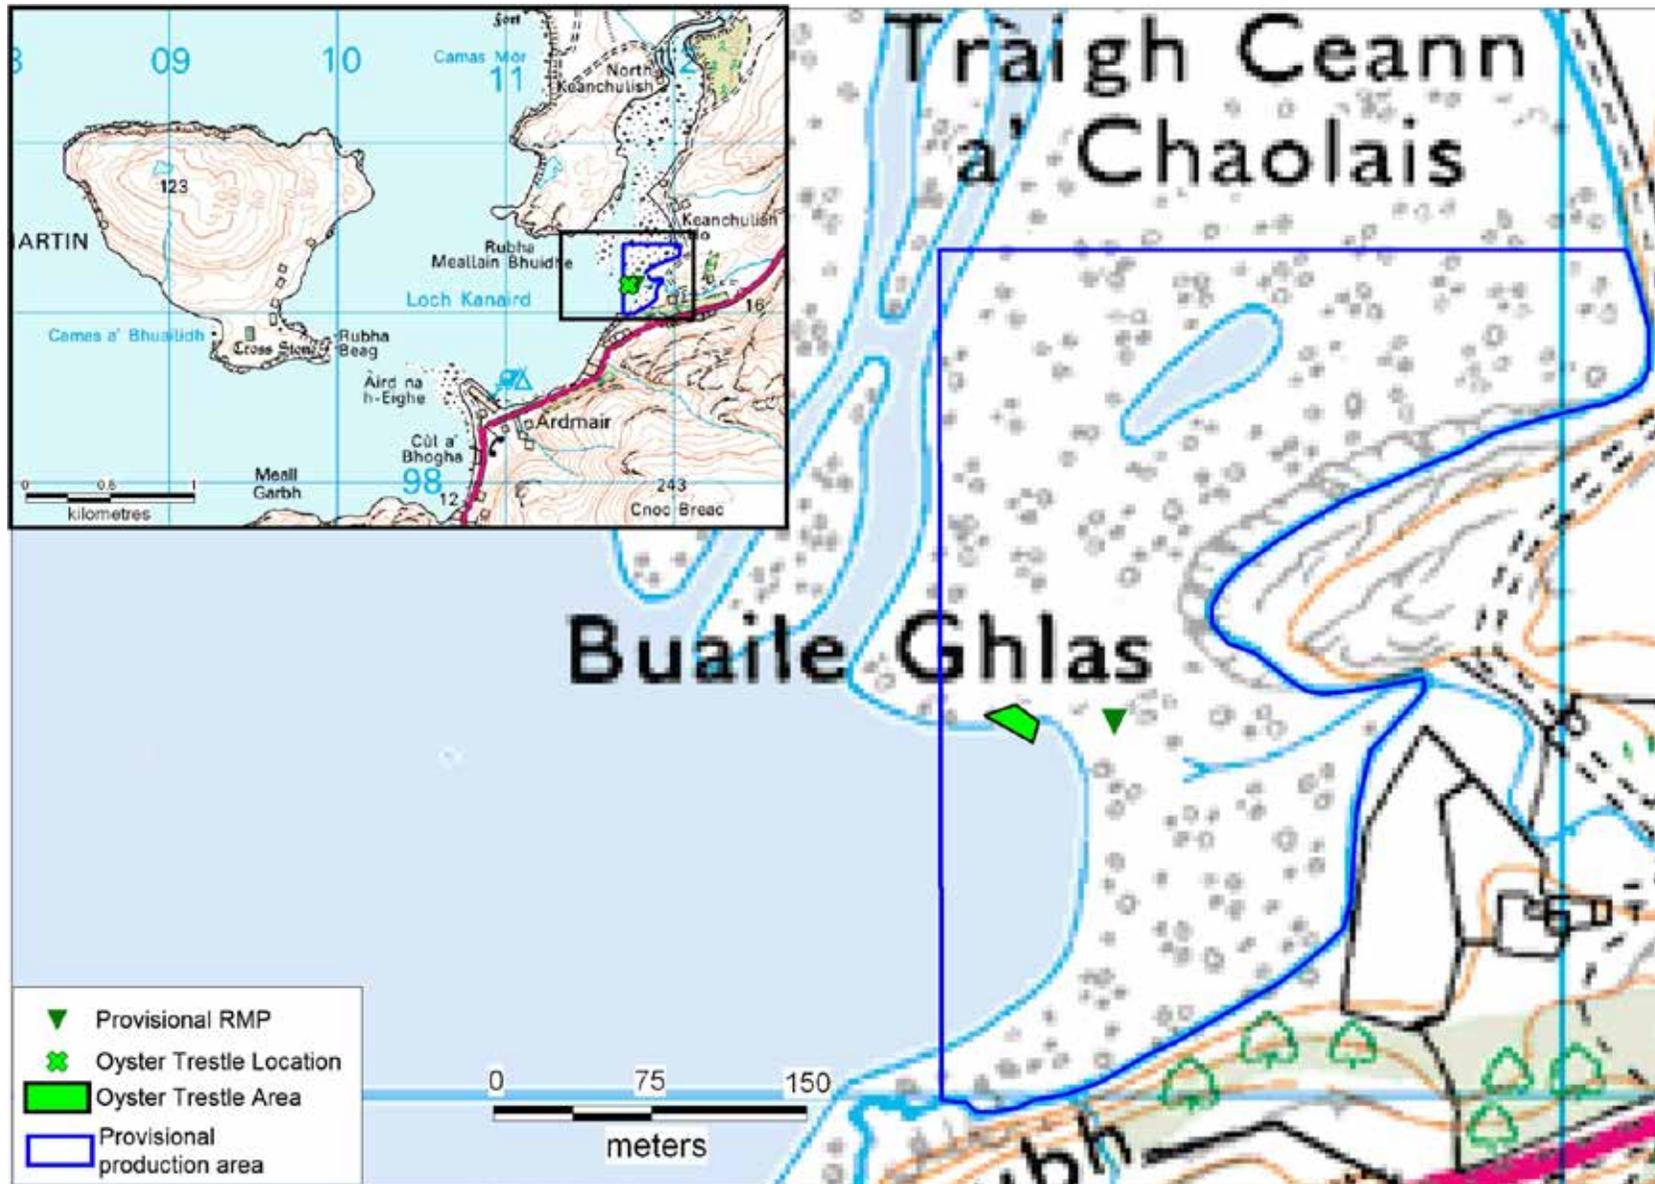
Figure 2.1 Loch Kanaird Fishery

Pacific oysters are grown in poches and baskets supported on trestles located low in the intertidal zone; therefore the site is only accessible at low spring tide. Another trestle is located at the pRMP location, 50 m east. It is higher up the intertidal zone to allow easier access for sampling.

The fishery area recorded in the shoreline survey has been plotted and is presented in Figure 2.1 below.

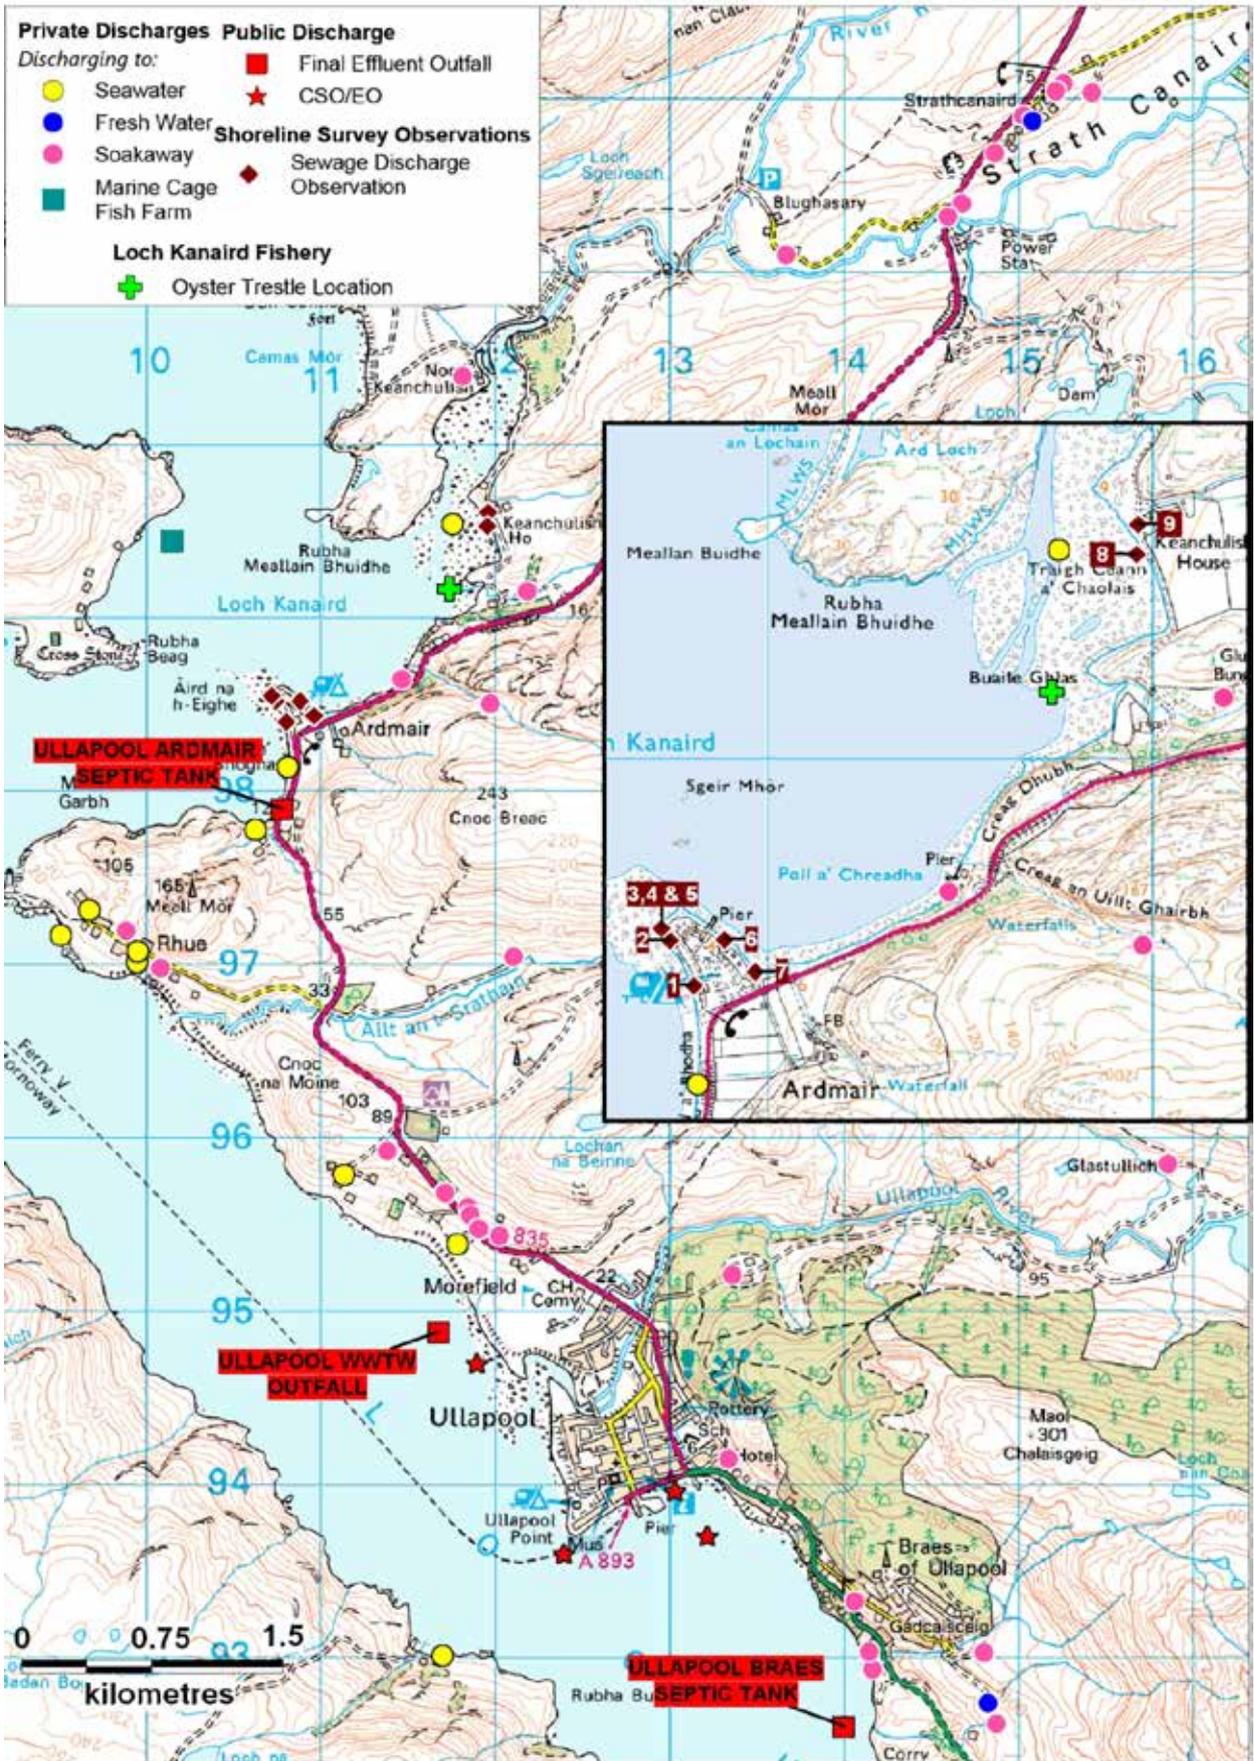
Figure 4.1 Map of discharges for Loch Kanaird

There are several private discharges within 500 m of the oyster farm. The discharge from Keanchulish House lies approximately 370 m north of the oyster farm, along the channel of the River Canaird. This house was not in use at the time of shoreline survey, and is only used intermittently. There are other septic tanks consented to discharge to soakaway upstream along the river. Any of these that have been diverted to discharge to the river or are malfunctioning would potentially cause additional impact to the fishery.

Similarly, if the consented soakaway near the Allt Glutton has been rerouted to discharge to the burn this would be expected to have a relatively direct impact on the fishery, as the watercourse discharges very near the trestles.

A number of discharge pipes were observed around Ardmair Point, the nearest of which lie approximately 1 km southeast of the oyster trestles. As these are related to seasonally occupied accommodation, it is likely that any impact from these would be greatest during the main tourist season of April to September.

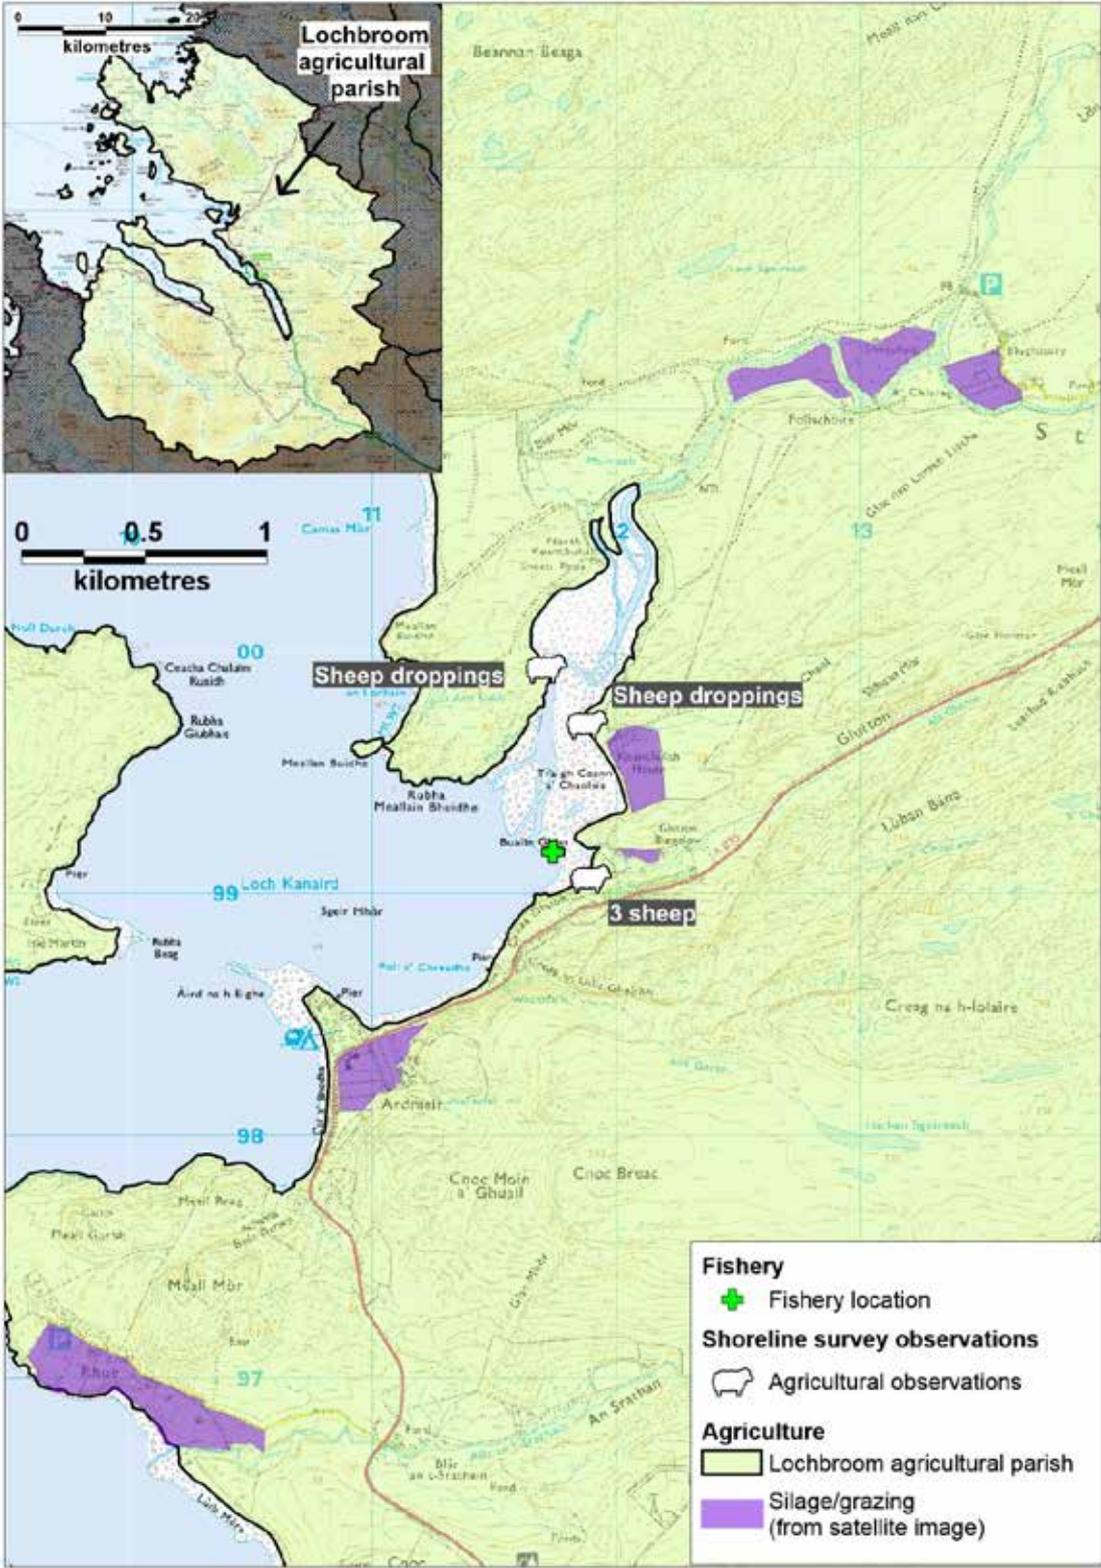
Figure 5.1 Livestock observations at Loch Kanaird

During the shoreline survey, three sheep in total were observed in a field southeast of the fishery and sheep droppings were present on the shoreline north of the fishery. Despite the low numbers of animals seen from the shoreline, it is likely that a much larger number of sheep are normally present in the area. Satellite images from Bing Maps (<http://www.bing.com/maps/?mkt=en-gb>) dated as having been taken in May 2012 (<http://mvexel.dev.openstreetmap.org/bing/>) showed large numbers of sheep present on fields along the upper River Canaird as well as at Keanchulish and Ardmair. At least some of the fields along the river and at Ardmair appeared to be used for silage production. Areas that appeared to be used for crop production and/or grazing are identified in Figure 5.1.

Any contributions of faecal contamination from livestock grazing in the area would be most likely to affect the areas of shellfish bed closest to the shoreline. Although few livestock were present during the survey, the sheep were in close range of the fishery

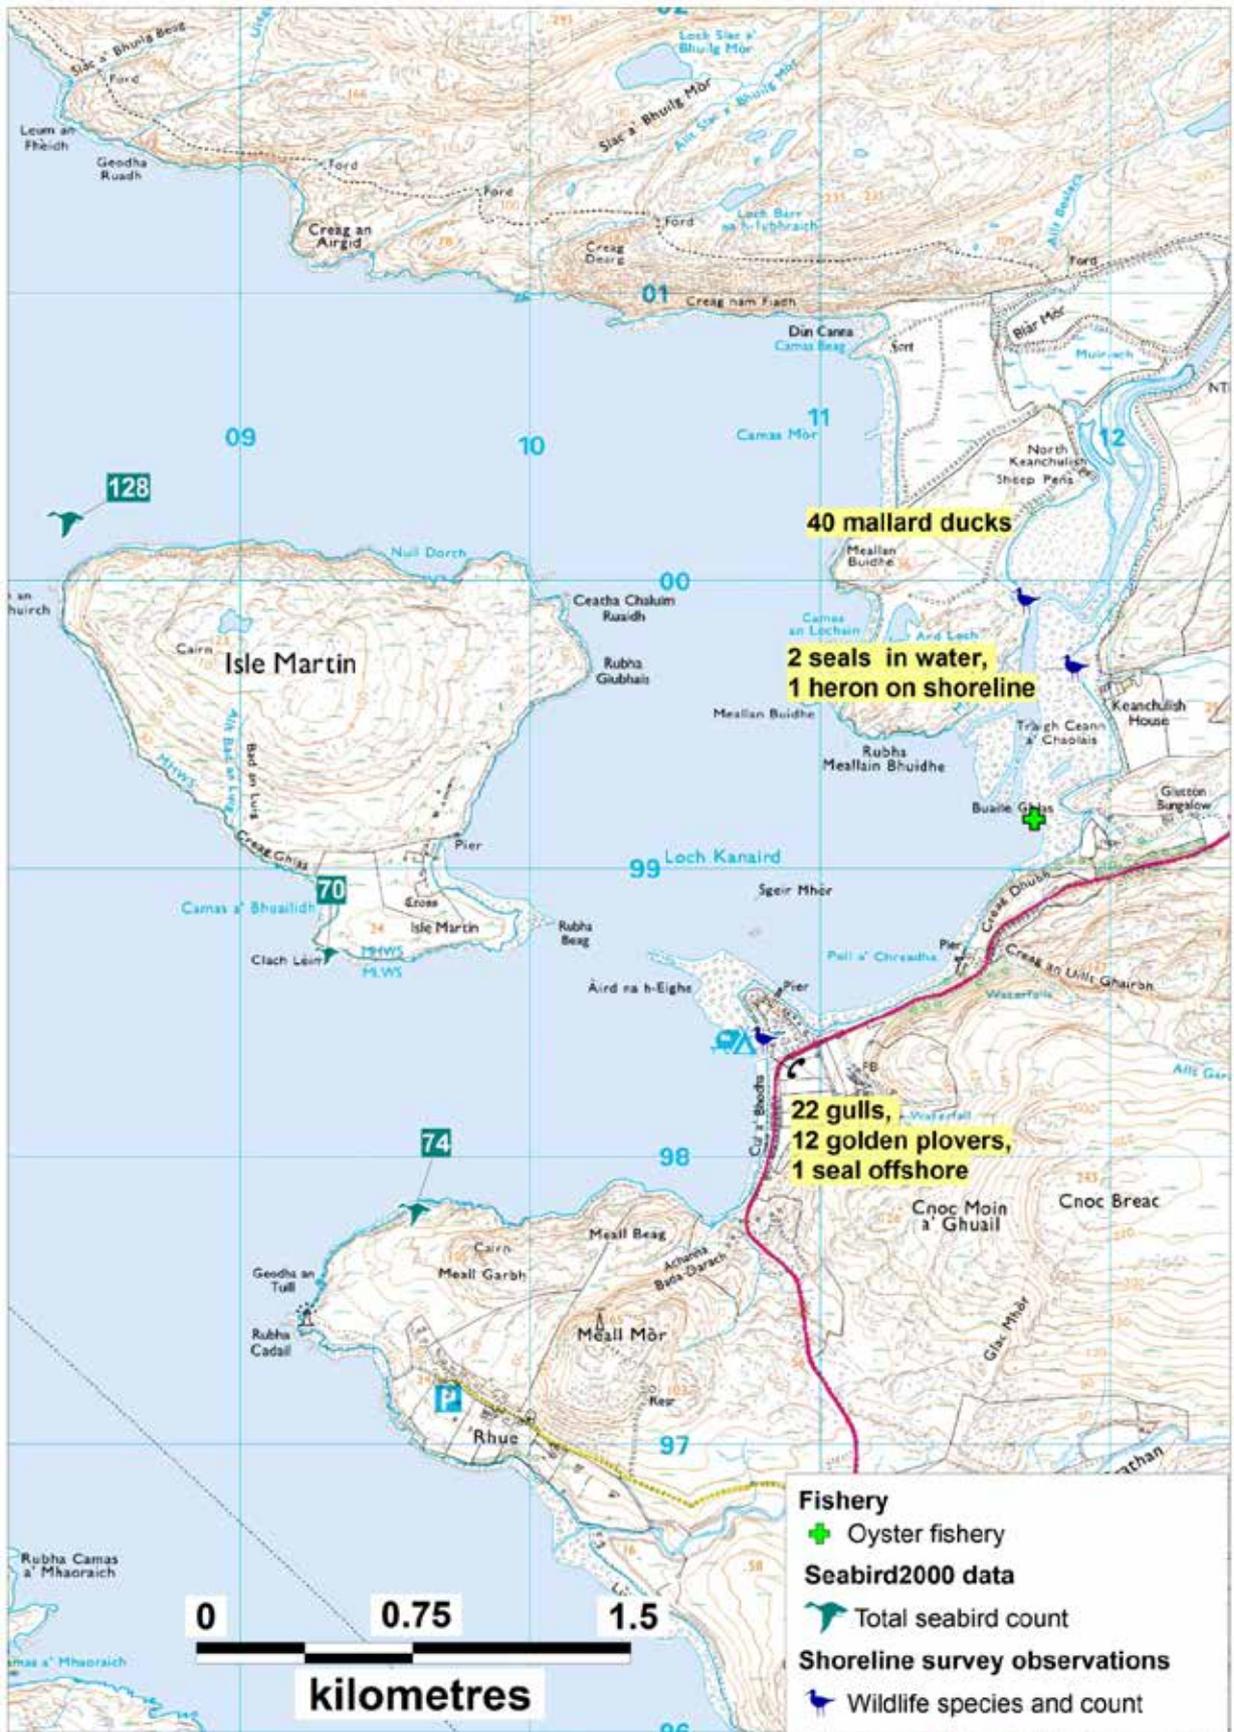
Figure 6.1 Map of wildlife around Loch Kanaird

Species potentially impacting on Inner Loch Kanaird include seals, seabirds and wading birds and deer. Much of the information about wildlife is from anecdotal accounts, and therefore it is not possible to establish the extent of potential impact from these animals. However, seasonal trends are expected particularly in seabirds as these animals are more likely to be on or near shore-based nesting areas during the summer nesting season.

Faecal contamination from animals on land, such as deer, are likely to be carried in freshwater runoff and watercourses. Faecal contamination from wading birds is likely to be higher north of the fishery, where there is extensive intertidal area, whereas contamination from seabirds may be higher to the south of the fishery, where there are more nesting areas.

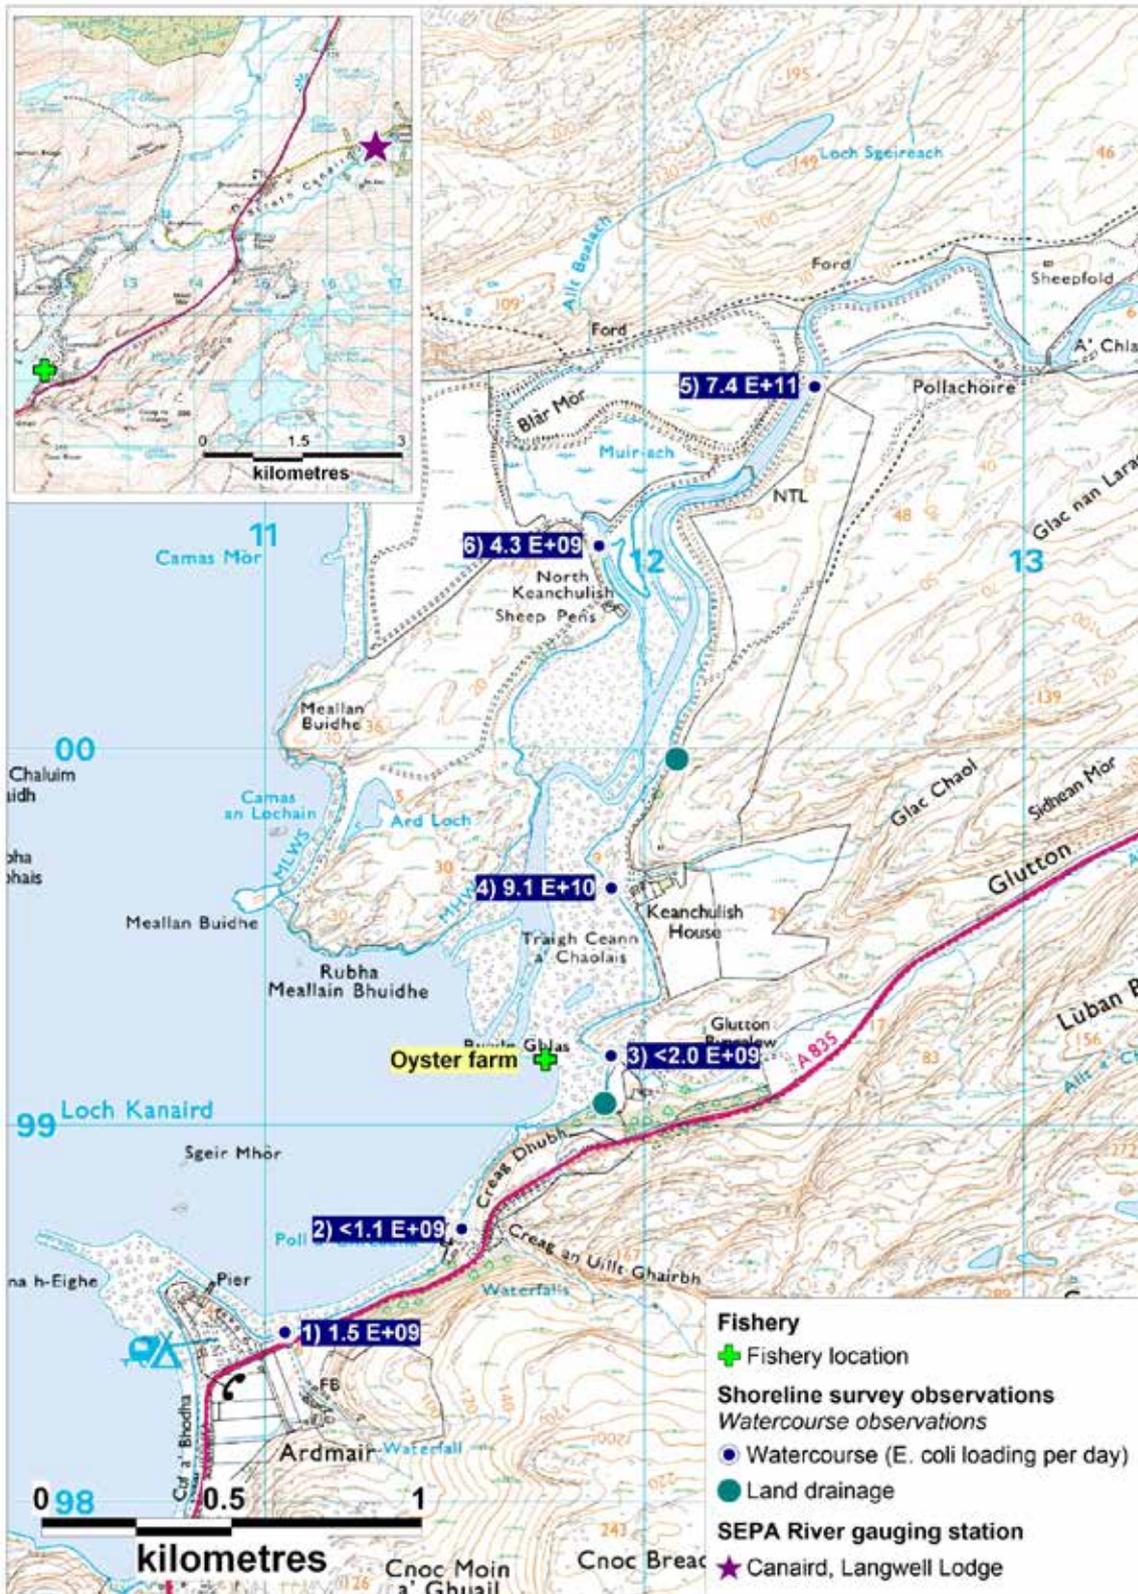
Figure 8.1 Map of watercourse loadings at Loch Kanaird.

The locations and loadings of measured watercourses as well as noted areas of land drainage are shown in Figure 8.1. Higher flows and *E. coli* levels would normally be expected in watercourses after significant rainfall.

Overall, freshwater inputs are expected to provide moderate levels of contamination to the oyster bed in Loch Kanaird, with the highest impact expected from the watercourses that discharge directly to the fishery. Of these, the highest loading was observed from the River Canaird.

All of the watercourses measured during the survey entering the area have significant flows. The oyster farm is situated at the mouth of the River Canaird, which carried the highest estimated loading of the watercourses sampled. The trestle area lies within 100 m of the river channel, and is therefore likely to be significantly influenced by contamination carried via this river. An area of land drainage and an unnamed watercourse (No 3) with a moderate estimated loading also discharge within 200 m east of the oyster farm. These are expected to contribute to contamination levels found at the oyster farm though their overall contribution may be less significant than that provided by the River Canaird.

The remaining watercourses discharge within 1 km of the fishery and were found to have moderate calculated loadings. Sheep were seen grazing near watercourse No. 3, and sheep droppings were seen along the shore northwest of No. 4, therefore livestock are likely to have contributed to faecal contamination found in these watercourses.

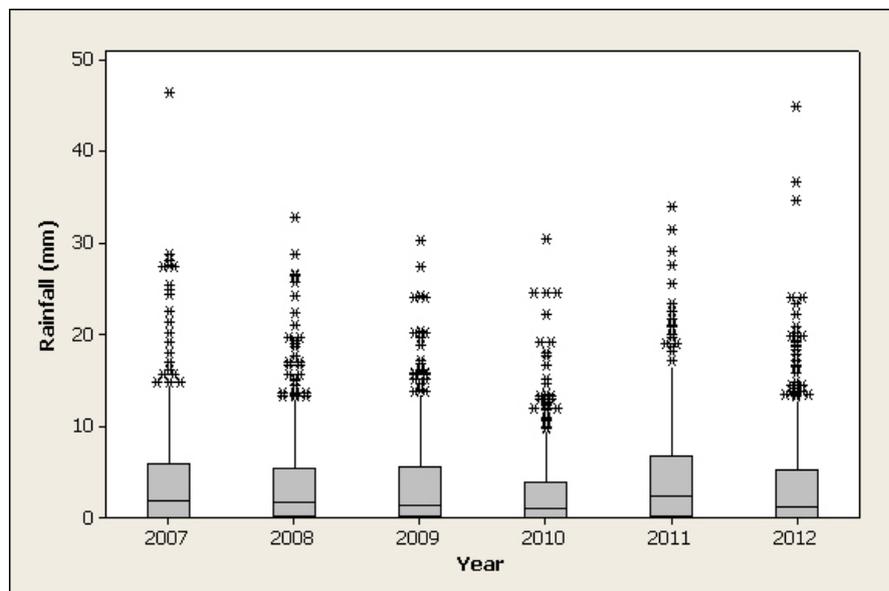
Figure 9.1 Box plot of daily rainfall values by year at Aultbea No.2 (2007 – 2012)

Total rainfall values varied from year to year, with 2010 being the driest year (a total of 1037 mm). The wettest year was 2011 (a total of 1672 mm). High rainfall events of greater than 30 mm/d occurred in all years.

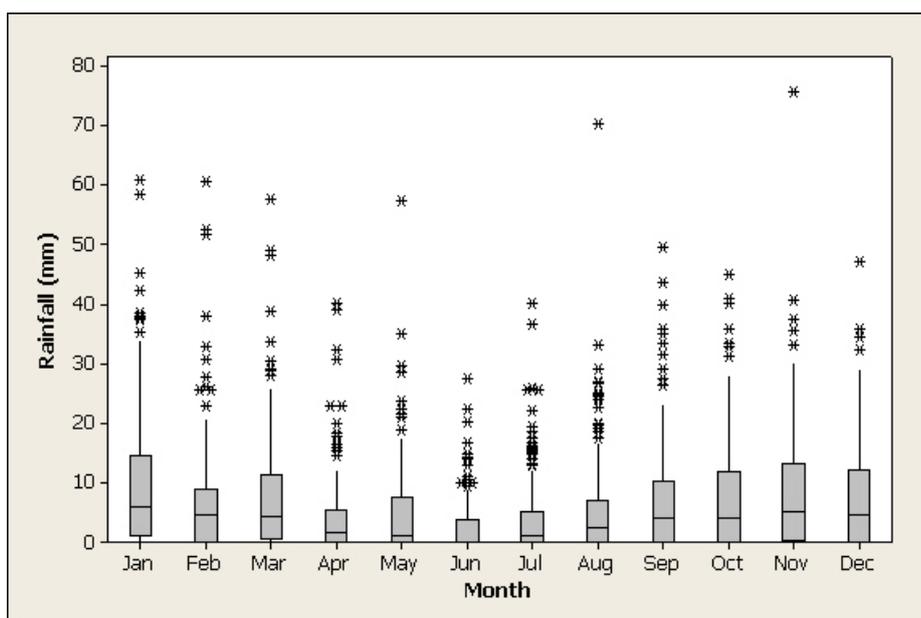
Figure 9.2 Box plot of daily rainfall values by month at Aultbea No.2 (2007 – 2012)

Rainfall was lower from April to July and higher from August to March. Rainfall values exceeding 30 mm/d were seen in all months except June. The highest rainfall events occurred in August and November.

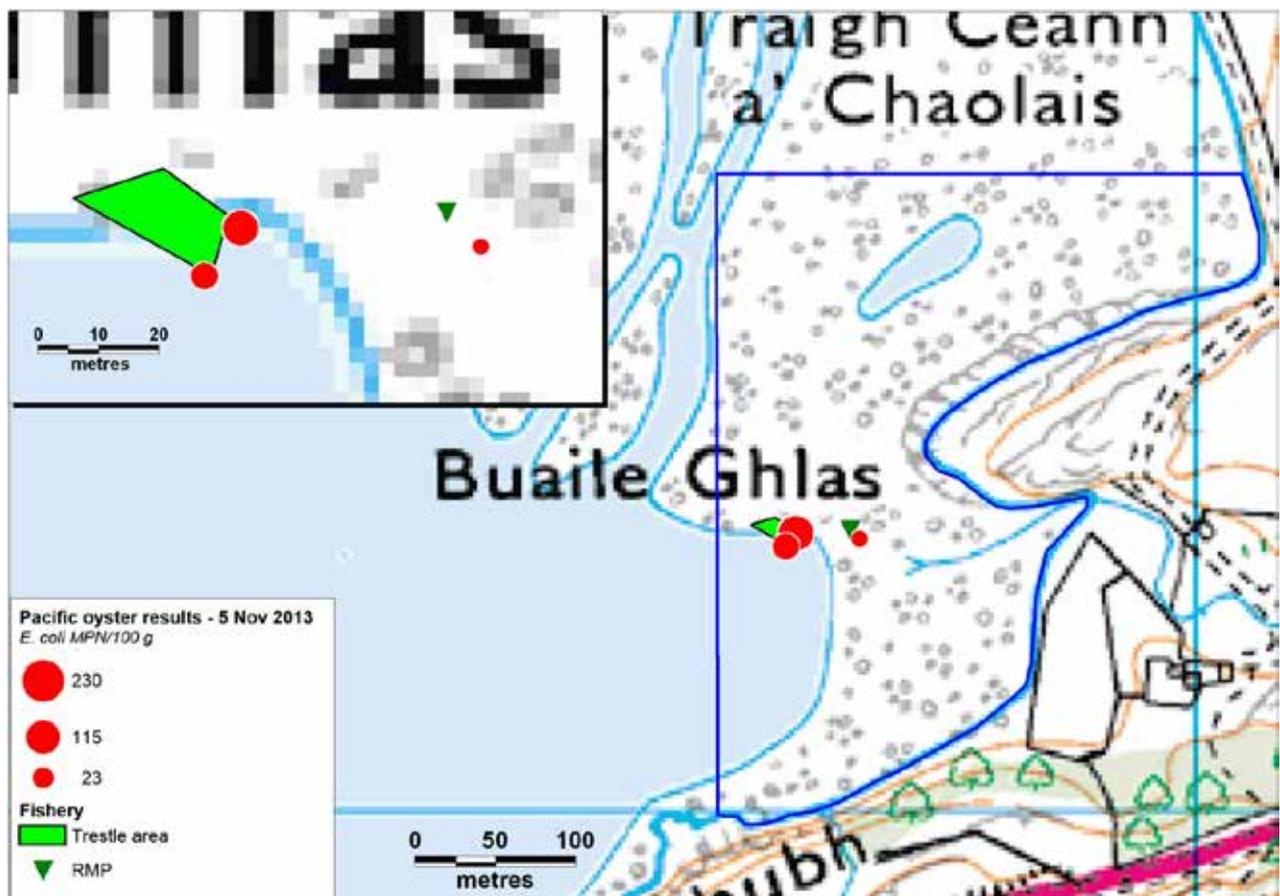
Figure 11.1 Map of reported sampling locations for Pacific oysters at Loch Kanaird

All results were below 230 MPN/100 g, with the highest result coming from the inshore corner of the oyster farm. Unfortunately, no samples were taken from the northern end of the oyster farm and therefore it is not possible to assess whether oysters at that end of the farm, nearer to the main flow of the River Canaird, would have had higher results.

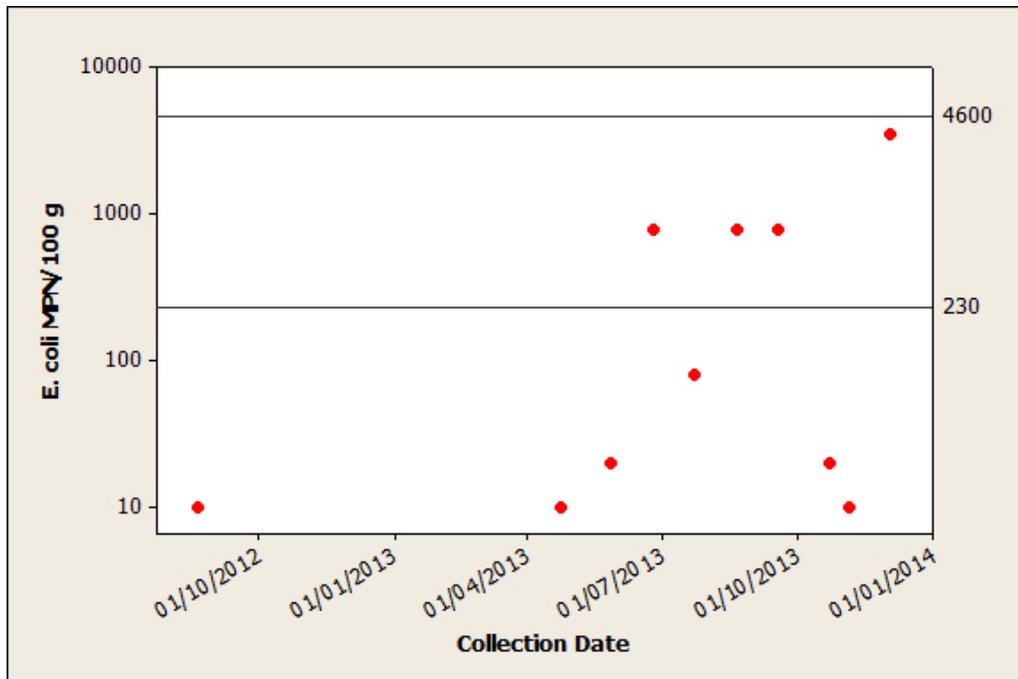
Figure 11.2 Scatterplot of *E. coli* results by collection date at Loch Kanaird

No samples were taken between 20/08/2012 and 22/4/2013. The highest result occurred in December. A single sample was submitted in August 2012, 8 months before regular sampling commenced in late April 2013. At the time of writing this report, a year's worth of continual monitoring data had not yet been completed. Due to the gap in the data, and the limited period of the data, it was not yet possible to determine whether there was any clear temporal pattern in the results.

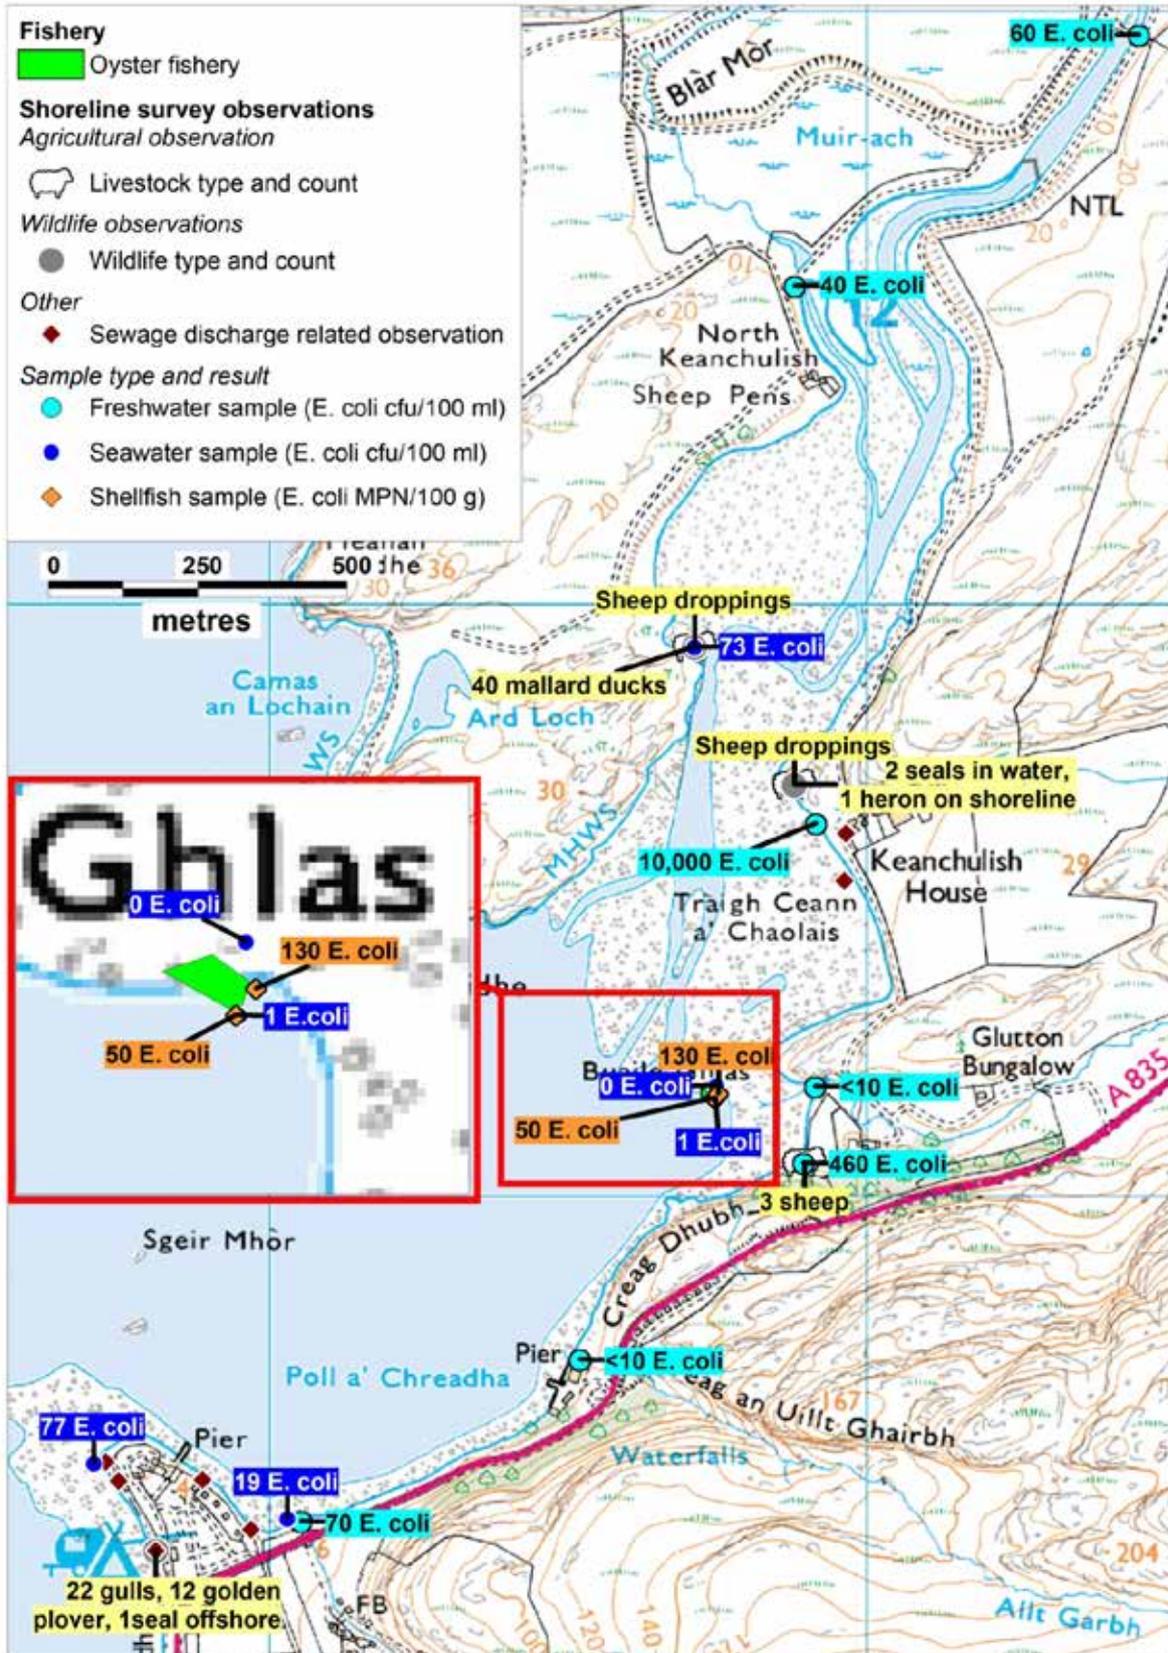
Figure 14.1 Map of shoreline survey observations at Loch Kanaid

Several isolated houses were observed set back from the shoreline to the north of the oyster farm. Ardmair Point Holiday Centre (camping/caravan park) and chalets are also located at Ardmair Point, though it was closed for winter. A laundrette and a chemical toilet disposal facility were associated with the park. Immediately below the park were a number of discharge pipes along the shore, with an associated smell of sewage. A seawater sample taken close to these discharges returned a result of 77 *E. coli* cfu/100 ml. A seawater sample was also taken from the northern side of Ardmair Point, adjacent to the slipway and pier close to a group of chalets and it returned a result of 19 *E. coli* cfu/100 ml. A suspected discharge pipe was observed on shore below Keanchulish House but was not sampled as it was only seen at low tide after the completion of the survey.

Infrastructure related to boating activity was seen in Ardmair, where there were 10 boats on offshore moorings and at Ardmair Point, with two production rafts moored at two of the four offshore moorings. An unoccupied mooring buoy was also observed south of the oyster trestles and three boats seen on the shoreline along south of the fishery.

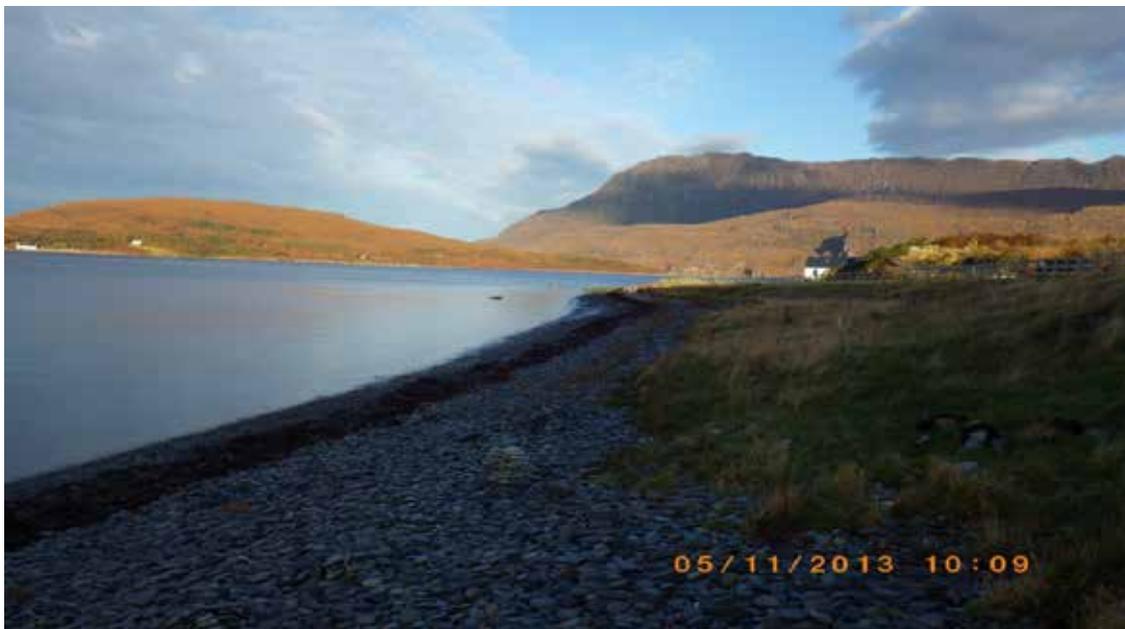
Fig 3. Ardmair peninsula from the SW. Taken at beginning of survey (waypoint 1). Toilet block (with chemical toilet emptying facilities) is the building in centre right of photo. Discharge pipe noted in Fig. 4 is by rocks immediately below building.

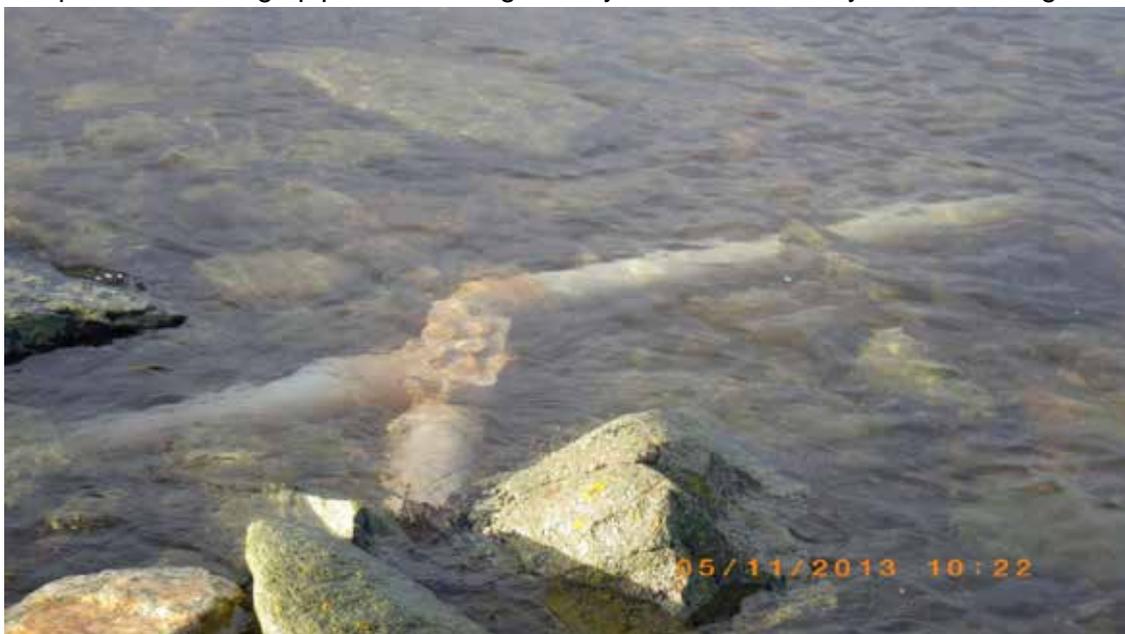
Fig 4. Joint discharge pipe running into water below site of Caravan Park (waypoint 4)

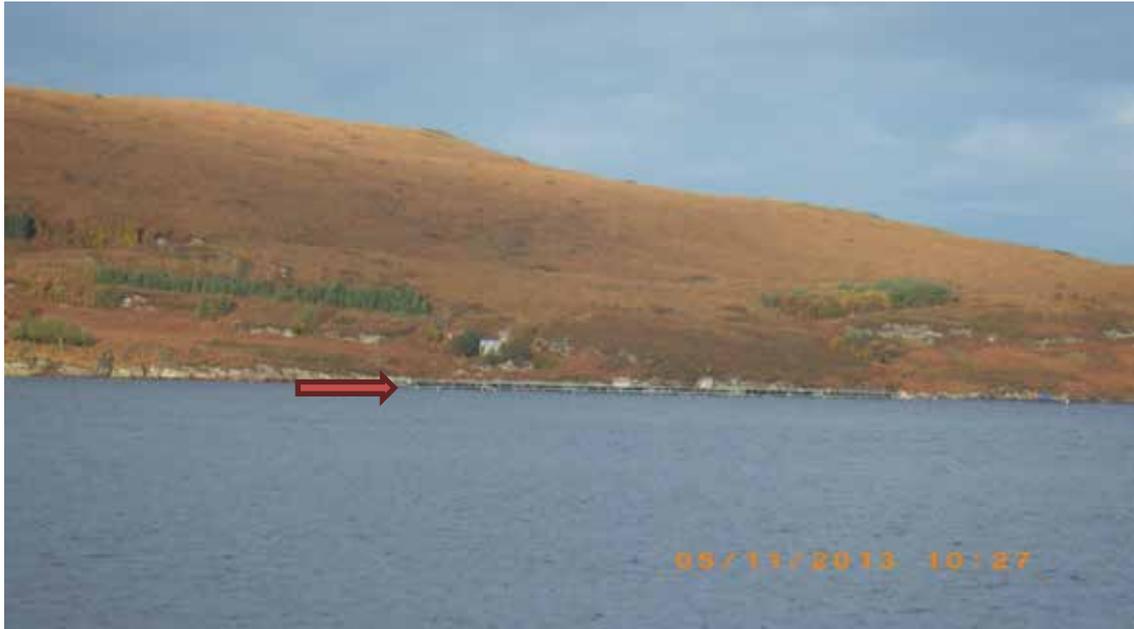
5	05/11/2013	9:25	NH 10706 98551	210707	898552		LKSW1	Extra seawater sample taken due to smell and discharge pipes. LKSW1
6	05/11/2013	9:28	NH 10728 98560	210729	898561	Fig 5		Third pipe running onto foreshore - several broken sections present, with no flow observed in broken sections. Fish farm noted, and photographed on opposite side of bay.
7	05/11/2013	9:32	NH 10845 98552	210845	898553			Concrete pier with ten boats at anchor (two yachts, one small fishing vessel & seven small pleasure craft). Seven additional empty buoys.
8	05/11/2013	9:35	NH 10887 98524	210888	898524			Manholes (two) noted on shoreline below chalet style dwellings - no pipes visible on foreshore.
9	05/11/2013	9:39	NH 10969 98439	210969	898440	Fig 6		A third manhole cover (concrete) below chalet style buildings - no pipe visible on foreshore.
10	05/11/2013	9:41	NH 11035 98448	211035	898448			Small slipway north of chalet buildings.

Fig 5. Fish farm cages on opposite side of bay. Photo taken from waypoint 6 looking NW.

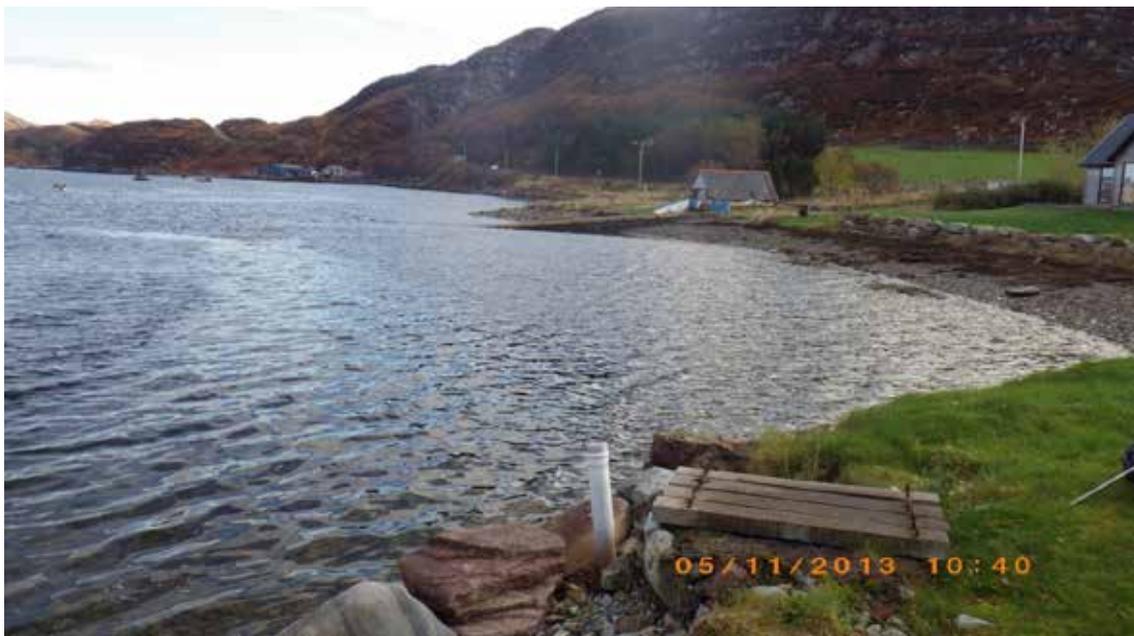
No.	Date	Location (NGR)	Associated Photograph (Appendix 4)	Description
1	05/11/2013	NH 1081 9840		Two raised pipes on beach - caravan park above.
2	05/11/2013	NH 1075 9852		Manhole on shore immediately below chemical toilet emptying point & laundrette on campsite. Discharge pipe visible on shore (10cm uPVC), but disappears below tide line.
3	05/11/2013	NH 1073 9855	Fig 4	Second discharge pipe running from caravan site, smell of sewage present in the air. This pipe connects with the pipe seen in observation 2. Not possible to see the discharge due to the state of the tide.
4	05/11/2013	NH 1073 9856	Fig 5	Third pipe running onto foreshore - several broken sections present, with no flow observed in broken sections.
6	05/11/2013	NH 1089 9852		Manholes (two) noted on shoreline below chalet style dwellings - no pipes visible on foreshore.
7	05/11/2013	NH 1097 9844	Fig 6	A third manhole cover (concrete)* below chalet style buildings - no pipe visible on foreshore.

Fig 6. View looking NE from waypoint 9 showing concrete manhole cover in foreground, slipway in middle distance, and fish farm in far distance on upper left.

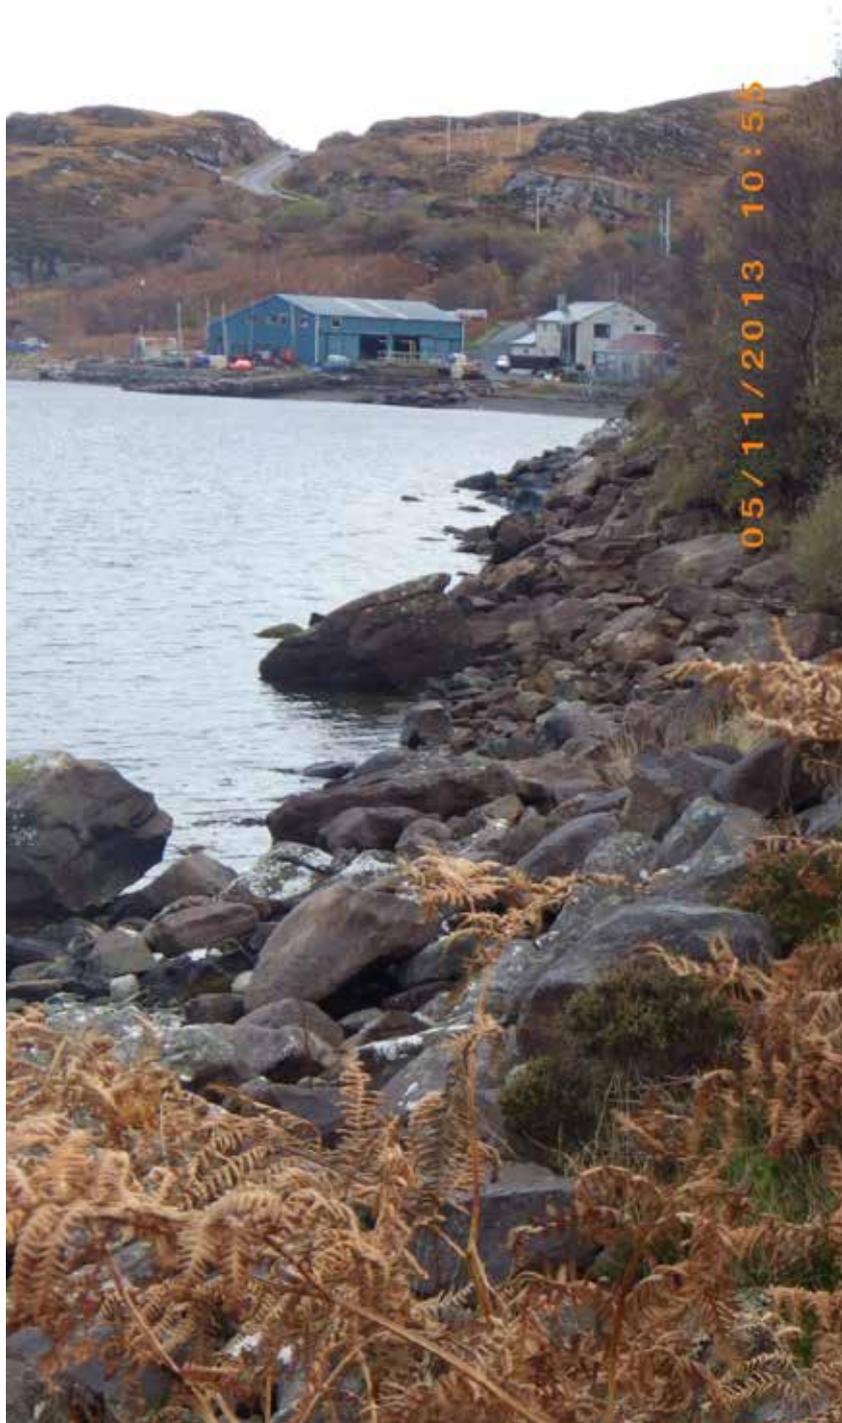
Fig 7. Closer view of fish farm base, and short section of shoreline that proved too difficult to traverse, taken from waypoint 14. Location of stream sampled in waypoint 15 is immediately behind large blue shed.

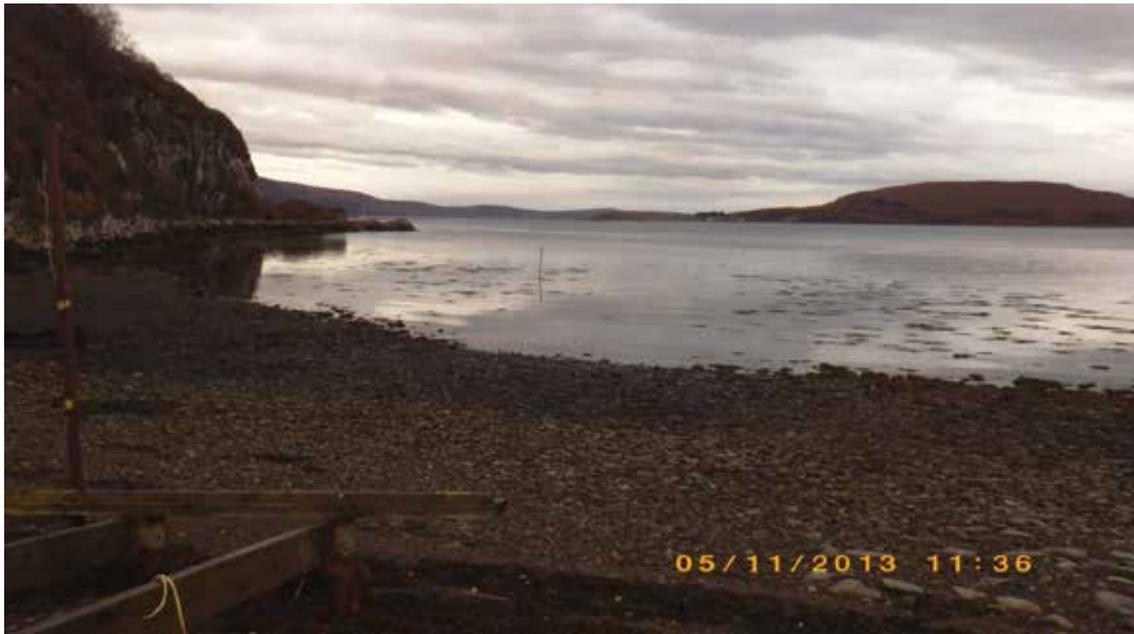
Fig 8. Looking SW from corner of S end of production area (waypoint 17). Shoreline proved difficult to access on centre left for planned water sample, so replacement sample was taken from small inflow on beach to immediate left of photo.
