Scottish Sanitary Survey Report

Sanitary Survey Report
Loch Kanaird
RC-625-1233-13
May 2014

Report Title	Loch Kanaird Sanitary Survey Report
Project Name	Scottish Sanitary Survey
Client/Customer	Food Standards Agency Scotland
Cefas Project Reference	C5792C
Document Number	C5792C_2013_17
Revision	1.0
Date	09/05/2014

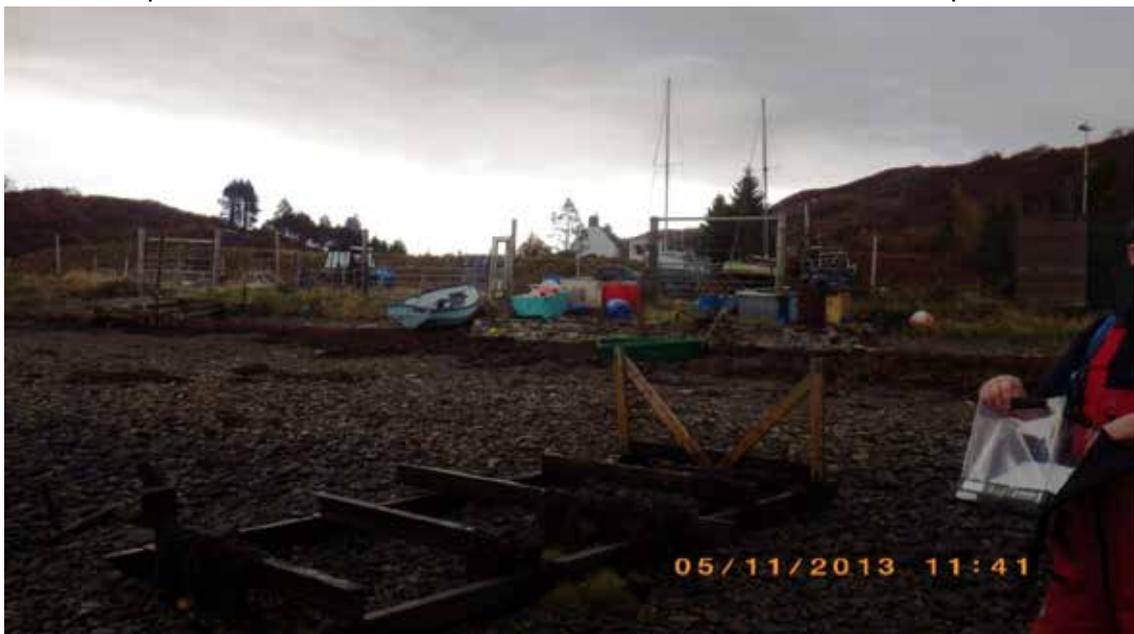
Fig 9. Looking up the shore above at the south end of the production area (waypoint 17) showing vessels stored ashore.

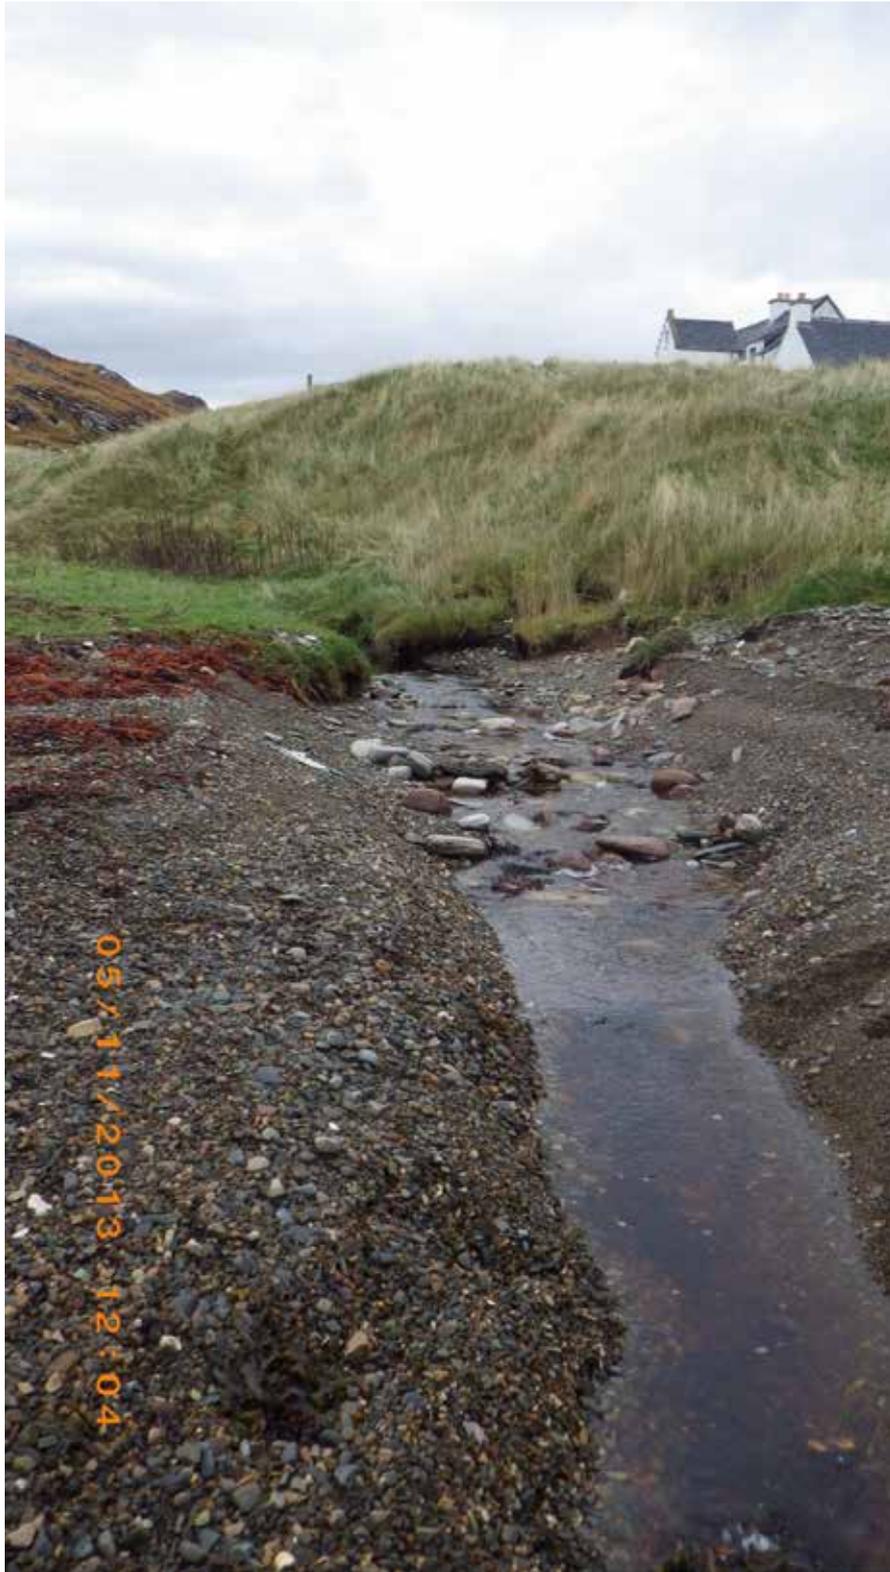
Fig 10. Stream running onto shore below Keanchulish House (waypoint 20), Site of freshwater sample LKFW5.

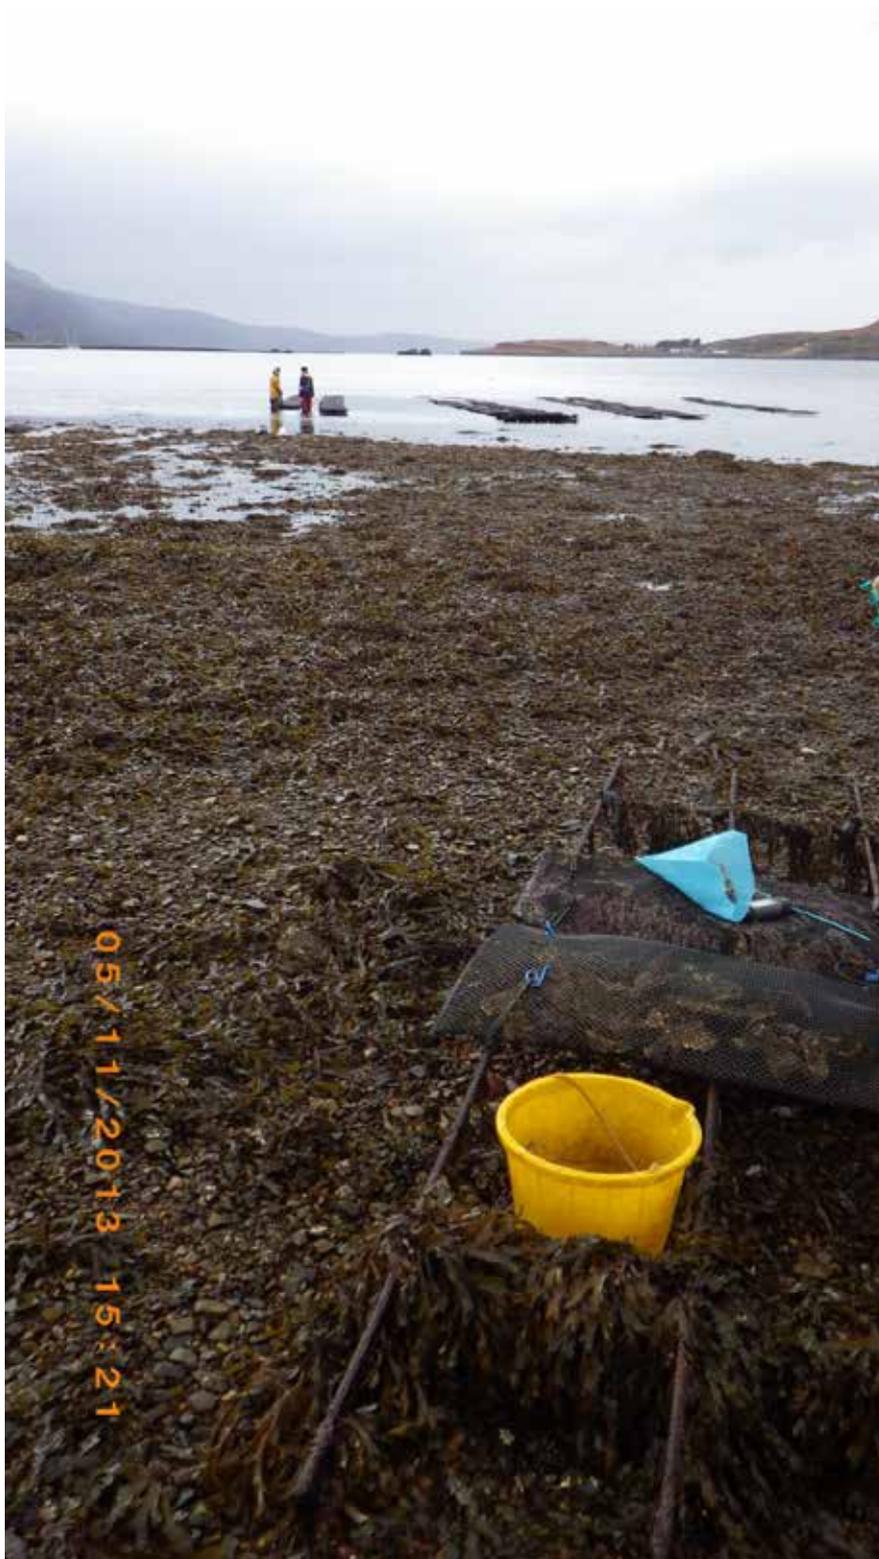
Fig 12. RMP site (foreground, waypoint 39), with main oyster trestles in distance (boundaries marked as waypoints 31-34)

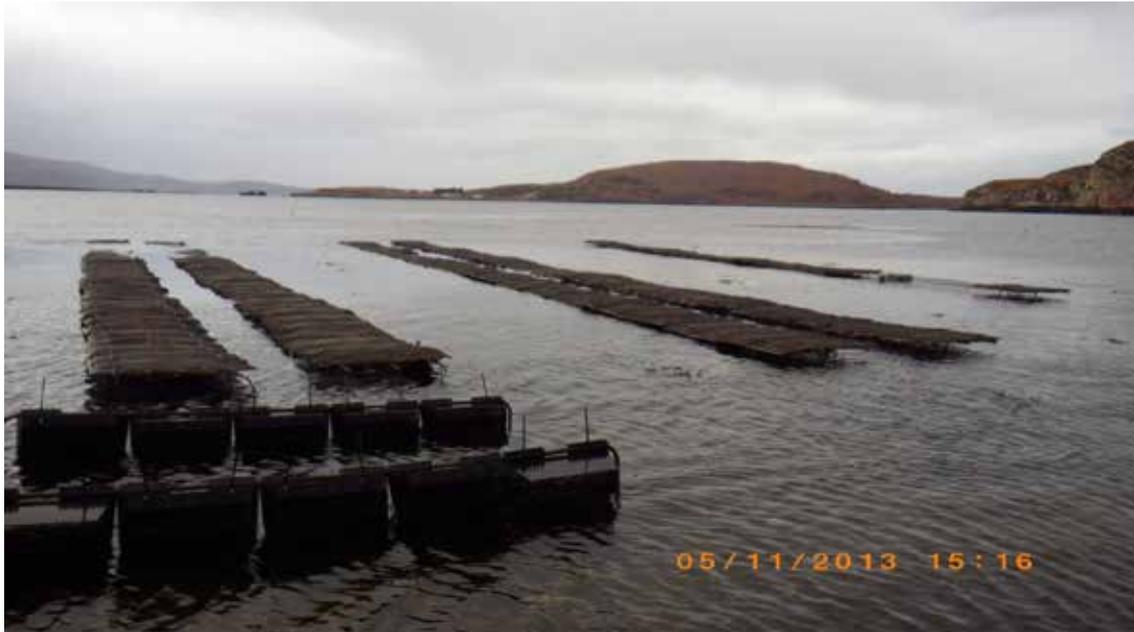
Fig 13. Main oyster cultivation site, looking W. Photo taken from waypoint 36.

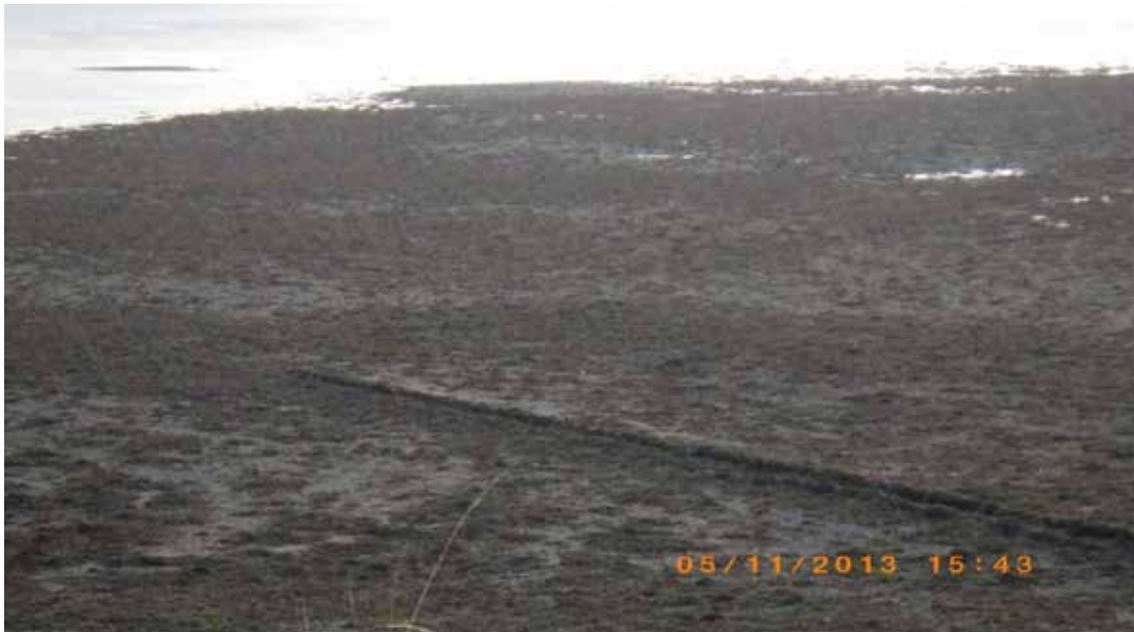
Fig 14. Discharge pipe noted below Keanchulish house at location NH 11926 99459, no waypoint was taken for this. Photo taken at waypoint 40.

There are several private discharges within 500 m of the oyster farm. The discharge from Keanchulish House lies approximately 370 m north of the oyster farm, along the channel of the River Canaird. This house was not in use at the time of shoreline survey, and is only used intermittently. There are other septic tanks consented to discharge to soakaway upstream along the river. Any of these that have been diverted to discharge to the river or are malfunctioning would potentially cause additional impact to the fishery.
