Shellfish Water Quality Investigation Report

Portsmouth Harbour

Submitted to:	Defra and Environment Agency
Date submitted:	25 September 2012
Report compiled by:	Carlos J. A. Campos, Owen C. Morgan, Nicola Mitchard, Ian Udal
Approved by:	Simon Kershaw (Cefas)
Version & date:	1.1 (May 2012)

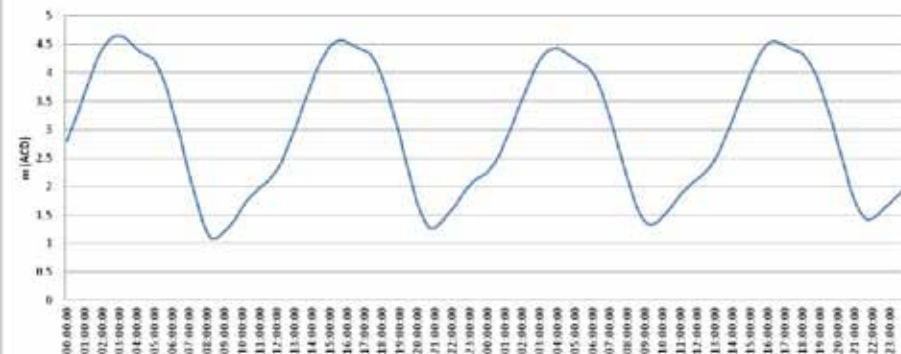
Weather forecast	<p>Figure 3. Water levels recorded on survey days from POL tide gauge in Portsmouth Harbour. http://www.pol.ac.uk/ntslf/data.html. Site: Portsmouth (Port: P008) Latitude:50.8026 Longitude:-1.1118 Proudman Oceanographic Laboratory Datum information: The data refer to Admiralty Chart Datum (ACD)</p> <p>Met Office Inshore Waters: <u>Selsey Bill to Lyme Regis</u> Wind: variable (3 or 4 becoming southwest 4 or 5 later) Sea state: smooth or slight Weather: showers at first Visibility: good</p>
Air temperature	11°C
Wind	14Km h ⁻¹ (07:00h)
Precipitation	None at time of survey
Cloud cover	16% (10:00)
Rivers/streams/springs (gauged) BNG	Wallington River North Fareham/Spurlings Farm: 0.094 m ³ s ⁻¹ (Figure 3A) Cams Hall golf course (stream from lake) (Figure 3B) Wallington River at Wallington (A27 bridge) (Figure 3C) Stream Heavy Reach creek adj. STW
Key discharges identified (Cefas database)	Upper Wharf/Fareham CSO (Figure 3D) Salterns Lane CSO (Figure 3E) Wicor Mill Lane WPS CSO/EO Cyanamid PS

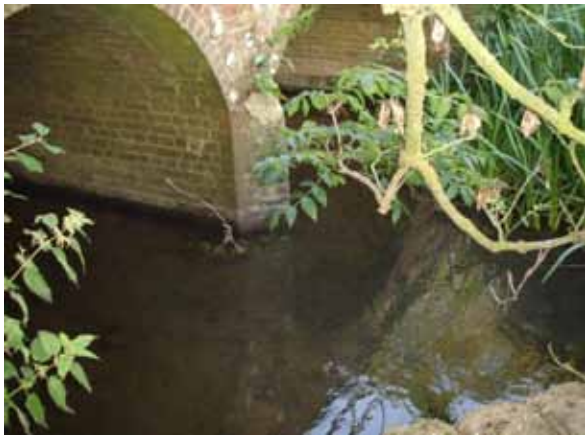
A

Figure 4. Sites where surface water samples were collected during the shoreline surveys. A: River Wallington at North Fareham/Spurlings Farm; B: Outfall adj. Cams Hall South Park golf course; C: River Wallington at Wallington Bridge (A27); D: Town Quay Upper Wharf/Fareham CSO; E: Salterns

- § The River Wallington represents a significant source of microbiological contamination to the shellfish water. The concentration of faecal coliforms in the sample collected downstream of the urban area of Wallington was lower than that in the sample upstream of North Fareham. More targeted studies are required to understand the relative contributions of urban and agricultural runoff to the overall load of contamination from the river Wallington.

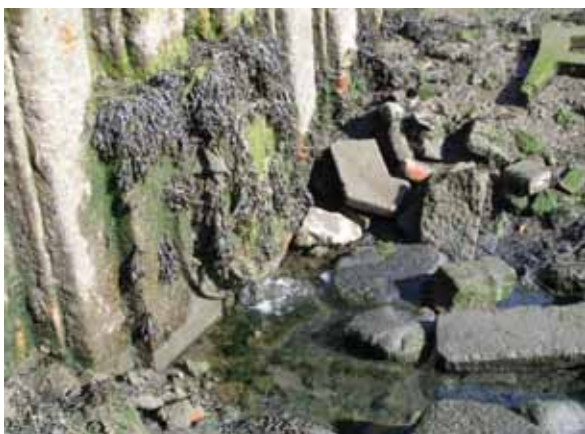
E

Lane adj West End STW; F: unidentified discharge at Fleetlands Creek.

- § The most significant point sources of contamination observed were Fareham CSO and Salterns Lane CSO and, to a lesser extent, Tichbourne Way PS/Brewers Lane Gosport CSO. All of these discharge directly to the shellfish water. The high concentrations of faecal indicators detected at the time of the survey are consistent with crude or primary treated effluent. It is likely that there may be households misconnecting their waste appliances to the surface water system.

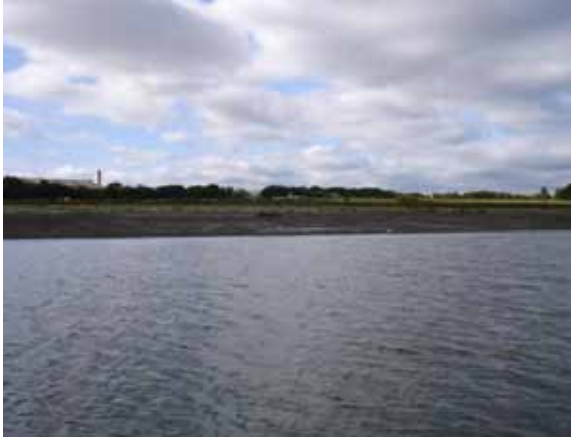
G

Figure 4. Sites where surface water samples were collected during the boat/shoreline surveys (cont.). G: Fareham Lake - Peewit Island (designated shellfish water monitoring point); H: Portchester Lake (designated shellfish water monitoring point); I: Fountain Lake near Continental Ferry terminal.

- § Levels of faecal coliforms in seawater samples collected in Peewit Island, Portschester Castle and near the Ferry Terminal were low indicating good water quality in the harbour at the time of the survey.

- § Levels of faecal coliforms in cockles collected in both surveys were consistent with class B under the hygiene controls.
- § Patches of commercially sized cockles were observed in Peewit Island and Portschester Castle in sufficient numbers for sampling in the proximity of the designated sampling points. Larger cockles from previous year classes were considerably less abundant. Alternatively, Manila clams could be used as sentinel species should cockle densities decrease significantly in the future,

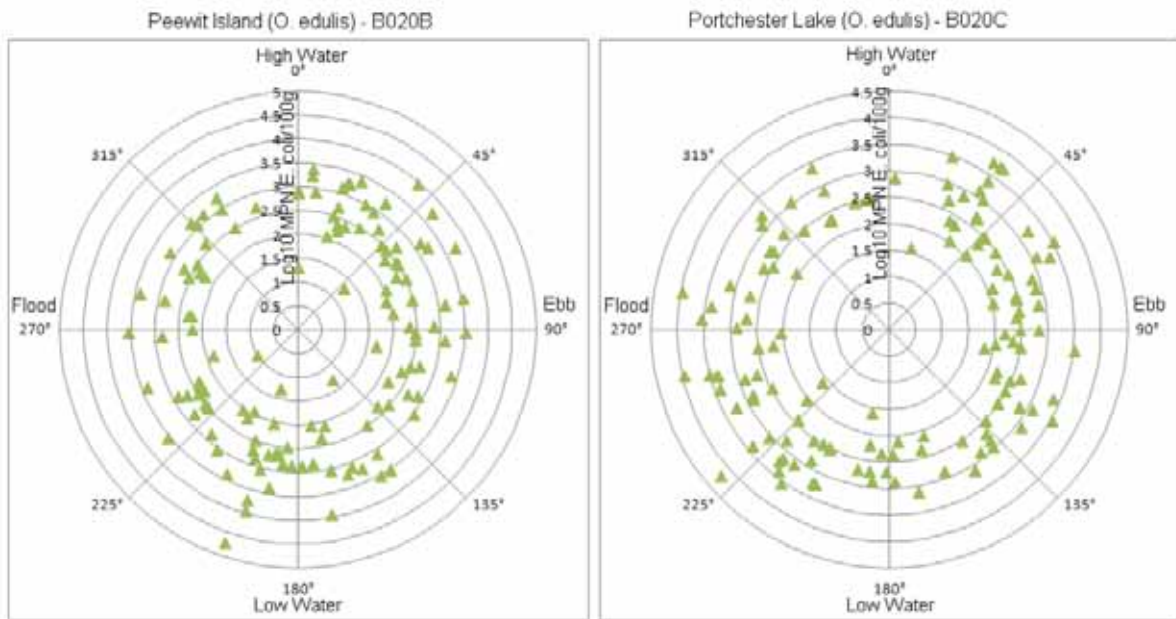
Circular statistics were used to understand whether tidally-driven mechanisms would exert a significant effect on the quality of shellfish flesh. Figure 6 shows polar plots of *E. coli* levels in oysters against tidal state on the high-low cycle. There is a good distribution of *E. coli* results over the tidal cycle. No significant differences were found between the levels of contamination in oysters from

Peewit Island (circular linear correlation $r=0.03$; $p=0.892$) and Portchester Lake (circular linear correlation $r=0.18$; $p=0.014$) and tidal stage.

Figure 6. Polar plots of *E. coli* levels in native oysters against tidal state in Portsmouth Harbour.

The results indicate that the shellfish water is at risk of being significantly impacted by microbiological contamination at any given stage of the tidal cycle. Due to the expected bi-directional impacts, further improvements to intermittent discharges in Portsmouth and Gosport are likely to promote the potential for dilution in the deeper areas of the lower harbour and improve the overall quality of the shellfish water.
