Scottish Sanitary Survey Report

Sanitary Survey Report
Loch Bay
SL-117-275-04
April 2014

Report Title	Loch Bay Sanitary Survey Report
Project Name	Scottish Sanitary Survey
Client/Customer	Food Standards Agency Scotland
Cefas Project Reference	C5792C
Document Number	C5792C_2013_15
Revision	V1.0
Date	07/04/2014

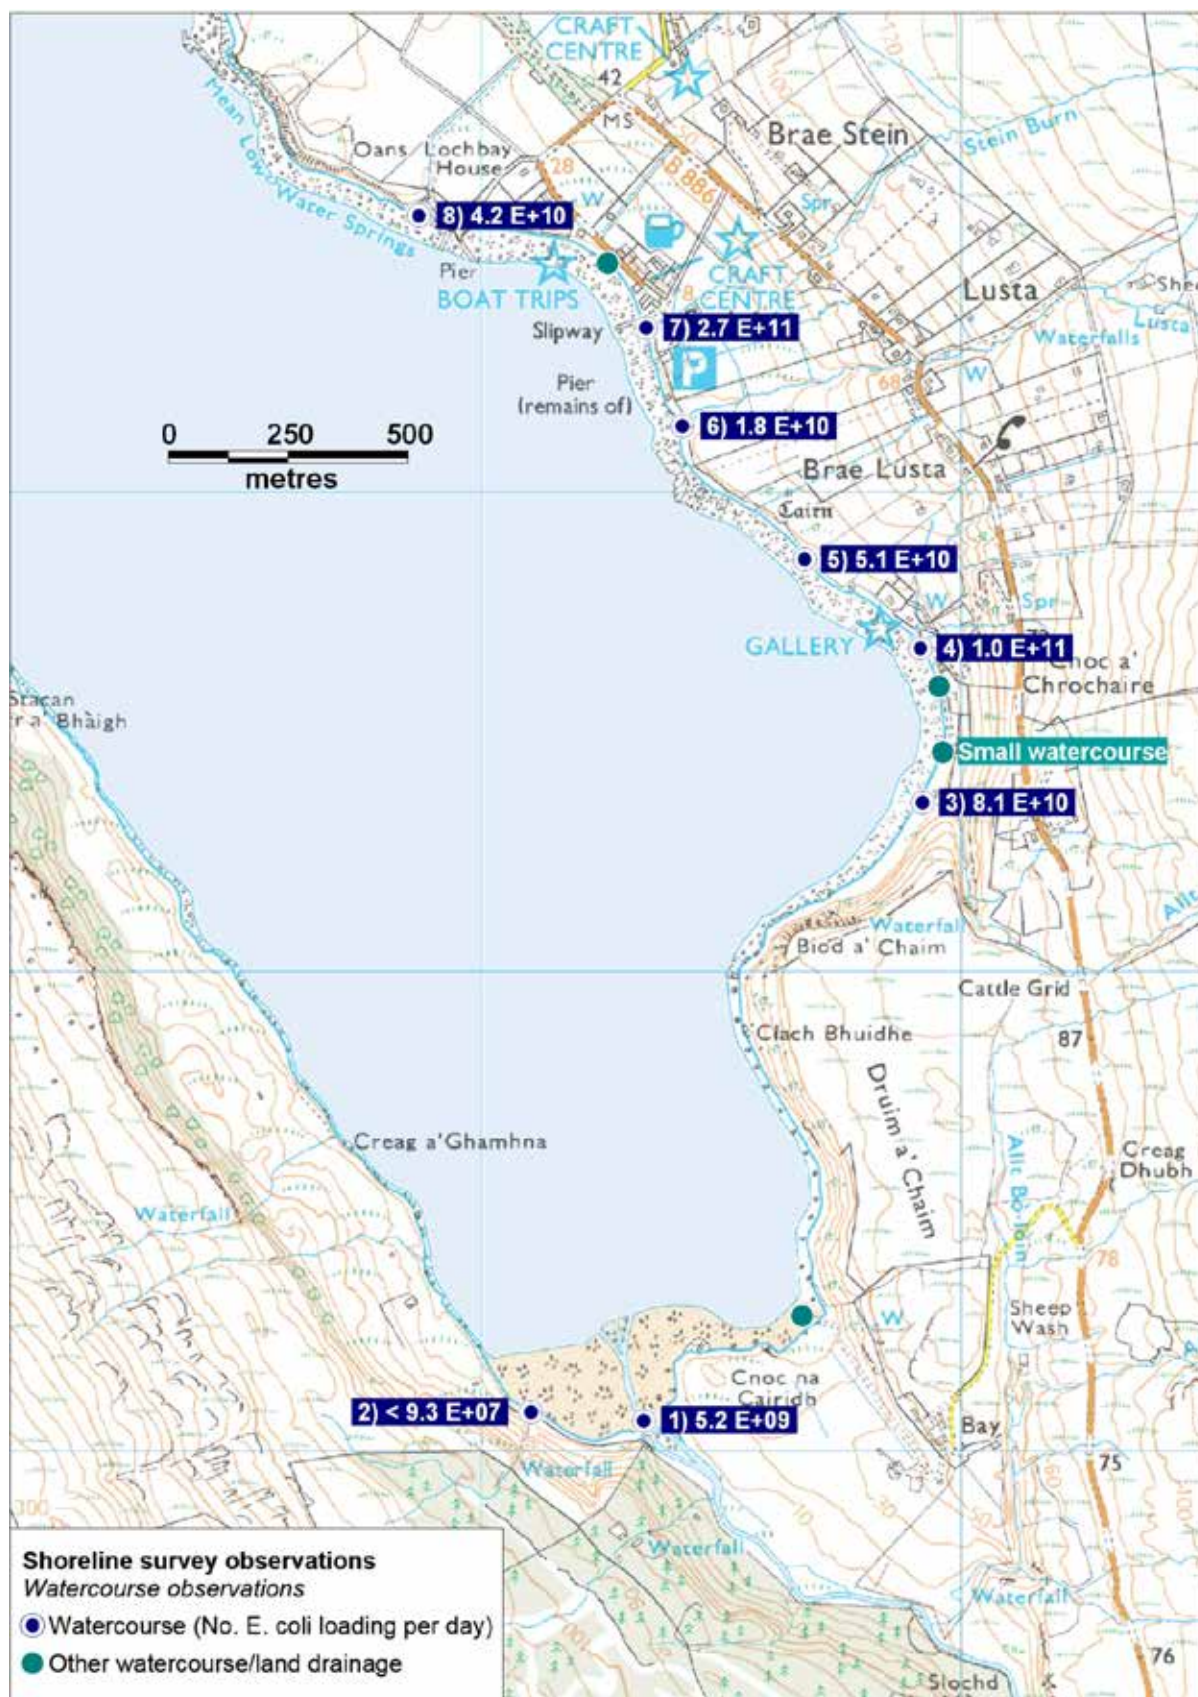
Figure 8.1 Map of watercourse loadings at Loch Bay.

centre of the cockle bed and had an moderate estimated loading. An unnamed watercourse flows across the west end of the cockle bed and had an estimated loading two orders of magnitude lower than that of the Bay River. The Bay River drains a significantly larger catchment area that includes improved pasture area, which may explain the higher loading. The area of land drainage noted on shoreline adjacent to the eastern extent of the shellfish bed may represent a significant contamination source when flowing, as it drains an area that includes the houses identified at Bay and therefore could potentially carry diffuse contamination from human sources under very wet conditions.

Watercourses that flowed through the crofted areas around Stein were found to have the moderately to high loadings, with the highest loadings recorded from Stein Burn (2 km north of the cockle bed) and a small, unnamed watercourse adjacent to houses approximately 1.5km NE of the cockle bed.

The locations and loadings of measured watercourses as well as noted areas of land drainage are shown in Figure 8.1.

Overall, freshwater inputs are expected to provide moderate levels of contamination to the shellfish bed in Loch Bay, with the highest impact expected from the watercourses and land drainage that discharge directly to the shellfish bed. Of these, the highest loading was observed from the Bay River.

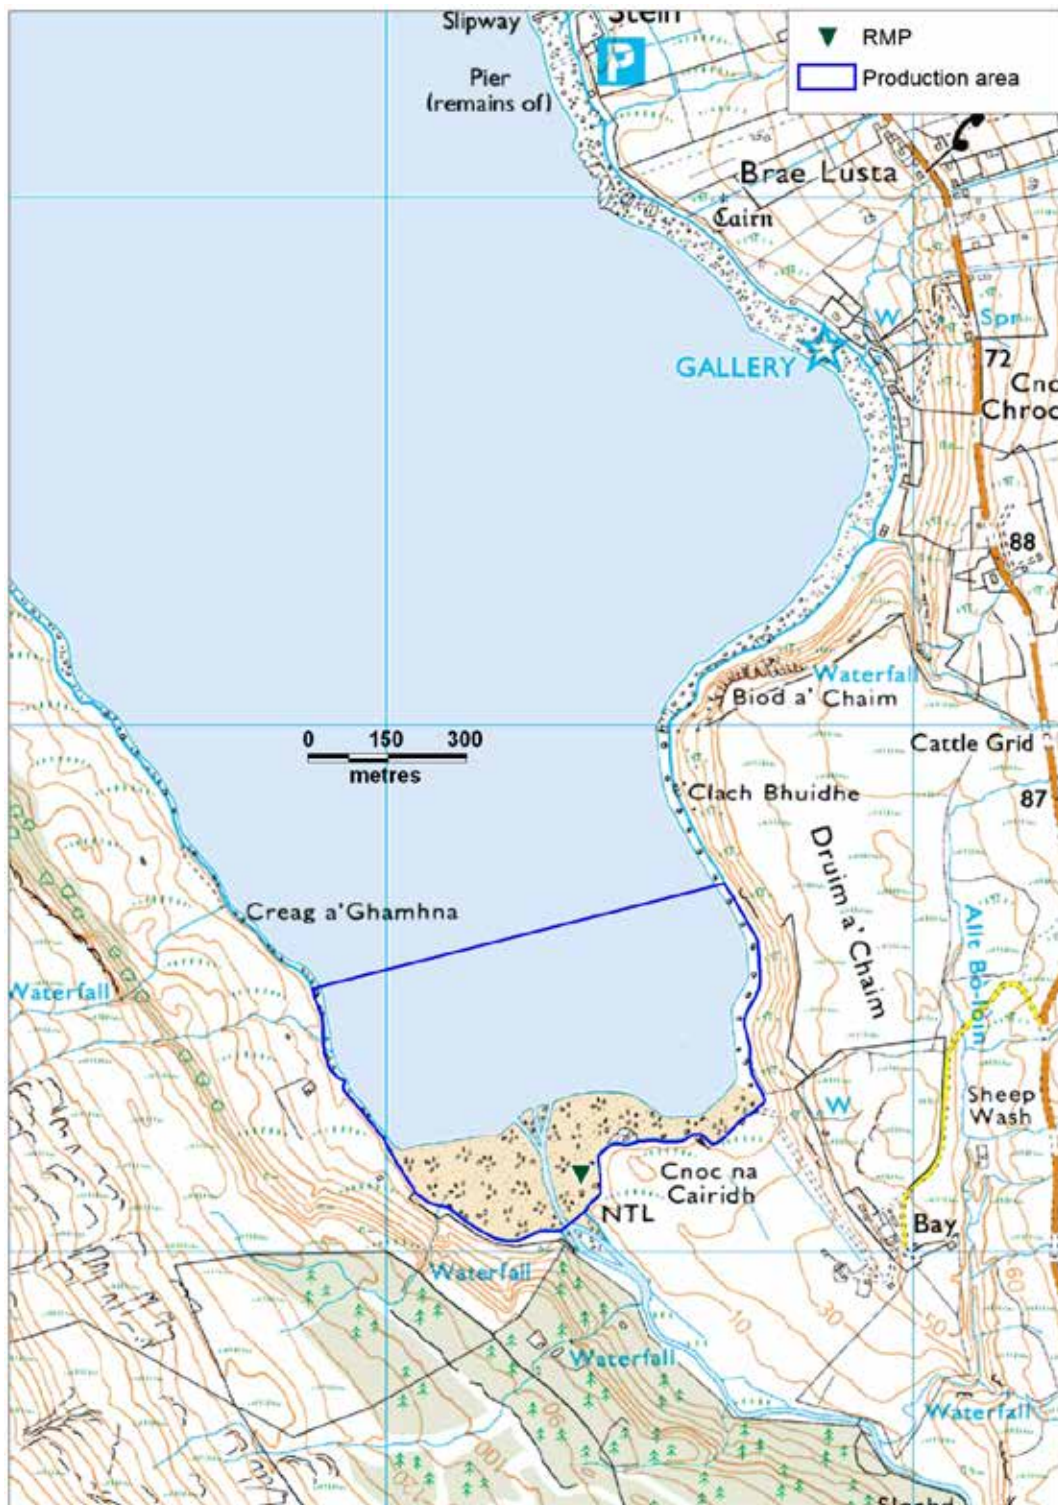
Figure 17.1 Map of recommendations at Loch Bay

A sampling tolerance of 50 m is considered adequate to allow for sufficient animals to be gathered for sampling purposes.

No material changes are recommended to the production area boundaries, which already exclude potential sources of faecal contamination to the NE of the cockle bed. It is recommended, however, that the production area boundaries be specified to extend to MHWS.

Should classification monitoring continue, monthly sampling is recommended due to expected and observed seasonal variations in inputs and contamination levels.

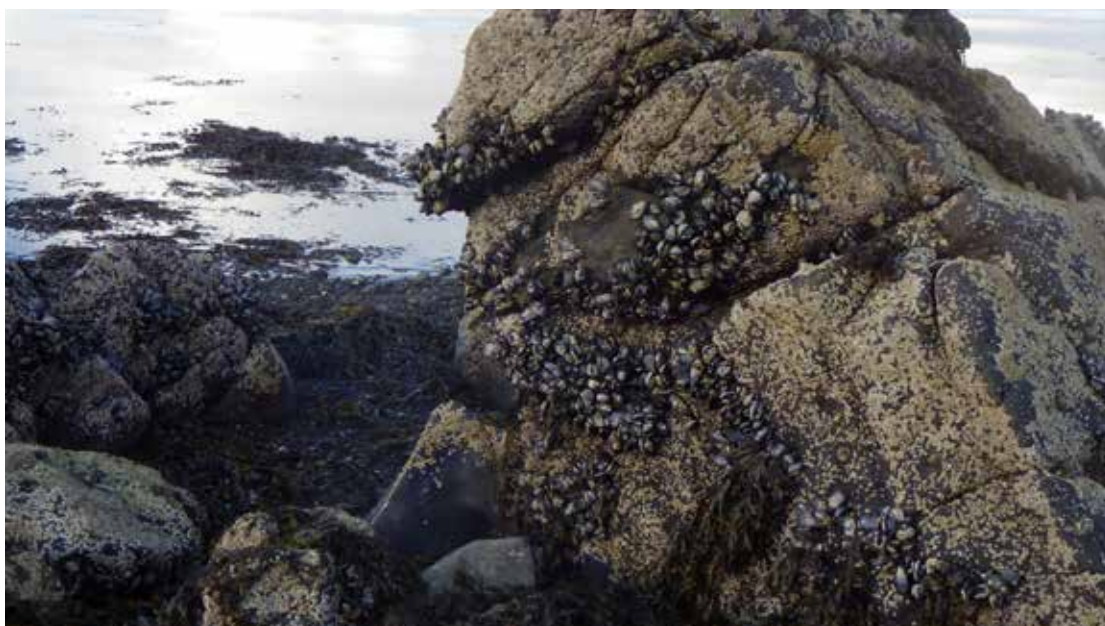
Figure 5. Extra shellfish sample LBSF2 taken from shore mussels as cockles were very small and sparse. Associated with waypoint 6.

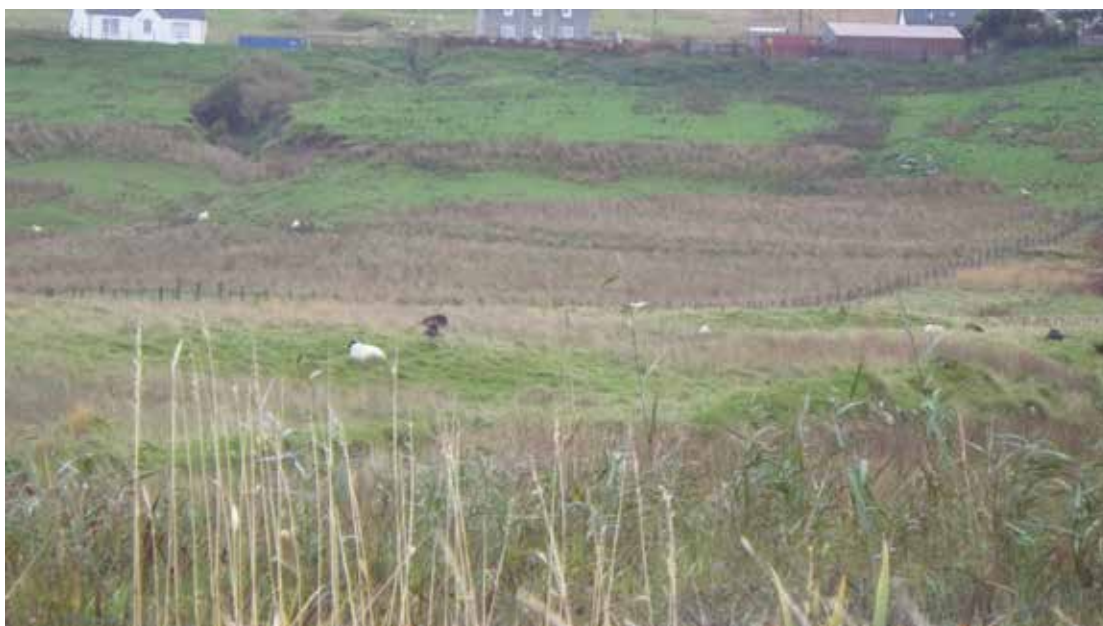
During the shoreline survey 10 cattle and 20 sheep in total were observed in the fields south of the fishery. On the eastern shoreline approximately 35 sheep were observed in fields inland from the survey route. The Ordnance Survey map identifies a cattle shelter on the eastern shoreline; however it was not confirmed during the shoreline survey whether this was still in use. Two sheep dips were located by SEPA in the area; the closest is located inland south of the production area, close to where the livestock were observed during the shoreline survey.

Figure 11. Approximately thirty five sheep in field immediately above Lusta Burn.
Associated with waypoint 27.

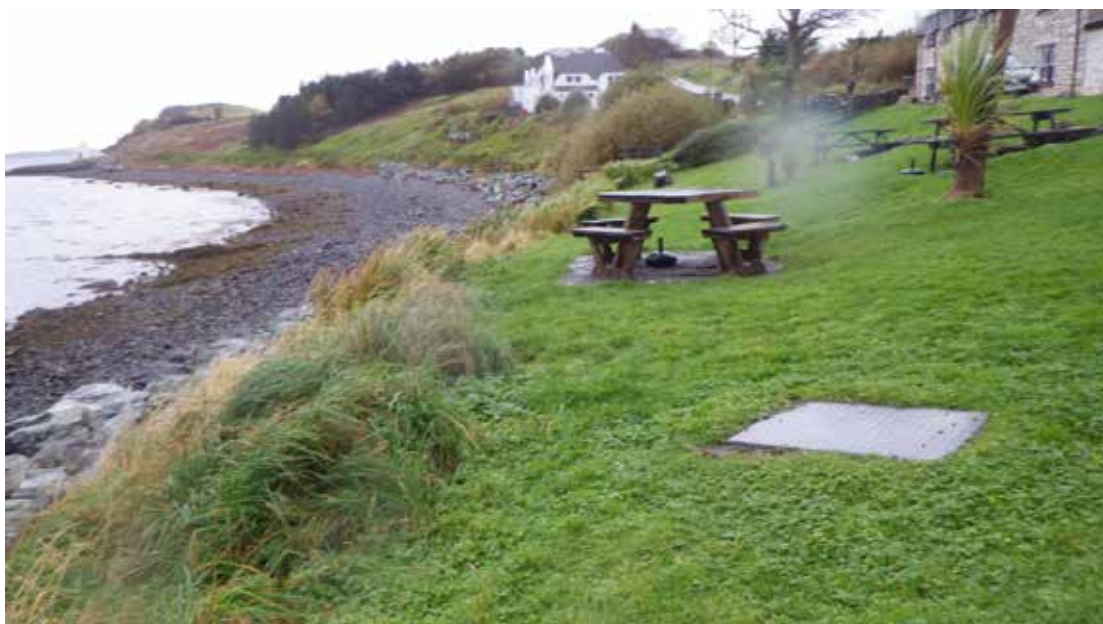
Observation 1 reports a manhole cover above the shore at Stein. No discharge was noted but several consents plot in the vicinity and this probably serves as an inspection point for one of them.

Figure 14. Manhole cover above shore, below Stein Inn. No discharges onto shore below. Associated with waypoint 32.

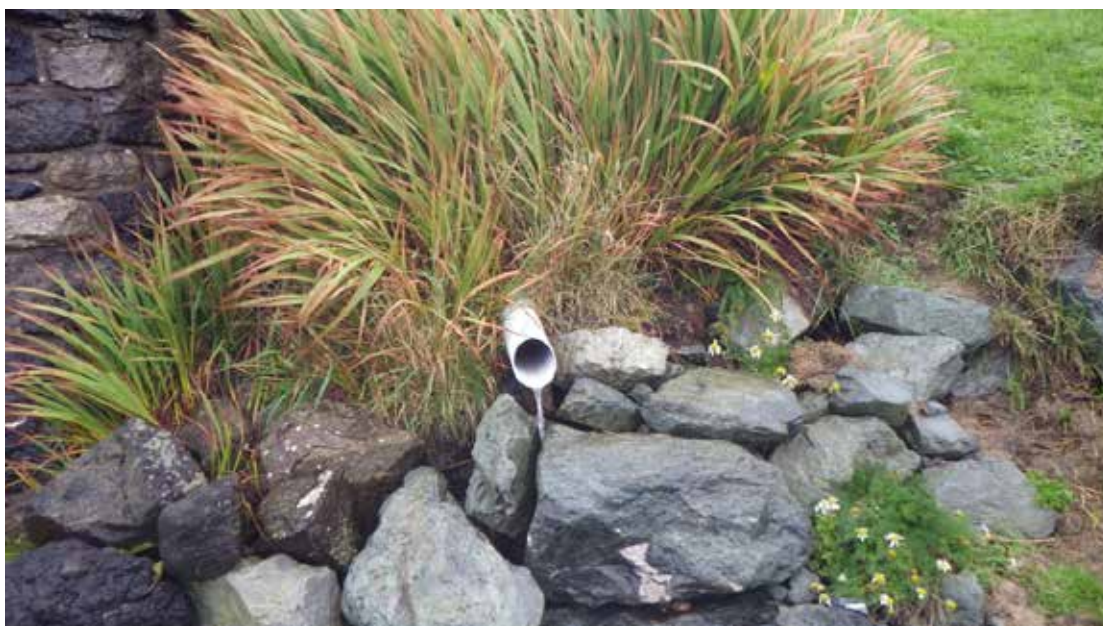
No.	Date	Associated Photograph (Appendix 5)	<i>E. coli</i> (cfu/100ml)	Description
1	22/10/2013	Fig14	-	Manhole cover above shore, below Stein Inn. No observed discharges onto shore below.
2	22/10/2013	Fig15	5000	Sample taken from 10cm UPVC pipe draining onto foreshore (contaminated).

Figure 15. Unplanned freshwater sample LBFW 8 taken from 10cm UPVC pipe draining onto foreshore (contaminated). Associated with waypoint 33.

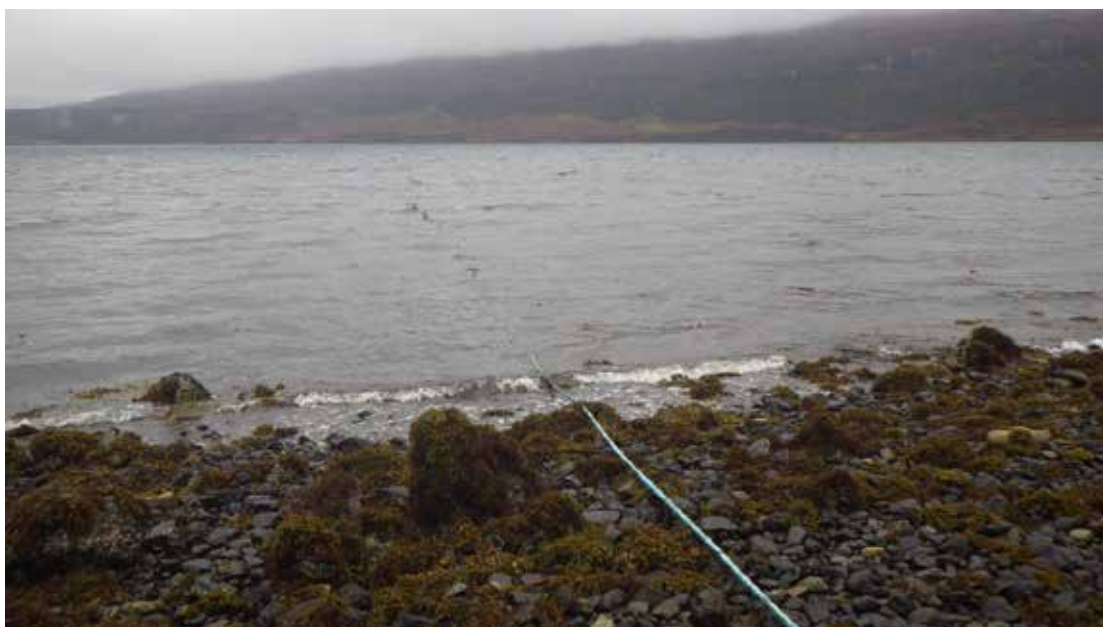
Figure 16. Three centimetre diameter blue plastic pipe running from above shore into water. Associated with waypoint 35.
