# Scottish Sanitary Survey Project

Sanitary Survey Report  
Loch Leurbost and Loch Leurbost:  
Crosbost  
LH 168, LH 339  
March 2011

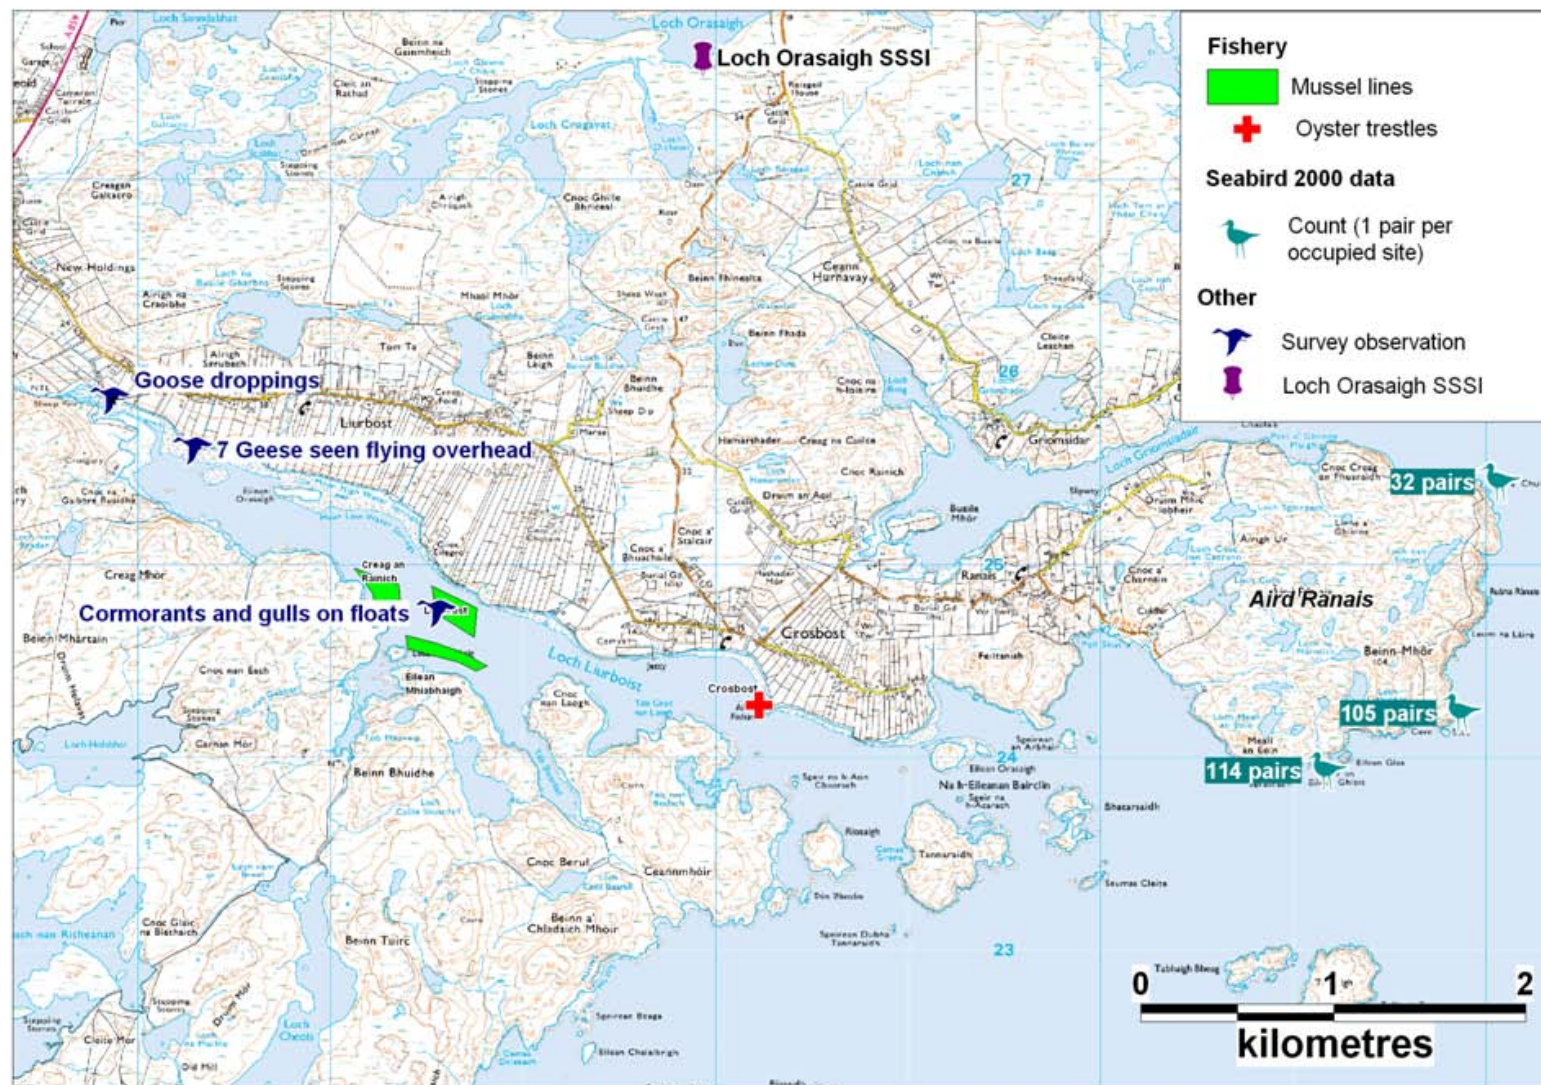
**Figure 8.1 Map of seabird distributions at Loch Leurbost**

Seabird 2000 data has been provided for a 5 km radius of Loch Leurbost. In total there are three separate wildlife observations for the area. All three observations were located east of Loch Leurbost on the cliffs of Aird Ranais headland, see Figure 8.1. The observations were three groups of fulmars, in fairly large numbers of 32, 105, and 114.

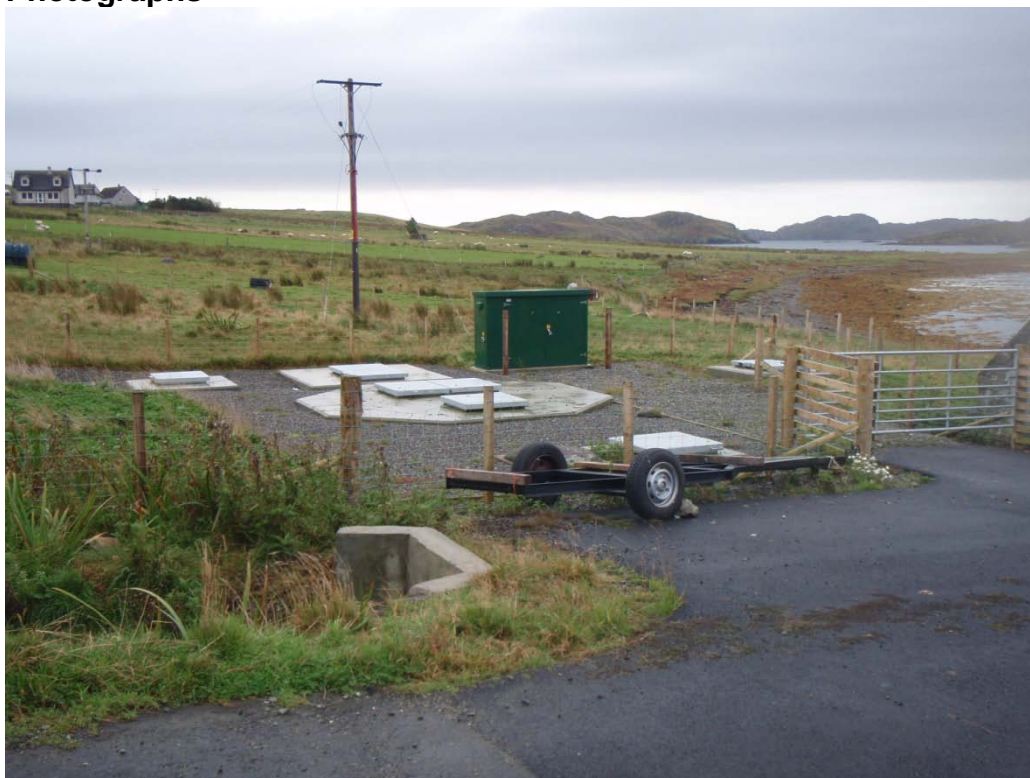
Figure 5. Newer septic tank at Crosbost

Four septic tanks were identified during the shoreline survey. Three of these were associated with the Scottish Water septic tanks listed in Tables 4.1 and 4.2. Number 3 was a new septic tank and what was most likely the storm storage tank (Appendix 8, Figures 11 & 12). The location corresponded roughly with items 1A and 1B in Table 4.1. An access cover was observed further east along the shoreline, in line with Items 1C and 1D in Table 4.1.

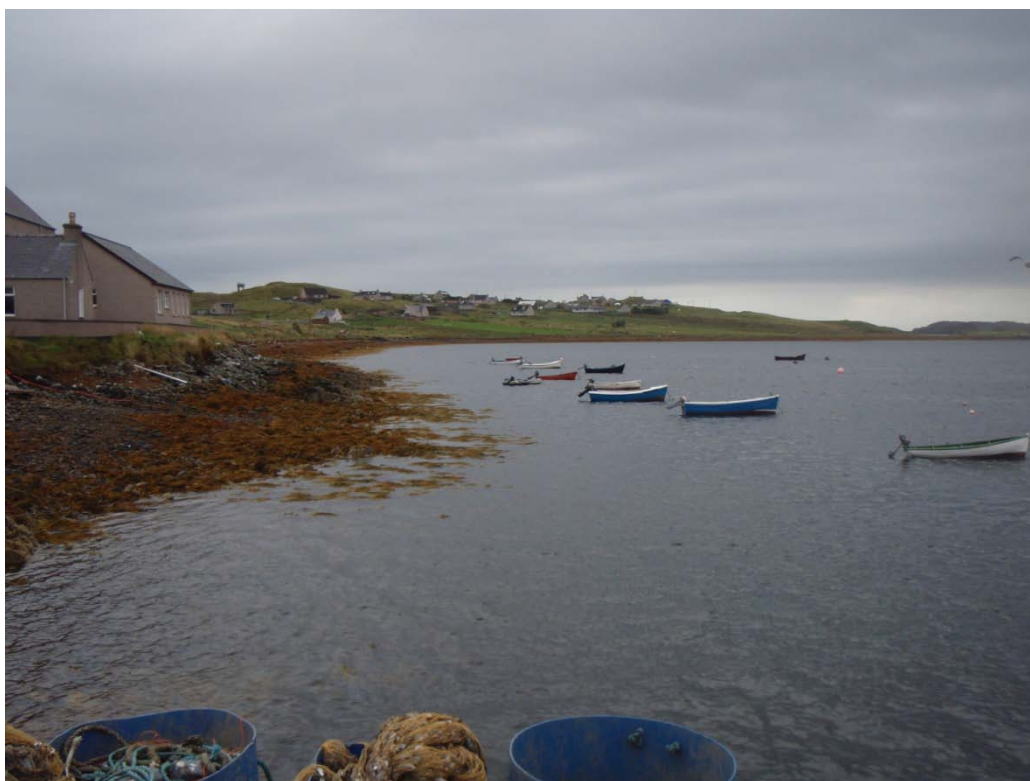
Figure 6. Small boats east of Crosbost pier

No.	Date	Time	NGR	East	North	Associated photograph	Description
1	21/09/2010	09:50	NB 39162 24551	139162	924551	Figure 5	WWTW Crosbost.
2	21/09/2010		NB 38682 24507	138682	924507	Figure 6	Crosbost pier, 24 small workboats and tenders, 4 larger workboats on other side of loch
3	21/09/2010		NB 37484 24597	137484	924597	Figure 7,8	Mussel service barge used for harvesting at Eilean Mhiabhaig
4	21/09/2010		NB 37760 24496	137760	924496		Mussel samples 1 (bottom) and 2 (top), water sample 3, droppers to 7 meters
5	21/09/2010		NB 37393 24595	137393	924595		Mussel samples 4 (bottom) and 5 (top), water sample 6
6	21/09/2010		NB 37123 24980	137123	924980		Mussel farm - no stock on this site
7	21/09/2010		NB 37548 24744	137548	924744		Occassional cormorants and gulls on floats
8	21/09/2010		NB 37552 24854	137552	924854		Mussel sample 7 (bottom) and 8 (top), water sample 9
9	21/09/2010	12:10	NB 37504 24600	137504	924600		Classification and biotoxin samples, water temperature 12.5C

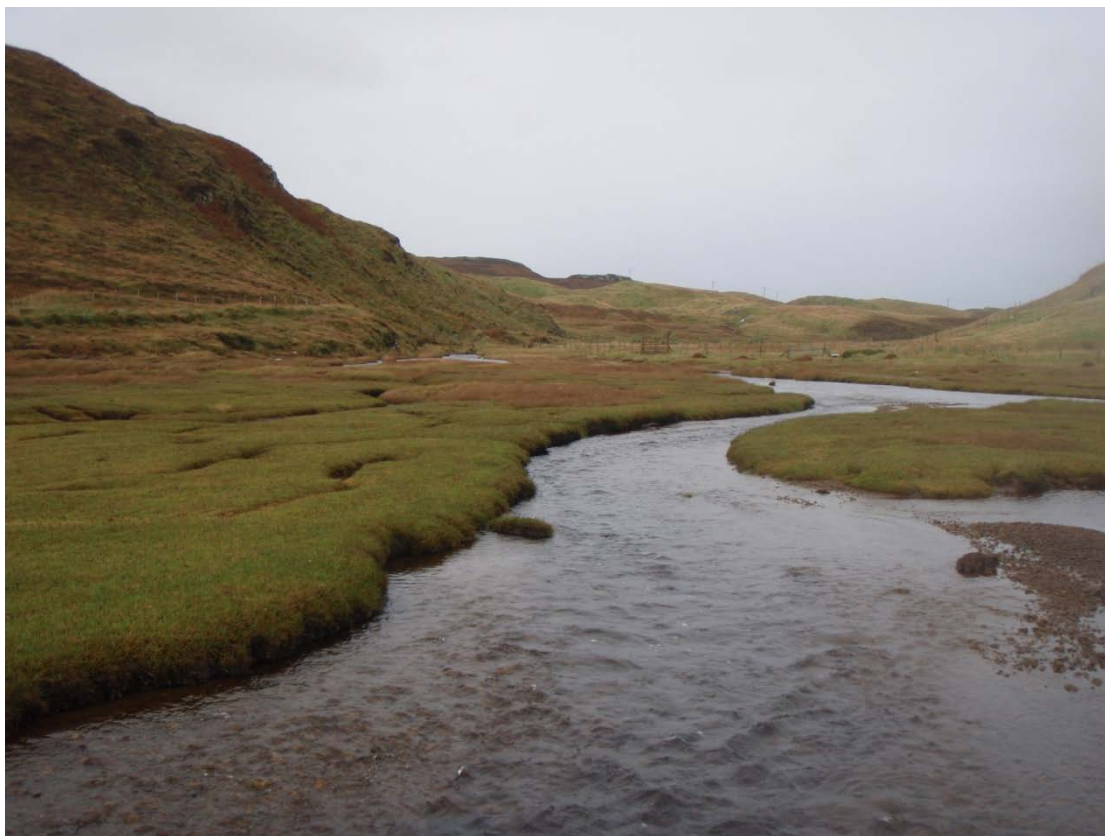
Figure 9. Part of the stream at the head of Loch Leurbost

10	23/09/2010	10:02	NB 35762 25907	135762	925907		Stream feeding into head of loch, water sample 22, w 1.7m, d1 0.1m flow 0.304m/s, d2 0.08m flow 0.275 m/s
11	23/09/2010	10:05	NB 35739 25890	135739	925890	Figure 9	Stream at head of loch, water sample 23, w 6.7m, d 0.36m, flow 0.6 m/s
12	23/09/2010		NB 35727 25873	135727	925873		Stream at head of loch 3, water sample 24, w 3m, d 0.23m, flow 1.146 m/s
13	23/09/2010		NB 35708 25824	135708	925824		Branch 4 of stream at head of loch, no water sample, w 2.7m, d 0.32, flow 0.743m/s
14	23/09/2010		NB 35851 25852	135851	925852		Goose droppings
15	23/09/2010		NB 35916 25831	135916	925831		Shed for sheep dipping, boat
16	23/09/2010		NB 35984 25802	135984	925802		Small, shallow stream - not measured or sampled
17	23/09/2010		NB 36097 25763	136097	925763		Land drainage
18	23/09/2010		NB 36281 25592	136281	925592		7 geese seen flying overhead
19	23/09/2010		NB 36447 25570	136447	925570		Land drainage

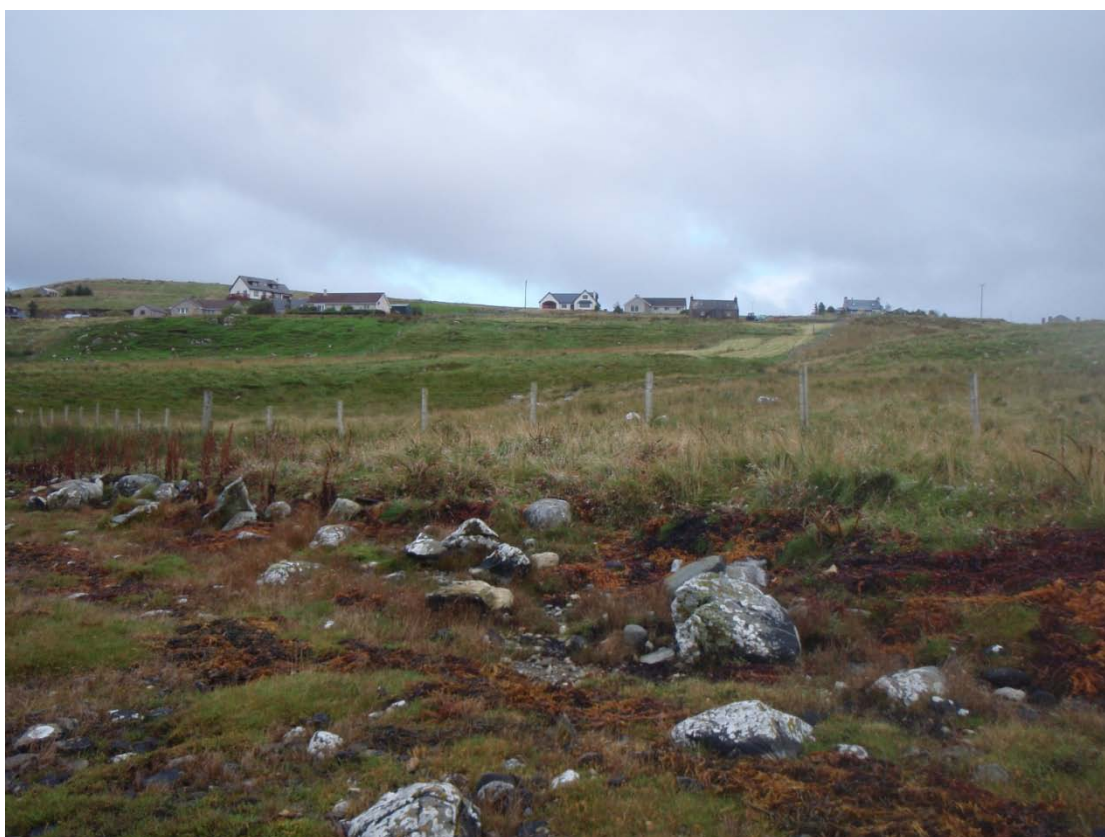
Figure 10. Homes and livestock above north shore

20	23/09/2010		NB 36449 25553	136449	925553		Sample 25, sea water
21	23/09/2010	11:03	NB 36609 25567	136609	925567		Stream, water sample 26, w 1.3m, d 0.27m, flow 0.622m/s
22	23/09/2010		NB 36654 25503	136654	925503	Figure 10	Photograph looking up shore. 16 sheep observed on hill above opposite shore, 24 more at head of loch
23	23/09/2010	11:23	NB 37285 25355	137285	925355		Stream, water sample 27, w 0.7m, d 0.27m, flow 0.222m/s

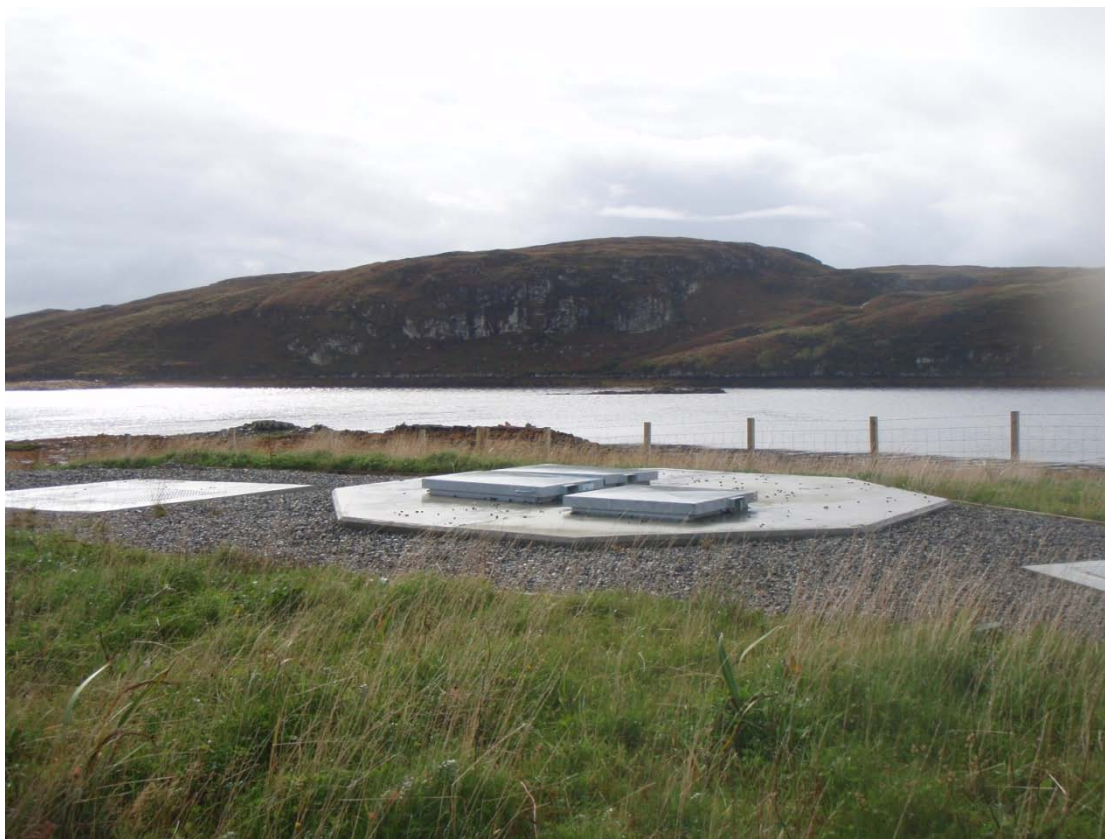
Figure 11. Septic tank at Leurbost, near head of loch

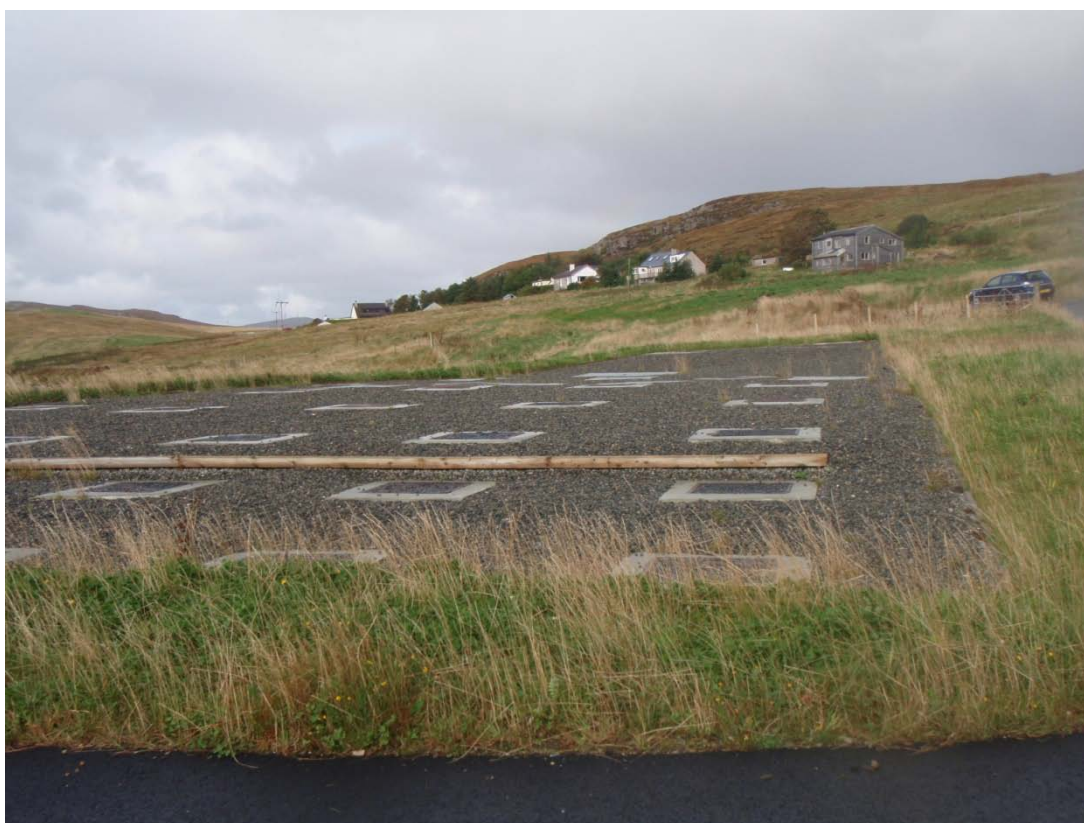
Figure 12. View looking north across septic tank installation toward road

No.	Date	Time	NGR	East	North	Associated photograph	Description
24	23/09/2010	11:29	NB 37348 25298	137348	925298		Stream, not sampled or measured
25	23/09/2010		NB 36603 25565	136603	925565		Concreted and steel access cover on shoreline
26	23/09/2010		NB 36220 25676	136220	925676	Figure 11,12	Septic tank, photograph
27	23/09/2010		NB 39225 24297	139225	924297	Figure 13	Oyster farm, one row of wide trestles. West end of oyster trestles, norovirus sample, water sample 28
28	23/09/2010		NB 39238 24262	139238	924262		East end of oyster trestles
29	23/09/2010		NB 39166 24528	139166	924528		Stream, water sample 29, w 0.45m, d 0.11, flow 0.455m/s
30	23/09/2010		NB 40136 24418	140136	924418	Figure 14	Septic tank at small bay, 5 small boats on moorings, 2 sheep on shoreline, photograph
31	23/09/2010		NB 39281 24560	139281	924560		1 horse, 32 sheep on crofts between septic tank and oyster farm
32	23/09/2010		NB 39635 24423	139635	924423		2 sheep on garden and porch, house uphill from road

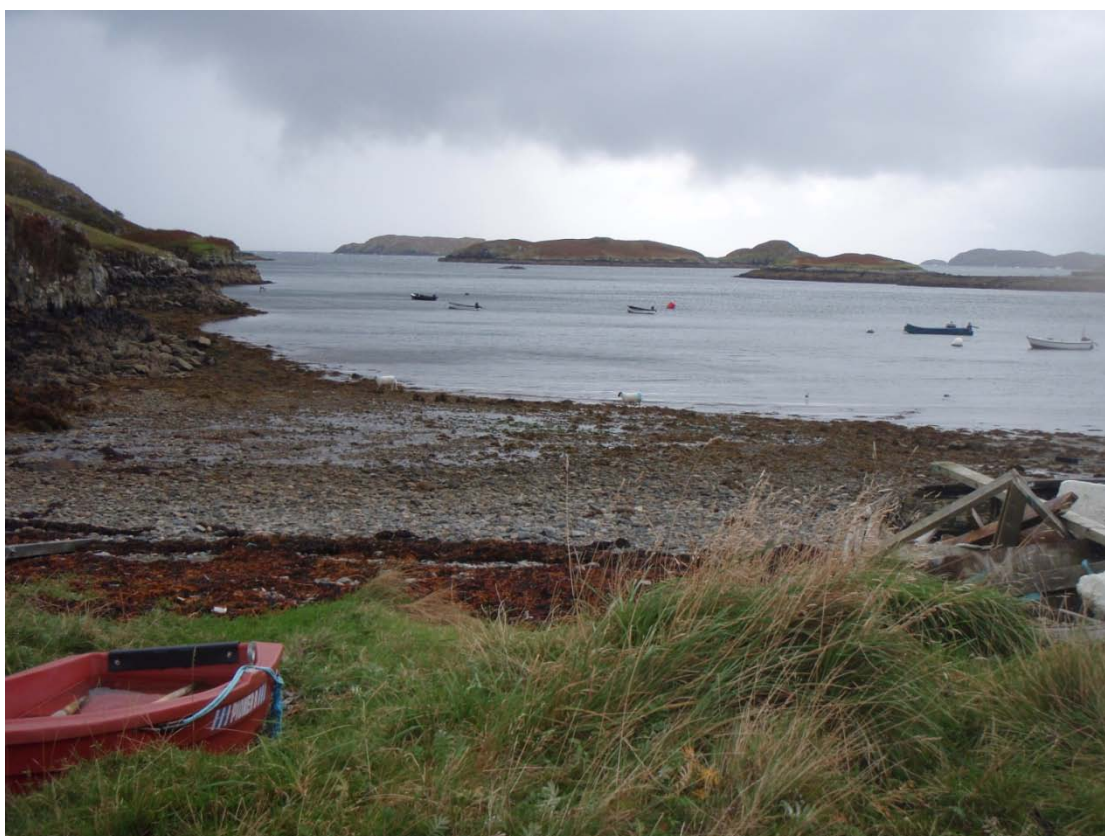
Figure 14. Near septic tank on small bay at east end of Crosbost, sheep on shore

Item 4 was a Scottish Water septic tank found at the eastern end of Crosbost, at the head of an inlet approximately 1 km east of the oyster farm. No consent was identified for this discharge. It was found to be listed in the SEPA Shellfish Growing Water report for Outer Loch Leurbost (SEPA 2011) as Crossbost (East) Scottish Water Asset No. 2770, an unconsented discharge with a population equivalent (PE) of 80.

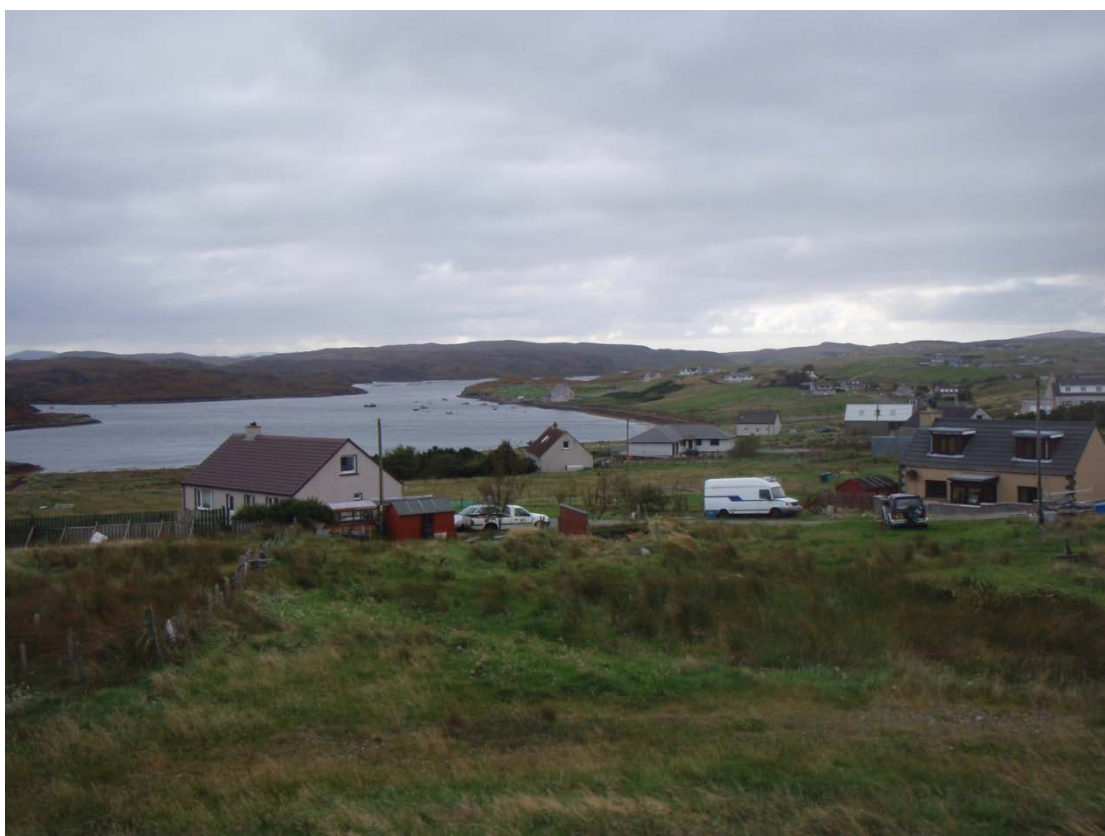
Figure 15. View looking west along north shore from east Crosbost

33	23/09/2010		NB 39886 24324	139886	924324		4 sheep
34	23/09/2010		NB 39650 24410	139650	924410		2 horses uphill
35	23/09/2010		NB 39574 24464	139574	924464	Figure 15	8 sheep uphill from road, 1 downhill, view looking west along shore
36	23/09/2010		NB 38989 24656	138989	924656		4 cattle downhill from road
37	23/09/2010		NB 38834 24682	138834	924682		House under construction
38	23/09/2010		NB 38768 24562	138768	924562		Church hall/ car park
39	23/09/2010		NB 38289 24651	138289	924651	Figure 16	Septic tank/WWTW
40	23/09/2010		NB 38554 24743	138554	924743		8 sheep across road from entrance to WWTW
41	23/09/2010		NB 38441 24976	138441	924976		10 sheep uphill from road
42	23/09/2010		NB 38359 25142	138359	925142		9 sheep plus 22 further uphill and to west
43	23/09/2010		NB 38292 25262	138292	925262		6 sheep
44	23/09/2010		NB 37698 25720	137698	925720		8 sheep downhill
45	23/09/2010		NB 37481 25760	137481	925760		18 sheep downhill

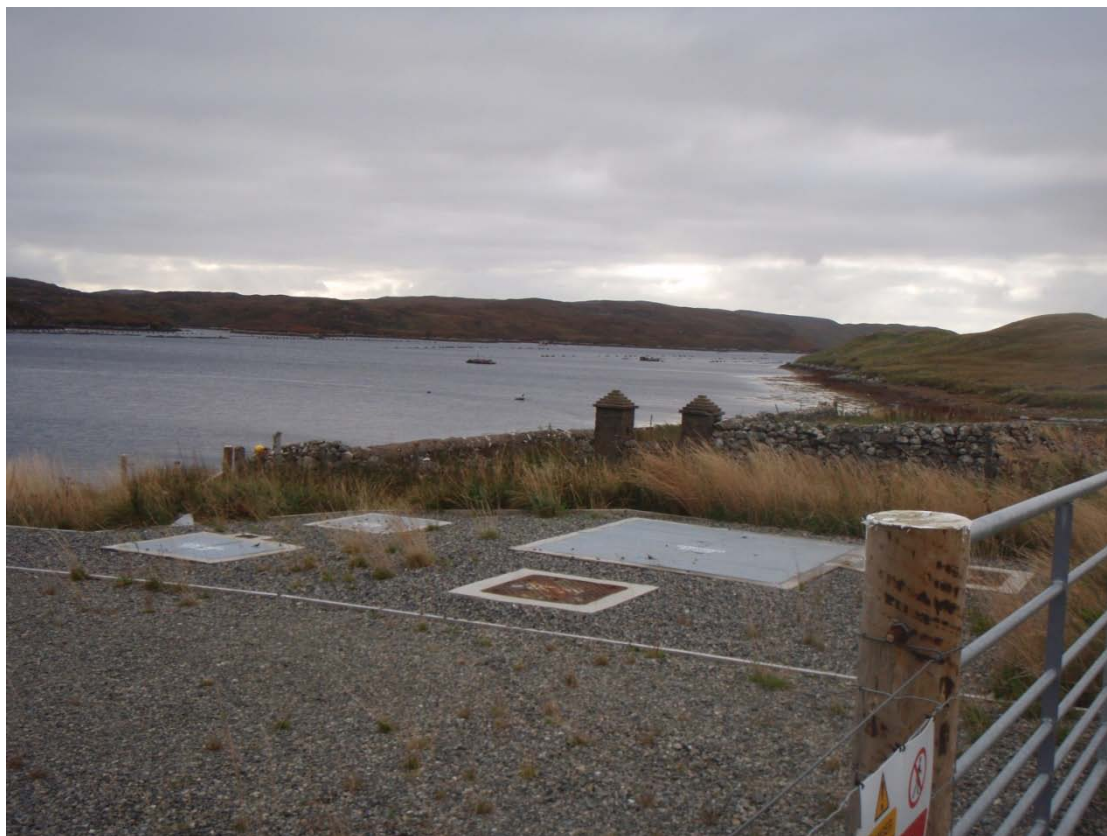
Figure 16. Septic tank with mussel farms visible in background

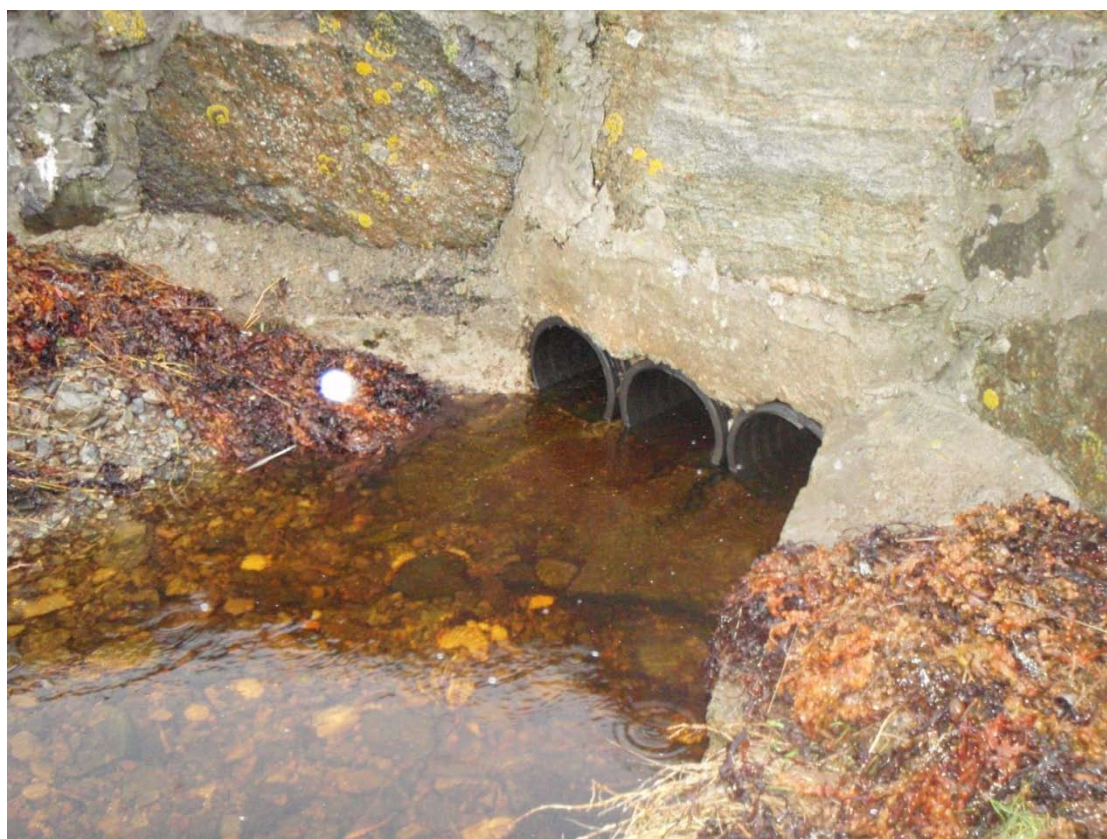
Figure 17. Stream flowing through culvert, East Crosbost
