Scottish Sanitary Survey Project

Sanitary Survey Report Vaila Sound and Vaila Sound: Riskaness SI288 and SI289 August 2009

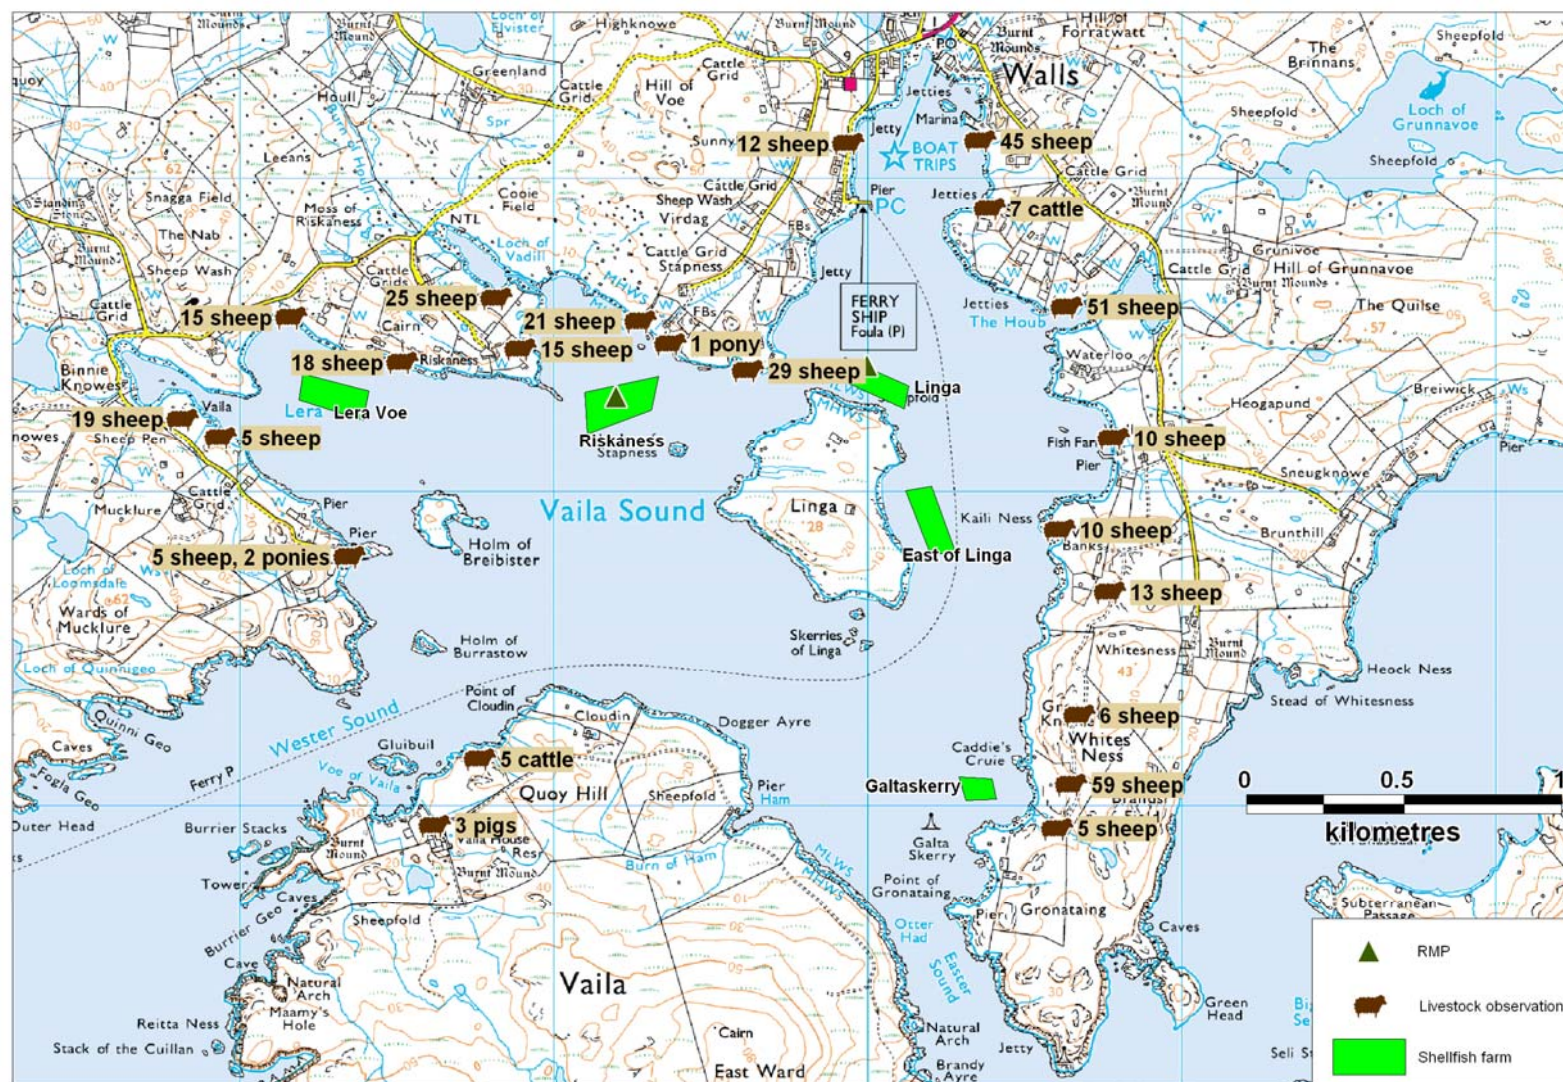
Figure 7.1 Livestock observations at Vaila Sound

The shoreline survey confirmed that sheep grazed widely around the Vaila Sound coastline. Several cattle and three pigs were also observed on the nearby island of Vaila, although no pigs were reported by RERAD in the agricultural census on confidentiality grounds due to the small number of holdings. Sheep were fairly evenly spread around the shoreline of the two production areas. Geographical spread of contamination at the shores of the sound is therefore likely to be fairly even.

Numbers of sheep will approximately double during May following the birth of lambs, and decrease in the autumn as they are sent to market. Therefore higher impacts from livestock may be expected during this period.

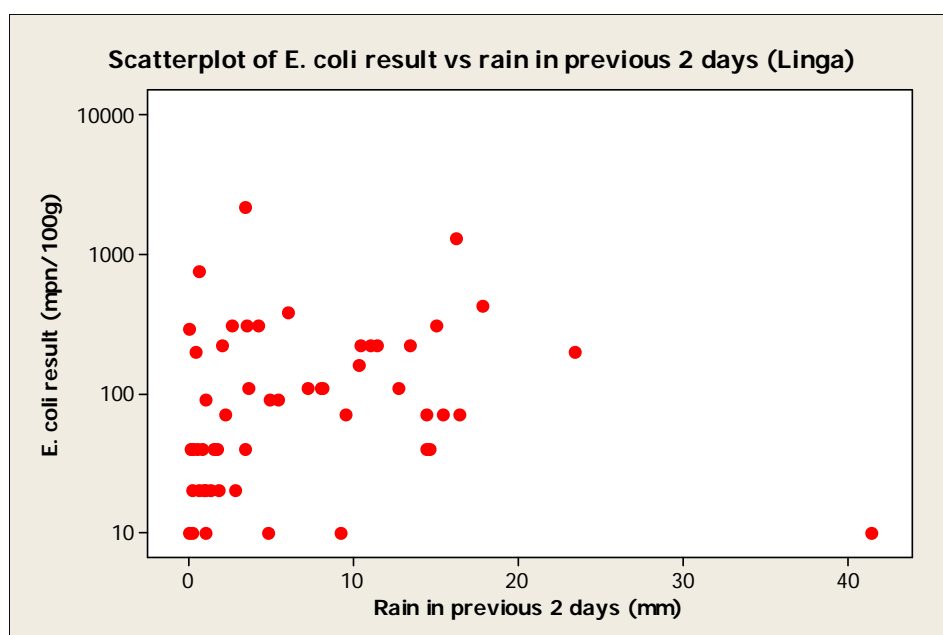
Figure 11.12 Scatterplot of *E. coli* result vs rainfall in previous 2 days (Linga)

A significant positive correlation was found between the ranked *E. coli* result and the ranked rainfall in the previous two days for Linga (Spearman's Rank correlation=0.349, $p=0.010$, Appendix 5).

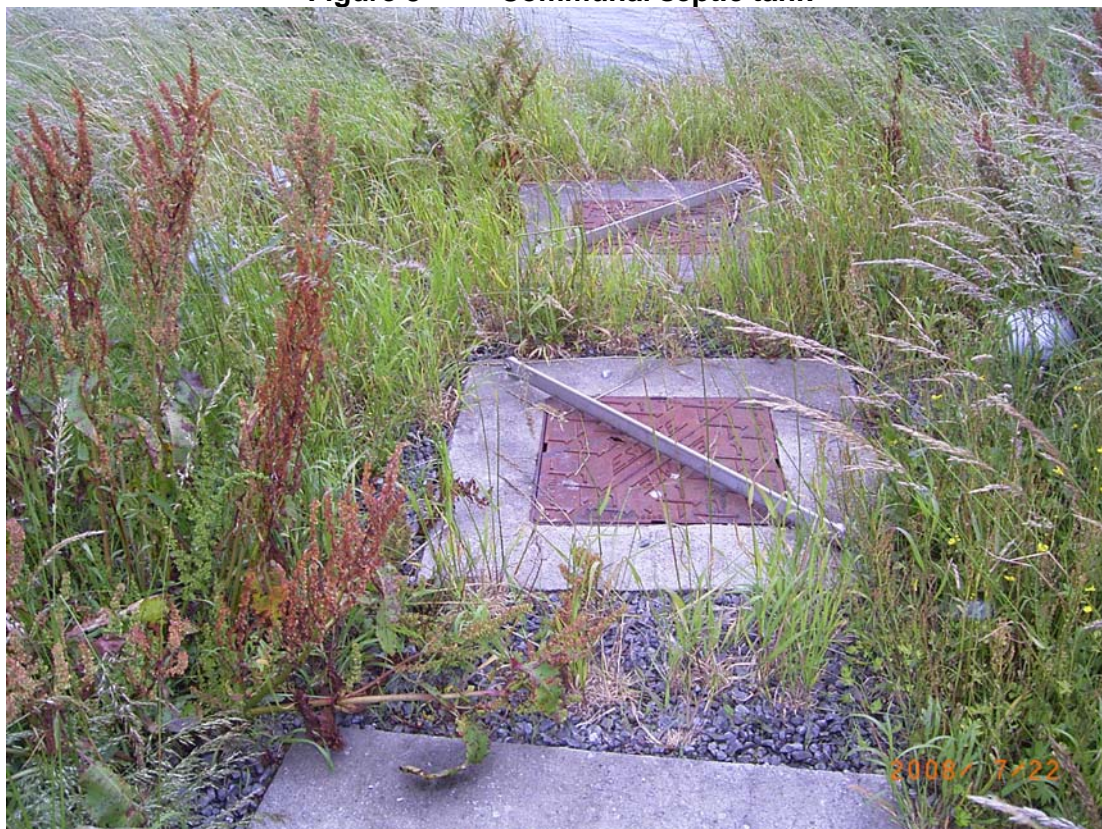
Figure 9 Private septic outfall
