# Scottish Sanitary Survey Project

## Restricted Sanitary Survey Report

Loch Ryan North

DG 500

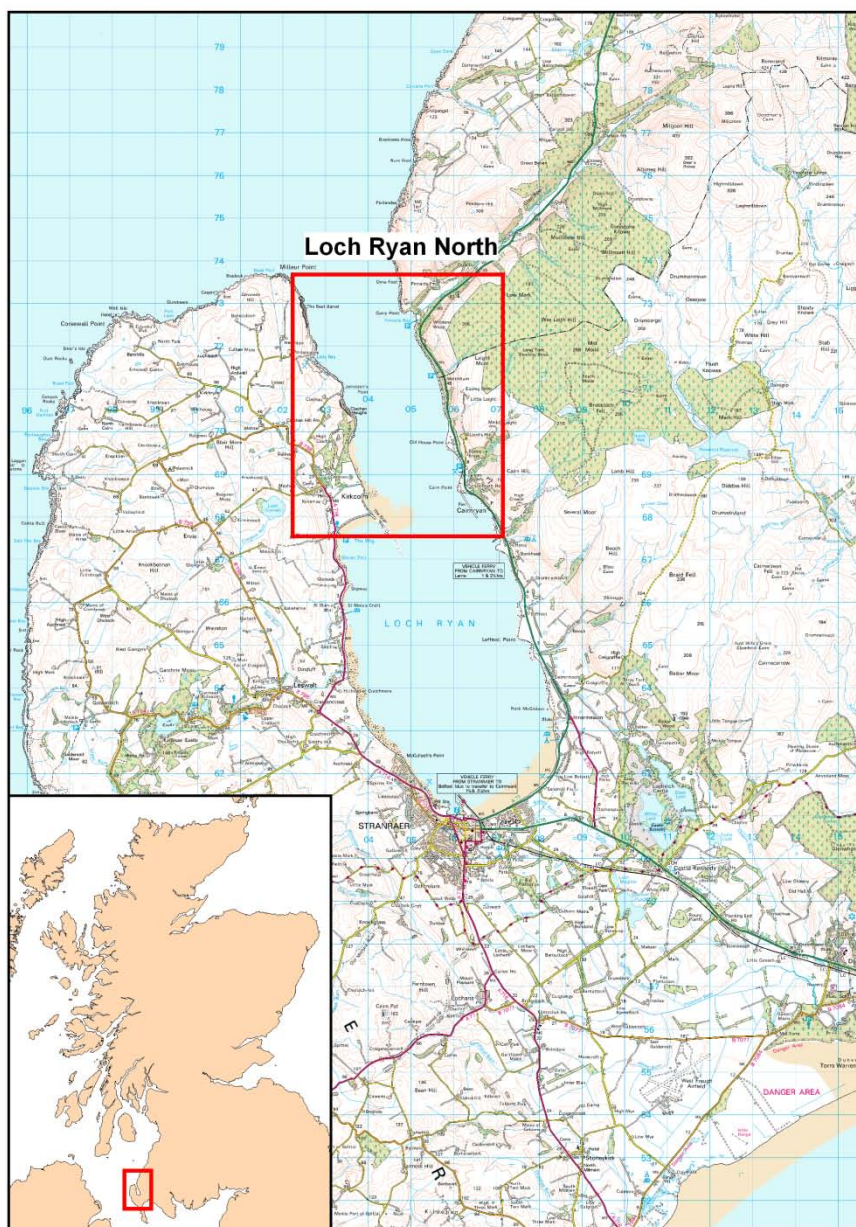
Figure 1.1 Location of Loch Ryan North

Loch Ryan is a mainly shallow, sheltered sea loch on the western coast of Scotland (see Figure 1.1). It is a natural harbour that provides calm waters for ferries operating from Scotland to Northern Ireland. The loch is approximately 13 km long from north to south and 4.8 km wide, at its widest point. To the north of Loch Ryan is the Firth of Clyde and the Atlantic Ocean.

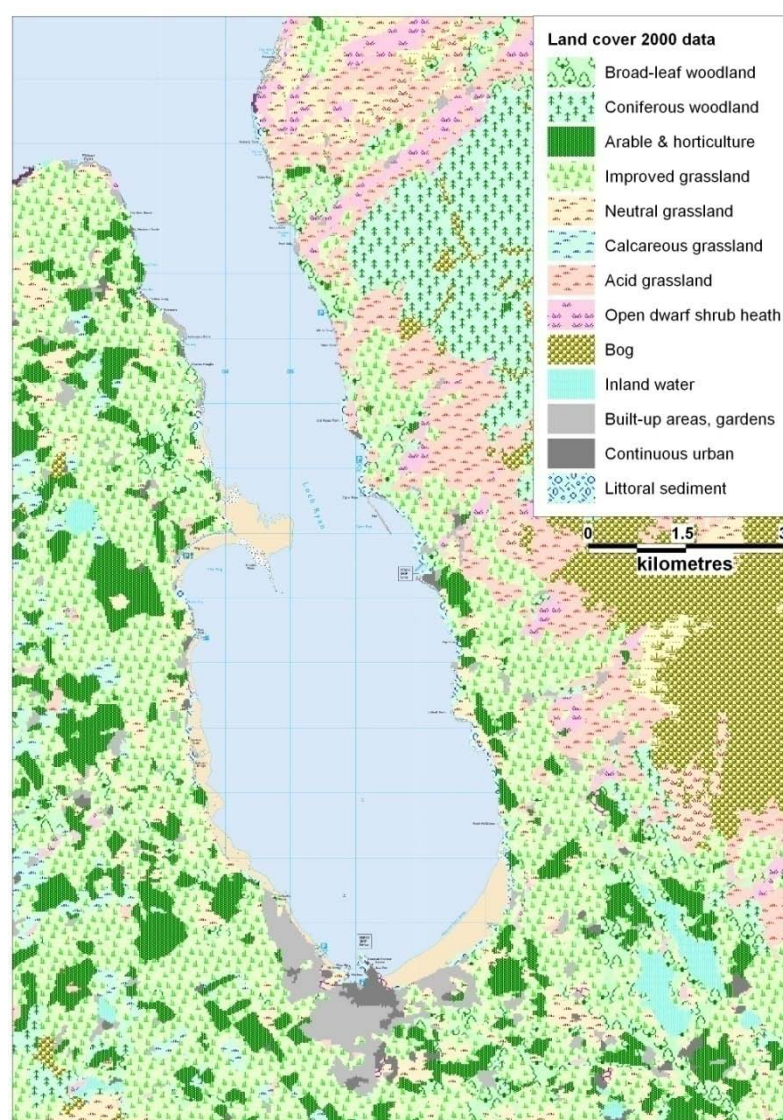
Figure 1.2 Land Cover 2000 data for Loch Ryan North

Land Cover 2000 data indicates that the land surrounding Loch Ryan is dominated by six main types of land cover: improved grassland, arable & horticulture, acid grassland, coniferous woodland, open dwarf shrub heath and bog. There are also smaller areas of broad-leaf woodland, calcareous grassland and littoral sediment. The west side of the loch is predominantly improved grassland with patches of arable and horticultural land. Inland of the east shore of the loch there is a large area of coniferous woodland to the north and a large area of bog to the south. Along the eastern coastline there are areas of improved grassland and some areas of arable and horticultural land, acid grassland, open dwarf shrub heath and neutral grassland. The large built up area to the south of the loch, is the town of Stranraer (see Figure 1.2). The settlements of Cairnryan and Kirkcolm are also shown. On the west side of the loch, the Landcover 2000 data shows there are smaller areas of built up land, which may be other village or camping grounds.

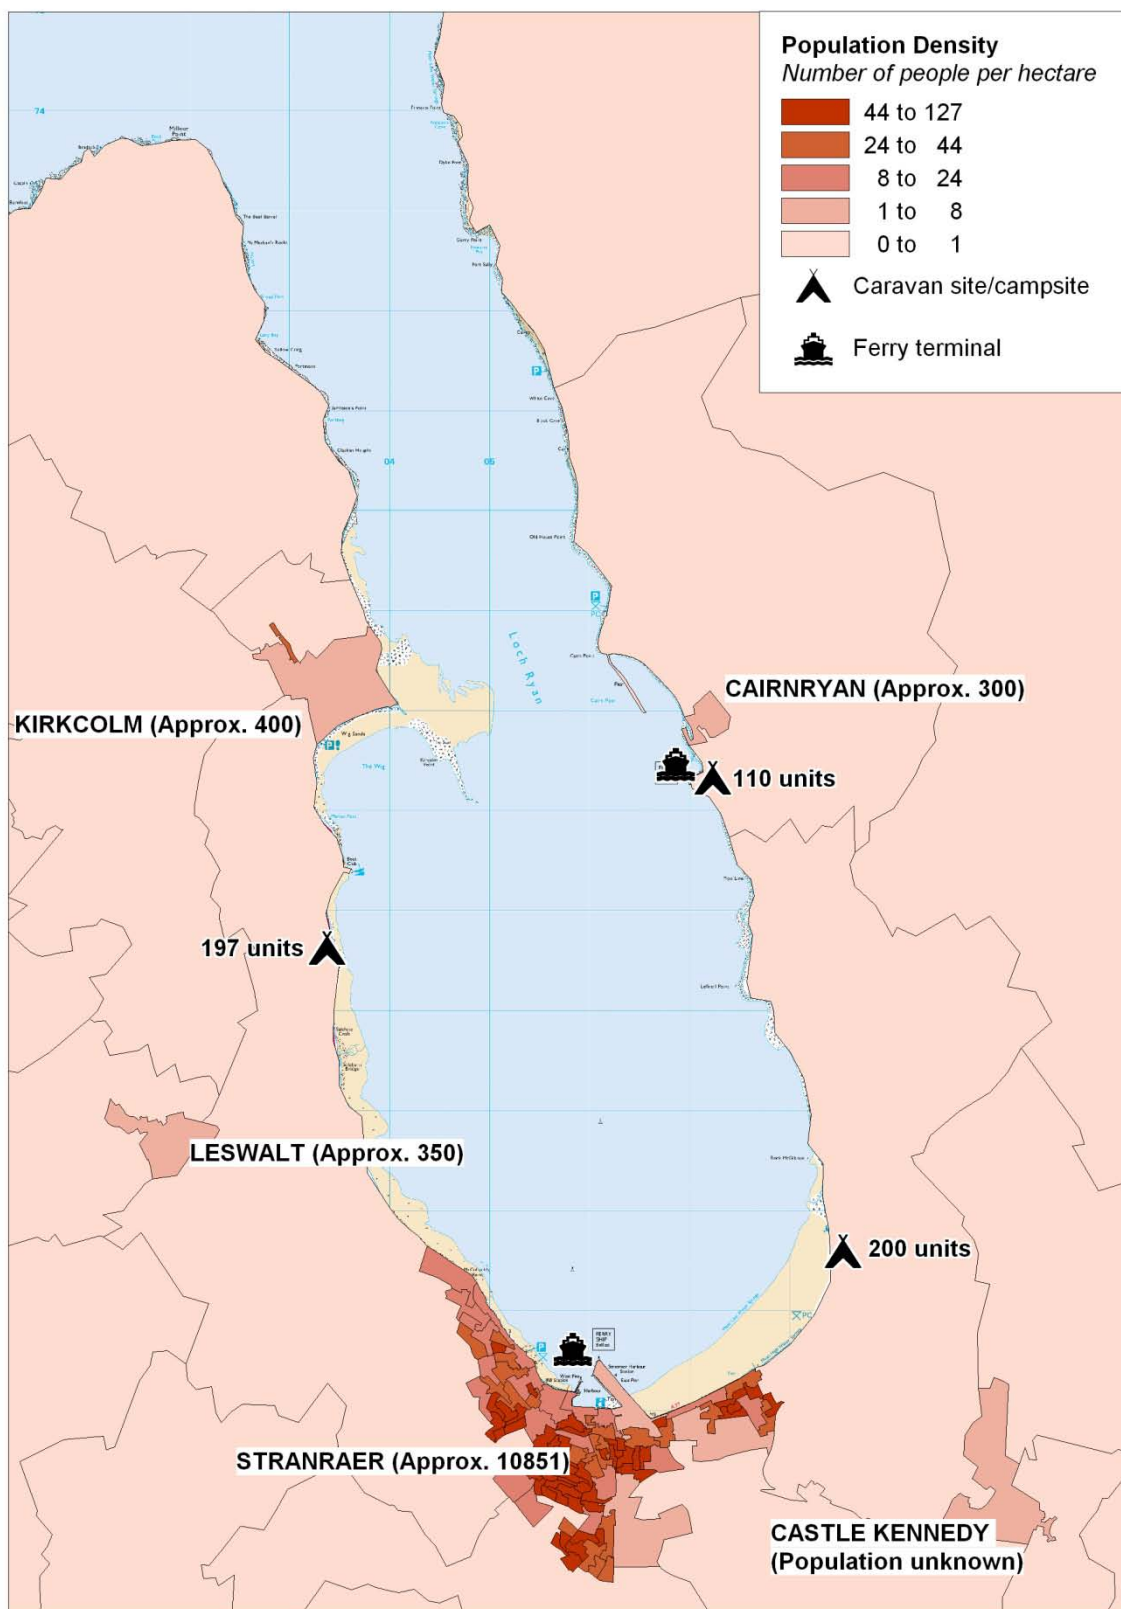
Figure 1.3 Population density of census output areas surrounding Loch Ryan

Due to the large size of Stranraer and the close proximity of Kirkcolm and Cairnryan to the production area, it is likely that sewage discharges from all three settlements will contribute to the faecal contamination of the shellfish bed. Due to the three large caravan sites, it is expected that the population in the area will increase significantly during the summer holiday months. The sewage from both of the ferries is taken off at their destinations Larne and Belfast, so this will not be a contributing factor.

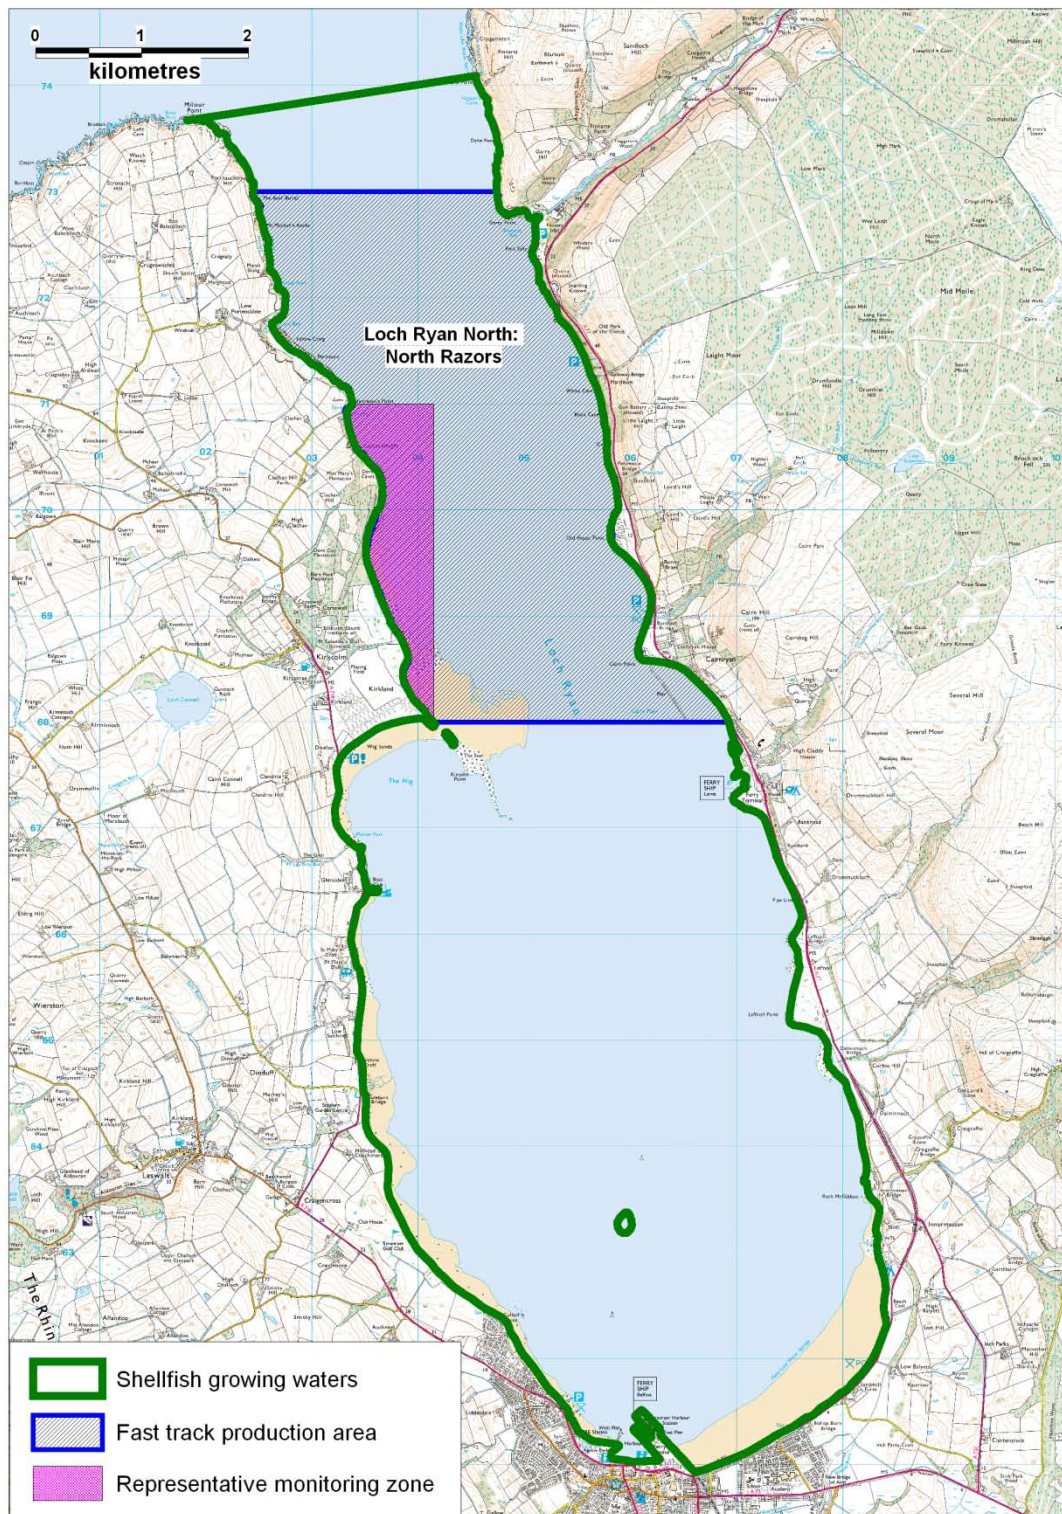
Figure 2.1 Loch Ryan North fishery

The entire loch is designated as a shellfish growing water, which encompasses the area lying south of a line from NX 0181 7367 (Milleur Point) to NX 0454 7409 (Finnarts Point) and extending to MHWS (see Figure 2.1).

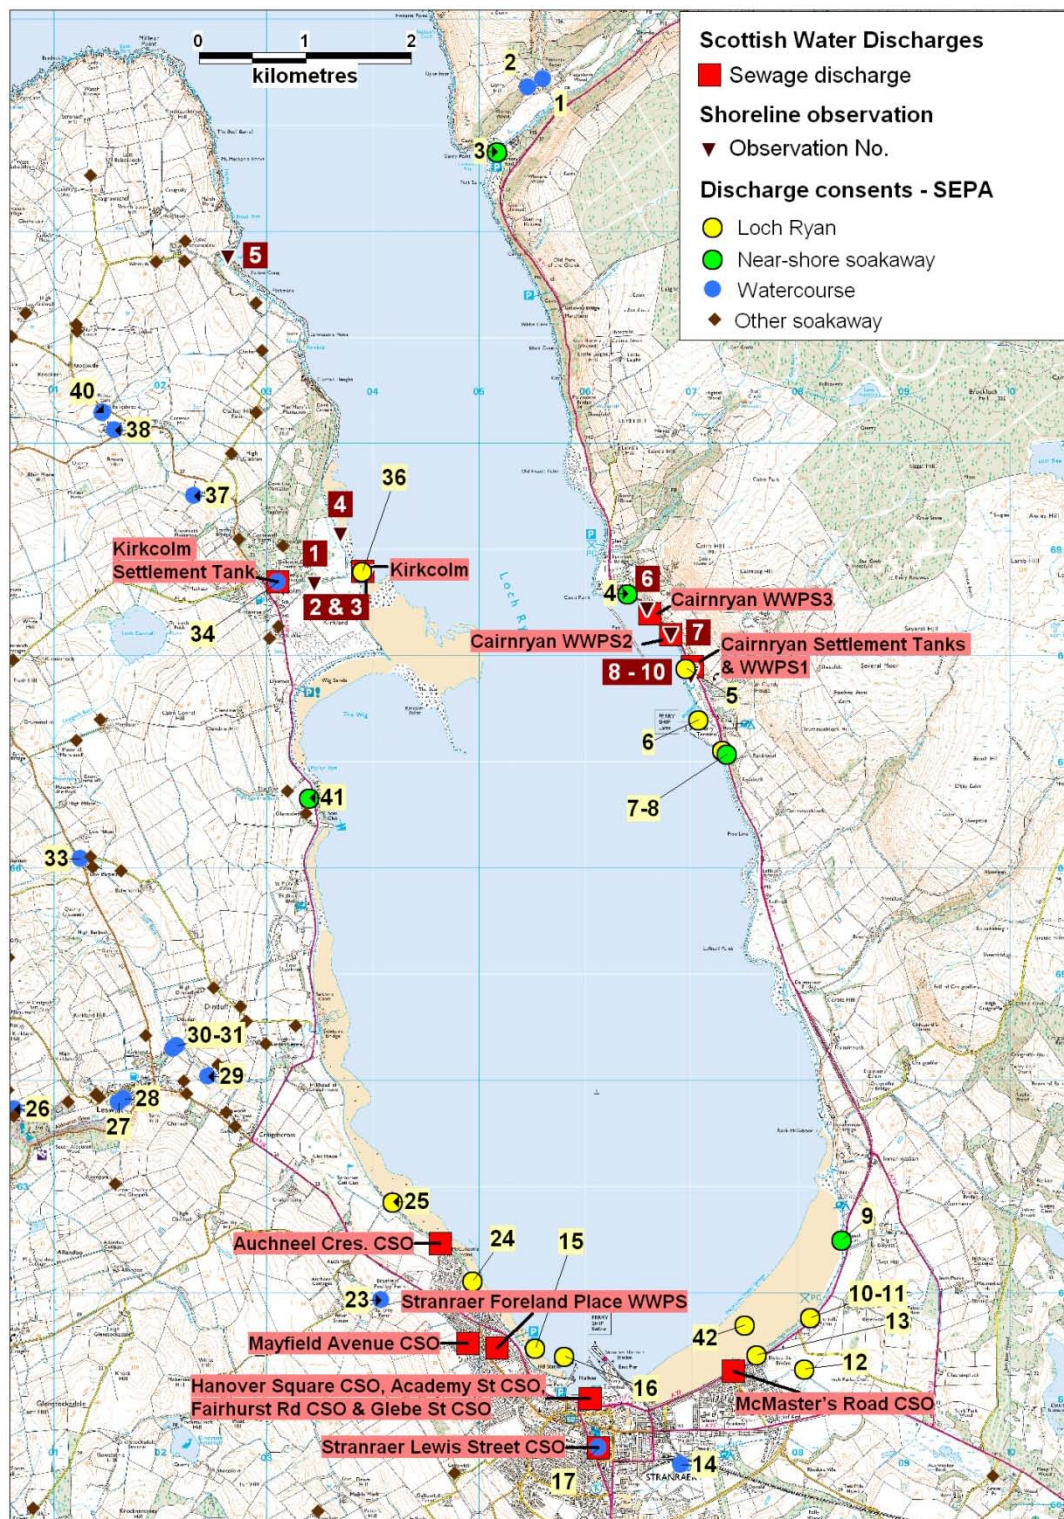
Figure 3.1 Loch Ryan sewage discharges

During the shoreline survey four outfall pipes (two of which were dry at the time), one septic tank, three septic tank pumping stations and a sewage works were observed. The sewage works and two of the outfall pipes were located at Kirkcolm and the three pumping stations, a single septic tank and the remaining outfall pipe were observed at Cairnryan.

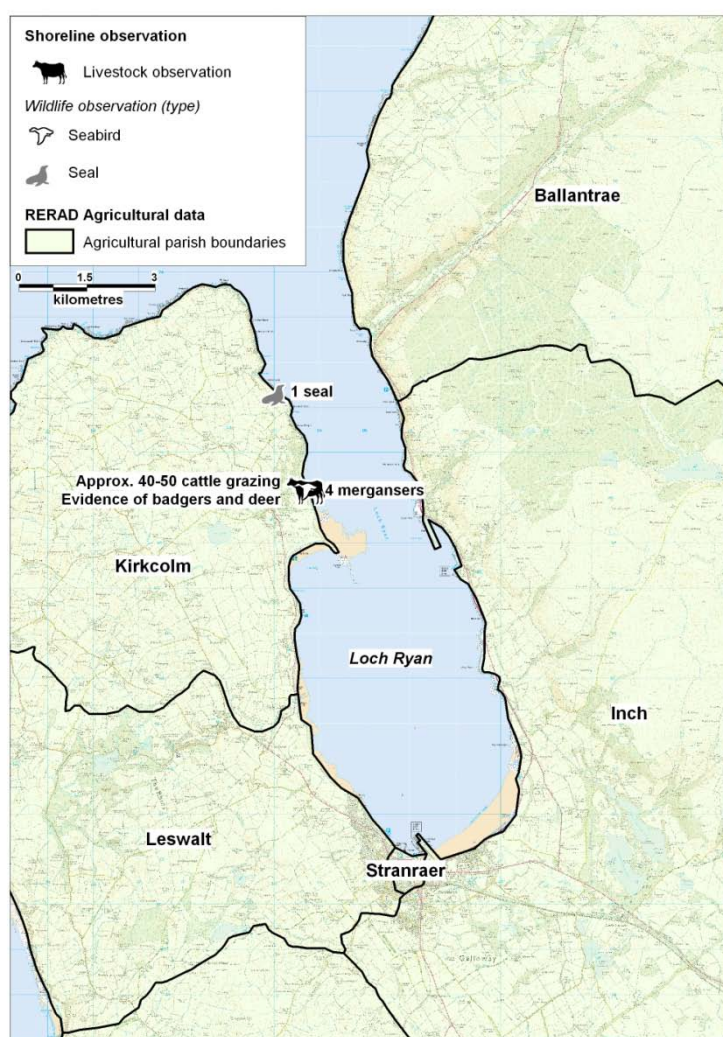
Figure 4.1 Livestock and wildlife observations and agricultural parish boundaries surrounding Loch Ryan

At the time of the shoreline survey various seabirds and wildfowl were observed along the north west shoreline, though, except for 4 mergansers no specific numbers were recorded. A single seal was also observed resting on rocks on the north western shoreline. In addition to mergansers, gulls, oyster catchers, ducks and geese were also observed on the western shoreline but numbers or location were not recorded. In the same area that mergansers were observed there was evidence of badgers and deer. It is possible that other animals including otters and other seabirds may be present in the area. The distribution and numbers of these species was not investigated. Impact from geese is likely to be highest on or near grass fields where they graze. Gulls may be found over much of the area and are as likely to deposit droppings on the sea as on land. Diffuse pollution from wildlife impacts is likely to be carried in streams via rainfall runoff.

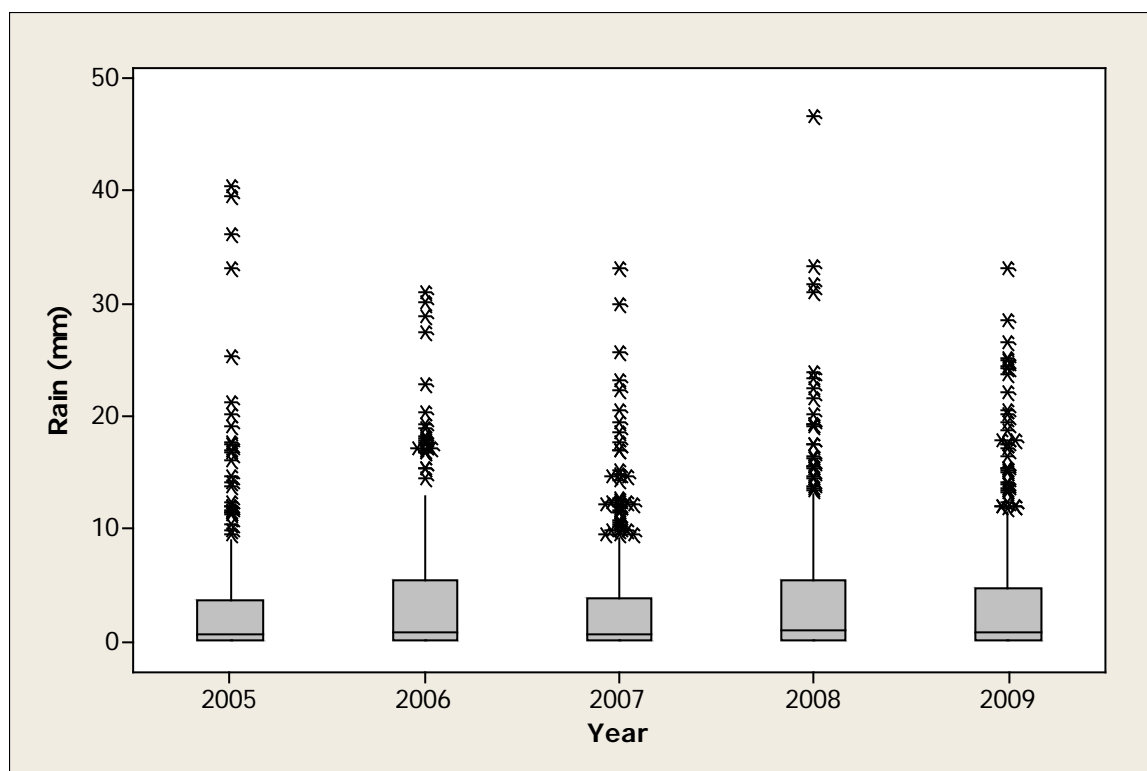
Figure 5.1 Box plot of daily rainfall values by year at Castle Kennedy, 2005-2009

Figure 5.1 shows that there was some variation in rainfall patterns between the years presented here, with 2005 and 2007 being marginally drier than 2006, 2008 and 2009. Extreme rainfall events were greater in 2005, an otherwise dry year, and in 2008.

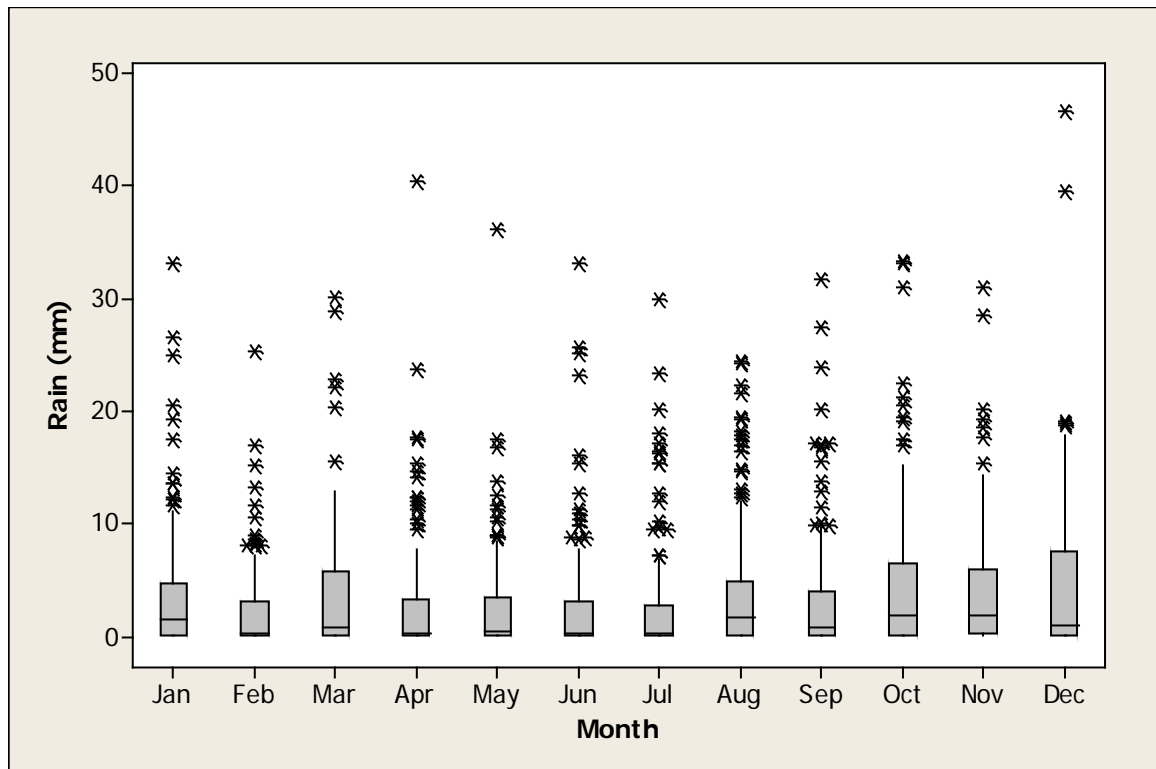
Figure 5.2 Box plot of daily rainfall values by month at Castle Kennedy, 2005-2009

Figure 5.2 indicates that the wettest months were October to December and March. February and April to July were the driest months. Days with high rainfall greater than 25 mm occurred during all months apart from February. For the period considered here (2005-2009), 52% of days experienced rainfall less than 1 mm, and 9% of days experienced rainfall of 10 mm or more. Extreme rainfall events (>3 mm) occurred in all months but February and August in this dataset. Rainfall of 40 mm or more in a day occurred during April (an otherwise dry month) and December.

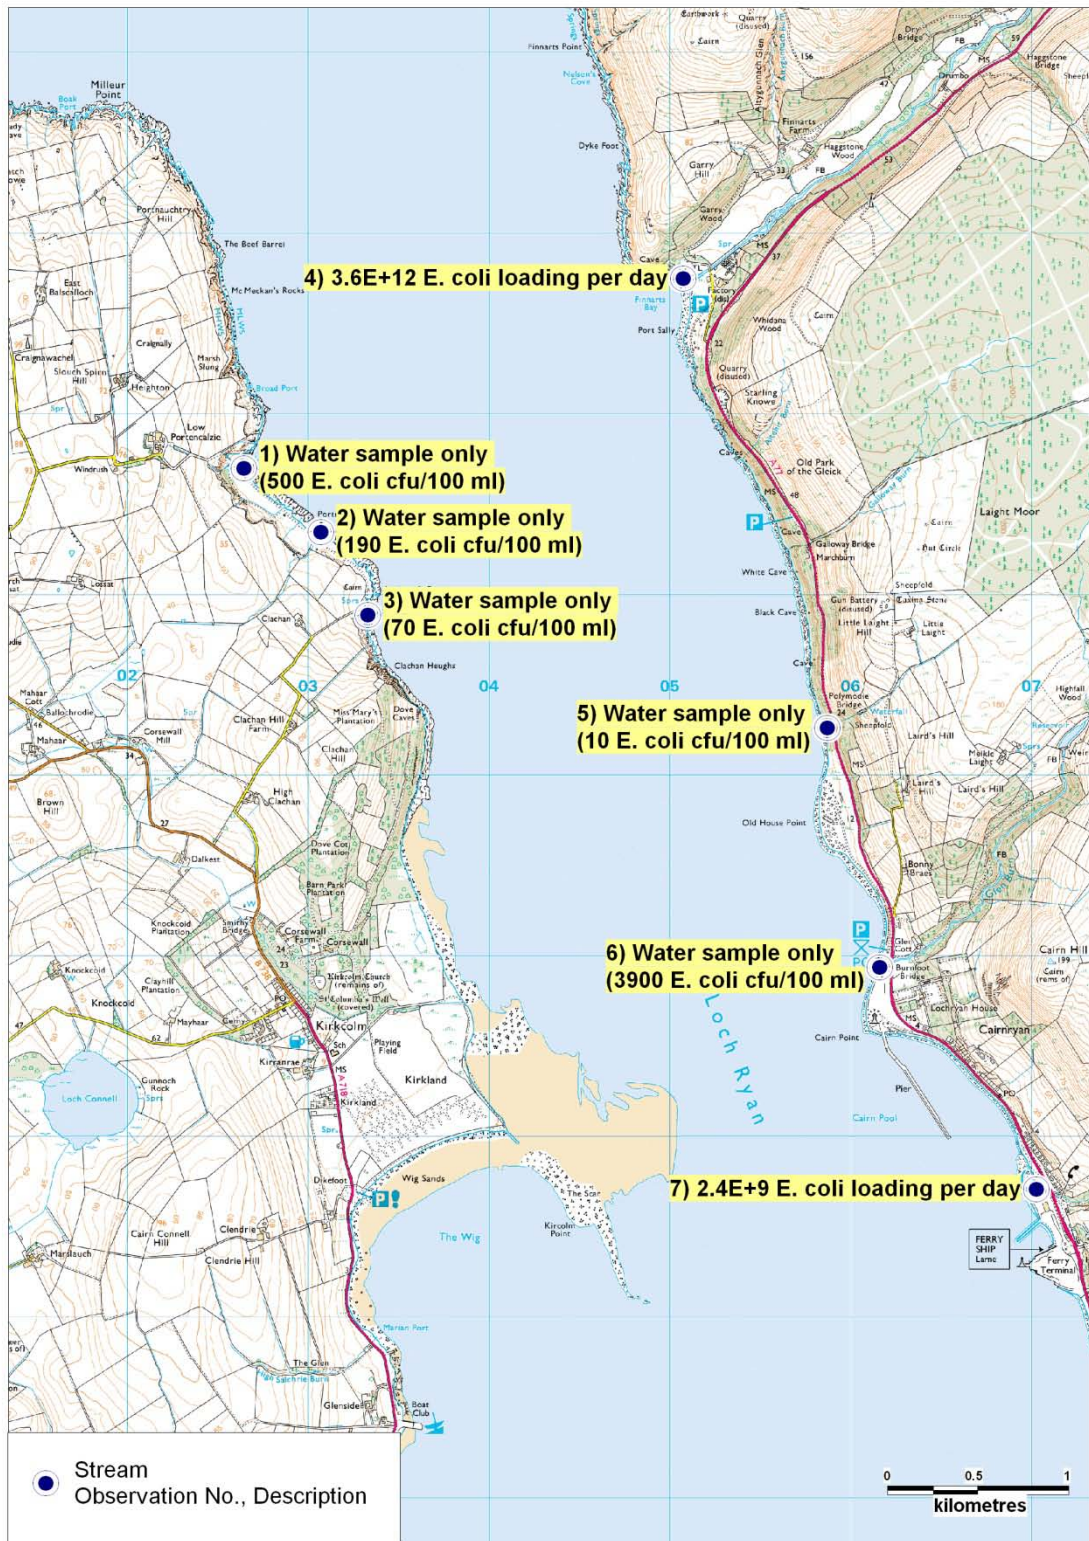
Figure 6.1 Stream loadings and *E. coli* results at Loch Ryan North

It was only possible to calculate loadings for the two larger burns. The Water of App had the largest *E. coli* loading of  $3.6 \times 10^{12}$  per day: it receives human sewage discharge via two private (primary) sewage discharges. The water sample taken from Glenburn showed the highest *E. coli* concentration at 3900 cfu/100 ml.

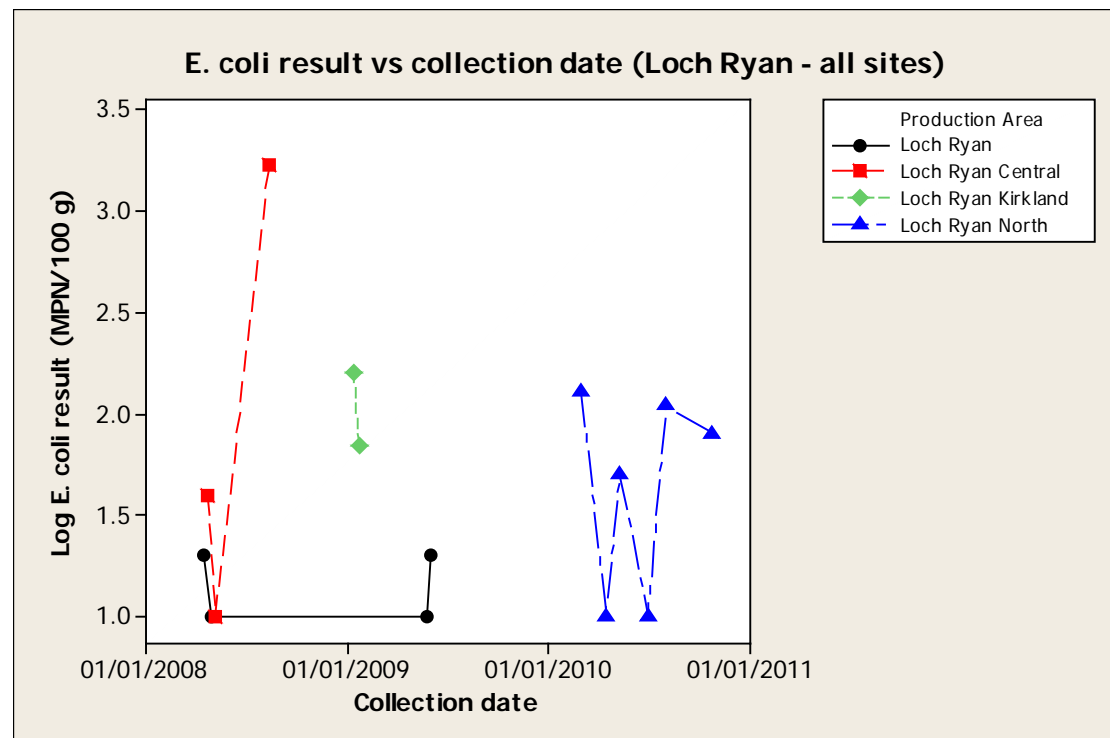
Figure 7.1 Scatter plot of *E. coli* result (MPN/100 g) for razor clams vs. collection date on log scale

No overall trends are apparent from Figure 7.1. A total of five samples were collected in 2008, four in 2009 and six in 2010. The sample with the highest result of 1700 *E. coli* MPN/100 g was taken in 2008.

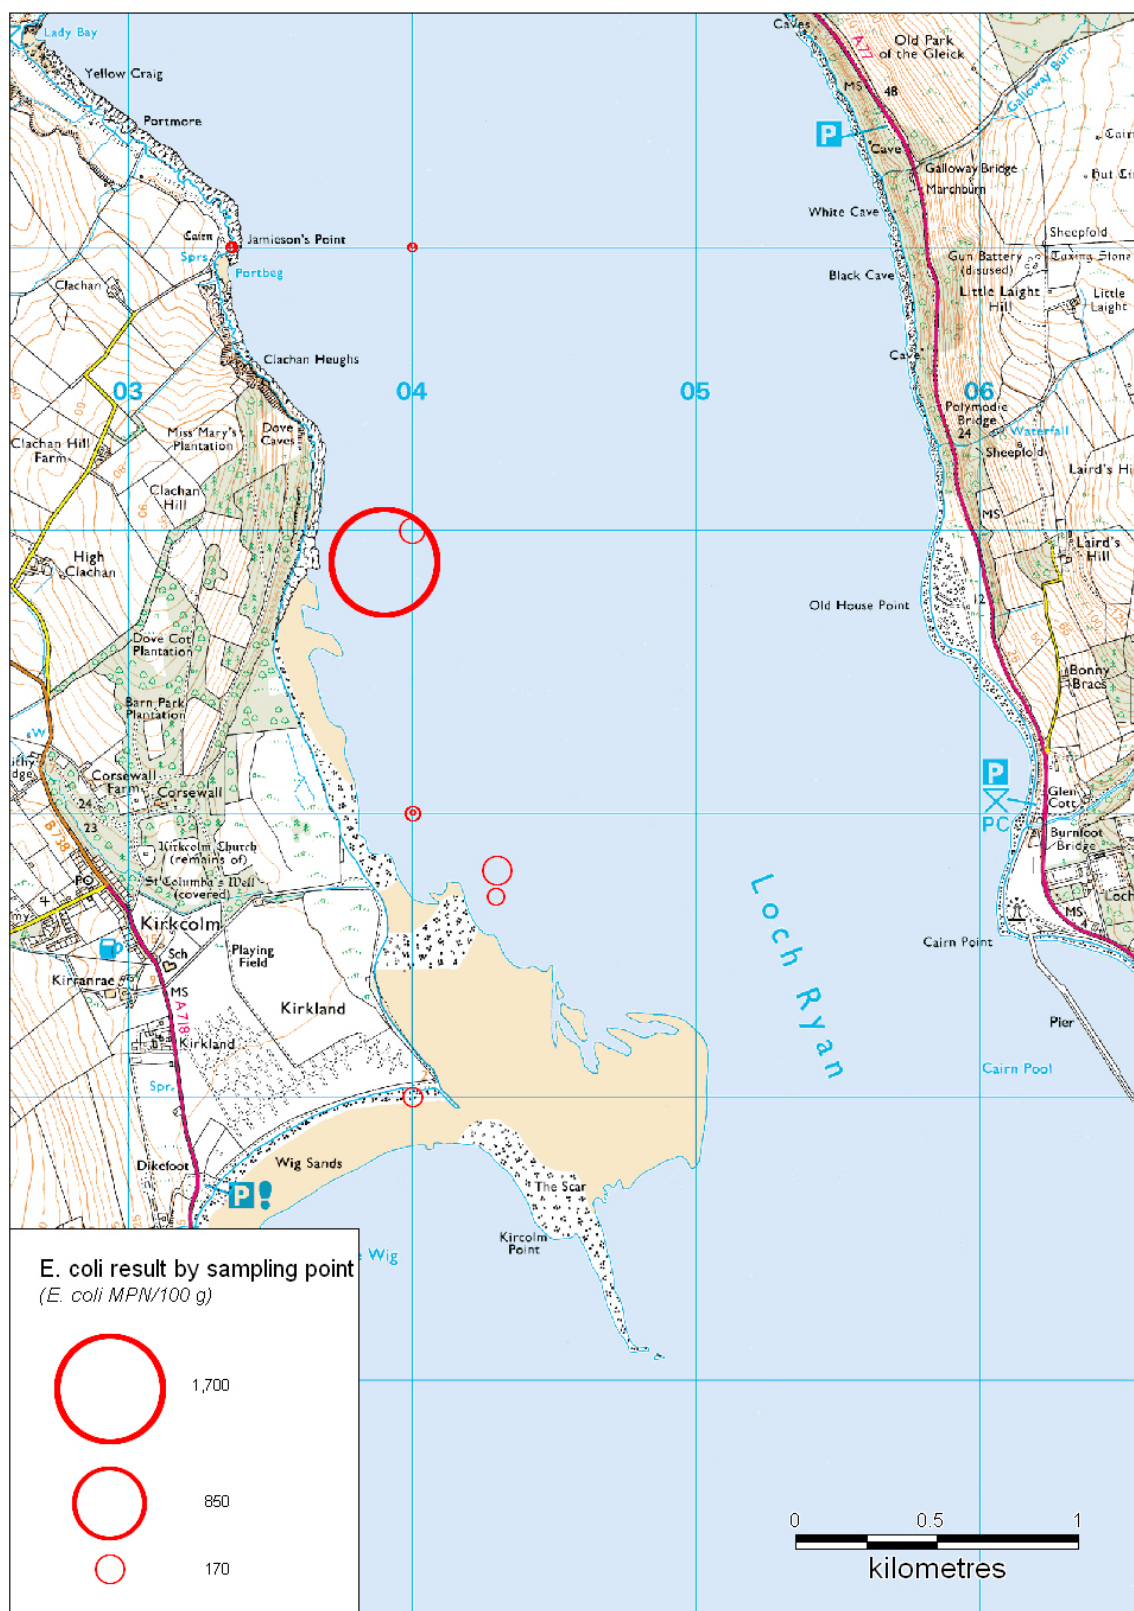
Figure 7.2 *E. coli* result (MPN/100 g) by sampling location for razor clams at Loch Ryan

Figure 7.2 shows a thematic map with the *E. coli* results plotted at the sampling locations of razor clams at Loch Ryan. Monitoring results were higher in the southern half of the production area. The plotted location of one of the samples fell just to the south-east of the production area and RMZ boundaries and the plotted locations of two of the samples fell just to the east of the RMZ boundaries. However, the sampling locations were only recorded to the nearest 100 m.

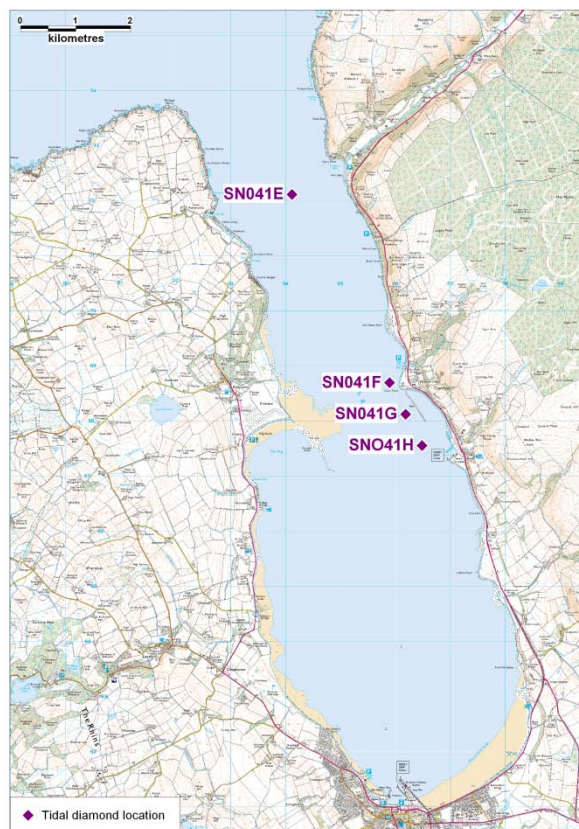
Figure 8.2 Loch Ryan OS Map<sup>2</sup>

Loch Ryan is approximately 15 km long. Edwards and Sharples (1991) identify that there is one sill within the loch. The sill runs across the loch at the point of the top of the western shore drying area. There is a basin within the loch that is a maximum of approximately 15 m in depth: this lies off the eastern shore opposite The Spit. Depths also increase to more than 10 m at the mouth of the loch. The hydrographic chart in Figure 8.1 shows there is a significant drying area (also marked as shellfish beds on the chart) at both the south-eastern end of the loch and on the western side in the vicinity of the razor clam bed, where this forms The Spit. There is also drying area on the south-western side of the loch. Depths in the region of the of the razor fishery range up to about 5 m. The southern end of the loch past the spit are generally shallow (<5 m), apart from an area south of the Cairnryan ferry terminal, where depths reach up to 8 m and the ferry channel down to Stranraer has a maintained depth of 5 m. Figure 8.2 shows the Ordnance Survey map of Loch Ryan, with the locations of tidal diamonds plotted.

Tidal stream information available was from TotalTide for four tidal diamonds (SN0441E, SN041F, SN041G, SN041H) located in Loch Ryan (see Figure 8.2). The tidal diamond information is given below in Tables 8.1 to 8.4. The associated spring tidal streams are shown in Figure 8.4 (flood tide) and Figure 8.5 (ebb tide).

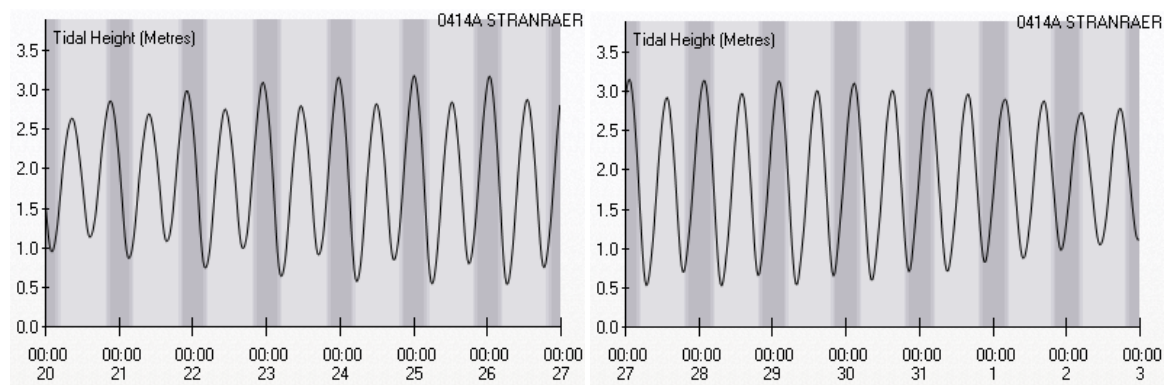
Figure 8.3 Tidal curves for Stranraer

The two tidal curves in Figure 8.3 are for the port of Stranraer, the standard harmonic port located at the head of Loch Ryan. These have been output from UKHO TotalTide. The first is for seven days beginning 00.00 GMT on 20<sup>th</sup> August 2010. The second is for seven days beginning 00.00 GMT on 27<sup>th</sup> August 2010. Together they show the

predicted tidal heights over high/low water for the full neap/spring tidal cycle during which the shoreline survey was undertaken.

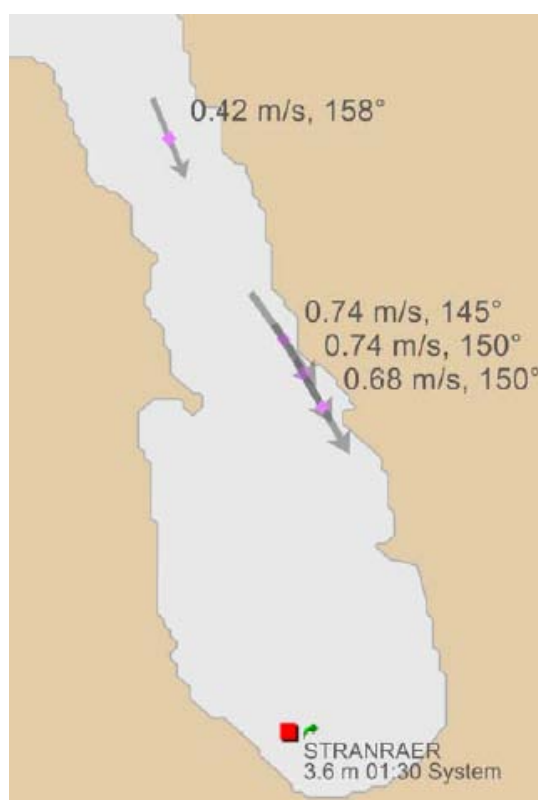
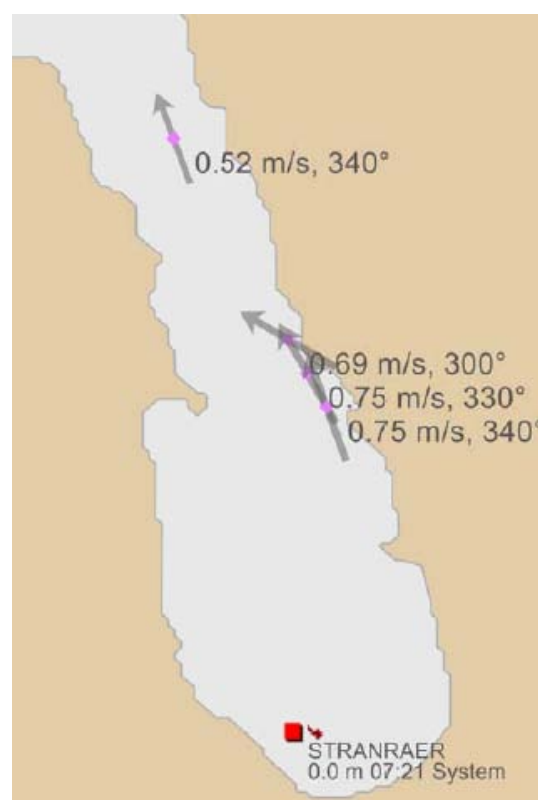
Figure 8.4 Spring flood tide at Loch Ryan

The tidal stream predictions from TotalTide indicate that the peak current speeds off the eastern shore of the loch are in the order of 0.7 m/s (1.4 knots). Under these conditions, contaminants would travel approximately 10 km over a flood or ebb tide, ignoring any dilution or dispersion. The streams in the vicinity of the basin (and the eastern side of the fishery) run parallel to the shore throughout the flood and ebb tides. Towards the loch mouth, this bidirectional flow is modified to some extent.

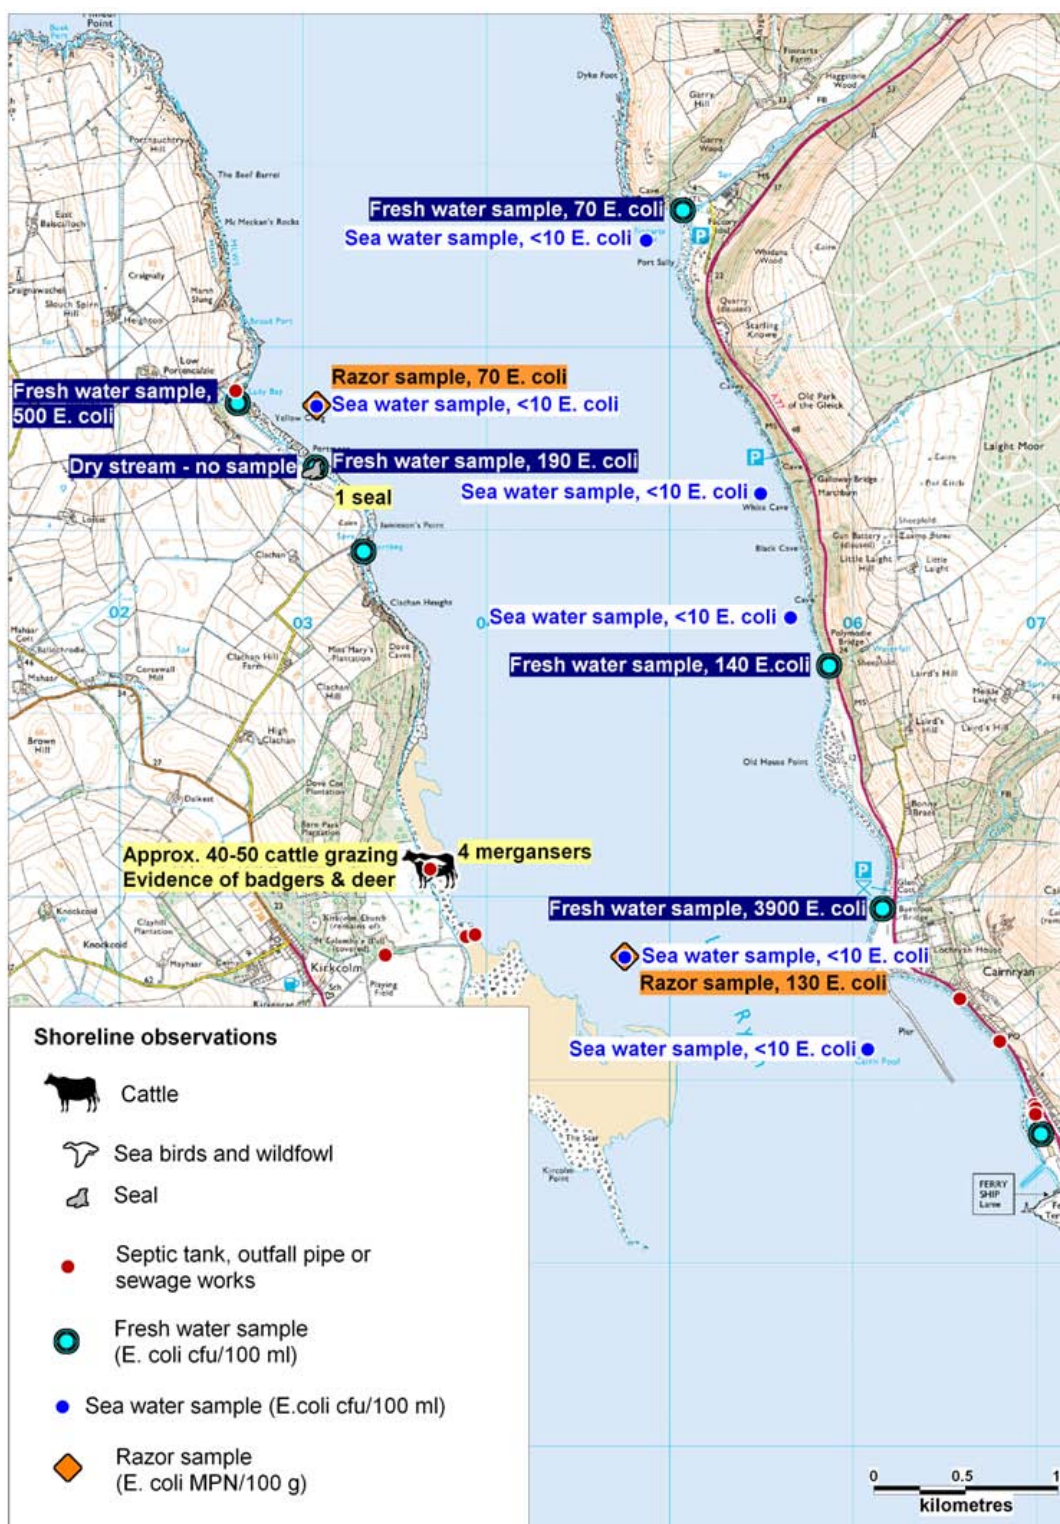
Figure 9.1 Summary of shoreline observations

A map is provided in Figure 9.1 that shows the relative locations of the most significant findings of the shoreline survey.

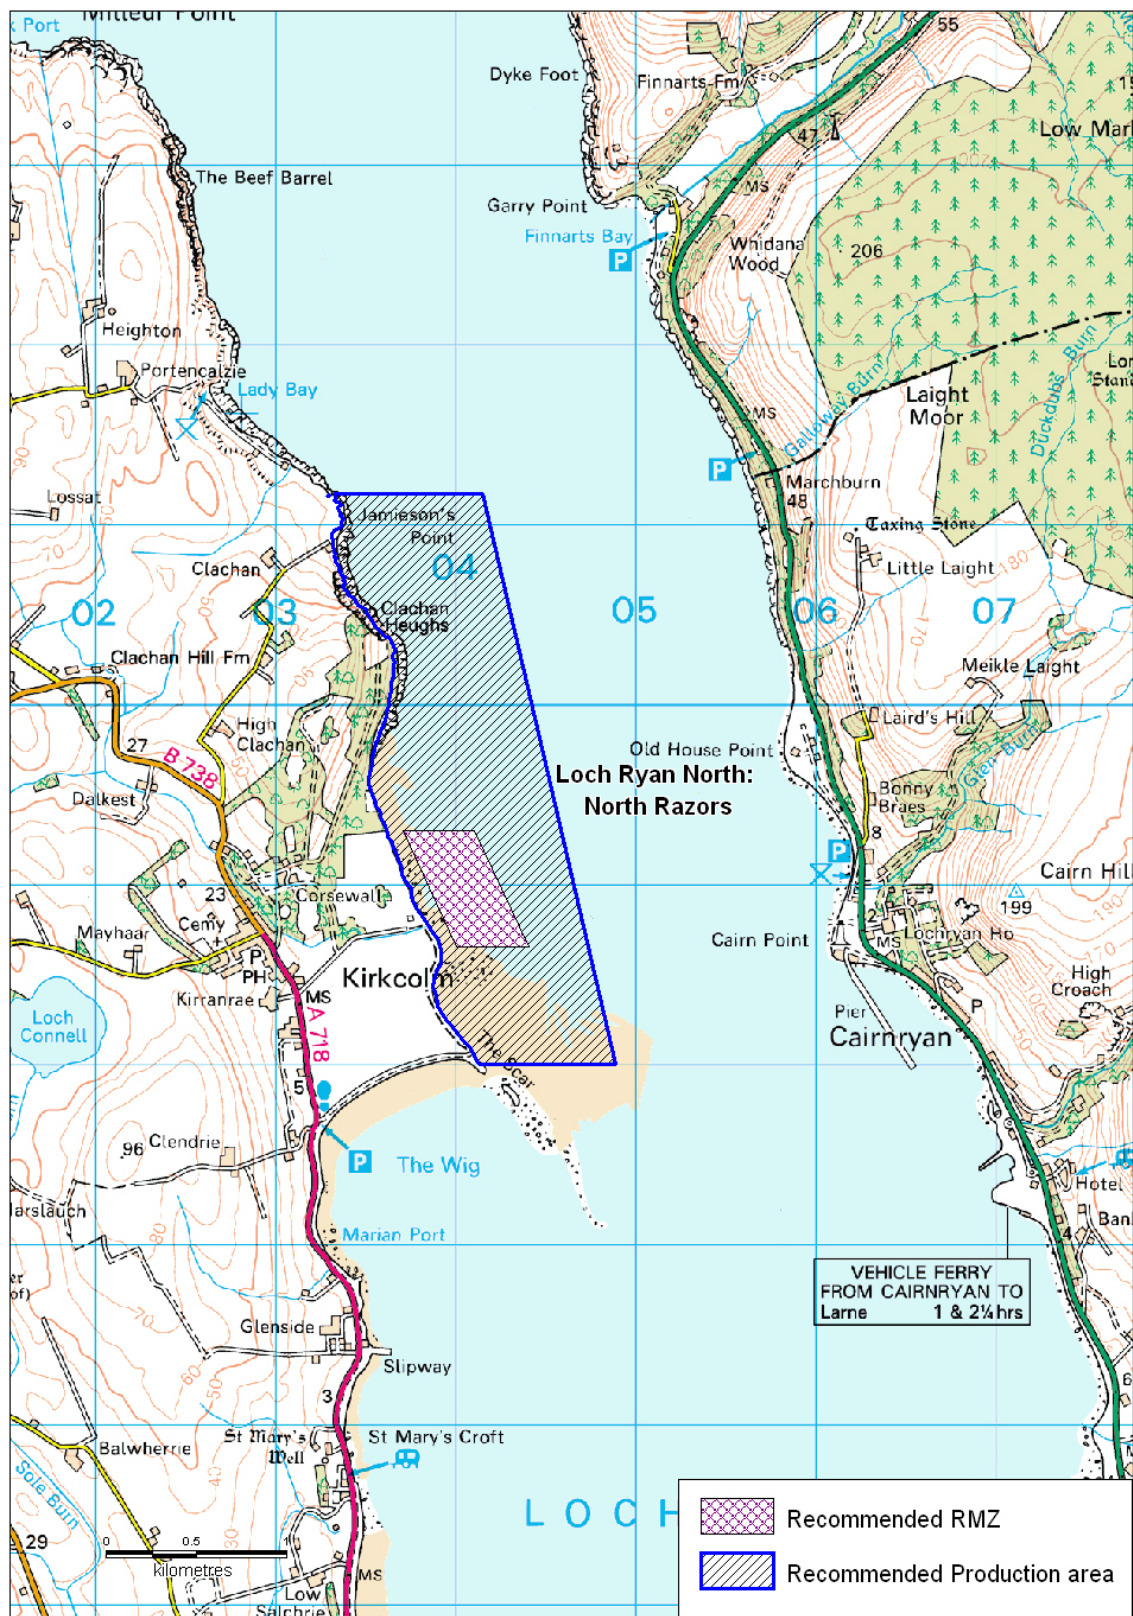
Figure 11.1 Recommendations for Loch Ryan North

The recommended production area is the area bounded by lines drawn between NX 0330 7117 and NX 0414 7117 and between NX 0414 7117 and NX 0488 6800 and between NX 0488 6800 and NX 0413 6800 extending to MHWS. This area encompasses the extent of the known razor clam fishery and excludes potential sources of contamination on the eastern shore of the loch and to the north of the present fishery.

The recommended monitoring zone is the area bounded by lines drawn between the following points: NX 0370 6930; NX 0410 6930; NX 0440 6865; NX 0400 6865. This is the area known to be covered by the present razor fishery and is close to the main identified sources of contamination on the western shore. The area should be large enough to allow samples to be obtained on an ongoing basis.
