# Scottish Sanitary Survey Project

## Restricted Sanitary Survey Report

Loch Ryan North

DG 500

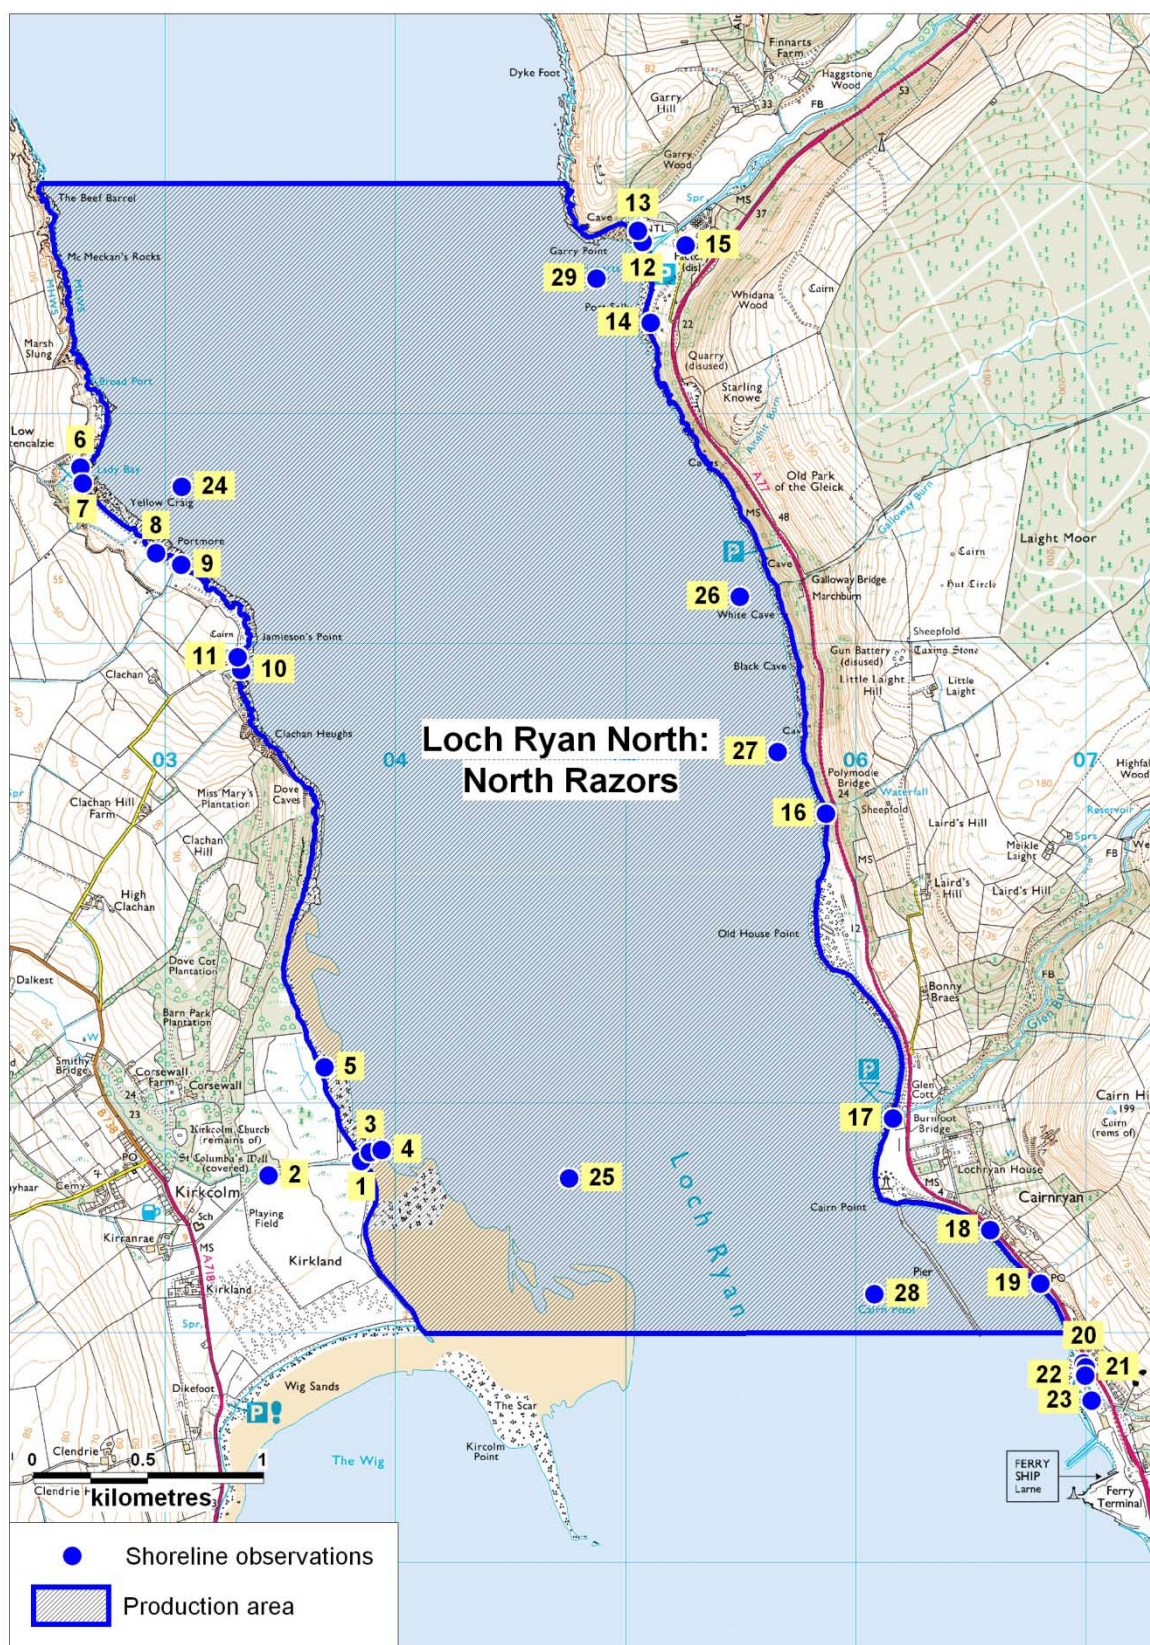
Figure 1. Shoreline observations

6	01/09/2010	12:41	NX02631 71768	202631	571768		FW LR002	Fresh water sample 2 (LR002). Outfall pipe at Lady Bay, no flow to measure. Large numbers of razor shells on shore.
7	01/09/2010	12:57	NX02643 71700	202643	571700	Figure 8 & figure 9	FW LR003	Small stream fresh water sample 3 (LR003): Depth 0.01-0.02 m, width 0.10 – 0.22 m. Flow measurement not possible.
8	01/09/2010	13:18	NX 02961 71396	202961	571396			Evidence of stream – dry. Dog walkers x 2 on beach, 3 dogs.
9	01/09/2010	13:23	NX 03070 71347	203070	571347	Figure 10	FW LR004	Spring fresh water sample 4 (LR004). not able to take flow – too winding and pebbly. Seaweed and razor and mussel shells in stream. Seal on rocks.
10	01/09/2010	13:45	NX03330 70888	203330	570888		FW LR005	Small stream, fresh water sample 5 (LR005).
11	01/09/2010	13:54	NX 03315 70944	203315	570944		FW LR006	Runoff from soakaway, fresh water sample (contaminated) 6 (LR006).

12	02/09/2010	10:04	NX05073 72750	205073	572750	Figure 11	FW LR015	Stream, fresh water sample 7 (LR015): Width 3.9 m, depth 0.50 – 0.90 m. Flow (pooh stick method) 3.04m/s.
13	02/09/2010	10:12	NX05055 72799	205055	572799			Unknown fixed structure – no pipe work evident nearby, cover for tank from disused food factory.
14	02/09/2010	10:24	NX05109 72398	205109	572398	Figure 12		New culvert - Horse manure on shoreline.
15	02/09/2010	10:31	NX 05261 72734	205261	572734	Figure 13		Disused seafood factory (has not been in use for 6-7 years).
16	02/09/2010	11:10	NX05871 70264	205871	570264	Figure 14	FW LR016	Culvert – fresh water sample 8 (LR016). Flow measurement not possible. Width 1.74m.
17	02/09/2010	11:44	NX 06162 68938	206162	568938	Figure 15	FW LR017	Stream. Fresh water sample 9 (LR017): Width 1 m, depth 0.45 m, Flow measurement not possible – too many obstructions.

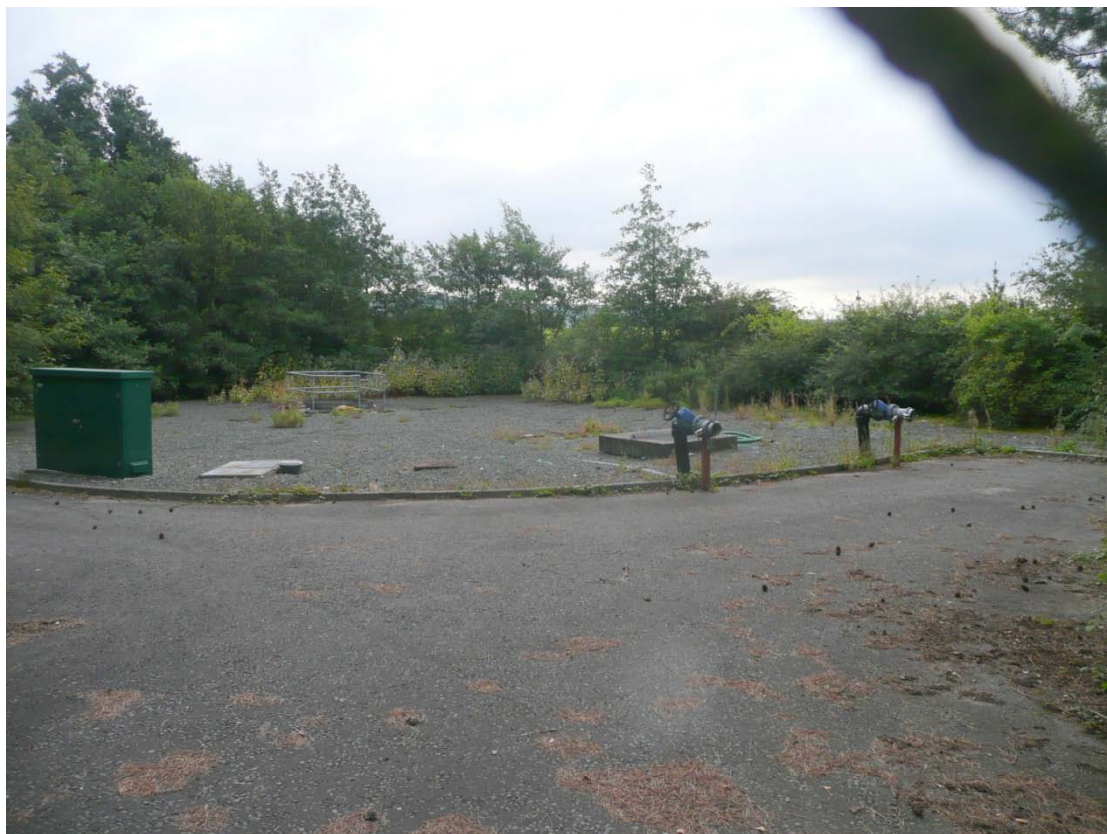
Figure 4. Kirkcolm sewage works

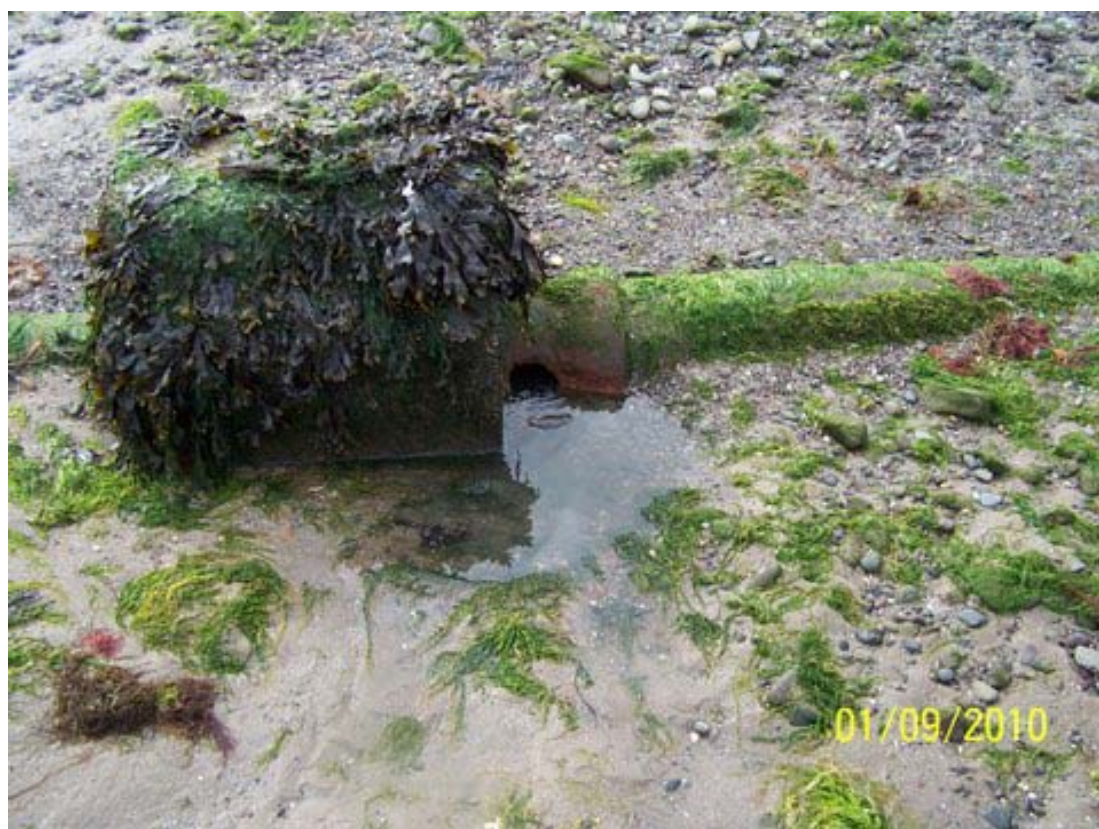
Figure 5. Sewage outfall pipe, location of water sample LR001

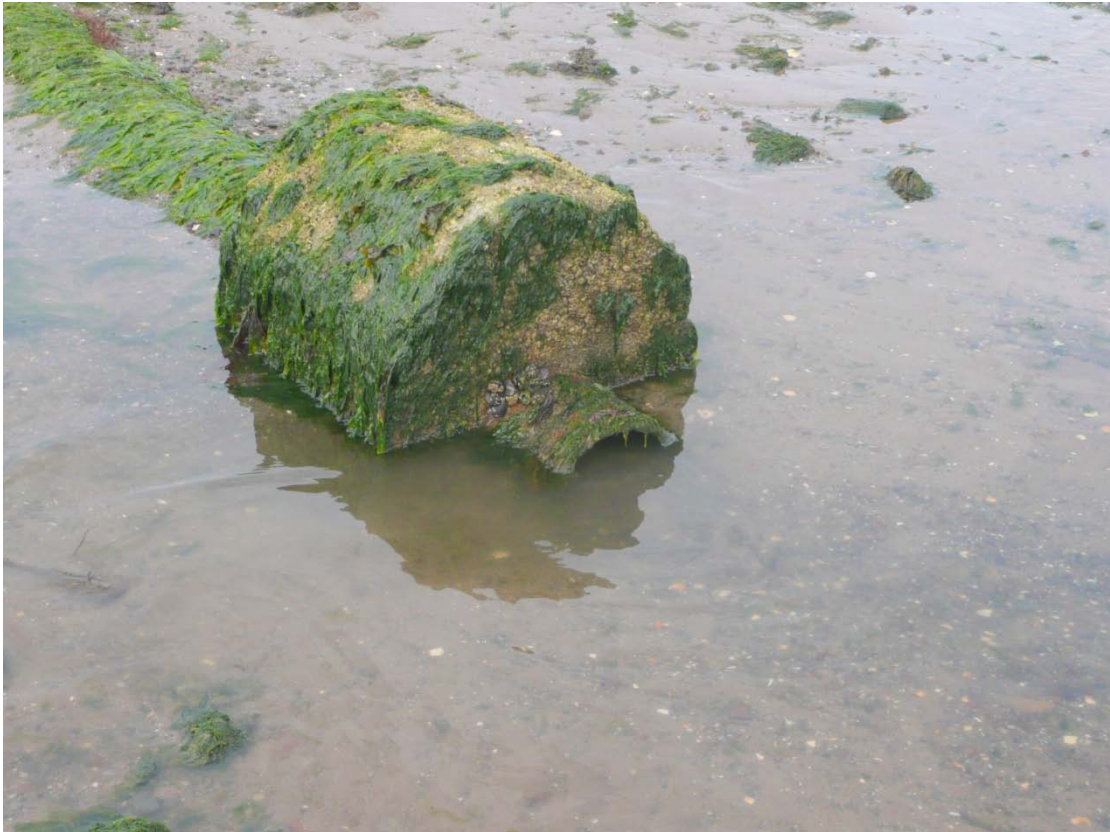
Figure 6. End of outfall pipe

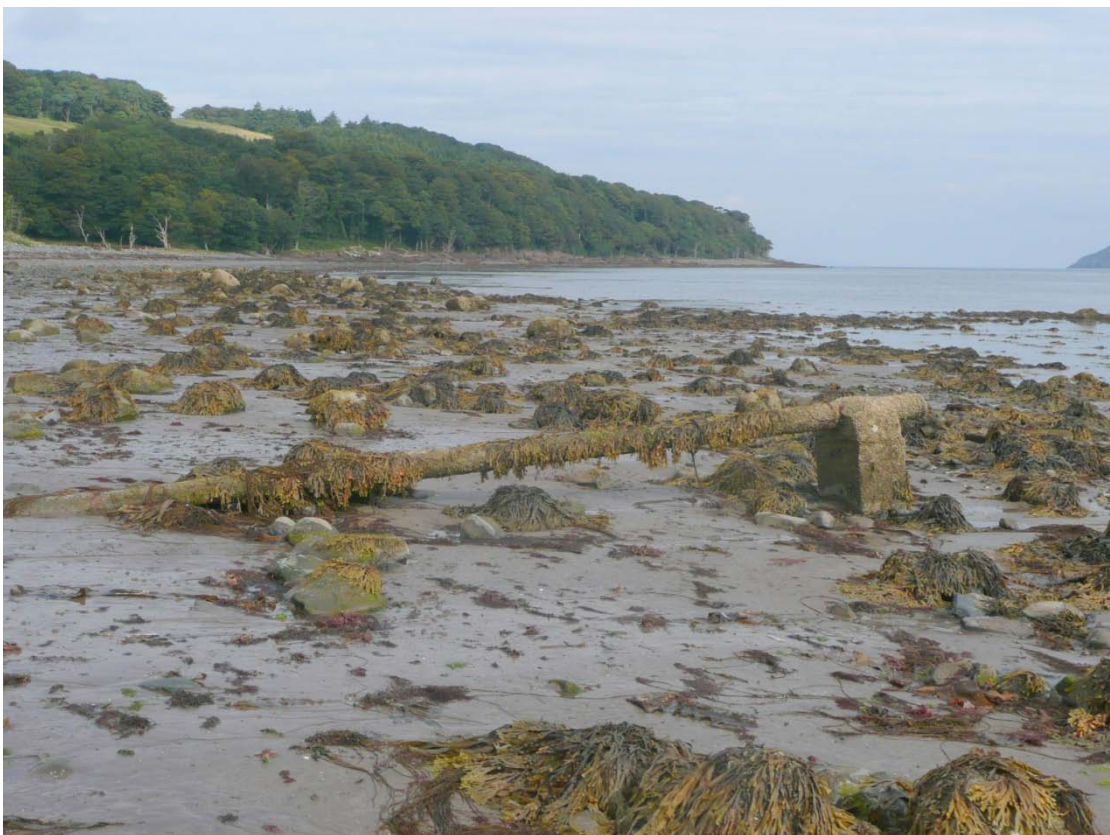
Figure 7. Disused pipe

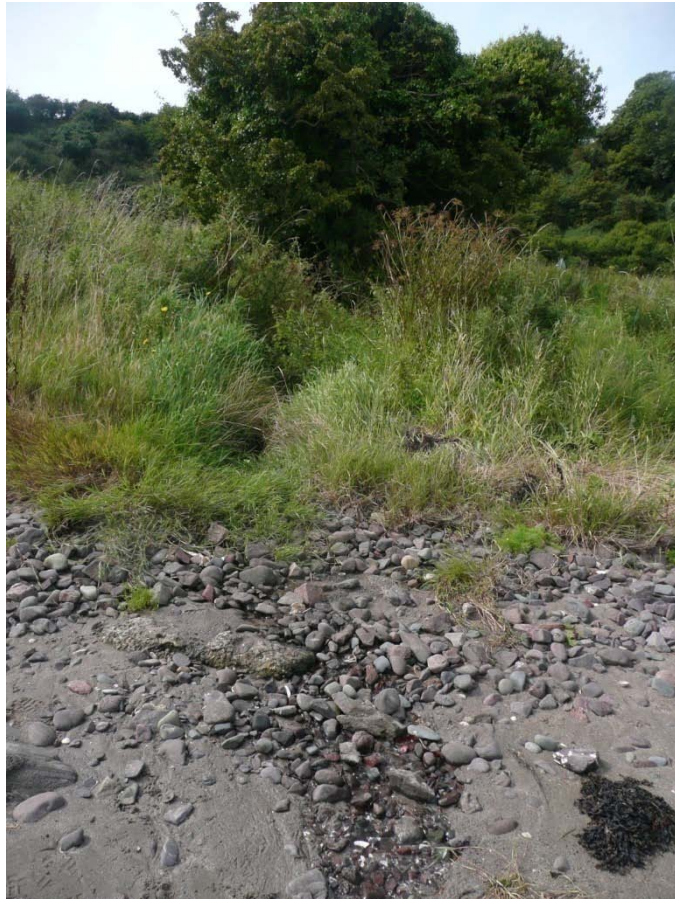
Figure 8. Small fresh water stream, location of water sample LR003

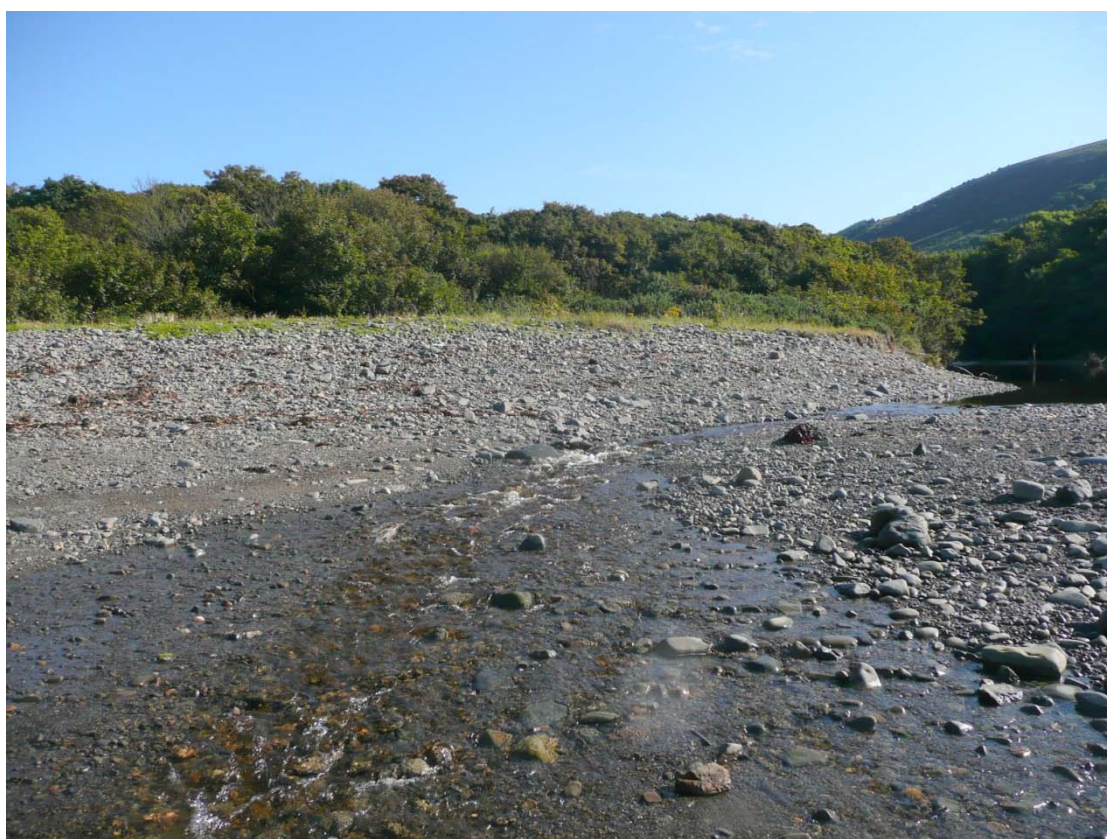
Figure 11. Stream, location of water sample LR015

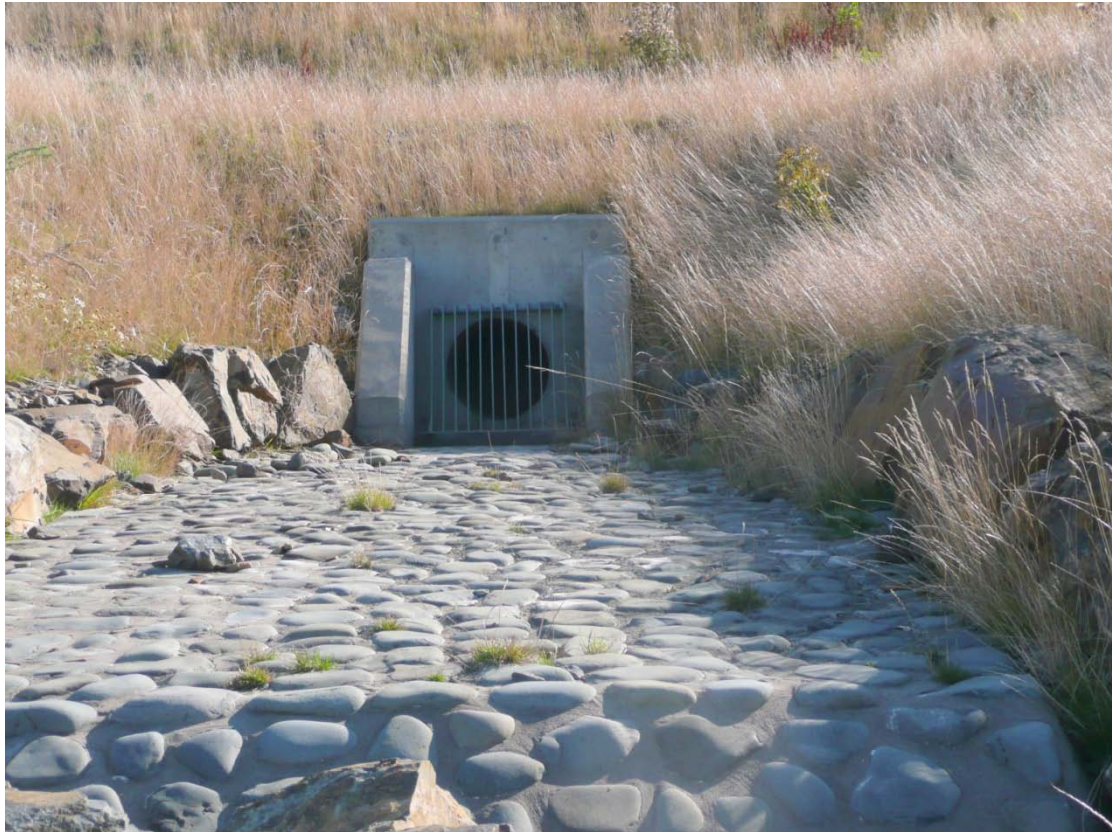
Figure 12. New culvert

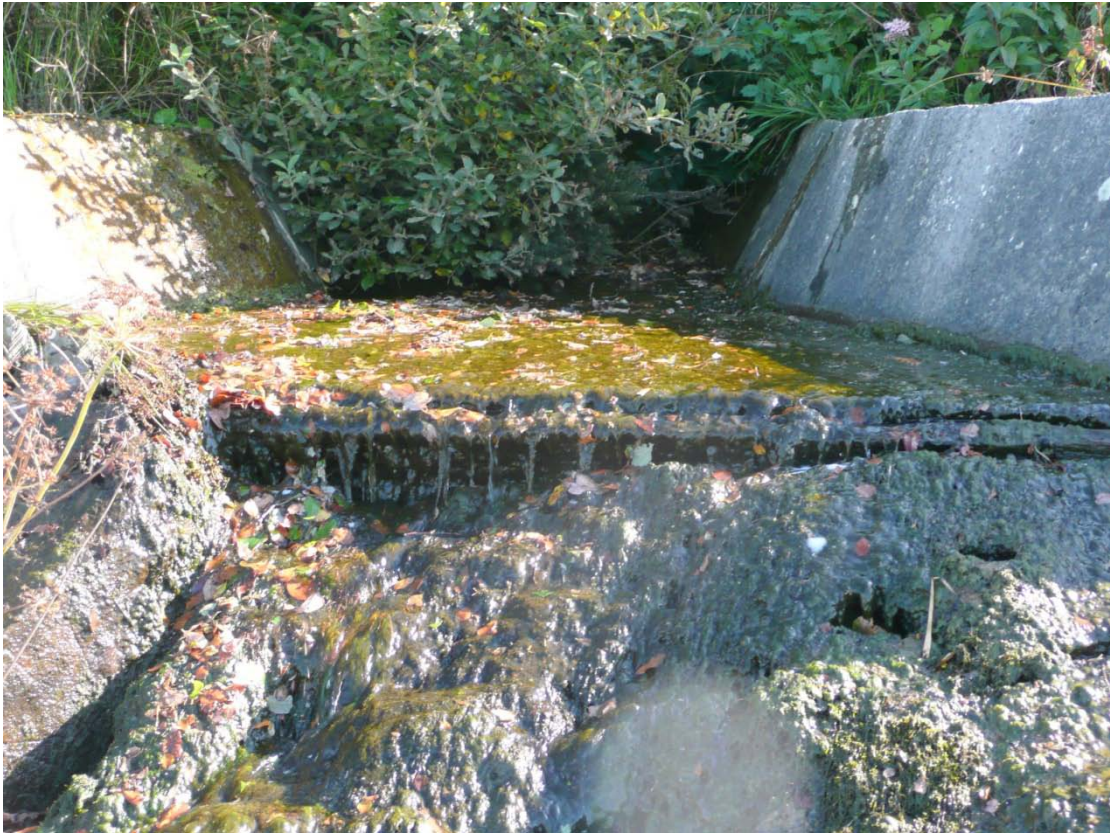
Figure 14. Culvert, location of water sample LR016

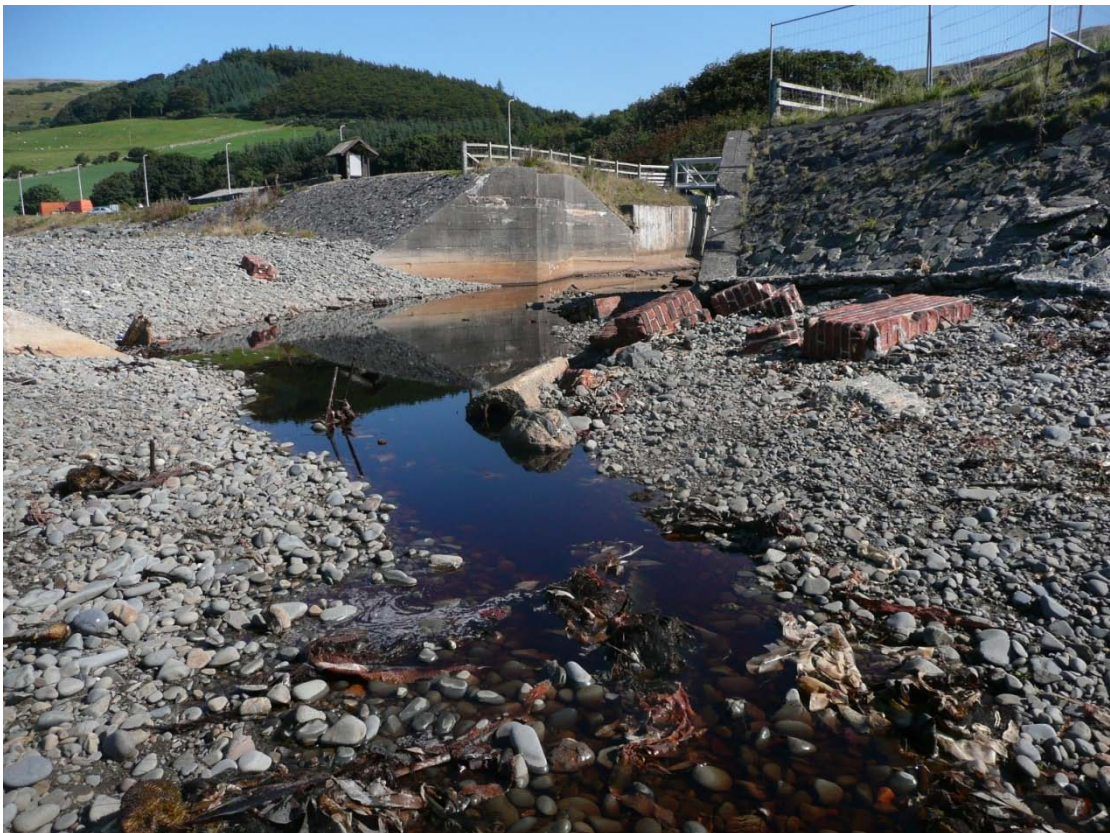
Figure 15. Stream, location of water sample LR017

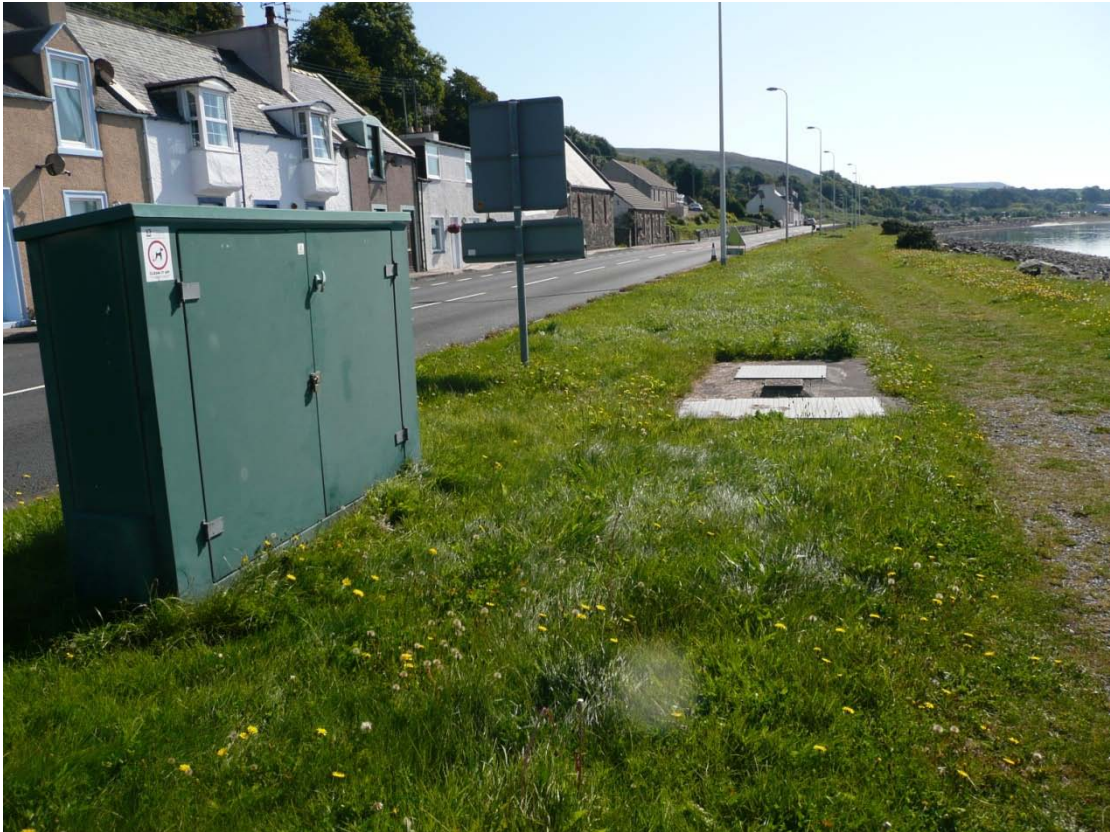
Figure 16. Septic tank outflow 2

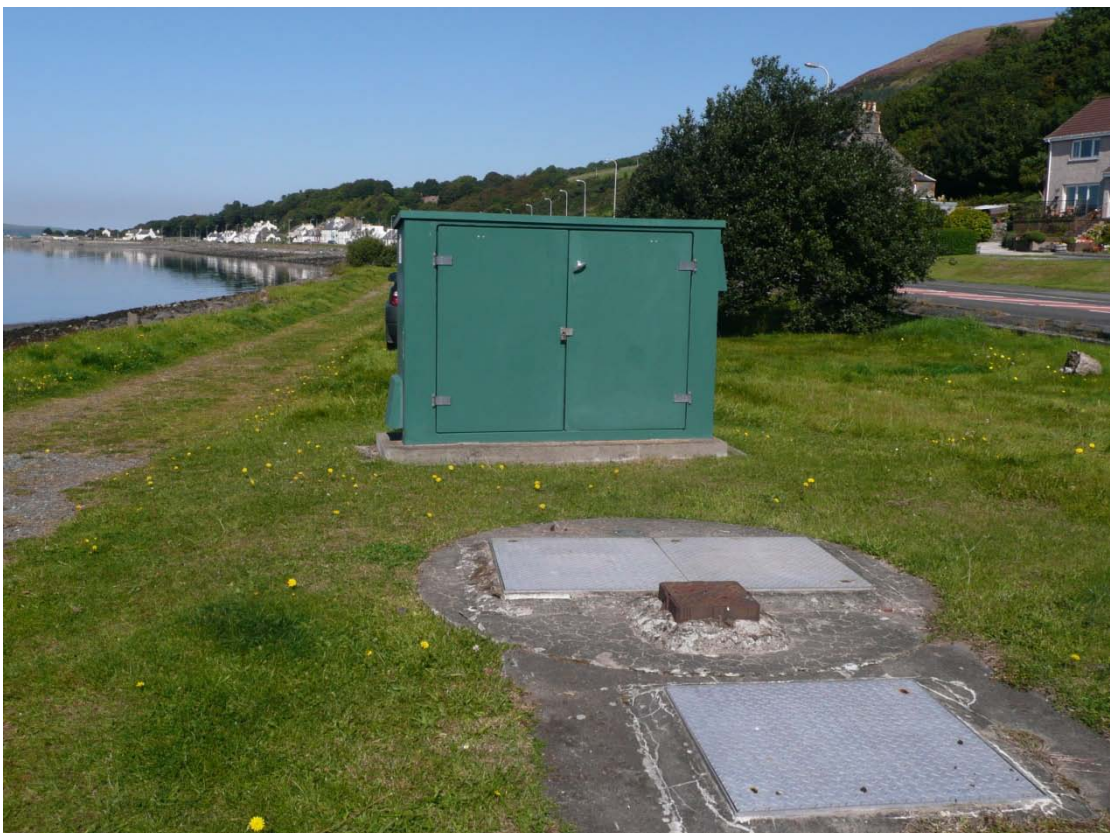
Figure 17. Septic tank outflow 3

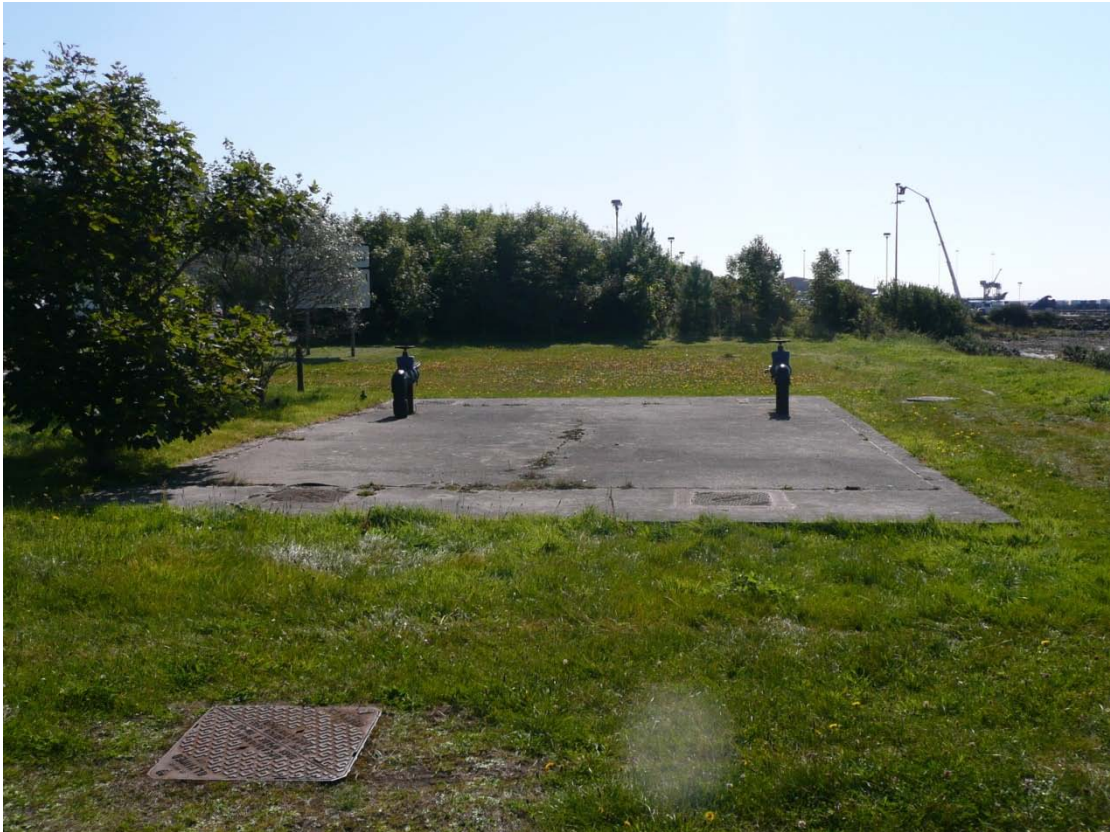
Figure 18. Septic tank

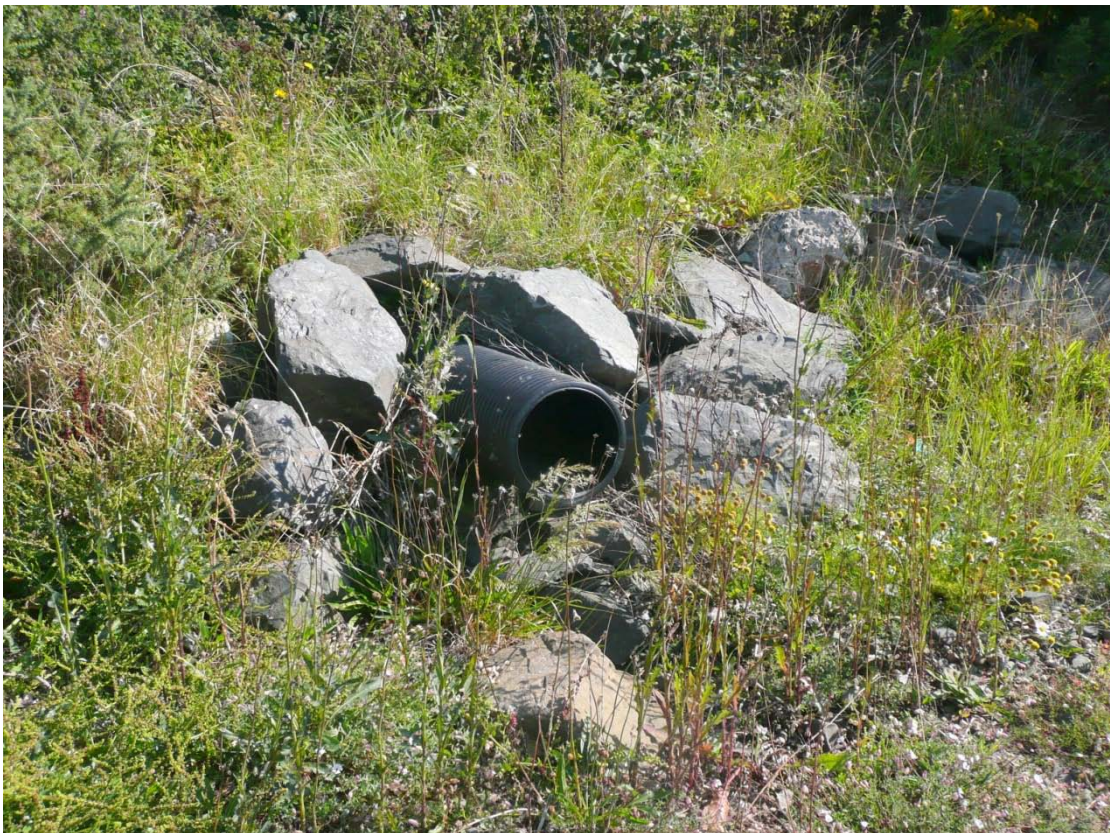
Figure 19. Black outfall pipe – dry

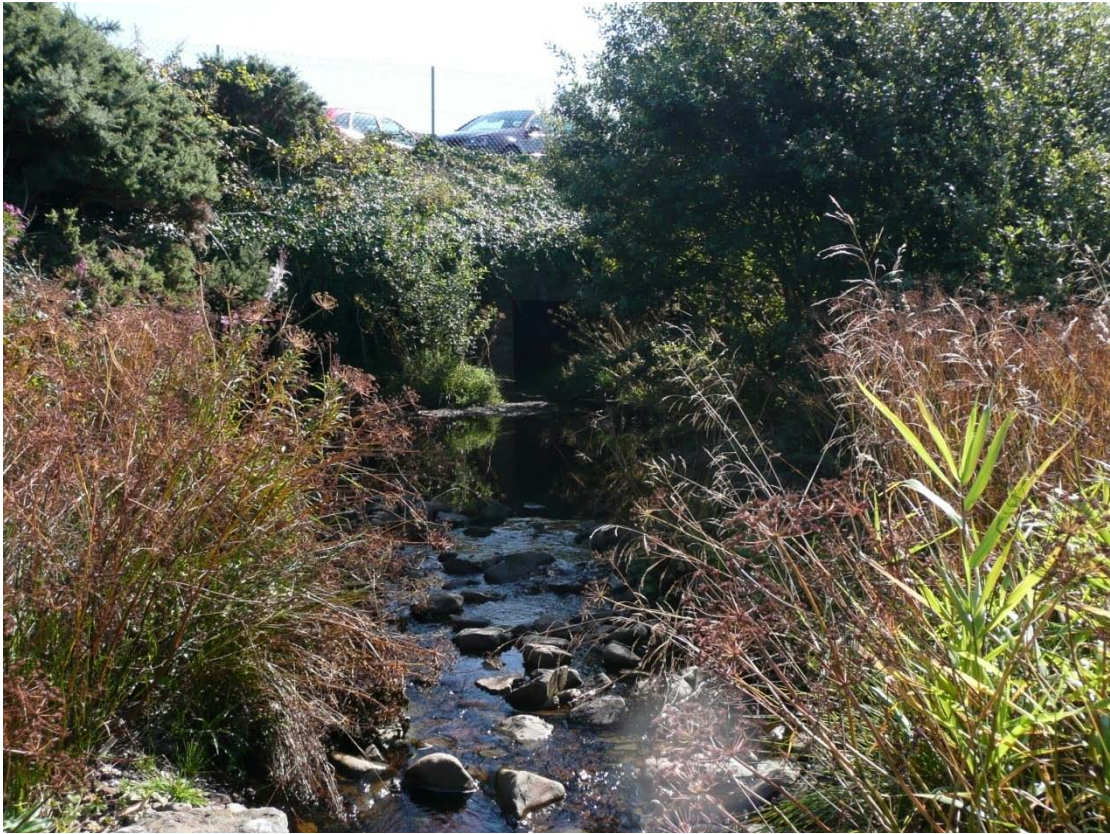
Figure 20. Glenburn, location of water sample LR018
