Helford Estuary Sanitary Survey

Review

March 2014

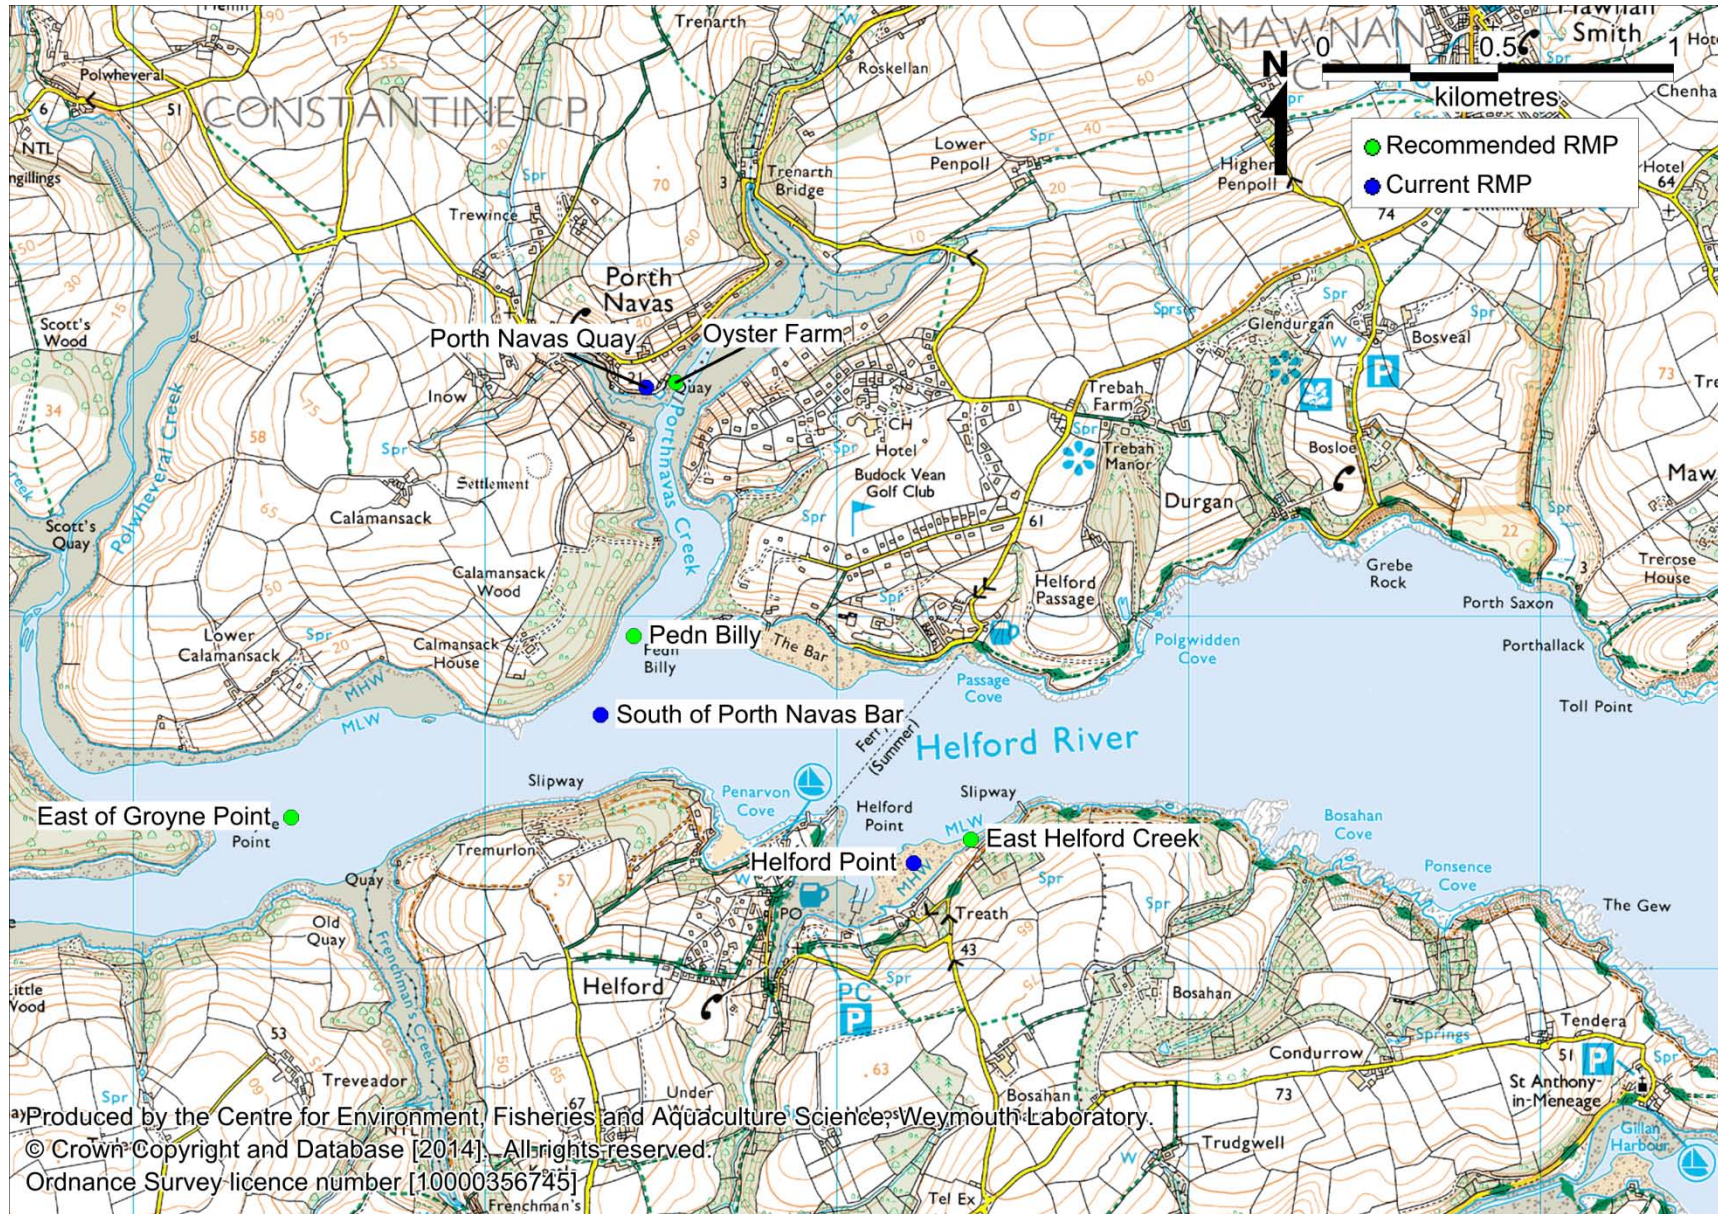
Figure 4.3: Current and recommended mussel RMPs. East of Groyne Point remains unchanged.

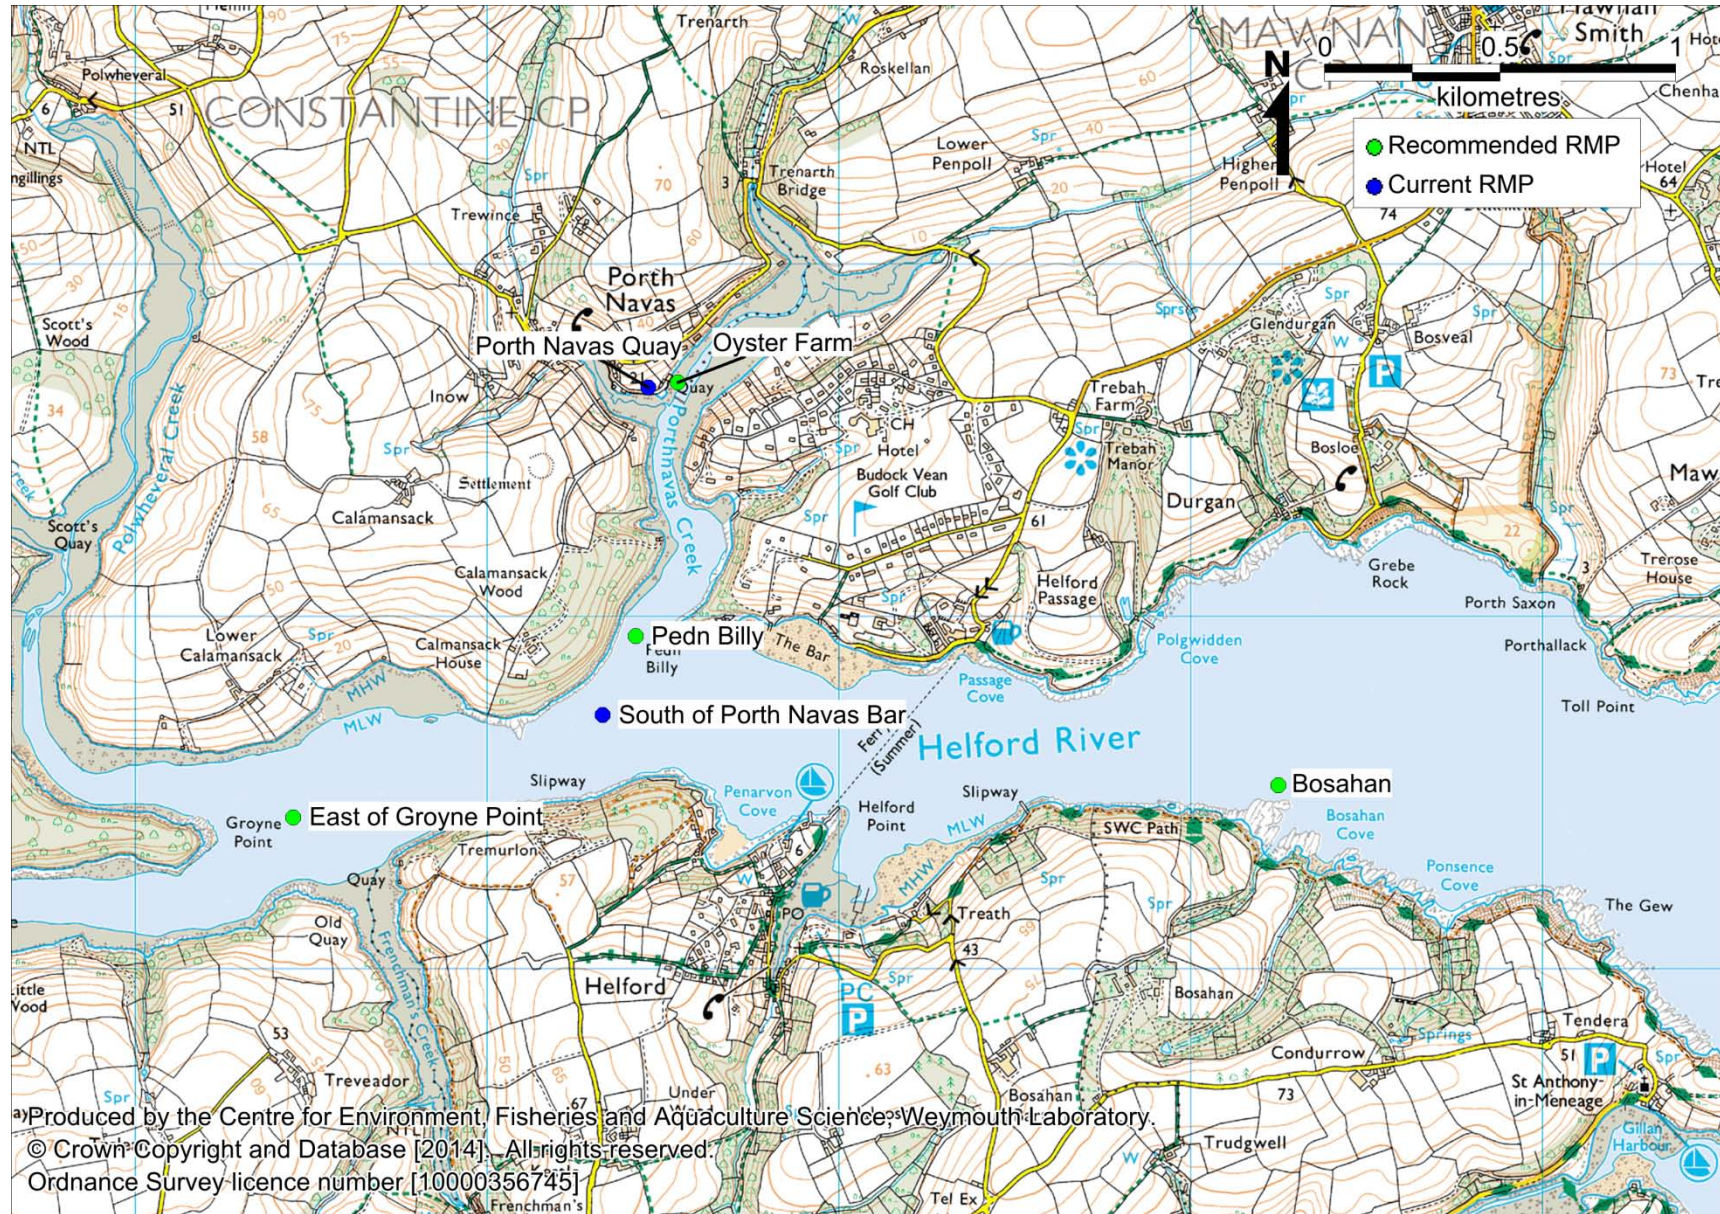
Figure 4.4: Current and recommended oyster RMPs. East of Groyne Point and Bosahan remain unchanged.

The current location of the RMP for this zone is 'sheltered' from much of the contamination from upstream by the quay. It is therefore recommended that the RMP be relocated to the north-eastern side of the quay.

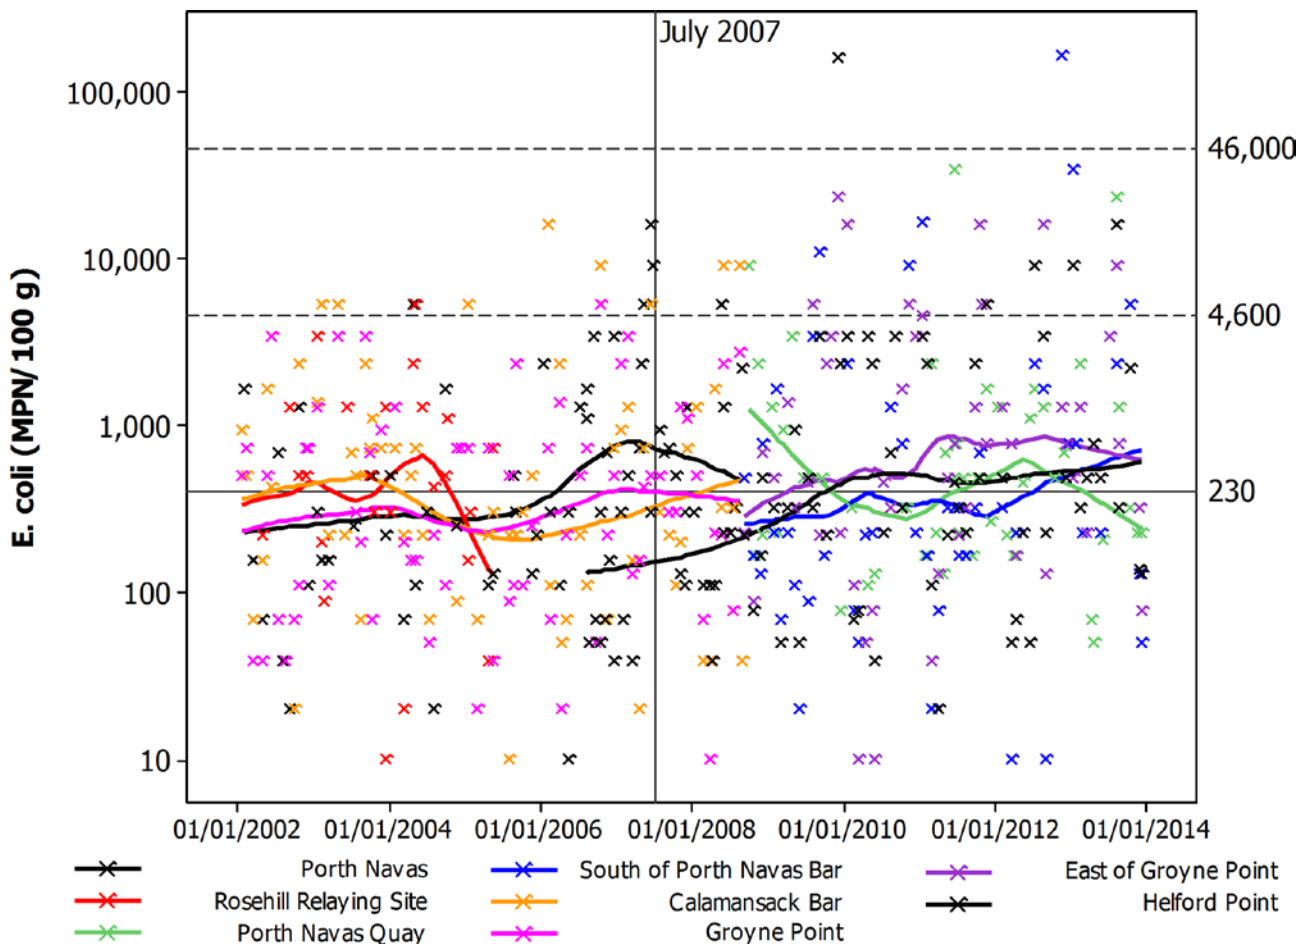
Figure 8.7: Scatterplot of *E. coli* results for mussels overlaid with loess lines.

There appears to have been a slight increase in the level of *E. coli* at Helford point as supported by the significant T-test result for samples taken before and after August 2008. While the T-test to compare samples taken before and after June 2007 showed no significant difference in results here before and after the installation of the Helford STW, too few samples were taken before the installation of the STW to confidently determine whether the STW has had an impact on shellfish contamination or not. Results at East of Groyne Point also appear to have increased since sampling started there in 2008. There have been more high results in mussels since 2008. It is possible that this is due to changes in contamination levels in the estuary. However as the sampling locations were changed in 2008, it is likely that the increase in high results reflects more protective locations for sampling as recommended by the sanitary survey.

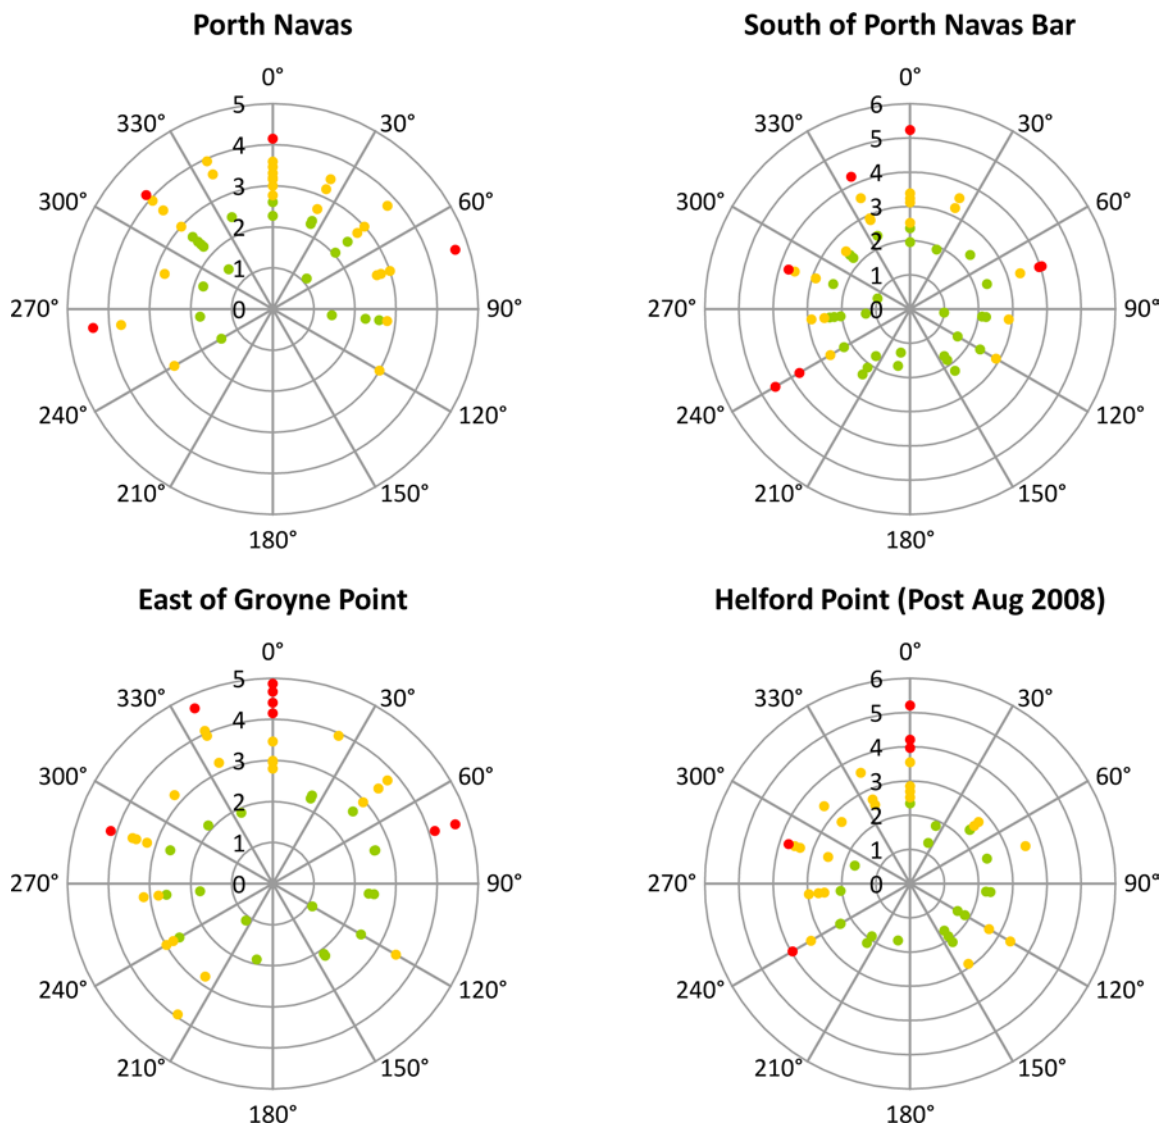
Figure 8.15 to Figure 8.17 present polar plots of log₁₀ *E. coli* results against the spring neap tidal cycle for each RMP. Full/new moons occur at 0°, and half moons occur at 180°, and the largest (spring) tides occur about 2 days after the full/new moon, or at about 45°, then decrease to the smallest (neap tides) at about 225°, then increase back to spring tides. Results of 230 *E. coli* MPN/100g or less are plotted in green, those from 231 to 4,600 are plotted in yellow, and those exceeding 4,600 are plotted in red.

Figure 8.15: Polar plots of log₁₀ *E. coli* results (MPN/100g) at mussel RMPs against spring/neap tidal state

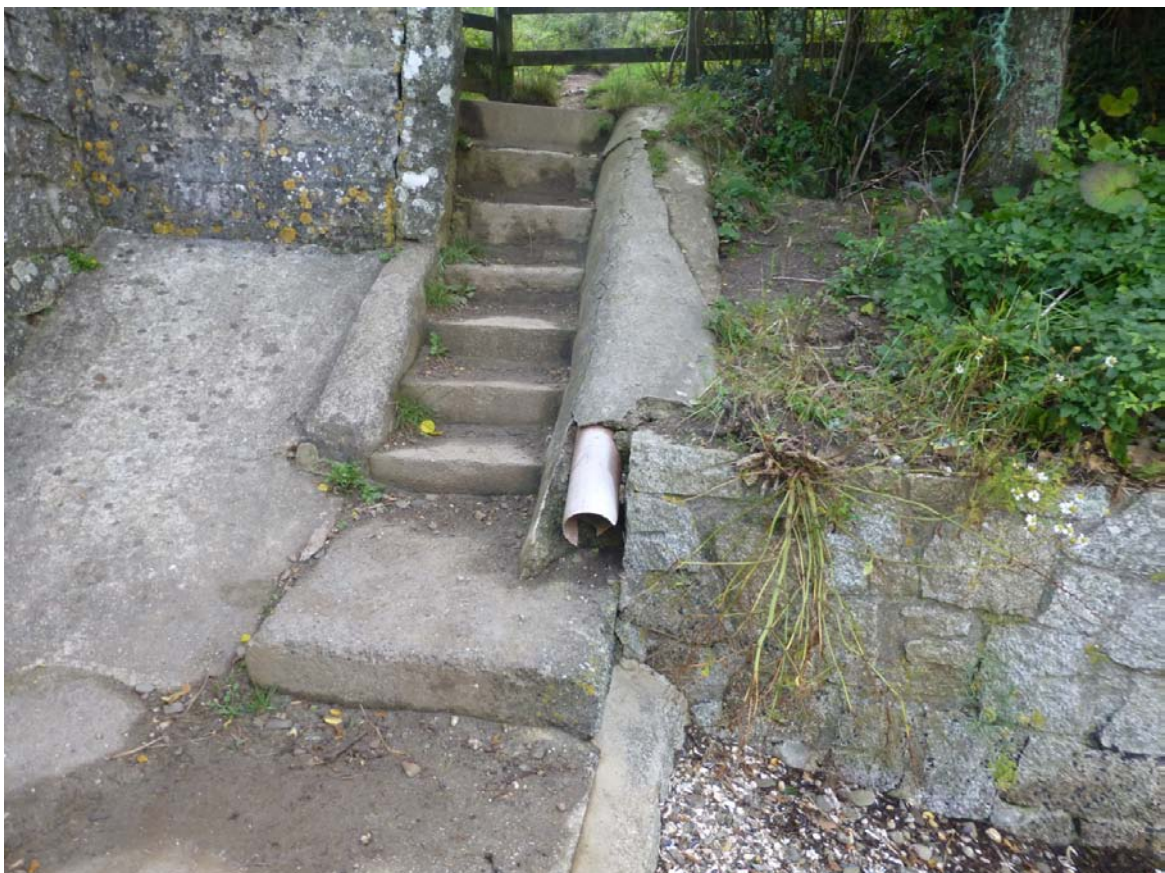
23	SW7664026841	08:37	Cow faeces in field.	
24	SW7641026933	08:44	Broken plastic pipe (15 cm diameter). Not flowing. Other smaller pipes not flowing.	Figure I.20
25	SW7641126933	08:44	Dead shell (mussels) on strand line.	Figure I.21
26	SW7641126932	08:45	Black plastic pipe (20 cm diameter). Flow/depth too shallow to take sample. Possibly discharge from private package treatment plant.	Figure I.22
27	SW7600126948	08:53	Possible mussel poaching site - as reported to by passing member of public. Dog being walked on beach.	
28	SW7631426930	09:00	Culverted stream, land drainage flowing under road onto beach (sample F10).	Figure I.23
29	SW7628428031	09:42	Boats moored at edges of creek.	Figure I.24
30	SW7550627640	10:40	Duchy oyster farm holding area in estuary.	Figure I.25 & Figure I.26
31	SW7772926145	12:41	18 cows in field.	
32	SW7771726132	12:48	Stream to Ponsence Cove beach (sample F15).	
33	SW7733626272	13:00	Stream (sample F16).

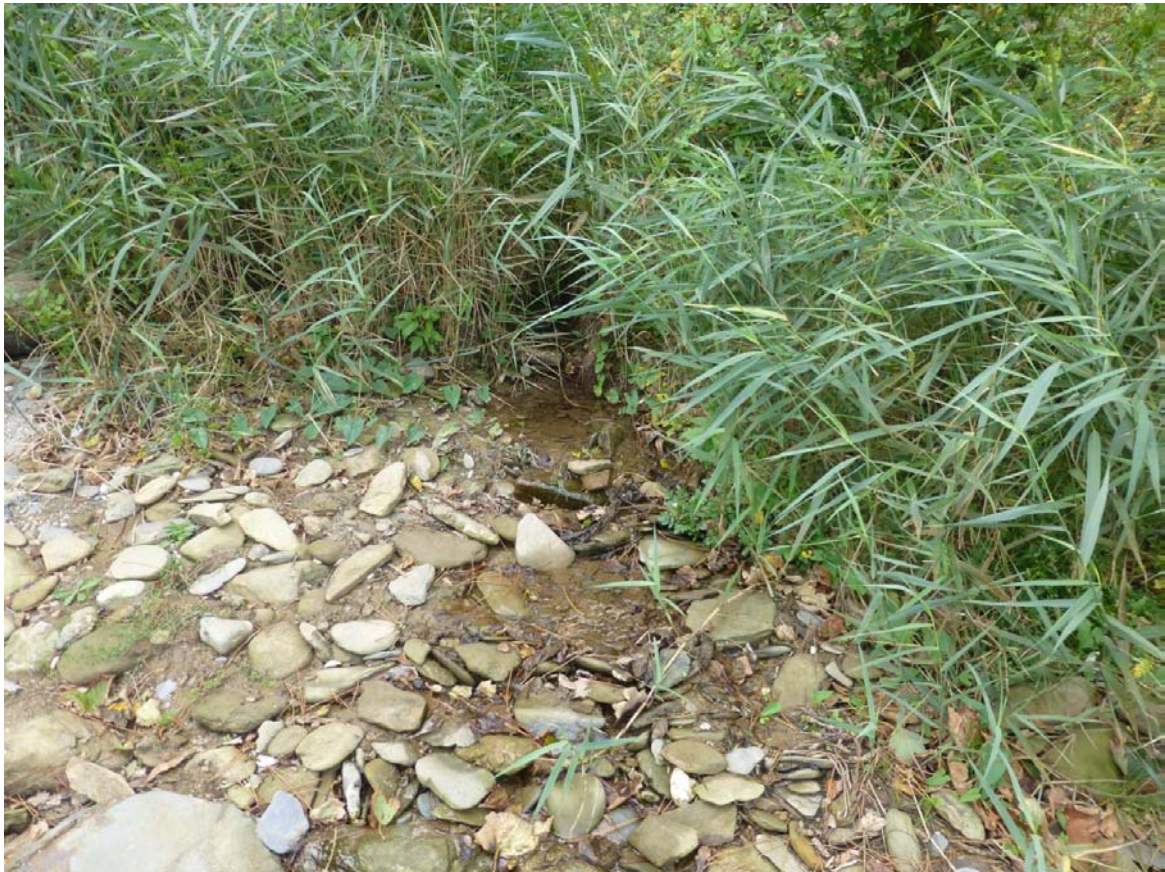
34	SW7720026322	13:08	Stream running across footpath soaking into beach. Too small to sample.	Figure I.27
35	SW7653326465	13:23	Mussels on rocks.	
36	SW7618326187	13:36	Concrete culvert onto beach (40 cm x 40 cm). Lots of gutweed observed at outfall (sample F20).	Figure I.28
37	SW7592326181	13:44	Helford STW outfall pipe exposed but not flowing.	Figure I.29

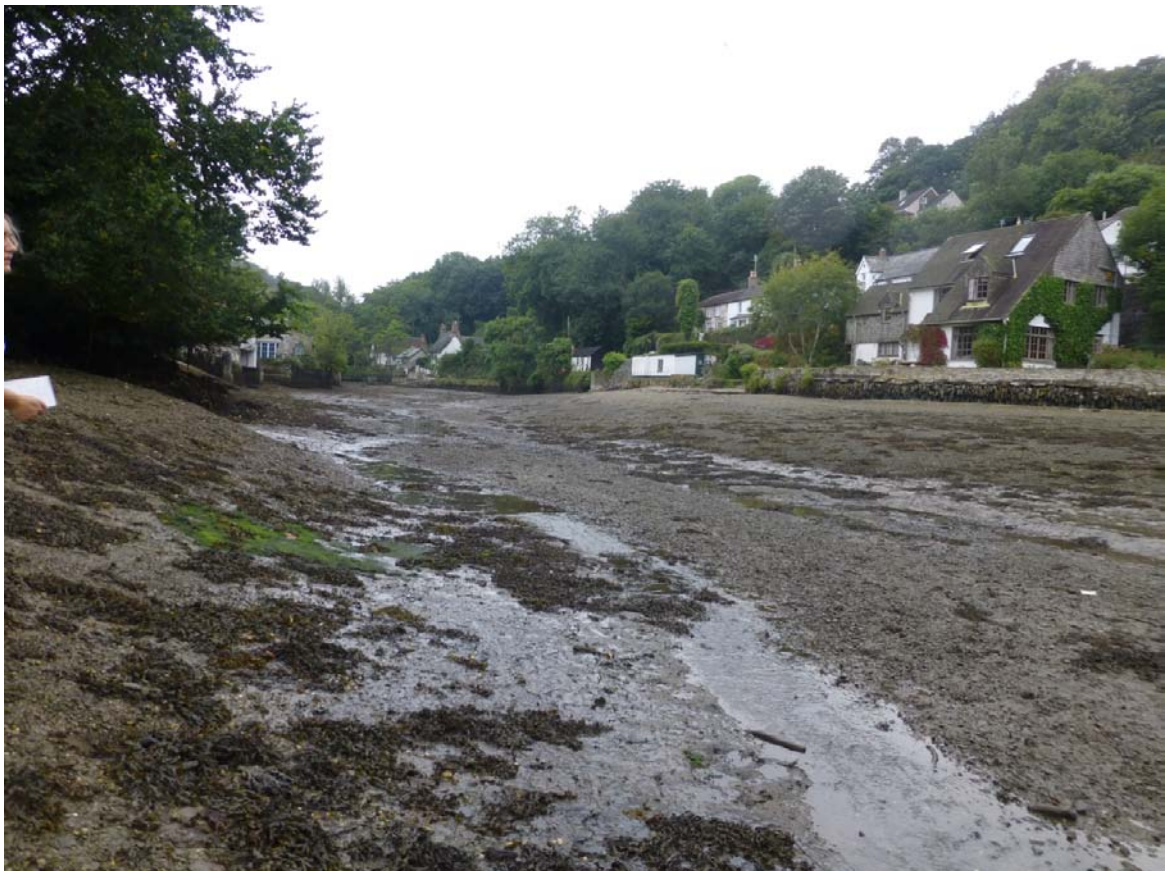
Several small streams were observed flowing into the estuary. Of these streams, Helford Brook (observation 38) returned the highest *E. coli* concentration (1,500 cfu/100 ml) equivalent to a loading of 7.58×10^9 cfu/day.

Observation no.	NGR	Time	Description	Photo
38	SW7585226119	13:50	Stream (sample F22).	Figure I.30
39	SW7585626223	13:55	Iron pipe with missing valve cover (under concrete slipway) and terracotta pipe (10 cm diameter). Neither flowing. Possibly discharge from Shipwright PS.	Figure I.31
40	SW7601226439	14:00	Mussels on rocky shoreline

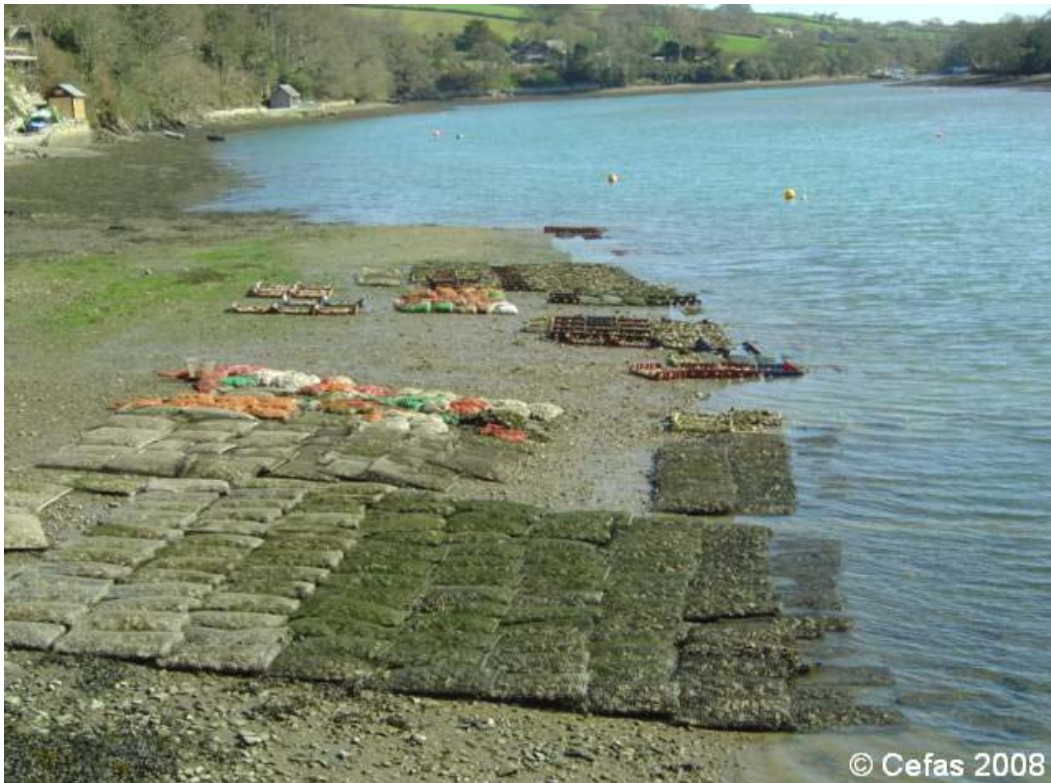
Figure 2. Native oysters in bags ready for marketing at Porth Navas Quay.

In the past, oysters, clams and mussels were brought to the estuary for growing in cages deposited on the river bed (Helford Voluntary Marine Conservation Area, 2006). Currently, the commonly used farming method for mussels is bottom culturing. Juvenile mussels and oysters are collected from wild beds and placed in sheltered areas for growing to a marketable size (Figure 2). Native oyster seeds are also brought from the Fal and Solent estuaries for growing on beds (Helford Voluntary Marine Conservation Area, 2006).

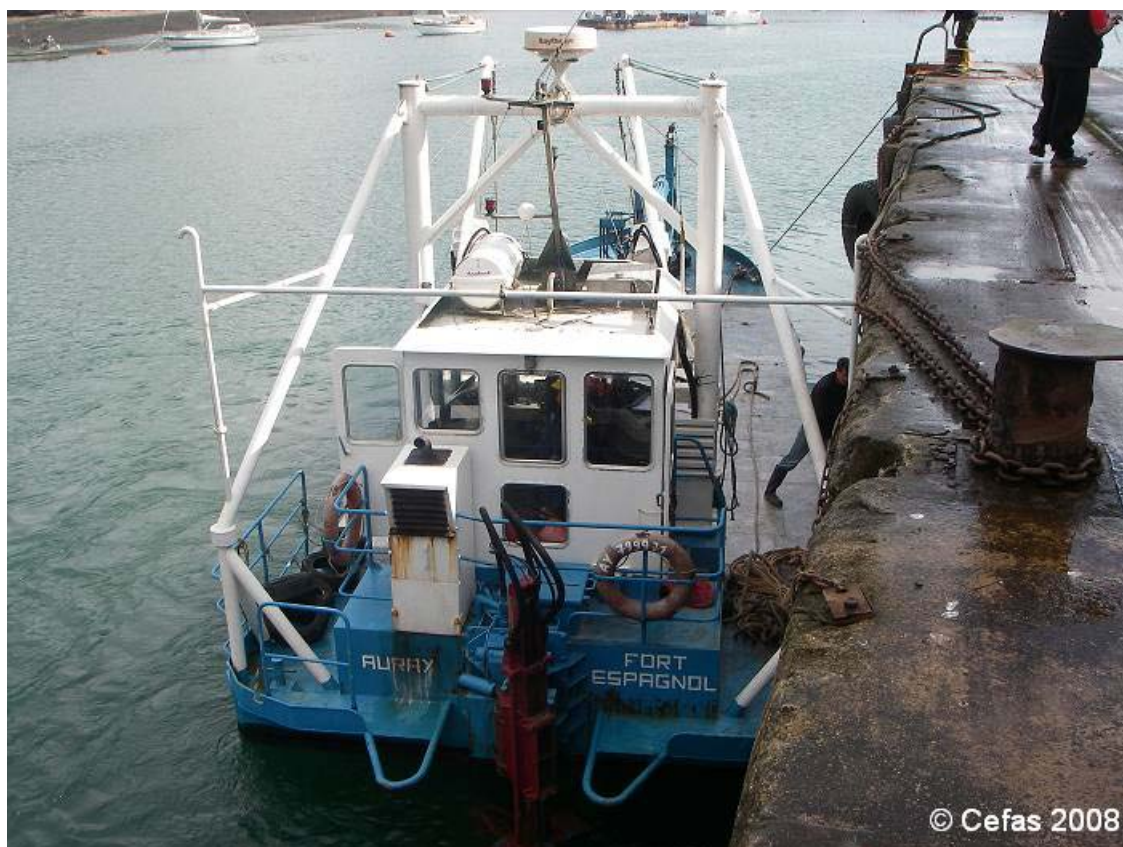
Figure 8. Boat used for dredging bivalve shellfish in the Helford Estuary.

Harvesting of native oysters is carried out using iron-frame dredges from boats (Figure 8) that can collect up to 100 oysters each pull (Helford Voluntary Marine Conservation Area, 2006). However, a significant proportion of bivalve harvesting within the estuary is done by hand. Pacific oysters at Bosahan are to be recovered by hand from cages hauled aboard a boat.

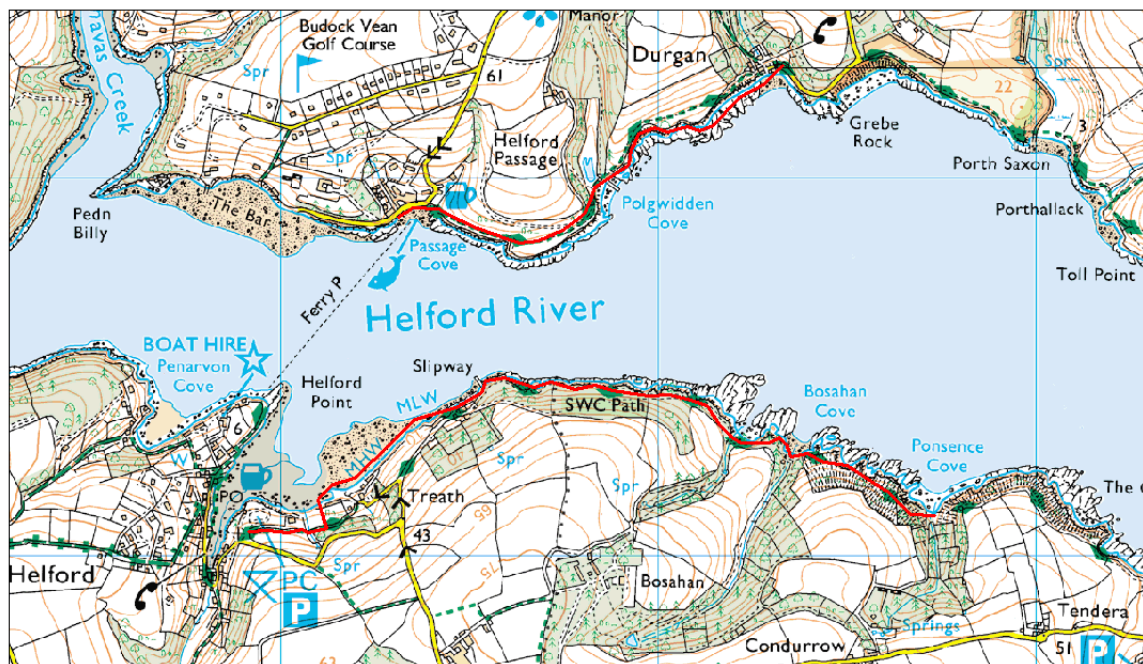
Figure 40. Area surveyed (red line).

The principal focus of the survey was the vicinity of the new shellfish harvesting area at Bosahan Cove. Two main areas were surveyed from Durgan Village to the western limit of Helford Passage, on the northern shoreline and from Helford to the streams at Condurrow, in the southern shoreline (Figure 40).

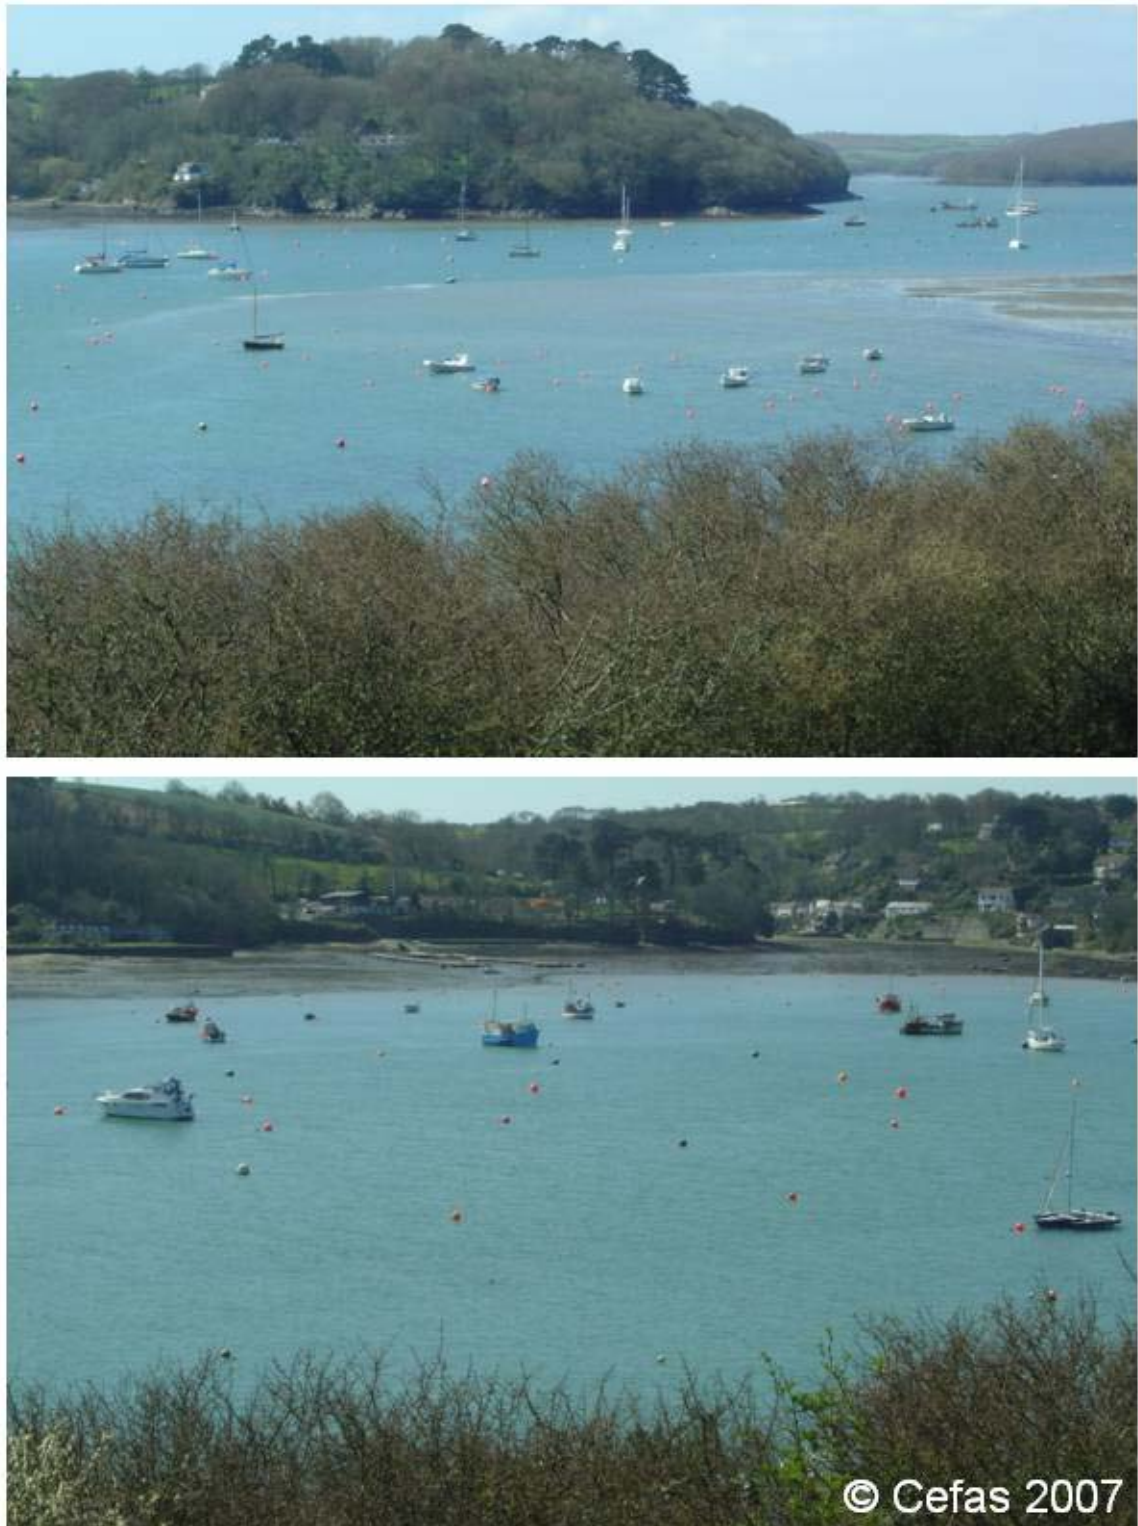
Figure 41. Moored boats off Helford Passage.

Sailing boats were seen to be mostly concentrated between Porth Navas Creek and Helford Passage (Figure 40). Helford Passage is a small village of holiday cottages, from where the Helford River Boats operate for boat hire, ferry services and moorings. More than 60 boats were moored off Helford Passage. There is a small slipway at Durgan. However although there are several moorings could be seen in the bay, no boats were observed moored at the time of the survey. About 20 moored boats were observed in Helford Creek, east of Helford Point (Figure 41).

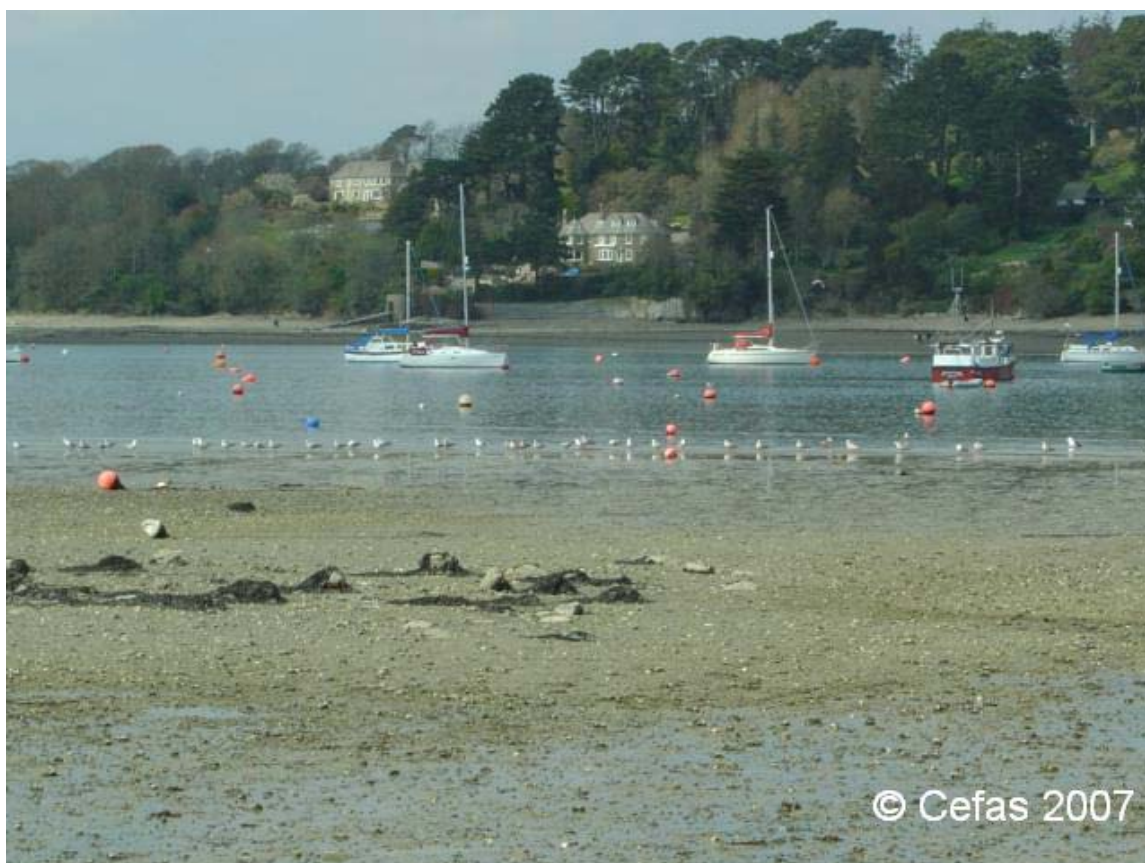
Figure 42. Moored boats in Helford Creek.

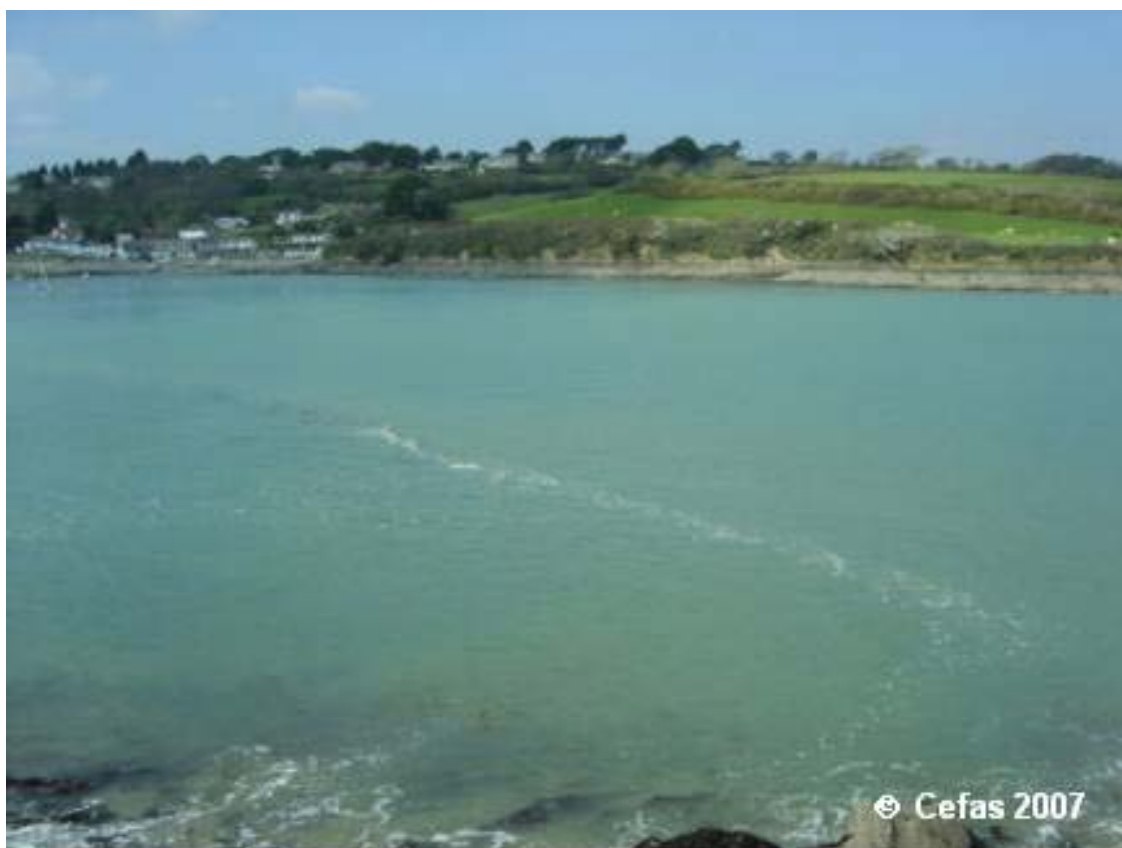
Figure 44. View of a tide-line (convergent front) in the Helford Estuary.

A line of concentrated foam and detritus extending up the estuary during the early flood phase of the tide was photographed from Bosahan Cove (Figure 44). This feature, a result of converging water masses, evidences the presence of tidal fronts in the Helford Estuary.

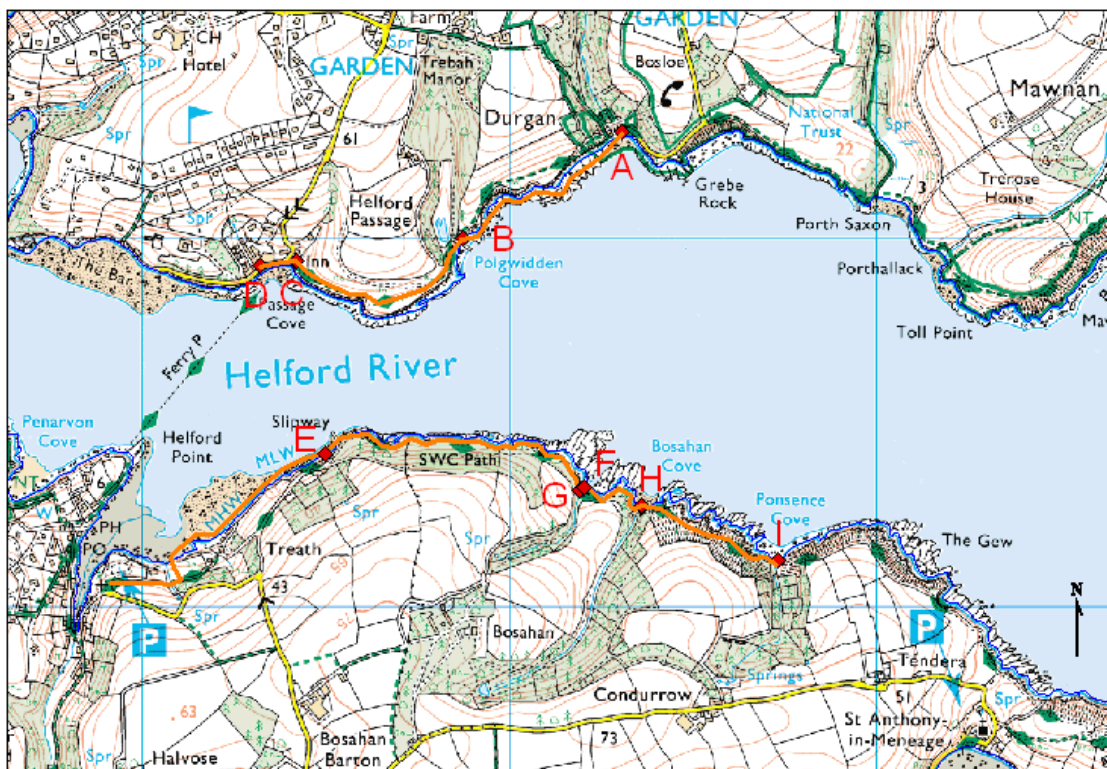
Figure 45. Area surveyed including locations of sites sampled in the Helford Estuary.

The coordinates and descriptions of sites (A-I) sampled are given in Table 15 and the locations are shown in Figure 45.

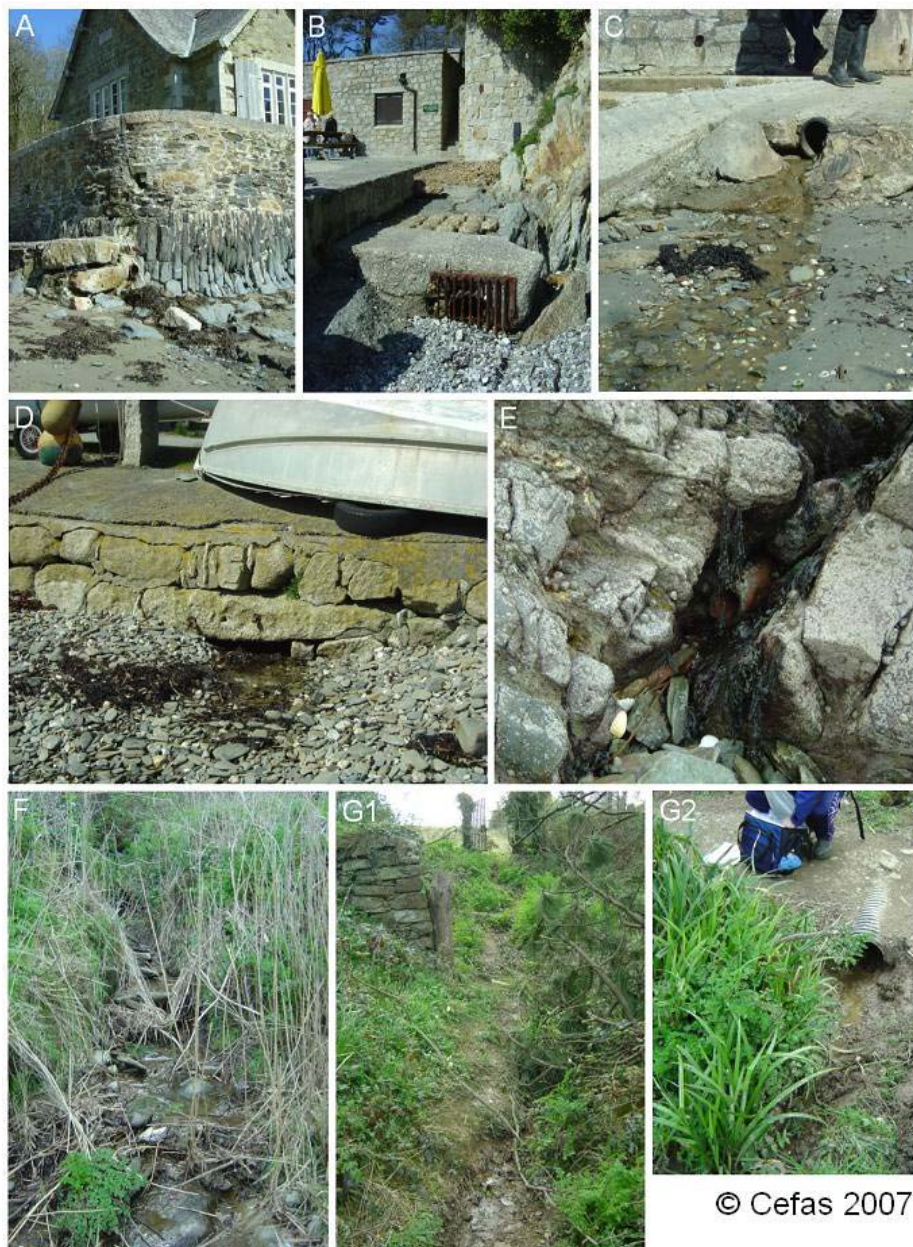
Figure 46. Sites sampled during the shoreline survey.

Samples were taken from piped discharges at Durgan (Figure 46 A), Polgwidden Cove (Figure 46 B) and Passage Cove (Figure 46 C, D). In addition, five streams were sampled between Treath (Figure 45 E) and Ponsence Cove. Three of these streams are in the vicinity of Bosahan Cove. All discharges were noted to have low flows and were clear in appearance with the exception of Site C.
