Scottish Sanitary Survey Programme

Sanitary Survey Report Seilebost LH-249 October 2013

Report Title	Seilebost Sanitary Survey Report	
Project Name	Scottish Sanitary Survey	
Client/Customer	Food Standards Agency Scotland	
Cefas Project Reference	C5792C	
Document Number	C5792C_2013_9	
Revision	Final V1.0	
Date	6/1/2014

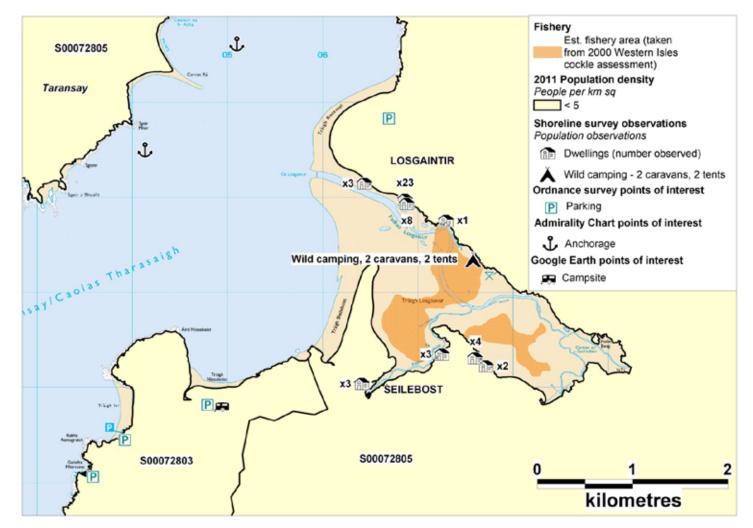
Figure 3.1 Population map for the area in the vicinity of Seilebost

The small settlements of Seilebost and Losgaintir are located within the vicinity of Seilebost fishery. Seilebost located on the southern shoreline consists of approximately a dozen houses along the road running adjacent to the shoreline. Seilebost primary school, which appears on the OS map on a spit of land west of Seilebost, closed in June 2013. Losgaintir on the northern shoreline is slightly larger with approximately thirty five dwellings observed during the shoreline survey. Census output area S00072805, which surrounds Seilebost and includes Taransay (which is not populated), covers 67 km² and has a total population of 85. The adjacent census output area S00072803 covers 24 km² and has a total population of 62. It is likely that the dwellings surrounding Seilebost are accountable for majority of the population in S00072805 and therefore the overall population density shown in Figure 3.1 is not representative in this case. During the shoreline survey, two tents and two caravans were observed on the northern shoreline. No other tourist accommodation was observed.

Overall, impacts from human sources to the water quality of the shellfish bed are likely to be low due to the low population density of the area, with any effects predominating in the north where the greater concentration of dwellings are located.

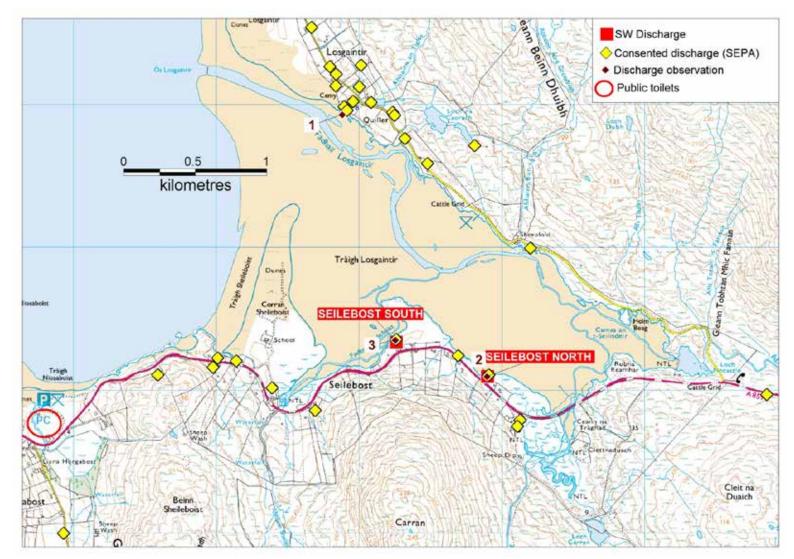
Produced by Cefas Weymouth Laboratory. © Crown Copyright and Database 2014. All rights reserved. Ordnance Survey licence number [GD100035675] Figure 4.1 Map of discharges near the Seilebost production area

SEPA provided information on a total of 42 consented discharges in the requested area. Those considered most relevant in terms of potential contribution to faecal contamination at the fishery are listed in Table 4.2 and shown in Figure 4.1. A total of 27 consented discharges were considered to be potentially impacting on the production area. Incomplete information was received regarding the nature of some of the discharges, and where data is missing

Observation 1 relates to a concrete structure assumed to be a septic tank. No discharge was noted during the shoreline survey. This structure looks like it may be a septic tank with overflow pipe, and based on its location may relate to either consent CAR/R/1053689 or CAR/R/1053690.

Observation 3 relates to a small, unnamed watercourse culverted under the road, which discharges to the foreshore. The sample taken from this watercourse returned a result of 630000 *E. coli* cfu/100ml which indicated a high level of faecal contamination entering the production area from this watercourse. This is reinforced by the observed strong smell of sewage on the shore. This is presumed to come from the Seilebost South public septic tank (WPC/N/70204).

The outfall for the Seilebost North septic tank was found further east of Seilebost, and a seawater sample taken from near the end of the pipe returned a result of 3800 *E. coli* cfu/100 ml.

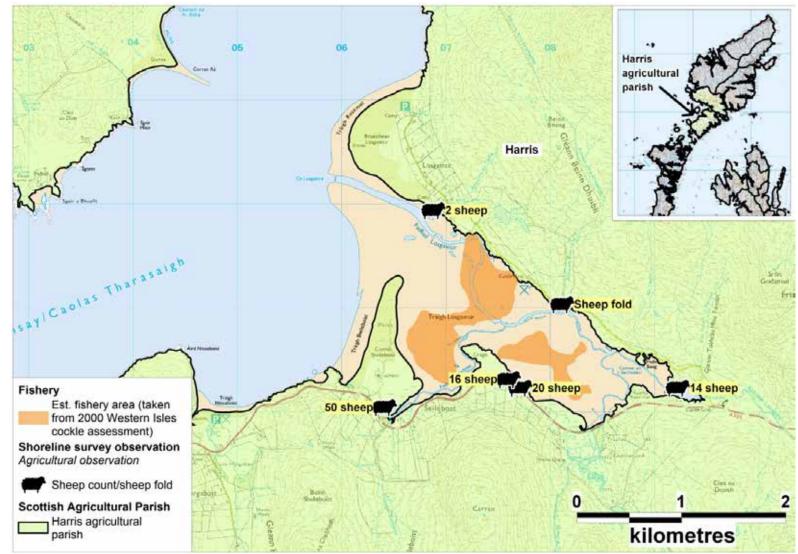
Produced by Cefas Weymouth Laboratory. © Crown Copyright and Database 2014. All rights reserved. Ordnance Survey licence number [GD100035675] Figure 5.1 Agricultural parish boundary and livestock observations

A source of spatially relevant information on livestock population in the area was the shoreline survey (see Appendix 5) which only relates to the time of the site visit on the 7th July 2013 (see Table 5.1). Observations made during the survey are dependent upon the viewpoint of the observer some animals may have been obscured by the terrain. The spatial distribution of animals observed and noted during the shoreline survey is illustrated in Figure 5.1.

During the survey sheep were observed grazing along the shoreline adjacent to the fishery. In total approximately 86 sheep were observed grazing along the southern shoreline and 16 sheep were observed along the northern shoreline. A sheep fold was also present on the northern shoreline.

Any contributions of faecal contamination from livestock grazing in the area would be most likely to affect the areas of shellfish bed closest to the shoreline. The distribution of animals observed at the time of the shoreline survey implies that the impact would be greatest on the southern side of the bed: however, the distribution may change with time.

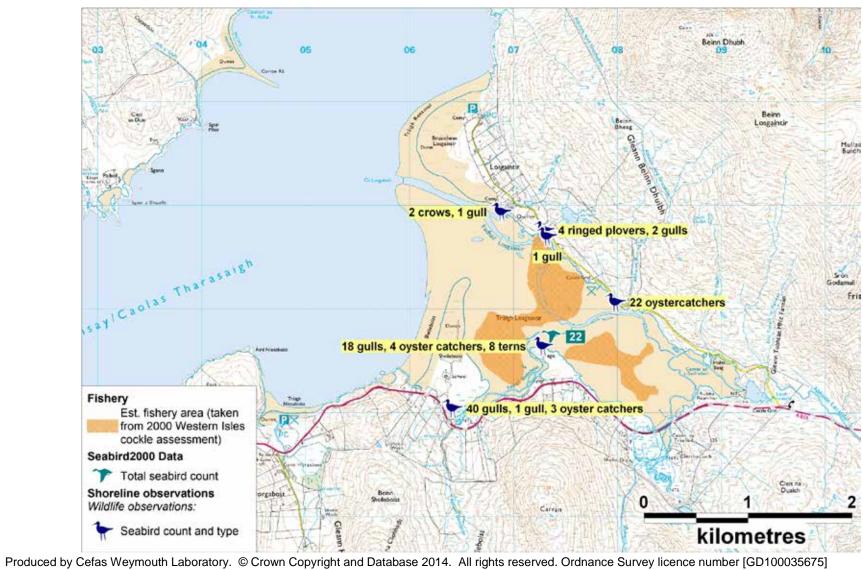
Figure 6.1 Map of wildlife around Seilebost

During the shoreline survey, birds were the only species that was identified during the survey. Eight terns were noted close to the location of the known Arctic tern nesting site; species included Arctic, Common and Little terns. Gulls were the most regularly spotted species, with one single count of 40 birds. Other birds noted included oystercatchers, crows and a four ringed plover. It is likely that many different bird species will use the sand banks at Seilebost to rest and forage on and it is expected that their populations will vary from day to day.

Contributions from wildlife to faecal contamination levels at the fishery are expected to be modest, with seabirds contributing most directly at the location of the cockle bed. A breeding colony of terns, as well as gulls and wading birds are present at or very near the cockle bed and droppings deposited at low tide will be resuspended and available for uptake by the cockles as the tide comes in. Seasonal variation in the numbers and types of bird present is expected, though little specific data on this variation was found.

Given the location of the nesting site, other seabird observations, and the small size of the area, it is expected that any effects may eb seen across the whole cockle bed. Impacts of other wildlife species are expected to be low and unpredictable in location and time.

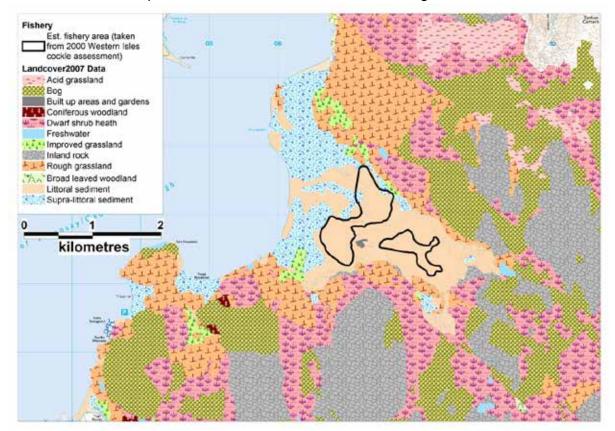
Figure 7.1 LCM2007 land cover data for the area around Seilebost

The Land Cover Map 2007 data for the area is shown in Figure 7.1 below:

Faecal indicator organism export coefficients for faecal coliform bacteria have been found to be approximately 8.3x10⁸ cfu/km²/hr for areas of improved grassland and approximately 2.5x10⁸ cfu/km²/hr for rough grazing (Kay, et al., 2008). The contributions from all land cover types would be expected to increase significantly after rainfall events, however this effect would be particularly marked from improved grassland areas (roughly 1000-fold) (Kay, et al., 2008).

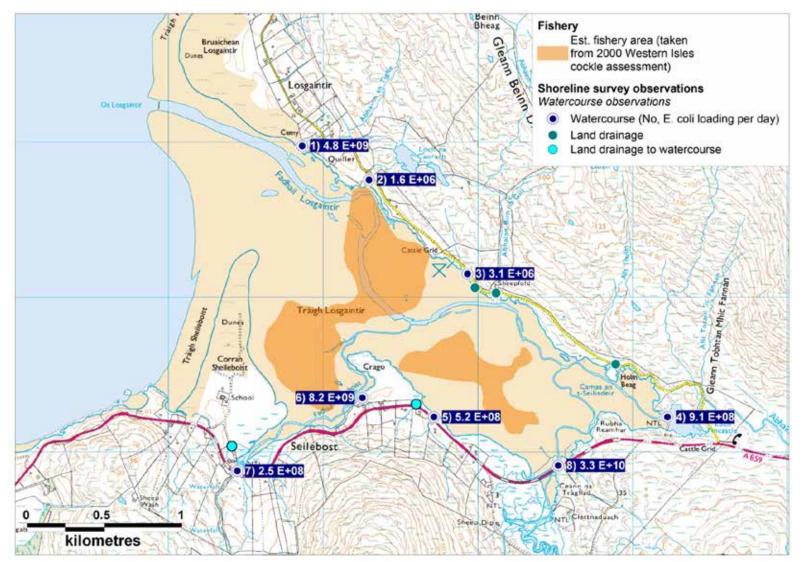
Produced by Cefas Weymouth Laboratory. © Crown Copyright and Database 2014. All rights reserved. Ordnance Survey licence number [GD100035675] Figure 8.1 Map of watercourse loadings at Seilebost

Information on flows and microbial content was only available from the shoreline survey conducted on the 23rd and 24th July 2013. The weather was noted to the warm and dry in the 48 hrs prior to the survey, and on both survey days, except for one heavy shower on the first survey day. The watercourses listed in Table 8.1 are noted to be the most significant freshwater inputs to the Seilebost area.

Width	Depth	Flow	Loading (<i>E. coli</i> per day)	
No.	NGR	Description	(m)	(m)	(m ³ /d)		
1	NG 0686 9898	Abhainn an Tighe	0.26	1.60	1000	4.8x10 ⁹	
2	NG 0730 9876	Unnamed watercourse 0.55 0.02 0.7				1.6x10 ⁶	
3	NG 0793 9815	Land drainage	-	-	0.5	3.1x10 ⁶	
4	NG 0922 9723	Abhainn Lacasdal (via Loch Fincastle)	1.00	0.15	4500	9.1x10 ⁸	
5	NG 0772 9723	Piped burn	0.50	0.02	0.5	5.2x10 ⁸	
6	NG 0725 9735	Unnamed Watercourse	0.70	0.03	1.3	8.2x10 ⁹	
7	NG 0645 9688	Abhainn Sheileboist	2.20	0.10	2500	2.5x10 ⁸	
8	NG 0852 9692	Abhainn Gil an Tailleir	3.00	0.83	9300	3.3x10 ¹⁰

At the time of the shoreline survey, the estimated loadings were low to moderate. However, due to the proximity to the shellfish bed, they will potentially have a significant impact on microbiological quality. Loadings would be expected to increase after significant rainfall events. The impact of the watercourses entering the inner (eastern) part of the area will change over an ebbing tide as water becomes confined to the main channels. Contamination from the watercourses entering the outer (western) part of the area will be taken over the shellfish beds on the incoming tide but the extent (and dilution) will change as the tide depth increases. Due to the nature of the substrate, the sand banks at Seilebost are likely to shift with time and will result in freshwater channel formation also changing. This may result in differences in the impact that each watercourse will have on the cockle bed over time.

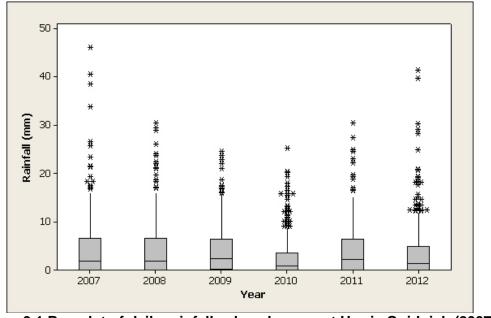
Figure 9.1 Box plot of daily rainfall values by year at Harris Quidnich (2007 – 2012)

Total rainfall varied markedly from year to year, with 2010 being the driest year (a total of 977 mm). The wettest year was 2007 (a total of 1633 mm). High daily rainfall values of more than 30 mm/d occurred in 2007, 2008, 2011 and 2012 and an extreme rainfall event of nearly 50 mm/d was seen in 2007.

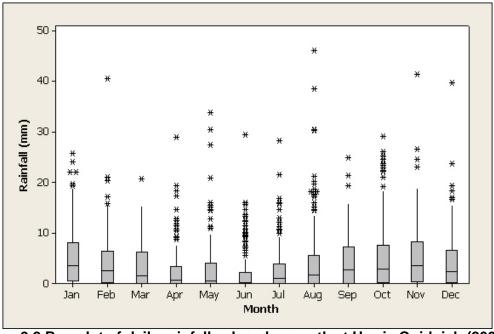
Figure 9.2 Box plot of daily rainfall values by month at Harris Quidnich (2007 – 2012)

Rainfall was lowest between April and July and highest from August to March. Rainfall values exceeding 30 mm/d were seen in February, May, August, November and December. The 2007 extreme event occurred in August.

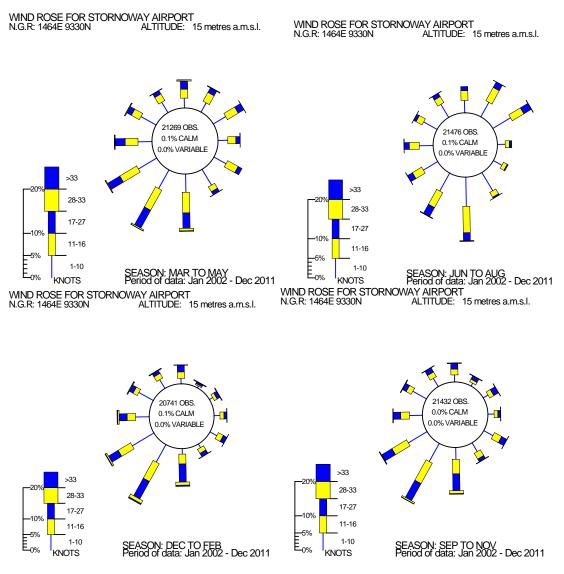
Figure reproduced under license from Meteorological Office. Crown Copyright 2012. Figure 9.3 Seasonal wind roses for Stornoway Airport

Wind data was collected from Stornoway Airport and summarised in seasonal wind roses in Figure 9.3 and annually in Figure 9.4.

Overall, winds were predominantly from the southwest. However, during summer, southerly winds predominated and there were also relatively strong winds from the north-west. Wind is an important factor in the spread of contamination as it has the ability to drive surface water at about (3%) of the wind speed (Brown, 1991) so a gale force wind (34 knots or 17.2 m/s) would drive a surface water current of about 1 knot or 0.5 m/s. Therefore strong winds can significantly alter the pattern of surface currents. Strong winds also have the potential to affect tide height depending on wind direction and local hydrodynamics of the site. A strong wind combined with a spring tide may result in higher than usual tides, which will carry any accumulated faecal matter at and above the normal high water mark into the fishery area.

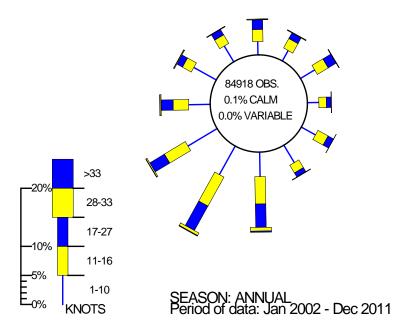
Figure reproduced under license from Meteorological Office. Crown Copyright 2012. Figure 9.4 Annual wind rose for Stornoway Airport

WIND ROSE FOR STORNOWAY AIRPORT N.G.R: 1464E 9330N ALTITUDE: 15 metres a.m.s.l.

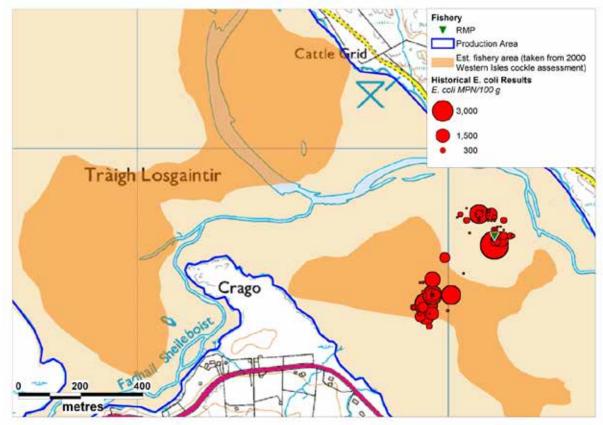
Figure 11.1 Map of reported sampling locations for common cockles at Seilebost

The geographical locations of all sample results assigned to Seilebost have been thematically mapped in Figure 11.1. The sampling locations split roughly into two clusters; one within 150 m of the RMP (NG 0815 9772), and the other to southwest of the RMP.

Samples with results of >1000 *E. coli* MPN / 100 g were taken from both areas. Seven of these came from the southern cluster and four came from the northern cluster. The highest sample result (5400 *E. coli* MPN / 100 g) from the northern cluster. A two sample t-test was conducted on log_{10} -transformed data in order to determine whether there was a statistically significant difference between the two areas. The geometric means of the results at the north and south clusters were 2.338 and 1.909, respectively. A statistically significant difference was found between samples taken from the northern and southern sites (t value= -2.24, p= 0.029, df 55). Therefore, although the highest result was obtained from the northern cluster of sampling locations, the average level of contamination was higher at the southern cluster.

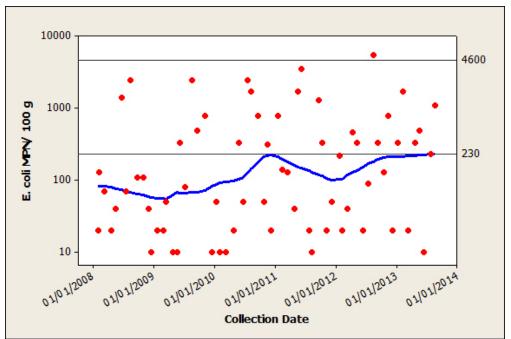
Figure 11.2 Scatterplot of *E. coli* results by collection date at Seilebost, fitted with a lowess line

A scatterplot of *E. coli* results against date for Seilebost is presented in Figure 11.2. The dataset is fitted with a lowess trend line. Lowess trendlines allow for locally weighted regression scatter plot smoothing. At each point in the dataset an estimated value is fitted to a subset of the data, using weighted least squares. The approach gives more weight to points near to the x-value where the estimate is being made and less weight to points further away. In terms of the monitoring data, this means that any point on the lowess line is influenced more by the data close to it (in time) and less by the data further away. A trend line helps to highlight any apparent underlying trends or cycles.

The trend in contamination levels showed a slight increase over the period.

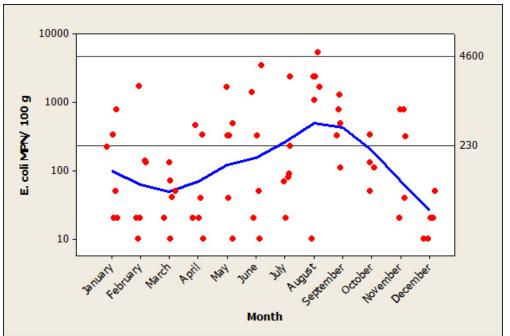
Figure 11.3 Scatterplot of *E. coli* results by month at Seilebost, fitted with a lowess line

Contamination levels show a strong seasonal increase, peaking in August before declining again.

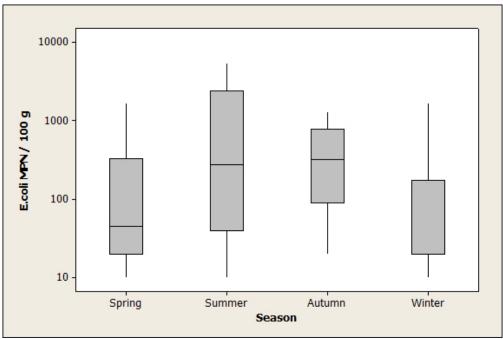
Figure 11.4 Boxplot of *E. coli* results by season at Seilebost

For statistical evaluation, seasons were split into spring (March-May), summer (June-August), autumn (September-November) and winter (December-February). A boxplot of *E. coli* results by season is presented in Figure 11.4.

A significant difference was found between *E. coli* results by season (one-way ANOVA, p = 0.017, Appendix 4), with sample results in summer being higher than those taken in winter.

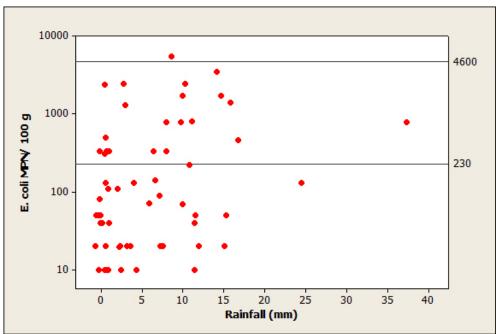
Figure 11.5 Scatterplot of *E. coli* results against rainfall in the previous two days at Seilebost

A scatterplot of *E. coli* results against total rainfall recorded on the two days prior to sampling is displayed in Figure 11.5. Jittering was applied to results at 0.02 (x-axis) and 0.001 (y-axis) respectively.

A significant correlation was found between *E. coli* results and rainfall in the previous two days (Spearman's rank correlation r = 0.323, p = 0.013).

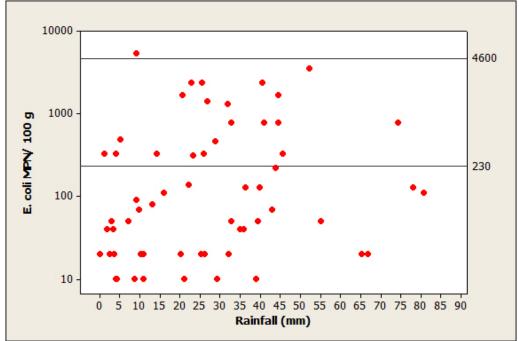
Figure 11.6 Scatterplot of *E. coli* results against rainfall in the previous seven days at Seilebost

A significant correlation was found between *E. coli* results and rainfall during the previous seven days(Spearman's rank correlation r = 0.278, p = 0.033).

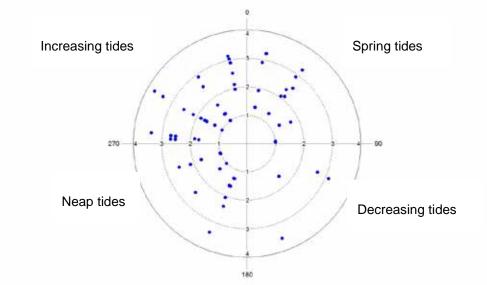
Figure 11.7 Polar plots of log₁₀ *E. coli* results against the spring/neap tidal cycle at Seilebost

No significant correlation was found between $\log_{10} E$. *coli* results and the spring/neap tidal cycle (circular-linear correlation r = 0.166, p = 0.17). The majority of samples were taken on increasing tides.

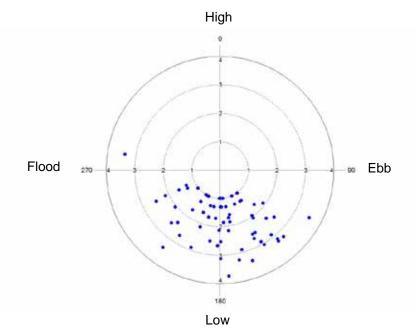
Figure 11.8 Polar plots of log₁₀ *E. coli* results against the high/low tidal cycle at Seilebost

High and low water data from West Loch Tarbert was extracted from POLTIPS-3 in August 2013. This site was the closest to the production area (approximately 6 km to the northwest) and it is assumed that tidal state will be similar between sites.

A significant correlation was found between $\log_{10} E$. *coli* results and the high/low tidal cycle (circular-linear correlation r = 0.329, p = 0.001). As expected for the type of fishery, the majority of samples were taken around low tide. Higher results tended to be seen on the ebb side of low tide than on the flood side.

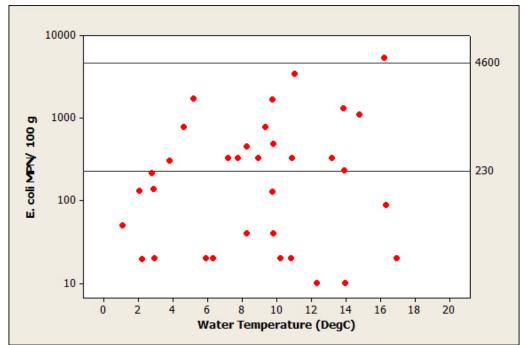
Figure 11.9 Scatterplot of *E. coli* results against water temperature at Seilebost

No significant correlation was found between *E. coli* results and water temperature (Spearman's rank correlation r = 0.126, p = 0.479). Samples were taken over a wide range of water temperatures between 1 and 17° C.

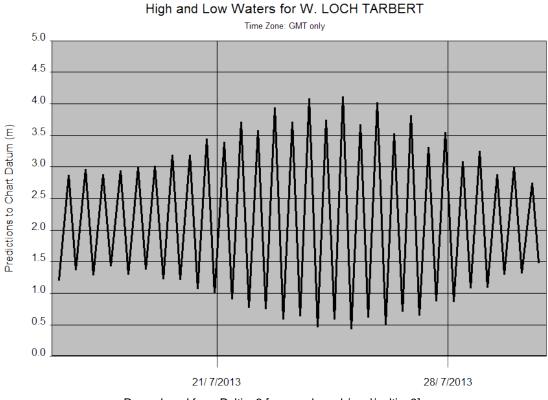
Standard tidal data for West Loch Tarbert are given below and the spring/neap cycle of tidal height around the time of the survey (23-24 July 2013) is shown in figure 13.3.

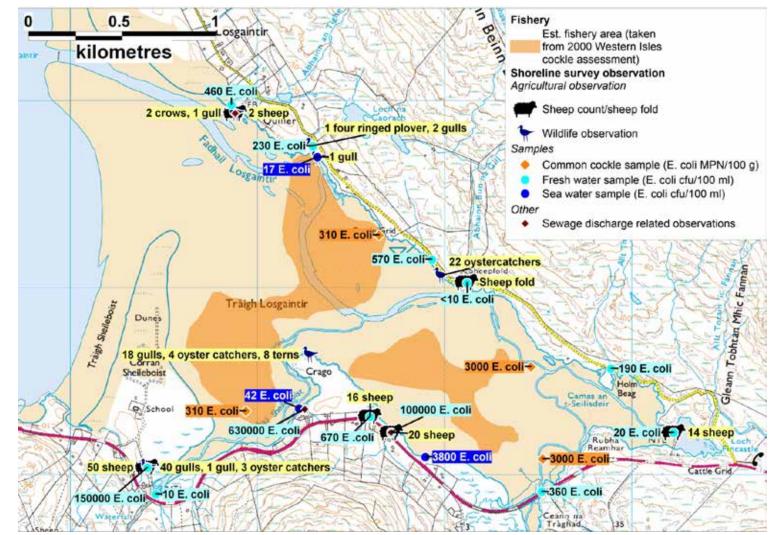
Produced by Cefas Weymouth Laboratory. © Crown Copyright and Database 2014. All rights reserved. Ordnance Survey licence number [GD100035675] Figure 14.1 Principal shoreline survey observations at Seilebost

Birds were the only type of wildlife observed during the shoreline survey: species included seagulls, herring gulls, oyster catchers, crows, ringed plover, arctic tern, common tern and little tern. Gulls were the most prevalent birds encountered.

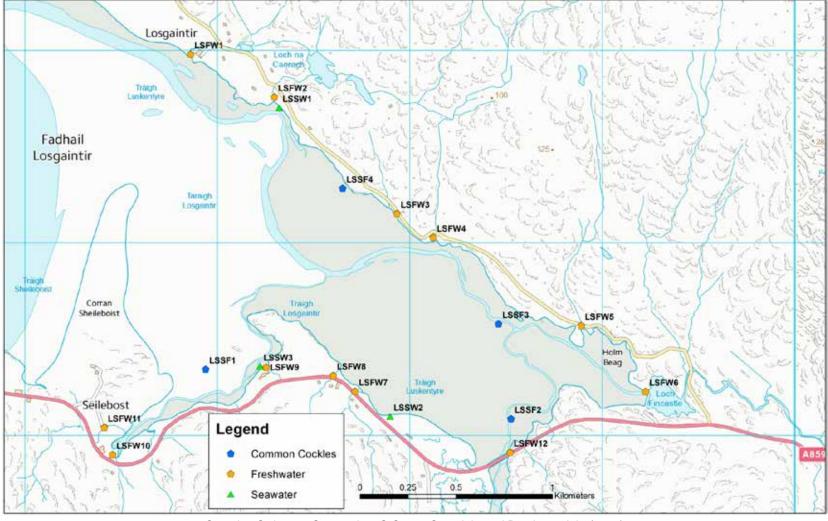
Contains Ordnance Survey data © Crown Copyright and Database right (2013) Figure 2. Seilebost samples

Cockles were collected by hand by the survey team at low tide from the four locations shown in Figure 2. During the survey, cockles were not found to be consistently abundant throughout the production area and some digging in various different areas of the mud/sand was necessary in order to find an area with plentiful cockles for sampling. Mr Paul Tyler suggested that the number of cockle gatherers varies with up to six people being seen there at any one time. As far as Mr Tyler is aware, little harvesting appears to occur at Seilebost between April and November when the site is at classification 'B'. Most of the harvesting seems to occur when the site is at classification 'A', however, as Mr Tyler is there just one day a week, he stressed that he cannot be certain that this is the case and is based only on what he has observed when he is present on-site.

Water samples were collected at sites marked on the map shown in figure 2.

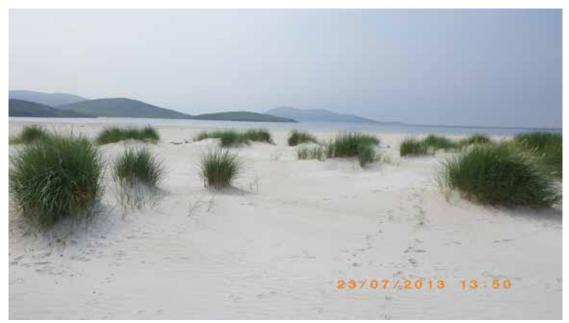
Figure 3. Land cover along the shoreline survey route at Seilebost is mostly sand and sand dunes with rough grass. Associated with waypoint 1.

No.	Date	Time	NGR	East	North	Associated photograph	Associated sample	Description
1	23/07/2013	13:49	NG 06438 99148	106438	899148	Figure 3		Start of survey at Seilebost. Land cover here is mostly sand and sand dunes with rough grass. Open sea with no boats visible. No birds. Three houses visible.
2	23/07/2013	14:03	NG 06861 98980	106861	898980		LSFW1	Planned freshwater sample. Associated with waypoint 3.
3	23/07/2013	14:04	NG 06863 98978	106864	898979			River running onto shore from sand dunes. Width = 26 cm ; Depth = 1.6 m ; Flow = 0.029 m/s ; SD = 0.019 . Two houses behind river. No pipes or septic tanks visible. Approximately twenty one houses on opposite side of the shore. Three fish jumping in the river.
4	23/07/2013	14:12	NG 06881 98934	106882	898934	Figure 4		Concrete structure in front of house behind river. Two sheep, two crows and one seagull on shore. Eight houses and one static caravan behind shore.

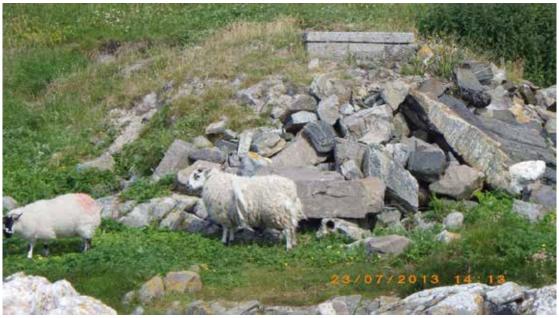
Figure 4. Concrete structure in front of house behind river. Two sheep on shore. Associated with waypoint 4.

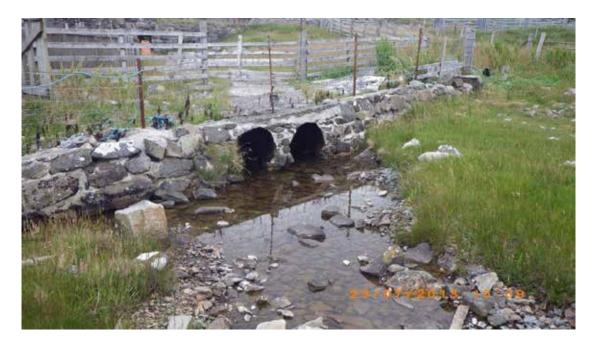
Figure 5. Two pipes running under road and under sheep fold next to road. Associated with waypoints 13 and 14. Planned freshwater sample LSFW4.

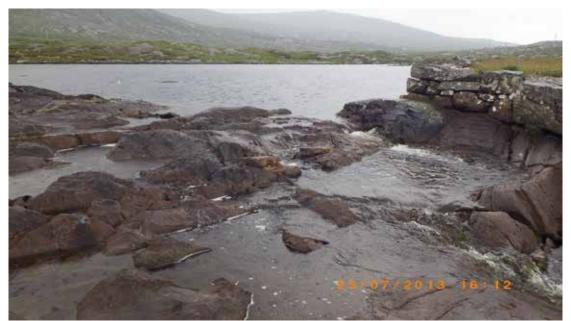
Figure 6. River flowing out from Loch Fincastle at the head of Loch Seilebost. Associated with waypoints 17 and 18. Planned freshwater sample LSFW6.

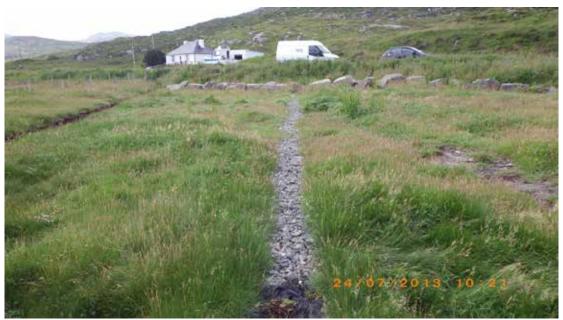
Figure 7. Public discharge onto shore, covered over with stones until it reaches the beach. Associated with waypoint 20 and 21. Planned seawater sample LSSW2.

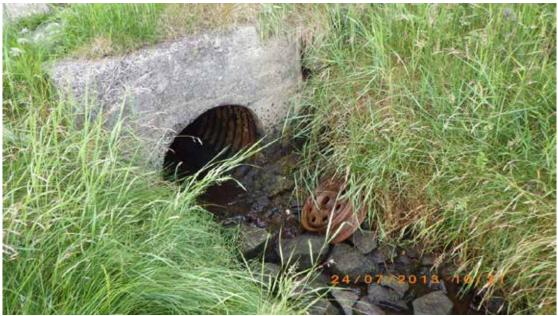
Figure 8. Concrete pipe directing a burn under the road from a hill onto shore. Associated with waypoints 22 and 23. Planned freshwater sample LSFW7.

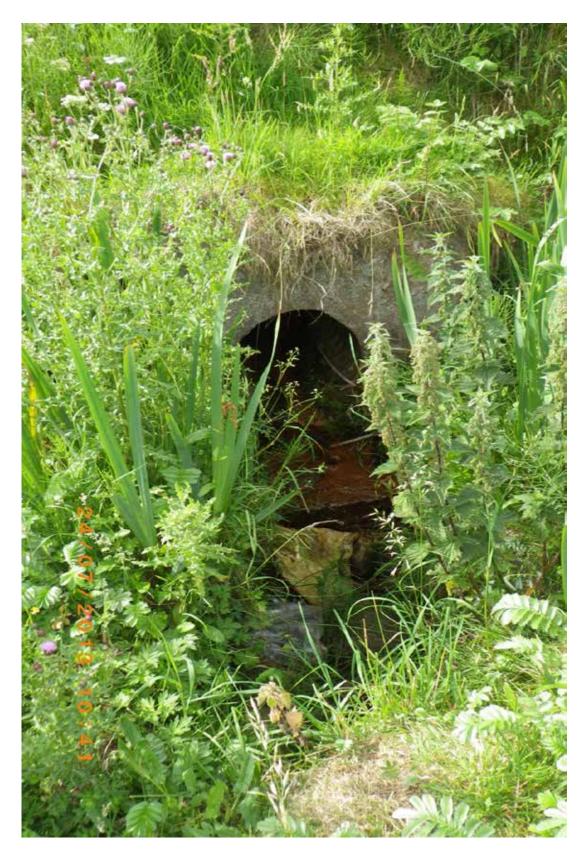
Figure 9. Watercourse piped under road onto shore from hill. Associated with waypoints 24 and 25. Planned freshwater sample LSFW8

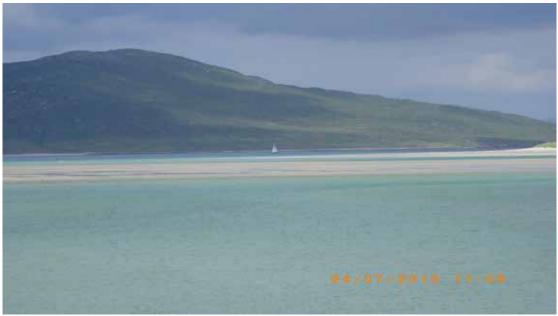
Figure 10. One sailing boat out to sea. Associated with waypoint 26.

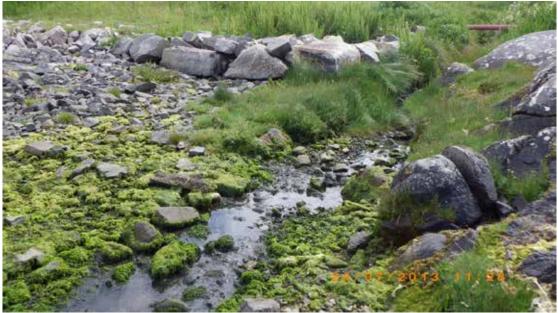
Figure 11. Watercourse running from under road onto shore with of green algae present. Associated with waypoints 27 and 28. Planned freshwater sample LSFW9.

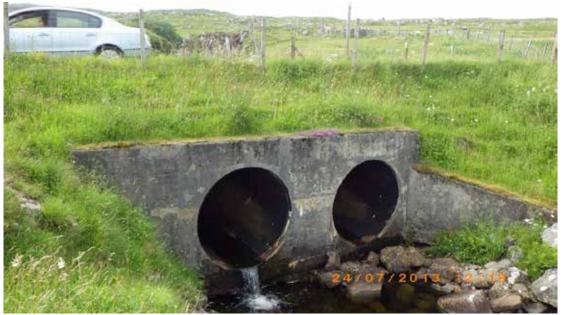
Figure 12. Two large pipes of 1.5 m width directing watercourse under road onto shore. Associated with waypoints 30 and 31. Planned freshwater sample LSFW10.

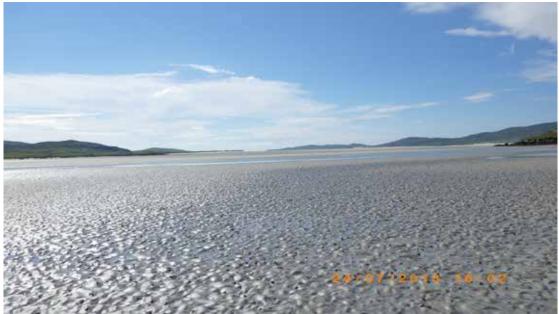
Figure 13. Associated with waypoint 40. Planned shellfish sample LSSF3.

39	24/07/2013	15:03	NG 08525 97087	108526	897087		LSSF2	Planned shellfish sample. Site 3 on Survey Plan Map.
40	24/07/2013	15:56	NG 08461 97579	108461	897579	Figure 13	LSSF3	Planned shellfish sample. Site 2 on Survey Plan Map.
41	24/07/2013	16:41	NG 07650 98283	107651	898284		LSSF4	Planned shellfish sample. Site 1 on Survey Plan Map.
