Scottish Sanitary Survey Project

Restricted Sanitary Survey Report
Northton Beach
LH 531
March 2011

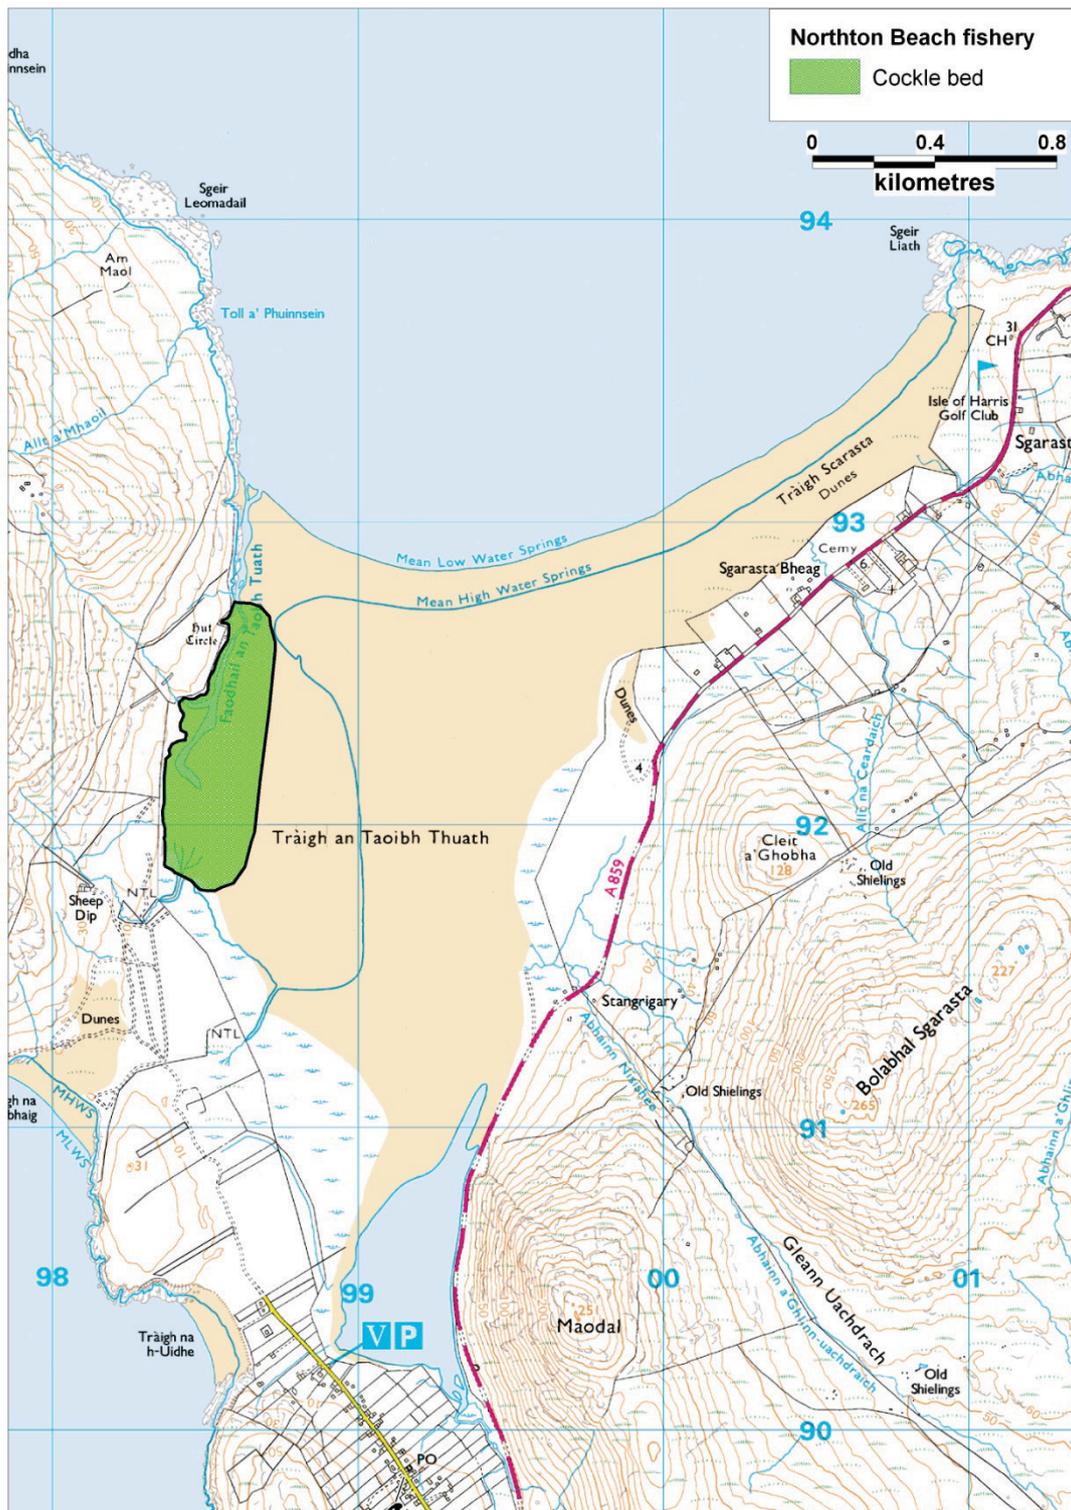
Produced by Cefas Weymouth Laboratory © Crown Copyright and Database 2011. All rights reserved. Ordnance Survey licence number [GD100035675]
Figure 2.1 Northton Beach fishery

The fishery at Northton Beach (LH 531 964 04) is comprised of a common cockle (*Cerastoderma edule*) bed.

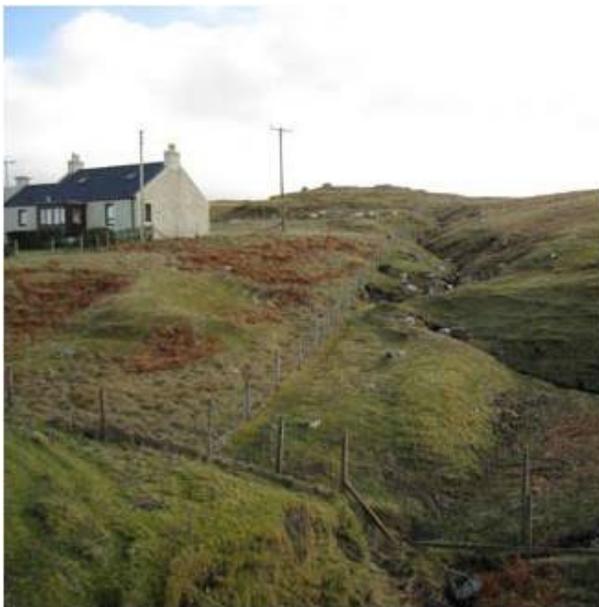
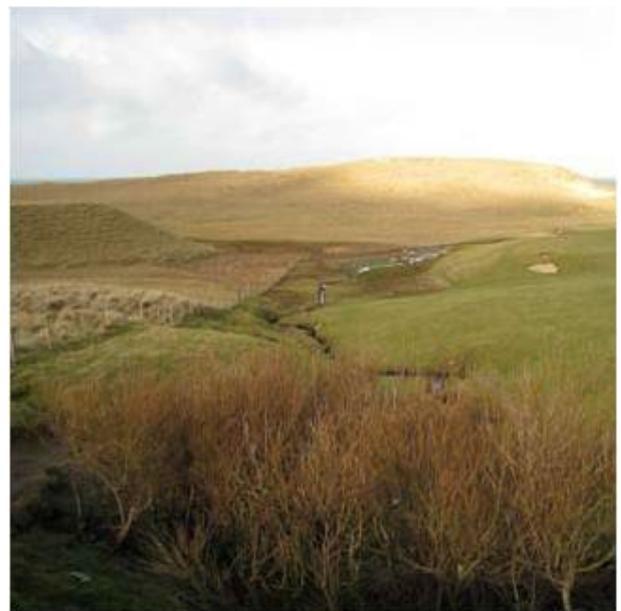
Figure 6. and 7: NG 02560 94000 looking SE and NW, showing how most watercourses in the area drain into the sand dunes and not directly into the sea.

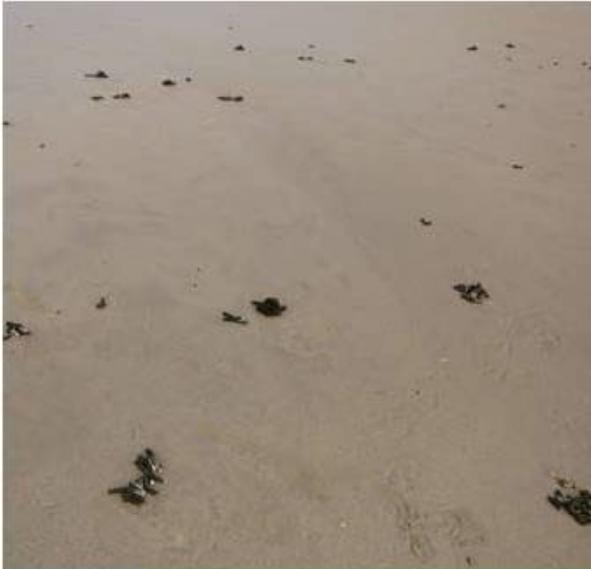
Figure 30. Goose droppings at NF 99070 90680 Figure 31. Scum at NF 99040 90650

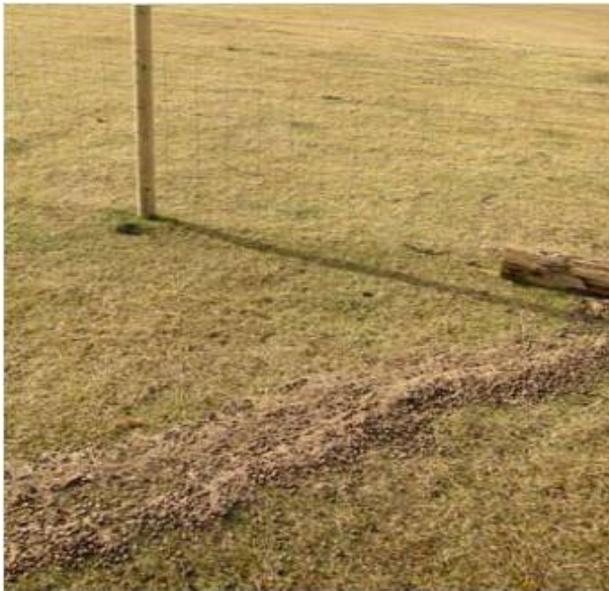
Figure 32. Sheep droppings on tideline NF 99050 890980 Figures 33 – 35. Saltmarsh at NF 99410 90020 Looking SW
