# Scottish Sanitary Survey Project

## Restricted Sanitary Survey Report

Luce Bay Razors  
DG 499  
November 2010

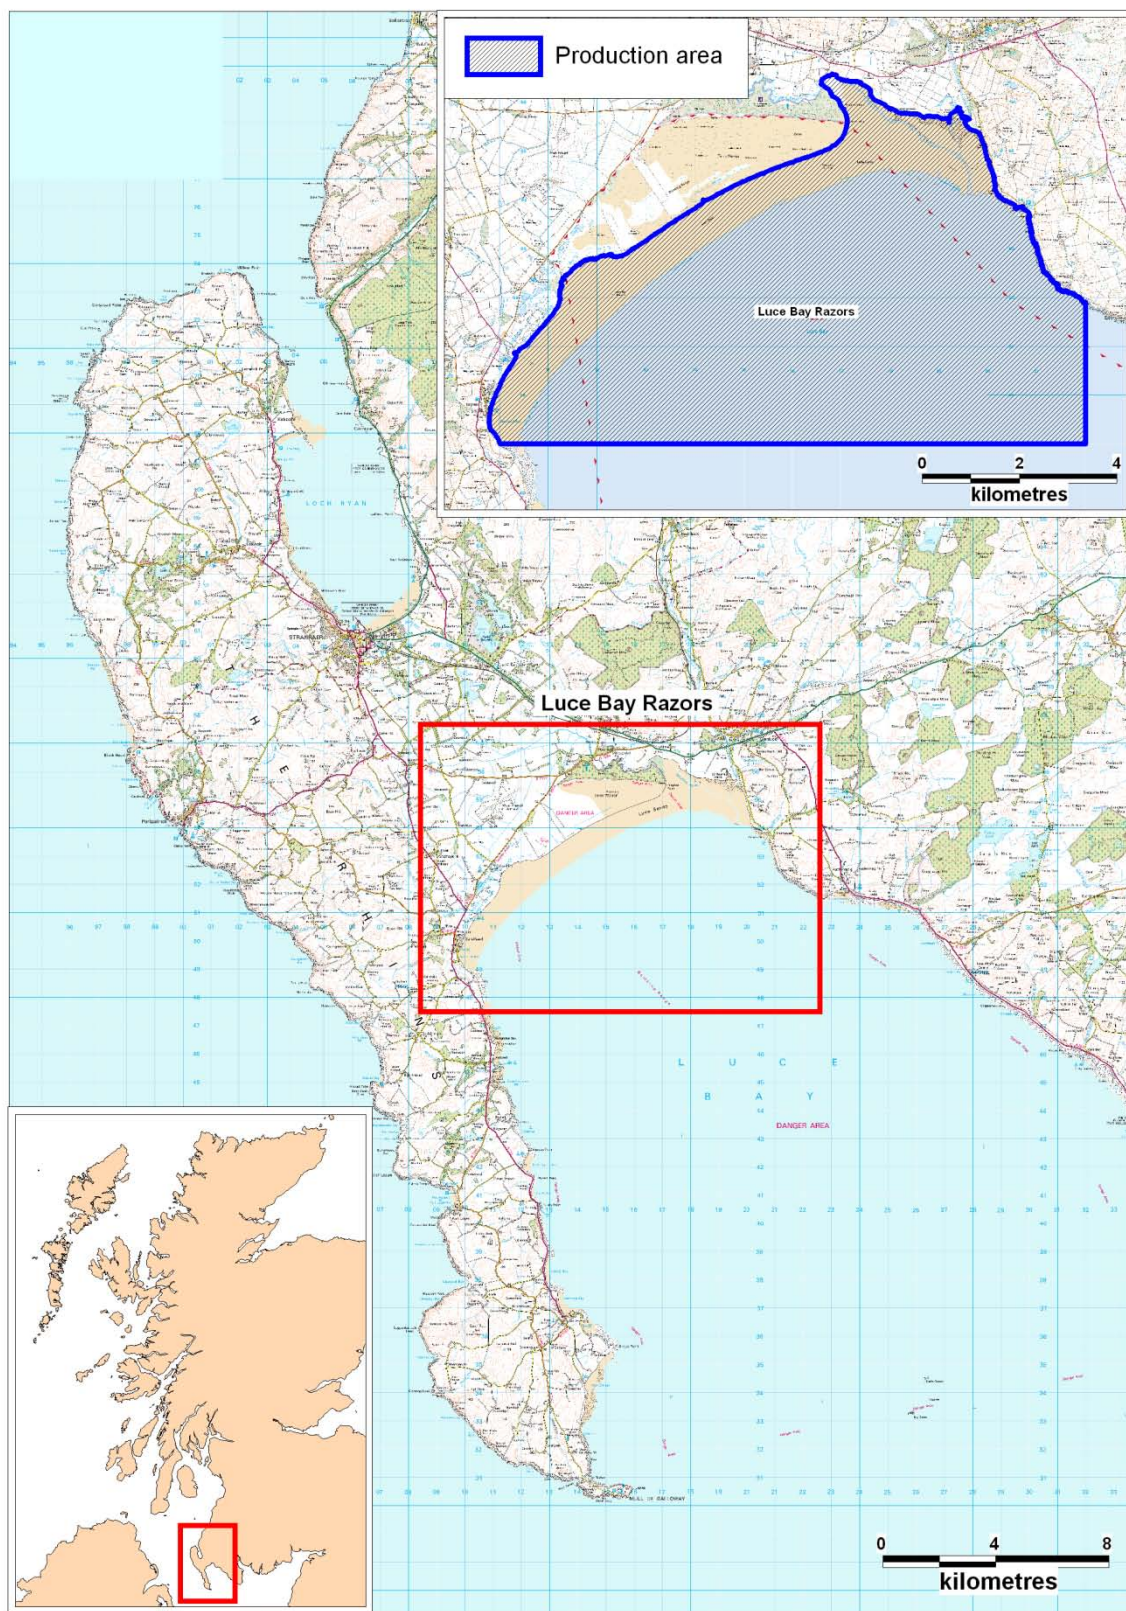
Figure 1.1 Location of Luce Bay Razors

Luce Bay is a broad, shallow, embayment on the south west coast of Scotland (see Figure 1.1). Luce Bay is bounded by the Rhins of Galloway peninsula on the west and the Machars peninsula on the east. The bay is 30 km wide at its entrance (from the Galloway headland – Mull of Galloway to the Machar headland – Burrow Head) and approximately 11 km wide within the inner bay. There is an extensive intertidal area and most of the bay is sheltered from wave action. Luce Bay was designated a Special Area of Conservation in 2005 due to its important dune, seashore and seabed habitats. The bay is also an active Ministry Of Defence firing range and training area.

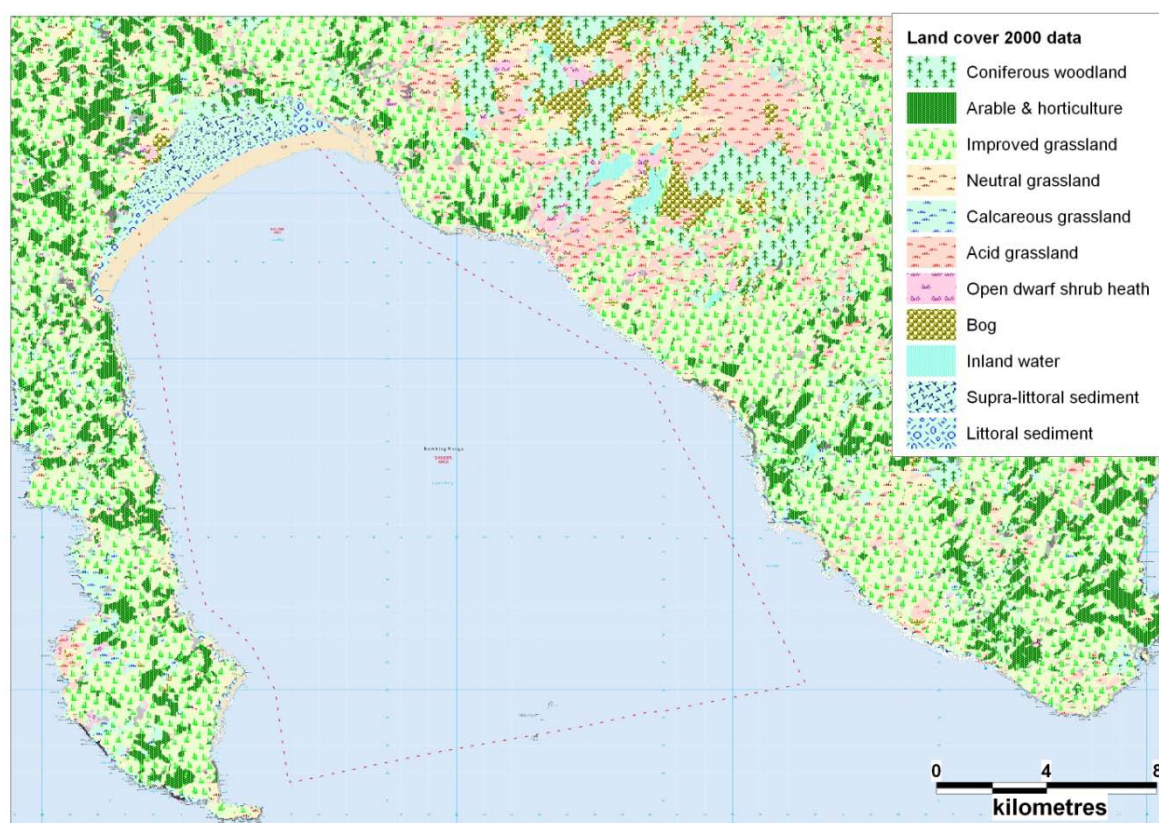
Figure 1.2 Land Cover 2000 data for Luce Bay Razors

Land Cover 2000 data indicates that the land surrounding Luce Bay is a mixture of six main types of land cover: improved grassland, agricultural and horticulture, acid grassland, coniferous woodland, open dwarf shrub heath and bog. There are also smaller areas of calcareous grassland, littoral sediment and supra-littoral sediment. The west and north shoreline of the bay is predominantly improved grassland with patches of arable and horticultural land. The east side shoreline of the bay is more varied with areas of coniferous woodland, acid grassland, bog and neutral grassland in addition to areas of improved grassland and agricultural and horticultural land (see Figure 1.2).

Faecal coliform contributions from improved grassland have been shown to be approximately  $8.3 \times 10^8$  cfu km<sup>-2</sup> hr<sup>-1</sup> (Kay et al, 2008). The contributions to the contamination of shellfish from all land cover types would be expected to increase significantly after marked rainfall events. This increase would be highest, at more than 100-fold, for improved grassland. The large areas of improved grassland adjacent to the majority of the shoreline surrounding the bay would be expected to contribute to contamination levels carried in surface runoff to the razor clam beds.

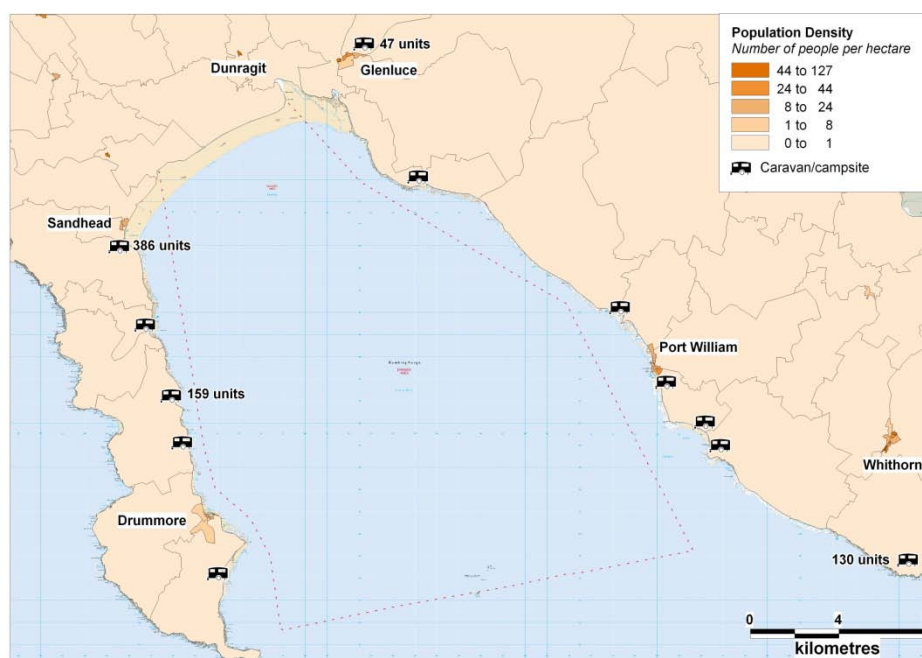
Figure 1.3 Population density of census output areas surrounding Luce Bay

Human population figures from the 2001 census were obtained from the General Register Office for Scotland on the population within the census output areas in the vicinity of the Luce Bay Razors production area. Figure 1.3 shows the population density of the census output areas that are adjacent to Luce Bay.

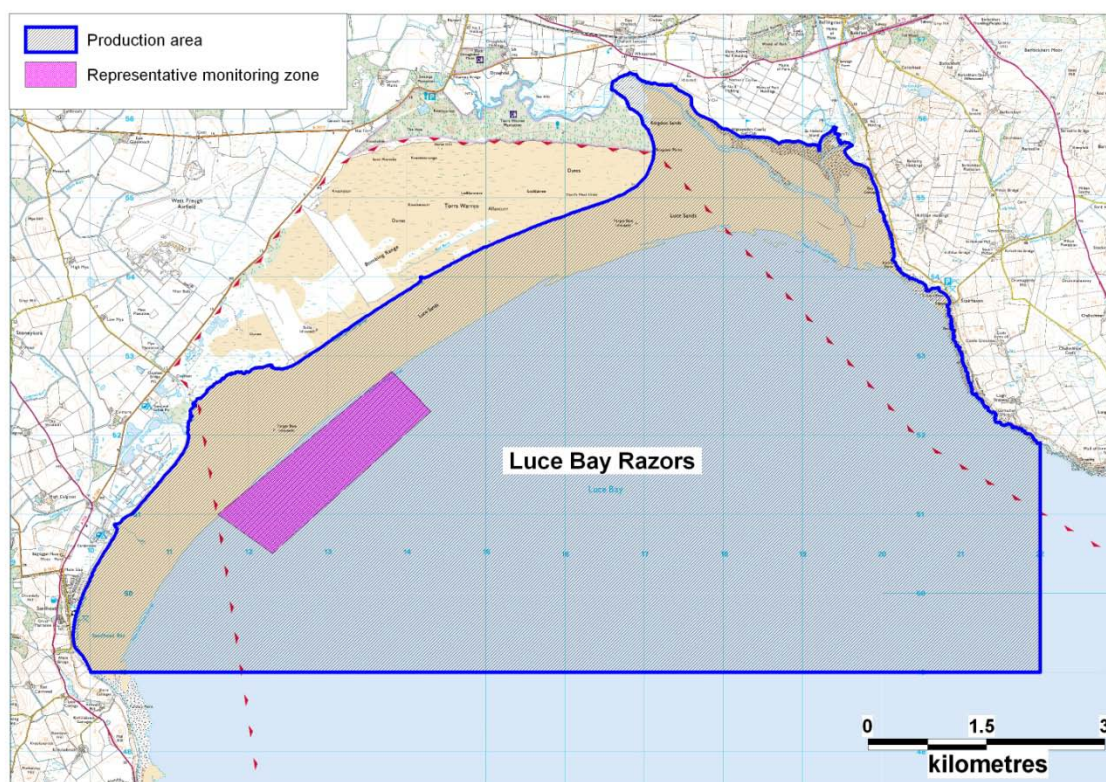
Figure 2.1 Luce Bay Razors fishery

The fast track classification production area boundaries for Luce Bay Razors were identified by the Food Standards Agency (FSA) as the area bounded by lines drawn between points NX 1000 4900 to NX 2200 4900 to NX 2200 5190 extending to MHWS (see Figure 2.1). Due to the substantial number of Fast Track samples already submitted, the area has been given a provisional 'A' classification all year round. FSA Scotland had permitted for samples to be harvested from a representative monitoring zone located within the harvesting area boundary. This sampling area is defined by the points NX1160 5100, NX 1230 5050, NX 1430 5230, NX 1380 5280 and NX 1160 5100. The razor bed at Luce Bay does not lie within a designated shellfish growing water.

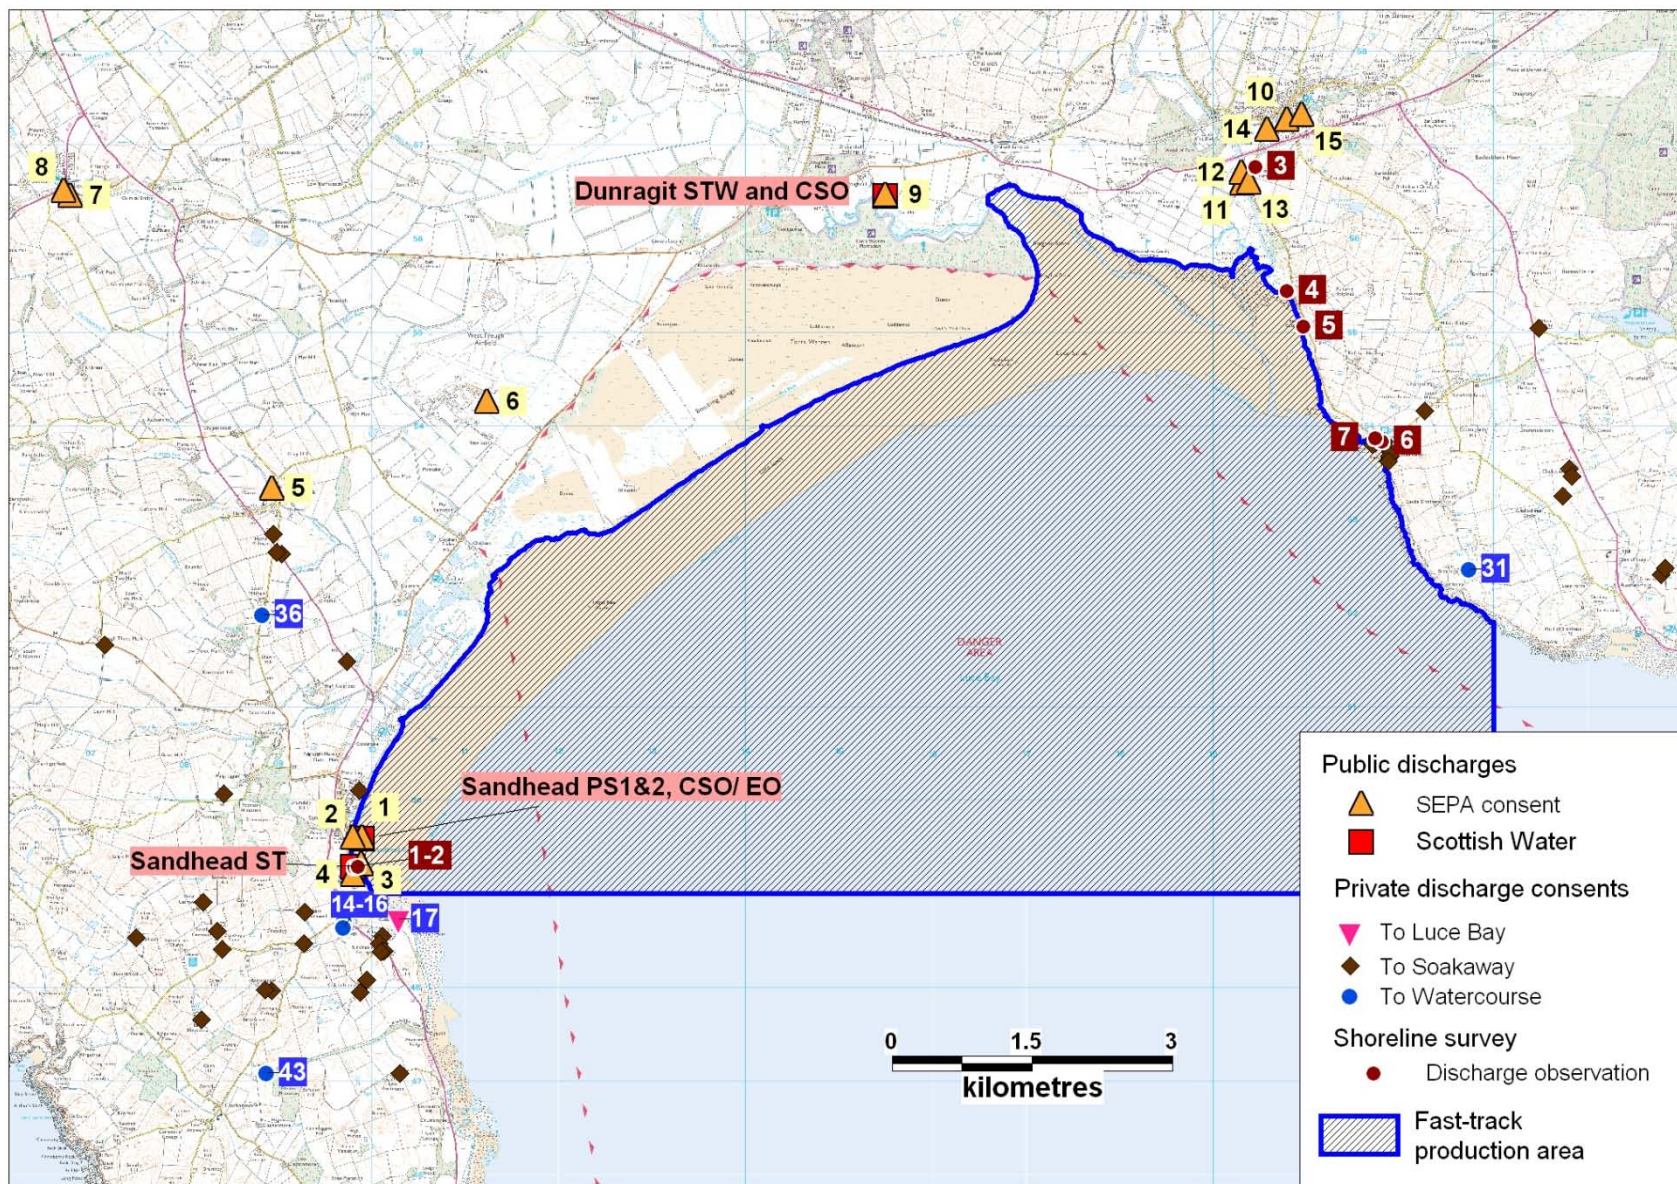
Figure 3.1 Luce Bay sewage discharges

Overall, the primary sources of sewage to the fishery are the discharges directly to the bay at Sandhead on the western end of the sands and those to Piltanton Burn and Luce Water at the eastern end of the sands, as well as the smaller septic tanks along the eastern shore. The soakaway systems identified near to observations 7 and 8 lie very close to the shoreline, and in one case below MHWS. These are likely to pose a risk to water quality in the near vicinity.

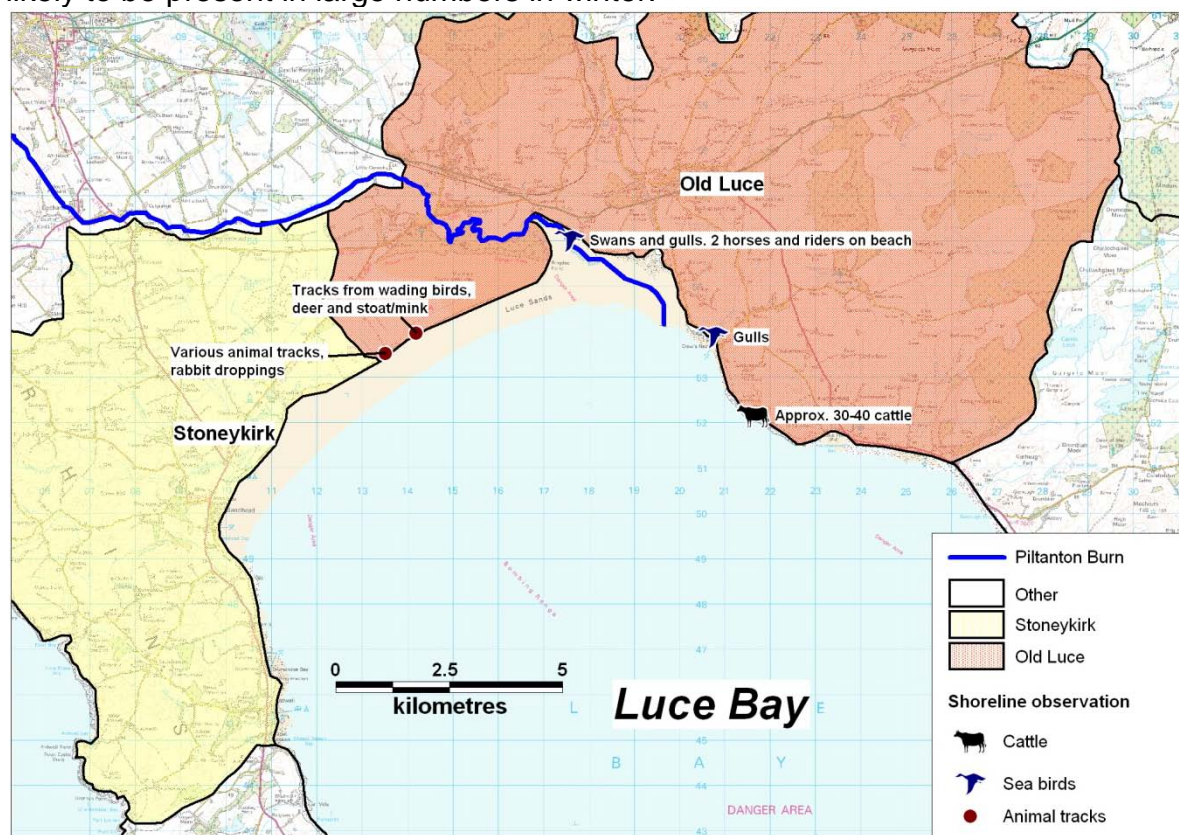
Figure 4.1 Agricultural parish boundaries and animals observed at Luce Bay

Agricultural census data to parish level was provided by the Rural Environment, Research and Analysis Directorate (RERAD) for the parishes Stoneykirk and Old Luce which are adjacent to the Luce Bay production area (see Figure 4.1). The two parishes encompass an area of 203 km<sup>2</sup>. Reported livestock populations for the parishes in 2009 are listed in Table 4.1. RERAD withheld data for reasons of confidentiality where the small number of holdings reporting would have made it possible to discern individual farm data. Any entries which relate to less than five holdings, or where two or fewer holdings account for 85% or more of the information, are replaced with an asterisk.

At the time of the shoreline survey various animal tracks including those from deer, stoat/mink and wading birds were observed along the central shoreline of the bay. Although numbers were not recorded swans and gulls were observed on the north east shoreline of the bay.

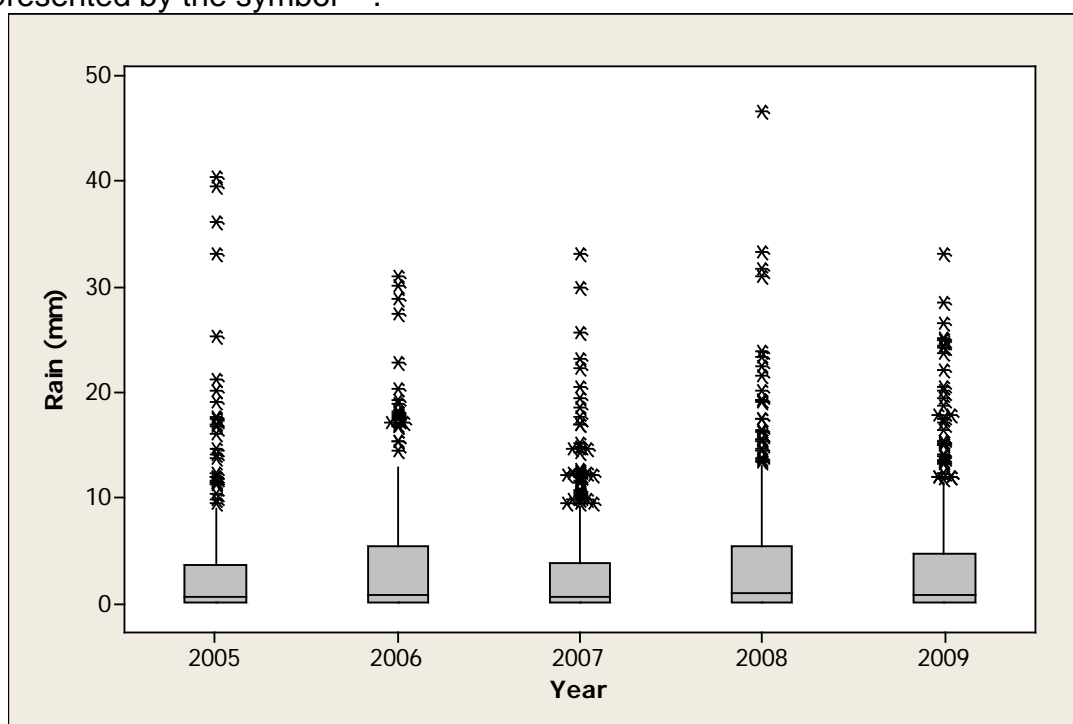
Figure 5.1 Box plot of daily rainfall values by year at Castle Kennedy, 2005-2009

Figure 5.1 shows that 2005 and 2007 were generally drier than 2006, 2008 and 2009.

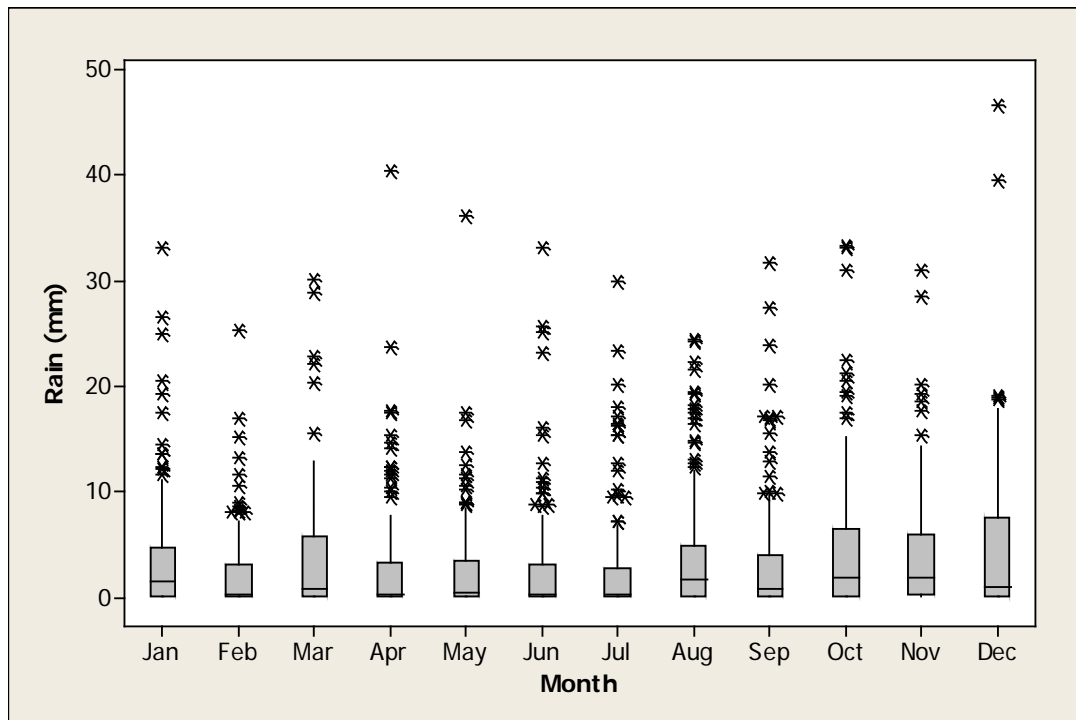
Figure 5.2 Box plot of daily rainfall values by month at Castle Kennedy, 2005-2009

Figure 5.2 indicates that the wettest months were October to January and March. February and April to July were the driest months. Days with rainfall greater than 25 mm occurred during all months apart from February. For the period considered here (2005-2009), 52% of days experienced rainfall less than 1 mm, and 9% of days experienced rainfall of 10 mm or more.

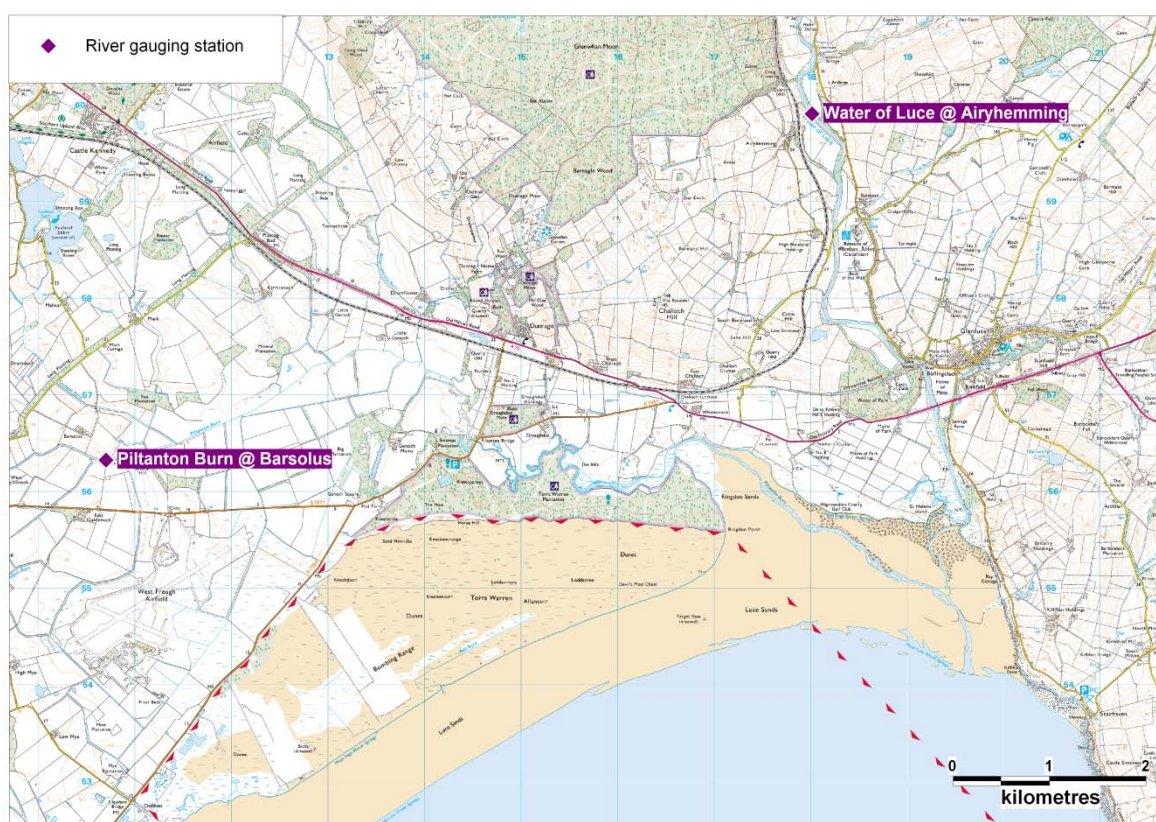
Figure 6.1 River gauging stations at Luce Bay

There are two river gauging stations in the vicinity of Luce Bay. Both of these were on watercourses that were identified as discharging into the eastern corner of the bay and thus potentially relevant to the Luce Bay assessment (see Figure 6.1). The location of both of watercourses was recorded during the shoreline survey. Piltanton Burn was sampled and measurements of size and flow were recorded. The Water of Luce was sampled and measurements of size but not flow were recorded (see Table 6.1). The river gauging station on the Water of Luce (NX 180 599) has a catchment area of 171 km<sup>2</sup>, a mean flow of 6.09 m<sup>3</sup>s<sup>-1</sup> and a 90% quartile of 16.376 m<sup>3</sup>s<sup>-1</sup>. The river gauging station at Piltanton Burn (NX 107 564) has a catchment area of 34.2 km<sup>2</sup>, a mean flow of 0.72 m<sup>3</sup>s<sup>-1</sup> and a 90% quartile of 1.827 m<sup>3</sup>s<sup>-1</sup>. Flows (m<sup>3</sup> per day) and loadings (*E. coli* per day) for both watercourses have been calculated using the river gauging station mean flow data and the dimensions taken during the shoreline survey (see Table 6.1).

The watercourses listed in Table 6.1 were recorded and sampled and measured where possible, during the shoreline survey. The locations are shown on the map presented in Figure 6.1. Where the bacterial loading is labelled on the map, the scientific notation is written in digital format, as this is the only format recognised by the mapping software. So, where normal scientific notation for 1000 is 1 x 10<sup>3</sup>, in digital format it is written as 1E+3.

Only the north end of the bay was surveyed, so not all streams were sampled, measured and/or recorded. The weather was dry during the survey period. The largest watercourse flowing into the northern end of the bay recorded during the shoreline survey was the Piltanton Burn.

The stream with the greatest calculated loading, (using measurements taken from the shoreline survey), of  $6.8 \times 10^{11}$  *E. coli* per day, was the Piltanton Burn located in the eastern corner of the bay. The data collected at the Piltanton Burn was similar to the data provided by the river gauging station, with a 0.3 difference in the calculated *E. coli* loading per day. Although the flow was not measured at the Water of Luce, an *E. coli* loading per day of  $2.1 \times 10^{12}$  was calculated using the river gauging station flow data and the shoreline survey measurements. This indicates that the *E. coli* loading per day is potentially greater at the Water of Luce compared to Piltanton Burn and would therefore have a greater impact on the shellfish bed. Both of these watercourses receive sewage effluent from upstream villages.

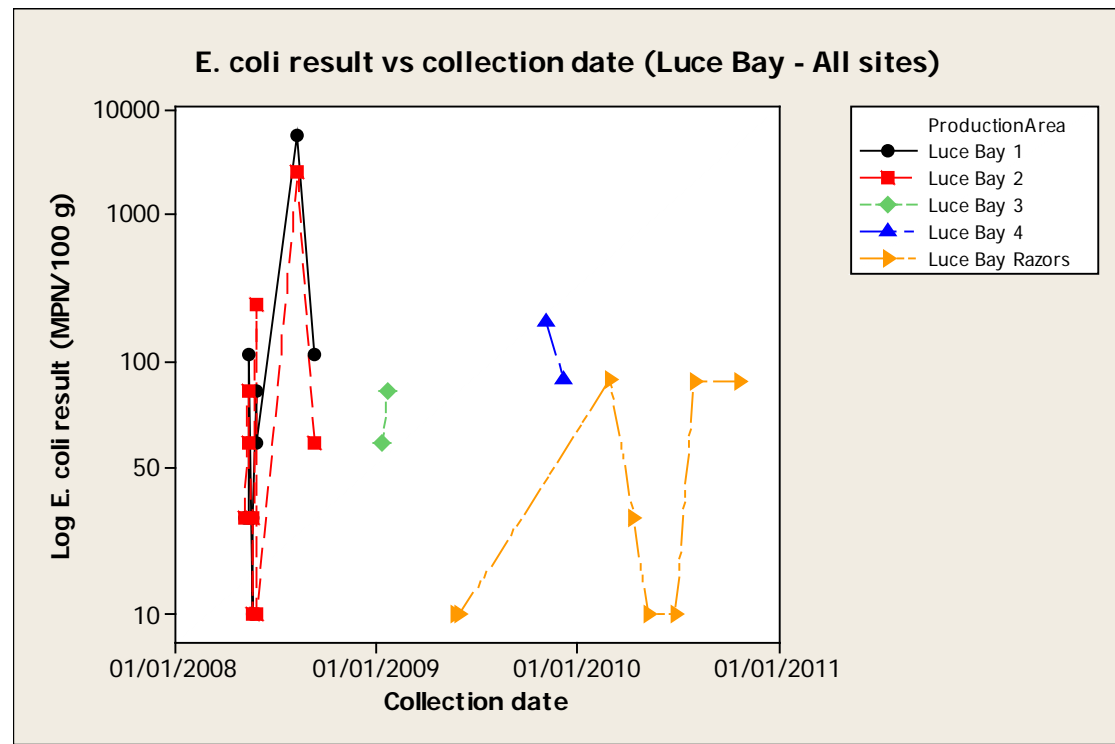
Figure 7.1 Scatter plot of *E. coli* result (MPN/100 g) for razor clams vs. collection date

Figure 7.1 presents a scatter plot of the individual log *E. coli* results against date for all razor clam samples taken from Luce Bay for all sites.

Overall, there does not appear to be a consistent seasonal trend in results. Interpretation is complicated by the small data sets at several different sites.

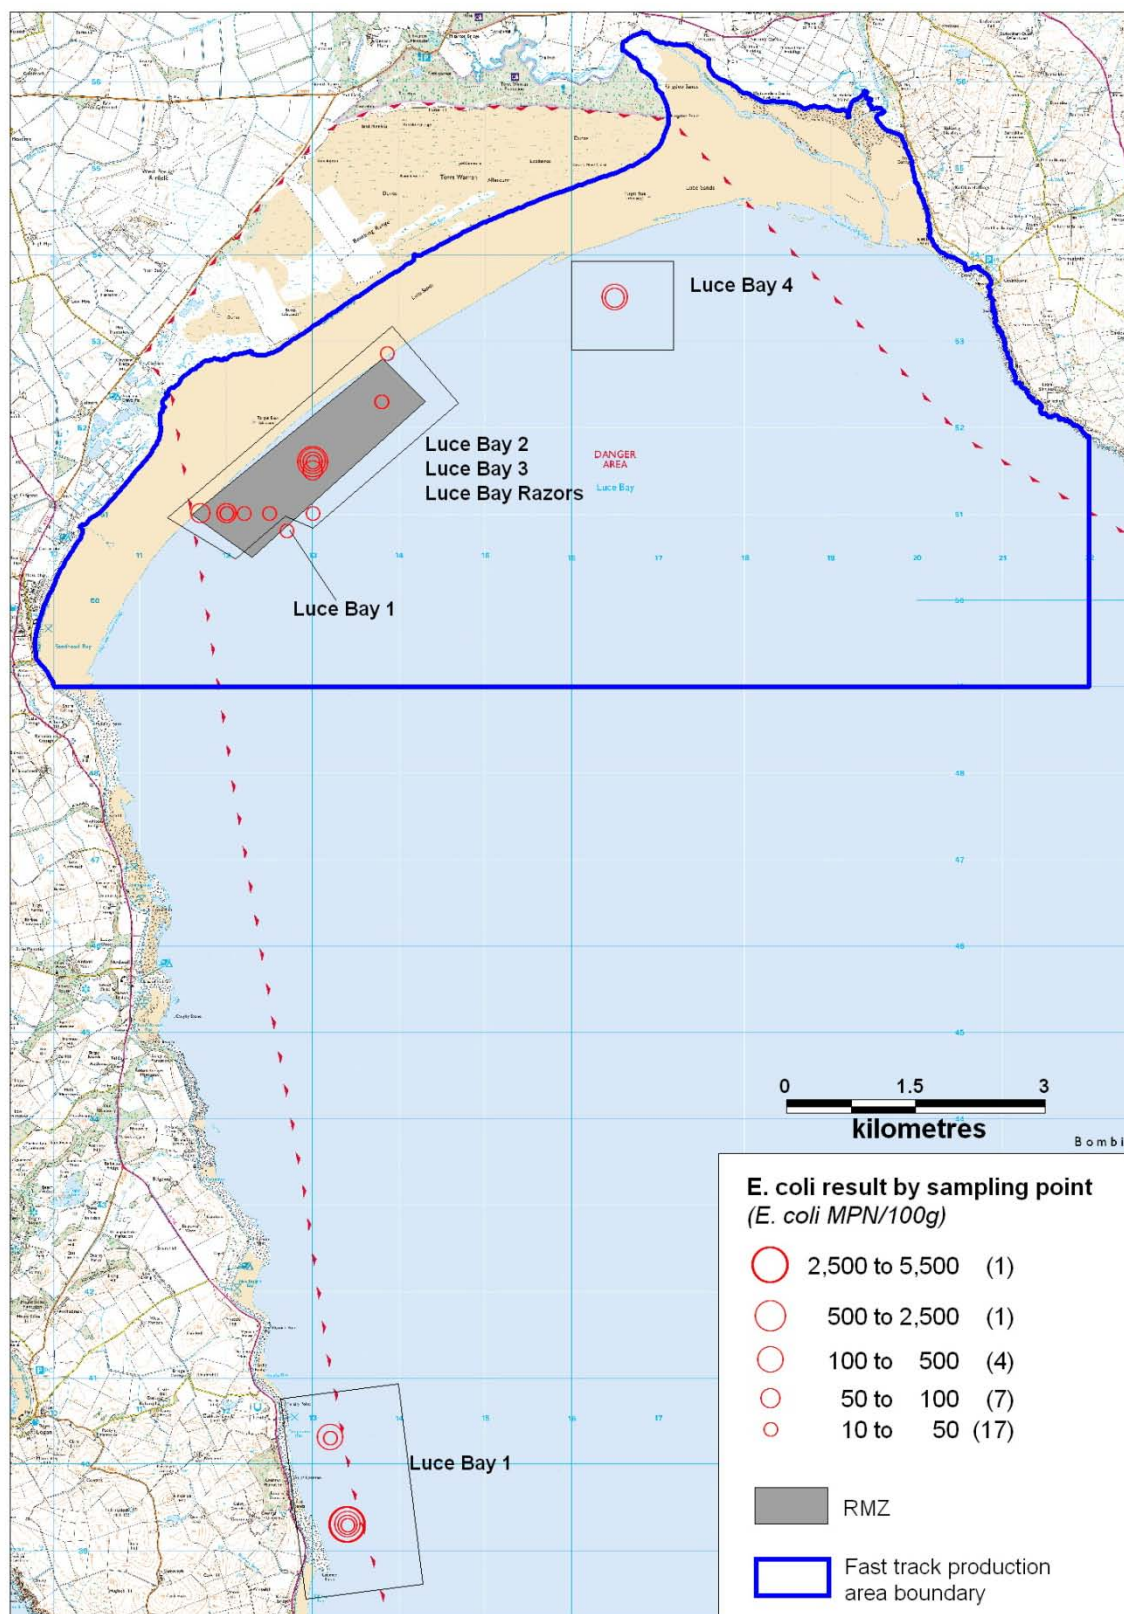
Figure 7.2 *E. coli* result (MPN/100 g) by sampling location for razor clams at Luce Bay

Figure 7.2 shows a thematic map with the *E. coli* results plotted at the sampling locations of razor clams at Luce Bay. The samples shown at the far south western end of Luce Bay at Terally Point fall outside the production area, indicating that the shellfish bed extends outside of the current production area boundaries. The highest result (5,400 *E. coli* MPN/100 g) was seen at Terally Point. The second highest result (2,400 *E. coli* MPN/100 g) was seen at Luce Bay 2, located towards the centre of the inner bay immediately below mean low water springs. All other results were <230 *E. coli* MPN/100 g. No general spatial tendency is apparent in the data.

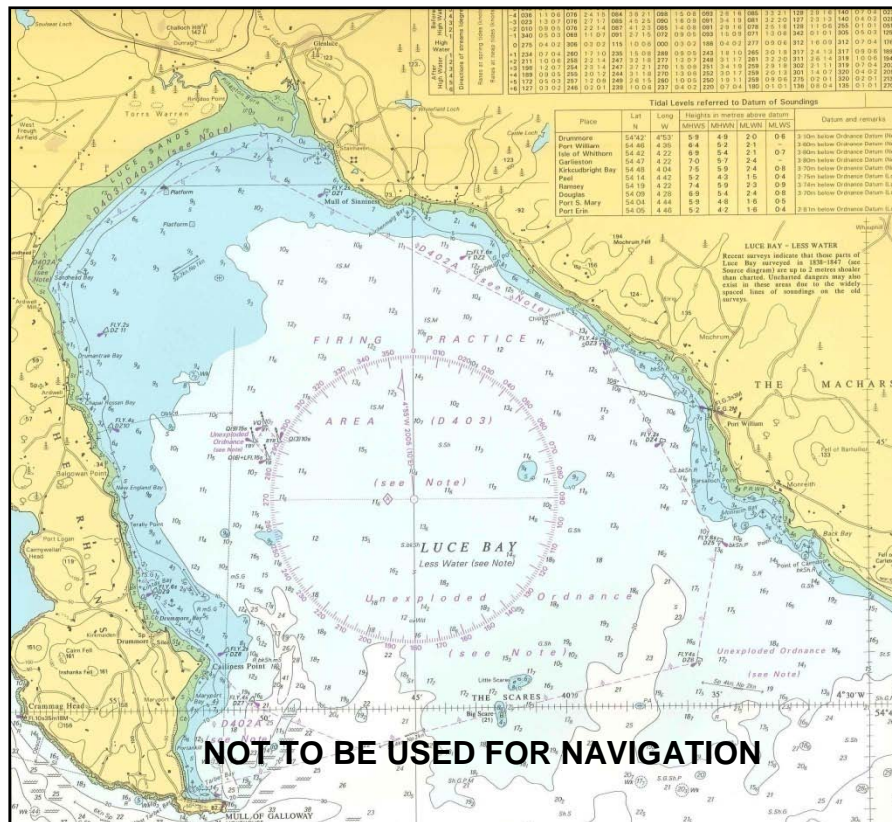
Figure 8.1 Luce Bay Admiralty chart

The Admiralty chart in Figure 8.1 shows there is a drying area situated along the immediate shoreline of the bay, including Luce Sands. Depths in the northern part of the bay adjacent to Luce Sands are generally shallow (<10 m), and towards the centre of the bay the depth increases to 20 m. Past The Scares at the opening of Luce Bay, depths reach up to 30 m. Figure 8.2 shows the Ordnance Survey map of Luce Bay, with the tidal diamond plotted on.

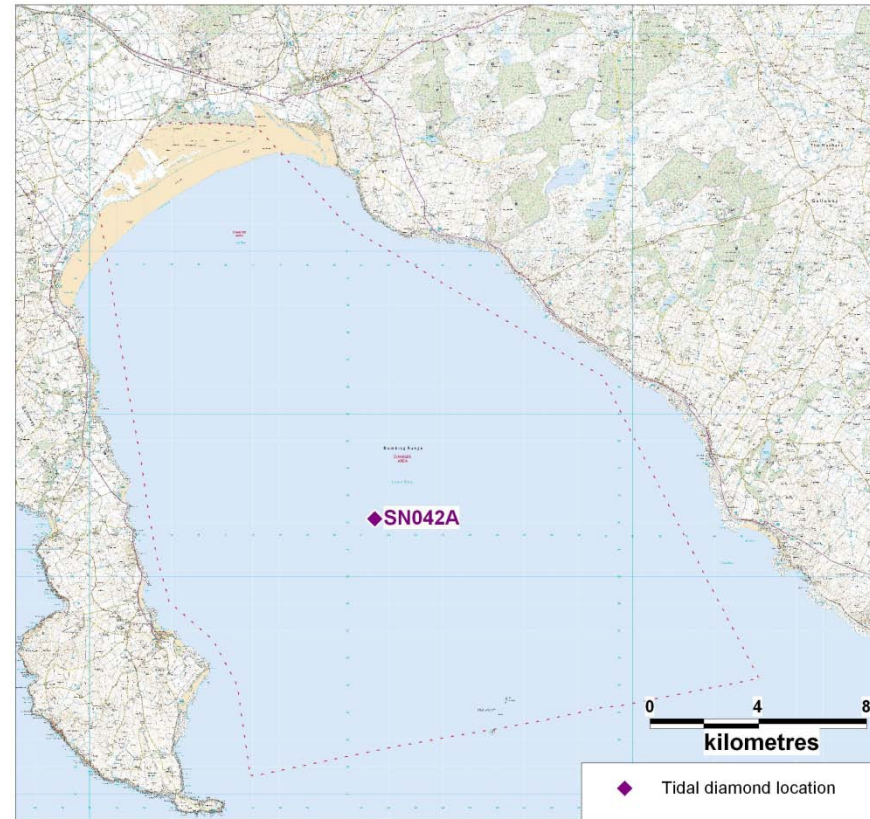
Figure 8.2 Ordnance Survey map of Luce Bay

Tidal stream information available was from TotalTide for the tidal diamond SN042A located in Luce Bay (see Figure 8.2). The tidal diamond information is given below in Tables 8.1. The associated spring tidal streams are shown in Figure 8.4 (flood tide) and Figure 8.5 (ebb tide).

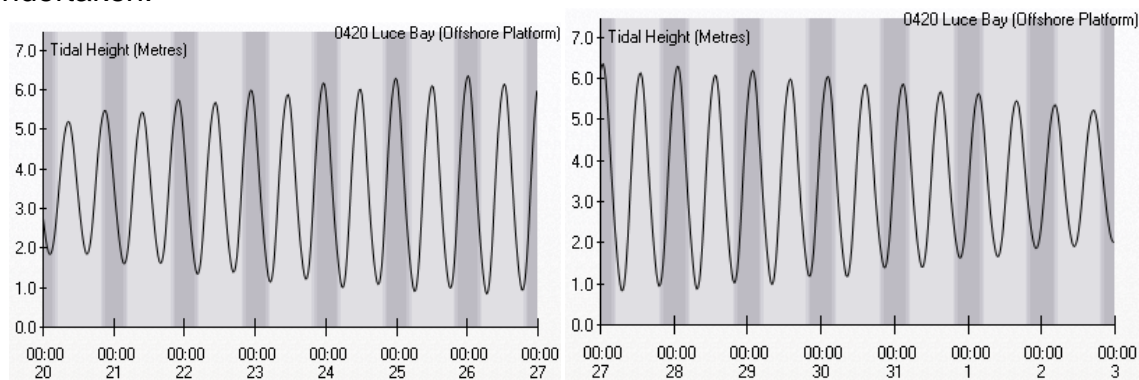
Figure 8.3 Tidal curves for Luce Bay (Offshore Platform)

The two tidal curves in Figure 8.3 are for the port of Luce Bay (Offshore Platform), the secondary non-harmonic port located in central Luce Bay. These have been output from UKHO TotalTide. The first is for seven days beginning 00.00 GMT on 20<sup>th</sup> August 2010. The second is for seven days beginning 00.00 GMT on 27<sup>th</sup> August 2010. Together they show the predicted tidal heights over high/low water for the full neap/spring tidal cycle during which the shoreline survey was undertaken.

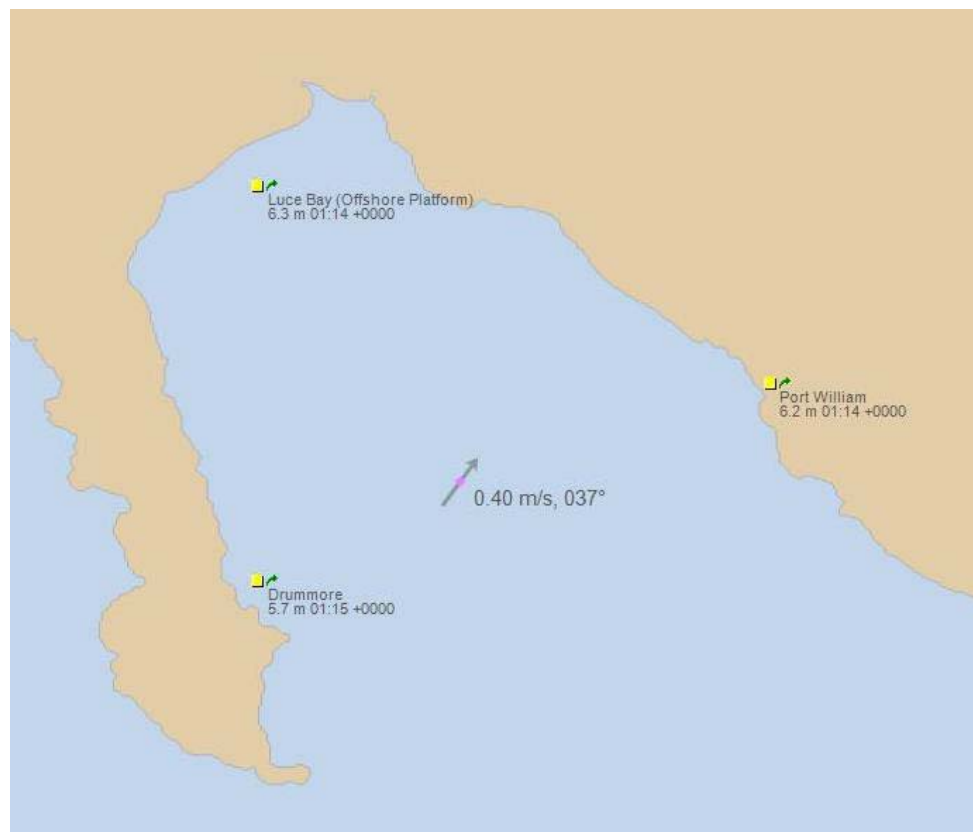
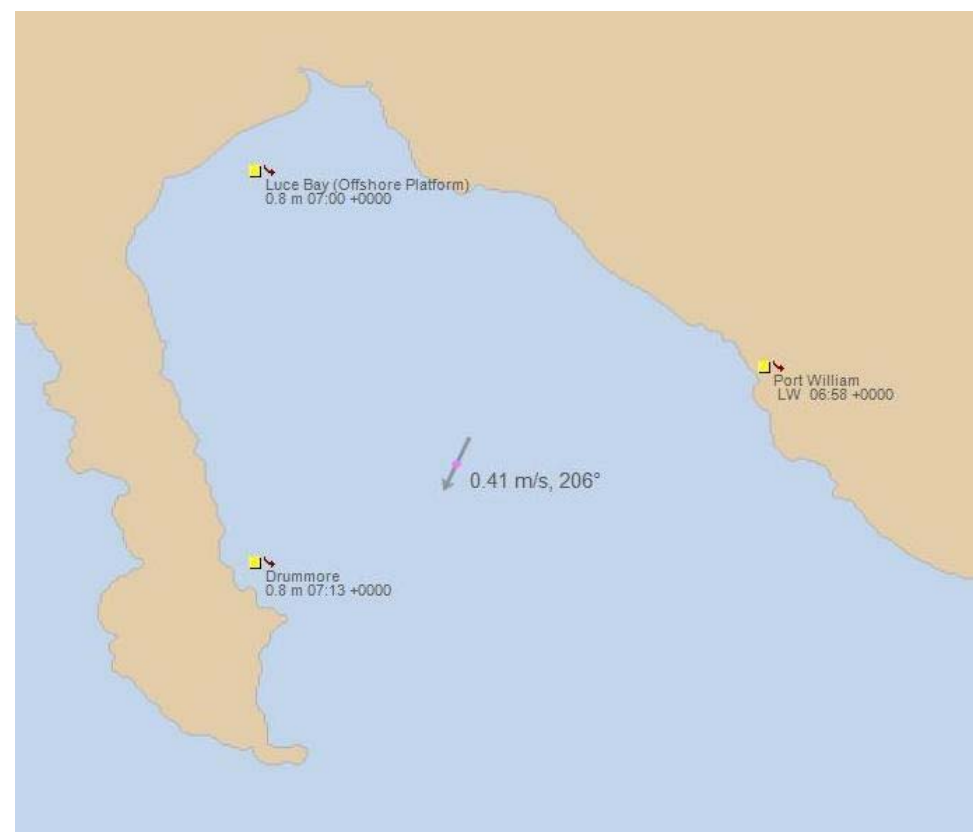
Figure 8.4 Spring flood tide at Luce Bay

There will be two effects of water movement in the transport of contaminants in relation to the fishery. On the ebbing tide, contamination from local sources will be taken across the drying area towards the bay. In addition, on the ebb tide, contaminants will be swept around the bay in an anticlockwise direction. On the flood tide, the flow will be in the opposite direction. Given the relatively shallow depths, dilution will be limited at any one point but both significant dilution and dispersion will occur under the distances (>10 km) across the fishery. Winds from the south or southeast may tend to entrain contamination arising from Piltanton Burn and Luce River at the head of the bay, potentially allowing it to persist over the shellfish bed for longer periods, thereby increasing exposure times.

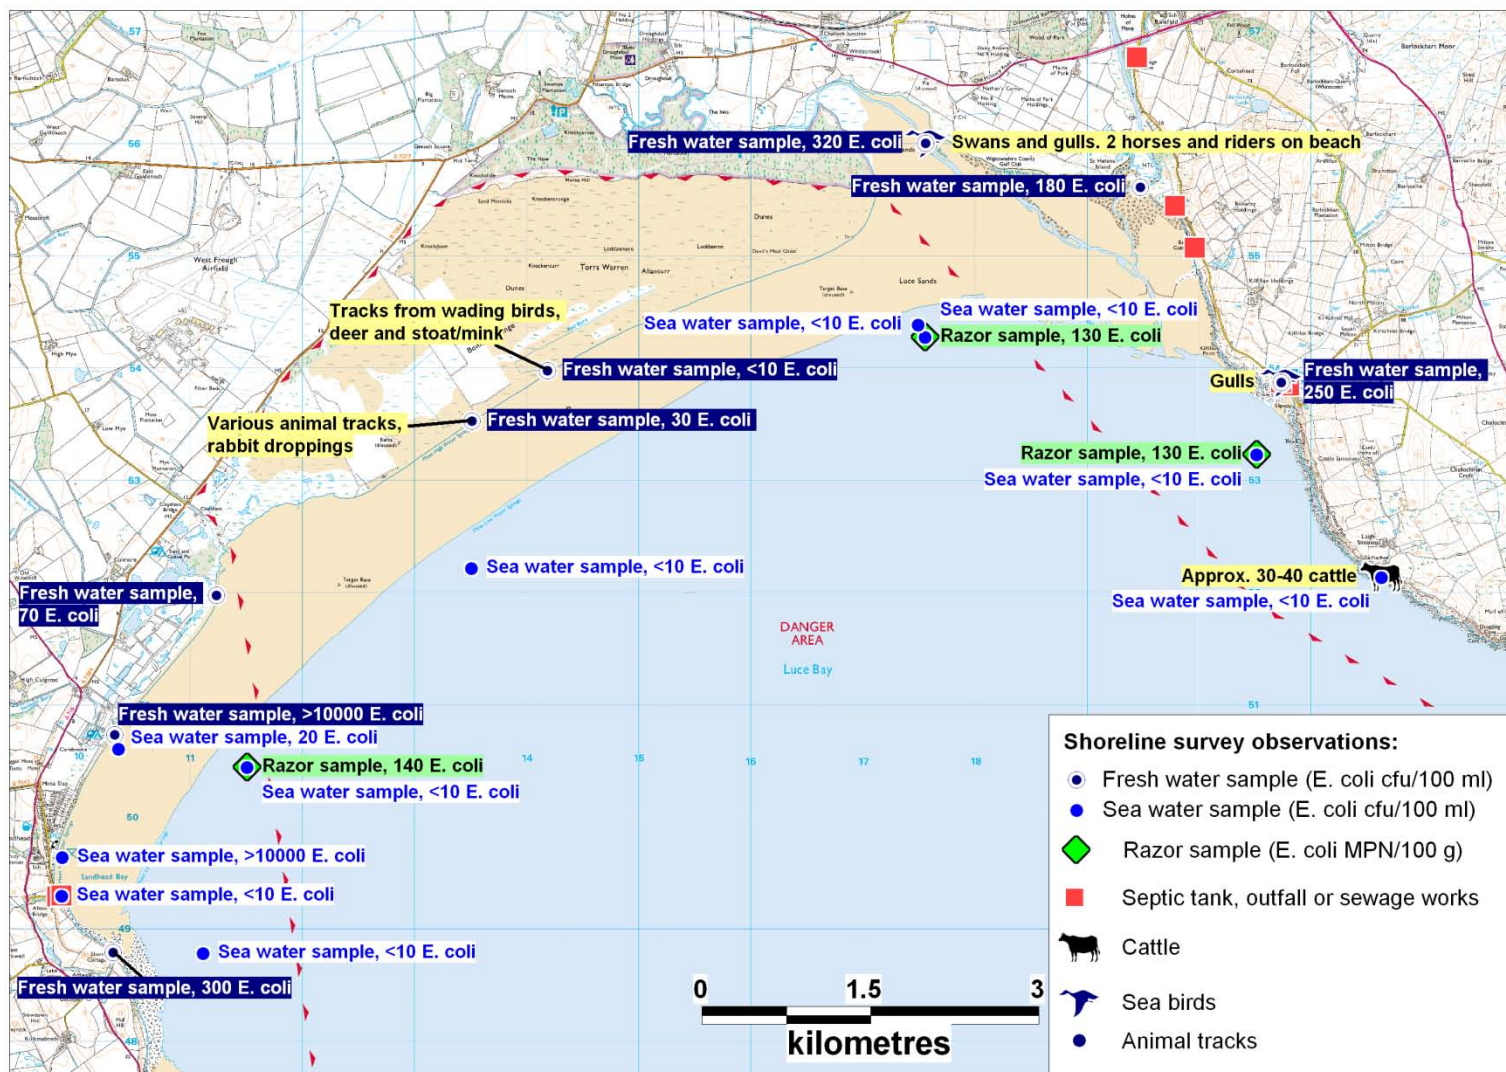
A map is provided in Figure 9.1 that shows the relative locations of the most significant findings of the shoreline survey.

Produced by Cefas Weymouth Laboratory. © Crown Copyright and Database 2011. All rights reserved. Ordnance Survey licence number [GD100035675]  
 Figure 9.1 Summary of shoreline observations

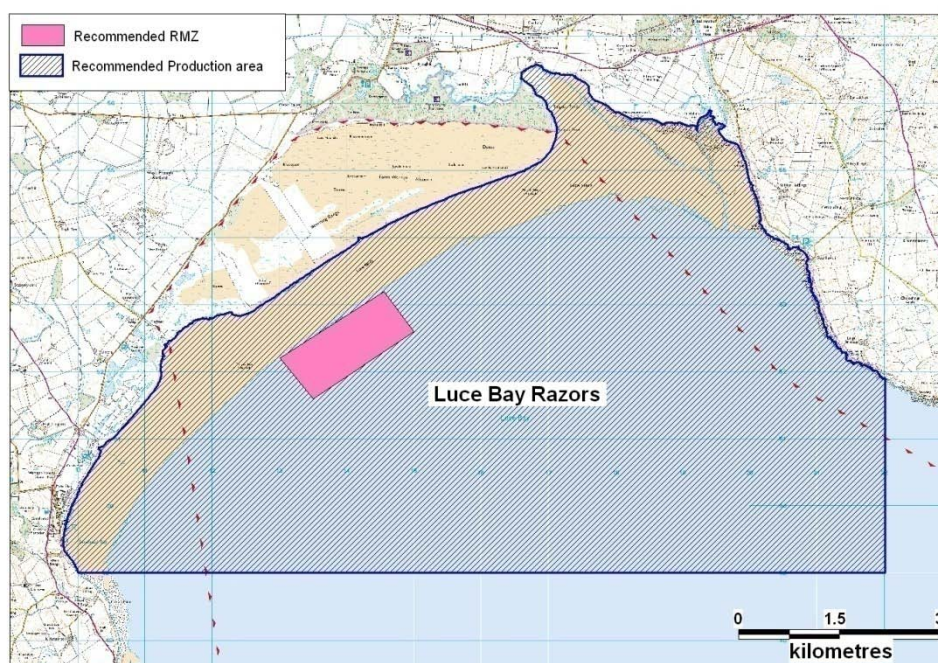
Figure 11.1 Recommendations for Luce Bay Razors

Monitoring should be undertaken on the north-west side of the bay to reflect the two areas where the principles sources of contamination lie (north and west). An RMZ is recommended to reflect the diverse sources of contamination and the difficulty of sources sufficient razors from a small location on an ongoing basis. The recommended RMZ is defined by the following points.

It is recommended that the area is kept as that defined for the fast track classification, i.e. "The area bounded by lines drawn between points NX 1000 4900 to NX 2200 4900 to NX 2200 5190 extending to MHWS".

It is recommended that sampling within the new RMZ be undertaken on a monthly basis and the frequency reviewed on the basis of a year's worth of results.
