# Scottish Sanitary Survey Project

## Restricted Sanitary Survey Report

Luce Bay Razors  
DG 499  
November 2010

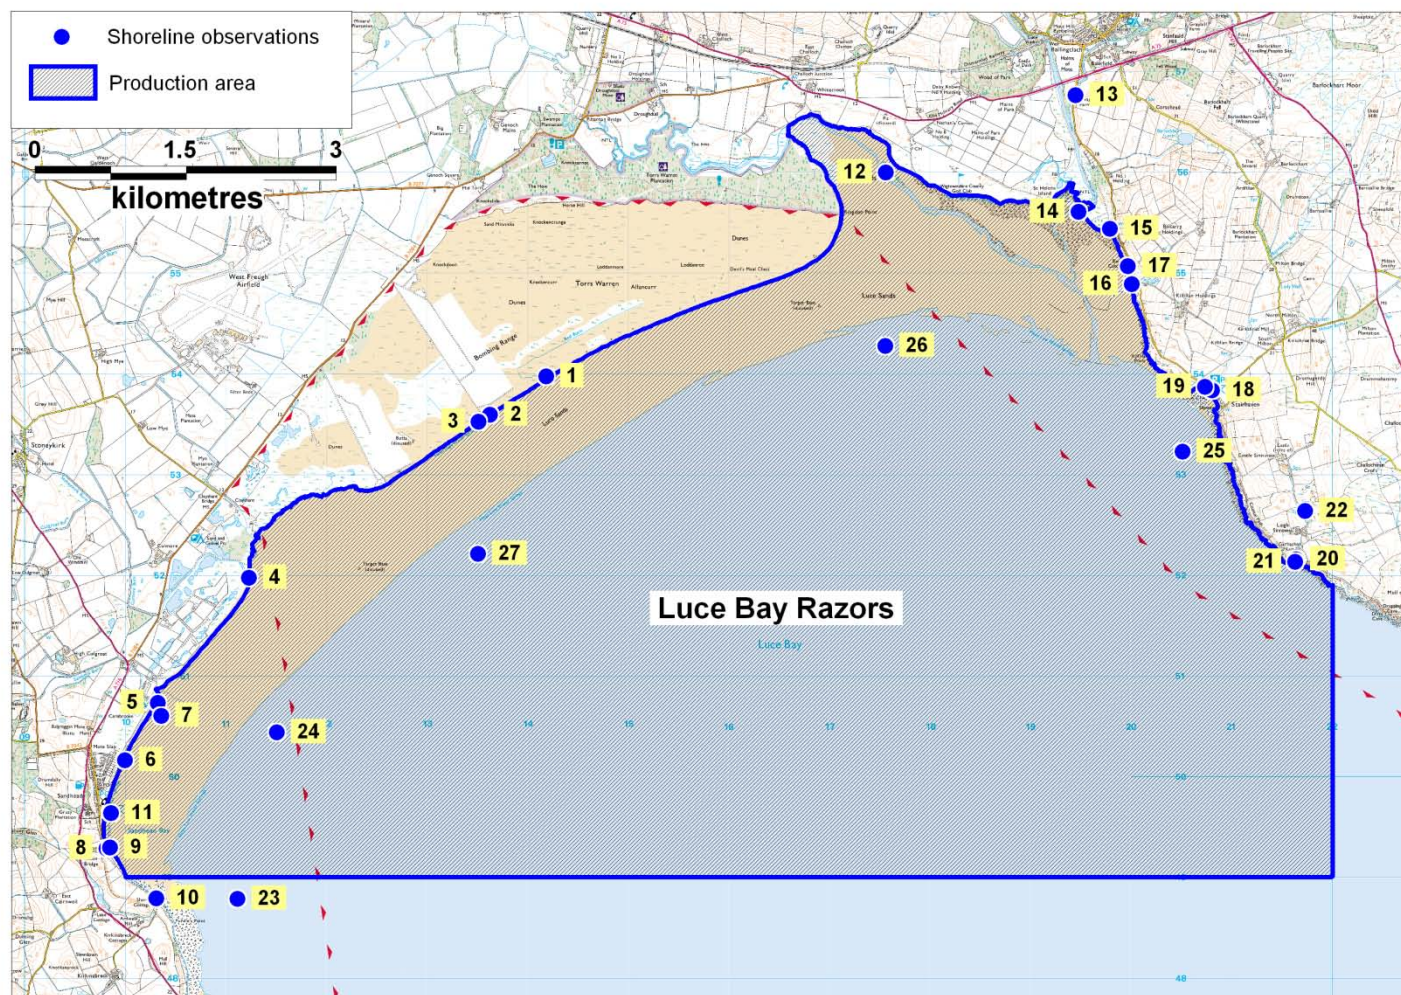
Figure 1. Shoreline observations

No.	Date	Time	NGR	East	North	Associated photograph	Associated sample	Description
1	30/08/2010	09:41	NX 14183 53982	214183	553982	Figure 4	FW LB001	Stream, Fresh water sample 1 (LB001) Depth 0.04 m, width 1.2m, flow measured with flow meter later found to be faulty. Tracks from wading birds, deer and stoat/mink, razor, clam & whelk shells.
2	30/08/2010	10:14	NX 13623 53601	213623	553601	Figure 5		Evidence of a stream but not flowing at time of survey
3	30/08/2010	10:22	NX 13512 53532	213512	553532	Figure 6	FW LB002	Stream, Fresh water sample 2 (LB002) Depth 0.06 m at channel 0.02 m at edges. Width 1.4m, no flow recorded due to meter problems. Various animal tracks, rabbit droppings, temp 15°C. Wind speed 3.4 knots.
4	30/08/2010	10:57	NX 11229 51980	211229	551980	Figure 7	FW LB003	Stream, Fresh water sample 3 (LB003). Depth 0.28 – 0.40 m, width 3.10 m, no flow recorded due to meter problems. Wind 5 ½ - 6 knots, temp 13 ½ °C. Dog walkers on beach.

5	30/08/2010	11:42	NX 10321 50738	210321	550738	Figure 8	FW LB004	Stream, Fresh water sample 4 (LB004). Depth 0.05 m, width 1.05m, average flow 0.15m/s (using pooh stick method).
6	30/08/2010	13:10	NX 09993 50168	209993	550168	Figure 9		New culvert – outlet boarded up.
7	30/08/2010	13:32	NX 10355 50610	210355	550610	Figure 10	SW LB005	Sea water sample 5 (LB005) Salinity 32 ppt.
8	30/08/2010	14:13	NX 09810 49293	209810	549293	Figure 11		Sandhead Septic Tank
9	30/08/2010	14:19	NX 09846 49301	209846	549301	Figure 12	SW LB006	Sea water sample 6 (LB006) Outlet pipe. Seawater sample salinity 30 ppt
10	30/08/2010	14:40	NX 10307 48796	210307	548796	Figure 13	FW LB007	Stream, Fresh water sample 7 (LB007) Width 1.1m, depth 0.05 m, average flow 0.024m/s (using pooh stick method)
11	31/08/2010	09:15	NX09853 49644	209853	549644	Figure 14,15 & 16	SW LB008	Sewage outlet, sea water sample 8 (SW LB008) Salinity 10 ppt, temp 12° C, Wind East 1.5 knots

12	31/08/2010	10:07	NX 17561 56008	217561	556008	Figure 17	FW LB009	Piltanton Burn fresh water sample 9 (LB009): Width 26 m, depth 0.20 m, average flow 0.90m/s (using pooh stick method). Shrimp, flounders in abundance. Swans and seagulls observed. 2 horses and riders on beach. Agricultural land and 18 hole golf course also adjacent to survey area.
13	31/08/2010	10:44	NX 19447 56775	219447	556775	Figure 18		Glenluce Sewage Works.
14	31/08/2010	11:15	NX 19476 55616	219476	555616	Figure 19	FW LB010	Luce River fresh water sample 10 (LB010): Width 9.4 m, depth 0.24-0.25 m, 7.99m/s (using pooh stick method). Temp 15°C, wind speed 3 knots. Flounder in river. Large numbers of mussel shells and clams, scallop and oyster shells.
15	31/08/2010	11:39	NX 19788 55449	219788	555449			Septic tank.
16	31/08/2010	12:13	NX 20006 54898	220006	554898			Spring – no flow measure.

No.	Date	Time	NGR	East	North	Associated photograph	Associated sample	Description
17	31/08/2010	12:23	NX 19965 55075	219965	555075			Septic tank outfall from house.
18	31/08/2010	13:13	NX 20805 53846	220805	553846	Figure 20		Stairhaven septic tank.
19	31/08/2010	13:17	NX 20733 53878	220733	553878	Figure 21	FW LB011	Stream at Stairhaven. Fresh water sample 11 (LB011): width 3.6 m, depth range 0.10-0.19 m, flow 0.118m/s (using pooh stick method). 13 new houses on septic tanks. Many people on beach, fishing boat in bay, gulls, public toilets on septic tank. Small spring on beach emerging from the retaining wall - Stairhaven.
20	31/08/2010	14:18	NX 21641 52167	221641	552167			Spring/burn outlet – dry (at Laigh Sinniness)
21	31/08/2010	14:22	NX 21629 52141	221629	552141	Figure 22	SW LB012	Sea water sample 12 (LB012). Laigh Sinniness Farm, very rocky bay. Agricultural land surrounding it, 30-40 cattle in fields above bay.

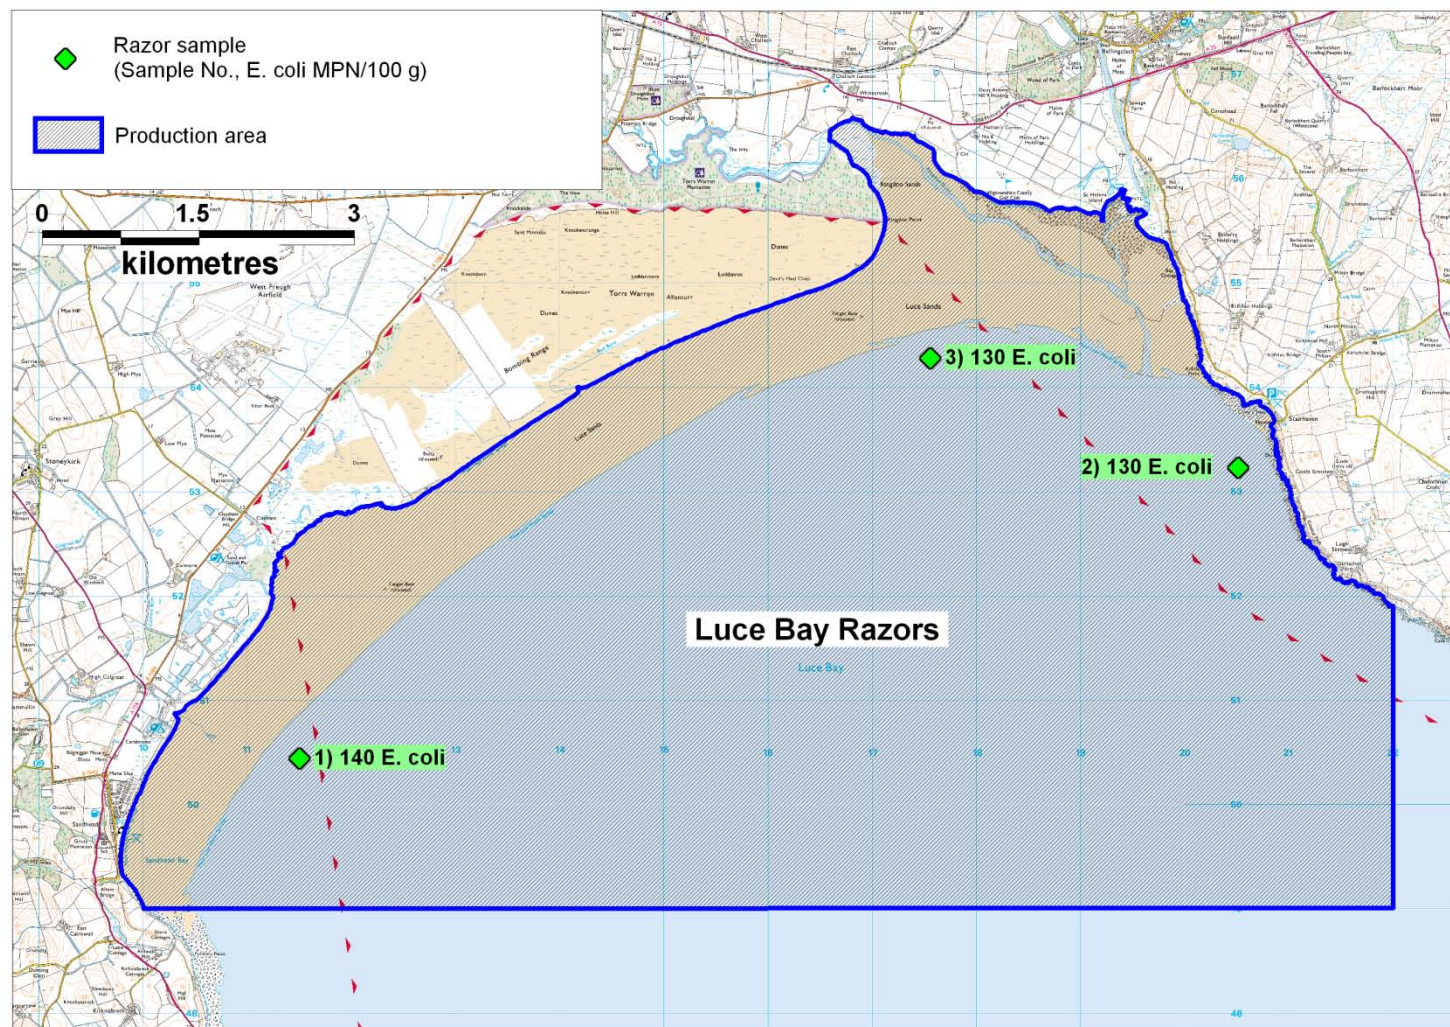
Figure 4 Shellfish sample results

No.	Date	Sample	Grid Ref	Sample Type	<i>E. coli</i> (MPN/100g)
1	02/09/2010	LB015	NX 1150250447	Razors	140
2	02/09/2010	LB019	NX 2051453235	Razors	130
3	02/09/2010	LB020	NX 1755654283	Razors	130

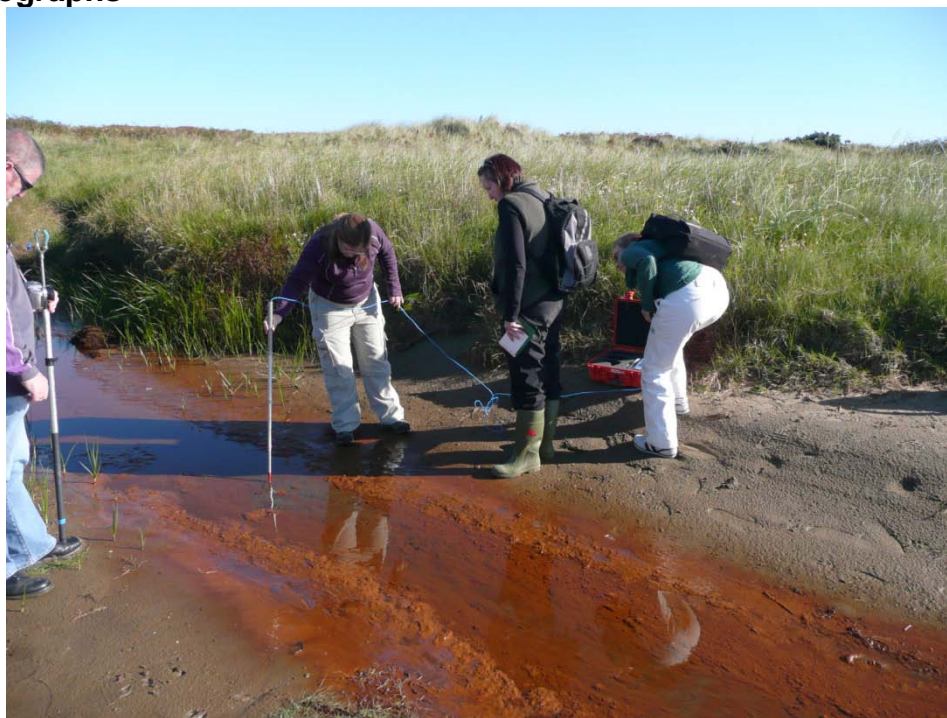
Figure 4. Stream, location of water sample LB001

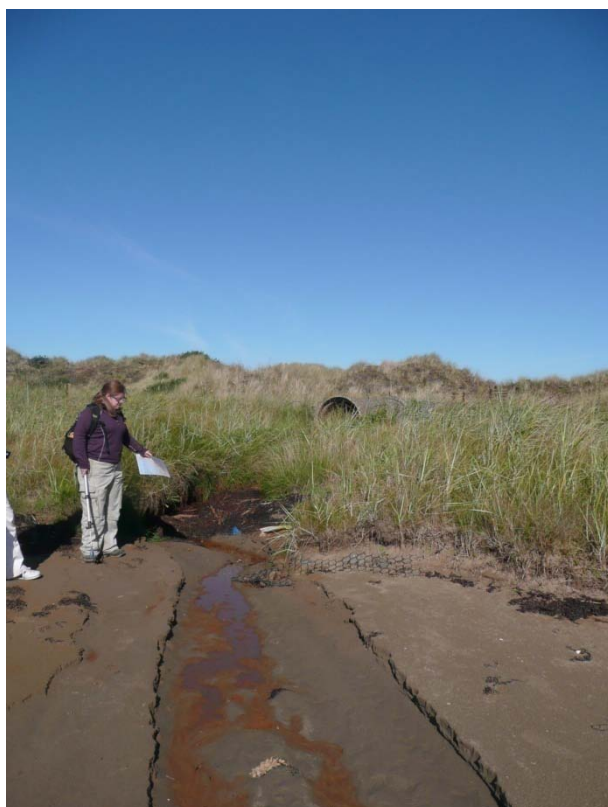
Figure 5. Stream, no flow

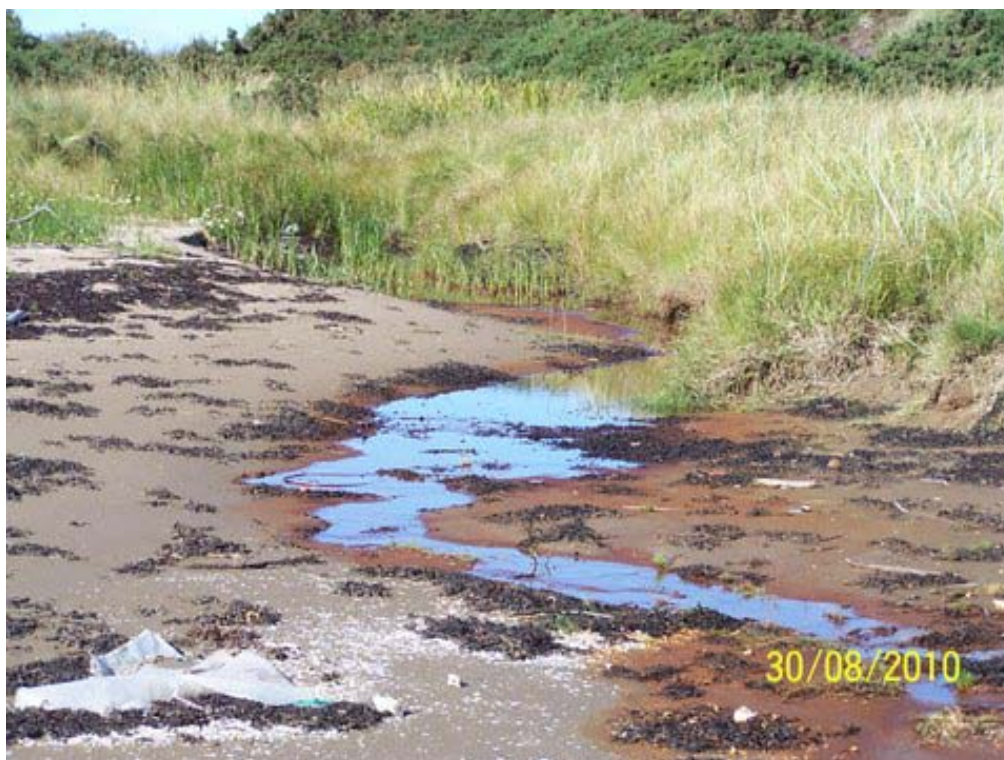
Figure 6. Stream, location of water sample LB002

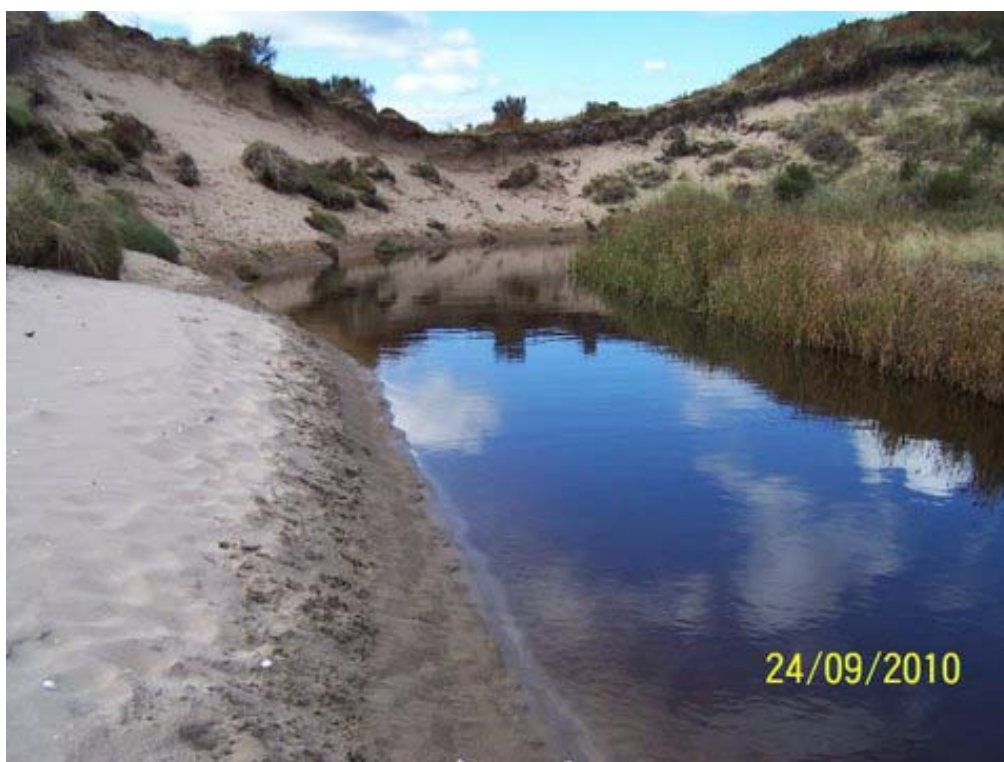
Figure 7 Stream, location of water sample LB003

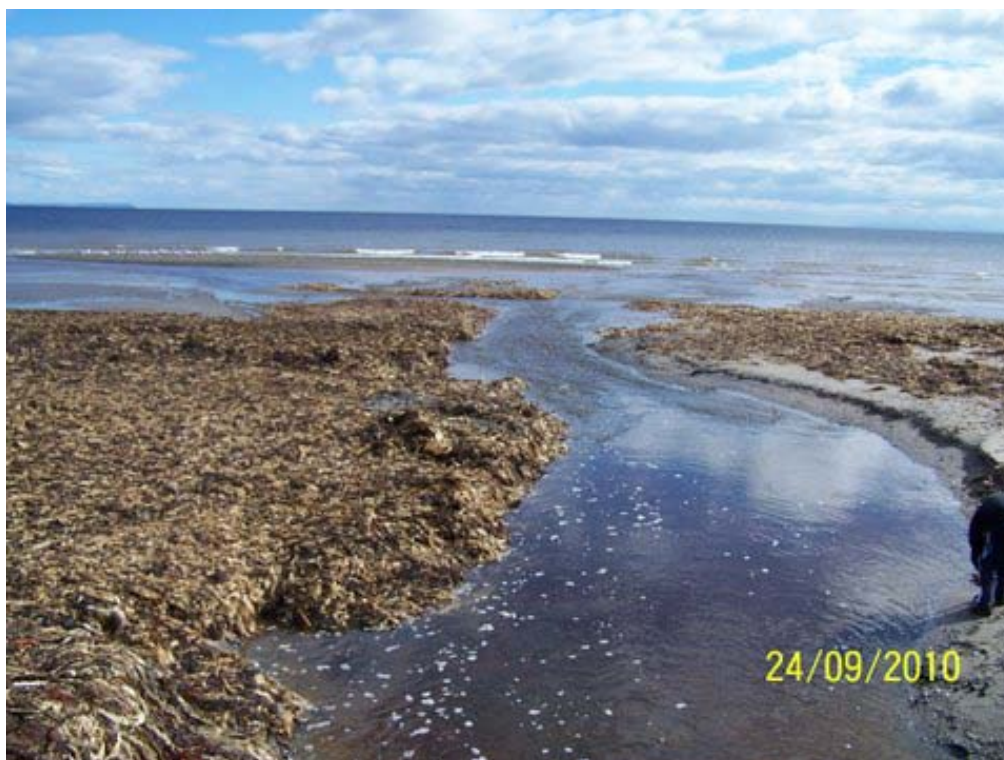
Figure 8. Stream, location of water sample LB004

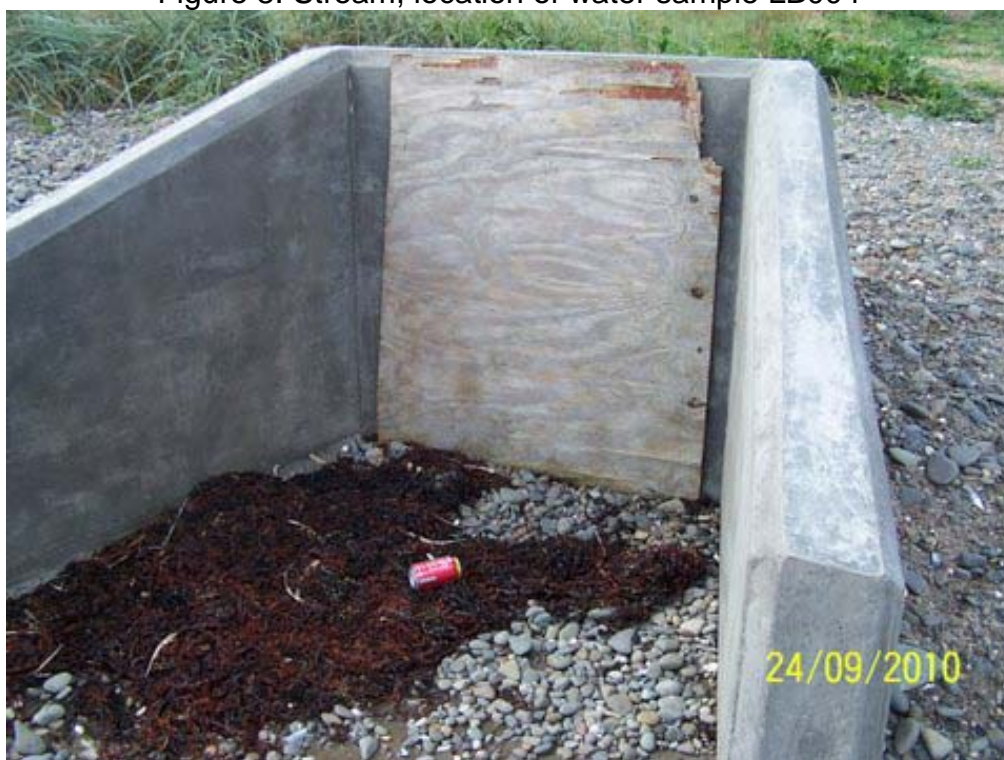
Figure 9. New culvert – boarded up

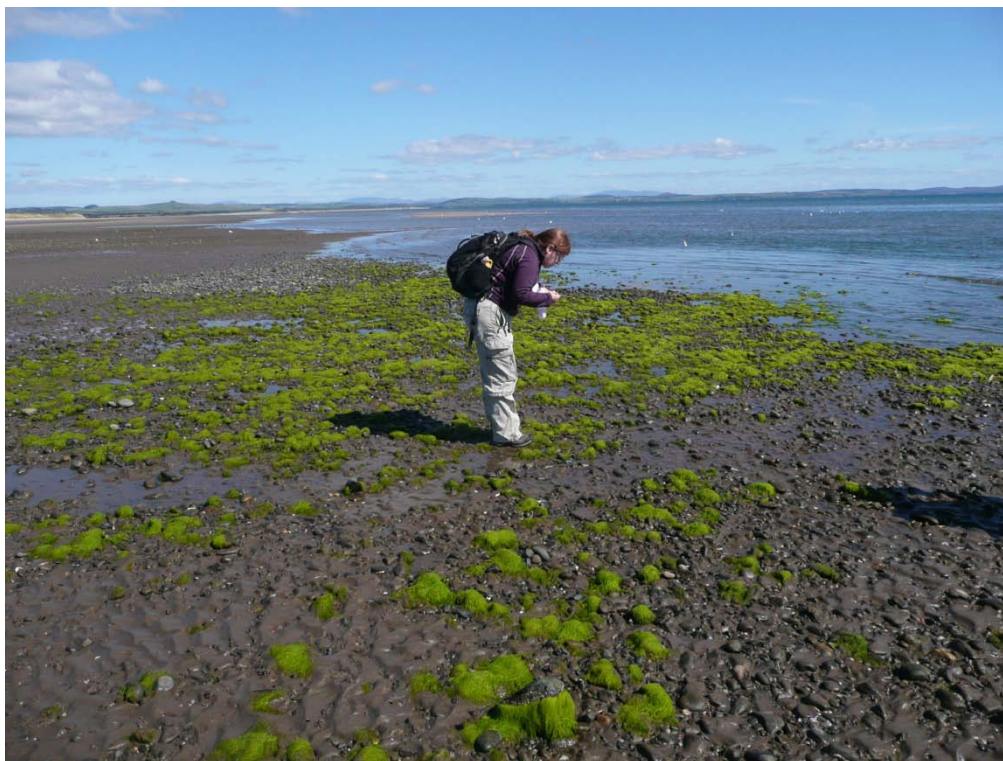
Figure 10. Location of sea water sample LB005

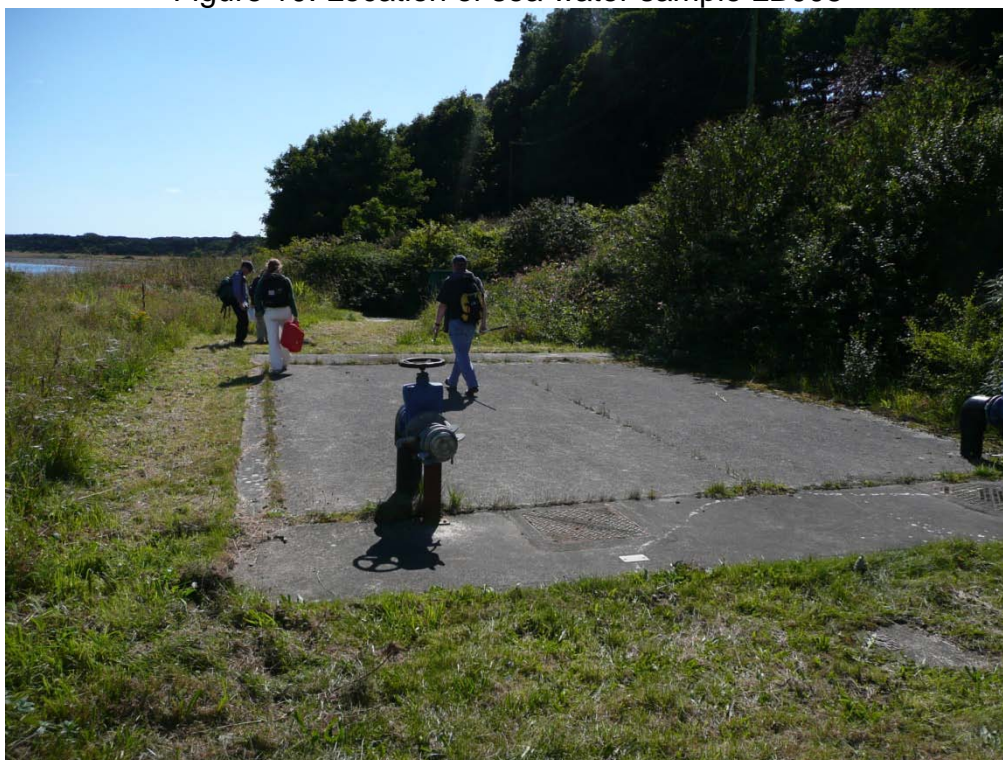
Figure 11. Sandhead septic tank

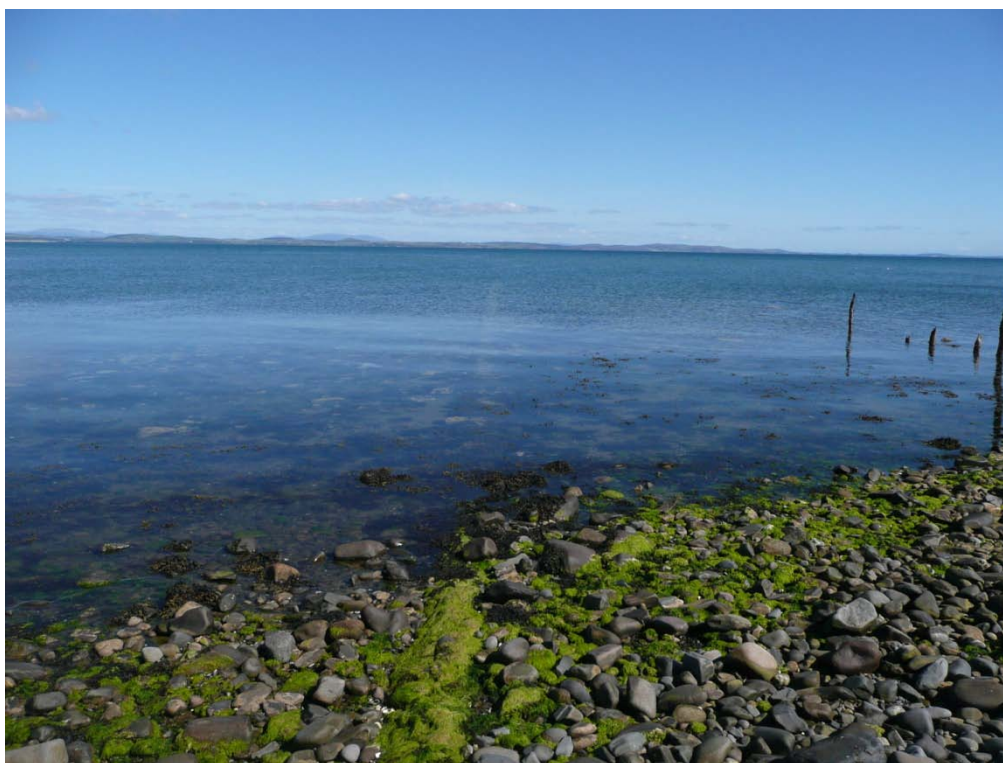
Figure 12. Location of sea water sample LB006

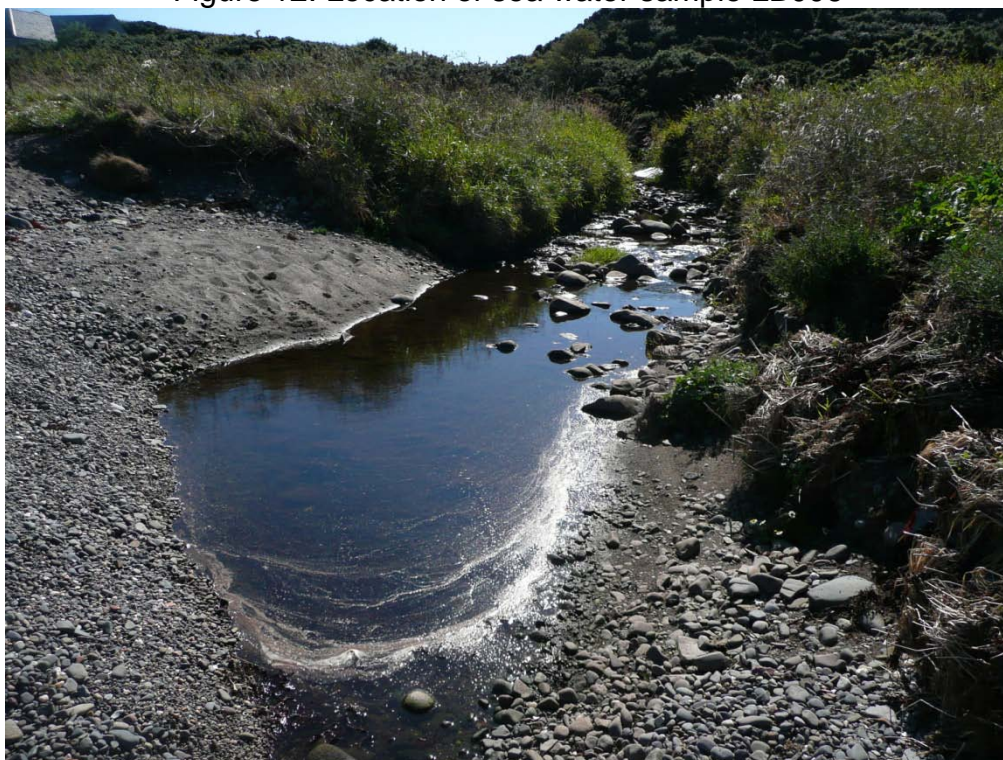
Figure 13. Stream, location of water sample LB007

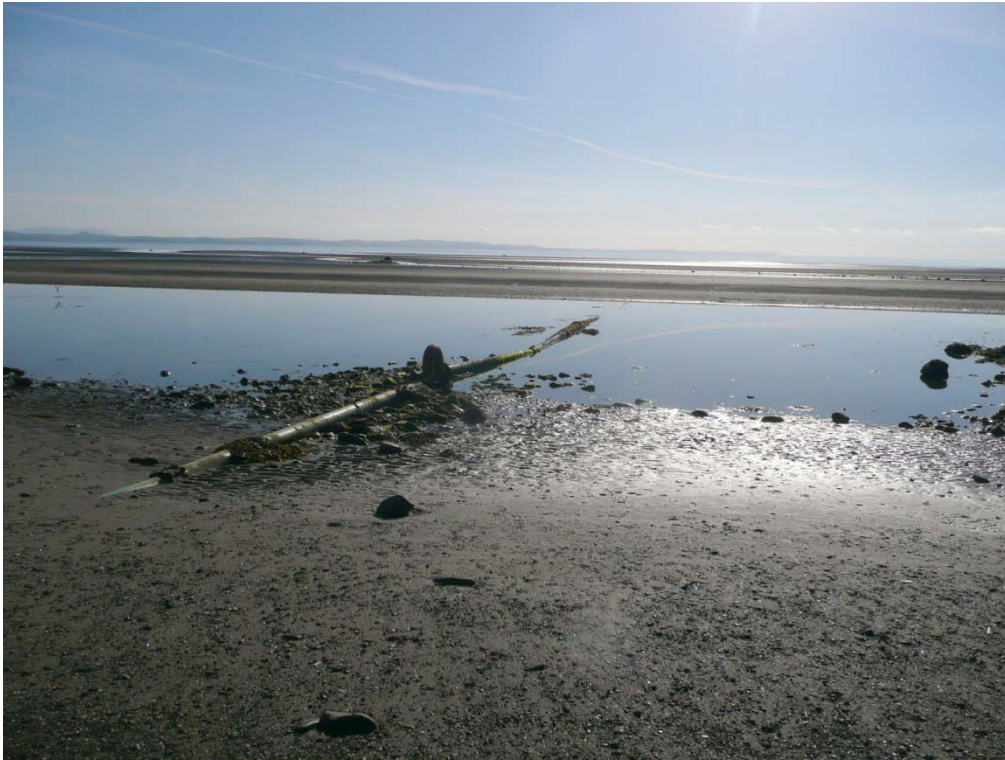
Figure 14. Outfall pipe

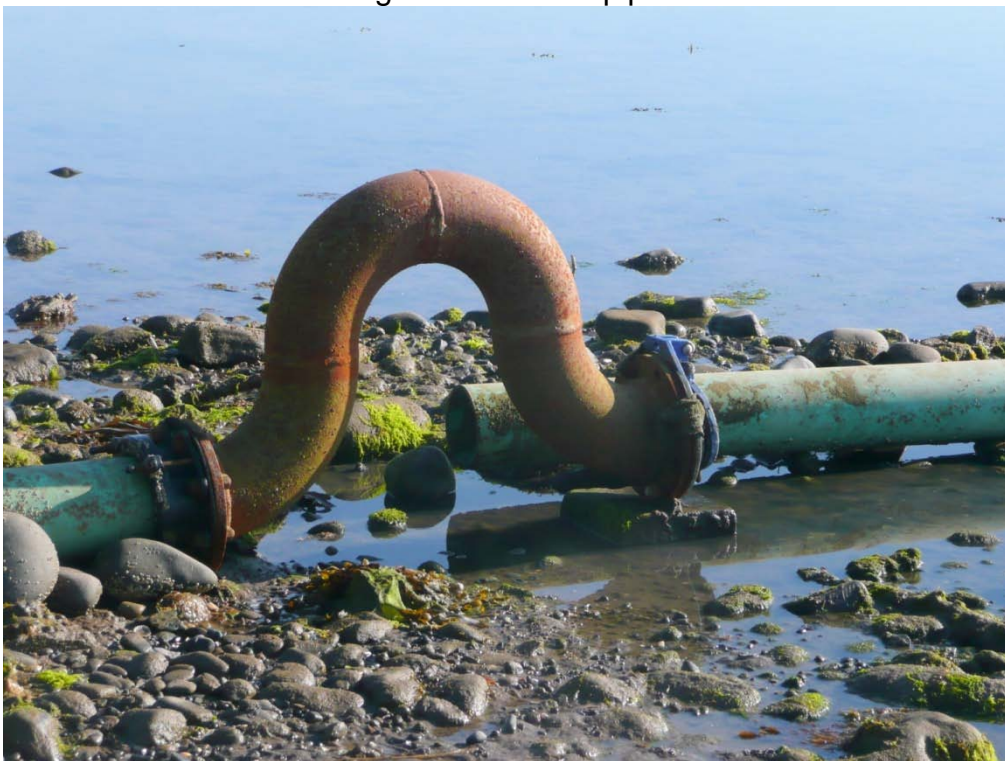
Figure 15. Link in outfall pipe, shown in Figure 14

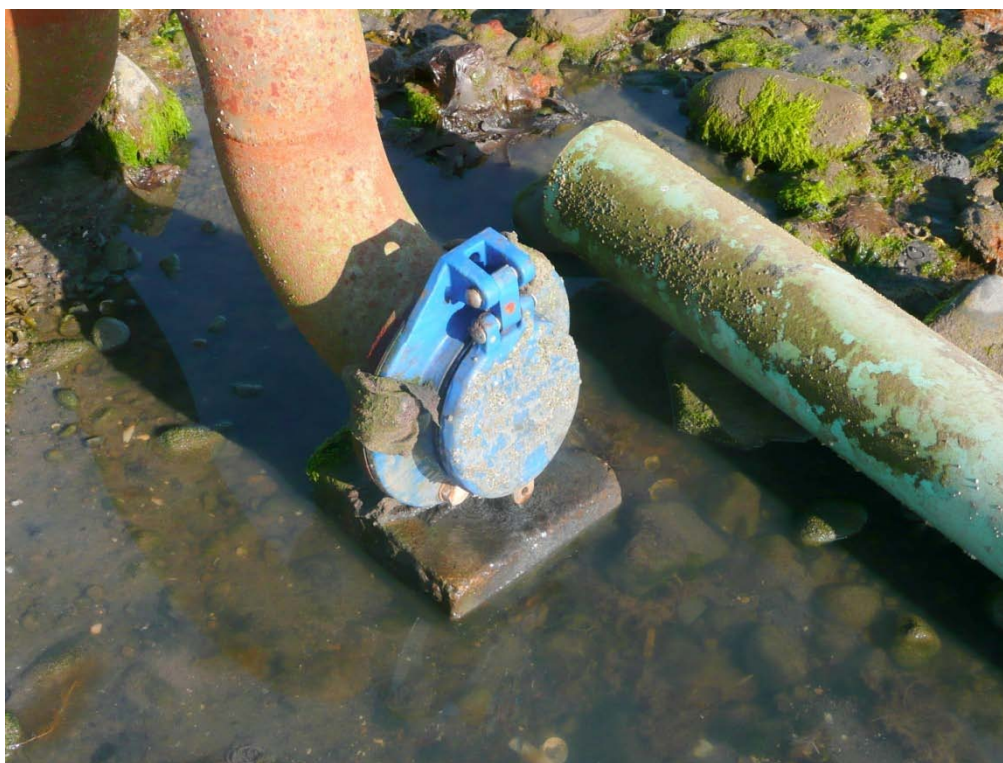
Figure 16. End of outfall pipe shown in figures 15 & 16, location of sea water sample LB008

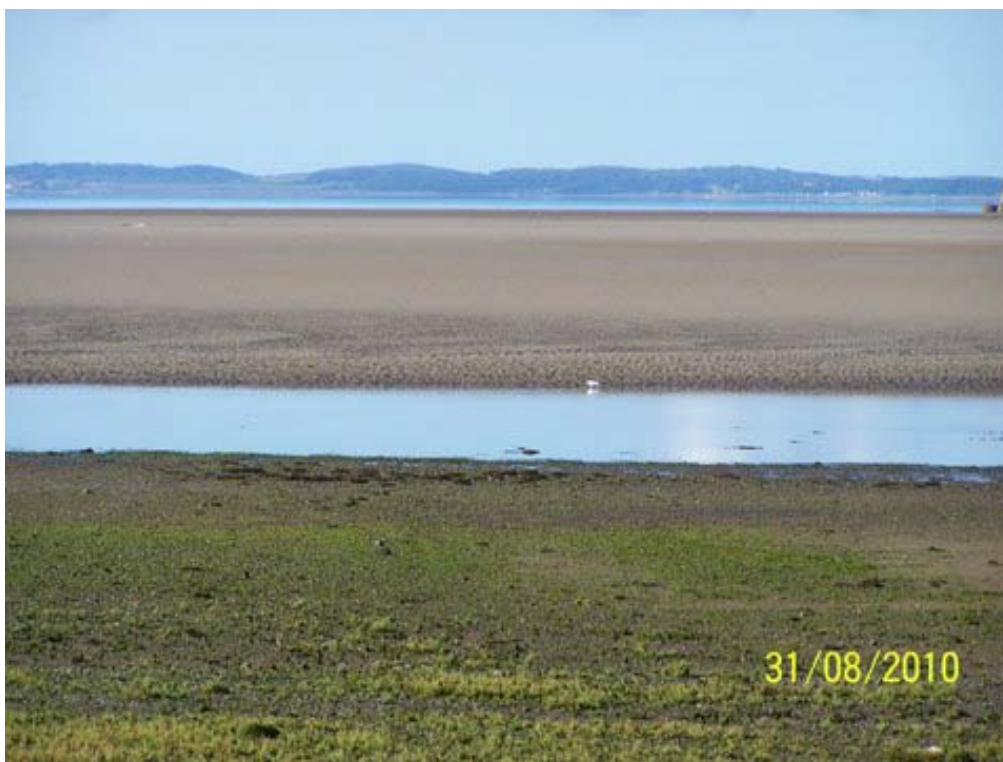
Figure 17. Piltanton Burn, location of water sample LB009

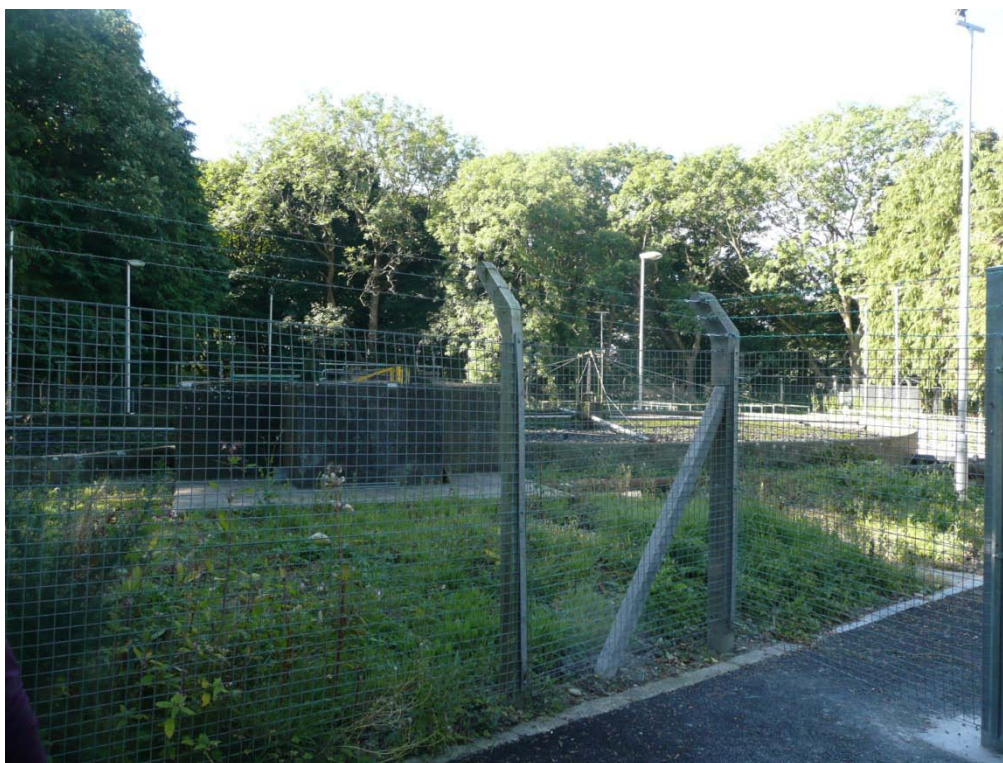
Figure 18. Glenluce sewage works

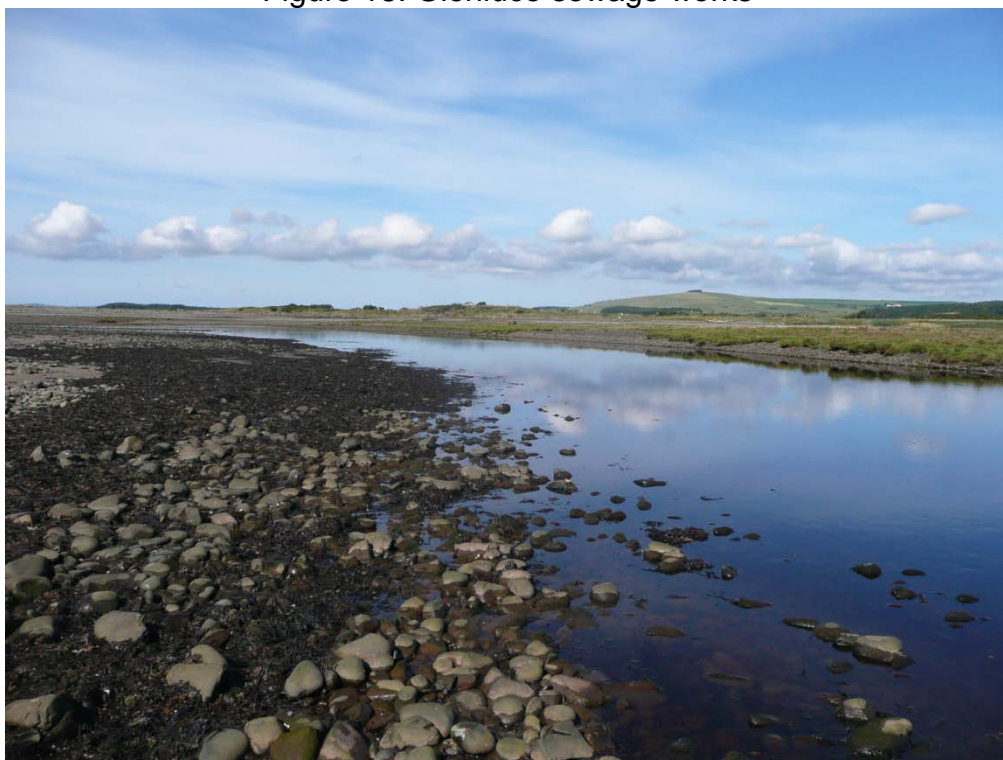
Figure 19. Luce River, location of water sample LB010

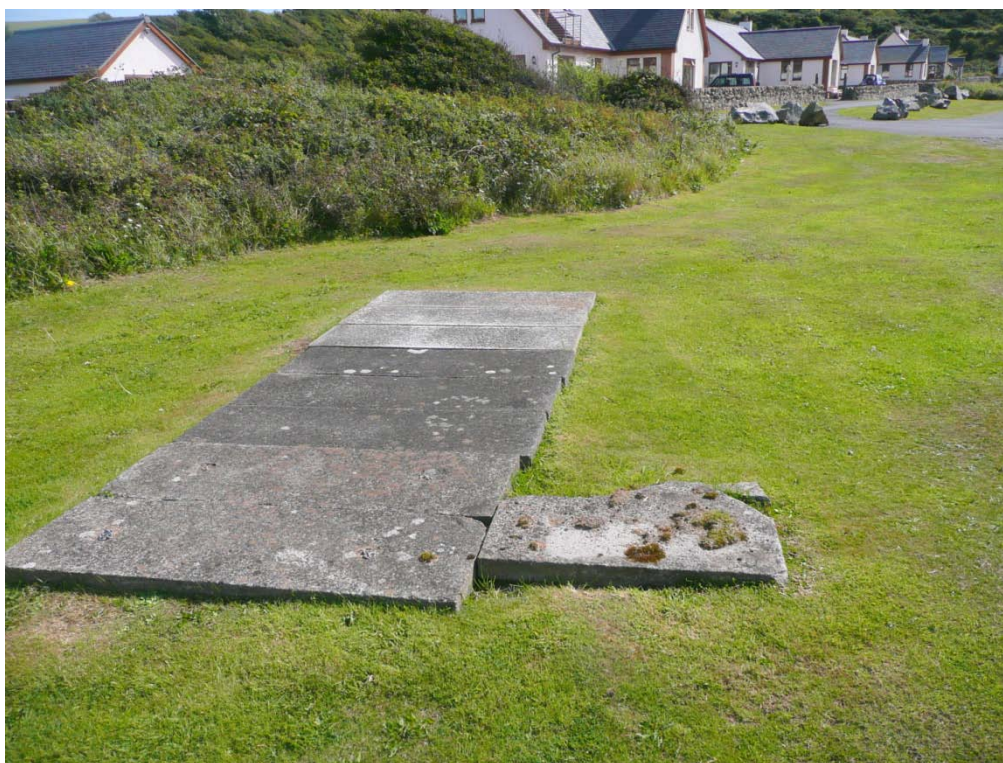
Figure 20. Stairhaven septic tank

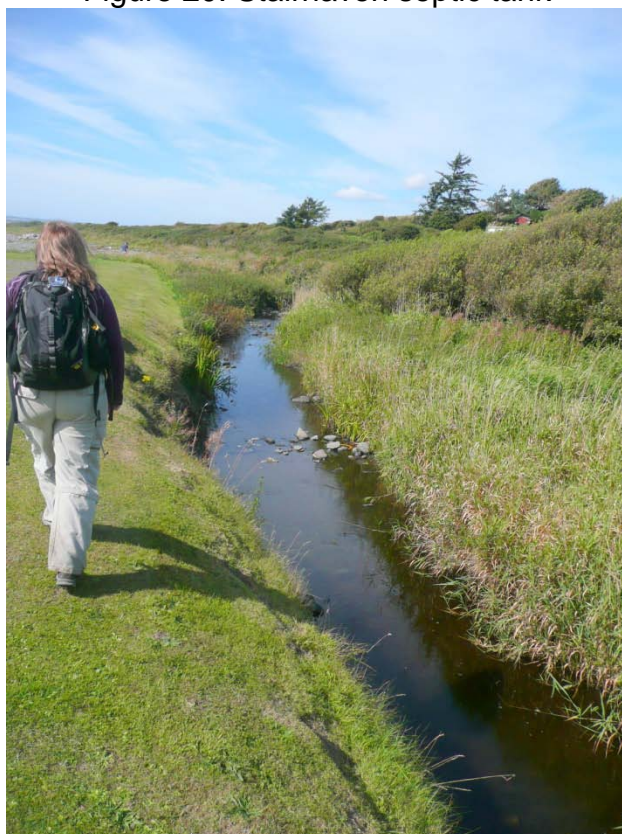
Figure 21. Stream, location of water sample LB011

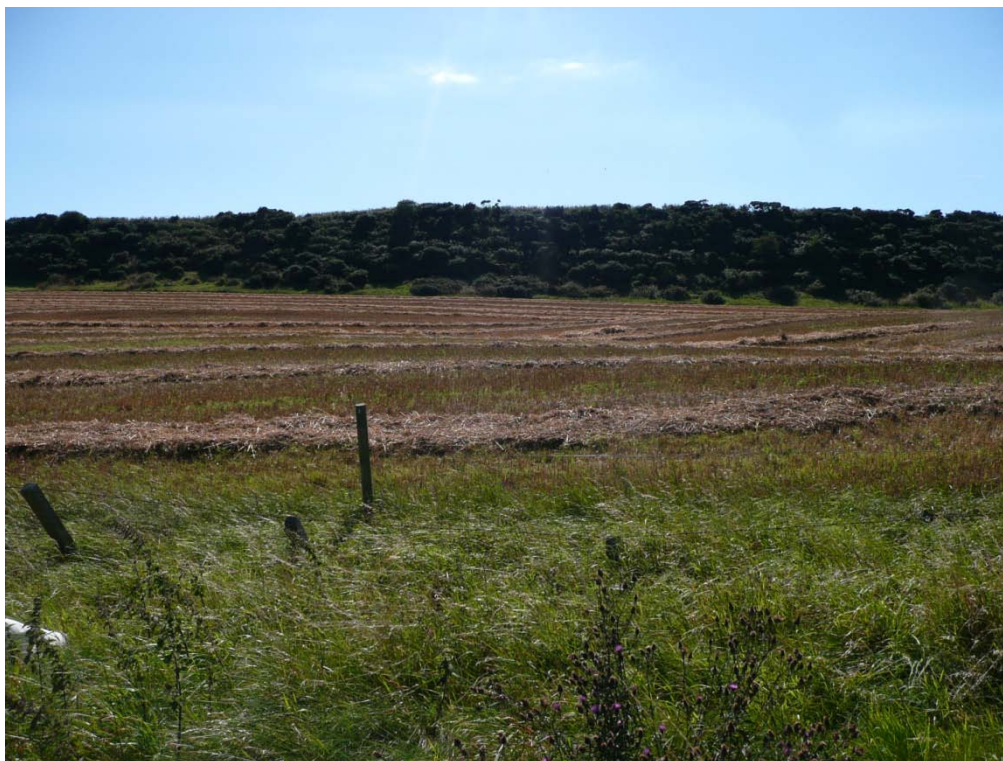
Figure 22. Agricultural land surrounding Laigh Sinniness
