Southampton Water Sanitary Survey

Review

January 2015

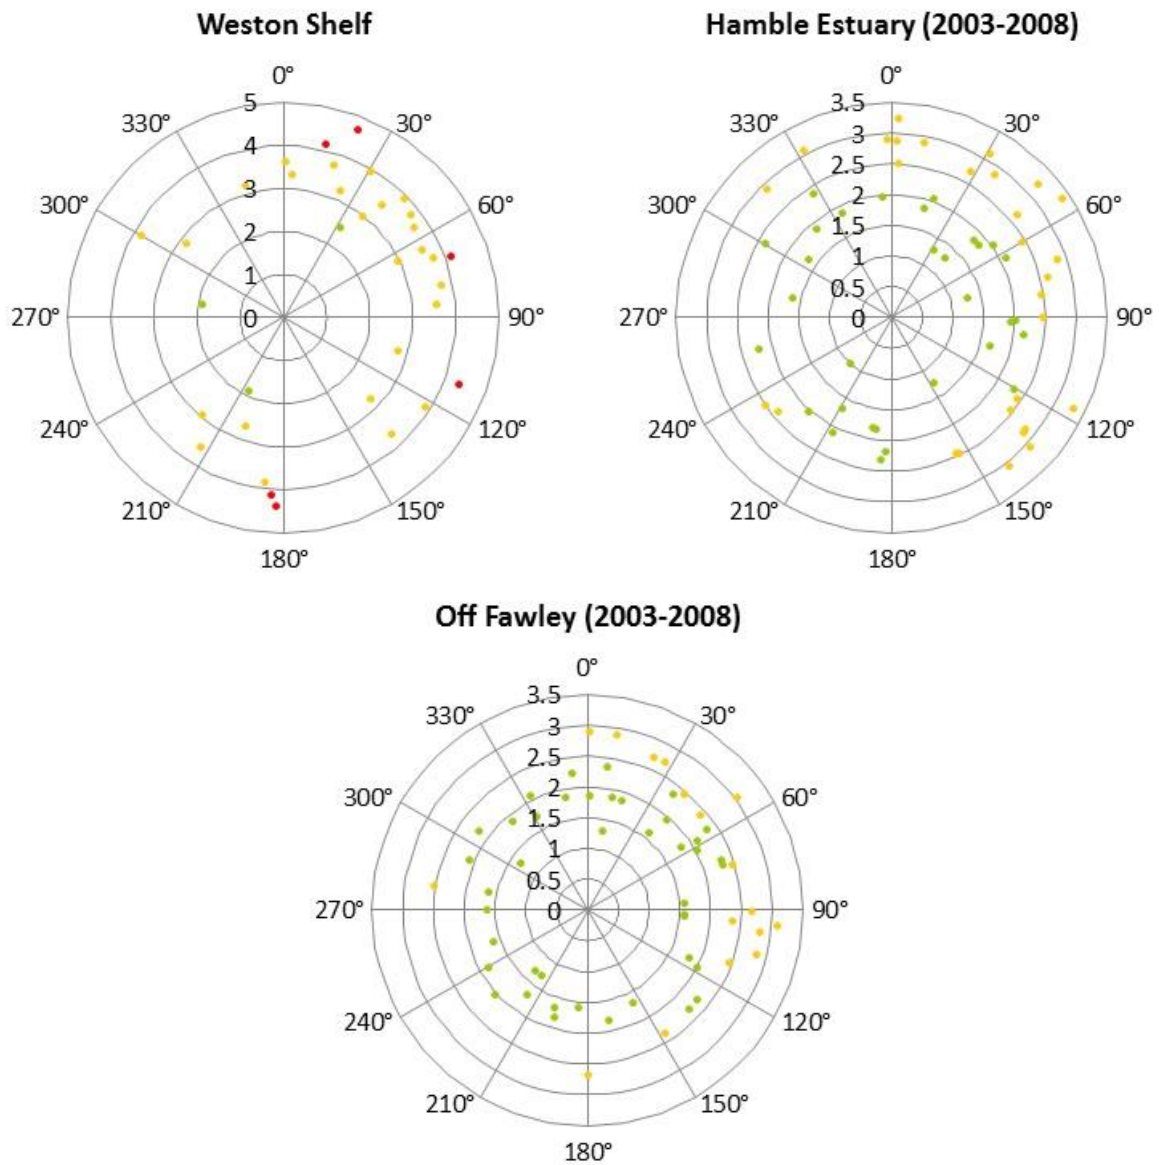
Figure 8.11: Polar plot of \log_{10} *E. coli* results (MPN/100 g) at native oyster RMPs against high/low tidal state

Figure 8.11 and Figure 8.12 present polar plots of log₁₀ *E. coli* results against tidal states on the high/low cycle for the correlations indicating a statistically significant effect. High water at Southampton is at 0° and low water is at 180°. Results of 230 *E. coli* MPN/100 g or less are plotted in green, those from 231 to 4,600 *E. coli* MPN/100 g are plotted in yellow, and those exceeding 4,600 *E. coli* MPN/100 g are plotted in red.

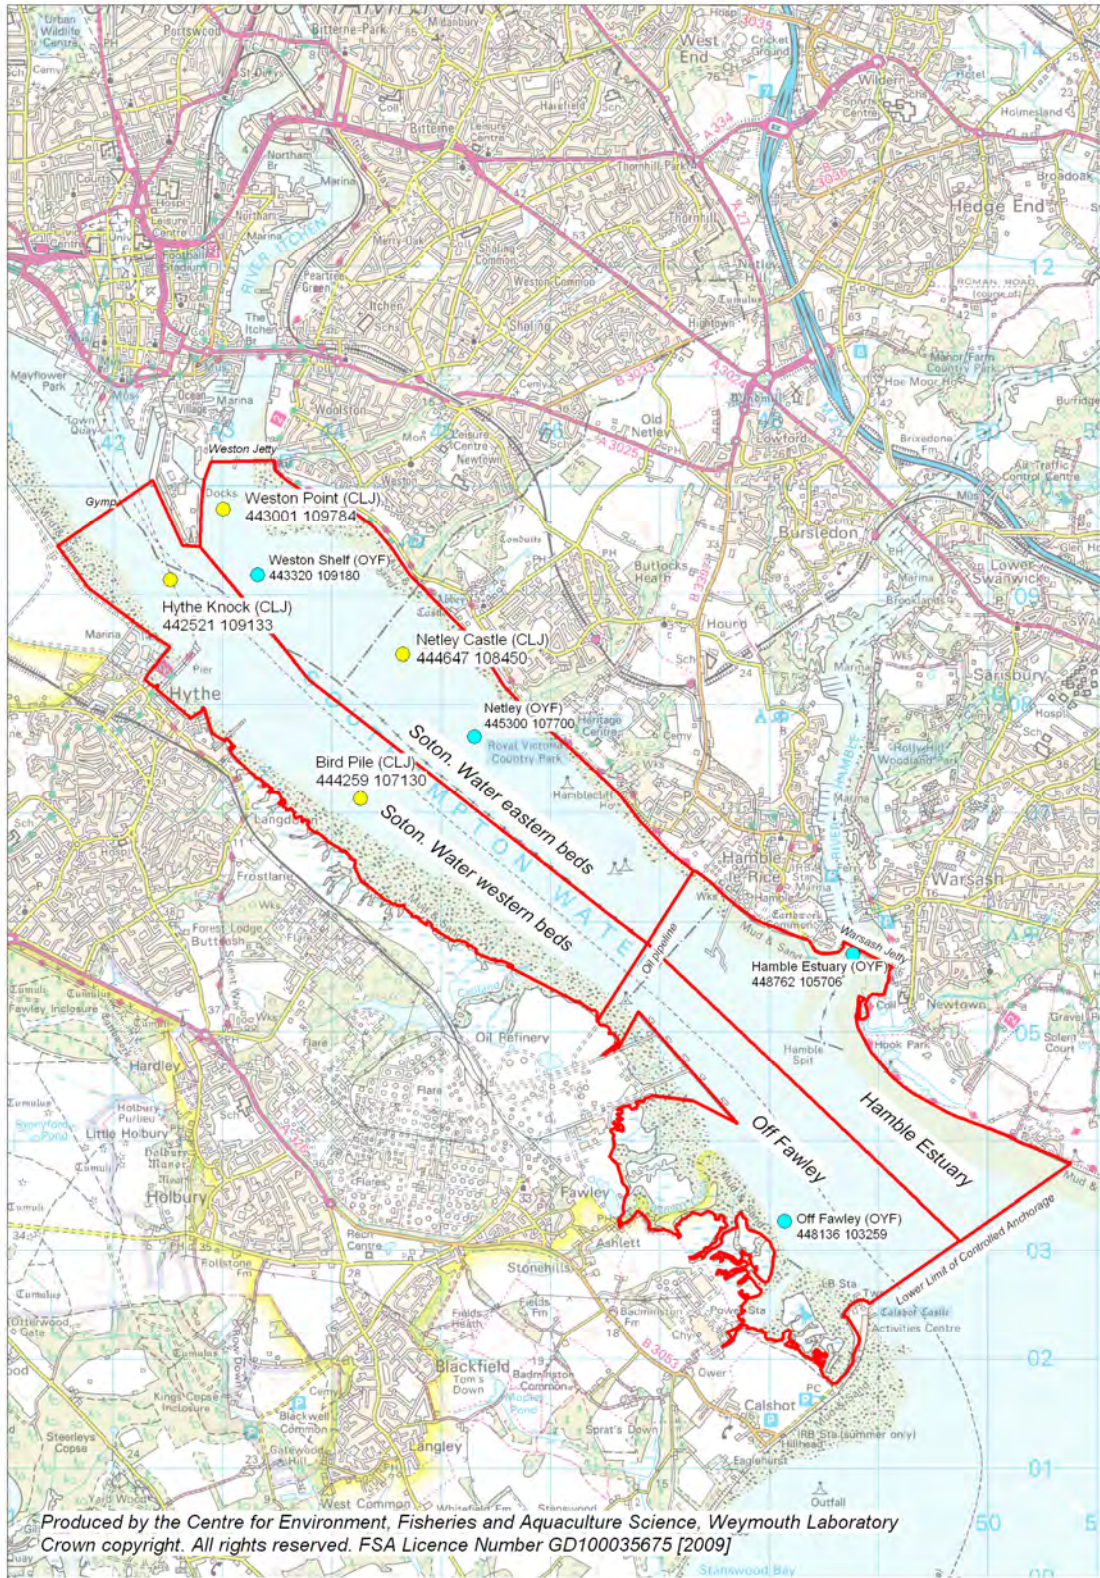
Figure 1: Classification zones and recommended monitoring points

Table 1: Recommended monitoring points in Southampton Water production area
