Scottish Sanitary Survey Project

Restricted Sanitary Survey Report

Kilbride Bay

AB 420

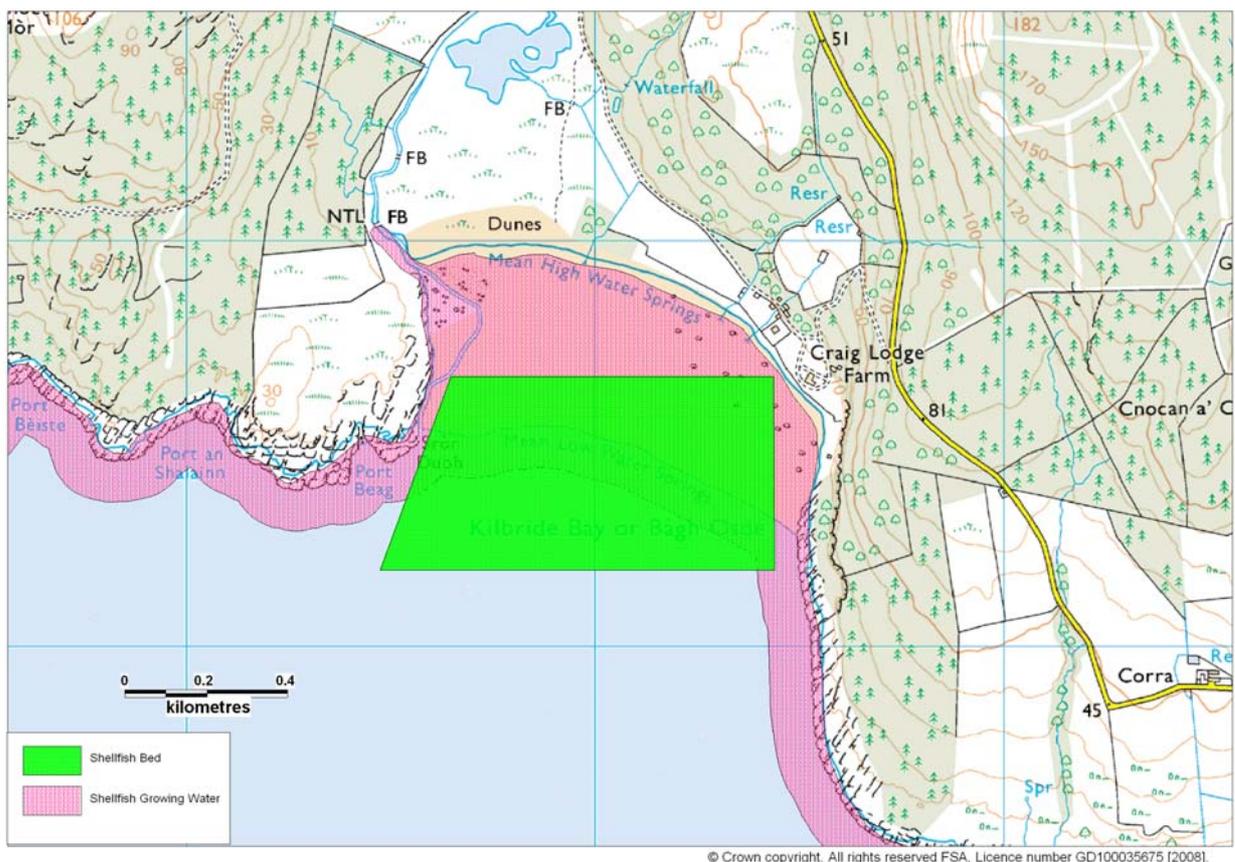
Figure 2.1 Kilbride Bay fishery

The actual shellfishery covers the area bounded by lines drawn between NR 95647 66666, NR 96438 66666, NR 96440 66190 and NR 95473 66190. The shellfish bed itself falls partly within the designated Shellfish Growing Water.

Razor fish are harvested using diving and both suction pump methods.

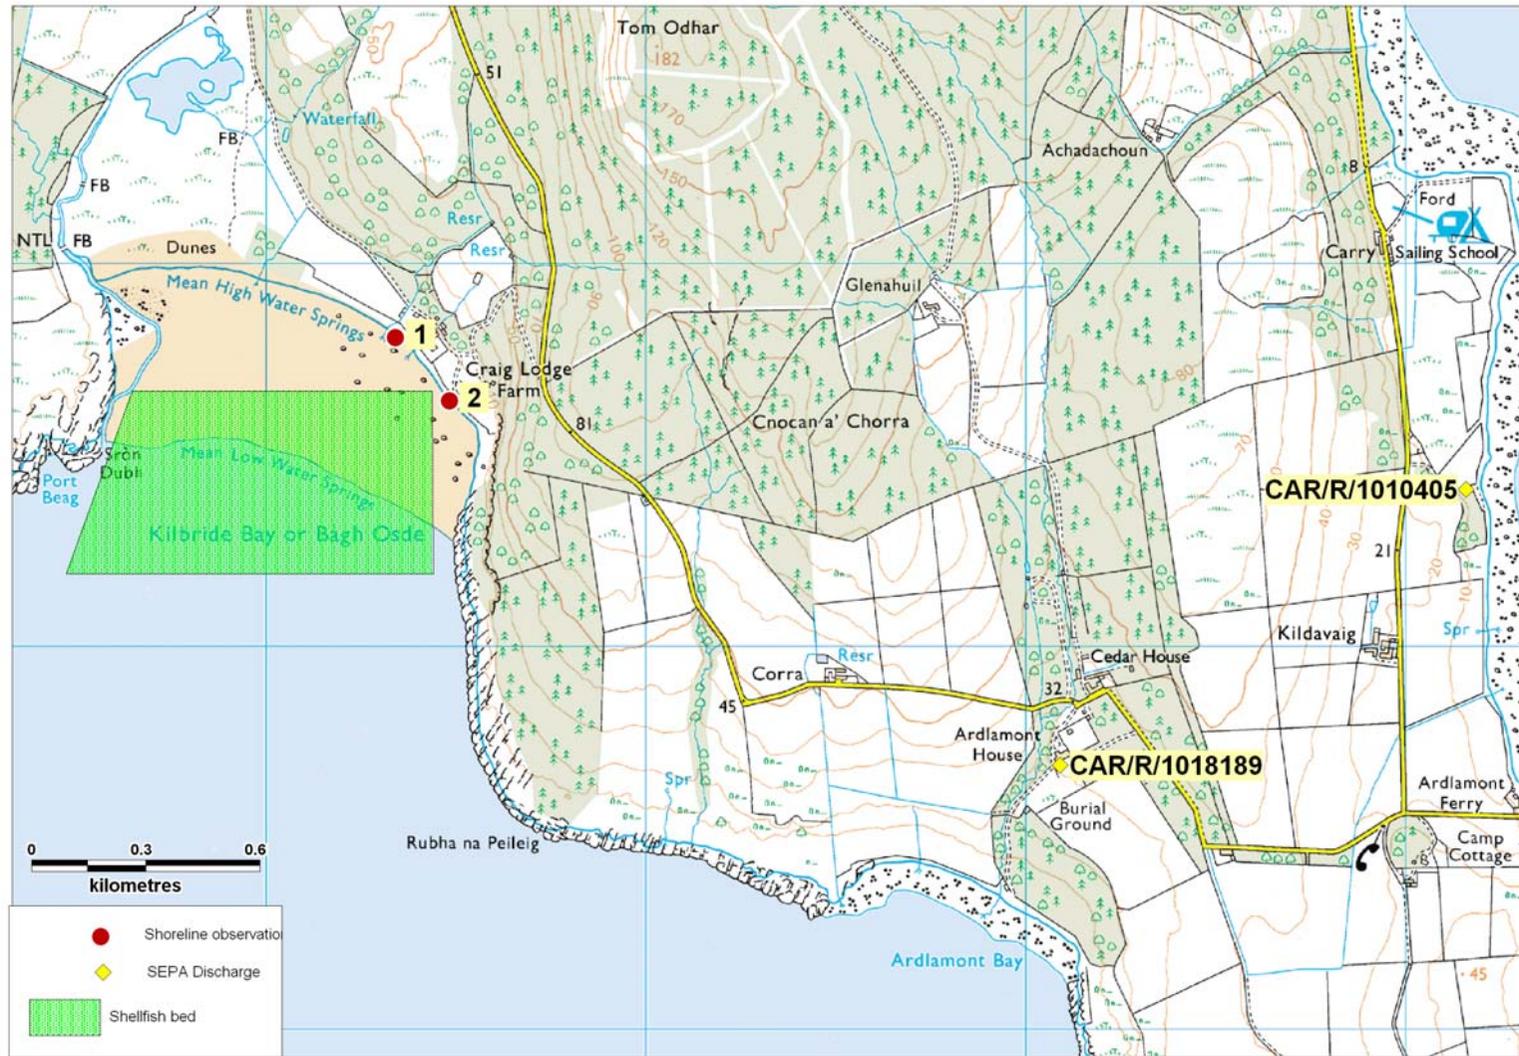
Figure 3.1 Sewage discharges near Kilbride Bay

Observations of additional discharges made during the shoreline survey including outfall pipes are listed in Table 3.2. Their locations have been included in the mapped discharges in Figure 3.1. Further details can be found in the shoreline survey report in Appendix 1. On the day of survey, the cast iron pipe was discharging clean water so it is unknown whether the pipe ever carries foul discharge.

Overall, discharges from the outfall pipes closest to the eastern end of the bay are likely to have the greatest impact on water quality at the fishery.

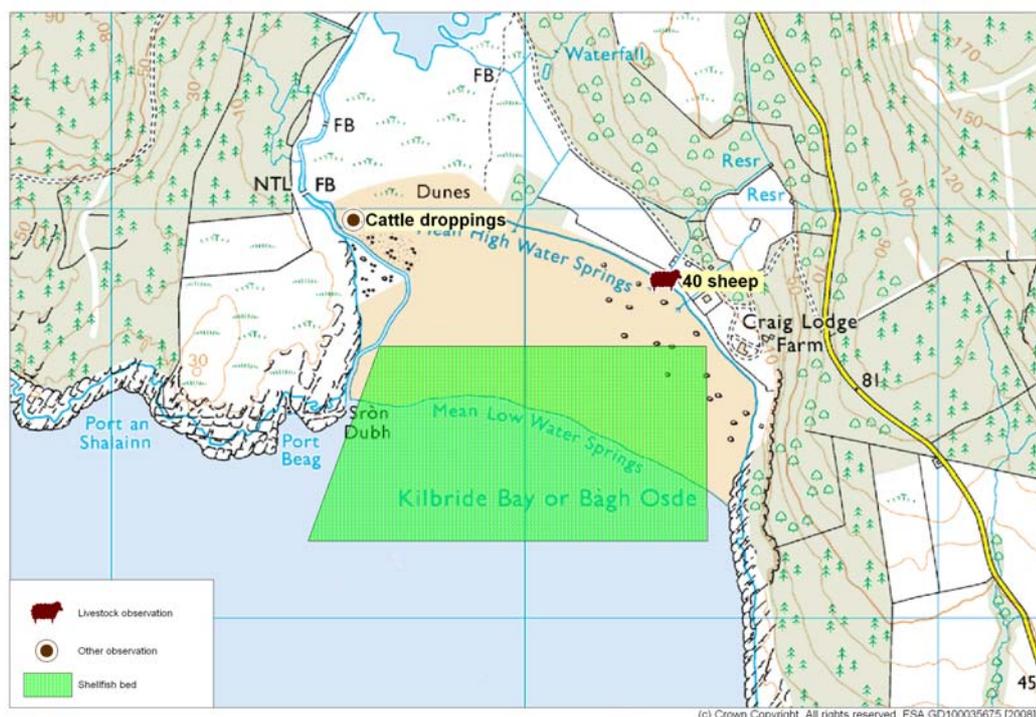
Figure 4.1 Livestock observation at Kilbride Bay

During the shoreline survey, 40 sheep were observed in a field adjacent to the bay near Craig Lodge Farm. Fresh cow pats and hoof prints were seen on western end of the beach near the Allt Osda, however there were no cattle visible in the area on the day (see Figure 4.1).

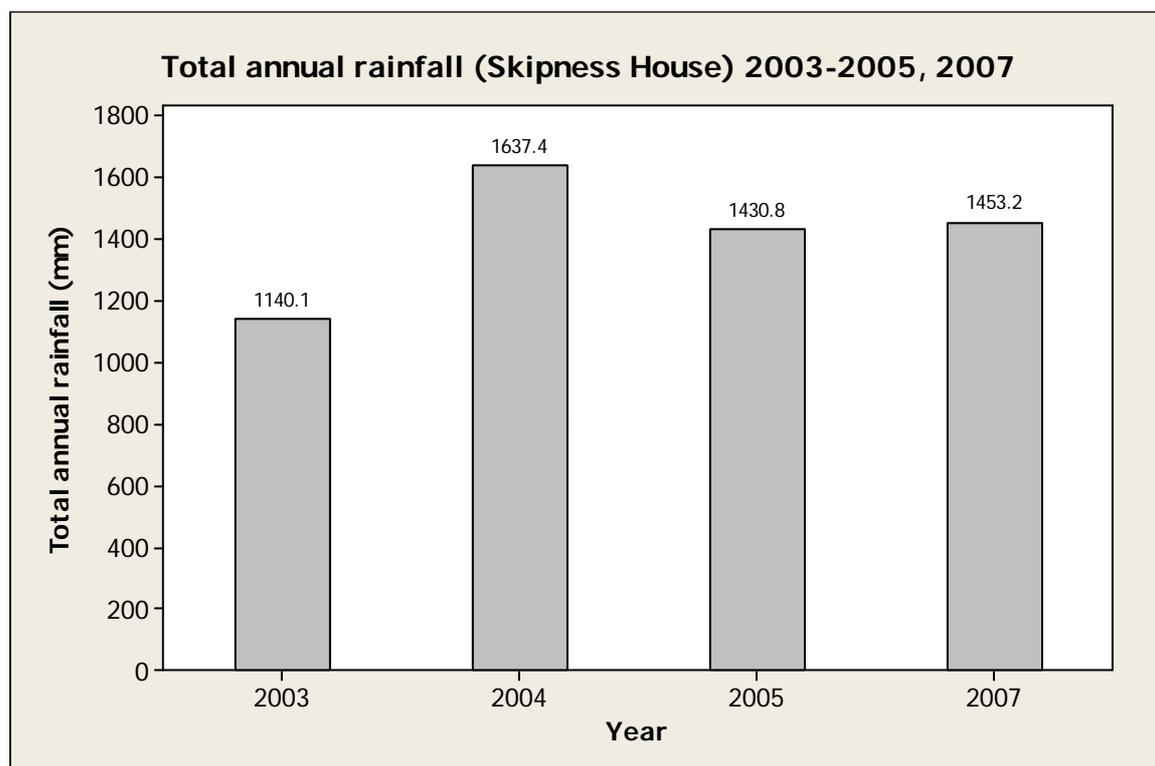
Figure 5.1 Total annual rainfall at Skipness House 2003 – 2005, 2007.

Rainfall records from Skipness House are nearly complete for years 2003-2005 and 2007. However, there were no records for January, November or December 2006. Therefore, total annual rainfall was calculated using only data from years with complete records, and is presented in Figure 5.1.

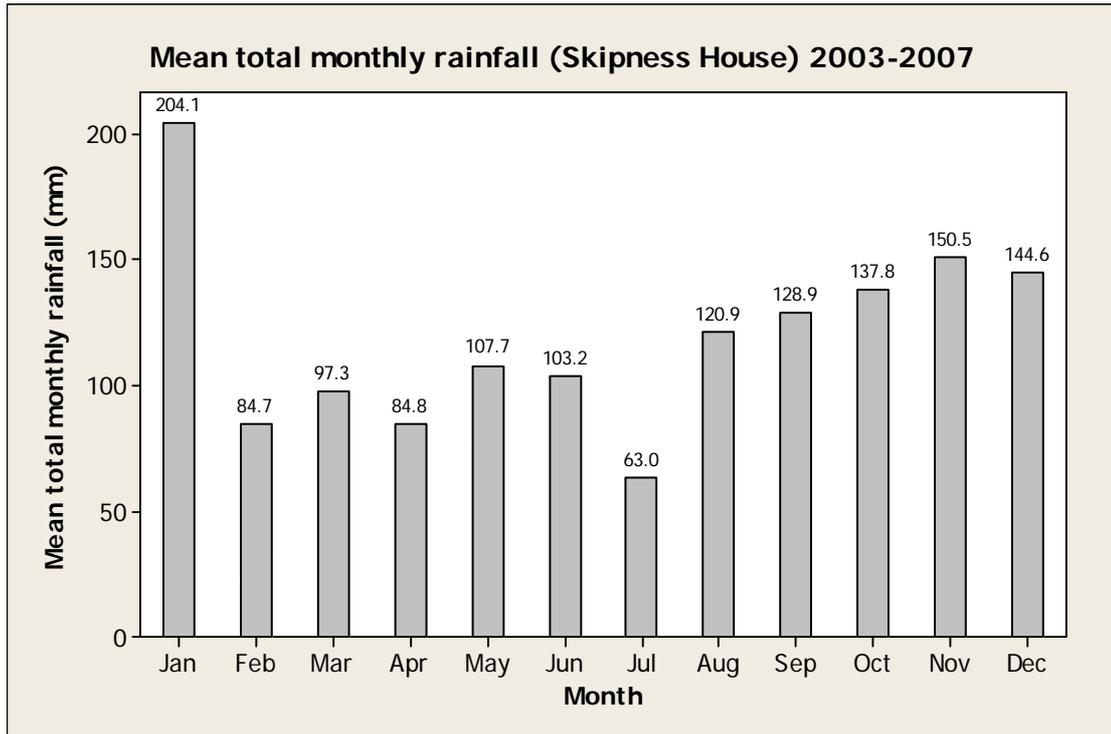
Figure 5.2 Mean total monthly rainfall at Skipness House 2003 – 2007.

Mean monthly rainfall was calculated using all available data; however the mean calculation was altered by dividing the total monthly rainfall by four years instead of five years for those months with missing data.

The wettest month was January and then November and December. For the period considered here (2003 – 2007), only 33.77% of the days experienced no rainfall. 15.52% of days experienced rainfall of 1mm or less. The greatest increases in rainfall from one month to the next occurred in January and August.

It can be expected that levels of rainfall dependant faecal contamination entering the production area from these sources will be higher during months in which higher rainfall is observed, in this case August to January inclusive.

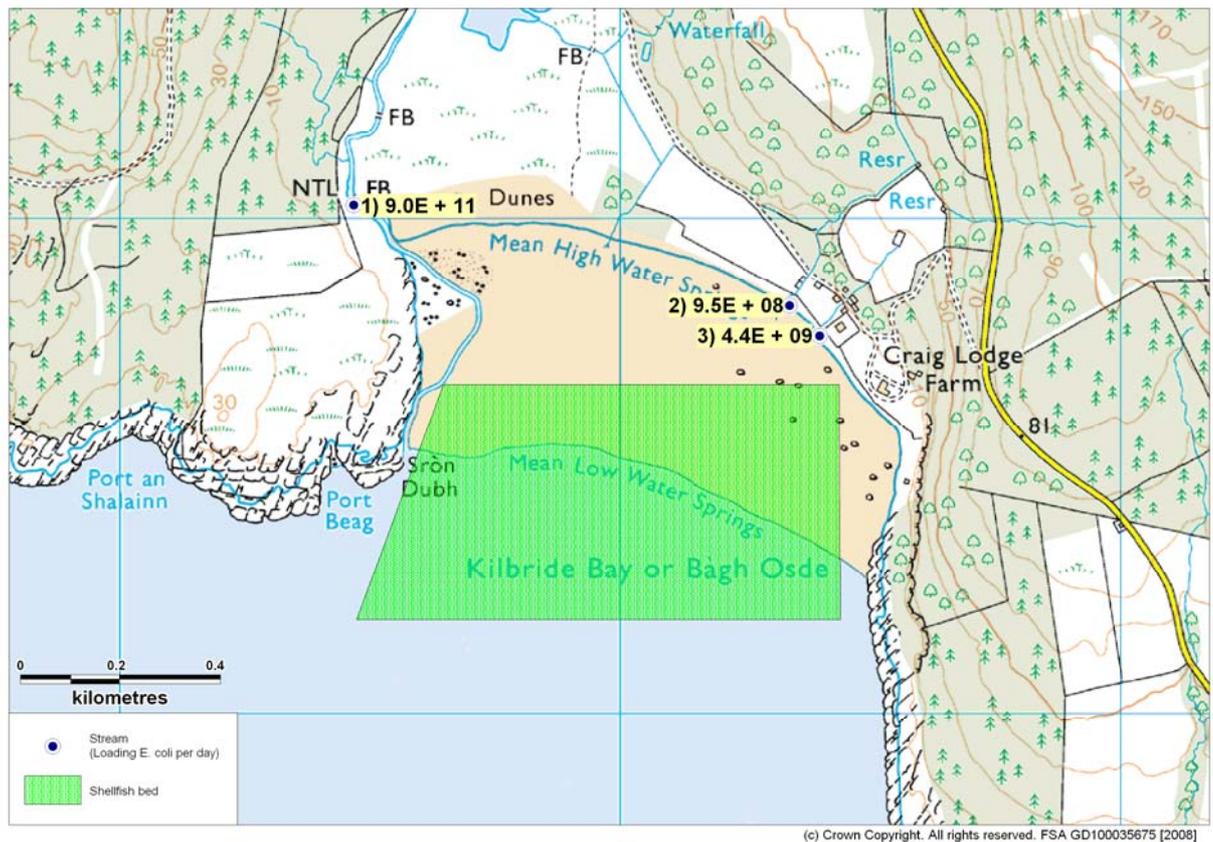
Figure 6.1 Location of streams and loadings at Kilbride Bay

Four streams discharge into Kilbride Bay. Their locations are shown in Figure 6.1. Three of these streams were sampled during the shoreline survey, representing the largest freshwater inputs into Kilbride Bay. Measurements taken on the day of survey may not be representative of flow conditions at all times of the year.

The Allt Osda is by far the largest of the streams, draining a catchment area of 15.8 km² that stretches 10 km north from the shoreline and includes a number of farms and the small settlement of Millhouse. It was also the most contaminated of the three. Only one discharge consent was noted for this settlement by SEPA and though it was for a soakaway to land, as the stream passes near the area it is possible that some septic tanks there may discharge directly to it. Livestock held

The other two measured streams pass through woodland and past a farm on the eastern side of the bay. These showed still significant loadings of *E. coli* on the day of survey, despite the fact that they did not drain a significant land area.

All of these streams deliver significant levels of faecal contamination to the fishery, with the highest probable impact nearest the mouth of the Allt Osda at the western end of the bay as this carried substantially higher loadings than the other two streams combined.

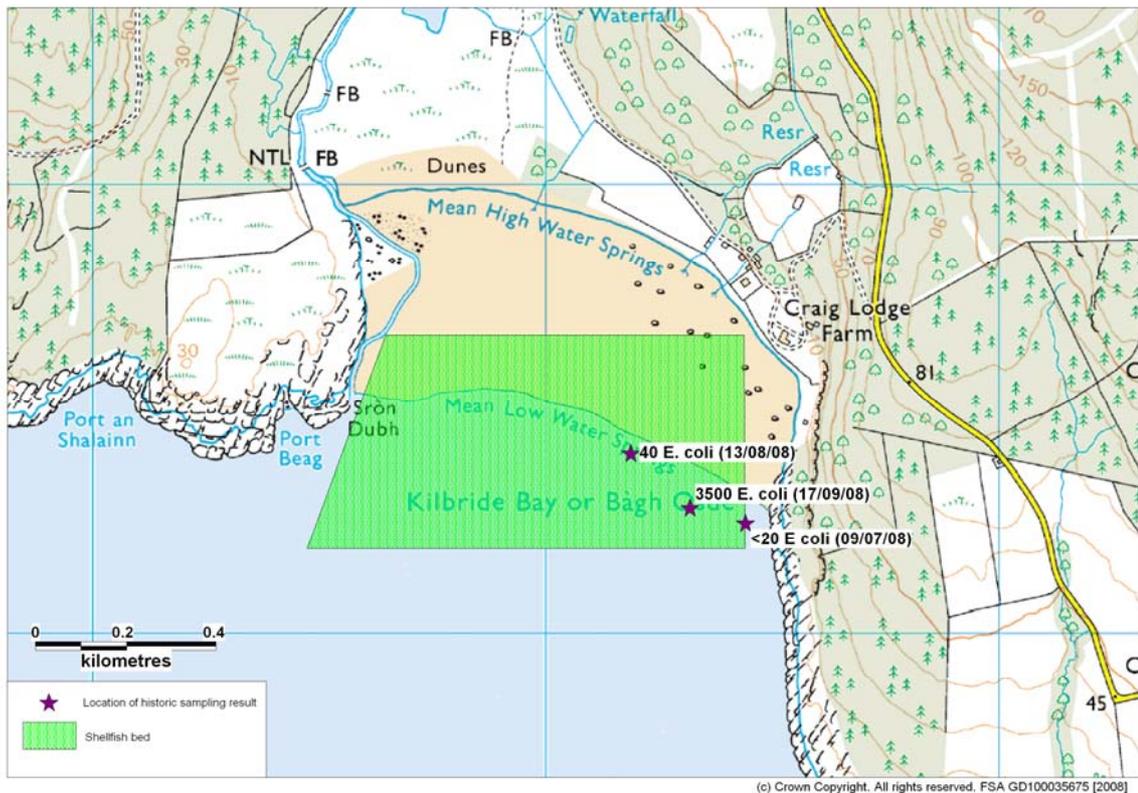
Figure 7.1 Location of monitoring results at Kilbride Bay

There is an insufficient monitoring history at Kilbride Bay to undertake analysis of results. Only three shellfish hygiene monitoring results for razor clams are available for Kilbride Bay. The first was taken on 09/07/2008 and had a result of <20 *E. coli* per 100 g, the second result was taken on 13/08/2008 and had a result of 40 *E. coli* per 100 g and the third was taken on 17/09/08 and had a sample of 3500 *E. coli* per 100 g. A further sample was taken from the western side of the bay on 17/09/08 to satisfy sampling requirements associated with the shoreline survey and this contained 500 *E. coli* per 100 g.

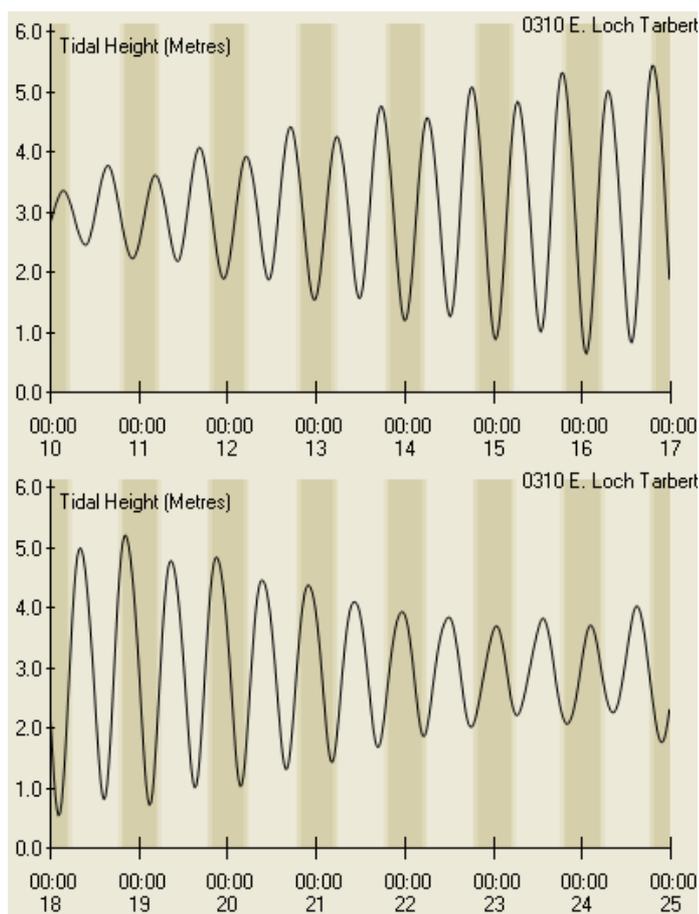
Figure 8.3 Tidal curves for East Loch Tarbert

The two tidal curves below are for the port of East Loch Tarbert, the nearest tidal port. They have been output from UKHO TotalTide. The first is for seven days beginning 00.00 GMT on 10th September 2008. The second is for seven days beginning 00.00 GMT on 18th September 2008. Together they show the predicted tidal heights over high/low water for a full neap/spring tidal cycle.

East Loch Tarbert lies approximately 9km northwest of Kilbride Bay. Times of high and low water are likely to be slightly earlier at Kilbride Bay as the tidal port lies further up the loch and away from the open sea.

Predicted heights are in metres above chart datum. The tidal range at spring tide is approximately 4.2 m and at neap tide 1.6 m.

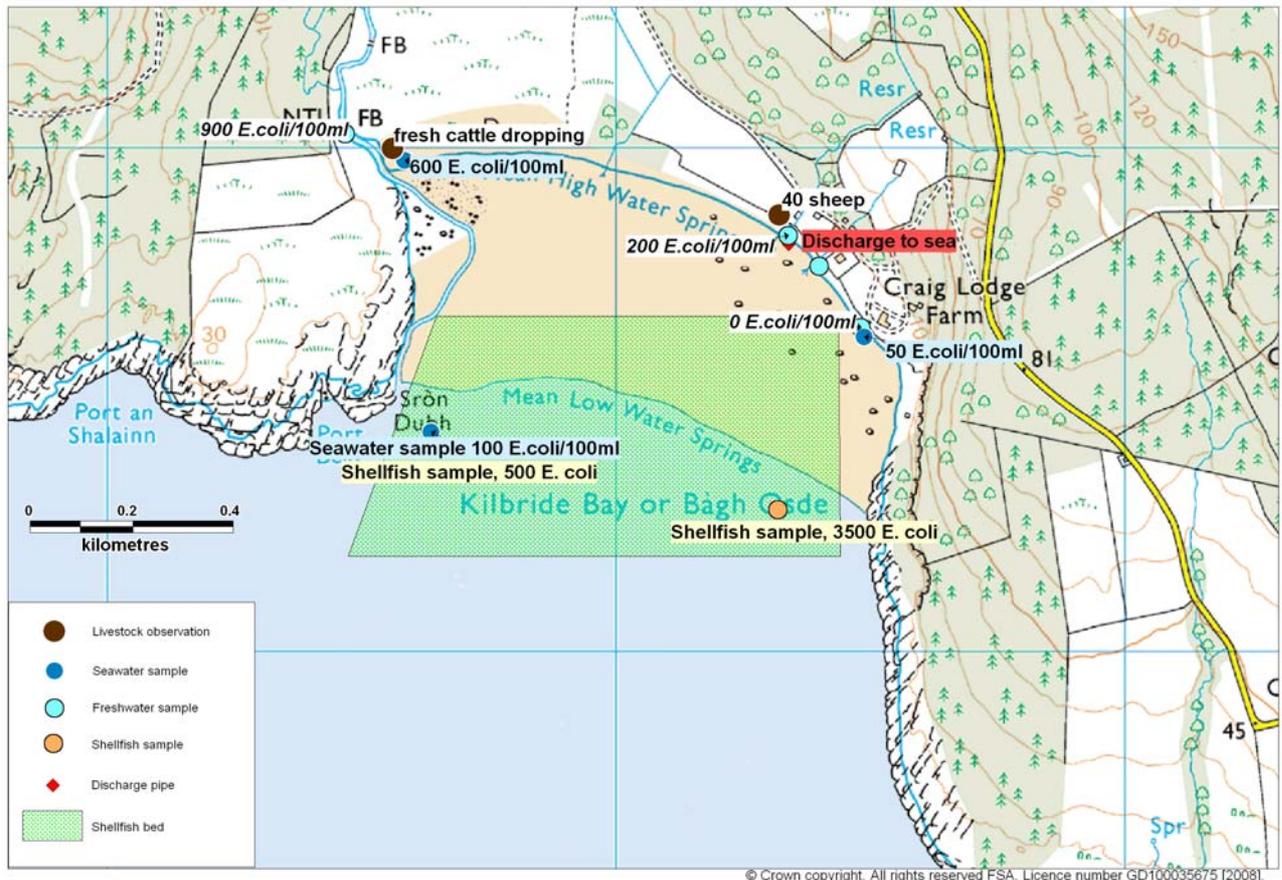
Figure 9.1 Summary of shoreline observations

The map provided in Figure 9.1 shows the relative locations of the most significant findings of the shoreline survey. Where the bacterial concentration is labelled, the scientific notation is written in digital format, as this is the only format recognised by the mapping software. So, where normal scientific notation for 1000 is 1×10^3 , in this case it would be written as 1E+3.

- Allt Osda burn at western end of bay carrying contaminated runoff to fishery.
- Input from livestock grazing on and near the shoreline.
- Septic pipes and streams observed at eastern end of bay.

A seawater sample collected from adjacent to the burn contained 600 E.coli cfu/100 ml and both shellfish samples contained concentrations higher than the limit for Class A.

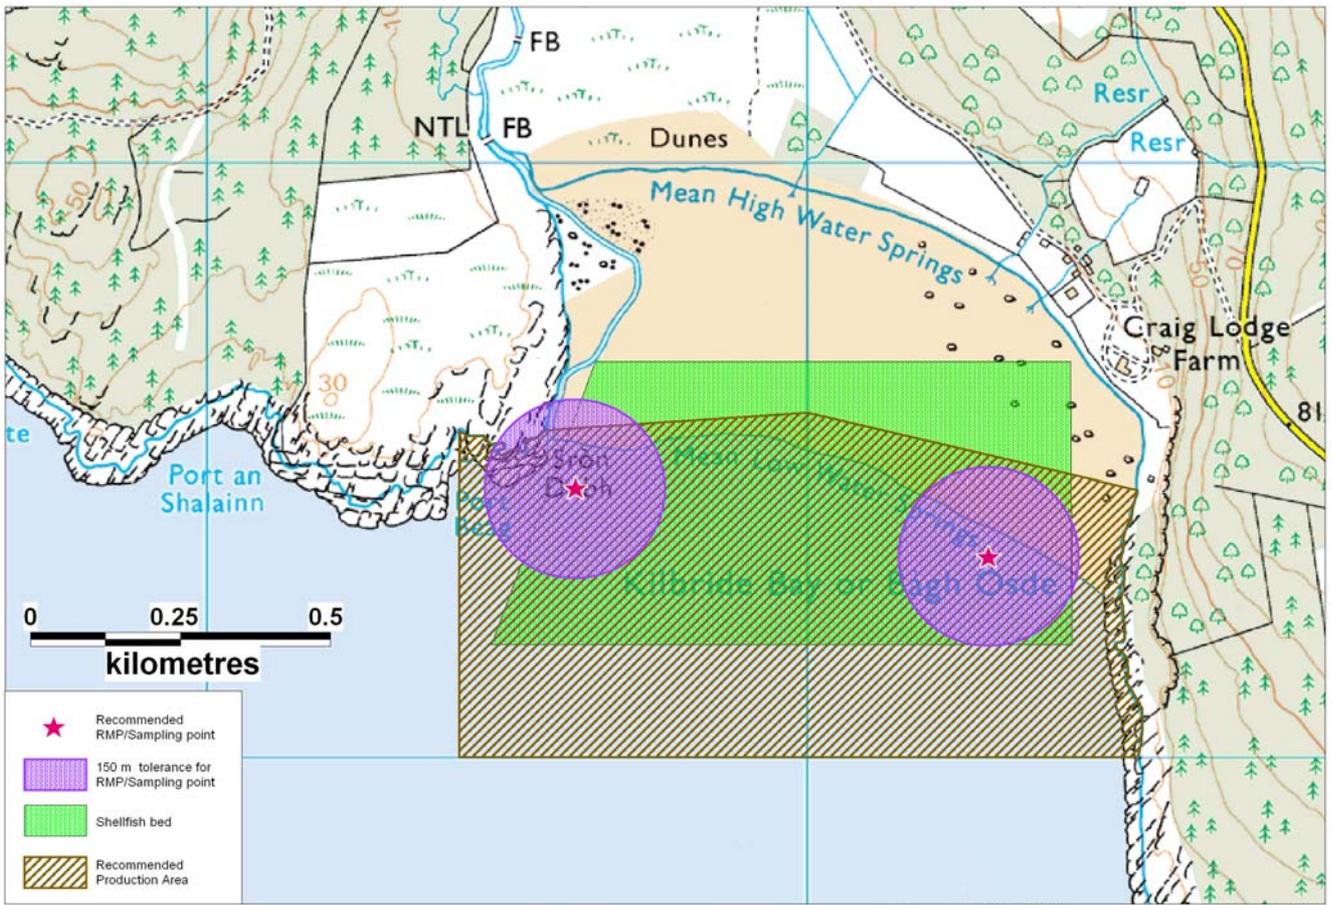
Figure 11.1 Kilbride Bay recommendations

The Kilbride Bay Production Area is recommended to be the area bounded by lines drawn between NR 9542 6655 and NR 9542 6600 and between NR 9655 6600 and NR 9555 6645 and between NR 9600 6658 and NR 9556 6655 extending to MHWS (Figure 11.1).

This area excludes the northernmost extent of the shellfish bed as it is not currently fished and is also closer to noted sources of contamination.

Due to inconsistency in bacteriological results obtained from both water and shellfish sampling, it is recommended that an extended bacteriological survey be conducted in parallel with monitoring sampling. Significant known sources of contamination exist at either end of the bay and so before a single RMP for the production area can be established it is necessary to determine whether significant variation in contamination levels exists between the two sides of the production area.

The recommended interim RMP is NR 9630 6634 and the recommended parallel sampling point is NR 9561 6645. Both sites should be sampled on the same day for 6 months, after which the results will be assessed to see whether the two points can be rationalised to one.

Sampling frequency is recommended to be monthly as the harvester intends to harvest year round when possible.

Sampling tolerance is recommended to be 150 metres to allow for sufficient availability of stock for sampling.

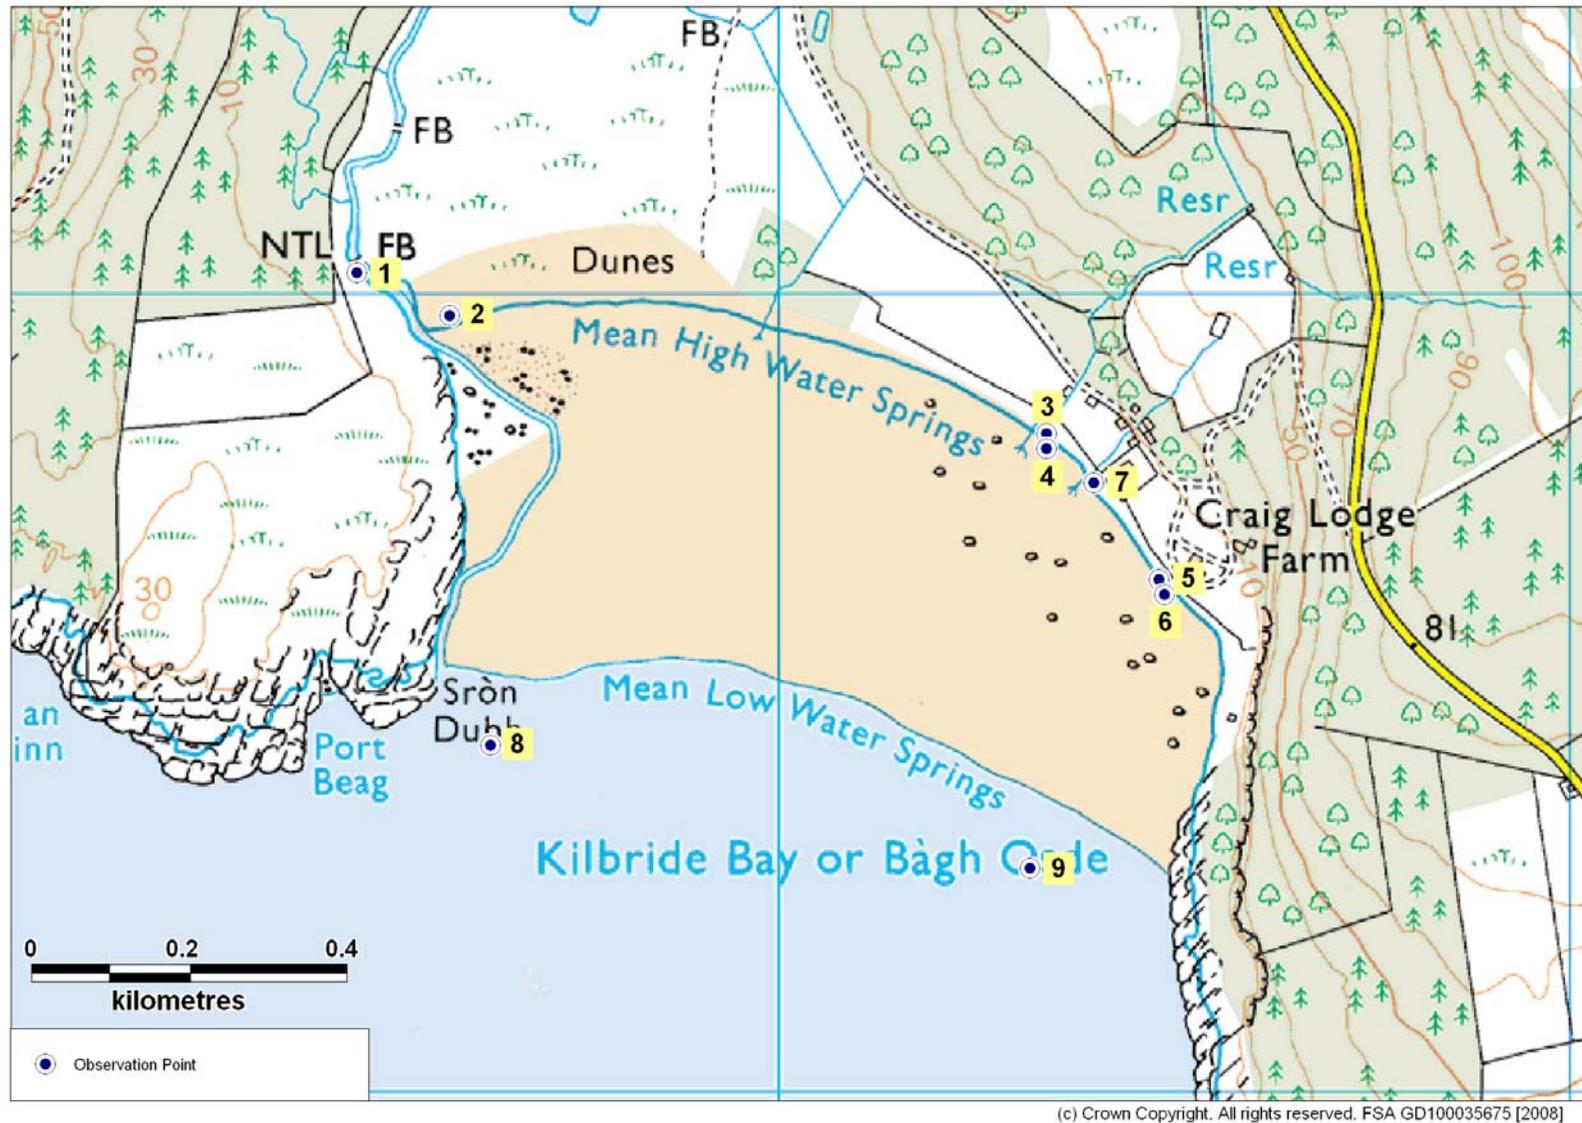
Figure 1. Shoreline Observations

Three streams were observed during the shoreline survey. The Allt Osda and two unnamed streams were measured and sampled. A fourth stream, the Allt a Chaorainn, was found to not flow directly into the sea. It ran along a ditch parallel to the beach to join the next stream to the east. Flow measurements at observation point three include this stream.

Observations can be found in Table 1.

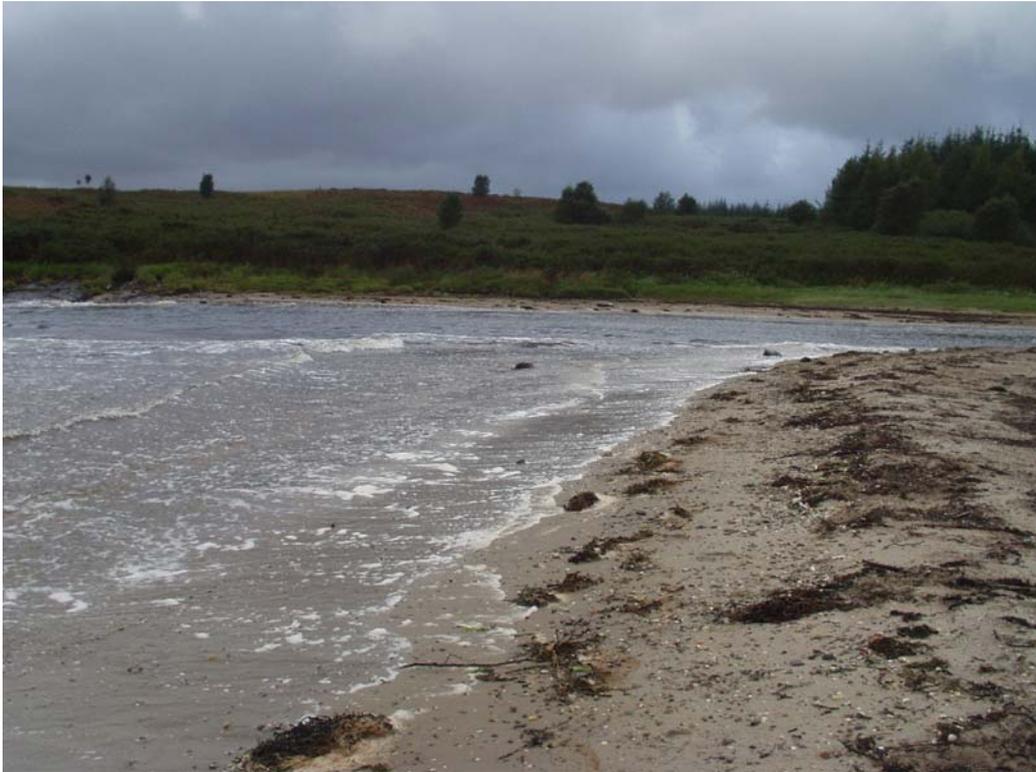
Figure 4. Kilbride Bay, collection point of seawater sample 2

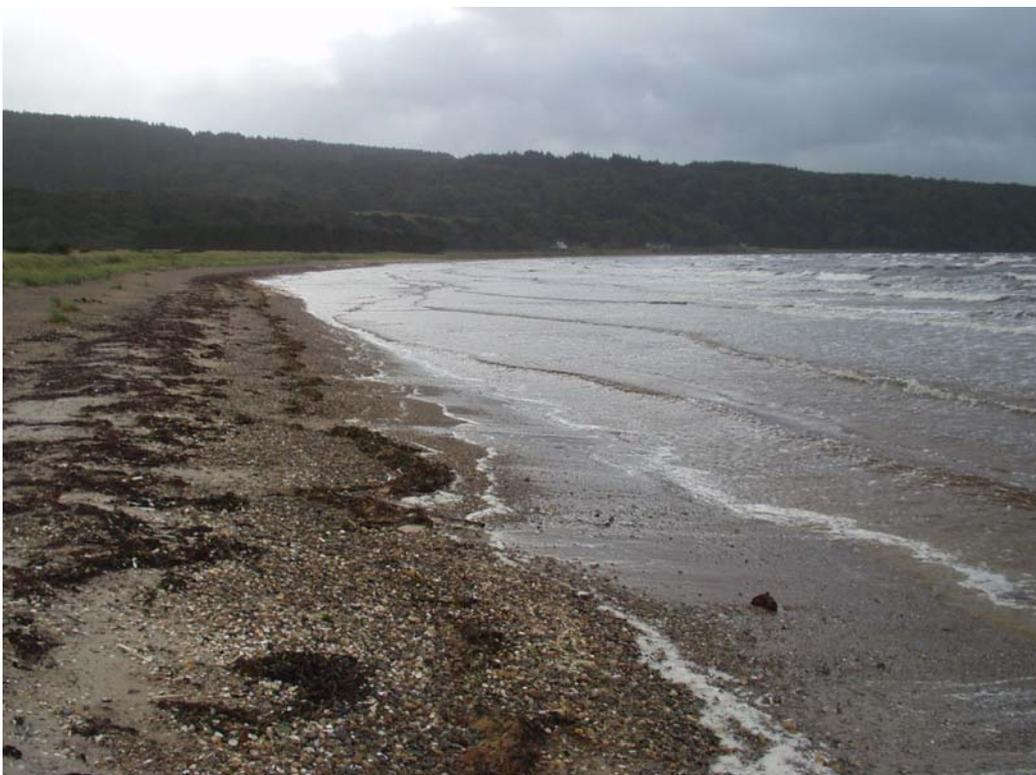
Figure 5. Kilbride Bay

| No. | Date | Time | NGR | East | North | Associated photograph | Description |
|---|---|---|---|---|---|---|--|
| 2 | 11/09/2008 | 10:36 | NR 95585 66976 | 195585 | 666976 | Figures 4 & 5 | Sea water sample K2. Salinity 1016. Fresh cow pats and hoof prints on beach – no animals in sight. |
