Scottish Sanitary Survey Project

Sanitary Survey Report
Burwick: Shalders Ayre
SI 416 821 08
March 2009

Burwick: Shalders Ayre
SI 416

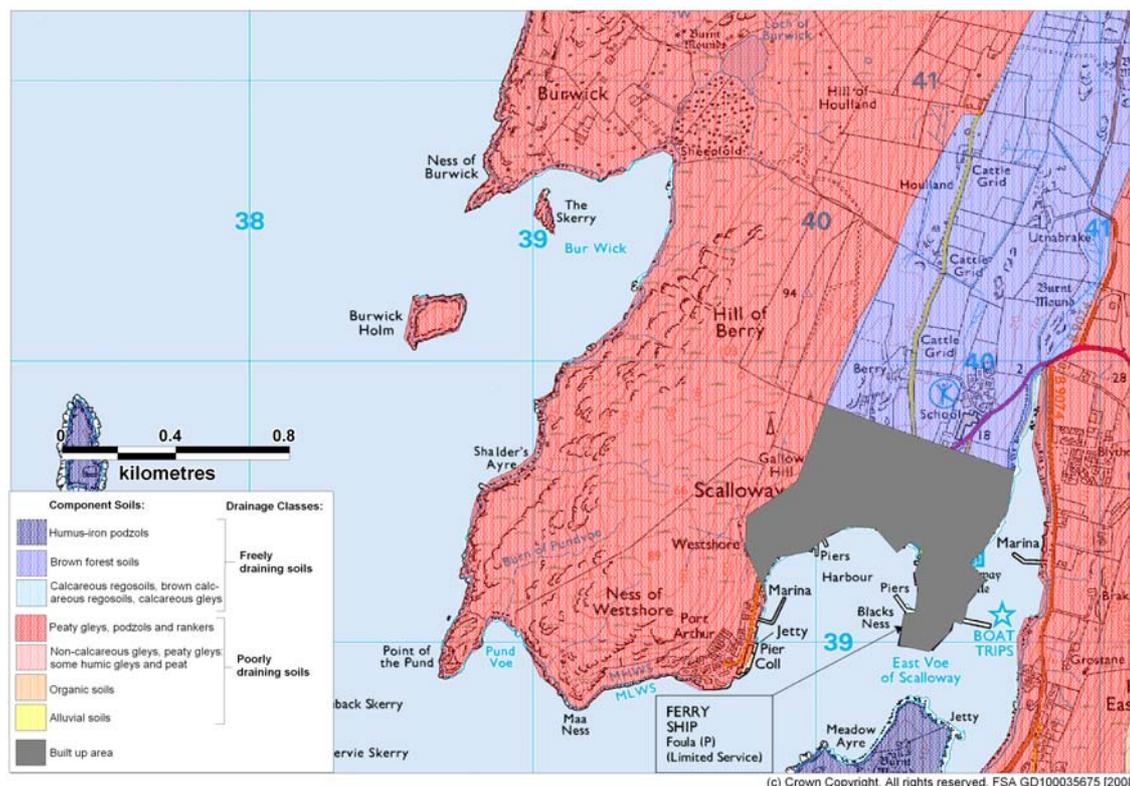
Figure 5.1 Component soils and drainage classes for Burwick.

Geology and soil types were assessed following the method described in Appendix 2. A map of the resulting soil drainage classes is shown in Figure 5.1. Areas shaded red indicate poorly draining soils while areas shaded blue indicate more freely draining soils.

There are three main types of component soil in this area. The most dominant is composed primarily of peaty gleys, podzols and rankers and is classed as poorly draining. This soil type covers the coastline directly adjacent to the Burwick production area and a strip further inland past Scalloway harbour.

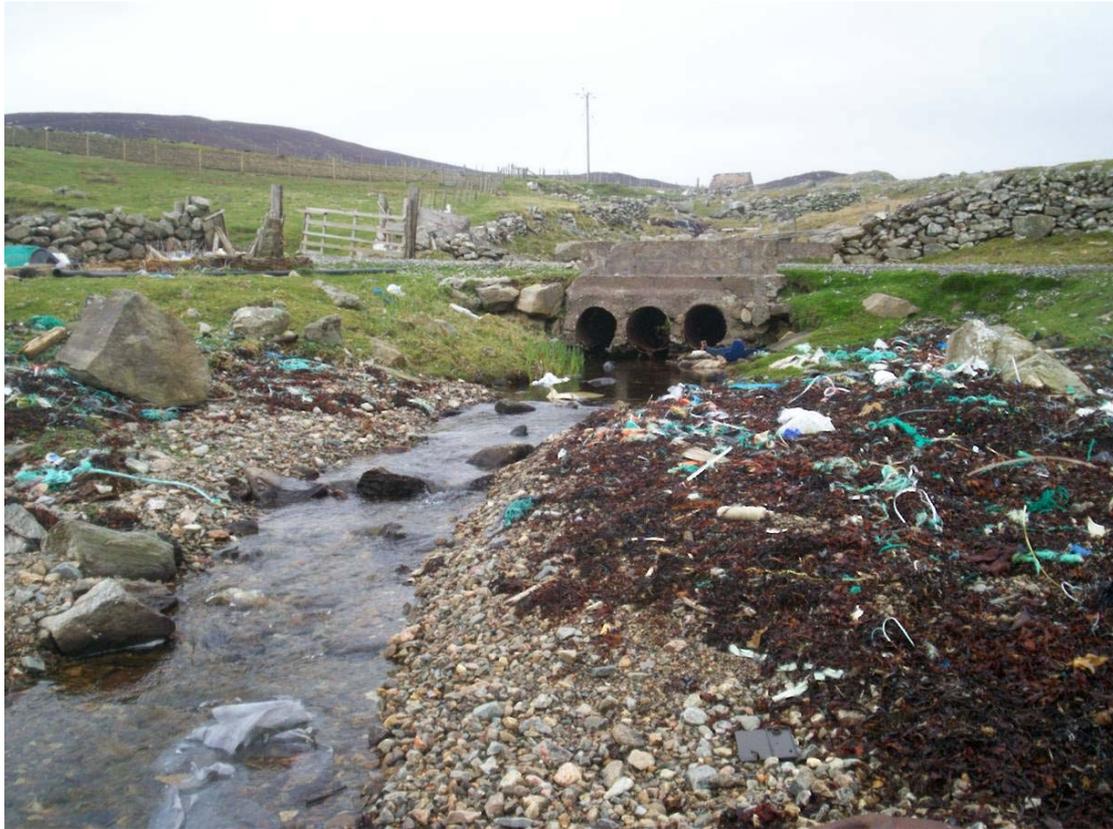
Figure 9. Stream at Burwick

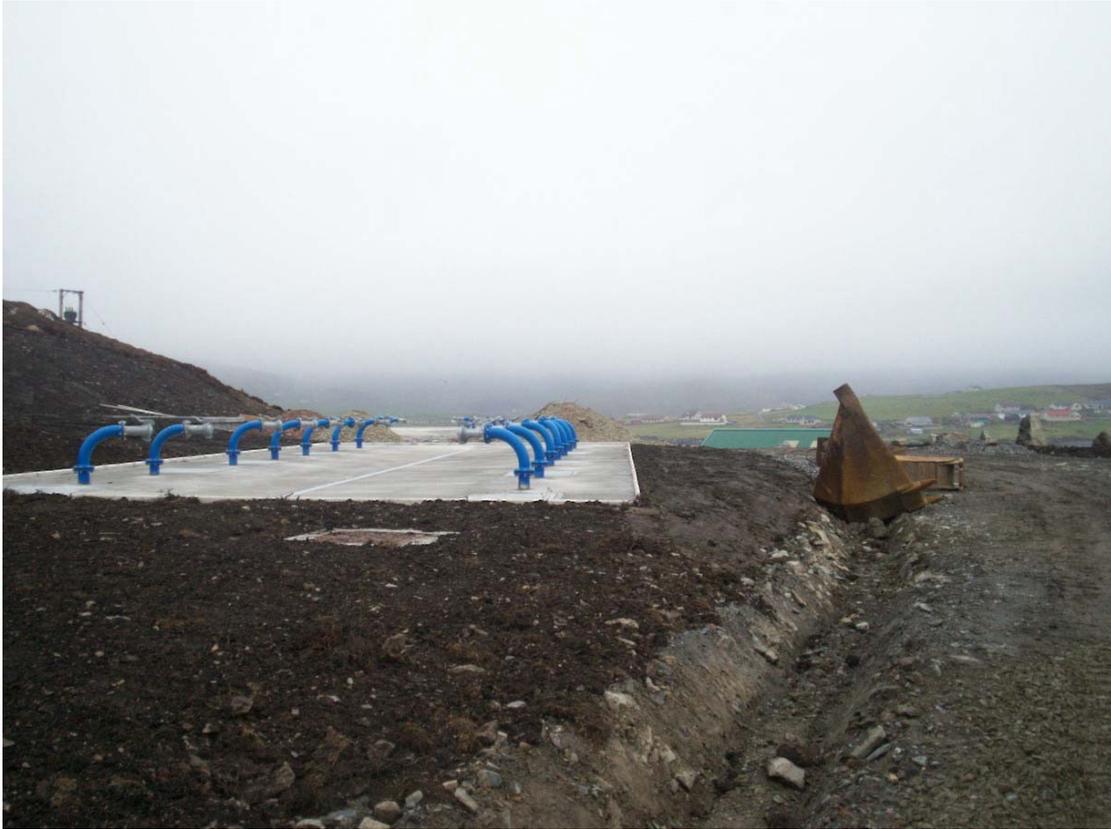
Figure 11. Maa Ness new septic tank
