# Scottish Sanitary Survey Project

**Restricted Sanitary Survey Report  
Carradale Bay  
AB 511  
February 2010**

## Carradale Bay AB 511

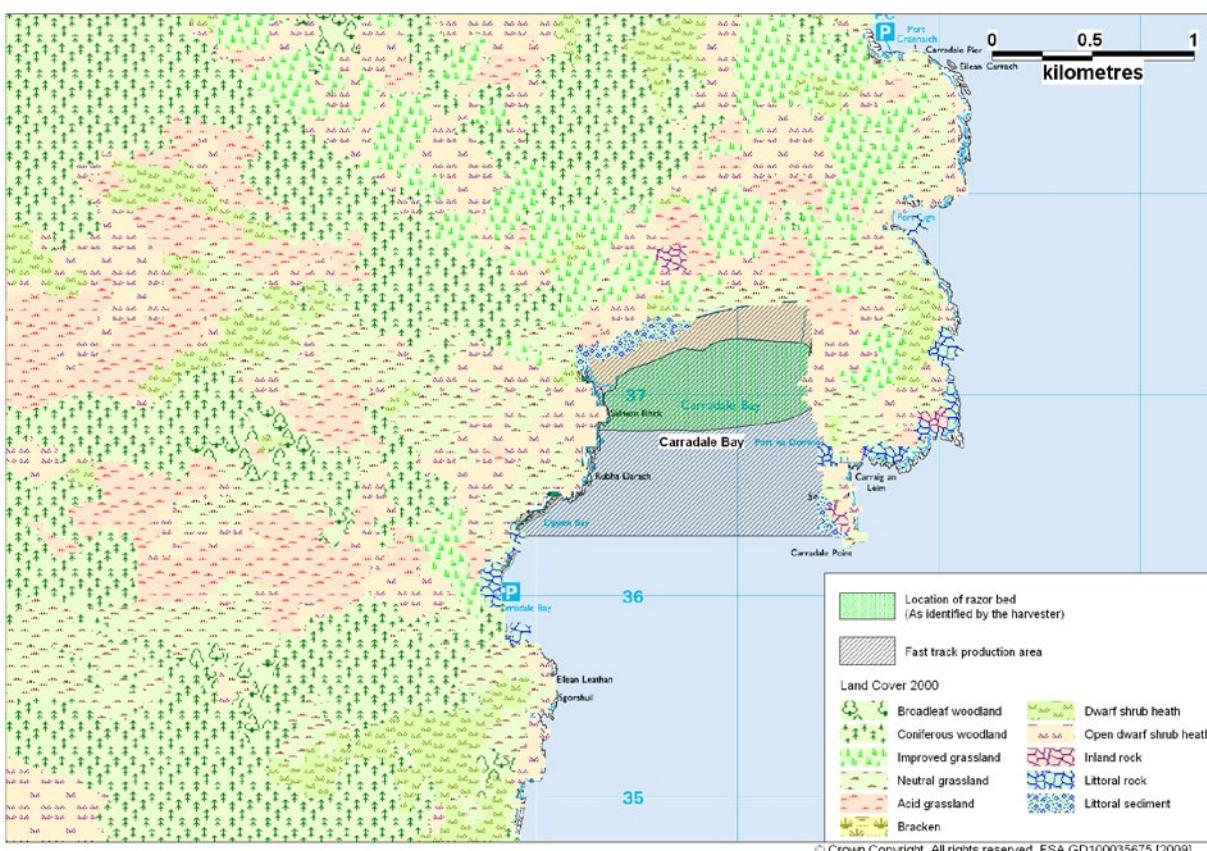
Figure 1.2 Land Cover 2000 data for Carradale Bay

Land Cover 2000 data indicates that the land surrounding Carradale Bay is a mixture of neutral and acid grassland, open heath land, and improved grassland with large areas of coniferous woodland further inland (see Figure 1.2).

Faecal coliform contributions from improved grassland have been shown to be approximately  $8.3 \times 10^8$  cfu km $^{-2}$  hr $^{-1}$  (Kay et al, 2008). The contributions to the contamination if shellfish from all land cover types would be expected to increase significantly after marked rainfall events. This increase would be highest, at more than 100-fold, for improved grassland. Areas of improved grassland surrounding Carradale Bay would be expected to contribute the most to contamination levels carried in surface runoff to this side of the razor clam bed – these areas are mainly located to the north of the bay.

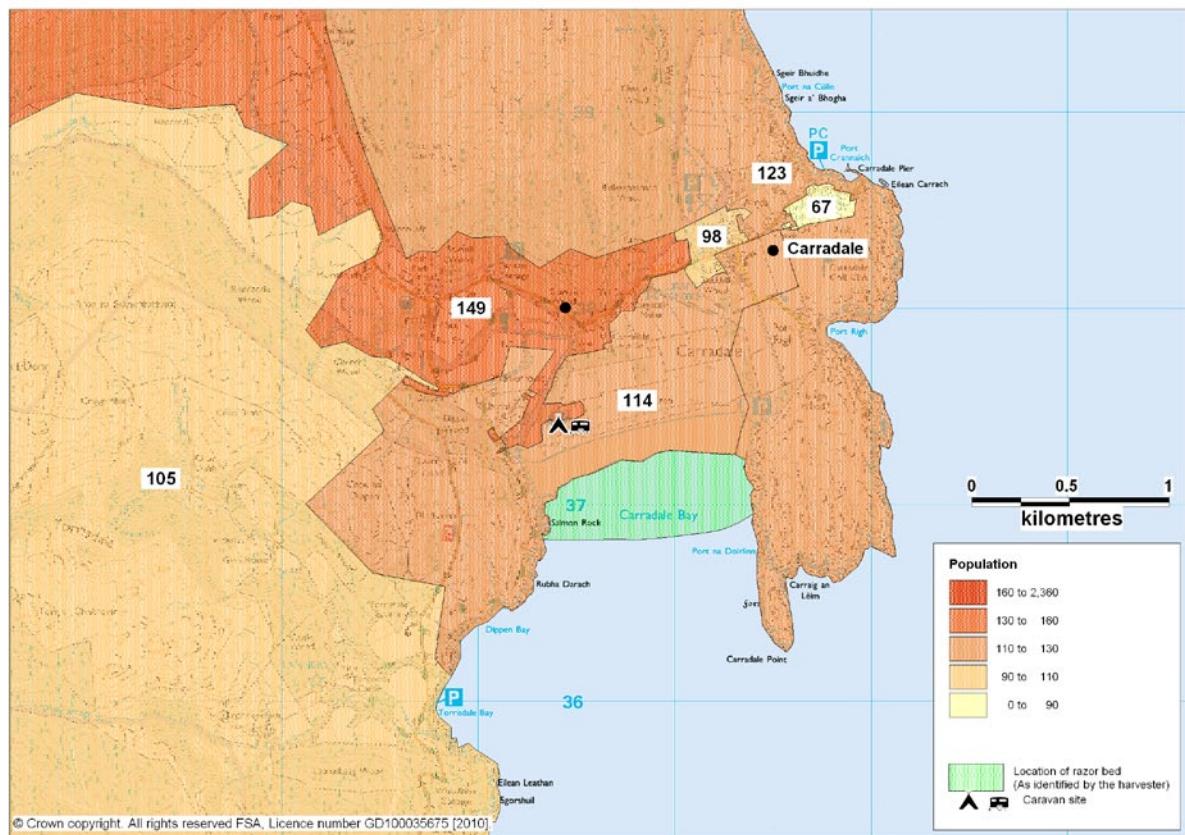
Figure 1.3 Human population surrounding Carradale Bay

Figure 1.3 shows 2001 Census information obtained from the General Register Office for Scotland on the population within the census output areas in the vicinity of Carradale Bay. There are two census output areas with populations of 114 and 123 that are directly adjacent to Carradale Bay. The population surrounding Carradale Bay is mainly located in the village of Carradale, which is split into east and west sides by the Carradale Estate. There is a caravan park located at the western side of the beach that includes 4 pine lodges, static caravans and approximately 70 visitor pitches. The park operates from March to October, with

The main sources of human faecal contamination will therefore be associated with the caravan park and other homes on the west side of the bay and the main village of Carradale, although those in the east Carradale area will tend to more directly influence water quality in Kilbrannan Sound, outside of the bay.

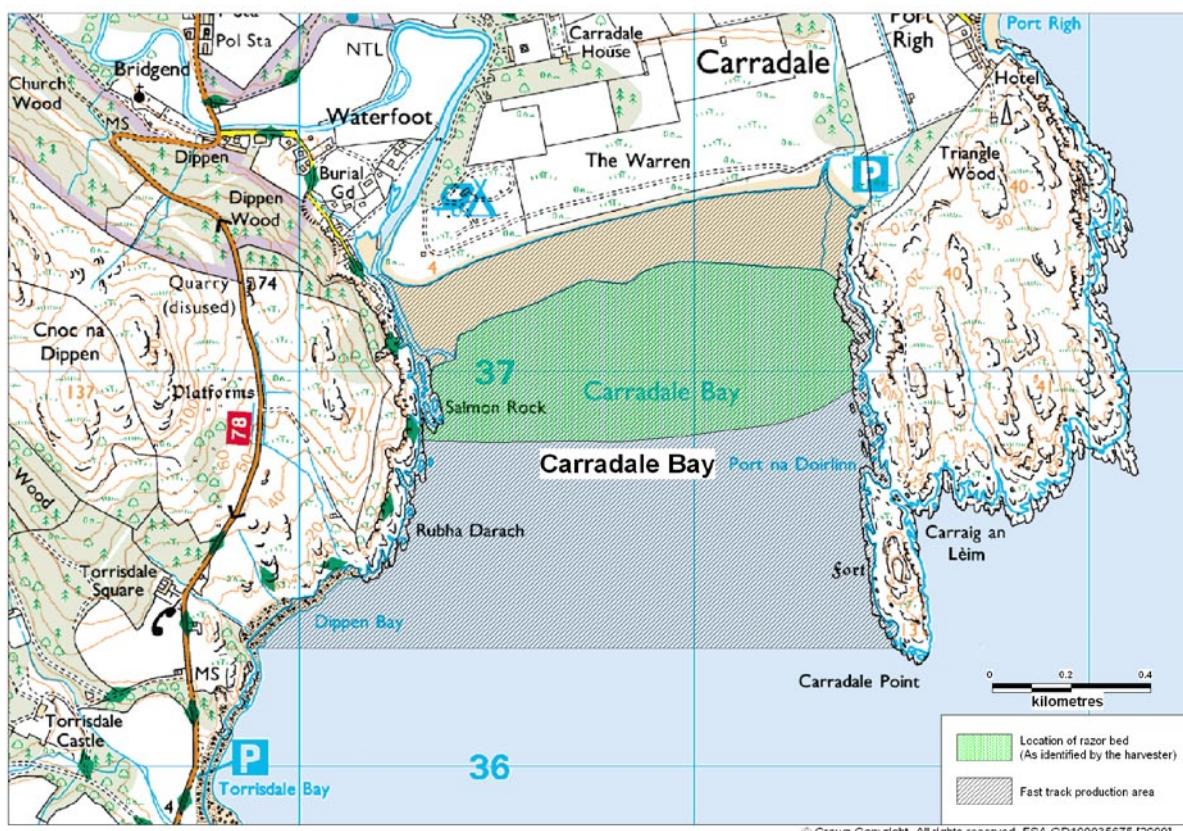
Figure 2.1 Carradale Bay fishery

The harvester has outlined the boundaries of the actual razor bed which lies within the fast track production area (see Figure 2.1). The razors will be hand dived and harvesting is planned to take place throughout the year.

The shellfish bed is located within Carradale Bay. The harvester identified the boundaries of the bed to lie within the bay (see Figure 2.1), however historical *E. coli* monitoring results indicate that razor clams are present slightly further south of the area identified. The razors will be hand dived and harvesting is planned to take place throughout the year.

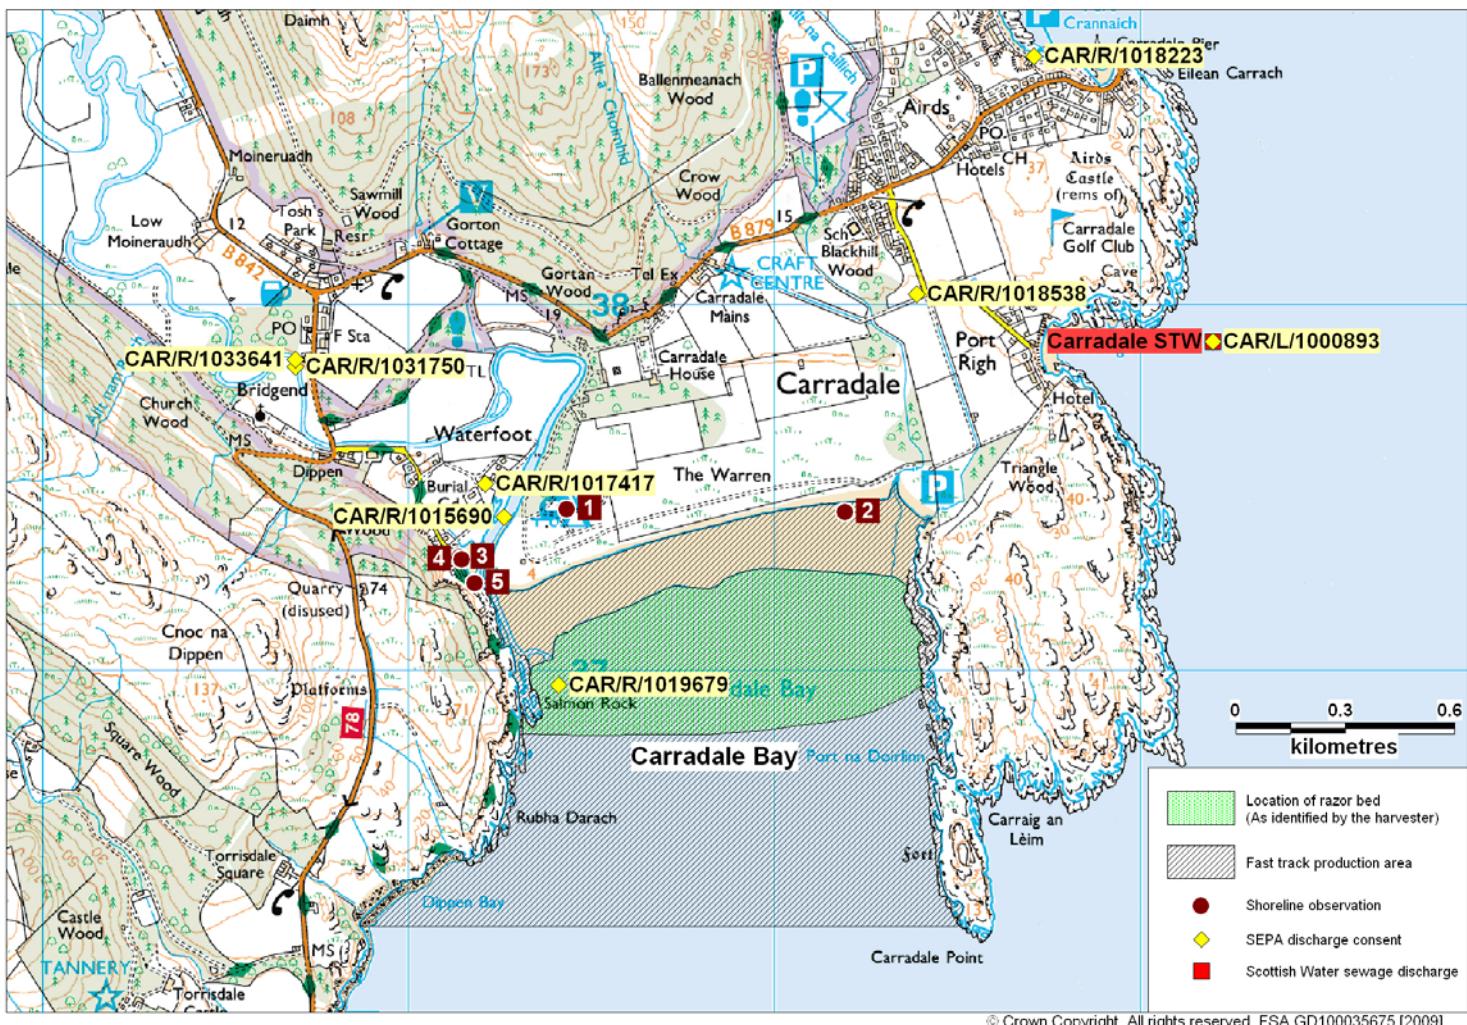
Figure 3.1 Sewage discharges at Carradale Bay

A caravan site toilet block, sanitary debris, outfall pipes and possible septic tanks were also observed during the shoreline survey and these are listed in Table 3.3. Their locations have been included in the mapped discharges in Figure 3.1. Further details can be found in the shoreline survey report in the appendix. The shoreline survey concentrated on the area around Carradale Bay and therefore neither the discharges higher up Carradale Water, nor the discharge to Kilbrannan Sound associated with Carradale STW, were confirmed visually.

Overall, the majority of the sewage discharges are located on the western side of the bay, where four of the SEPA consents discharge into Carradale Water which flows into Carradale Bay. Contamination inputs are therefore expected to be higher on the western side of the shellfish bed.

The majority of the sewage discharges are concentrated at the north-western side of the bay and four of them discharge into Carradale Water which flows into the bay. Therefore contamination of the shellfish bed from sewage discharges is likely to be greatest on the north-western side.

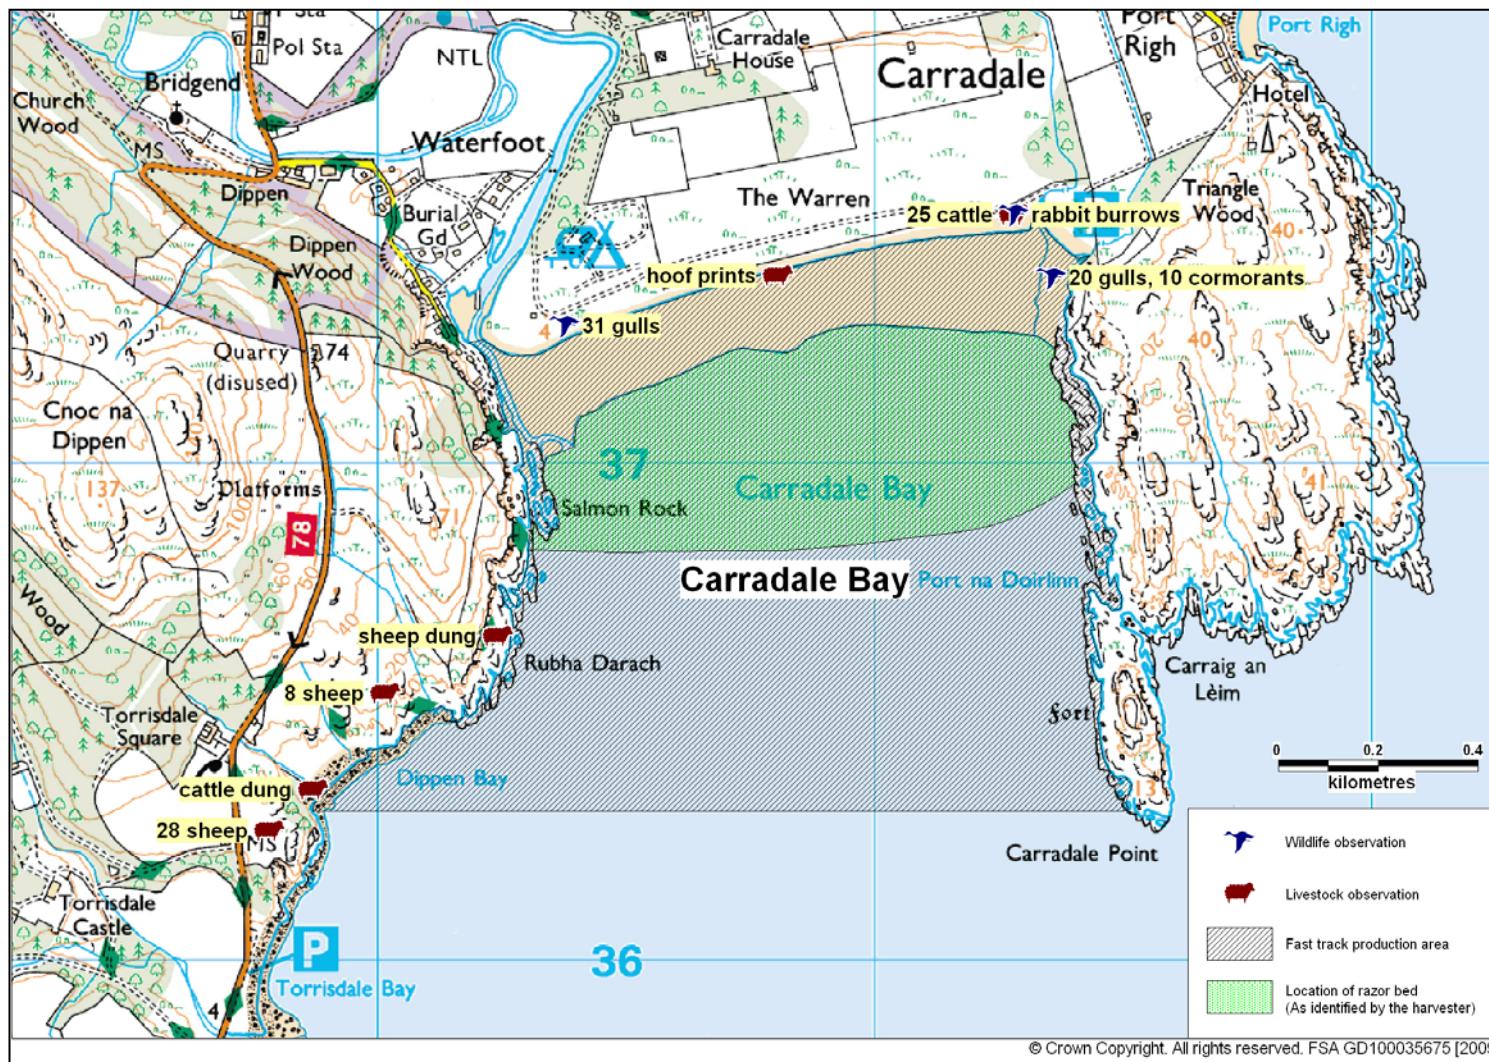
Figure 4.1 Livestock and wildlife present at Carradale Bay during the shoreline survey

During the shoreline survey approximately 25 cattle were observed on the shoreline on the north-east side of the bay (see Figure 4.1). On the south western coastline of the bay a further 8 sheep were observed adjacent to Dippen Bay and a further 28 sheep were observed just south of Dippen Bay.

During the shoreline survey approximately 20 gulls and 10 cormorants were observed on the eastern side of Carradale Bay and a further 30 gulls were observed on the western side (see Figure 4.1). Seabirds such as gulls will always be present on and around Carradale Bay but their distribution is likely to be even over time and as such would not materially affect the assessment. Rabbits were spotted at scattered locations along each side of the shoreline. No other wildlife was observed at the time of the shoreline survey.

During the shoreline survey approximately 25 cattle were observed on the shoreline on the east side of the bay (see Figure 4.1). On the south western coastline of the bay a further 8 sheep were observed adjacent to Dippen Bay and a further 28 sheep were observed just south of Dippen Bay. All livestock was observed close to the shoreline. Due to the proximity of the livestock to the shellfish bed, agricultural sources are considered to be a significant source of contamination in the area. The north eastern and south western parts of the shellfish bed are likely to experience the largest amount of contamination from livestock on the basis of the limited information available.

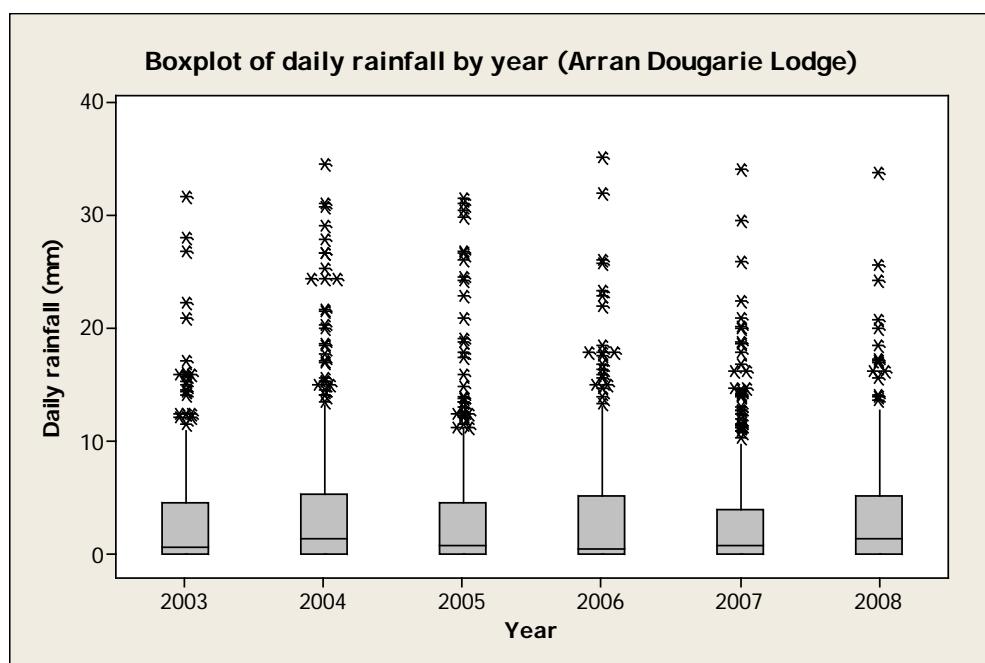
Figure 5.1 Boxplot of daily rainfall at Arran Dougarie Lodge by year

Figure 5.1 shows that there was relatively little variation between years observed.

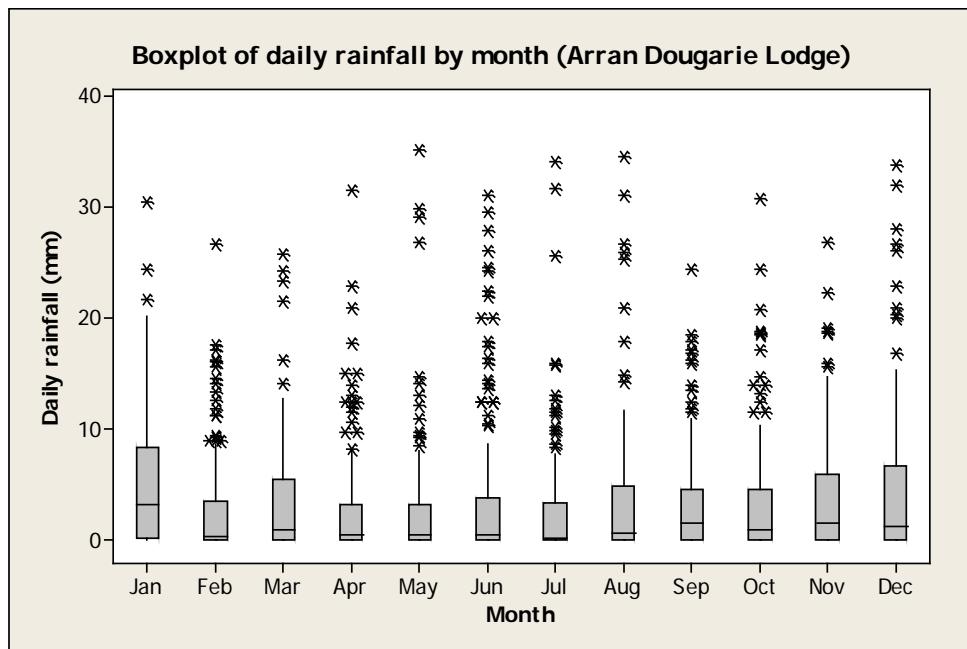
Figure 5.2 Boxplot of daily rainfall values at Arran Dougarie Lodge by month

The wettest months were December and January. For the period considered here (2003 – 2008), 35% of days for which records were available experienced no rainfall while 52% of days experienced rainfall of 1mm or less. The mean rainfall was less than 10 cm per day. Maximum recorded daily rainfall was greater than 30 cm. High rainfall events (>20 mm per day) were recorded during all months. The highest daily rainfall recorded here fell in May, generally one of the driest months.

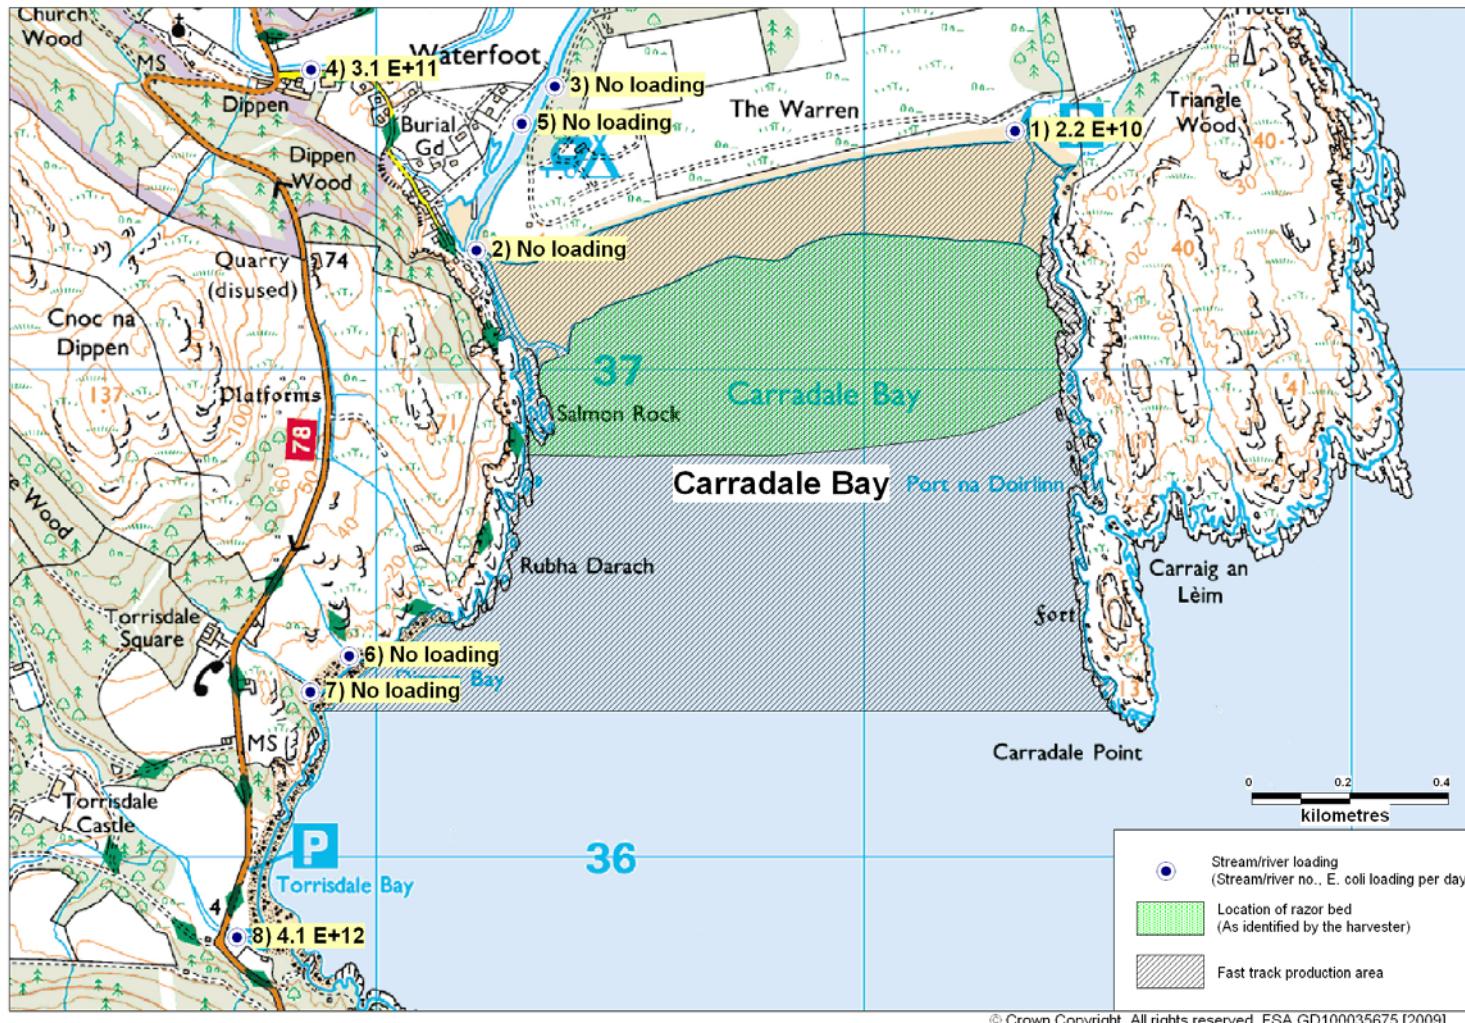
Figure 6.1. Location of stream/river flows and loadings at Carradale Bay

There is no river gauging station in the vicinity of Carradale Bay. A total of eight fresh water inputs were observed discharging into the sound. Only three of these streams were of a measurable size and had a measurable flow. These streams represented the largest freshwater inputs to the area and are listed in Table 6.1 and mapped in Figure 6.1.

Where the bacterial loading is labelled on the map, the scientific notation is written in digital format, as this is the only format recognised by the mapping software. So, where normal scientific notation for 1000 is  $1 \times 10^3$ , in this case it would be written as 1E+3.

largest *E. coli* loading of  $4.1 \times 10^{12}$ . The two other streams sampled also had high *E. coli* loadings of  $3.1 \times 10^{11}$  (Carradale Water) to  $2.2 \times 10^{10}$  (unnamed stream). Overall it is expected that the freshwater inputs into Carradale Bay will have an intermediate effect on the bacterial contamination of shellfish, especially on the western side of the bay where the two streams (Carradale Water and Torrisdale Burn) had the higher *E. coli* loadings.

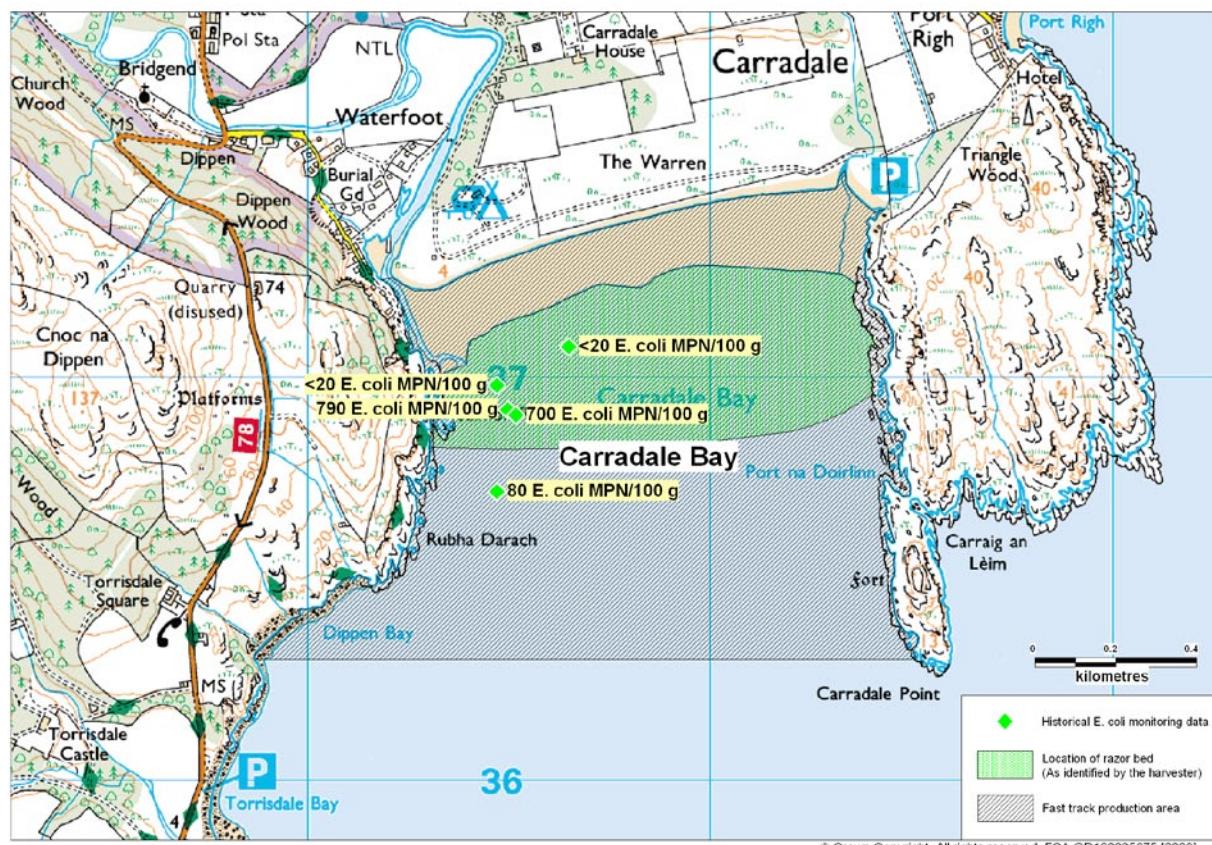
Figure 7.1 Geographical location of Carradale Bay historical *E. coli* monitoring results

Figure 7.1 shows the location of the historical *E. coli* monitoring results. There are not enough results to assess the geographical pattern of results statistically. However, it can be seen that the two highest results were obtained from almost the same location, although sampled a week apart.

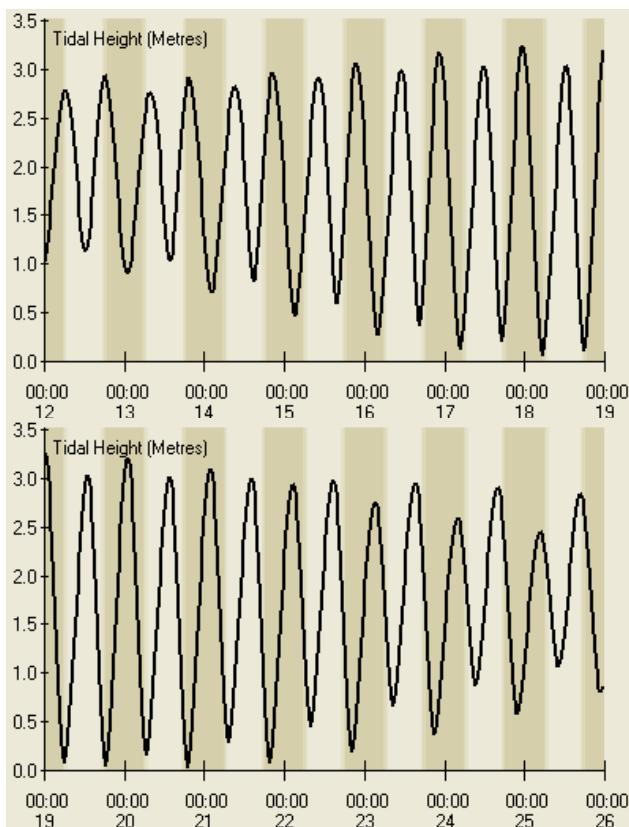
Figure 8.3 Tidal curves for Carradale

The two tidal curves below are for the port of Carradale, the nearest secondary port— they have been output from UKHO TotalTide. The first is for seven days beginning 00.00 GMT on 12<sup>th</sup> October 2009. The second is for seven days beginning 00.00 GMT on 19<sup>th</sup> October 2009. Together they show the predicted tidal heights over high/low water for a full neap/spring tidal cycle.

MHWS	3.1 m
MHWN	2.6 m
MLWN	1.1 m
MLWS	0.4 m

Predicted heights are in metres above chart datum. The tidal range at spring tide is therefore approximately 2.7 m and at neap tide 1.5 m.

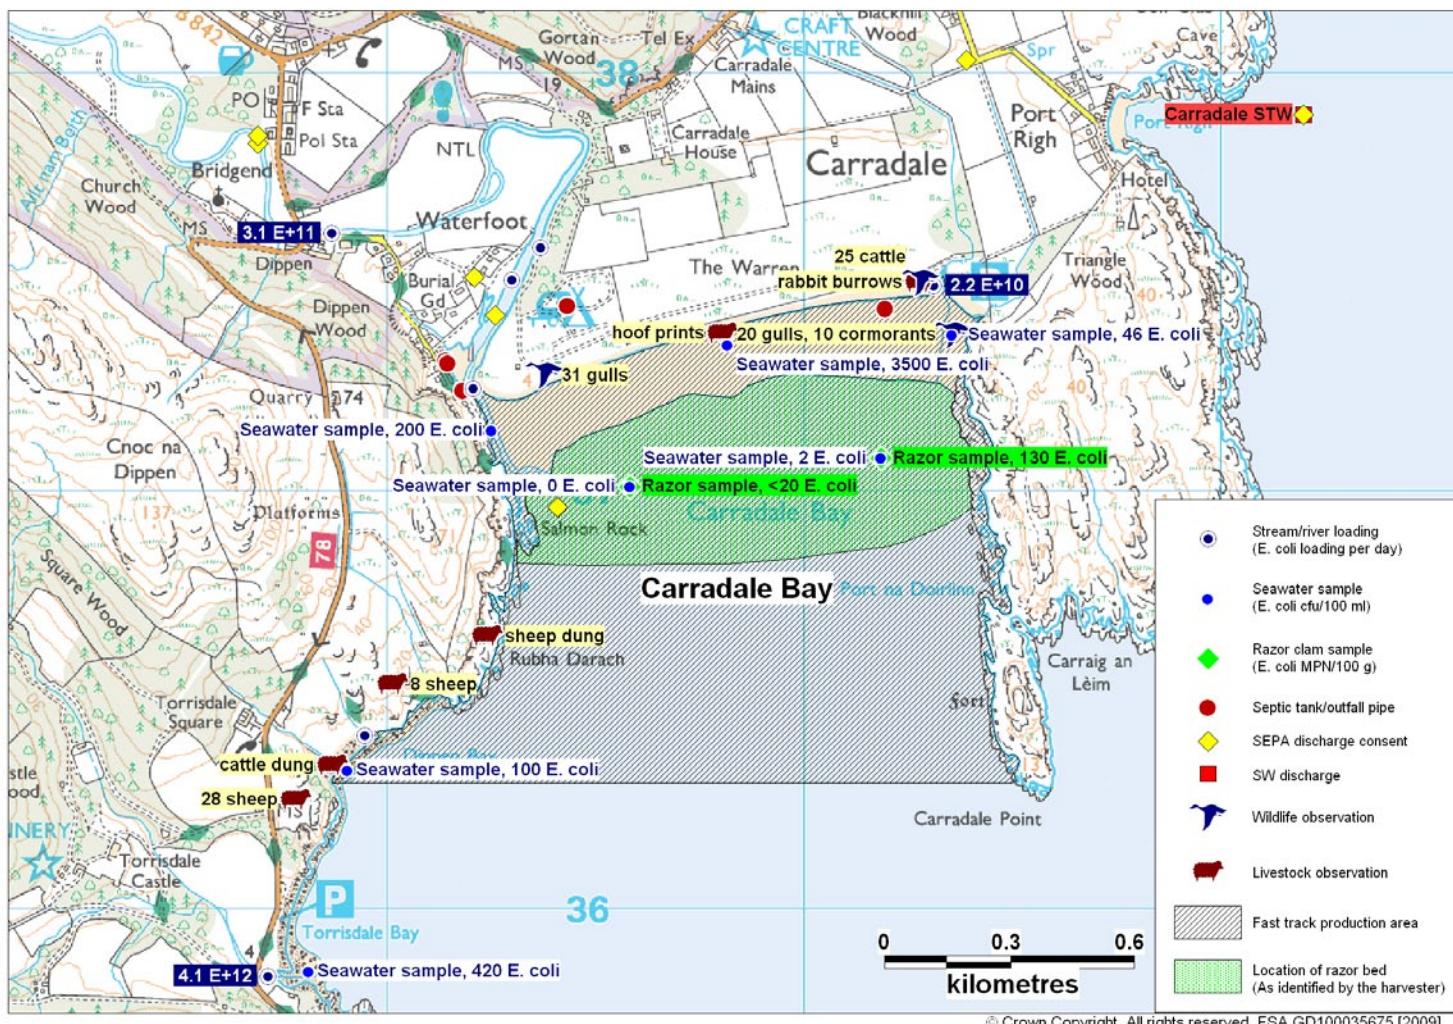
Figure 9.1 Summary of shoreline observations

A map is provided in Figure 9.1 that shows the relative locations of the most significant findings of the shoreline survey. Where the bacterial concentration is labelled, the scientific notation is written in digital format, as this is the only format recognised by the mapping software. So, where normal scientific notation for 1000 is  $1 \times 10^3$ , in this case it would be written as 1E+3.

- Contaminated freshwater streams in the area
- Sewage outfall pipes discharging into the area
- Livestock grazing on the shoreline

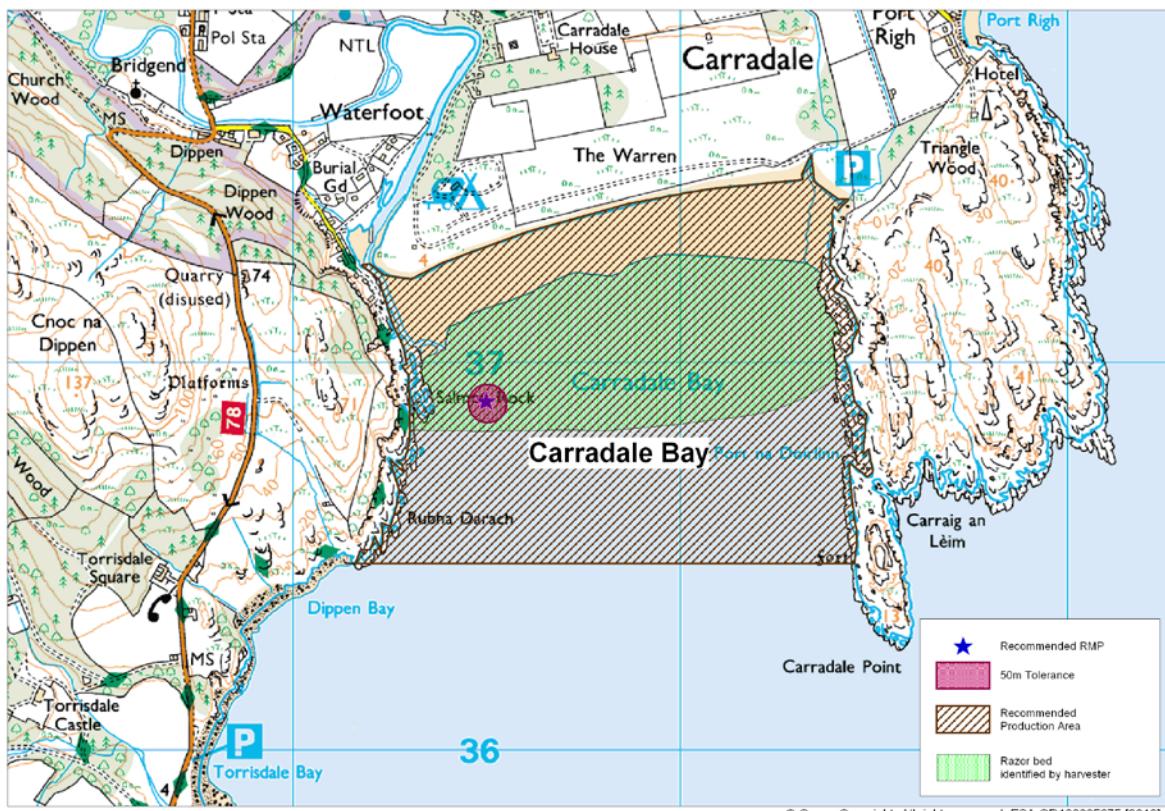
The area bounded by lines drawn between NR 8016 3648 to NR 8145 3648 extending to MHWS.

This area covers both the shellfish bed as identified by the harvester and the location of all of the shellfish samples taken to date, while moving the south-western boundary further away from the potential contamination source at Torrisdale Burn.

It is recommended that the RMP be located at NR 8050 3690 in the western side of the shellfish bed likely to be subject to the greatest contamination. The recommended tolerance is 50 m – this recognises the potential difficulty of gathering sufficient razors close to the identified point while constraining the sampling to that area identified as of higher risk.

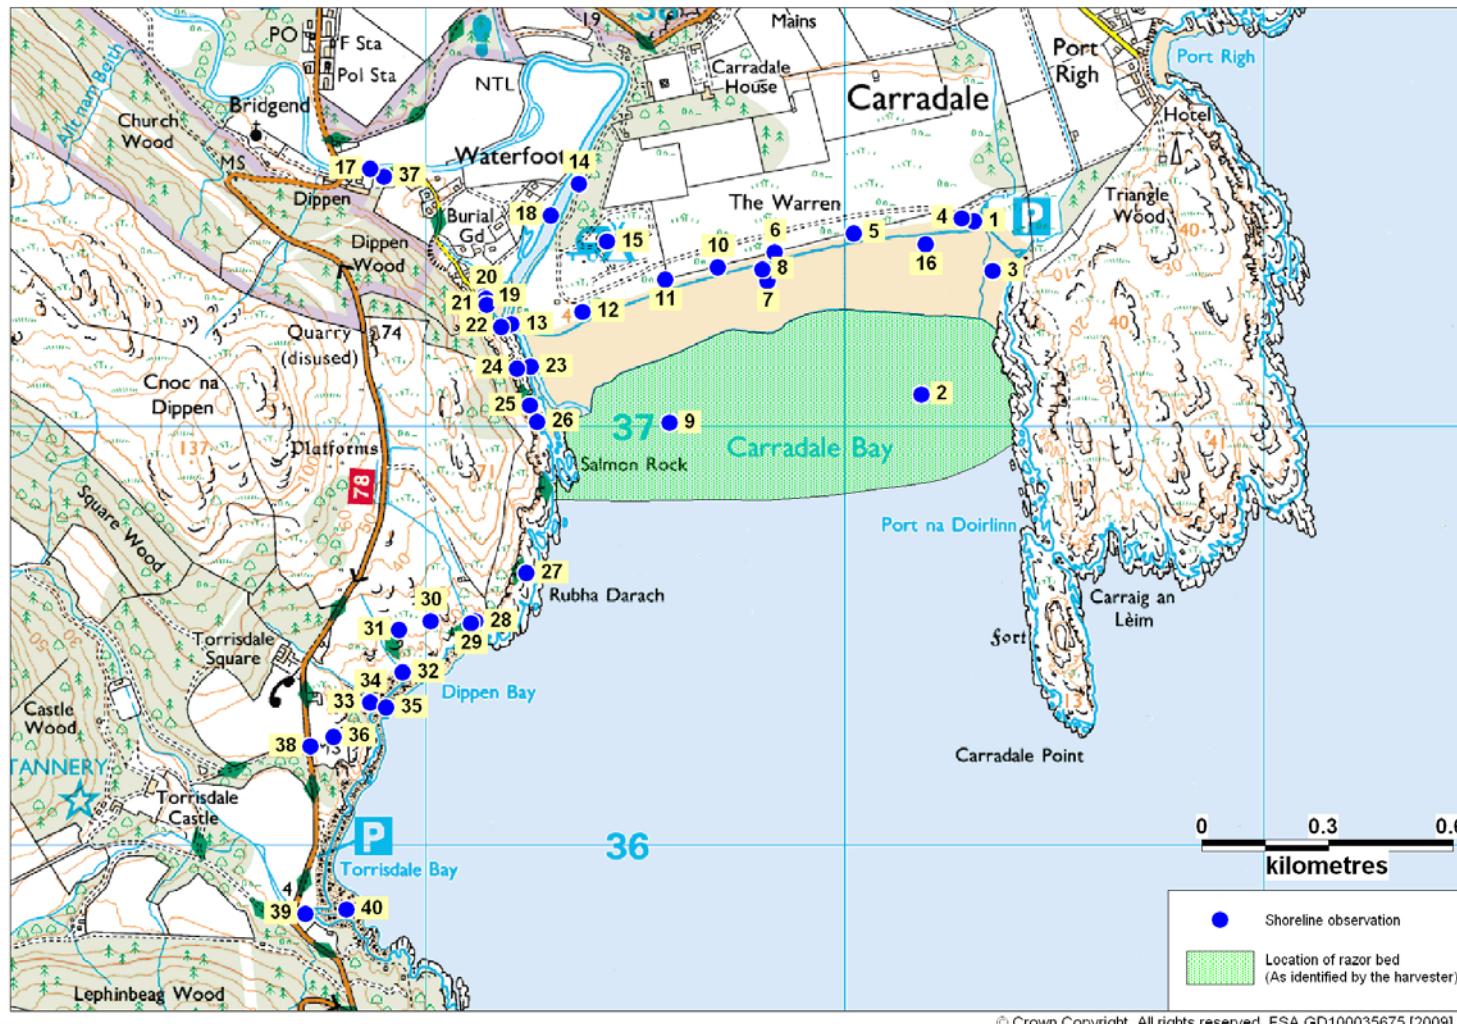
Figure 1. Shoreline Observations

No.	Date	Time	NGR	East	North	Associated photograph	Description
1	14/10/2009	08:58	NR81311 37491	181311	637491	4	Stream east side of bay W 1.51, D 0.15, F 0.571. Carradale fresh water sample (CFW) 1
2	14/10/2009	09:00	NR 81186 37078	181186	637078	-	Razor sample (CBR) 1, Seawater sample (CBSW) A, Sal - 35 ppt, water temp 14C
3	14/10/2009	09:09	NR81356 37373	181356	637373	-	Carradale seawater sample (CSW) 1, Sal - 20 ppt. 20 seagulls on shore, 10 cormorants/shags on rock to point
4	14/10/2009	09:14	NR81281 37499	181281	637499	-	Cattle dung on sand, 25 cattle in field behind shore. Farm buildings, rabbit burrows.
5	14/10/2009	09:19	NR81023 37463	181023	637463	-	Static caravan in field behind shore
6	14/10/2009	09:23	NR 80835 37418	180835	637418	-	Static caravan in field behind shore
7	14/10/2009	09:25	NR 80818 37349	180818	637349	-	Carradale seawater sample (CSW) 2, Sal - 19 ppt
8	14/10/2009	09:28	NR 80805 37377	180805	637377	-	Horse hoof prints in sand

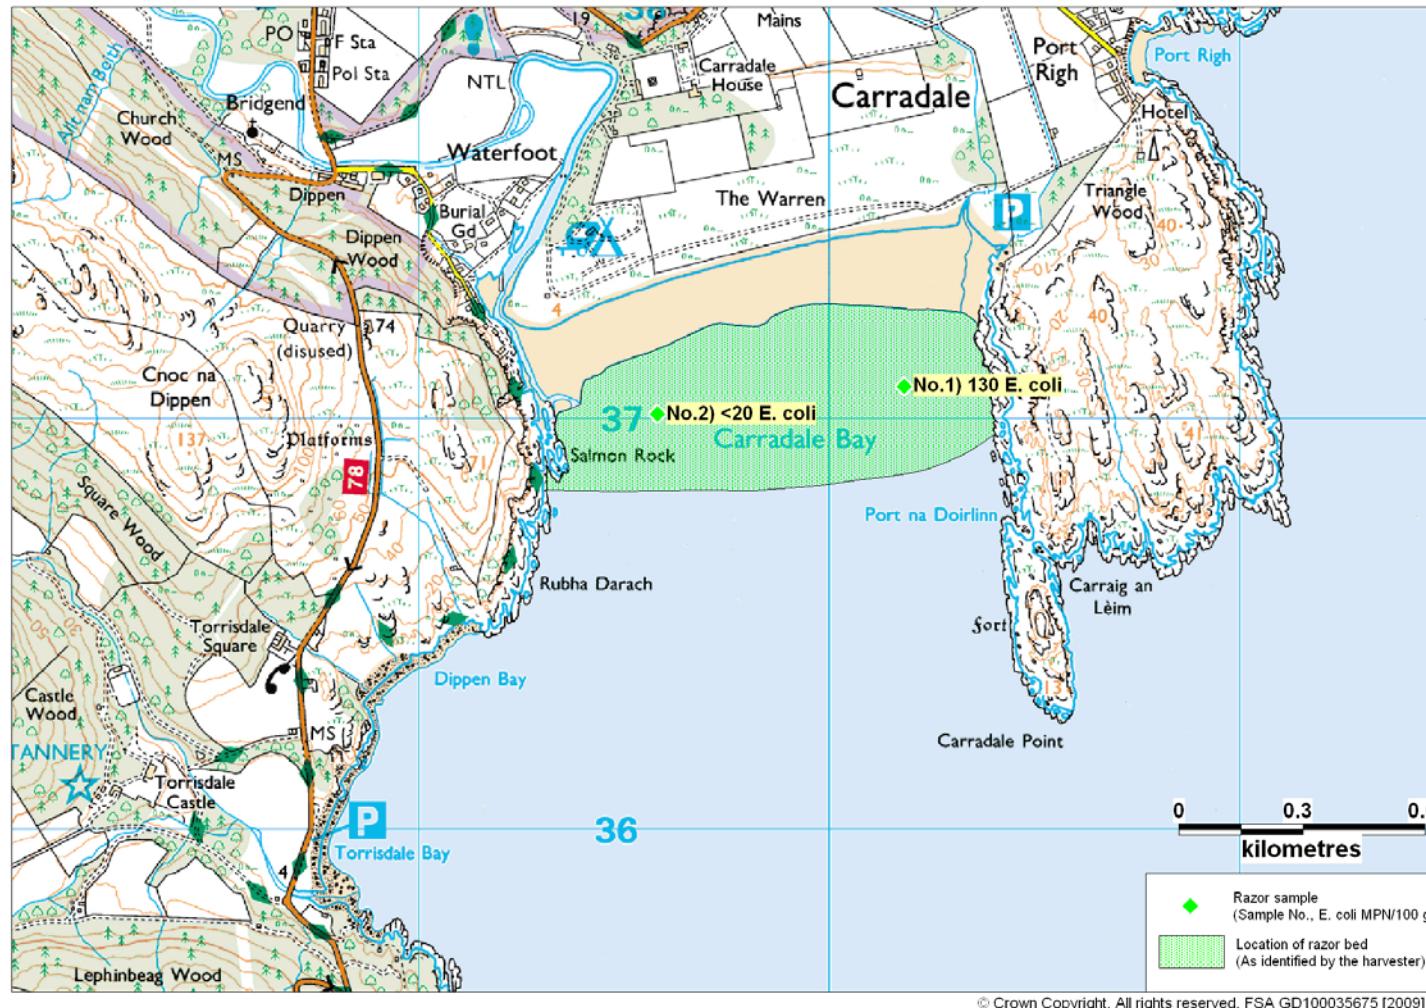
Figure 3. Shellfish sample results

No.	Date	Sample	Grid Ref	Type	<i>E. coli</i> (MPN/100 g)
1	14/10/2009	CBR1	NR 81186 37078	Razor clams	130
2	14/10/2009	CBR2	NR 80583 37010	Razor clams	<20

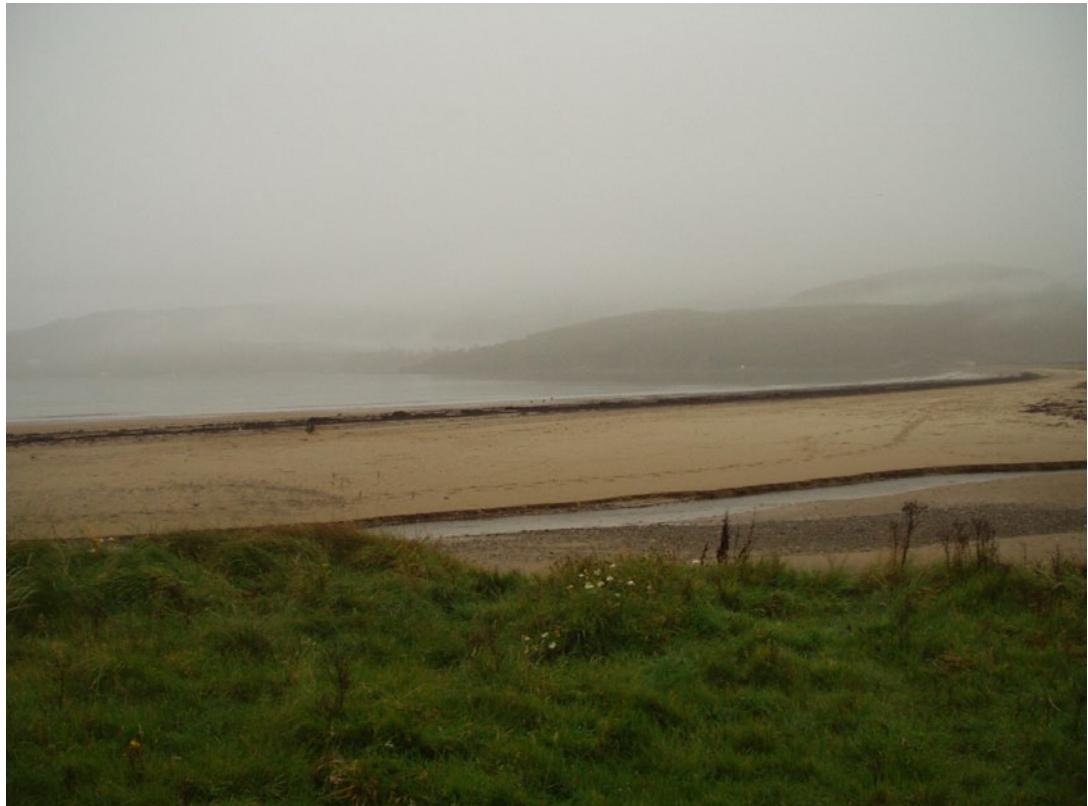
Figure 4. Stream on east side of the bay, location of fresh water sample 1 (CFW1)

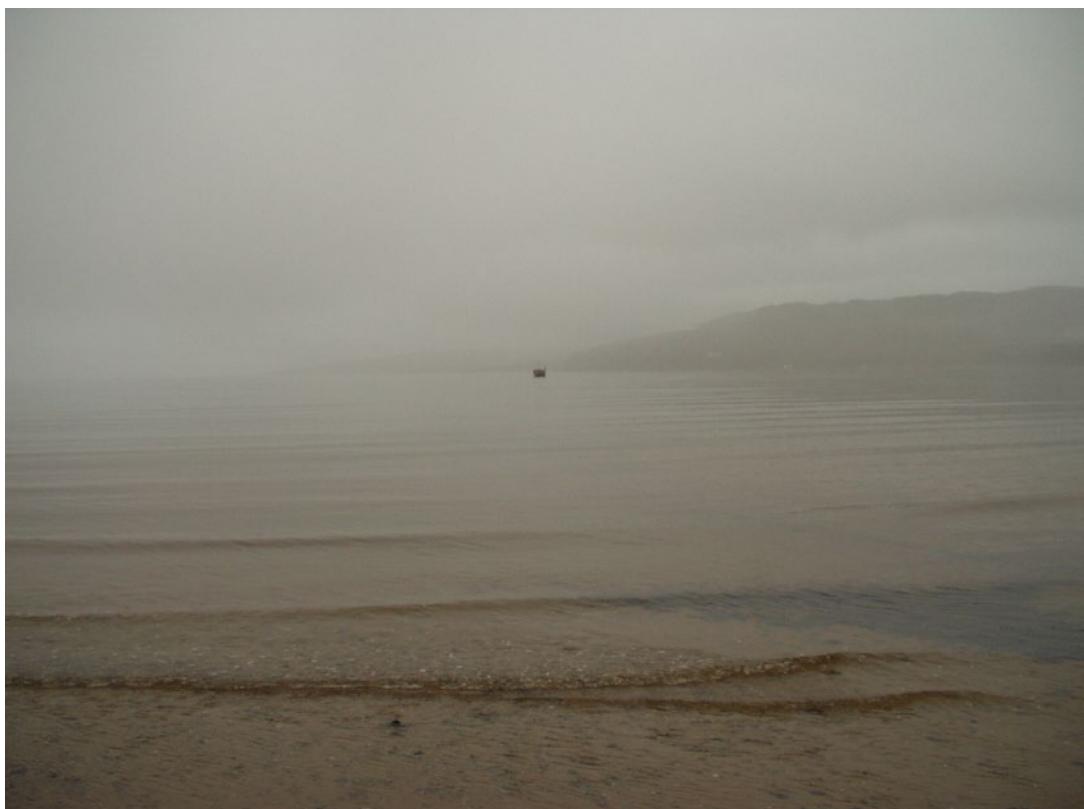
Figure 5. Location of sea water sample 16 (CSWB)

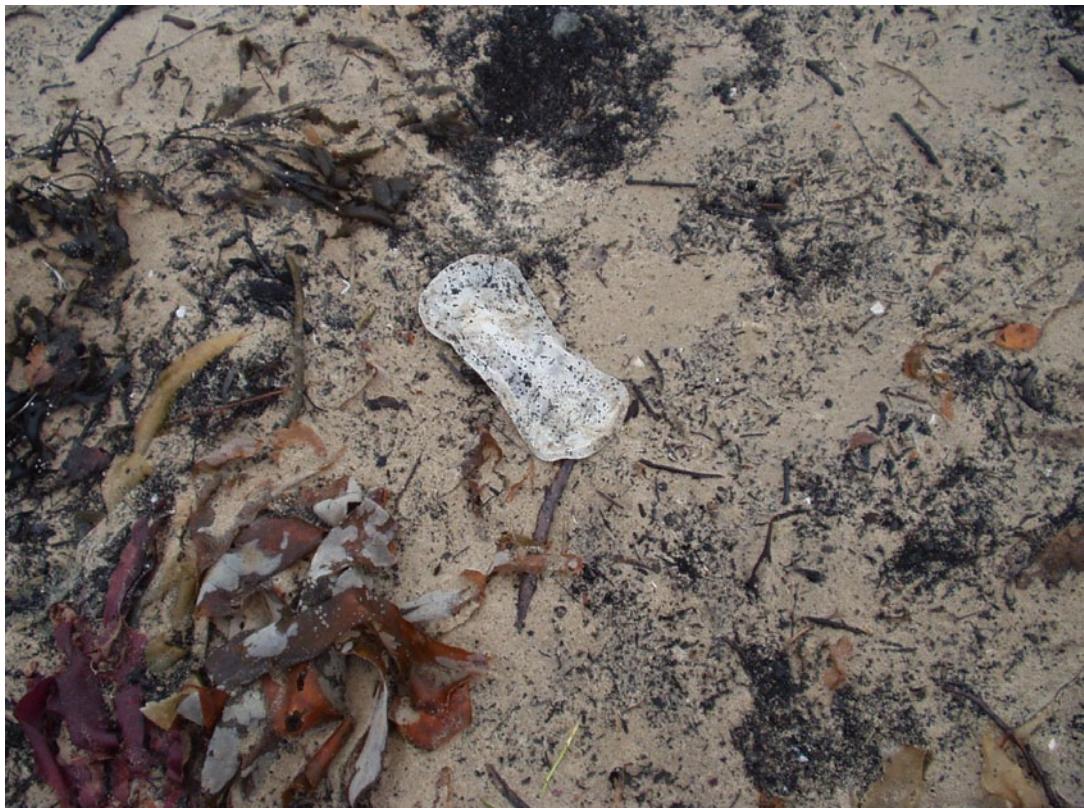
Figure 6. Sewage related debris at high tide mark

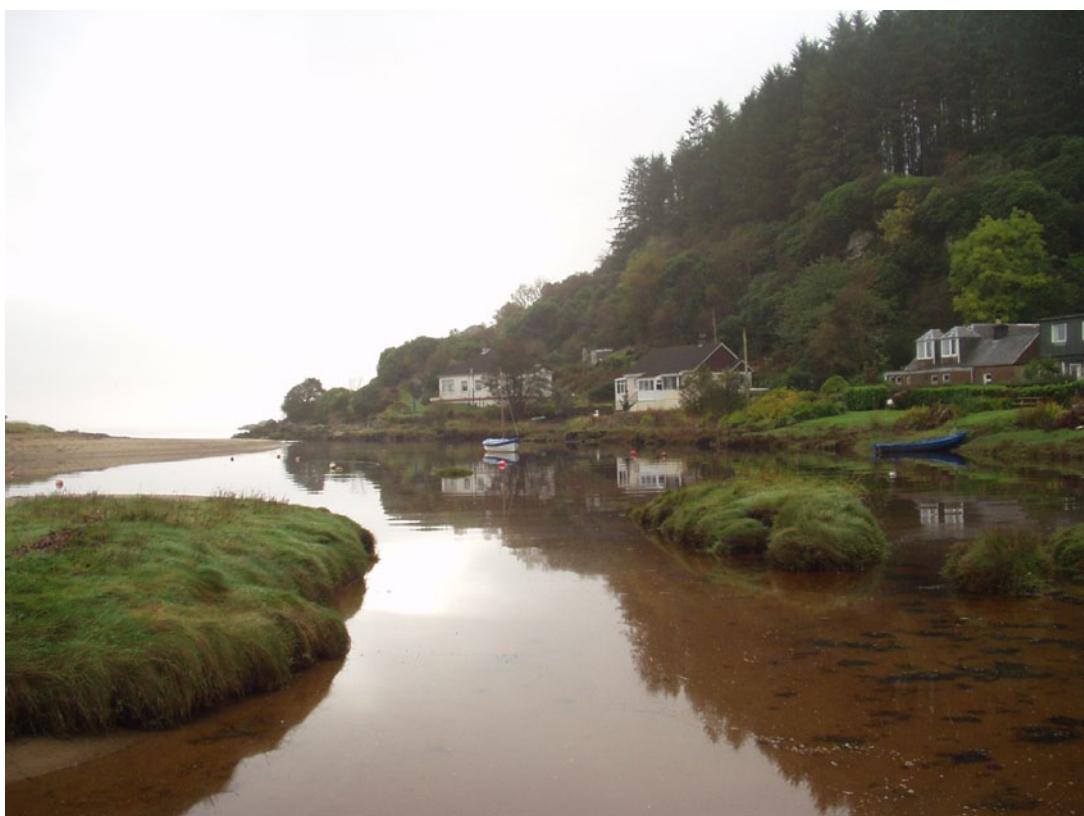
Figure 7. Location of fresh water sample 5 (CFW5)

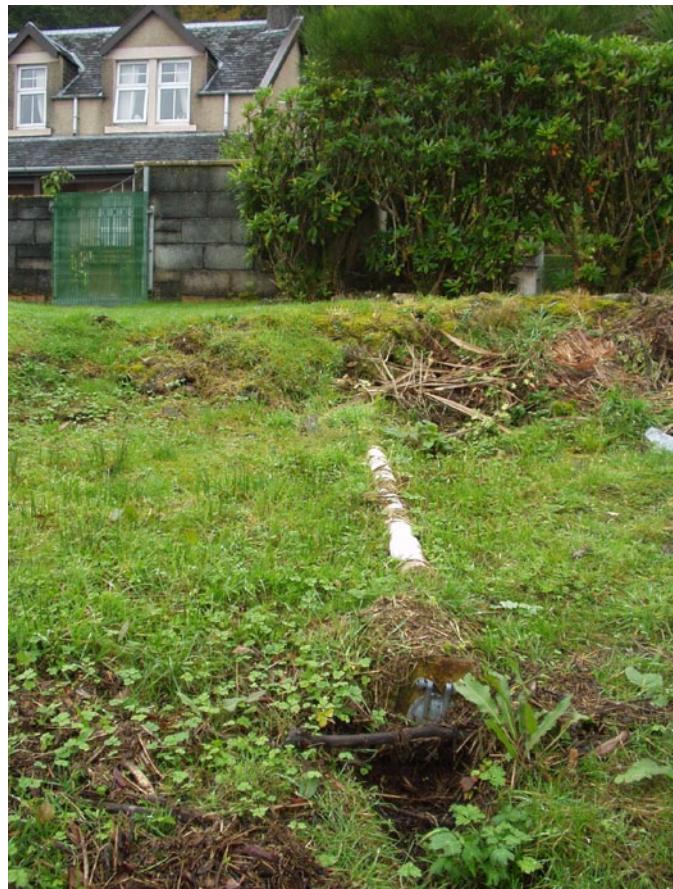
Figure 8. Pipe underneath house, no flow at time of shoreline survey
