# Scottish Sanitary Survey Project

**Restricted Sanitary Survey Report  
Carradale Bay  
AB 511  
February 2010**

## Carradale Bay AB 511

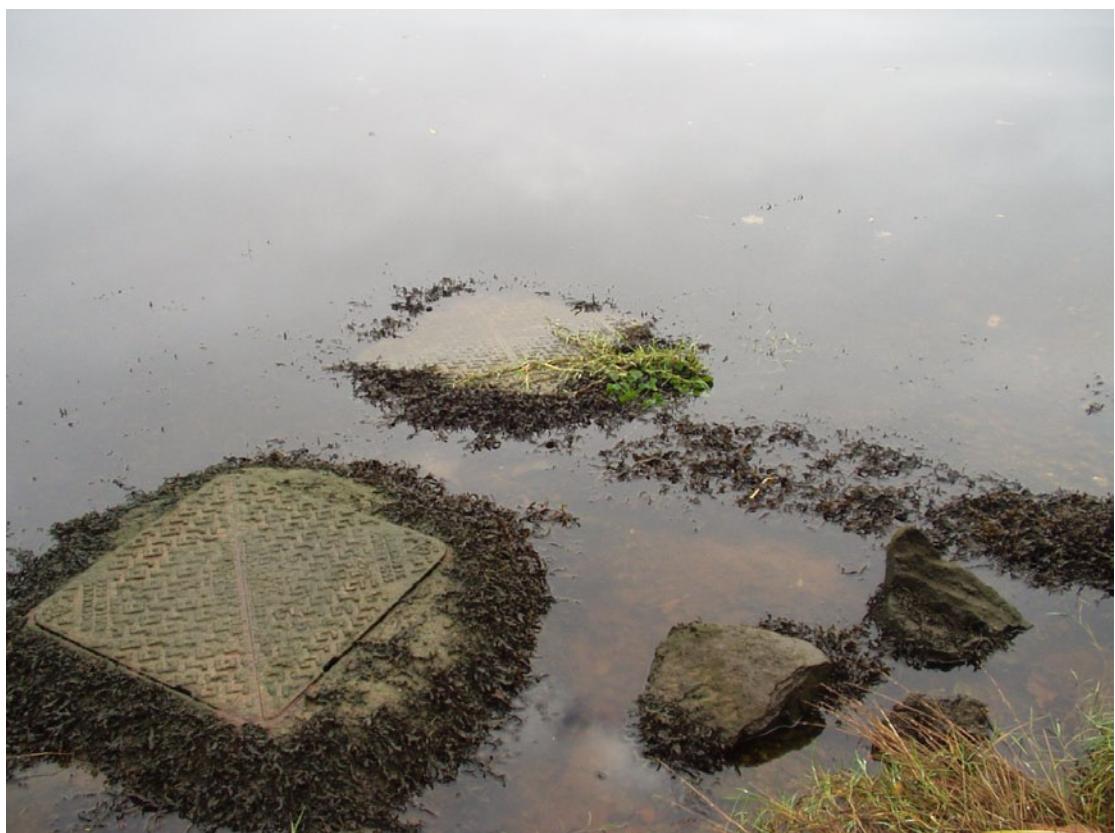
Figure 9. Possible septic tanks

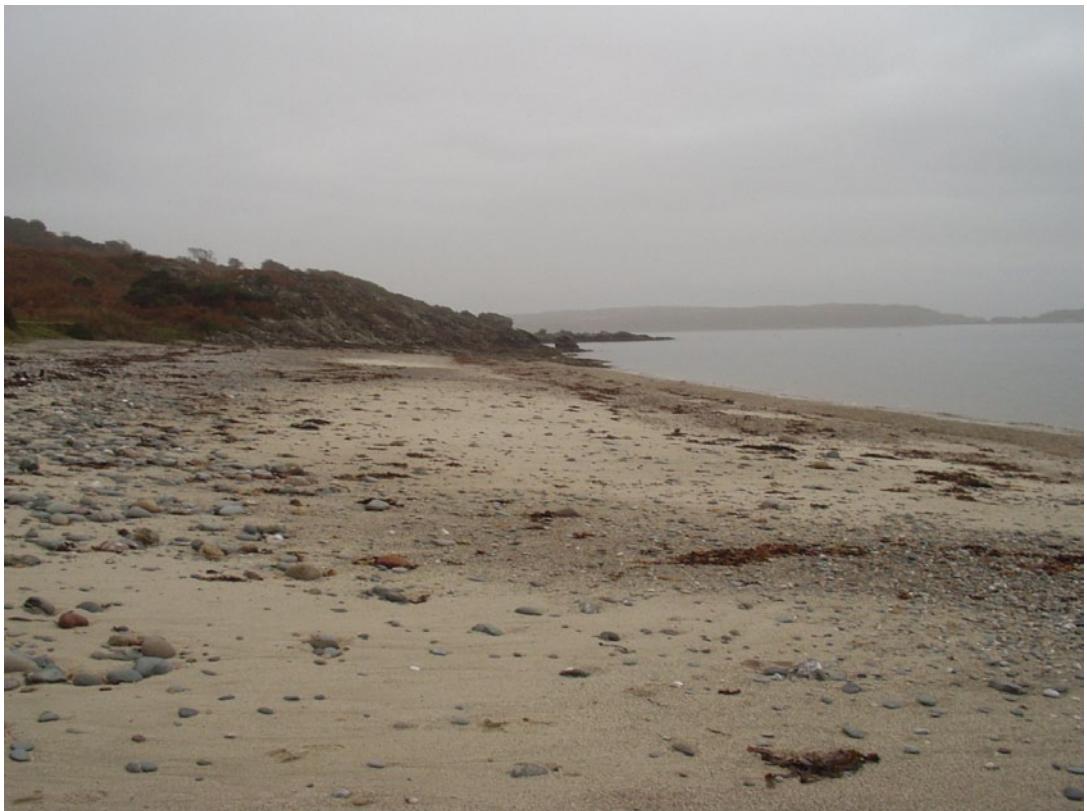
Figure 10. Location of sea water sample 13 (CSW4)
