Scottish Sanitary Survey Review

Busta Voe Lee North

October 2014

Report Title	Busta Voe Lee North Sanitary Survey Review
Project Name	Scottish Sanitary Survey Programme
Client/Customer	Food Standards Agency in Scotland
Cefas Project Reference	C6316D
Document Number	C6316D_2014_5
Revision	V1.0
Date	27/10/2014

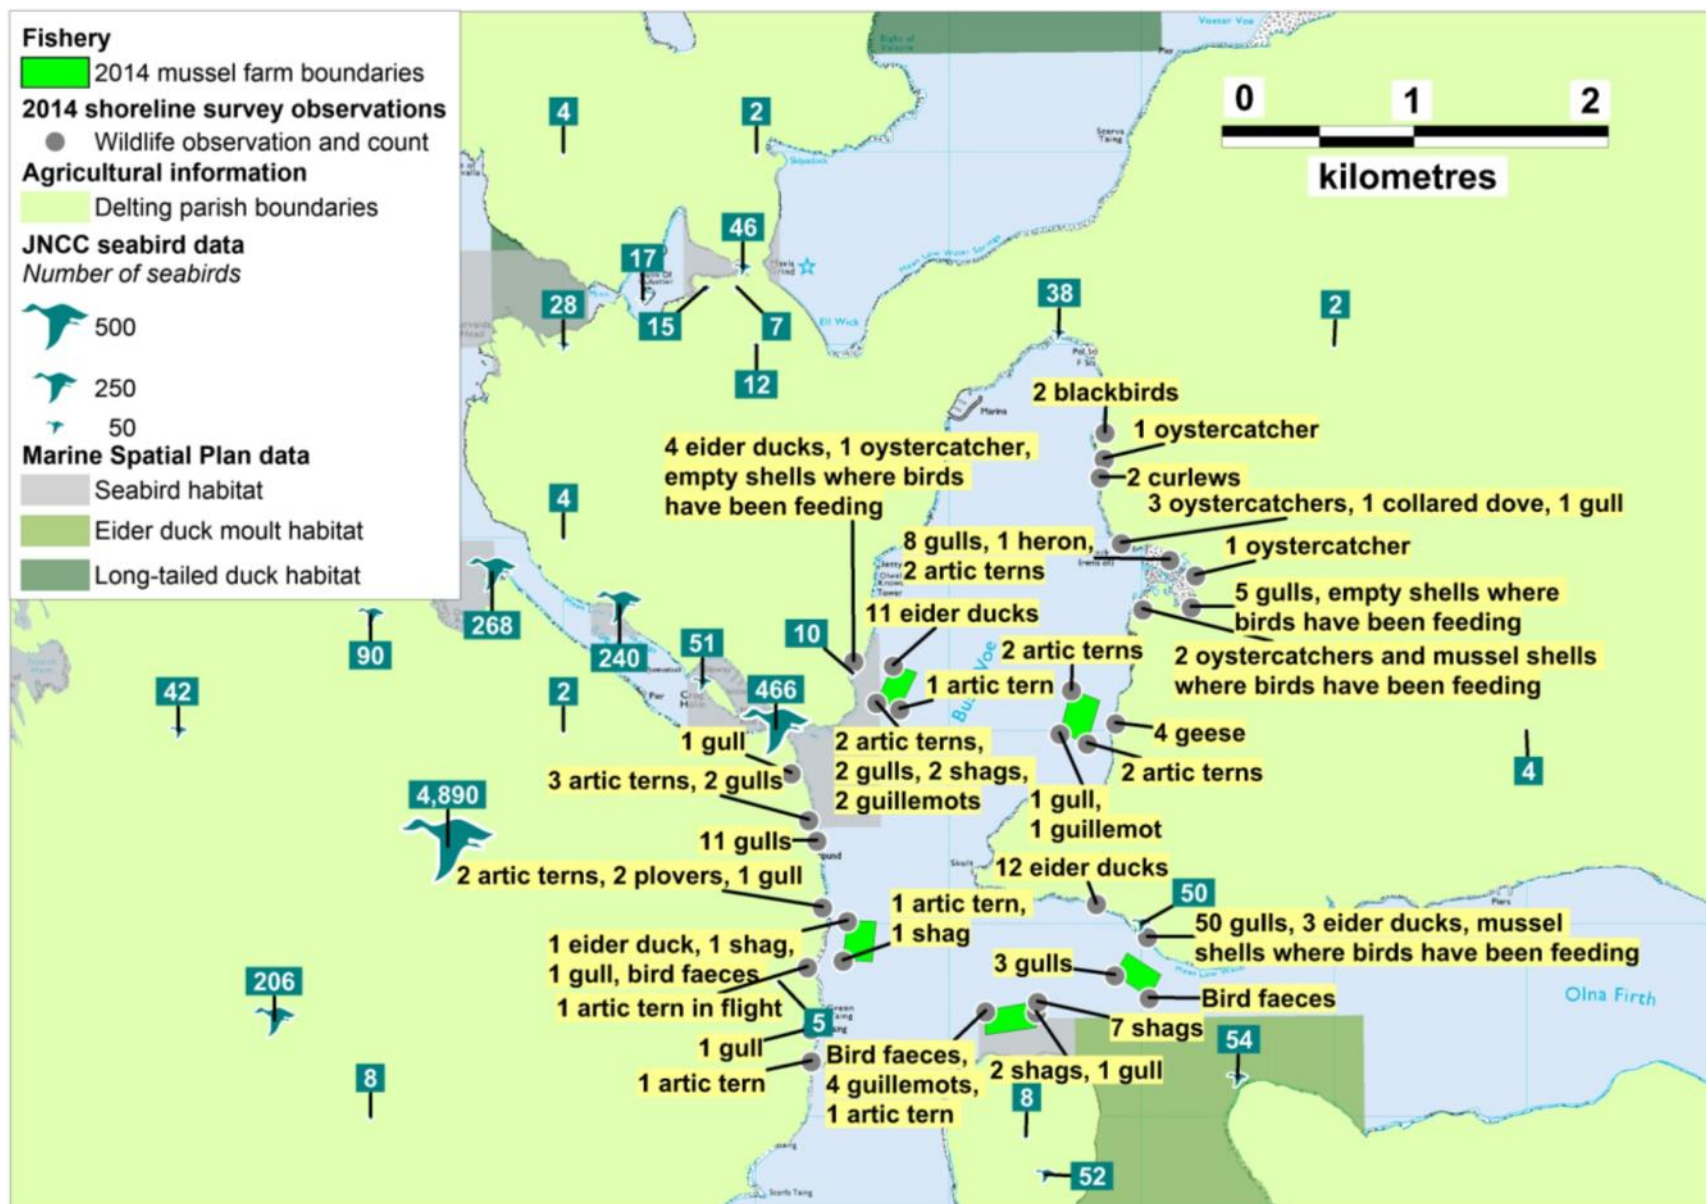
Figure 4.1 Map of wildlife around Busta Voe Lee North, including observations made during the 2014 shoreline survey

The highest abundance, and therefore the greatest contamination impact, of nesting birds is expected during the spring-summer breeding season. Birds were the only wildlife observed during the 2014 shoreline survey. Gulls were the most abundant, with the highest number (n=50) noted flying from the shoreline adjacent to the Wetherstaness fishery. Other species observed included various seabirds and seaducks, geese and wading birds. Bird droppings were also reported on buoys at Busta Voe Lee, North of Linga and at Wetherstaness fisheries.

Overall seabirds continue to represent the most significant contamination source from wildlife to the Busta Voe Lee North area. In particular, large nesting colonies for fulmar are located to the southwest, though birds were widely distributed throughout the area during the survey. Eider ducks and geese may also contribute to contamination levels, and may in particular impact the southeast area of the voe around North of Linga and Wetherstaness fisheries. Impacts are also expected from seals, though the timing and locations of these are unpredictable.

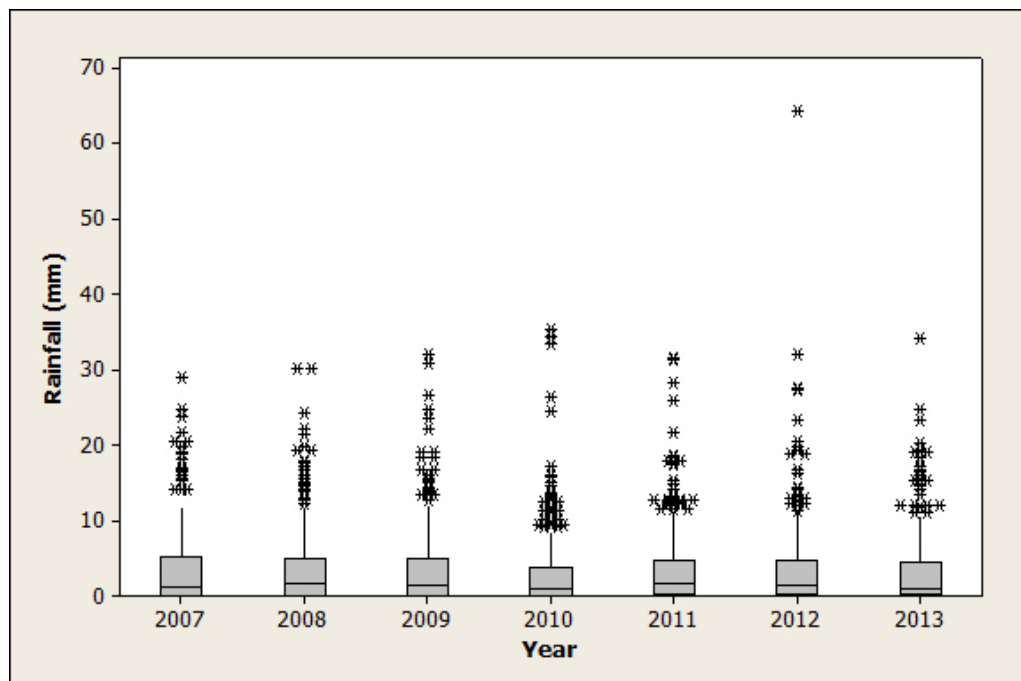
Figure 6.1 Boxplot of daily rainfall at Lerwick by year (2007-2013)

In both data sets, the bulk of the observations were below 10 mm rainfall/day, with the majority of years yielding at least one rainfall event >30 mm. Incidence of a rainfall event >60 mm occurred in both datasets: in 2004 and again in 2012.

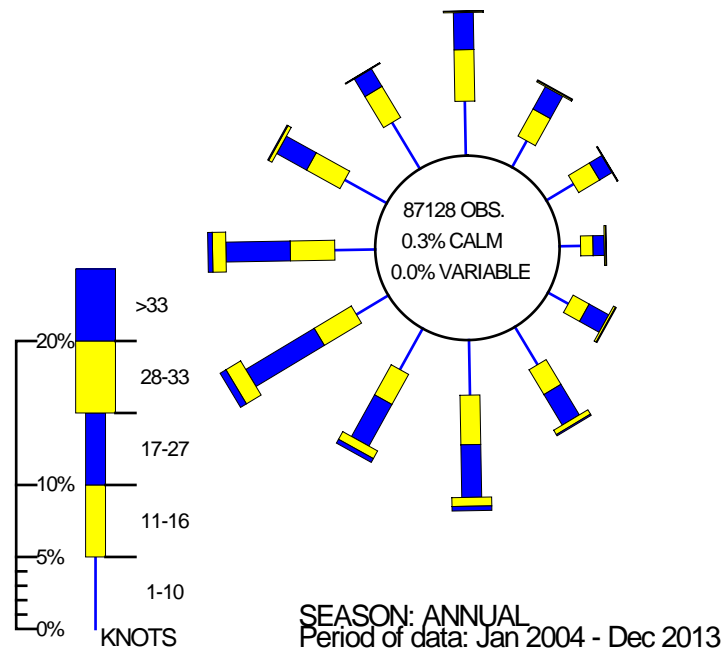
Figure 6.4 Annual wind rose for Lerwick (2004-2013)

Overall the annual wind direction showed that wind was stronger when coming from the west than the east, and winds from the southerly direction were stronger than those from the north. The strongest winds tended to come from the southwest quarter although winds from the north occurred relatively frequently. During the summer, winds were also often seen from the north-northeast. Winds were strongest during the winter and were weakest during the summer. The local topography and direction of Busta Voe Lee North is likely to cause a variation in wind patterns to those shown in the wind roses (Lerwick is located on the east coast of mainland Shetland, whilst Busta Voe is on the west coast). Busta Voe is relatively sheltered by the surrounding land although westerly winds will have an effect on the wider water body system as Swarbacks Minn, at the southern end of Busta Voe, opens to the west.

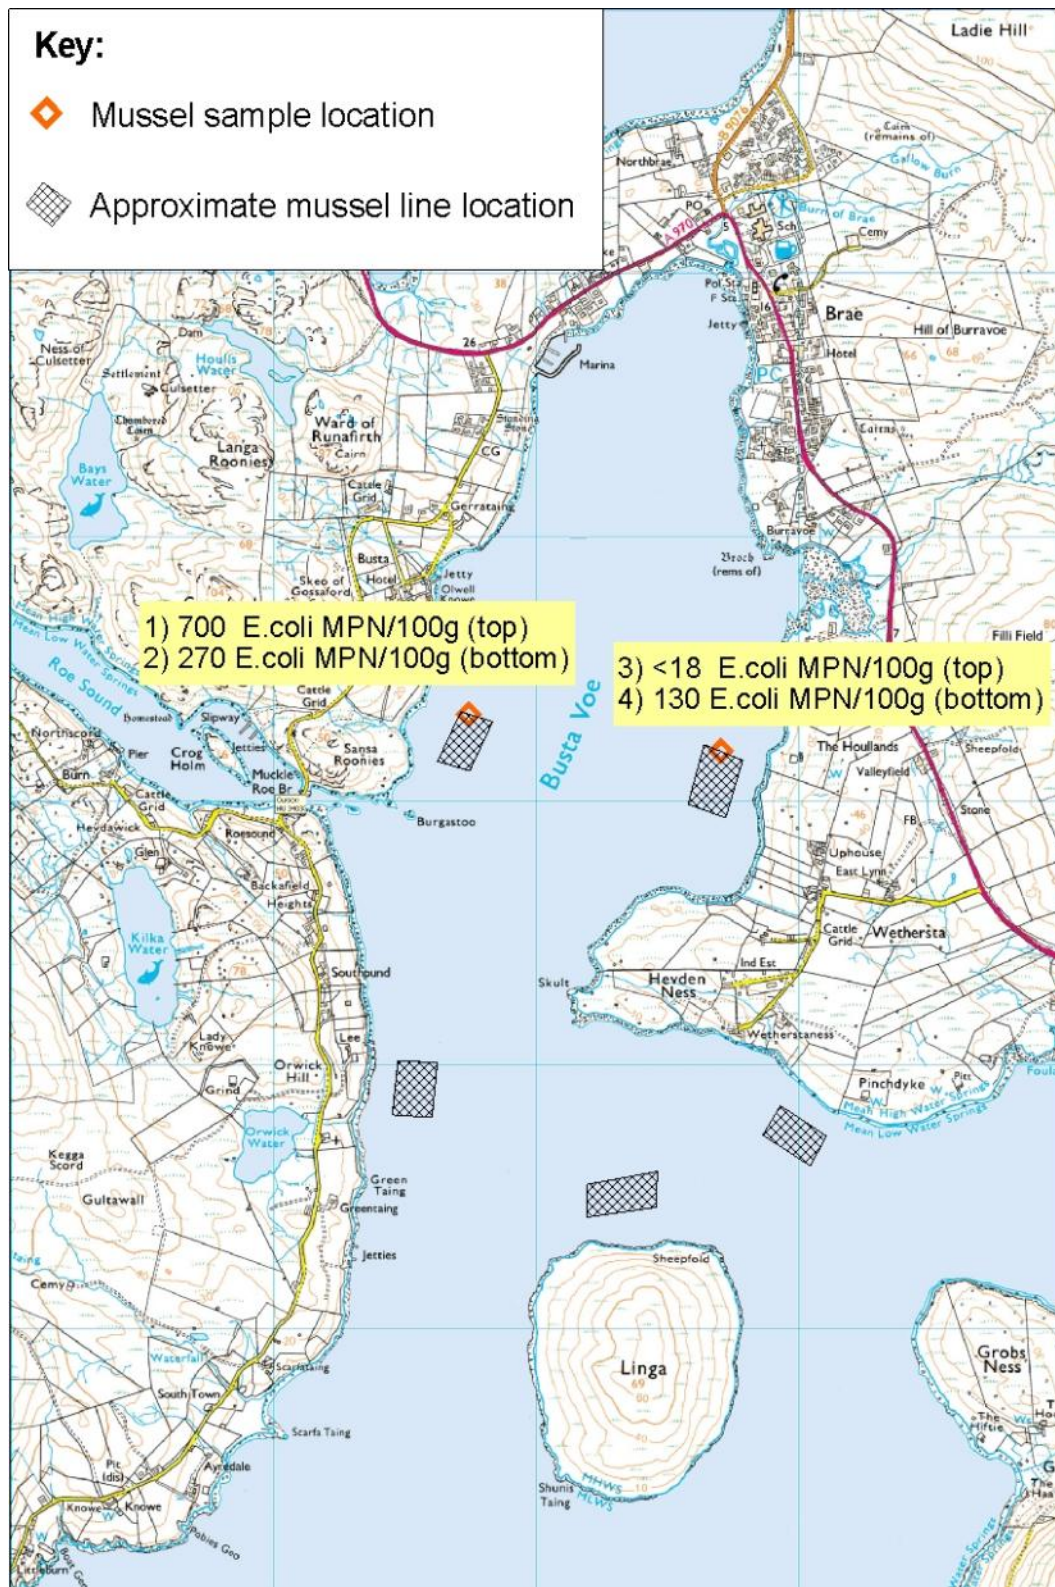
**Figure 2 Map of water sample results and salinity profile locations
Busta Voe Lee North.**

Bacteriology results are present in Table 2 and 3 and mapped in Figures 2 and 3.

Seawater samples were also tested for salinity at SSQC Ltd. In the field salinity profiles were collected using a YSI Professional Plus handheld meter and CT probe which had an accuracy of (± 0.35 ppt). Results are presented in Table 4 and locations of the profiles are mapped in Figure 2.

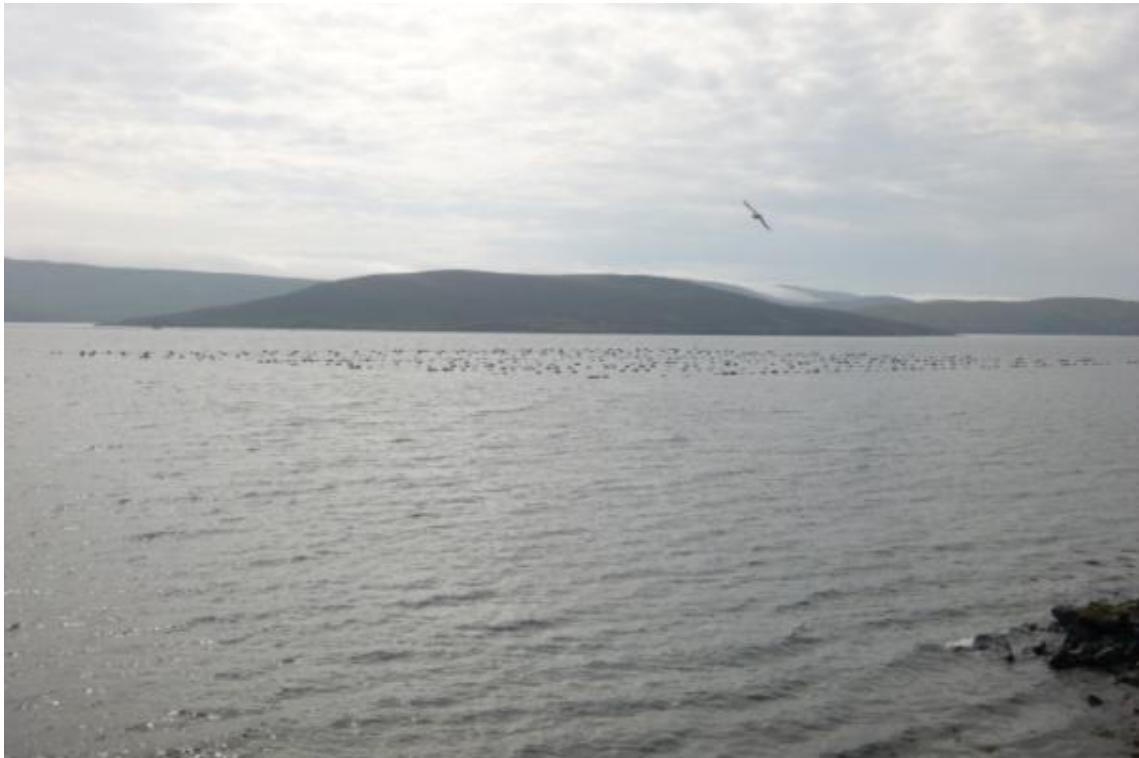
The Busta Voe Lee fishery consisted of ten mussel lines running parallel to the eastern shoreline of Muckle Roe (Figure 4). All lines were double headed longlines with 10 metre droppers. The site is licensed for ten 155 metre twin-headline longlines.

Figure 4 – Mussel lines at the Busta Voe Lee fishery looking east.

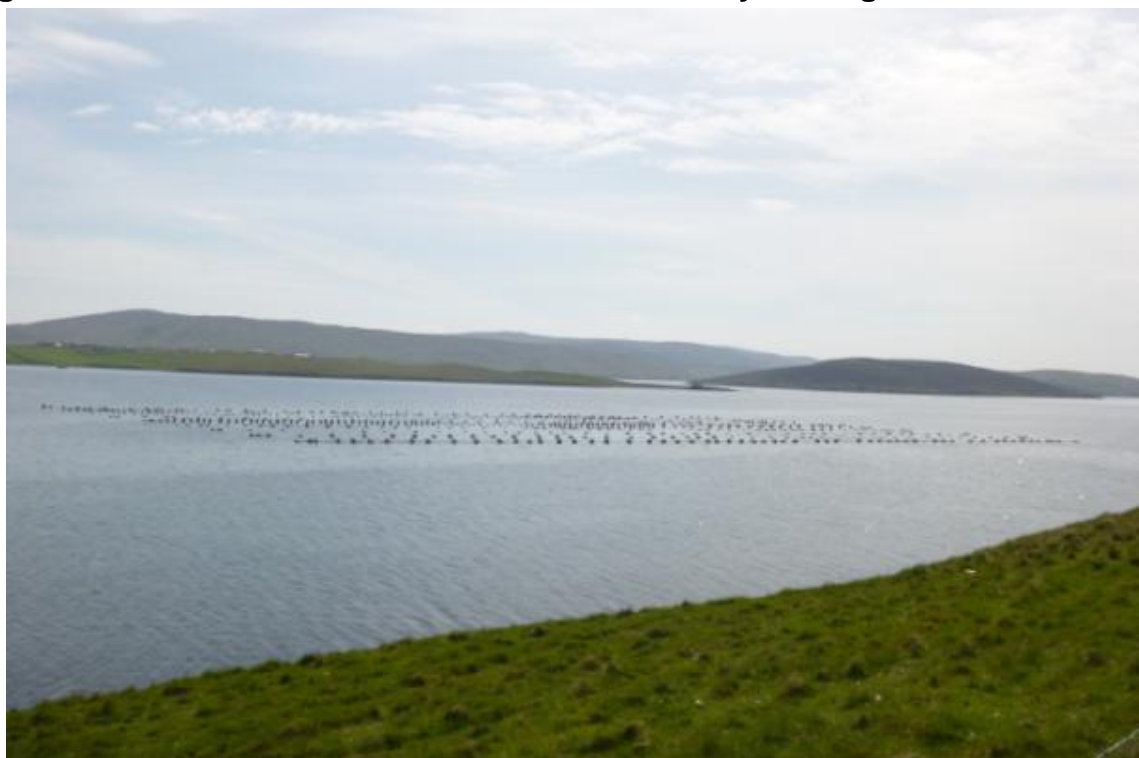
The Busta Voe fishery consisted of nine mussel lines running parallel to the western shoreline of Busta Voe (Figure 5). All lines were double headed longlines with 10 metre droppers. Two mussel samples were collected at the north end of the site. The site is licensed for nine 200 metre twin-headline longlines.

Figure 5 – Mussel lines at the Busta Voe fishery looking south east.

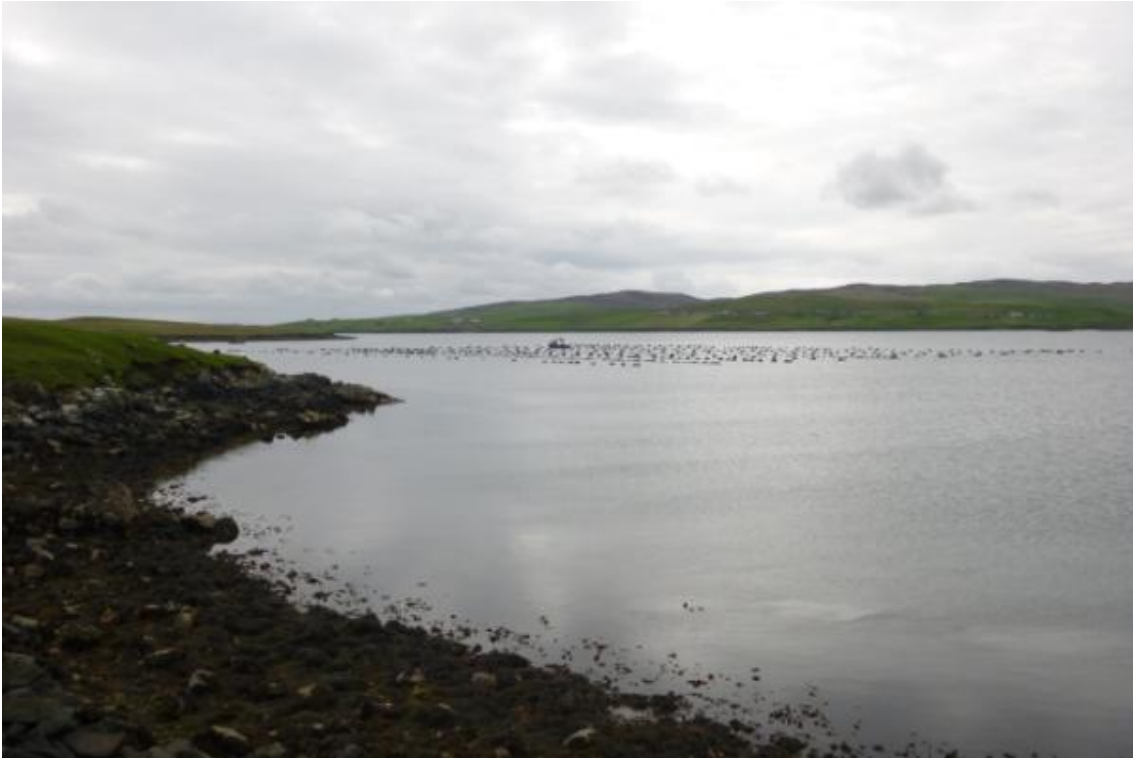
The Hevden Ness fishery consisted of ten mussel lines running parallel to the eastern shoreline of Busta Voe (Figure 6). All lines were double headed longlines with 10 metre droppers. Two mussel samples were collected from the north end of the site. The site is licensed for ten 220 metre twin-headline longlines.

Figure 6 – Mussel lines at the Hevden Ness fishery looking south west with a large workboat on site.

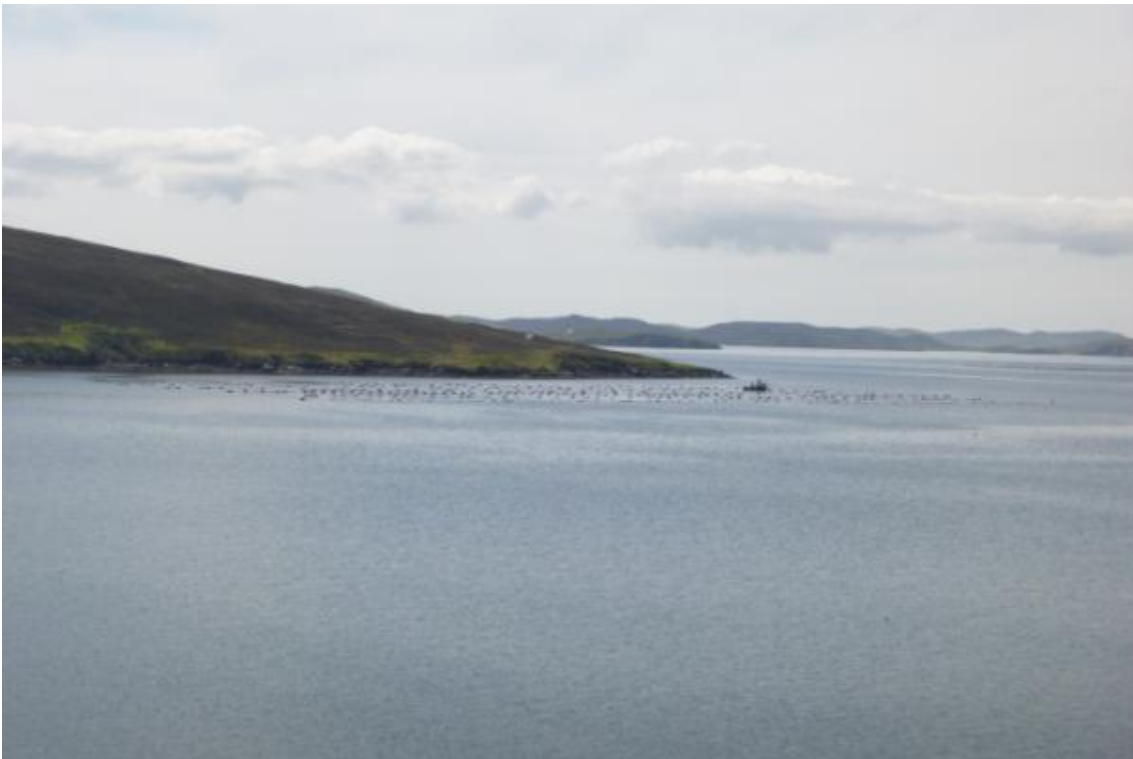
The North of Linga fishery consisted of six mussel lines running parallel to the northern shoreline of the island of Linga (Figure 7). All lines were double headed longlines with 10 metre droppers. The site is licensed for ten 260 metre twin-headline longlines.

Figure 7 – Mussel lines at the North of Linga fishery looking south west with a large workboat on site.

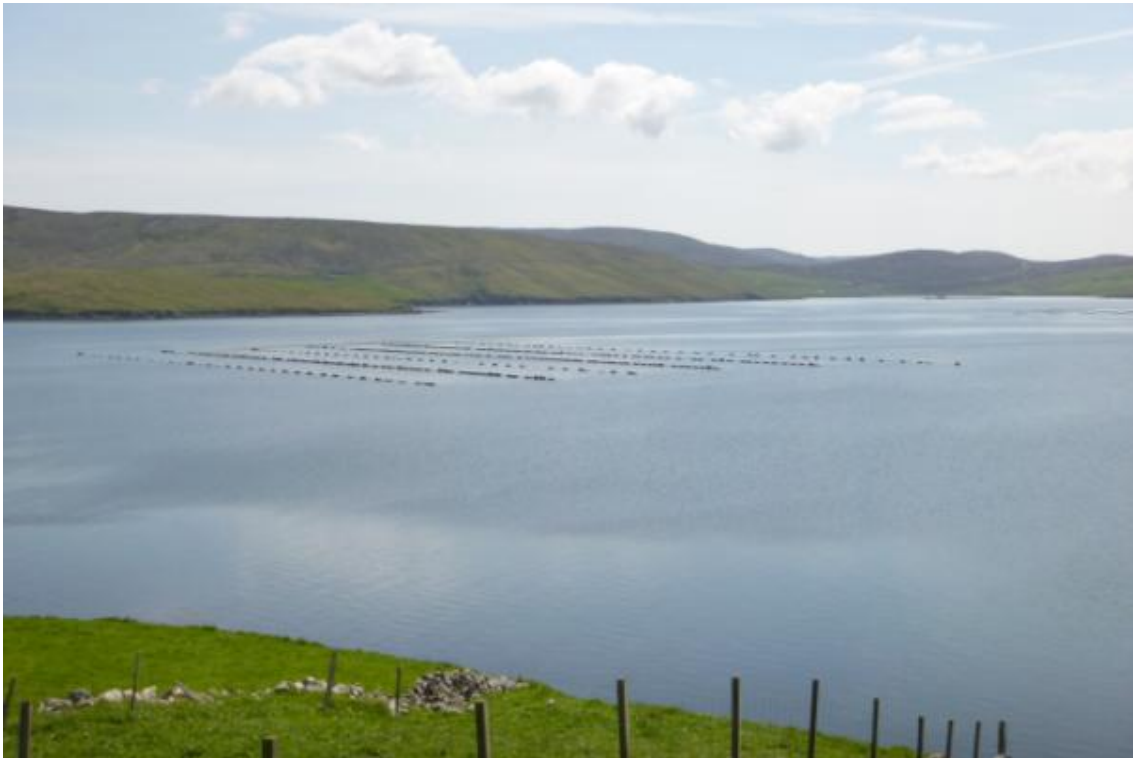
The Wetherstaness fishery consisted of six mussel lines running parallel to the southern shoreline at Wetherstaness (Figure 8). All lines were double headed longlines with 10 metre droppers. The site is licensed for ten 200 metre twin-headline longlines.

Figure 8 – Mussel lines at the Wetherstaness fishery looking south.

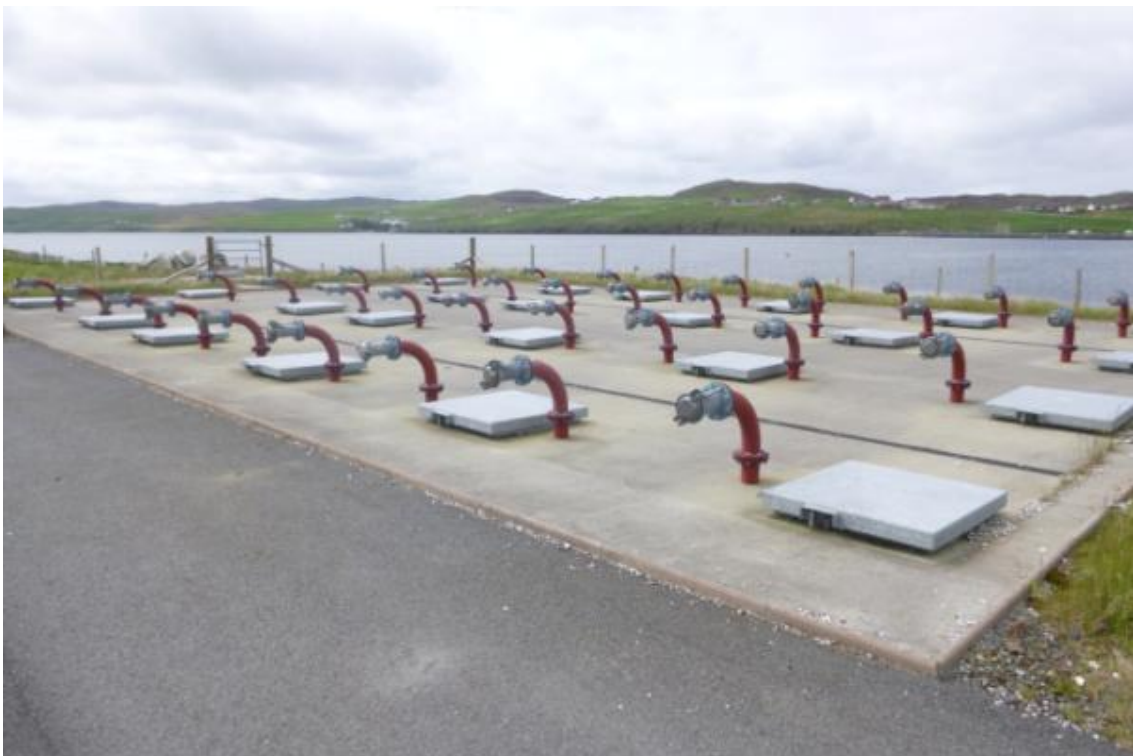
Figure 9 – Brae community septic tank.

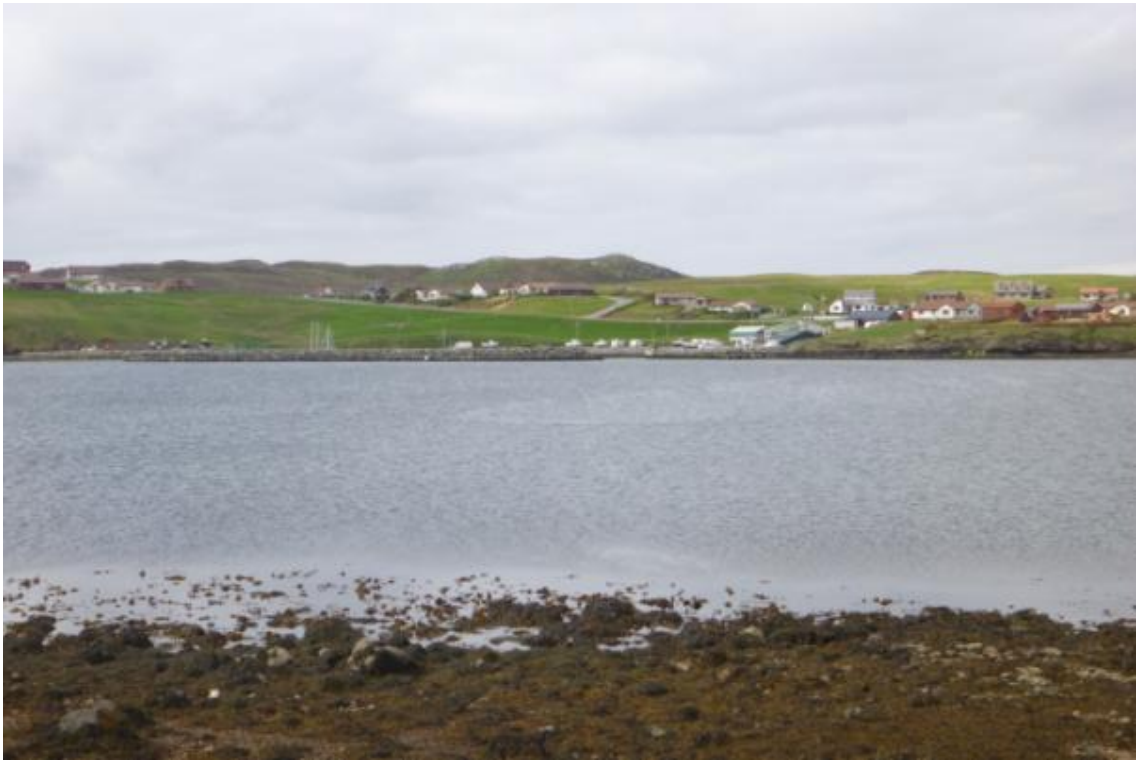
A disturbance in the water was noted a distance offshore from the Brae community ST and was thought to be stemming from the new outfall pipe despite no visible pipe onshore. A seawater sample taken from the shoreline adjacent to the ST returned a low result of 1 *E. coli* cfu/100 ml, suggesting little contamination at that location at the time of the shoreline survey.

Figure 10 – Disturbed area short distance from the shore adjacent to the Brae community septic tank, possibly the end of the discharge pipe.

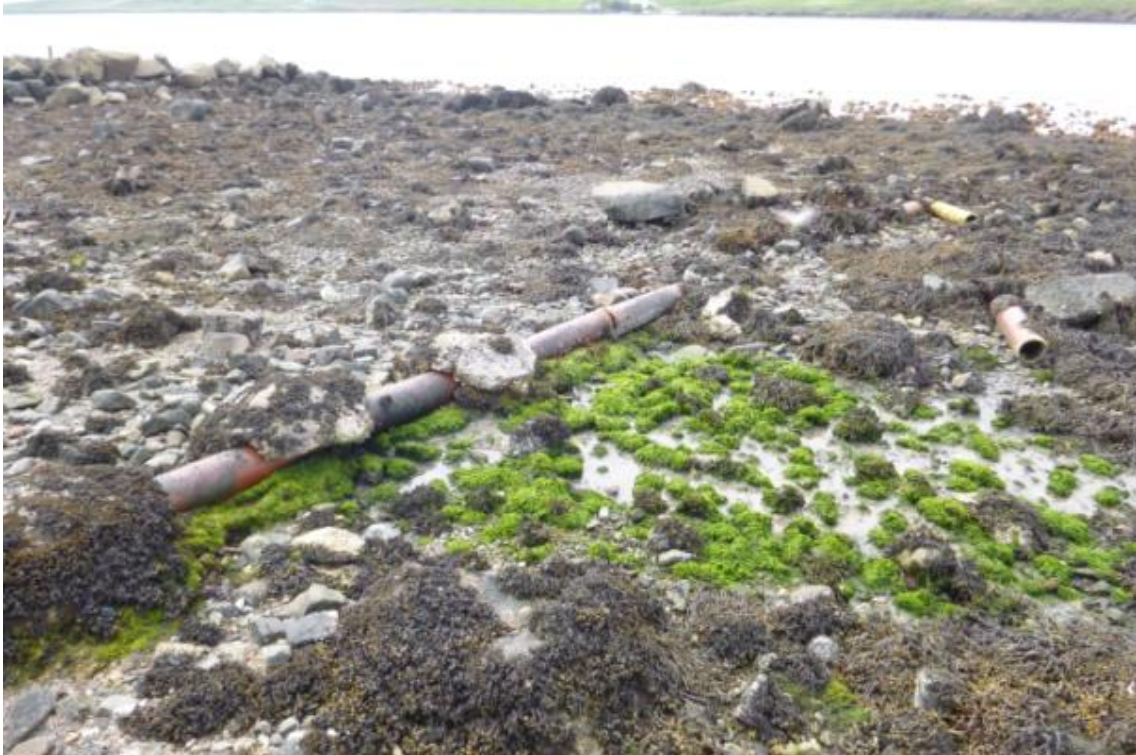
A broken pipe with an associated grey discharge was noted close to a ST associated with a white house located on the northeast shore, approximately 200 m south of the Brae ST. No sample was taken at this discharge, which lies approximately 1.1 km north of the Hevden Ness fishery.

Figure 11 – Broken pipe with a grey discharge associated with a septic tank below a house in Brae.

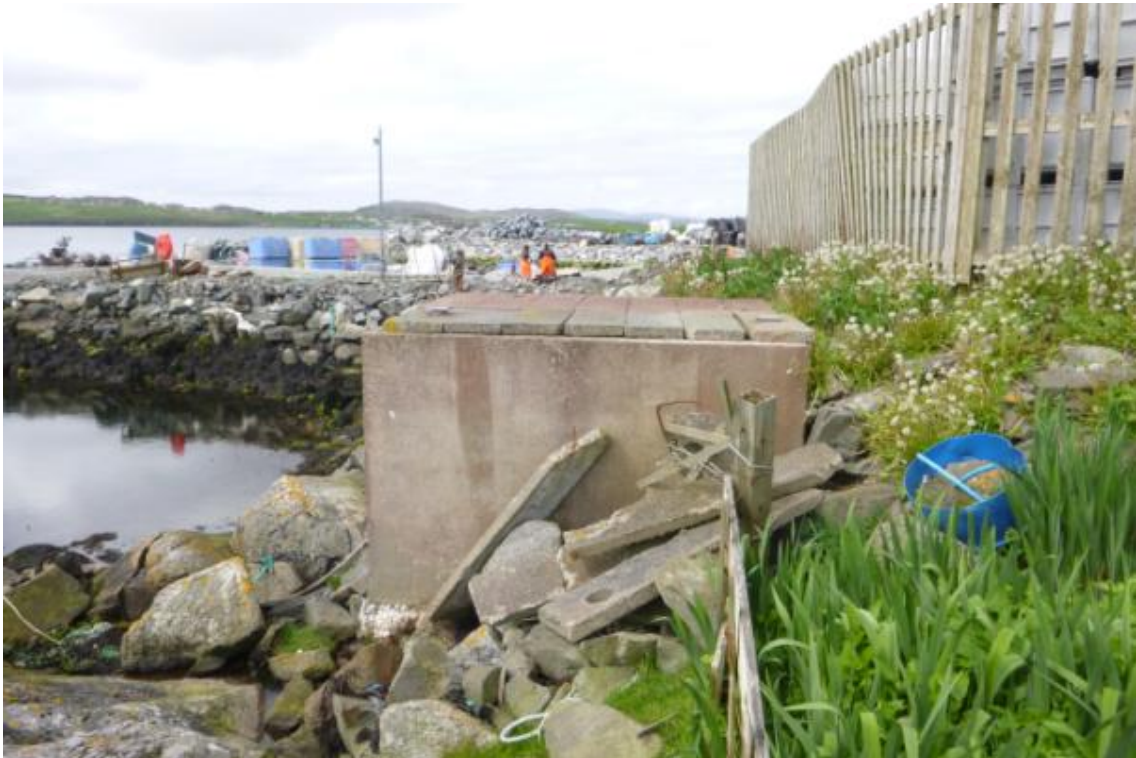
Four other functioning STs were observed during the 2014 survey, one of which was noted to be leaking. This leaking ST was thought to be associated with Blueshell Mussels shore-base and was situated approximately 300 m northeast from Hevden Ness fishery. A seawater sample taken in-front of this tank returned a moderately high result (with respect to the range usually seen in Shetland shoreline surveys) of 48 *E. coli* cfu/100 ml. This discharge was also noted close to observation no. 8 and corresponded to a private, primary treated discharge to land soakaway (CAR/R/1070899) identified by SEPA in 2012. The origin of this discharge therefore remains unclear.

Figure 12 – Septic tank beside the Blueshell Mussels shorebase.

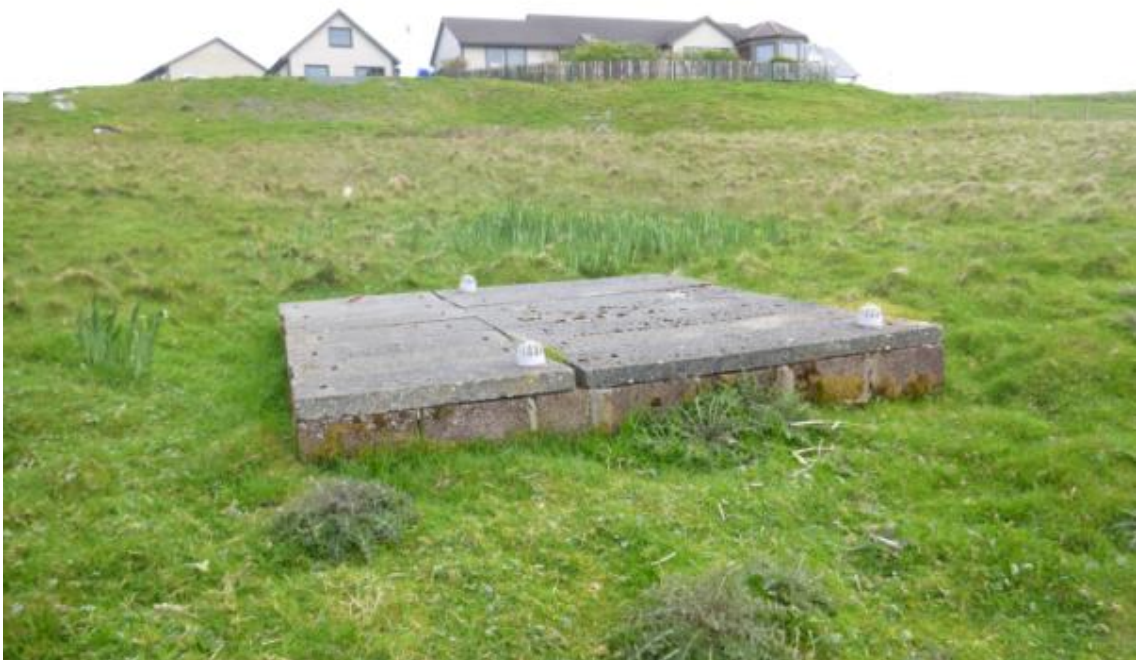
Figure 13 – Septic tank associated with houses at Sparl.

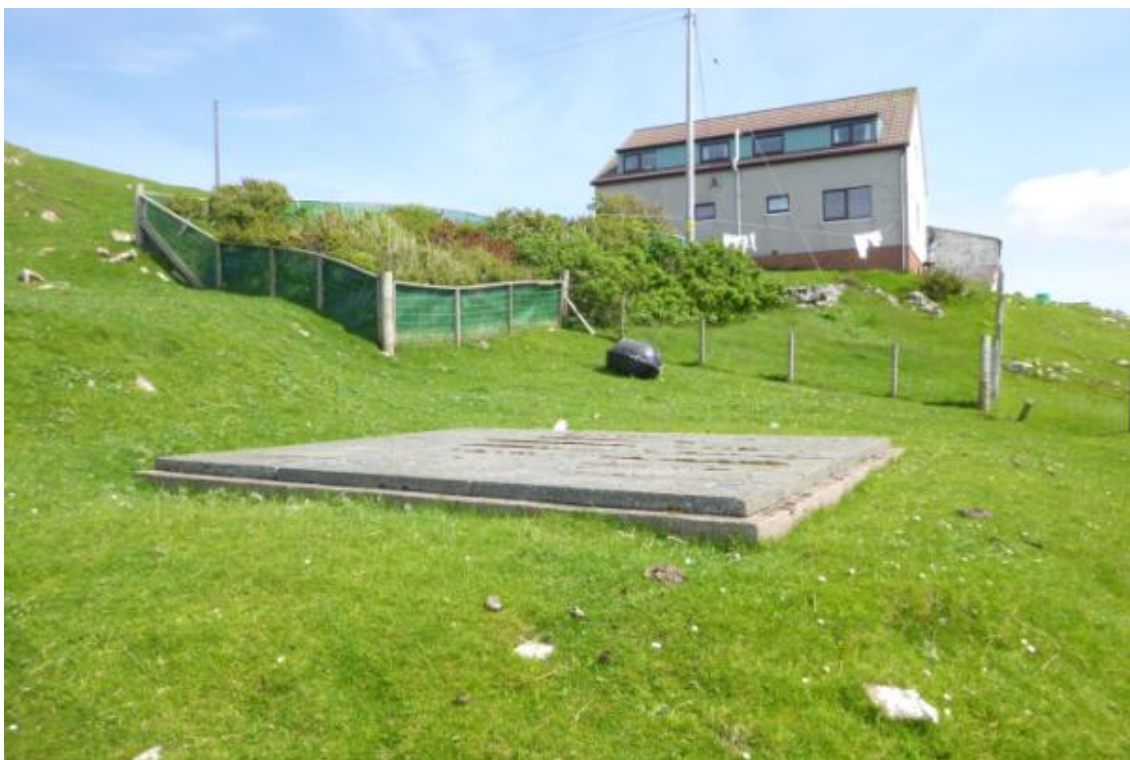
Figure 14 – Septic tank servicing a house at Wetherstaness.

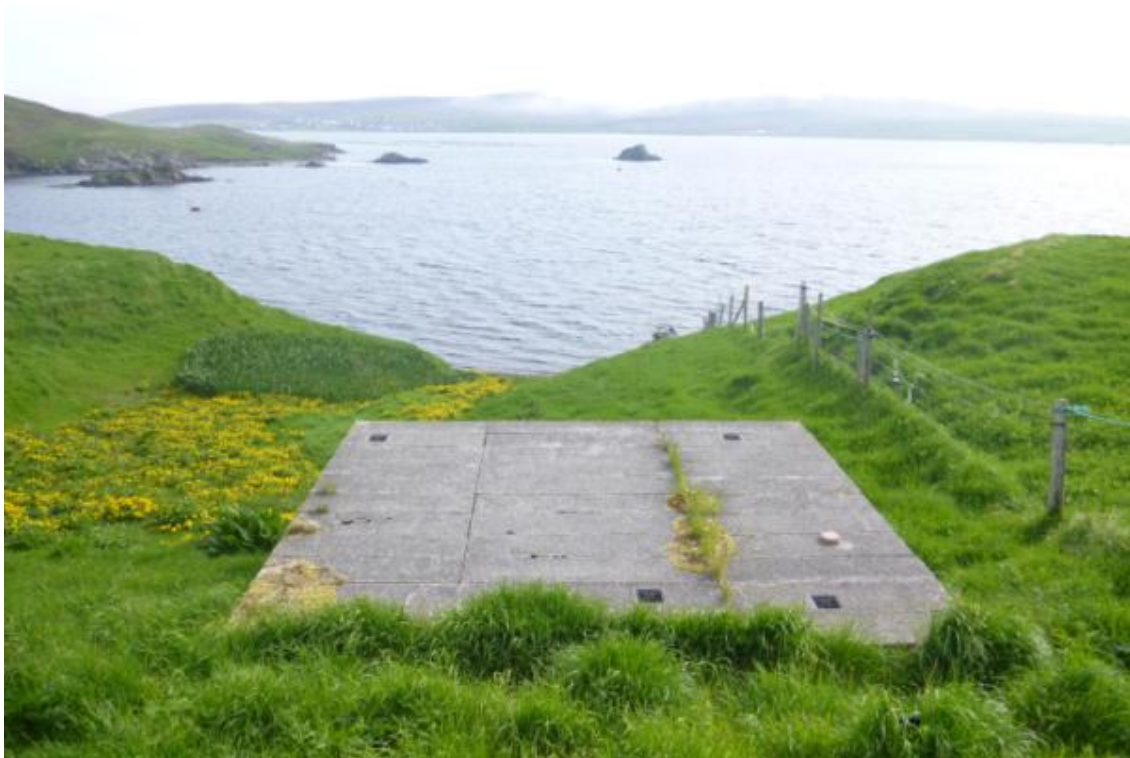
Figure 15 – Septic tank south of the Muckle Roe bridge.

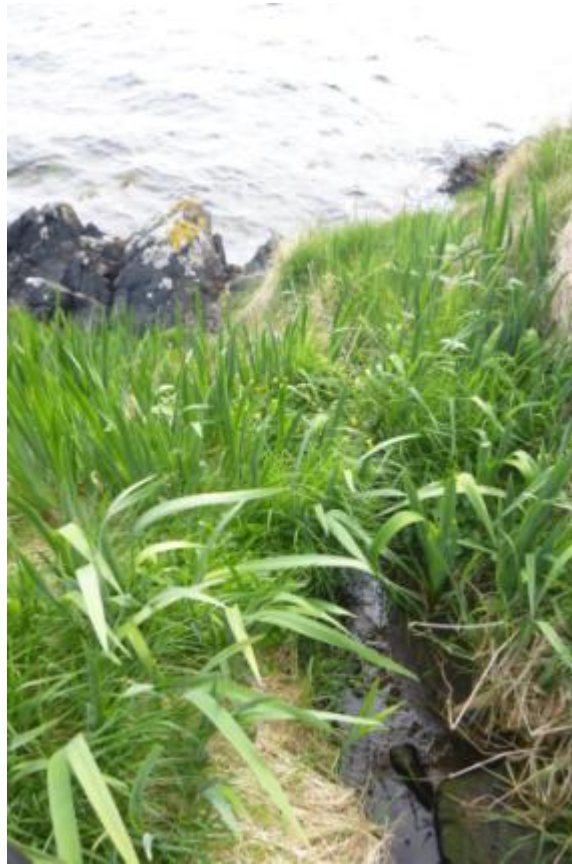
Ten freshwater samples were obtained from watercourses around Busta Voe, five on the western shore and five from the eastern shore. Nine of the ten samples obtained were outlined in the sampling plan, with one additional sample being obtained from the east shore in the Brae area. A freshwater sample which was outlined in the sample plan near the north end of the Busta Voe fishery was not obtained as no watercourse could be identified in the area. Eight of the ten watercourses sampled were found to have *E. coli* levels between 6-100 cfu/100ml. The two samples with the highest *E. coli* counts were from a small watercourse south of the Muckle Roe bridge (180 cfu/100ml) (Figure 16) and a sample from a watercourse discharging near the Busta Voe fishery (1400 cfu/100ml) (Figure 17).

Figure 16 – Small watercourse south of the Muckle Roe bridge.

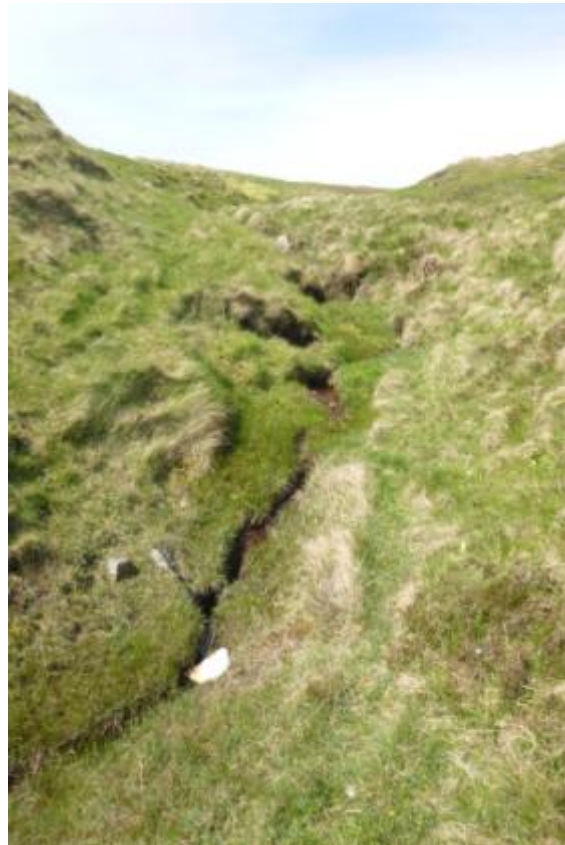
Figure 17 – Watercourse adjacent to the Busta Voe fishery.

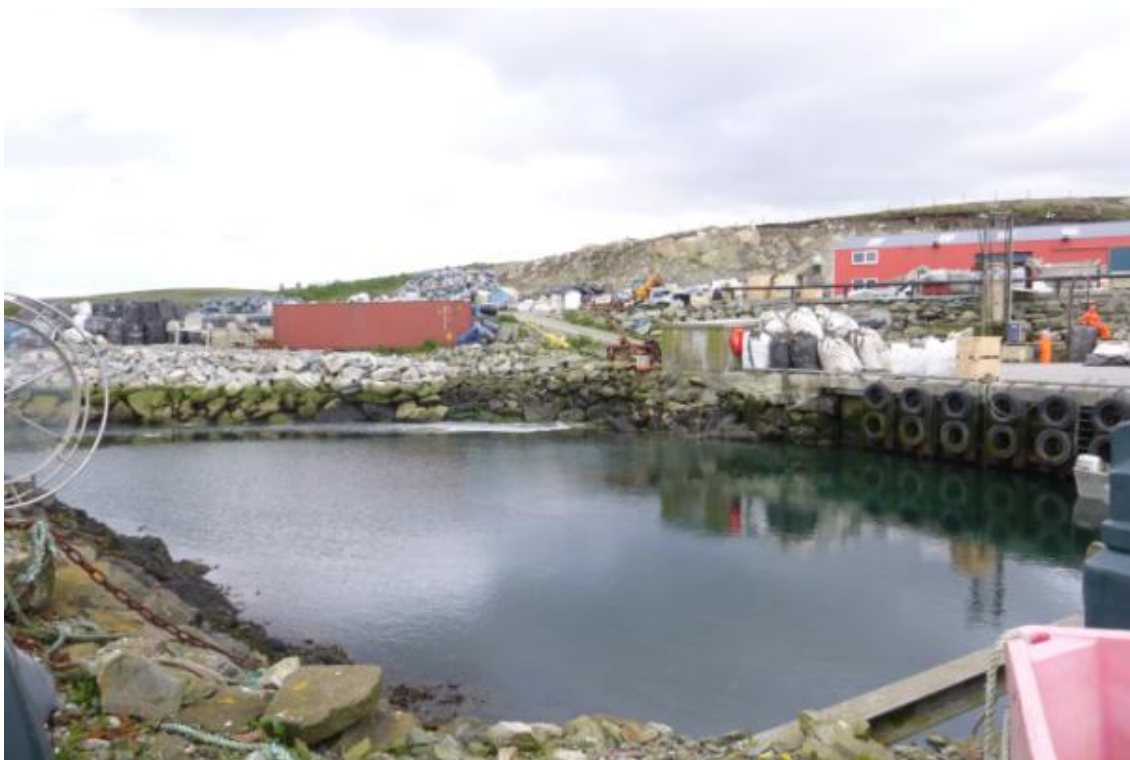
Figure 18 – Blueshell Mussels shorebase at Sparl.

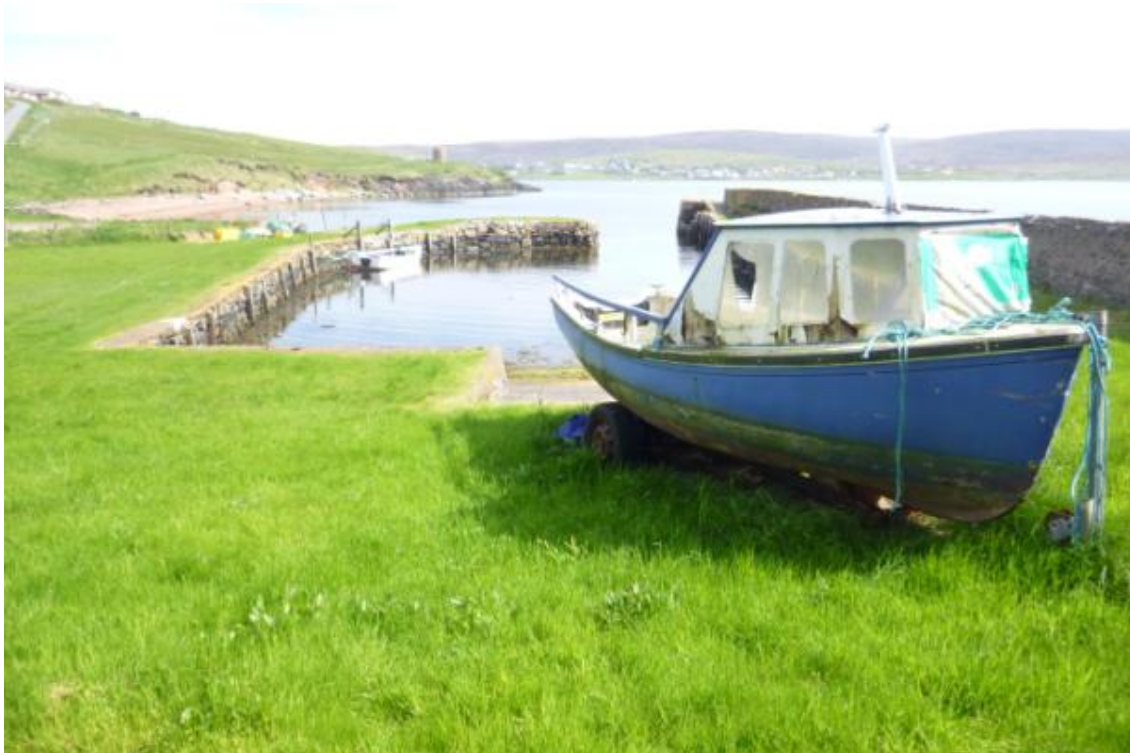
Figure 19 – Small harbour area at Busta.

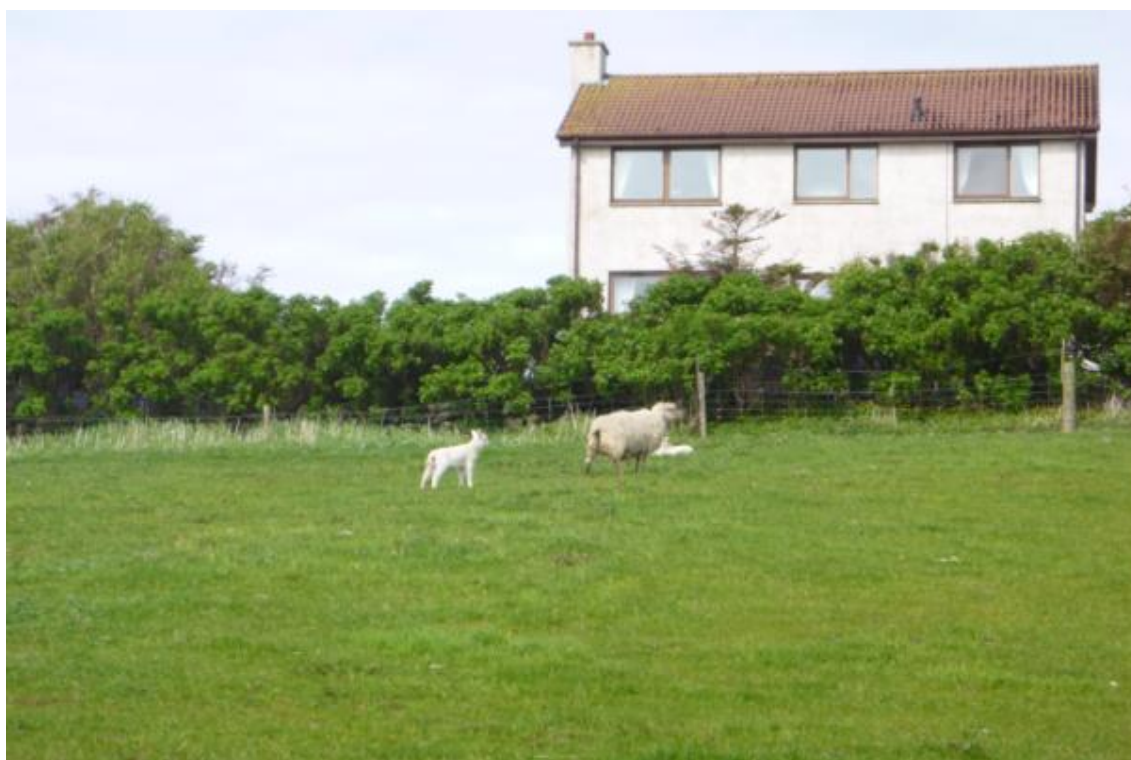
Figure 20 – Sheep grazing in a fenced area at Greentaing.

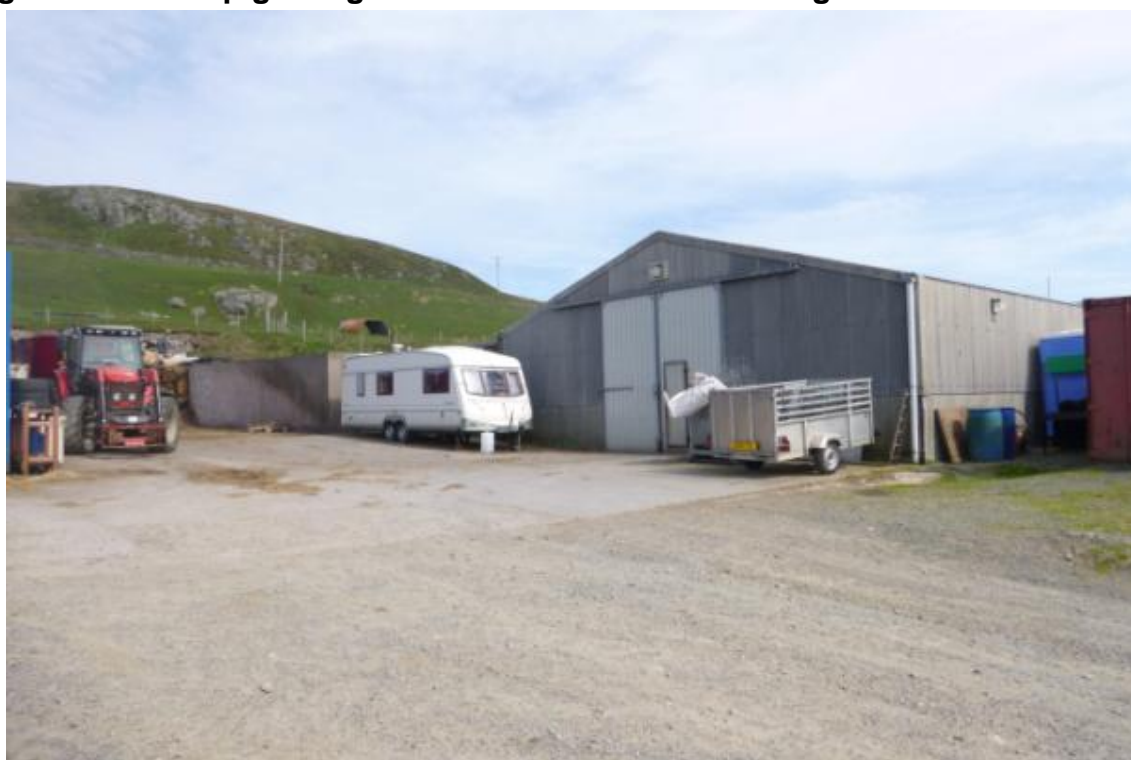
Figure 21 – Large agricultural building and silage pit at Busta.

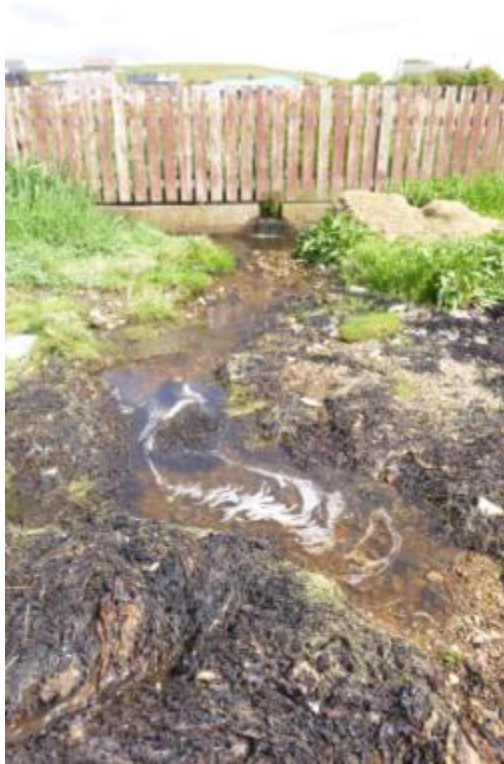
Figure 22 – Additional freshwater sample obtained from a watercourse below houses in Brae.

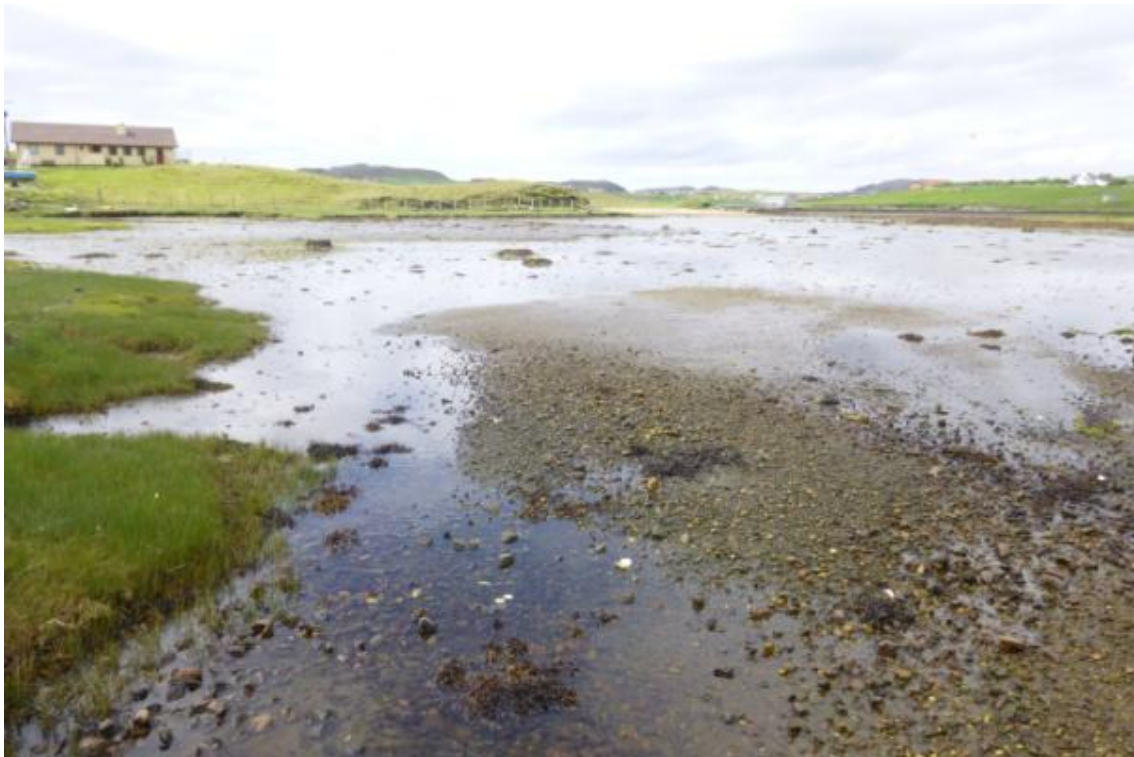
Figure 23 – Sand bank area south of Burravoe, accessible at low tide where birds were feeding.
