# Scottish Sanitary Survey Project

## Sanitary Survey Report

**Arisaig**  
**HL 004**  
**July 2010**

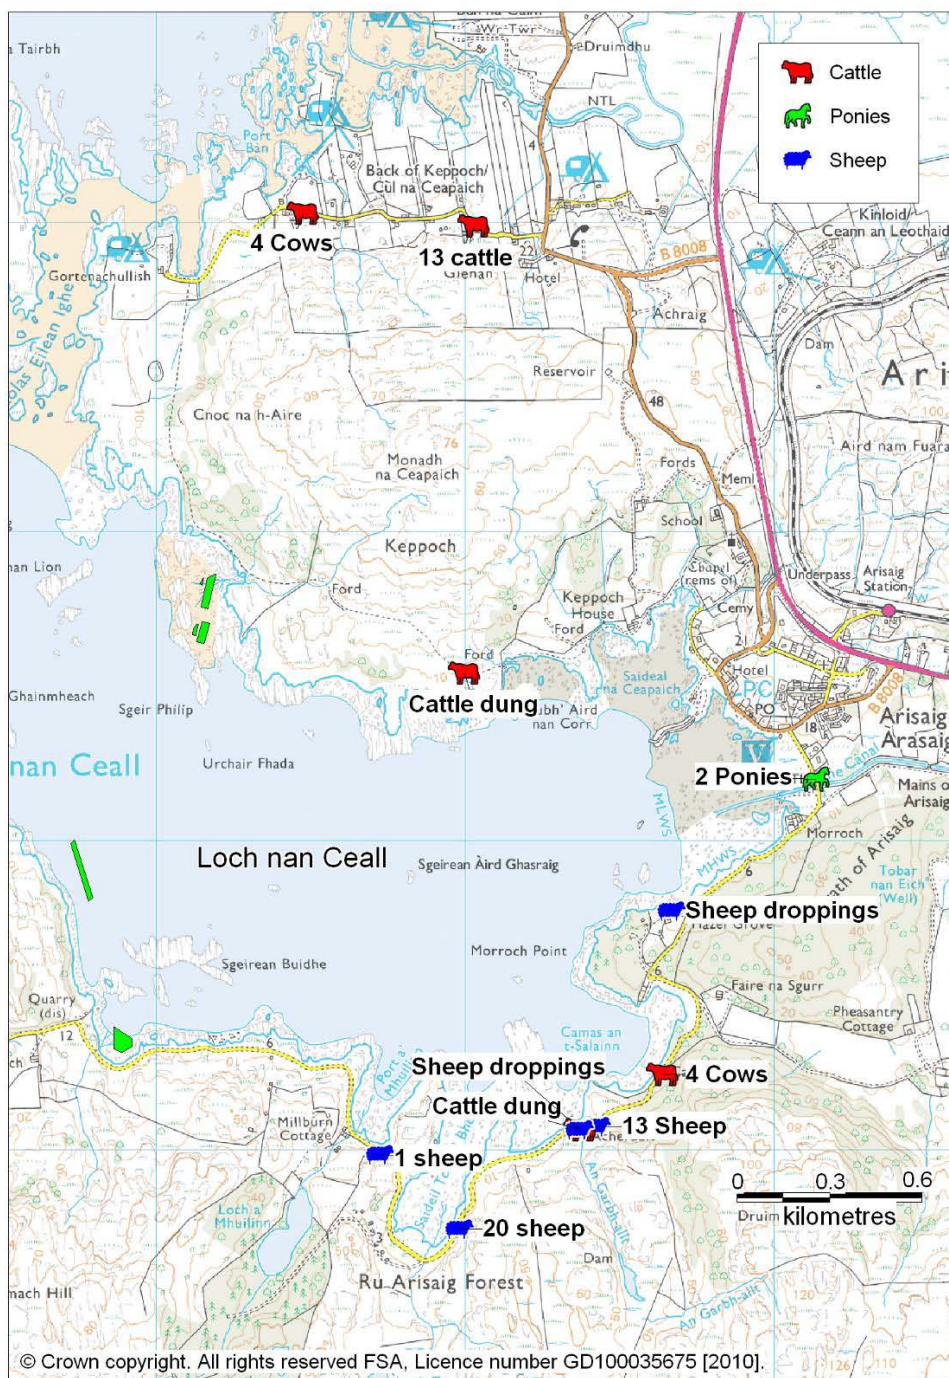
Figure 7.1 Livestock observed at Loch nan Ceall during shoreline survey

As can be seen from the figure, cattle and sheep were the predominant types of livestock observed, though two ponies were also seen adjacent to a canal on the outskirts of the village. The harvester also noted that he keeps approximately 80 cattle upstream from where the ponies were seen (not mapped). On the north shore of the loch, recently deposited cattle dung was observed along the footpath that leads to the area of oyster trestles near Sgier Philip though no animals were seen directly. The largest concentration of livestock was found southwest of the village, where 34 sheep and 4 cattle were observed. Cattle were also observed to

Overall, the contribution of livestock to levels of faecal bacteria in the waters is likely to be highest along the southern shore near the head of the loch, based on distributions observed during the shoreline survey. Impact is both through direct deposition onto the shoreline and via runoff from grazed areas. Any contamination from the cattle kept upstream will be carried via the burn leading to the canal and then into the head of the loch.

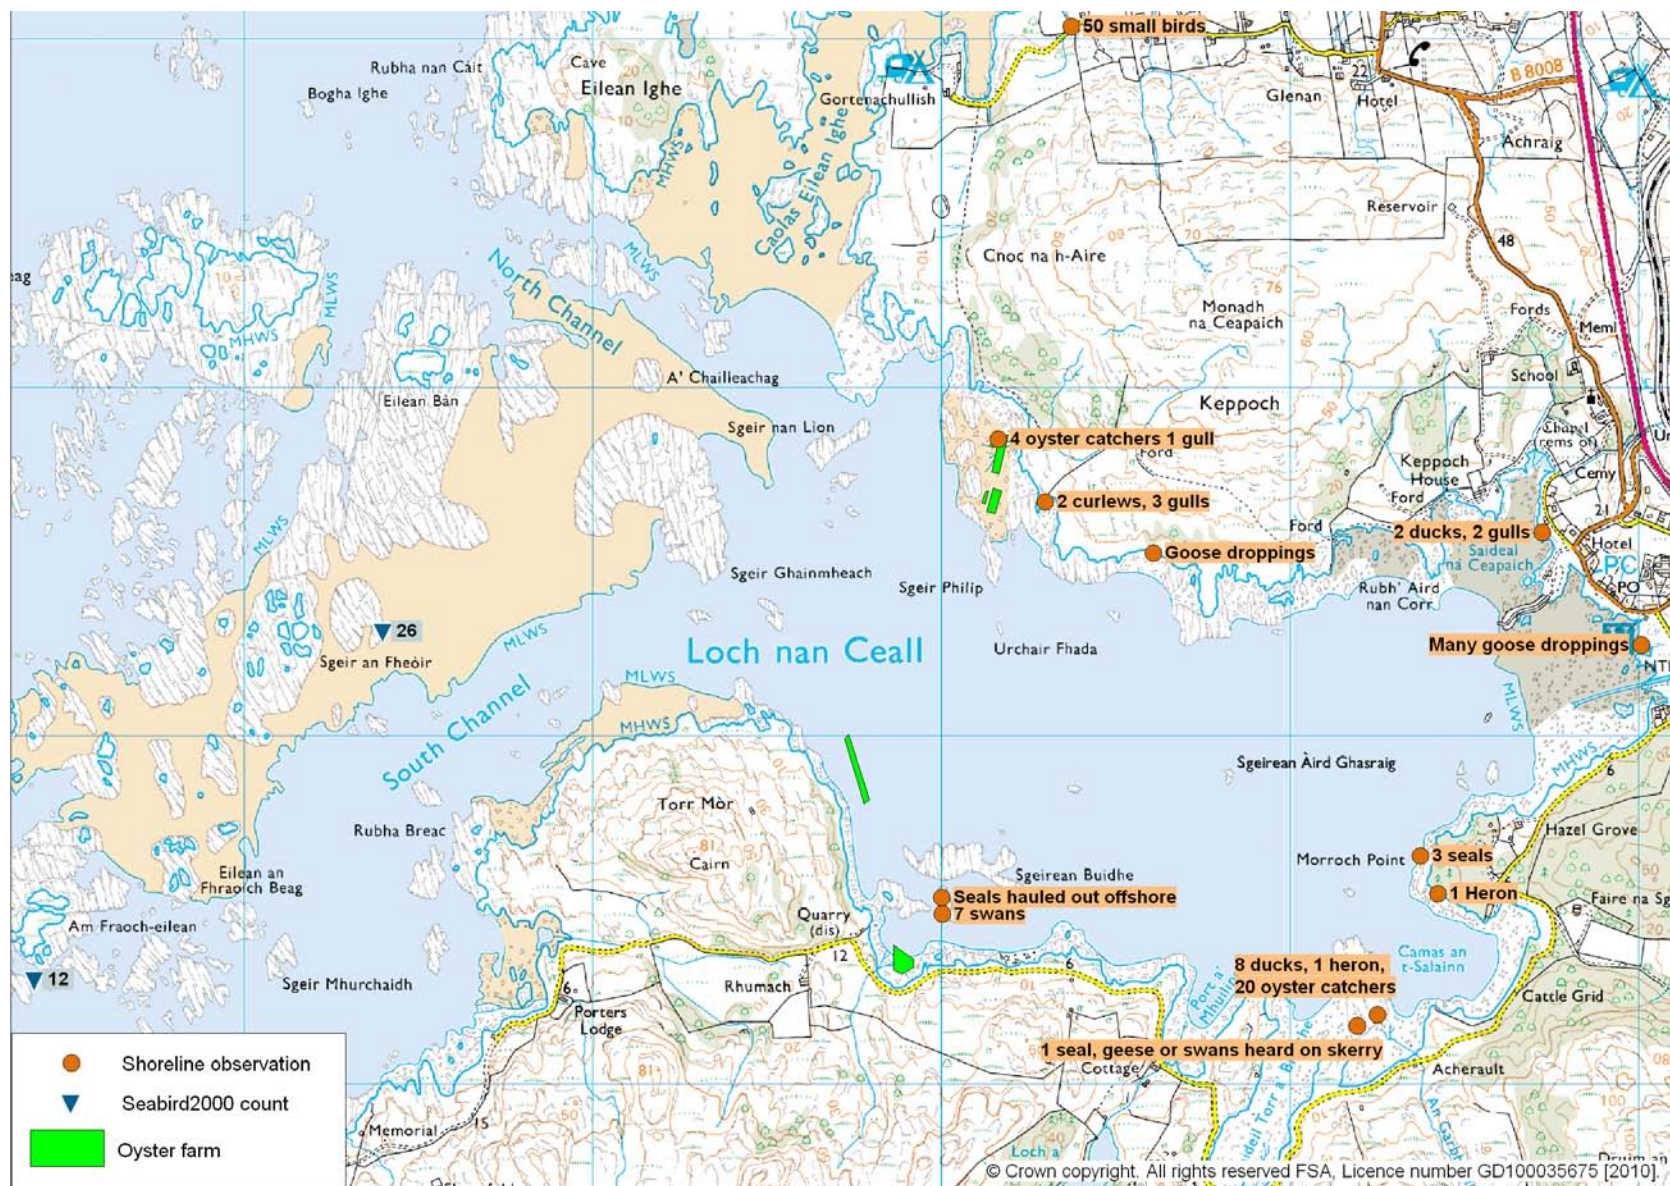
Figure 8.1 Breeding seabirds and wildlife observations at Loch nan Ceall

In summary, the main wildlife species potentially impacting on the production areas are seals, waterfowl, seabirds and deer. Seals are likely to be present year-round and were observed using skerries near Sgeirean Buidhe to haulout. Impacts from breeding seabirds are unlikely to directly affect either oyster farm due to the distance. Swans and Geese will tend to be found on areas of pasture, and there may be greater numbers present in the winter months if they overwinter in the area. Their faeces were seen on the shoreline on either side of the village, which is consistent with areas of improved pasture identified in Landcover2000 data. Contamination from deer will be carried into the production area by streams draining the surrounding hills and this will occur all year round. The impacts will be highest where streams enter the loch, and this may have a higher impact at the Sgeirean Buidhe site, where a stream runs through the trestle area.

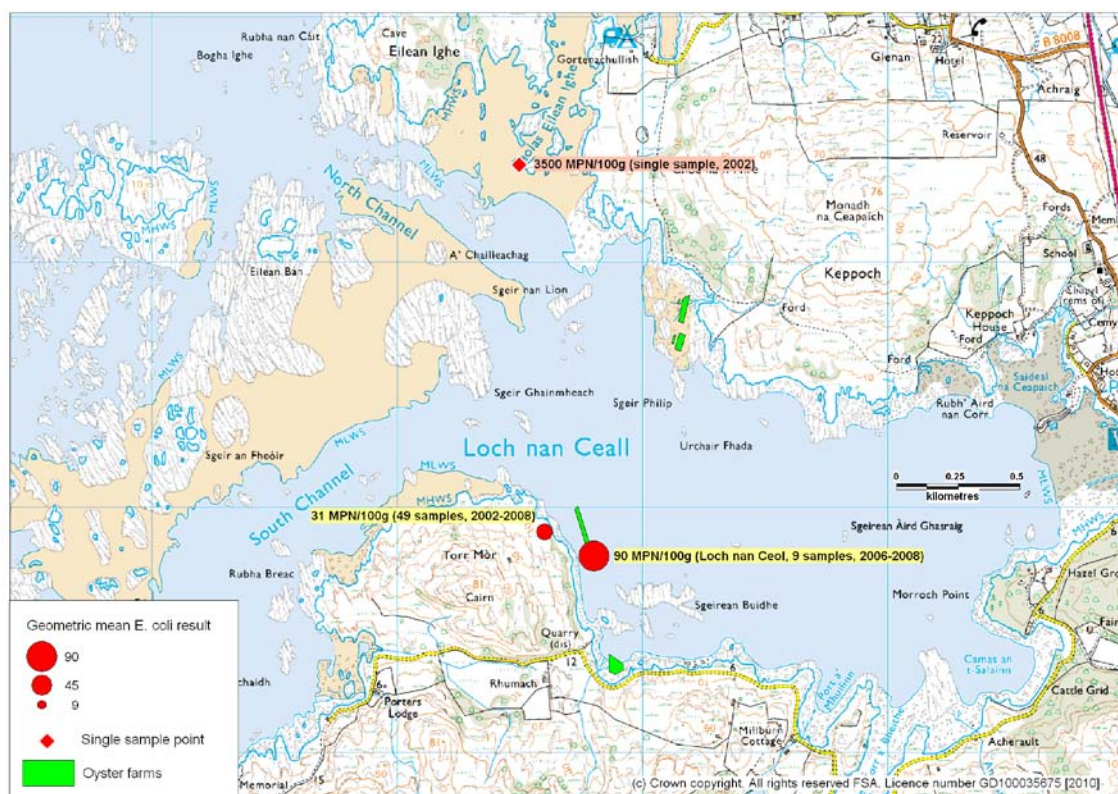
Figure 11.2 Map of sampling points and geometric mean result (mussels)

All but one of these samples originated from the Loch nan Ceol site. The sample which gave the highest result was the only sample taken from the North Channel site. Two locations were sampled at the Loch nan Ceol site, with results on average lower at the RMP, but this difference was not significant (T-test,  $T=-2.12$ ,  $p=0.057$ , Appendix 6). There was also no significant difference in the proportion of results exceeding 230 *E. coli* MPN/100g between either location sampled at Loch nan Ceol (Fishers Exact test,  $p=0.619$ , Appendix 6). These locations were never both sampled on the same occasion. All results greater than 230 MPN/100 g prior to 2008 (7 results) were reported against the nominal RMP and those from 2008 were reported against the other grid reference. Therefore, the variation in results may be due to the way that sampling location was reported over time rather than a true geographic effect.

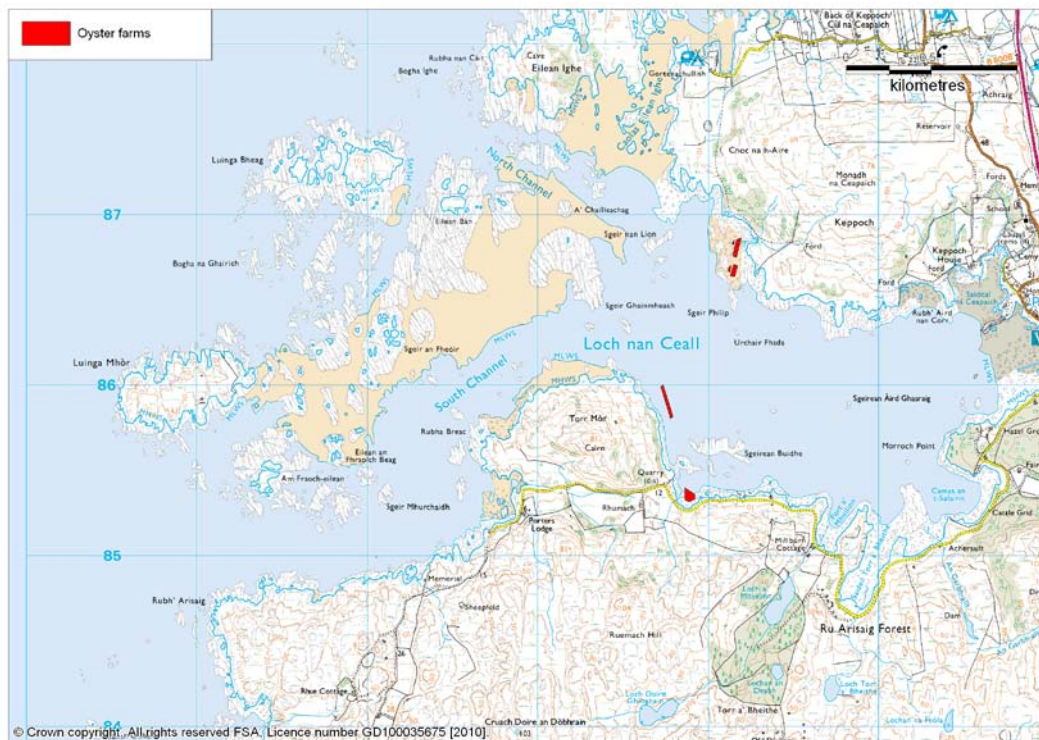
Figure 14.1 OS map of Loch nan Ceall

Currents in coastal waters and estuaries are driven by a combination of tide, wind and freshwater inputs. This section aims to make a simple assessment of water movements around the area. Figure 14.1 shows the OS map of Loch nan Ceall and Figure 14.2 shows the bathymetry of the loch.

The points where the streams were measured and sampled, together with the calculated loadings, are shown in Figure 14.1. Where the bacterial loading is labelled on the map, the scientific notation is written in digital format, as this is the only format recognised by the mapping software. So, where normal scientific notation for 1000 is  $1 \times 10^3$ , in digital format it is written as 1E+3.

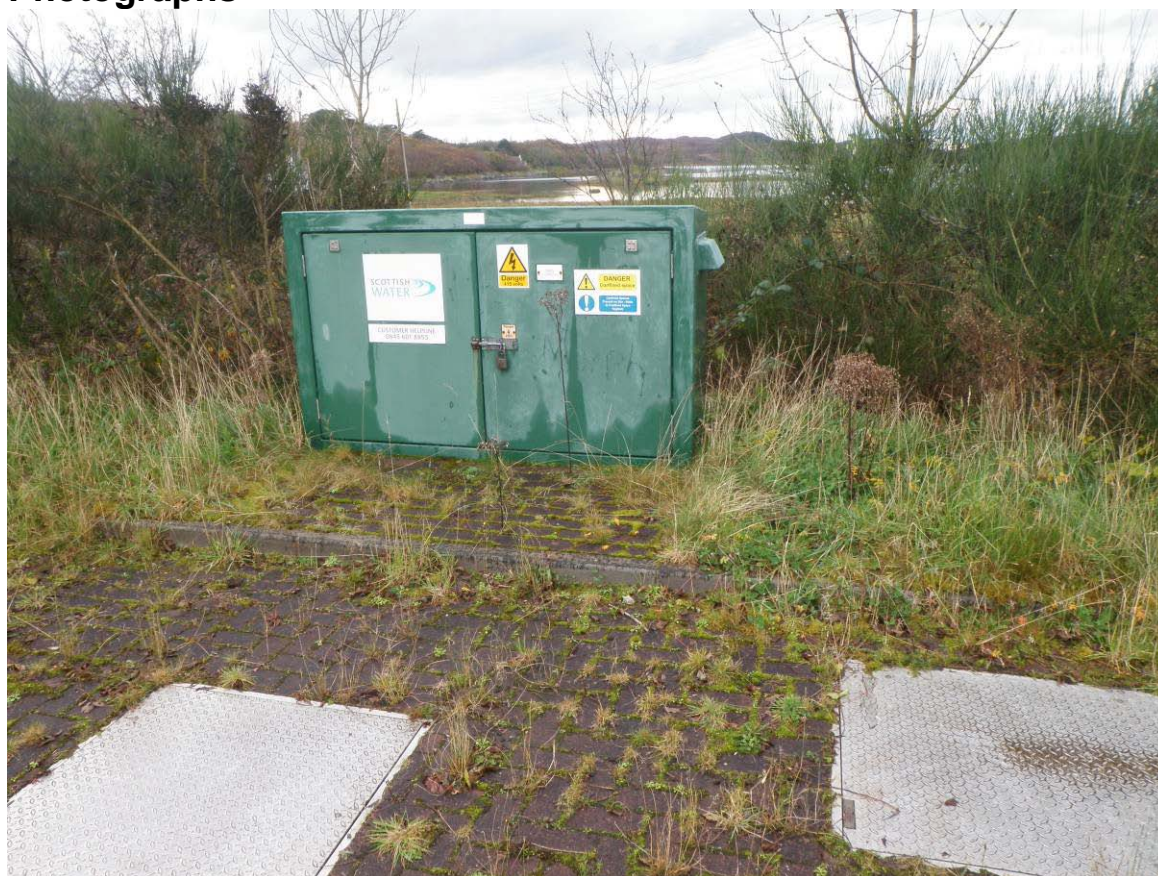
Figure 4 Septic tank at Arisaig

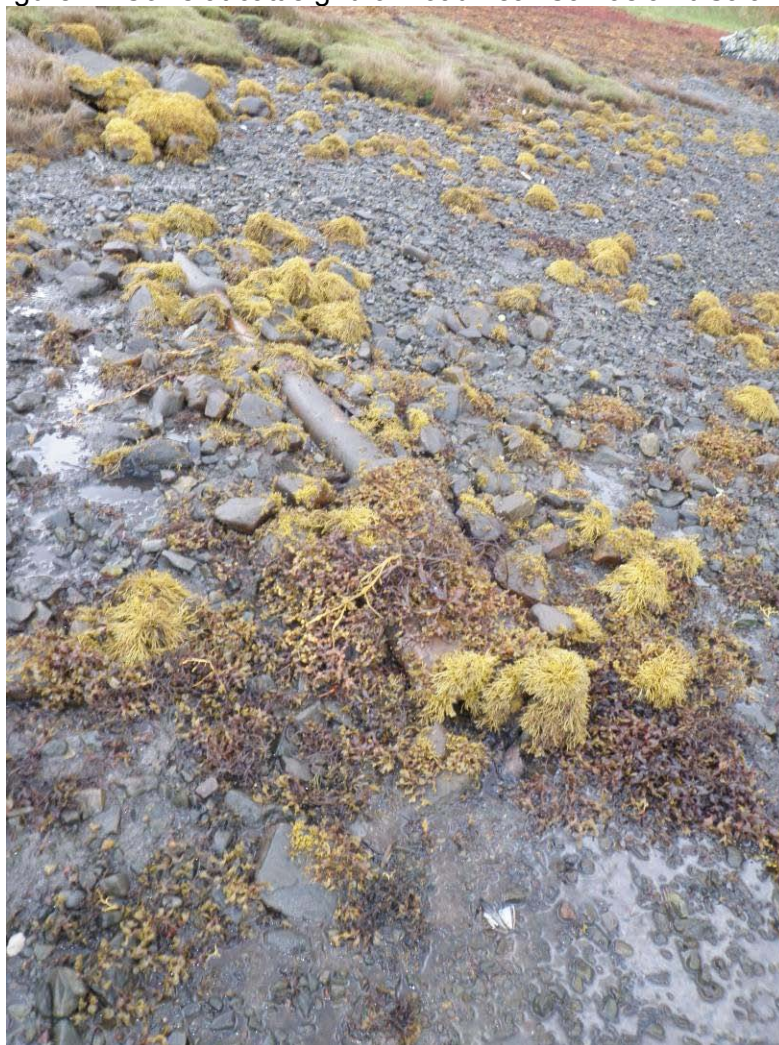
Figure 15 Discharge pipe on shore at Camas an t-Salainn

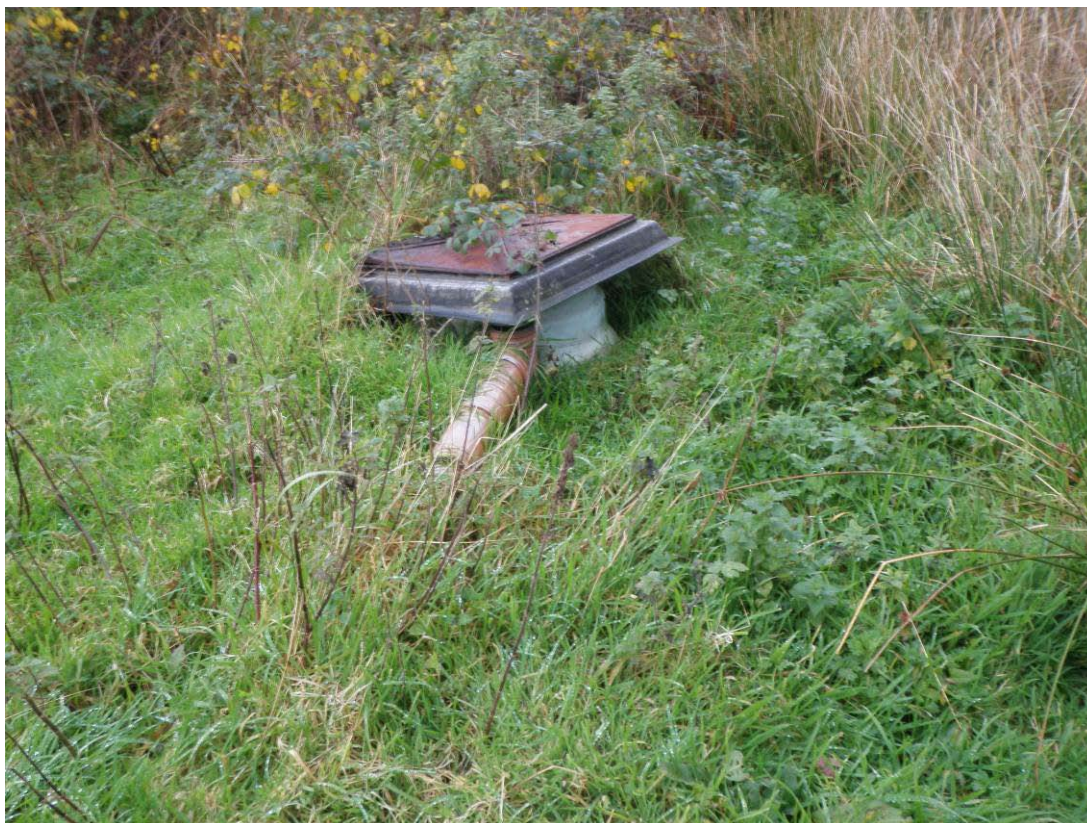
Figure 16. Septic tank with overflow pipe, Camas an t-Salainn

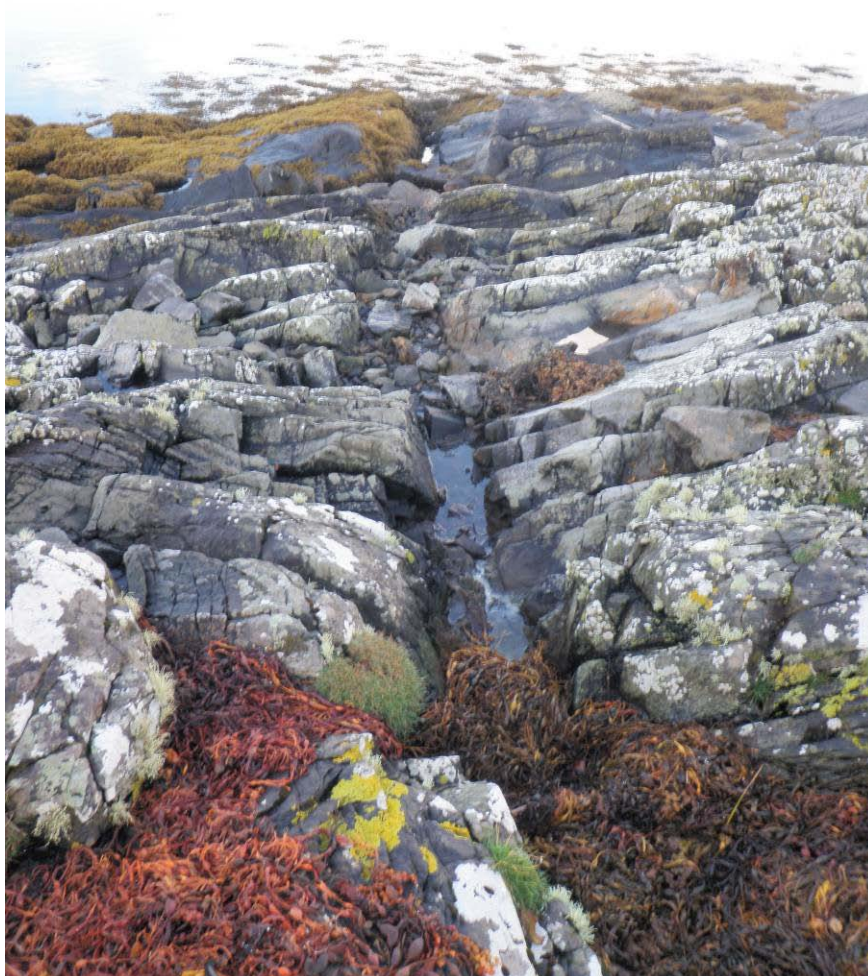
Figure 17 Small stream across rocky shore

37	21/10/2009	11:07:43	NM 65620 85509	165620	785509	Figure 17	Small stream with possible sewage fungus. Water sample ARG13
38	21/10/2009	11:25:42	NM 65426 85547	165426	785547		1 Heron
39	21/10/2009	11:38:09	NM 65431 85637	165431	785637		Discharge pipe - clay. 13cm diameter - flowing. Water sample ARG14
40	21/10/2009	11:45:03	NM 65437 85647	165437	785647		Stream and pipe both flowing slightly. House above. Water sample ARG15. Flow 30ml/40secs. Odour. 3 seals
41	21/10/2009	11:57:55	NM 65447 85672	165447	785672		Bottom of garden with 3 small land drains
42	21/10/2009	12:09:17	NM 65539 85759	165539	785759		House
43	21/10/2009	12:12:22	NM 65571 85763	165571	785763		Discharge pipe. Smelly, active but not flowing at time of survey
44	21/10/2009	12:21:06	NM 65617 85758	165617	785758		Pipe dribbling - looks dirty. Water sample ARG16. Flow 30ml in appr 40sec
45	21/10/2009	12:30:04	NM 65665 85764	165665	785764		Septic pipe. Water sample ARG17. 30ml/2sec

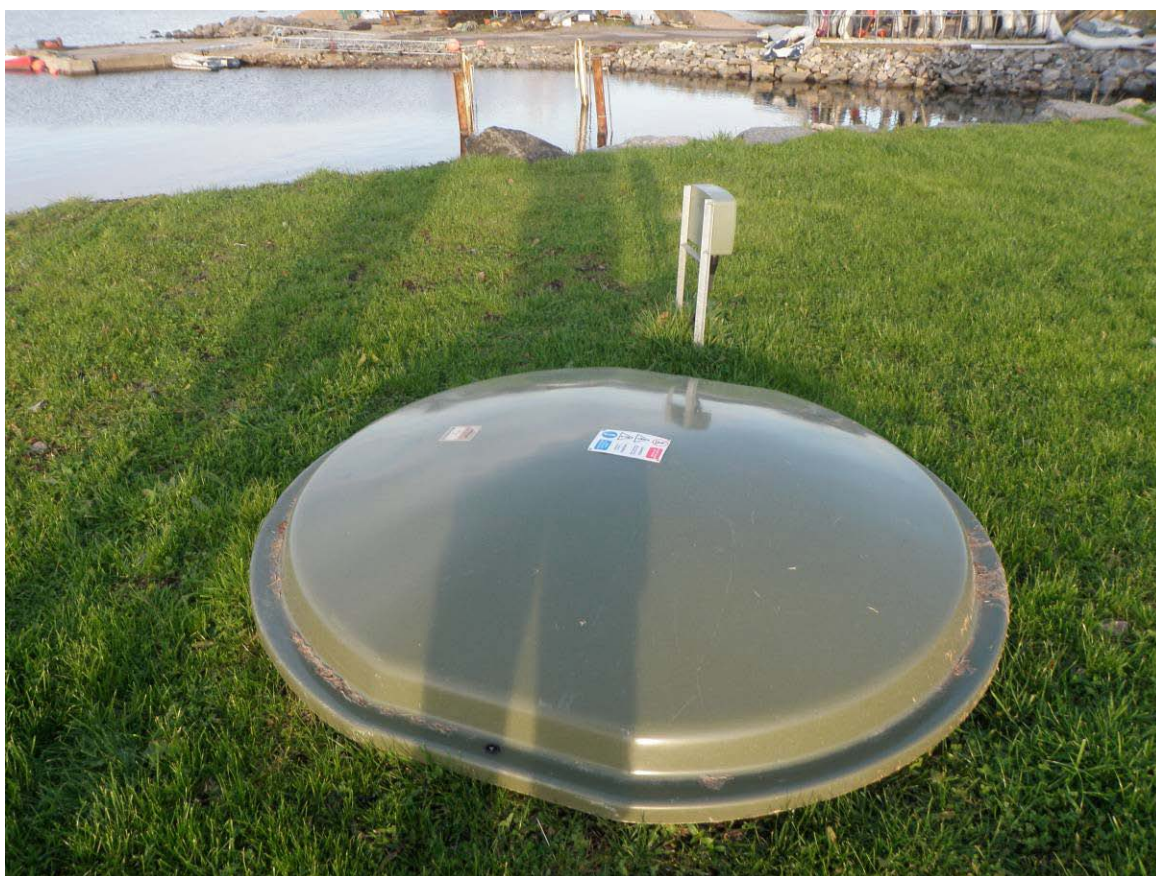
Figure 21 Septic tank at boatyard
