**Sanitary Survey Review**

**Mid Yell Voe**

**SI 216**

**May 2014**

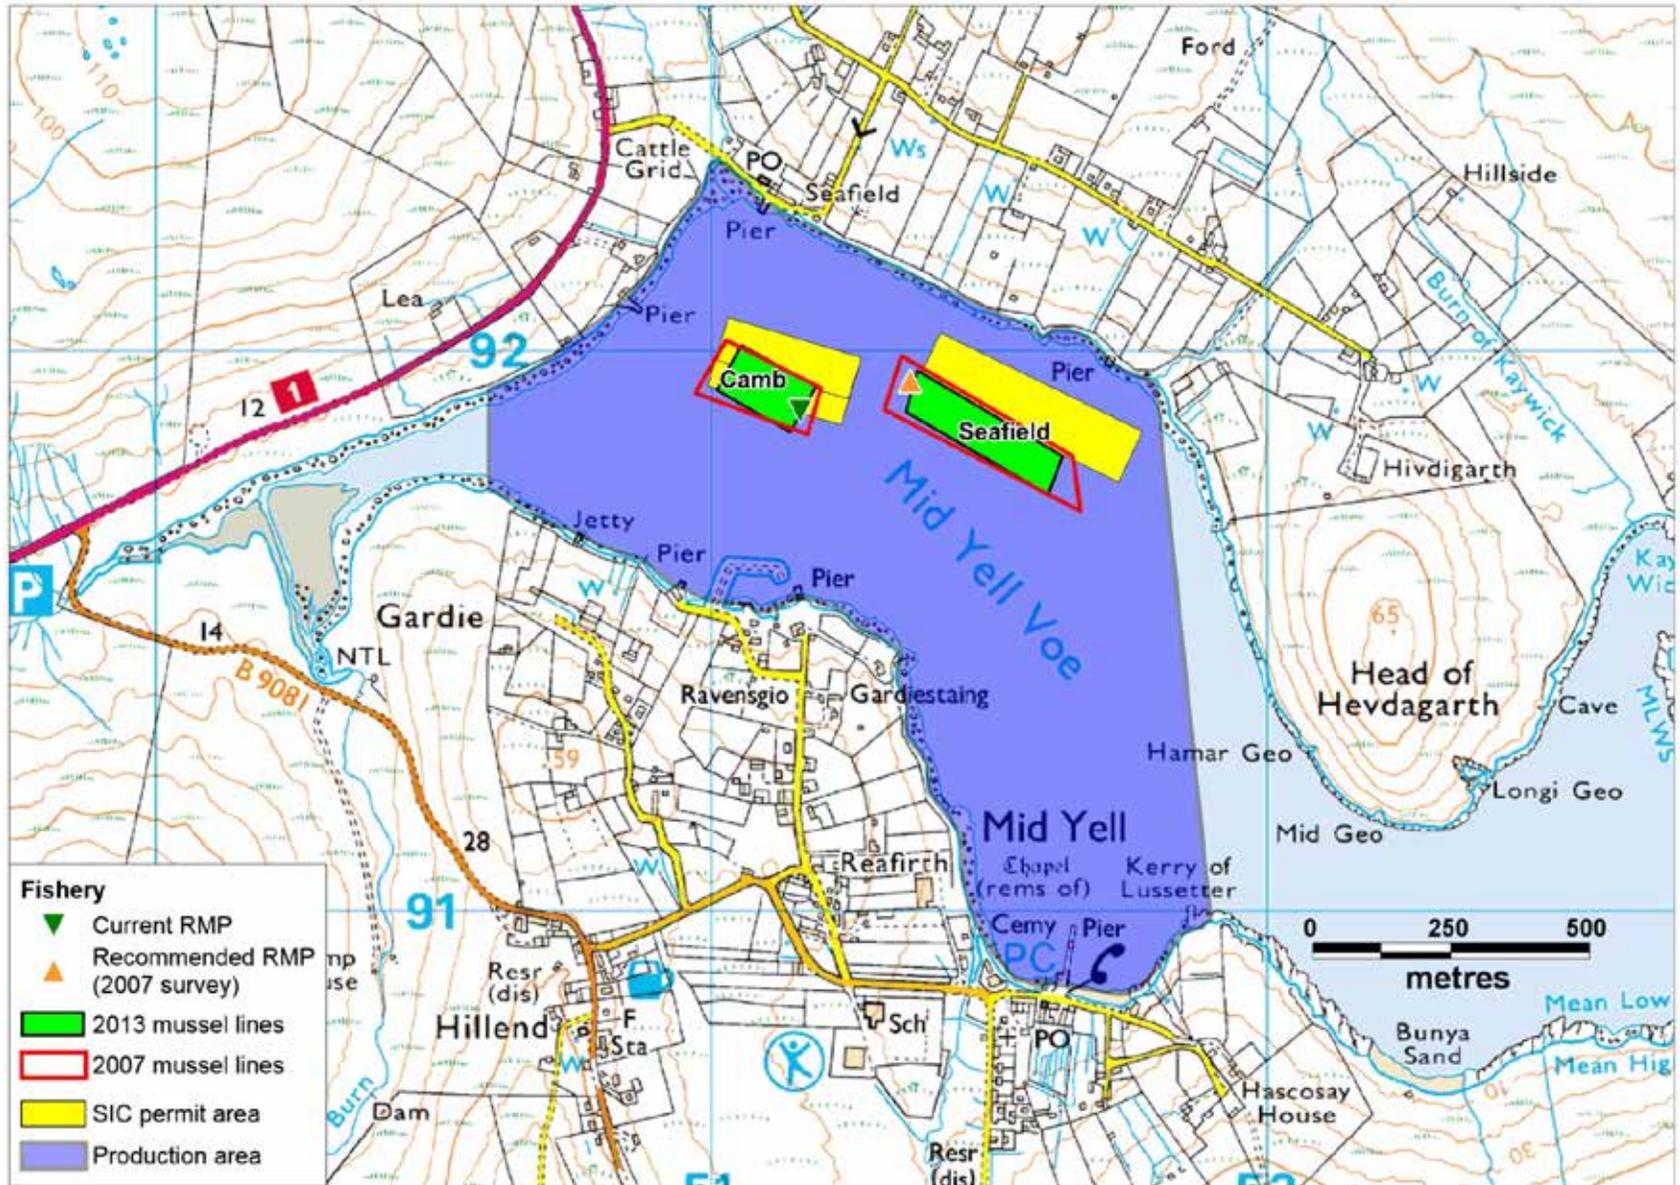
**Figure 2.1 Current fishery production area and SIC leases, with current and historical farm boundaries at Mid Yell Voe**

At the time of the 2013 shoreline survey, six longlines remained at each site, with 8 m droppers on the Seafield site and 5 m droppers on the Camb site. The recorded extents of both sites was slightly smaller than that recorded in the 2007 survey (Figure 2.1), however this may be due to the 2007 extents being recorded at the anchor buoy rather than at the ends of the support floats.

The production area boundaries remain as recommended in the 2007 sampling plan. The production area boundaries and RMP recommended in the 2007 report are displayed in Figure 2.1, along with the Shetland Islands Council permit area, current RMP and extents of the mussel farms from both the 2007 and 2013 shoreline surveys.

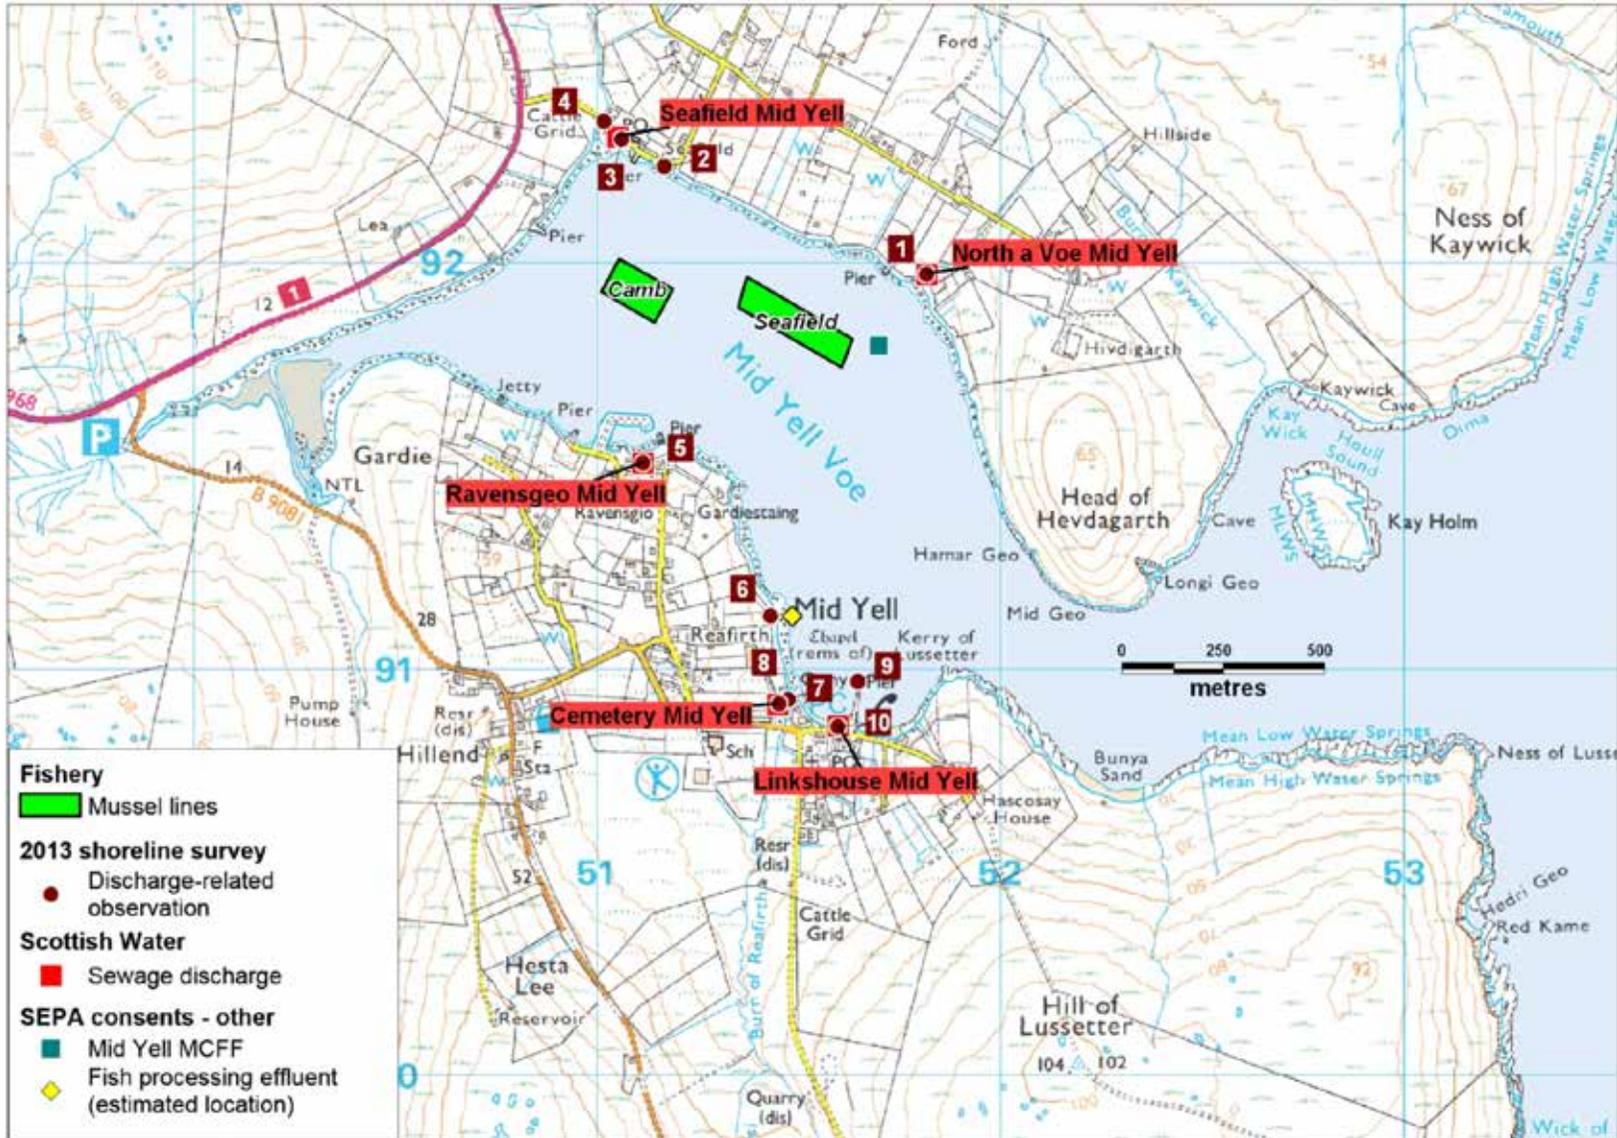
**Figure 3.2 Map of sewage discharges and associated shoreline survey observations**

Sewage infrastructure observed during the 2013 shoreline surveys is listed in Table 3.1 , with locations mapped in Figure 3.2. Further details of the 2013 survey observations can be found in the Appendix 2.

Public toilets were observed at the end of Linkshouse Pier in both the 2007 and 2013 surveys. A seawater sample taken at the end of a pipe entering into the voe in 2013 returned a moderate result of 90 *E. coli* cfu/ 100 ml.

A circular area of disturbed water 10 m offshore from the fish processing plant was observed during the 2013 survey. It reportedly had a brown colouration and gulls were noted to be feeding on the disturbed area. This is presumed to be the location of the final effluent discharge from the plant.

Subsequent to consultation on the draft of this review report, SEPA operations identified that they intended to carry out an evaluation of discharges identified as of potential risk at Mid Yell Voe.

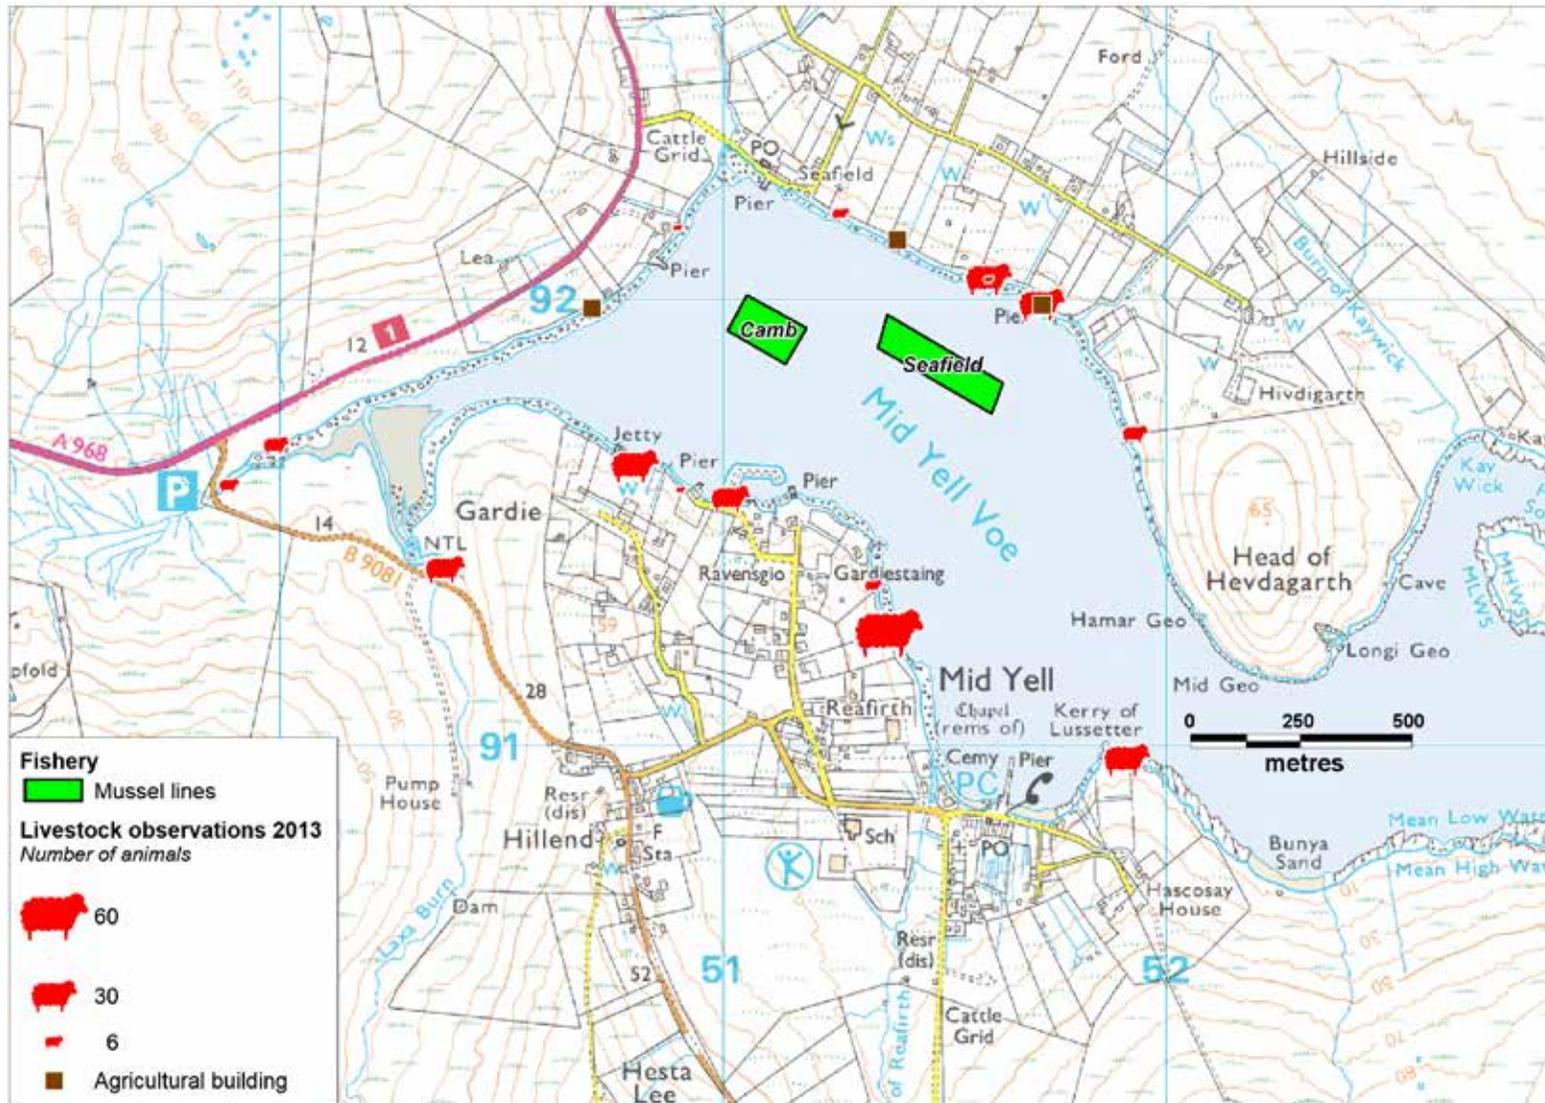
**Figure 4.1 Map of farm animals and associated observations made during the 2013 shoreline survey**

In the 2013 survey, a total of 271 sheep were observed grazing along the northern and southern shorelines. For the most part, sheep were found to be kept in fenced crofts with no access to the shore. However, one flock of 30 sheep was seen on the shoreline near the Seafield site. Open grazing was also noted at the head and southeast areas of the voe, though shore access along the southeast is likely to be prevented by the presence of steep escarpments. Sheep faeces were noted in most grazing areas and two areas outside fenced crofts along the north shore. This suggests that sheep escape the fenced areas and access the shoreline from time to time. No cattle were seen in 2013, though a small number of ponies was recorded.

Three agricultural buildings were noted along the northern shoreline. It was not clear whether the buildings were used to store equipment, livestock or feed. It is therefore unclear whether they represent a potential contamination sources to the mussel farms.

Overall, a larger number of livestock animals was recorded during the 2013 survey, the majority of which were seen along the southern shore of the voe. However, it is not clear whether this represents a change in the number of animals kept in the area or is merely due to differences in timing or viewpoint during the two surveys. The greatest impact to the fishery is likely to occur where animals have access to the shoreline or to watercourses, and where the mussel farms most closely approach the shore. Therefore, the greatest potential impact at the mussel farms is to the north side of the Seafield site.

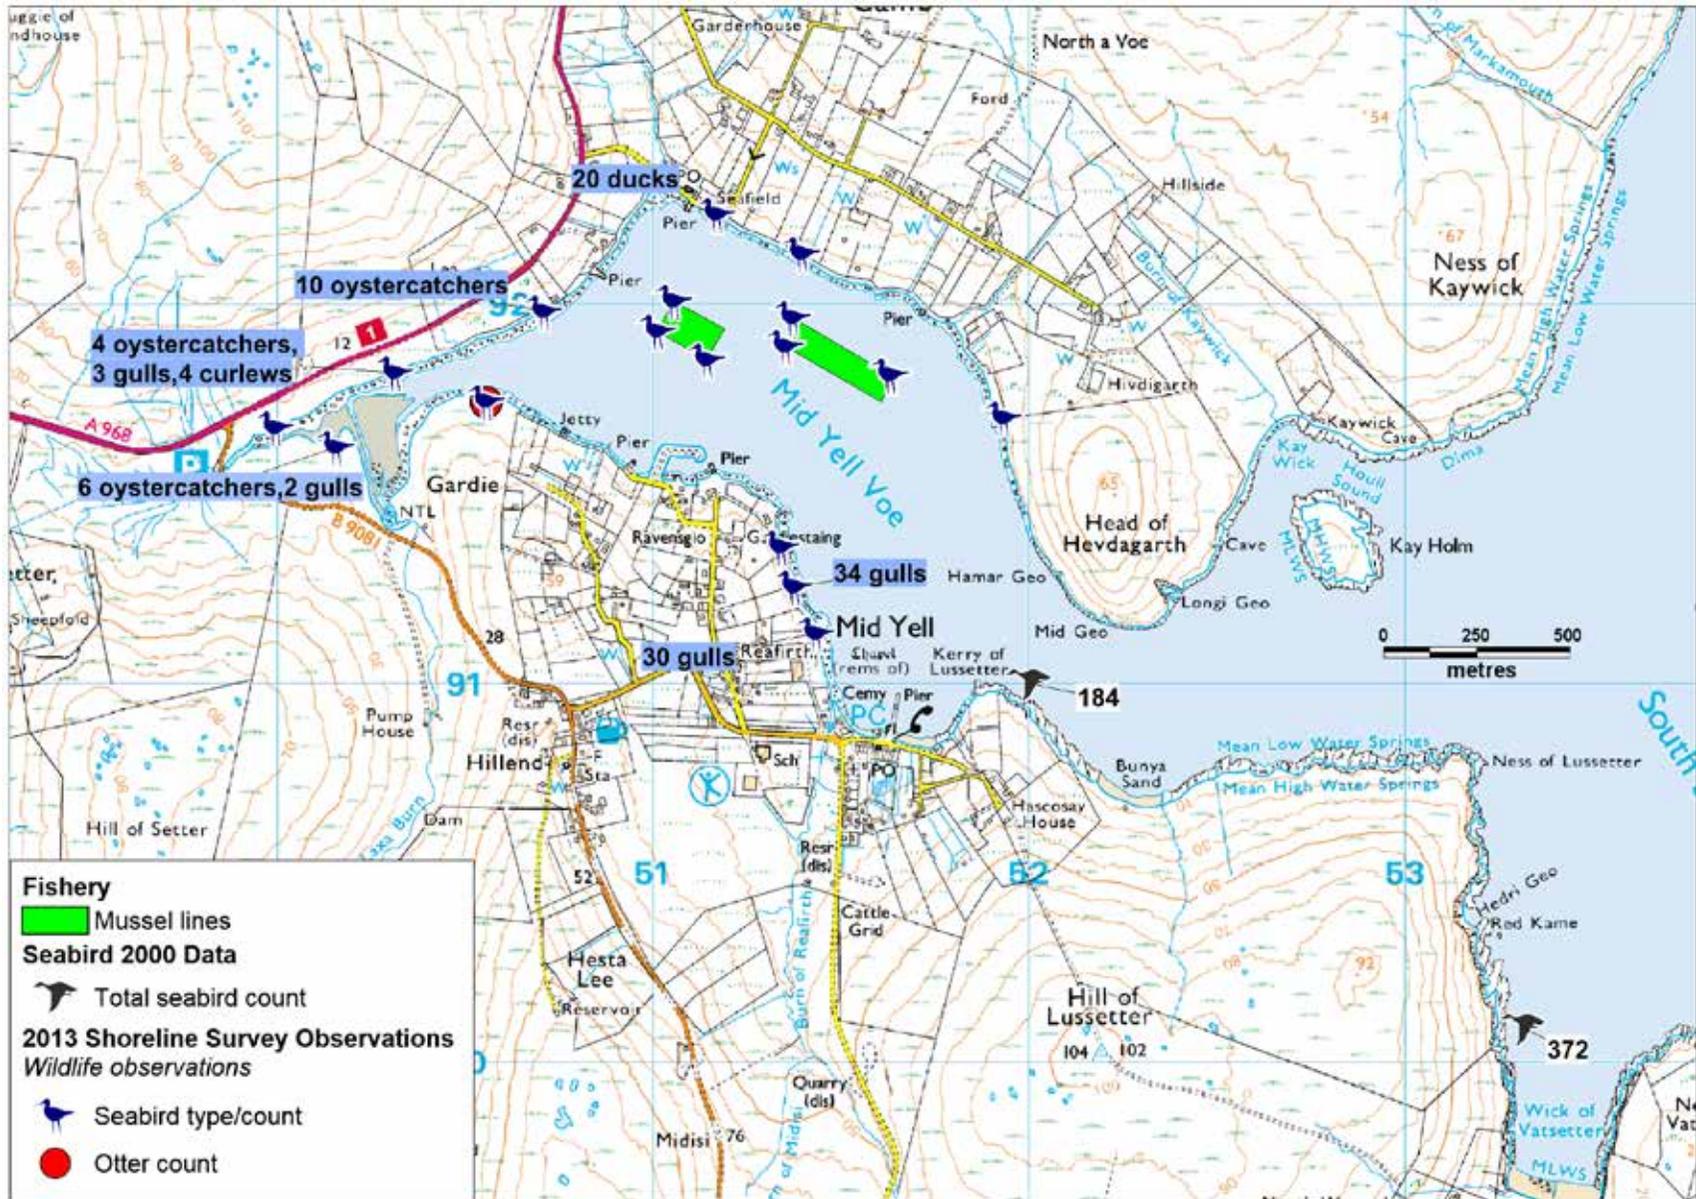
**Figure 5.1 Map of wildlife around Mid Yell Voe, including observations made during the 2013 shoreline survey**

It should be noted that Seabird 2000 sightings are recorded to the nearest 1 km and therefore some of the records may pertain to areas well outside the voe. Not all of the records included in Table 5.1 lie within the mapped area shown in Figure 5.1. Information on bird habitat from the Shetland Marine Spatial Plan (NAFC 2012) has also been included in Figure 5.1.

This data shows much of the voe is used by ducks and seabirds. Eider ducks are noted as present in winter. Seabird nesting areas located to the southeast of the fishery host relatively modest numbers of birds. Breeding seabirds are most likely to be present in these areas between April and August. Some species, such as some gulls and cormorants, will be present in the area throughout the year and were observed resting on the mussel floats during the 2013 shoreline survey. However, without more specific information on seasonal counts of birds in the area it is not possible to ascertain any clear seasonal variation in the contribution of faecal indicator bacteria to the fishery waters.

During the 2013 survey, birds were the most observed wildlife, with gulls the most commonly observed species. Birds and bird droppings were also noted on the mussel floats at the time of the survey, and therefore there is likely to be some direct deposition of droppings to the mussel farms. However, there is no information to suggest that any one part of the farms would be more impacted than another. Observations from the shoreline survey are shown in Figure 5.1. Labels are shown in the figure for any observations of greater than 5 individuals.

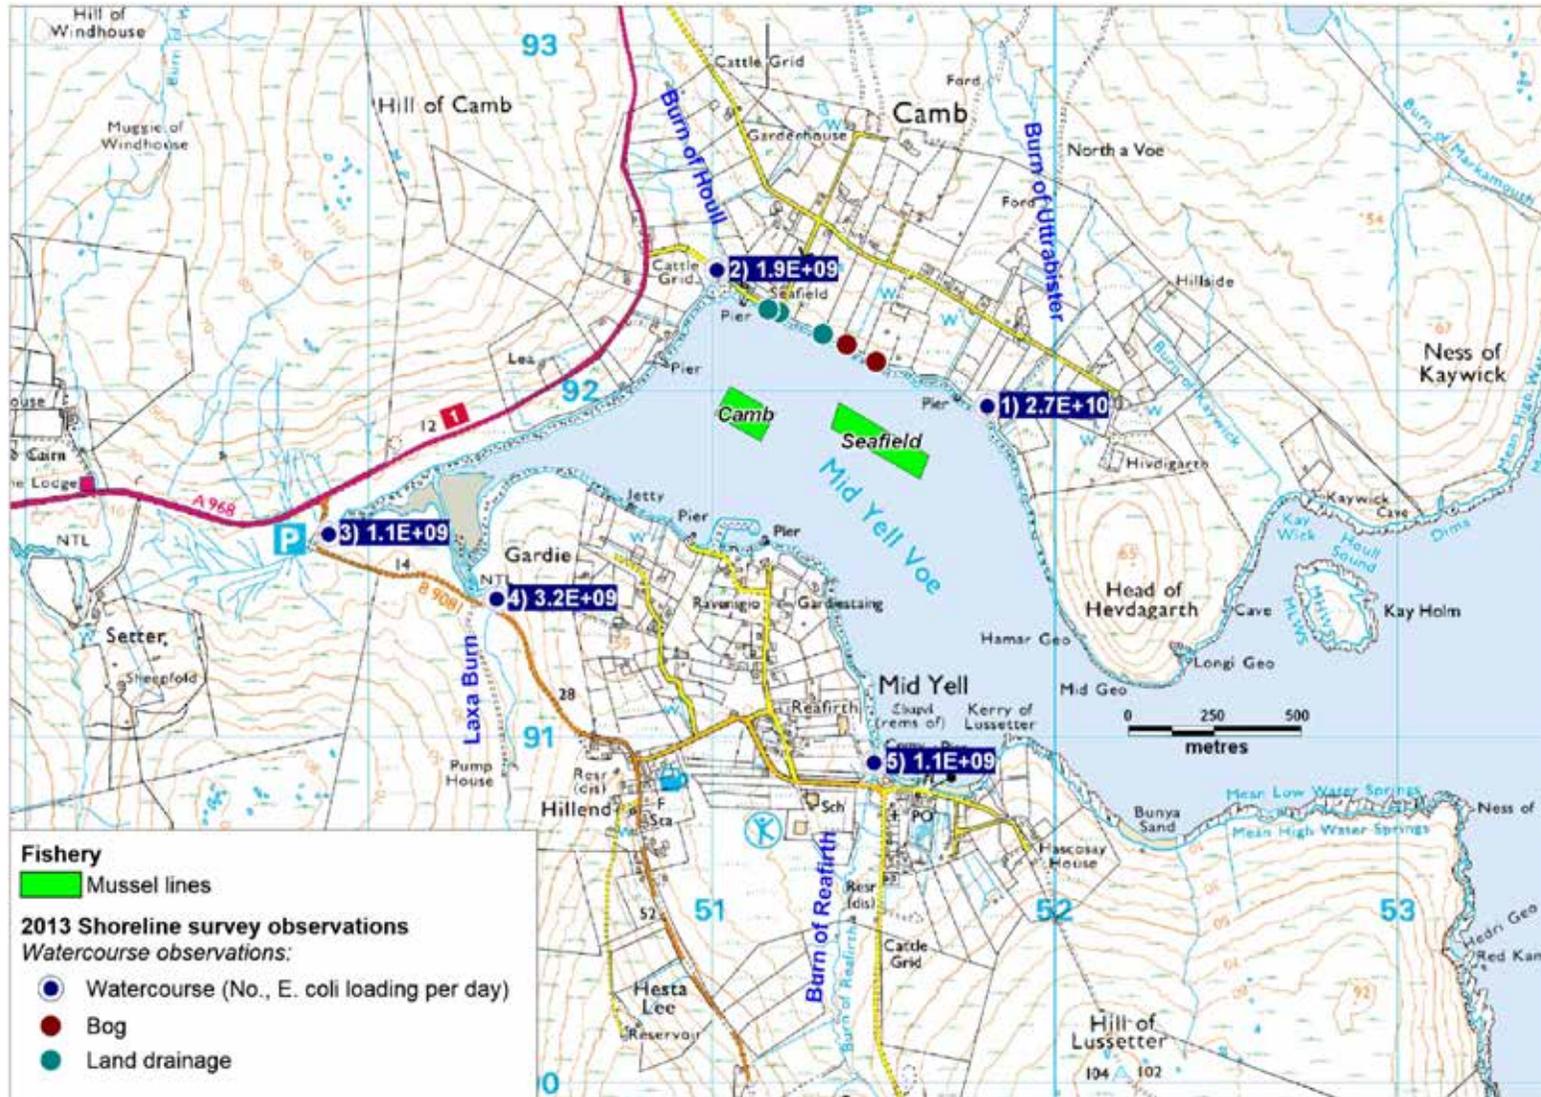
**Figure 6.1 Watercourse loadings into Mid Yell Voe, estimated from measurements made during the 2013 shoreline survey**

Two watercourses enter into Mid Yell Voe along the northern shoreline. The Burn of Houll enters Mid Yell Voe <500 m from the northwest corner of the Camb mussel farm. The Burn of Utrabister enters Mid Yell Voe <200 m from the northeast corner of the Seafield mussel farm. Two of the other watercourses are located at the head of the voe and the fifth is located on the southern shore, at Mid Yell. These three watercourses are each approximately 1 km from the nearest mussel farm.

Estimated *E. coli* loadings were calculated for three out of the five major freshwater inputs into Mid Yell Voe in 2007. The estimated loadings were higher in 2007 than in 2013 for all three of these major watercourses, which may have been due to the slightly wetter conditions during the earlier survey. The highest loading estimated

The impact from freshwater-borne contamination is anticipated to be greatest around the northeast end of the Seafield site, which lies nearest the outlet of the Burn of Uttrabister. The Camb site is also likely to receive freshwater input from watercourses to the north and southwest of it, however the combined estimated loading carried by these watercourses was lower than that observed at Burn of Uttrabister. The likely impact from these watercourses will depend on the predicted movement of contaminants and the potential for dilution.

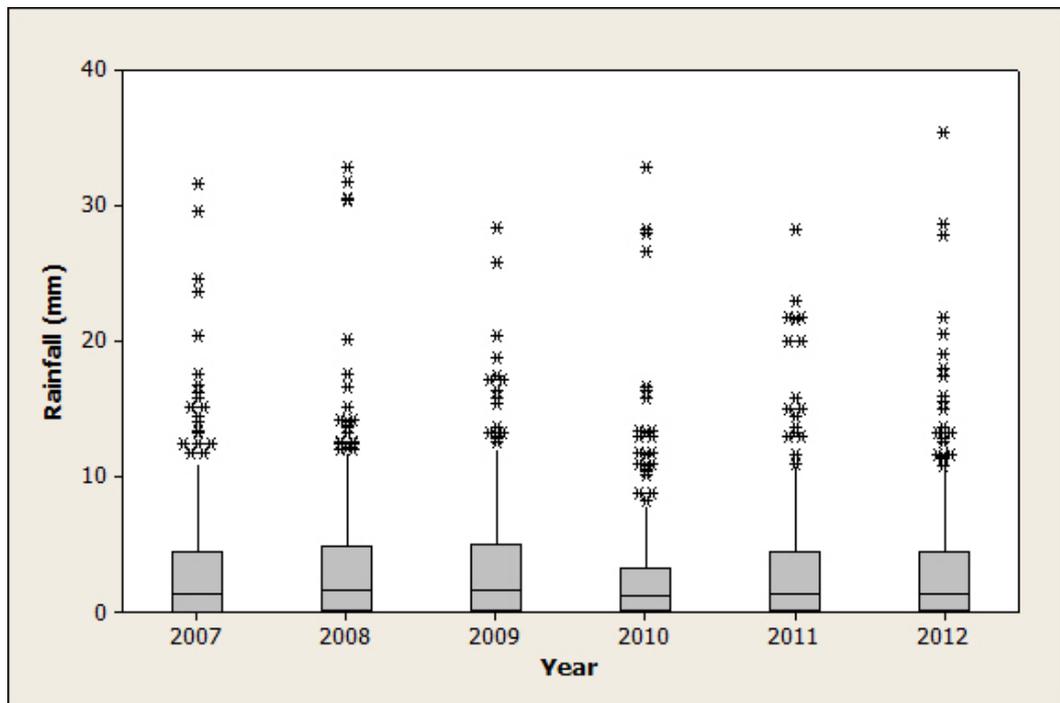
Figure 7.1 Boxplot of daily rainfall at Baltasound by year (2007-2012)

In both periods, the majority of observations were below 5 mm rainfall/day. Rainfall events exceeding 30 mm/day occurred in all years except for 2009 and 2011 (and in 2003 and 2004 in the previous dataset). There were no rainfall events exceeding 40

mm/d in either dataset. Therefore, overall daily rainfall does not appear to have changed significantly across the assessed years.

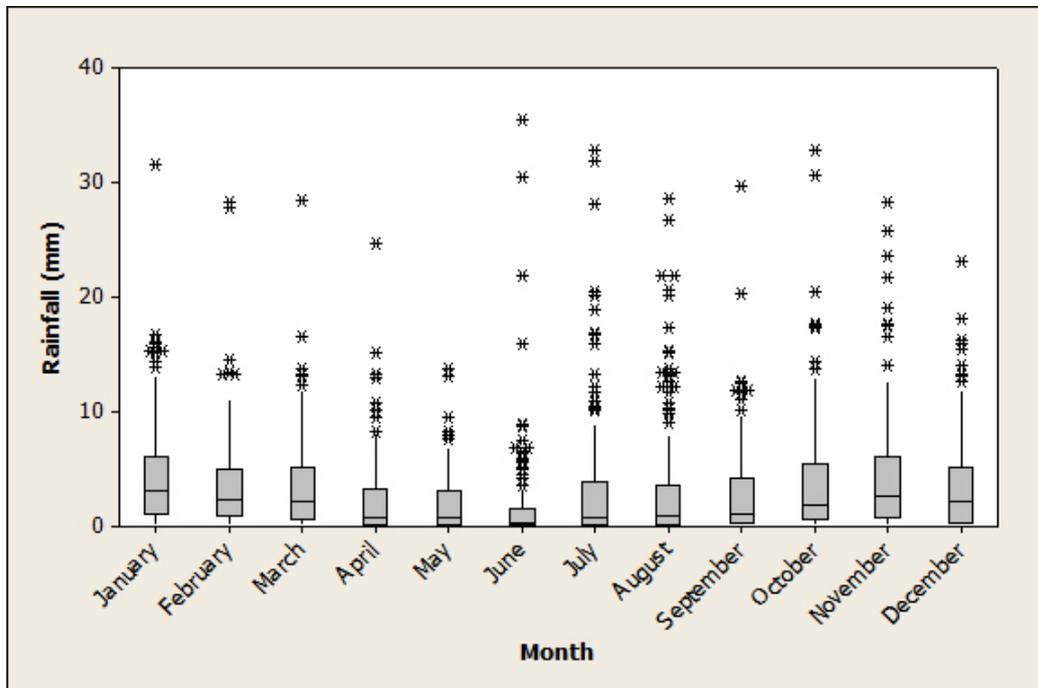
**Figure 7.2 Boxplot of daily rainfall at Baltasound by month (2007-2012)**

Figure 7.2 presents a boxplot of daily rainfall values by month for the 2007-2012 dataset. The period 2003-2006 had shown September to January to be the wetter months, and April to August drier. A similar trend was seen in data from the period 2007-2012, though July and August appeared to be comparatively wetter during 2007-2012 than during 2003-2006.

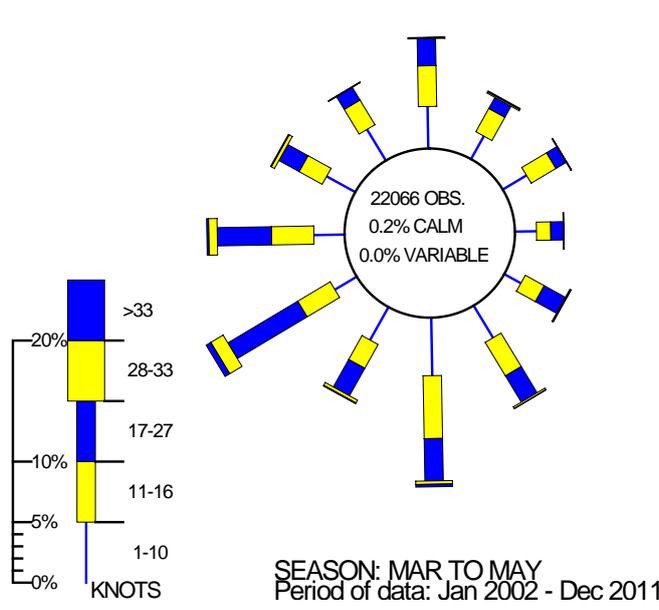
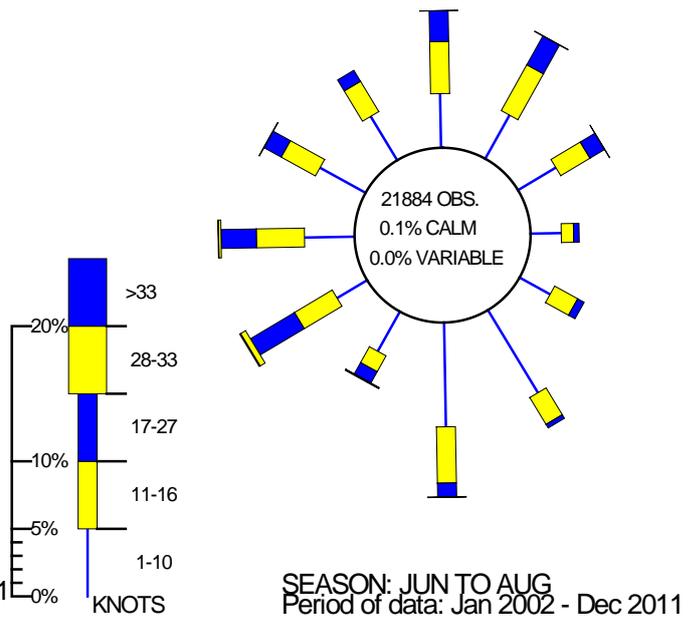
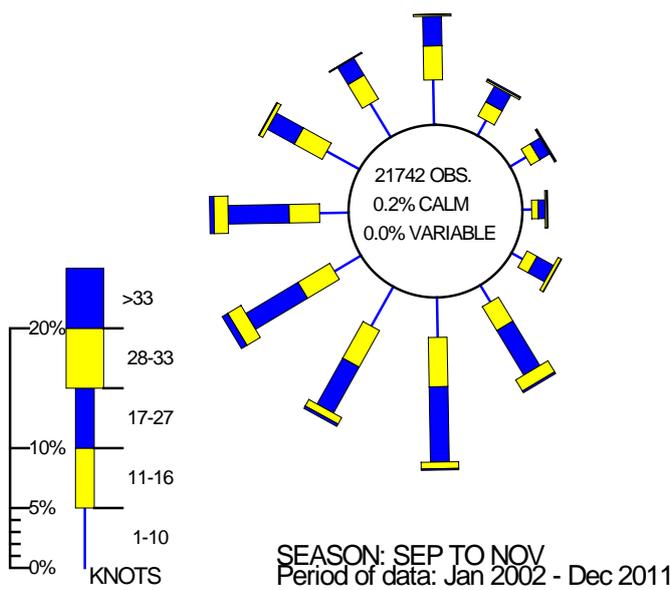
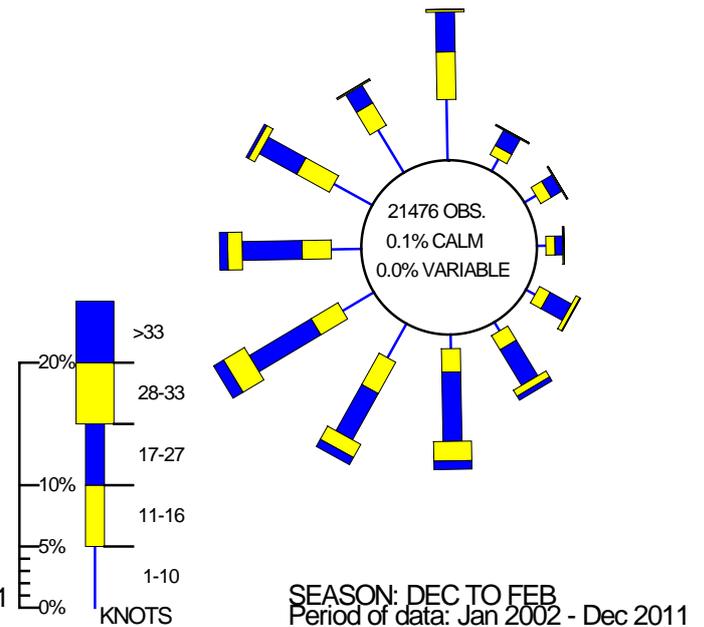
**Figure 7.3 Seasonal wind roses for Lerwick (2002-2011)**

Prevailing winds are south to south westerly, particularly in autumn and winter when the strongest winds come from this direction. However, strong north easterly and north westerly winds also occurred in summer, whilst spring winds were highest to the south-west. This is trend is seen in both datasets from 1996-2006 and 2007-2011. There are slight variations between years and seasons.

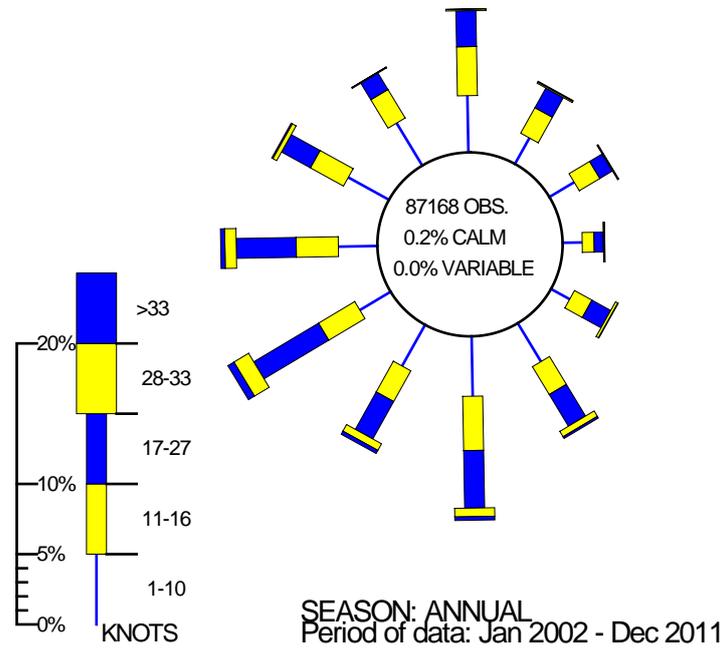
**Figure 7.4 Annual wind rose at Lerwick (2002-2011)**

The wind rose in Figure 7.4 shows that the overall prevailing annual wind direction is from the south and west. Winds are generally lighter during the summer months and strongest in the winter. Mid Yell Voe faces east and is sheltered from the open sea to some extent by the island of Hascosay.

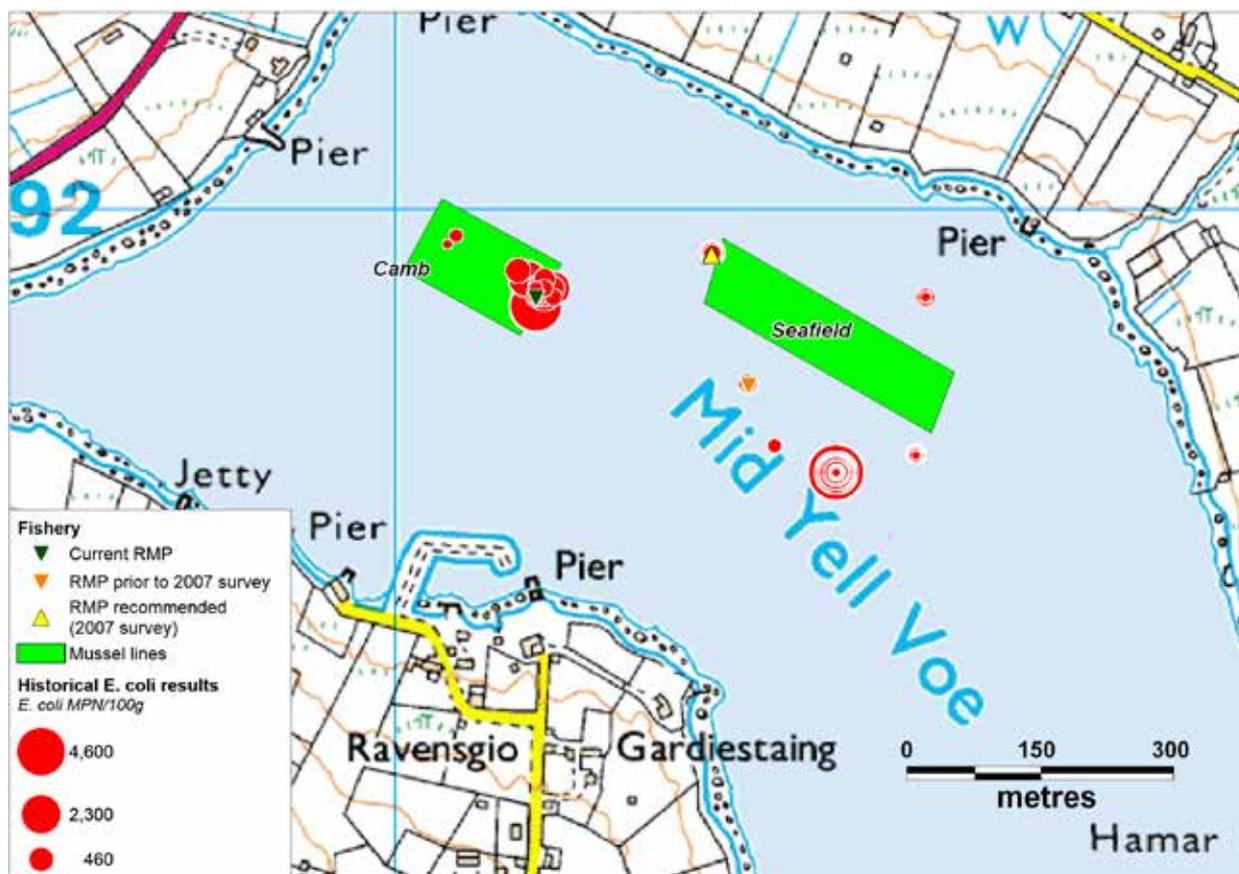
**Figure 8.1 Mussel sampling locations and magnitude of results at Mid Yell Voe**

The location of the historical and current RMPs and shellfish sampling locations for both sites over the sampling period 01/01/2007–7/03/2014 are displayed in Figure 8.1. One sample [CEFAS\_2913] was identified as unverified and had no associated location information, and is therefore not included in the figure. The size of the symbols are graduated in proportion to the magnitude of the *E. coli* result.

All samples taken from 10/07/2007 to 09/11/2010 (30 samples) were reported against a location approximately 400 m southeast of the current RMP at HU 515 917. Only 6 samples were taken at the RMP recommended in the sanitary survey report: these were taken between November 2011 and April 2012.

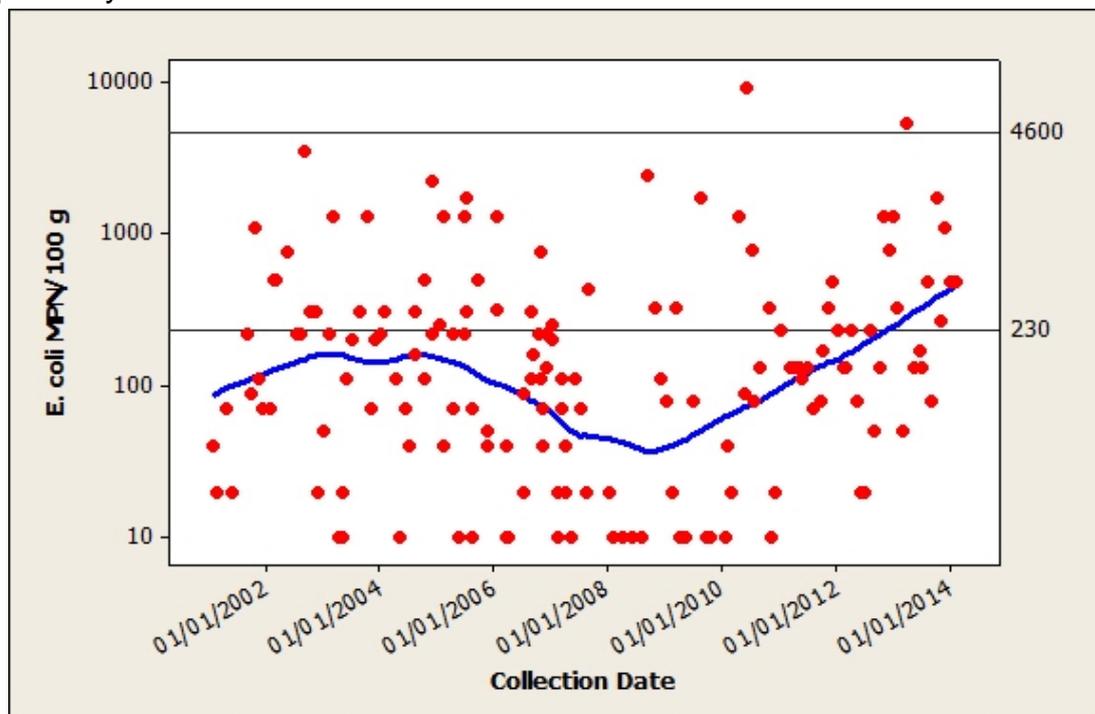
Figure 8.2 Scatterplot of Mid Yell Voe common mussel *E. coli* results by date (2001-2013), with a lowess line

The trend in *E. coli* results showed a dip between 2007 and 2009, after which results increased steadily. Since 2010, there have been two results greater than 4600 *E. coli* MPN/100 g and no results below the limit of detection (< 20 *E. coli* MPN/100 g). Of the results >4600, one occurred in 2010 and the other in 2013.

Although there was no statistically significant difference between results from 2001-2006 and 2007-2014, the trend in results over time showed a dip in 2008-2009 followed by a steady increase until present. There is therefore some indication from the monitoring results that water quality has deteriorated since 2010.

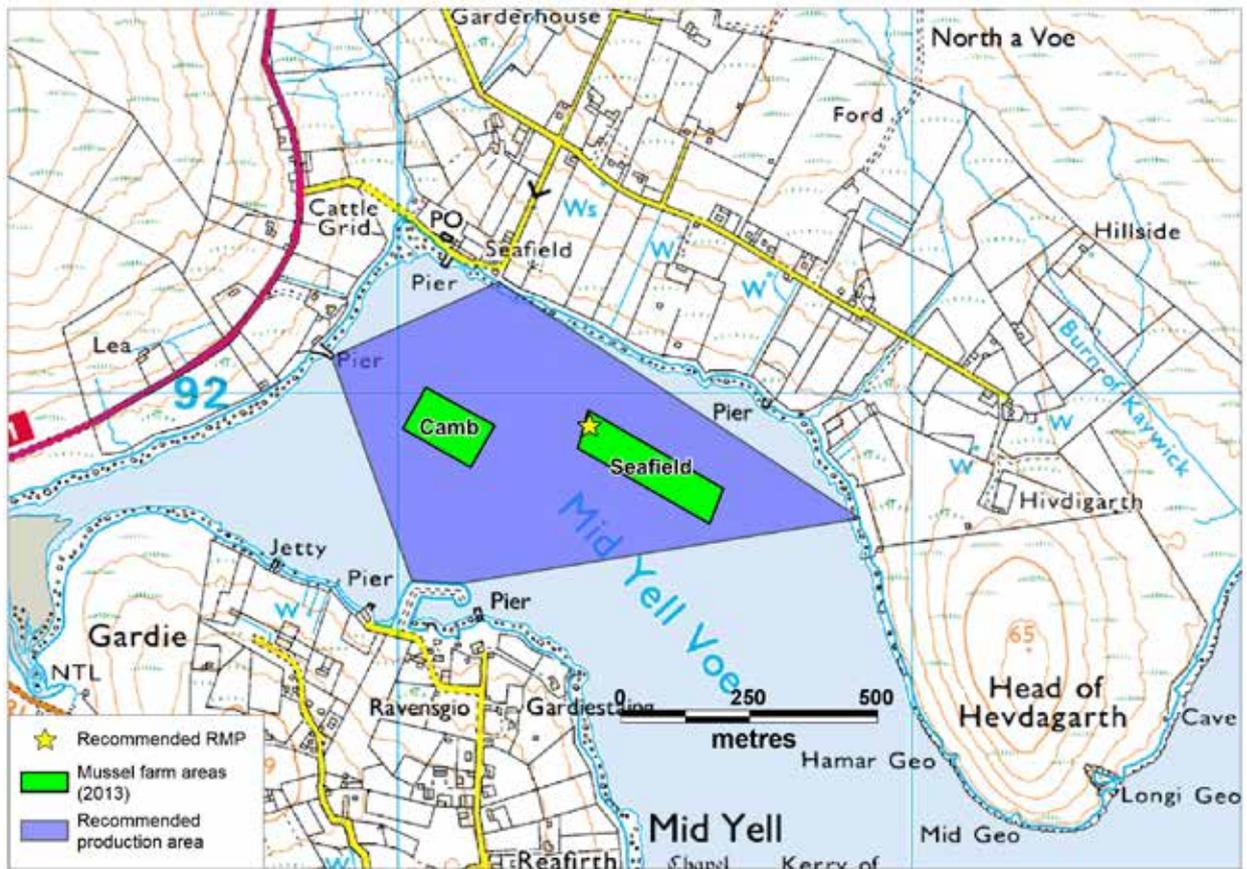
© Crown Copyright and Database 2014. All rights reserved. Ordnance Survey Licence number GD100035675.  
**Figure 11.1 Recommended production area boundaries and RMP – Mid Yell Voe**

It is recommended that monitoring be retained at monthly.

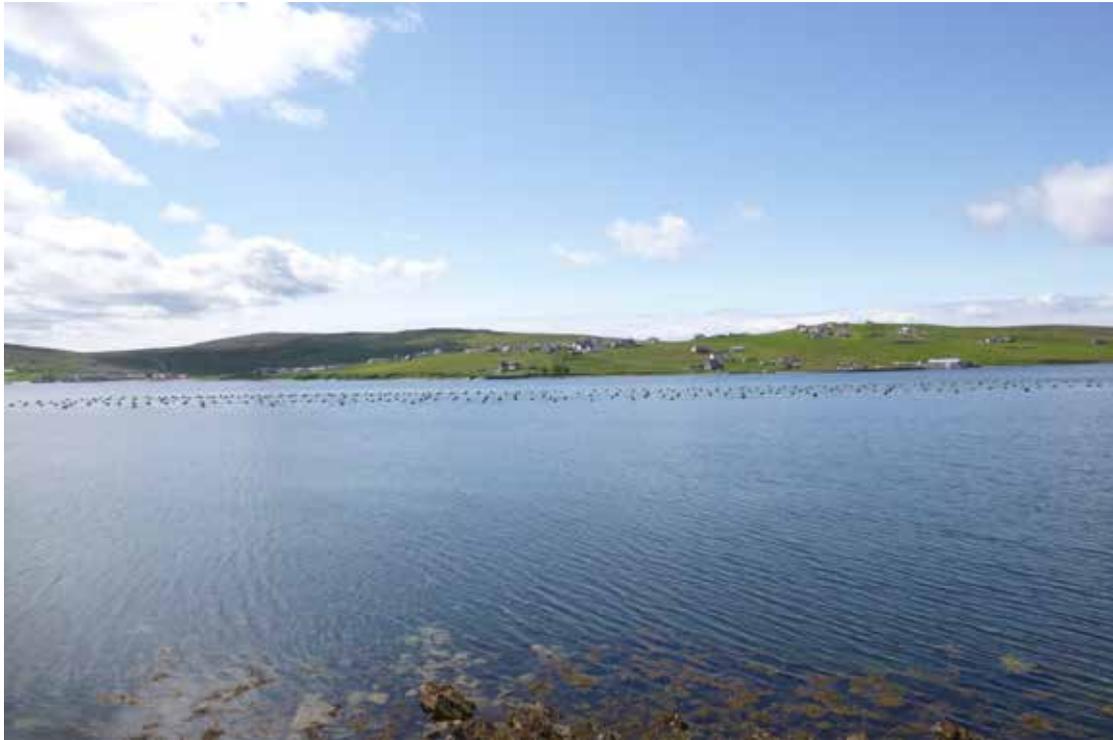
**Figure 4 – Mussel lines at the Seafield fishery looking south to Mid Yell.**

The Seafield fishery consisted of six mussel lines running parallel to the shoreline (Figure 4). All lines were double headed long lines with 8 metre droppers. Two mussel samples were collected near the south east corner of the site from the line closest to the shore taken from the top and bottom of a mussel line. Two mussel samples were also collected from the north west corner of the site from the line furthest from the shore, taken from the top and bottom of a mussel line.

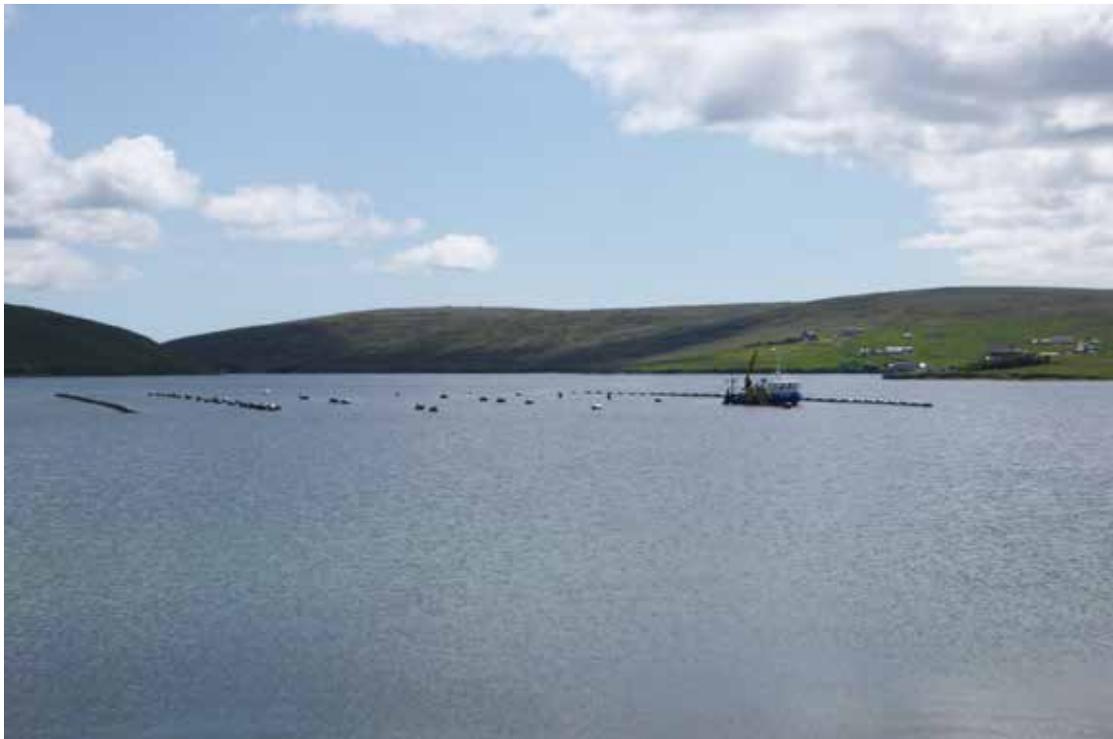
**Figure 5 – Mussel lines at the Camb fishery looking south to Mid Yell, with a workboat on site.**

The Camb fishery consisted of six mussel lines running parallel to the shoreline (Figure 5). All lines were double headed long lines with 5 metre droppers. Two mussel samples were collected from the north west corner of the site from the line furthest from the shore taken from the top and bottom of a mussel line.

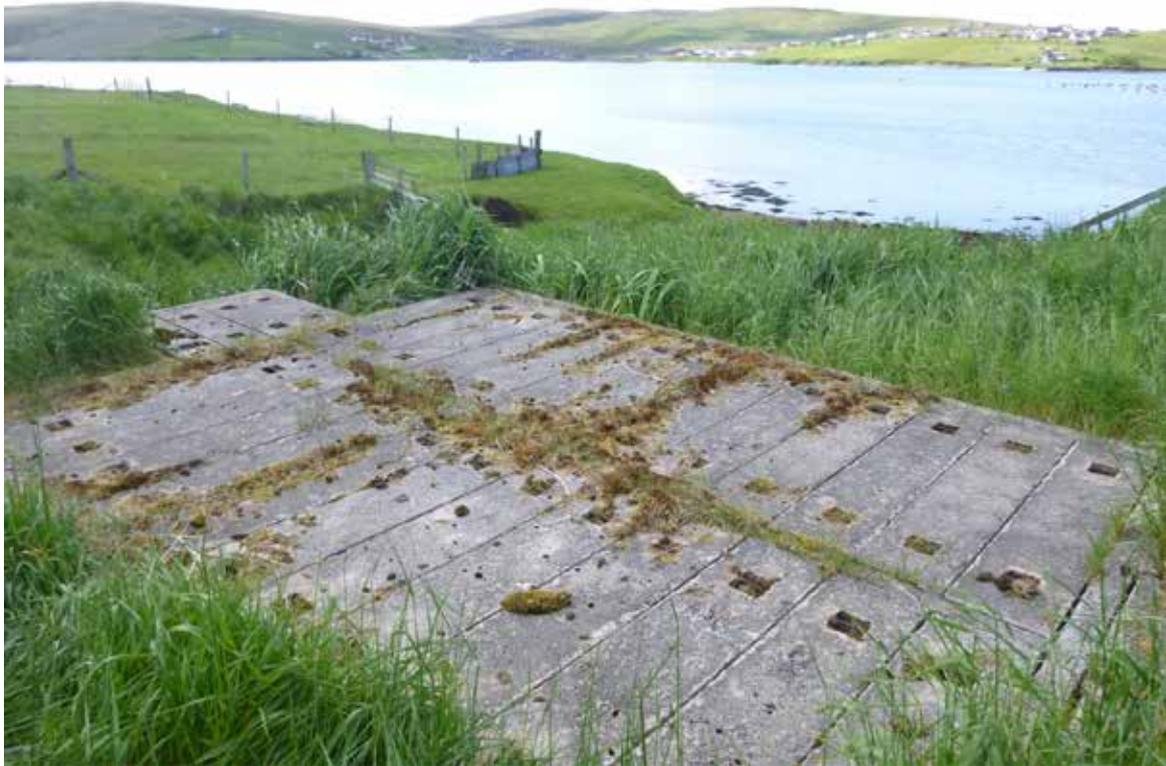
**Figure 6 – North a Voe Septic Tank**

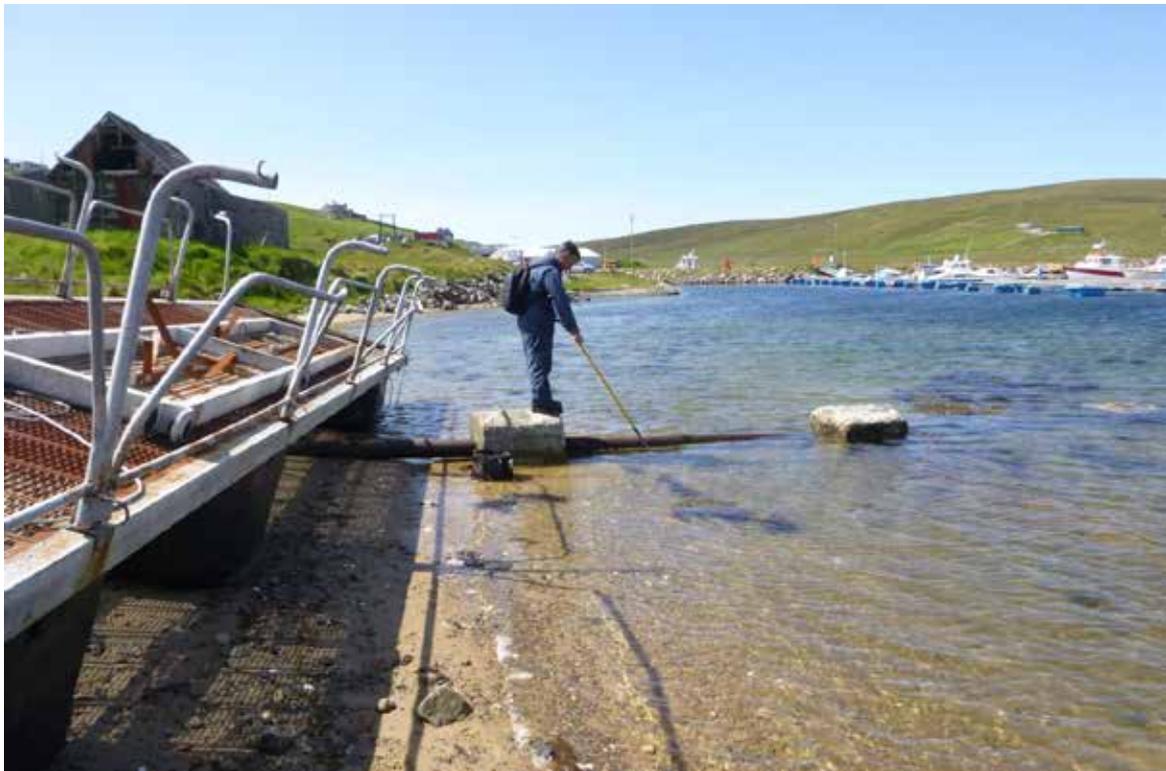
**Figure 7 – Sea water sample being obtained near the Ravensgio Septic Tank discharge pipe.**
