**Sanitary Survey Review**

**Mid Yell Voe**

**SI 216**

**May 2014**

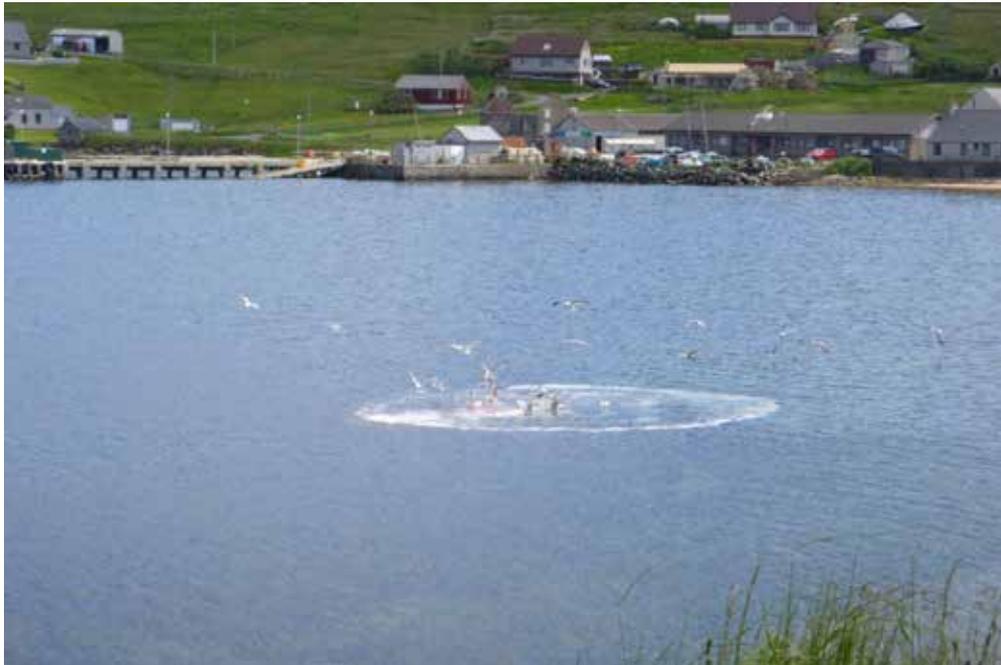
A circular area of disturbed water 10 m offshore from the fish processing plant was observed during the 2013 survey. It reportedly had a brown colouration and gulls were noted to be feeding on the disturbed area. This is presumed to be the location of the final effluent discharge from the plant.

**Figure 8 – Zone of disturbance in the water where gulls were feeding, possible discharge from the salmon processing factory at Reafirth.**

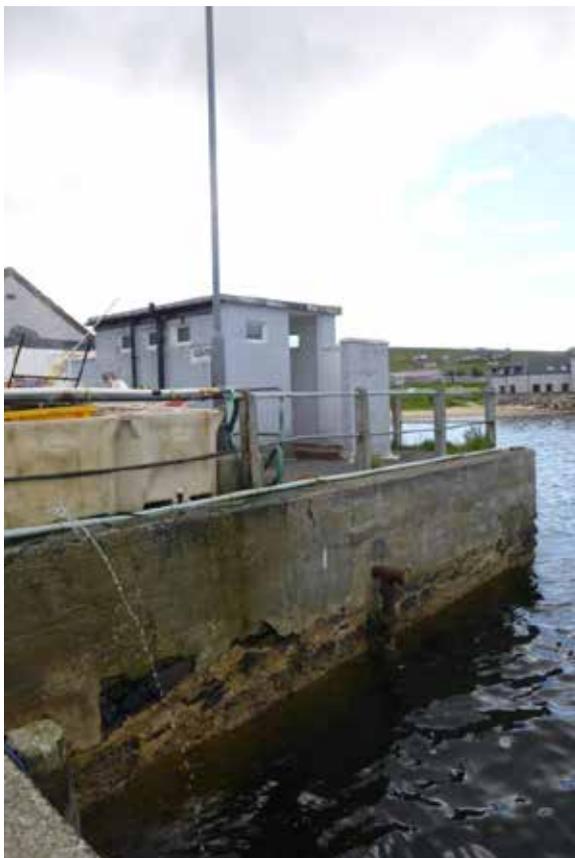
Public toilets were observed at the end of Linkshouse Pier in both the 2007 and 2013 surveys. A seawater sample taken at the end of a pipe entering into the voe in 2013 returned a moderate result of 90 *E. coli* cfu/ 100 ml.

**Figure 9 – Public toilets at the Linkshouse Pier, pipe leading to the sea possibly associated with discharge from the toilets.**

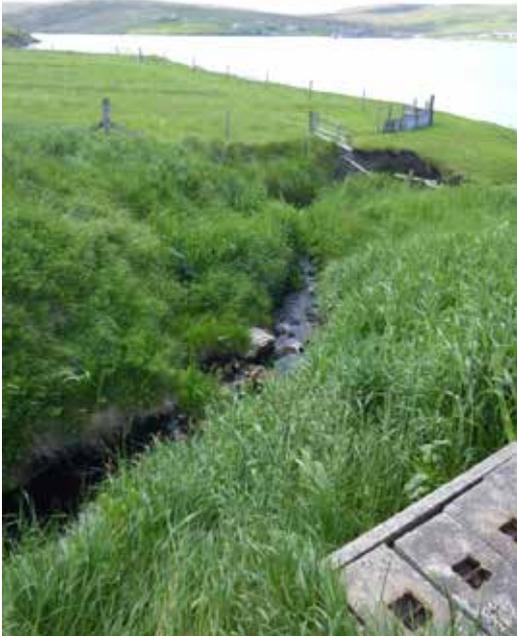
**Figure 10 – Large watercourse sampled adjacent to the North a Voe Septic Tank.**

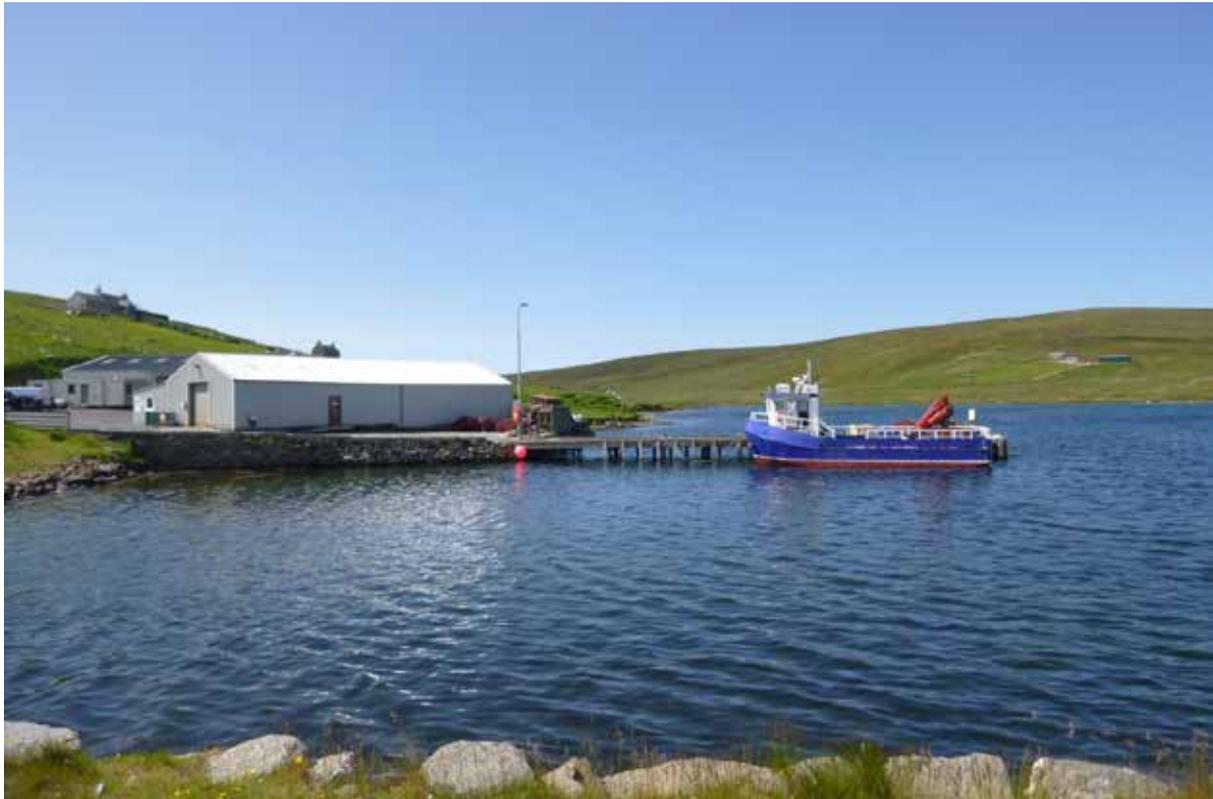
**Figure 12 – Meridian Salmon Farms shorebase at Ravensgio.**

Boat traffic in the Mid Yell Voe area is largely associated with mussel and salmon farming and also leisure boats. C&S Mussels who own both the Seafield and Camb fisheries berth a large workboat used to service their sites at the Linkshouse Pier, which was used to carry out the boat work for the survey and was on site at the Camb fishery during the shoreline walk. Creel fishermen are also known to use the Linkshouse Pier to land their catch. At the time of the survey no boats were berthed at the Linkshouse Pier. Meridian Salmon Farms Ltd. who own a number of salmon farms in the Yell and Unst area have a shorebase at Ravensgio (Figure 12) on the

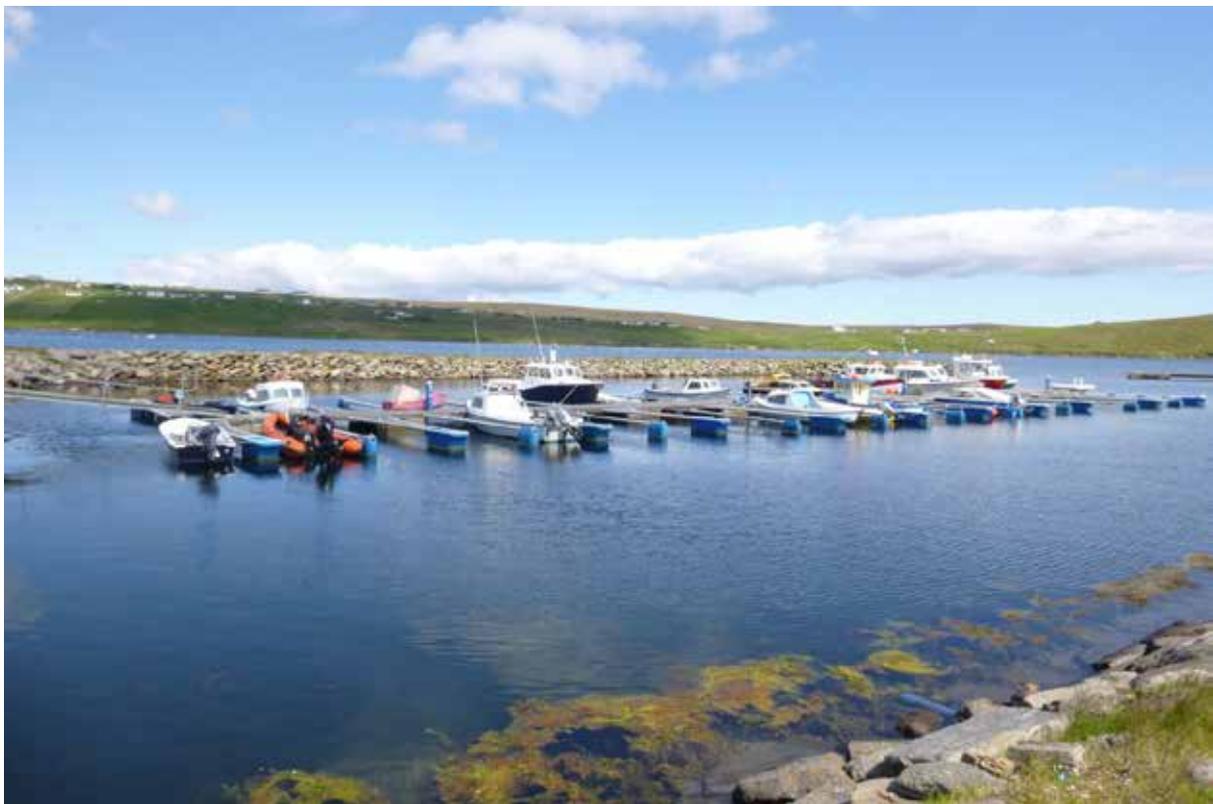
**Figure 13 – Mid Yell marina at Ravensgio.**

south shore of Mid Yell Voe which they use to service their sites around Yell. At the shorebase a large workboat was berthed at the pier, but other workboats are known to work out of this shorebase. There was a marina (Figure 13) adjacent to the Meridian Salmon Farms shorebase which had sixteen boats berthed and two small boats lying on the walkways of the marina. Also two boats were on trailers beside the marina. All these boats looked to be used for leisure purposes. At the Seafield Pier there were three small rowing boats moored on the land above the pier and one boat was observed in a shed adjacent to the pier. Three small disused fishing boats were moored on the land next to a house near the Ravensgio Pier. Three sailing boats were observed on land near the Linkshouse Pier, two next to the Linkshouse Septic Tank and one on the beach east of the pier.

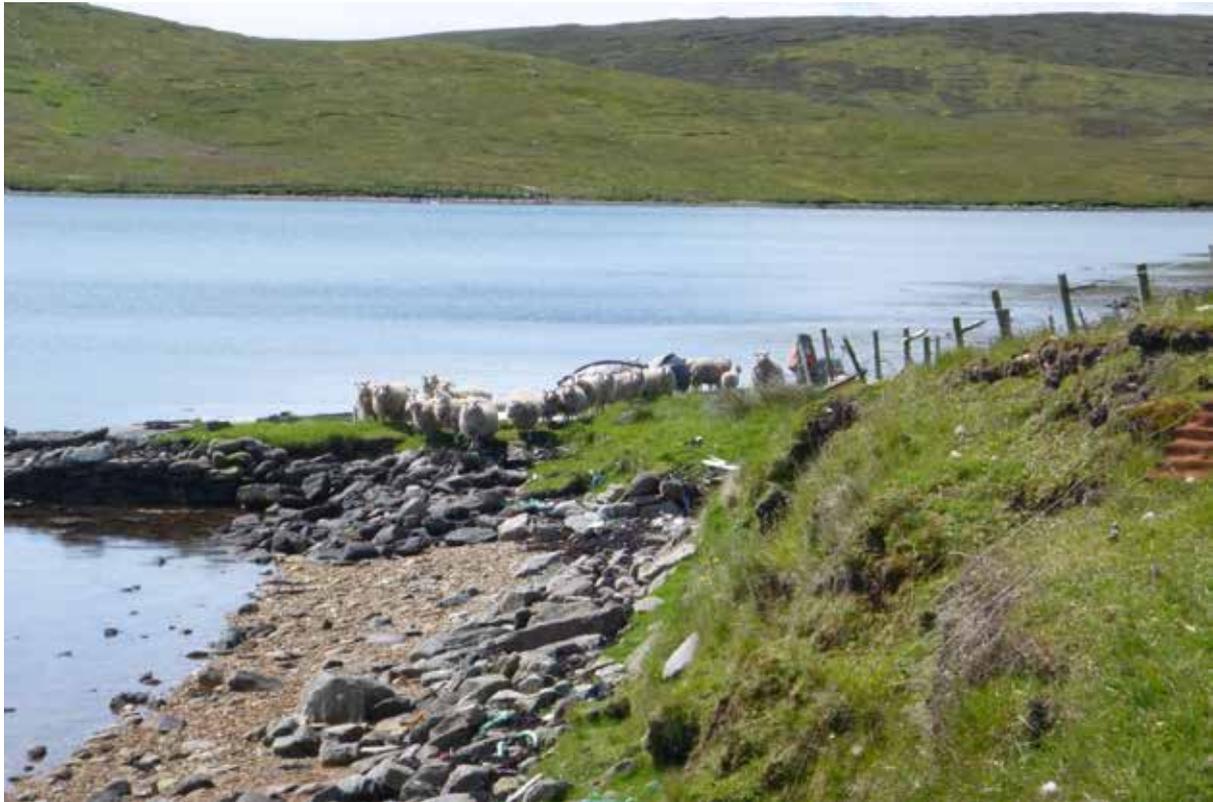
In the 2013 survey, a total of 271 sheep were observed grazing along the northern and southern shorelines. For the most part, sheep were found to be kept in fenced crofts with no access to the shore. However, one flock of 30 sheep was seen on the shoreline near the Seafield site. Open grazing was also noted at the head and southeast areas of the voe, though shore access along the southeast is likely to be prevented by the presence of steep escarpments. Sheep faeces were noted in most grazing areas and two areas outside fenced crofts along the north shore. This suggests that sheep escape the fenced areas and access the shoreline from time to time. No cattle were seen in 2013, though a small number of ponies was recorded.

**Figure 14 – Sheep with access to the shore near Seafield.**

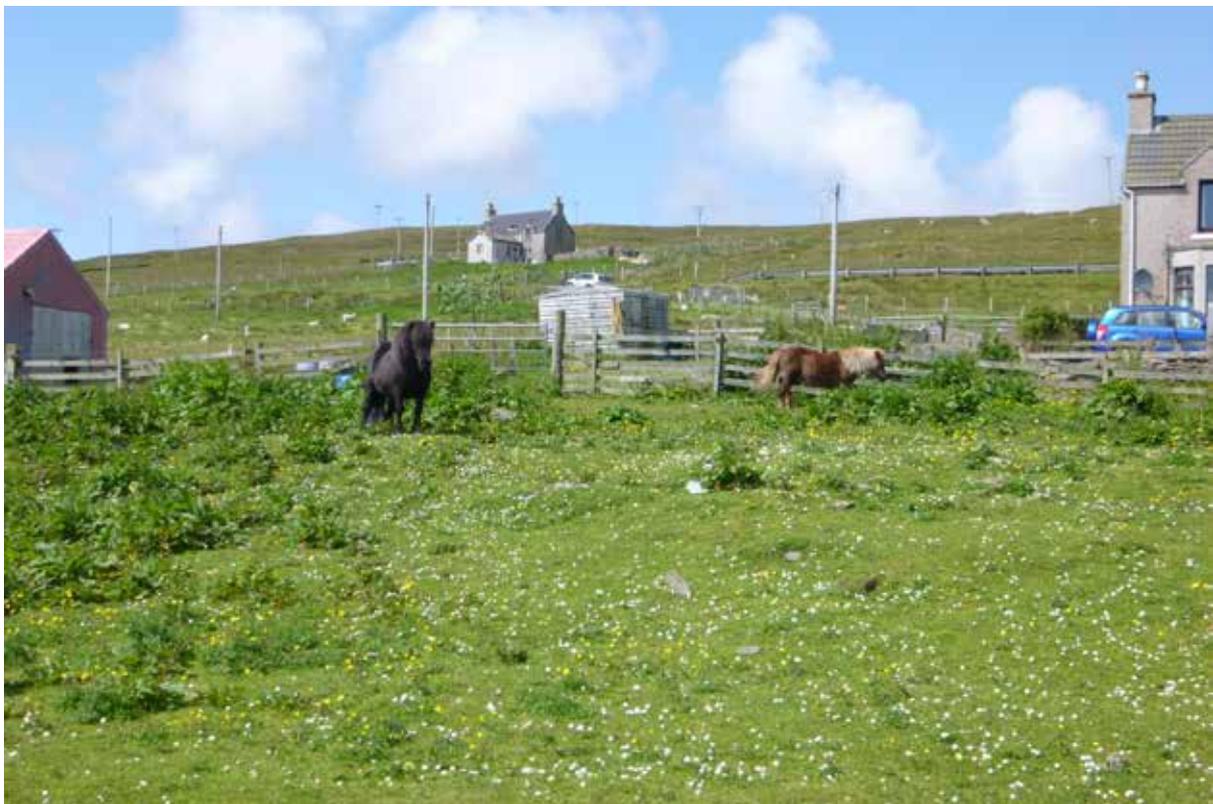
**Figure 15 – Shetland ponies in a field below a house at Seafield.**

Shetland ponies were observed on two occasions both on the northern shoreline in fenced areas below houses in the Seafield and Camb areas (Figure 15). The four animals noted did not have access to the shore.

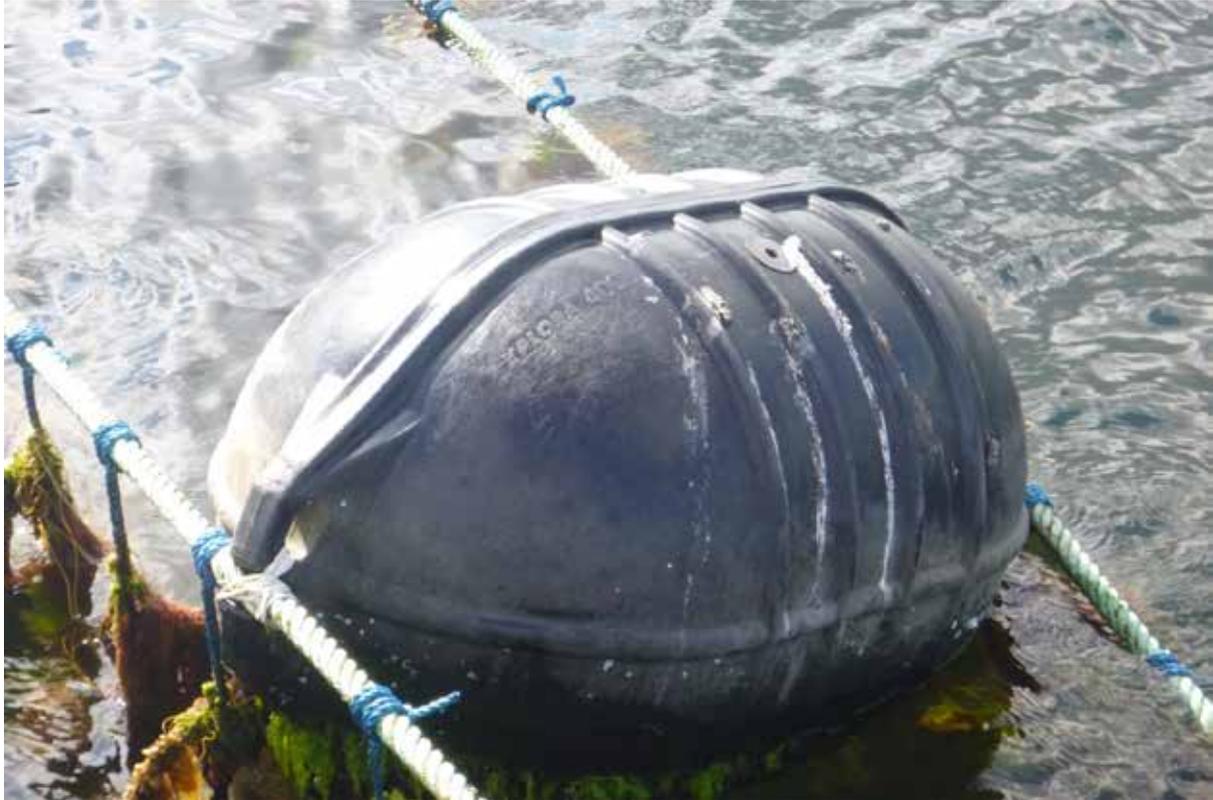
During the 2013 survey, birds were the most observed wildlife, with gulls the most commonly observed species. Birds and bird droppings were also noted on the mussel floats at the time of the survey, and therefore there is likely to be some direct deposition of droppings to the mussel farms. However, there is no information to suggest that any one part of the farms would be more impacted than another. Observations from the shoreline survey are shown in Figure 5.1. Labels are shown in the figure for any observations of greater than 5 individuals.

A variety of seabirds, wading birds and ducks were observed during the 2013 survey. Gulls and cormorants were seen to be sitting on mussel floats, and these are likely to contribute significantly to faecal bacterial levels in the immediate vicinity of the mussel farms. Seals and otters are also likely to be present around the area, though they are not known to be present in large numbers. The outer parts of the voe, to the south and east of the mussel farms, are known to be habitat for both

**Figure 16 – Bird faeces on a buoy at the Camb fishery.**
