# Scottish Sanitary Survey Report

## **Sanitary Survey Report Loch Slapin SL-194-290-08 September 2014**

<b>Report Title</b>	Loch Slapin
<b>Project Name</b>	Scottish Sanitary Survey
<b>Client/Customer</b>	Food Standards Agency Scotland
<b>Cefas Project Reference</b>	C6316A
<b>Document Number</b>	C6316A_2014_03
<b>Revision</b>	V1.0
<b>Date</b>	12/09/2014

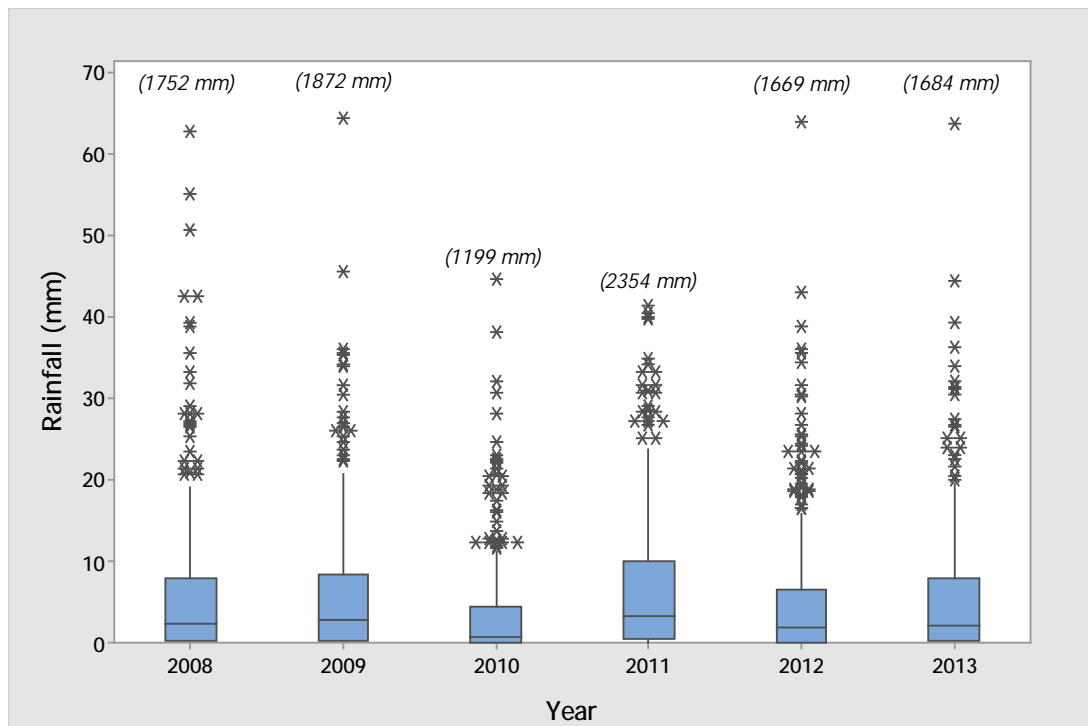
**Figure 9.1 Box plot of daily rainfall values by year at Skye: Lusa (2008 – 2013)**  
(total rainfall values in parentheses)

Daily rainfall values varied from year to year, with 2010 having the lowest total rainfall (1199 mm). The wettest year was 2011 (2354 mm). Rainfall values exceeding 40 mm/d occurred in all years, but high rainfall values exceeding 60 mm/d occurred in 2008, 2009, 2012 and 2013.

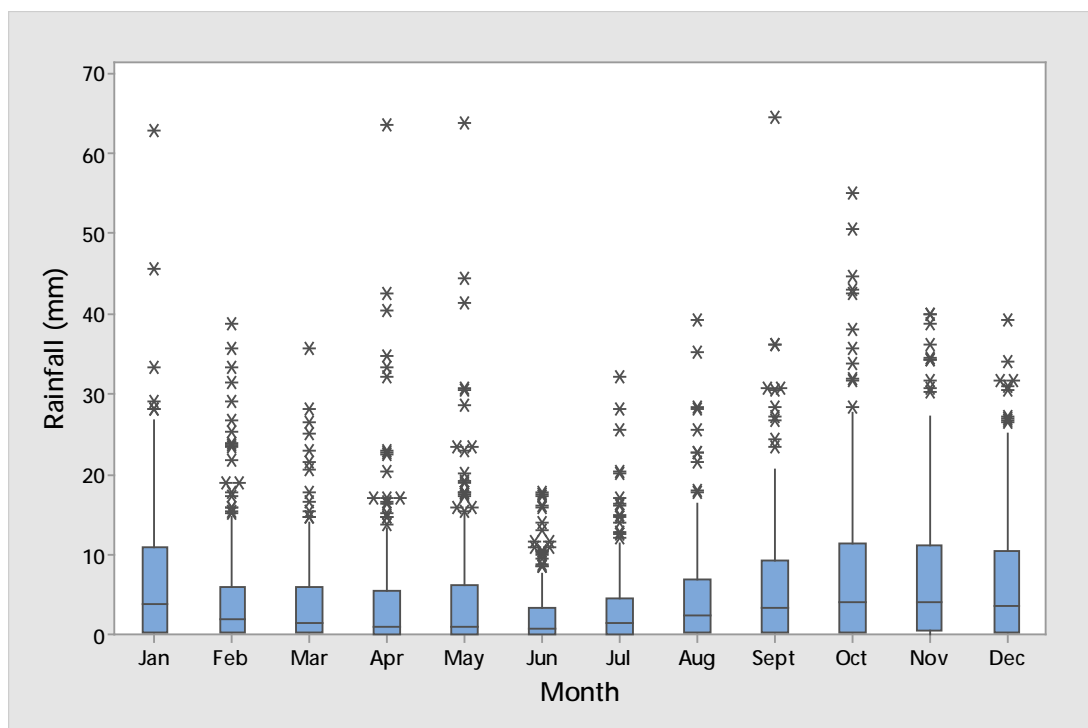
**Figure 9.2 Box plot of daily rainfall values by month at Skye: Lusa (2008 – 2013)**

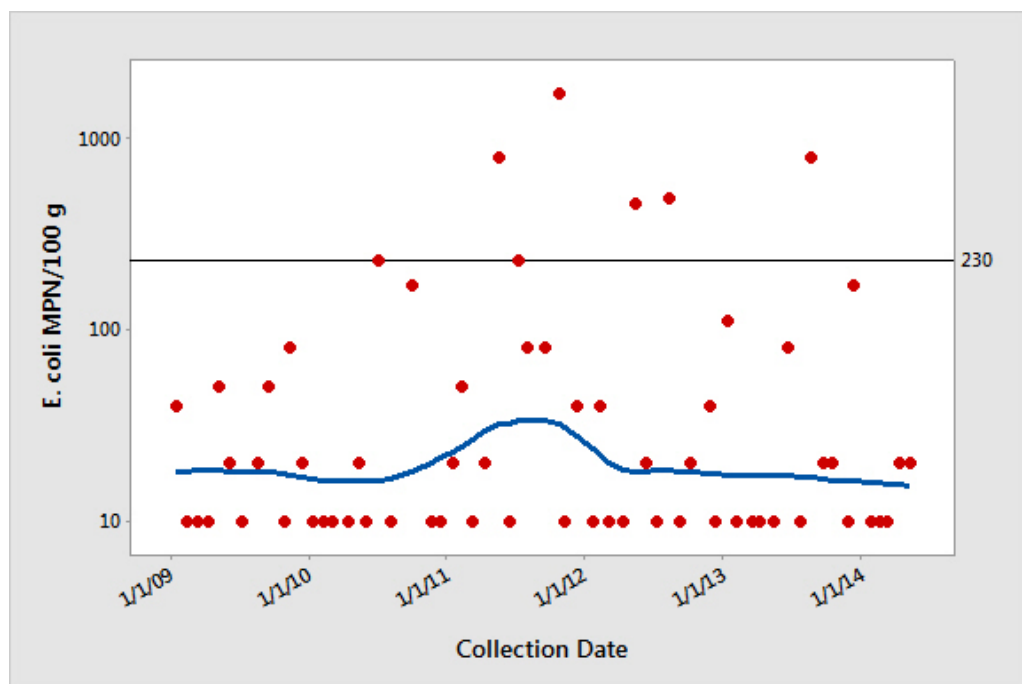
A scatterplot of *E. coli* results against date for Loch Slapin is presented in Figure 11.2. The dataset is fitted with a lowess trend line. Lowess trendlines allow for locally weighted regression scatter plot smoothing. At each point in the dataset an estimated value is fitted to a subset of the data, using weighted least squares. The approach gives more weight to points near to the x-value where the estimate is being made and less weight to points further away. In terms of the monitoring data, this means that any point on the lowess line is influenced more by the data close to it (in time) and less by the data further away. A trend line helps to highlight any apparent underlying trends or cycles.

**Figure 11.2 Scatterplot of *E. coli* results by collection date at Loch Slapin, fitted with a lowess line**

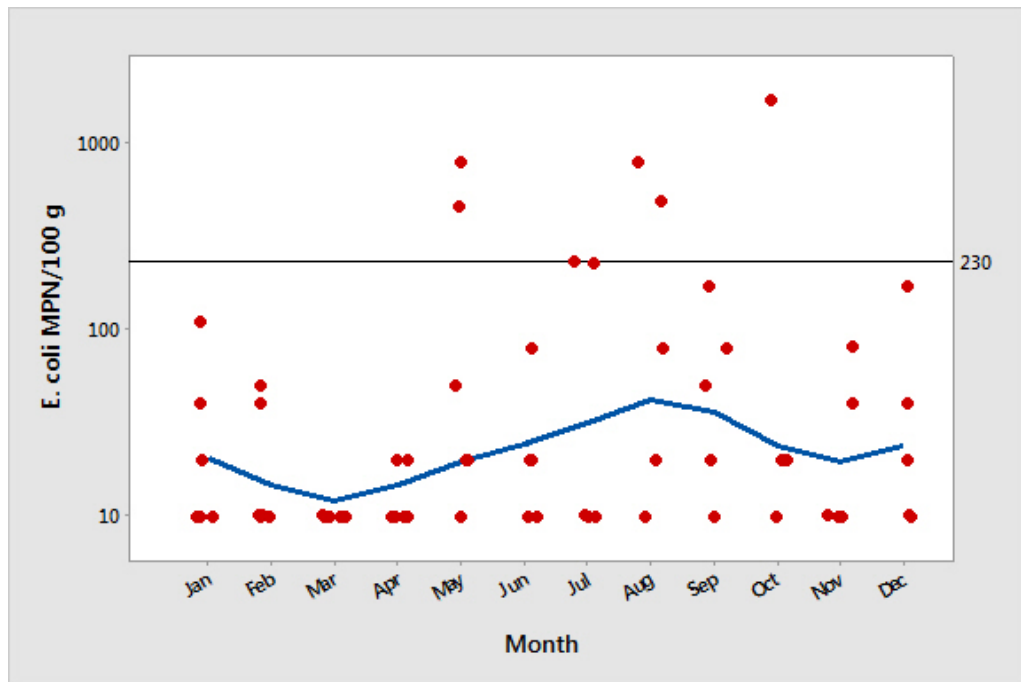
**Figure 11.3 Scatterplot of *E. coli* results by month at Loch Slapin, fitted with a lowess line**

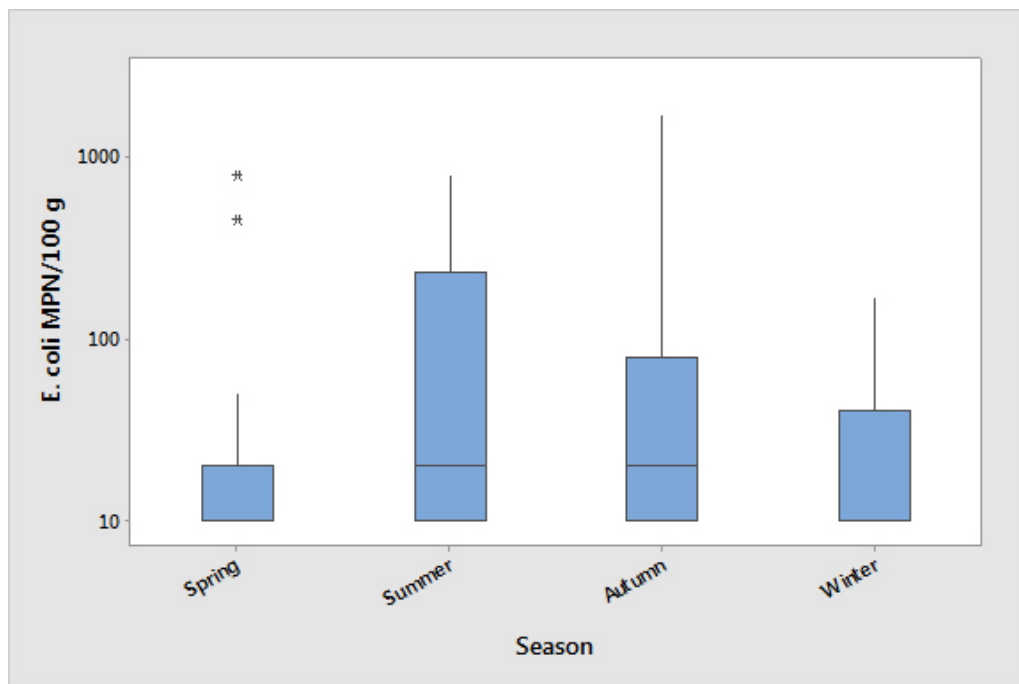
No statistically significant differences were found between *E. coli* results for Loch Slapin by season (one-way ANOVA,  $p = 0.36$ ) (Appendix 4).

**Figure 11.4 Boxplot of *E. coli* results by season at Loch Slapin**

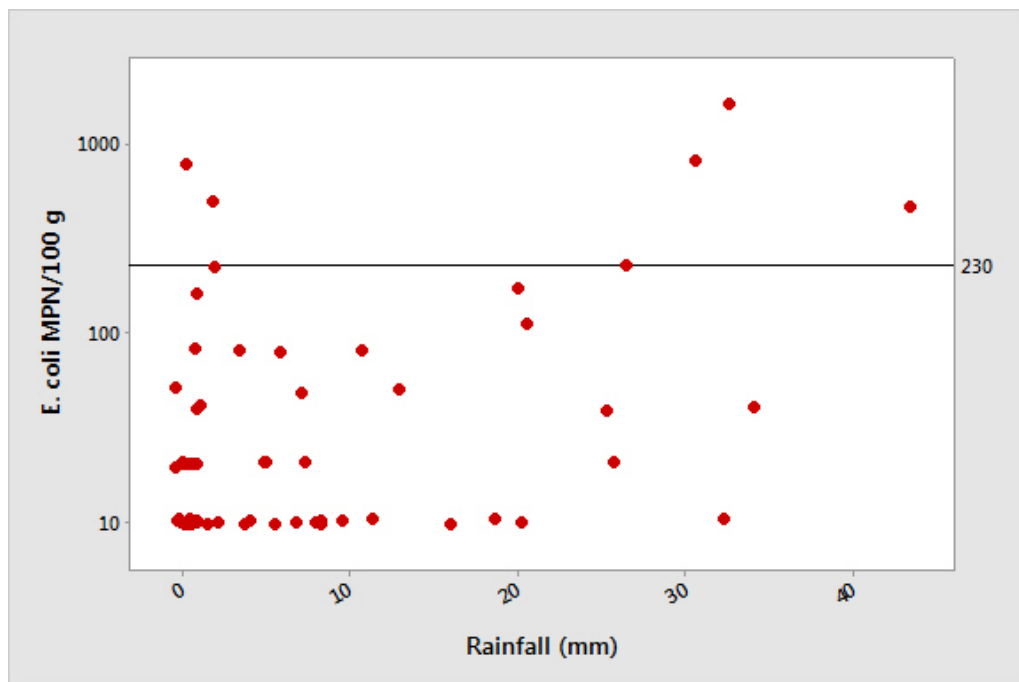
**Figure 11.5 Scatterplot of *E. coli* results against rainfall in the previous two days at Loch Slapin**

A statistically significant correlation was found between *E. coli* results and the previous two day rainfall (Spearman's rank correlation  $r = 0.260$ ,  $p = 0.047$ ). The proportion of results yielding results of  $<20$  *E. coli* MPN/100 g decreased with increasing rainfall.

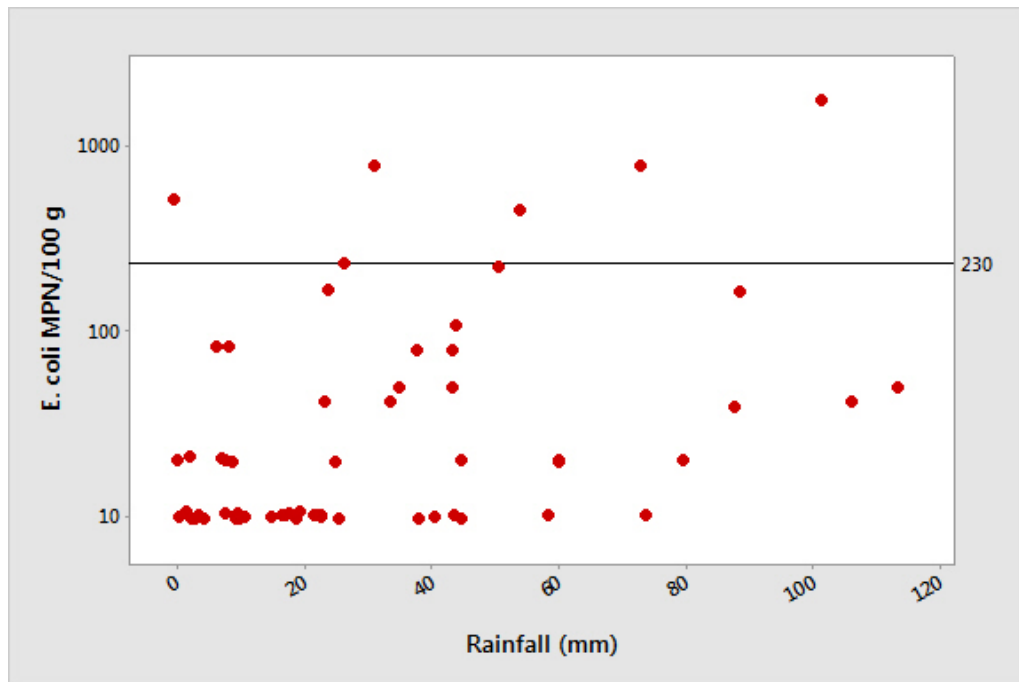
**Figure 11.6 Scatterplot of *E. coli* results against rainfall in the previous seven days at Loch Slapin**

A statistically significant correlation was found between *E. coli* results and the previous seven day rainfall (Spearman's rank correlation  $r = 0.391$ ,  $p = 0.002$ ). Again, the proportion of results yielding results of  $<20$  *E. coli* MPN/100 g decreased with increasing rainfall.

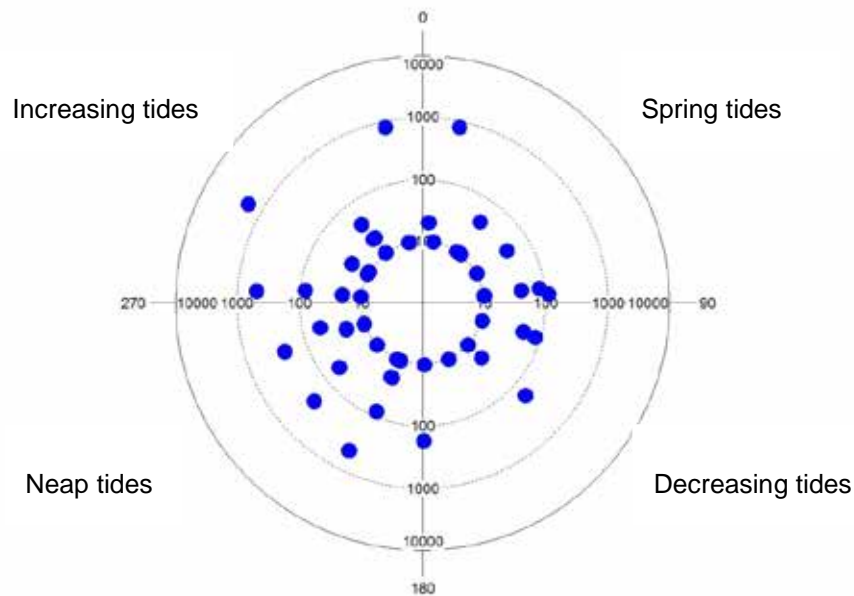
**Figure 11.7 Polar plots of *E. coli* results on the spring/neap tidal cycle at Loch Slapin**

No statistically significant correlation was found between  $\log_{10}$  *E. coli* results and the spring/neap tidal cycle (circular-linear correlation  $r = 0.080$ ,  $p = 0.677$ ).

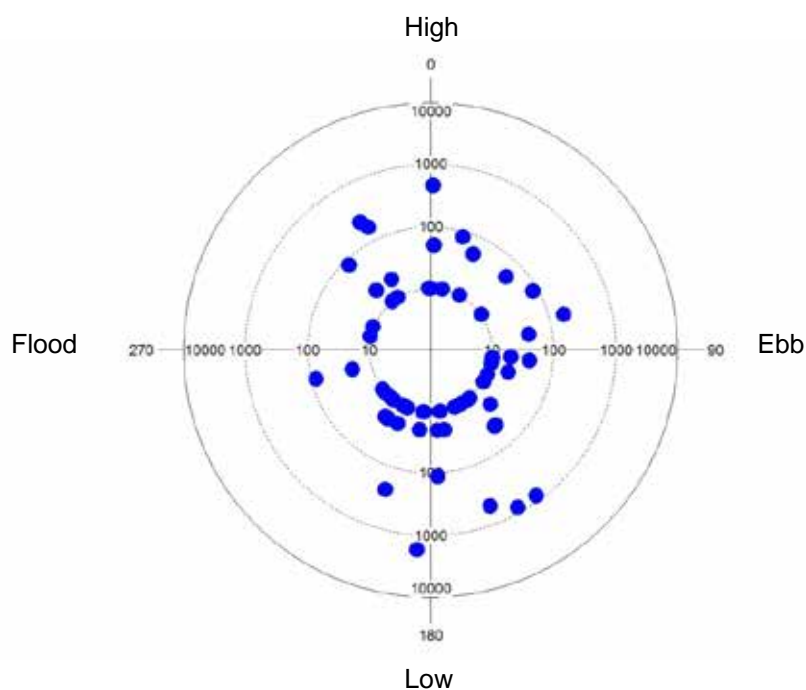
**Figure 11.8 Polar plots of  $\log_{10}$  *E. coli* results on the high/low tidal cycle at Loch Slapin**

No statistically significant correlation was found between  $\log_{10}$  *E. coli* results and the high/low tidal cycle (circular-linear correlation  $r = 0.09$ ,  $p = 0.643$ ).

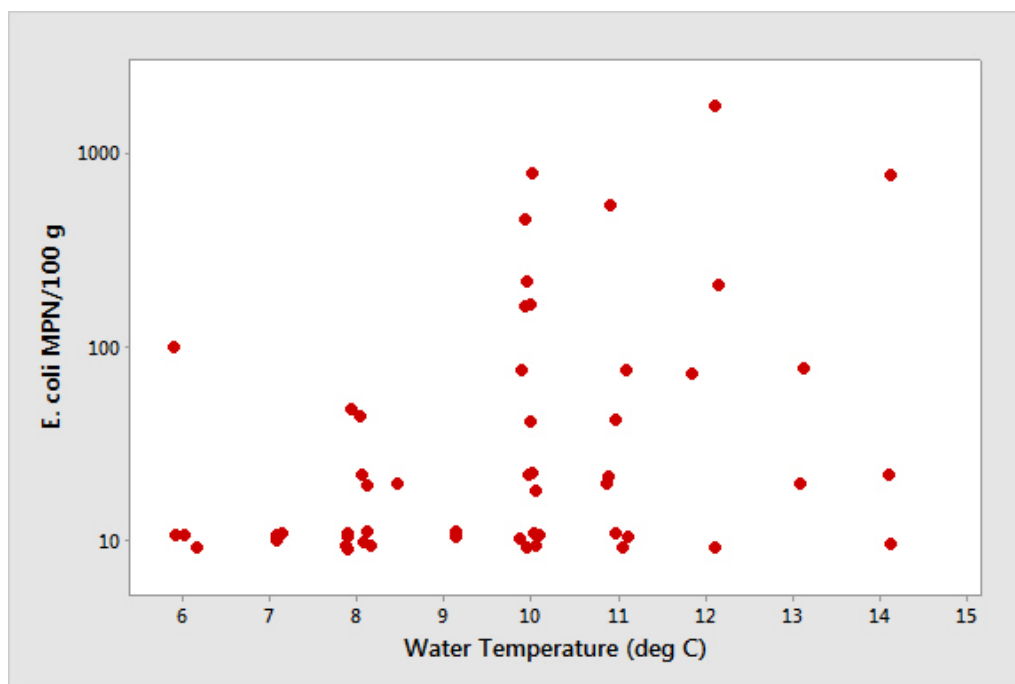
**Figure 11.9 Scatterplot of *E. coli* results against water temperature at Loch Slapin**

A statistically significant correlation was found between *E. coli* results and water temperature (Spearman's rank correlation  $r = 0.400$ ,  $p = 0.003$ ). The results  $\geq 230$  *E. coli* MPN/100 g were taken at sea water temperatures between 10 and 14°C.

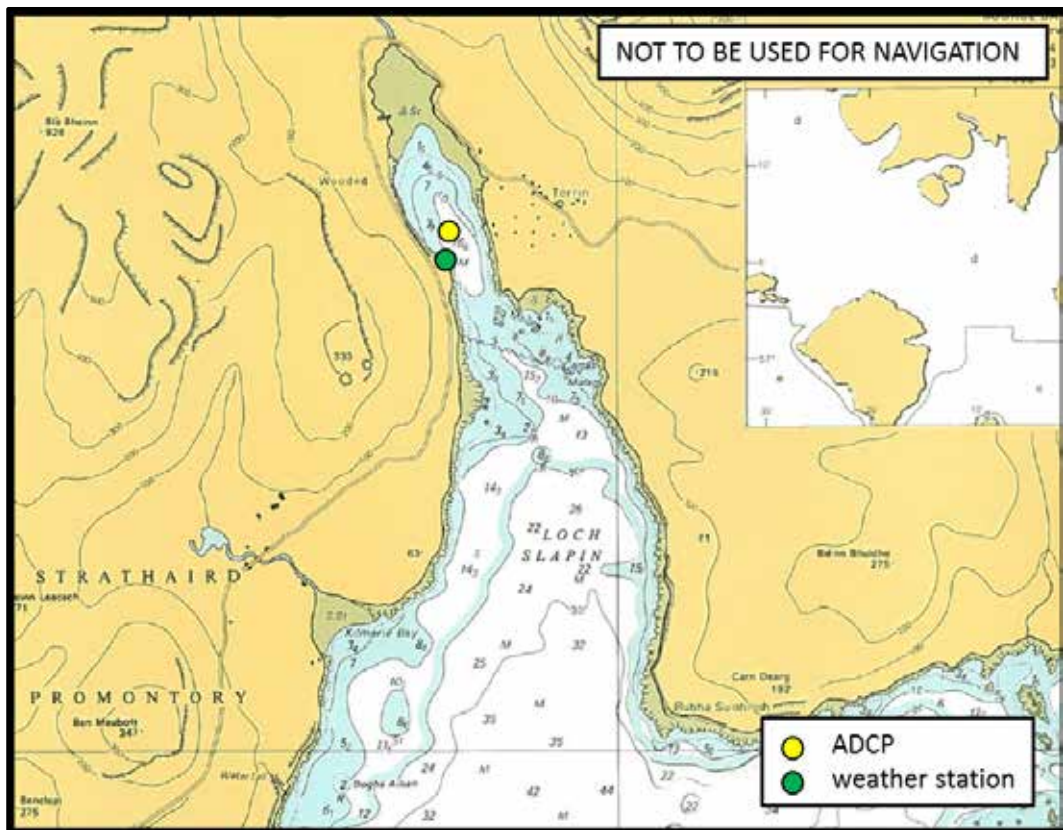
Figure 13.2 shows the bathymetry of Loch Slapin. One sill is found in the loch, extending from Leac nan Craobh, 500 m south of the slipway at Faoilean (see Figure 13.1). The sill is 500 m in width at high water, and has a mean depth of 3 m and a maximum depth of 7 m (Edwards & Sharples, 1986). The basin to the north of this sill has a maximum depth of 17 m. To the south of the sill, bathymetry deepens toward the mouth of the loch, where depths of approximately 35 m are reached at the assessment area boundary.

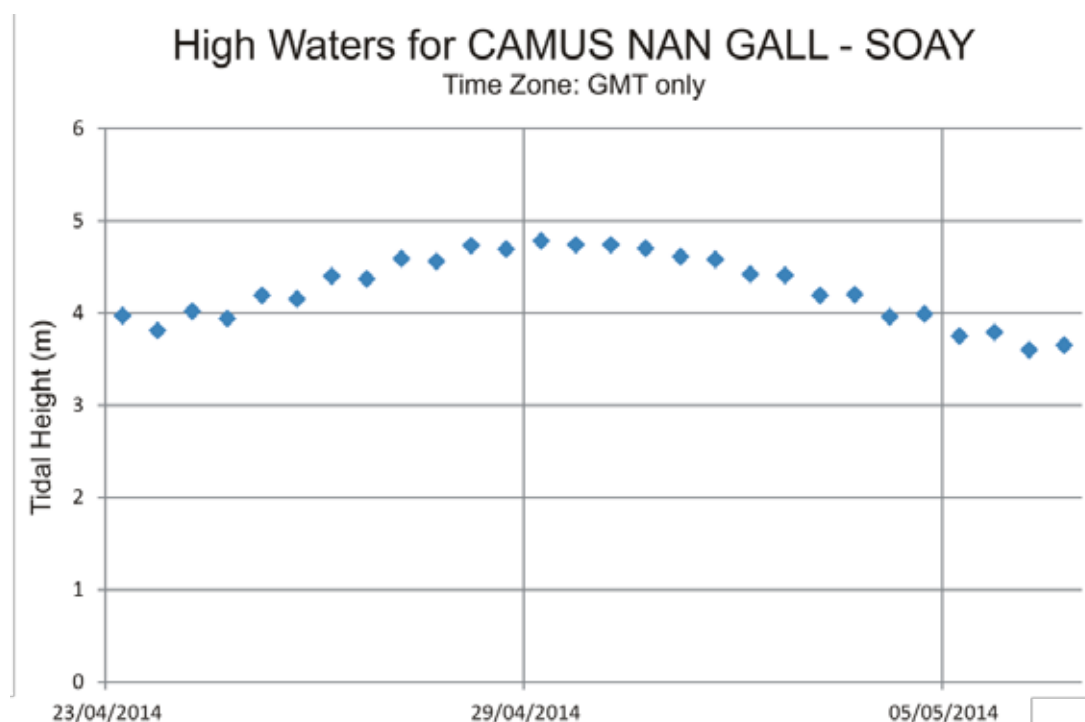
**Figure 13.3 Two week tidal curve (high water predictions only) for Camus Nan Gall, Soay.**

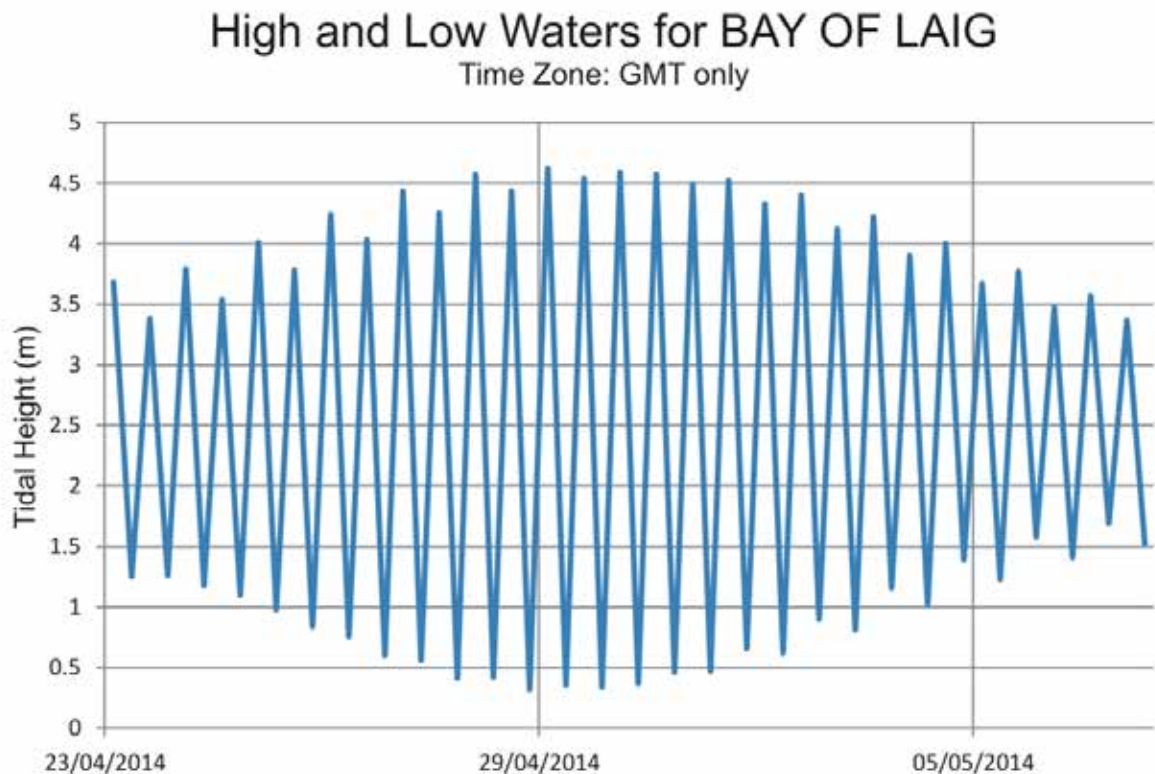
**Figure 13.4 – Two week tidal curve for Bay of Laig, Inner Hebrides.**  
 Reproduced from Poltips3 [www.pol.ac.uk/appl/poltips3]

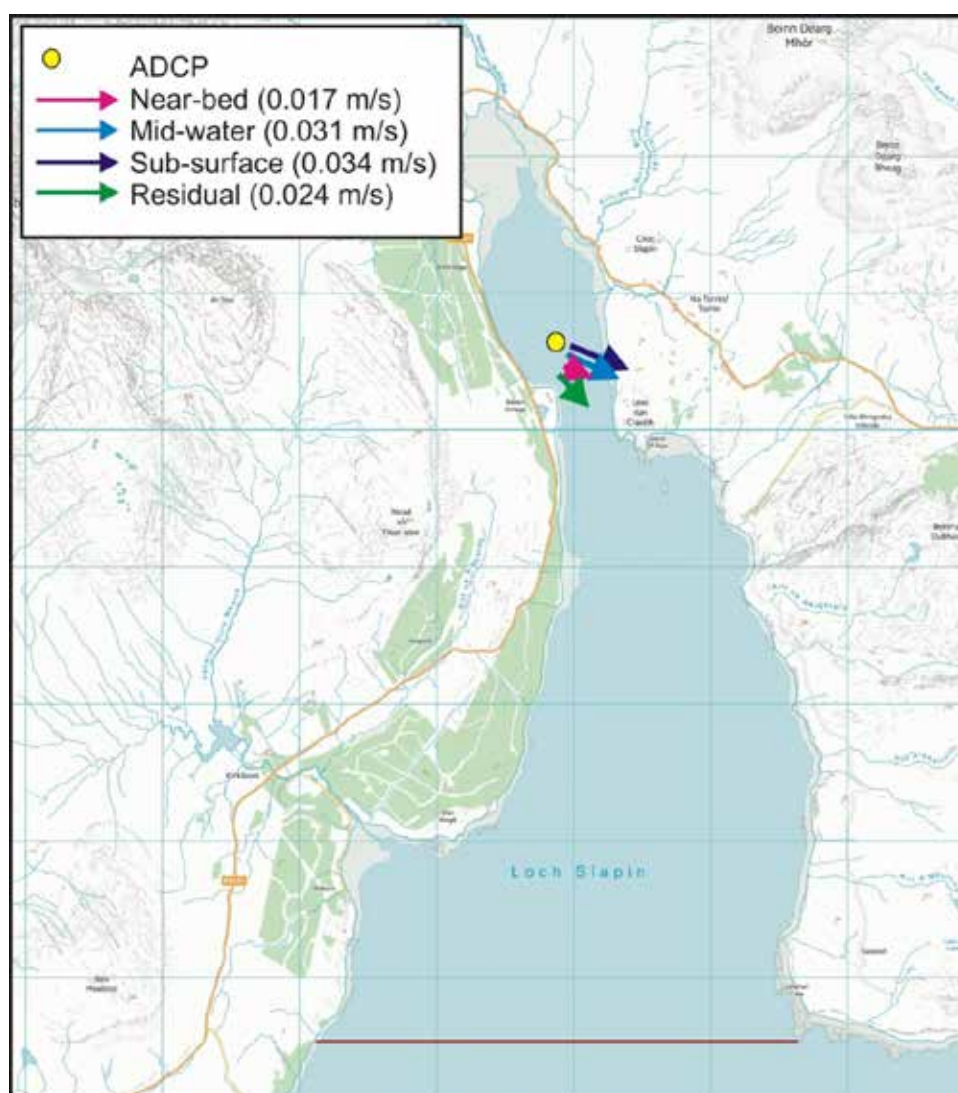
**Figure 13.5 Map showing 2008 Loch Slapin sample site within the assessment area. Using the principal current amplitude at each measured depth and the assumption of a uniform sinusoidal tide, the cumulative transport distance and direction that might be expected during each phase of the tide is shown above.**

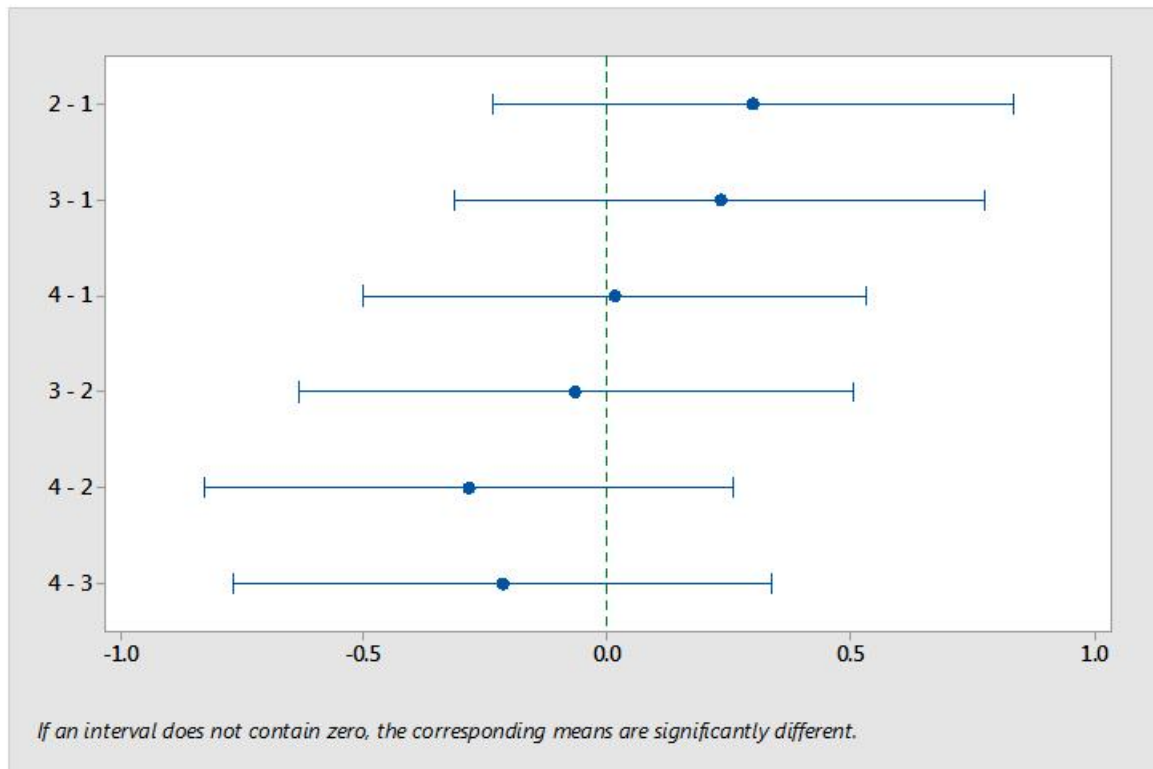
**Figure 1** Tukey comparison between Loch Slapin  $\log_{10} E. coli$  and season

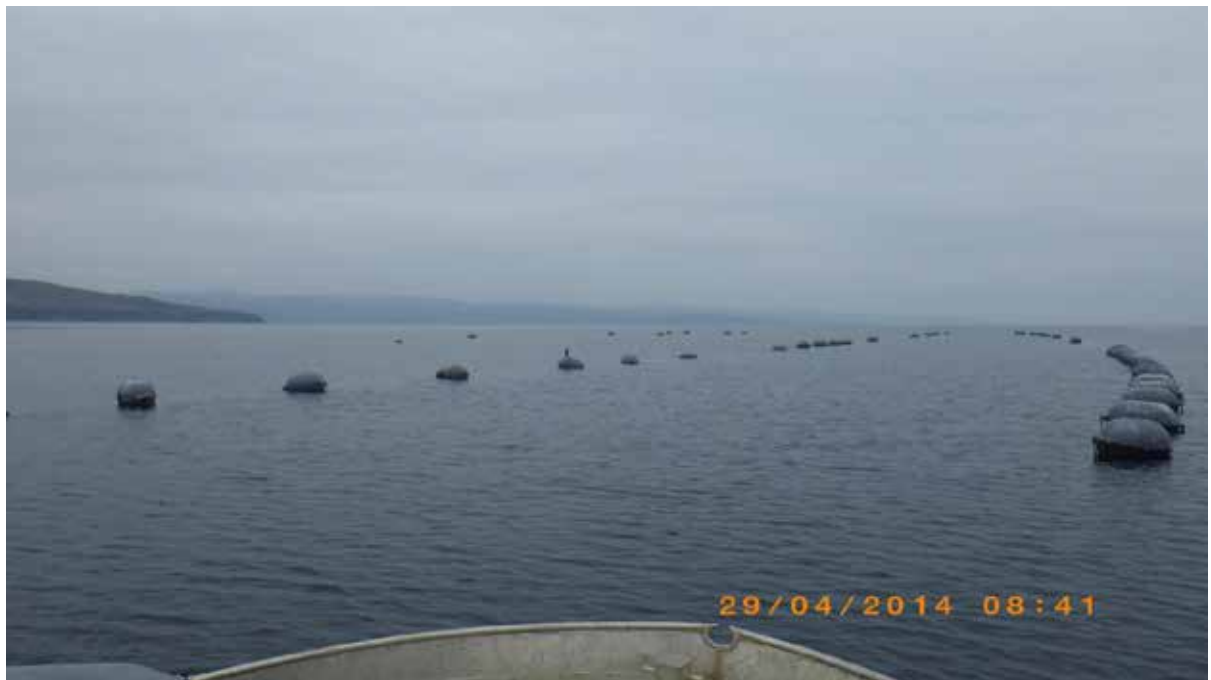
**Figure 3. NW corner of mussel lines at Loch Slapin. Associated with waypoint 1.**

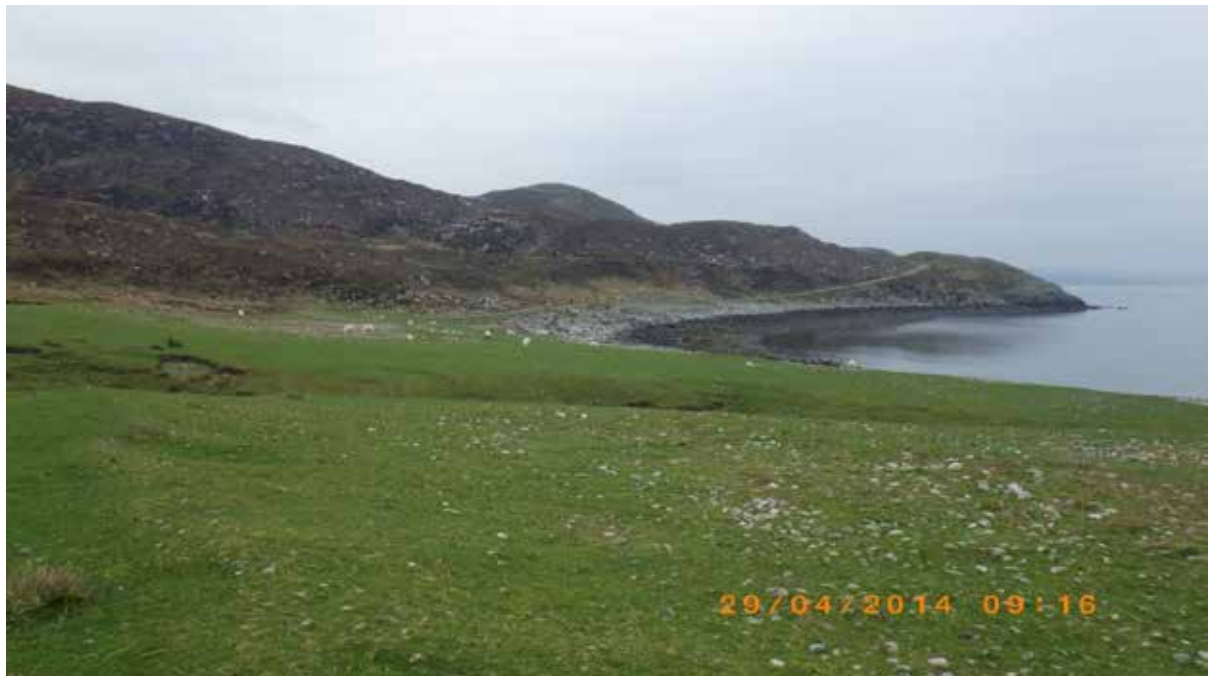
**Figure 4. Start of shoreline walk at Pole on NE shore of Loch Slapin. Eighteen sheep on shore, eleven adults and seven lambs. Associated with waypoint 12.**

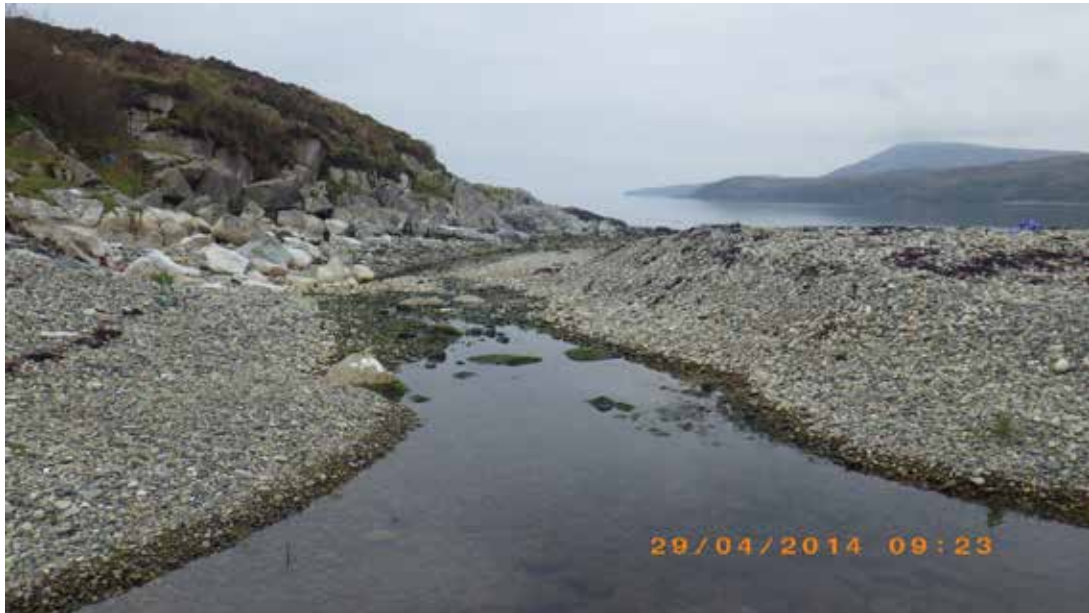
**Figure 5. Planned freshwater sample. River running to shore with quarry behind. Associated with waypoints 14 and 15. Site of LSFW1.**

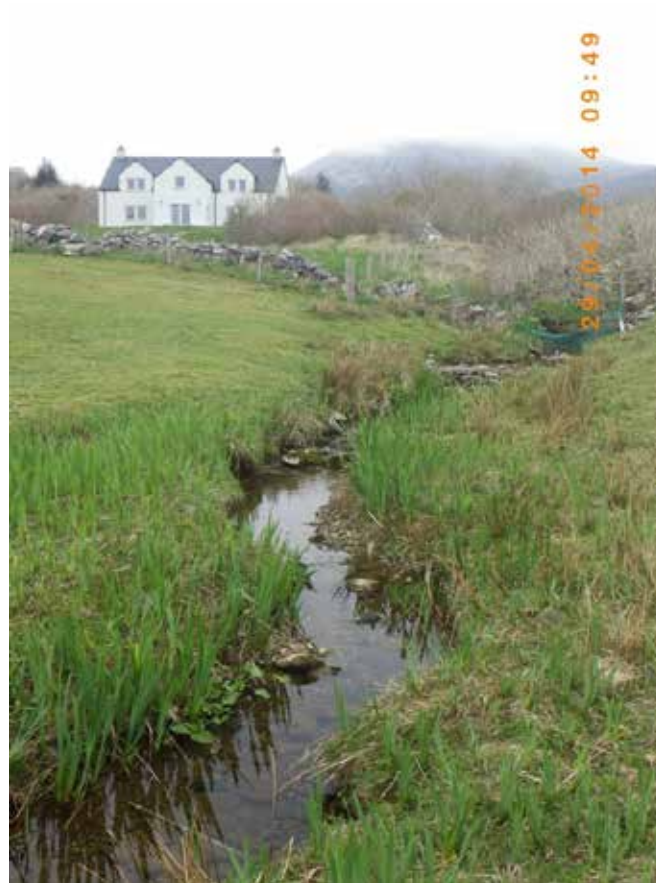
**Figure 6. Planned freshwater sample. River running onto shore with house behind. Associated with waypoints 16 and 17. Site of LSFW2.**

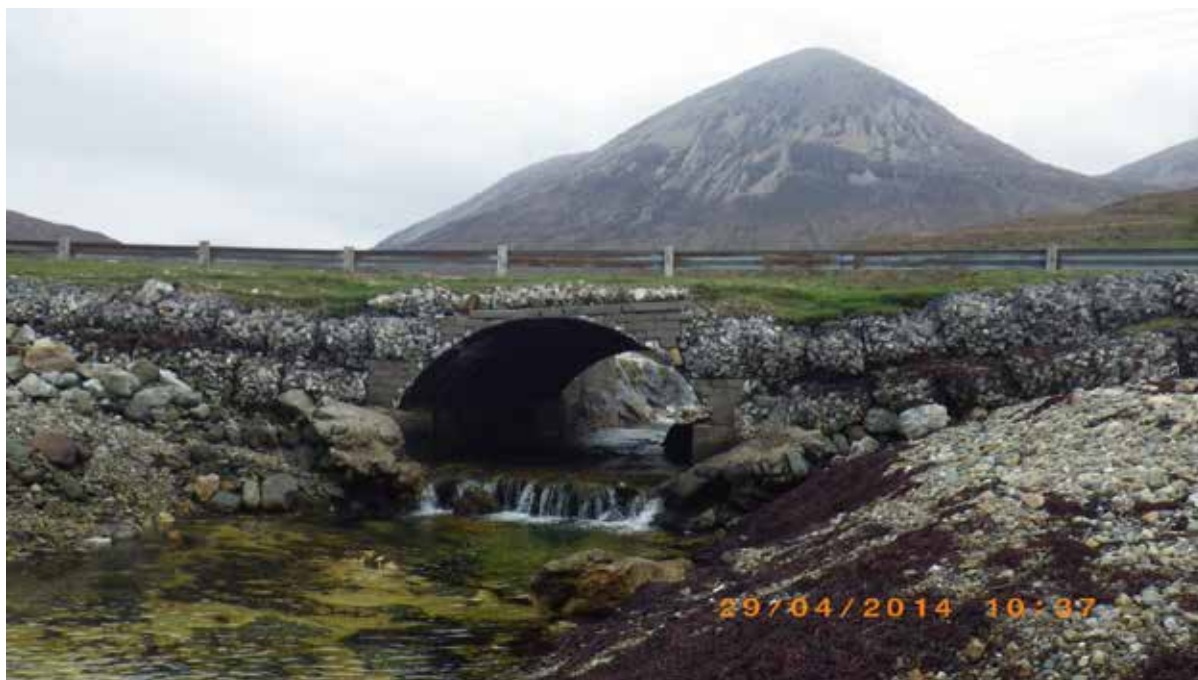
**Figure 7. Planned freshwater sample. Large watercourse running under road onto shore. Associated with waypoints 24 and 25. Site of LSFW4.**

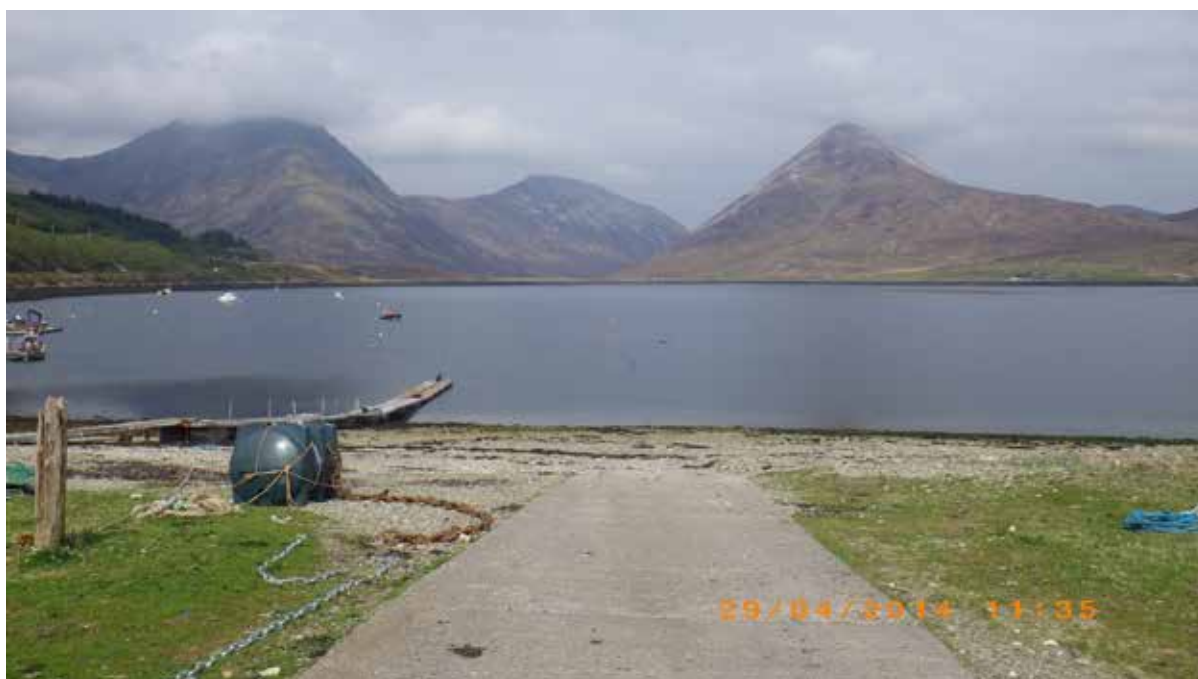
**Figure 8. Planned seawater sample from slipway. Associated with waypoint 27. Site of LSSW3.**

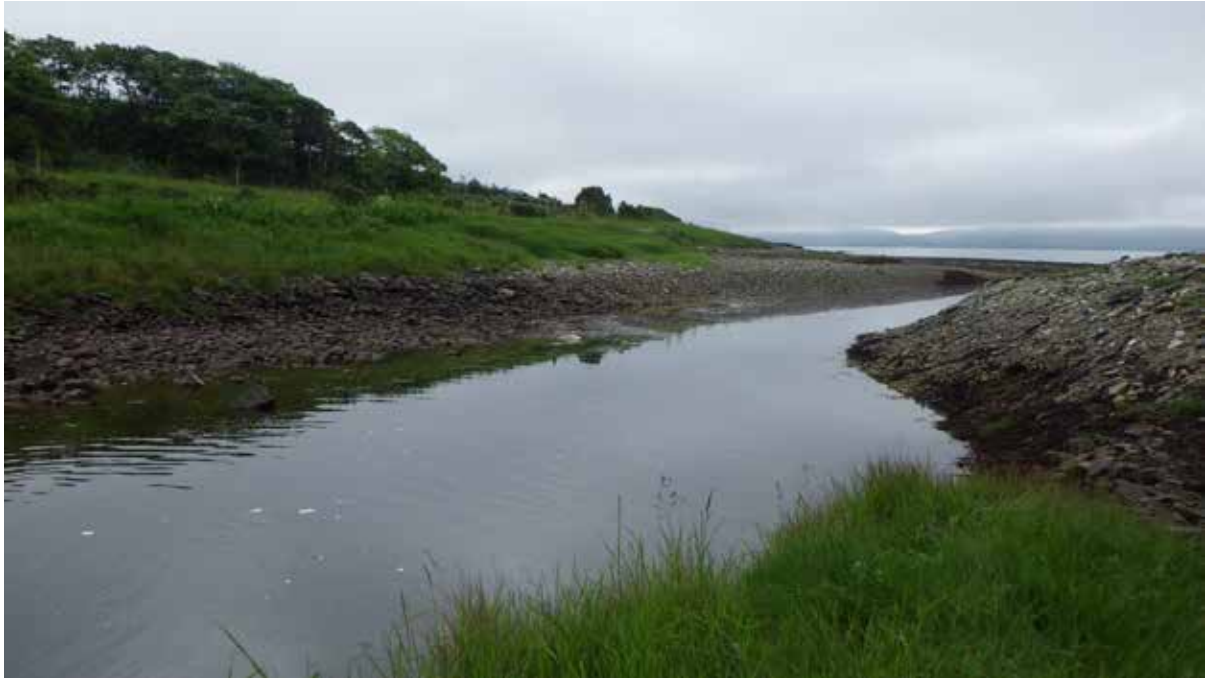
**Figure 3. Watercourse running onto shore next to house at Kilmarie. Associated with waypoints 1 & 2. Location of freshwater sample LSFW1.**

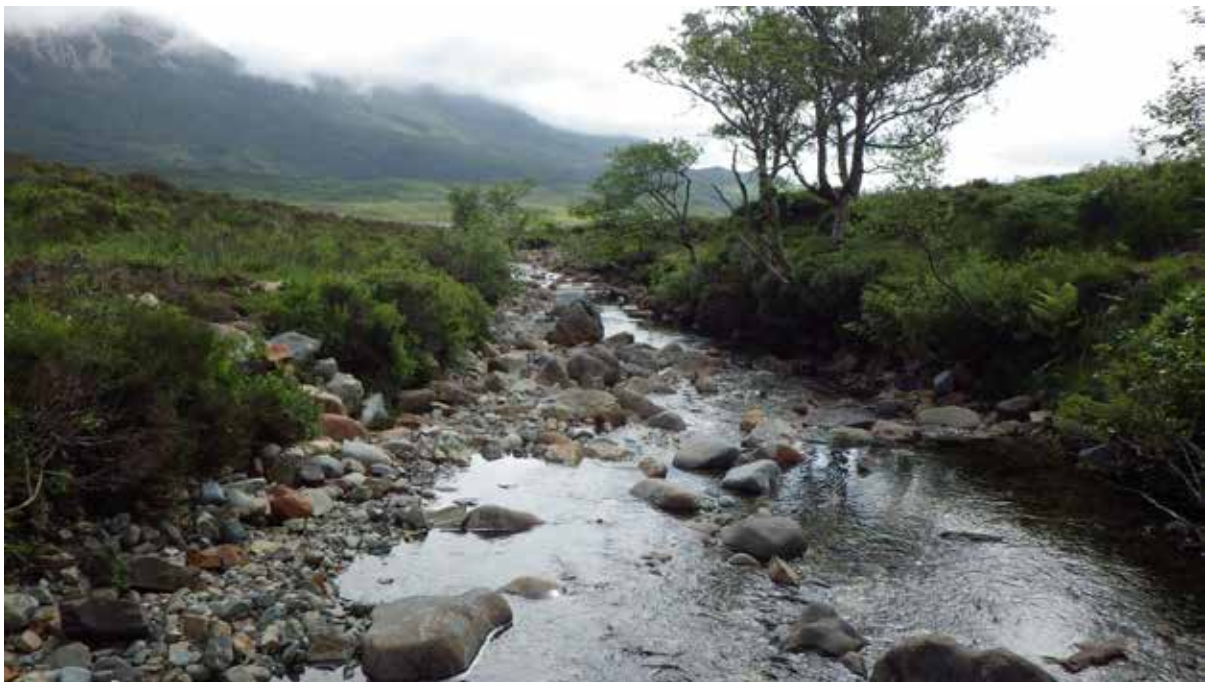
**Figure 4. Watercourse running under road onto shore by car park. Associated with waypoints 4 & 5. Location of freshwater sample LSFW2.**

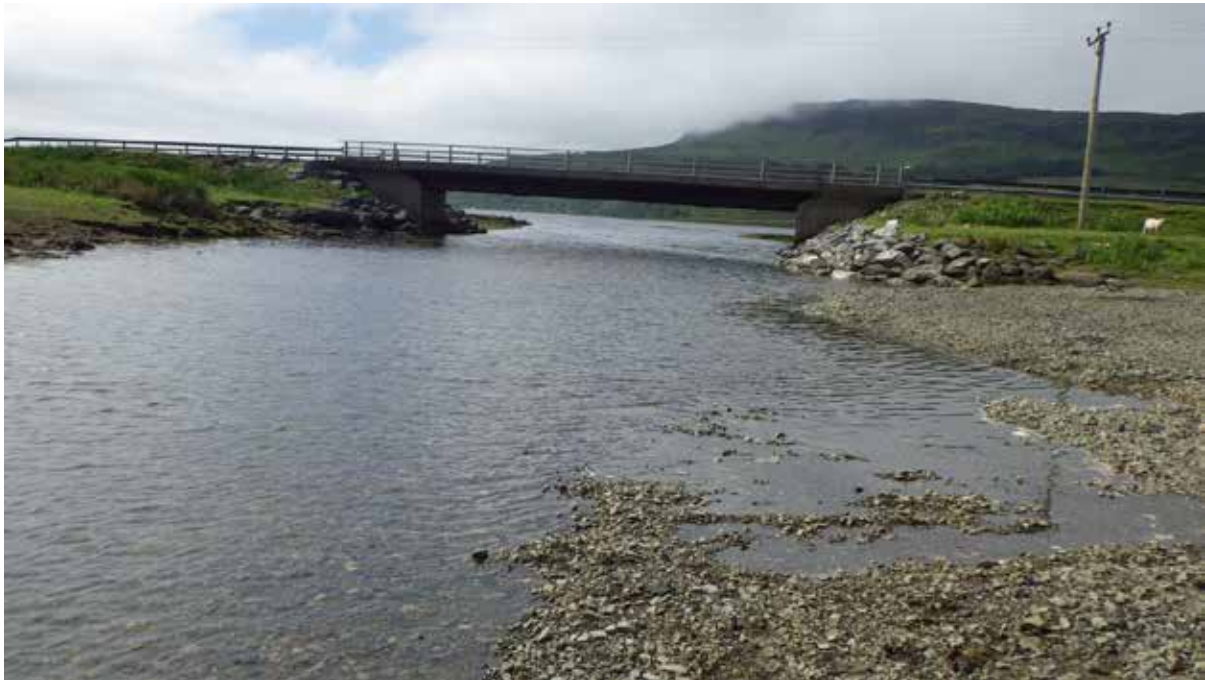
**Figure 5. Large watercourse at head of Loch Slapin. Associated with waypoints 6 & 7. Location of freshwater sample LSF3.**

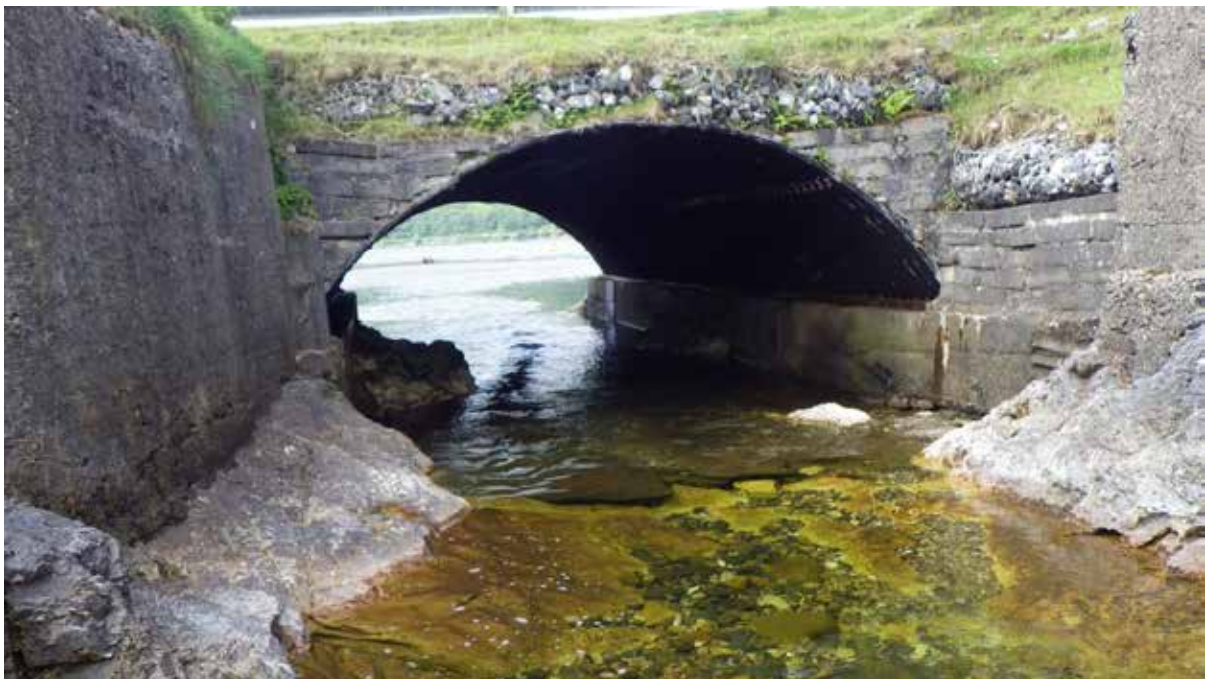
**Figure 6. Watercourse running under road onto shore next to sheep pen. Associated with waypoints 8 & 9. Location of freshwater sample LSF4.**

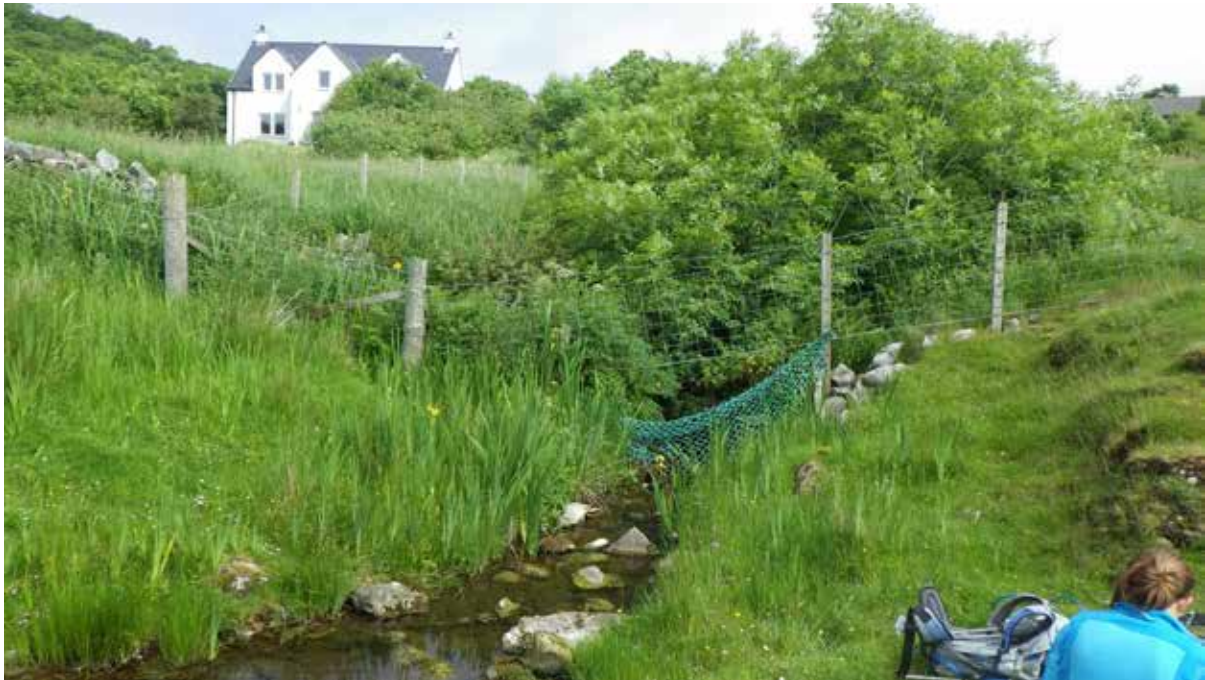
**Figure 7. Unnamed watercourse running onto shore below house. Associated with waypoints 12 & 13. Location of freshwater sample LSF7.**
