# Scottish Sanitary Survey Report

## **Sanitary Survey Report Loch Melfort AB178, AB672, AB673, AB674 June 2015**

<b>Report Title</b>	Loch Melfort Sanitary Survey Report
<b>Project Name</b>	Scottish Sanitary Survey
<b>Client/Customer</b>	Food Standards Agency Scotland
<b>Cefas Project Reference</b>	C6316A
<b>Document Number</b>	C6316A_2014_17
<b>Revision</b>	1.1
<b>Date</b>	11/06/2015

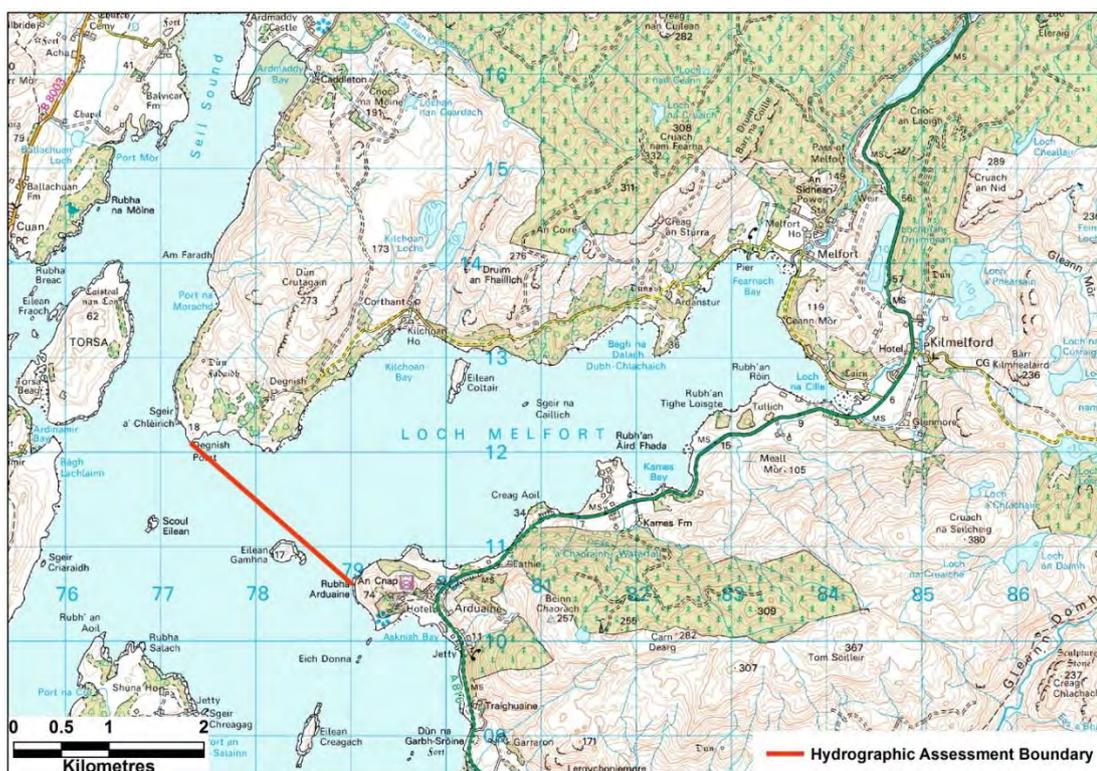
Figure 13.1 Extent of the Loch Melfort hydrographic assessment area

The Loch Melfort assessment area is situated in Argyll on the west coast of Scotland. The assessment area comprises the whole of Loch Melfort, with the western assessment area boundary stretching between Degnish Point in the north and Rubha Arduaine in the south. The landscape around the assessment area is characterised by low hills, areas of commercial forestry, and several small freshwater lochs. Many small streams flow into the assessment area from these lochs and the surrounding hills. Two more substantial streams flow into the loch at the villages of Melfort and Kilmelford. A map of the assessment area can be found in Figure 13.1.

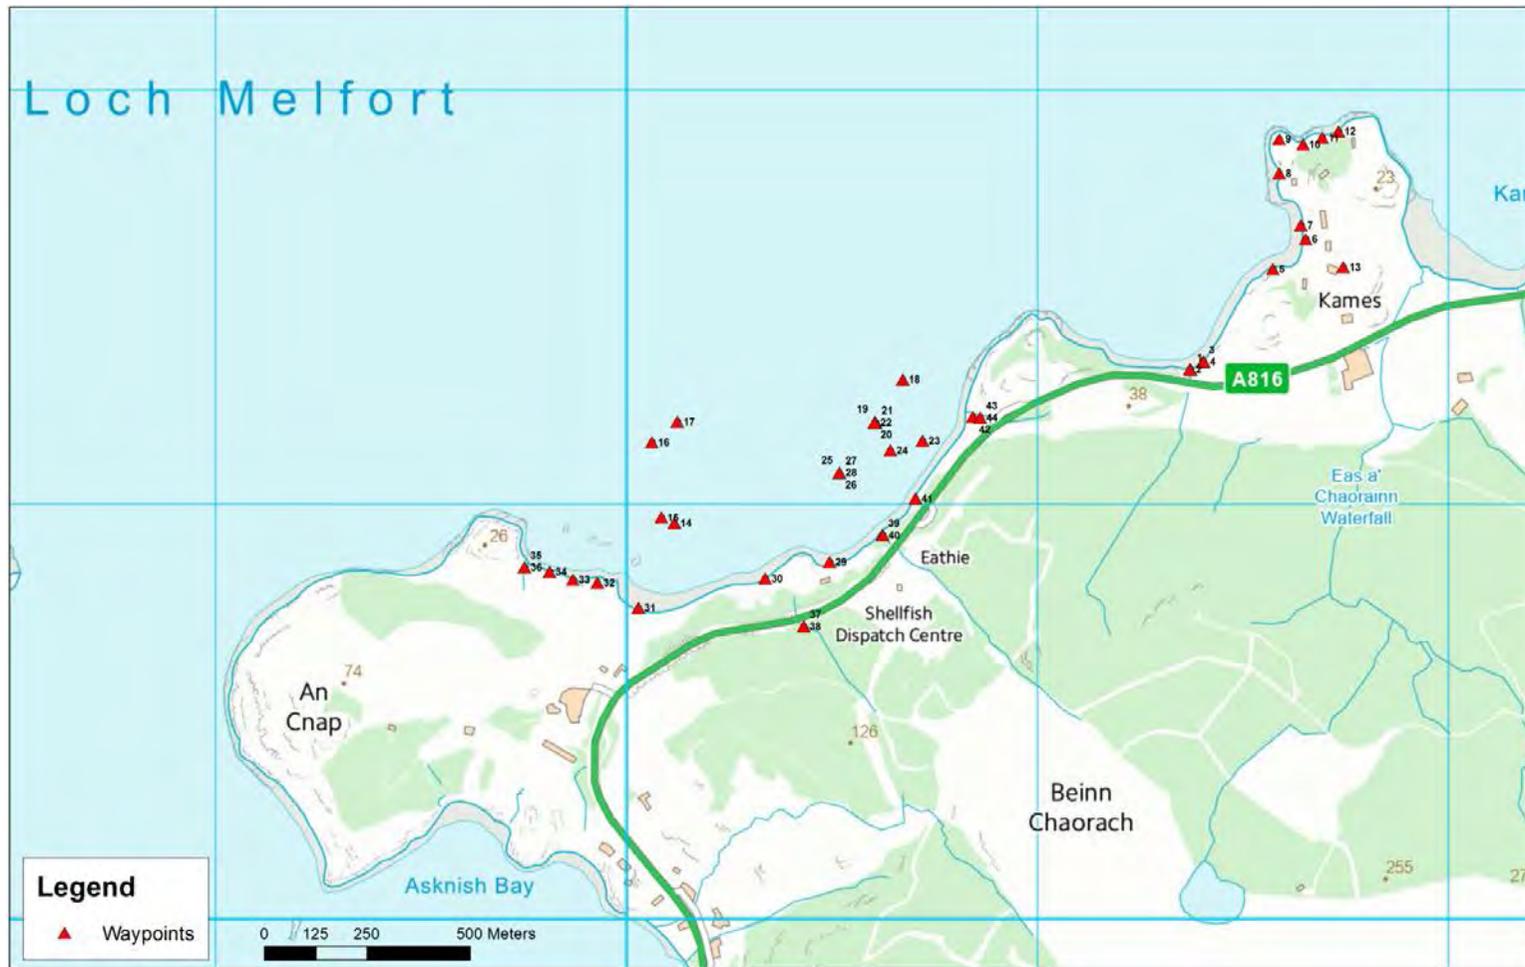
Contains Ordnance Survey data © Crown Copyright and Database right (2014).  
 Figure 1. Loch Melfort waypoints.

The specific observations made at each waypoint can be found in Table 1, with each of the waypoint locations displayed in Figure 1.

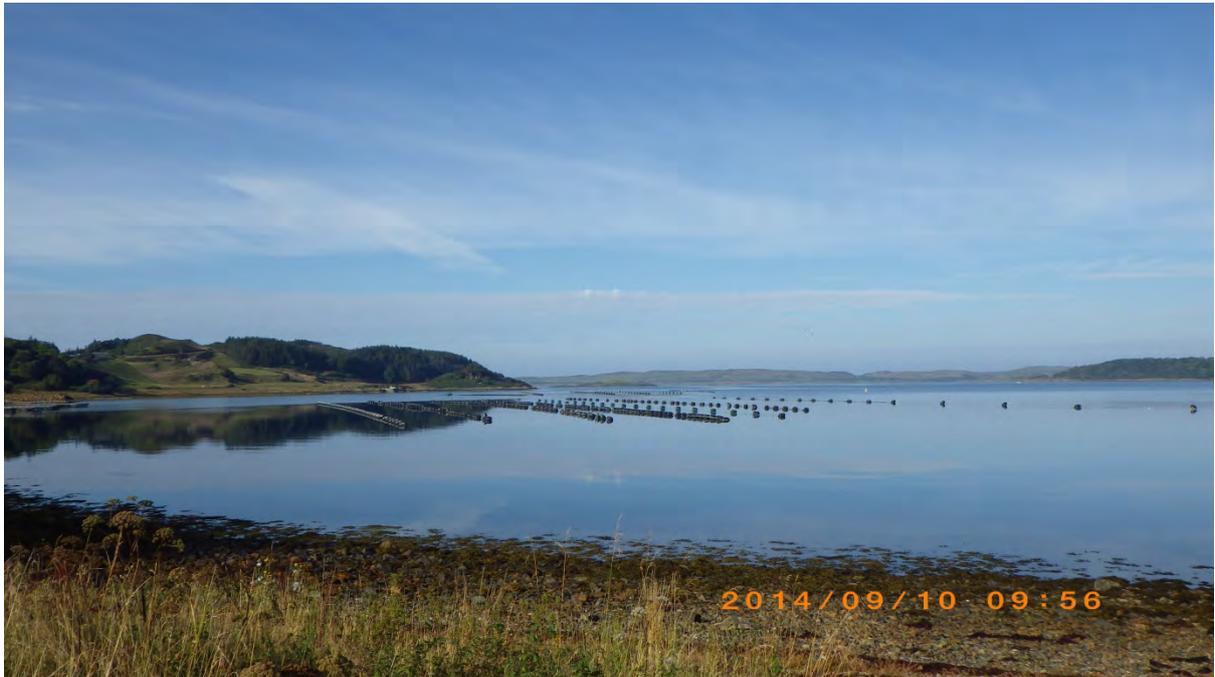
Figure 3. Overview of Production area. Associated with waypoint 4.

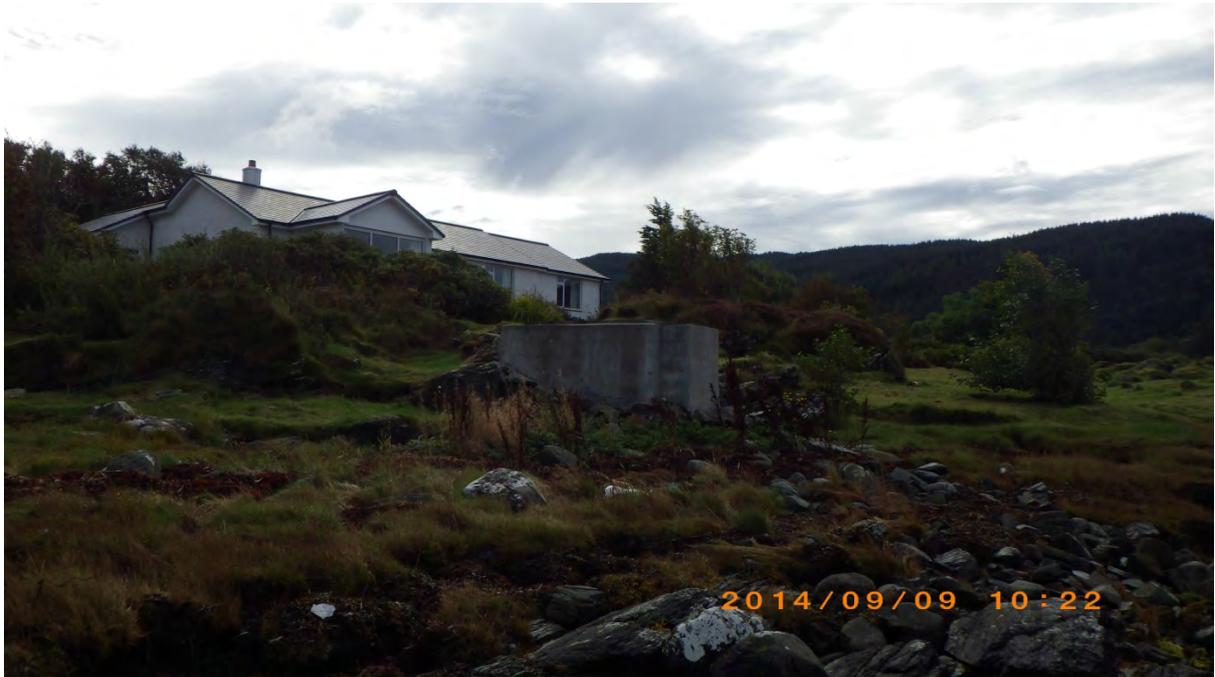
Figure 5. Large concrete structure on shore, no pipes observed. Associated with waypoint 8.

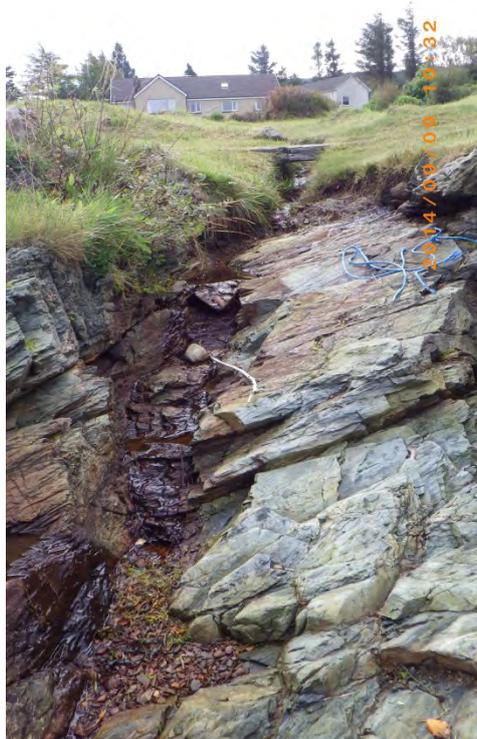
Figure 6. Two very small burns converging with house behind, no flow. Associated with waypoint 10.

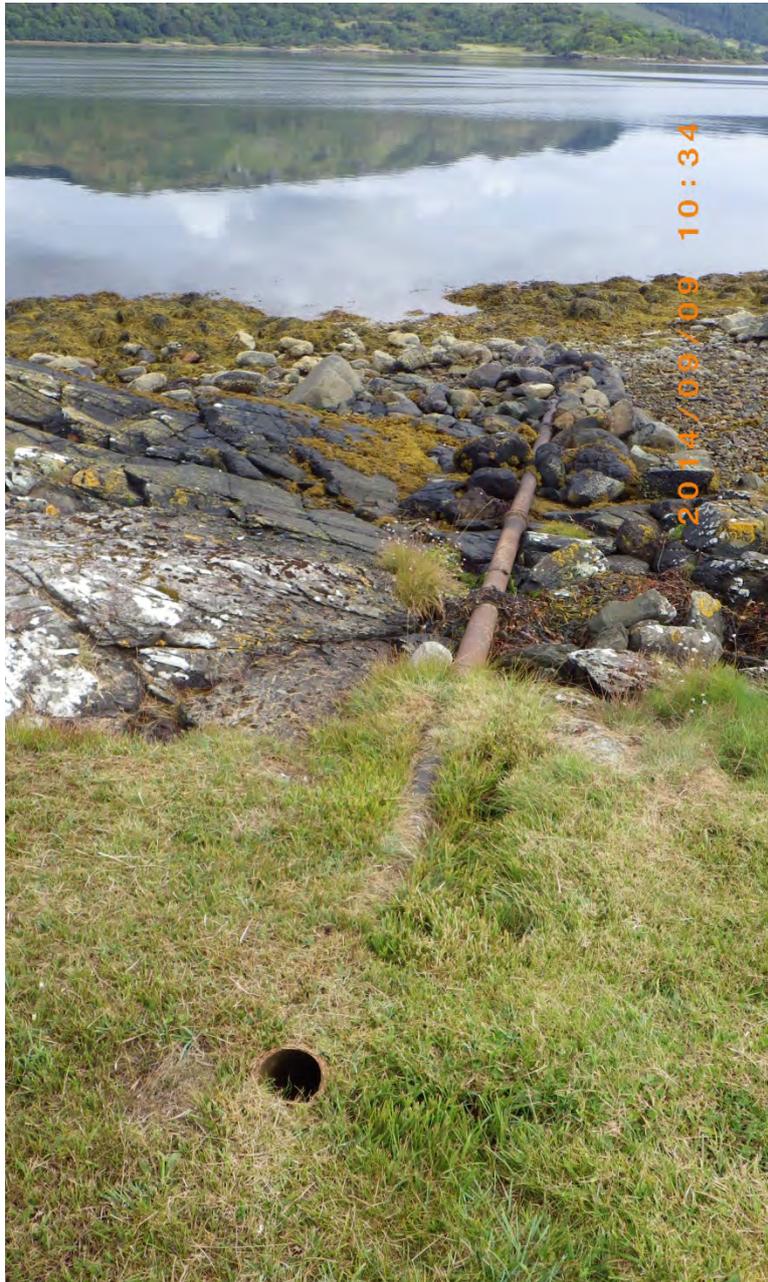
Figure 7. Metal pipe leading from shore into loch with house behind. Associated with waypoint 11.

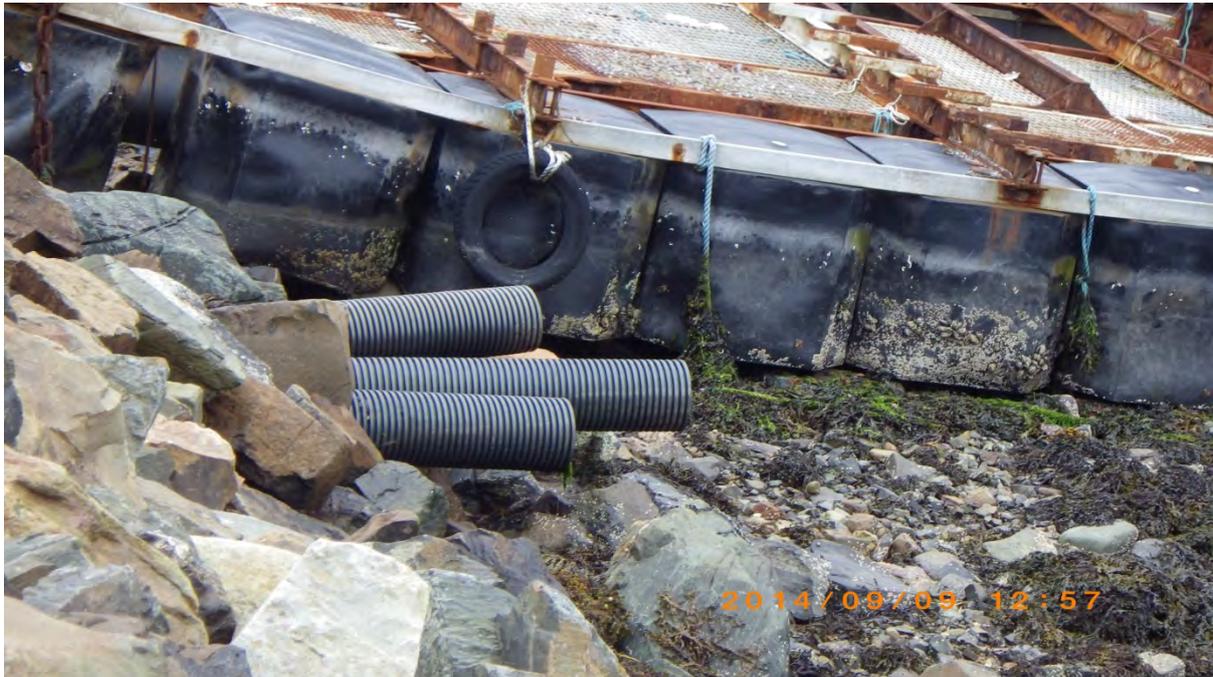
Figure 9. Black plastic pipes next to pier. No flows. Associated with waypoint 29.

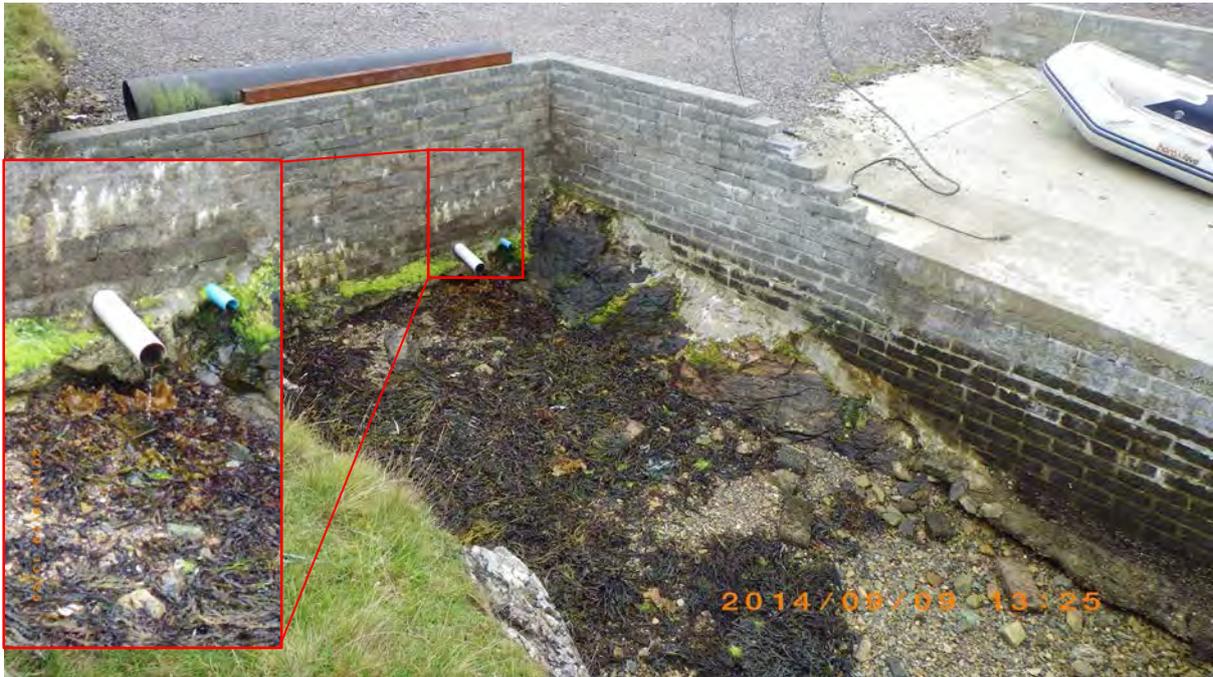
Figure 10. Plastic pipes, small flow but cannot access (see insert for detail). One small pleasure boat and one RIB on shore. Associated with waypoint 34.

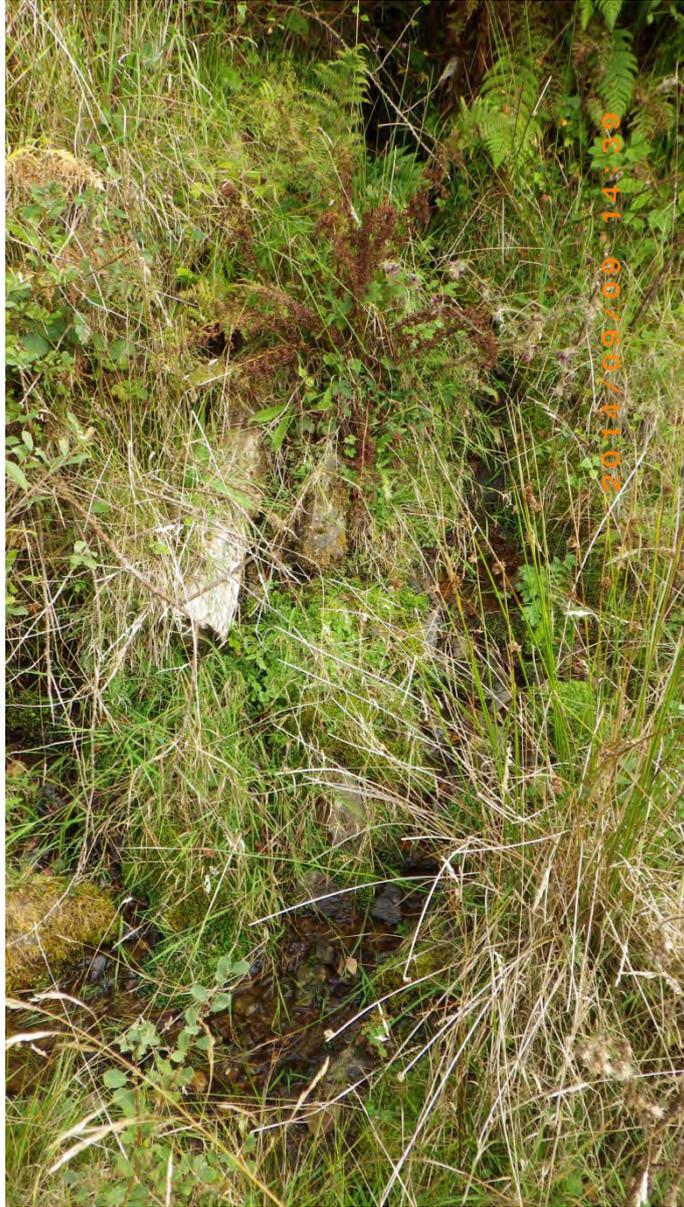
Figure 11. Very small overgrown burn from above road onto shore. Associated with waypoint 37, sample location of LMFW3
