Scottish Sanitary Survey Review

Campbeltown Loch AB-029-008-04 February 2014

| Report Title | Campbeltown Loch Review | | | | |
| Project Name | Scottish Sanitary Survey | | | | |

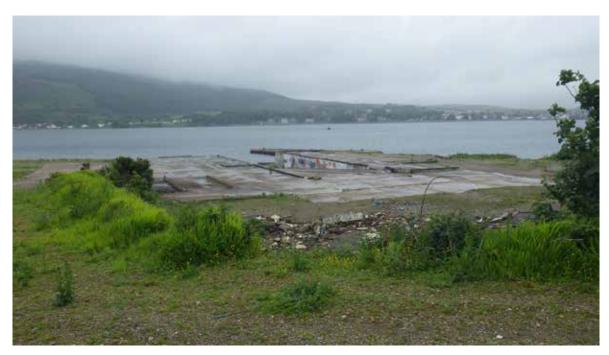
| No. | Date | Time | NGR | East | North | Associated photograph | Associated sample | Description |
|---|---|---|---|---|---|---|---|--|
| 12 | 02/07/2013 | 9:39 | NR 73494 20400 | 173494 | 620401 | Fig 4 | | Site of old Campbeltown Boat Yard (disused), no sign of any discharges, some waste materials on shore. |

Figure 4: Overview of the abandoned site of the Campbeltown boatyard, looking SW across Campbeltown Loch (Waypoint 12)

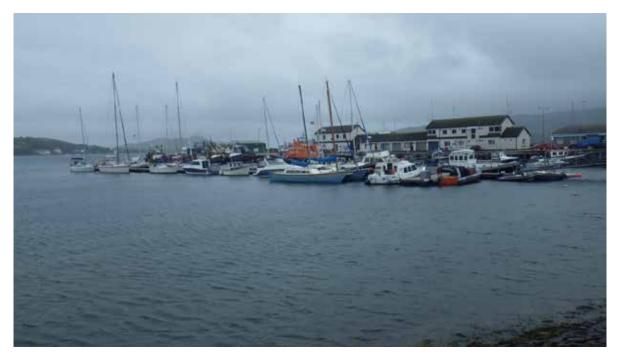
| No. | Date | Time | NGR | East | North | Associated photograph | Associated sample | Description |
|---|---|---|---|---|---|---|---|--|
| 27 | 02/07/2013 | 10:52 | NR 72038 20549 | 172039 | 620550 | Fig 8 | | View of pontoon and old quay, 11 yachts, 7 smaller powerboats on pontoon, on main pier 9 fishing boats and 1 lifeboat. Bird count: 80 herring gulls. |

Figure 8: Old Quay in Campbeltown town centre with pontoon system in foreground and main pier behind. (Waypoint 27)

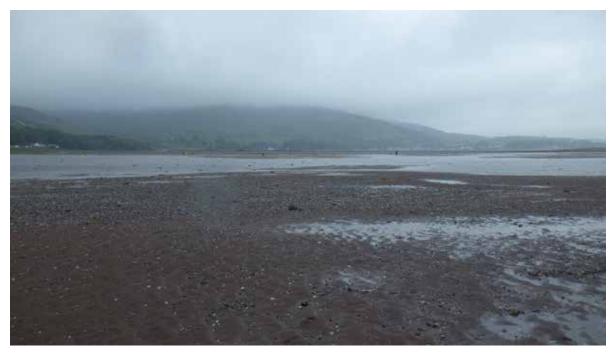
| No. | Date | Time | NGR | East | North | Associated photograph | Associated sample | Description |
|---|---|---|---|---|---|---|---|--|
| 30 | 02/07/2013 | 12:47 | NR 74657 19963 | 174658 | 619963 | Fig 9 | CLSF1 | Shellfish sample 1 - cockles |

Figure 9: Fishery area in Kildalloig Bay, looking SW towards The Doirlinn. Campbeltown is situated to the right of the photograph. (Waypoint 30)

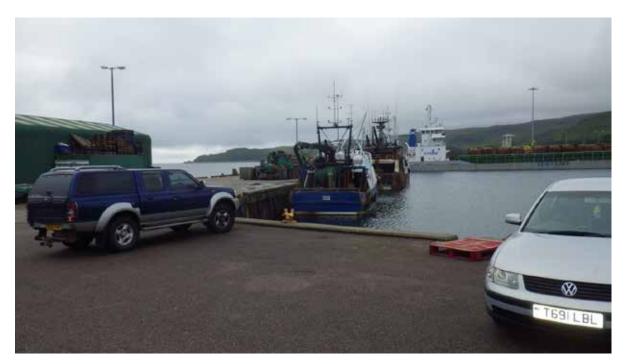
| No. | Date | Time | NGR | East | North | Associated photograph | Associated sample | Description |
|---|---|---|---|---|---|---|---|---|
| 35 | 03/07/2013 | 8:50 | NR 72190 20519 | 172191 | 620520 | Fig 10 | | Boat count, old quay, 7 fishing vessels, one lifeboat, 4 yachts & 4 smaller pleasure craft at pontoon. Noticed some oil on water. |

Figure 10: South side of Old Quay, with fishing vessels present, and vessel 'Scot Ranger' loading wood on the New Quay. (Waypoint 35)

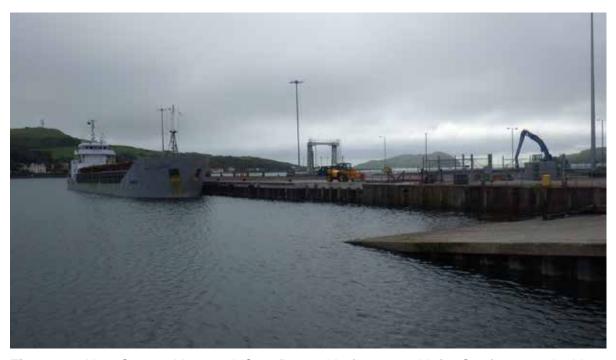
| No. | Date | Time | NGR | East | North | Associated photograph | Associated sample | Description |
|---|---|---|---|---|---|---|---|---|
| 37 | 03/07/2013 | 8:59 | NR 72185 20304 | 172185 | 620305 | Fig 11 | | Vessel 'Scot Ranger' at New Quay berth, loading wood. |

Figure 11: New Quay, with vessel 'Scot Ranger' in foreground left. Car ferry terminal is on the far side of the pier, with linkspan visible in centre. (Waypoint 37)

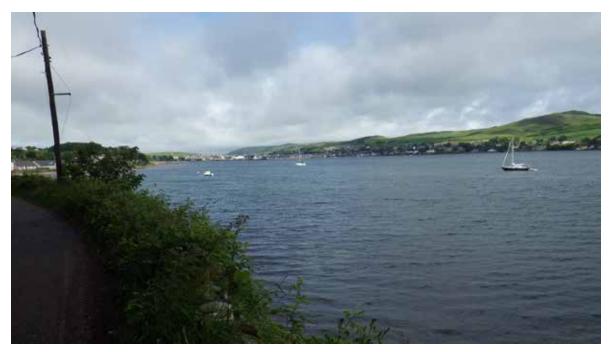
| No. | Date | Time | NGR | East | North | Associated photograph | Associated sample | Description |
|---|---|---|---|---|---|---|---|---|
| 57 | 03/07/2013 | 10:32 | NR 73420 19136 | 173421 | 619137 | Fig 15 | | General photo of the bay area. |

Figure 15: Overview of upper Campbeltown Loch, looking North West from Glenramskill. (Waypoint 57)

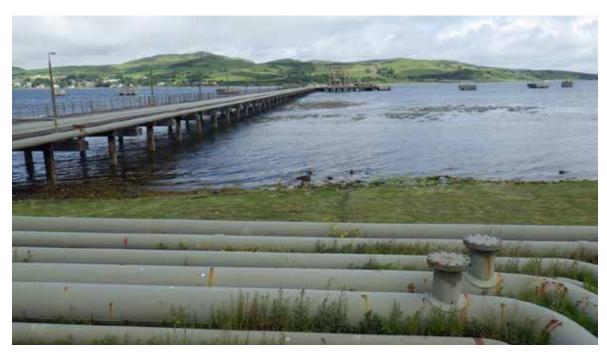
Figure 17: NATO refuelling Pier. (Waypoint 63)
