## Beaulieu River Sanitary Survey

Review

February 2015

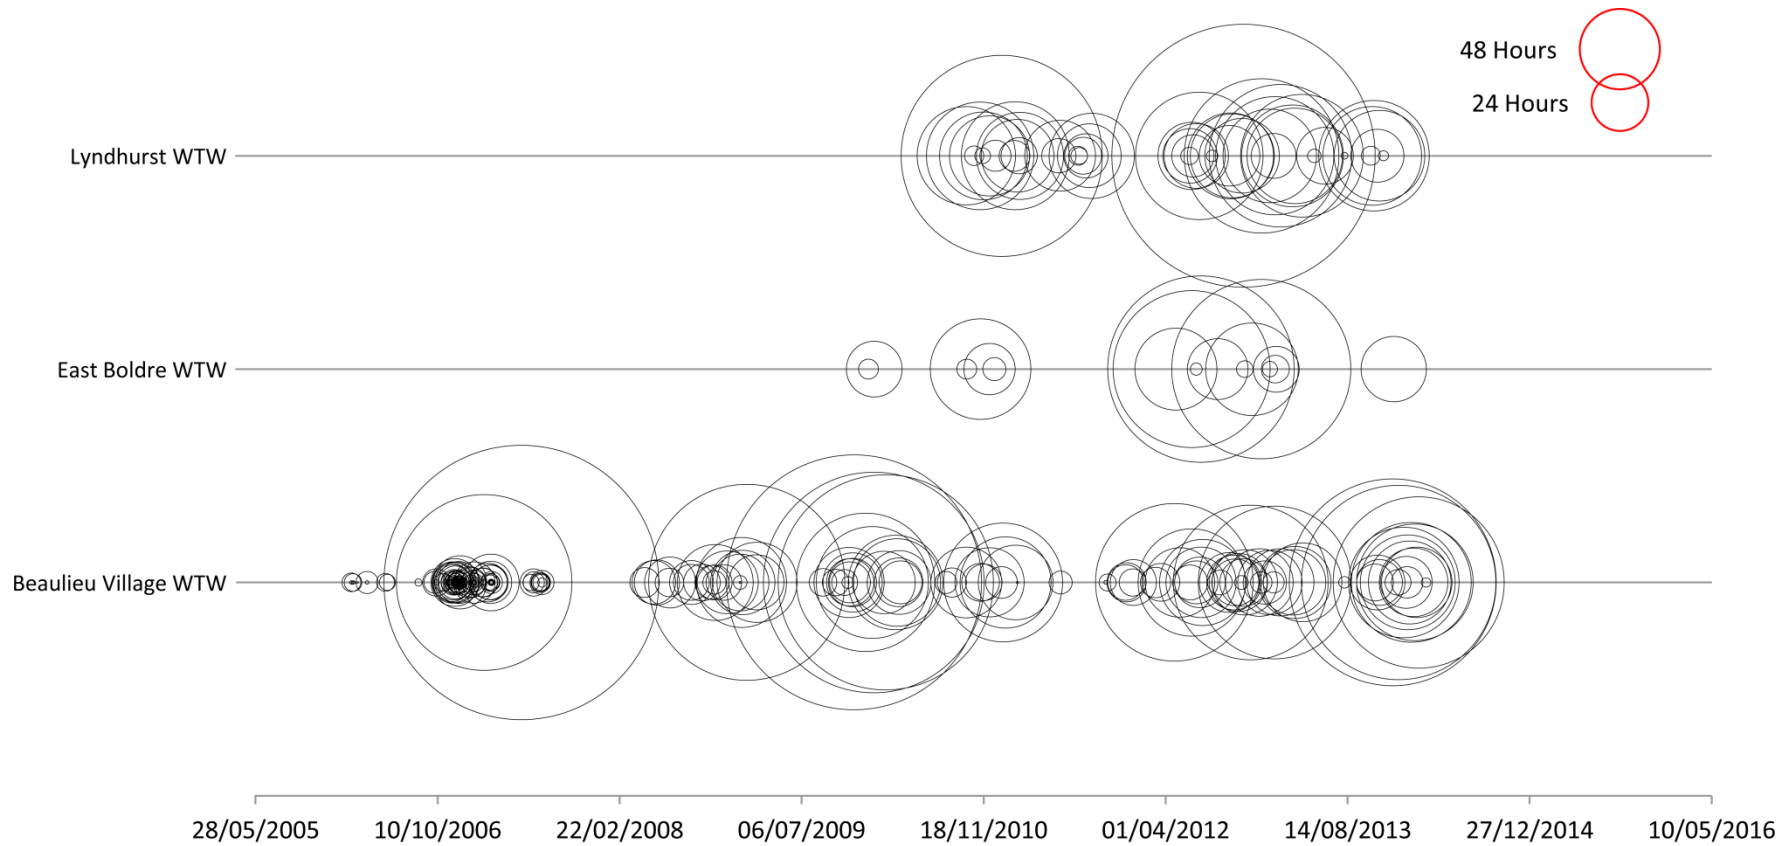
There are ten water company owned intermittent discharges that are consented within the Beaulieu catchment (Table 5.2). Two of these were reported in the 2009 report. Table 5.4 and Figure 5.3 show the spills from the Beaulieu Village WwTW, East Boldre STW and Lyndhurst WwTW intermittent discharges. The spill data for East Boldre STW and Lyndhurst WwTW were not available between 2006 and 2009 or in 2014 at the time of writing. All of the discharges have spilled for more than 3% of the time in at least one of the years that data were available. Beaulieu Village WwTW and Lyndhurst WwTW discharges spilled very often, with Lyndhurst WwTW spilling for more than 3% of the time in all years where data were available.

**Figure 5.3: Bubble plot of spills from intermittent discharges in the Beaulieu catchment.**  
*Contains Environment Agency information © Environment Agency and database right*

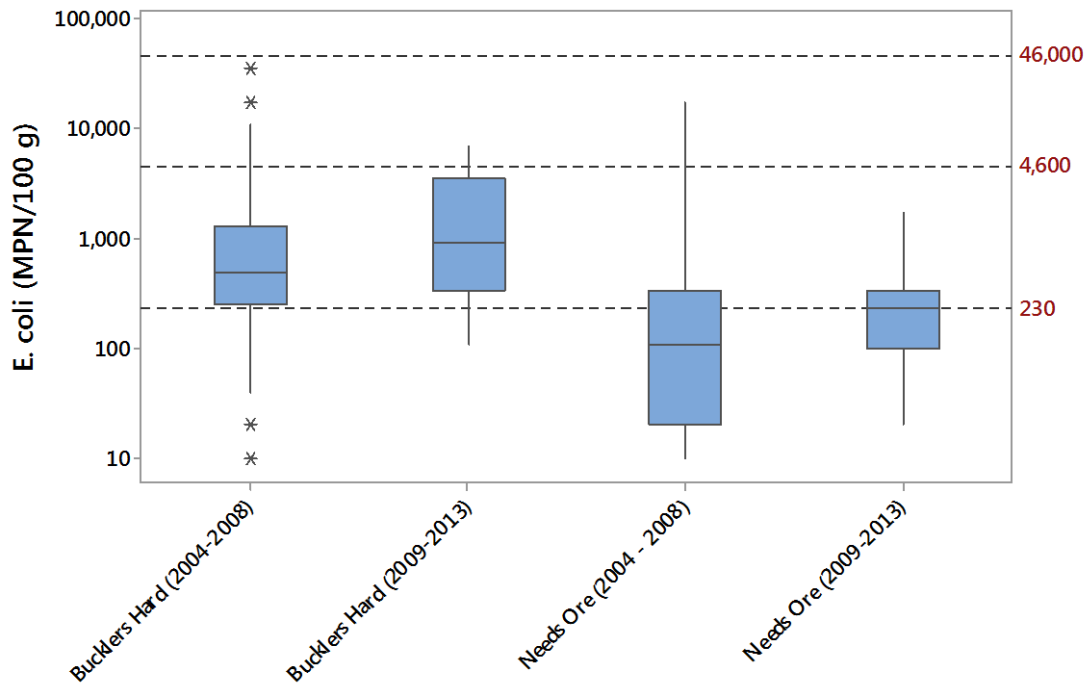
**Figure 8.2: Boxplots of *E. coli* results from native oyster RMPs.**

*E. coli* levels exceeded 4,600 MPN/100 g at Bucklers Hard in more than 10% of samples both before and after 2008, but never exceeded 46,000 MPN/100 g. One-way ANOVA tests revealed significant differences in *E. coli* levels between the sites ( $p < 0.001$ ). Post ANOVA Tukey tests showed that Buckler's Hard had significantly higher *E. coli* levels than Needs Ore both before and after 2008.

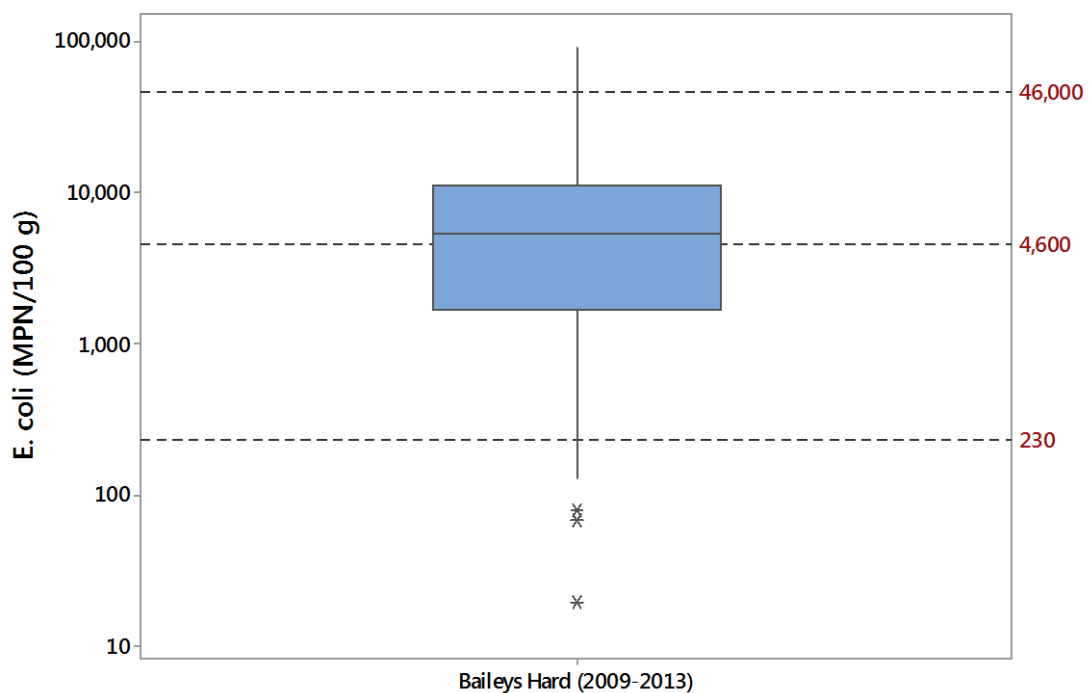
**Figure 8.3: Boxplots of *E. coli* results from *Tapes* spp.**

*E. coli* levels at Baileys Hard exceeded 46,000 MPN/100 g on 5.7% of occasions.

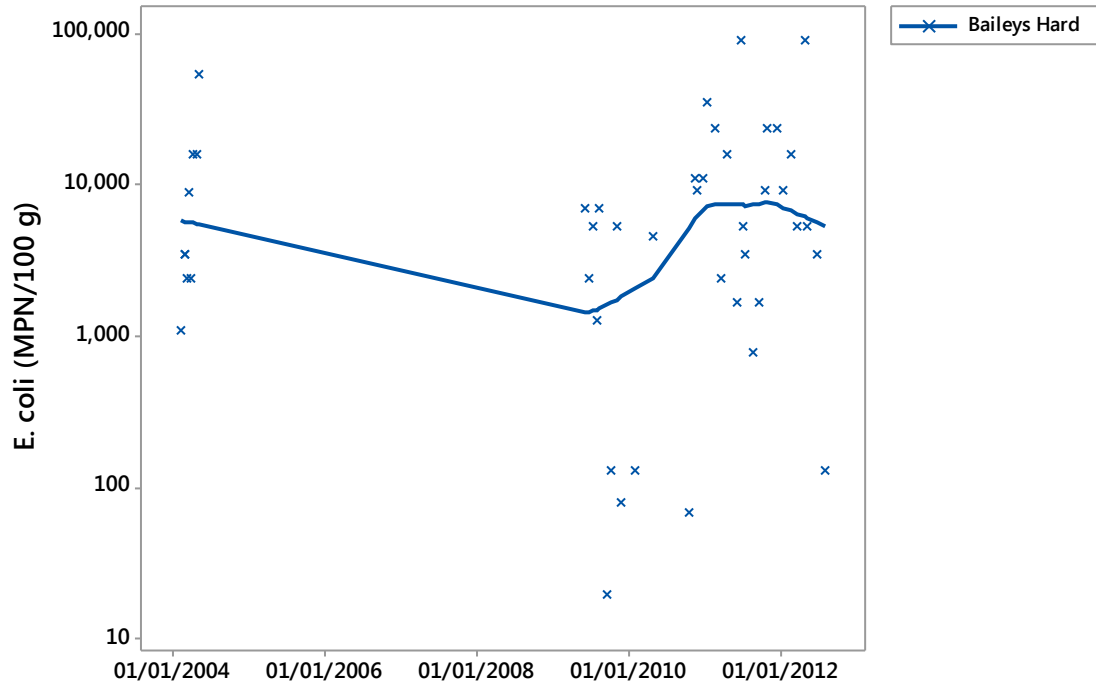
Figure 8.5: Scatterplot of *E. coli* results for *Tapes* spp. overlaid with loess line.

*E. coli* levels have remained fairly stable at the Baileys Hard *Tapes* spp. RMP since 2004. However, there have been several results below 1,000 MPN/100 g since 2008, which had previously not been seen at this RMP.

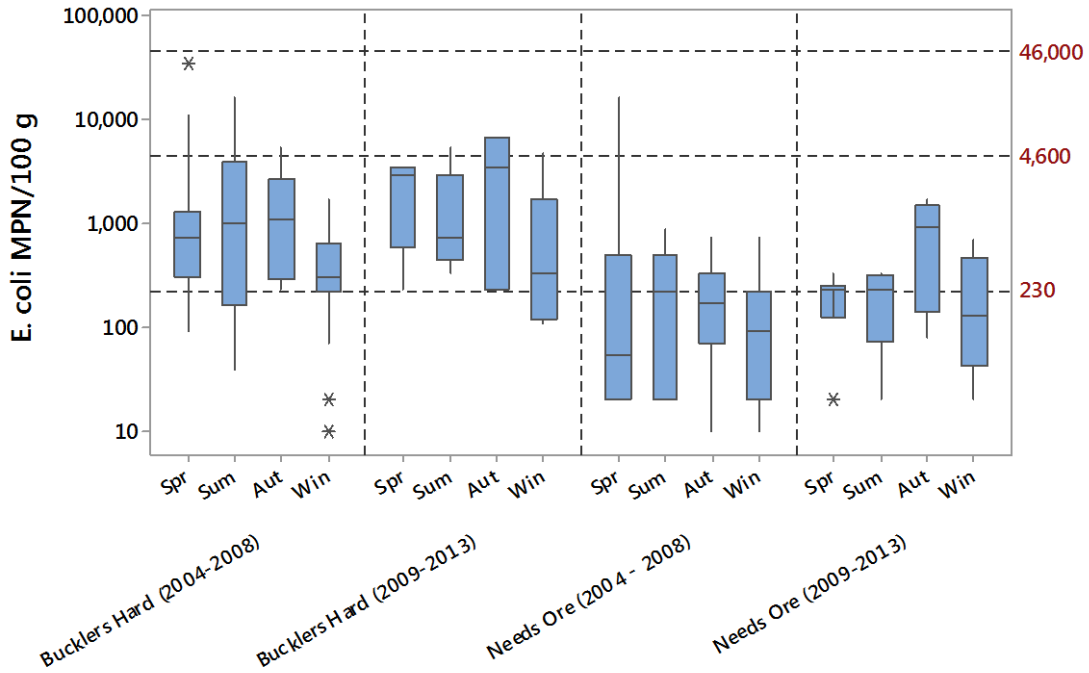
**Figure 8.6: Boxplot of *E. coli* results for native oysters by RMP and season**

One-way ANOVAs showed that there were no significant variations in *E. coli* levels between seasons at any of the native oyster RMPs ( $p=0.069$  to  $0.364$ ).

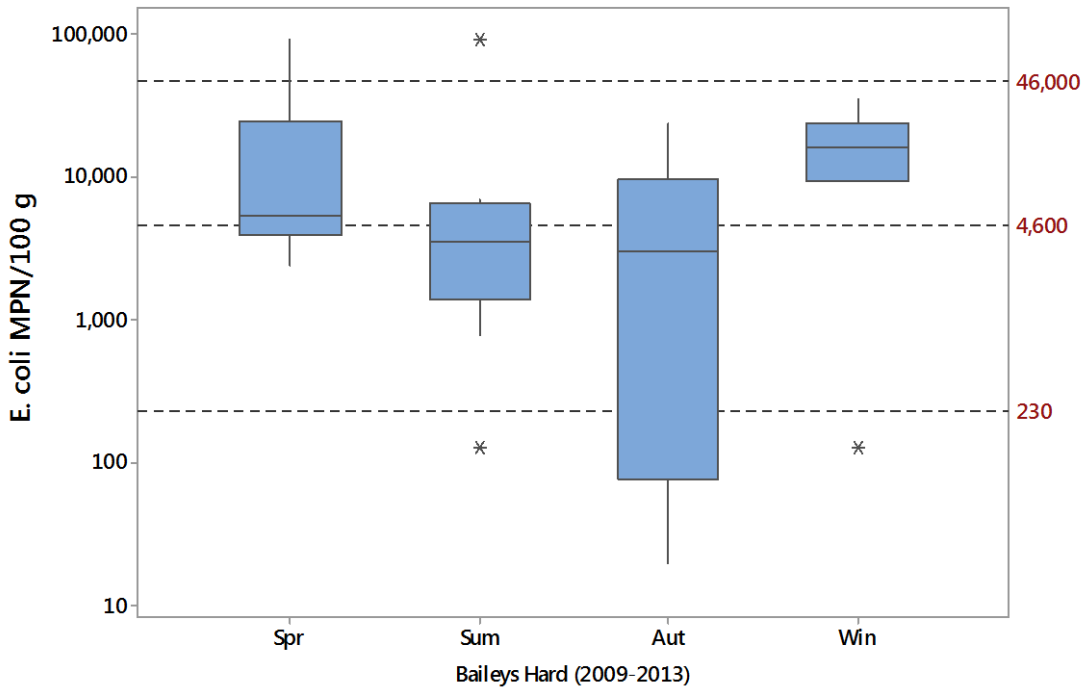
**Figure 8.7: Boxplot of *E. coli* results for *Tapes* spp. by RMP and season**

One-way ANOVAs showed that there were no significant variations in *E. coli* levels between seasons at the Baileys Hard RMP ( $p=0.118$ ).

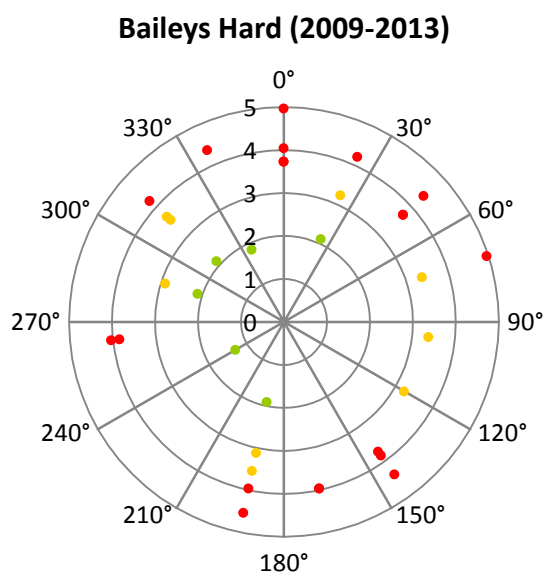
Figure 8.8 presents a polar plot of log<sub>10</sub> *E. coli* results against the spring neap tidal cycle for the Baileys Hard *Tapes* spp. RMP. Full/new moons occur at 0°, and half moons occur at 180°, and the largest (spring) tides occur about 2 days after the full/new moon, or at about 45°, then decrease to the smallest (neap tides) at about 225°, then increase back to spring tides. Results of 230 *E. coli* MPN/100 g or less are plotted in green, those from 231 to 4,600 are plotted in yellow, and those exceeding 4,600 are plotted in red.

**Figure 8.8: Polar plot of log<sub>10</sub> *E. coli* results (MPN/100 g) at against spring/neap tidal state**

Despite significant correlations calculated between *E. coli* levels and the spring/neap tidal state, there is no pattern distinguishable pattern in Figure 8.8.

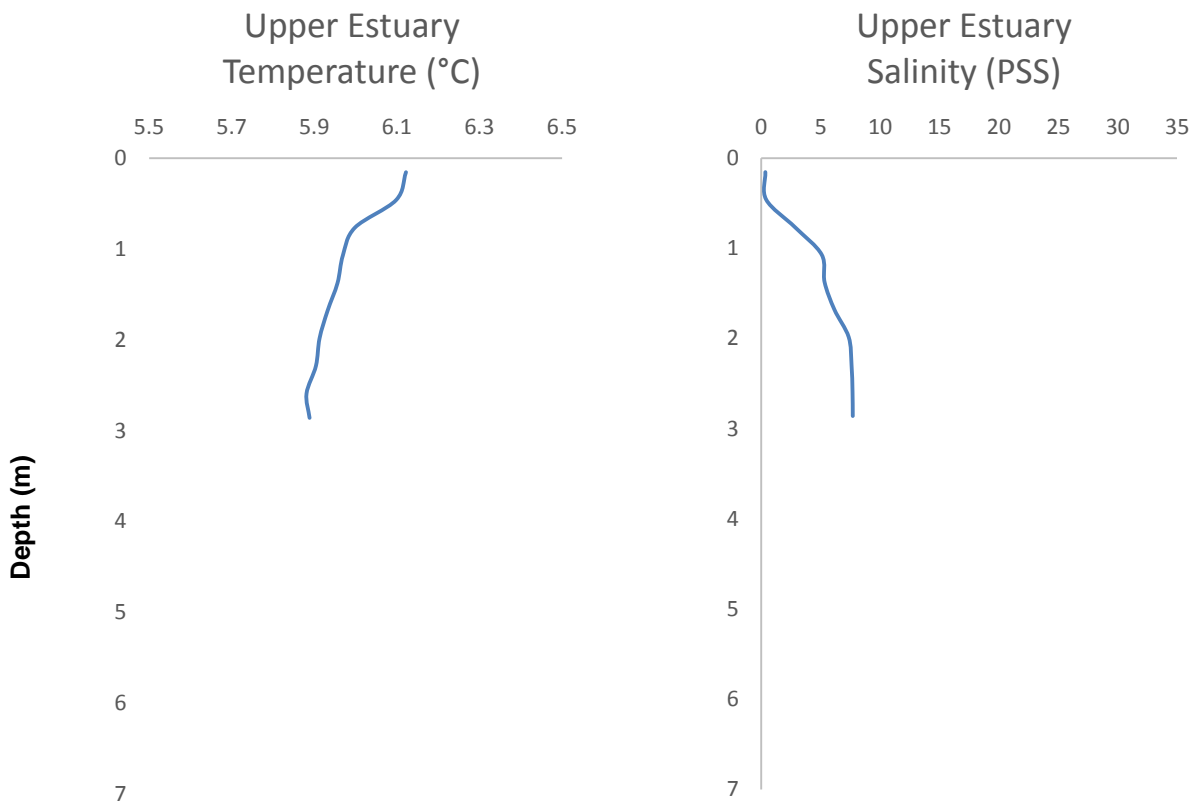
**Figure I.4 CTD 2**

In the upper estuary (CTD 2) there was a large freshwater influence, as demonstrated by the salinity ranges recorded, from 0 PSS at the surface increasing to 7.7 PSS at 2.9 metres. The temperature is fairly constant between 5.9 and 6.1 °C.

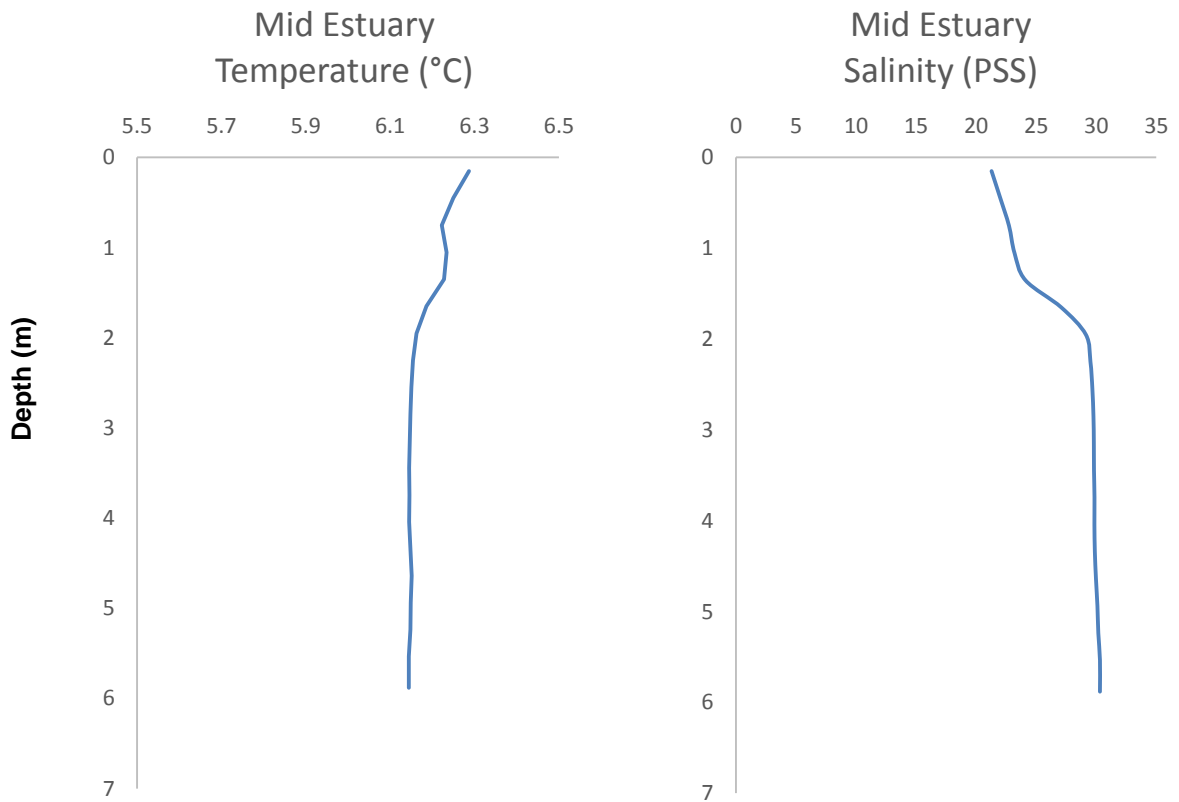
**Figure I.5 CTD 3**

In the mid estuary (CTD 3) there is incomplete mixing with lower salinities being recorded in the surface waters and higher salinities at depth.

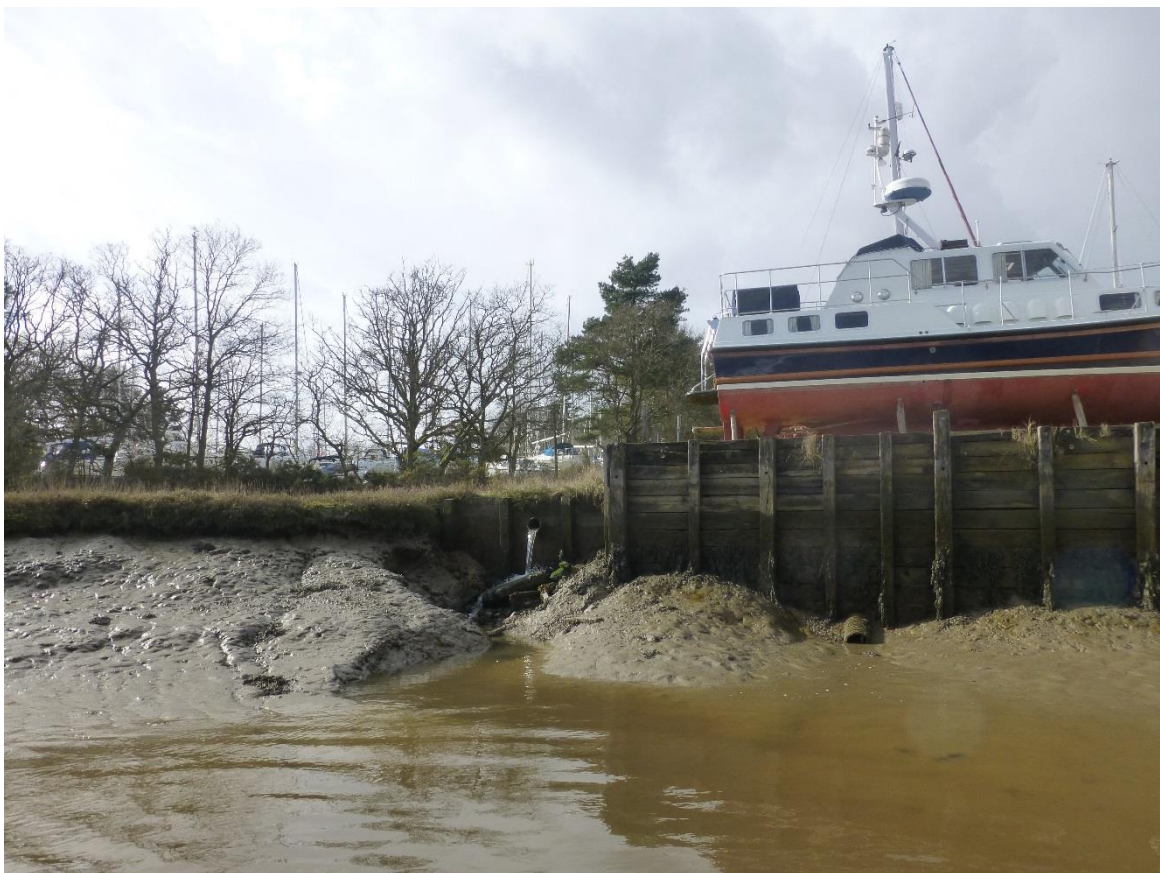
**Figure I.13**

13	SU4074100285	23/02/2015	11:01 Pipe, flowing (0.09m x 0.03m x 0.384 m/s), B05	Figure I.13
14	SU4078900203	23/02/2015	11:08 Bucklers Hard STW outfall (0.43m x 0.01m x 0.058m/s), B06	
15	SU4077700194	23/02/2015	11:09 Culverted stream, flowing	
16	SU4104300159	23/02/2015	11:30 Pipe, dribbling	
17	SU4101500146	23/02/2015	11:32 Pipe in quay, dribbling	
18	SZ4159899850	23/02/2015	11:40 ~ 30 ducks	
19	SZ4157098832	23/02/2015	12:11 Stream, flowing, B07	
20	SZ4361698122	23/02/2015	13:30 ~ 40 gulls	
21	SU4042201299	23/02/2015	13:30 Spearbed Copse Private discharge submerged	Figure I.14
22	SU3967801738	23/02/2015	13:41 Possible septic tank	
23	SU3967301795	23/02/2015	13:43 ~ 30 gulls	
24	SU3967601901	23/02/2015	13:45 Unnamed stream culverted, flowing, B08	
25	SU3934601870	23/02/2015	13:52 Submerged culvert	Figure I.15
26	SU3911601939	23/02/2015	13:55 Beaulieu Village WwTW continuous and intermittent discharge
